RE: MSIG ref: 577120 PLY | Third party vehicle XD7288K

PRELIMINARY ADVICE OF VEHICLE NO: XD 7288K

ADJUSTMENT ON REPAIR COST FOR VEHICLE NO. XD 7288K

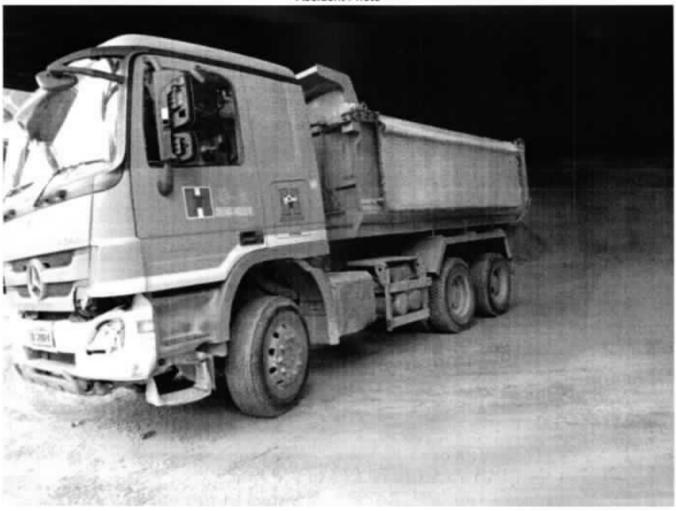
Accident Photo

ON 22/11/2018 @ 11215HRS I WAS DRIVING MY COMPANY VEHICLE BEARING NO. XD7288K HEADING TO ISLAND CONCRETE @ PANDAN ROAD FOR LOADING 20MM STONE. AFTER UPON REACHING SITES I WAS REVERSING MY TRUCK TO BE IN POSITION FOR LOADING. SUDDENLY THERE IS A WHEEL LOADER NO. 11 REVERSE AND HIT MY FRONT LEFT. MY VEHICLE WAS BADLY DAMAGE. THERE WAS NO INJURIES IN THIS ACCIDENT.
