LKK Auto Consultants Pte Ltd

Vehicle No. SJN 4919G
Insured Veh. SKS 2555Y
Claim No.
Policy No. DMCFHQ18-000174
Accident Date 27/11/2018
Inspection Date 29/11/2018

ADJUSTMENT ON REPAIR COST FOR VEHICLE NO. SJN 4919G

PHOTOGRAPHS FOR VEHICLE NO. SJN 4919G

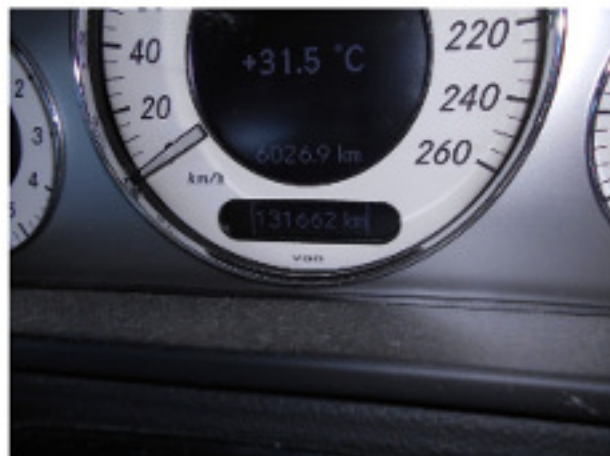
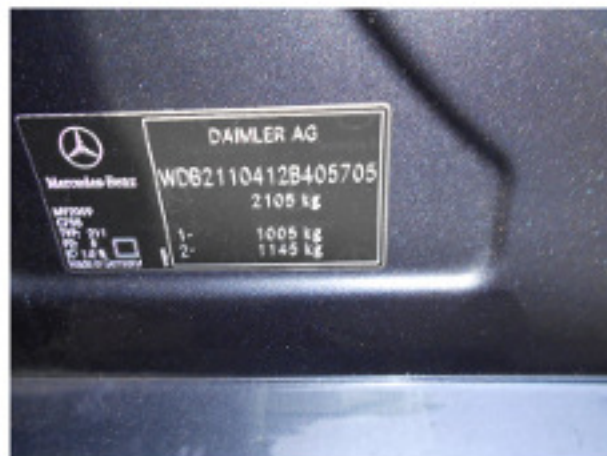
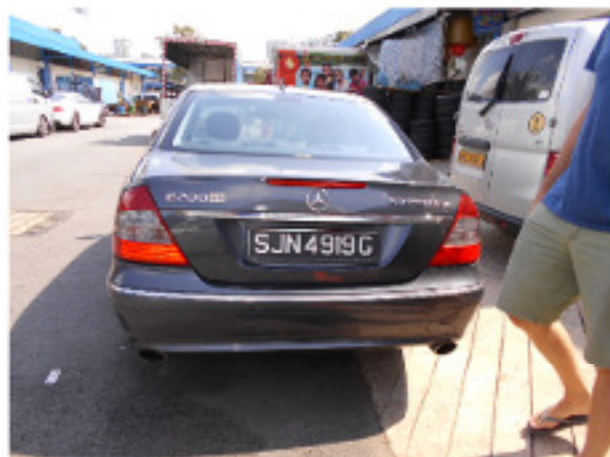
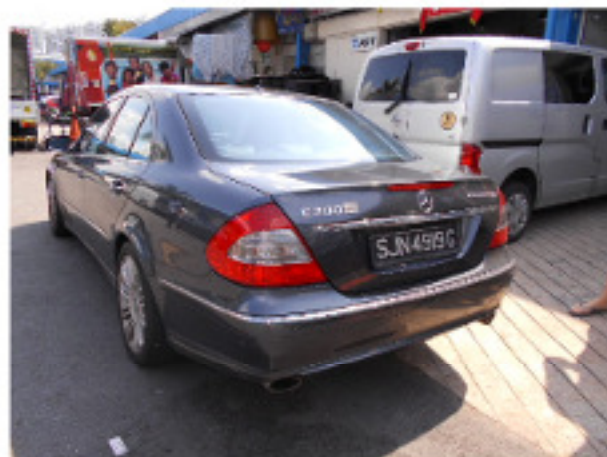
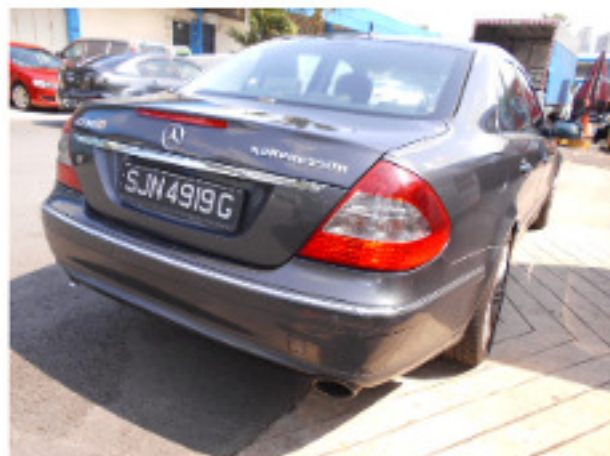
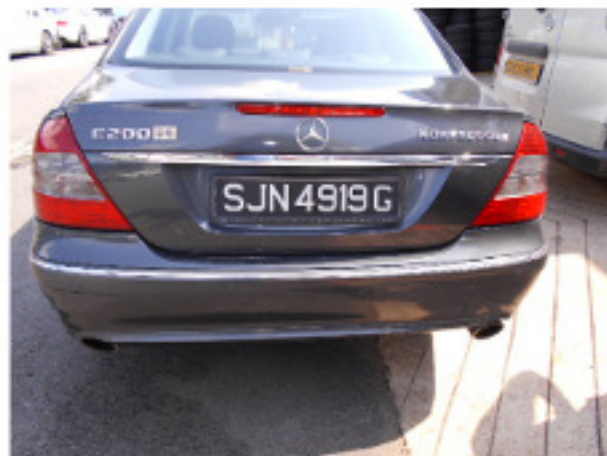
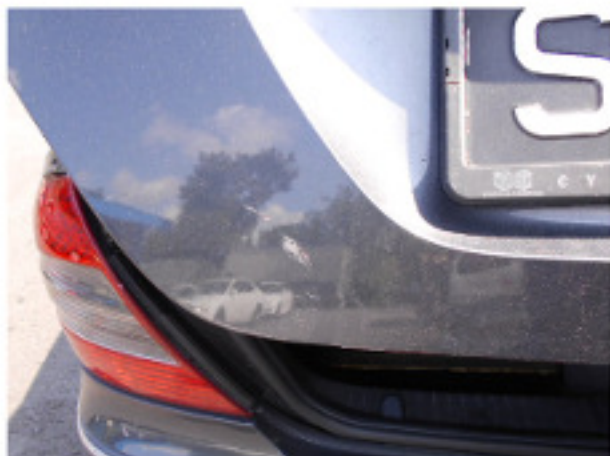
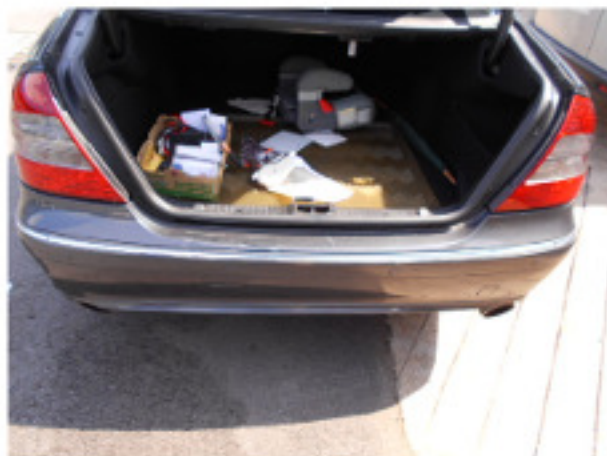
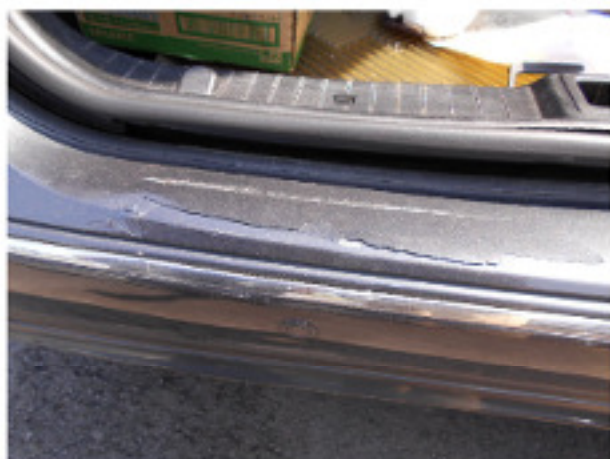
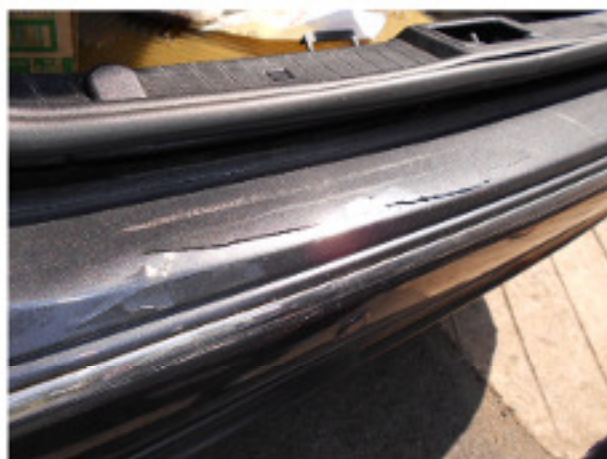
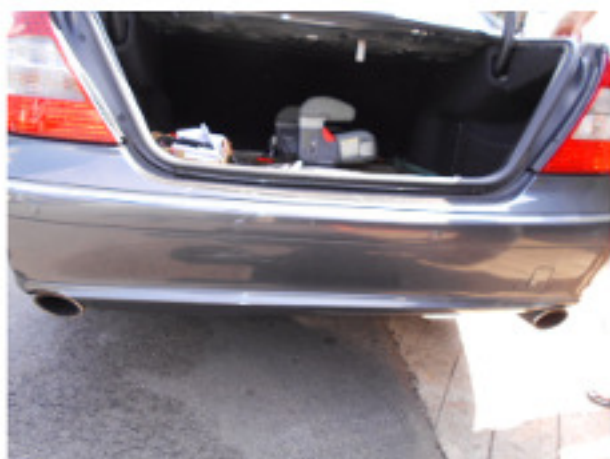
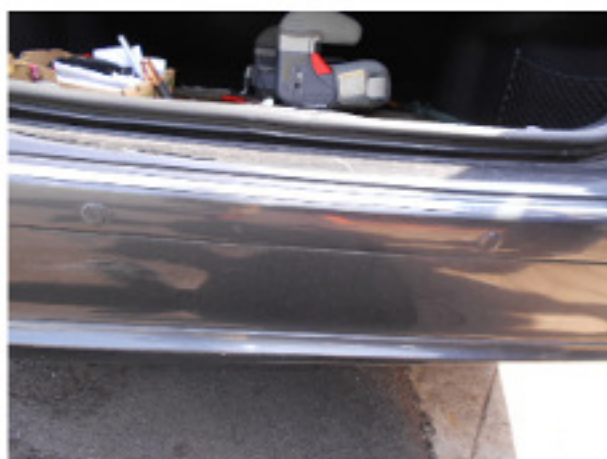
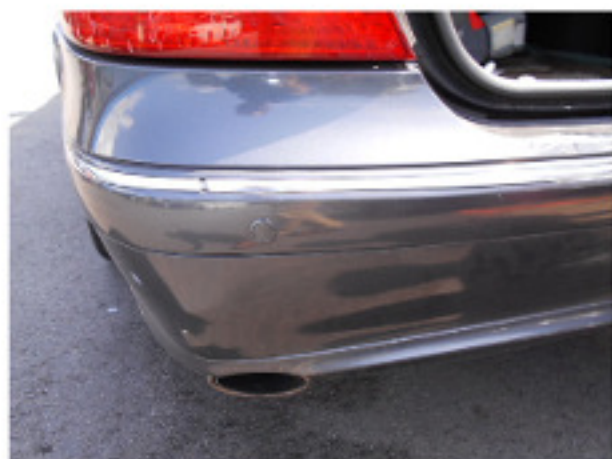
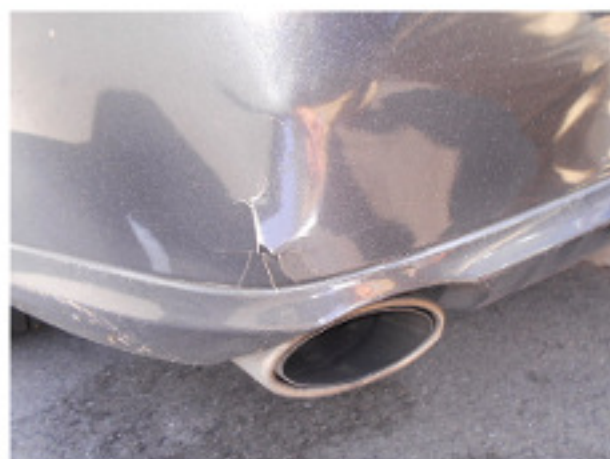
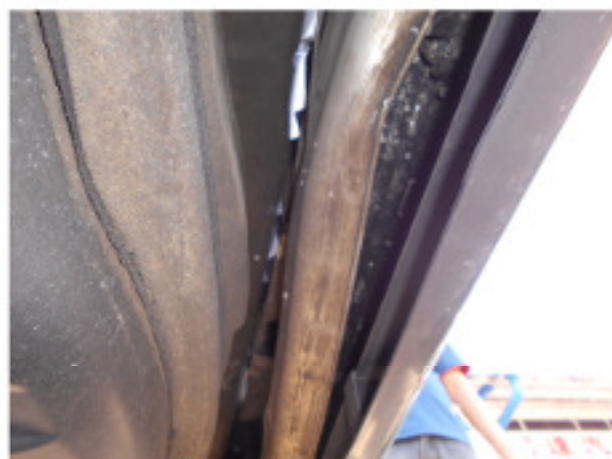
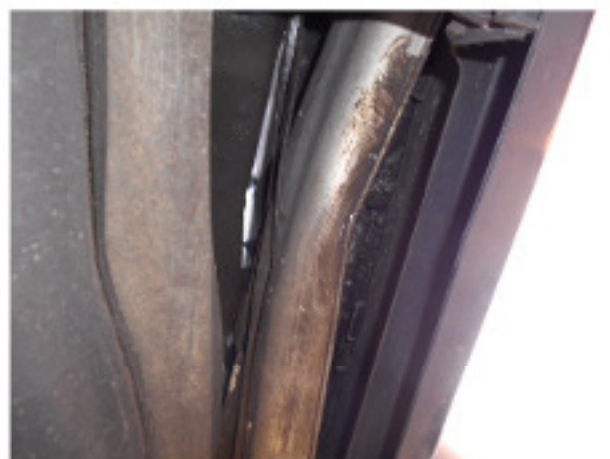
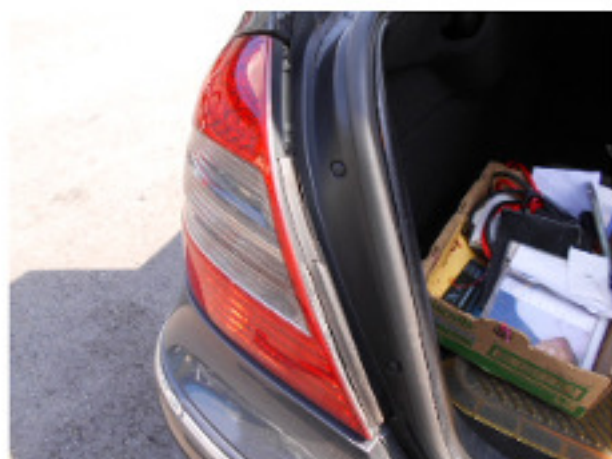
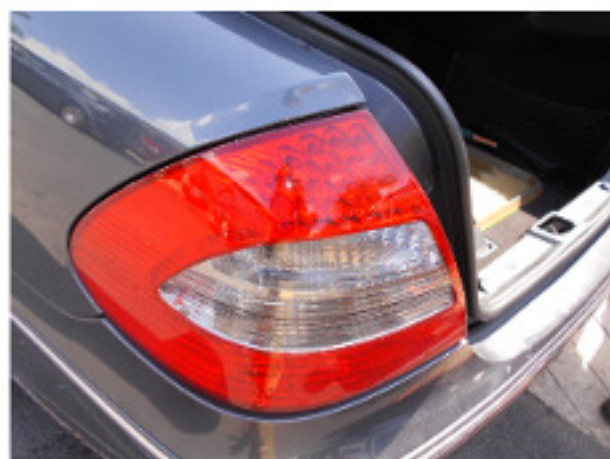
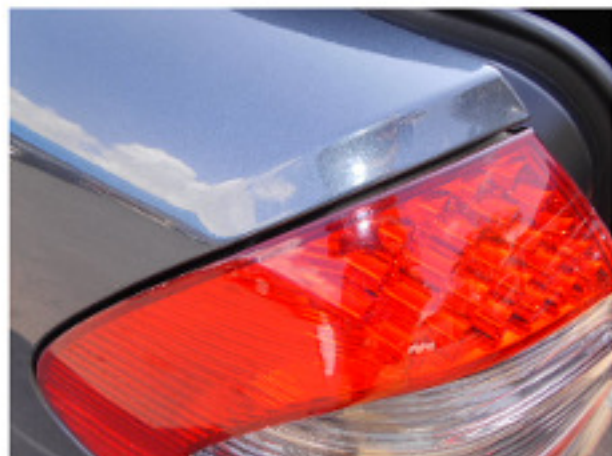
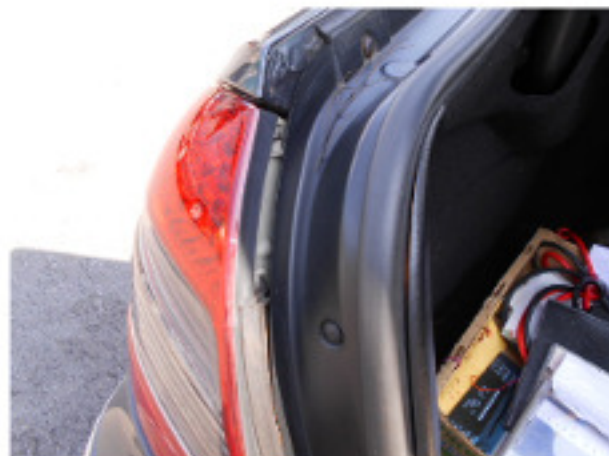
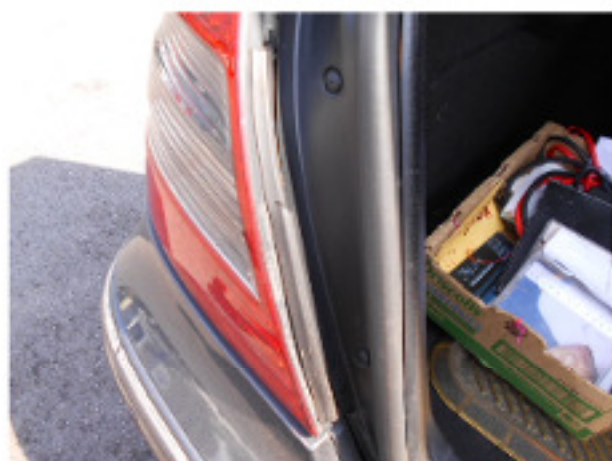
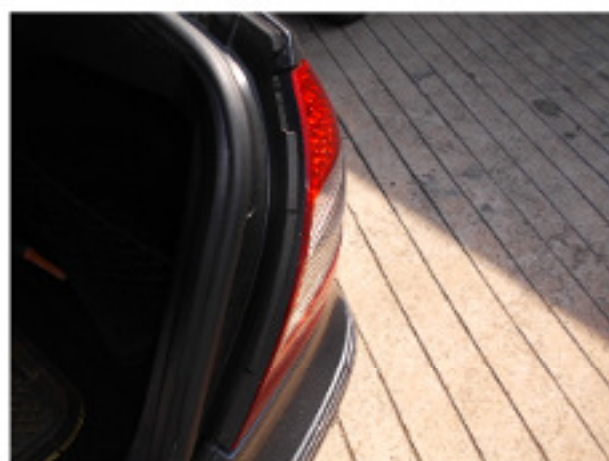
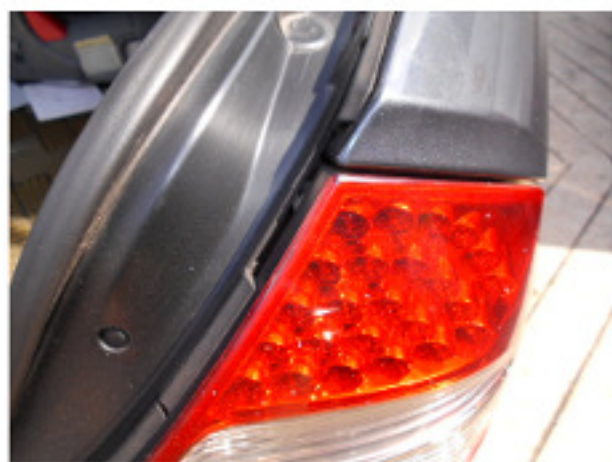
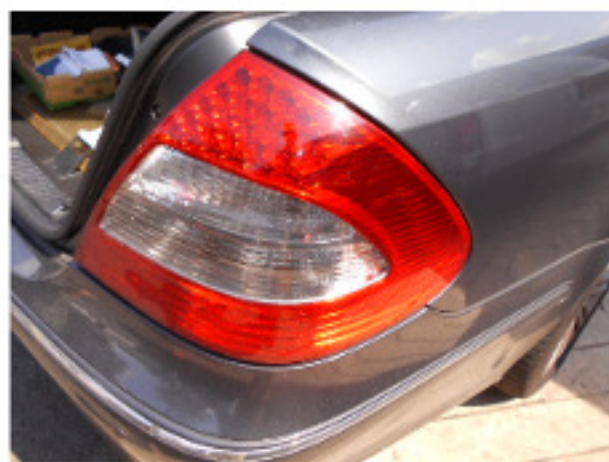
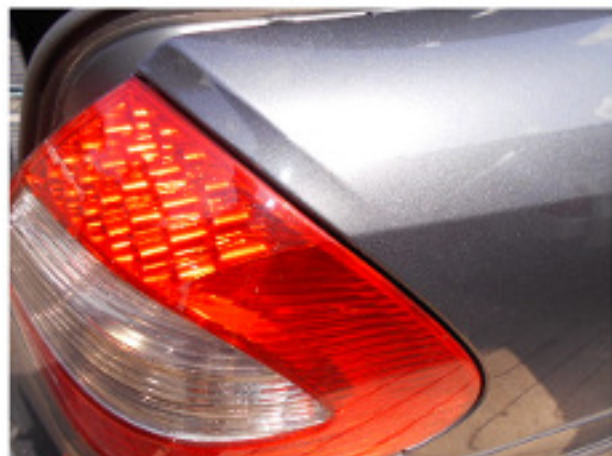
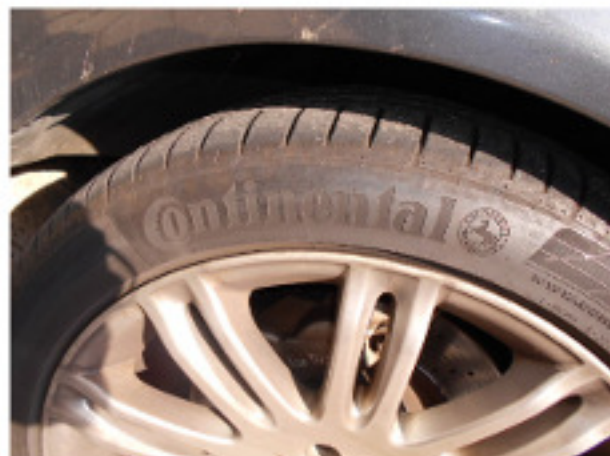
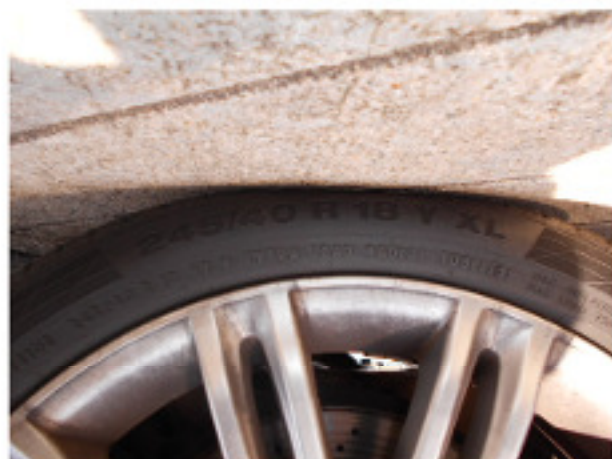
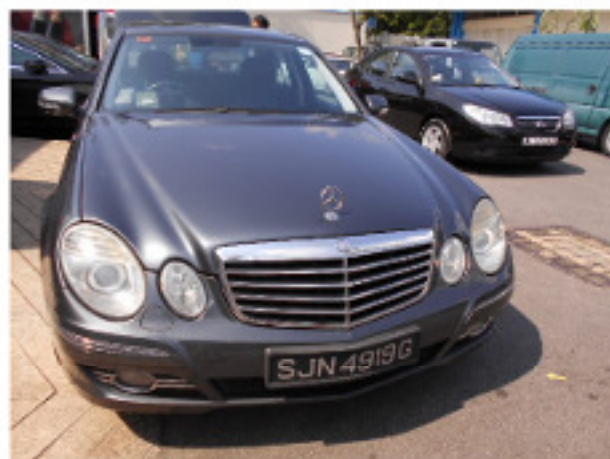
4. Description of Damages				
	THE VEHICLE SUSTAINED DAMAGES AT THE REAR PORTION. DAMAGES SEE DETAILS.			
5. General Information				
	Accident Date	27/11/2018	Inspection Date	29/11/2018
	Survey held at	FALCON-AIR AUTO SERVICES PTE LTD BLK 8 PANDAN LOOP SINGAPORE 128226		
5a. Remarks				
	A)THE INSPECTION WAS CONDUCTED ON A"WITHOUT PREJUDICE" BASIS. B)IN ACCORDANCE TO YOUR INSTRUCTIONS, WE HAVE NOT AUTHORISED REPAIRS.			
5b. Estimate Days of Repair				
	ESTIMATED NORMAL PERIOD FOR REPAIR:		3 Working Days

Qty	Description of Parts	Condition	Estimate By Workshop (\$)	Our Adjusted (\$)
	<u>REPLACEMENT OF PARTS</u>			
1	REAR BUMPER	DEFORMED	1,665.00	1,665.00
1	REAR BUMPER REINFORCEMENT	BENT	545.00	545.00
1	REAR BUMPER CHROME CENTRE	NECESSARY	180.00	180.00
2	REAR BUMPER CHORME MOULDING @ \$125.00	NECESSARY	250.00	250.00
	LESS 10% DISCOUNT		-264.00	-264.00
			2,376.00	2,376.00
	<u>SPECIAL NETT ITEMS</u>			
1	REVERSE SENSOR (SN)	NOT WORKING	200.00	200.00
			200.00	200.00
	<u>LABOUR</u>			
	TO REMOVE / REPLACE REVERSE SENSOR & CHECK WIRING.		100.00	60.00
	SPRAY PAINTING.		700.00	600.00
	TO REPAIR REAR END PANEL, BOOTLID, REAR CHASSIS INCLUDES KNOCKING & REPLACEMENT OF PARTS.		600.00	400.00
			1,400.00	1,060.00
	GRAND TOTAL		3,976.00	3,636.00
	RECOMMENDED COST OF LUMP SUM REPAIRS (TO ITS PRE-ACCIDENT CONDITION)			2,900.00
