From: Frankie THAY (SPF) <Frankie_THAY@spf.gov.sg>
Sent: Wednesday, 28 November 2018 2:48 PM
To: assignments; Catherine Chong
Cc: Rosalyn TAN (SPF); Abdul Rahman MOHAMAD SALIM (SPF); Olivia Lau (LKKAuto)
Subject: RE : AEMD/105/009/2018/169 Pre-repair Inspect for SG1059M

Estimated Cost of Repair job for SG 1059M (along GUARD POST ENTERING AIRPORT TERMINAL 1 involving SG1059M & PA4063Y)

ADJUSTMENT ON REPAIR COST FOR VEHICLE NO. SG 1059M

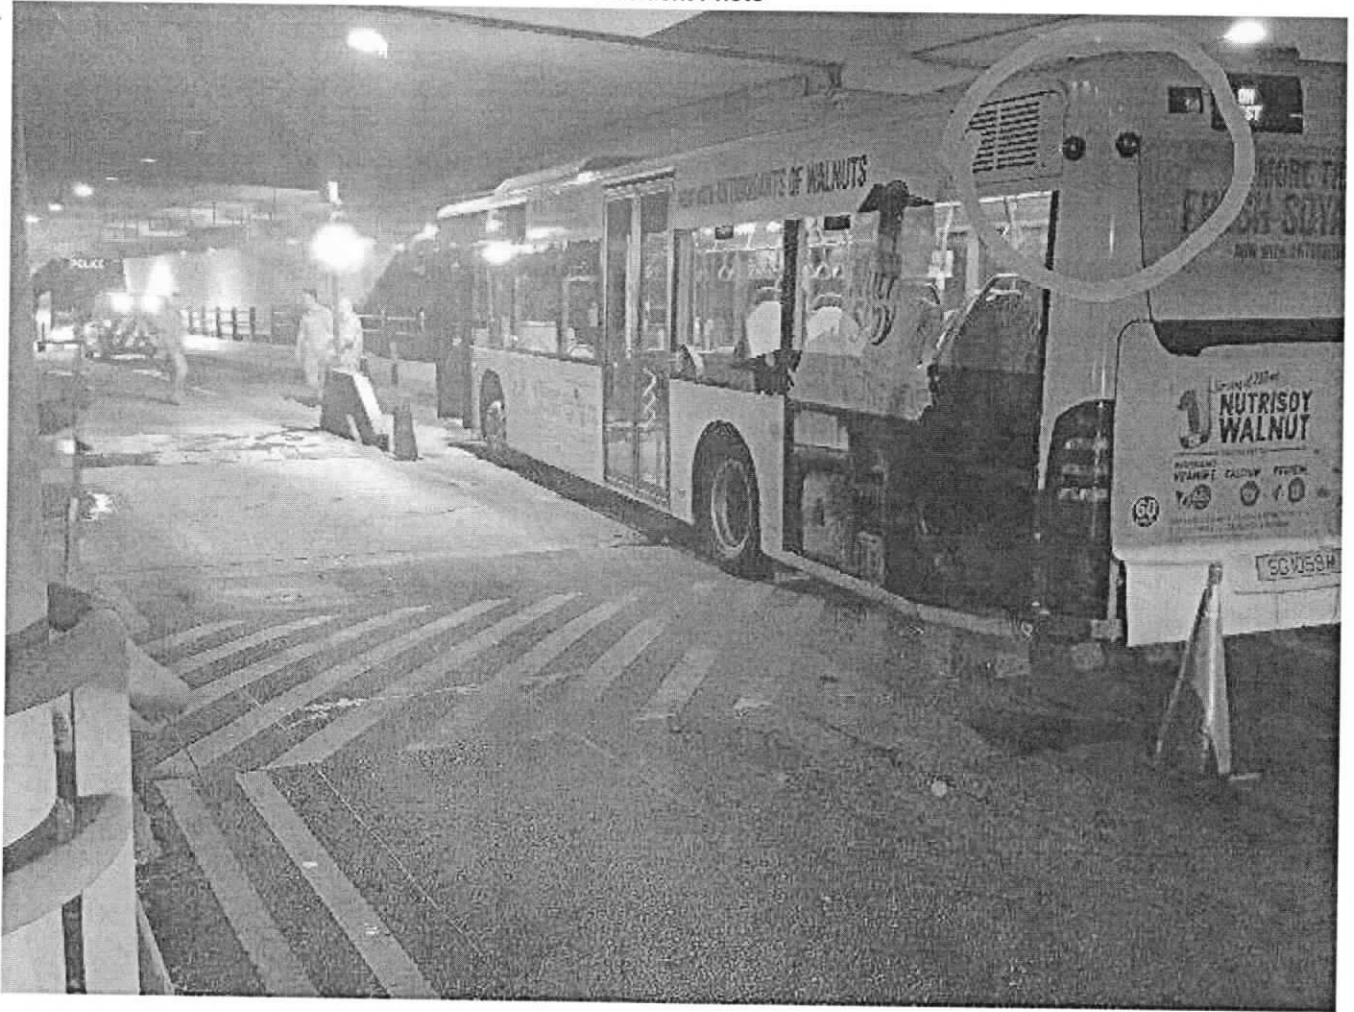
Accident Photo

AT GUARD POST ENTERING PASSENGER TERMINAL 1 BUS INTERCHANGE, I WAS STOPPED BY THE POLICE OFFICER AS THEY HAD TO CONDUCT A ROUTINE CHECK ON MY BUS BEFORE ALLOWING ME TO ENTER THE TERMINAL. THE OFFICERS FOUND A WHITE BAG LEFT UNATTENDED AT ONE OF THE SEATS ON THE BUS AND I WAS ASKED TO DRIVE MY BUS TO THE RIGHT SIDE SO THAT THEY CAN PERFORM FURTHER CHECK ON THE BUS. WHILE THEY WERE CONDUCTING THEIR CHECKS, THE REAR RIGHT OF A POLICE BUS BEARING REGISTRATION NO. PA4063Y DRIVING ON THE LANE TO MY LEFT COLLIDED ONTO MY LEFT OF MY BUS AS IT WAS DRIVING PAST THE GUARD POST.

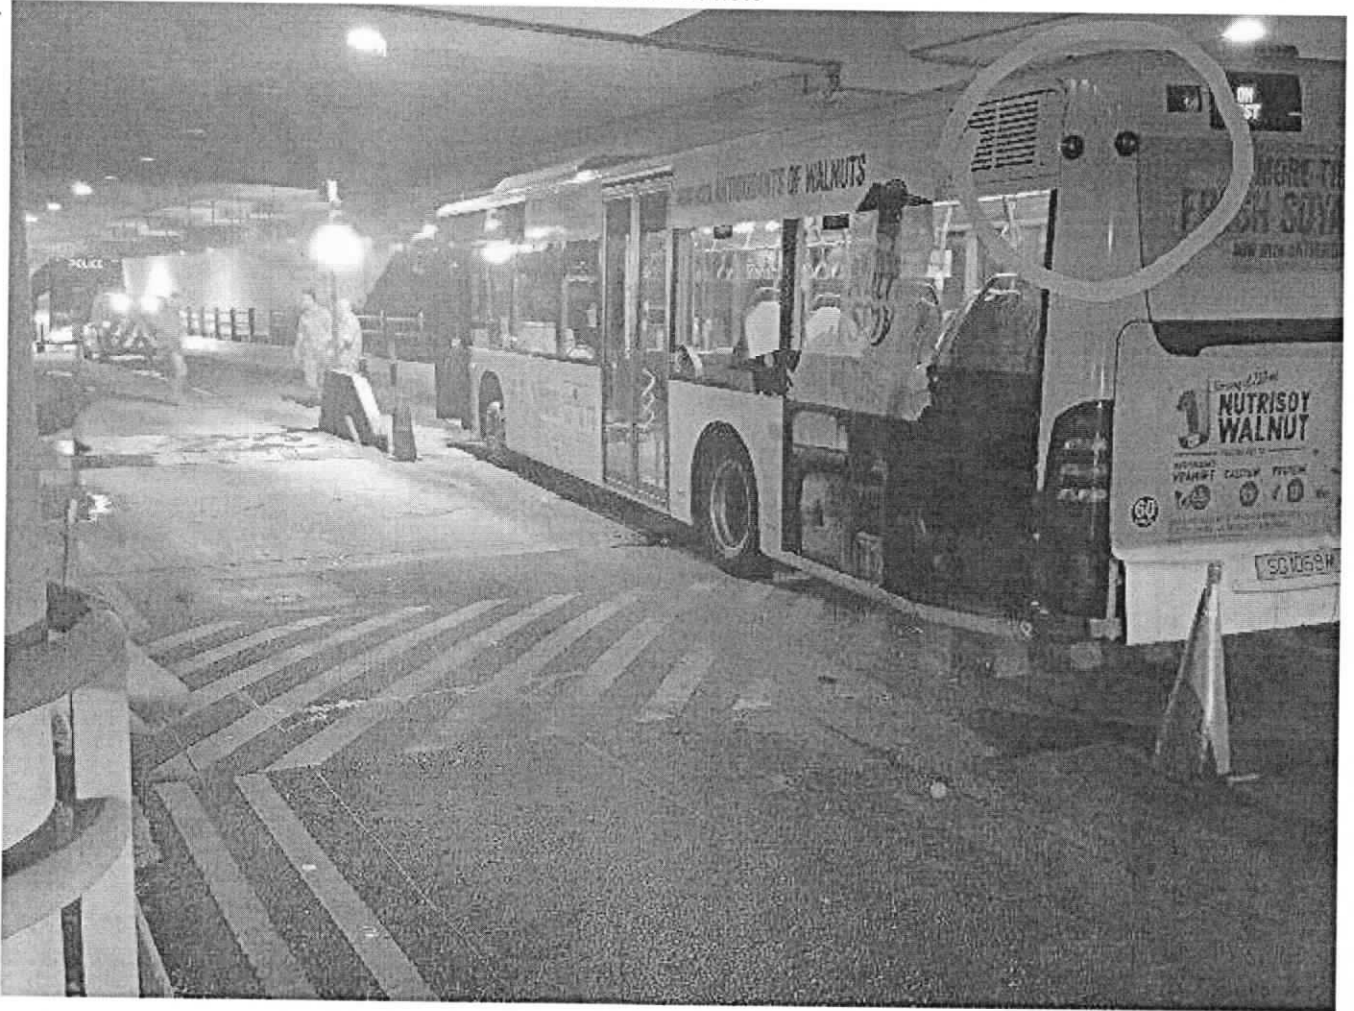
Accident Photo

4. Description of Damages			
THE VEHICLE SUSTAINED DAMAGES AT THE N/S REAR PORTION. DAMAGES SEE DETAILS.			
5. General Information			
Accident Date	09/11/2018	Inspection Date	29/11/2018
Survey held at	GO AHEAD LOYANG PTE LTD LOYANG BUS DEPOT 2 LOYANG WAY SINGAPORE 508776		
5a. Remarks			
A)THE INSPECTION WAS CONDUCTED ON A"WITHOUT PREJUDICE" BASIS. B)IN ACCORDANCE TO YOUR INSTRUCTIONS, WE HAVE NOT AUTHORISED REPAIRS.			
5b. Estimate Days of Repair			
ESTIMATED NORMAL PERIOD FOR REPAIR:		4 Working Days
