Your Ref : M574771
Our Ref : CS/MSG18021682/N

7 December 2018

**AUTOMOBILE TECHNICAL INVESTIGATION REPORT OF INCIDENT
INVOLVING SKT 842B AND SLD 2244L ON 25 OCTOBER 2018**

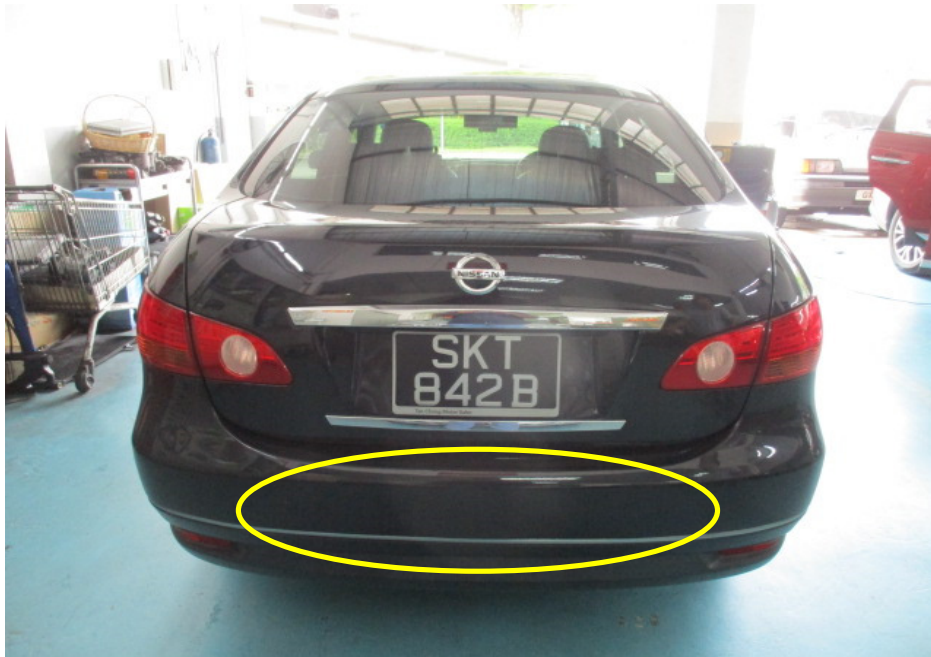
Photo 1 shows the general view of the rear portion of the Nissan upon our inspection. The damage to the Nissan was observed to be confined to its rear portion, at the centre portion (circled).

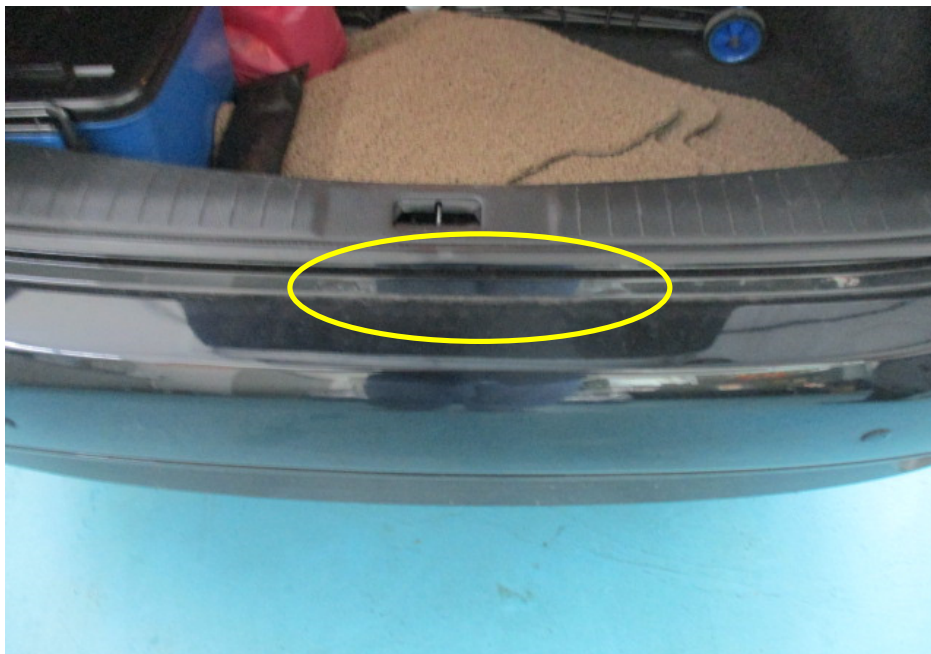
Photo 2 shows upon closer examination, we noted a gap between the boot lid weather strip and rear bumper at the centre portion (circled).

18. Firstly, the gap between the boot lid weather strip and rear bumper at the centre portion of the Nissans' rear bumper was caused by an object pushing the rear bumper slightly inwards. Secondly, the paint scratch marks on the centre portion of the Nissans' rear bumper were caused by an object pressing against the Nissan's rear bumper. If one was to consider the faint whitish distortion marks that were observed on the top centre portion of the Mercedes' number plate frame, it would then appear that these damages found on the centre portion of the Nissan's rear bumper were caused by the top centre portion of the Mercedes's front number plate frame.

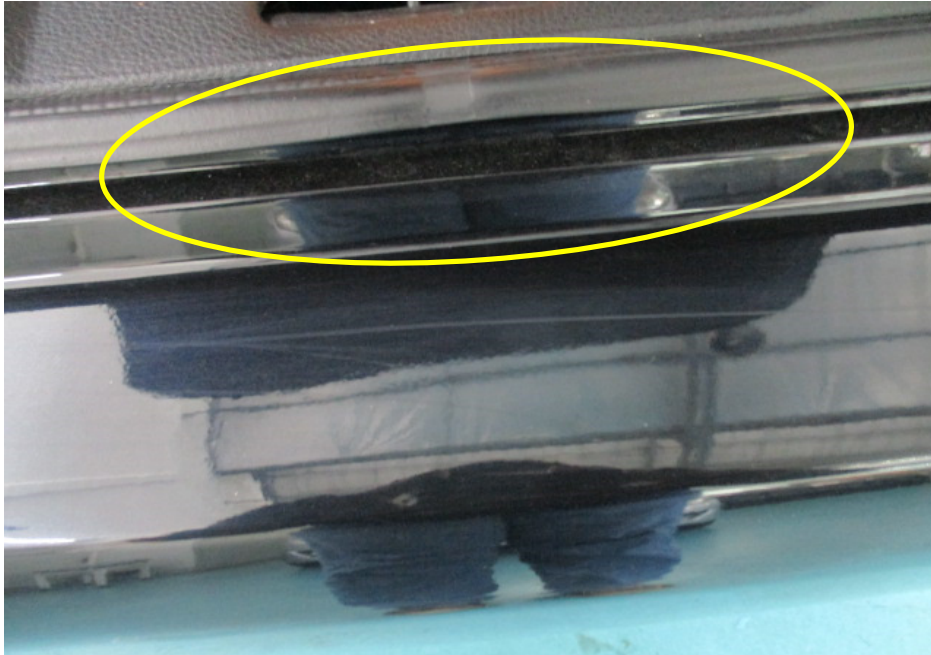
Photo 3 shows a closer view of the gap between the boot lid weather strip and rear bumper at the centre portion, indicating that the rear bumper reinforcement and possibly the rear end panel of the Nissan had been pushed slightly inwards (circled).

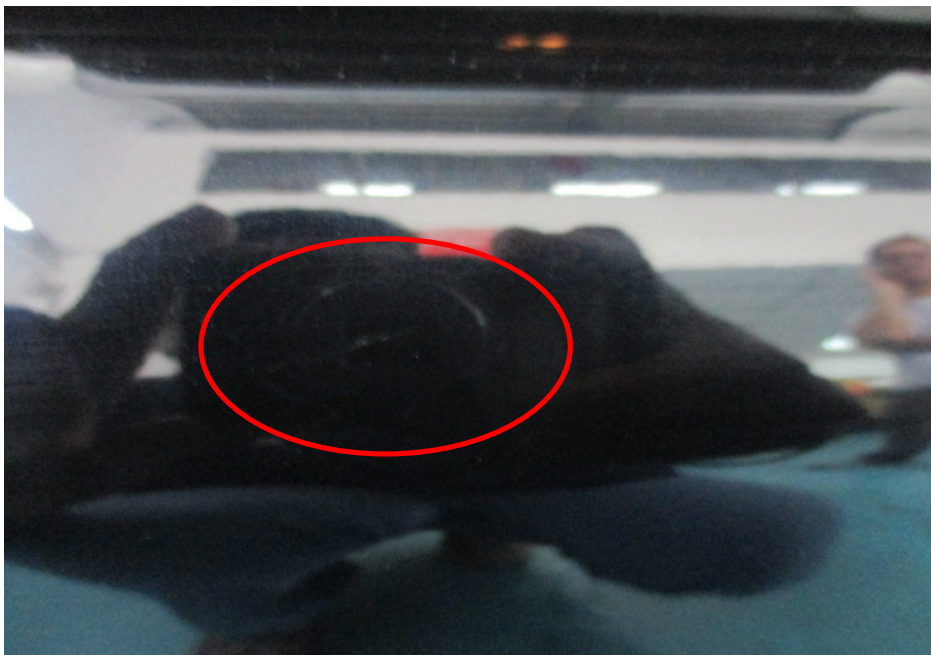
Photo 4 shows a close up view of the paint scratch marks found on the centre portion of the Nissan's rear bumper (circled).

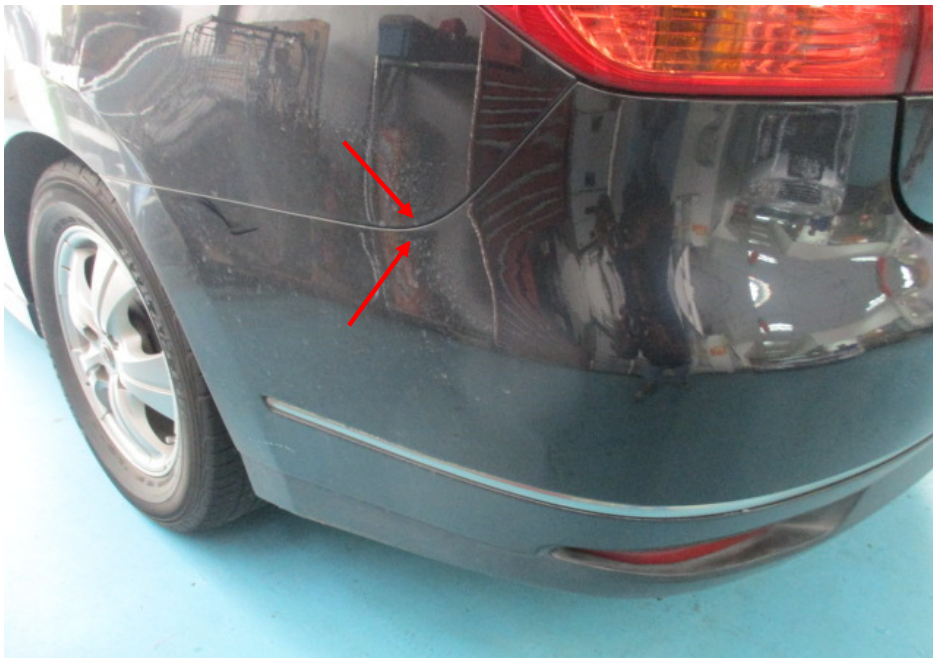
Photo 5 shows a closer view of the left corner edge of the rear bumper of the Nissan. We observed that there was no misalignment at the corner edges (arrowed).

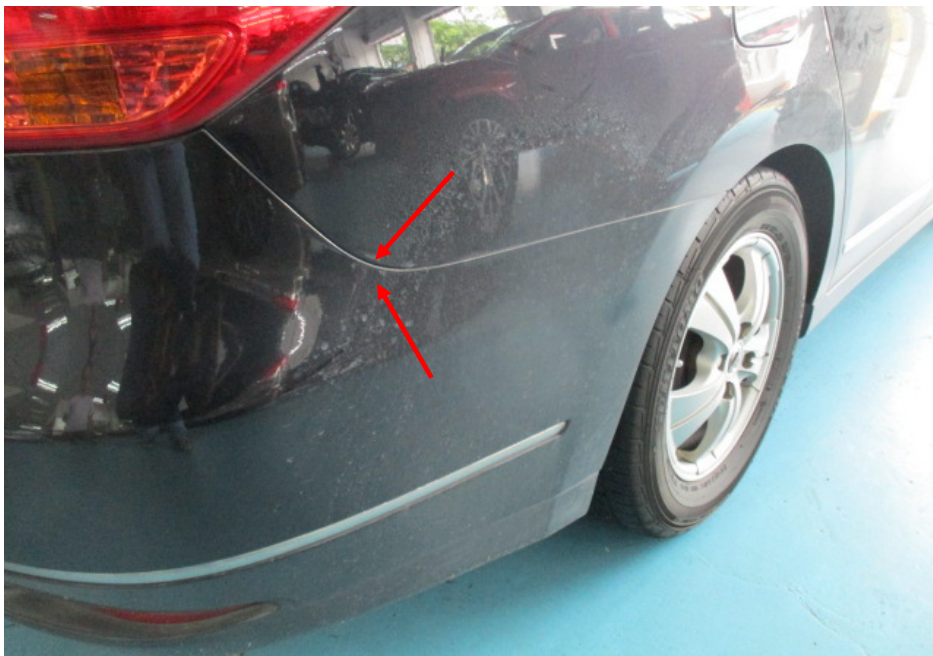
Photo 6 shows a closer view of the right corner edge of the rear bumper of the Nissan. We observed that there was no misalignment at the corner edges (arrowed).

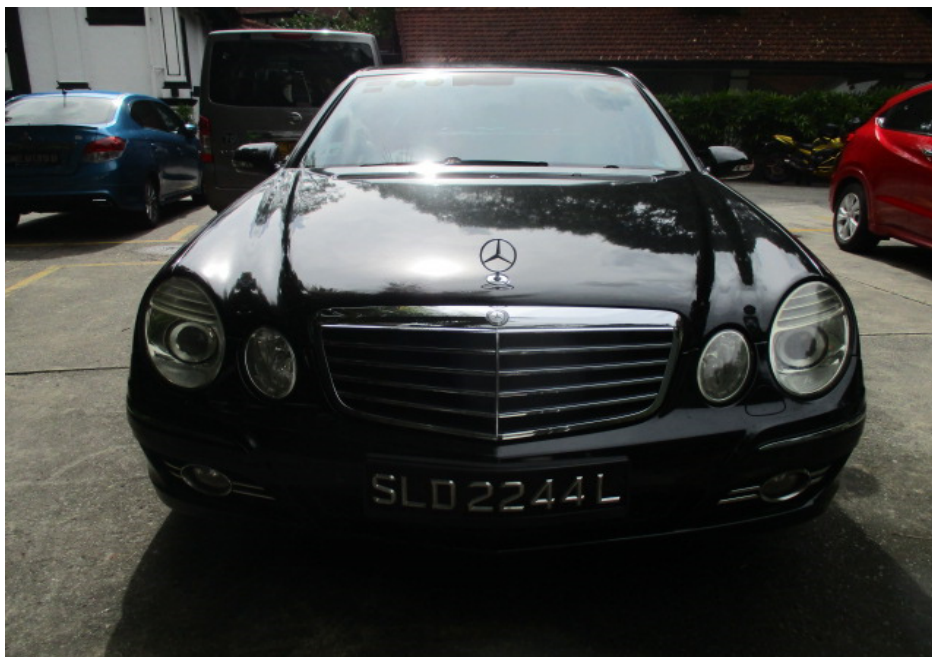
Photo 7 shows the general view of the front portion of the Mercedes at the time of our inspection. We observed faint whitish distortion marks on the top centre portion of the Mercedes's front number plate frame. We also observed that there were no dents or cracks on its front number plate

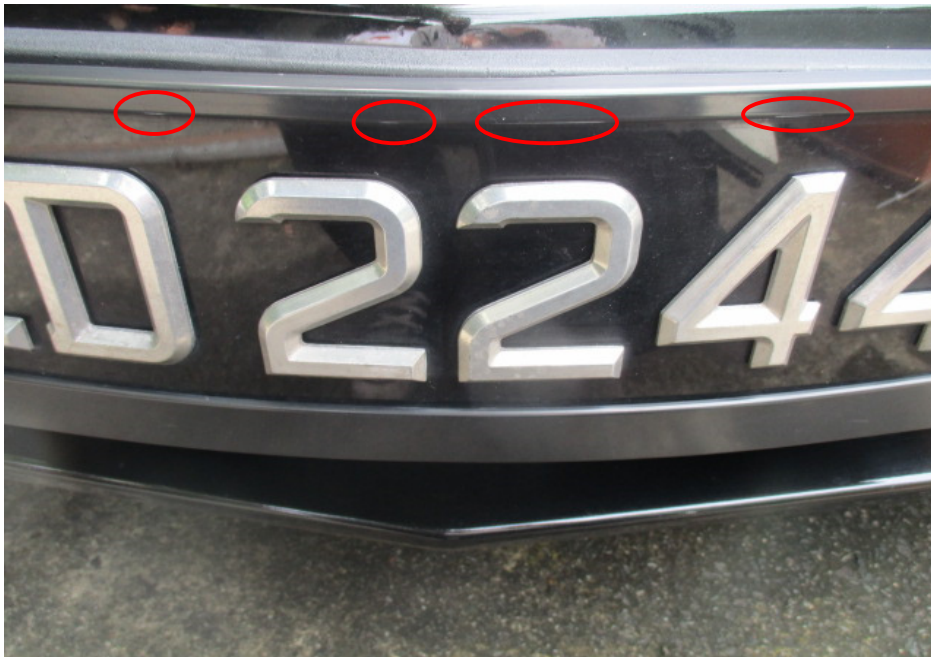
Photo 8 shows a closer view of the faint whitish distortion marks on the top centre portion of the Mercedes's front number plate frame (circled). We also observed that there were no dents or cracks on its front number plate.

19. Although there was no obvious crack or break on the front number plate frame of the Mercedes at the time of our inspection, it could be due to the impact force arising from the contact being not significant enough to have stretched past the material strength of the front number plate frame. In this aspect, one would have to consider the material stiffness of the Mercedes's front number plate frame, which is constructed of hard plastic, against the thermoplastic (soft plastic) material of the Nissan's rear bumper.

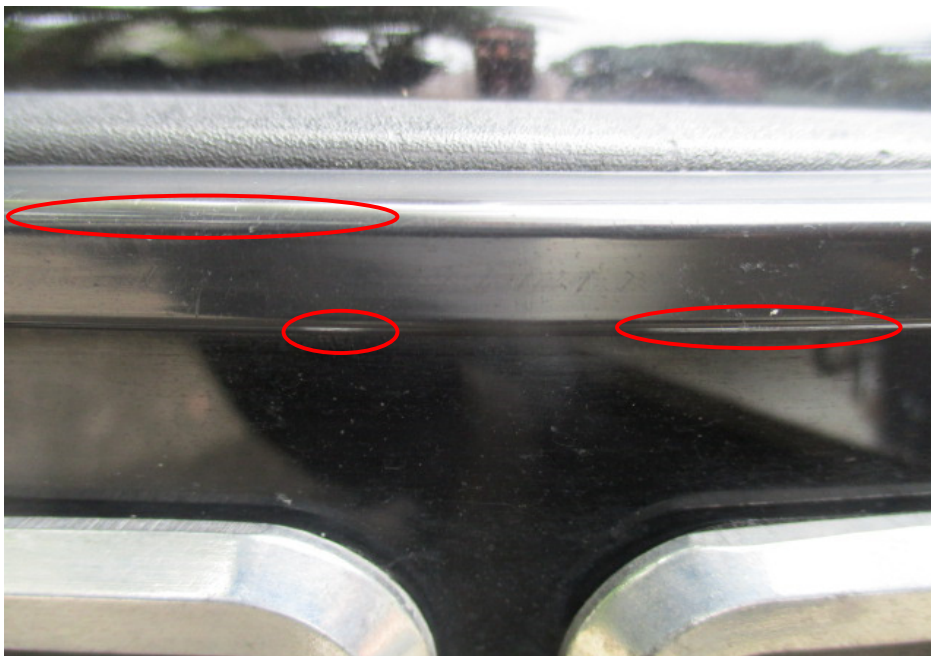
Photo 9 shows a close up view of the faint whitish distortion marks on the top centre portion of the Mercedes's front number plate frame (circled). We also observed that there were no dents or cracks on its front number plate.

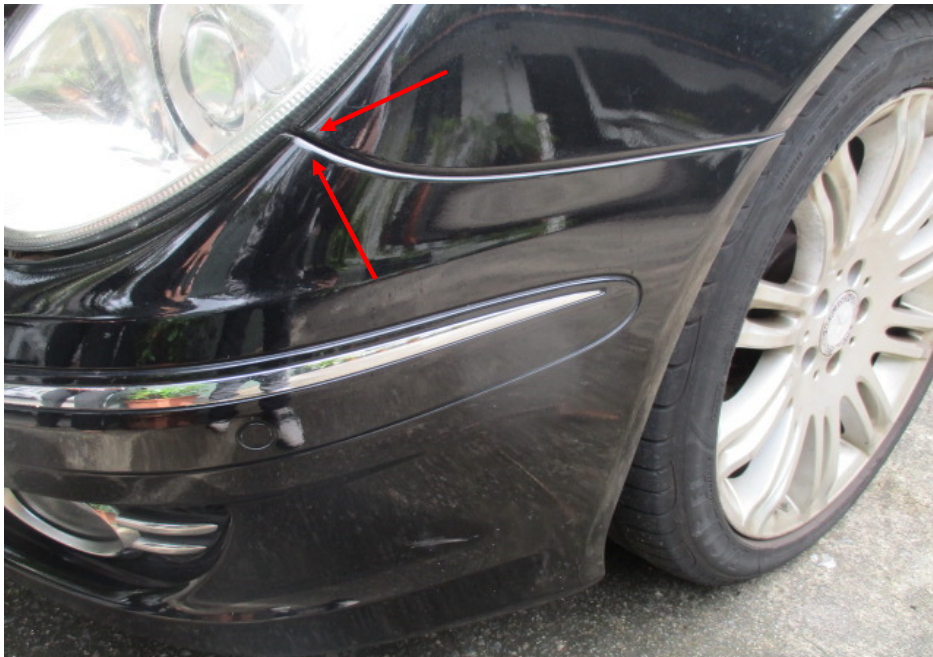
Photo 10 shows a closer view of the left corner edge of the front bumper of the Mercedes. We observed that there was no misalignment at the corner edges (arrowed).

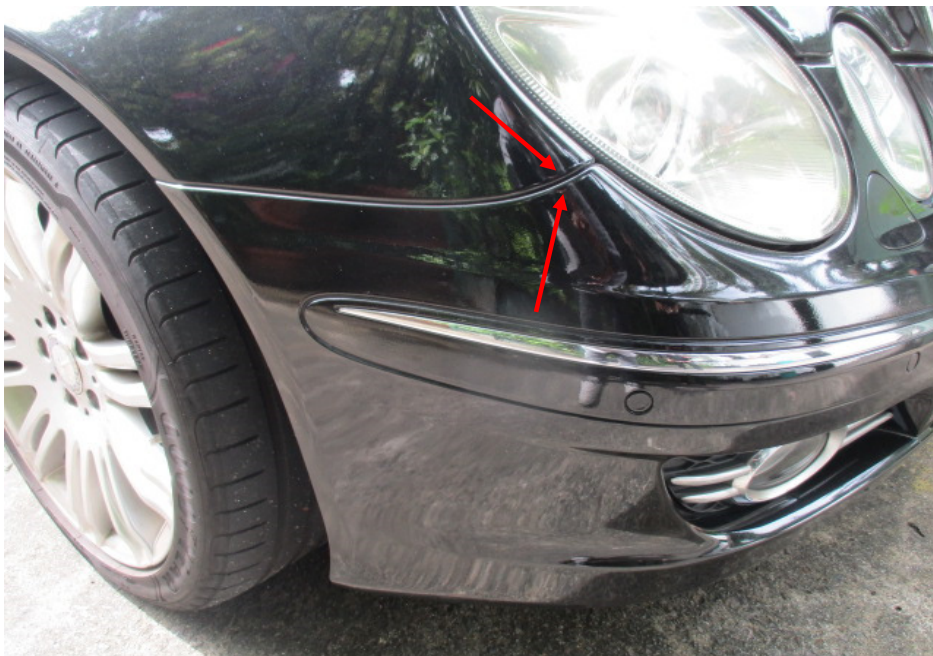
Photo 11 shows a closer view of the right corner edge of the front bumper of the Mercedes. We observed that there was no misalignment at the corner edges (arrowed).

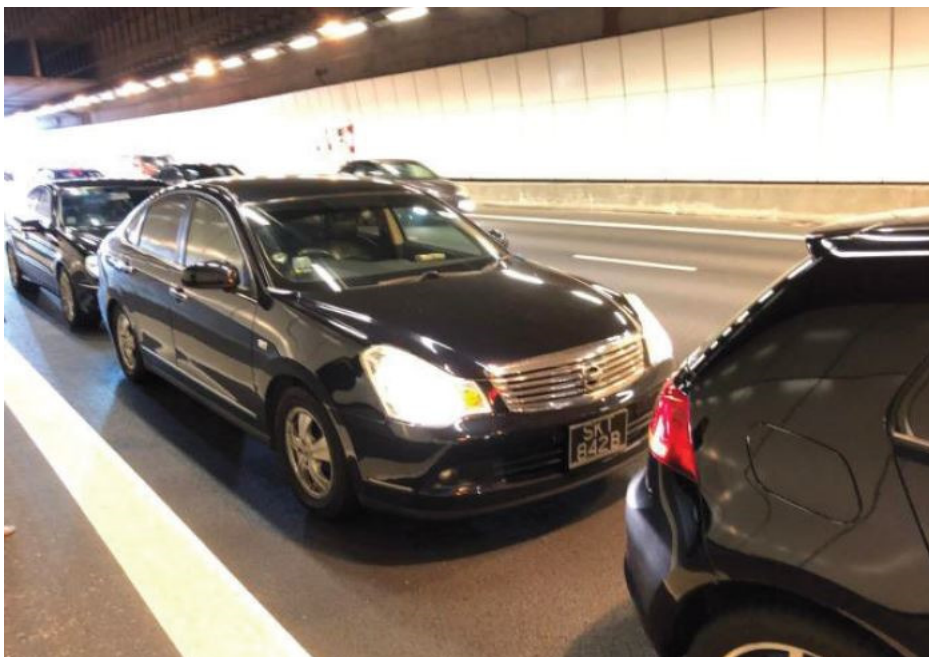
Photo 12 shows a front view of the position of the Involved Motor Cars after the accident. The Mercedes was observed to be directly behind the Nissan.

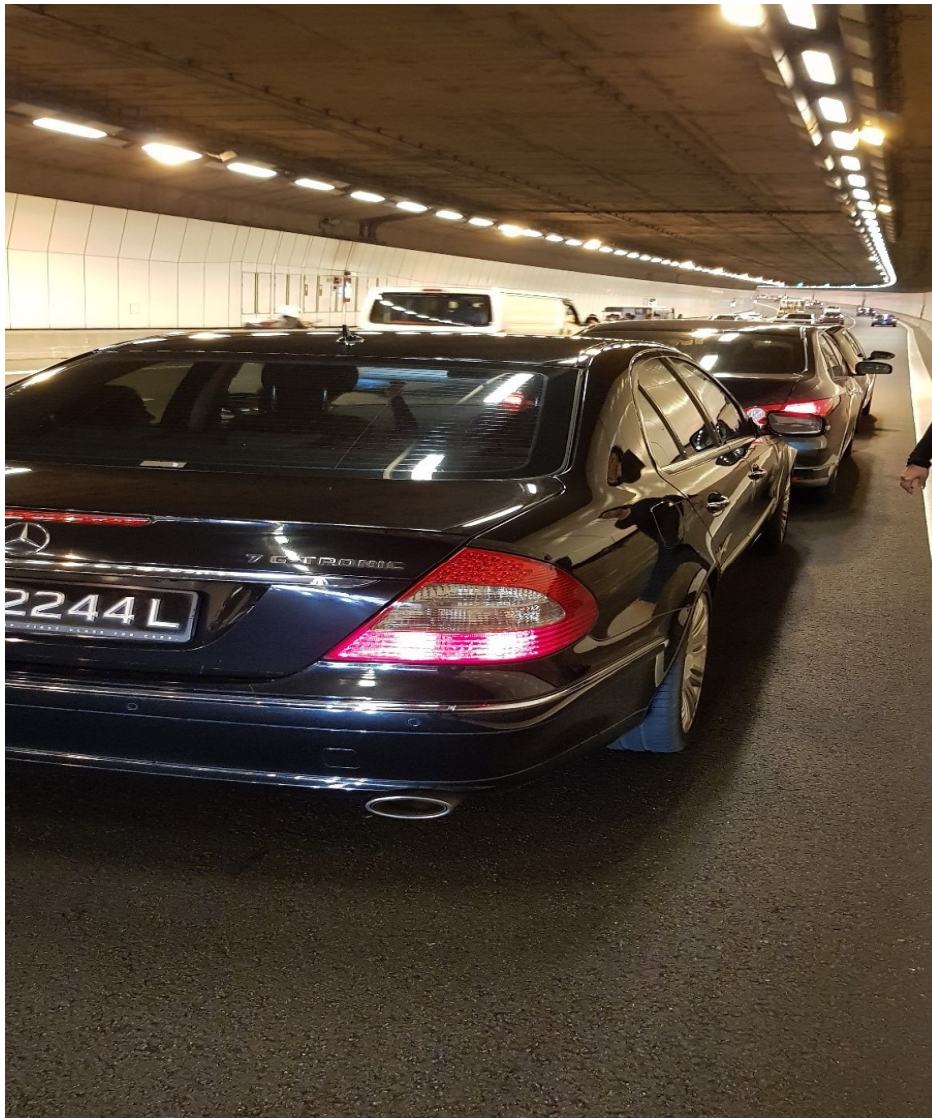
Photo 13 shows a rear view of the position of the Involved Motor Cars post-accident. The Mercedes was observed to be directly behind the Nissan.

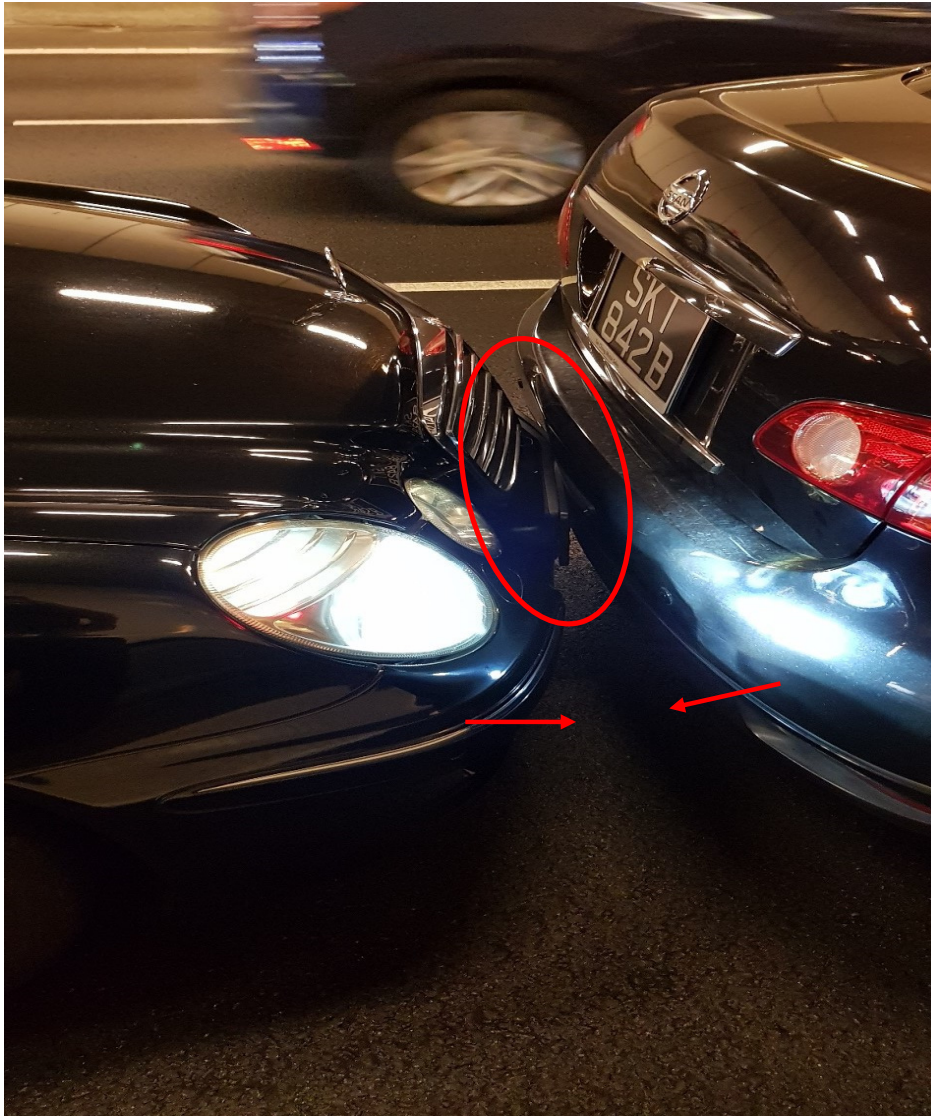
Photo 14 shows a right side view of the final position of the Involved Motor Cars at the accident location. The front centre portion of the Mercedes was observed to be directly in contact with the rear centre portion of the Nissan (circled). It can be observed that there was no contact between the rear right portion of the Nissan and the front right portion of the Mercedes (arrowed).

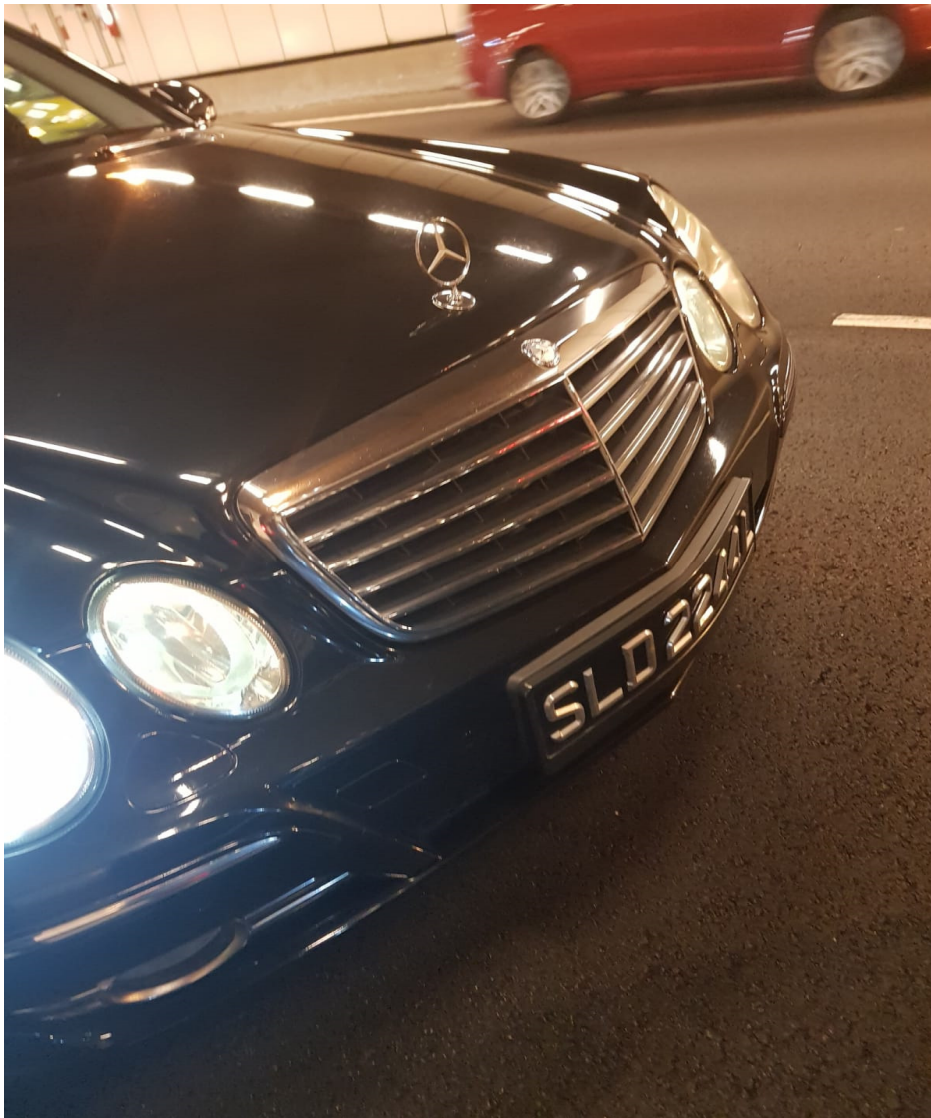
Photo 15 shows the position of the Mercedes post- accident. Ms Teresa mentioned that she had reversed the Mercedes post- accident.

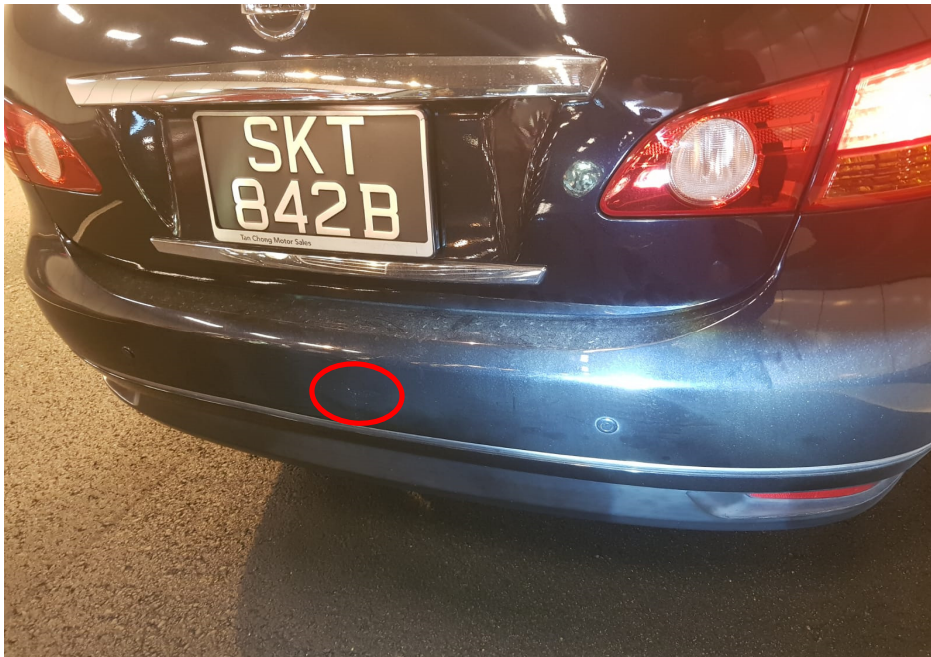
Photo 16 shows the position of the Nissan after the accident. The paint scratch marks on the centre portion of the rear bumper can be seen (circled). However there was no deformity observed on the rear bumper of the Nissan as there was no distortion of the reflected objects.

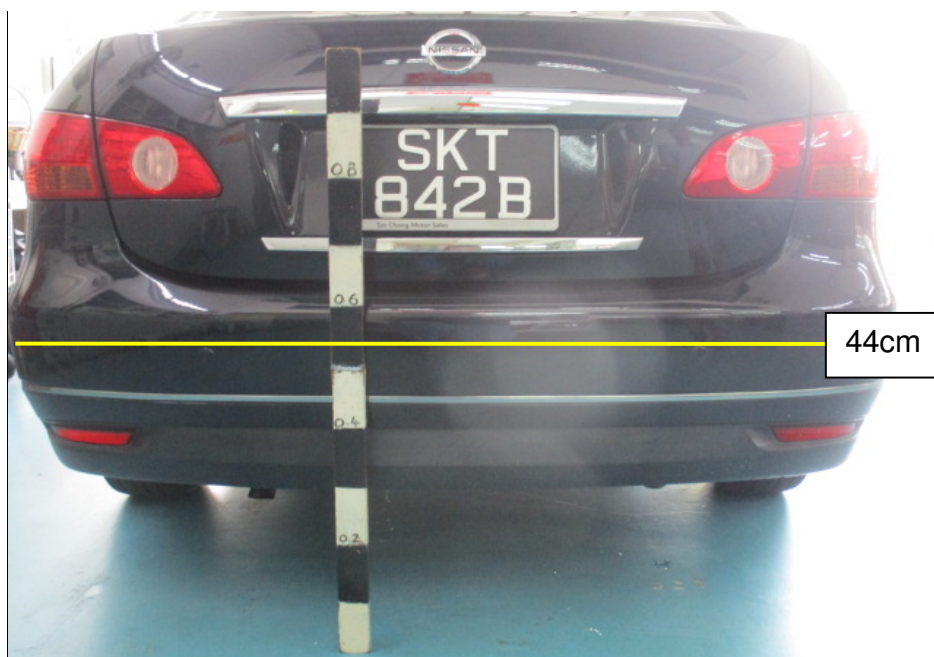
Photo 17 shows the height measurement being conducted on the rear portion of the Nissan. The height above ground level of the centre portion of the rear bumper of the Nissan, at the area where the paint scratch marks were found was measured to be approximately 44cm.

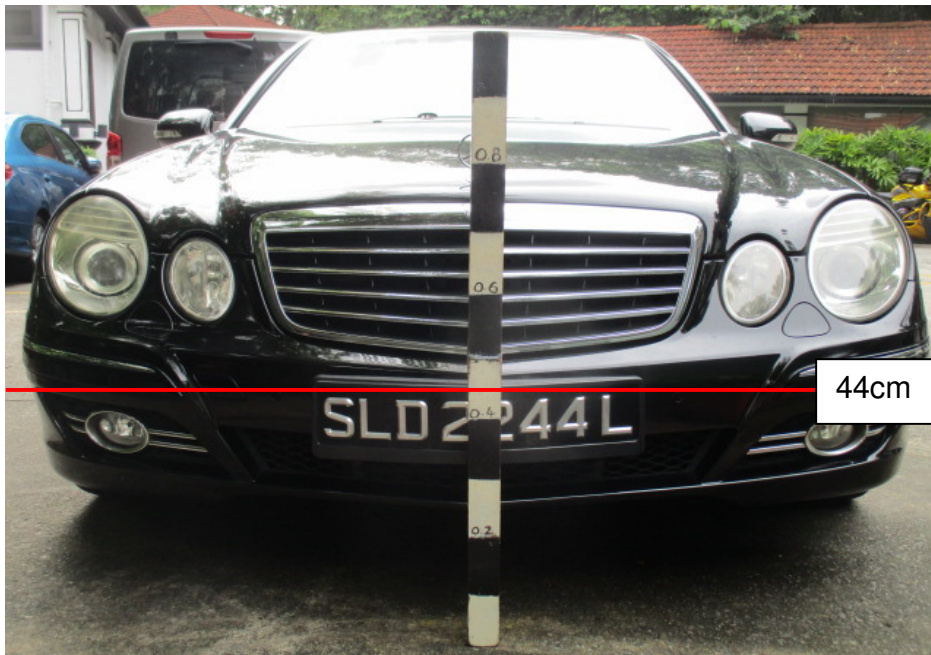
Photo 18 shows the height measurement being conducted on the frontal portion of the Mercedes. The body part at 44cm above ground was the top portion of the Mercedes' front number plate frame where the faint whitish distortion marks were found.

- a) the height above ground level of the centre portion of the rear bumper of the Nissan, at the area where the paint scratch marks were found was measured to be approximately 44cm;
- b) the body part at 44cm above ground was the top portion of the Mercedes' front number plate frame where the faint whitish distortion marks were found;
- e) the height measurements appear to support the findings of possible contact between the rear portion of the Nissan and the front portion of the Mercedes. The damage observed on the rear bumper of the Nissan was a result of this contact and corresponds to the damage observed on the front portion of the Mercedes.
