Your Ref : 561344/IT  
Our Ref : CS/MSG18011062/D

01 November 2018

**AUTOMOBILE TECHNICAL INVESTIGATION REPORT OF INCIDENT  
INVOLVING SBN 8998X AND SLB 2822D ON 13 JUNE 2018**

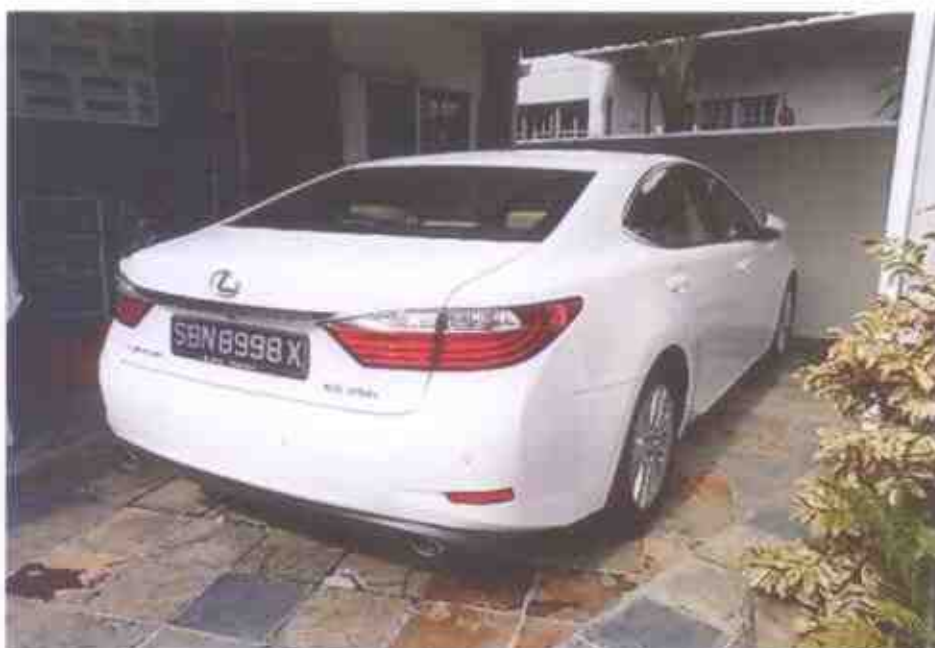
Photo 1 shows a general view of the rear right body of the Third Party Vehicle at the time of my inspection on 04 July 2018. The damage sustained to the Third Party Vehicle was confined to its rear right fender.

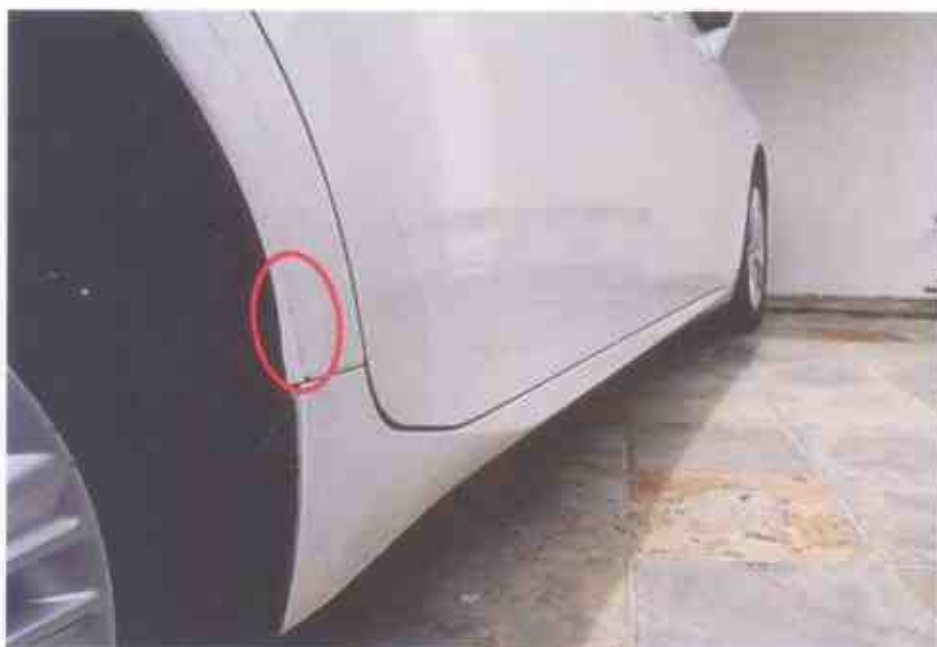
Photo 2 shows a closer view of the damaged area of the Third Party Vehicle. This was at the lower part of its rear right fender (circled), at the area just before its rear right wheel.

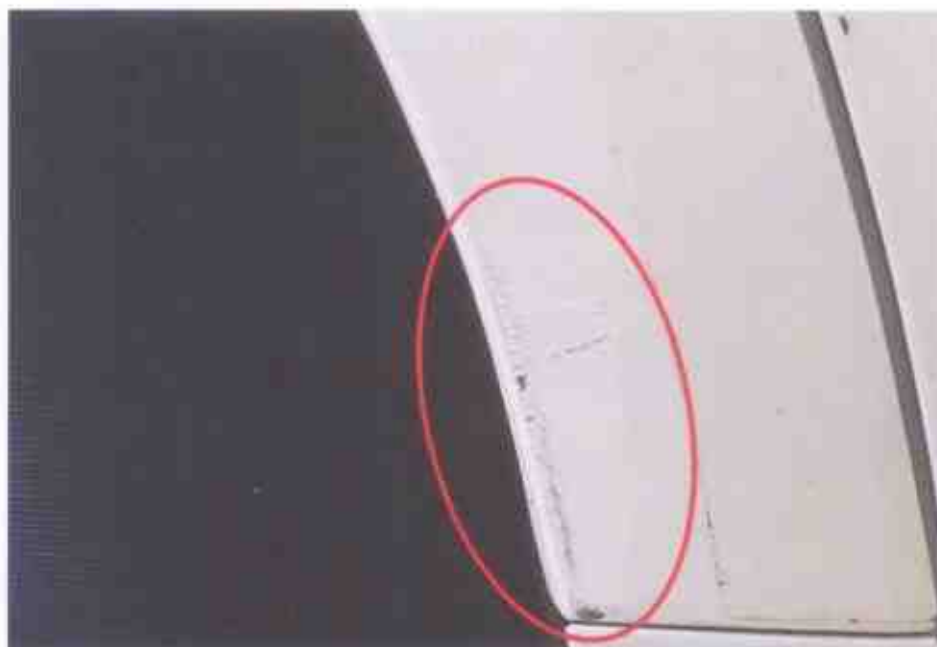
**Photo 3** shows a closer view of the damage sustained to the Third Party Vehicle. The damage (circled) was observed to be of grazing pattern that had cut into the rear right fender of the Third Party Vehicle.

16. Having investigated and technically analyzing the material evidence available at the time of writing this report, I am of the opinion that the damage to the lower part of the rear right fender of the Third Party Vehicle was caused by contact of grazing nature with the front left tyre and front left wheel rim of the Insured Vehicle. The damage is consistent to the reported circumstance of incident that was described by the driver of the Third Party Vehicle.

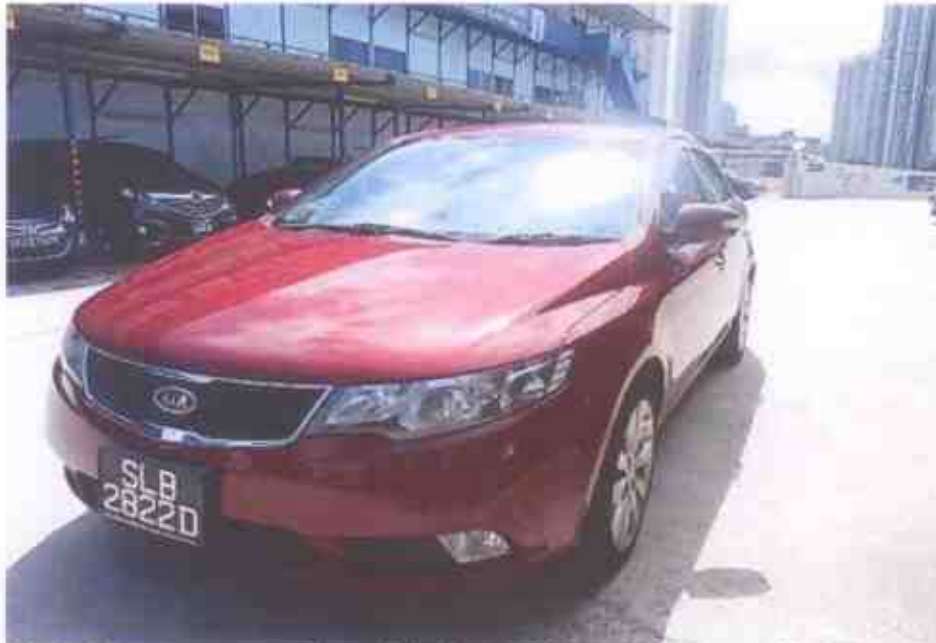
**Photo 4** shows a general view of the front left body of the Insured Vehicle at the time of my inspection on 28 June 2018. The mileage recorded at the time of my inspection was 141,223km. Given the description of events, my inspection had focused on the left side of the Insured Vehicle.

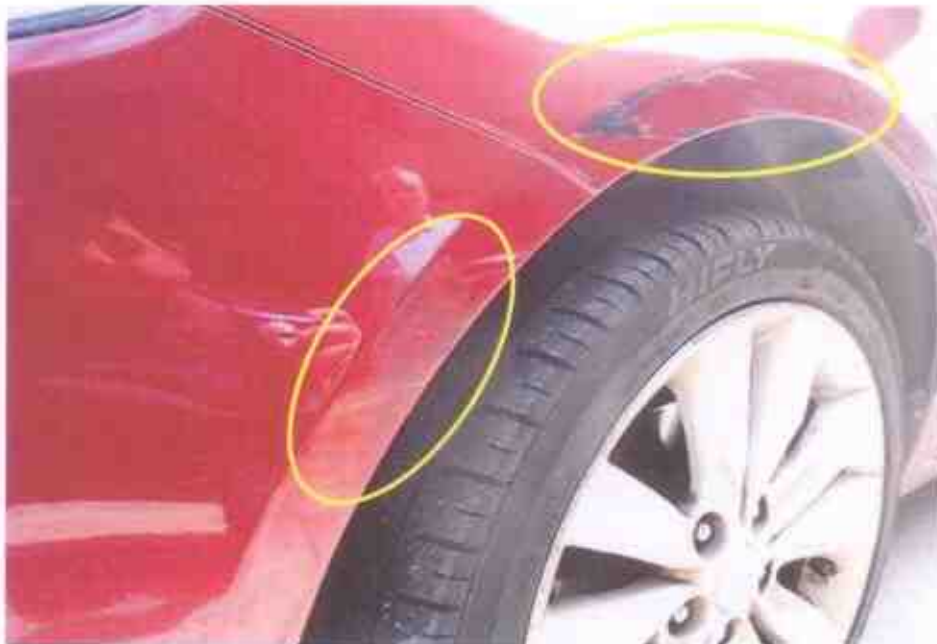
**Photo 5** shows the grazed marks (circled) that were seen on the front bumper and front left fender of the Insured Vehicle at the time of my inspection.

12. From the measurements, it was noted that the height of the damaged areas on the Involved Motor Cars do not correspond to each other. Hence, it can be established that the damage of grazing pattern on the rear right fender of the Third Party Vehicle was not caused by the front bumper and the front left fender of the Insured Vehicle. Similarly, the grazed marks on the front bumper and the front left fender of the Insured Vehicle were not caused by the rear right fender of the Third Party Vehicle.

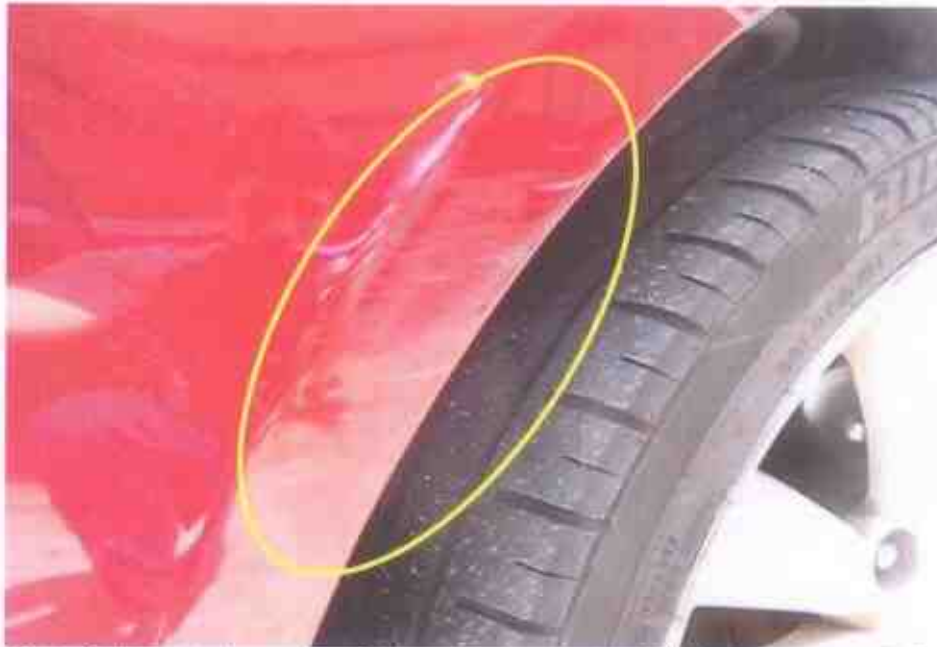
**Photo 6** shows a closer view of the grazed marks (circled) that were seen on the front bumper of the Insured Vehicle.

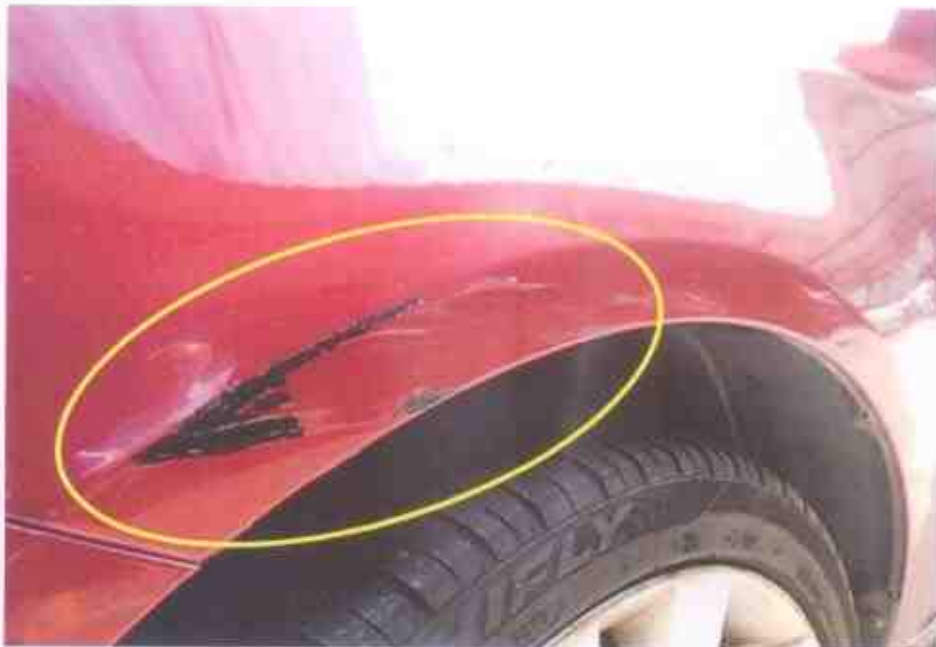
**Photo 7** shows a closer view of the grazed marks (circled) that were seen on the front left fender of the Insured Vehicle.

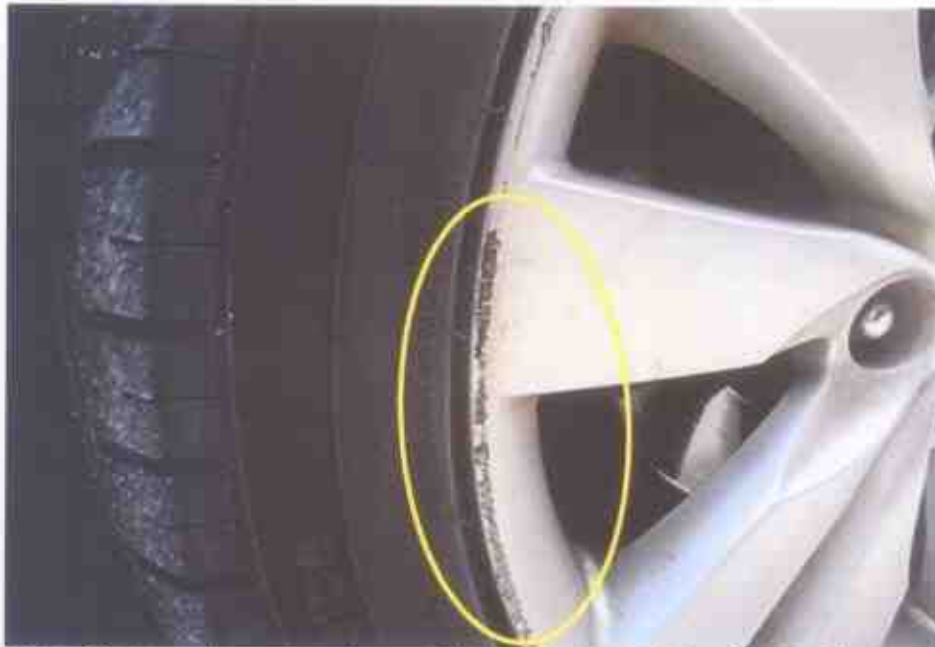
Photo 8 shows the outer edges of the front left wheel rim found with grazed marks (circled). The grazed marks were seen almost around the entire circumference of the wheel rim.

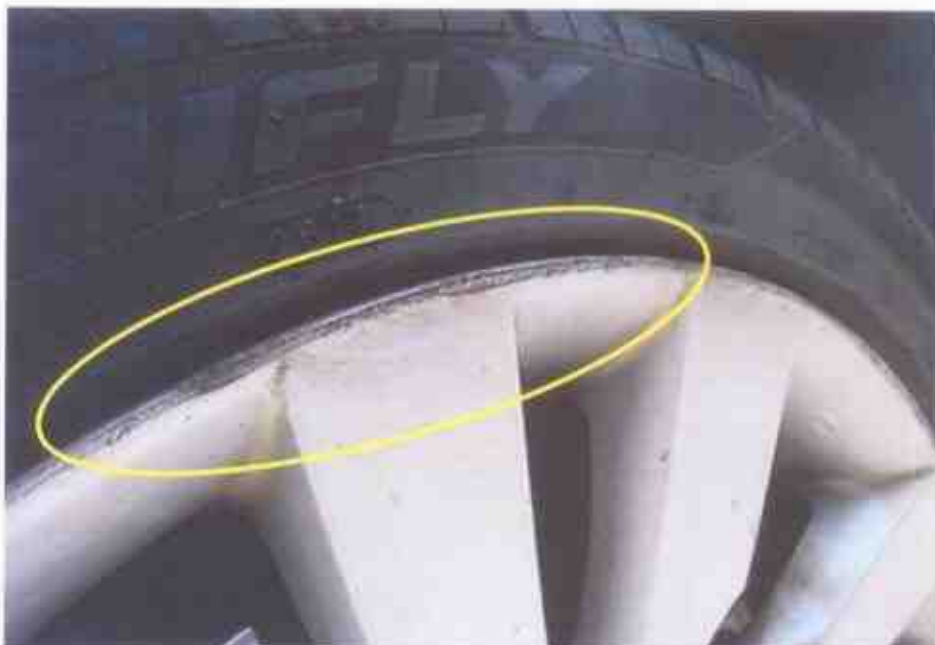
Photo 9 shows the outer edges of the front left wheel rim found with grazed marks (circled). The grazed marks were seen almost around the entire circumference of the wheel rim.

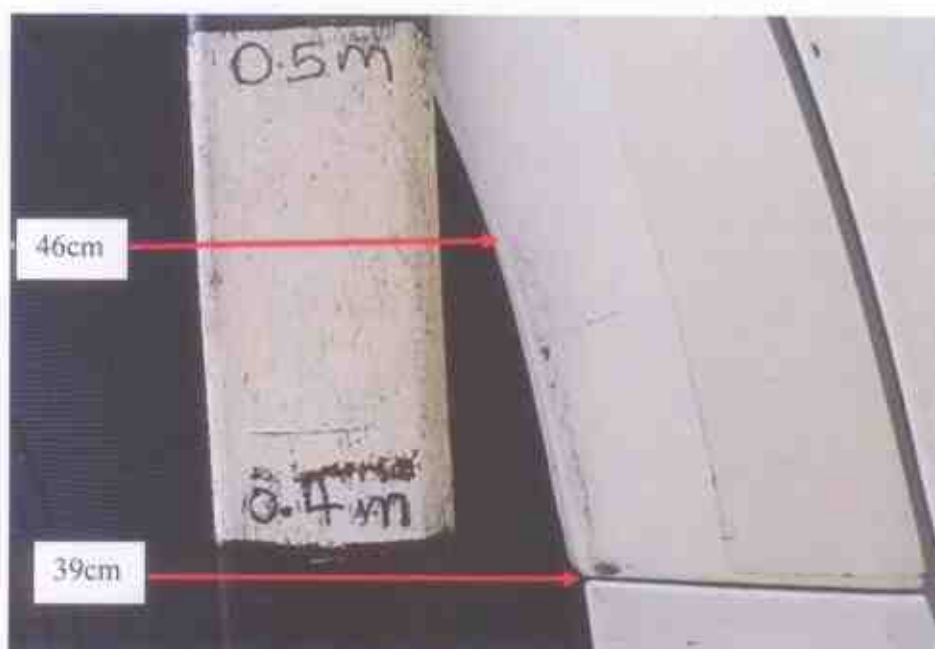
11. Height measurements carried out to the Third Party Vehicle revealed that the damaged area was approximately 39cm to 46cm above ground level height. Height measurements carried out to the Insured Vehicle revealed that the grazed marks that were seen on the front bumper and front left fender of the Insured Vehicle was approximately 47cm to 67cm above ground level. See photo 10 & 11 below.

Photo 10 shows the height measurement that was carried out to the damaged area of the Third Party Vehicle. The lowest point of the damaged area at the rear right fender of the Third Party Vehicle was approximately 39cm above ground level while the highest point of the damaged area was approximately 46cm above ground level.

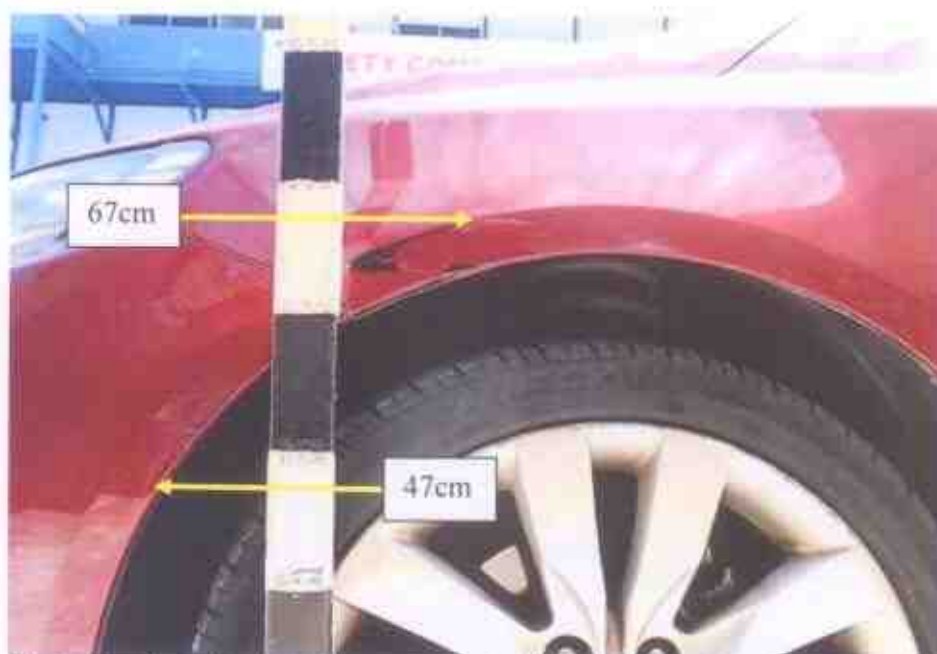
Photo 11 shows the height measurement that was carried out to the damaged area of the Insured Vehicle. The lowest point of the damaged area was approximately 47cm above ground level while the highest point of the damaged area was approximately 67cm above ground level.

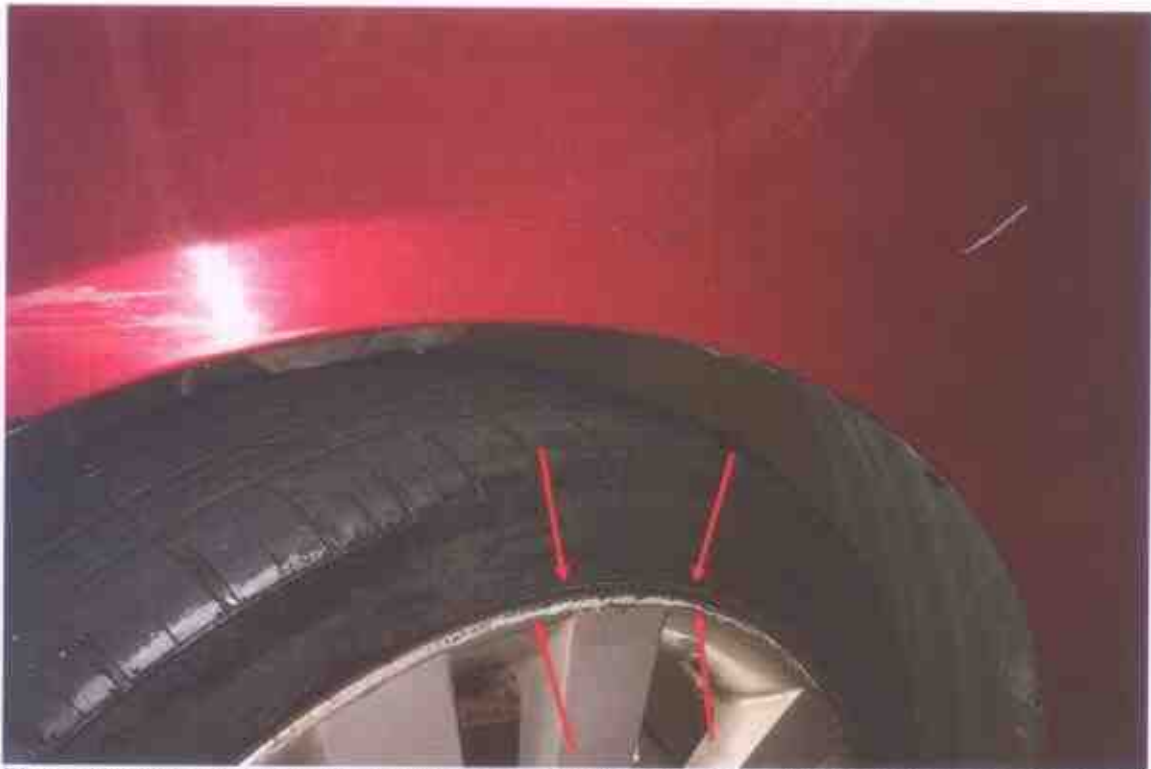
14. Although the damage to the rear right fender was not caused by the body panels of the Insured Vehicle, my close examination of the photographs taken at the incident location revealed that the damage could have possibly been caused by the front left wheel rim and front left tyre of the Insured Vehicle. White coloured marks were found on the outer sidewall of the front left tyre and outer edges of the front left wheel rim. This colour corresponds to the body of the Third Party Vehicle. See photo 12 below.

15. According to the driver of the Third Party Vehicle, the incident occurred when the Insured Vehicle was reversing in an attempt to adjust its parking position. If this was the case, then the contact between the Involved Motor Cars could have occurred when the front left wheel rim and front left tyre of the Insured Vehicle were turned slightly in order for the Insured Vehicle to reverse and adjust its parking position. This caused a protrusion of the front left tyre and front left wheel rim from the body of the Insured Vehicle, resulting in contact with the lower part of the rear right fender of the Third Party Vehicle. Hence the physical evidence on the front left tyre and front left wheel rim of the Insured Vehicle, at the incident location, appear to correspond to the events reported by the driver of the Third Party Vehicle.

Photo 12 shows the white coloured marks (arrowed) on the outer sidewall of the front left tyre and outer edges of the front left wheel rim of the Insured Vehicle. These were seen upon my close examination of the photographs that were taken at the incident location. The colour of the marks corresponds to the body colour of the Third Party Vehicle. This physical evidence suggests that there could have possibly been contact between the Insured Vehicle and Third Party Vehicle at the material time.
