Your Ref: TP/IP/60763/2018
Our Ref: CI/TPD18022198/Z

22nd January 2019

INSPECTION REPORT OF MOTORCYCLE FBJ 9677L

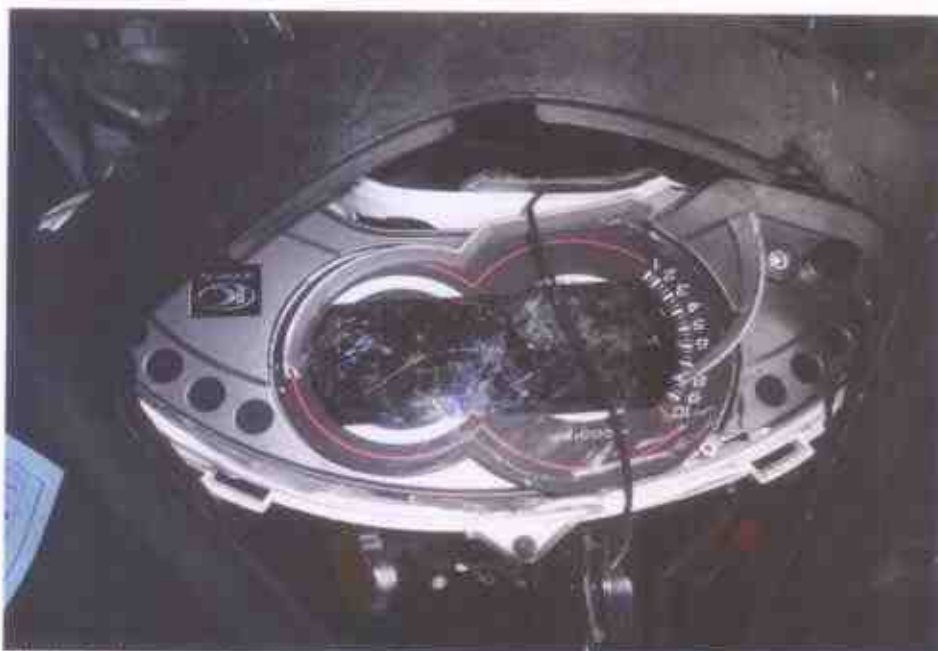
Photo 1 shows a close-up view of the speedometer of the Motorcycle at the time of our inspection. It was observed to have sustained with damages due to the accident collision.

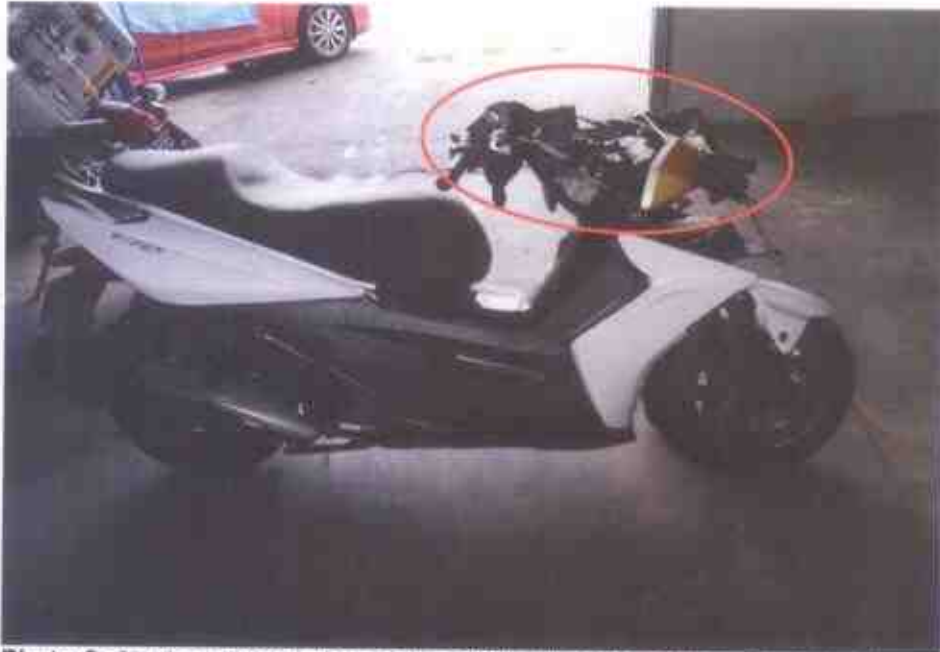
Photo 2 shows a general view of the right body of the Motorcycle at the time of our inspection. The Motorcycle frontal portion was observed to have sustained with damages due to the accident collision. (Circled)

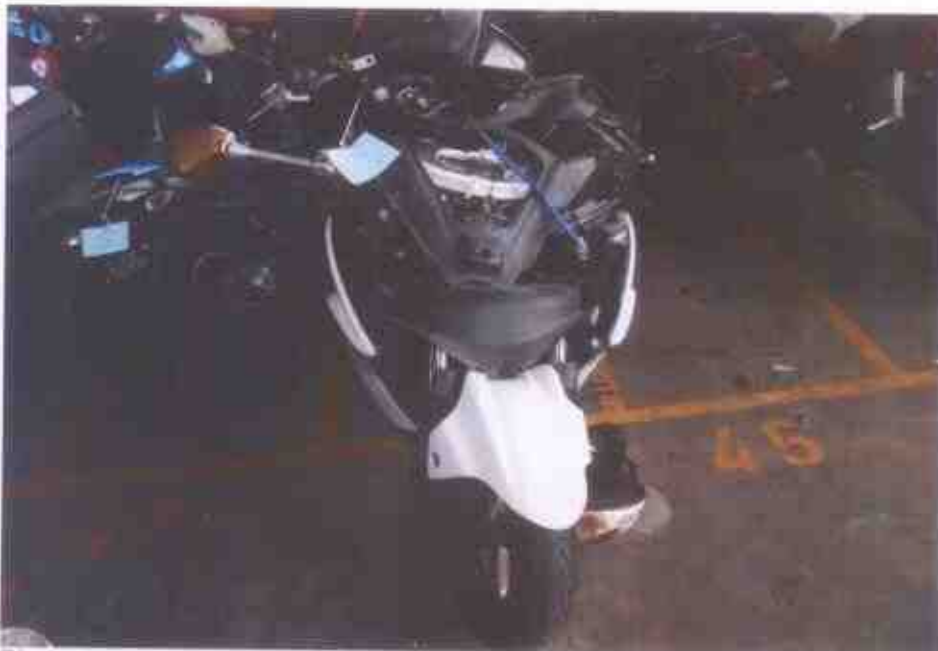
Photo 3 shows a general view of the frontal portion of the Motorcycle at the time of our inspection. The Motorcycle was observed to have sustained damages at the frontal portion.

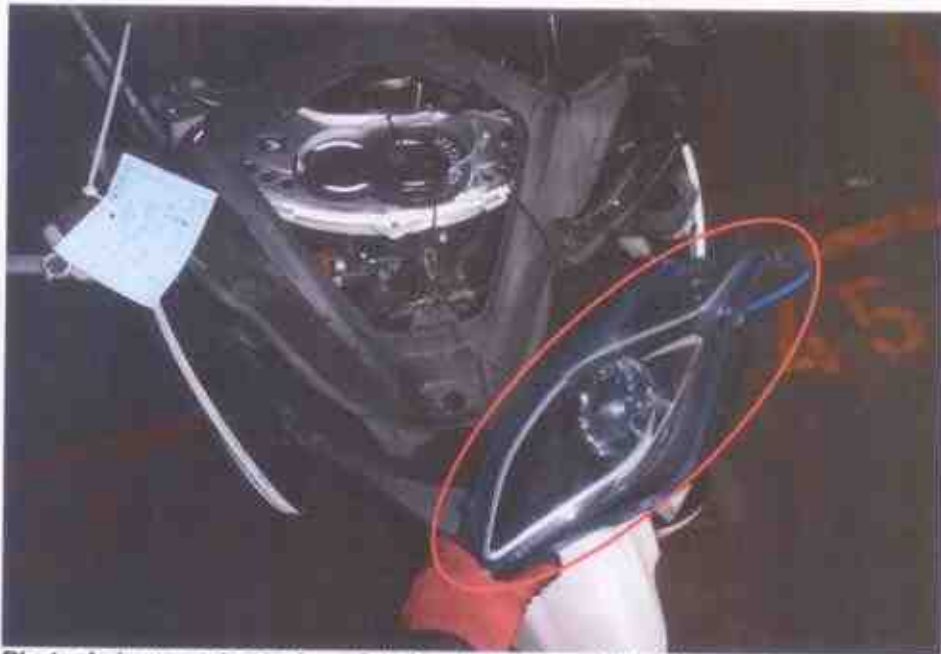
Photo 4 shows a closer view of the frontal portion of the Motorcycle at the time of our inspection. The headlamp Motorcycle was observed to be dislodged from the original installation due to the accident collision. (Circled)

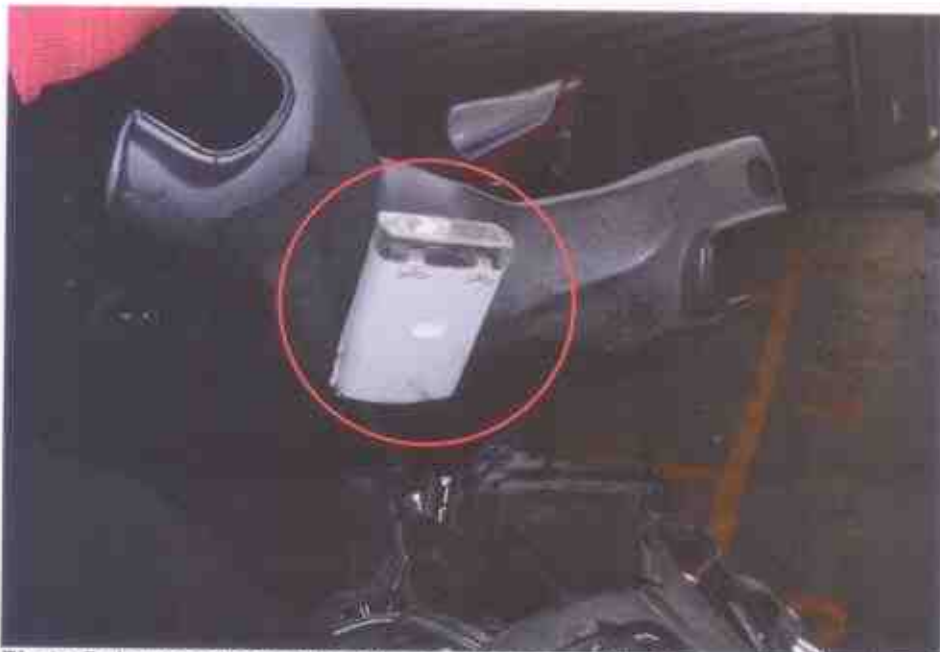
Photo 5 shows a closer view of the frontal portion of the Motorcycle at the time of our inspection. The Motorcycle was observed to have sustained dislodged In-Vehicle unit due to the accident collision. (Circled)

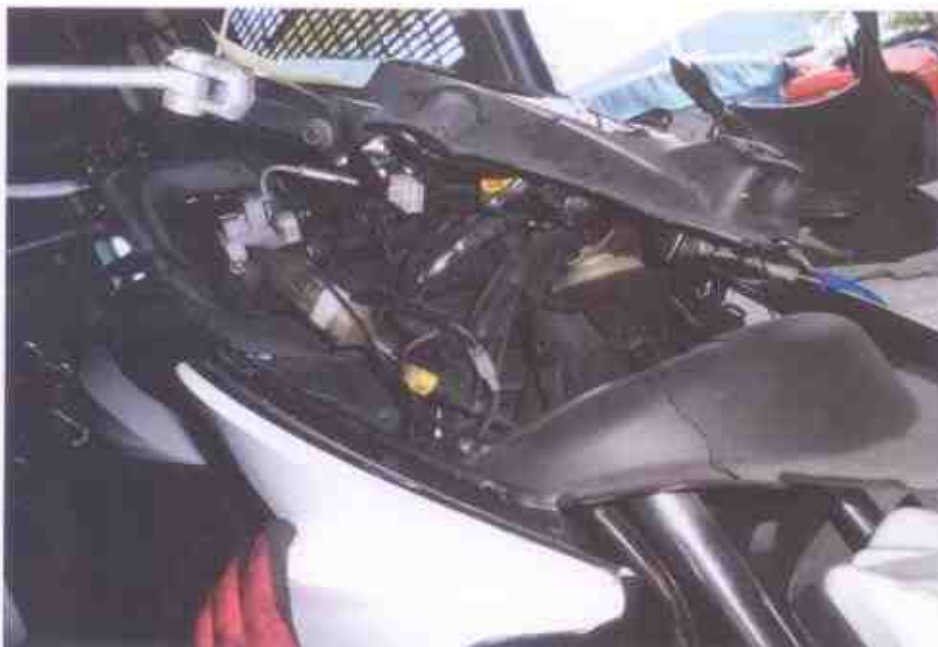
Photo 6 shows a close-up view of the frontal portion of the Motorcycle at the time of our inspection was observed to have sustained dislodged outer front fairing cover due to the accident collision. (Circled)

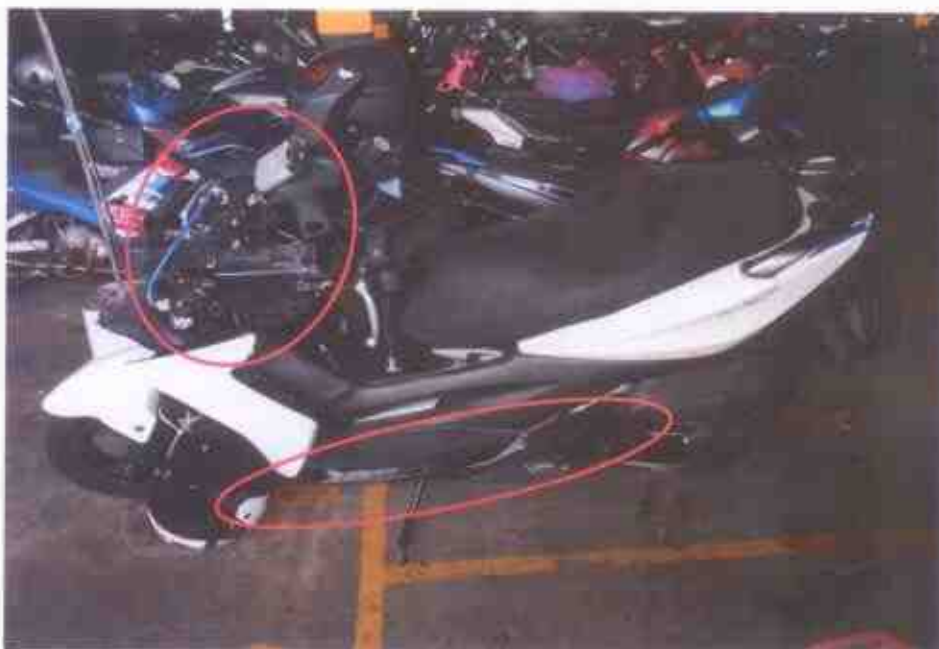
Photo 7 shows a general view of the left hand side of the Motorcycle at the time of our inspection. The Motorcycle was observed to have sustained damages due to the accident collision. (Circled)

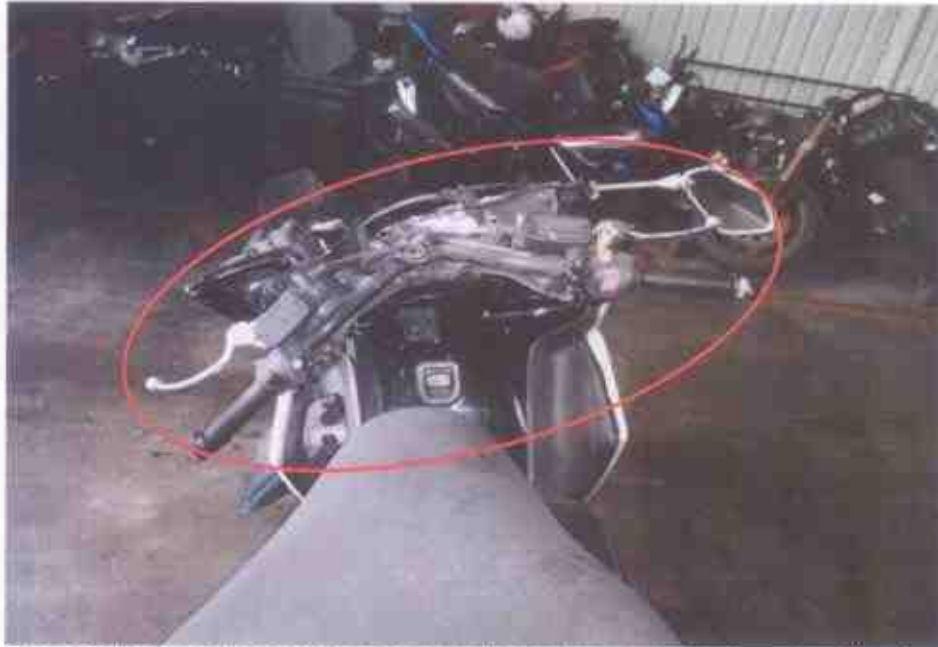
Photo 8 shows a closer view of damage handle bar of the Motorcycle at the time of our inspection. It was observed to have sustained damage due to the accident collision. (Circled)

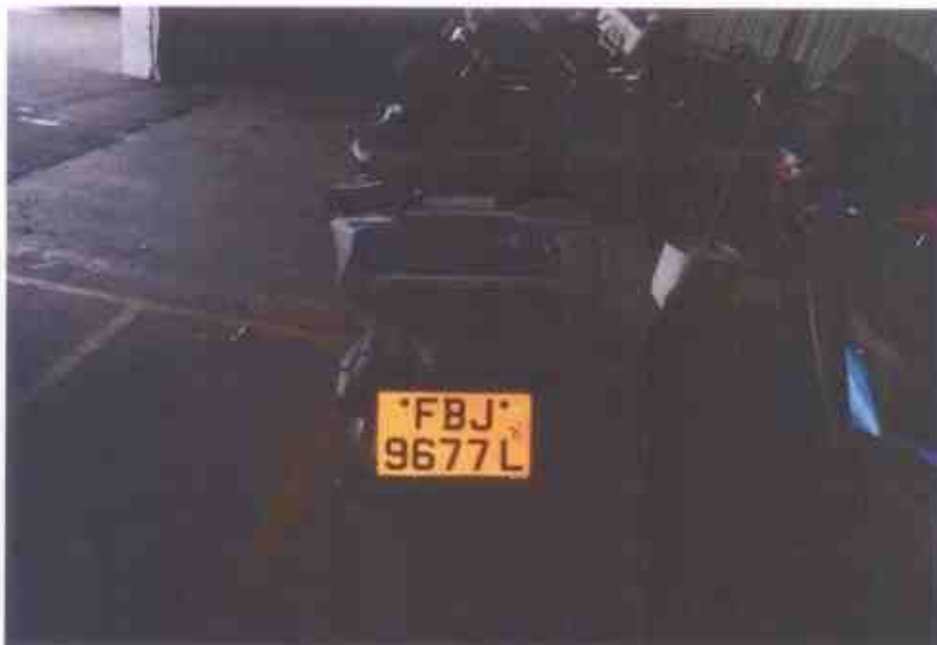
Photo 9 shows a view of the rear compartment box of the Motorcycle at the time of our inspection. It was observed to be unaffected by the accident.

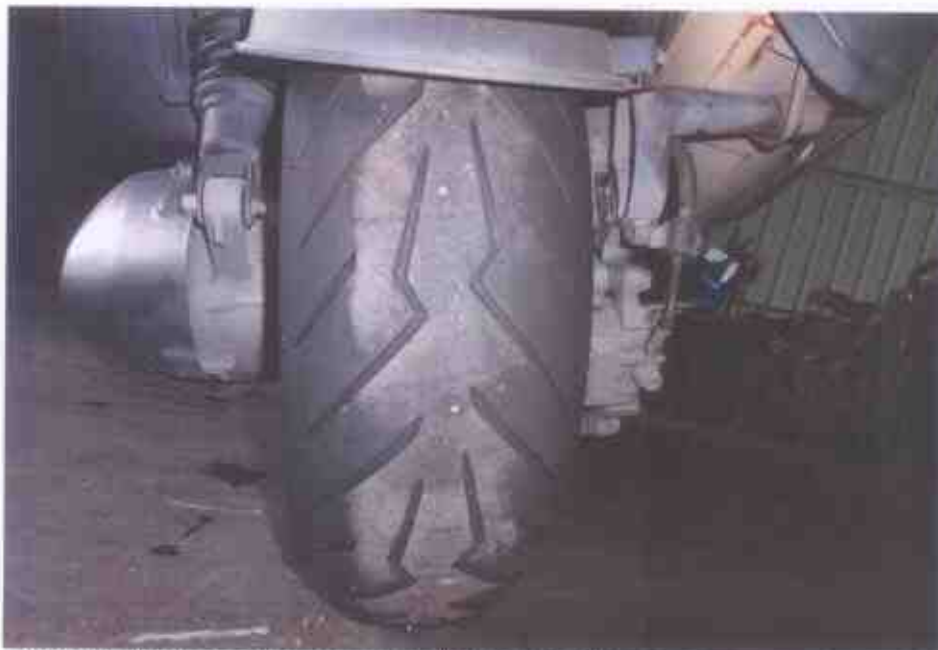
Photo 10 shows the rear tyre of the Motorcycle. The rear tyre was observed to be in serviceable condition with remaining tread depth of approximately 4mm. The tyre was also observed to be sufficiently inflated for vehicular operation.

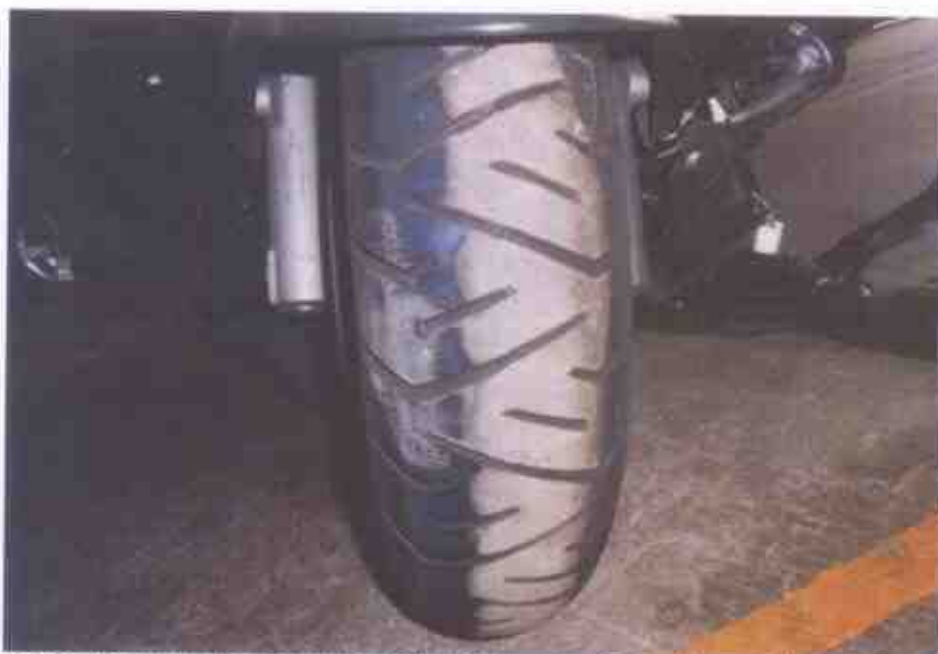
Photo 11 shows the front tyre of the Motorcycle. The pattern of the tread was clearly visible with remaining tread depth of approximately 3mm. There was no tear, burst mark(s) and/or punctured hole(s) on the sidewalls as well as across the tread of the front tyre.

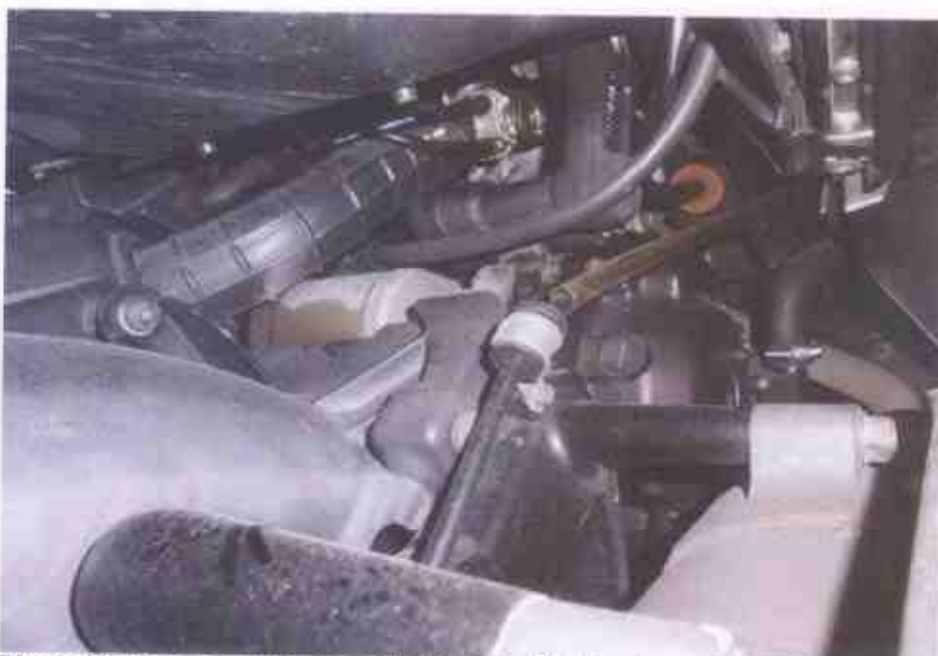
Photo 12 shows no sign(s) or indication(s) of fluid leakage observed around the engine area of the Motorcycle.

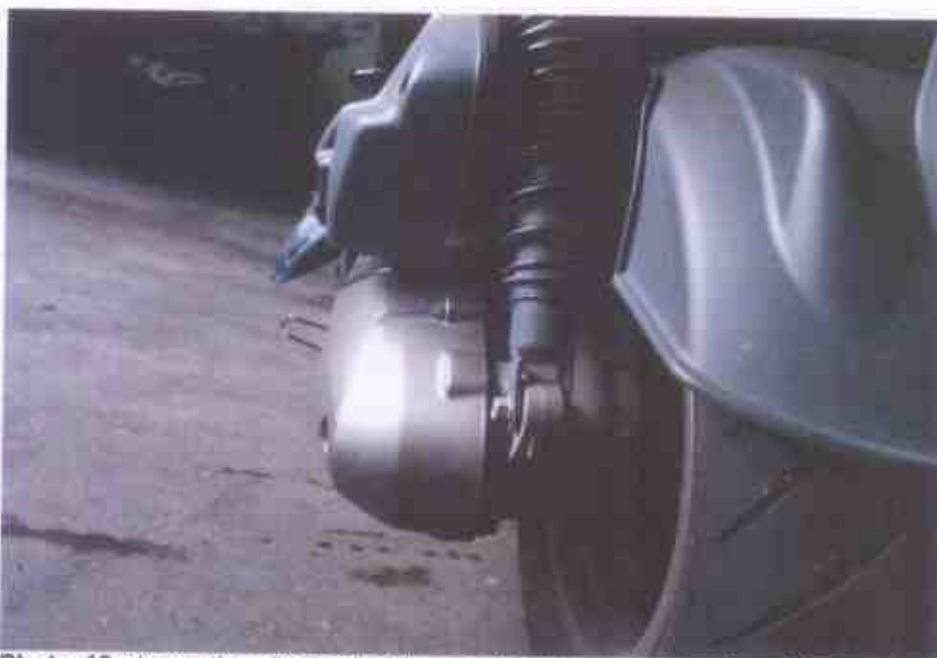
Photo 13 shows the shock absorber of the motorcycle was found to be intact without any misalignment.

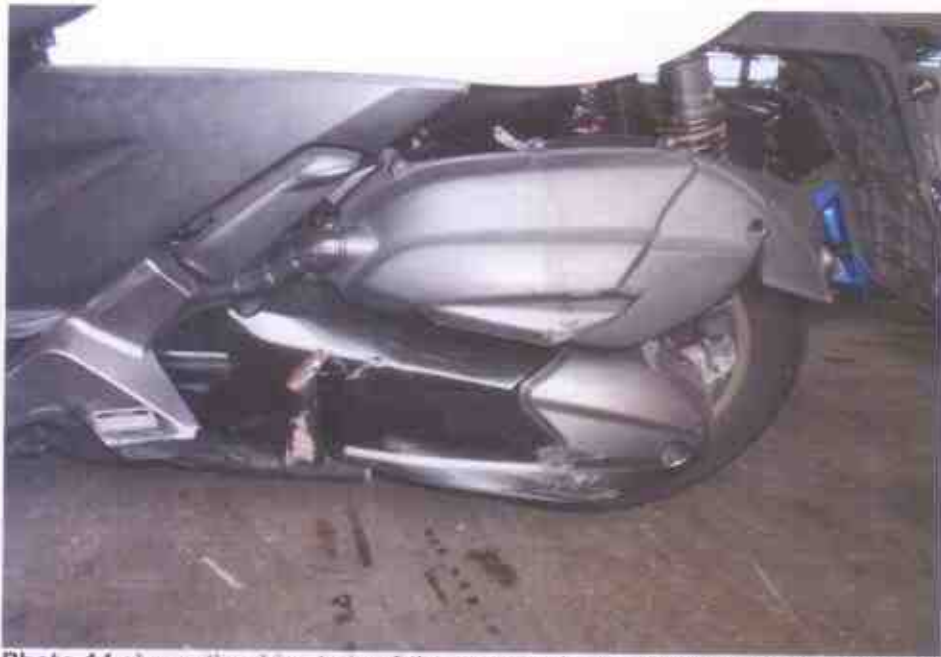
Photo 14 shows the drive train of the motorcycle was found to be intact without any misalignment.

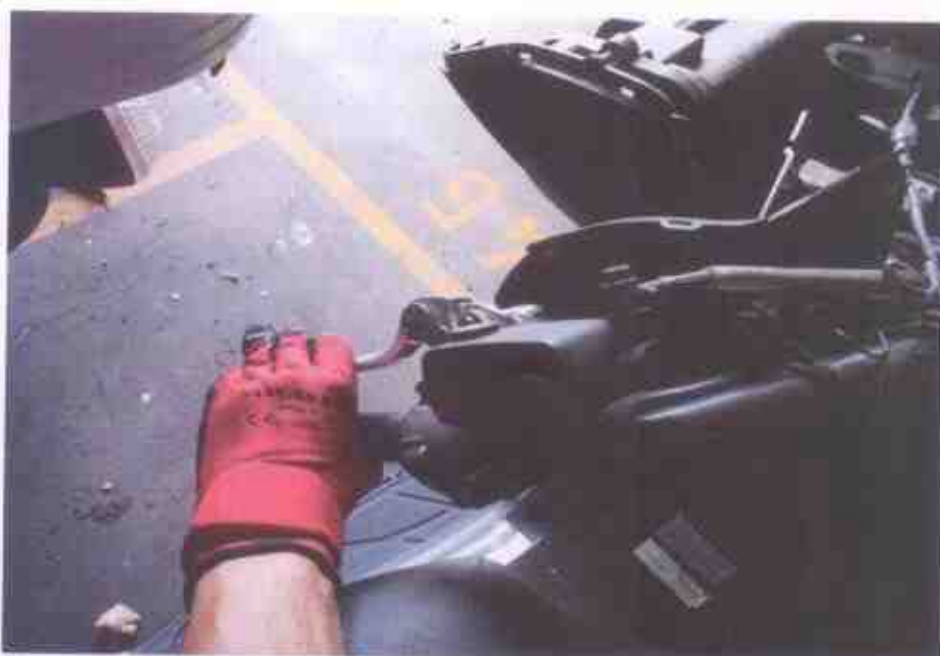
Photo 15 shows the steering system was observed to be in a serviceable condition. It was able to be steered to the full left & right at time of our inspection.

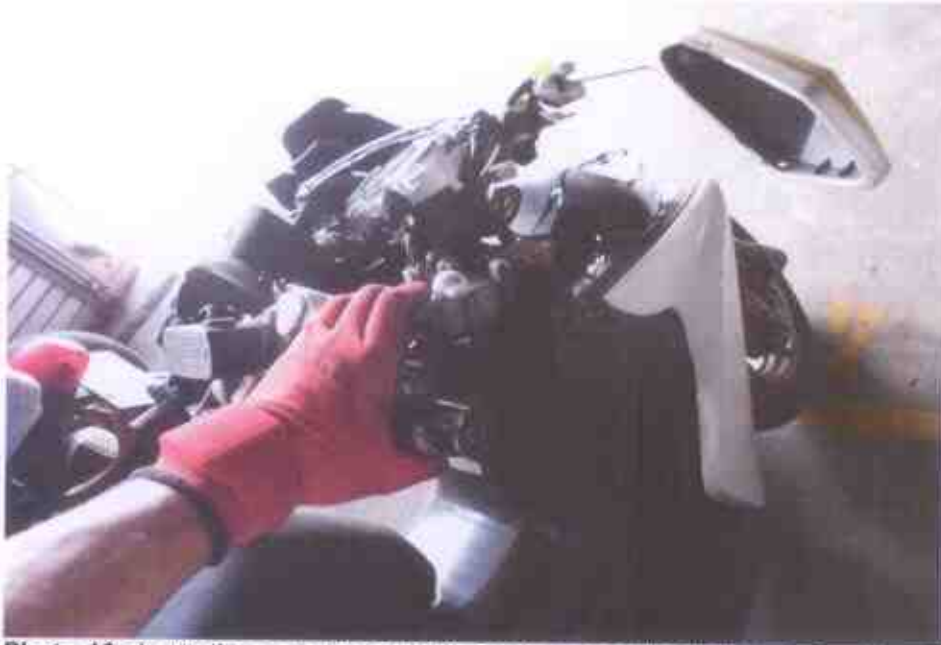
Photo 16 shows the static brake tests conducted on the Motorcycle front brake had appeared to indicate that the brake system of the Motorcycle was in serviceable condition. There was some resistance felt (spongy like feel) upon pressing the brake lever at the right side of the handle bar.

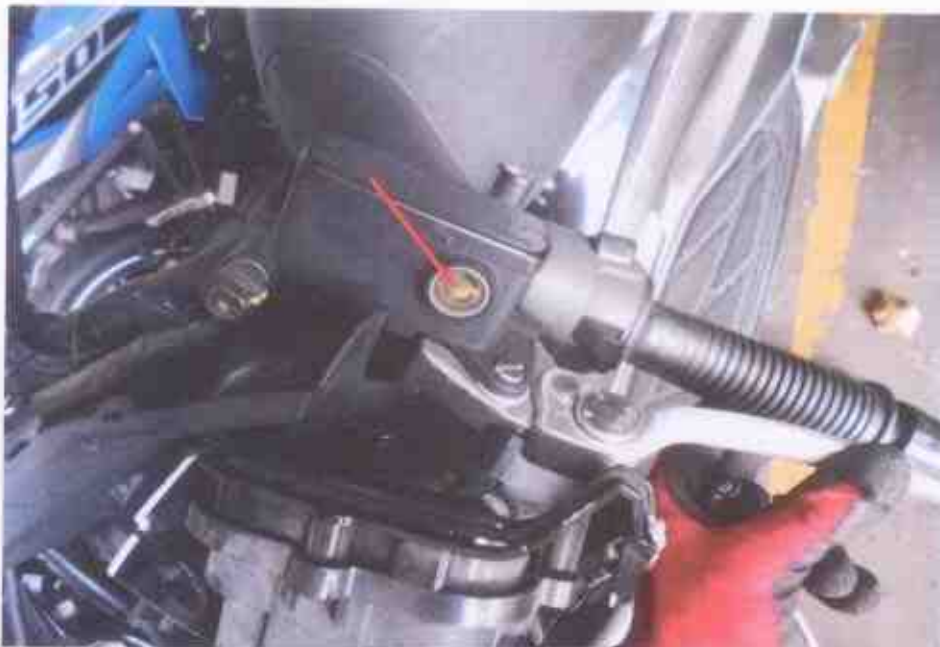
Photo 17 shows the rear brake fluid reservoir. Our checks on the brake fluid had also indicated that the brake fluid was of sufficient level for operational purposes, and without contamination.

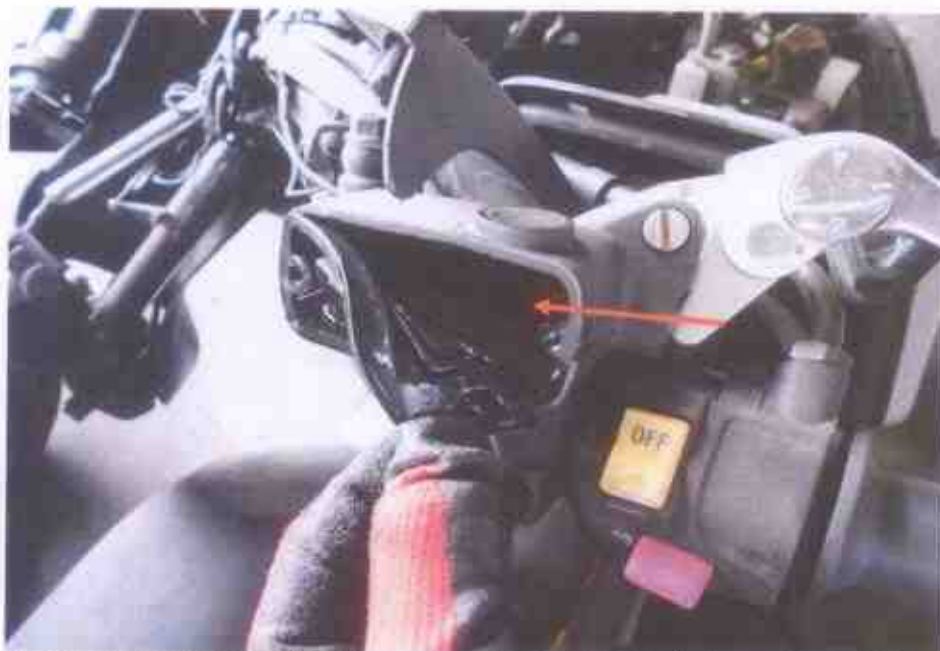
Photo 18 shows the brake fluid reservoir for front wheel brake on the right hand was noted to be of sufficient level for operational purposes, and without contamination.

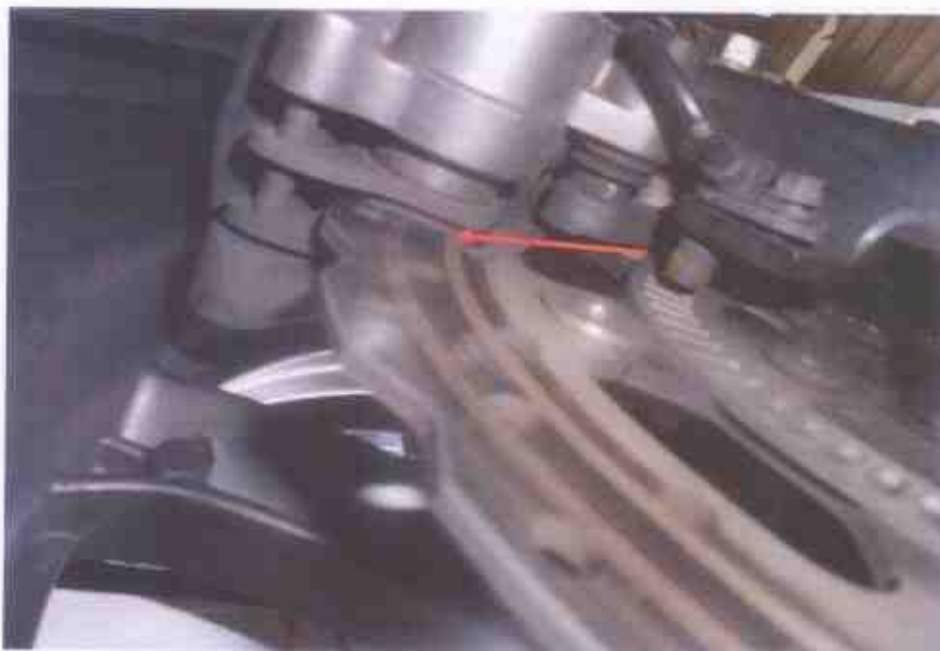
Photo 19 shows the brake pad for front wheel brake of the Motorcycle. The frictional material was observed to be at an adequately sufficient level at time of our inspection.
