Your Ref: TP/IP/60763/2018
Our Ref : CI/TPD18022199/Z

19th March 2019

MECHANICAL INSPECTION REPORT OF MOTOR TAXI SHA 9324G

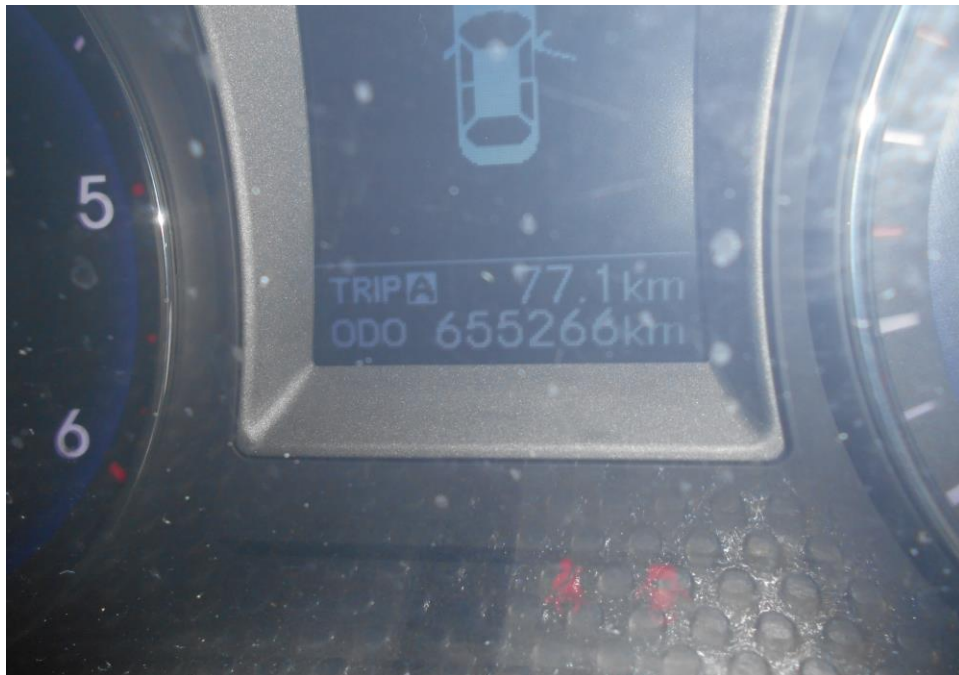
Photo 1 shows the mileage of the Motor taxi at the time of our inspection was recorded at 655266km.

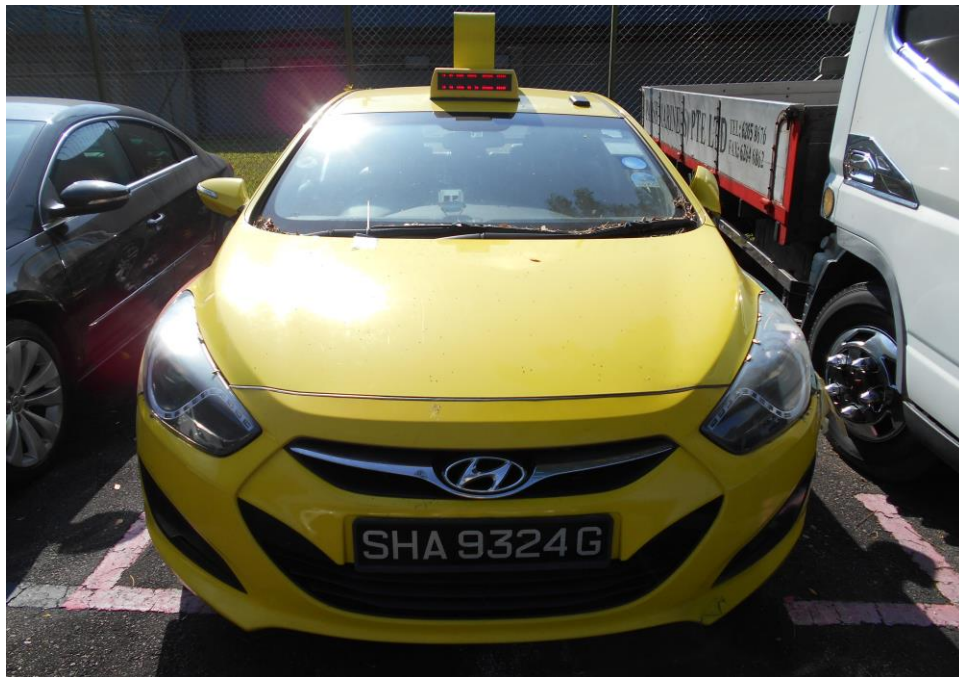
Photo 2 shows a general view of the front body of the Motor Taxi at the time of our inspection. The Motor Taxi was observed to be in good condition unaffected by the accident's impact collision.

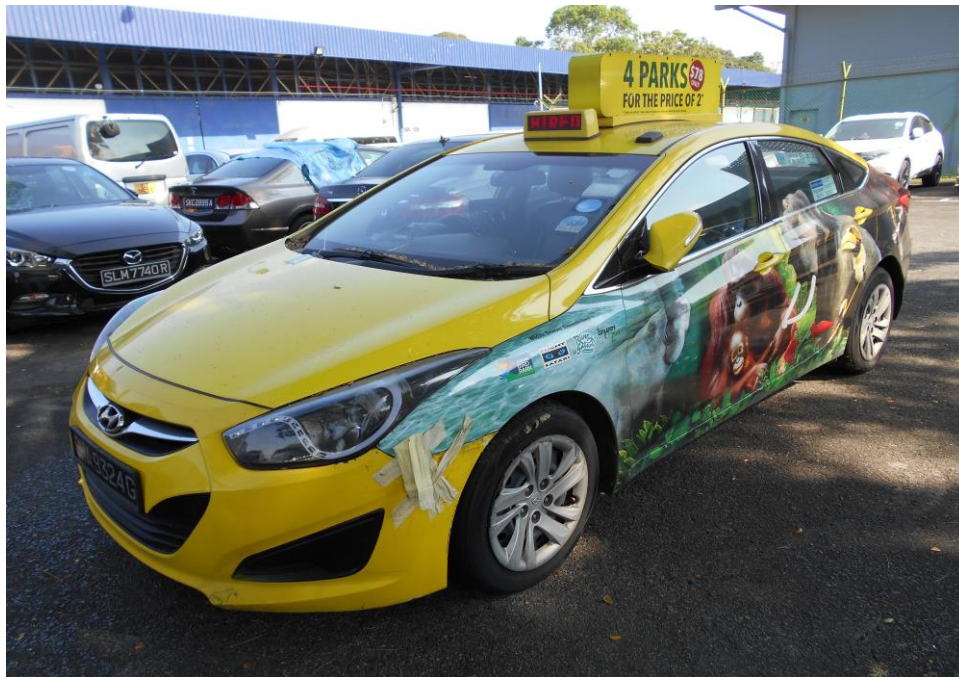
Photo 3 shows a general view of the front left body of the Motor Taxi at the time of our inspection. The Motor Taxi was observed to be in good condition unaffected by the accident's impact collision.

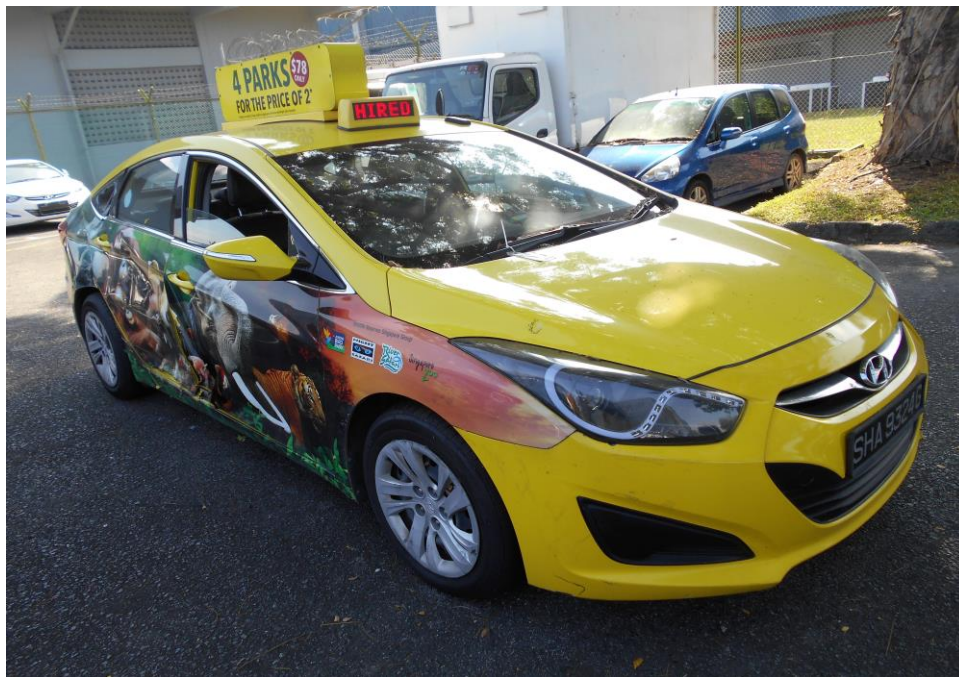
Photo 4 shows a general view of the front right body of the Motor Taxi at the time of our inspection. The Motor Taxi was observed to have sustained an impact damages that was confined to its right portion.

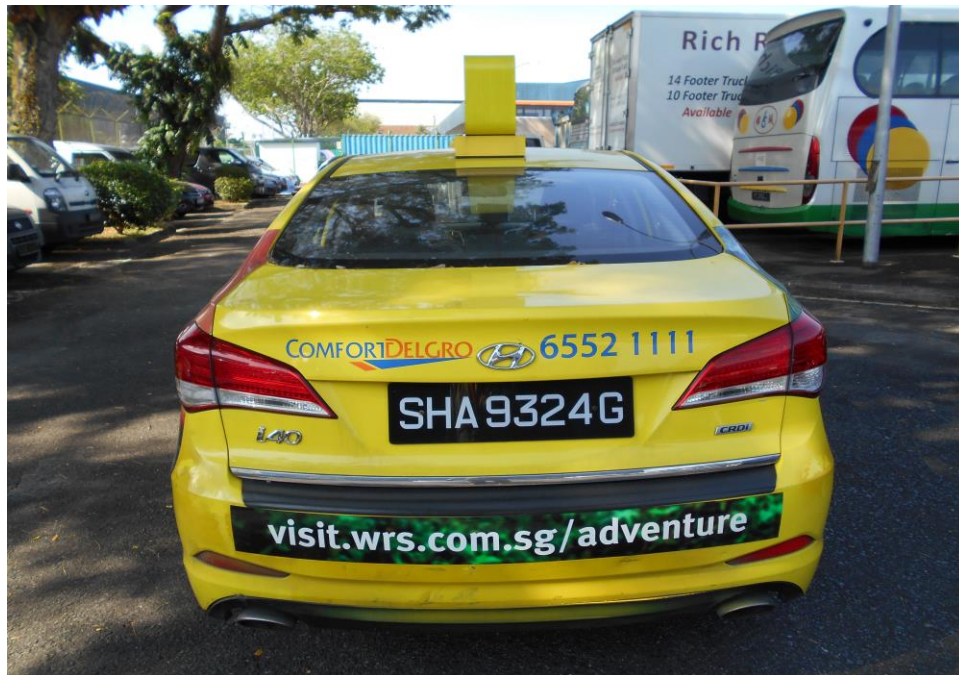
Photo 5 shows a general view of the rear body of the Motor Taxi at the time of our inspection. The Motor Taxi was observed to be in good general condition.

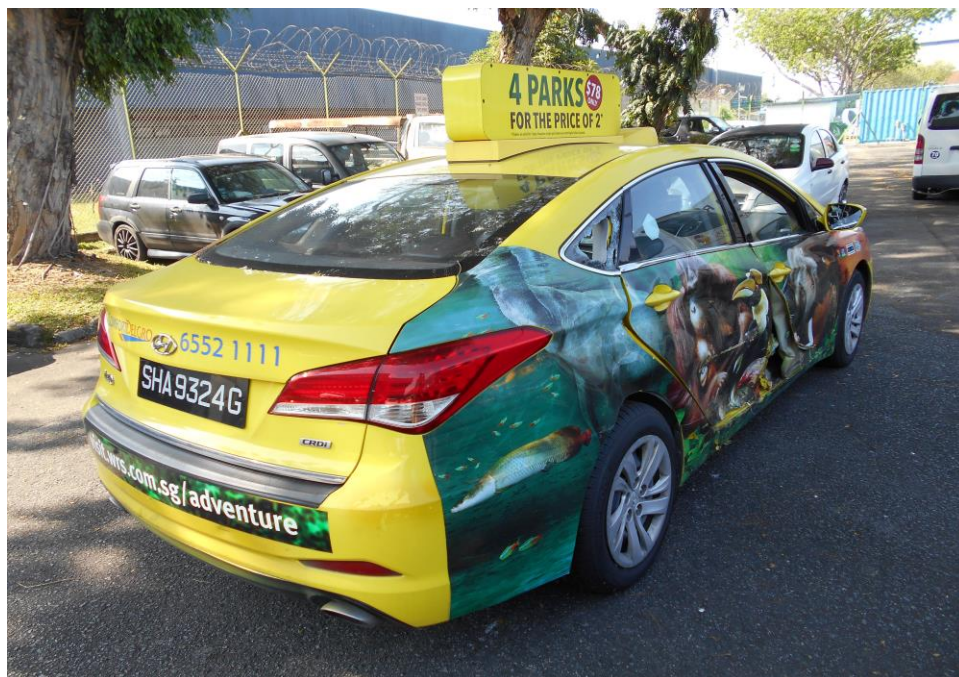
Photo 6 shows a general view of the rear right body of the Motor Taxi at the time of our inspection. The Motor Taxi was observed to have sustained an impact damages that was confined to its right portion.

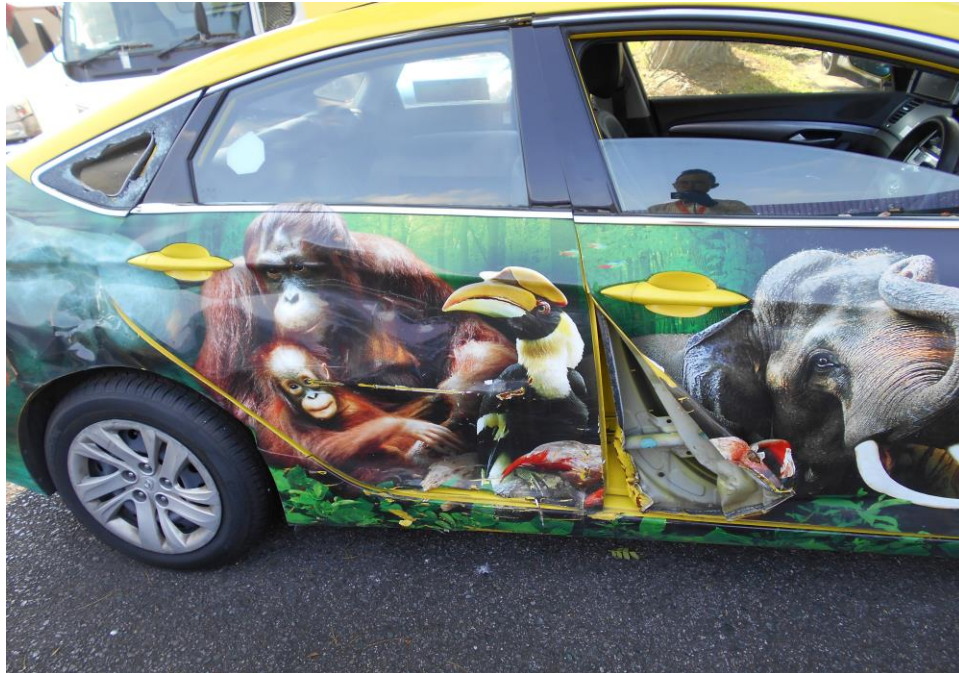
Photo 7 shows a semi close up view of the driver and passenger's door, rear quarter glass of the Motor Taxi at the time of our inspection. It had sustained damages likely due to the accident.

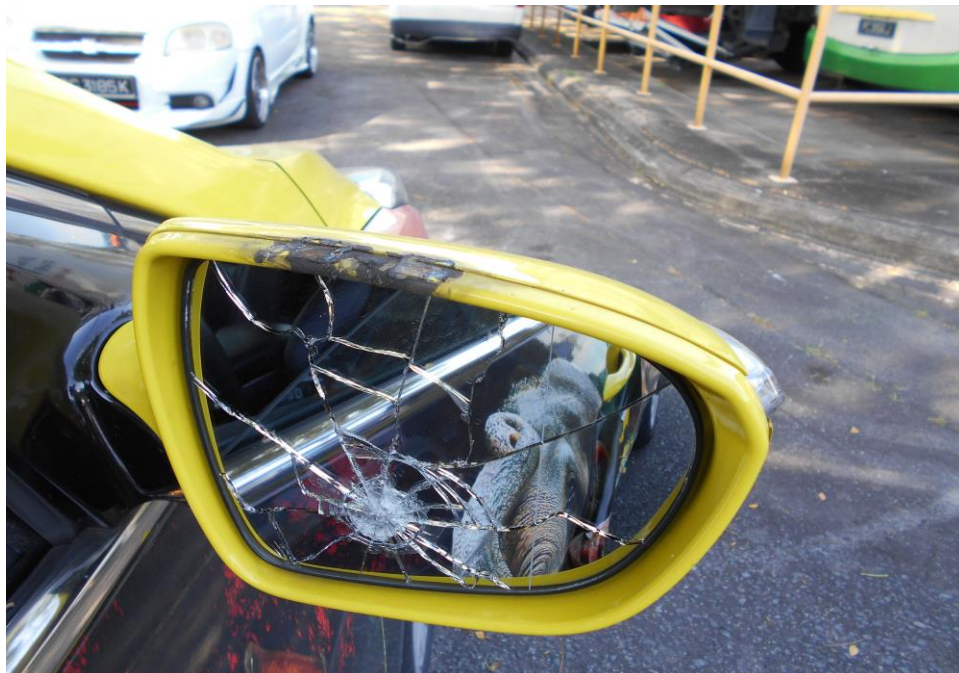
Photo 8 shows a close up view of the right side wing mirror of the Motor Taxi. It was observed to sustained damages at the time of our inspection.

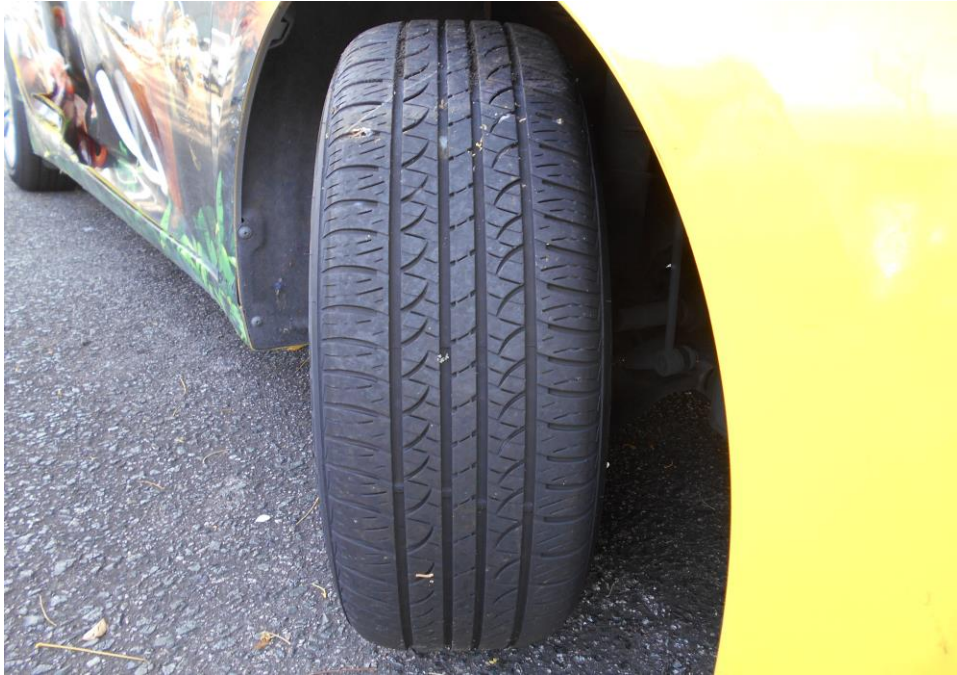
Photo 9 shows the condition of the front right tyre of the Motor Taxi, which was observed to be in serviceable condition with remaining tread depth of approximately 5mm. There was no tear, cut or burst mark(s) on the outer and the inner sidewalls.

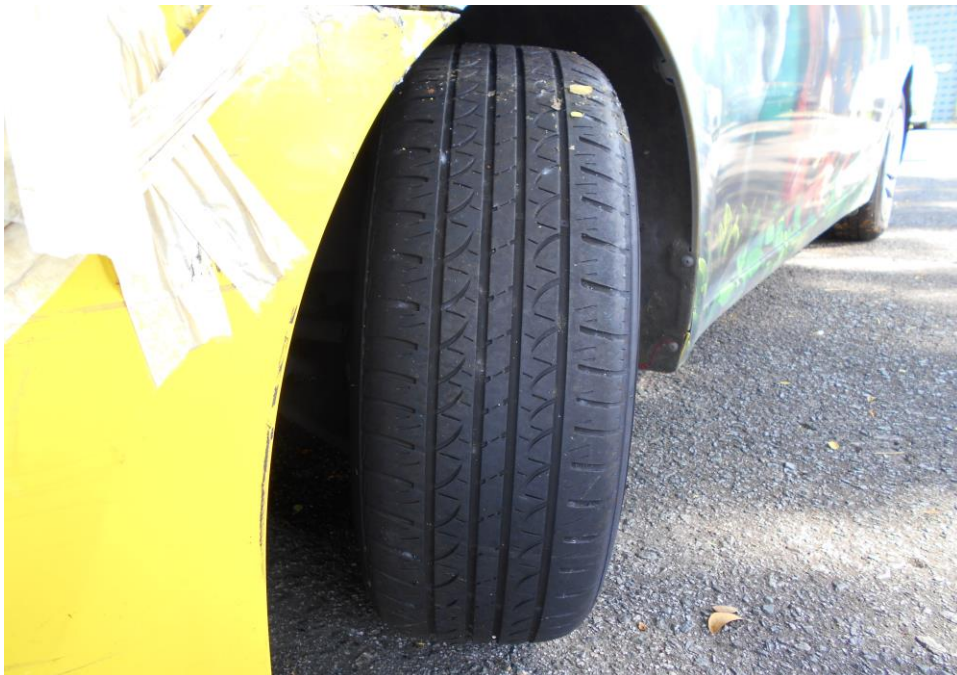
Photo 10 shows the condition of the front left tyre of the Motor Taxi, which was observed to be in serviceable condition with remaining tread depth of approximately 5mm. The tyre, which was wrapped around alloy wheel rim, was also observed to be sufficiently inflated for vehicular operation.

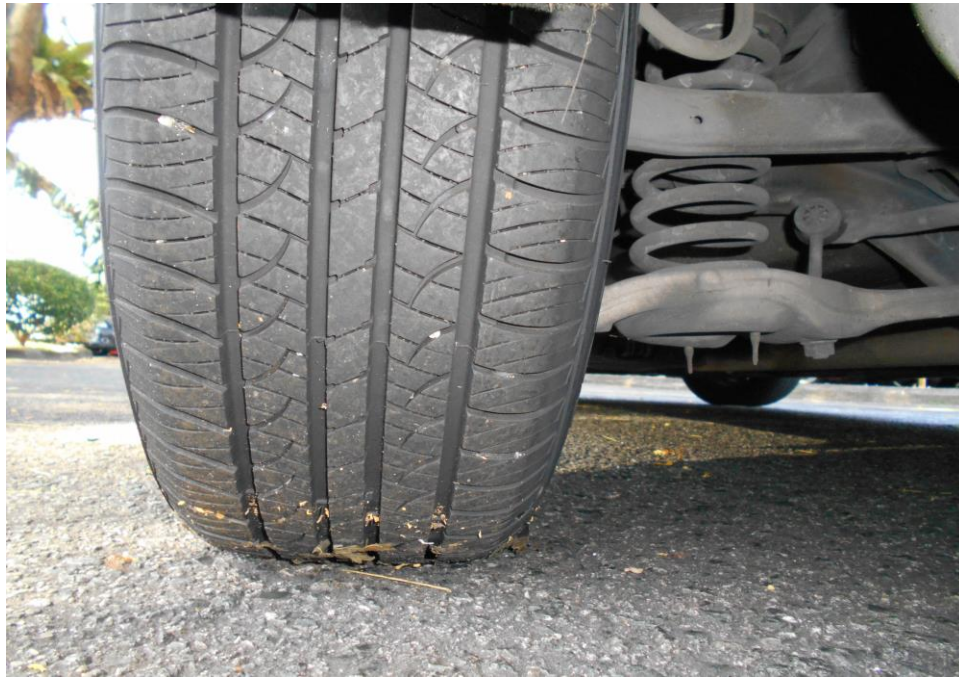
Photo 11 shows the condition of the rear left tyre of the Motor Taxi, which was observed to be in serviceable condition with remaining tread depth of approximately 6mm.

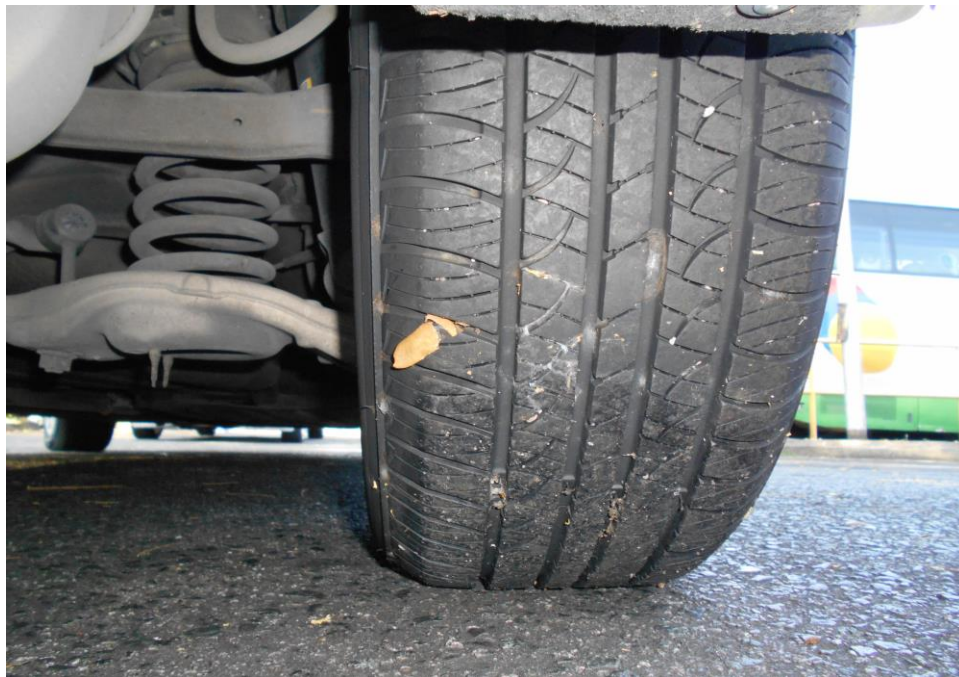
Photo 12 shows the condition of the rear right tyre of the Motor Taxi, which was observed to be in serviceable condition with remaining tread depth of approximately 6mm.

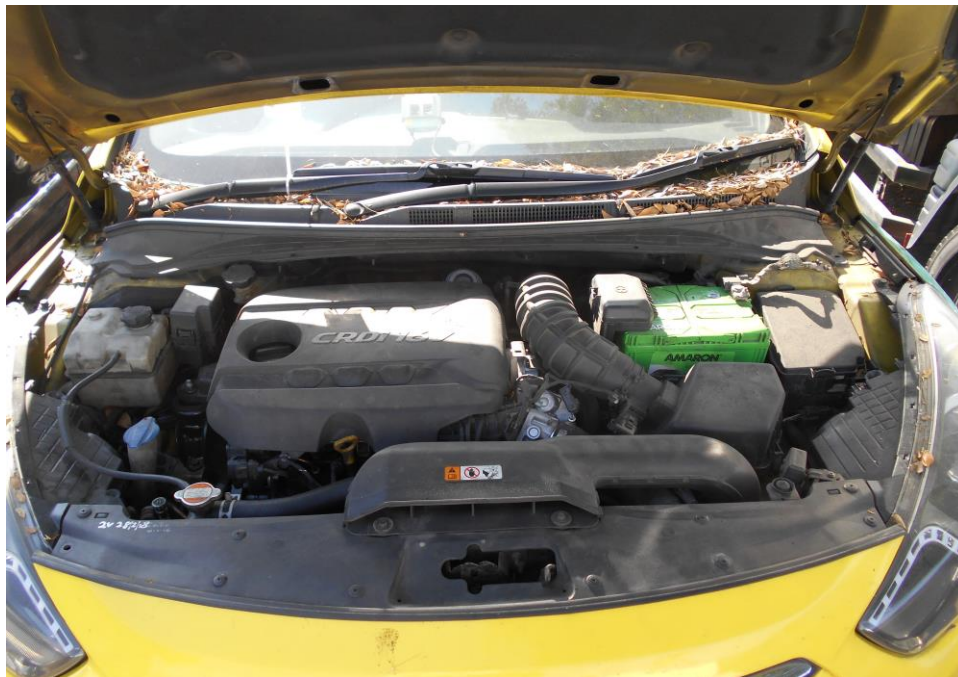
Photo 13 shows a general view of the Motor Car's engine compartment. The various parts and components inside the engine compartment were unaffected by the accident. There was also no sign(s) or indication(s) of fluid leakage and/or fluid stain within the engine compartment.

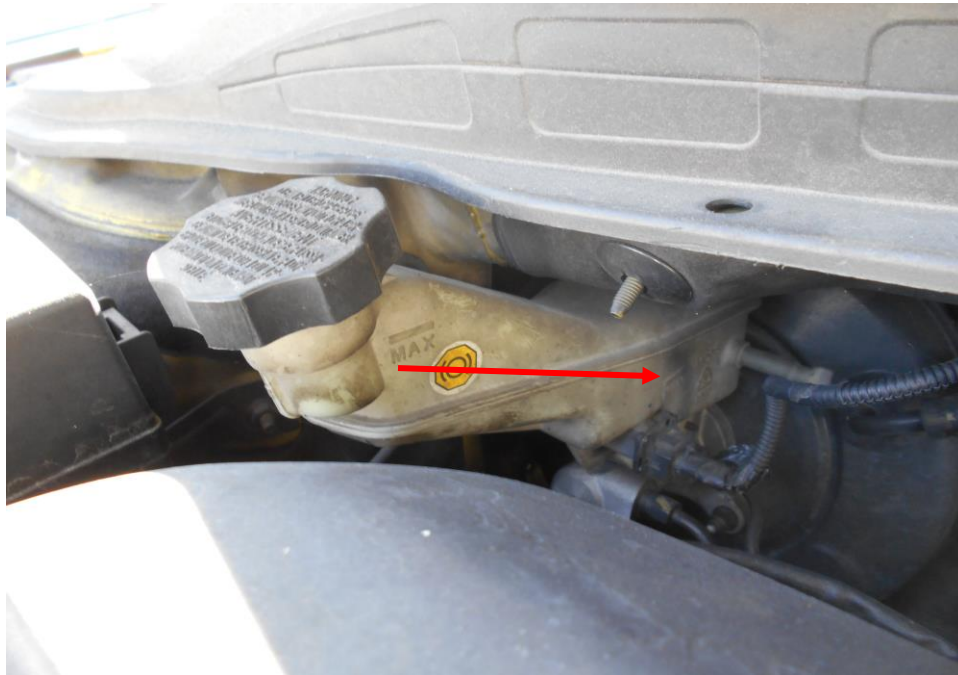
Photo 14 shows the brake fluid reservoir of the Motor Taxi at the time of our inspection. The brake fluid was observed to be of sufficient level (arrowed) and without any visible contamination.

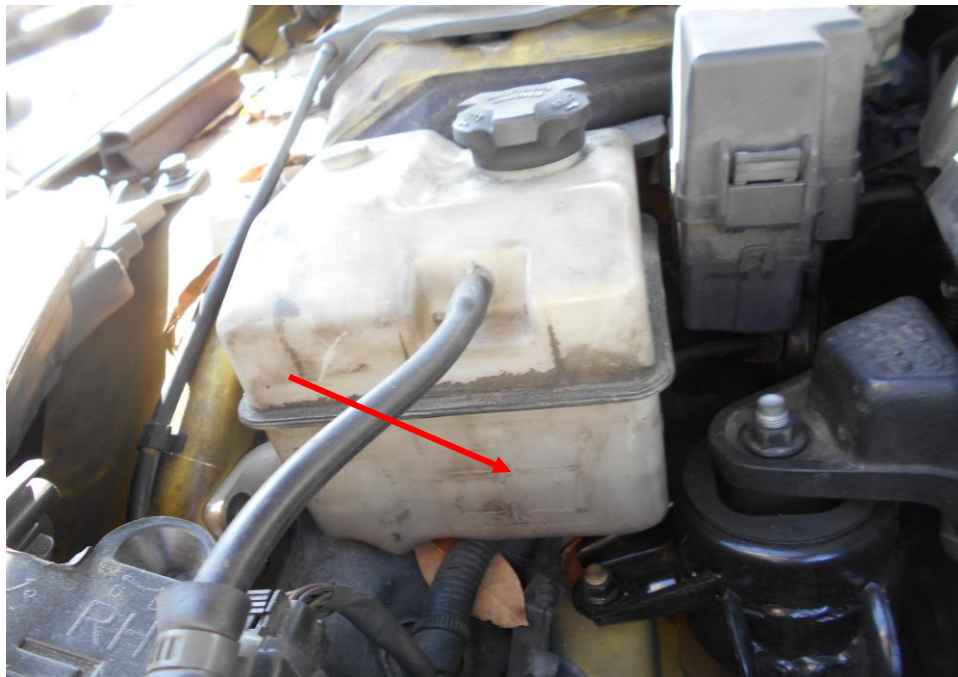
Photo 15 shows the engine coolant fluid reservoir of the Motor Taxi at the time of our inspection. The engine coolant fluid was observed to be of sufficient level and without any visible contamination.

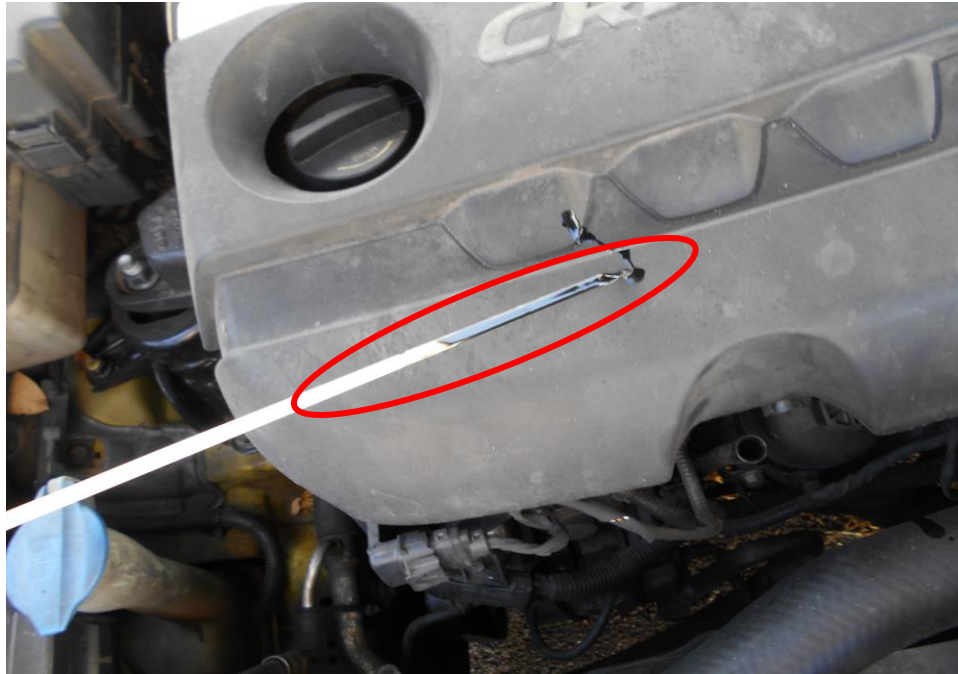
Photo 16 shows the engine oil dip stick of the Motor Taxi at the time of our inspection. The engine oil was observed to be of sufficient level and without any visible contamination.

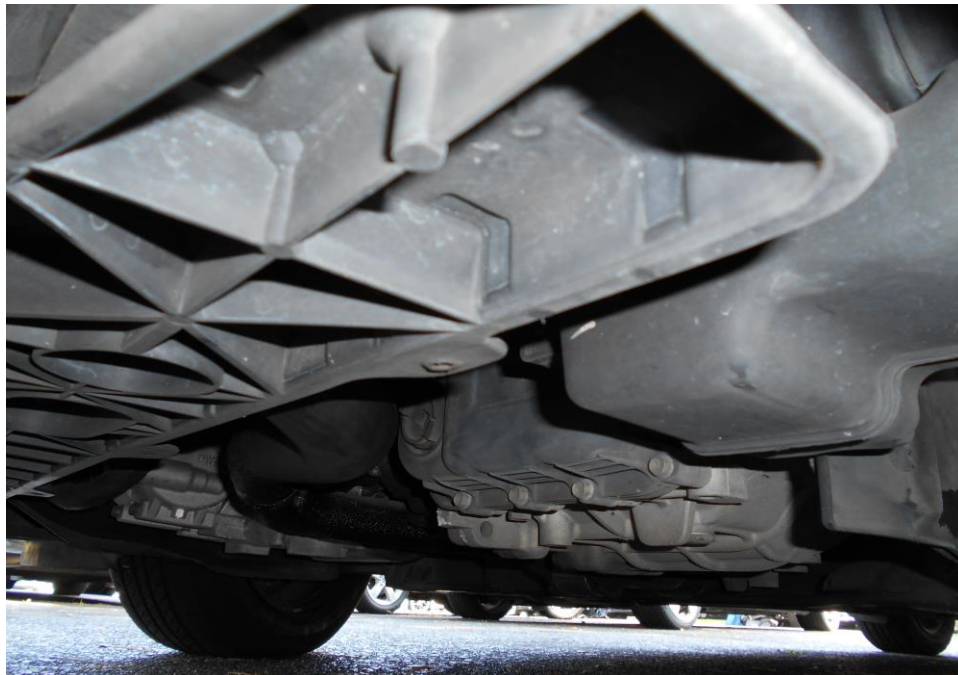
Photo 17 shows the engine underside of the Motor Taxi engine. The engine was observed to be free from fluid leakage at time of our inspection.

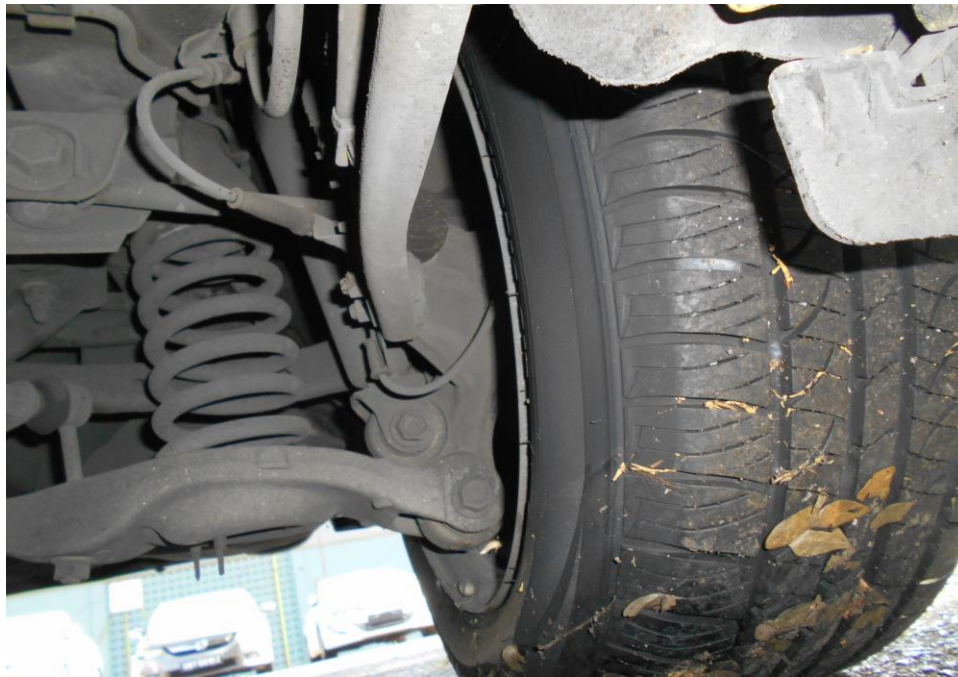
Photo 18 shows the rear left wheel of the Motor Taxi. We did not observe any leakage of brake fluid at the time of our inspection of the Motor Taxi. Our visual inspection of the various mechanical components of the Motor Taxi's braking system revealed all to be intact without visible damage.

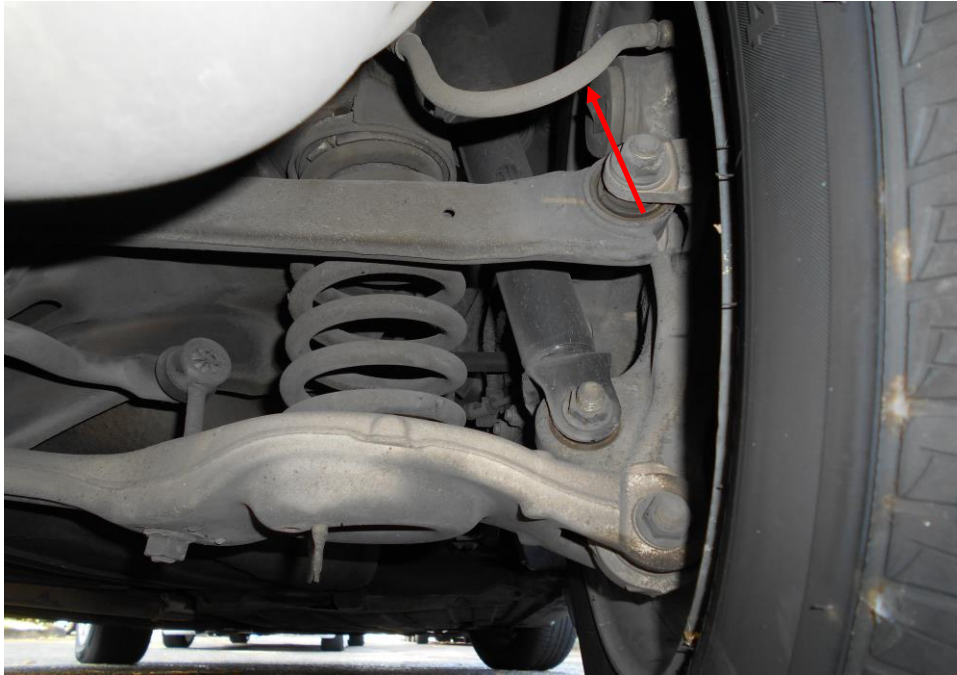
Photo 19 shows the brake hose (arrowed) at the rear right wheel of the Motor Taxi. We did not observe any leakage of brake fluid at the time of our inspection of the Motor Taxi. Our visual inspection of the various mechanical components of the Motor Taxi's braking system revealed all to be intact without visible damage.

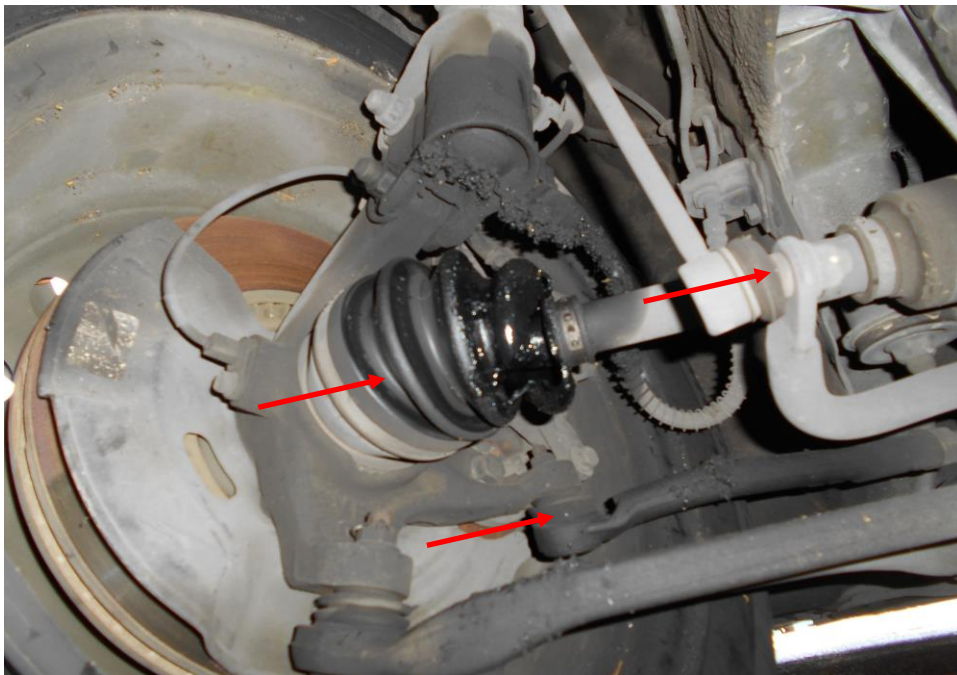
Photo 20 shows the various undercarriage components at the front right wheel of the Motor Taxi, in particular the steering tie rod (arrowed). The various steering components were all found to be intact, suggesting that the steering system of the Motor Taxi was likely to be in serviceable condition.

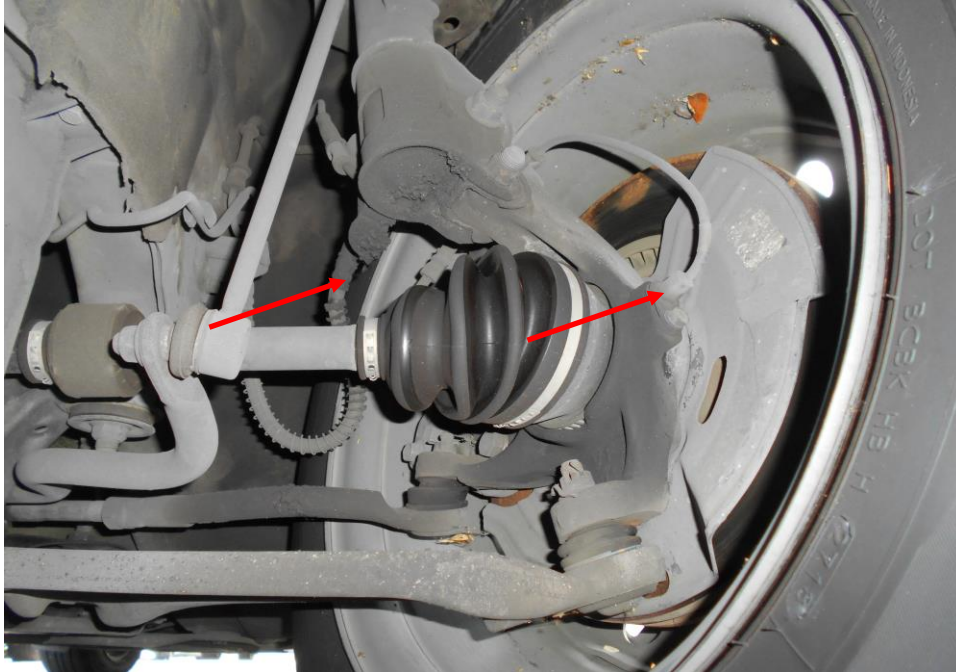
Photo 21 shows the various undercarriage components at the front left wheel of the Motor Taxi. We did not observe any leakage of brake fluid (arrowed) at the time of our inspection of the Motor Taxi. Our visual inspection of the various mechanical components of the Motor Taxi's braking system revealed all to be intact and without visible damage, indicating that the braking system was likely to be in serviceable condition at the material time of accident.

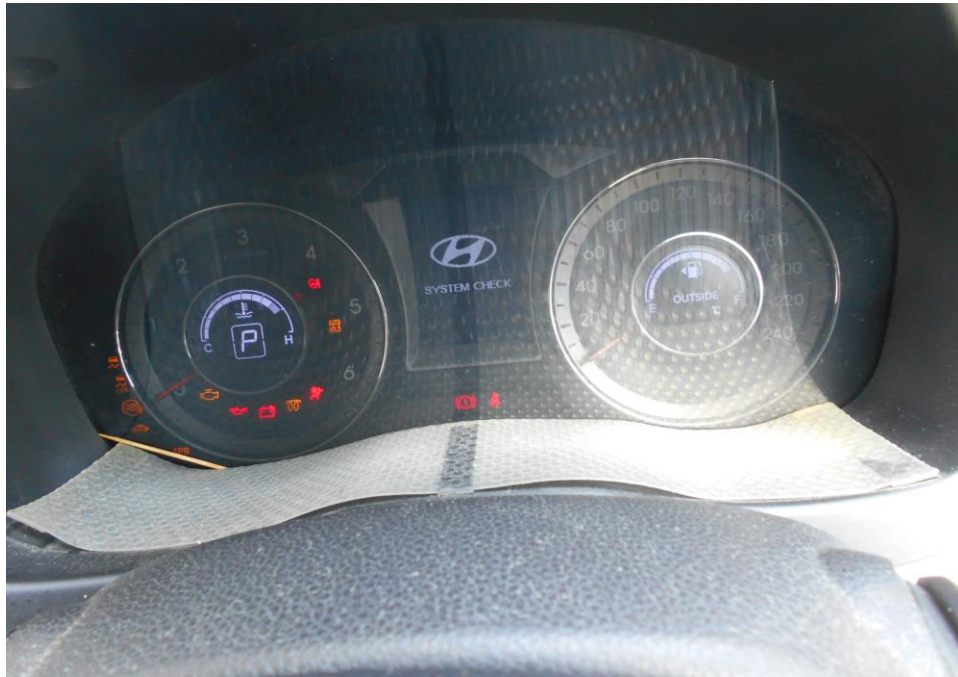
Photo 22 shows the warning lights for the various electronic operating systems of the Motor Taxi appearing on its instrument panel during the self-test when the engine is cranked, in particular the ABS light, SRS light, engine check light, battery light and diesel glow plug amongst others.

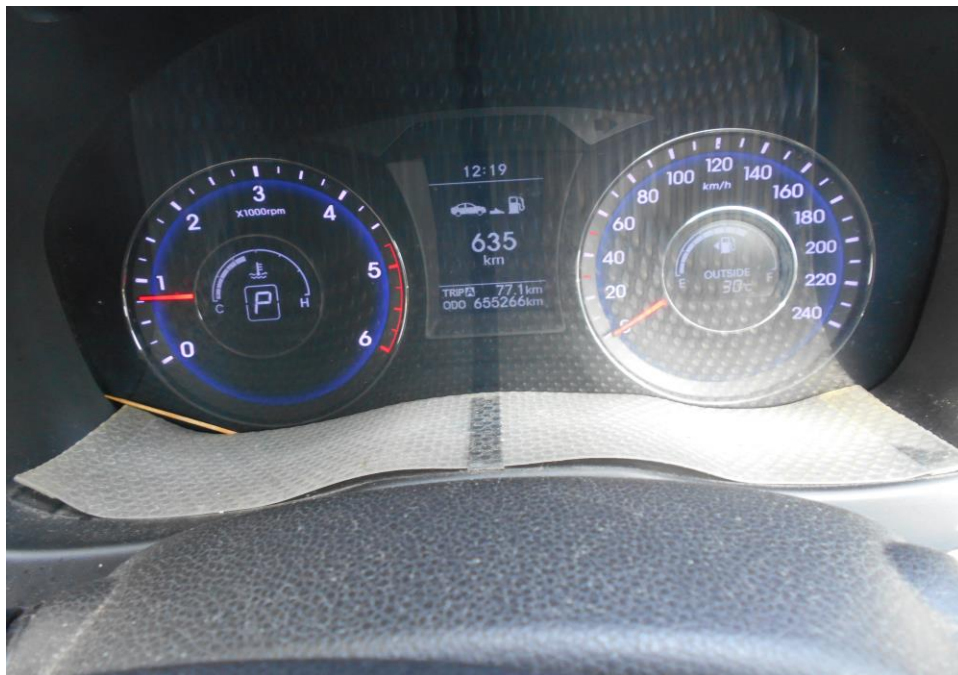
Photo 23 shows no warning lights illuminated on the instrument panel of the Motor Taxi after the engine was cranked. This would suggest that there was no abnormality to the various electronic operating systems of the Motor Taxi, like the ABS light engine check light, battery light and diesel glow plug.

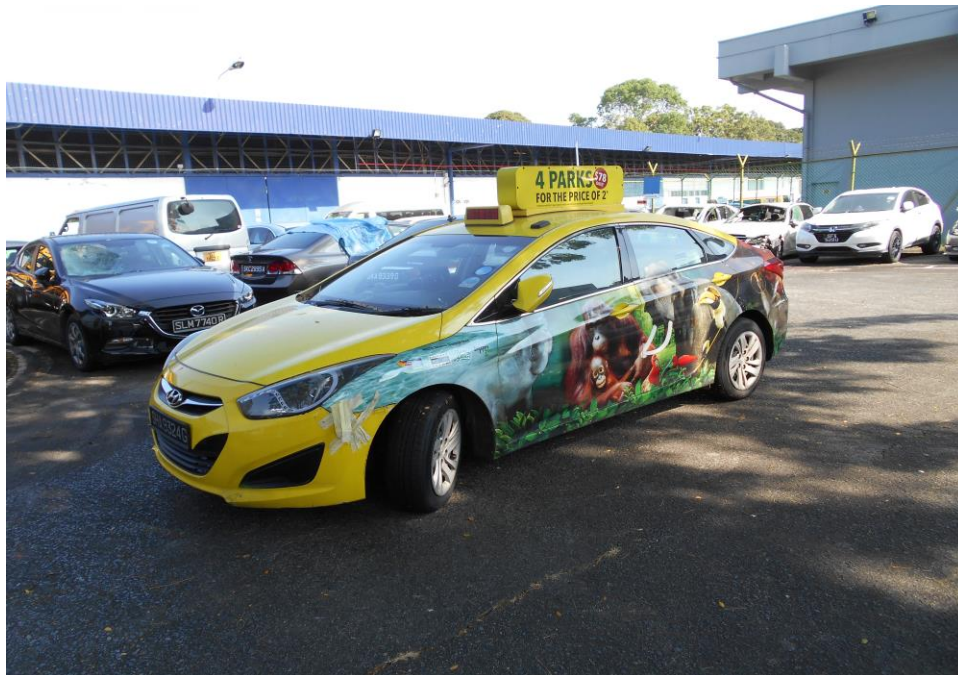
Photo 24 shows an operational test of the Motor Taxi. We were able to move the vehicle reverse, forward and backward normally.

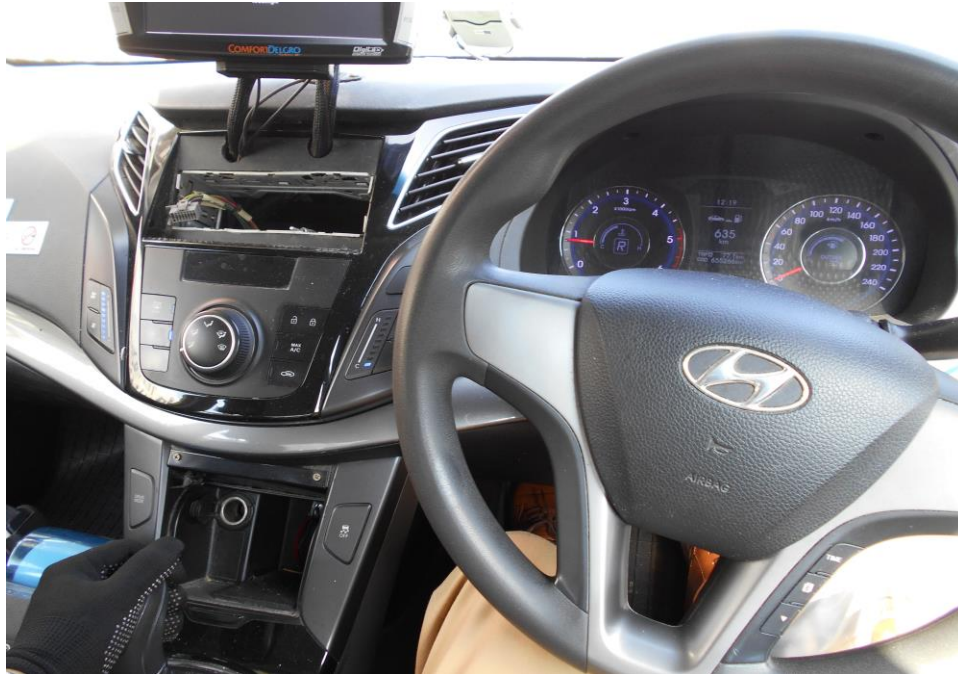
Photo 25 shows an operational test of the Motor Taxi. We were able to move the vehicle reverse, forward and backward normally.
