Your Ref: TP/IP/56239/2018
Our Ref :CI/TPD18022200/Z

Fatal Accident Investigation Team

MECHANICAL INSPECTION REPORT OF MOTORCYCLE JPH 1866

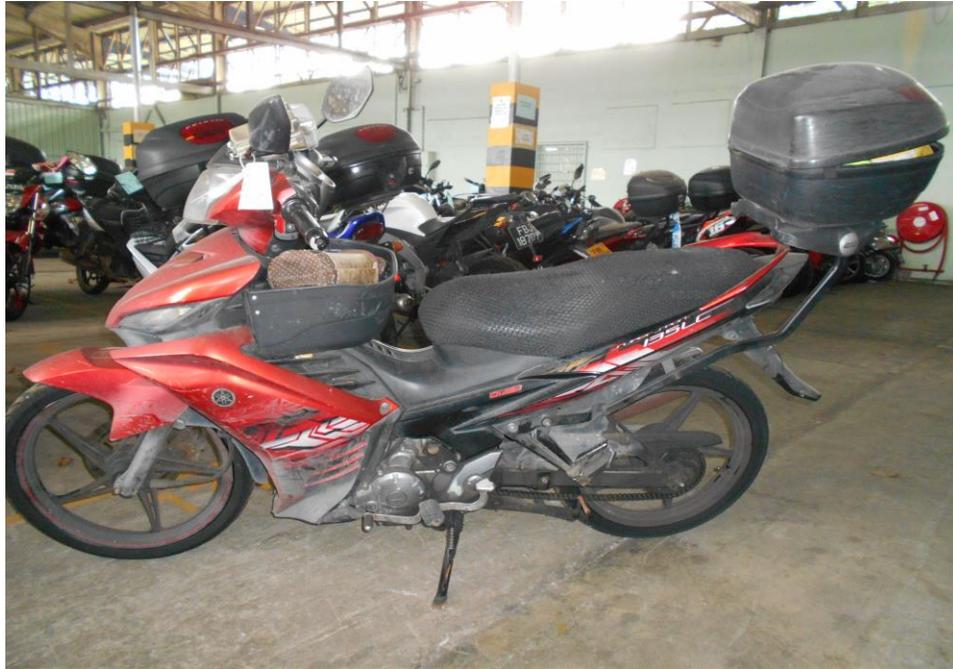
Photo 5 shows a general view of the left body of the Motorcycle at the time of our inspection. The Motorcycle was observed to be in good condition unaffected by the accident.

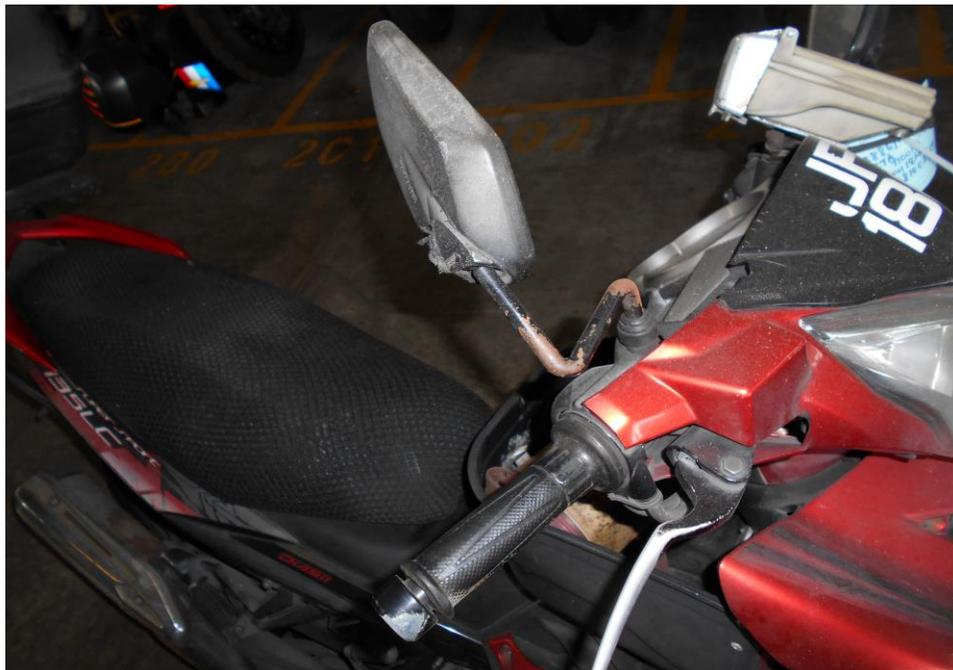
Photo 6 shows a close-up view of the right side wing mirror of the Motorcycle at the time of our inspection. It was observed to have sustained with relatively minor damages due to the accident collision.

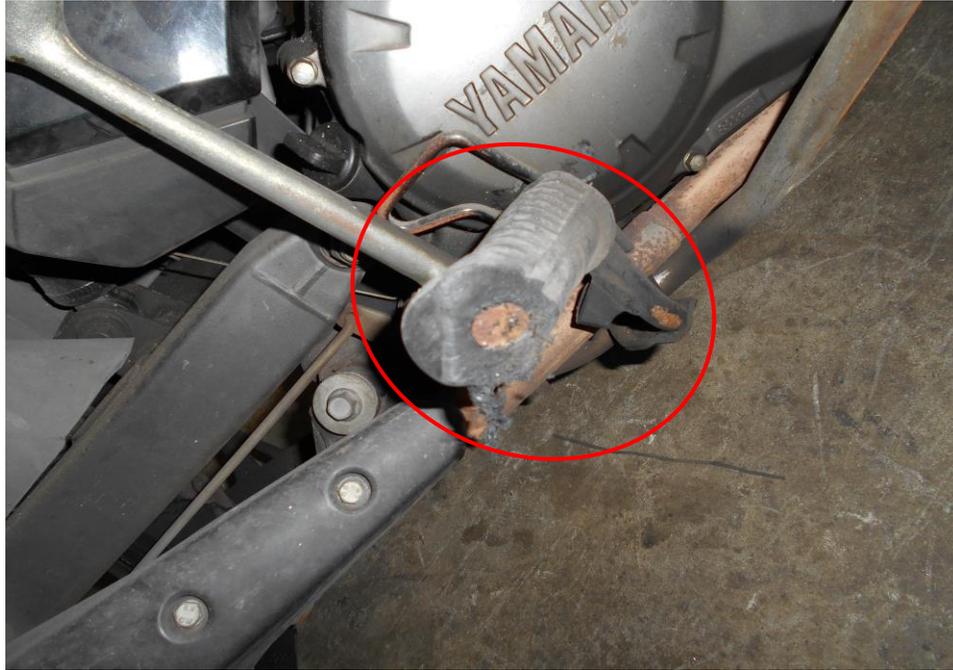
Photo 7 shows a close-up view of the right foot pedal of the Motorcycle at the time of our inspection. The Motorcycle was observed to have sustained with relatively minor damages due to the accident collision. (Circled)
