Your Ref: TP/IP/56239/2018
Our Ref :CI/TPD18022200/Z

08th February 2019

MECHANICAL INSPECTION REPORT OF MOTORCYCLE JPH 1866

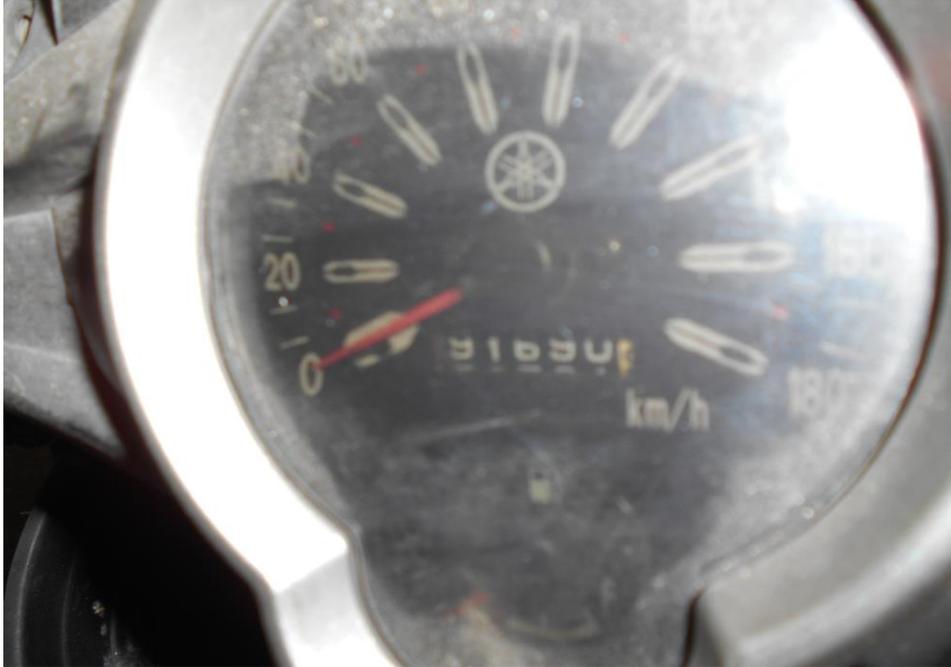
Photo 1 shows a close-up view of the mileage meter at time of our inspection. The mileage was recorded at 916909km.

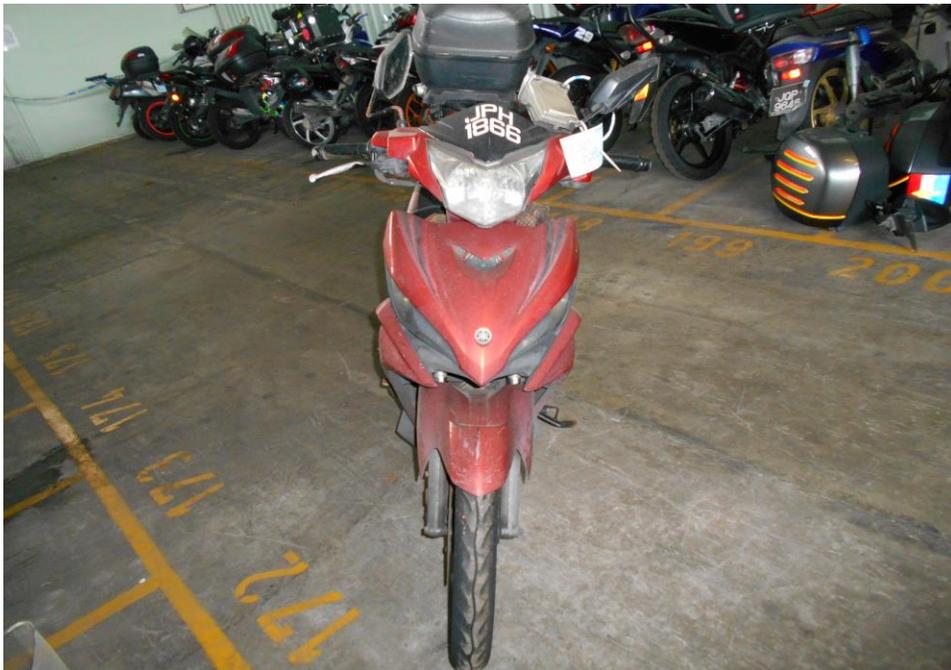
Photo 2 shows a general view of the front body of the Motorcycle at the time of our inspection. The Motorcycle was observed to have sustained relatively minor damages at time of inspection. The damages were observed to be confined to its right side of the Motor Cycle.

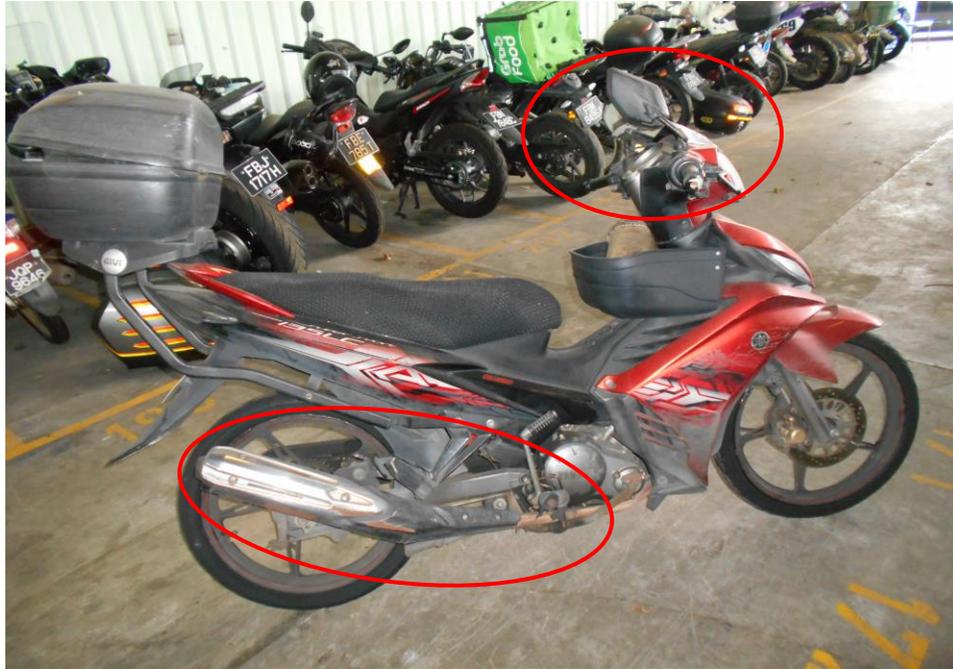
Photo 3 shows a general view of the right body of the Motorcycle at the time of our inspection. The Motorcycle was observed to have sustained relatively minor damages on the right side at time of our inspection.

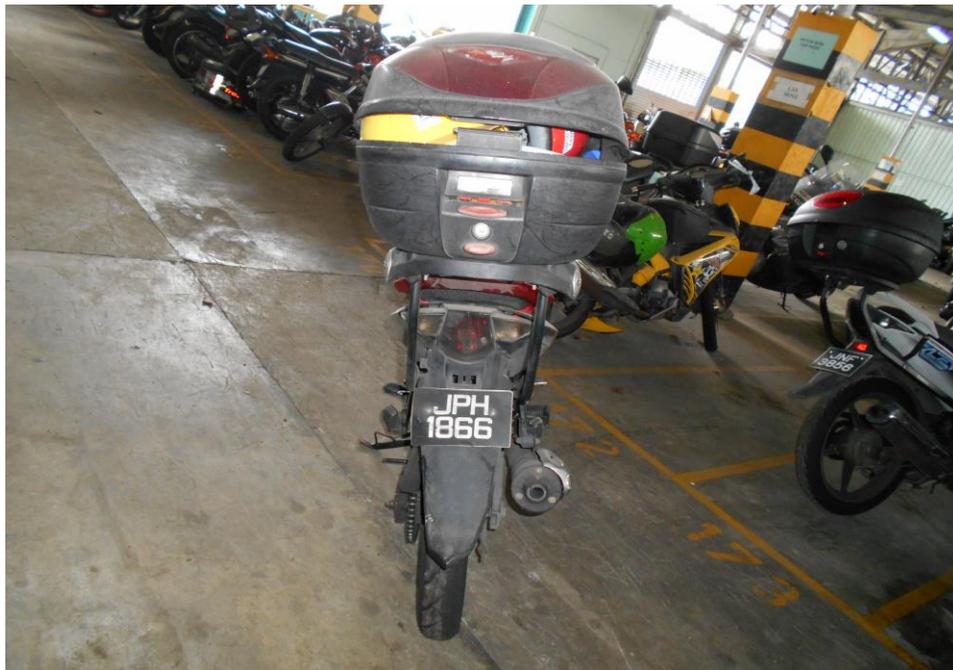
Photo 4 shows a general view of the rear body of the Motorcycle at the time of our inspection. The Motorcycle was observed to be in good condition unaffected by the accident.

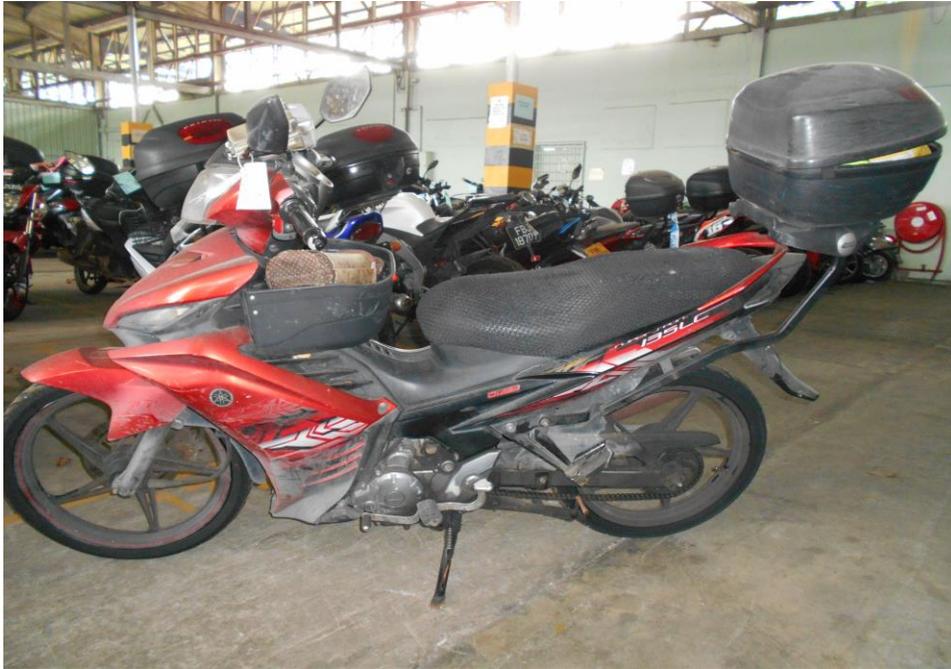
Photo 5 shows a general view of the left body of the Motorcycle at the time of our inspection. The Motorcycle was observed to be in good condition unaffected by the accident.

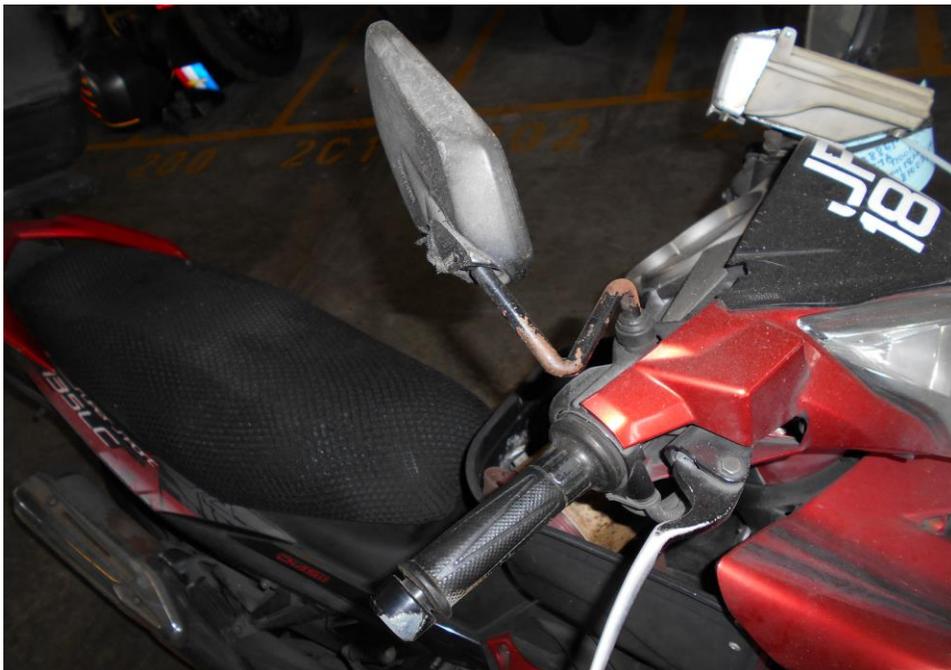
Photo 6 shows a close-up view of the right side wing mirror of the Motorcycle at the time of our inspection. It was observed to have sustained with relatively minor damages due to the accident collision.

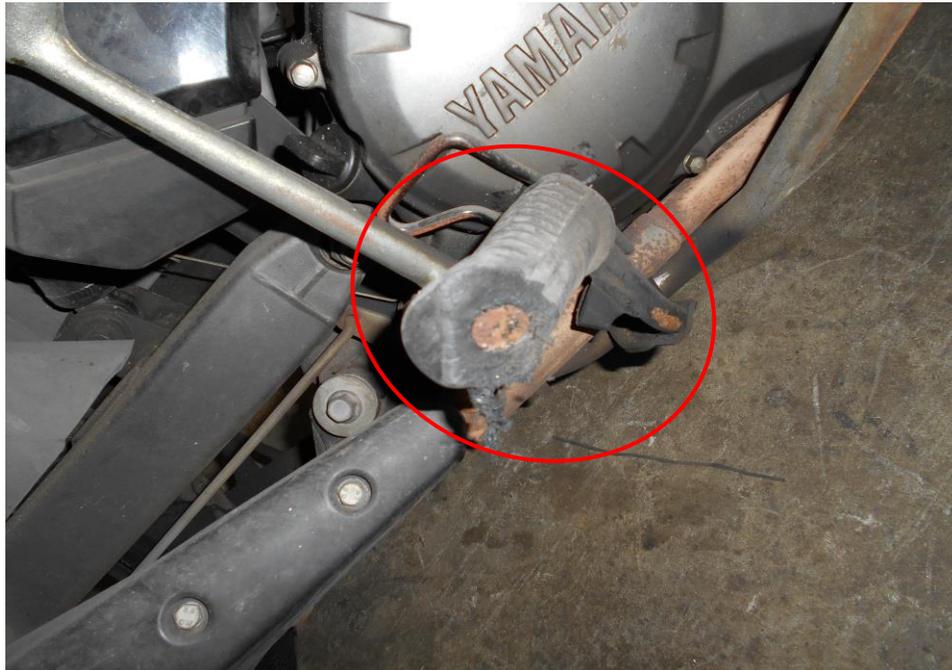
Photo 7 shows a close-up view of the right foot pedal of the Motorcycle at the time of our inspection. The Motorcycle was observed to have sustained with relatively minor damages due to the accident collision. (Circled)

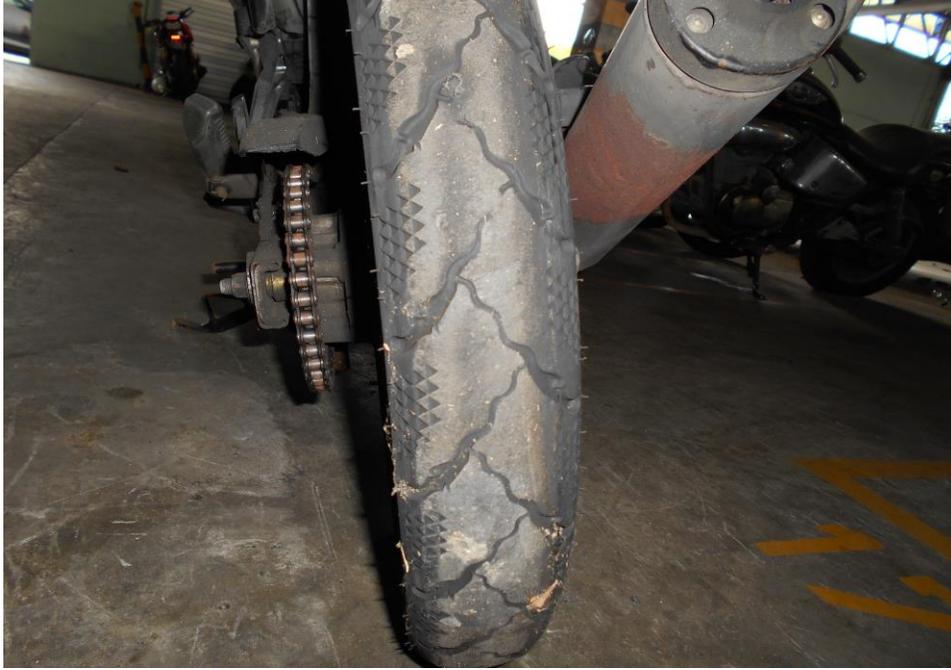
Photo 8 shows the rear tyre of the Motorcycle. The rear tyre was observed to be in serviceable condition with remaining tread depth of approximately 2mm. The tyre was also observed to be sufficiently inflated for vehicular operation.

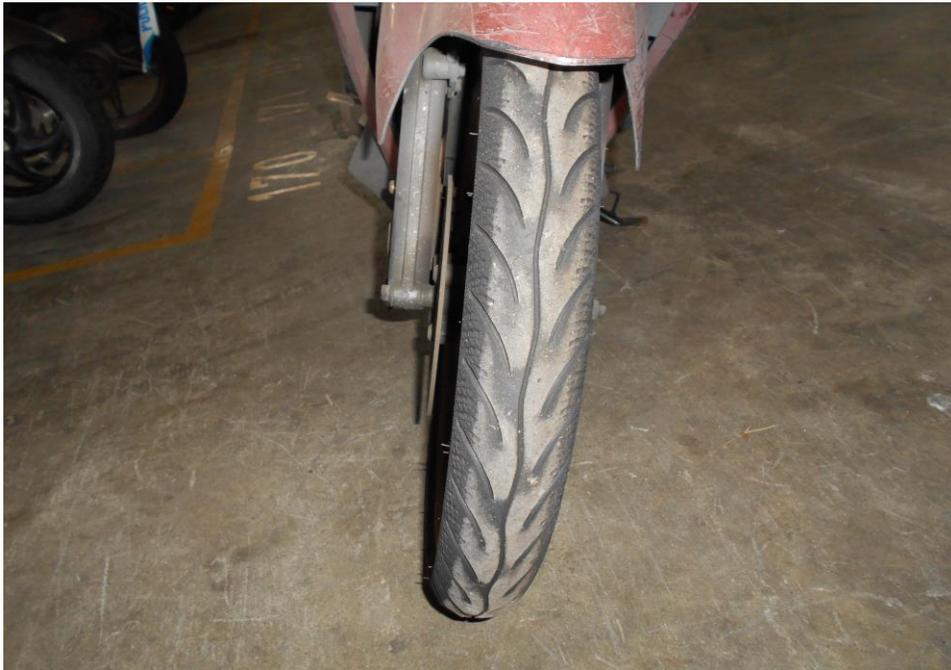
Photo 9 shows the front tyre of the Motorcycle. The front tyre was observed to be in serviceable condition with remaining tread depth of approximately 3mm. The tyre was also observed to be sufficiently inflated for vehicular operation.

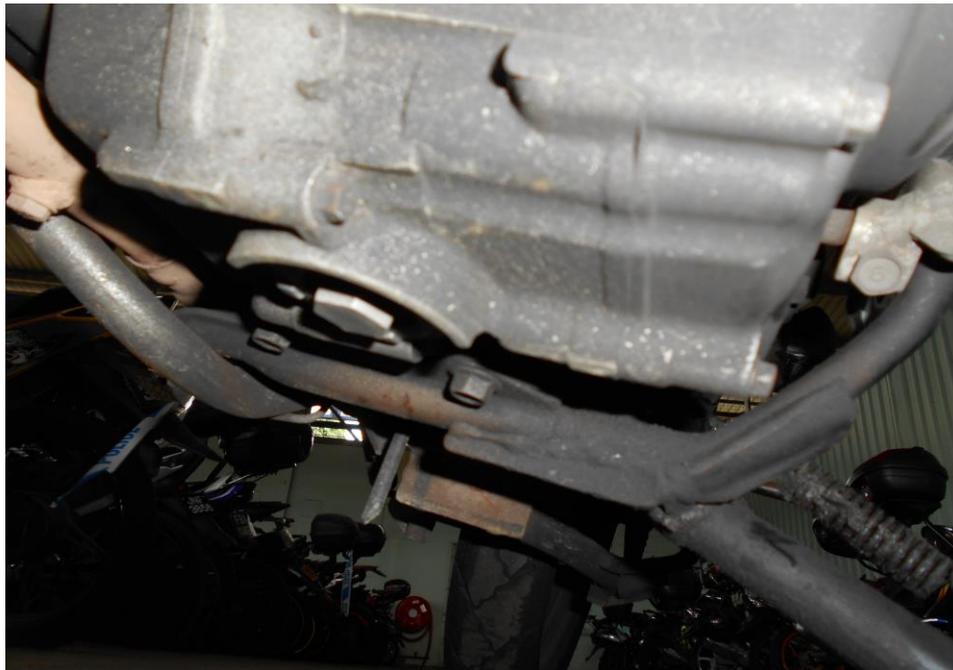
Photo 10 shows no sign(s) or indication(s) of fluid leak observed around the underside of the engine area of the Motorcycle.

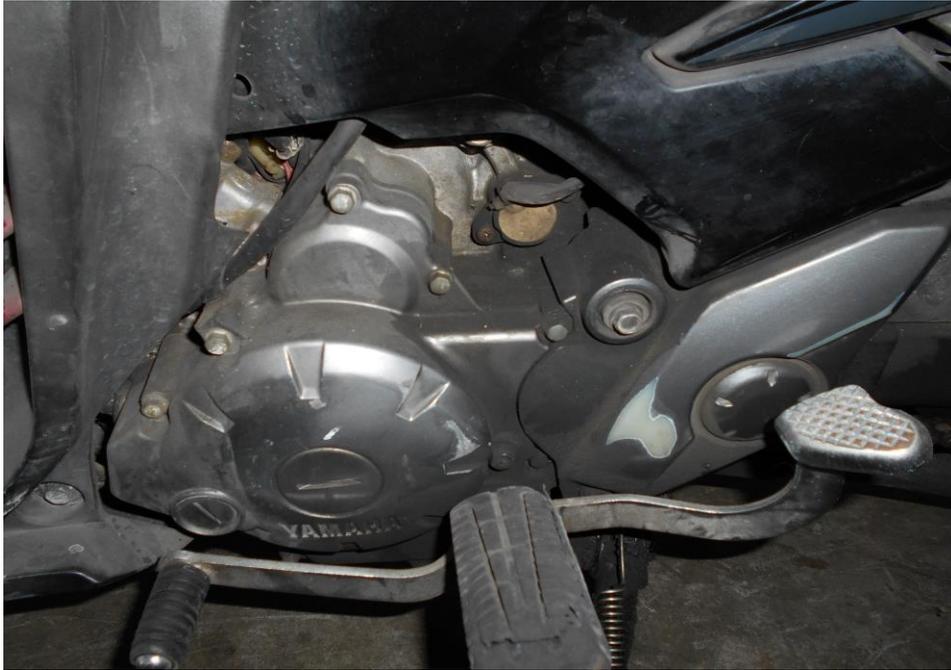
Photo 11 shows no sign(s) or indication(s) of fluid leakage stain observed around the engine area of the Motorcycle.

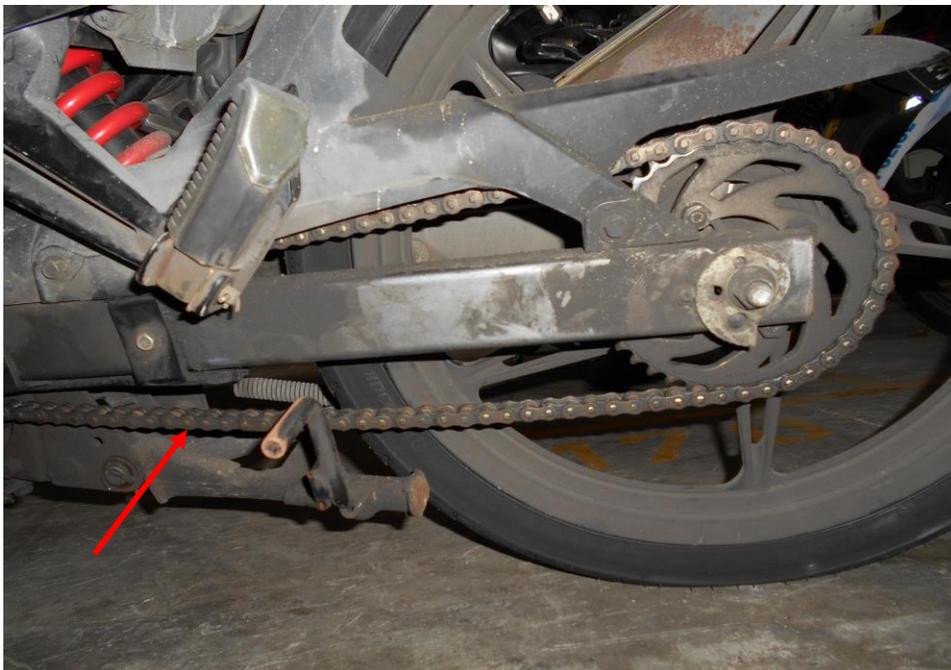
Photo 12 shows the general view of the gear train (arrowed) of the Motorcycle, which was observed to be intact with no misalignment. It was also adequately lubricated for operating purposes.

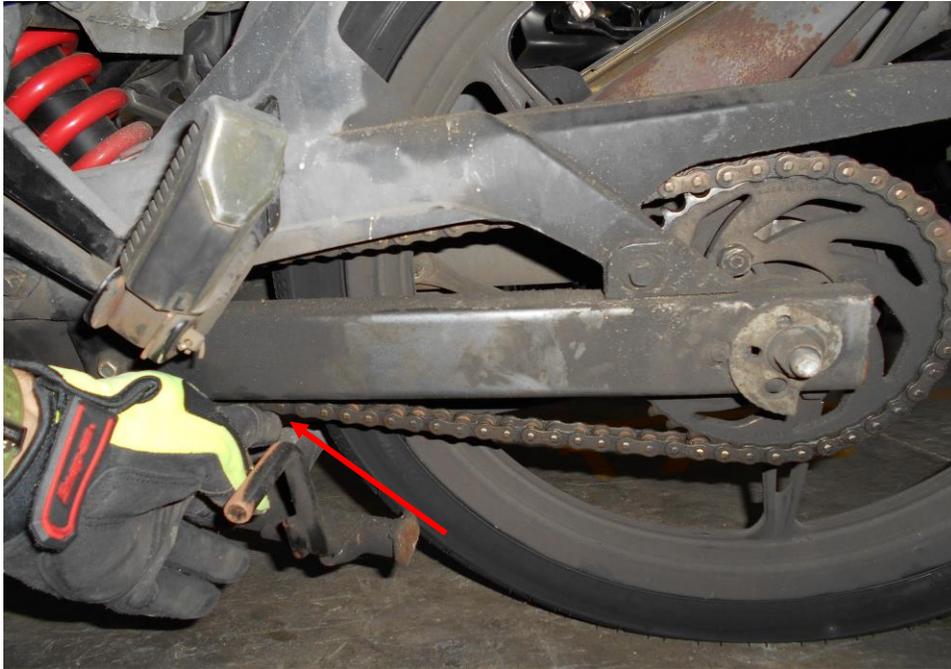
Photo 13 shows the general view of the gear train (arrowed) of the Motorcycle, which was observed to be intact with no misalignment. It was also adequately lubricated for operating purposes. Free play tension was also observed & found adequately acceptable.

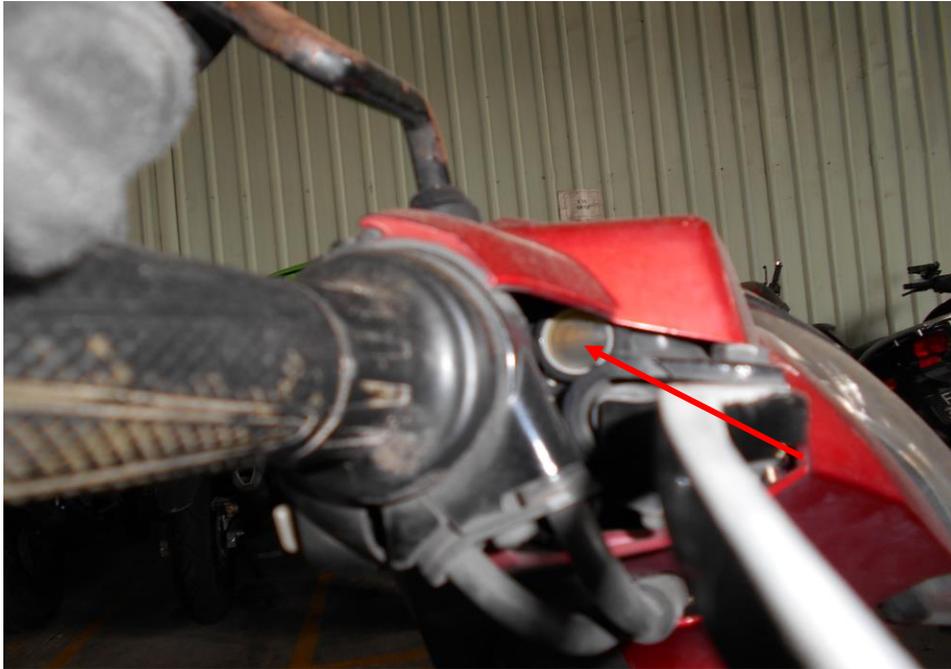
Photo 14 shows our checks on the brake fluid (front) reservoir had also indicated that the brake fluid was of sufficient level for operational purposes, and without contamination.

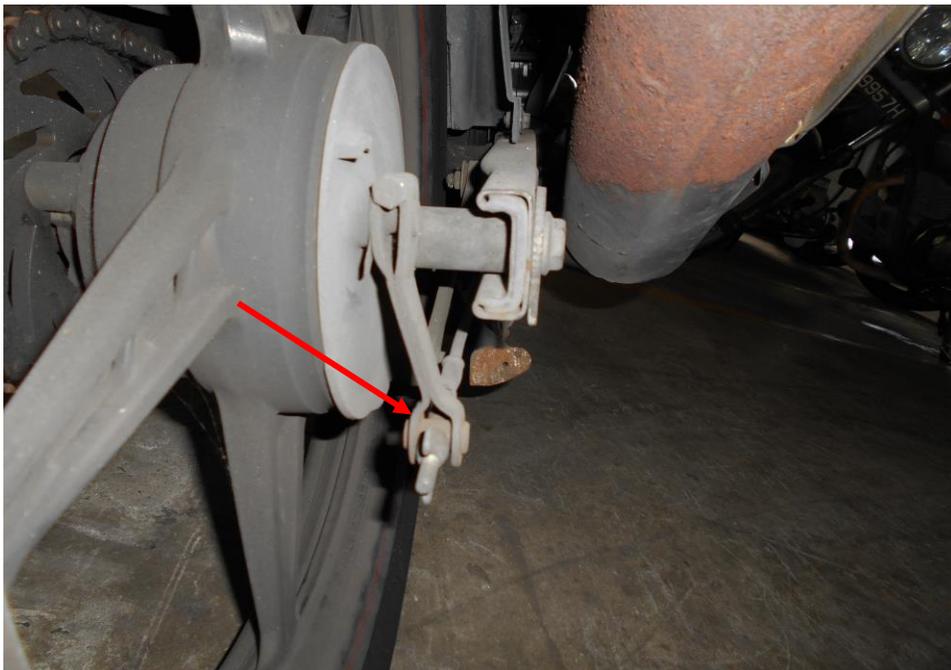
Photo 15 shows our checks on the brake fluid (rear) reservoir had also indicated that the brake fluid was of sufficient level for operational purposes, and without contamination.

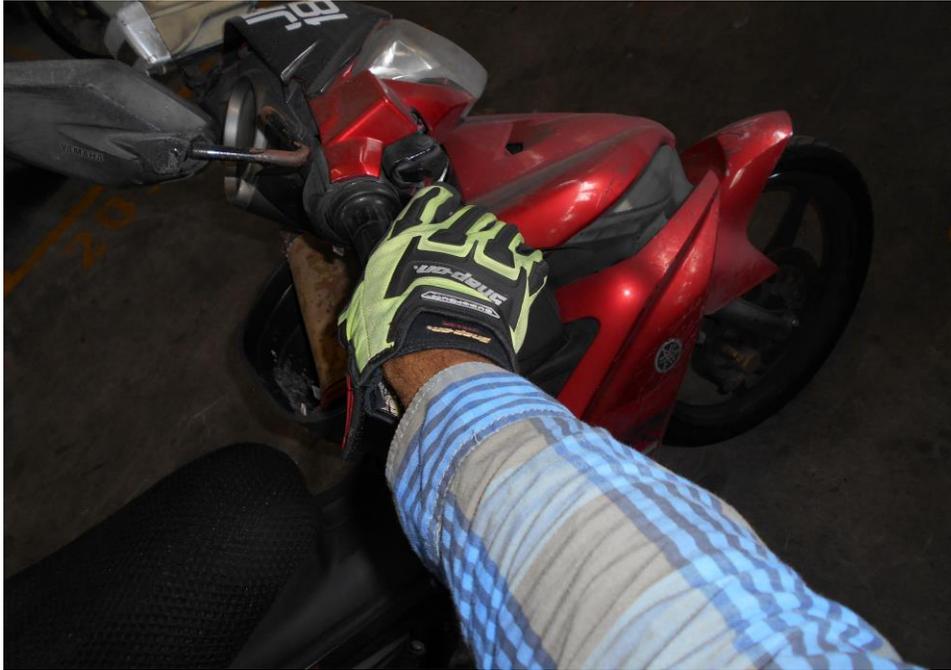
Photo 16 shows testing of the braking of the front brake in progress. There was some resistance felt (spongy like feel) upon pressing the brake lever.

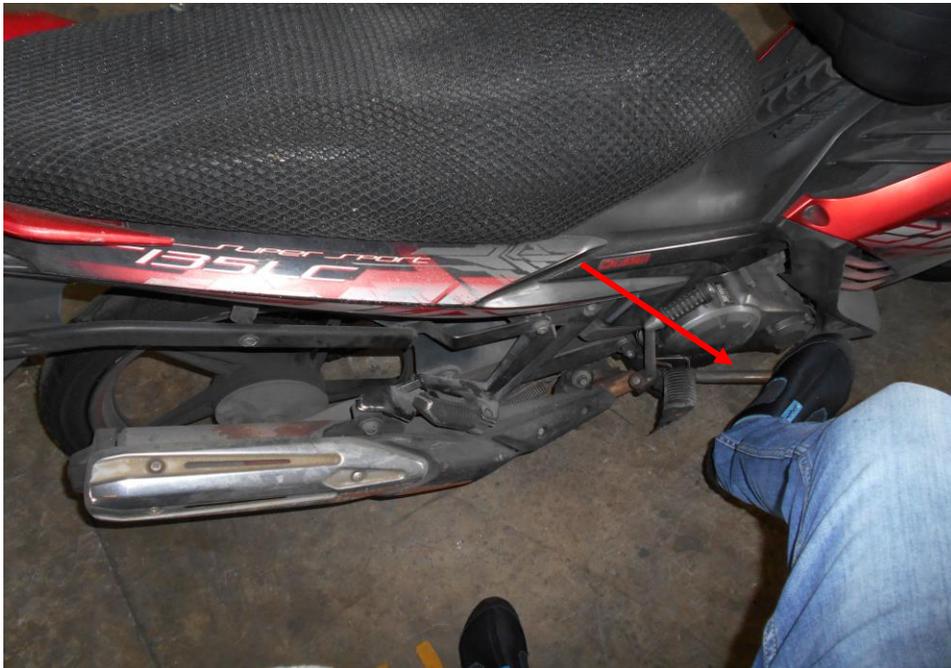
Photo 17 shows testing of the braking of the rear brake in progress. There was some resistance felt (spongy like feel) upon stepping on the brake pedal.

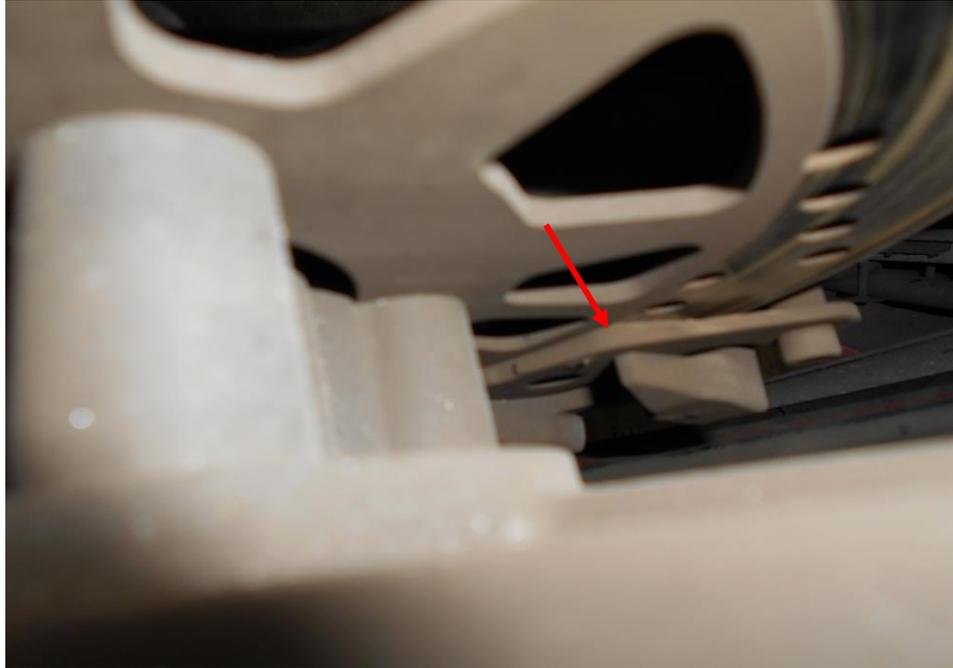
Photo 18 shows the front brake pad at time of our inspection. The frictional material was observed to be sufficient for operational purposes.
