Your Ref: TP/IP/56239/2018
Our Ref : CI/TPD18022201/Z

07th March 2019

MECHANICAL INSPECTION REPORT OF MOTOR BUS PC 1706K

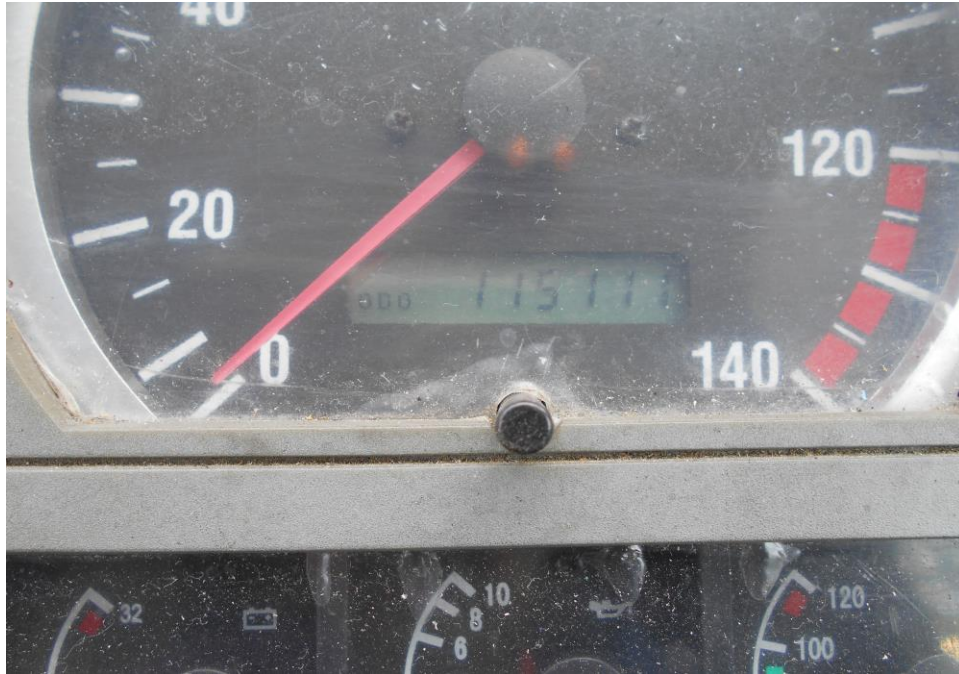
Photo 1 shows the mileage of the Motor Bus at the time of our inspection was recorded as 115111km.

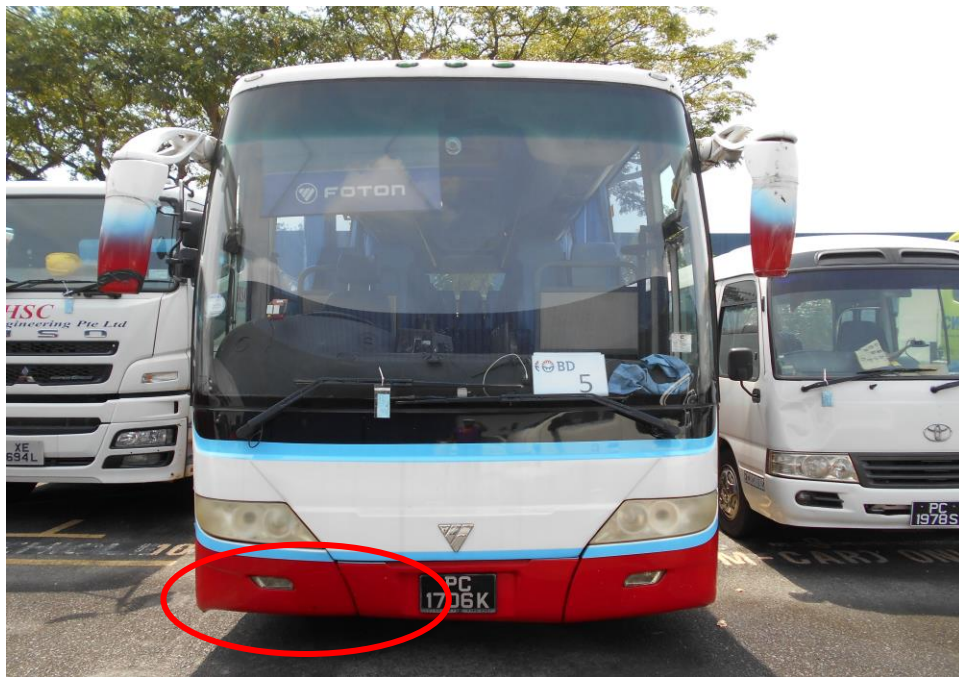
4. The mileage of the Motor Bus at the time of our inspection was recorded as 115111km.
5. The Motor Bus was observed to have sustained minor damage at its lower frontal right portion. Its front lower bumper was observed to be slightly dented at time of our inspection.
6. This was likely due to the consistency of the accident's case facts that 02 Motorcycle (JSJ 8870 & JPH 1866) was travelling on the left lane of a 4 lanes road when both motorcycles side swiped onto each other causing rider of motorcycle JPH 1866 to be flung to lane 3. As a result the rider was run over by Motor Bus PC 1706K travelling on lane 3. See photo 1 – 6 below.

Photo 2 shows a general view of the front body of the Motor Bus at the time of our inspection. The Motor Bus was observed to have sustained minor damage at its front lower right portion as a result of the accident's collision.

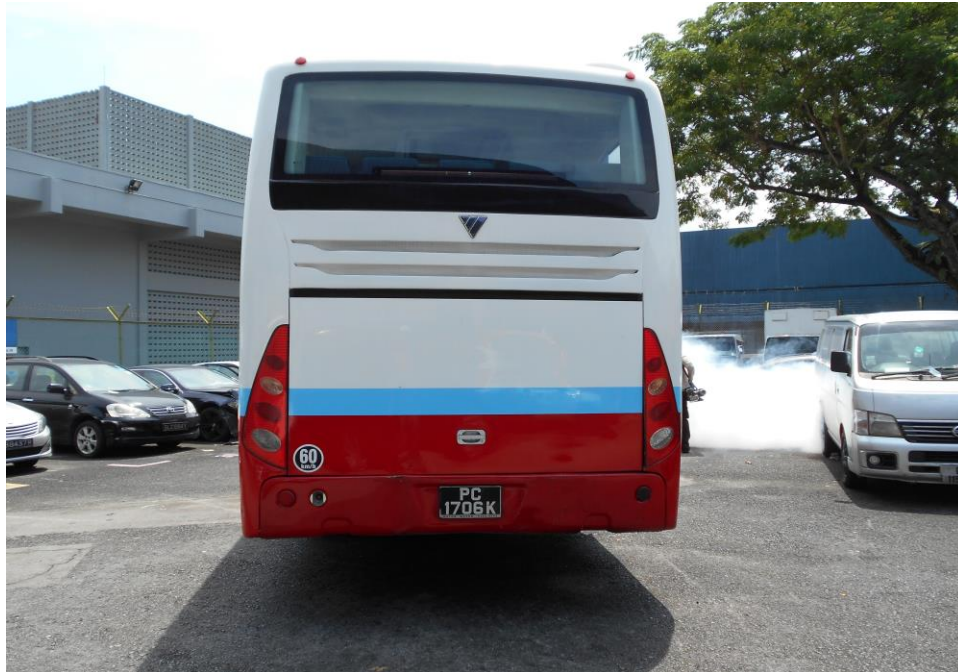
Photo 3 shows a general view of the rear portion of the Motor Bus at the time of our inspection. The Motor Bus was observed to be in good condition unaffected by the accident.

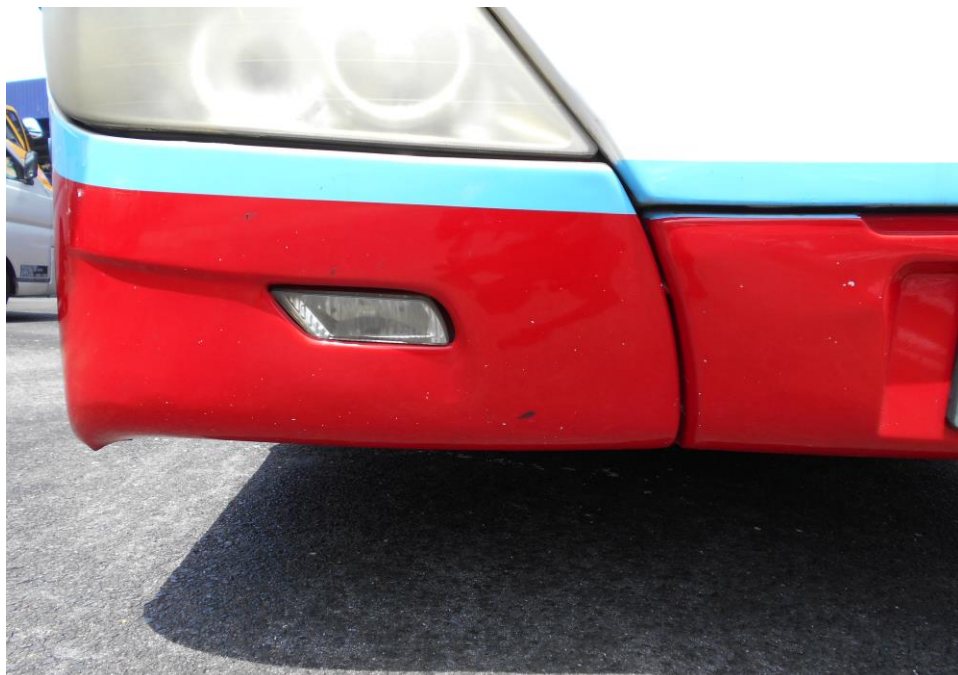
Photo 4 shows a close-up view of the front right lower bumper of the Motor Bus at the time of our inspection. The Motor Bus front right lower bumper was observed to sustained slight dent due to the accident's impact.

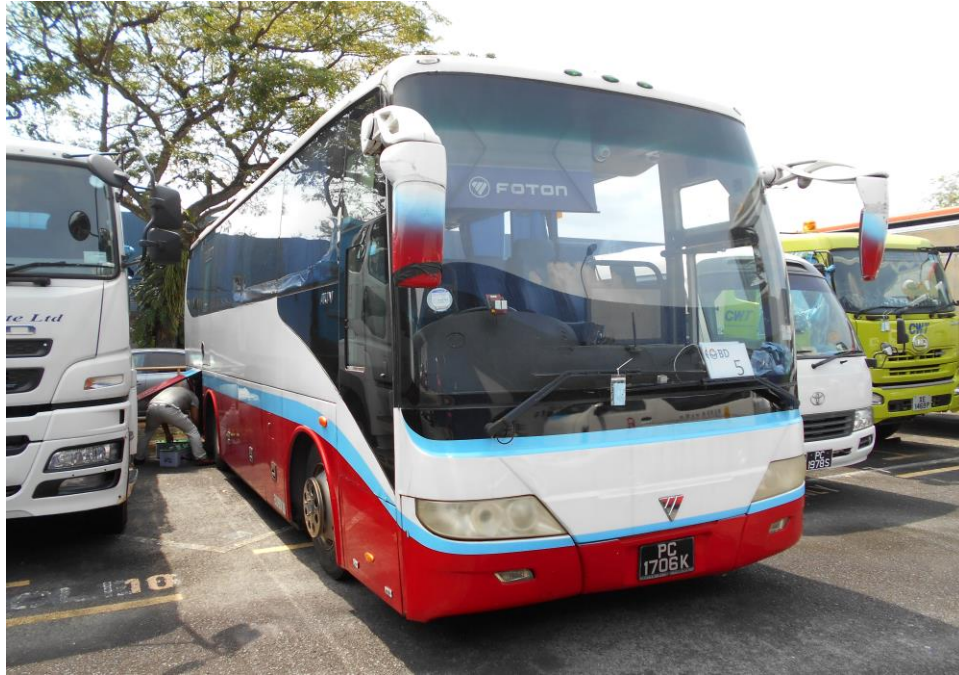
Photo 5 shows a general view of the front right of the Motor Bus at the time of our inspection. The Motor Bus front right lower bumper was observed to sustained slight dent due to the accident's impact.

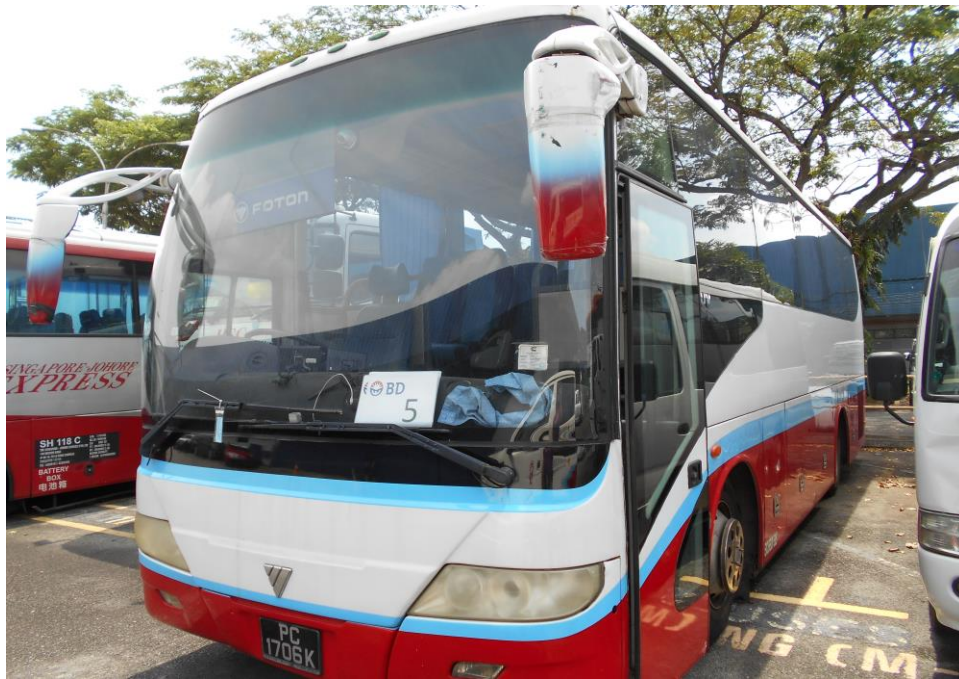
Photo 6 shows a general view of the front left of the Motor Bus at the time of our inspection. The Motor Bus front right lower bumper was observed to sustained slight dent due to the accident's impact.

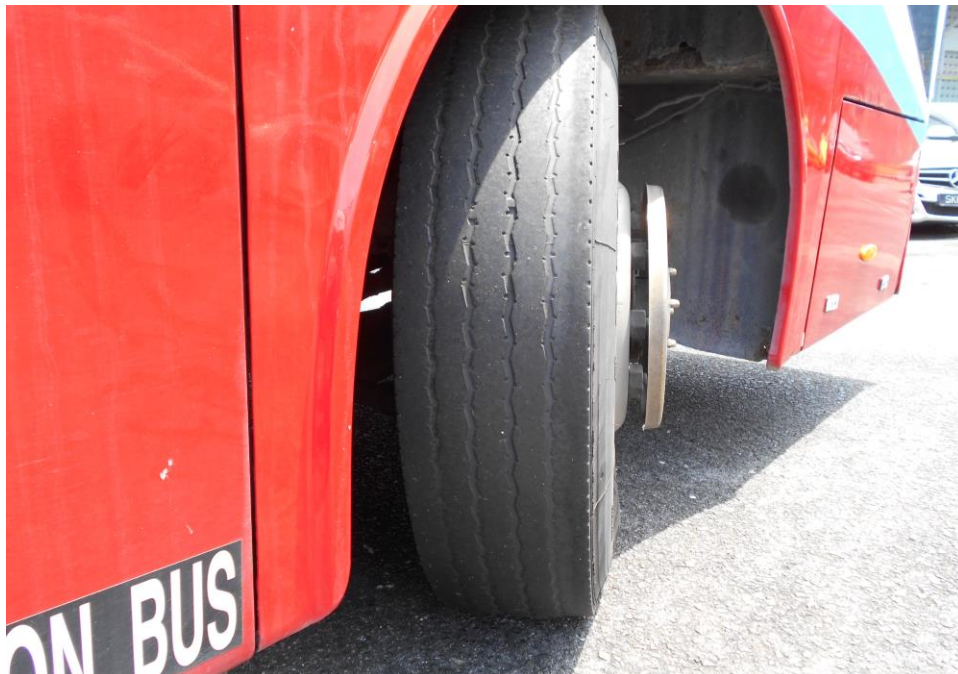
Photo 7 shows the condition of the front right tyre of the Motor Bus, which was observed to be in serviceable condition with remaining tread depth of approximately 2mm. The tyre was also observed to be sufficiently inflated for vehicular operation.

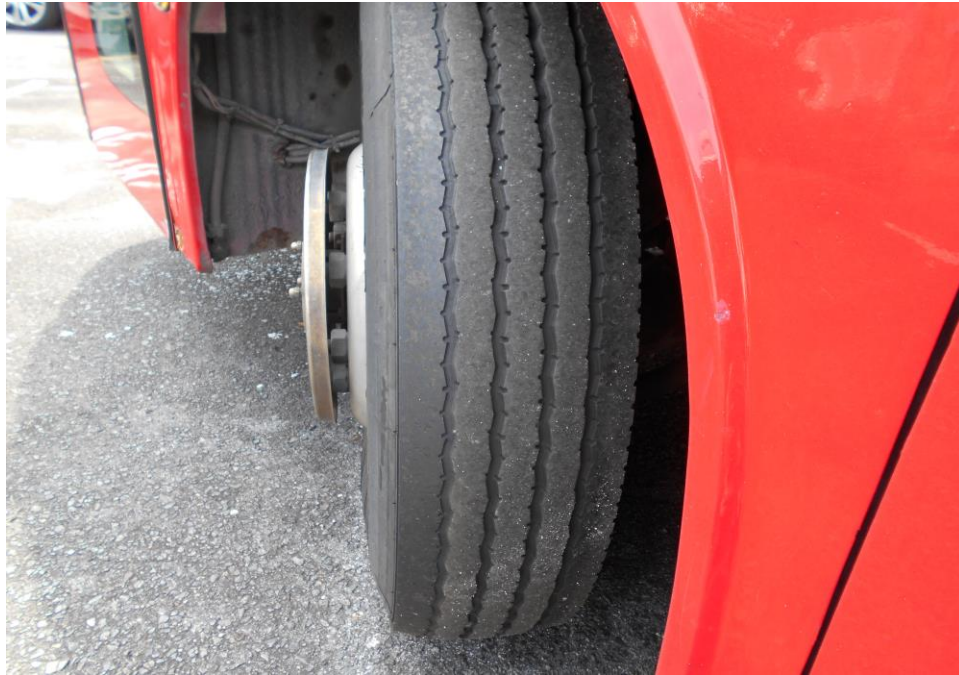
Photo 8 shows the condition of the front left tyre of the Motor Bus, which was observed to be in serviceable condition with remaining tread depth of approximately 7mm. The tyre was also observed to be sufficiently inflated for vehicular operation.

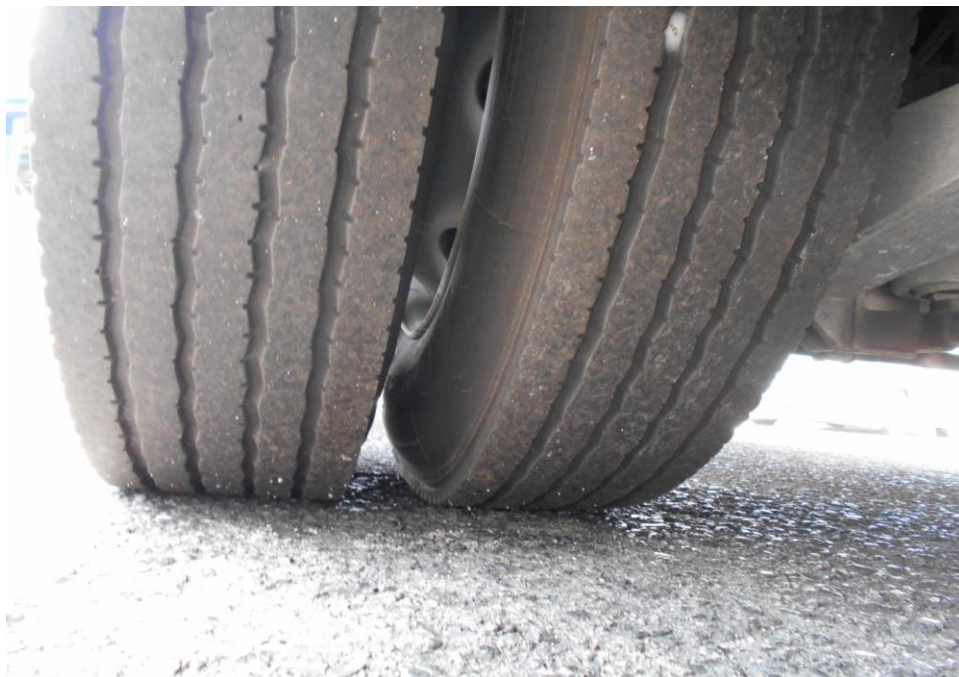
Photo 9 shows the condition of the rear right tyres of the Motor Bus, which were observed to be in serviceable condition with remaining tread depth of approximately 8mm. The tyres, which were wrapped around standard alloy wheels rims, were also observed to be sufficiently inflated for vehicular operation.

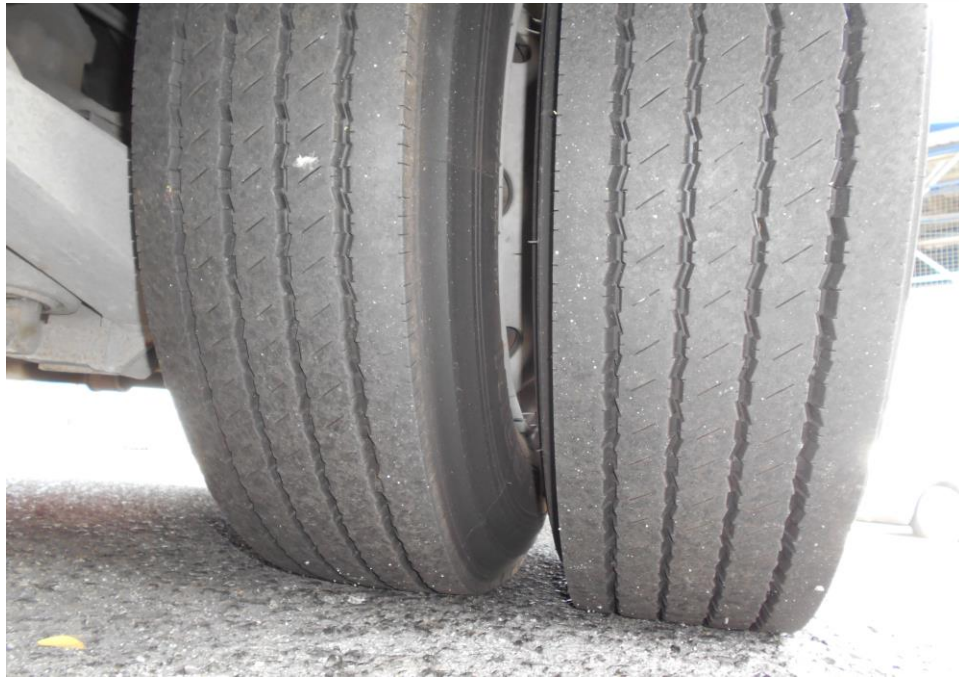
Photo 10 shows the condition of the rear left tyres of the Motor Bus, which were observed to be in serviceable condition with remaining tread depth of approximately 8mm. The tyres, which were wrapped around standard alloy wheel rims, were also observed to be sufficiently inflated for vehicular operation.

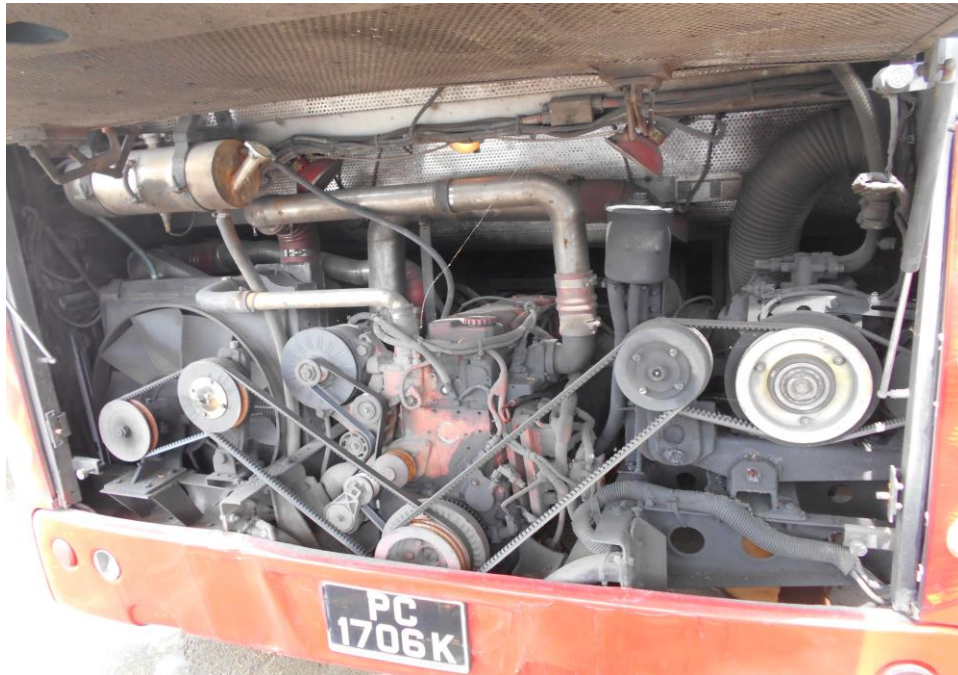
Photo 11 shows the engine compartment of the Motor Bus was located at the rear of the Motor Bus.

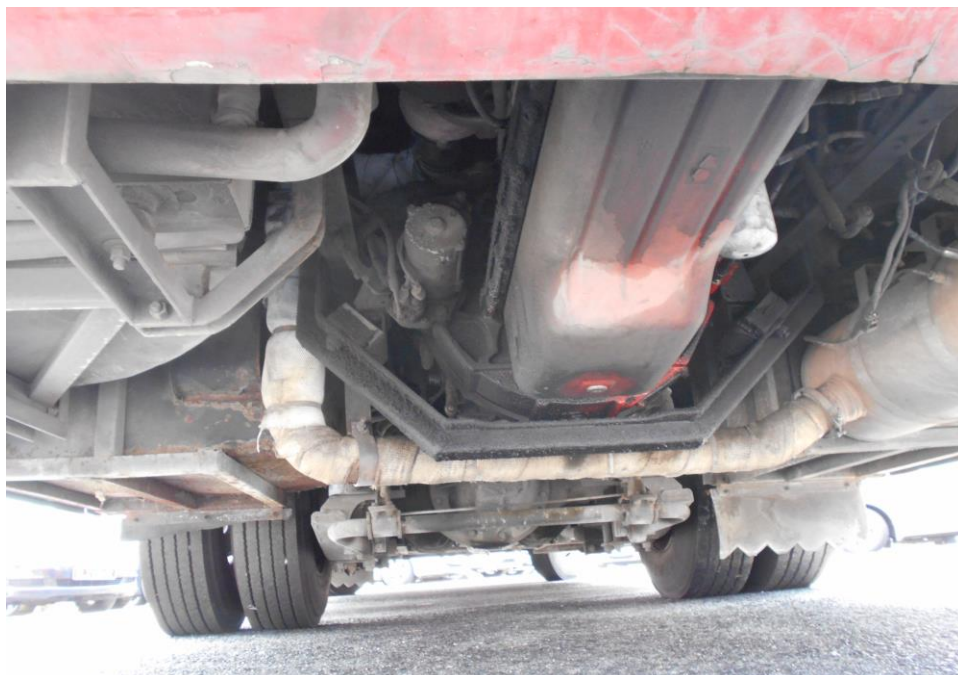
11. Our subsequent checks on the underside of the Motor Bus reveals some fluid stain sighted under the engine compartment. Further investigation found that the fluid stain was a pre-existed prior the accident & not a fresh fluid. This was due to some dirt observed on the fluid stain. Conclusively, it is not likely to be related to the accident. Visually, the various undercarriage components of the Motor Bus were observed to be intact and without any visible damage except for the damage caused by the accident. See photo 11 – 14 below.

Photo 12 shows the engine undercarriage of the Motor Bus. Some pre-existed fluid was observed at time of our inspection.

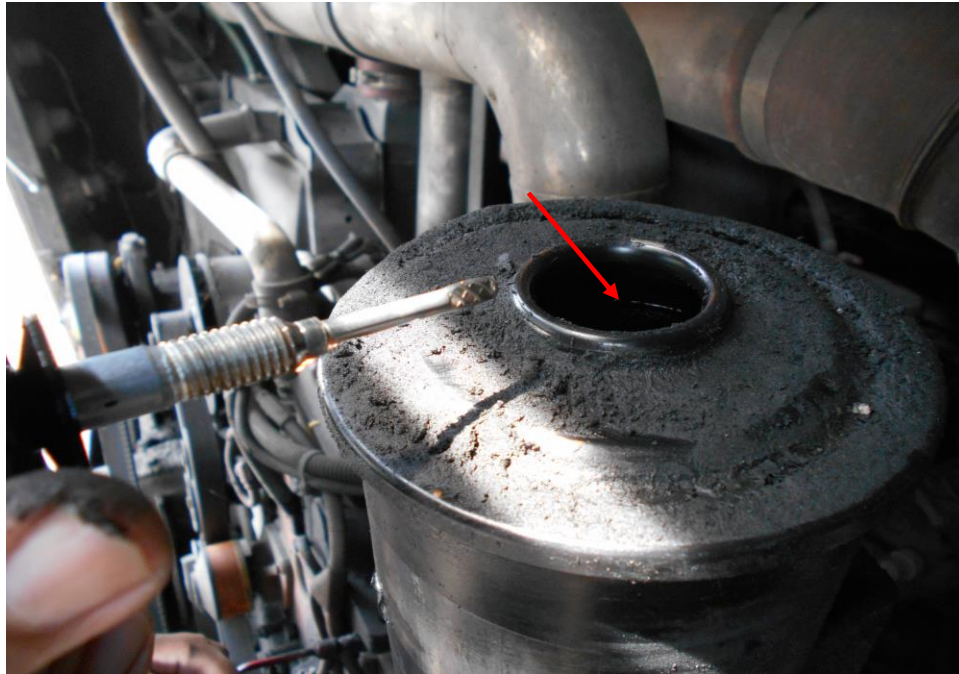
Photo 13 shows the power steering fluid of the Motor Bus. It was observed to be of sufficient level without any contamination at time of our inspection.

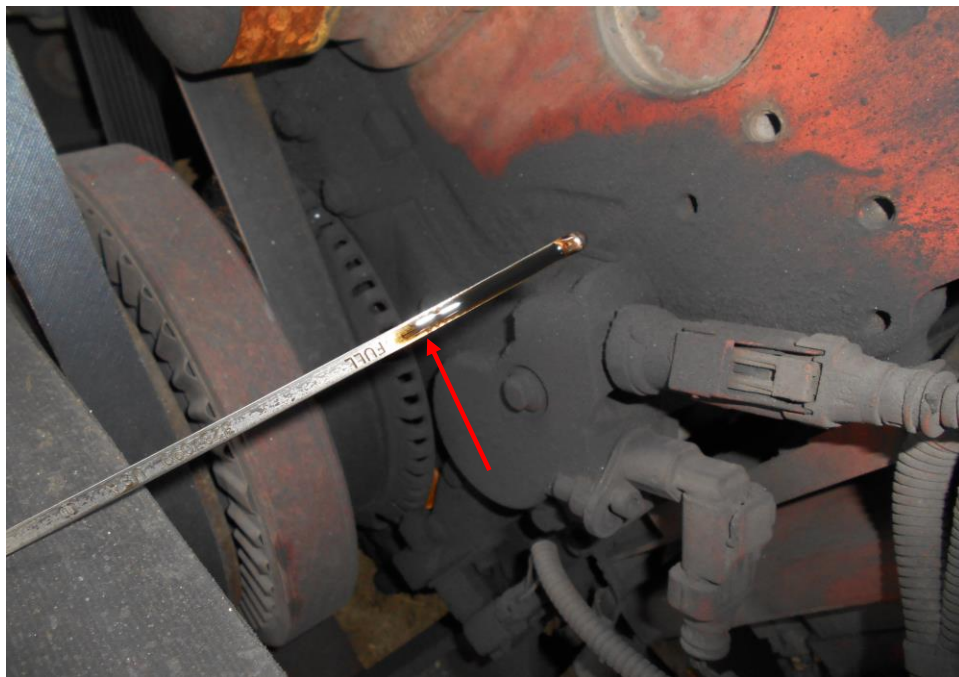
Photo 14 shows the engine fluid on the dip stick of the Motor Bus. It was observed to be of sufficient level without any contamination at time of our inspection.

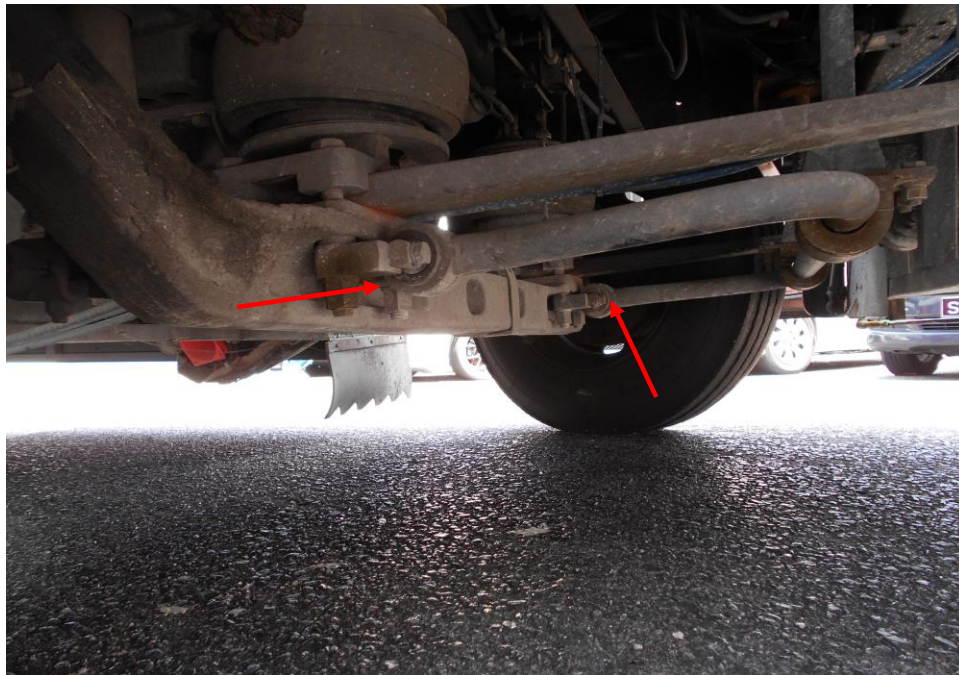
Photo 15 shows some of the mechanical components (arrowed) of the Motor Bus's steering system. Our visual check on the various mechanical components of the steering system revealed all to be intact and in good condition. The steering system of the Motor Bus likely to be in serviceable condition at the time of accident.

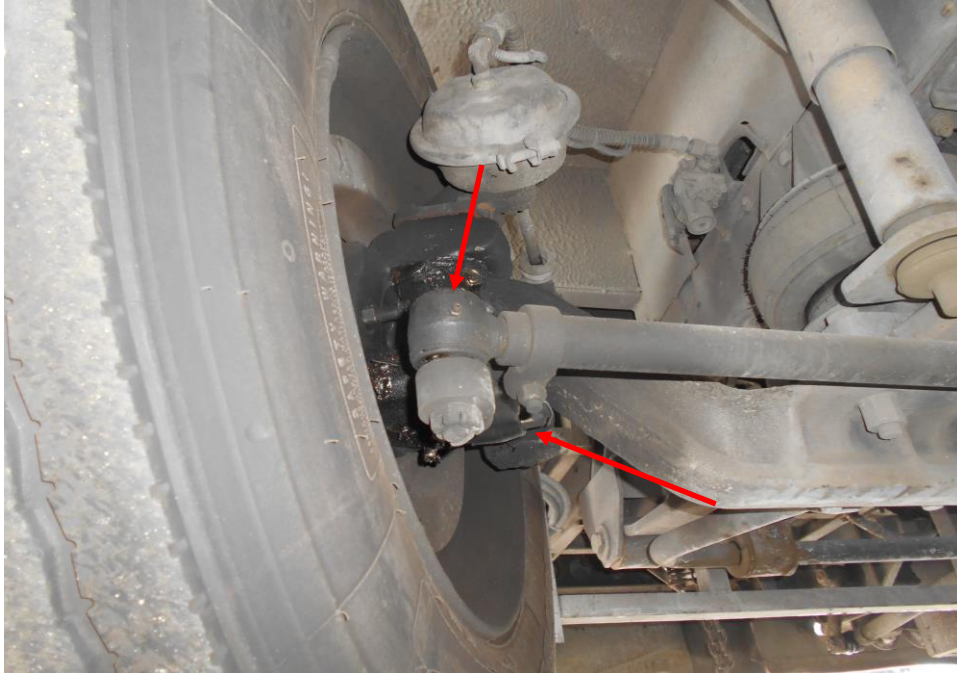
Photo 16 shows the front left wheel components of the front steering system of the Motor Bus. The various undercarriage components of the Motor Bus were all observed to be intact and without any visible damage. This had included the steering rack and steering ball joints (arrowed) of the Motor Bus, which were observed to be securely attached to the front left wheel and front right wheel.

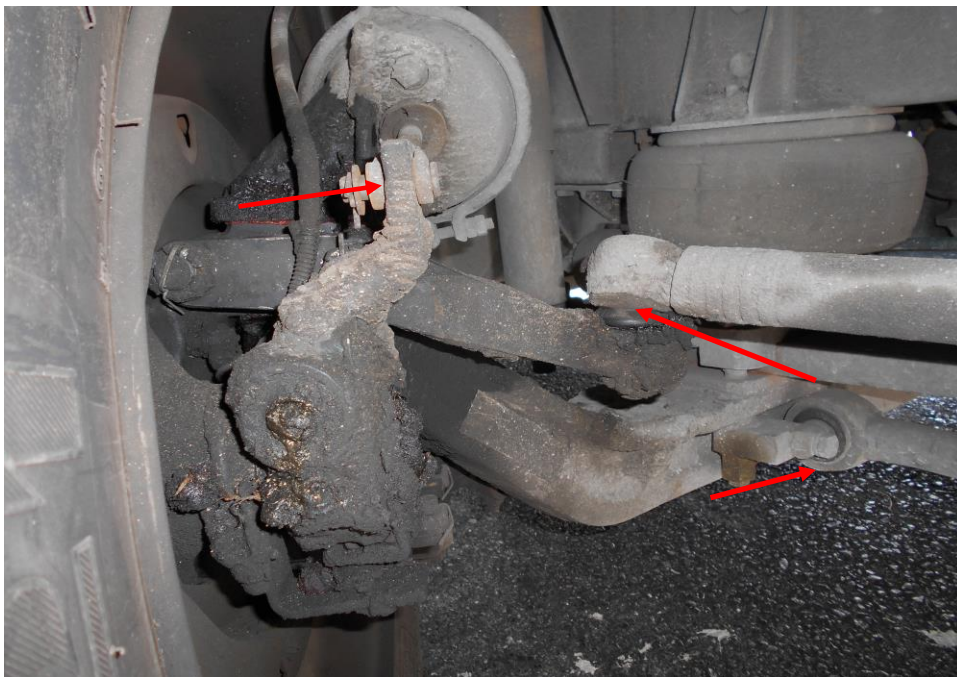
Photo 17 shows the front right wheel components of the front steering system of the Motor Bus. The various undercarriage components of the Motor Bus were all observed to be intact and without any visible damage. This had included the steering rack and steering ball joints (arrowed) of the Motor Bus, which were observed to be securely attached to the front left wheel and front right wheel.

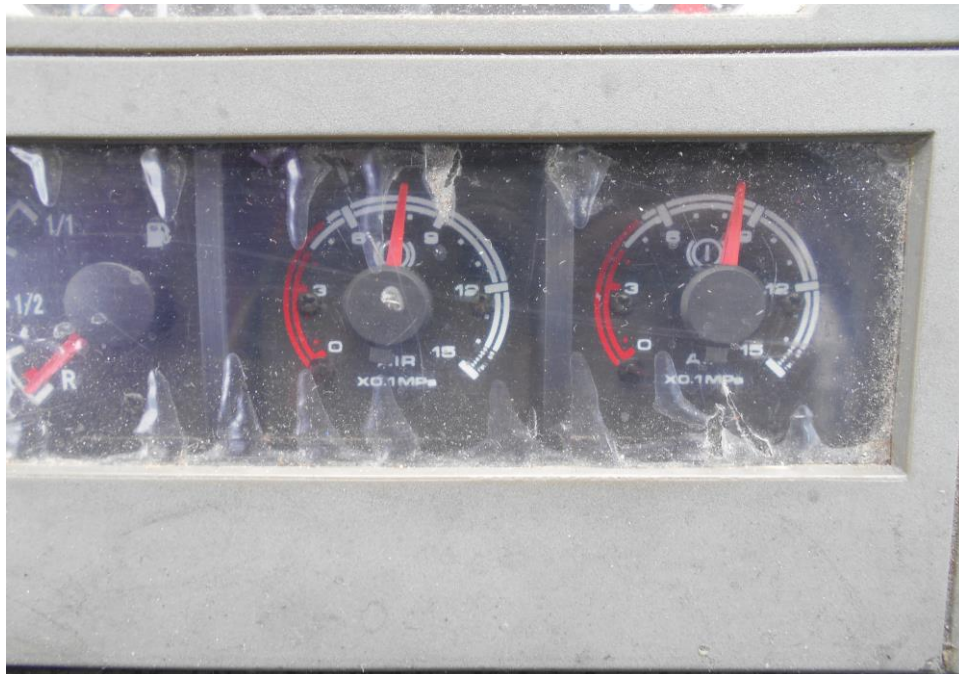
- 14.2 numbers of air tanks in particular were observed to be also in serviceable condition. Air built up to the operational level which is level 8.5 (On the display panel) for both air tanks for operational ready status after a warming up session prior the operational test. Both air tanks were monitored for about 10 minutes for an observation of any abnormalities. Both air tanks pressure found to be normal without any drop in pressure during the course of our monitoring session. This would indicate that there was no leak of air pressure from the air braking system of the Motor Bus. See photo 18 below.

Photo 18 shows pressure tanks were observed to be pressurised up to 8.5bars after the engine start-up. No drop in the pressure after a few minutes which means there's no air leakage from the air-braking system.

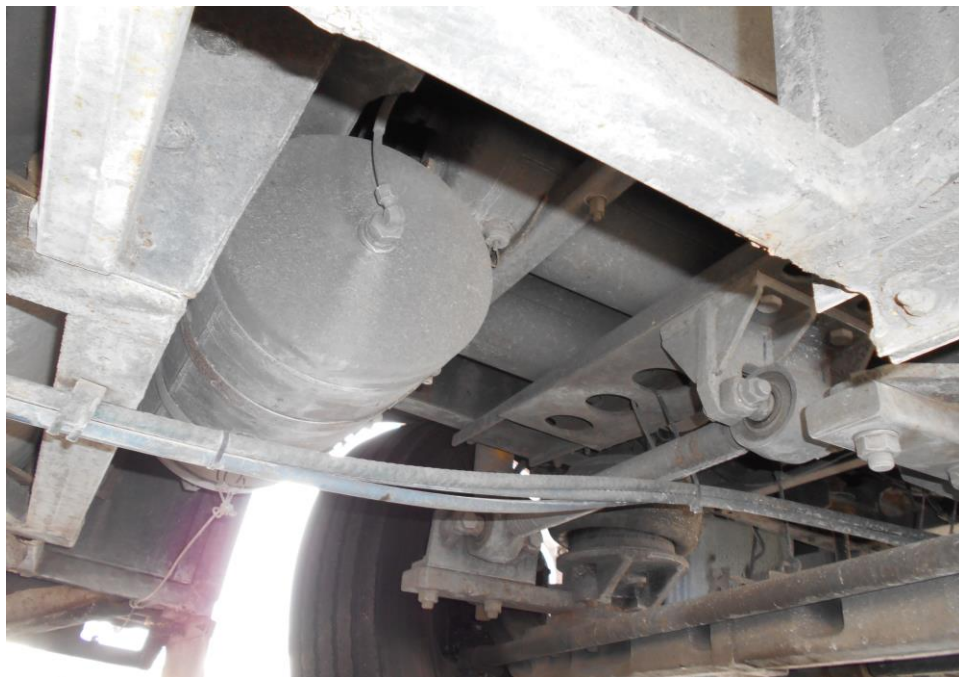
Photo 19 shows a general view of the air tank, valves, pipes and hoses, which are some of the components for the air-assisted braking system of the Motor Bus. This was at the underside of the Motor Bus's body. There were no damages observed at time of our inspection.

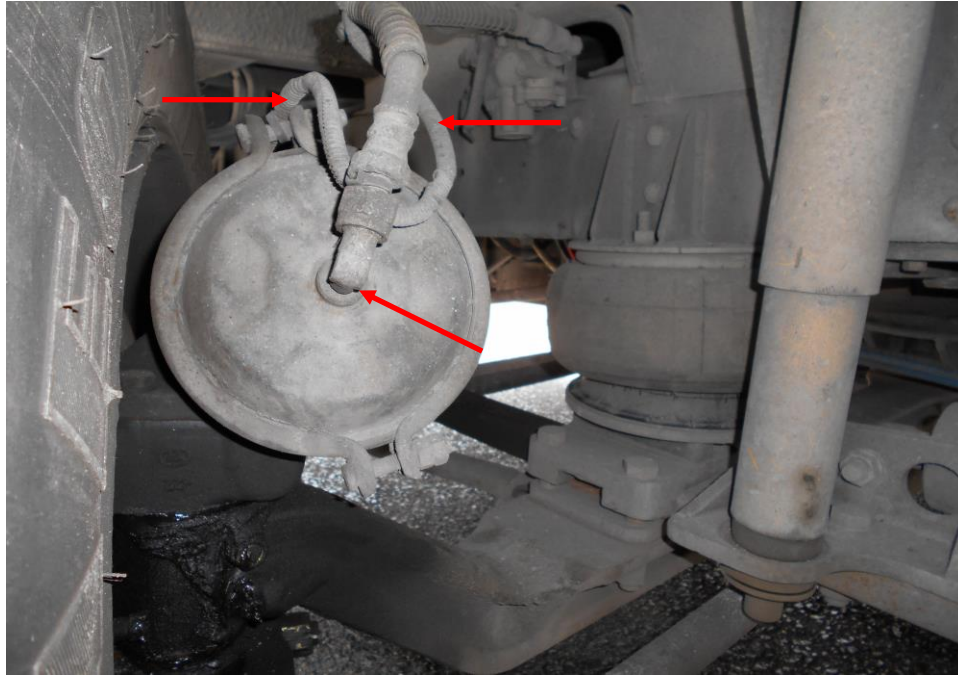
Photo 20 shows some of the mechanical components (arrowed) of the Motor Bus's braking system (including hoses). Our visual check on the various mechanical components reveals all to be intact and in good condition. It was in serviceable condition at the time of accident.

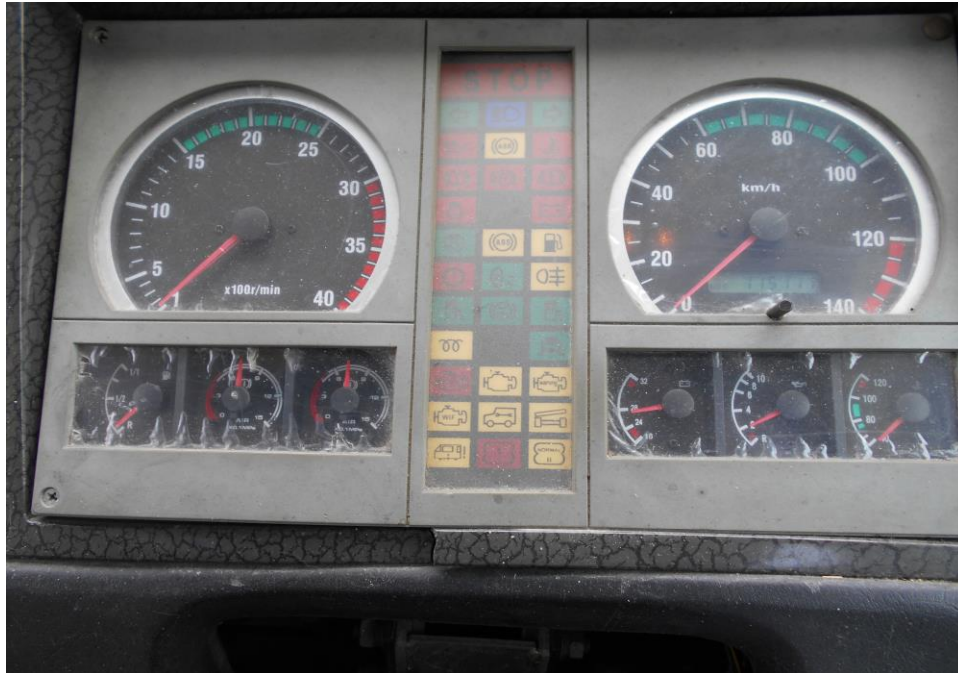
Photo 21 shows the indicators at the driver's seat, these systems were in working condition. This can be established from the warning lights disappearing from the instrument panel after the self-test.

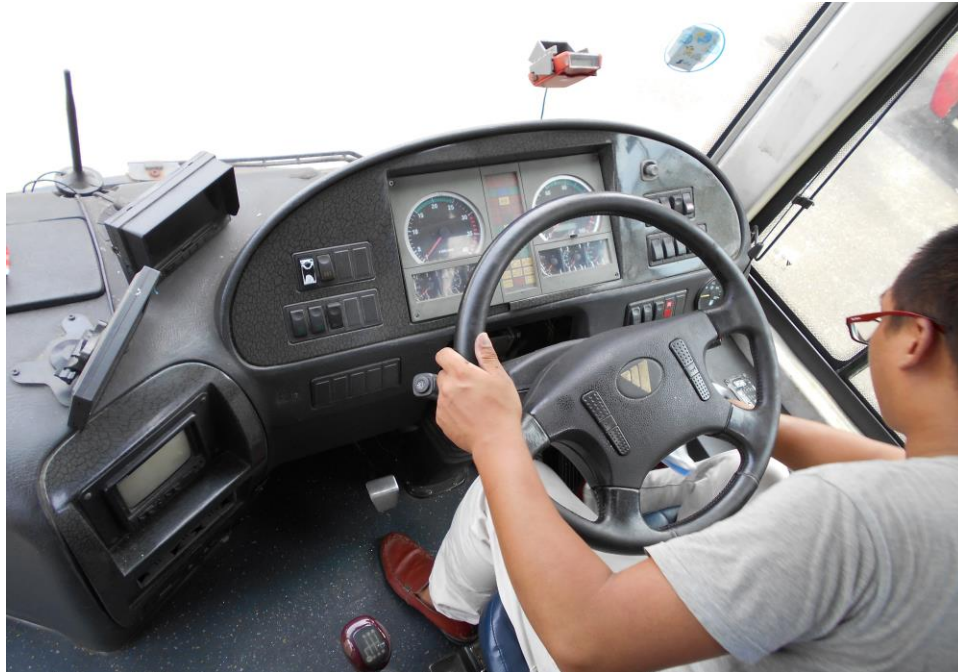
Photo 22 shows the bus driver while conducting the operational test. He was able to steer to the fullest left & right, moving forward, reverse and stop successfully at time of the operational test.

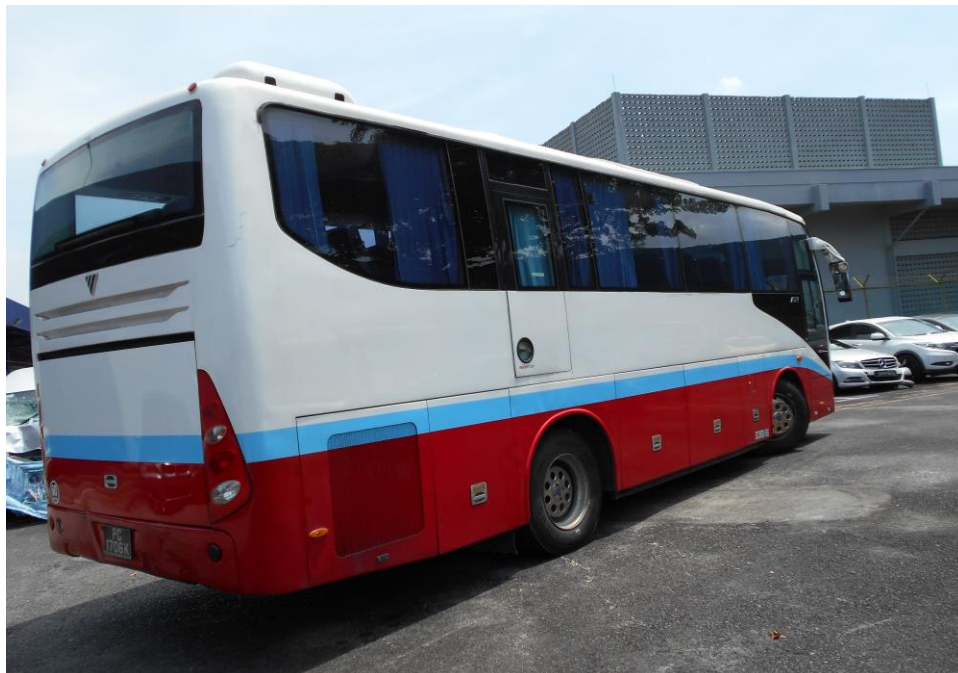
Photo 23 shows the operational test on the Motor Bus. The driver was able to move the Motor Bus forward, backward, turning left & right & stopping without any abnormalities.
