Your Ref: TP/IP/59297/2018  
Our Ref : CI/TPD18022203/Z

**Fatal Accident Investigation Team**

**MECHANICAL INSPECTION REPORT OF MOTOR BUS CB 7364H.**

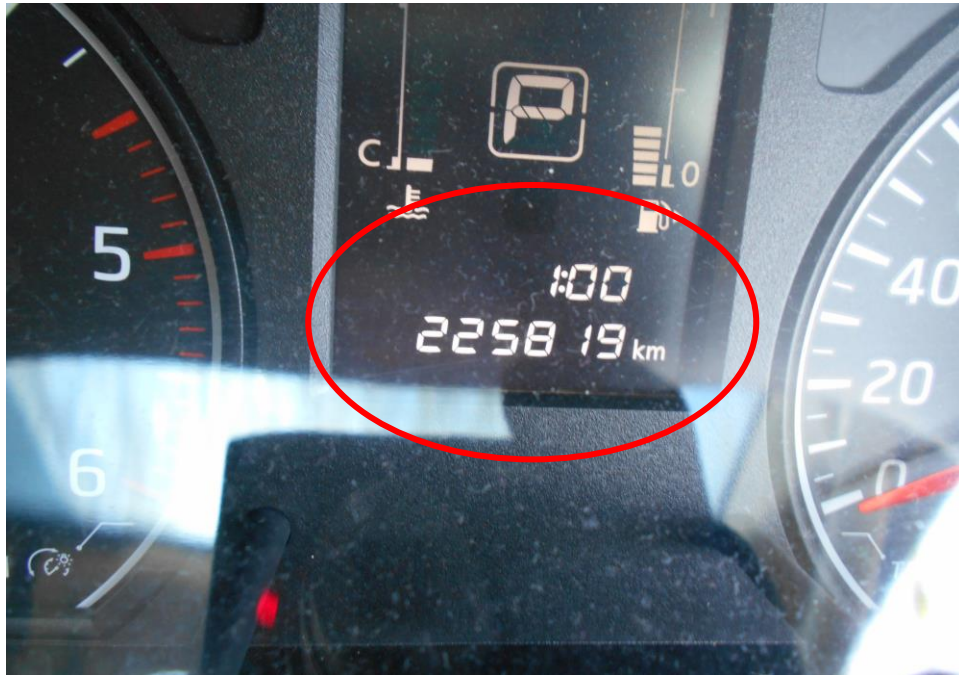
**Photo 1** shows the mileage of the Motor Bus was recorded at 225819km at time of our inspection.

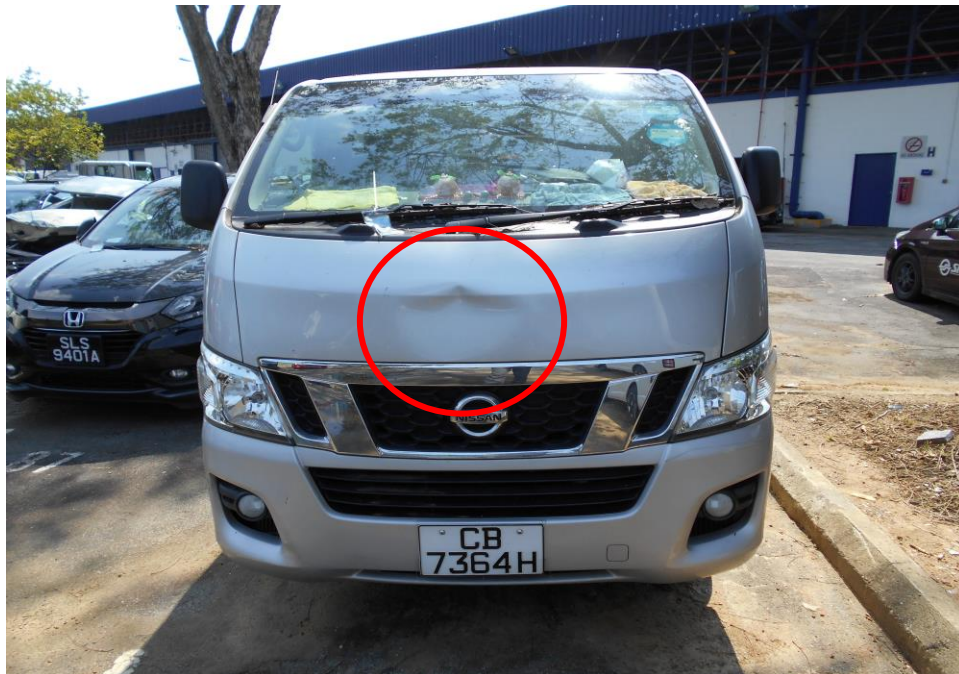
4. The mileage of the Motor Bus at the time of our inspection was 225819km.
5. The Motor Bus was observed to have sustained minor dent at its front centre panel likely due to the accident.
6. This was likely due to the consistency of the accident's case facts that the Motor Bus was entering slip road from Boon Lay Way into Yuan Ching Road when the Motor Bus collided onto a female cyclist who was cycling on the driver's right to left. See photo 1 to 7 below.

**Photo 2** shows a general view of the front body of the Motor Bus at the time of our inspection. The Motor Bus was observed to sustained damages at the front centre portion due to the accident's impact.

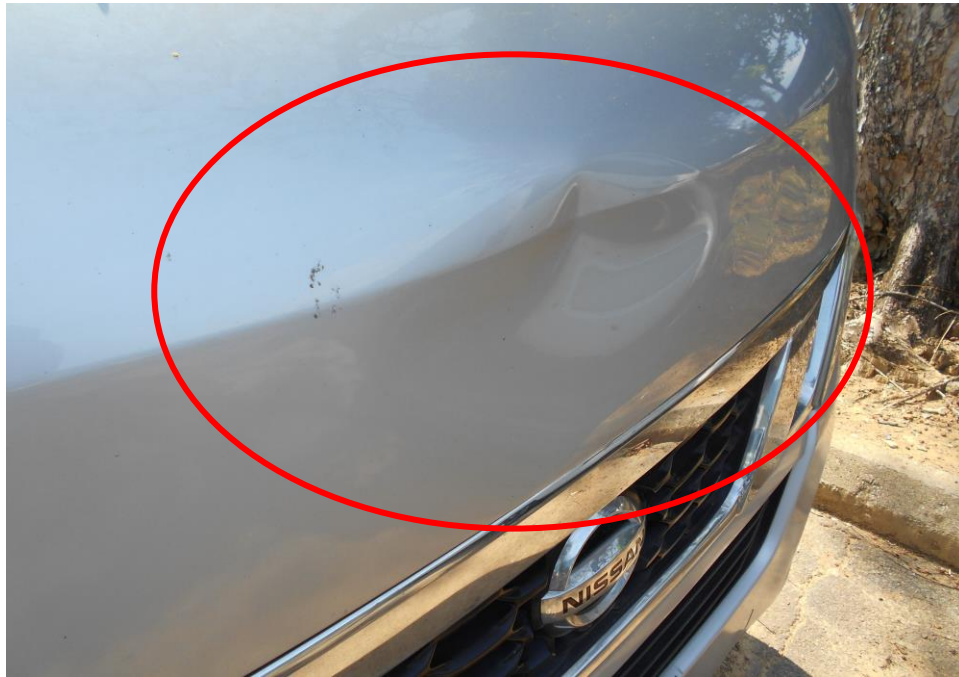
**Photo 3** shows a close-up view of the damages on the front centre panel of the Motor Bus at the time of our inspection. It was likely due to the accident's impact collision.

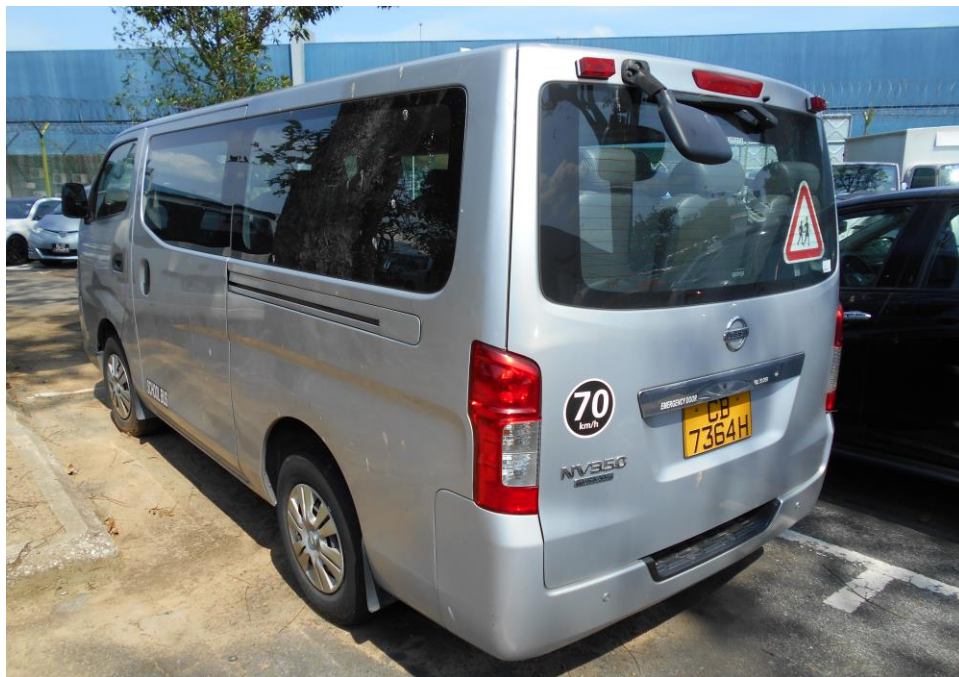
**Photo 4** shows a general view of the rear left body of the Motor Bus at the time of our inspection. The Motor Bus was observed to be in good general condition at time of inspection.

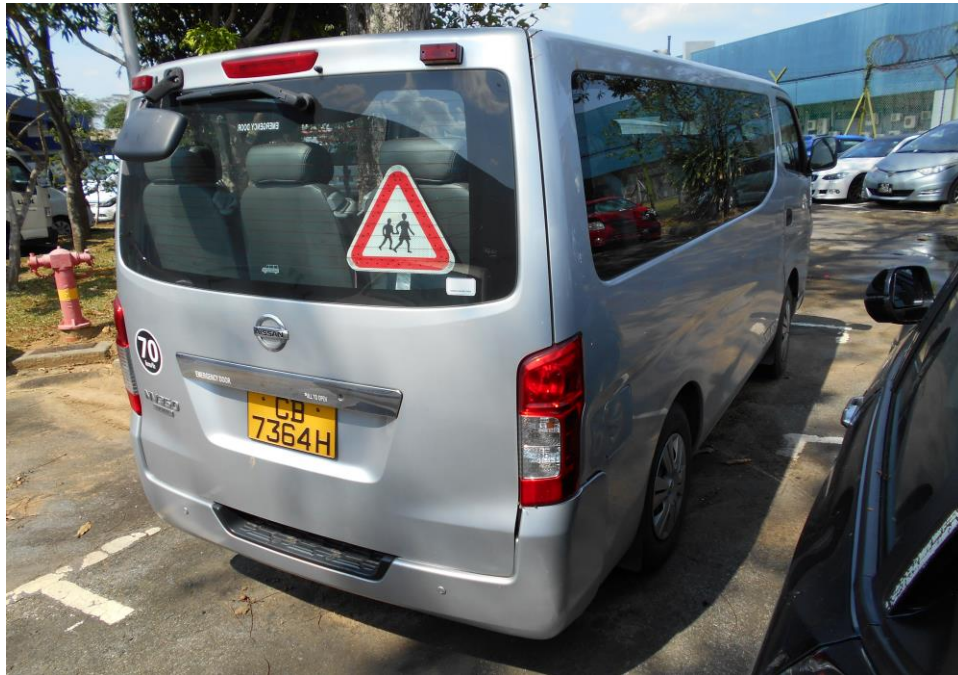
**Photo 5** shows a general view of the rear right body of the Motor Bus at the time of our inspection. The Motor Bus was observed to be in good general condition at time of inspection.

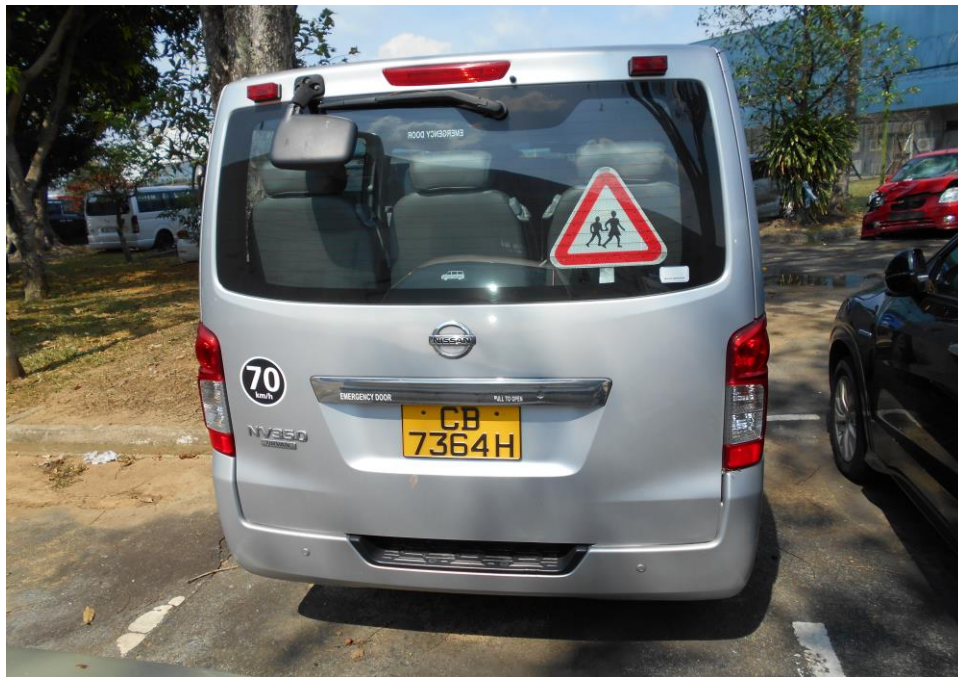
**Photo 6** shows a general view of the rear body of the Motor Bus at the time of our inspection. The Motor Bus was observed to be in good general condition at time of inspection.

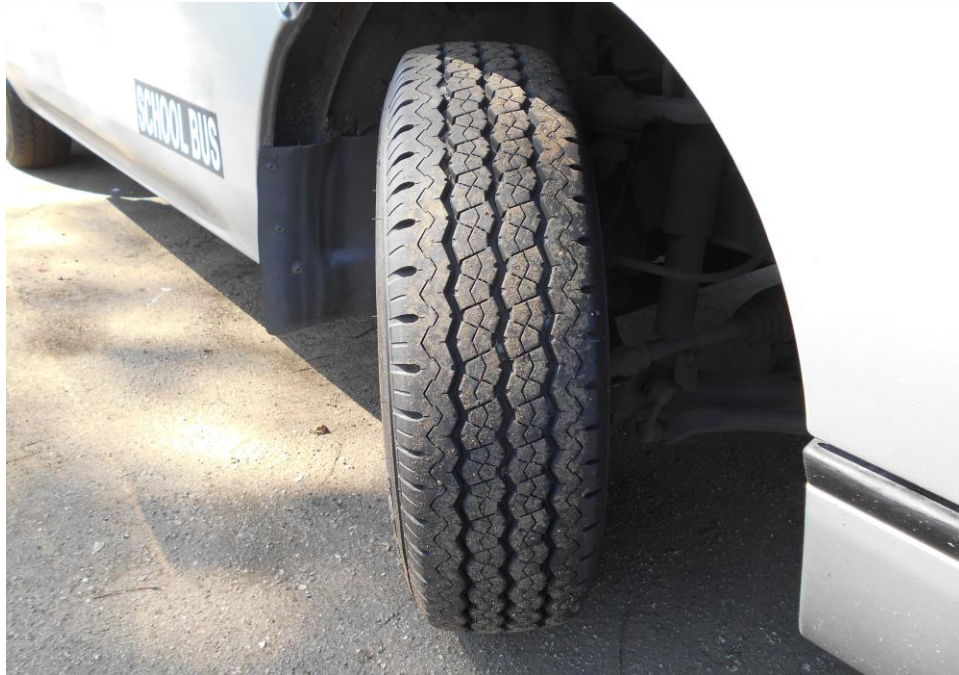
**Photo 7** shows the condition of the front right tyre of the Motor Bus, which was observed to be in serviceable condition with remaining tread depth of approximately 8mm. The tyres were all observed to be sufficiently inflated for vehicular operation with no tear, cut or burst mark(s) on the outer and the inner sidewalls as well as across the tread.

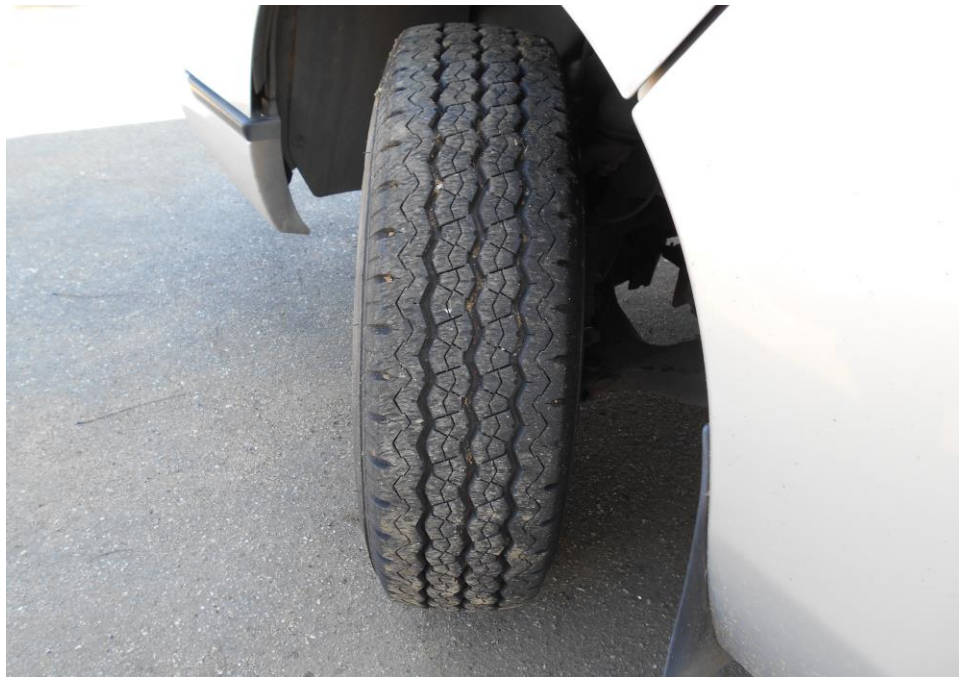
**Photo 8** shows the condition of the front left tyre of the Motor Bus, which was observed to be in serviceable condition with remaining tread depth of approximately 8mm. The tyre, which was wrapped around standard wheel rim, was also observed to be sufficiently inflated for vehicular operation.

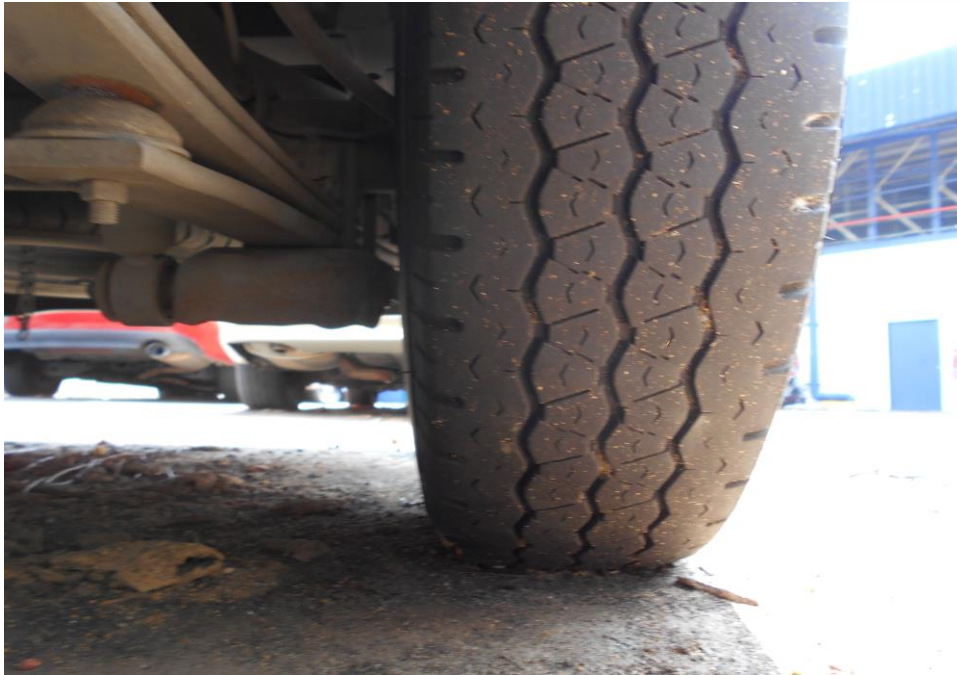
**Photo 9** shows the condition of the rear left tyre of the Motor Bus, which was observed to be in serviceable condition with remaining tread depth of approximately 6mm. The tyre, which was wrapped around standard wheel rim, was also observed to be sufficiently inflated for vehicular operation. There was also no significant damage found on the 6 wheel rims of the Motor Bus.

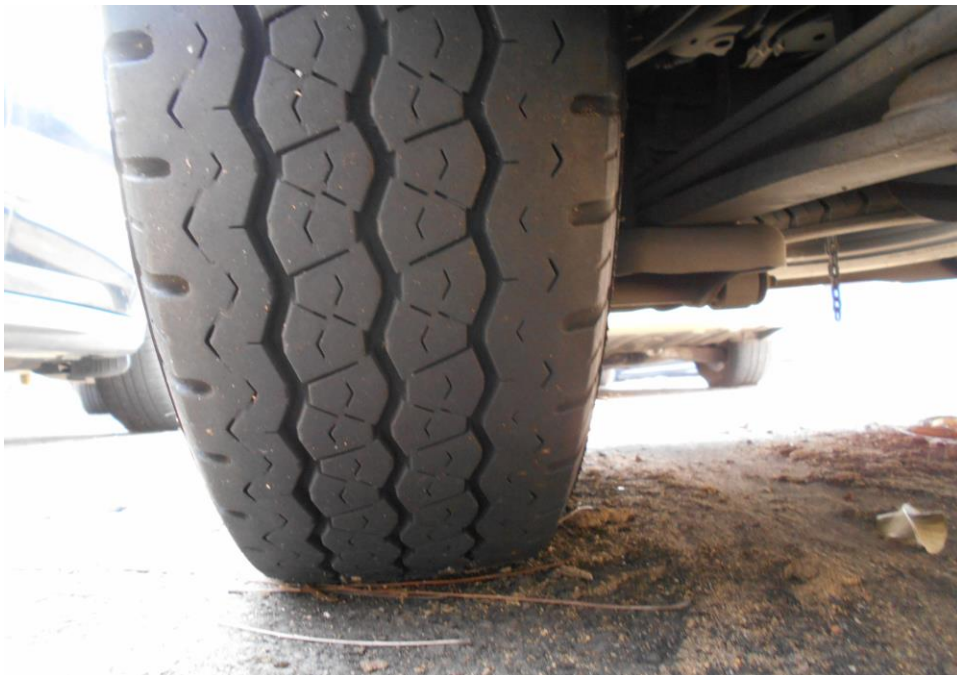
**Photo 10** shows the condition of the rear right tyre of the Motor Bus, which was observed to be in serviceable condition with remaining tread depth of approximately 7mm. There was also no tear, cut or burst mark(s) on the outer and the inner sidewalls as well as across the tread of the tyre, which was also sufficiently inflated for vehicular operation.

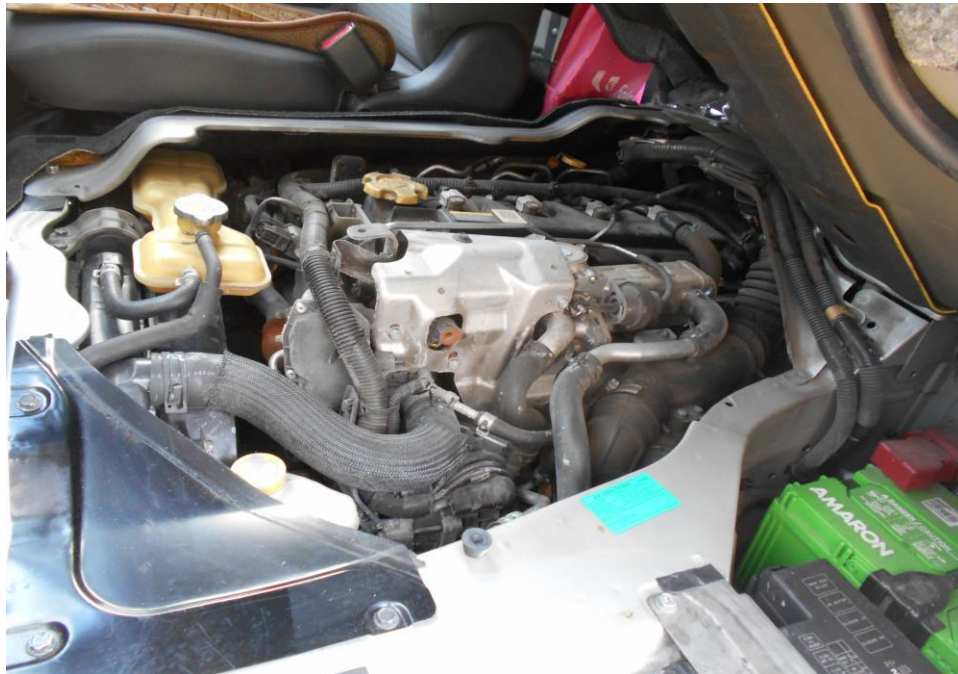
**Photo 11** shows a general view of the Motor Bus's engine compartment. The various parts and components inside the engine compartment were unaffected by the accident. There was also no sign(s) or indication(s) of fluid leakage and/or fluid stain within the engine compartment.

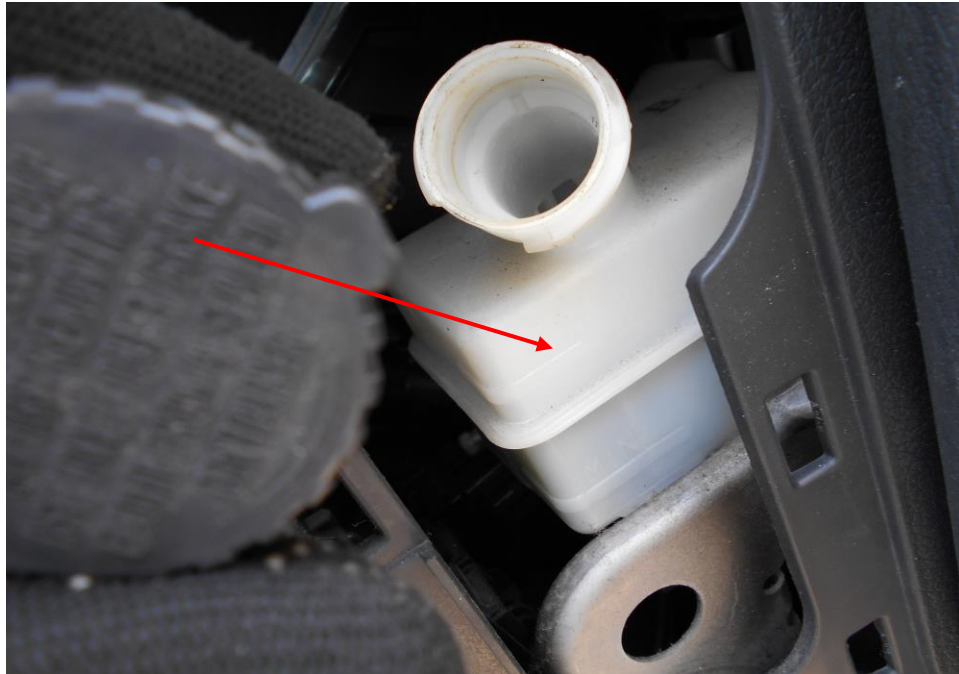
**Photo 12** shows the brake fluid reservoir of the Motor Bus at the time of our inspection. The brake fluid was observed to be of sufficient level and without any visible contamination.

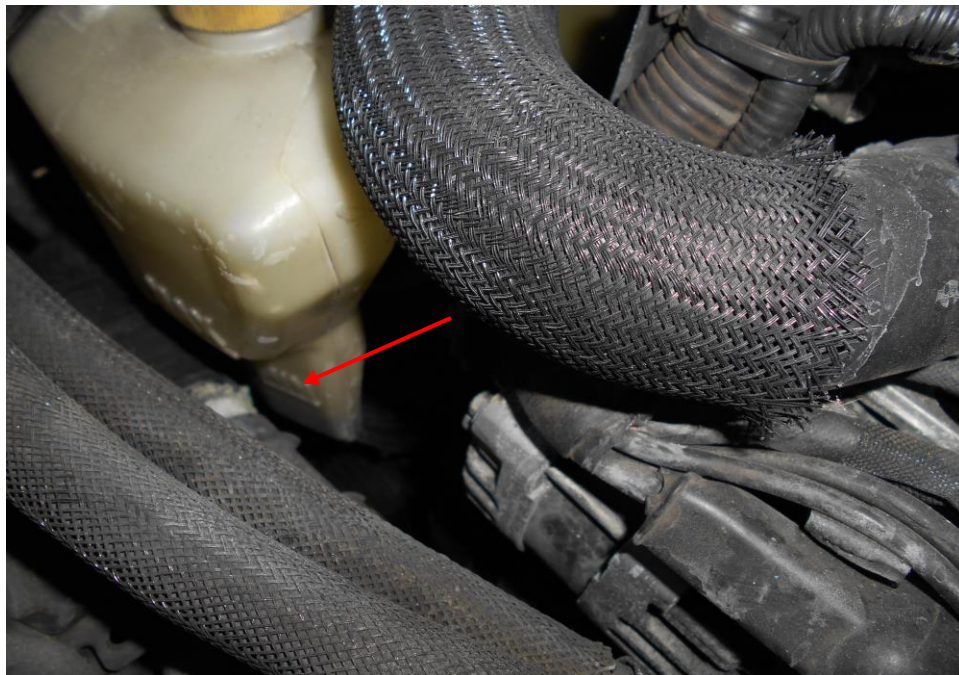
**Photo 13** shows the engine coolant fluid of the Motor Bus at the time of our inspection. It was observed to be of sufficient level and without any visible contamination.

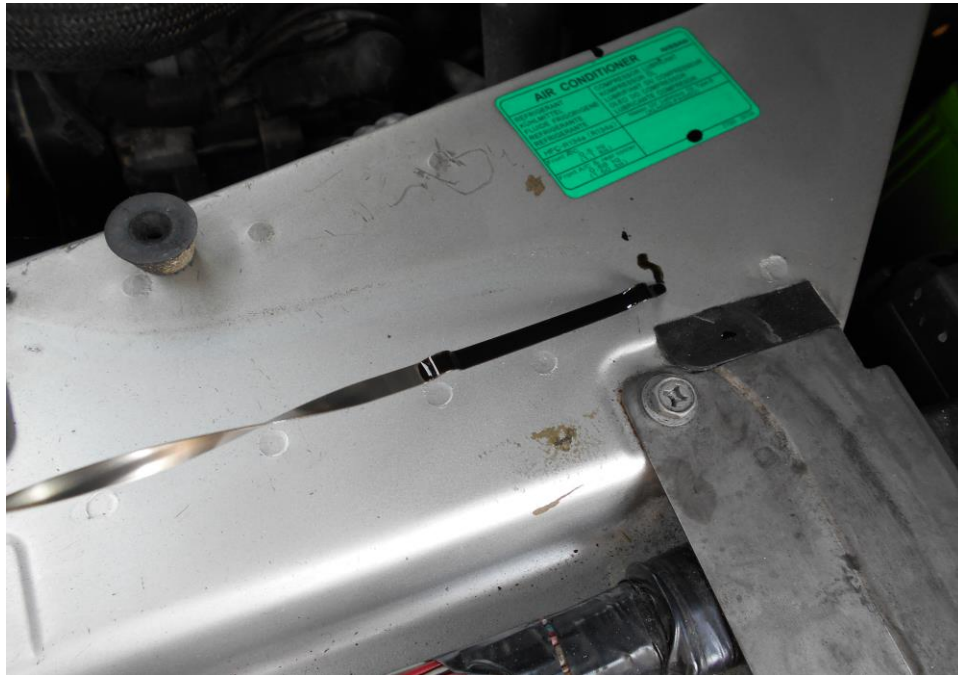
**Photo 14** shows the engine dip stick of the Motor Bus at the time of our inspection. The engine oil was observed to be of sufficient level and without any visible contamination.

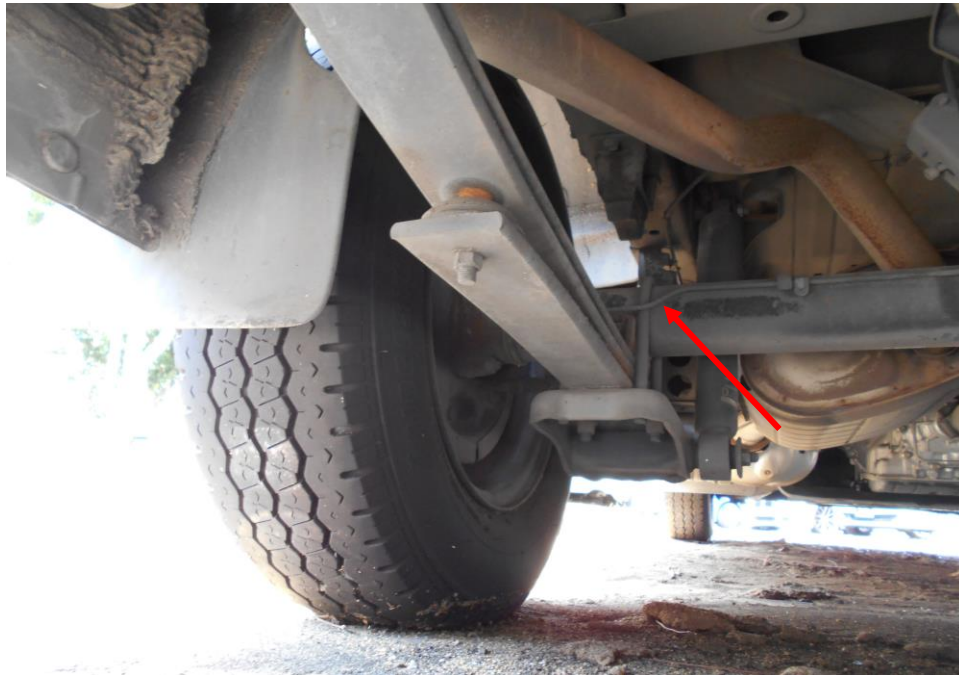
**Photo 15** shows the various undercarriage components at the rear left wheel of the Motor Bus, in particular the brake hose (arrowed). We did not observe any leakage of brake fluid at the time of our inspection of the Motor Bus.

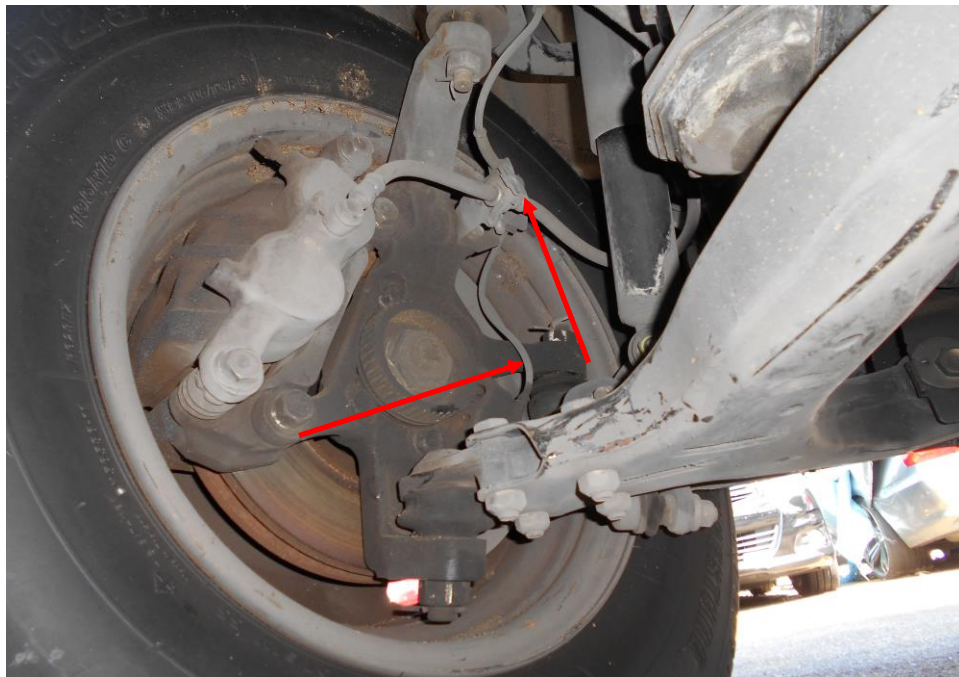
**Photo 16** shows the brake hose at the front left wheel of the Motor Bus. We did not observe any leakage of brake fluid. Our visual inspection of the various mechanical components of the Motor Bus's braking system revealed all to be intact and without visible damage, indicating that the braking system was likely to be in serviceable condition at the material time of accident.

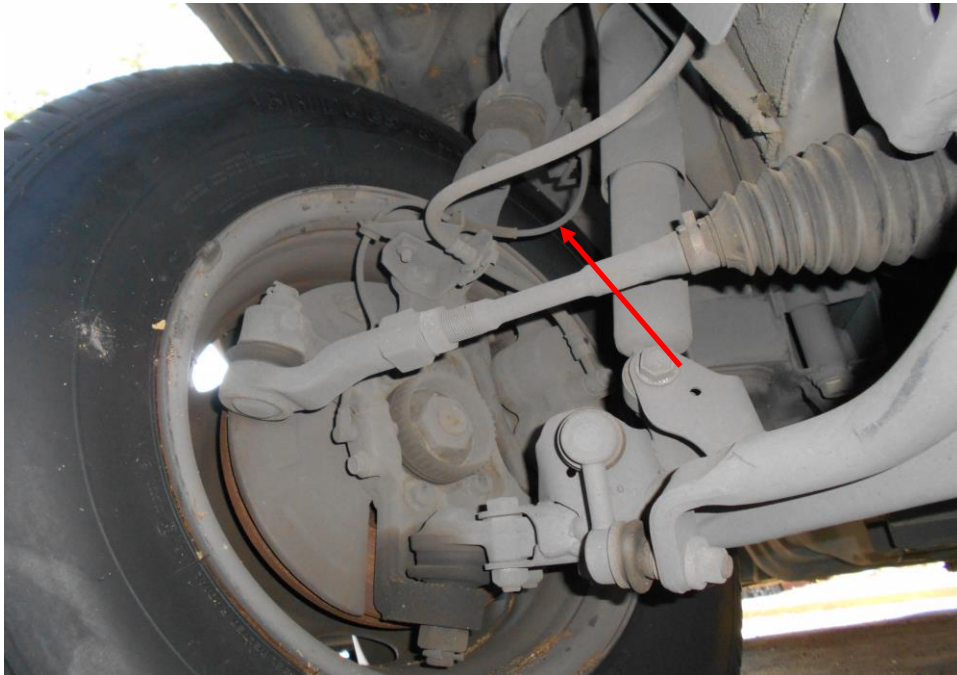
**Photo 17** shows the brake hose (arrowed) at the front right wheel of the Motor Bus. We did not observe any leakage of brake fluid at the time of our inspection of the Motor Bus. Our visual inspection of the various mechanical components of the Motor Bus's braking system, including its brake calliper, revealed all to be intact and without visible damage.

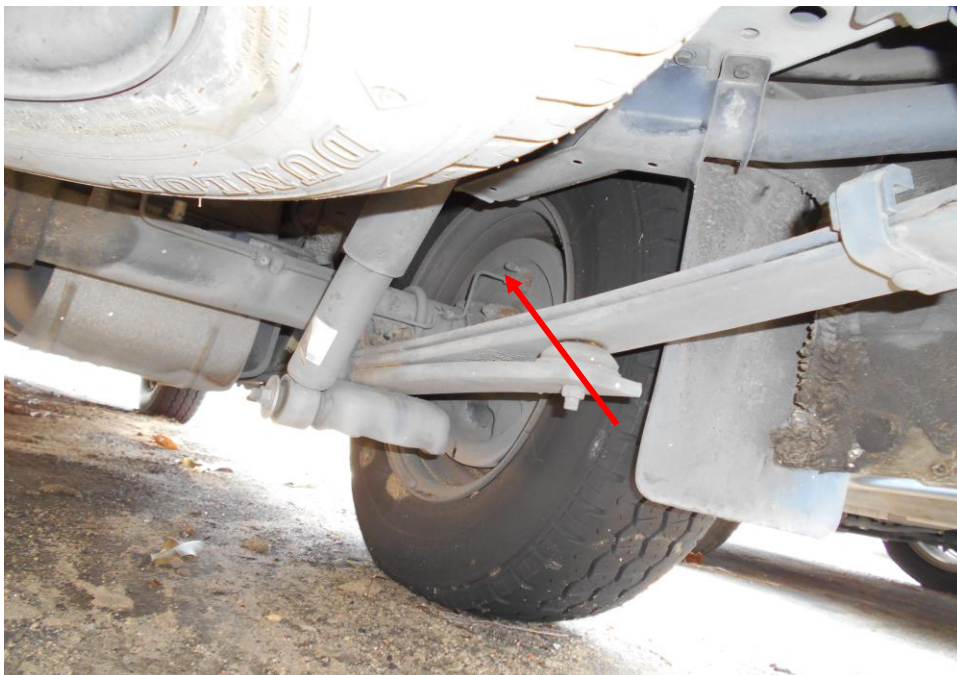
**Photo 18** shows the various undercarriage components at the rear right wheel of the Motor Bus. The various steering components were all found to be intact, suggesting that the steering system of the Motor Bus was likely to be in serviceable condition at the material time of accident. There was also no sign of fluid stain(s) observed on the various undercarriage components at the 4 wheels of the Motor Van.

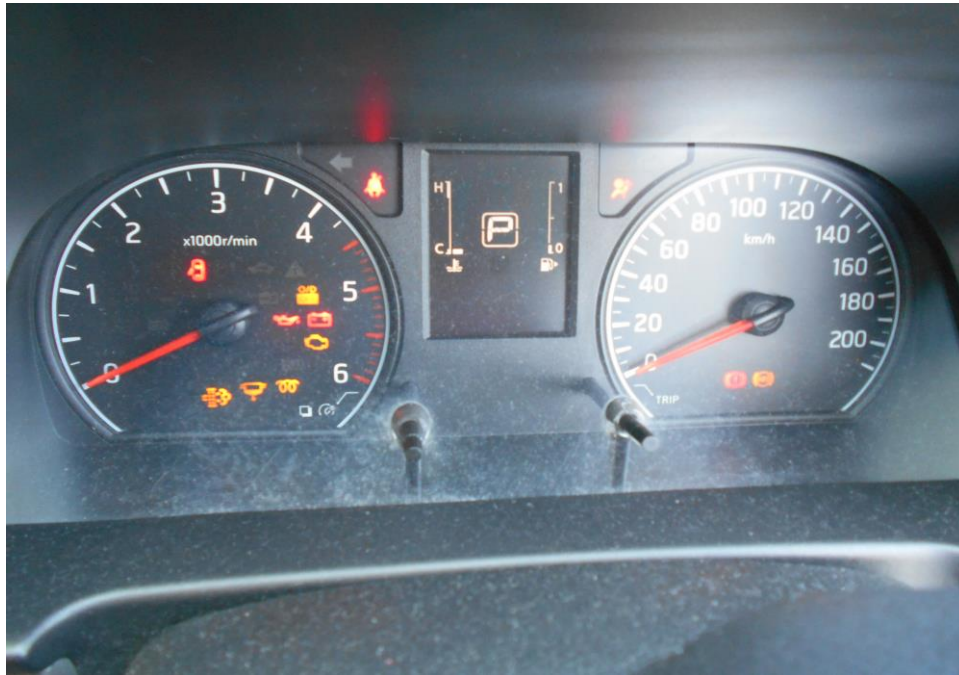
**Photo 19** shows the warning lights for the various electronic operating systems of the Motor Bus appearing on its instrument panel during the self-test when the engine was cranked.

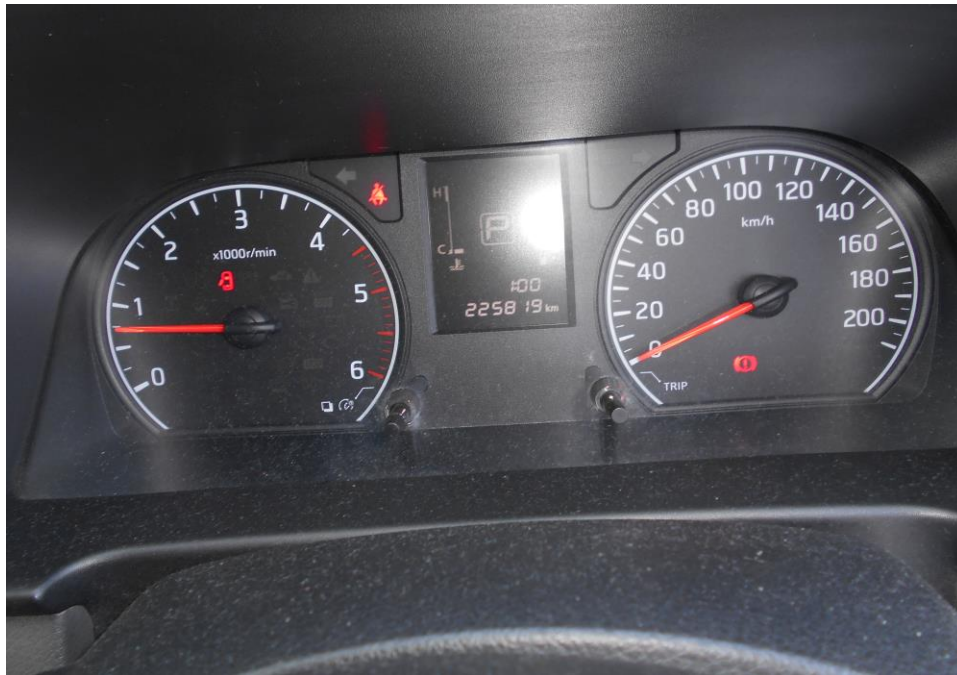
**Photo 20** shows no warning lights illuminated on the instrument panel of the Motor Bus after the engine was cranked. This would suggest that there was no abnormality to the various electronic operating systems of the Motor Bus.

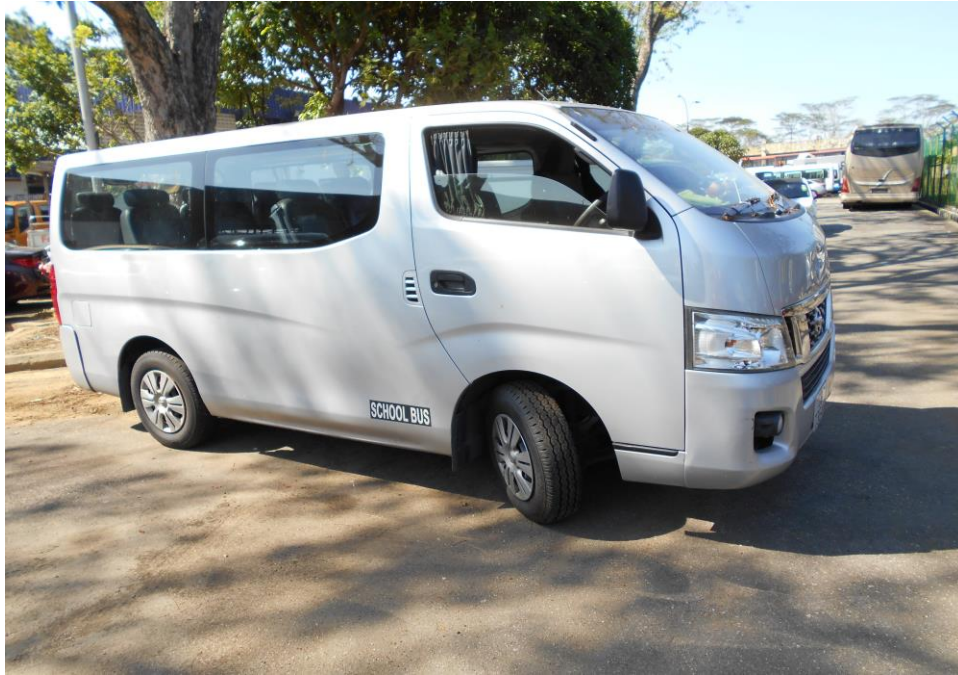
**Photo 21** shows a short operational test of the Motor Bus, to primarily determine whether there was any abnormality to its various operating systems like its engine system, its transmission system, steering system and braking system was subsequently carried out. The test was conducted by driving the Motor Bus forward, stopping, before reversing and coming to a stop again.

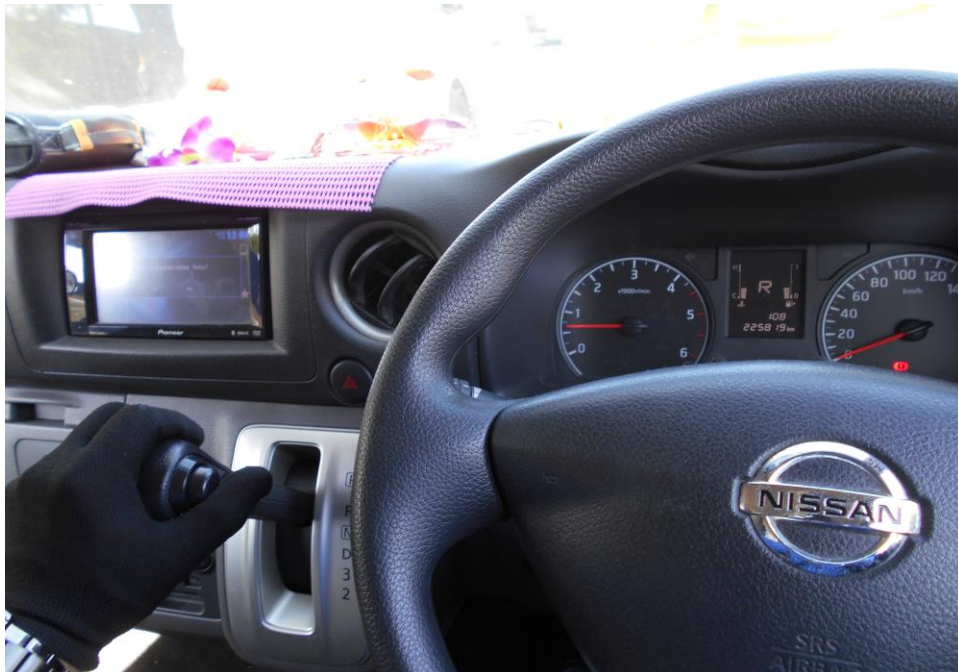
**Photo 22** shows a short operational test of the Motor Bus, the test was conducted by driving the Motor Bus forward, stopping, before reversing and coming to a stop again.
