Your Ref: TP/IP/58303/2018  
Our Ref :CI/TPD18022204/Z

**Fatal Accident Investigation Team**

**MECHANICAL INSPECTION REPORT OF MOTORCYCLE FW 8717X**

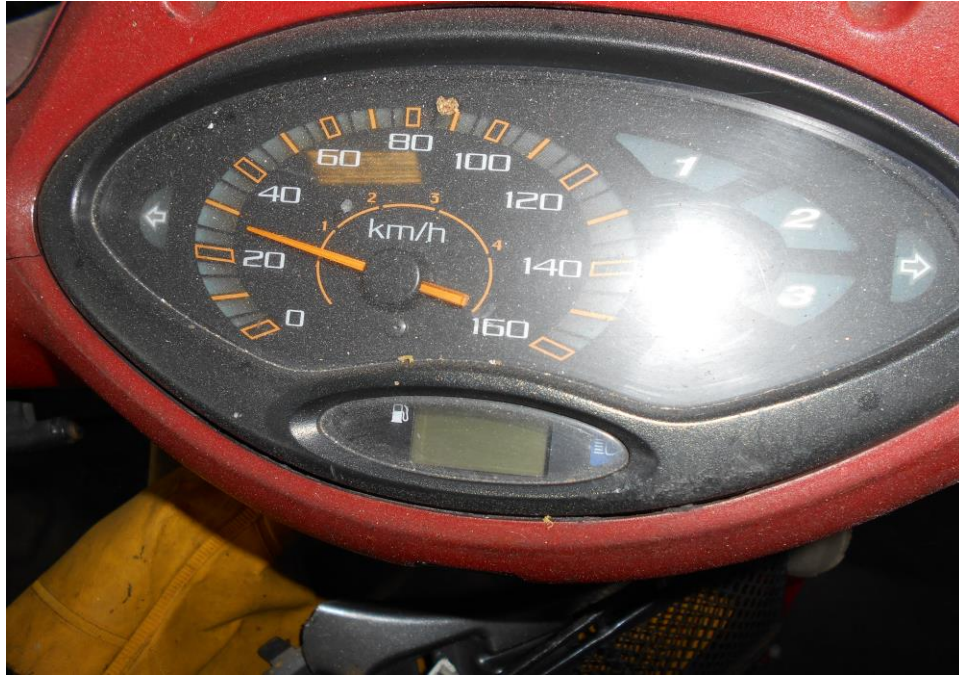
4. The mileage of the Motorcycle was not recorded due to the damages sustained to the ignition system as a result of the accident.
5. The Motorcycle was observed to have sustained minor damages at the frontal, left and right portion. The body parts that were found to have been damaged include its front right wing mirror, rear bracket, dislodged seat, middle bucket compartment and left mudguard amongst others as a result of the accident.
6. This was likely due to the consistency of the accident's case facts that the Motor Cycle rider was travelling along Ubi Avenue 3 towards Kaki Bukit where at the signalised junction of Eunus Link, he was being hit by a Motor Car (SGK 2283X) coming from his left side. See photo 1 to 7 below.

**Photo 1** shows a close-up view of the mileage meter at time of our inspection. It was unable to be operated likely due to the accident's impact which affects the ignition system.

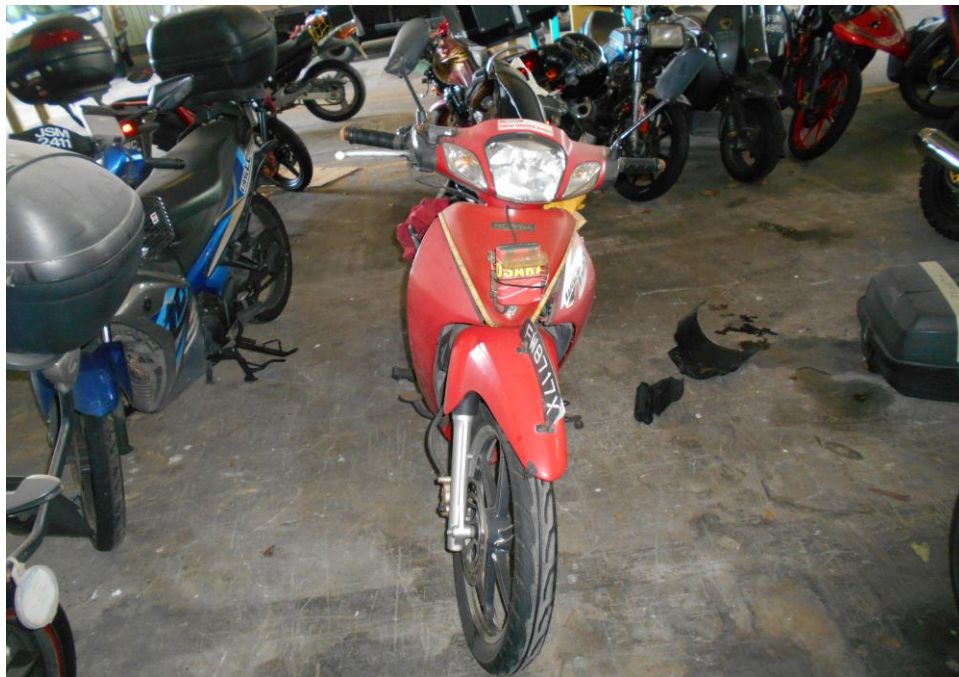
**Photo 2** shows a general view of the front body of the Motorcycle at the time of our inspection. The Motorcycle was observed to have sustained relatively minor damages at time of inspection. The damages were observed to be confined to its frontal, left & right side of the Motor Cycle.

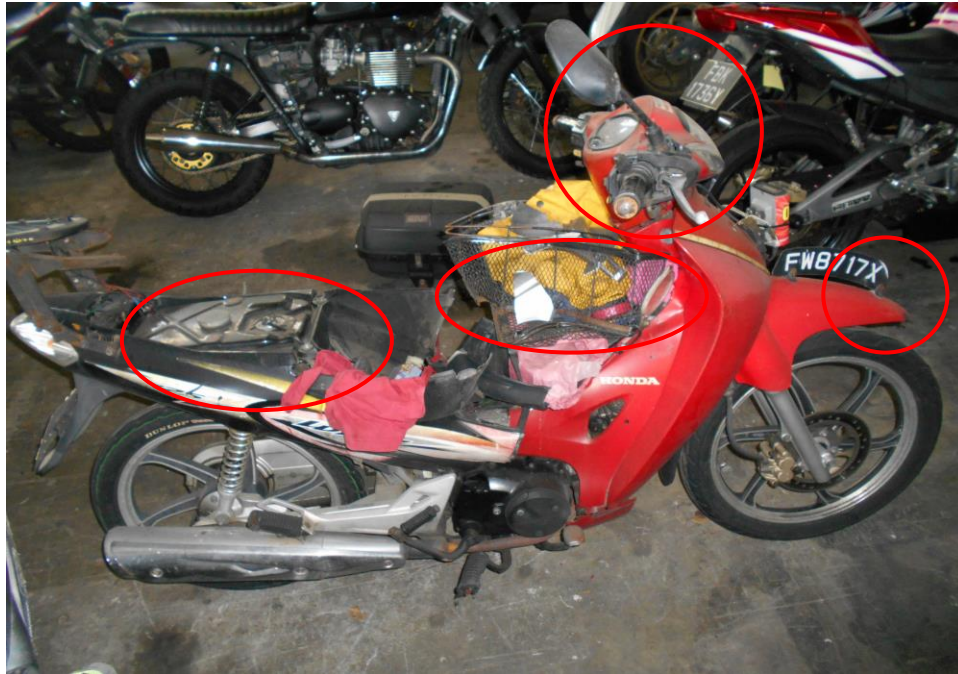
**Photo 3** shows a general view of the right body of the Motorcycle at the time of our inspection. The Motorcycle was observed to have sustained relatively minor damages on the right side of the Motor Cycle at time of our inspection.

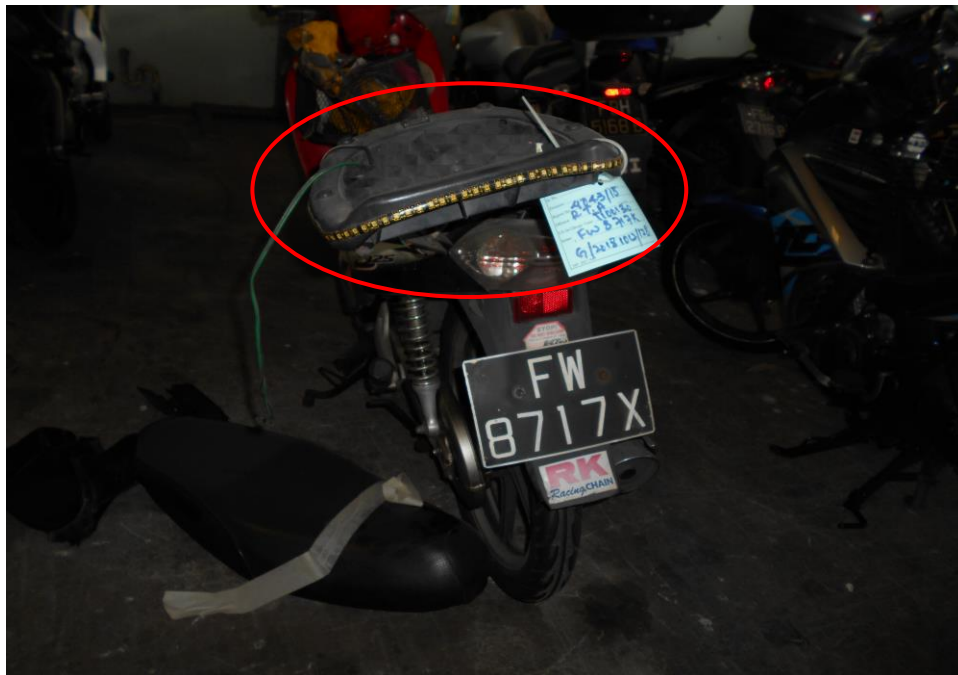
**Photo 4** shows a general view of the rear body of the Motorcycle at the time of our inspection. The Motorcycle was observed to have sustained relatively minor damage on the rear compartment bracket at time of our inspection.

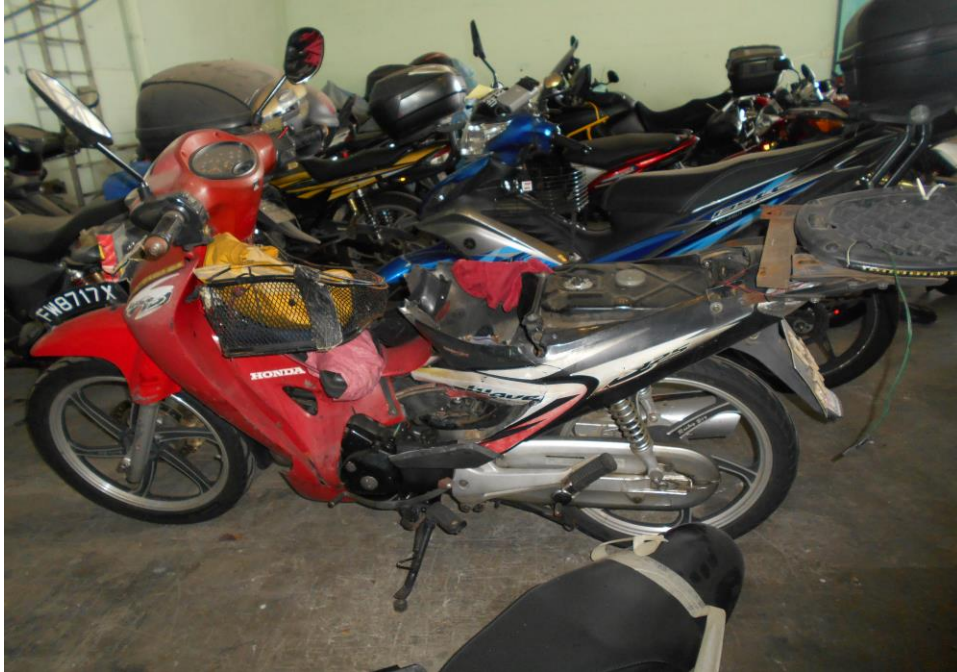
**Photo 5** shows a general view of the left body of the Motorcycle at the time of our inspection. The Motorcycle was observed to have sustained relatively minor damages on the left side of the Motor Cycle at time of our inspection.

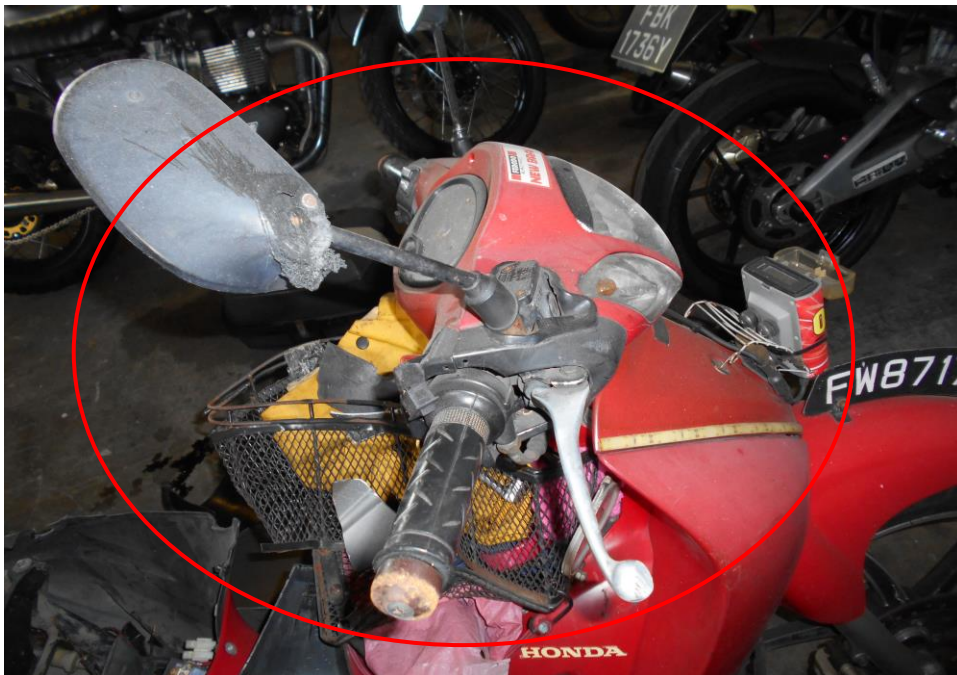
**Photo 6** shows a closer view of the front right portion of the Motorcycle at the time of our inspection. The Motorcycle was observed to have sustained with relatively minor damages due to the accident collision. (Circled)

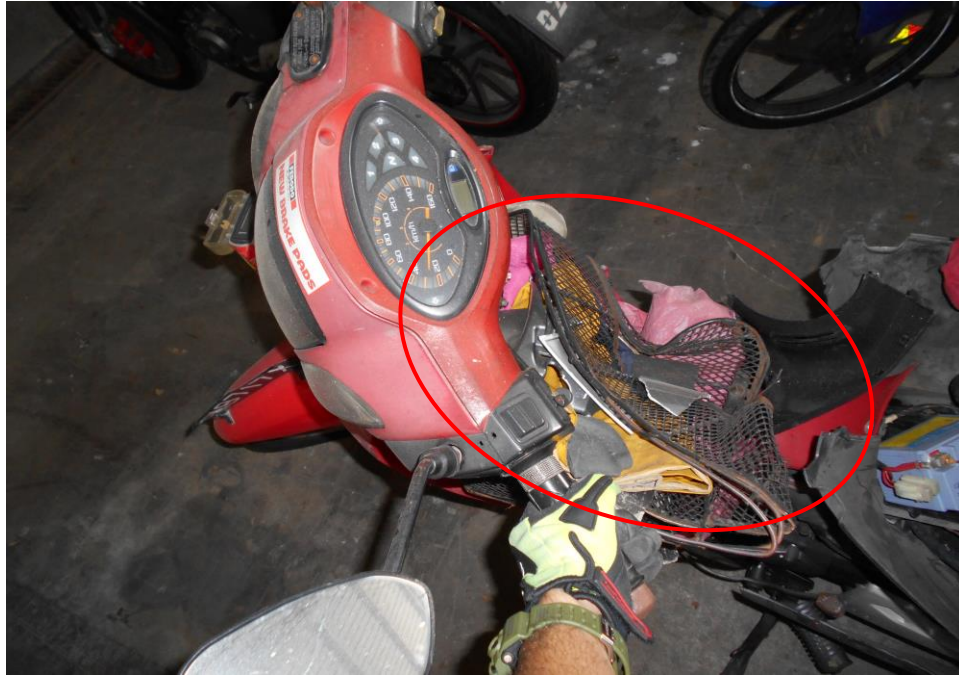
**Photo 7** shows a closer view of the middle bucket compartment of the Motorcycle at the time of our inspection. The Motorcycle was observed to have sustained with relatively minor damages due to the accident collision. (Circled)

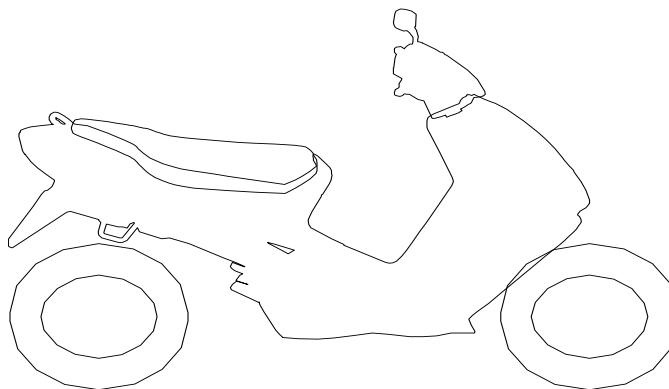
7. The condition of the Motorcycle's 2 tyres was observed to be in serviceable condition. The tread pattern of the 2 tyres was clearly visible. We did not observe any tear, burst mark(s) and/or punctured hole(s) on the sidewalls as well as across the tread of the 2 tyres. The 2 tyres were both observed to be sufficiently inflated for vehicular operation. The tyre brand, tyre size and remaining tread depth of the 2 tyres were recorded as follows:-

Dunlop TT900  
80/80 - R17 (4mm)

Dunlop TT900  
80/90 - R17 (4mm)

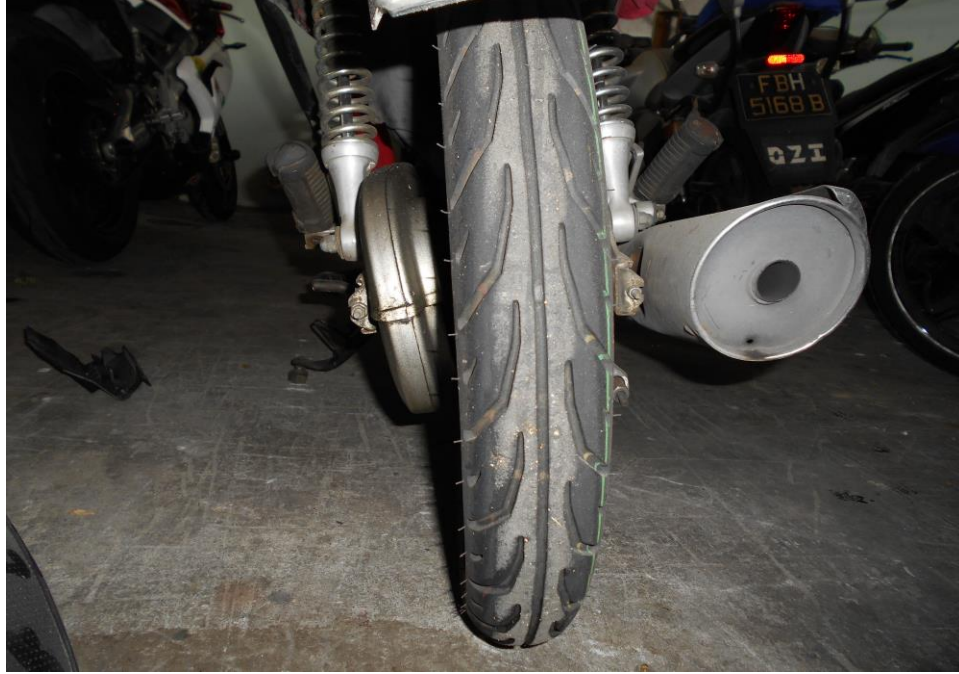
8. The rear tyre was wrapped around alloy wheel rims that were found to be without any significant damage. See photo 8 & 9 below

**Photo 8** shows the rear tyre of the Motorcycle. The rear tyre was observed to be in serviceable condition with remaining tread depth of approximately 4mm. The tyre was also observed to be sufficiently inflated for vehicular operation.

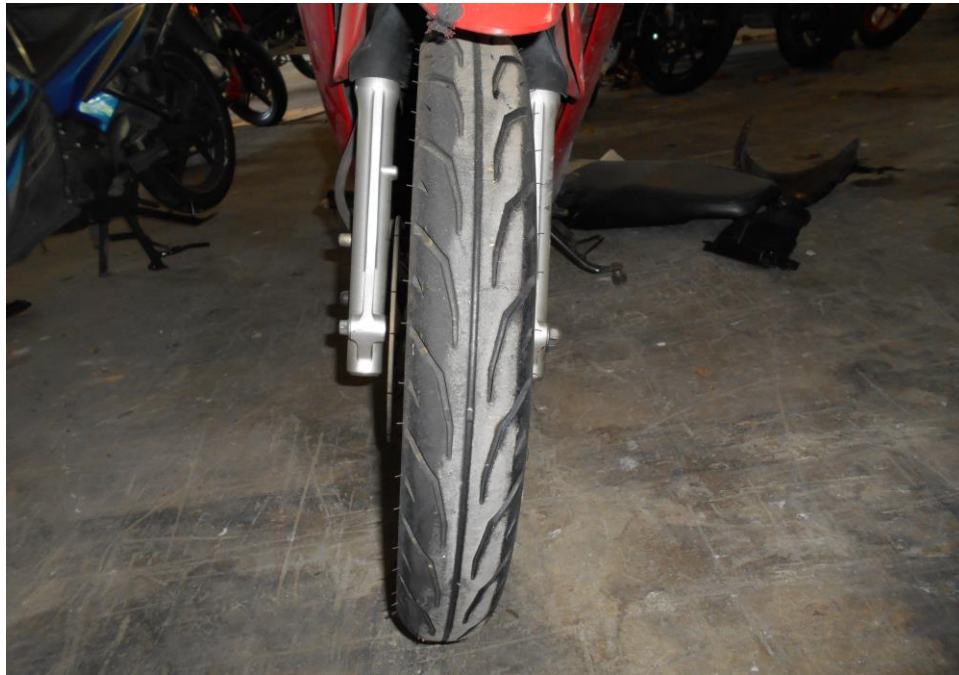
**Photo 9** shows the front tyre of the Motorcycle. The front tyre was observed to be in serviceable condition with remaining tread depth of approximately 4mm. The tyre was also observed to be sufficiently inflated for vehicular operation.

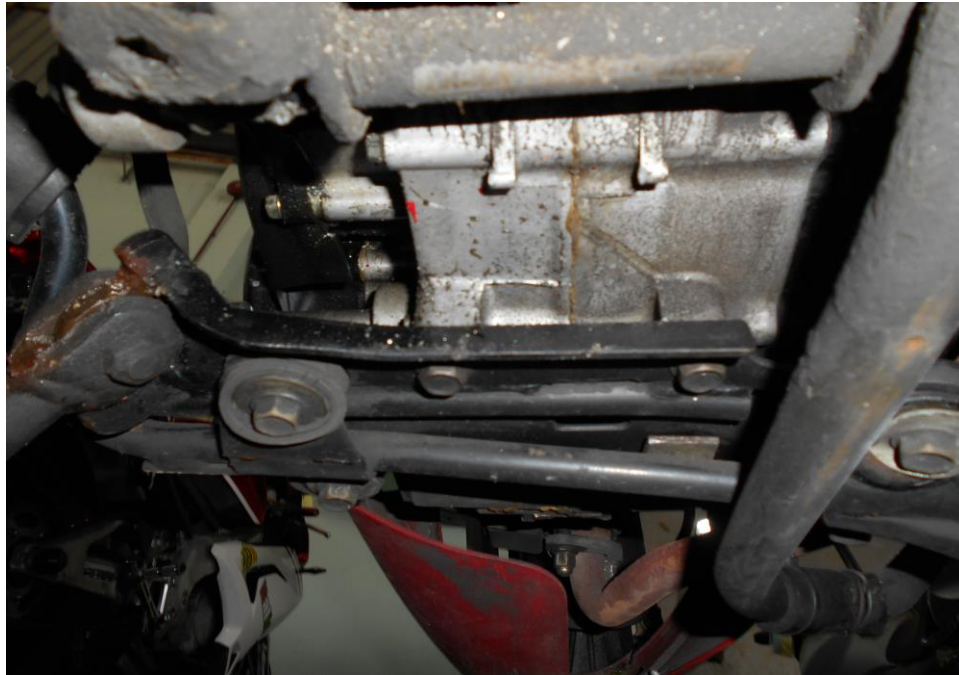
9. Upon examination of the Motorcycle's engine area, we had observed that the various engine related parts and components were intact with no visible damage. There was also no sign(s) or indication(s) of fluid leak observed around the engine area of the Motorcycle.
10. The gear chain of the motorcycle was found to be intact without any misalignment. It was also adequately lubricated for operating purposes. Free play tension test was also conducted & found adequately acceptable. See photo 10 – 12 below.

**Photo 10** shows no sign(s) or indication(s) of fluid leak observed around the underside of the engine area of the Motorcycle.

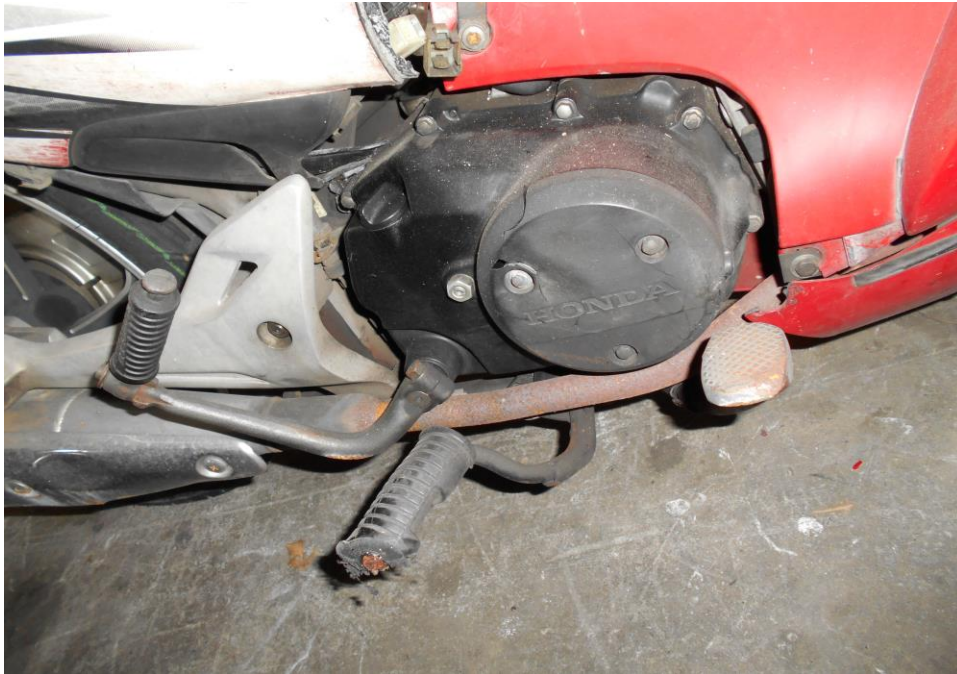
**Photo 11** shows no sign(s) or indication(s) of fluid leakage stain observed around the engine area of the Motorcycle.

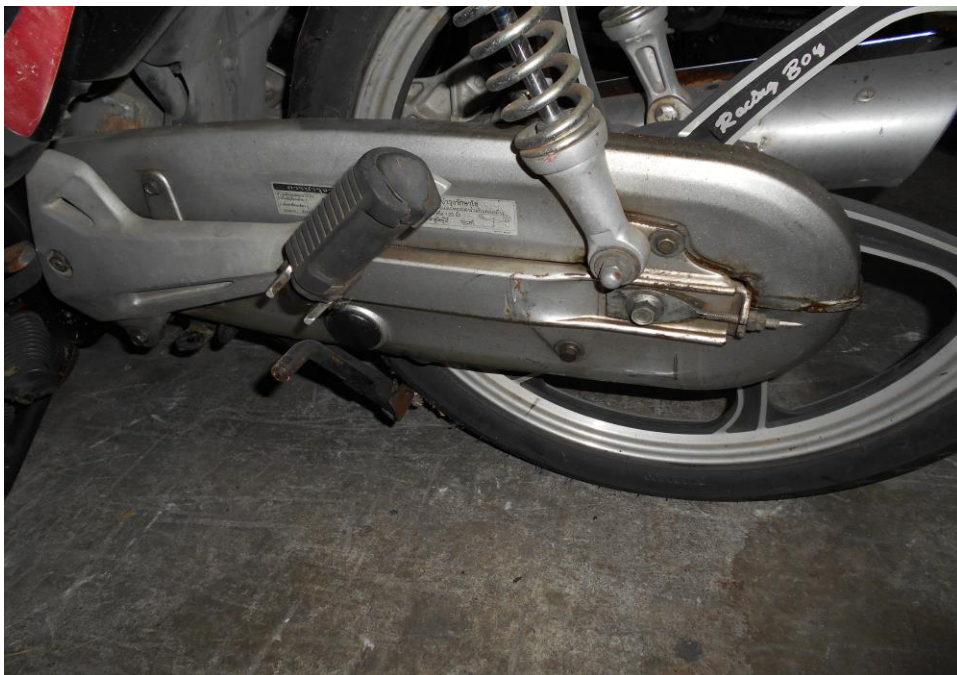
**Photo 12** shows the general view of the gear train (arrowed) of the Motorcycle, which was observed to be intact with no misalignment. It was also adequately lubricated for operating purposes.

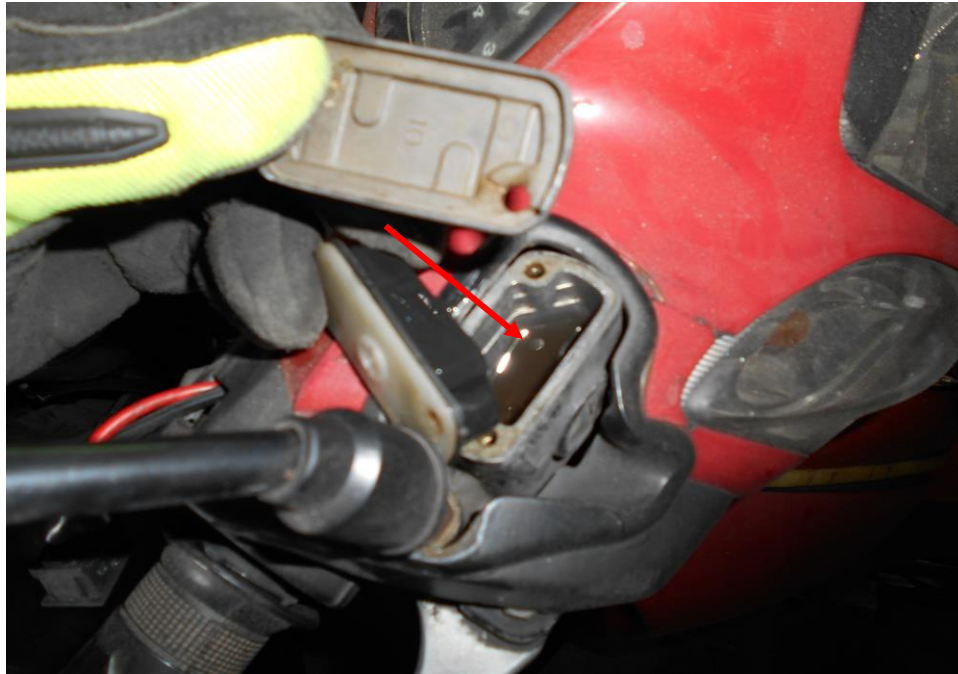
**Photo 13** shows our checks on the brake fluid (front) reservoir had also indicated that the brake fluid was of sufficient level for operational purposes, and without contamination.

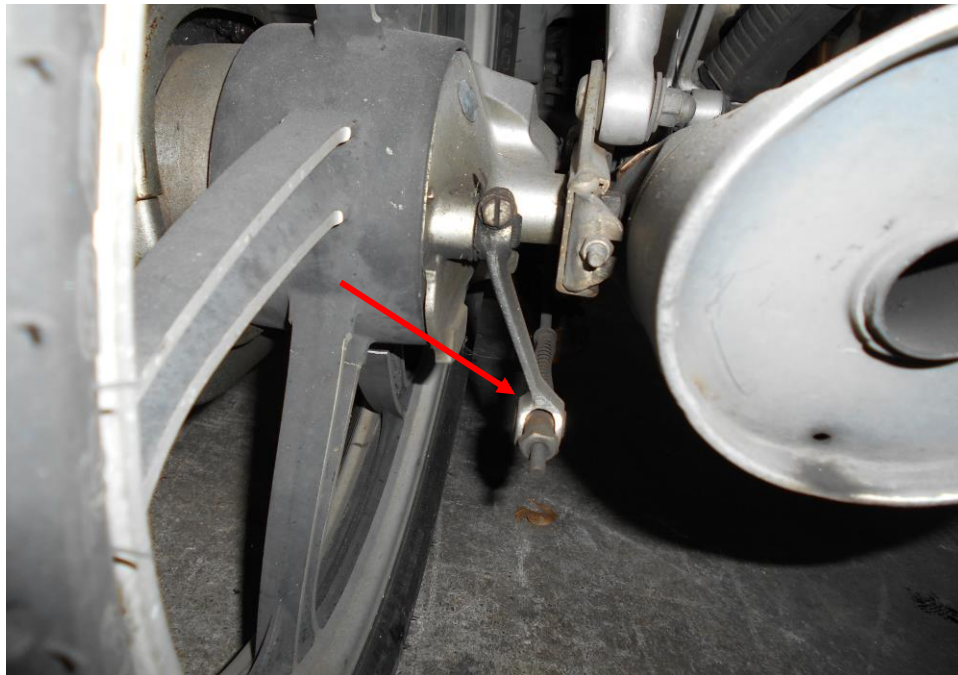
**Photo 14** shows our checks on the rear brake components had also indicated that the rear braking system was in serviceable condition at time of our inspection.

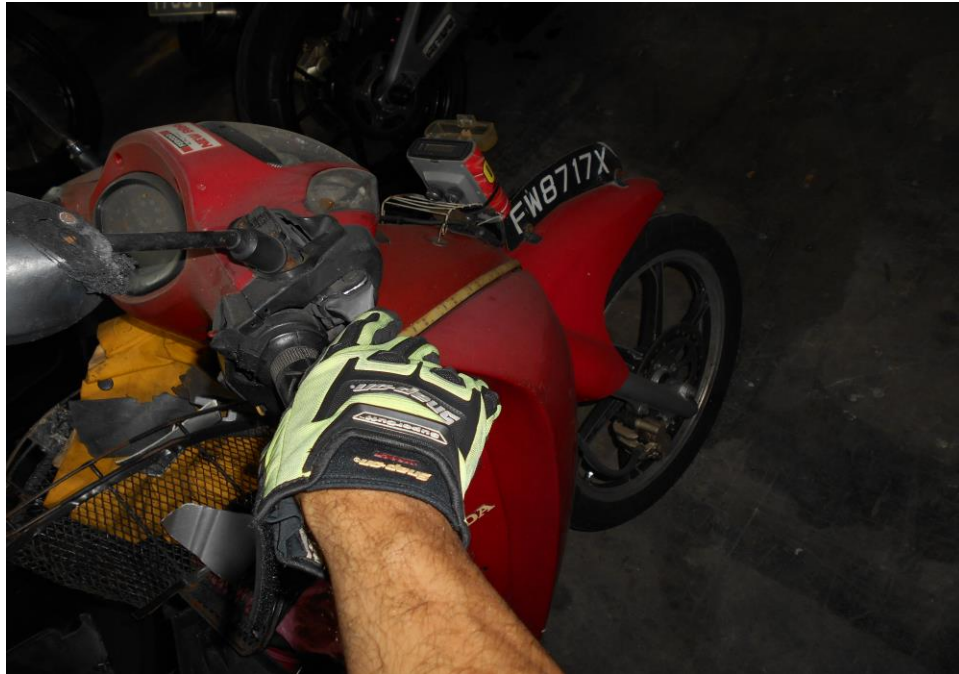
**Photo 15** shows testing of the braking of the front brake in progress. There was some resistance felt (spongy like feel) upon pressing the brake lever.

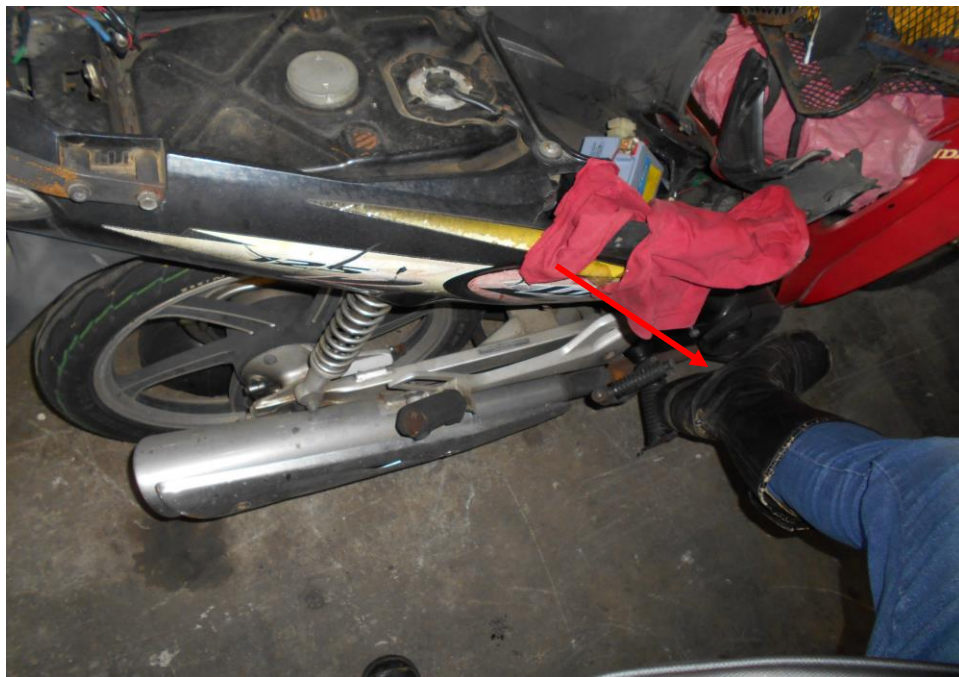
**Photo 16** shows testing of the braking of the rear brake in progress. There was some resistance felt (spongy like feel) upon stepping on the brake pedal.

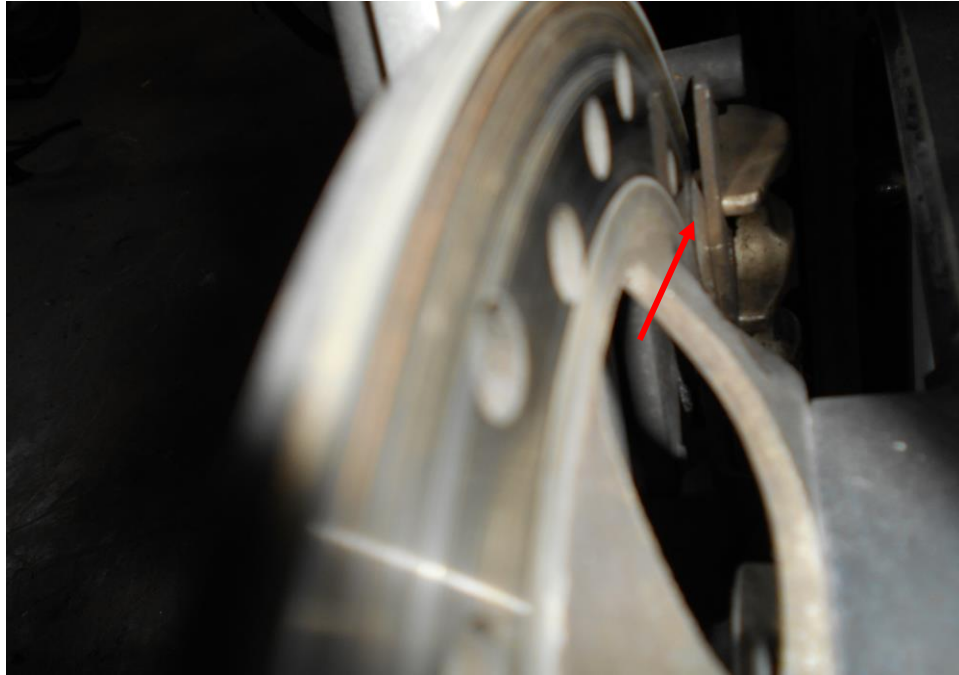
**Photo 17** shows the front brake pad at time of our inspection. The frictional material was observed to be sufficient for operational purposes.
