Your Ref: TP/IP/58303/2018
Our Ref : CI/TPD18022205/Z

MECHANICAL INSPECTION REPORT OF MOTOR CAR SGK 2283X

1. We refer to your request on 28th November 2018 to conduct a physical inspection of a motor car bearing registration number SGK 2283X (herein referred to as “**Motor Car**”), which was involved in a fatal road traffic accident on 12th October 2018.
2. The purpose of this inspection is to primarily determine if there was any possible mechanical failure to the Motor Car that may have contributed to the accident.
3. Following the request, we carried out a physical inspection of the Motor Car on 19th December 2018 at the premises of Traffic Police vehicle pound, 517 Airport Road Singapore 539942. We now set out below our observations and comments with respect to this inspection.

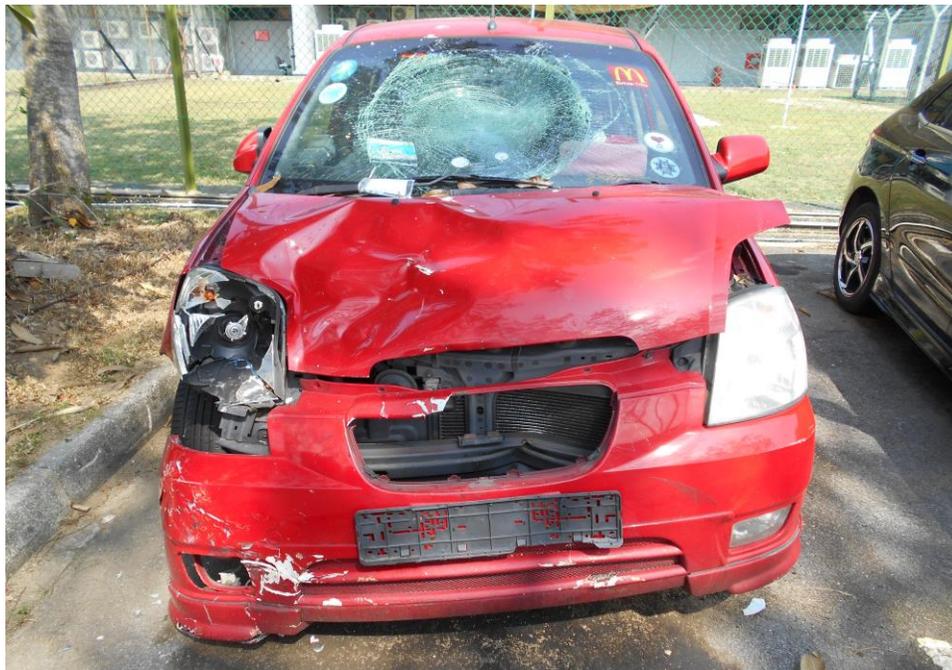
Photo 1 shows a general view of the frontal portion of the Motor Car at the time of our inspection. The Motor Car was observed to have sustained extensive impact damage at its frontal portion. The impact force was significant, causing the various parts and components inside the engine compartment to be damaged.

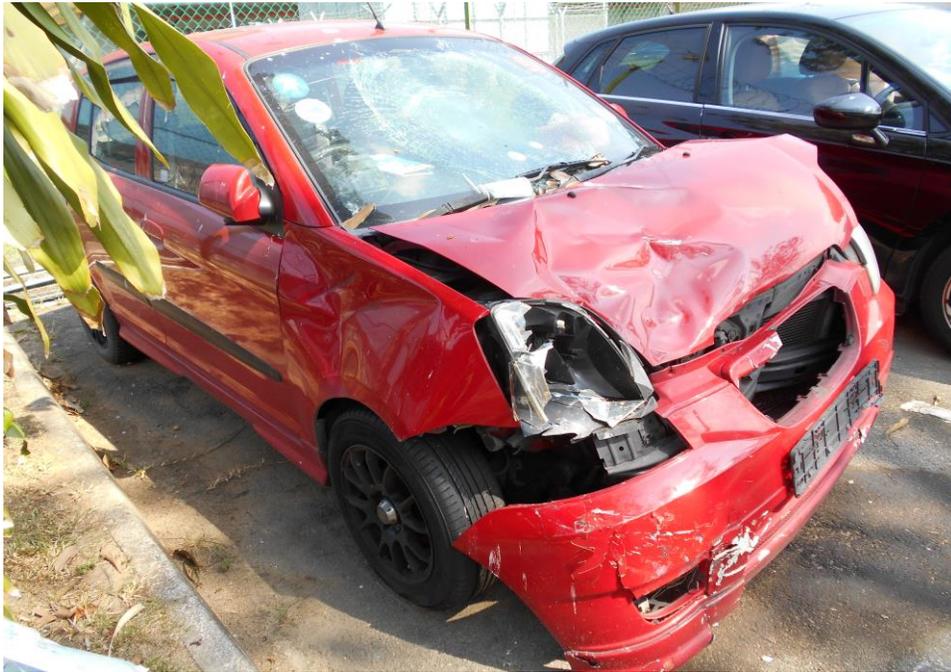
Photo 2 shows a general view of the front right portion of the Motor Car at the time of our inspection. The Motor Car was observed to have sustained extensive impact damage at its front right portion.

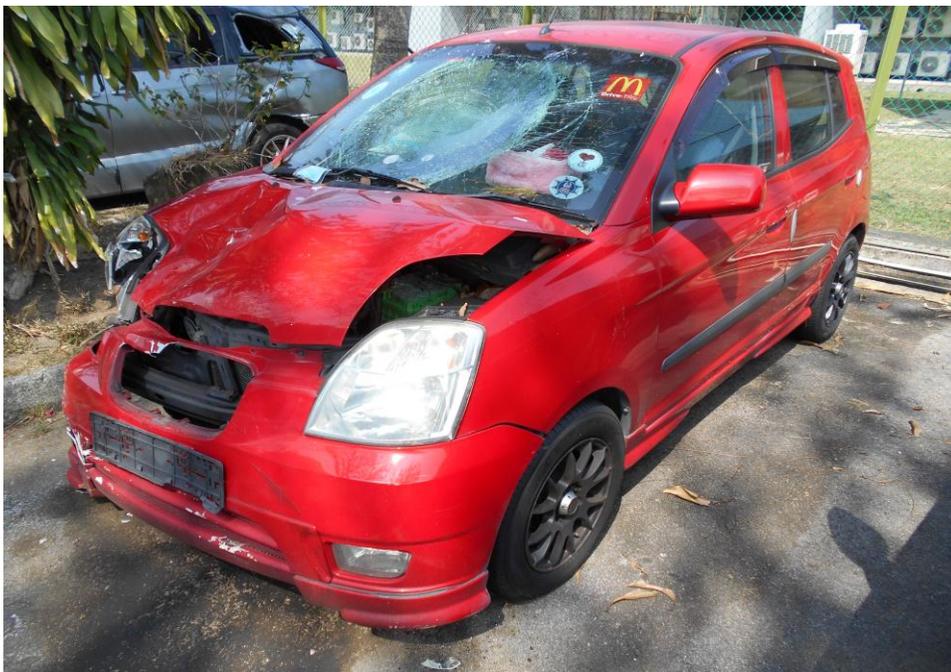
Photo 3 shows a general view of the front left portion of the Motor Car at the time of our inspection. The Motor Car was observed to have sustained extensive impact damage at its front left portion.

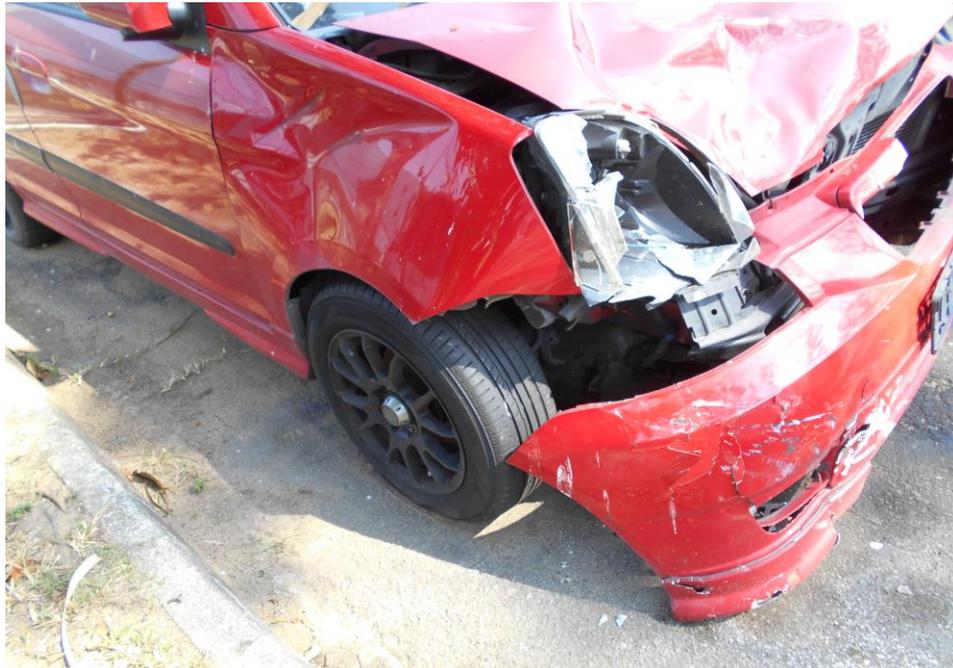
Photo 4 shows a closer view of the damage sustained on the front right of the Motor Car. The impact force was significant, causing the various parts and components inside the engine compartment to be pushed inwards, towards the rear of the Motor Car.

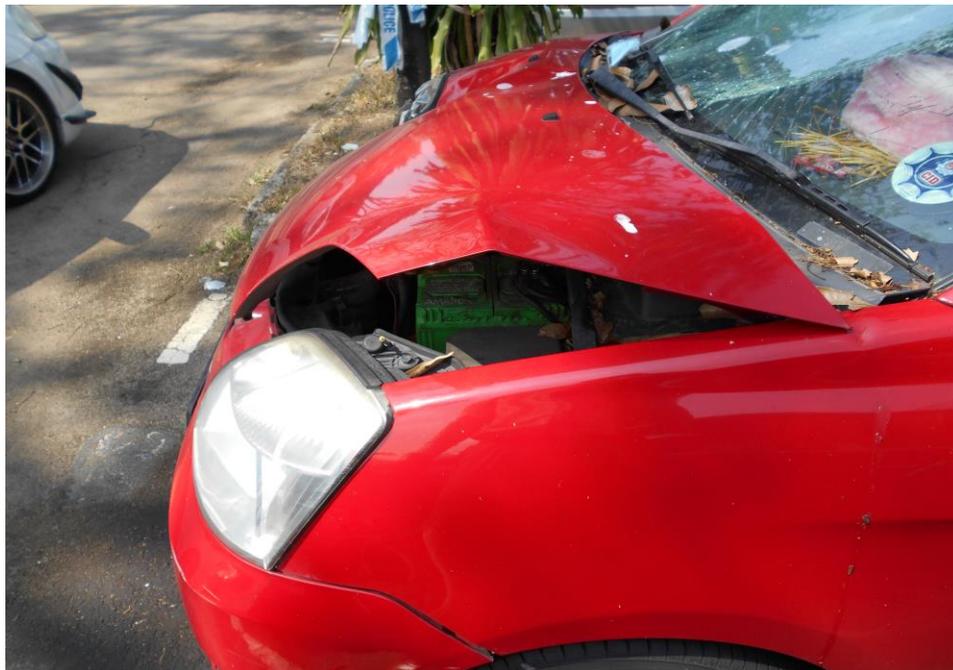
Photo 5 shows a closer view of the damage sustained on the front left of the Motor Car. The impact force was significant, causing the various parts and components inside the engine compartment to be pushed inwards, towards the rear of the Motor Car.

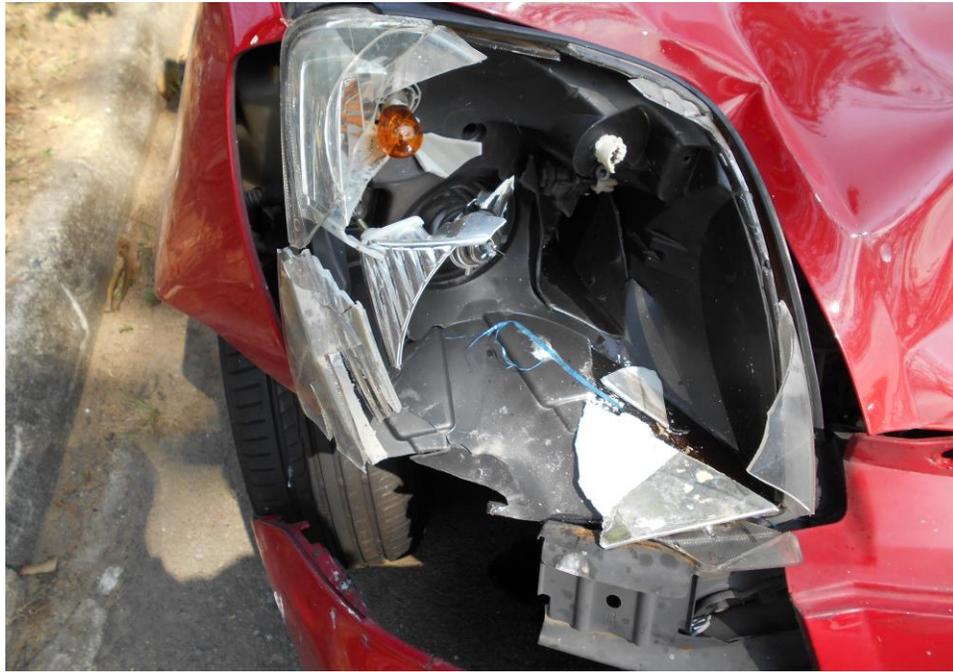
Photo 6 shows a closer view of the right side headlamp of the Motor Car. The impact force was significant, causing the various parts and components to be pushed inwards, towards the rear of the Motor Car.

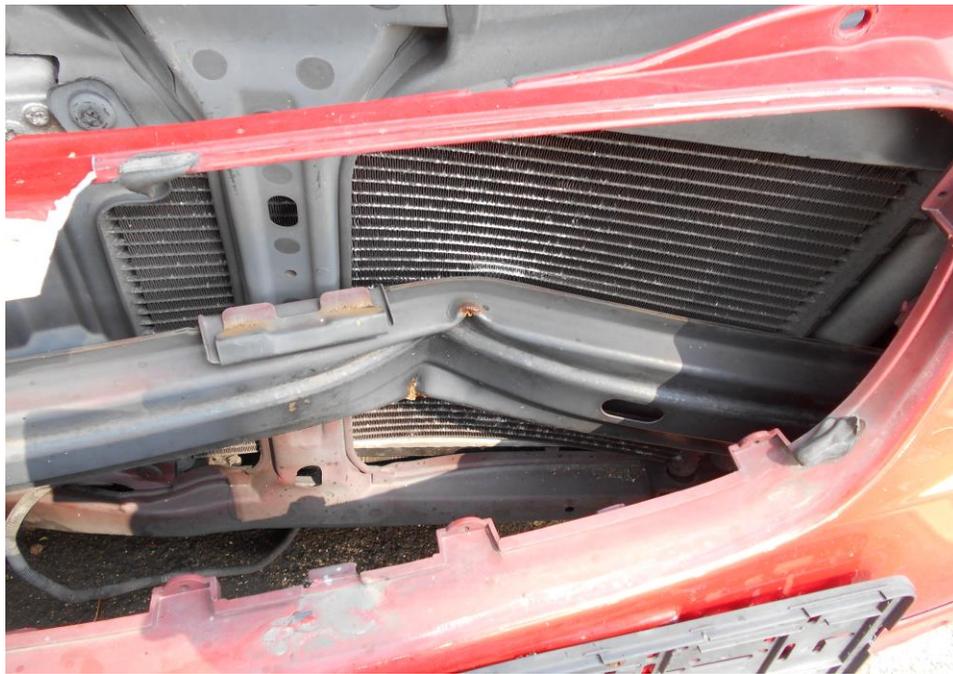
Photo 7 shows a closer view of the damaged radiator of the Motor Car from the front view. The impact force was significant, causing the various parts and components inside the engine compartment to be pushed inwards, towards the rear of the Motor Car.

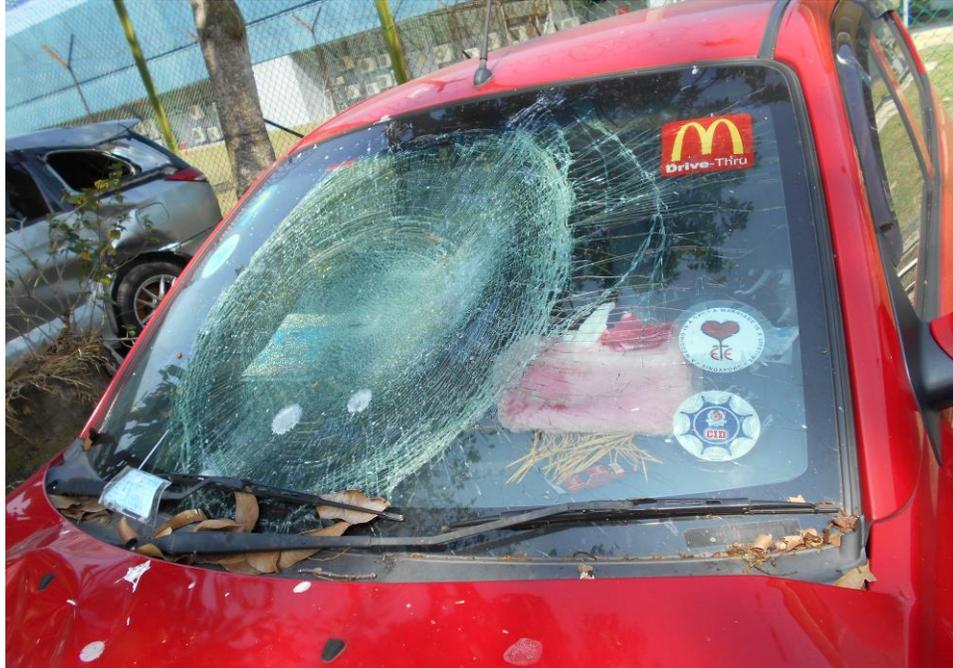
Photo 8 shows a closer view of the shattered windshield of the Motor Car. The impact force was significant, causing it to be cracked as a result of the accident.

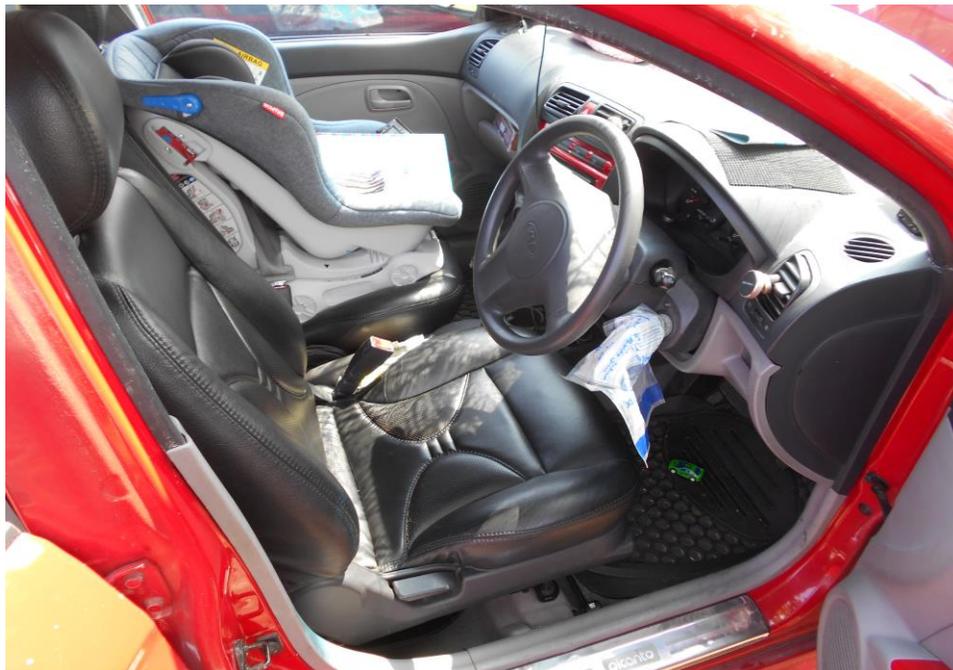
Photo 9 shows the interior portion of the Motor Car. The impact force did not affect the interior portion.

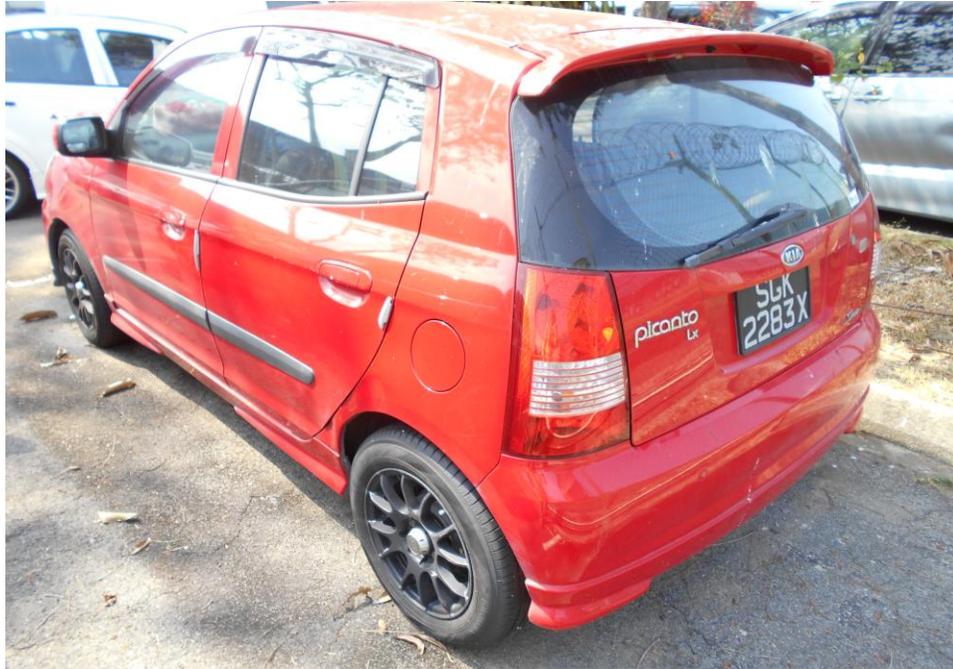
Photo 10 shows a general view of the rear left portion of the Motor Car at the time of our inspection. The rear portion was observed to be relatively unaffected by the accident.

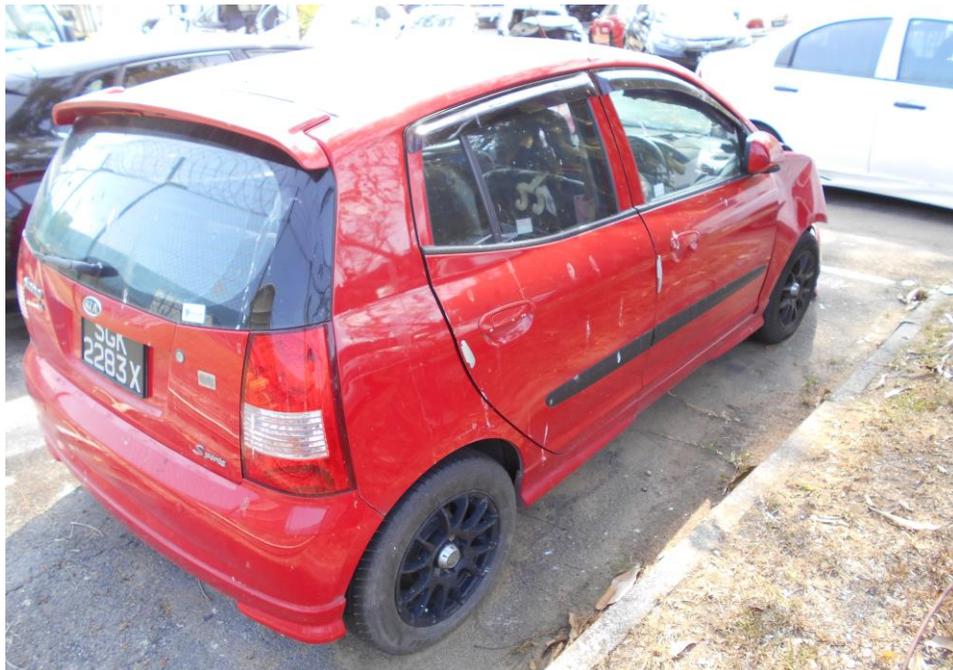
Photo 11 shows a general view of the rear left portion of the Motor Car at the time of our inspection. The rear portion was observed to be relatively unaffected by the accident.

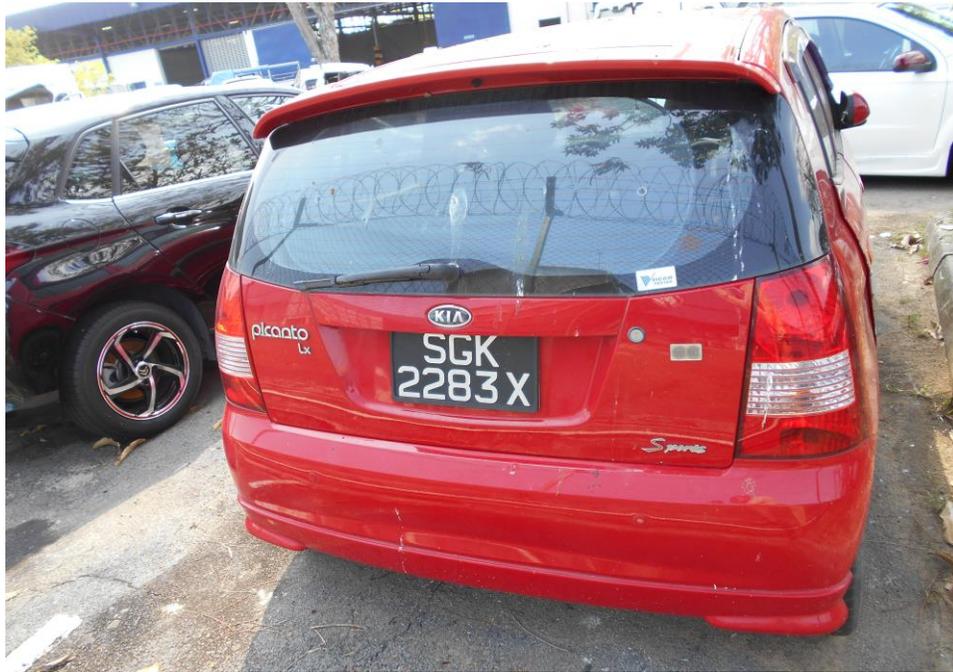
Photo 12 shows a general view of the rear right portion of the Motor Car at the time of our inspection. The rear portion was observed to be relatively unaffected by the accident.

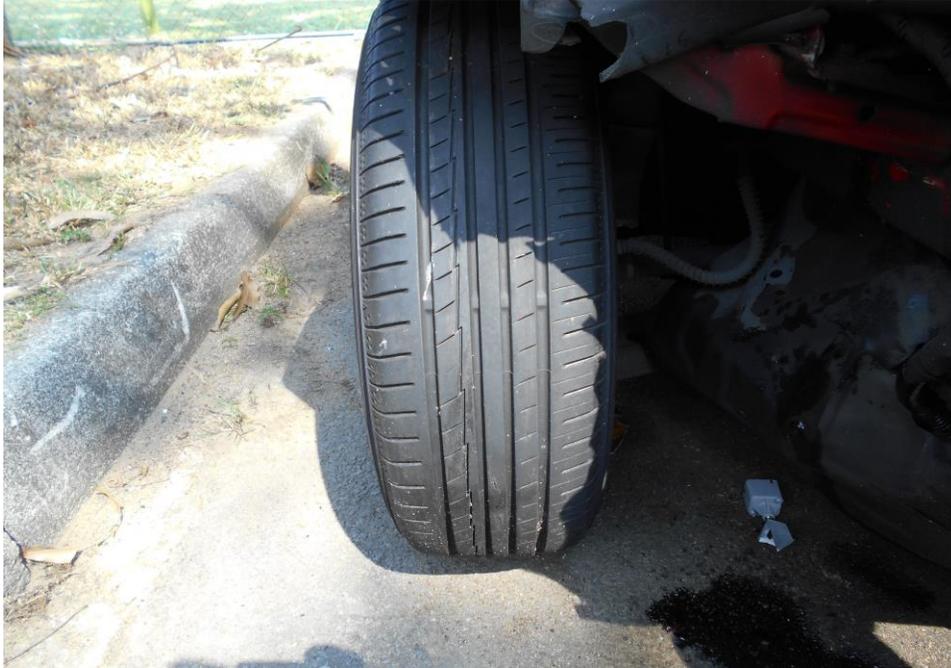
Photo 13 shows the condition of the front right tyre of the Motor Car, which was observed to be in serviceable condition with remaining tread depth of approximately 6mm.

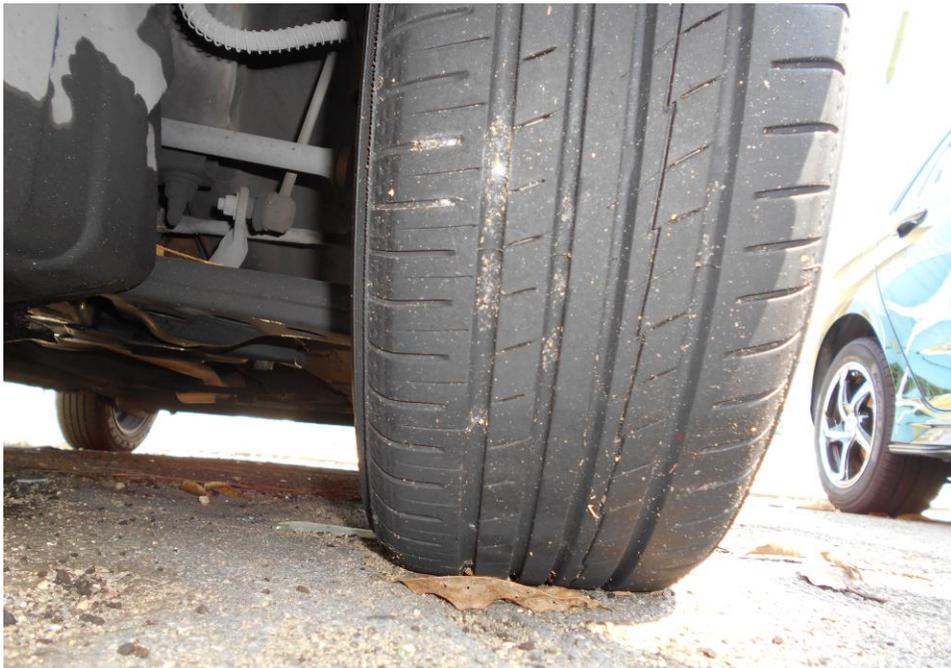
Photo 14 shows the condition of the front left tyre of the Motor Car, which was observed to be in serviceable condition with remaining tread depth of approximately 6mm.

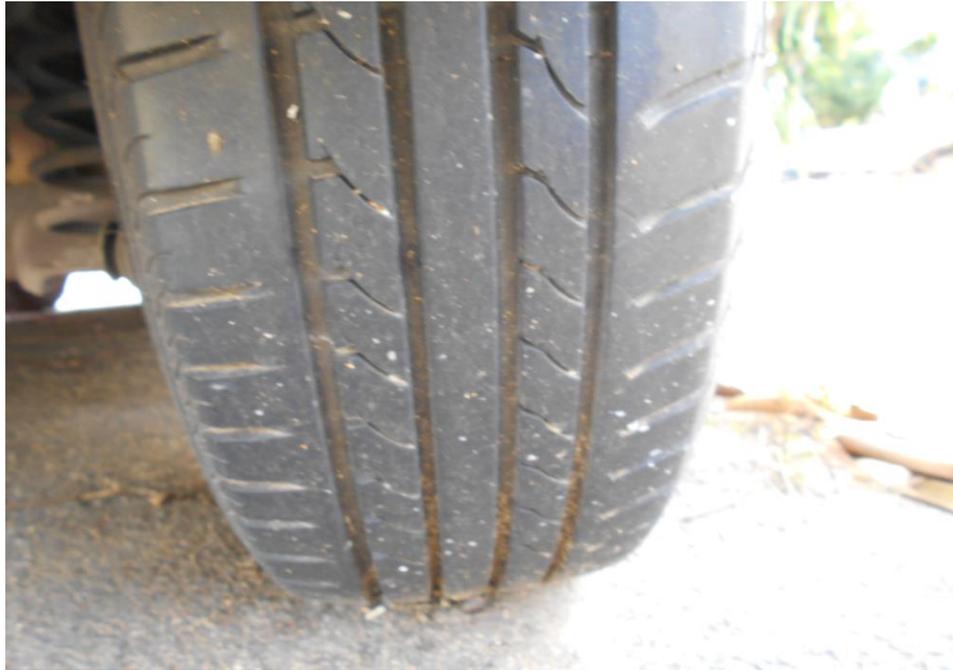
Photo 15 shows the condition of the rear right tyre of the Motor Car, which was observed to be in serviceable condition with remaining tread depth of approximately 5mm. There was also no tear, cut or burst mark(s) on the outer and the inner sidewalls as well as across the tread of this tyre.

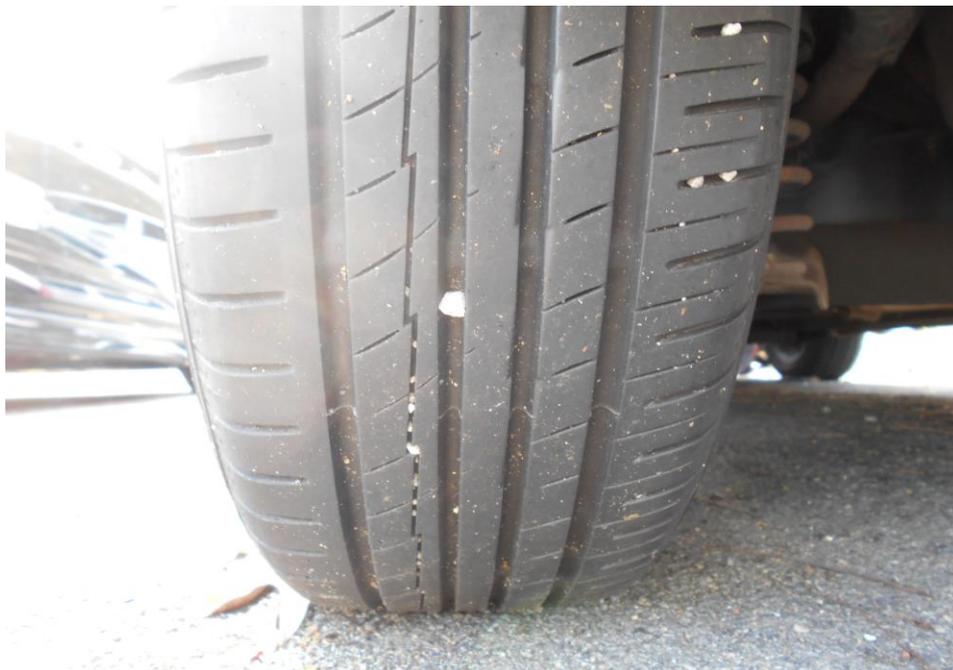
Photo 16 shows the condition of the rear left tyre of the Motor Car, which was observed to be in serviceable condition with remaining tread depth of approximately 5mm. There was also no tear, cut or burst mark(s) on the outer and the inner sidewalls as well as across the tread of this tyre.

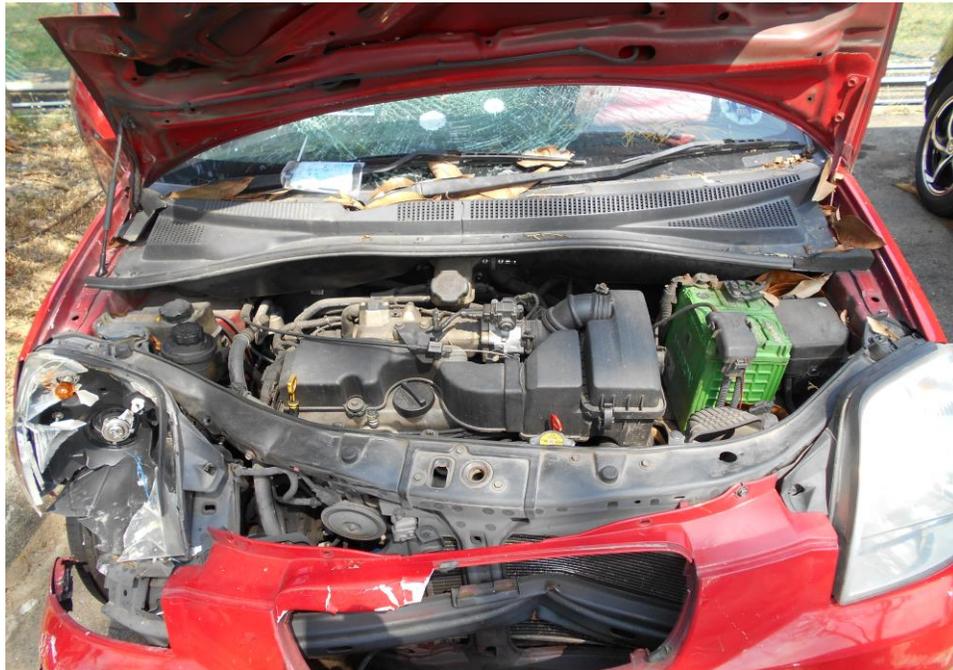
10. The engine compartment of the Motor Car was severely affected by the collision. Major parts and components inside the engine compartment were badly damaged. Parts like the radiator, power steering system amongst others were found to be damaged.

Photo 17 shows the close up view of the engine compartment of the Motor Car. It was observed to have sustained damages due to the accident's impact collision.

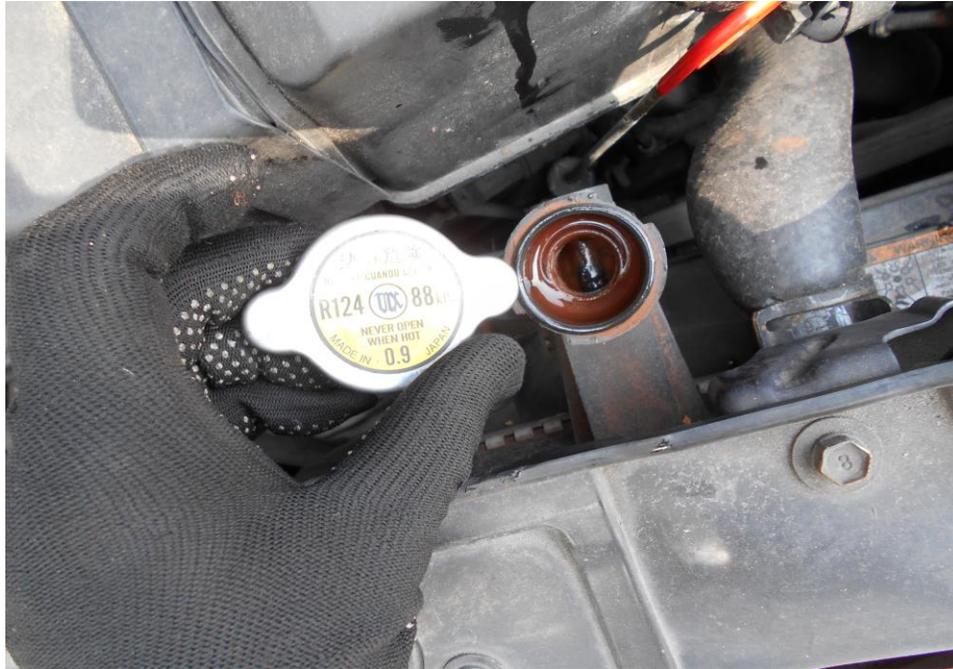
11. Leakage of the various operating fluids was noted. Operating fluid such as power steering fluids, engine coolant fluids were amongst the operating fluids that had sustained leakage from the respective tank/container. Given the extent of damages to the engine compartment, the leakages were likely due to the accident. The engine undercarriage was however observed to be covered with fresh fluid, suggesting leakage of fluid. There was no accumulation of dust and/or dirt particles on the engine housing where the fluid stains had formed. This would indicate that the fluid leakage was a fresh leak and likely to be a result of the accident. We were therefore unable to comment whether these operating fluids were of sufficient level and without contamination for vehicular operation prior to the accident. See photo 17 & 22 below.

Photo 18 shows the close up view of the radiator's coolant inlet. It was observed to be empty likely due to the leakage as a result of the accident.

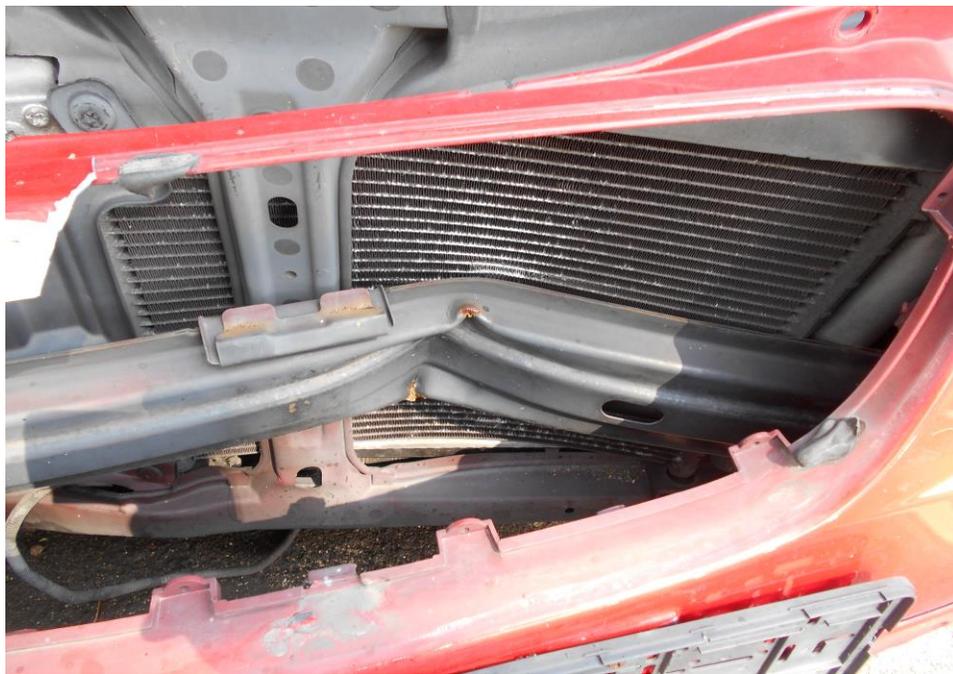
Photo 19 shows the close up view of the damaged radiator as a result of the accident which caused the coolant fluid leakage.

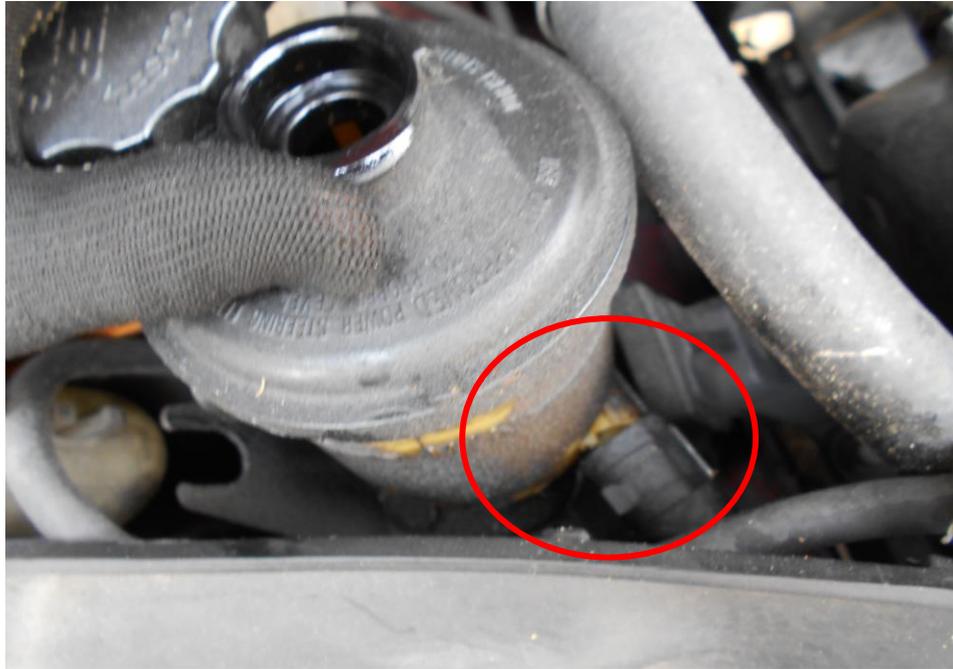
Photo 20 shows the close up view of the damaged power steering fluid reservoir as a result of the accident. It was observed to be cracked due to the accident.

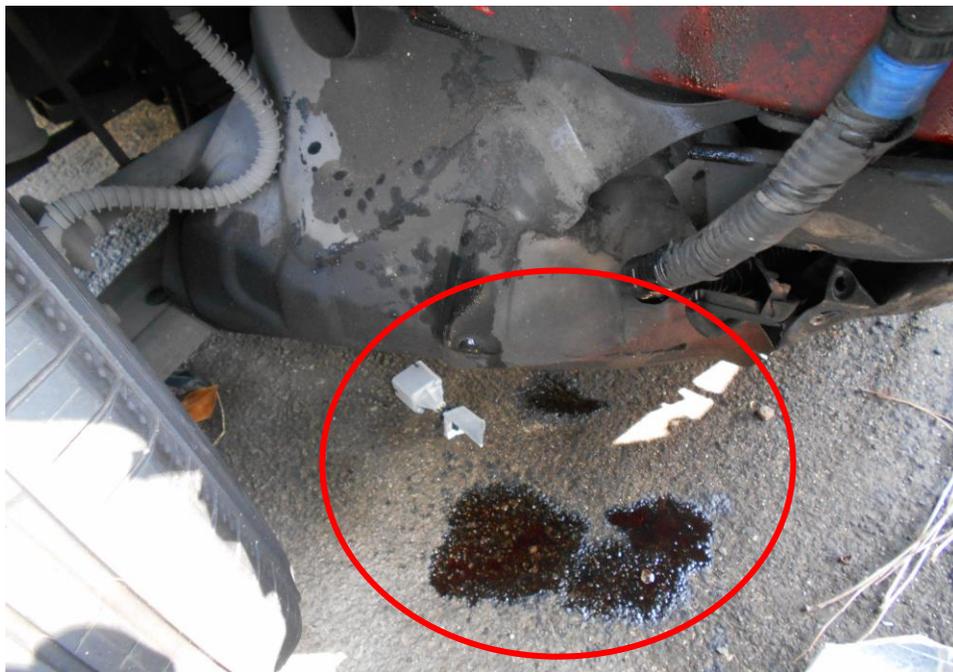
Photo 21 shows the close up view of the power steering fluid leakage on the ground underneath the engine due to the accident.

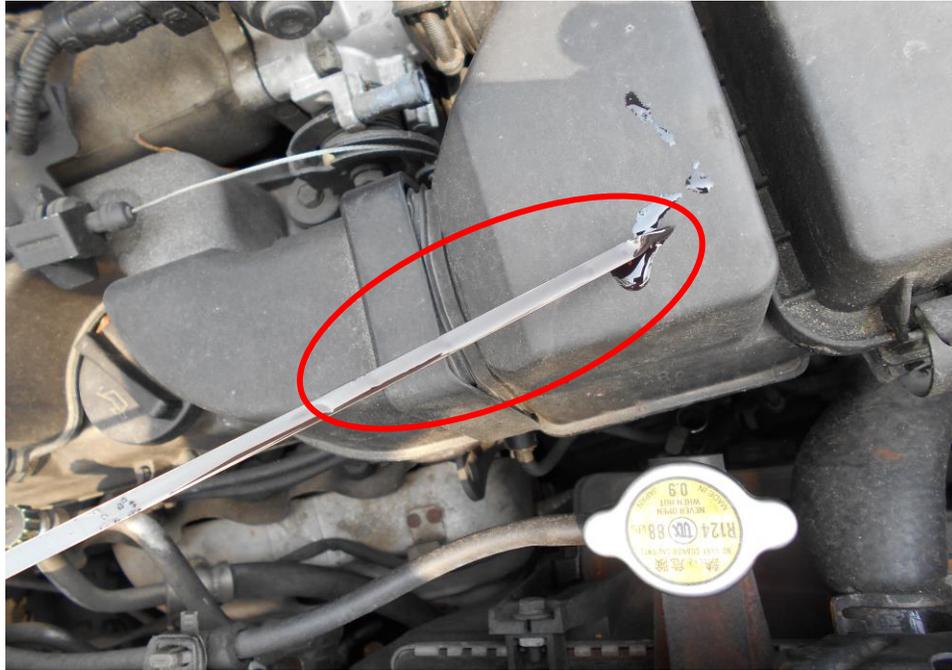
Photo 22 shows the close up view of the engine fluid dip stick of the Motor Car. It was observed to be at a sufficient level and without any contamination.

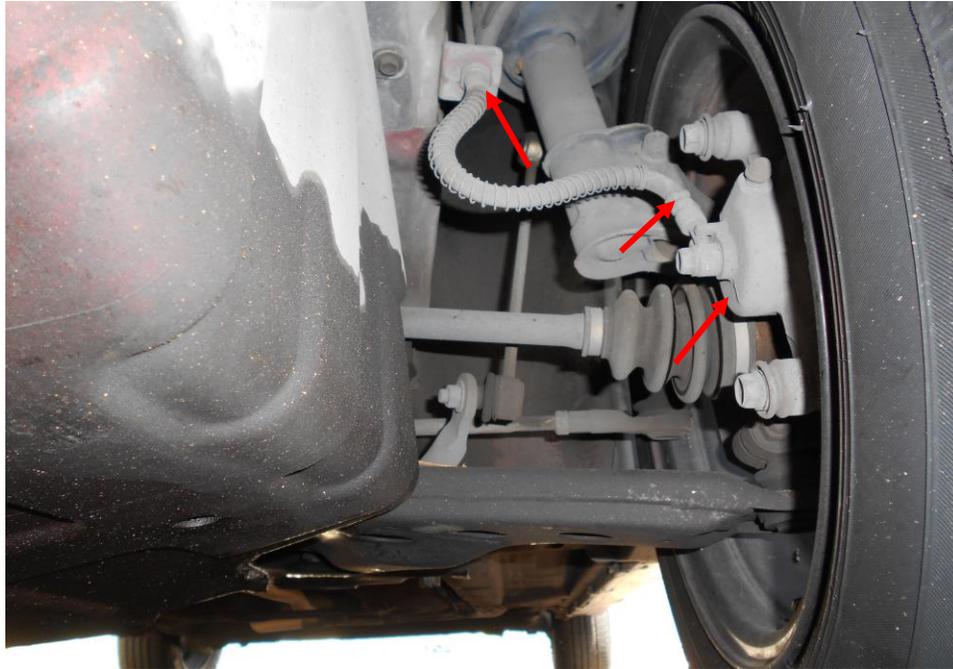
Photo 23 shows the braking components at the front left wheel of the Motor Car. We did not observe any leakage of brake fluid at the time of our inspection of the Motor Car.

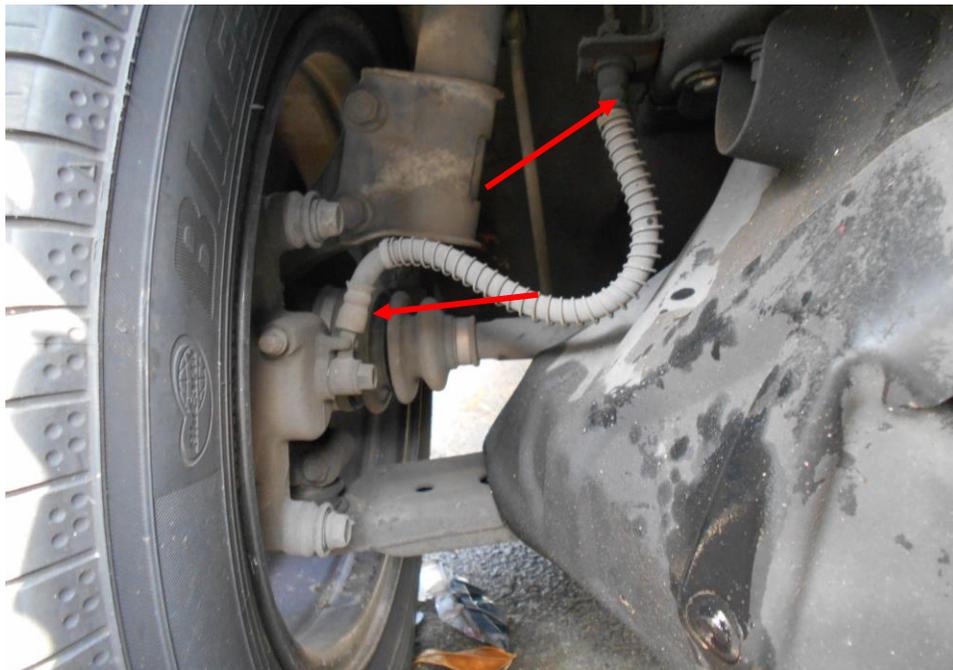
Photo 24 shows the braking components at the front right wheel of the Motor Car. We did not observe any leakage of brake fluid at the time of our inspection of the Motor Car.

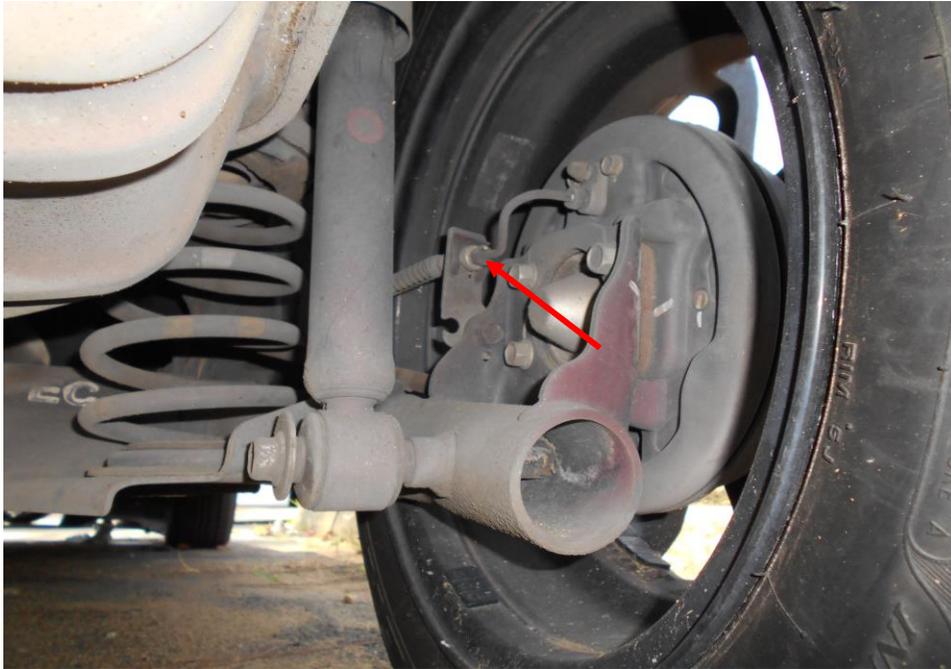
Photo 25 shows the braking components at the rear right wheel of the Motor Car. We did not observe any leakage of brake fluid at the time of our inspection of the Motor Car.

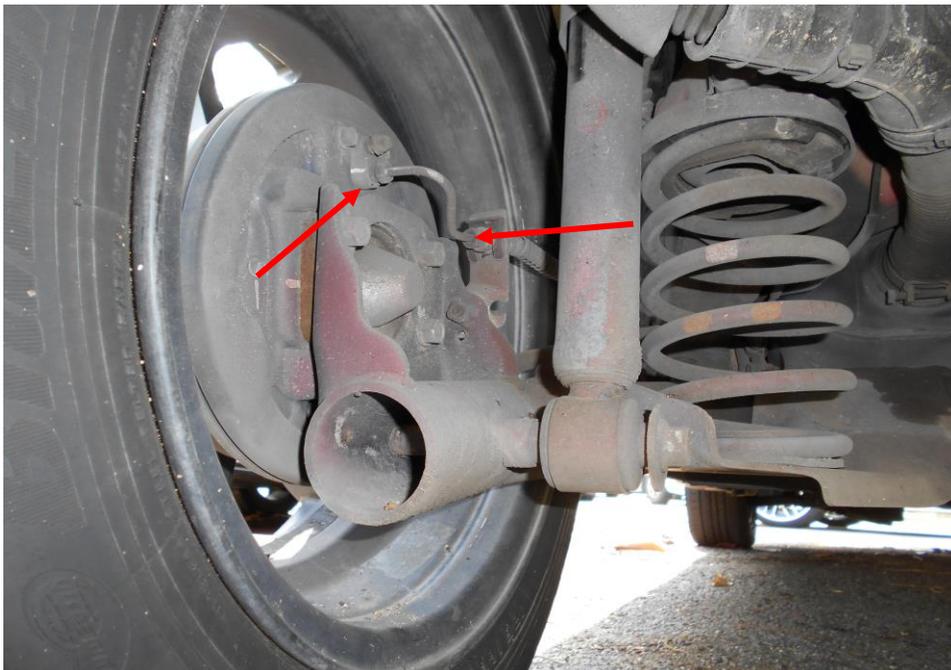
Photo 26 shows the braking components at the rear left wheel of the Motor Car. We did not observe any leakage of brake fluid at the time of our inspection of the Motor Car.
