Your Ref: TP/IP/63425/2018
Our Ref : CI/TPD18022206/Z

29th March 2019

MECHANICAL INSPECTION REPORT OF MOTOR CAR SBJ 7833R

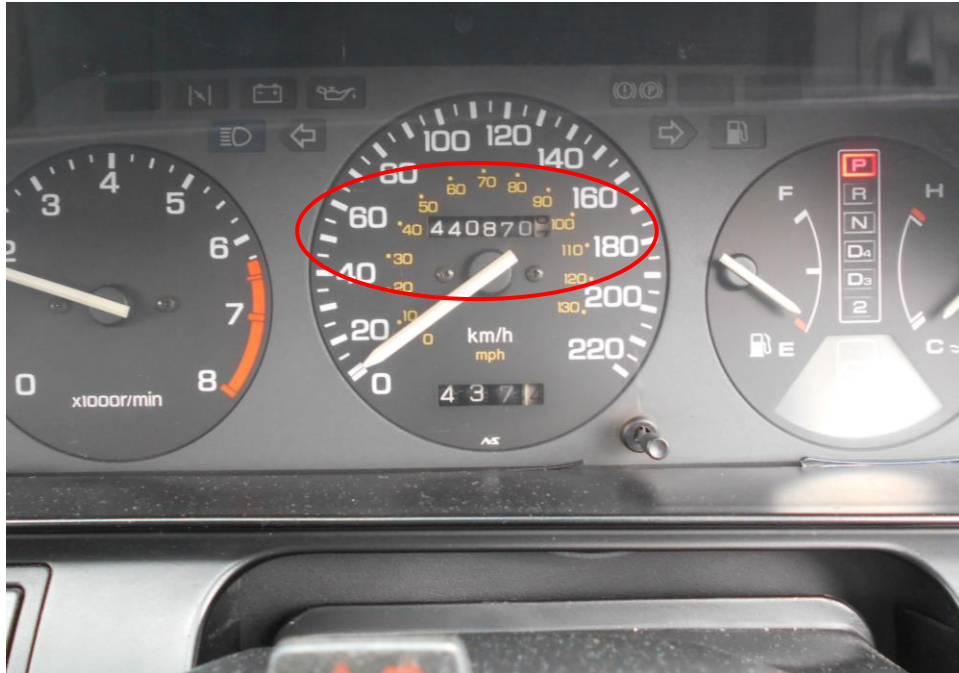
4. The mileage of the Motor Car recorded at the time of our inspection was 4408707 km.
5. The Motor Car did not sustain any damage which associates it to the accident. It was likely due to the Motor car had collided onto the pedestrian body parts.
6. This was likely due to the consistency of the accidents case facts that on 15th November 2018 at about 2146hrs, the driver of the Motor Car (SBJ 7833R) claimed that her brake did not respond when she stepped on the brake pedal. Thus, she could not brake in time and collided onto a pedestrian at a designated signalised pedestrian crossing; along Pasir Panjang Road. See photo 1 to 7 below.

Photo 1 shows the mileage of the Motor Car was 4408707 km.

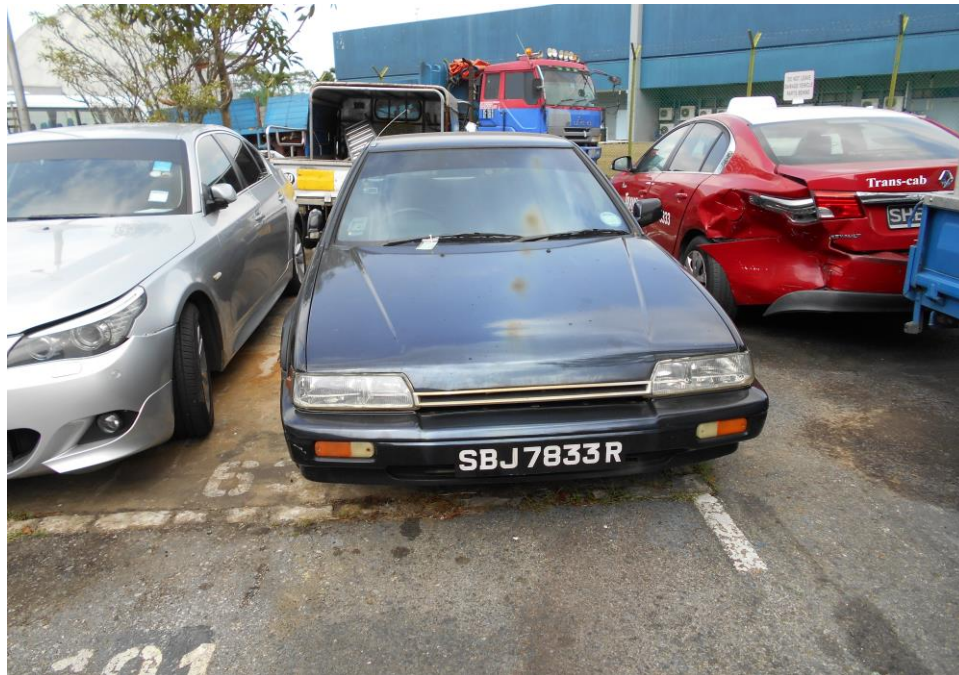
Photo 2 shows a general view of the front body of the Motor Car at the time of our inspection. The Motor Car was observed to be in good general condition unaffected by the accident.

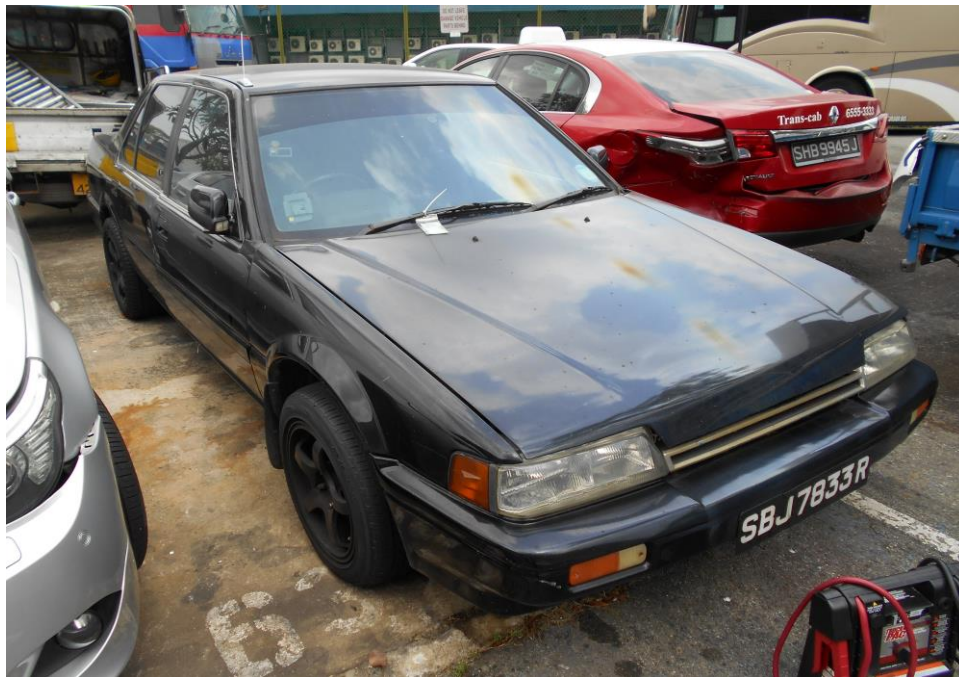
Photo 3 shows a general view of the front right body of the Motor Car at the time of our inspection. The Motor Car was observed to be in good general condition unaffected by the accident.

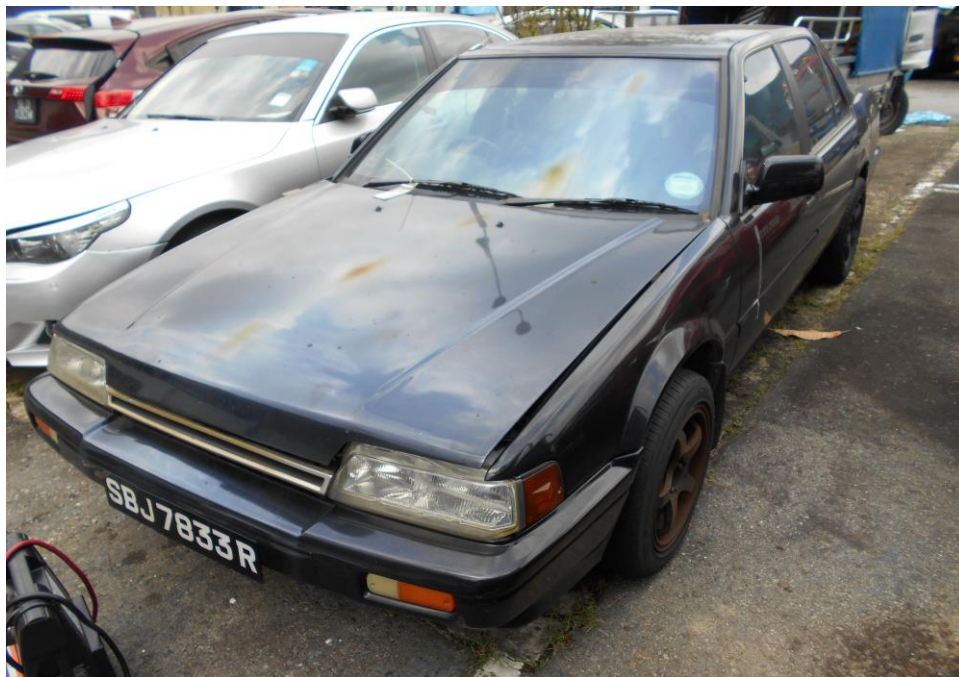
Photo 4 shows a general view of the front left body of the Motor Car at the time of our inspection. The Motor Car was observed to be in good general condition unaffected by the accident.

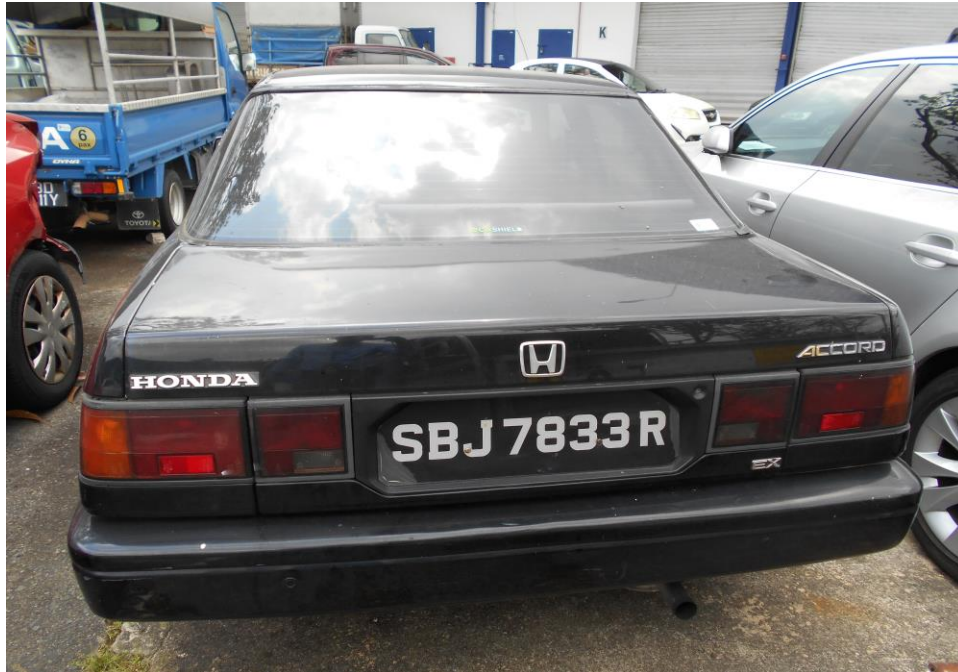
Photo 5 shows a general view of the rear body of the Motor Car at the time of our inspection. The Motor Car was observed to be in good general condition.

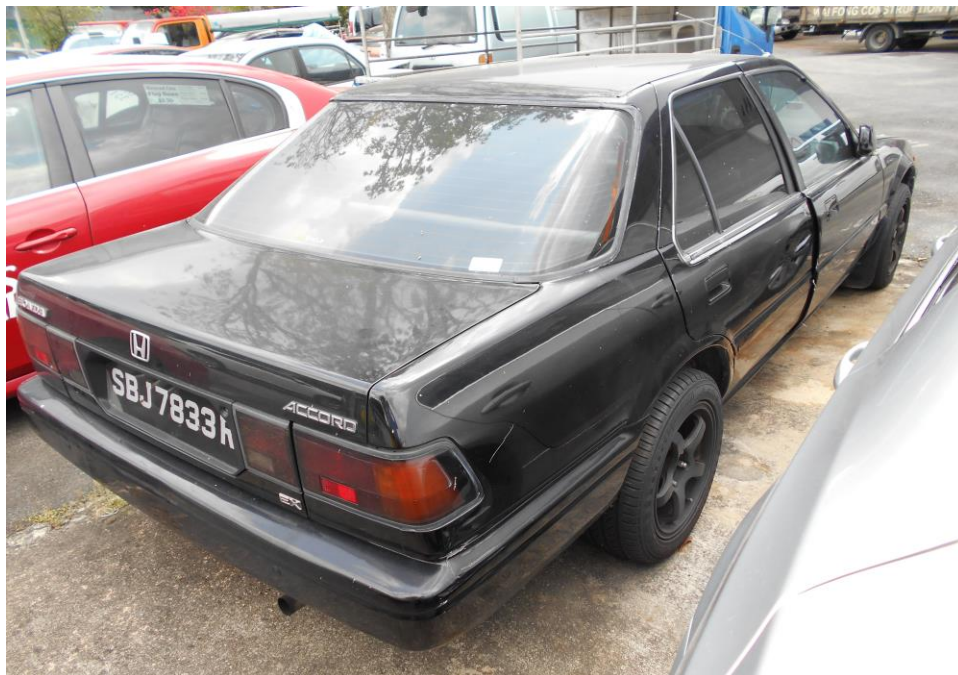
Photo 6 shows a general view of the front right body of the Motor Car at the time of our inspection. The Motor Car was observed to be in good general condition.

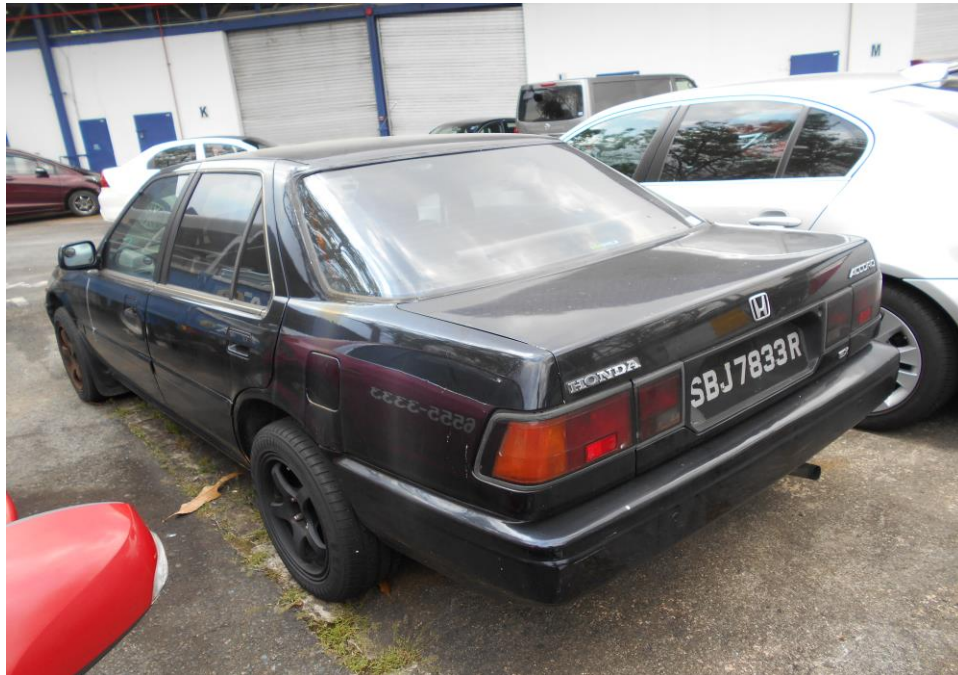
Photo 7 shows a general view of the rear right body of the Motor Car at the time of our inspection. The Motor Car was observed to be in good general condition.

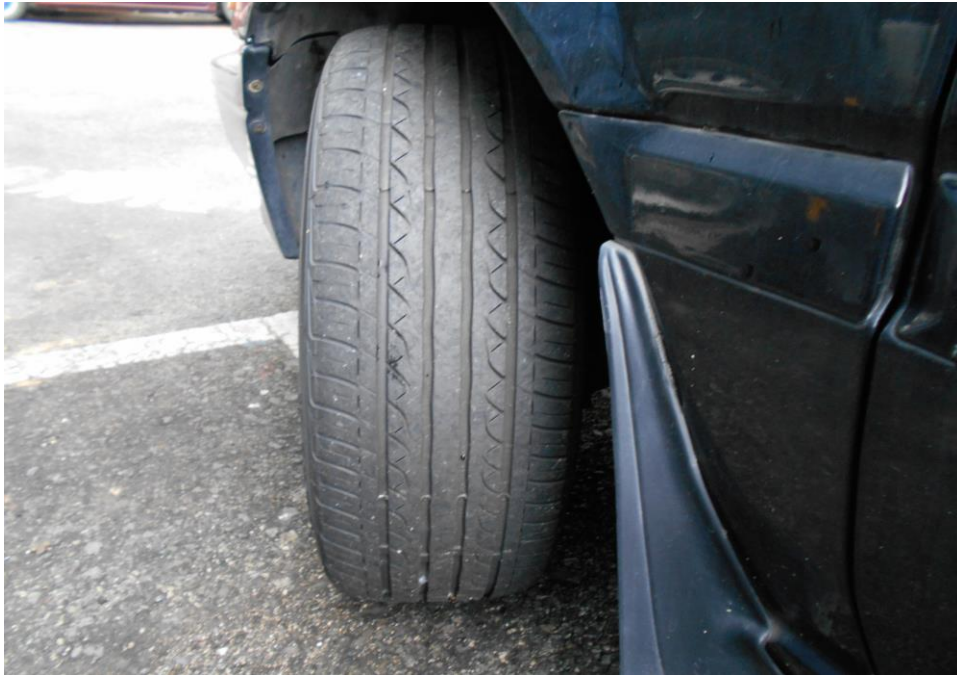
8. The 4 tyres were observed to be wrapped around alloy wheel rims that were found to be without any significant damage except for some marks of grazing nature on the outer spokes of the wheel rims, which are commonly associated to grazing against a road kerb. See photo 8 – 11 below.

Photo 8 shows the condition of the front left tyre of the Motor Car, which was observed to be in serviceable condition with remaining tread depth of approximately 4mm. The tyre, which was wrapped around alloy wheel rim, was also observed to be sufficiently inflated for vehicular operation. There was no tear, cut or burst mark(s) on the outer and the inner sidewalls as well as across the tread of the 4 tyres.

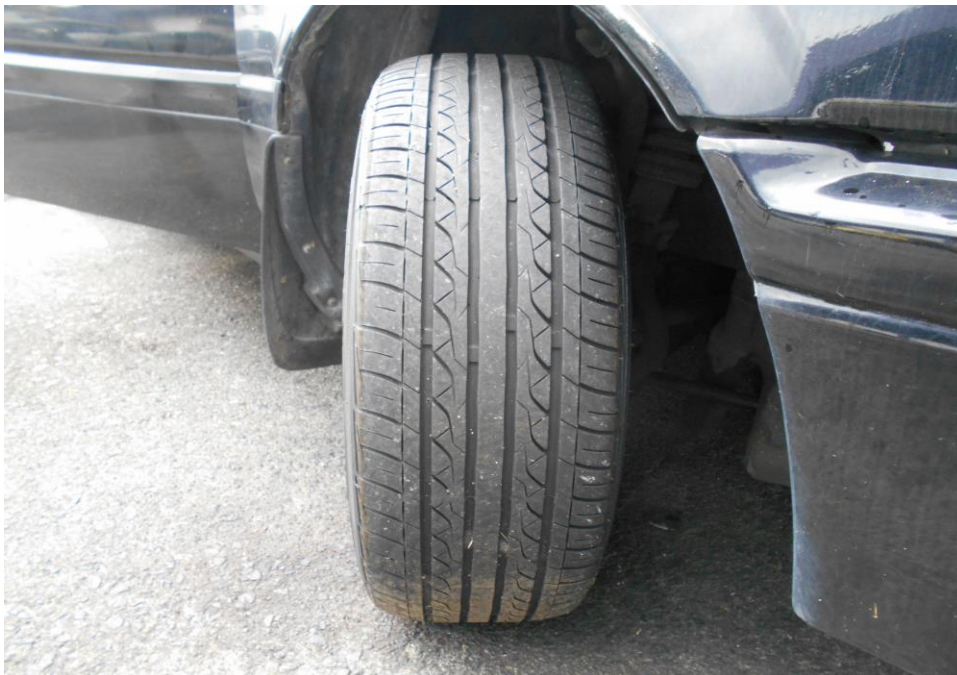
Photo 9 shows the condition of the front right tyre of the Motor Car, which was observed to be in serviceable condition with remaining tread depth of approximately 5mm. The tyre, which was wrapped around alloy wheel rim, was also observed to be sufficiently inflated for vehicular operation.

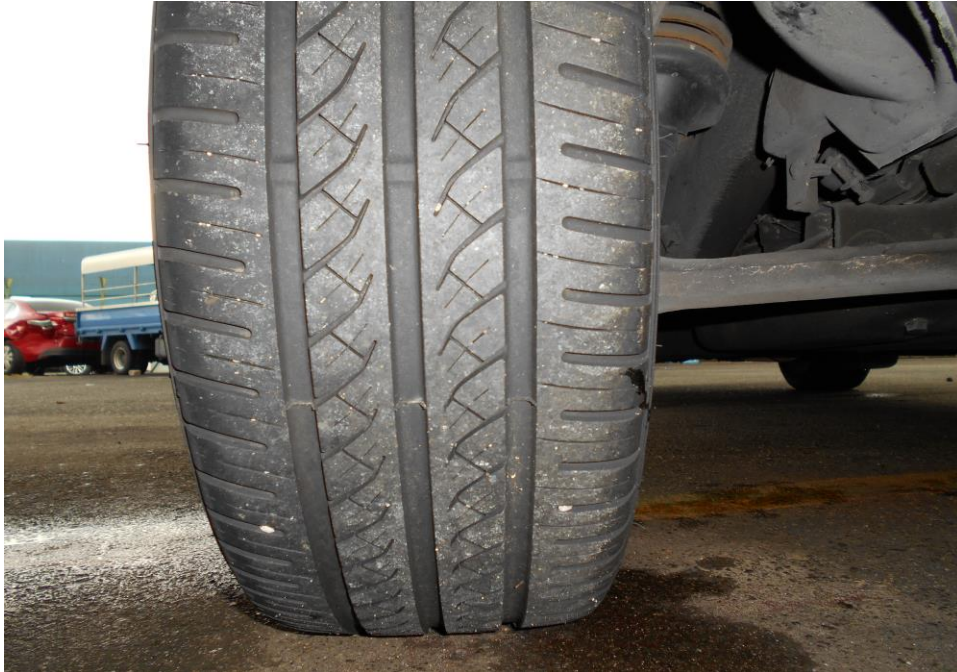
Photo 10 shows the condition of the rear left tyre of the Motor Car, which was observed to be in serviceable condition with remaining tread depth of approximately 5mm. The tyre, which was wrapped around alloy wheel rim, was also observed to be sufficiently inflated for vehicular operation.

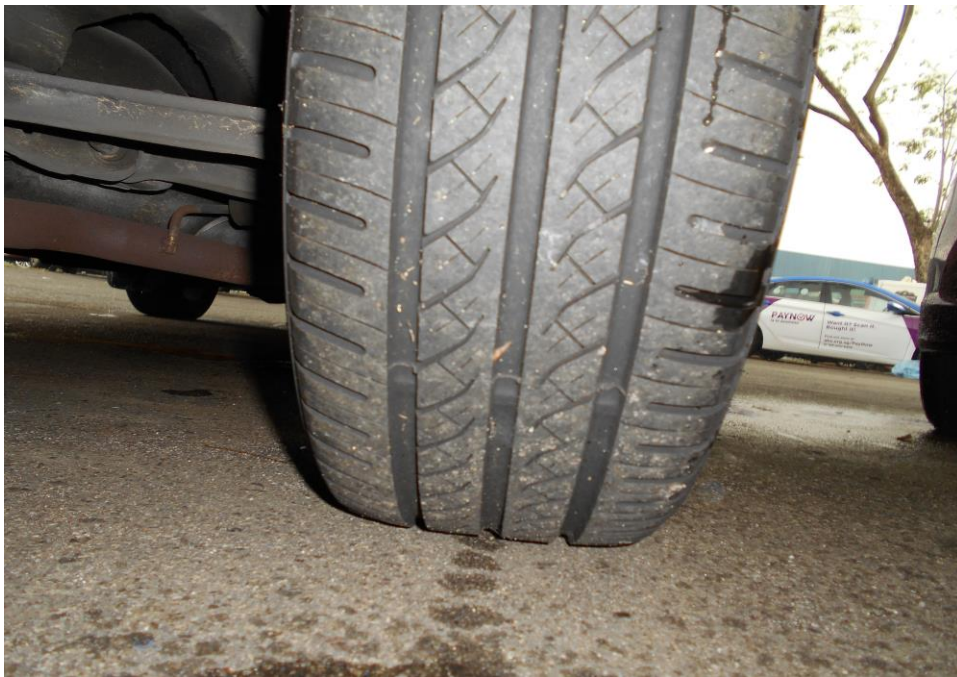
Photo 11 shows the condition of the rear right tyre of the Motor Car, which was observed to be in serviceable condition with remaining tread depth of approximately 5mm. There was also no tear, cut or burst mark(s) on the outer and the inner sidewalls as well as across the tread of the 4 tyres.

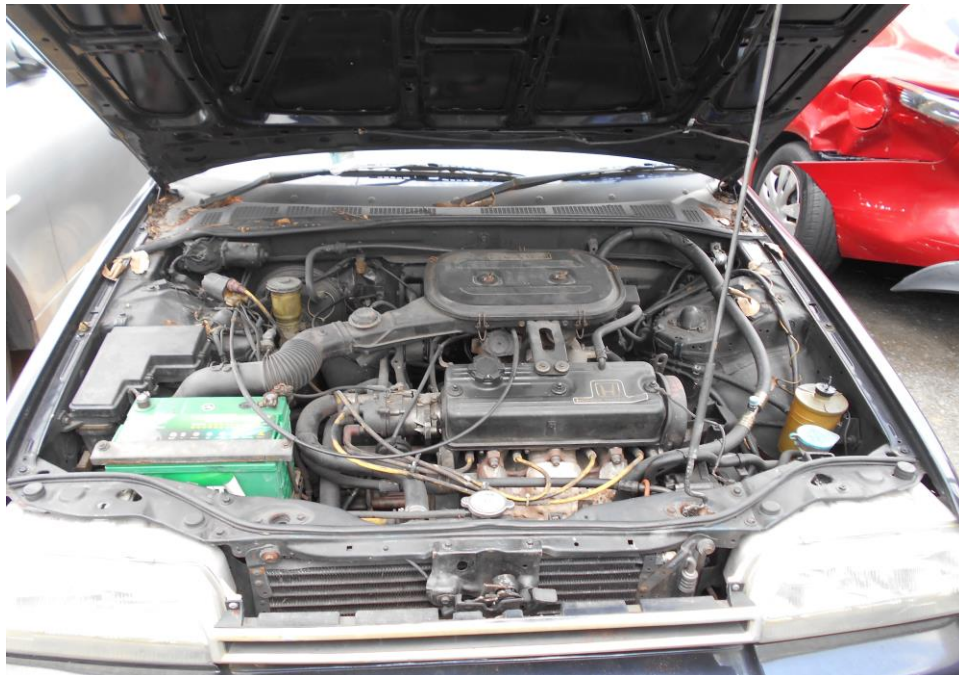
9. Upon examination of the engine compartment of the Motor Car, we had observed all the parts and components inside the engine compartment to be intact and unaffected by the accident. Operating fluids such as engine fluid, and engine coolant were found to be of sufficient level for operating purposes. Visually, there was also no contamination found to these fluids.

11. Examination of the engine compartment revealed no sign(s) or indication(s) of fluid leakage and/or fluid stain within the engine compartment of the Motor Car.

Photo 12 shows a general view of the Motor Car's engine compartment. The various parts and components inside the engine compartment were unaffected by the accident. There was also no sign(s) or indication(s) of fluid leakage and/or fluid stain within the engine compartment.

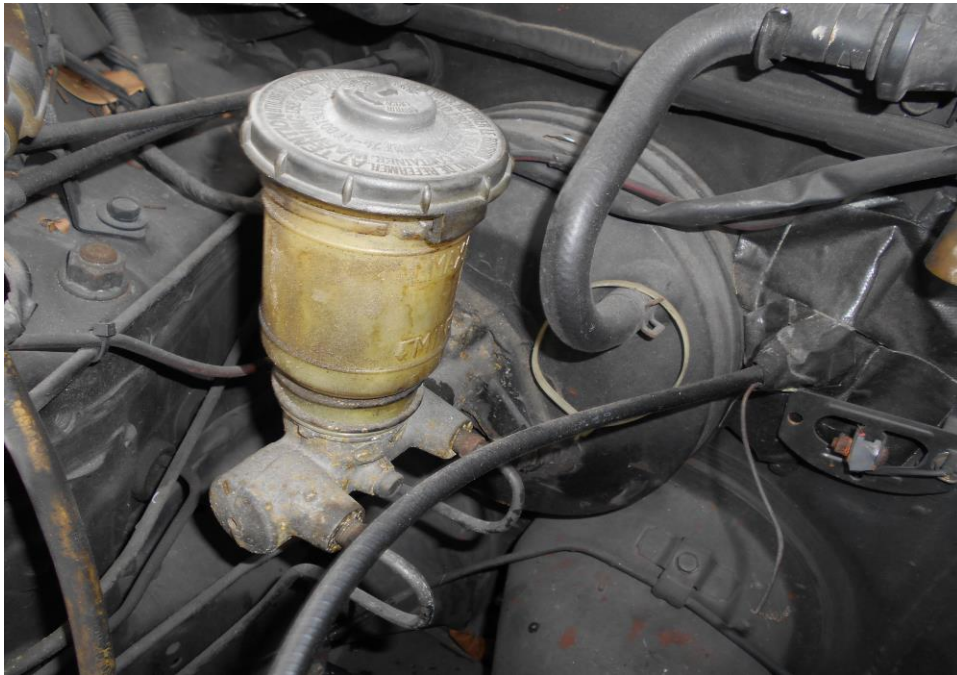
10. However, further examination on other operating fluids such as brake fluids and power steering fluids reveals that it was not sufficient for operational purposes. Power steering fluids was found to fall below the minimum marks in its reservoir tank. As for brake fluids, its reservoir tank was found to be empty. With these findings, there's evidence that these two operational components was not in its operational ready condition.

Photo 13 shows the brake fluid reservoir of the Motor Car at the time of our inspection. The brake fluid was observed to be empty at time of our inspection.

15. Static test on the braking system of the Motor Car revealed that we had experience an abnormal braking re-action when depressing the brake pedal. The foot brake pedal was found to be able to be depressed until it reaches the Motor Car floor board easily. However, a slight spongy feeling/ resistance were presence at time of our static test. See photo 18 - 21 below.

20. Notwithstanding that the braking system was found to be in working condition as the Motor Car was able to slow down and come to a complete stop upon depressing of the brake pedal, our operational test on the braking system does took a longer period of time to achieve the intention. We had to fully depress the brake pedal until it reaches the floor board to come to a complete stop. This was likely caused by the insufficient brake fluid which contributes to the ineffectiveness of the braking process. Hence, concluded that the braking system was not in serviceable condition prior to the accident. See photo 23 below.

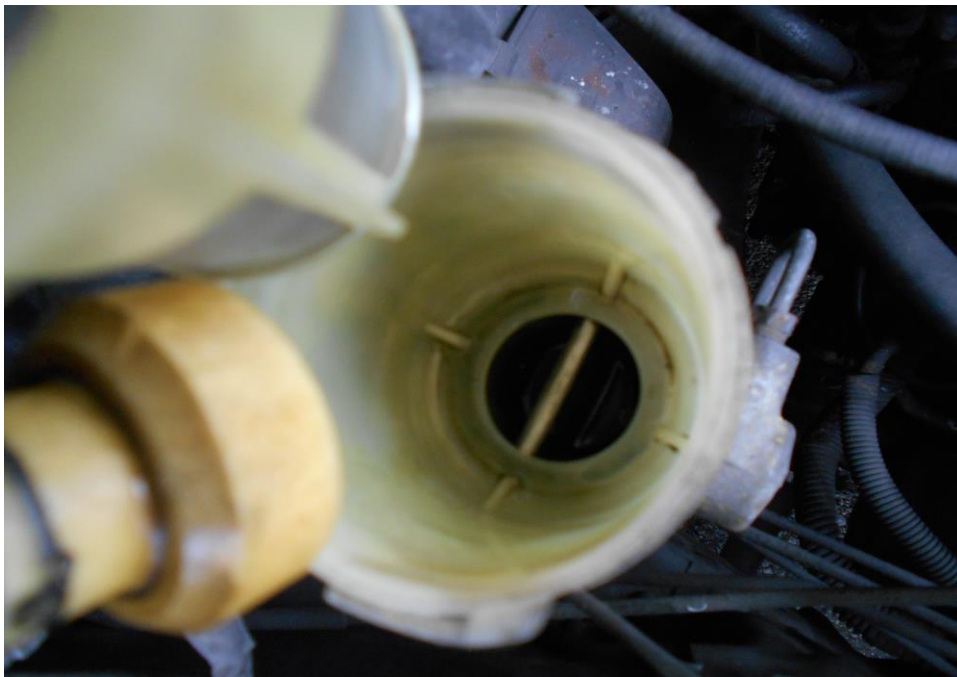
Photo 14 shows the brake fluid reservoir (internal view) of the Motor Car at the time of our inspection. The brake fluid was observed to be empty at time of our inspection.

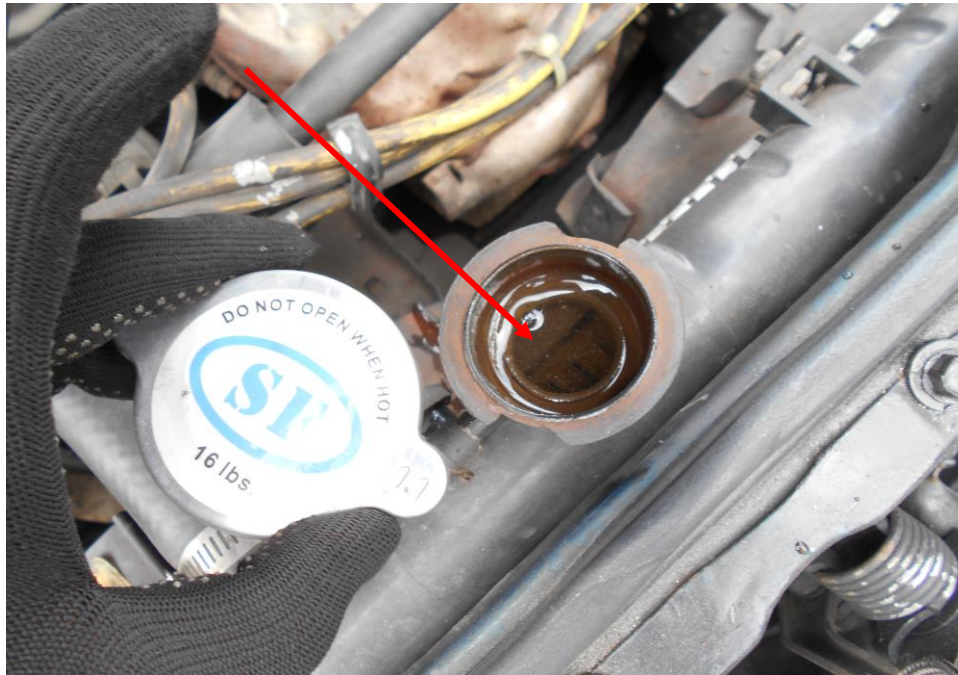
Photo 15 shows the coolant fluid reservoir of the Motor Car at the time of our inspection. The coolant fluid was observed to be of sufficient level and without any visible contamination.

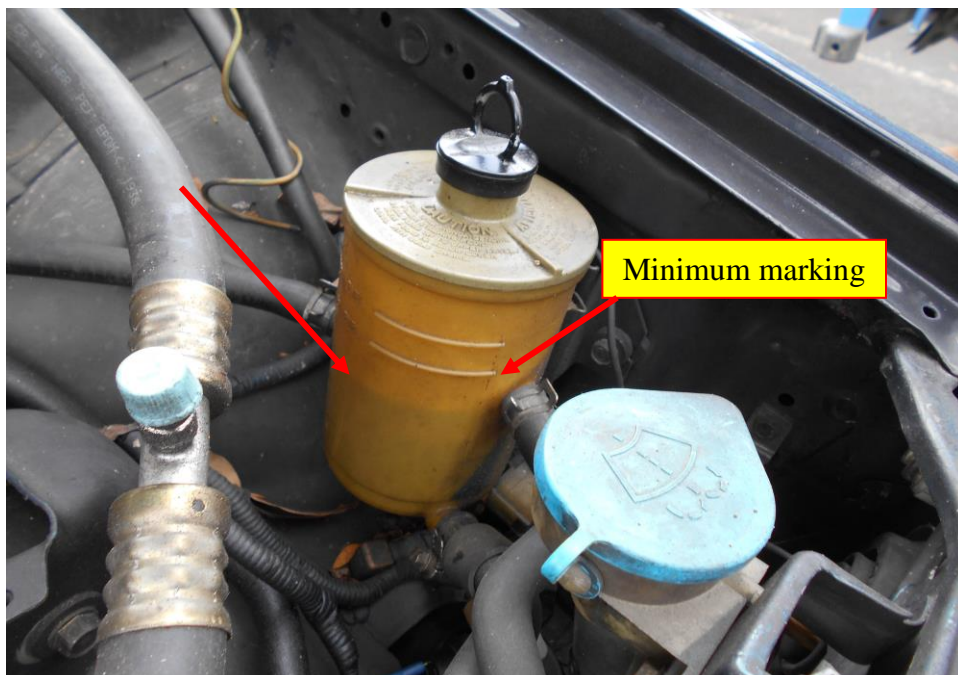
Photo 16 shows the power steering fluid reservoir of the Motor Car at the time of our inspection. The power steering fluid was observed to be insufficient level and falls below the minimum mark at time of our inspection.

14. Static test on the steering system of the Motor Car revealed that we had experience an abnormal free play and resistance when turning the steering wheel left and right to full lock positions. This was likely caused by the insufficient power steering fluid as mentioned in paragraph 10 earlier.

19. As for the steering system, the Motor Car was able to move forward and backward normally. However, it was observed not to be in smooth steering manoeuvring to the left & right. Its steering wheel was found to be jerky and heavy at times while conducting the operational test. This was likely caused by the insufficient power steering fluid which might affect the operational sequence.

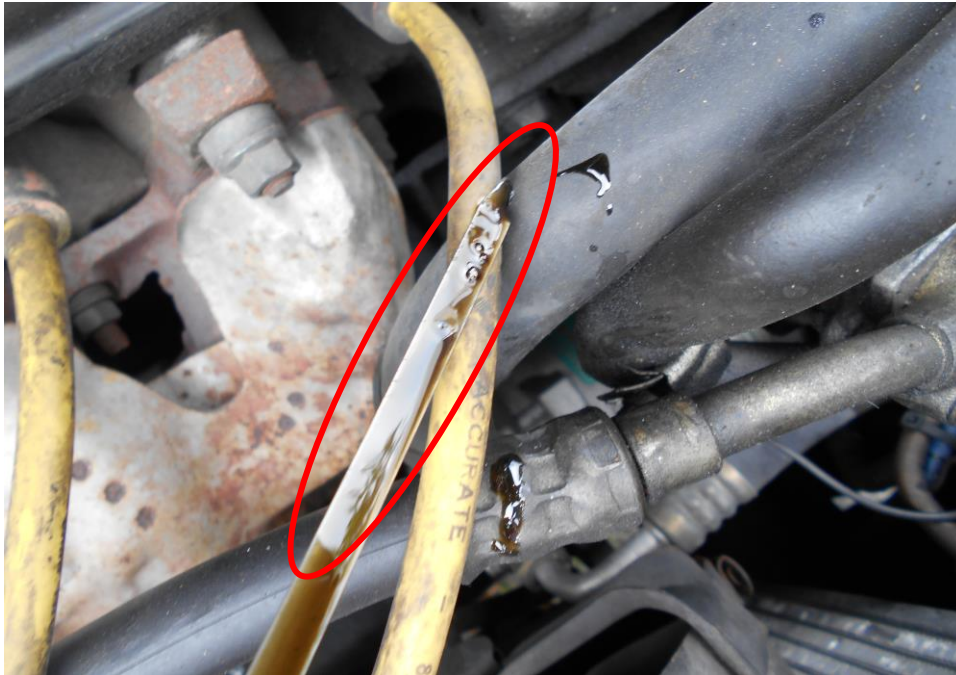
Photo 17 shows the engine oil dip stick of the Motor Car at the time of our inspection. The engine oil was observed to be of sufficient level and without any visible contamination.

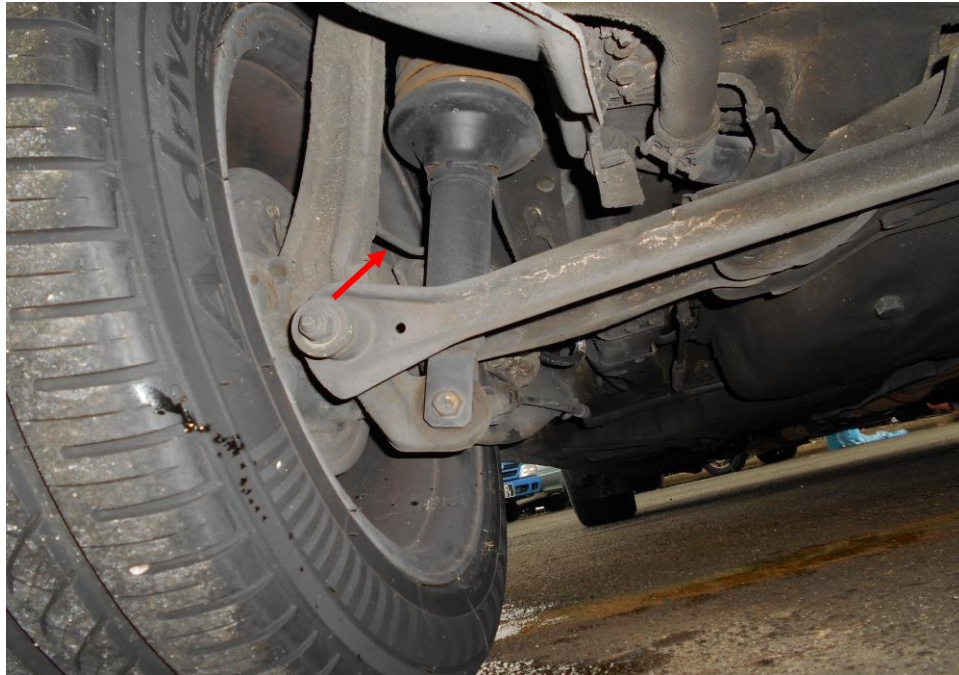
Photo 18 shows the brake hose (arrowed) at the rear left wheel of the Motor Car. We did not observe any leakage of brake fluid at the time of our inspection of the Motor Car. Our visual inspection of the various mechanical components of the Motor Car's braking system revealed all to be intact and without visible damage.

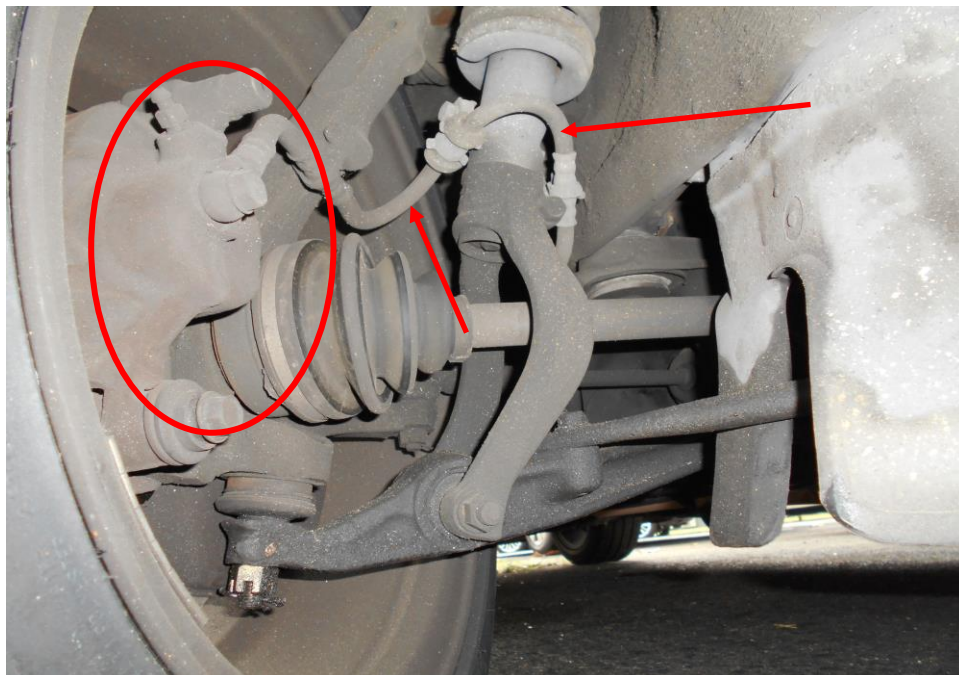
Photo 19 shows the brake hose (arrowed) at the front right wheel of the Motor Car. We did not observe any leakage of brake fluid at the time of our inspection of the Motor Car. Our visual inspection of the various mechanical components of the Motor Car's braking system, including its brake calliper (circled), revealed all to be intact and without visible damage, indicating that the braking system was likely to be in serviceable condition at the material time of accident.

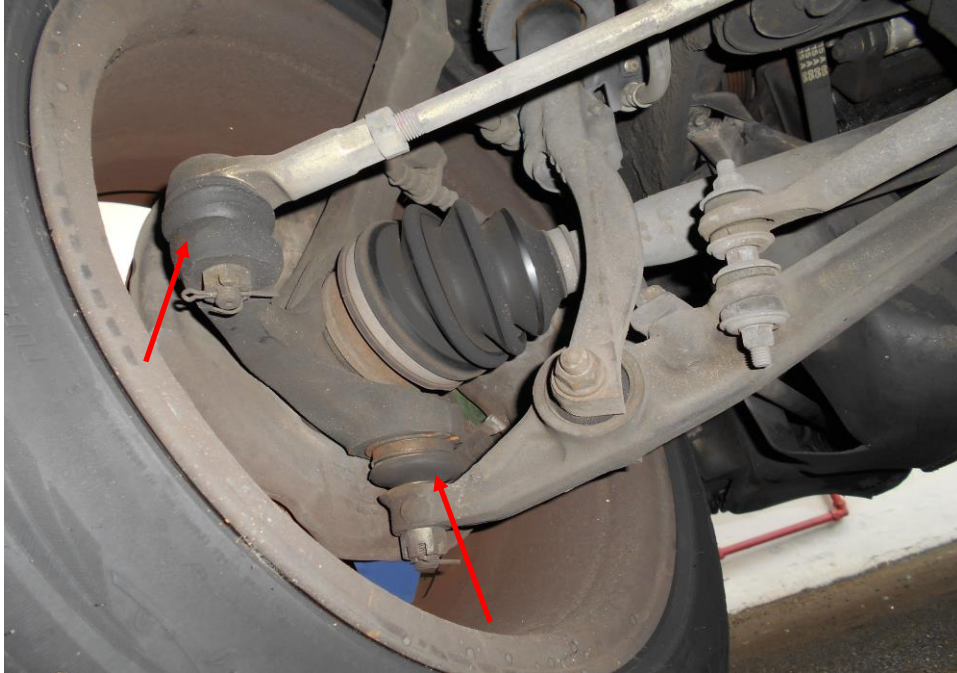
Photo 20 shows the various undercarriage components at the front left wheel of the Motor Car, in particular the steering tie rod (arrowed). The various steering components were all found to be intact, suggesting that the steering system of the Motor Car was likely to be in serviceable condition.

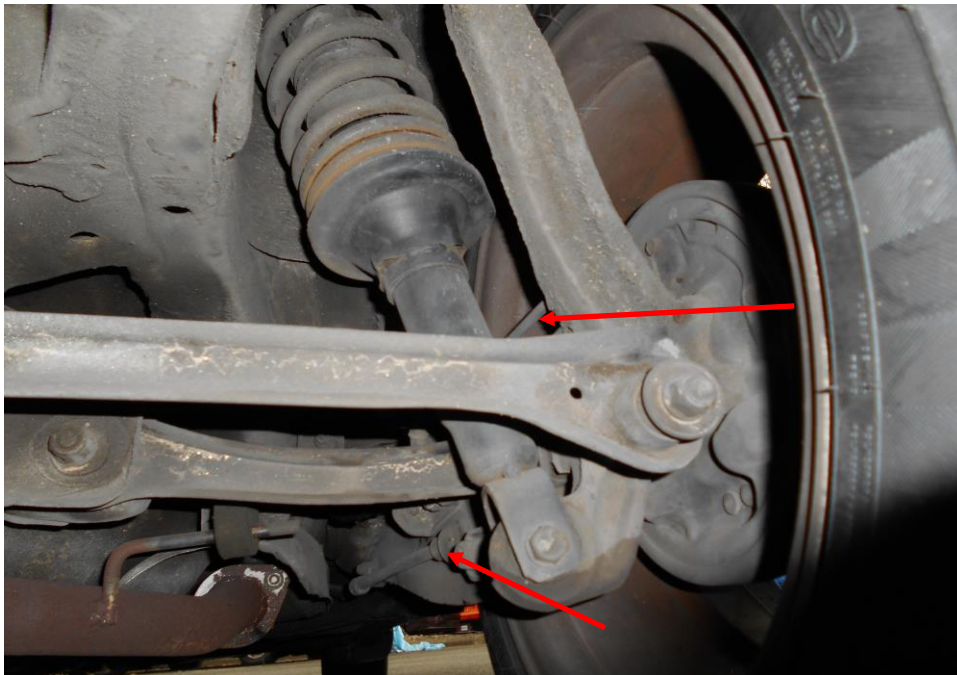
Photo 21 shows the various undercarriage components at the rear right wheel of the Motor Car. We did not observe any leakage of brake fluid at the time of our inspection of the Motor Car. Our visual inspection of the various mechanical components of the Motor Car's braking system revealed all to be intact without visible damage.

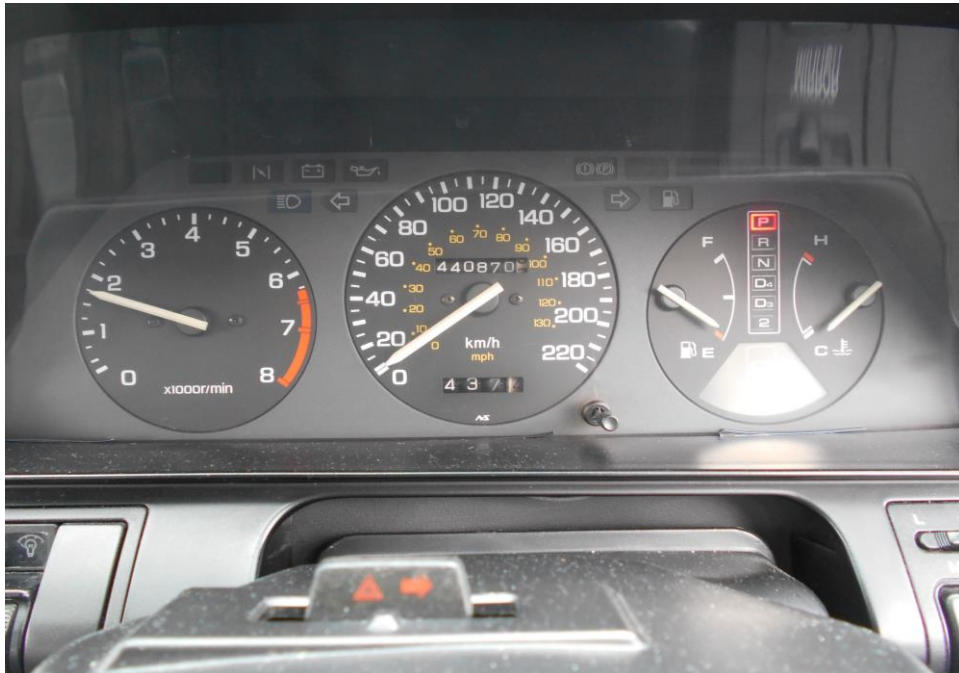
16. The Motor Car's automatic self-test of the functionality of its various electronic operating systems like the battery check light, engine fluid check light, fuel light and parking light during cranking of the engine had indicated that these systems were in working condition and without abnormality. This can be established from the warning lights disappearing from the instrument panel after the self-test. See photo 22 below.

Photo 22 shows no warning lights illuminated on the instrument panel of the Motor Car after the engine was cranked. This would suggest that there was no abnormality to the various electronic operating systems of the Motor Car.

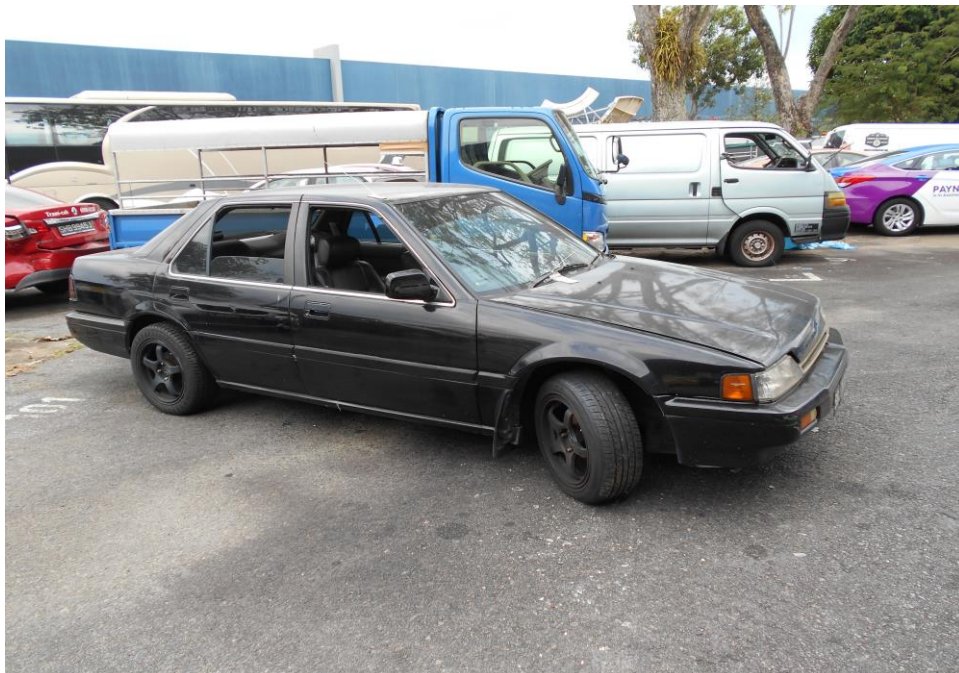
Photo 23 shows an operational test on the Motor Car. The steering wheel was able to be steered to the left & right. However, there were some abnormalities such as jerky and heavy on the steering wheel handling while conducting the operational test.
