Your Ref: TP/IP/64375/2018
Our Ref : CI/TPD18022208/Z

Fatal Accident Investigation Team

MECHANICAL INSPECTION REPORT OF MOTOR BUS PC 5941X.

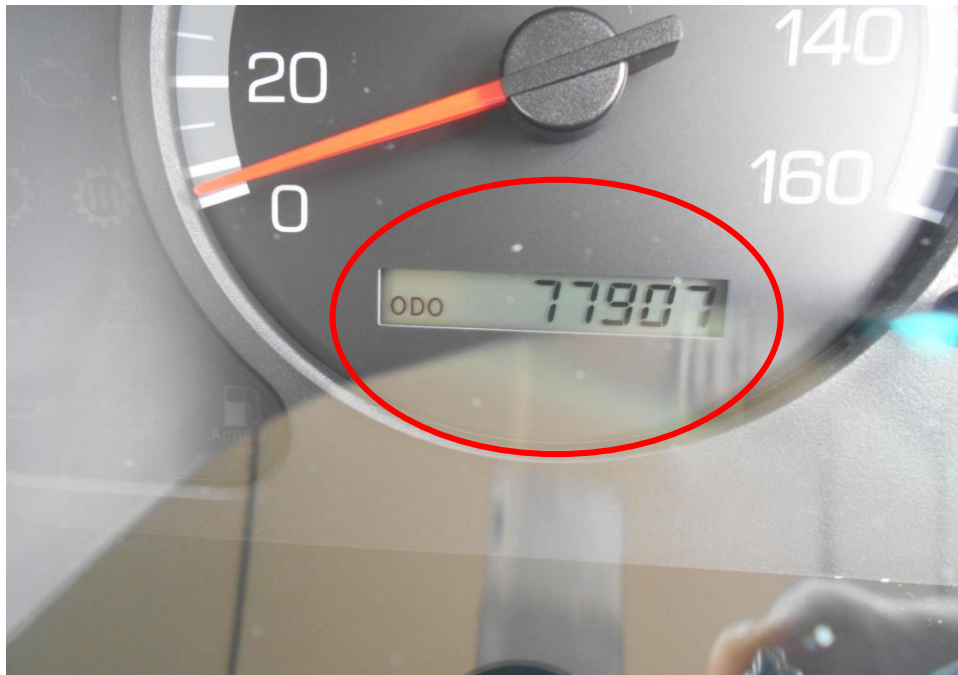
Photo 1 shows the mileage of the Motor Bus was recorded at 77907km at time of our inspection.

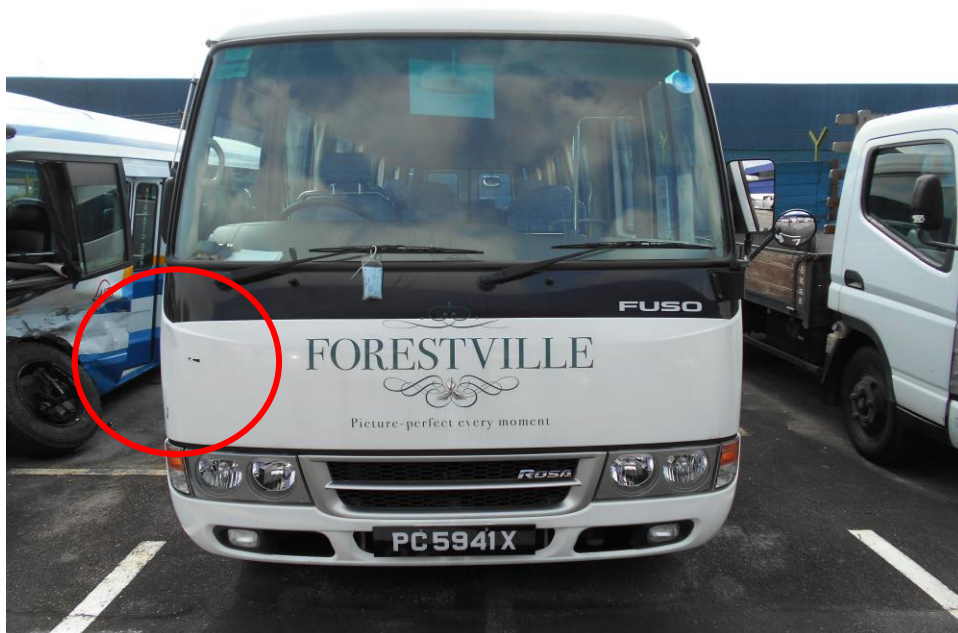
4. The mileage of the Motor Bus at the time of our inspection was 77907km.
5. The Motor Bus was observed to have sustained minor dent at its front right panel likely due to the accident.
6. This was likely due to the consistency of the accident's case facts that on 21st November 2018 at about 1907hrs, the Motor Bus pick-up 6 residents from Forestville Condo and he was proceeding to Woodlands MRT to alight them. While exiting from the said condo, the Motor Bus made a right turn from the exit point of the condo. Halfway making the intended right turn, the frontal right portion of the Motor Bus collided into the right side of a pedestrian while he was still walking ahead of the Motor Bus. See photo 1 to 6 below.

Photo 2 shows a general view of the front body of the Motor Bus at the time of our inspection. The Motor Bus was observed to sustained damages at the front right portion due to the accident's impact.

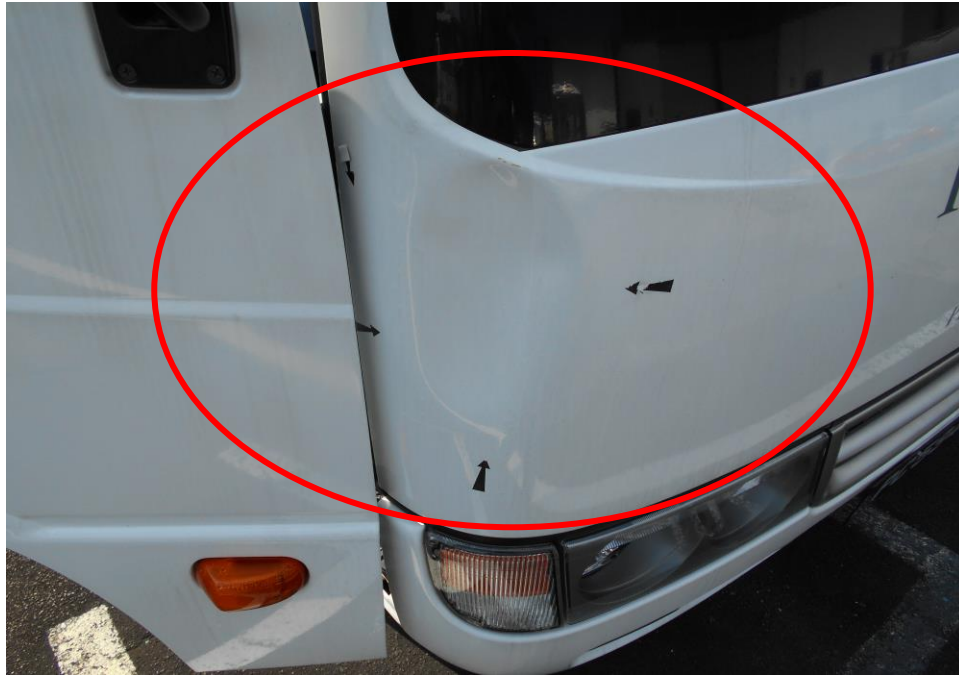
Photo 3 shows a close-up view of the damages on the front right panel of the Motor Bus at the time of our inspection. It was likely due to the accident's impact collision.

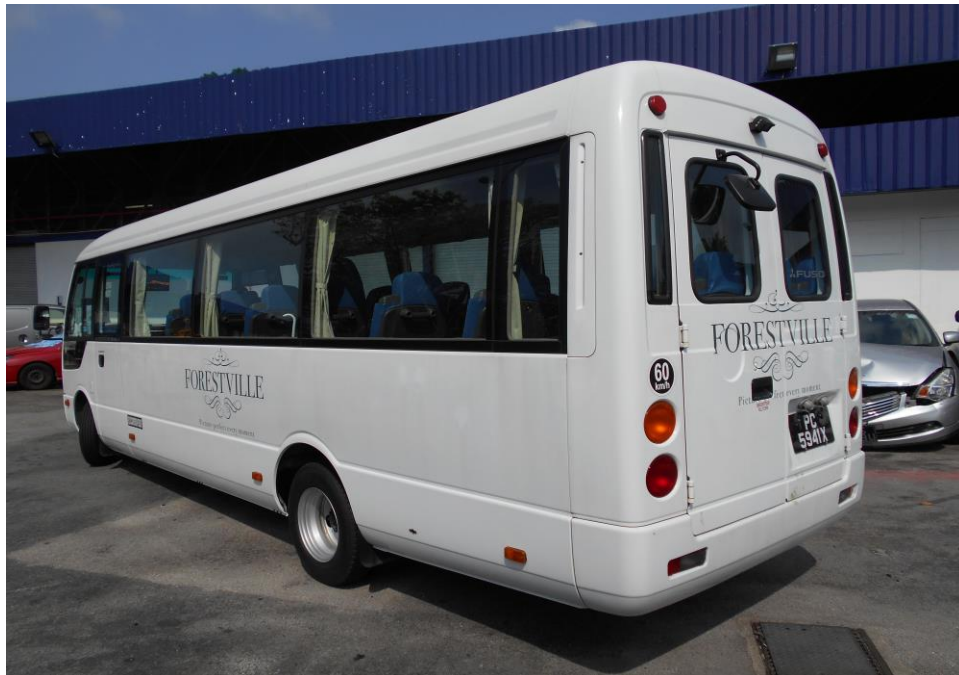
Photo 4 shows a general view of the rear left body of the Motor Bus at the time of our inspection. The Motor Bus was observed to be in good general condition at time of inspection.

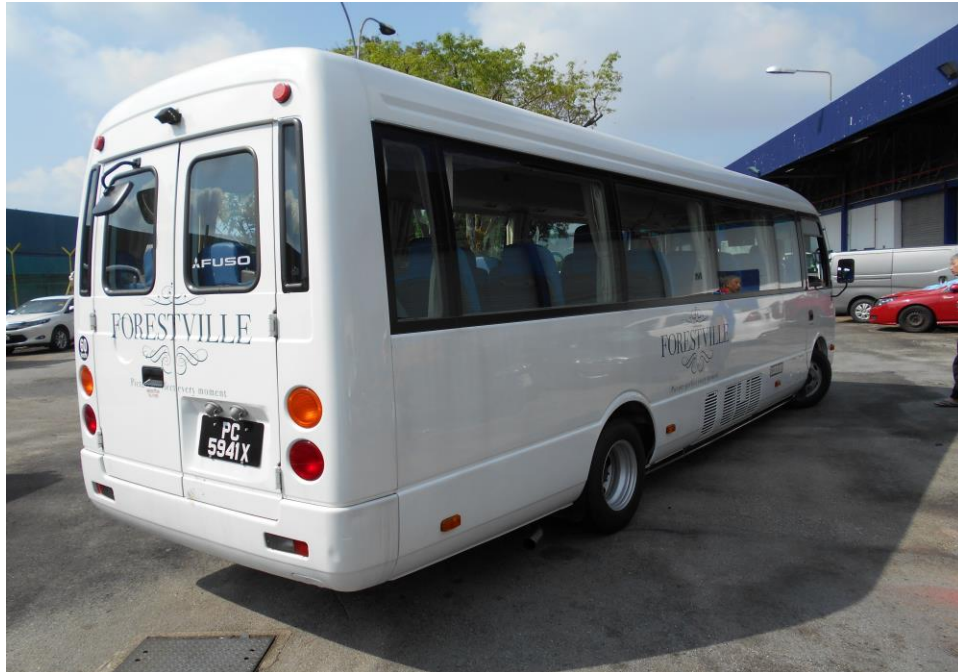
Photo 5 shows a general view of the rear right body of the Motor Bus at the time of our inspection. The Motor Bus was observed to be in good general condition at time of inspection.

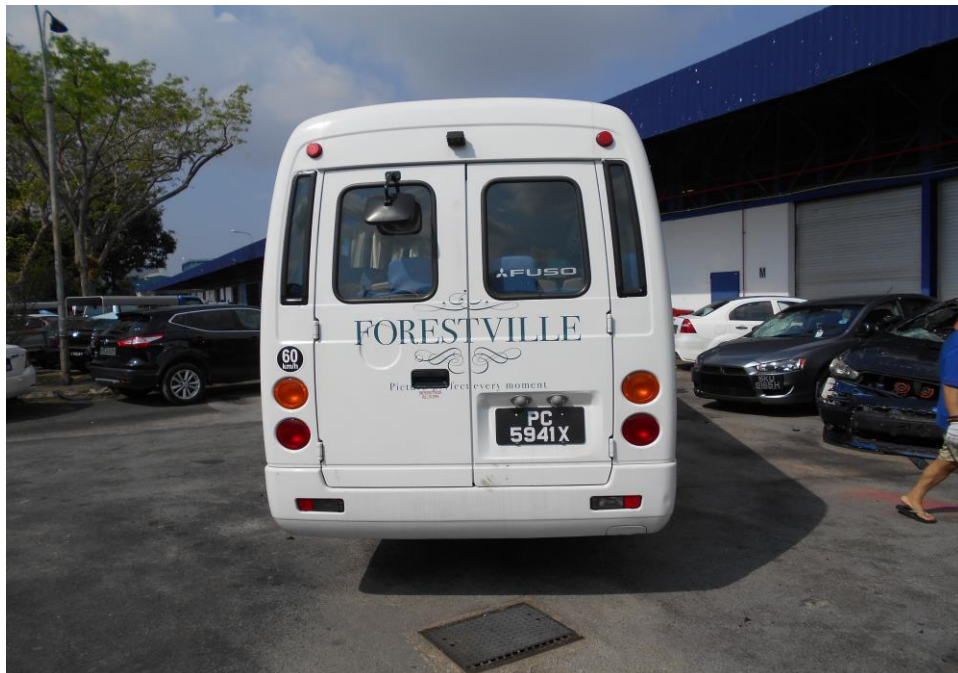
Photo 6 shows a general view of the rear body of the Motor Bus at the time of our inspection. The Motor Bus was observed to be in good general condition at time of inspection.

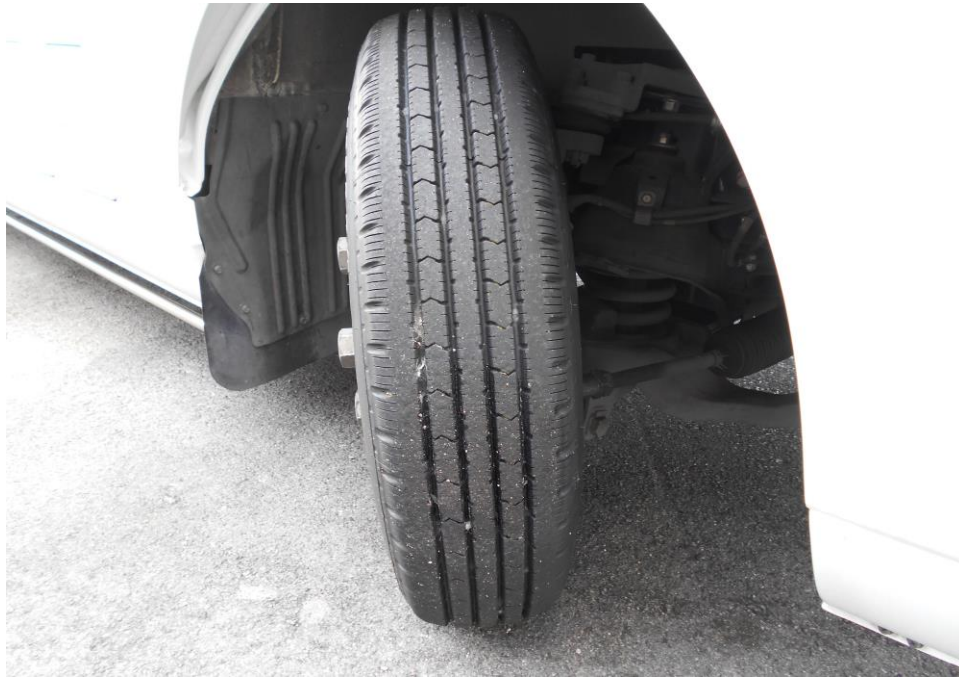
Photo 7 shows the condition of the front right tyre of the Motor Bus, which was observed to be in serviceable condition with remaining tread depth of approximately 8mm. The tyres were all observed to be sufficiently inflated for vehicular operation with no tear, cut or burst mark(s) on the outer and the inner sidewalls as well as across the tread.

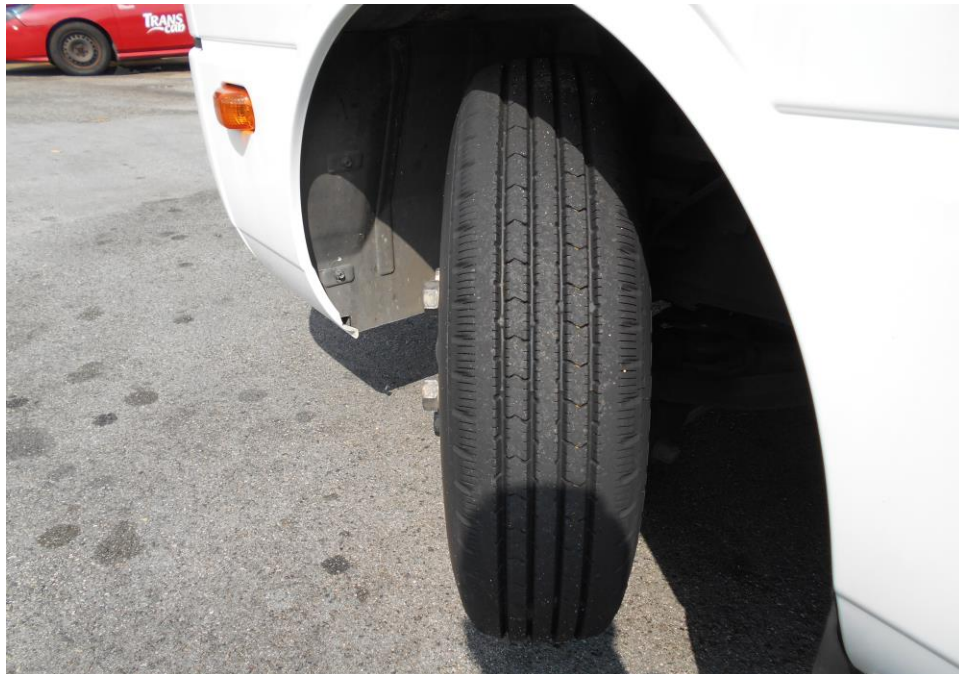
Photo 8 shows the condition of the front left tyre of the Motor Bus, which was observed to be in serviceable condition with remaining tread depth of approximately 8mm. The tyre, which was wrapped around standard wheel rim, was also observed to be sufficiently inflated for vehicular operation.

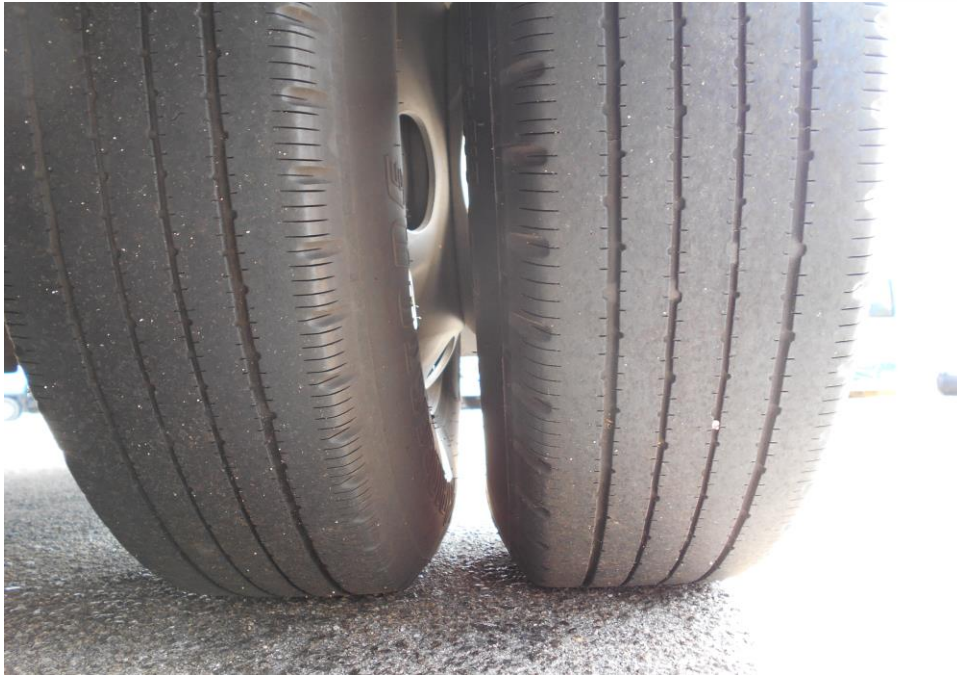
Photo 9 shows the condition of the rear left tyre of the Motor Bus, which was observed to be in serviceable condition with remaining tread depth of approximately 4mm. The tyre, which was wrapped around standard wheel rim, was also observed to be sufficiently inflated for vehicular operation. There was also no significant damage found on the 6 wheel rims of the Motor Bus.

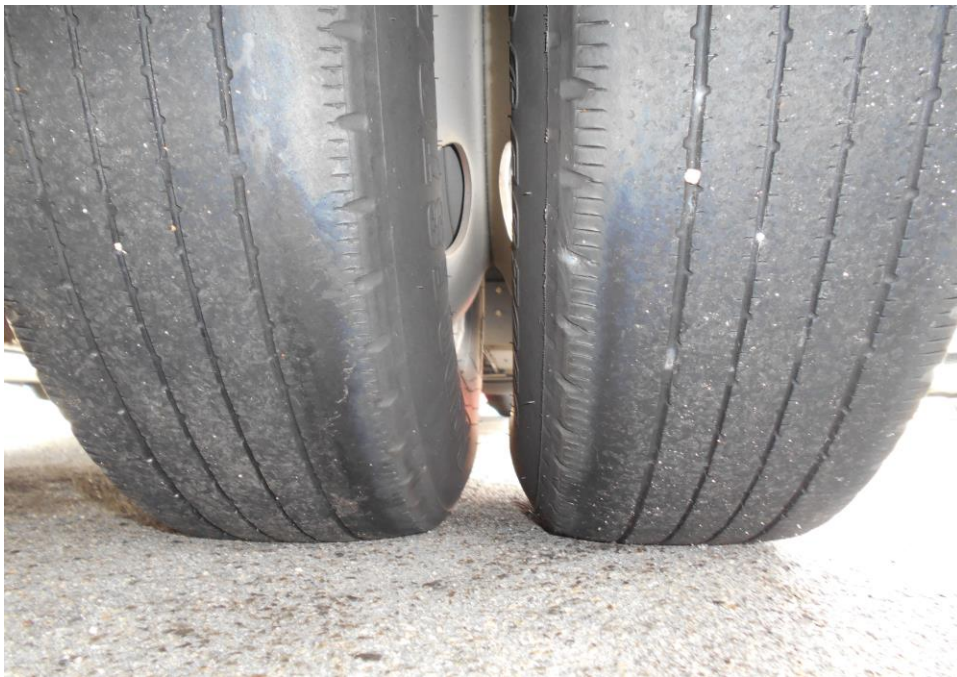
Photo 10 shows the condition of the rear right tyre of the Motor Bus, which was observed to be in serviceable condition with remaining tread depth of approximately 3mm. There was also no tear, cut or burst mark(s) on the outer and the inner sidewalls as well as across the tread of the tyre, which was also sufficiently inflated for vehicular operation.

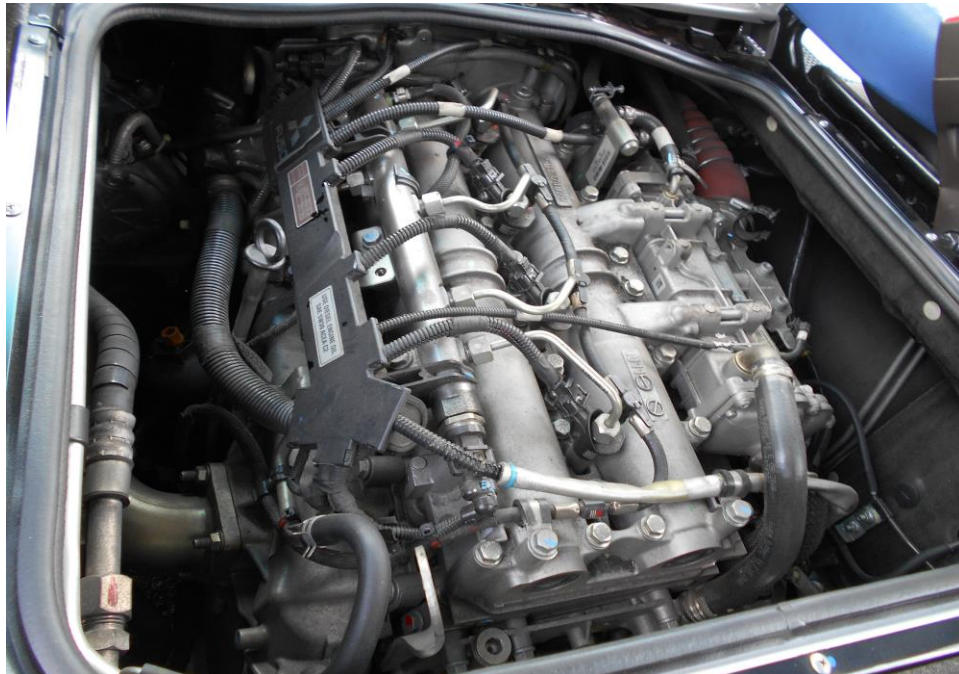
Photo 11 shows a general view of the Motor Bus's engine compartment. The various parts and components inside the engine compartment were unaffected by the accident. There was also no sign(s) or indication(s) of fluid leakage and/or fluid stain within the engine compartment.

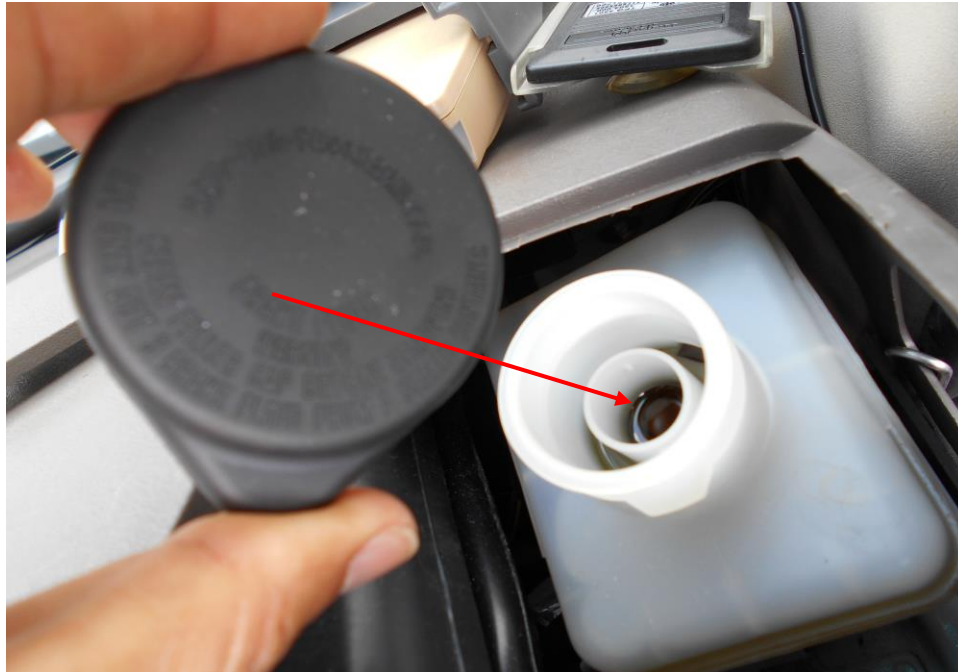
Photo 12 shows the brake fluid reservoir of the Motor Bus at the time of our inspection. The brake fluid was observed to be of sufficient level and without any visible contamination.

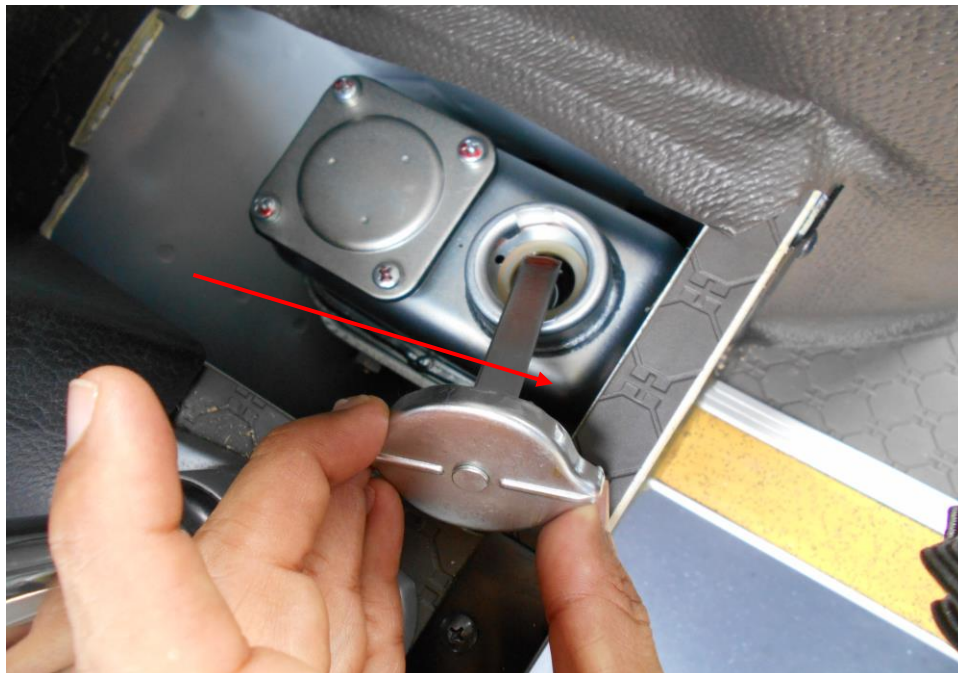
Photo 13 shows the power steering fluid of the Motor Bus at the time of our inspection. It was observed to be of sufficient level and without any visible contamination.

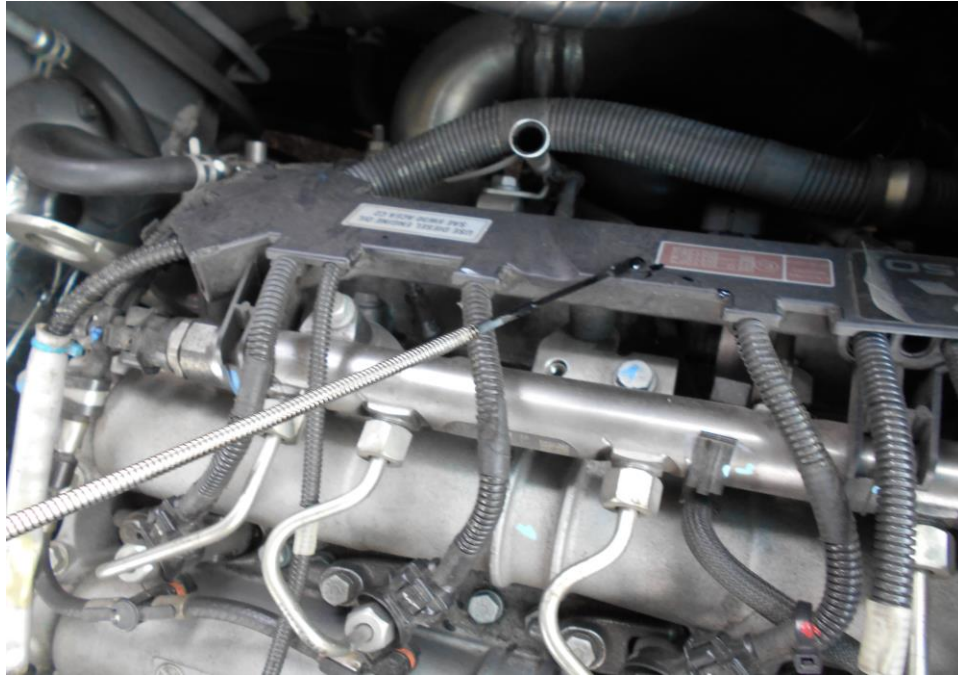
Photo 14 shows the engine dip stick of the Motor Bus at the time of our inspection. The engine oil was observed to be of sufficient level and without any visible contamination.

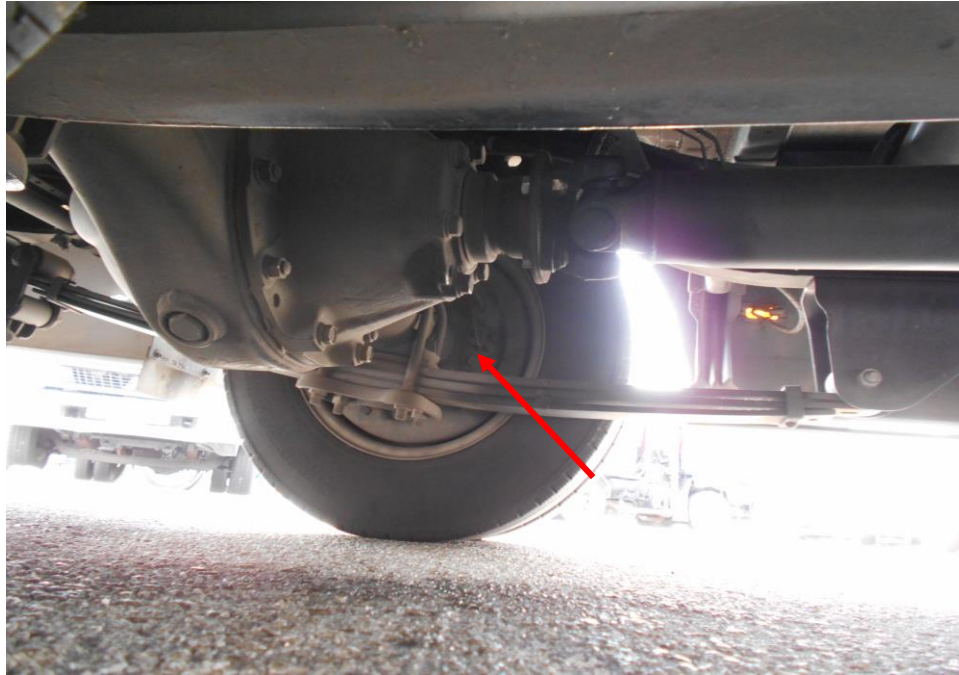
Photo 15 shows the various undercarriage components at the rear left wheel of the Motor Bus, in particular the brake hose (arrowed). We did not observe any leakage of brake fluid at the time of our inspection of the Motor Bus.

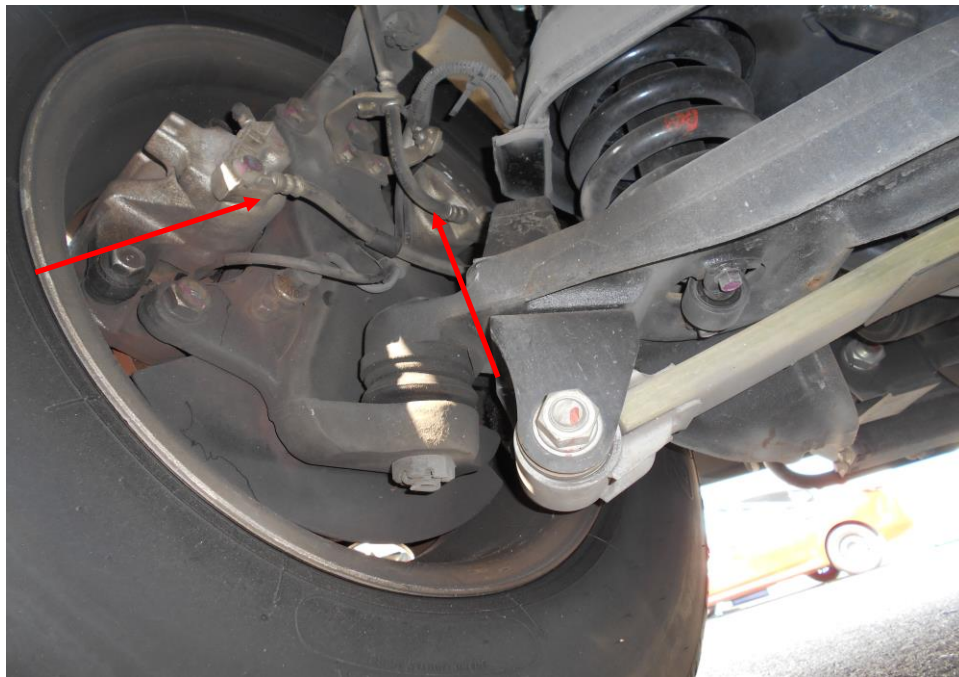
Photo 16 shows the brake hose at the front left wheel of the Motor Bus. We did not observe any leakage of brake fluid. Our visual inspection of the various mechanical components of the Motor Bus's braking system revealed all to be intact and without visible damage, indicating that the braking system was likely to be in serviceable condition at the material time of accident.

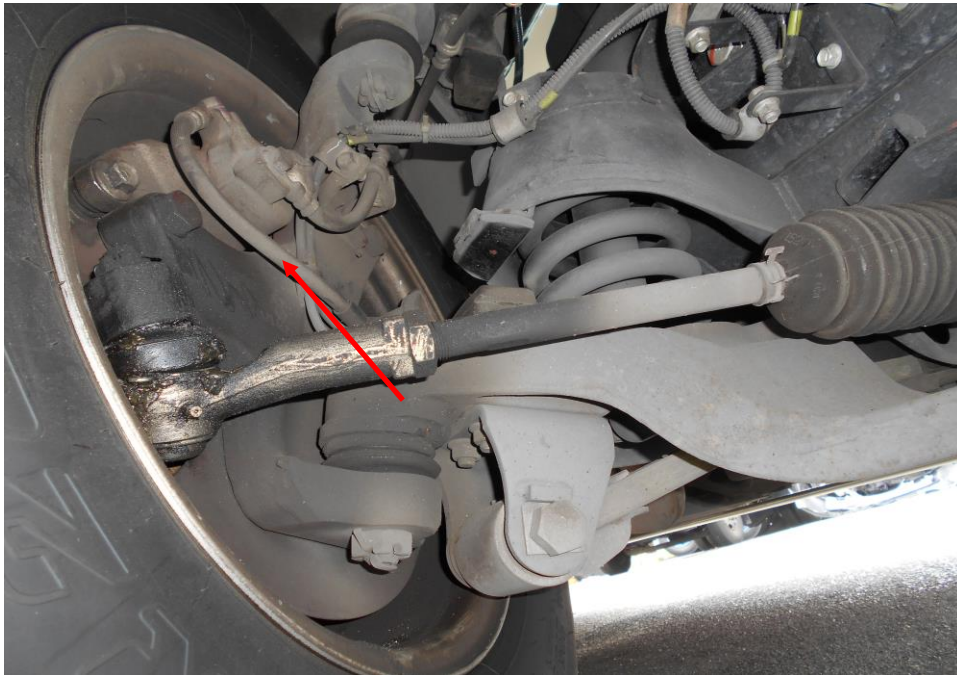
Photo 17 shows the brake hose (arrowed) at the front right wheel of the Motor Bus. We did not observe any leakage of brake fluid at the time of our inspection of the Motor Bus. Our visual inspection of the various mechanical components of the Motor Bus's braking system, including its brake calliper, revealed all to be intact and without visible damage.

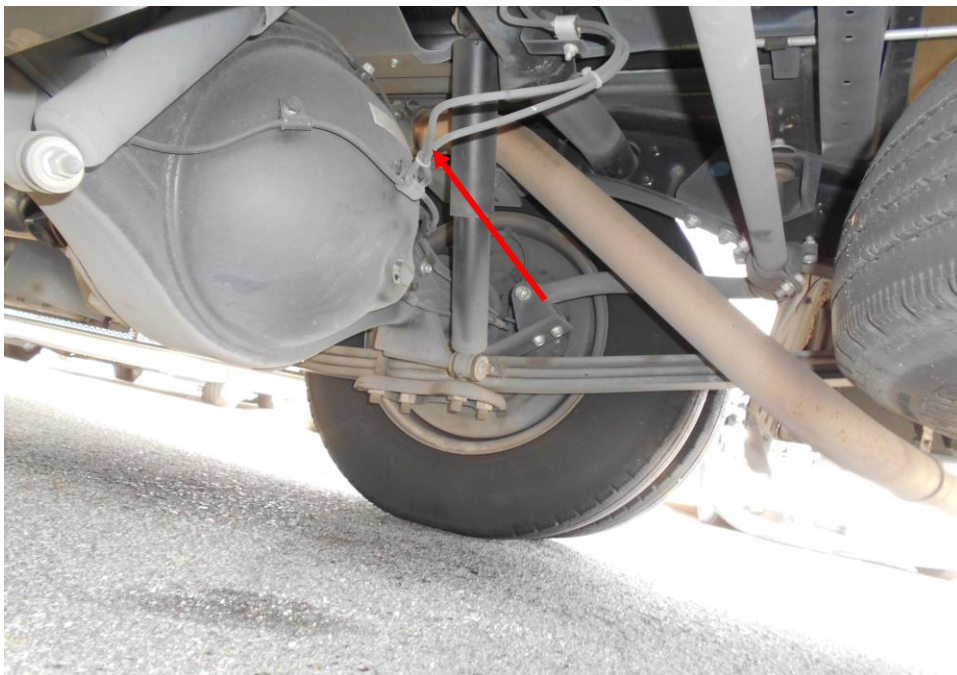
Photo 18 shows the various undercarriage components at the rear right wheel of the Motor Bus. The various steering components were all found to be intact, suggesting that the steering system of the Motor Bus was likely to be in serviceable condition at the material time of accident. There was also no sign of fluid stain(s) observed on the various undercarriage components at the 4 wheels of the Motor Van.

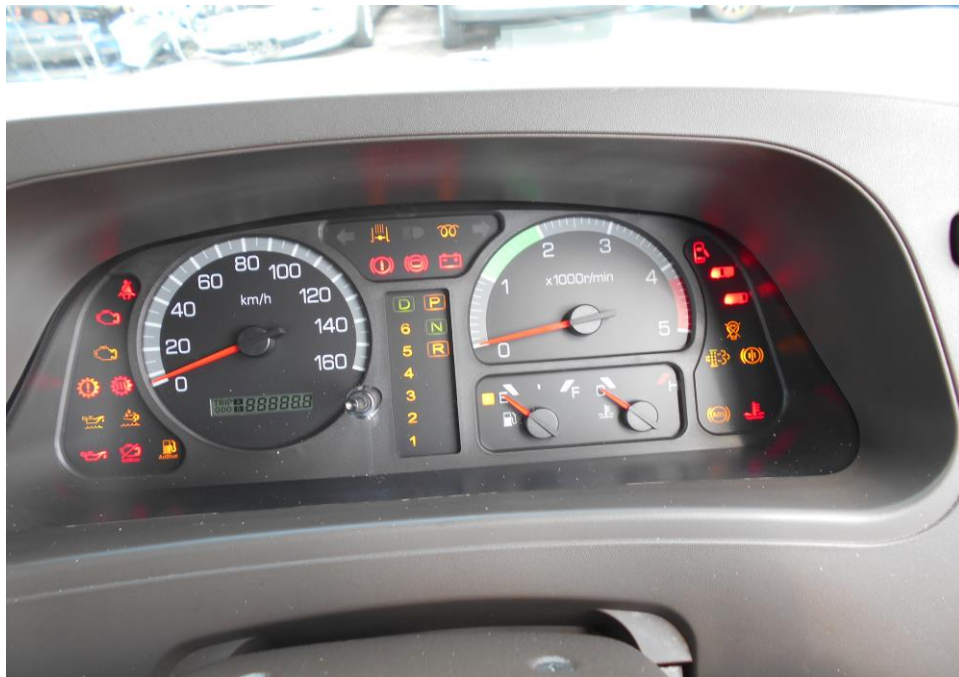
Photo 19 shows the warning lights for the various electronic operating systems of the Motor Bus appearing on its instrument panel during the self-test when the engine was cranked.

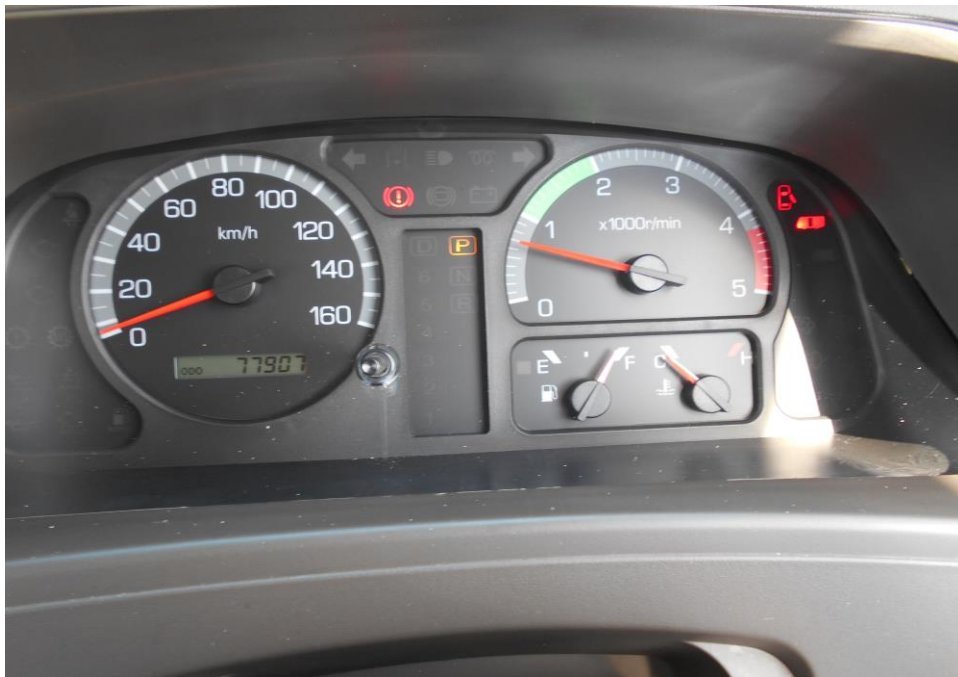
Photo 20 shows no warning lights illuminated on the instrument panel of the Motor Bus after the engine was cranked. This would suggest that there was no abnormality to the various electronic operating systems of the Motor Car.

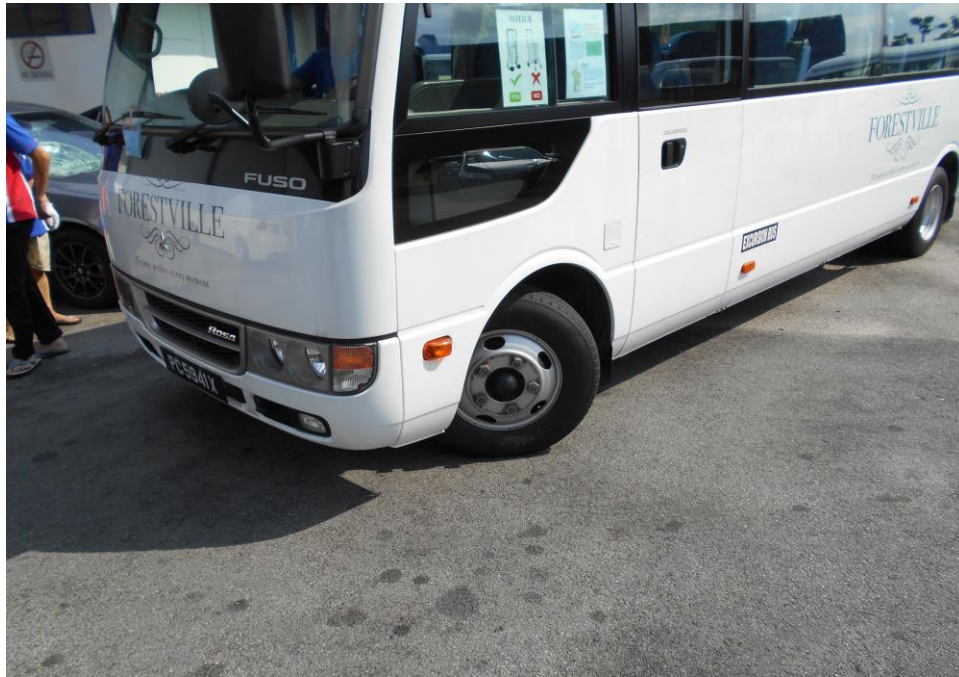
Photo 21 shows a short operational test of the Motor Bus, to primarily determine whether there was any abnormality to its various operating systems like its engine system, its transmission system, steering system and braking system was subsequently carried out. The test was conducted by driving the Motor Bus forward, stopping, before reversing and coming to a stop again.

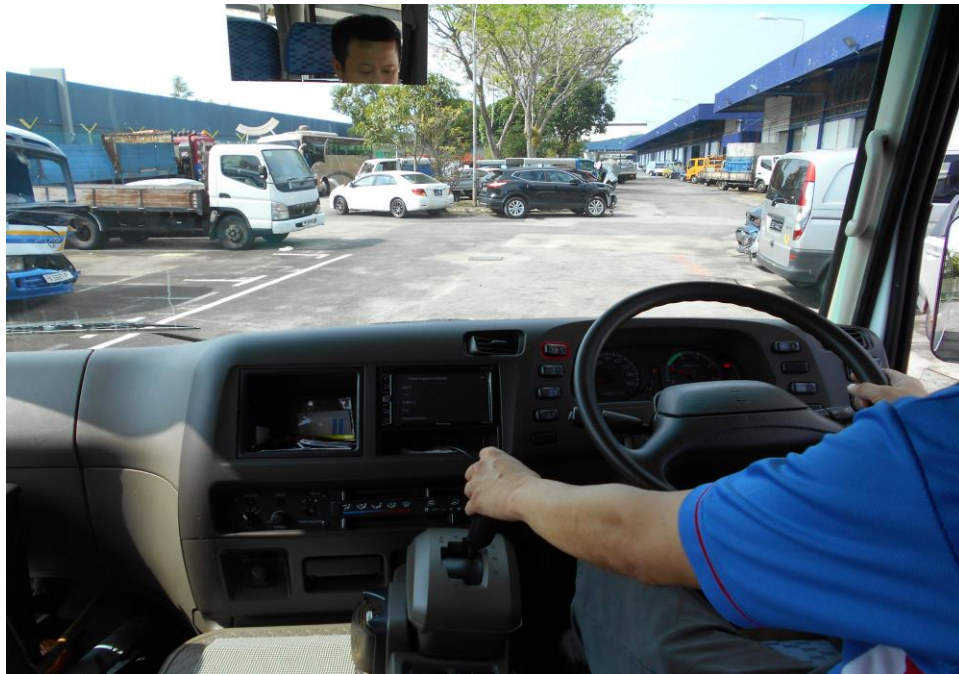
Photo 22 shows a short operational test of the Motor Bus, the test was conducted by driving the Motor Bus forward, stopping, before reversing and coming to a stop again.
