Your Ref: TP/IP/64127/2018
Our Ref :CI/TPD18022209/Z

Fatal Accident Investigation Team

MECHANICAL INSPECTION REPORT OF MOTORCYCLE FBG 3870A

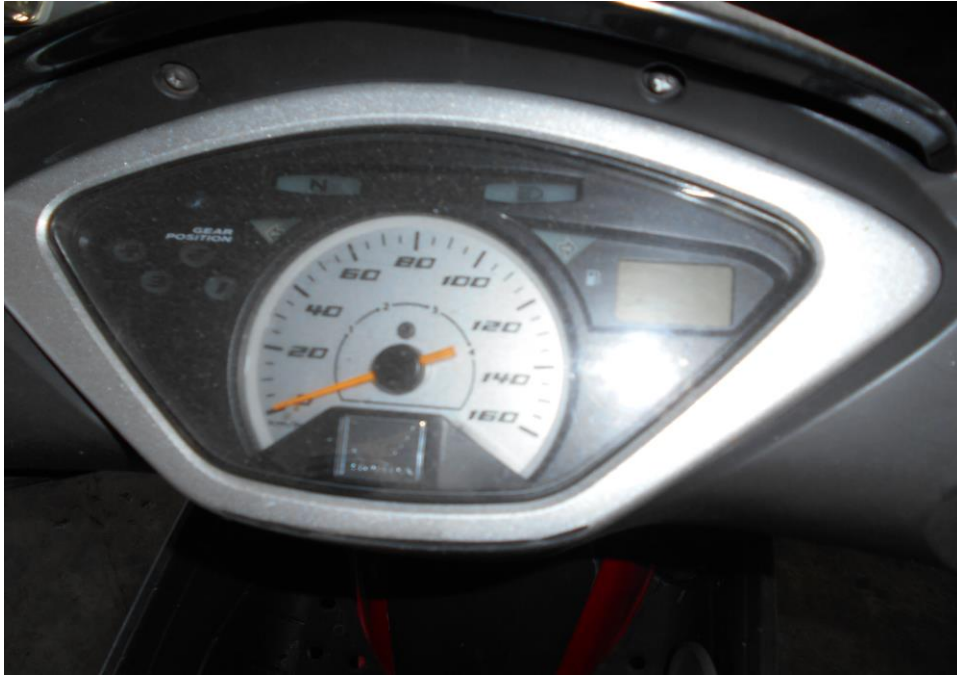
4. The mileage of the Motorcycle not recorded at time of our inspection due to the unavailability of the ignition key.
5. The Motorcycle was observed to have sustained minor damages at the frontal & right portion. The body parts that were found to have been damaged include its right hand side fairing, right handle, right hand brake lever, right wing mirror, right side headlamp, right rider & pillion foot rest and front mud guard amongst others as a result of the accident. See photo 1 to 7 below.

Photo 1 shows a close-up view of the mileage of the Motorcycle not recorded at time of our inspection due to the unavailability of the ignition key.

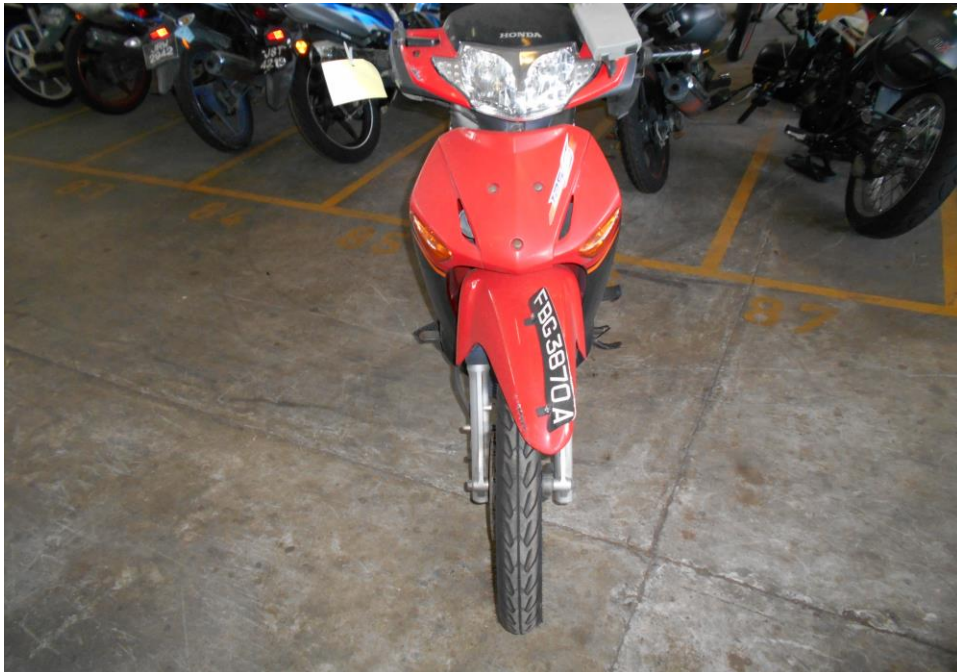
Photo 2 shows a general view of the front body of the Motorcycle at the time of our inspection. The Motorcycle was observed to have sustained relatively minor damages at time of inspection. The damages were observed to be confined to its front & right portion of the Motorcycle.

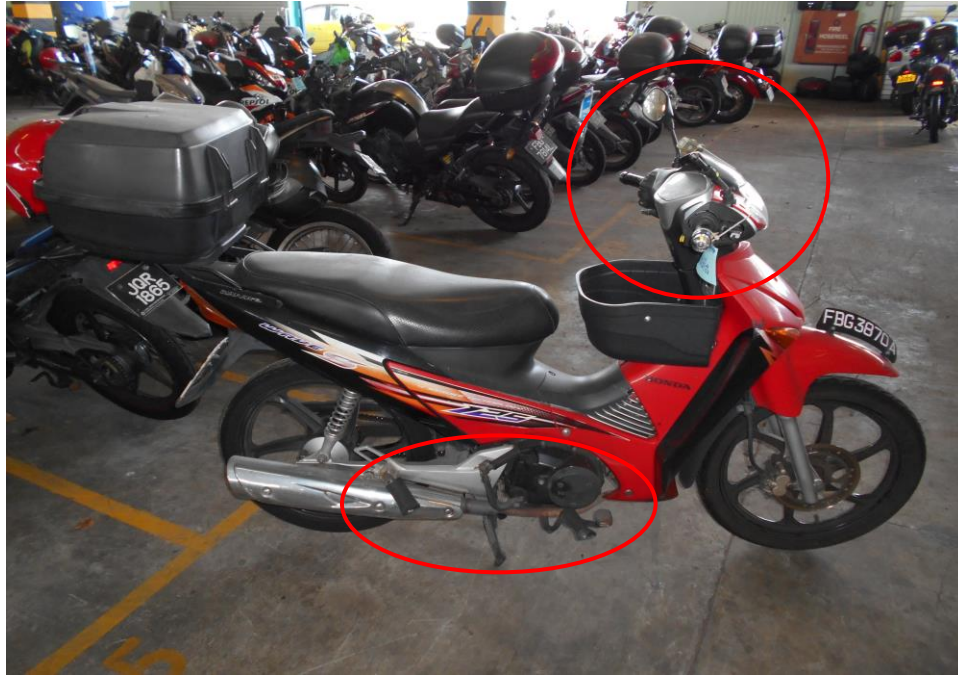
Photo 3 shows a general view of the right body of the Motorcycle at the time of our inspection. The Motorcycle was observed to have sustained relatively minor damages on the right side fairing, foot rest, handle, mud guard & brake lever at time of our inspection.

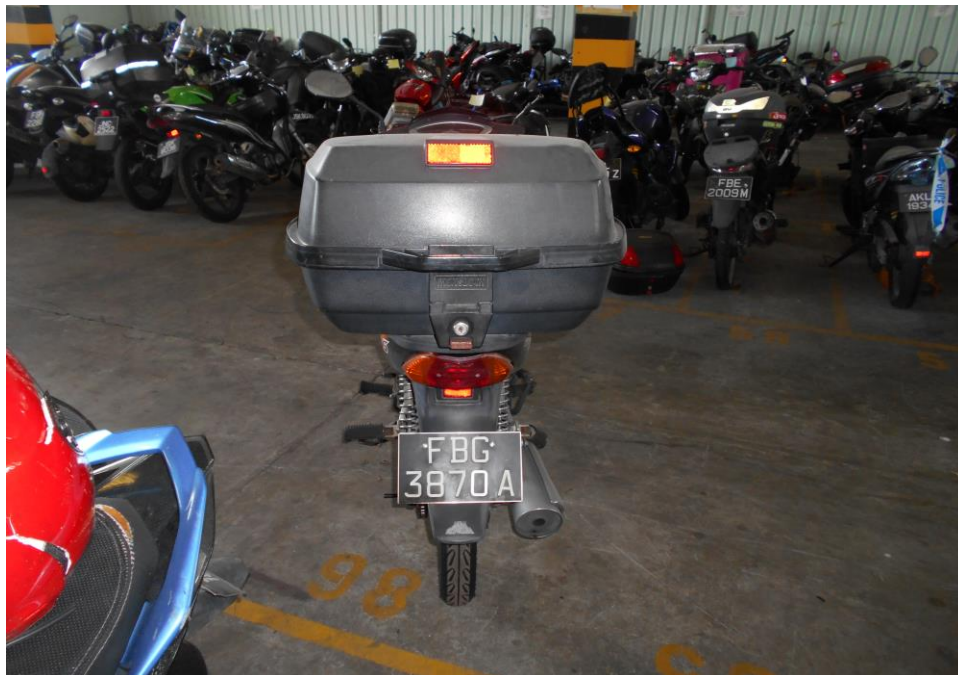
Photo 4 shows a general view of the rear body of the Motorcycle at the time of our inspection. The Motorcycle was observed to be in good condition unaffected by the accident.

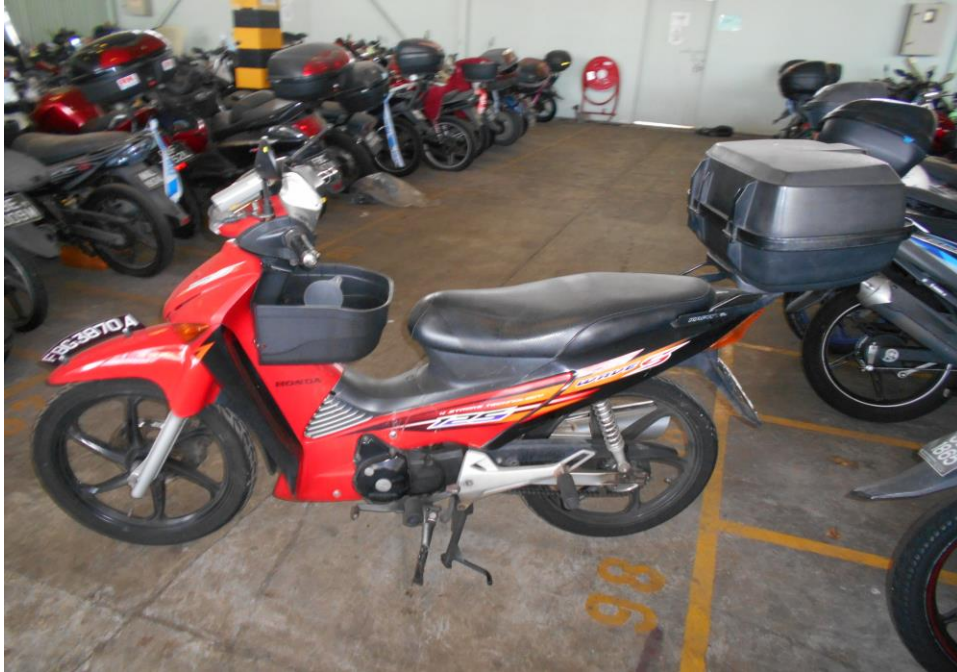
Photo 5 shows a general view of the left body of the Motorcycle at the time of our inspection. The Motorcycle was observed to have sustained relatively minor damages on the left side fairing at time of our inspection.

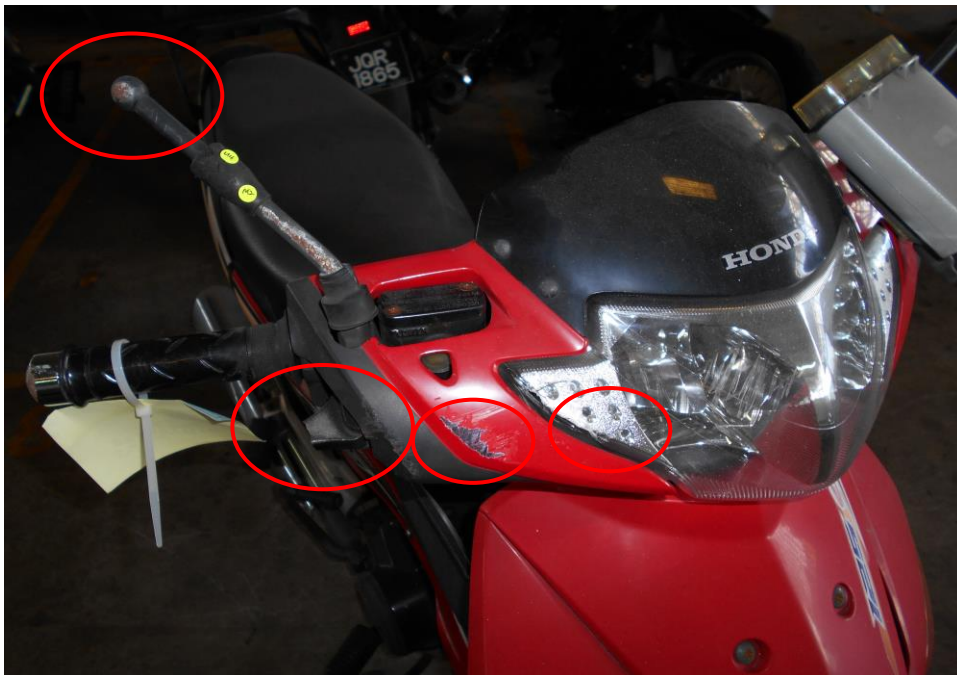
Photo 6 shows a closer view of the right damaged components of the Motorcycle at the time of our inspection. The Motorcycle was observed to have sustained with relatively minor damages due to the accident collision. (Circled)

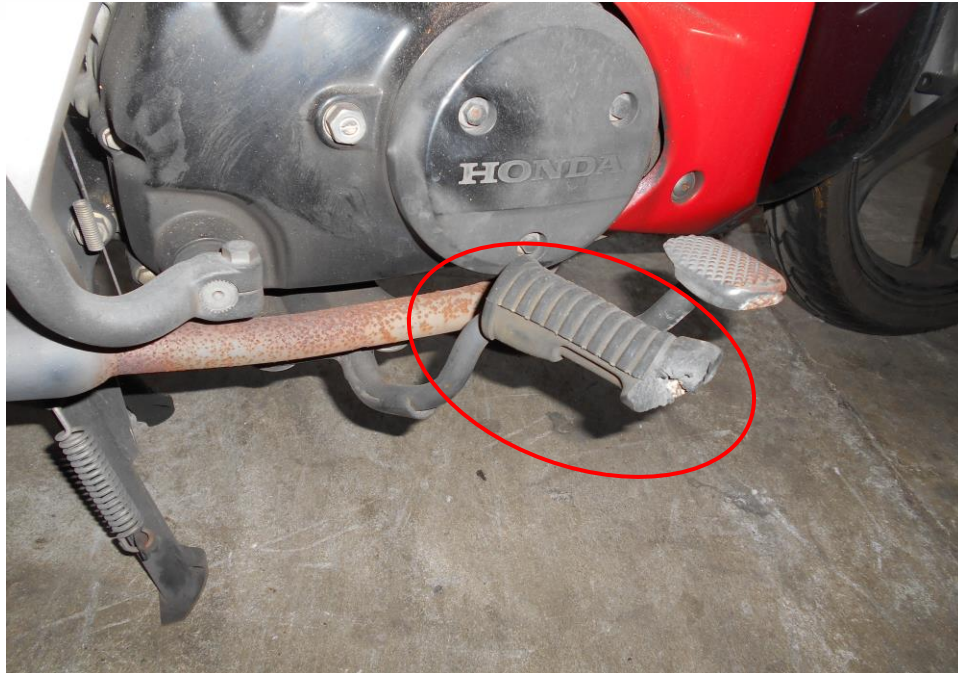
Photo 7 shows a closer view of the right rider's foot rest of the Motorcycle at the time of our inspection. The Motorcycle was observed to have sustained with relatively minor damages due to the accident collision. (Circled)

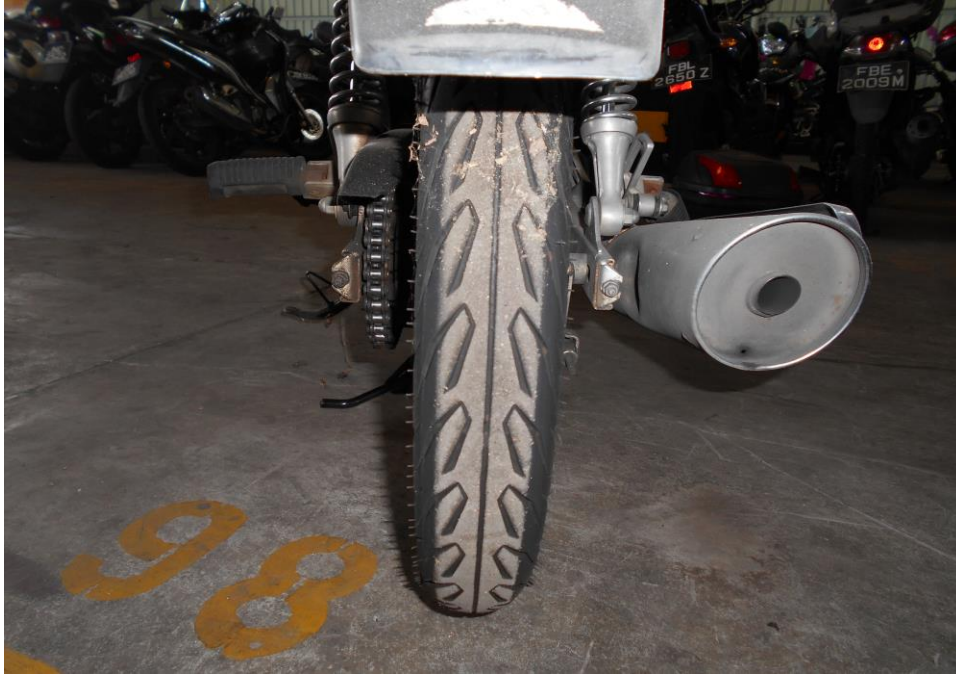
7. The rear tyre was wrapped around alloy wheel rims that were found to be without any significant damage. See photo 8 & 9 below

Photo 8 shows the rear tyre of the Motorcycle. The rear tyre was observed to be in serviceable condition with remaining tread depth of approximately 4mm. The tyre was also observed to be sufficiently inflated for vehicular operation.

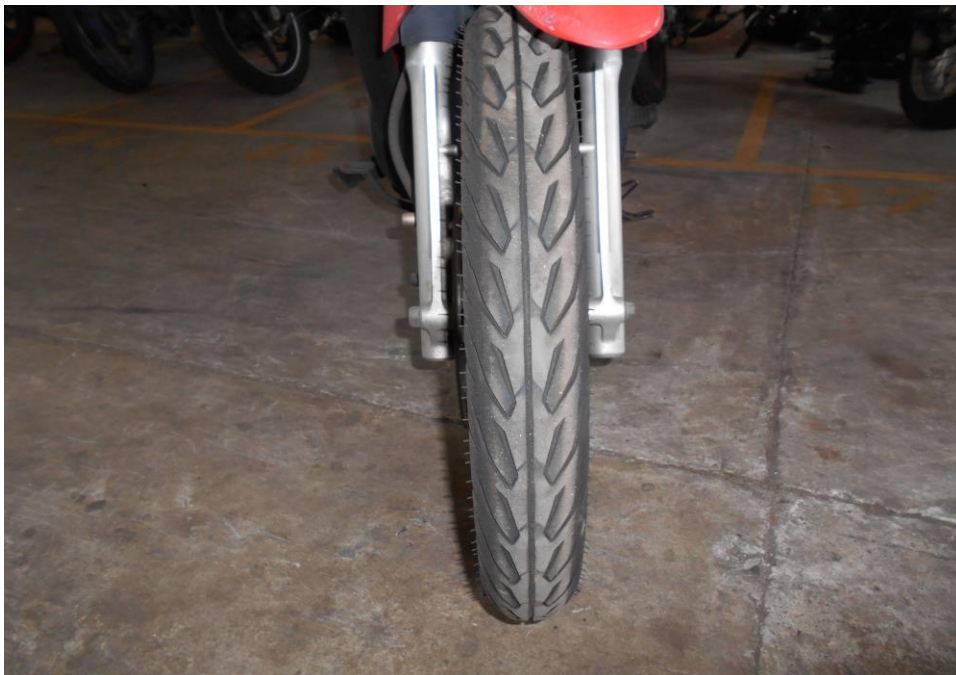
Photo 9 shows the front tyre of the Motorcycle. The front tyre was observed to be in serviceable condition with remaining tread depth of approximately 4mm. The tyre was also observed to be sufficiently inflated for vehicular operation.

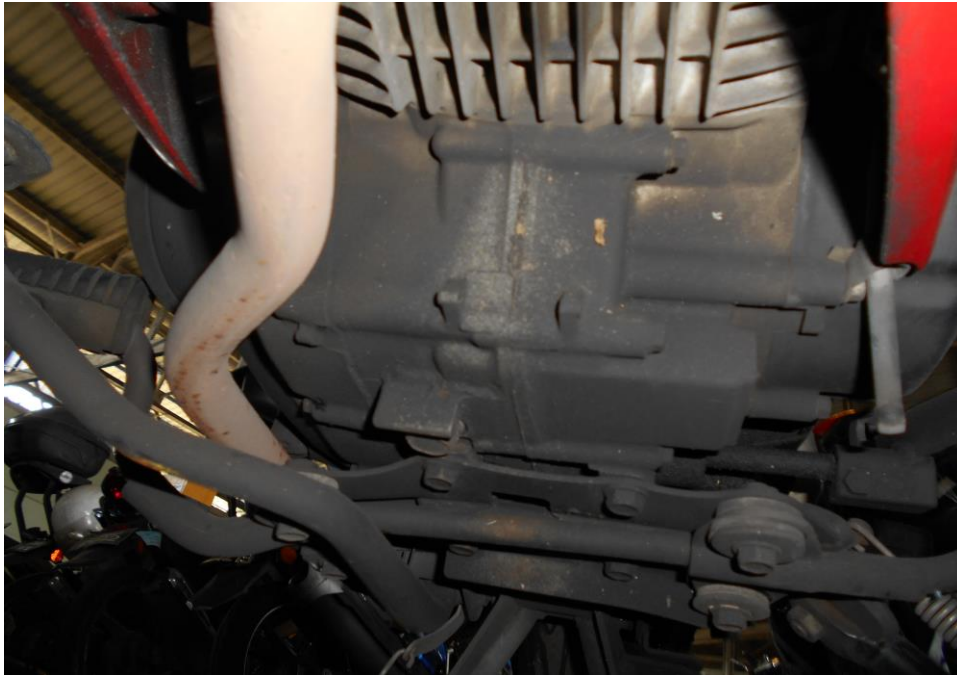
8. Upon examination of the Motorcycle's engine area, we had observed that the various engine related parts and components were intact with no visible damage. There was also no sign(s) or indication(s) of fluid leak observed around the engine area of the Motorcycle.
9. The gear chain of the motorcycle was found to be intact without any misalignment. It was also adequately lubricated for operating purposes. Free play tension test was also conducted & found adequately acceptable. See photo 10 – 13 below.

Photo 10 shows no sign(s) or indication(s) of fluid leak observed around the underside of the engine area of the Motorcycle.

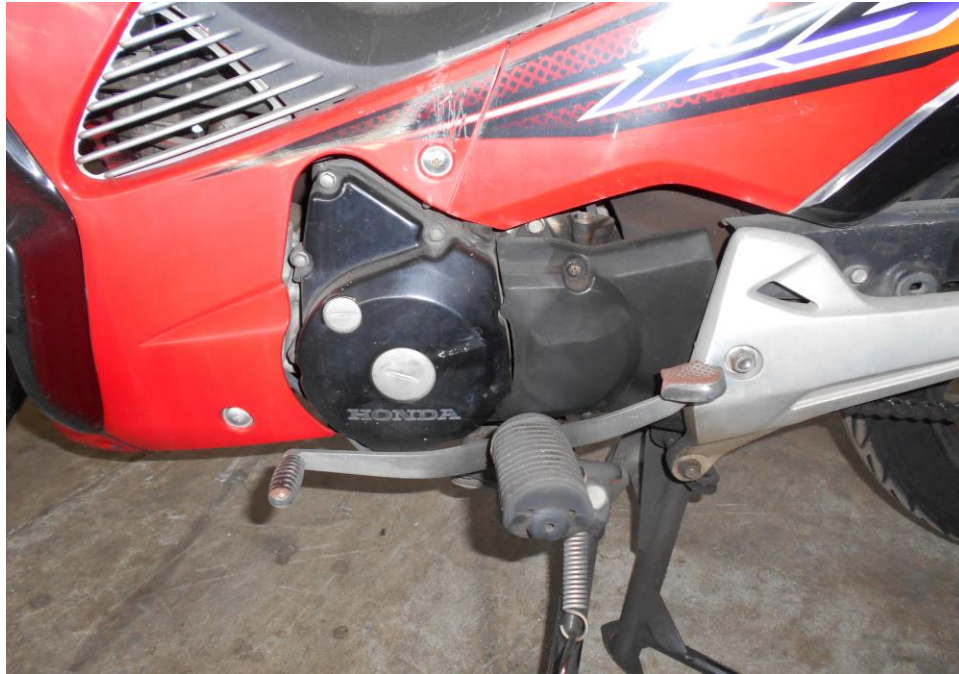
Photo 11 shows no sign(s) or indication(s) of fluid leakage stain observed around the engine area of the Motorcycle.

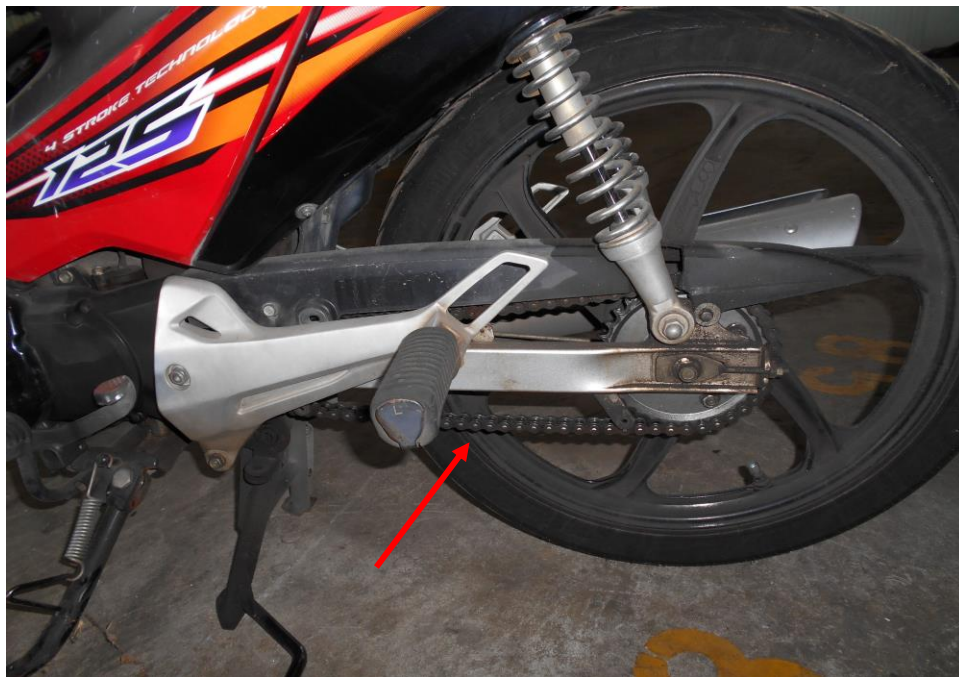
Photo 12 shows the general view of the gear train (arrowed) of the Motorcycle, which was observed to be intact with no misalignment. It was also adequately lubricated for operating purposes.

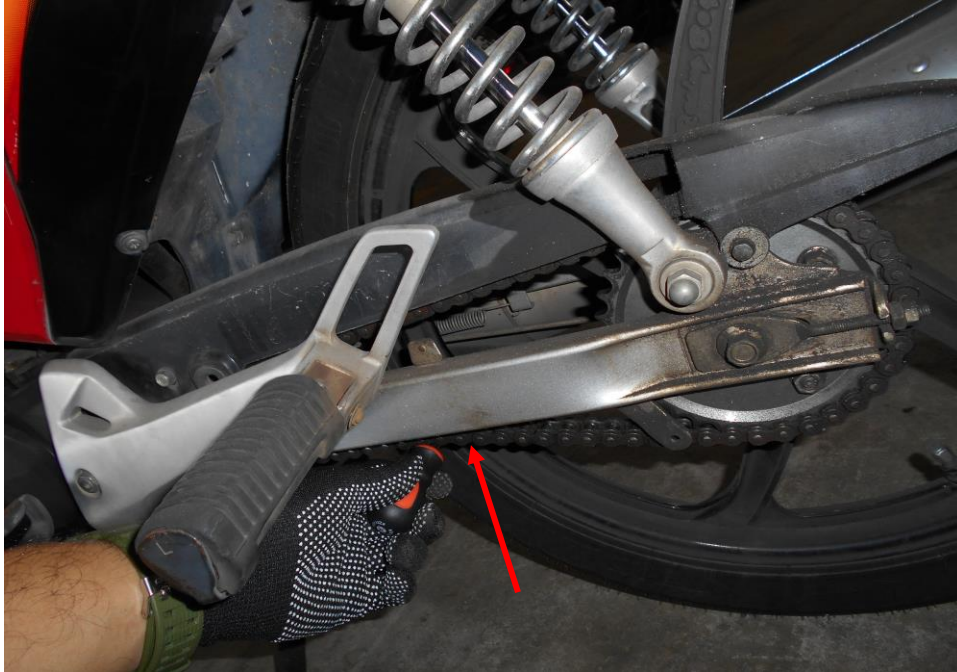
Photo 13 shows the general view of the gear train (arrowed) of the Motorcycle, which was observed to be intact with no misalignment. It was also adequately lubricated for operating purposes. Free play tension was also observed & found adequately acceptable.

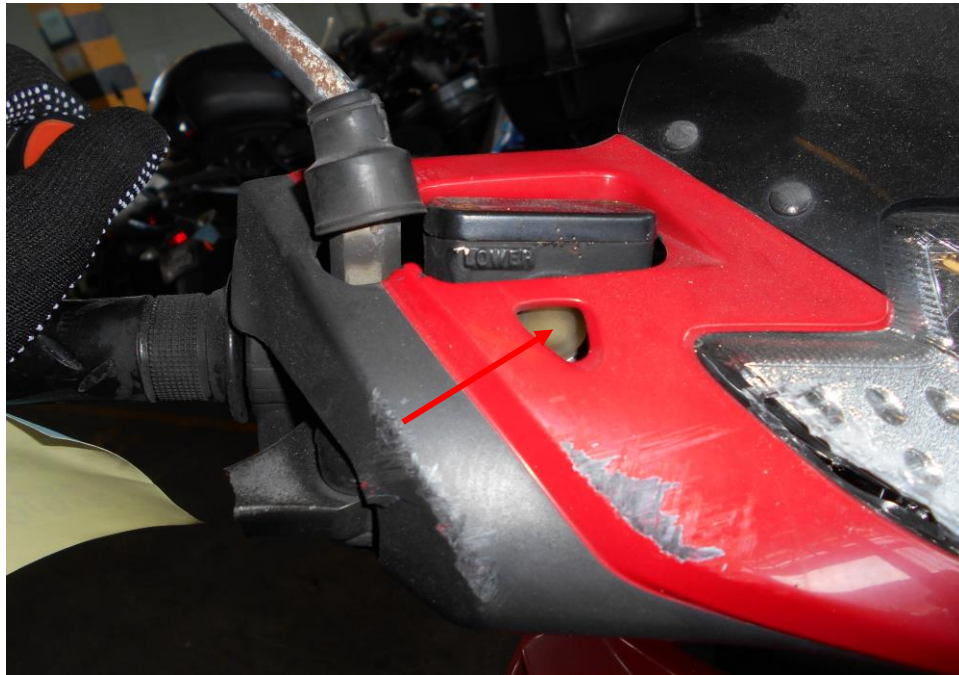
12. A static brake test was unable to be conducted on the Motorcycle front brake due to the damaged/broken hand brake lever. However, rear brakes test had appeared to indicate that the rear braking system of the Motorcycle was in serviceable condition.
13. The Motorcycle's braking system like the brake discs, brake callipers, brake foot pedal, rear brake mechanism and brake hoses revealed all to be intact and without damage despite broken front hand brake lever. There was braking reaction on the rear brake upon stepping on the brake pedal when we manually test the rear brake. This would indicate that there was no damage/abnormalities in the rear brake system. Our checks on the front brake fluid reservoir had also indicated that the brake fluid was of sufficient level for operational purposes, and without contamination.

Photo 14 shows our checks on the brake fluid (front) reservoir had also indicated that the brake fluid was of sufficient level for operational purposes, and without contamination.

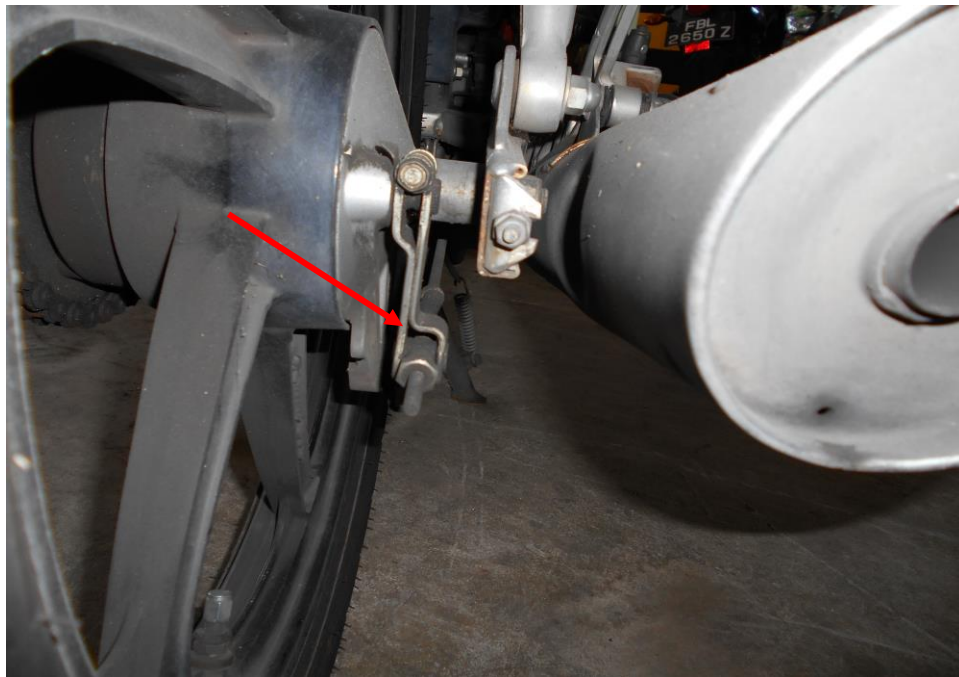
Photo 15 shows our checks on the rear brake mechanical components had also indicated that the rear brake was fit for operational purposes, without abnormalities unaffected by the accident.

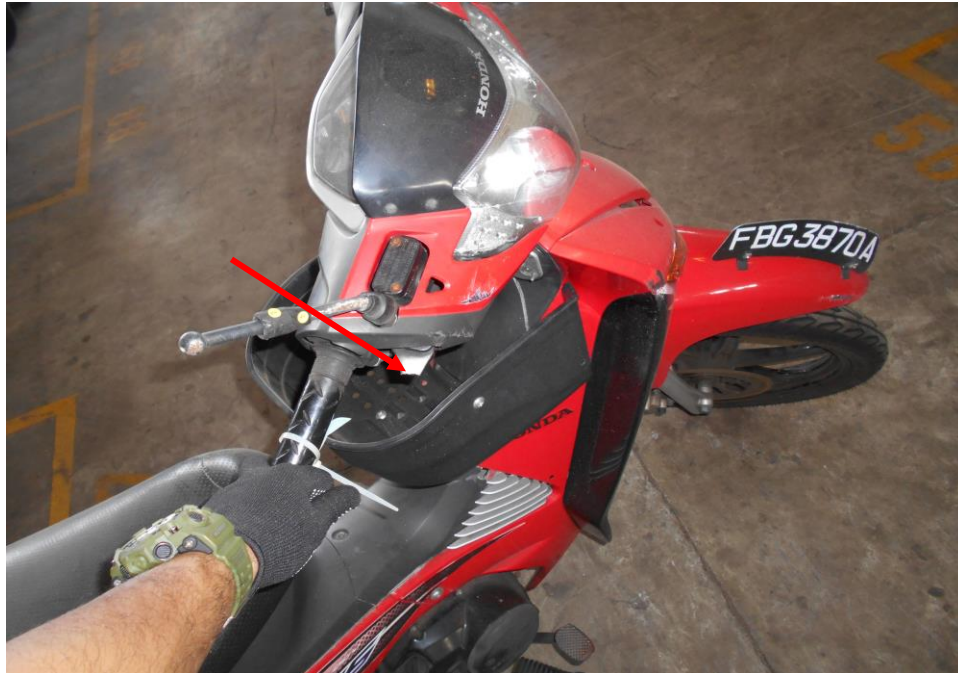
Photo 16 shows broken front brake lever as a result of the accident. This had disabled the static test on the front braking system.

16. Basing on our physical inspection of the Motorcycle, it appears that the steering system and braking system of the Motorcycle were all in serviceable condition despite broken front hand brake lever. We did not find any evidence(s) to suggest that there was possible mechanical failure to the Motorcycle that may have caused and/or contributed to the accident.
17. The tyres of the Motorcycle were found to be in a serviceable condition. There was no tear, cut or burst mark(s) on the outer and the inner sidewalls as well as across the tread of the tyre. It was sufficiently inflated for vehicular operation with remaining tread depth of approximately 4 mm.

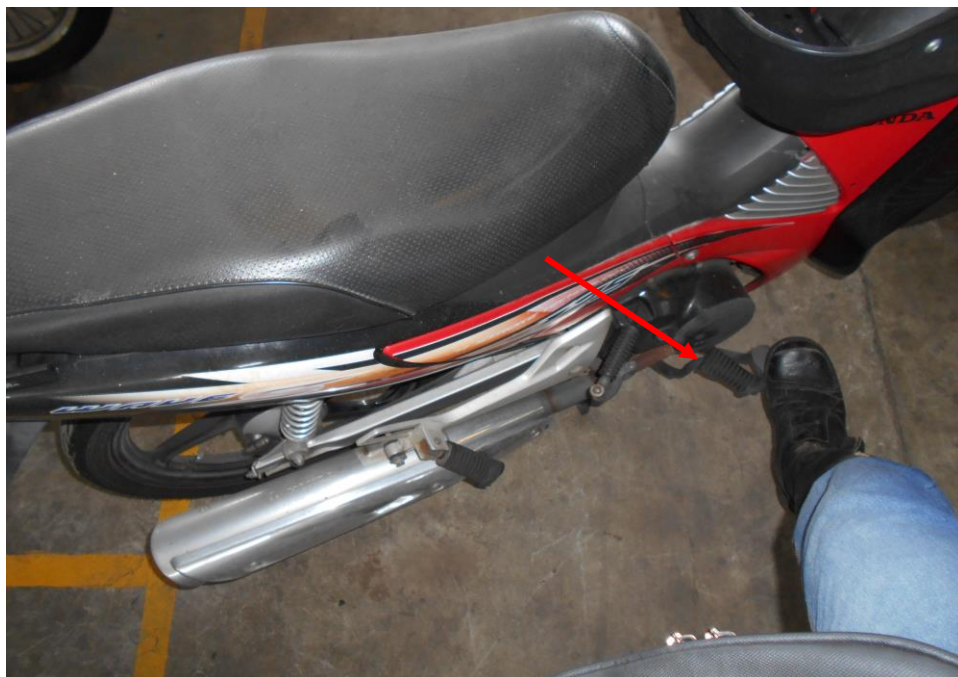
Photo 17 shows testing of the braking of the rear brake in progress. There was some resistance felt (spongy like feel) upon stepping on the brake pedal.

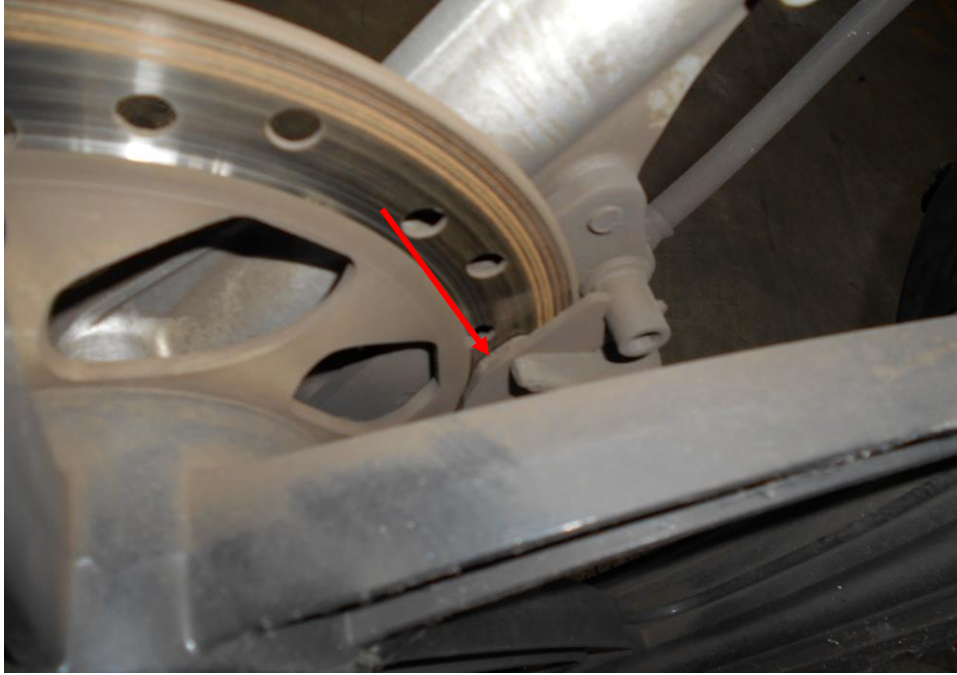
Photo 18 shows the front brake pad at time of our inspection. The frictional material was observed to be sufficient for operational purposes.
