Your Ref: TP/IP/64127/2018  
Our Ref : CI/TPD18022211/P

26<sup>th</sup> April 2019

**Fatal Accident Investigation Team**

**MECHANICAL INSPECTION REPORT OF MOTOR LORRY YM 5867T**

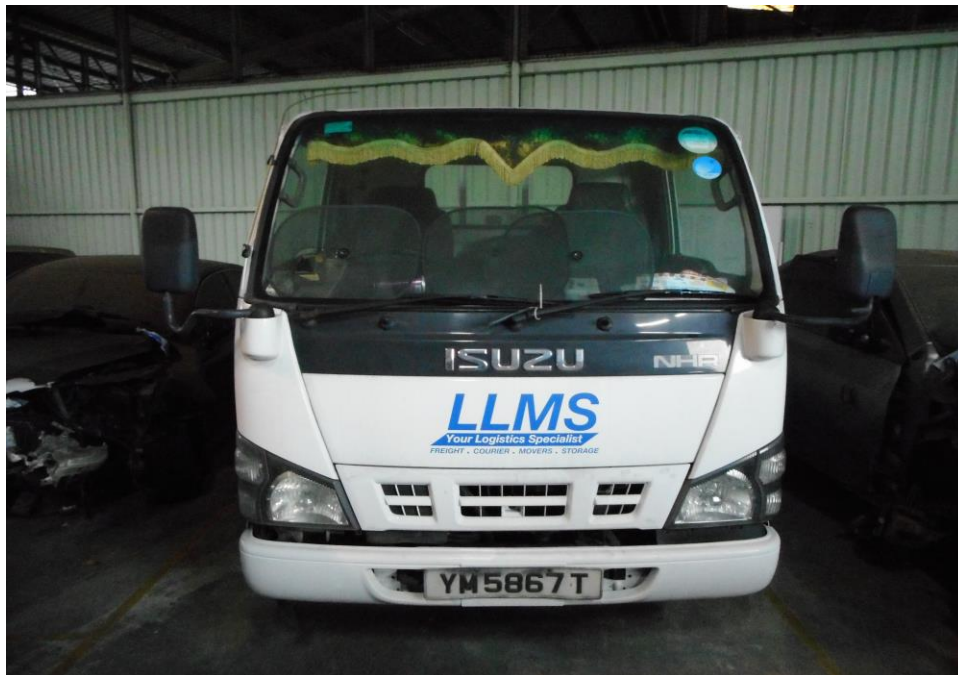
**Photo 1** shows a general view of the front left body of the Motor Lorry at the time of my inspection. The Motor Lorry was observed to be in good general condition.

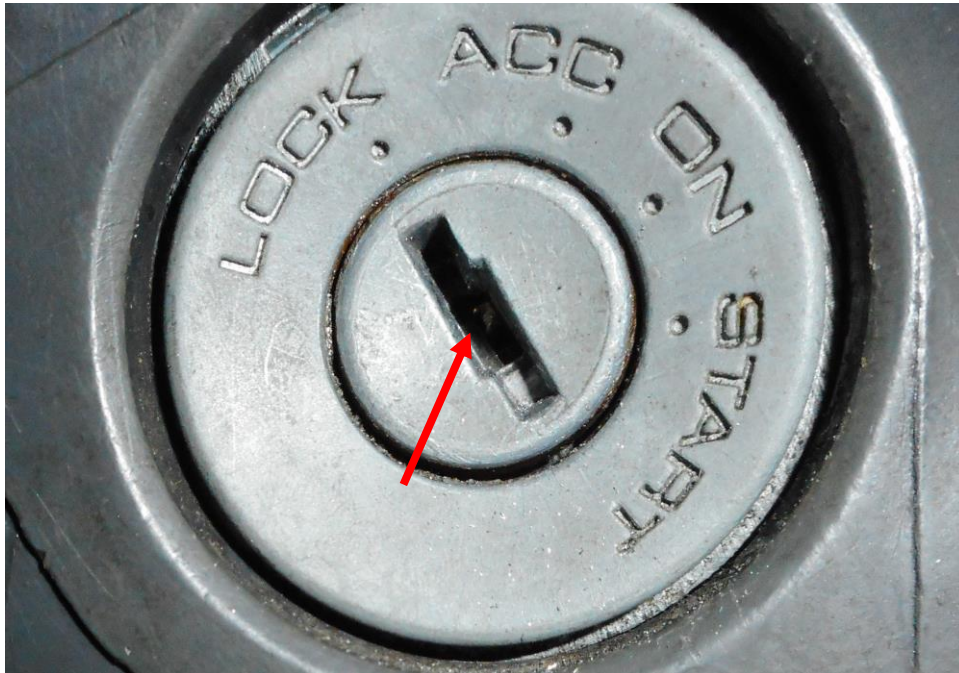
4. The mileage of the Motor Lorry was not able to be recorded due to a broken part of a key stuck in the ignition system (Unable to start) at the time of my inspection.
5. The Motor Lorry did not appear to have sustained any significant damage at the time of my inspection.

**Photo 2** shows a general view of the ignition part of the Motor Lorry at the time of my inspection. The broken key is stuck in the ignition rendering the Motor lorry unable to be started.

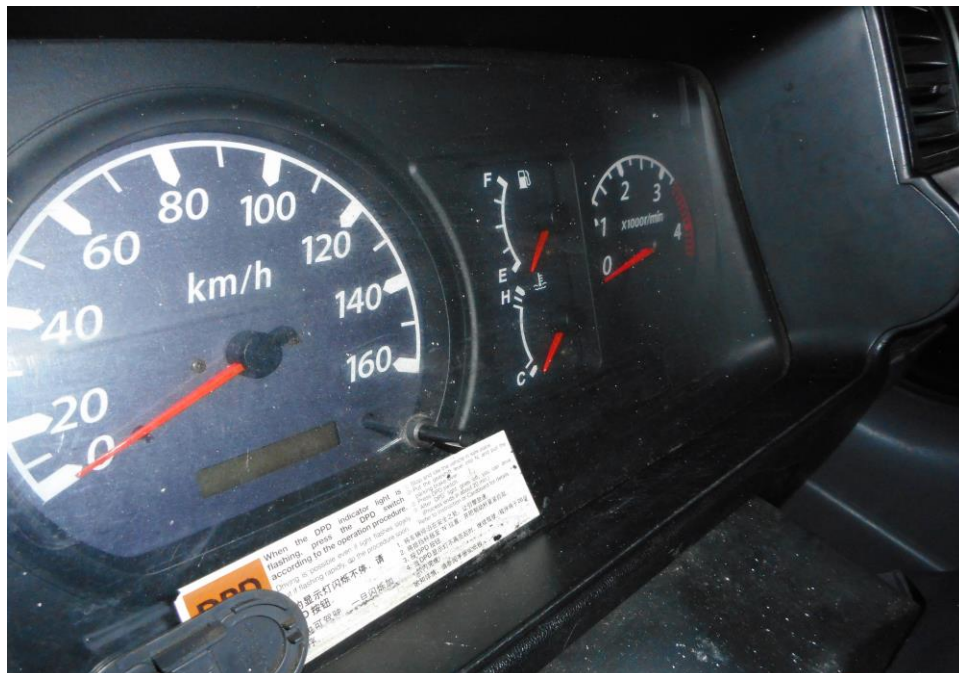
**Photo 3** shows a general view of the instrument cluster of the Motor Lorry at the time of my inspection. The mileage of the Motor Lorry was not recorded due to the Motor lorry (unable) to be started.

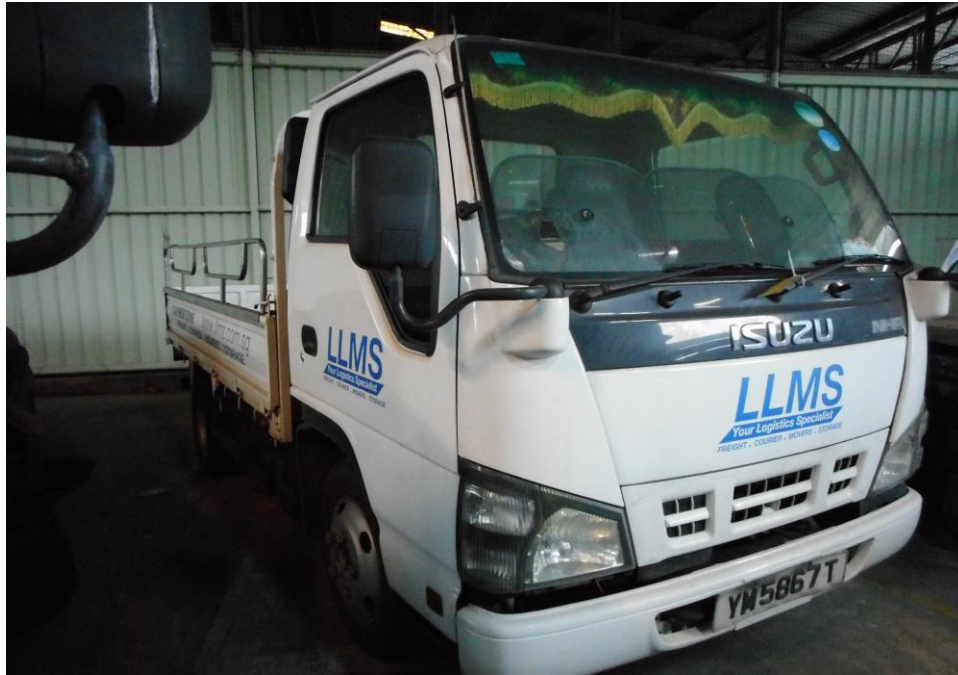
**Photo 4** shows a general view of the front right body of the Motor Lorry at the time of my inspection. The Motor Lorry was observed to be in good general condition.

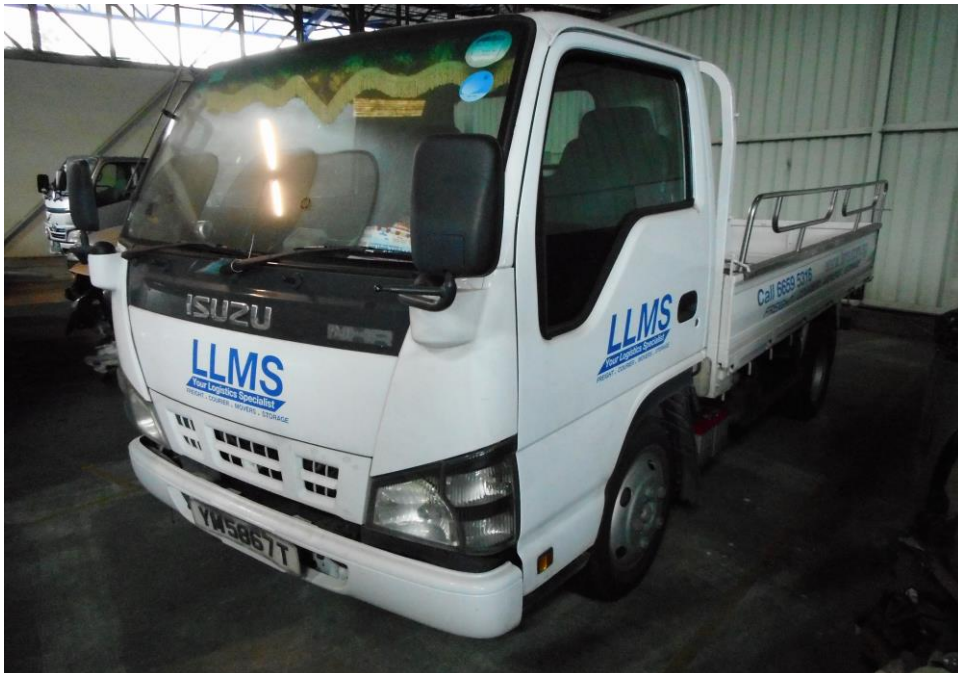
**Photo 5** shows a general view of the front right body of the Motor Lorry at the time of my inspection. The Motor Lorry was observed to be in good general condition.

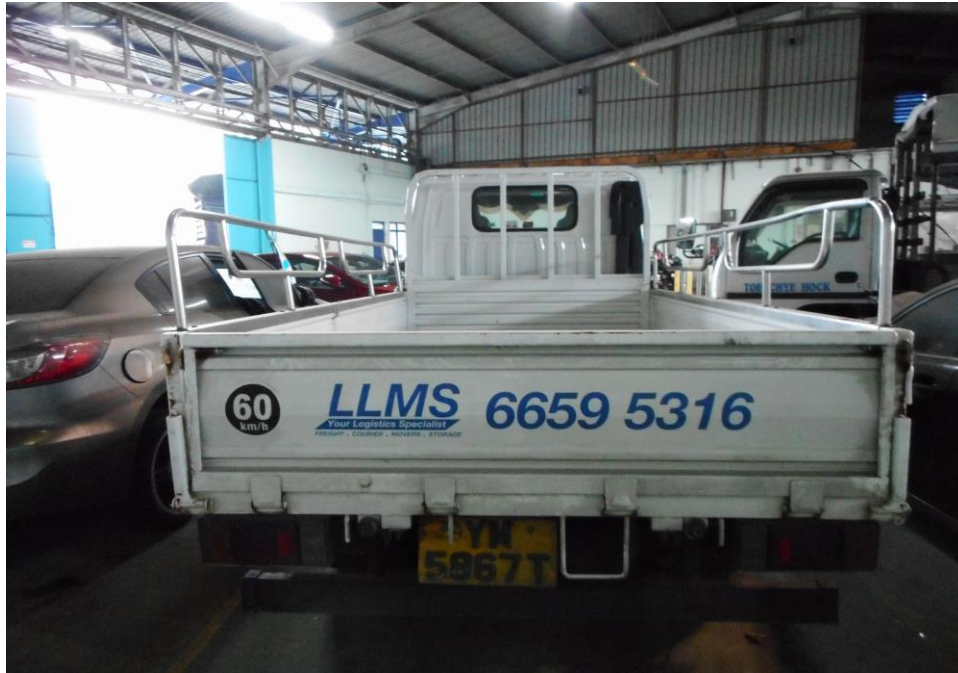
**Photo 6** shows a general view of the Motor Lorry's rear left body at the time of my inspection. There was no damage found to the rear portion of the Motor Lorry.

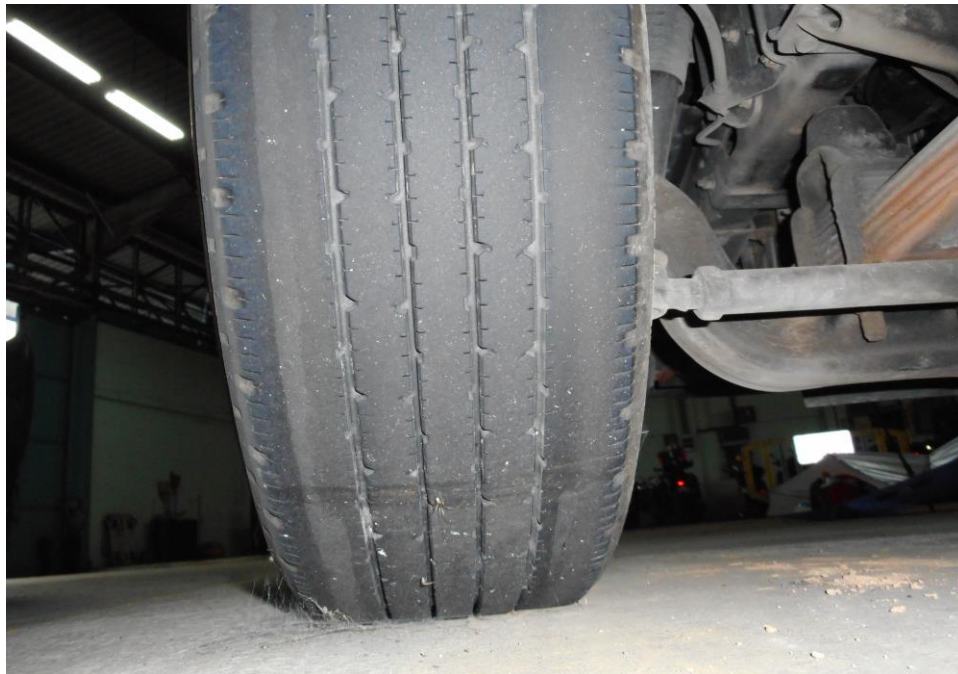
**Photo 7** shows the condition of the front left tyre of the Motor Lorry, which was observed to be in serviceable condition with remaining tread depth of approximately 5.3mm. The tyre, which was wrapped around standard alloy wheel rim, was also observed to be sufficiently inflated for vehicular operation. There was no tear, cut or burst mark(s) on the outer and the inner sidewalls as well as across the tread of the 6 tyres that were fitted on the Motor Lorry.

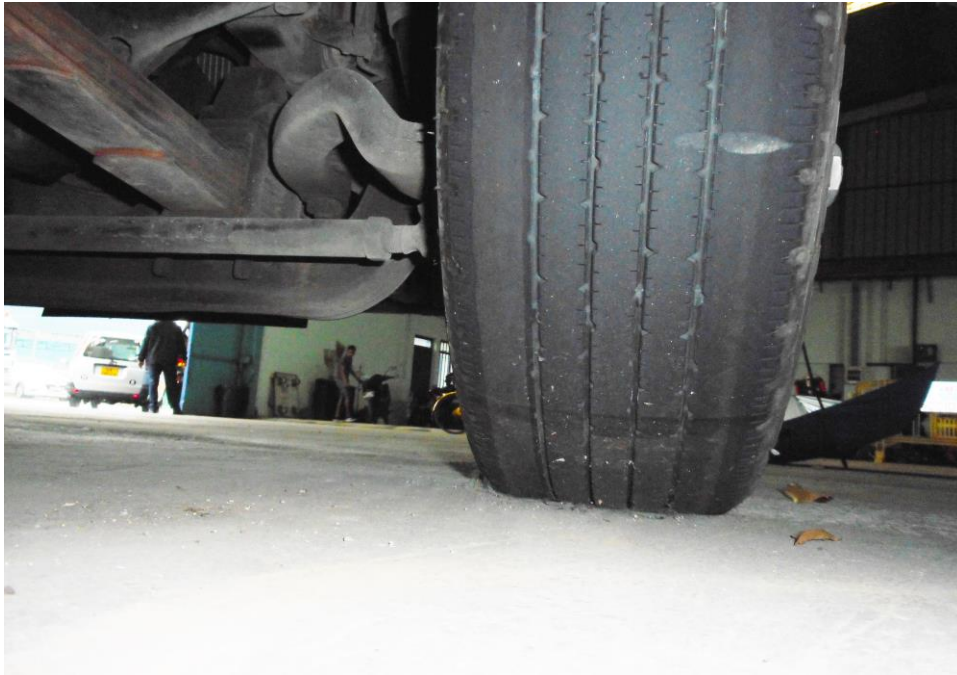
**Photo 8** shows the condition of the front right tyre of the Motor Lorry, which was observed to be in serviceable condition with remaining tread depth of approximately 4.9mm. The tyre, which was wrapped around standard alloy wheel rim, was also observed to be sufficiently inflated for vehicular operation.

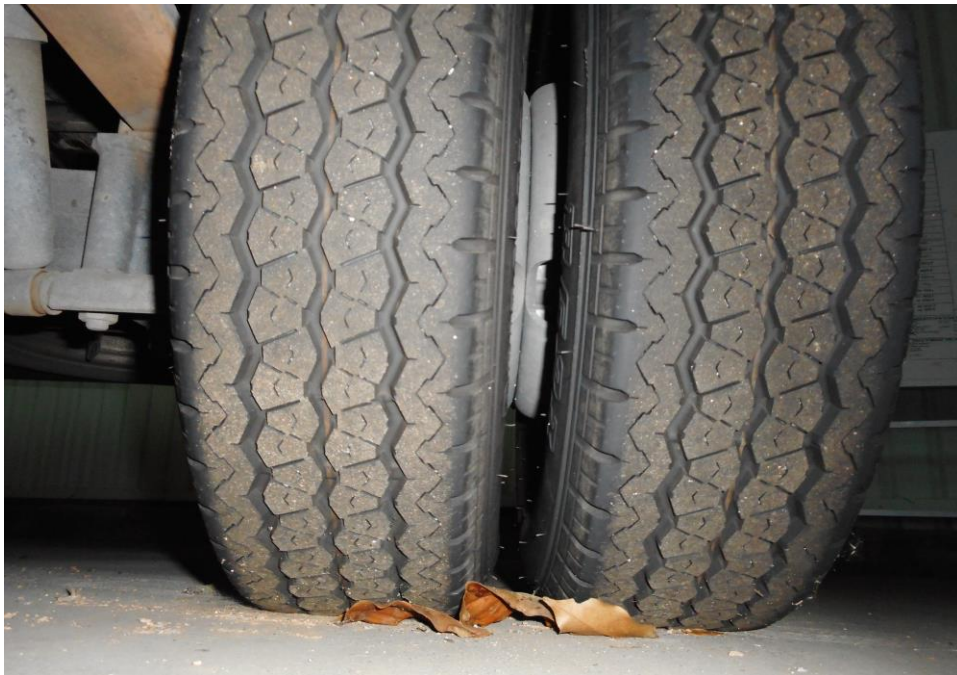
**Photo 9** shows the condition of the rear left tyres of the Motor Lorry, which was observed to be in serviceable condition with remaining tread depth of approximately 6mm. The tyres, which were wrapped around standard alloy wheel rim, were also observed to be sufficiently inflated for vehicular operation. There was also no damage found on all 6 alloy wheel rims of the Motor Lorry.

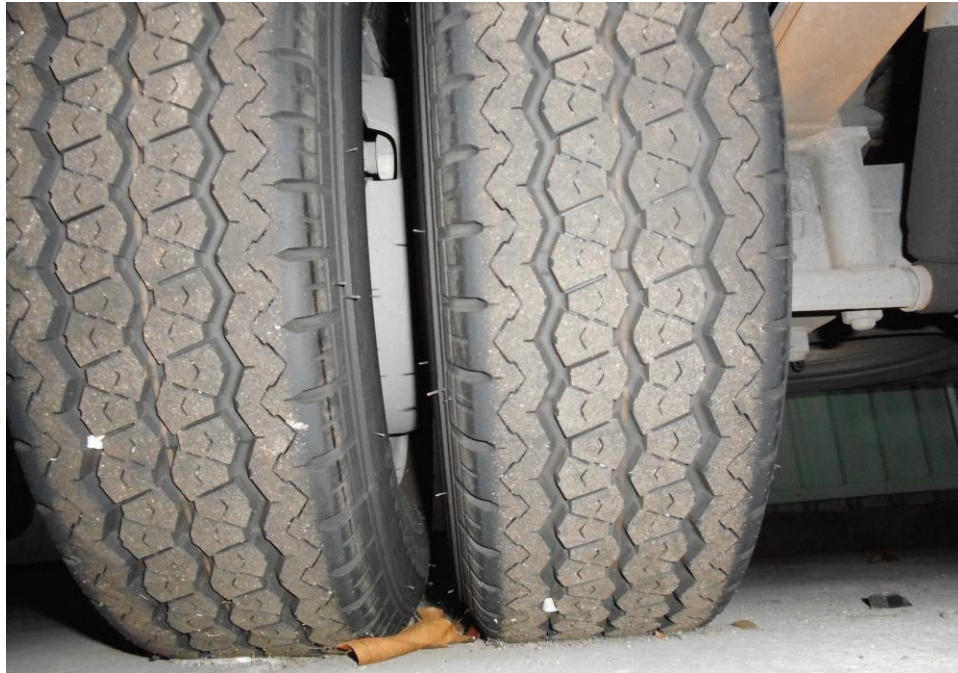
**Photo 10** shows the condition of the rear right tyres of the Motor Lorry, which were observed to be in serviceable condition with remaining tread depth of approximately 5.9mm. There was also no tear, cut or burst mark(s) on the outer and the inner sidewalls as well as across the tread of the 6 tyres that were fitted on the Motor Lorry.

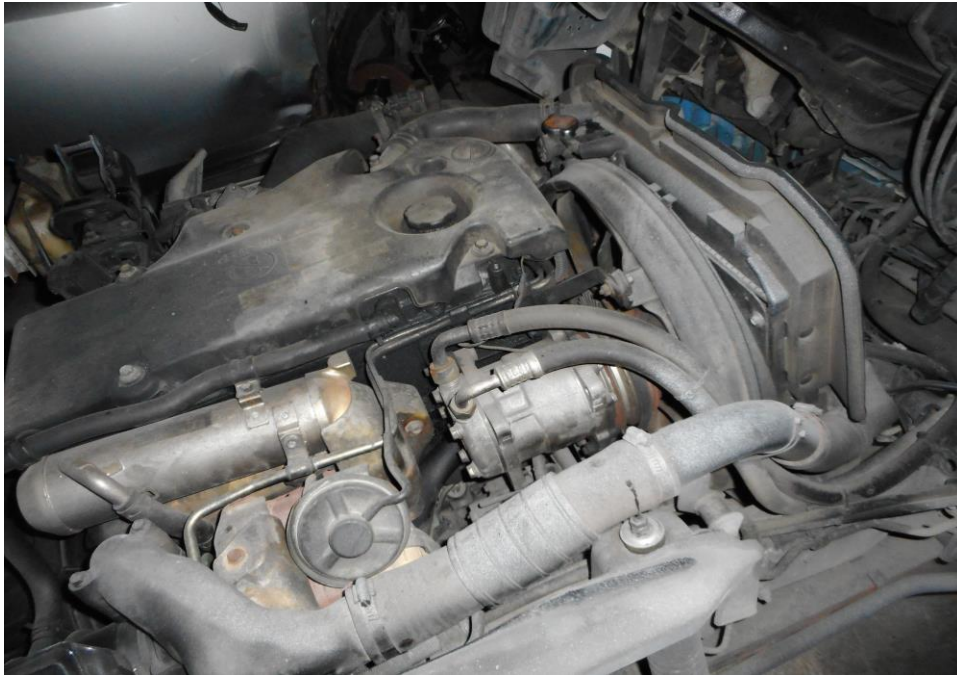
**Photo 11** shows a general view of the Motor Lorry's engine compartment, which was accessed by lifting the front cabin of the Motor Lorry. The various parts and components inside the engine compartment were unaffected by the accident. There was also no sign(s) or indication(s) of fresh fluid leakage and/or fluid stain within the engine compartment (photograph shows the engine compartment as viewed from the right front side of the Motor Lorry).

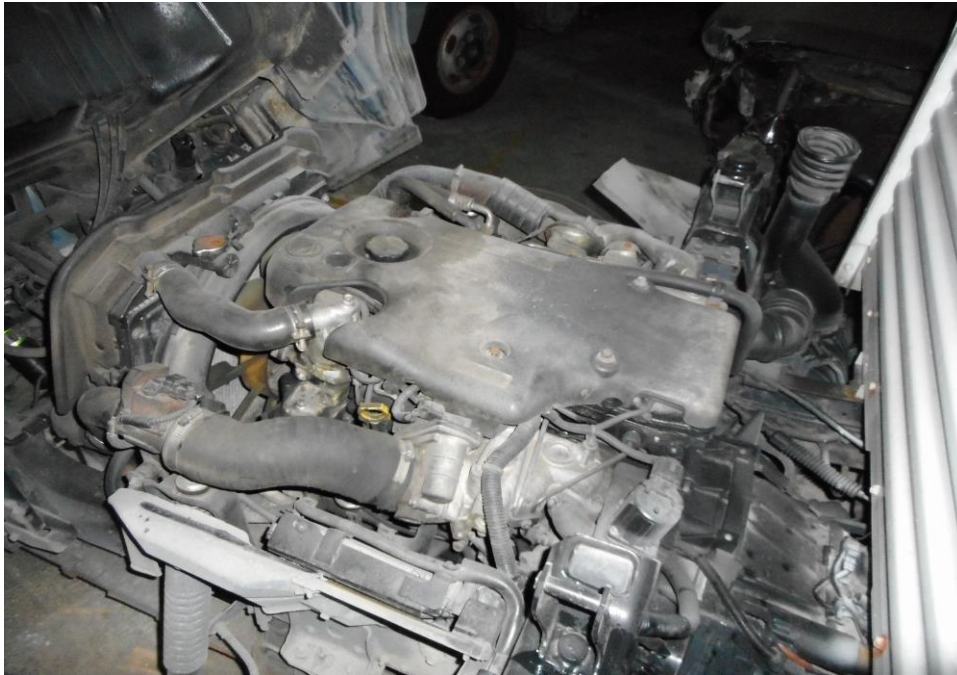
**Photo 12** shows a general view of the Motor Lorry's engine compartment, which was accessed by lifting the front cabin of the Motor Lorry. The various parts and components inside the engine compartment were unaffected by the accident. There was also no sign(s) or indication(s) of fresh fluid leakage and/or fluid stain within the engine compartment (photograph shows the engine compartment as viewed from the front left side of the Motor Lorry).

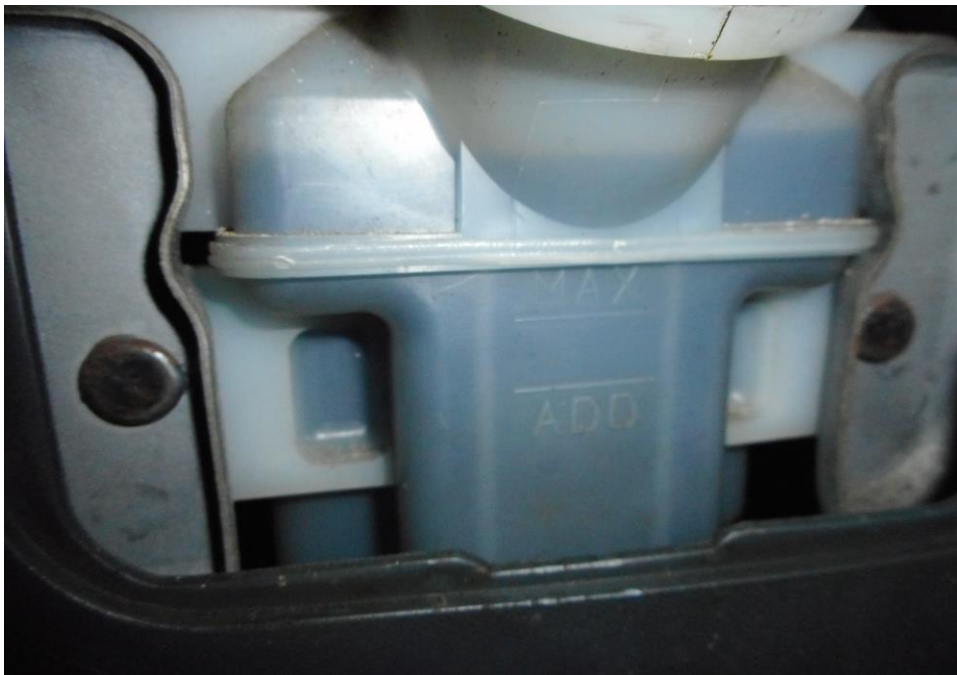
**Photo 13** shows the brake fluid reservoir of the Motor Lorry at the time of my inspection. The brake fluid was observed to be of sufficient level and without any visible contamination.

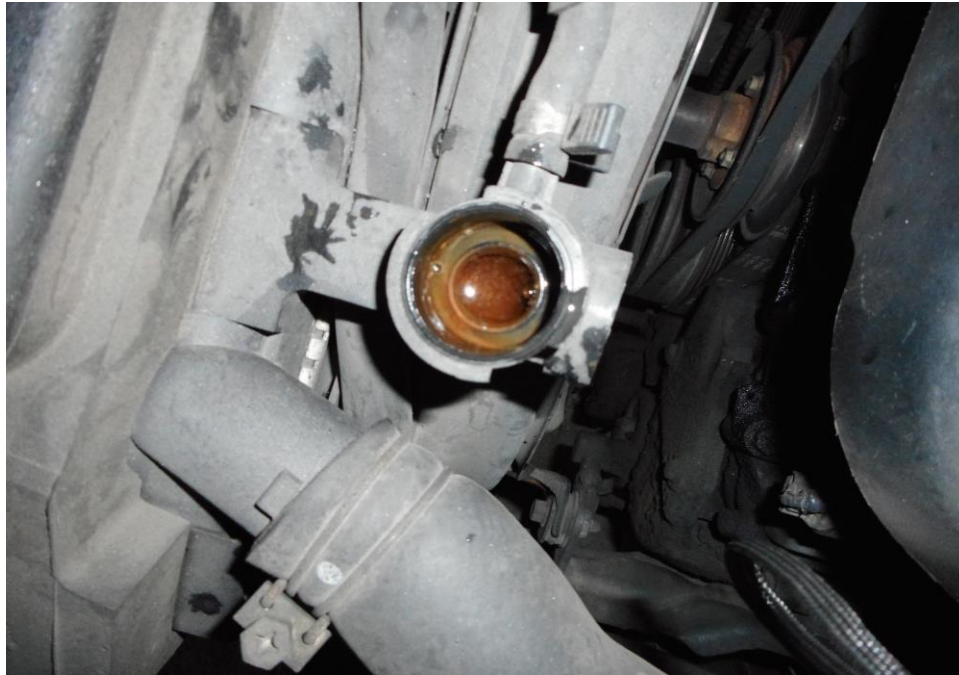
**Photo 14** shows the engine coolant reservoir of the Motor Lorry at the time of my inspection. The engine coolant was observed to be of sufficient level and without any visible contamination.

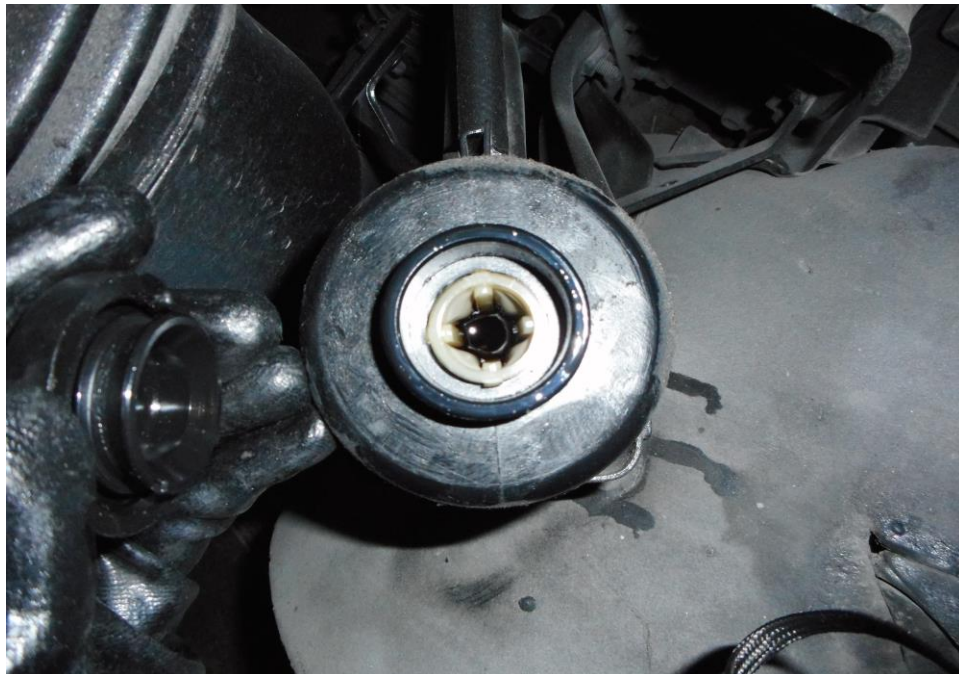
**Photo 15** shows the power steering fluid reservoir of the Motor Lorry at the time of my inspection. The power steering fluid was observed to be of sufficient level and without any visible contamination.

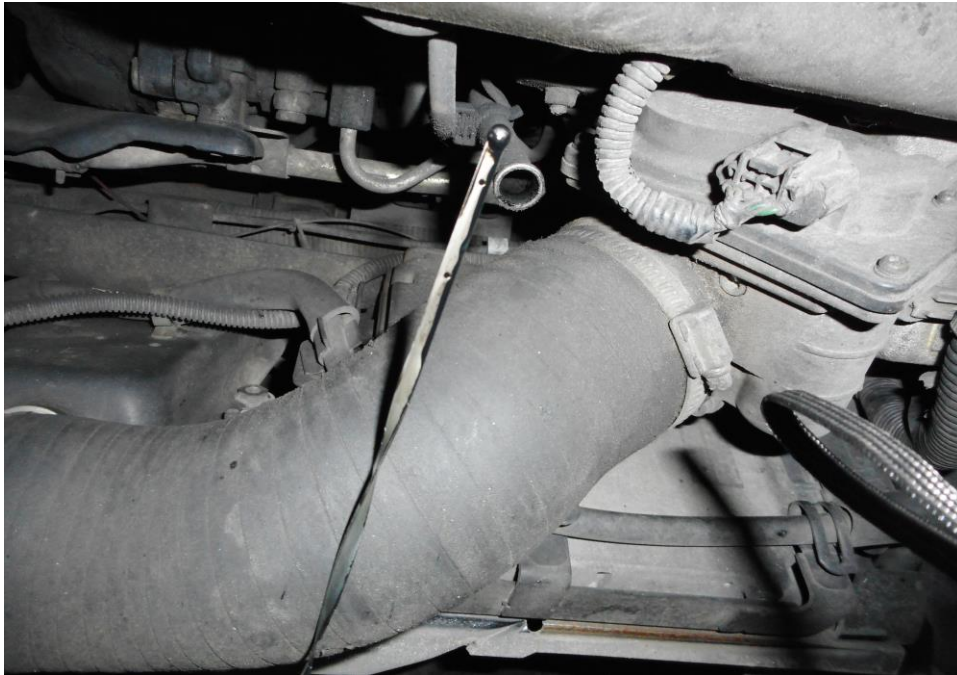
**Photo 16** shows the engine dip stick of the Motor Lorry at the time of my inspection. The engine oil was observed to be of sufficient level and without any visible contamination.

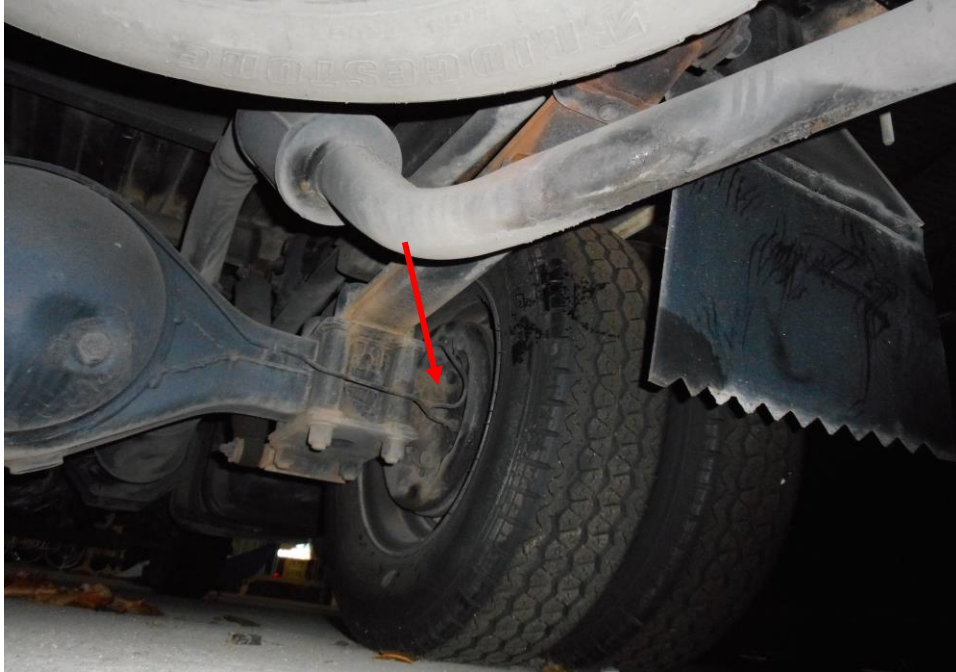
**Photo 17** shows the brake pipe (arrowed) at the rear right wheel of the Motor Lorry. I did not observe any leakage of brake fluid at the time of my inspection of the Motor Lorry. My static tests of the Motor Lorry's braking system, along with my visual examination of the various mechanical components in the braking system, had indicated that there was no internal leakage of pressure/vacuum. Hence the braking system of the Motor Lorry was likely to be in serviceable condition at the material time of accident.

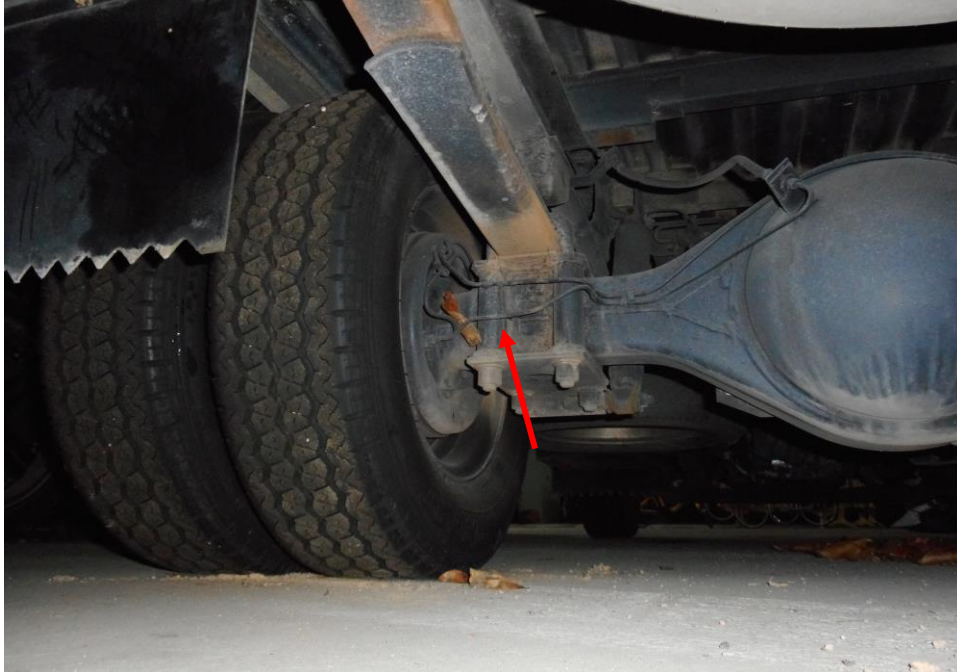
**Photo 18** shows the brake pipe (arrowed) at the rear left wheel of the Motor Lorry. I did not observe any leakage of brake fluid at the time of my inspection of the Motor Lorry. My static tests of the Motor Lorry's braking system, along with my visual examination of the various mechanical components in the braking system, had indicated that there was no internal leakage of pressure/vacuum. Hence the braking system of the Motor Lorry was likely to be in serviceable condition at the material time of accident.

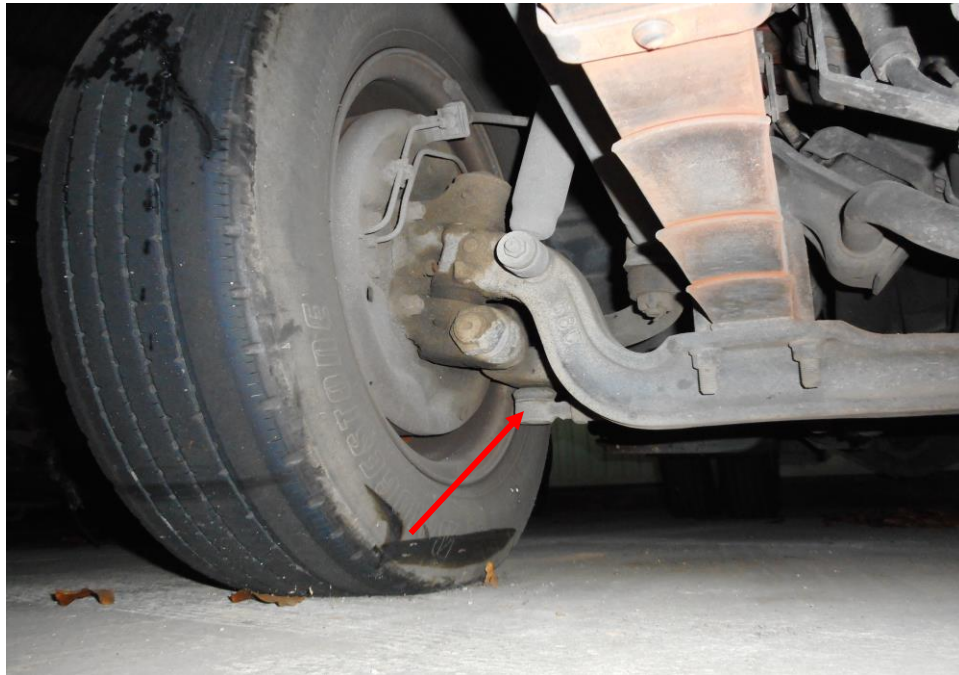
**Photo 19** shows the various undercarriage components at the front right wheel of the Motor Lorry, in particular the steering tie rod end (arrowed). The various steering components were all found to be intact, suggesting that the steering system of the Motor Lorry was likely to be in serviceable condition at the material time of accident. There was also no sign of fluid stain(s) observed on the various undercarriage components.

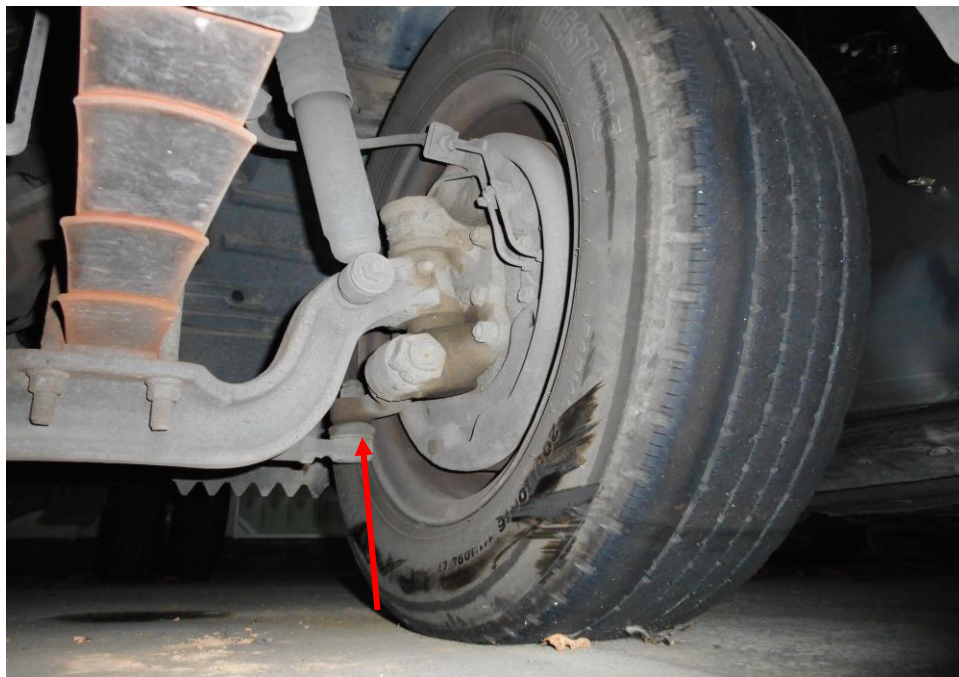
**Photo 20** shows the various undercarriage components at the front left wheel of the Motor Lorry, in particular the steering tie rod end (arrowed). The various undercarriage components of the Motor Lorry were all found to be intact without any visible damage. There was also no sign of fluid stain(s) observed on the various undercarriage components.
