Your Ref: TP/IP/64127/2018
Our Ref : CI/TPD18022211/P

Fatal Accident Investigation Team

MECHANICAL INSPECTION REPORT OF MOTOR LORRY YN 1397D

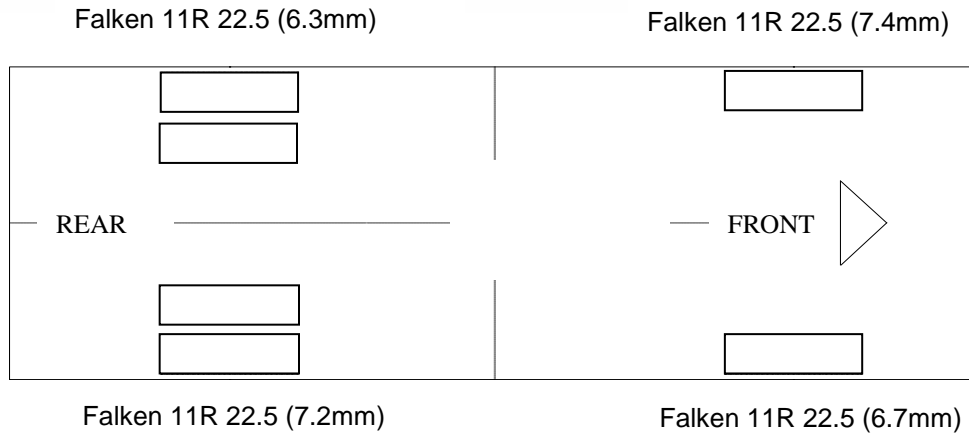
6. The 2 front tyres and 4 rear tyres of the Motor Lorry were observed to be in serviceable condition and sufficiently inflated for vehicular operation. I did not find any tear, cut or burst mark(s) on the outer and the inner sidewalls as well as across the tread of the 6 tyres. The tyre brand, tyre size and remaining tread depth of the 6 tyres of the Motor Lorry were recorded as follows:-

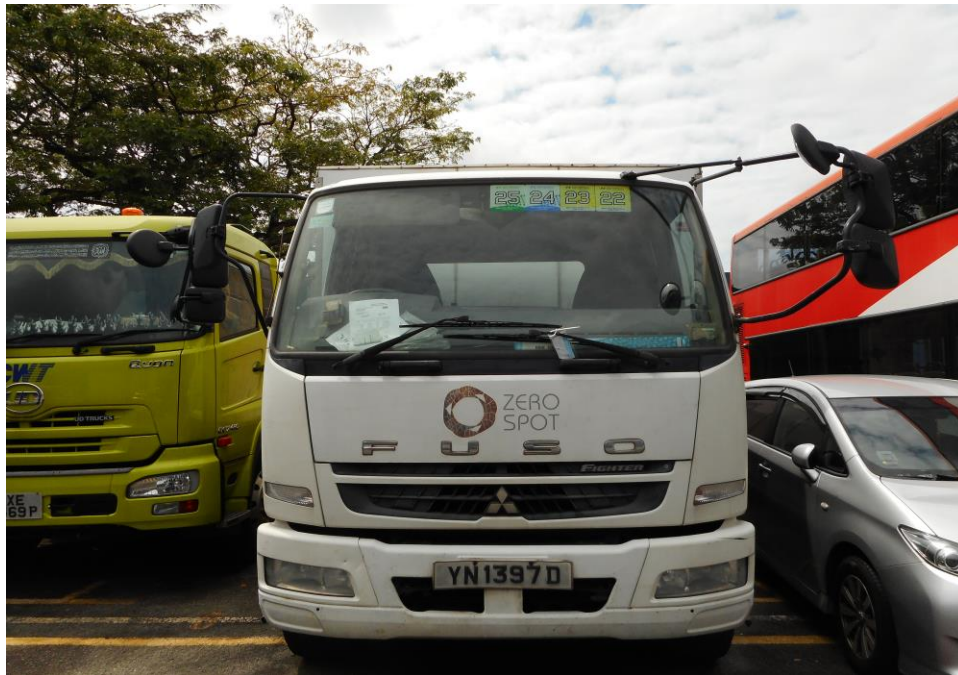
Photo 1 shows a general view of the front left body of the Motor Lorry at the time of my inspection. The Motor Lorry was observed to be in good general condition.

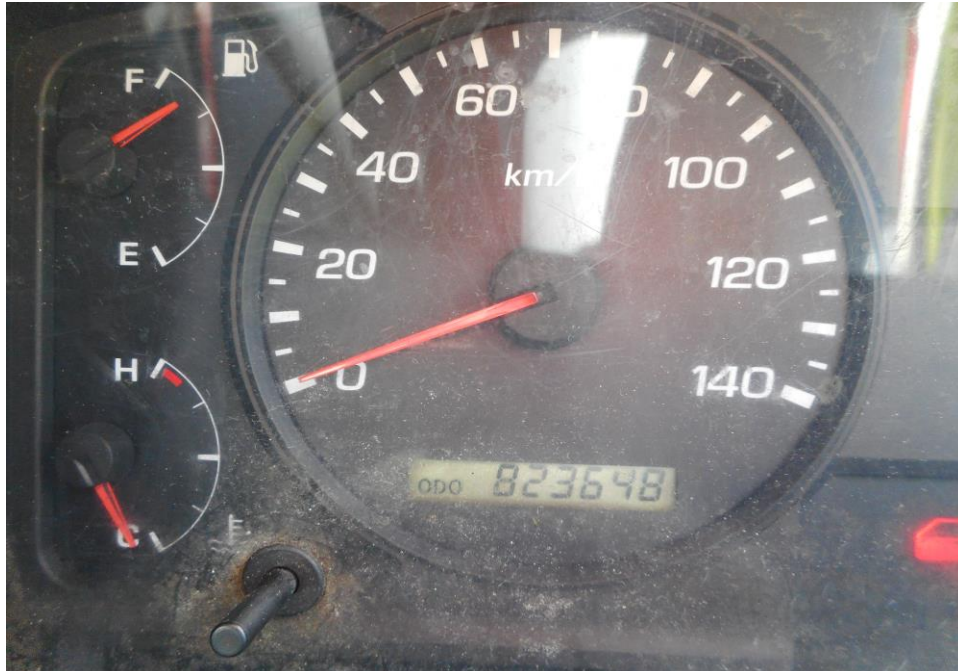
Photo 2 shows a general view of the instrument cluster of the Motor Lorry at the time of my inspection. The mileage of the Motor Lorry was 823,648km

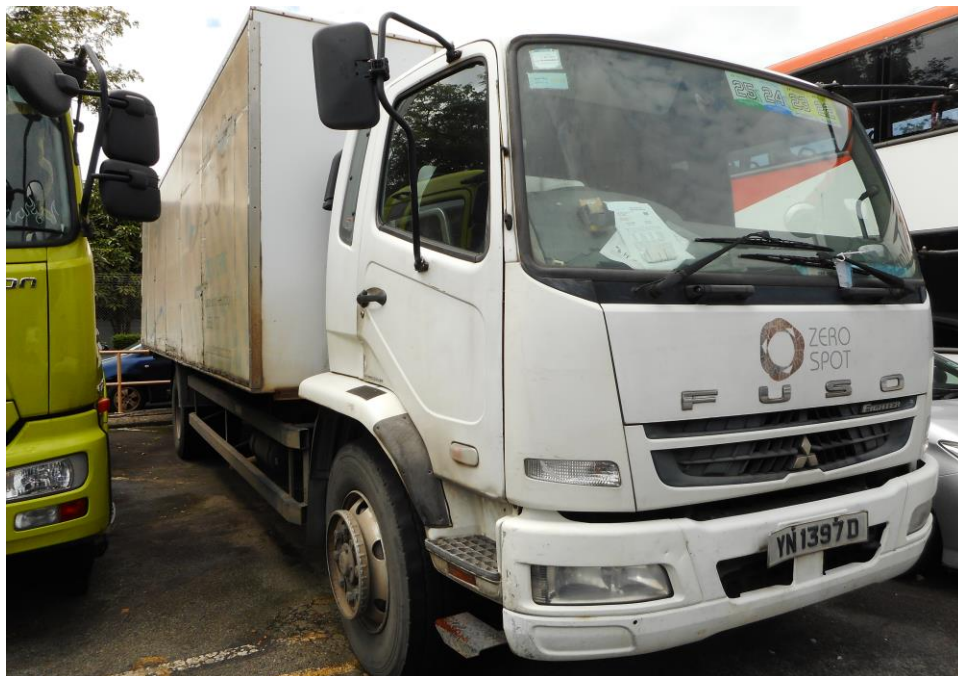
Photo 3 shows a general view of the front right body of the Motor Lorry at the time of my inspection. The Motor Lorry was observed to be in good general condition.

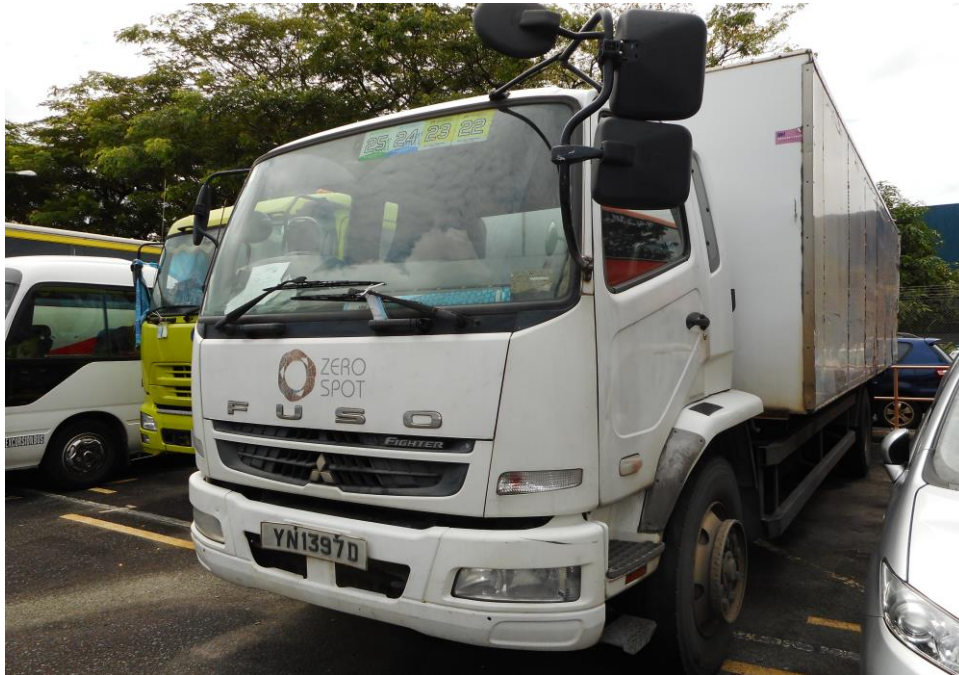
Photo 4 shows a general view of the front right body of the Motor Lorry at the time of my inspection. The Motor Lorry was observed to be in good general condition.

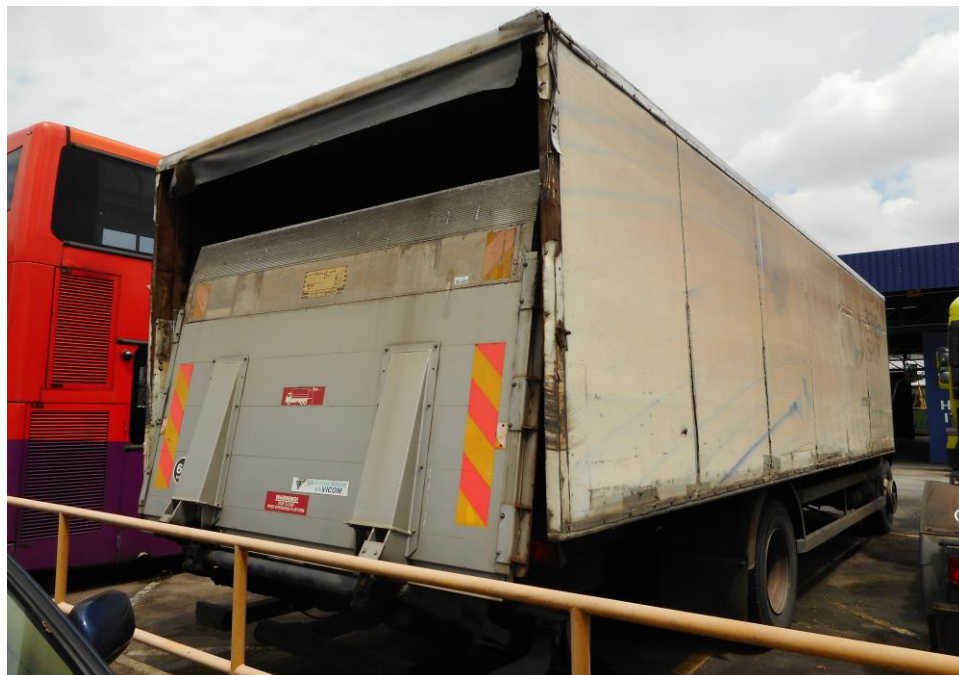
Photo 5 shows a general view of the Motor Lorry's rear left body at the time of my inspection. There was no damage found to the rear portion of the Motor Lorry.

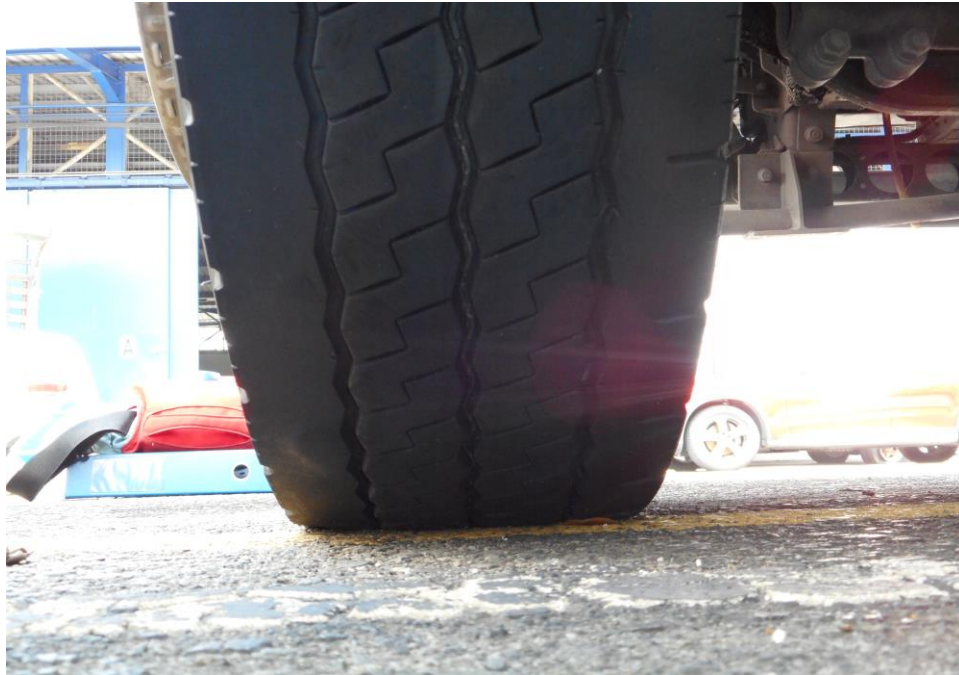
Photo 6 shows the condition of the front left tyre of the Motor Lorry, which was observed to be in serviceable condition with remaining tread depth of approximately 7.4mm. The tyre, which was wrapped around standard alloy wheel rim, was also observed to be sufficiently inflated for vehicular operation. There was no tear, cut or burst mark(s) on the outer and the inner sidewalls as well as across the tread of the 6 tyres that were fitted on the Motor Lorry.

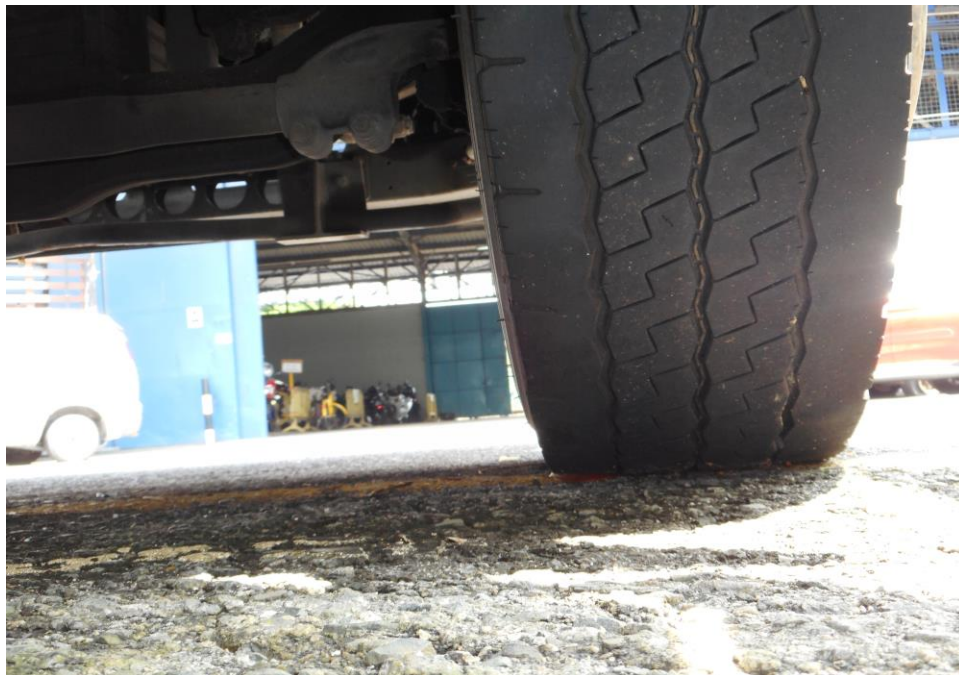
Photo 7 shows the condition of the front right tyre of the Motor Lorry, which was observed to be in serviceable condition with remaining tread depth of approximately 6.7mm. The tyre, which was wrapped around standard alloy wheel rim, was also observed to be sufficiently inflated for vehicular operation.

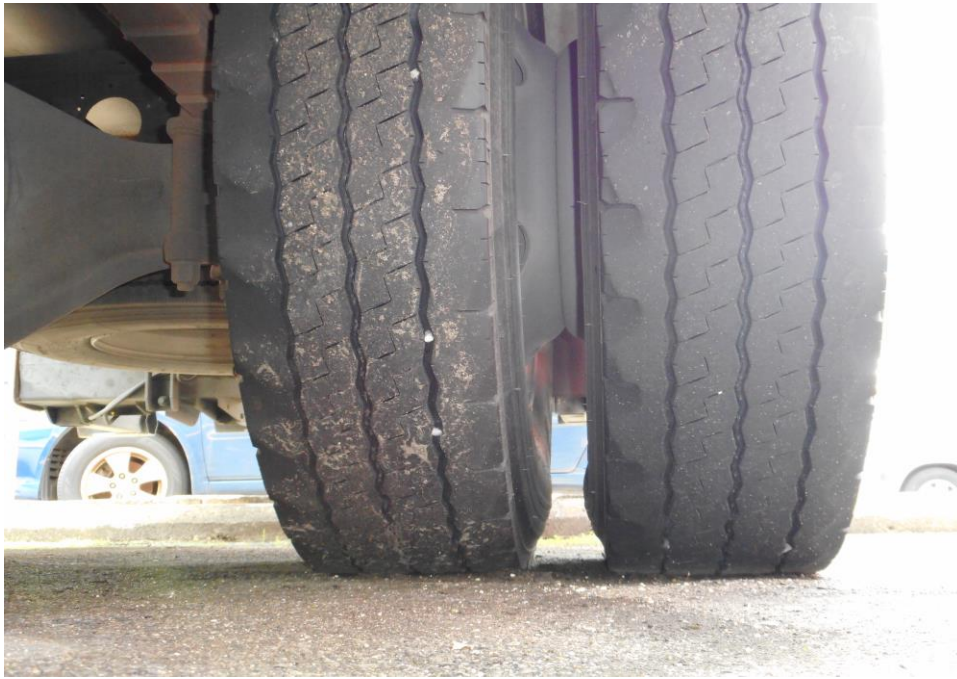
Photo 8 shows the condition of the rear left tyres of the Motor Lorry, which was observed to be in serviceable condition with remaining tread depth of approximately 6.3mm. The tyres, which were wrapped around standard alloy wheel rim, were also observed to be sufficiently inflated for vehicular operation. There was also no damage found on all 6 alloy wheel rims of the Motor Lorry.

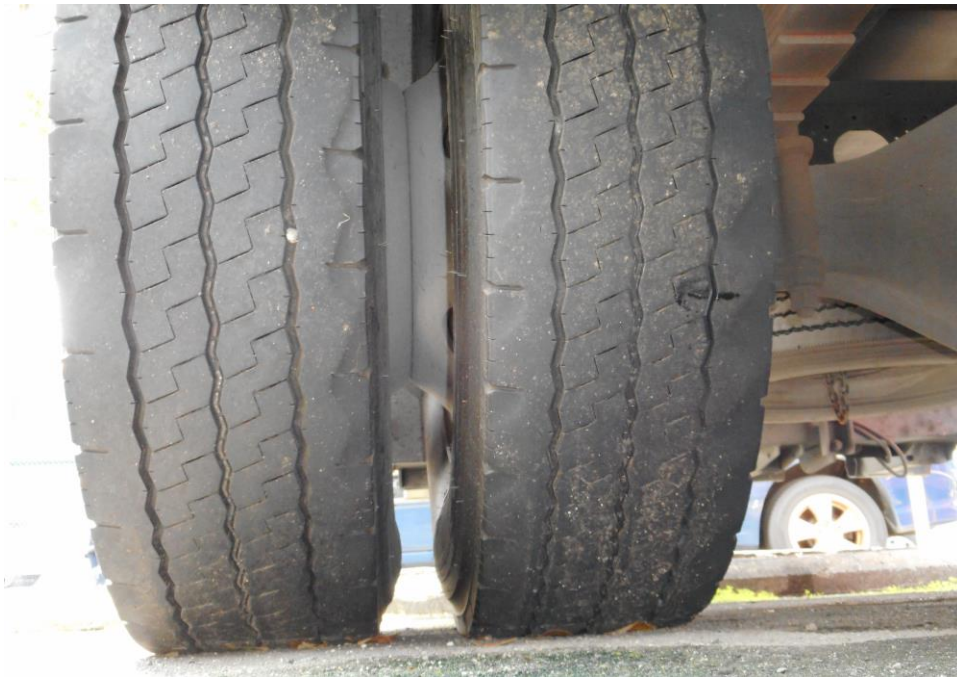
Photo 9 shows the condition of the rear right tyres of the Motor Lorry, which were observed to be in serviceable condition with remaining tread depth of approximately 7.2mm. There was also no tear, cut or burst mark(s) on the outer and the inner sidewalls as well as across the tread of the 6 tyres that were fitted on the Motor Lorry.

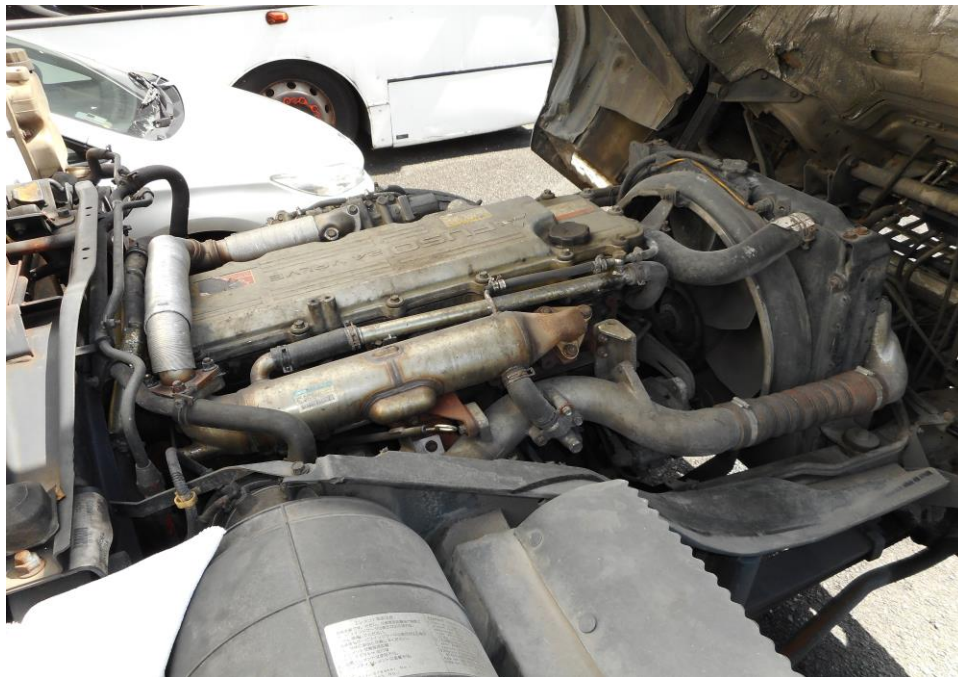
Photo 10 shows a general view of the Motor Lorry's engine compartment, which was accessed by lifting the front cabin of the Motor Lorry. The various parts and components inside the engine compartment were unaffected by the accident. There was also no sign(s) or indication(s) of fresh fluid leakage and/or fluid stain within the engine compartment (photograph shows the engine compartment as viewed from the right front side of the Motor Lorry).

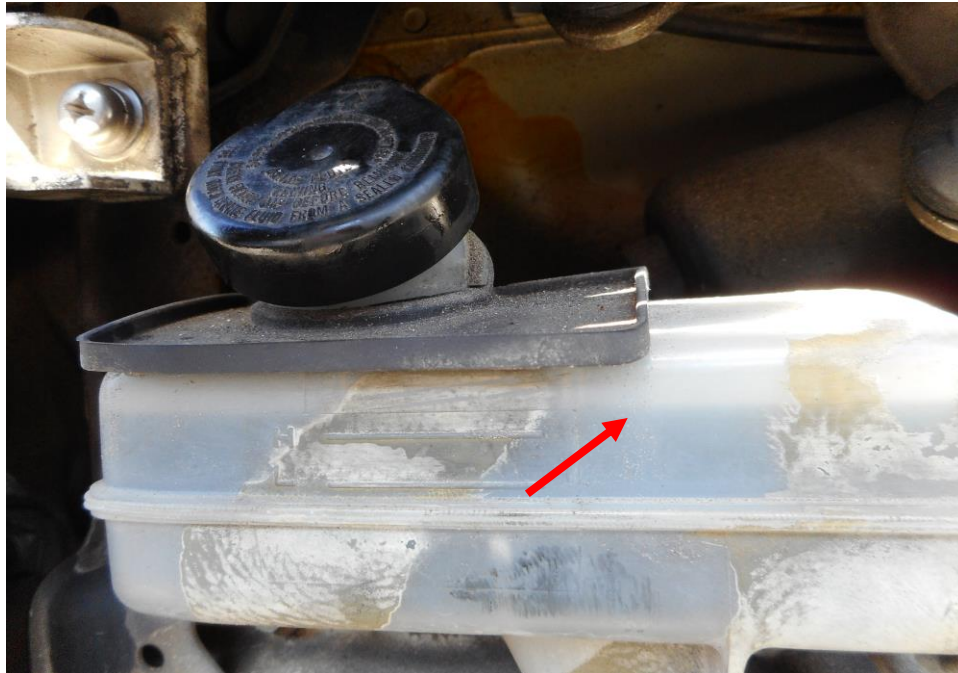
Photo 11 shows the brake fluid reservoir of the Motor Lorry at the time of my inspection. The brake fluid was observed to be of sufficient level (arrowed) and without any visible contamination.

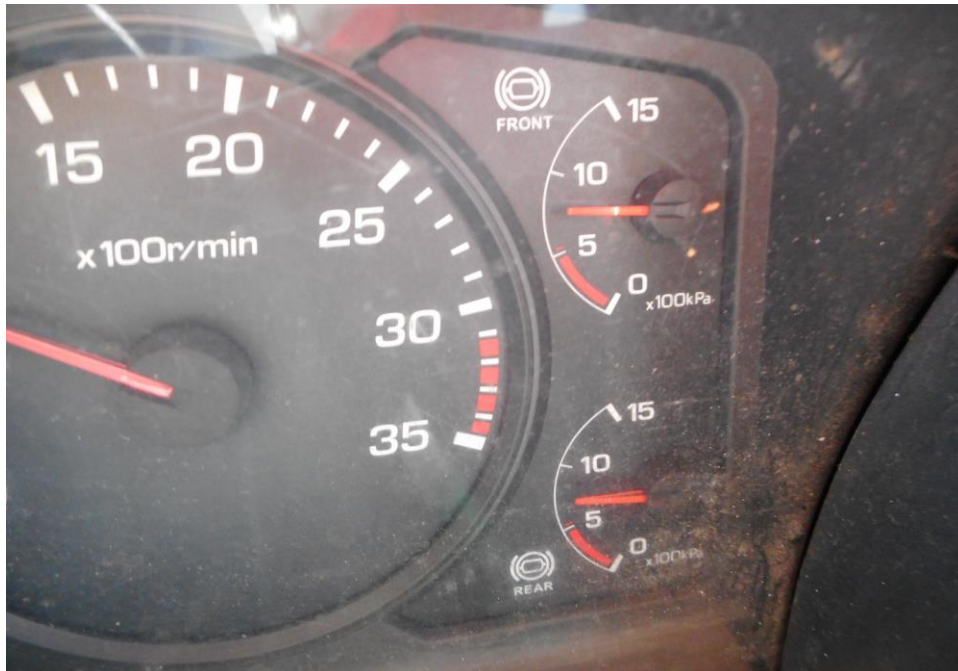
Photo 12 shows the air in the air brake cylinder of the Motor Lorry at the time of my inspection. The air in the cylinder was observed to be of sufficient level & serviceable at the time of the accident.

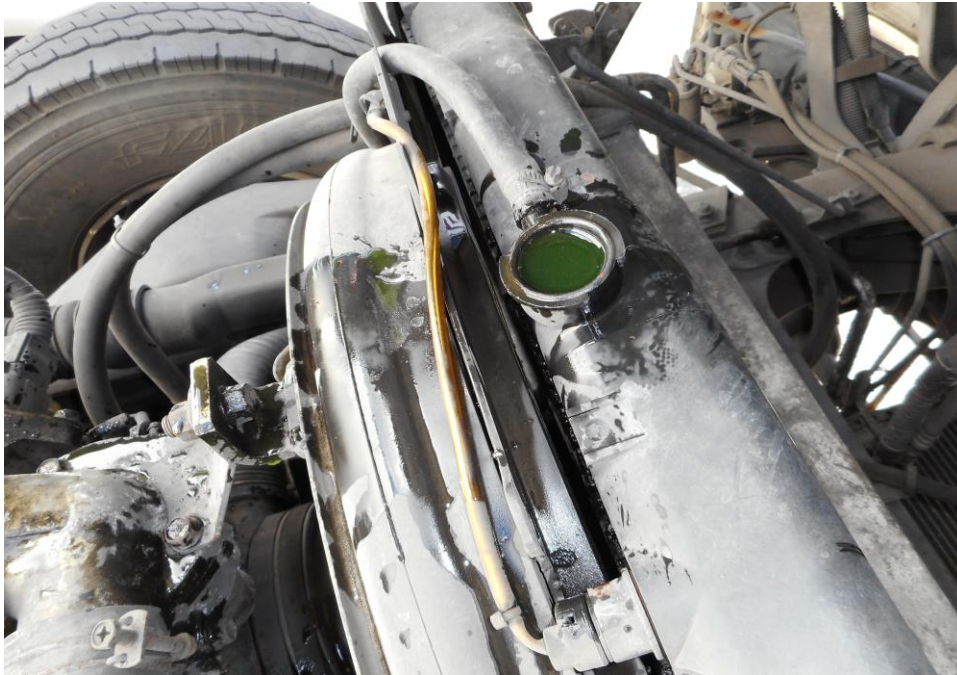
Photo 13 shows the engine coolant reservoir of the Motor Lorry at the time of my inspection. The engine coolant was observed to be of sufficient level and without any visible contamination.

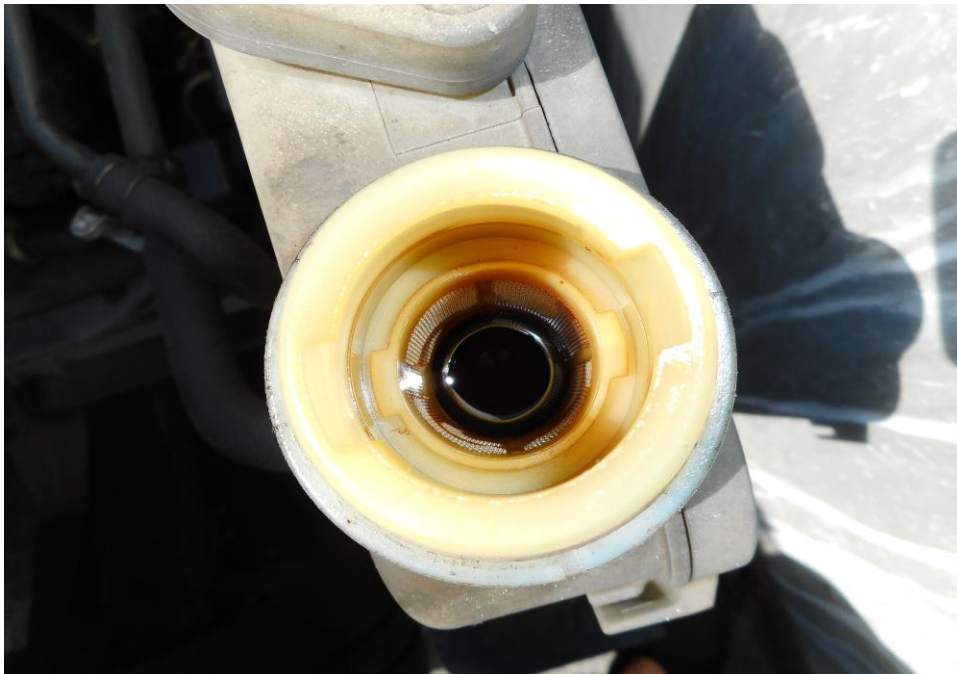
Photo 14 shows the power steering fluid reservoir of the Motor Lorry at the time of my inspection. The power steering fluid was observed to be of sufficient level and without any visible contamination.

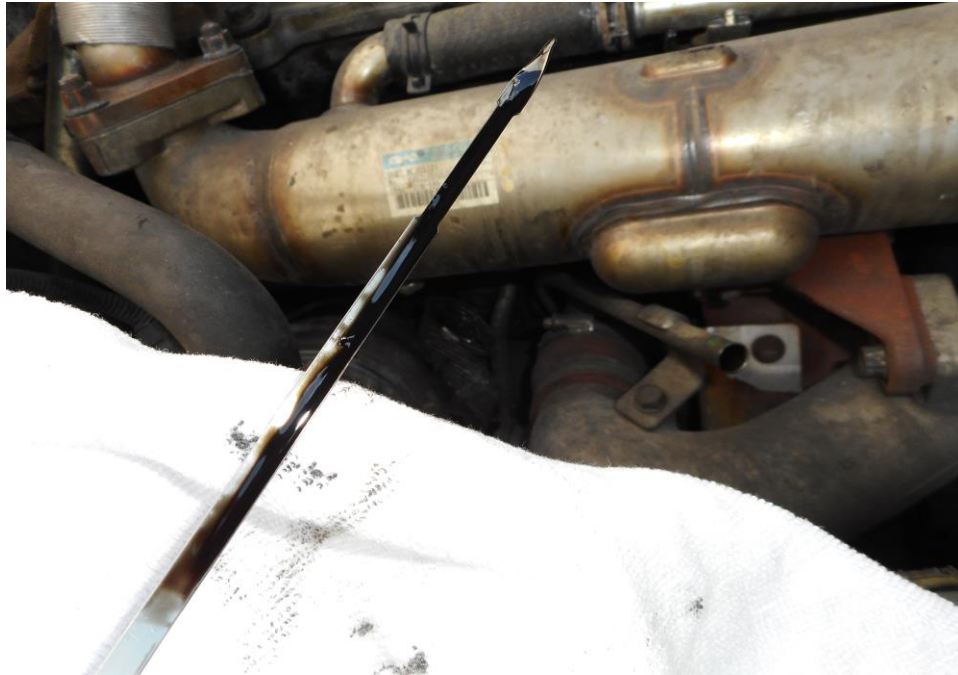
Photo 15 shows the engine dip stick of the Motor Lorry at the time of my inspection. The engine oil was observed to be of sufficient level and without any visible contamination.

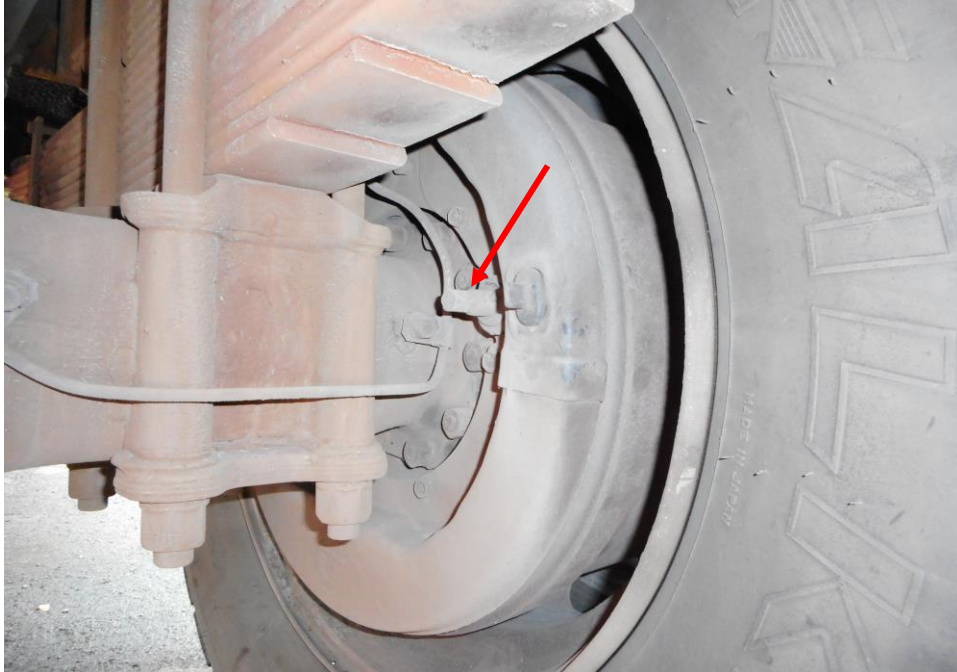
Photo 16 shows the brake pipe (arrowed) at the rear right wheel of the Motor Lorry. I did not observe any leakage of brake fluid at the time of my inspection of the Motor Lorry. My static tests of the Motor Lorry's braking system, along with my visual examination of the various mechanical components in the braking system, had indicated that there was no internal leakage of pressure/vacuum. Hence the braking system of the Motor Lorry was likely to be in serviceable condition at the material time of accident.

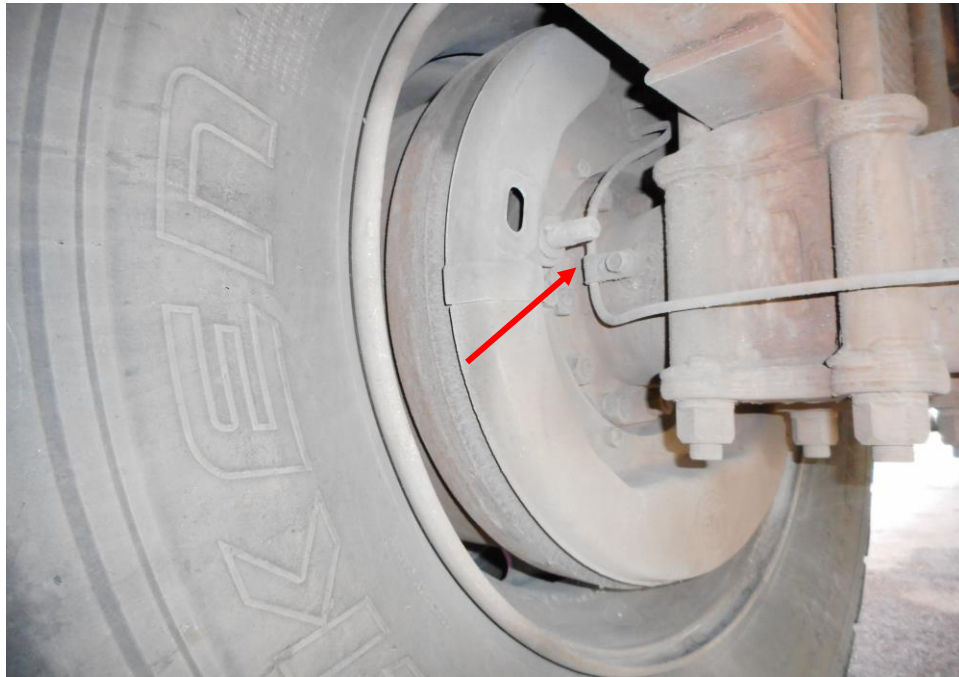
Photo 17 shows the brake pipe (arrowed) at the rear left wheel of the Motor Lorry. I did not observe any leakage of brake fluid at the time of my inspection of the Motor Lorry. My static tests of the Motor Lorry's braking system, along with my visual examination of the various mechanical components in the braking System, had indicated that there was no internal leakage of pressure/vacuum. Hence the braking system of the Motor Lorry was likely to be in serviceable condition at the material time of accident.

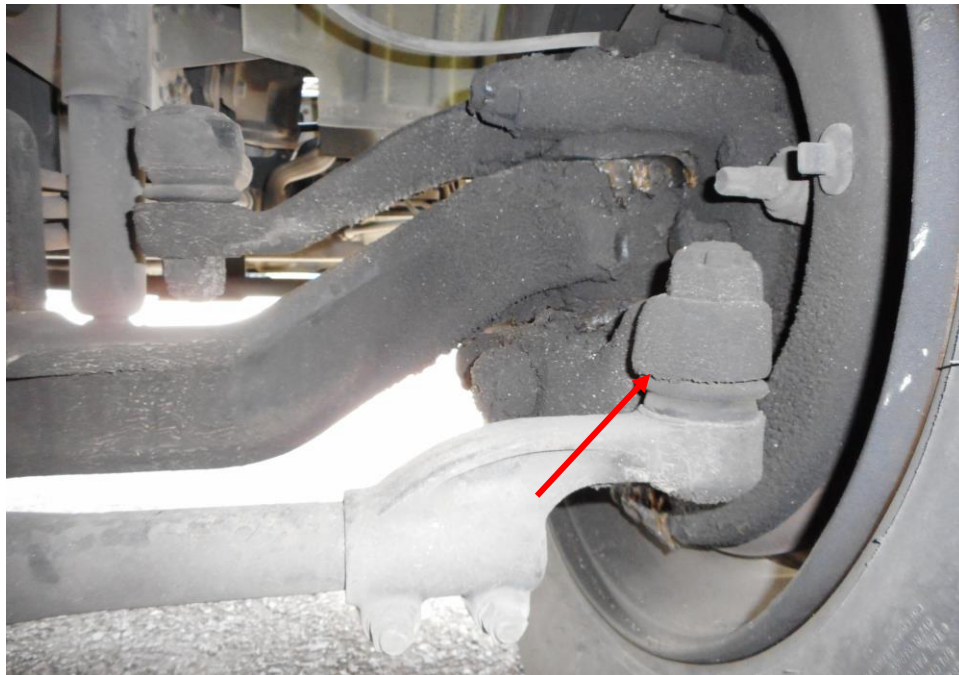
Photo 18 shows the various undercarriage components at the front right wheel of the Motor Lorry, in particular the steering tie rod end (arrowed). The various steering components were all found to be intact, suggesting that the steering system of the Motor Lorry was likely to be in serviceable condition at the material time of accident. There was also no sign of fluid stain(s) observed on the various undercarriage components.

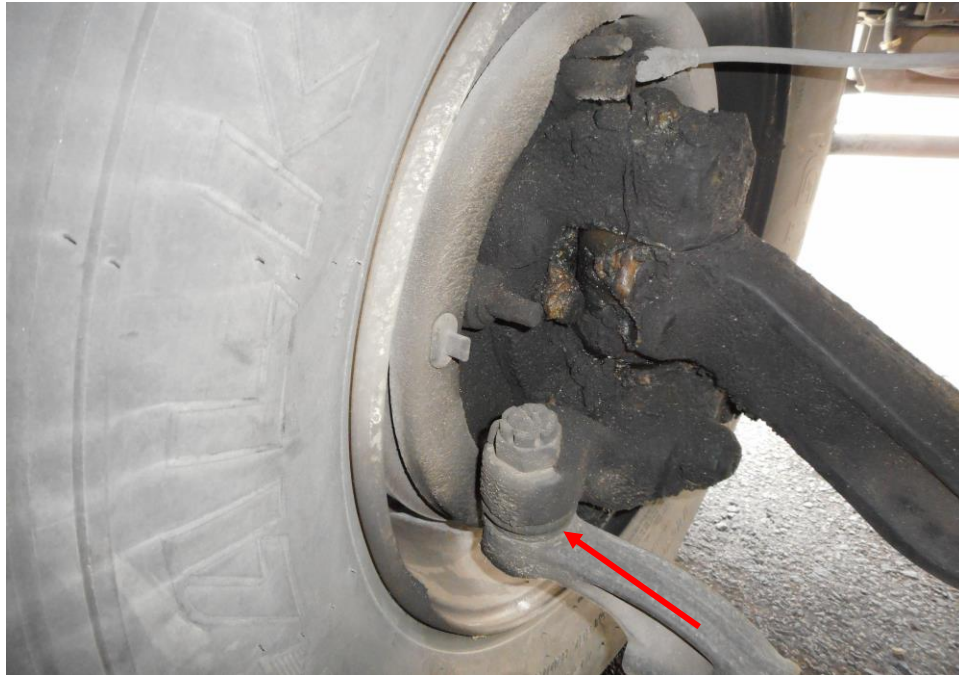
Photo 19 shows the various undercarriage components at the front left wheel of the Motor Lorry, in particular the steering tie rod end (arrowed). The various undercarriage components of the Motor Lorry were all found to be intact without any visible damage. There was also no sign of fluid stain(s) observed on the various undercarriage components.

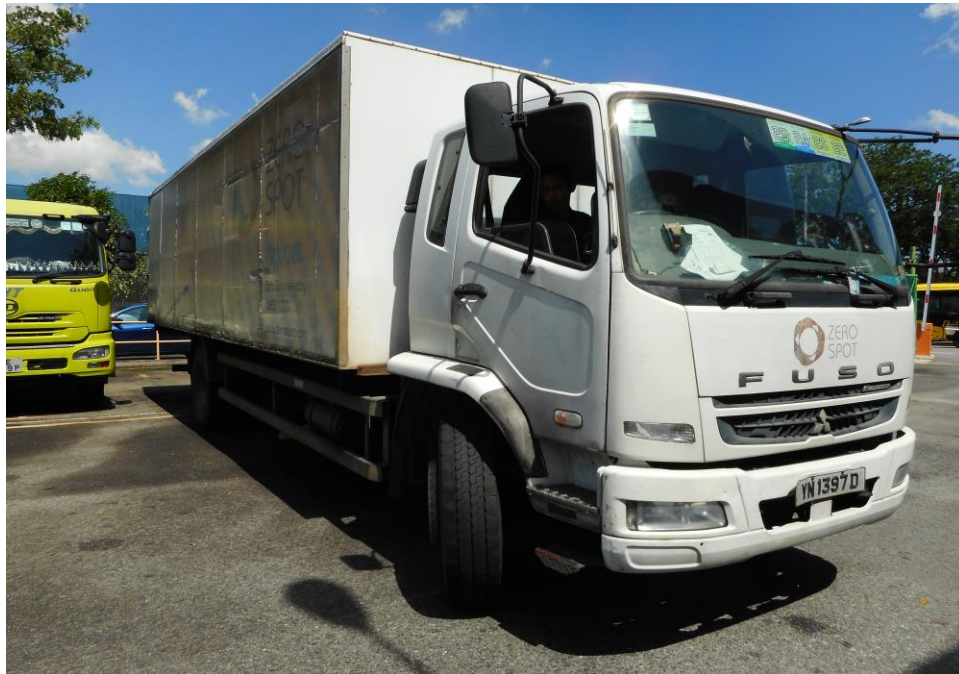
Photo 20 shows the front right wheel of the Motor Lorry turned to its full right. During my steering system test, I did not experience any abnormal free play and/or resistance when I had turned the steering wheel towards full left and full right. This would suggest that the steering system of the Motor Lorry was likely to be in serviceable condition at the material time of accident.
