Your Ref: TP/IP/56239/2018
Our Ref :CI/TPD18022215/Z

MECHANICAL INSPECTION REPORT OF MOTORCYCLE JSJ 8870

1. We refer to your request dated 28th November 2018 to conduct a physical inspection of a motorcycle bearing registration number JSJ 8870 (herein referred to as "**Motorcycle**"), which was involved in a fatal road traffic accident on 02nd October 2018.
2. The purpose of this inspection is to primarily determine if there was any possible mechanical failure to the Motorcycle that may have contributed to the accident.
3. Following the request, we had carried out a physical inspection of the Motorcycle on 21st December 2018 at the premises of Traffic Police vehicle pound, 517 Airport Road Singapore 539942. We now set out below our observations and comments with respect to this inspection.

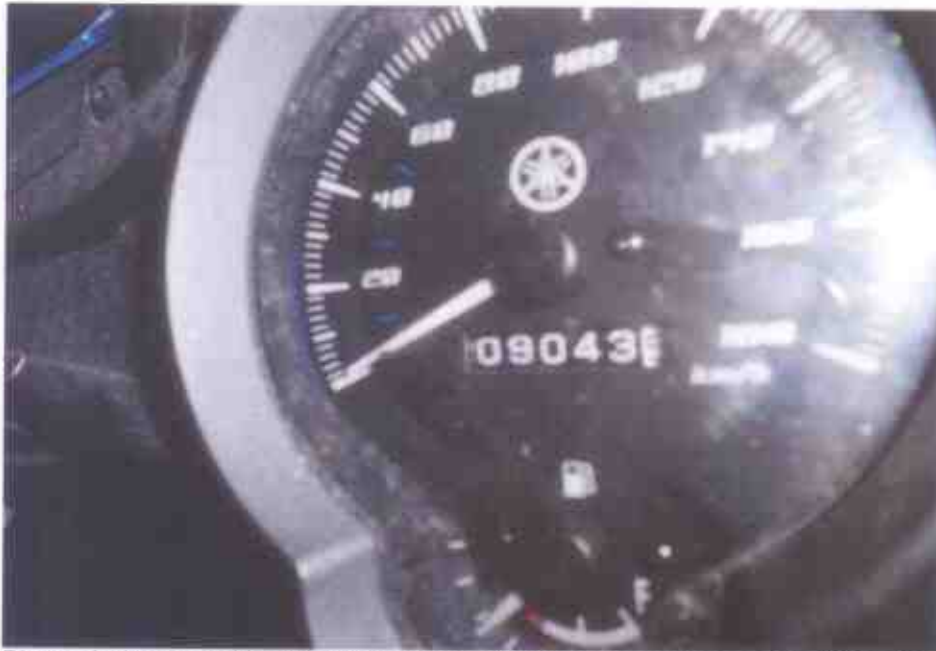
Photo 1 shows a close-up view of the mileage meter at time of our inspection. The mileage was recorded at 090435km.

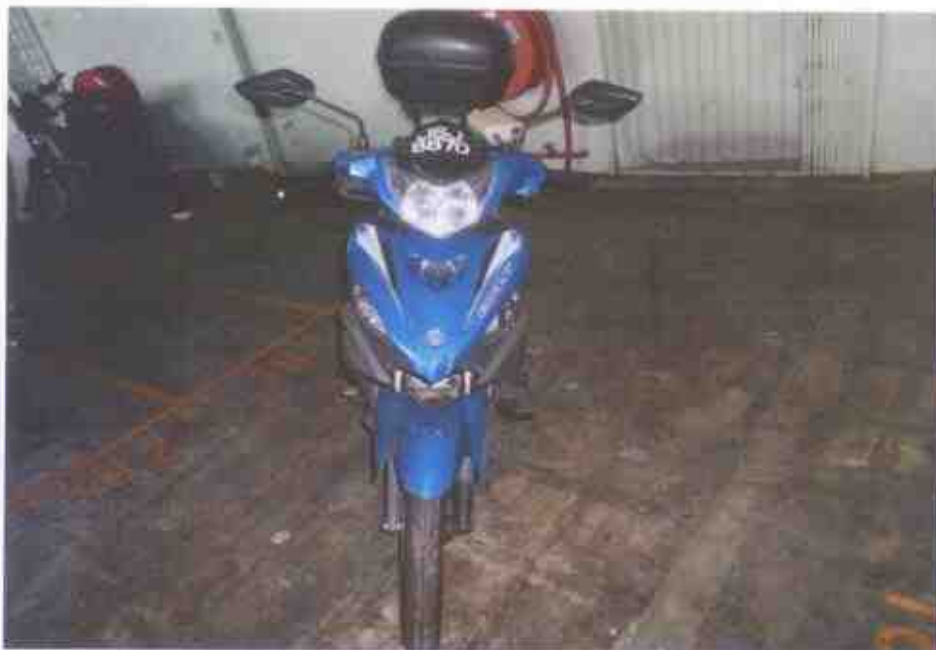
Photo 2 shows a general view of the front body of the Motorcycle at the time of our inspection. The Motorcycle was observed to have sustained relatively minor damages at time of inspection. The damages were observed to be confined to its right side of the front fairing.

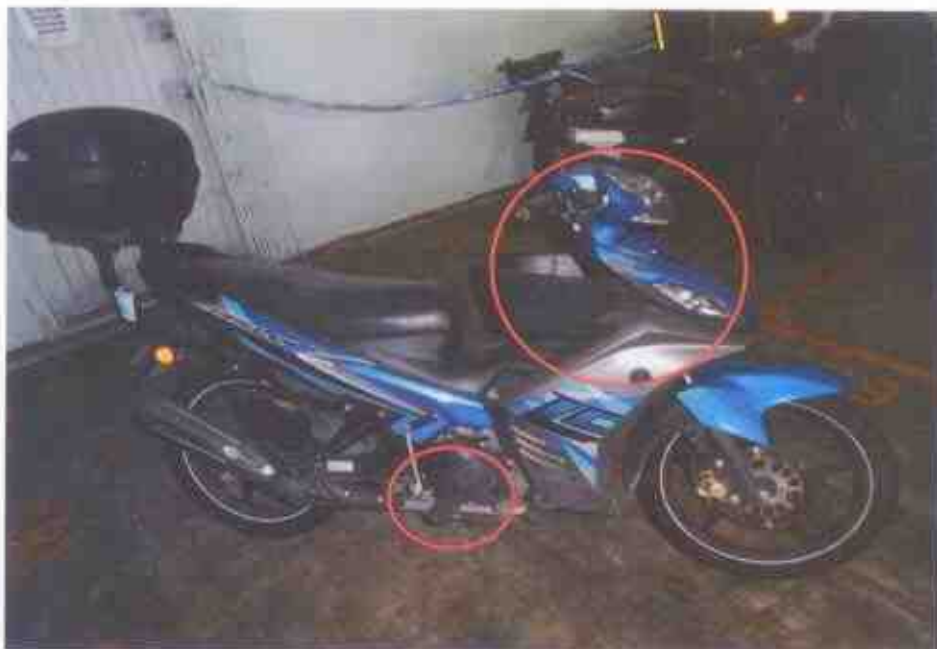
Photo 3 shows a general view of the right body of the Motorcycle at the time of our inspection. The Motorcycle was observed to have sustained relatively minor damages on the right side fairing at time of our inspection.

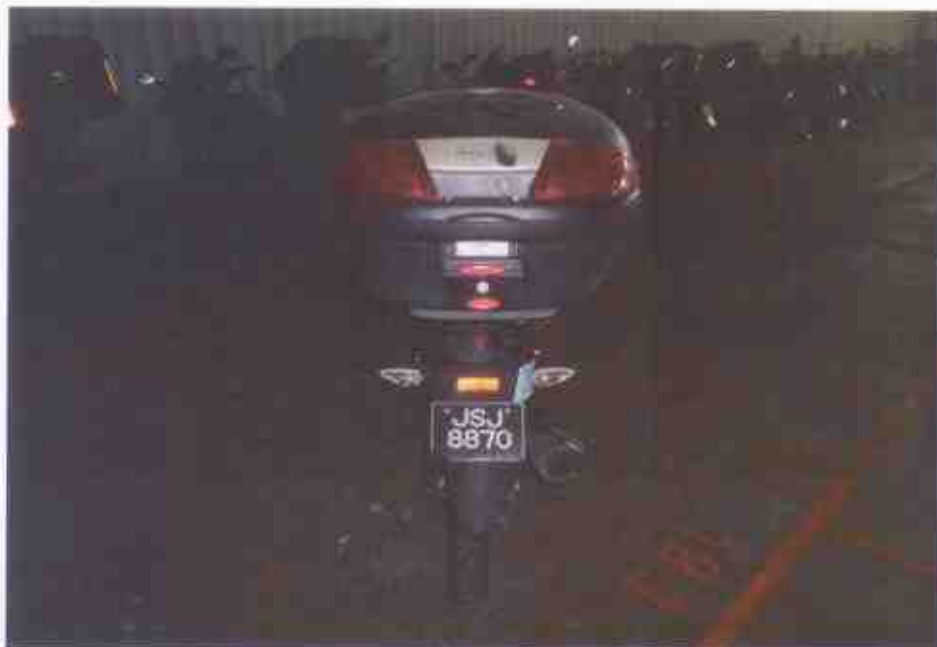
Photo 4 shows a general view of the rear body of the Motorcycle at the time of our inspection. The Motorcycle was observed to be in good condition unaffected by the accident at time of our inspection.

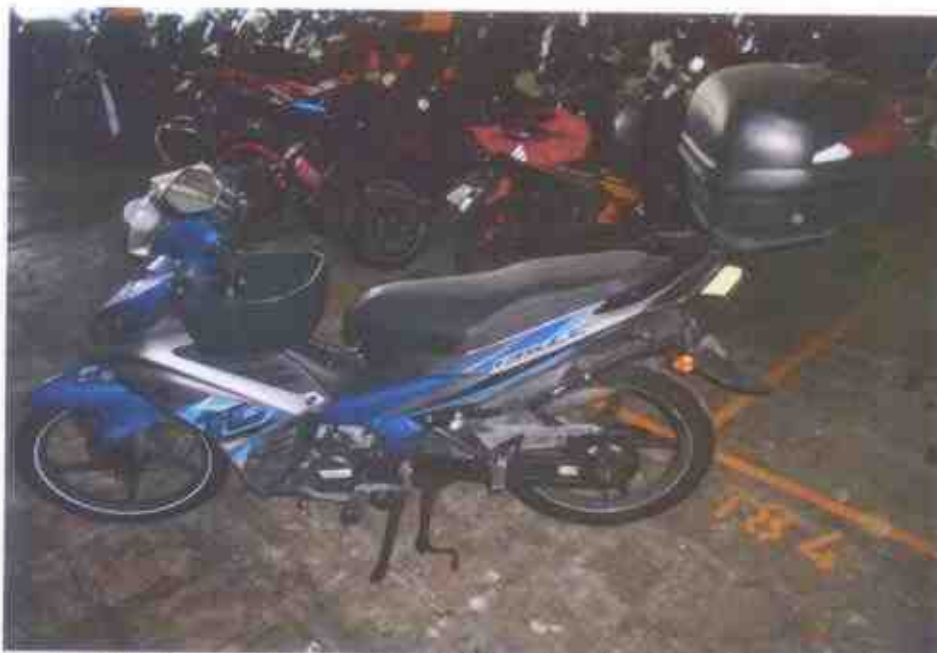
Photo 5 shows a general view of the left body of the Motorcycle at the time of our inspection. The Motorcycle was observed to be in good condition unaffected by the accident at time of our inspection.

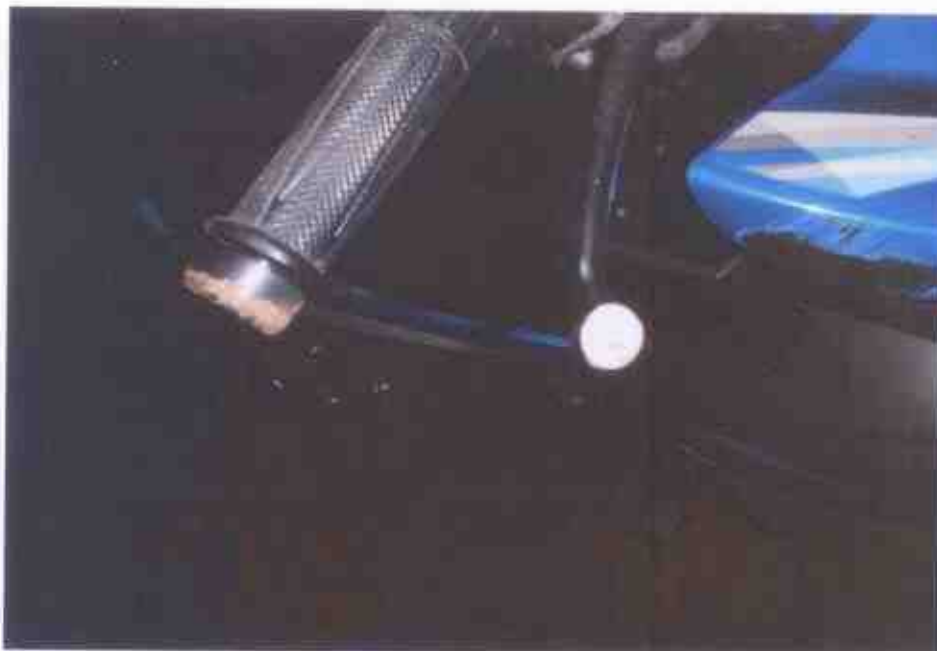
Photo 6 shows a closer view of the front right handle & brake lever of the Motorcycle at the time of our inspection. The Motorcycle was observed to have sustained with relatively minor damages due to the accident collision.

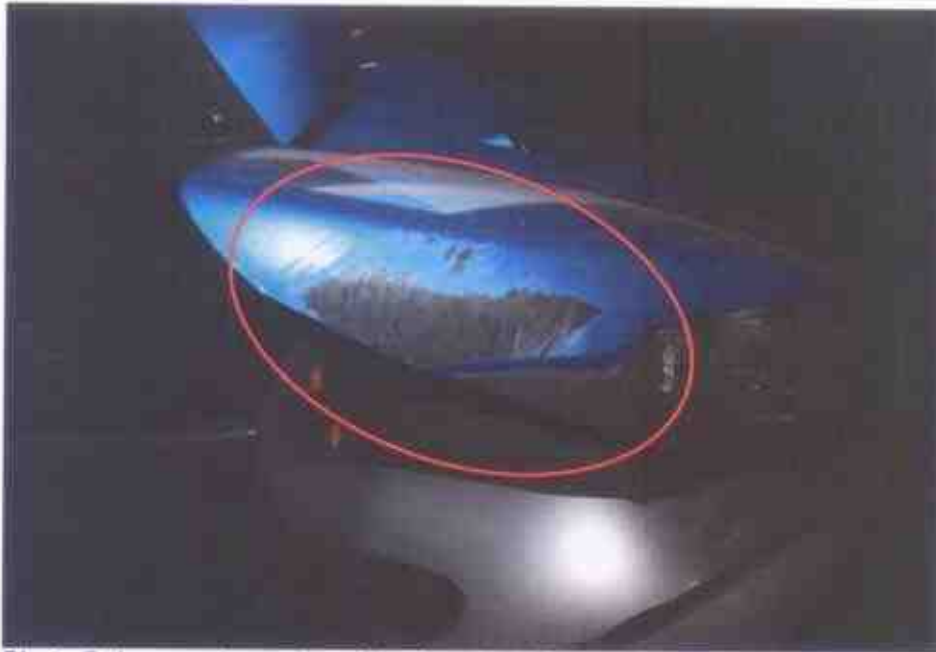
Photo 7 shows a closer view of the front right fairing of the Motorcycle at the time of our inspection. The Motorcycle was observed to have sustained with relatively minor damages due to the accident collision. (Circled)

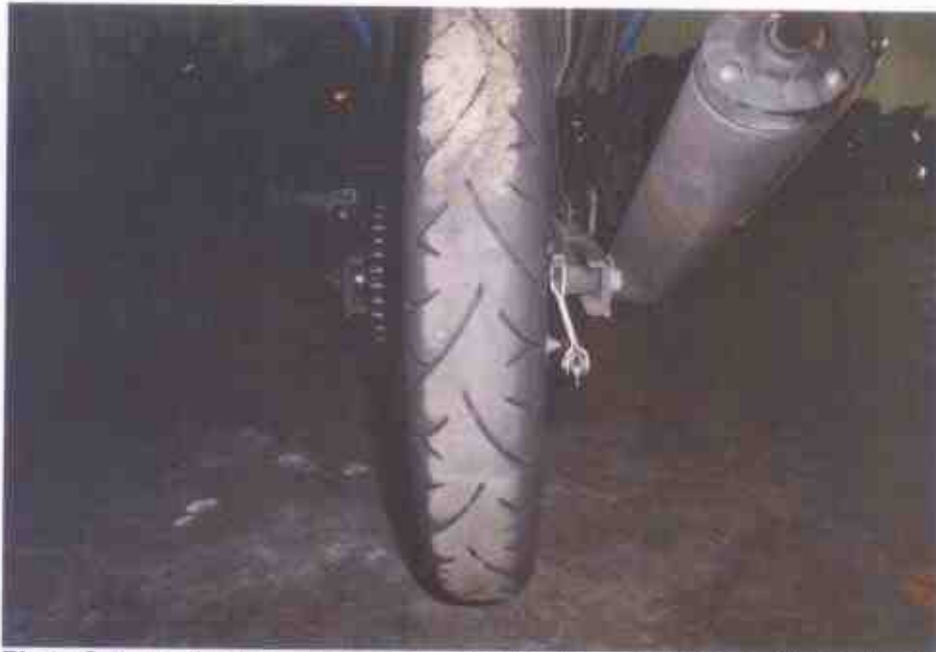
Photo 8 shows the rear tyre of the Motorcycle. The rear tyre was observed to be in serviceable condition with remaining tread depth of approximately 4mm. The tyre was also observed to be sufficiently inflated for vehicular operation.

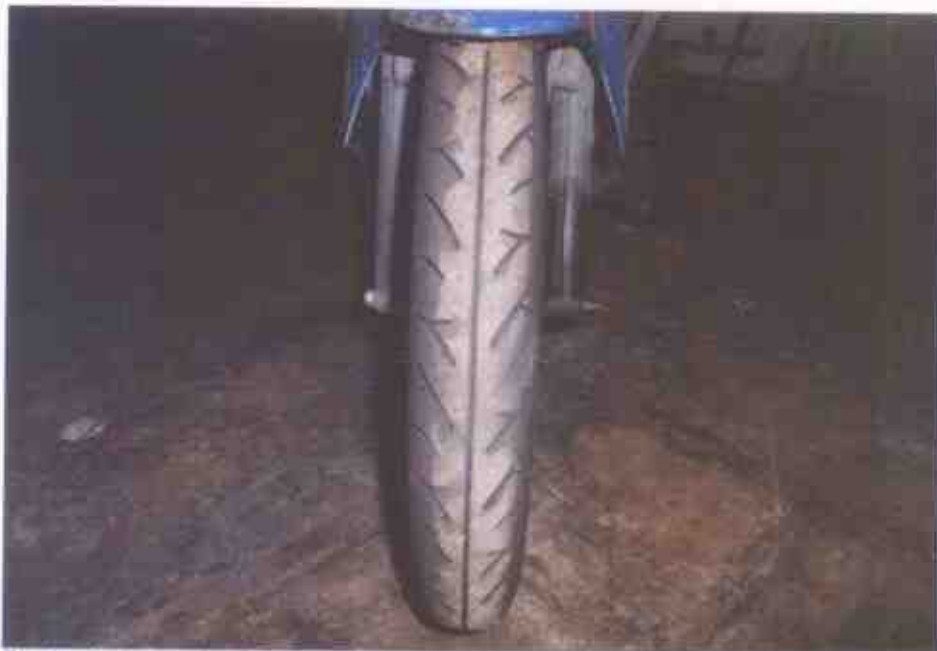
Photo 9 shows the front tyre of the Motorcycle. The front tyre was observed to be in serviceable condition with remaining tread depth of approximately 4mm. The tyre was also observed to be sufficiently inflated for vehicular operation.

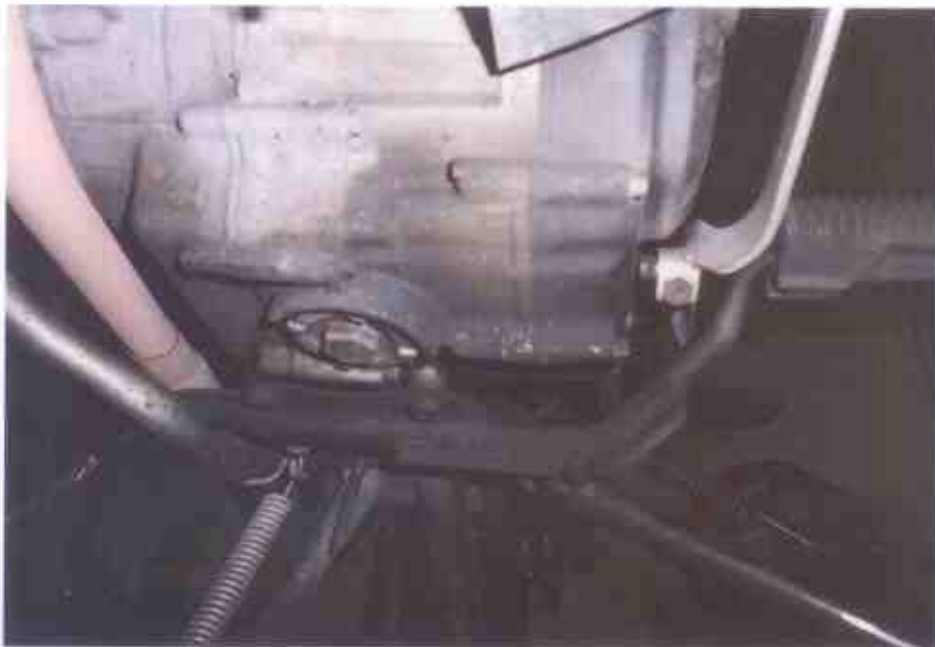
Photo 10 shows no sign(s) or indication(s) of fluid leak observed around the underside of the engine area of the Motorcycle.

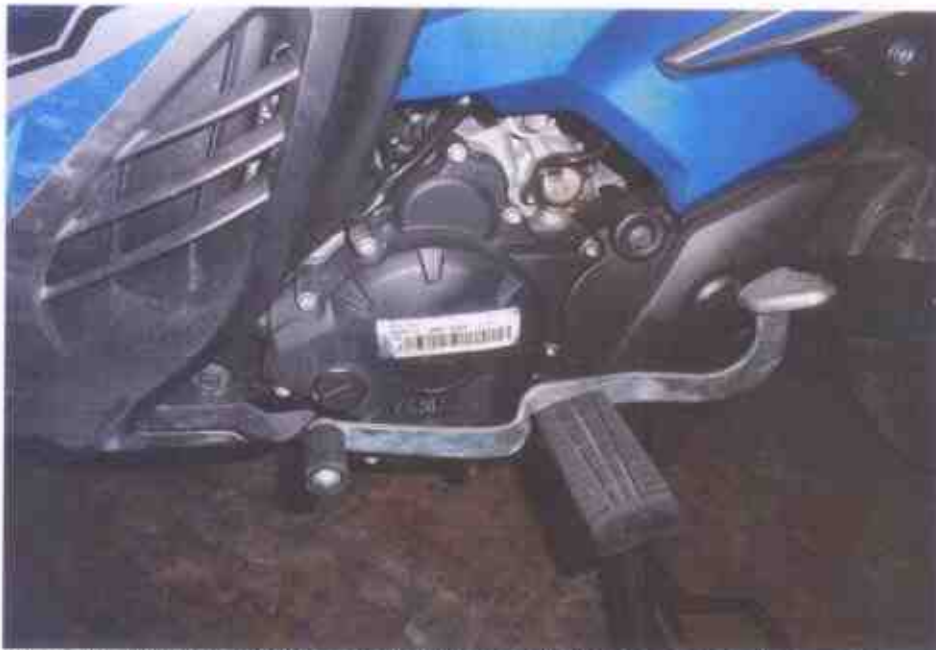
Photo 11 shows no sign(s) or indication(s) of fluid leakage stain observed around the engine area of the Motorcycle.

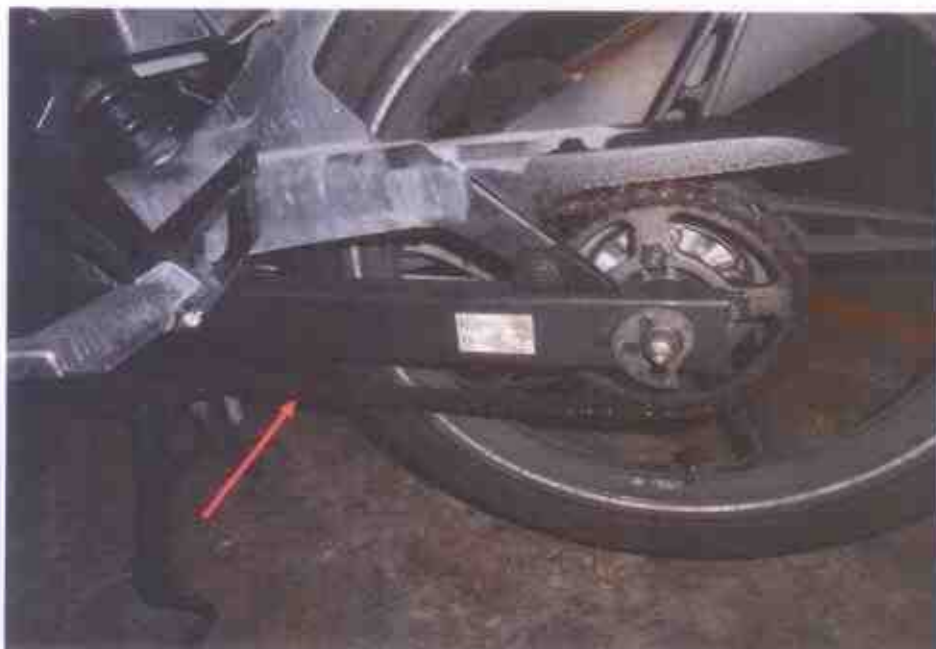
Photo 12 shows the general view of the gear train (arrowed) of the Motorcycle, which was observed to be intact with no misalignment. It was also adequately lubricated for operating purposes.

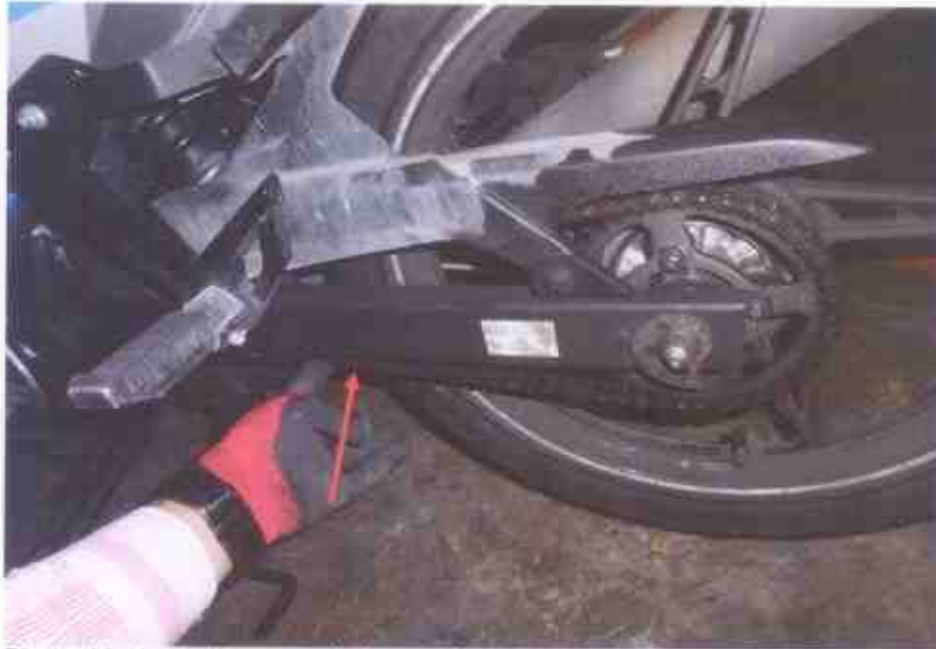
Photo 13 shows the general view of the gear train (arrowed) of the Motorcycle, which was observed to be intact with no misalignment. It was also adequately lubricated for operating purposes. Free play tension was also observed & found adequately acceptable.

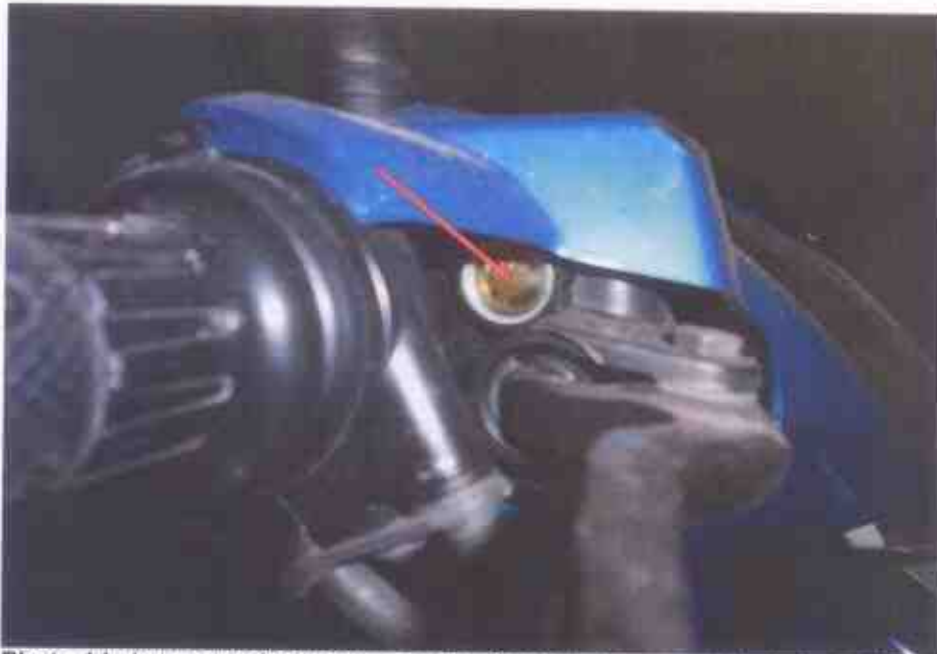
Photo 14 shows our checks on the brake fluid (front) reservoir had also indicated that the brake fluid was of sufficient level for operational purposes, and without contamination.

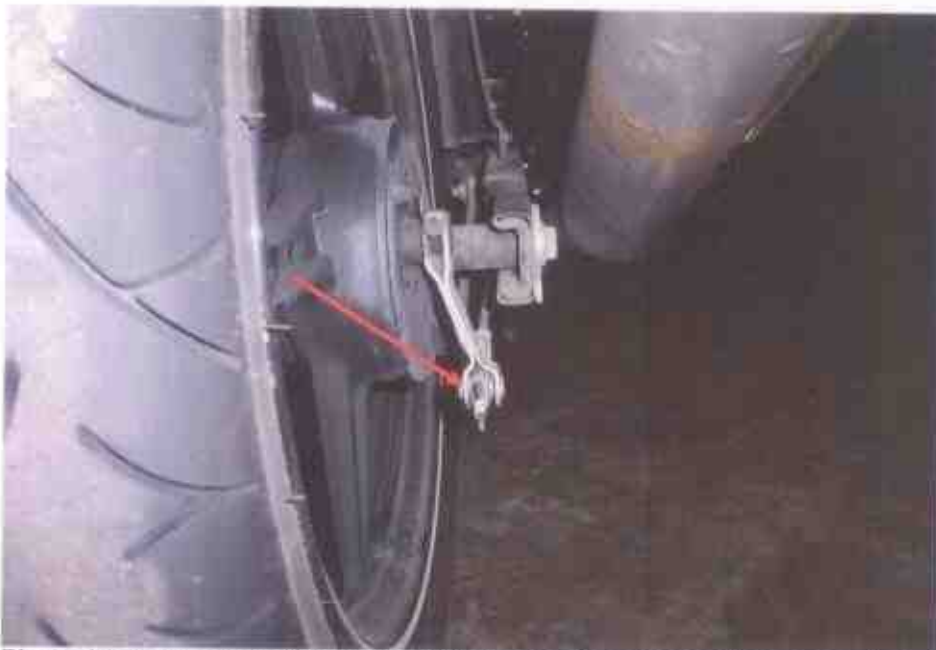
Photo 15 shows our checks on the braking component (rear) had also indicated that the braking system was of serviceable condition for operational purposes, and without abnormalities.

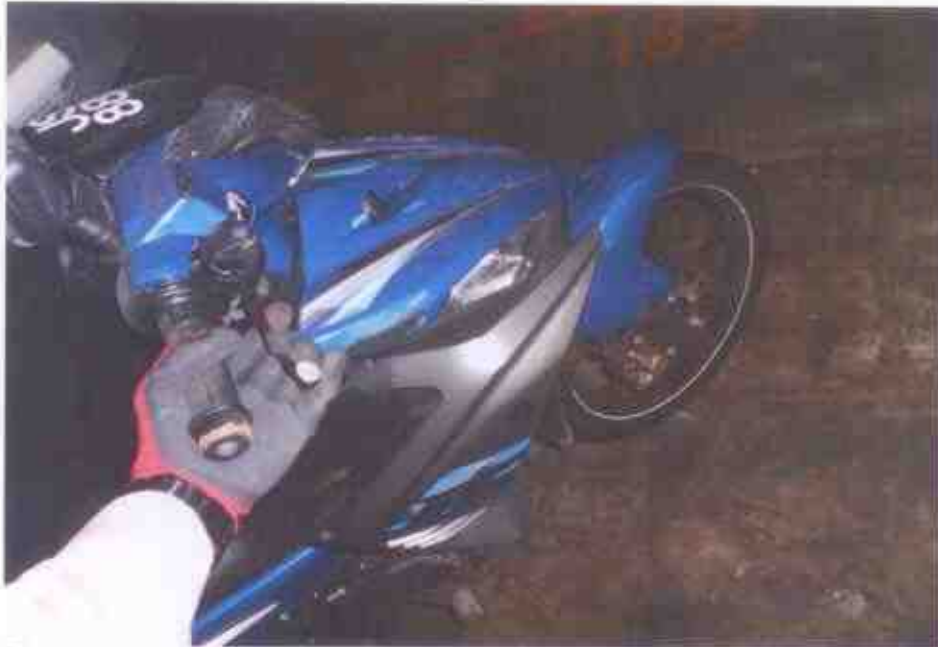
Photo 16 shows testing of the braking of the front brake in progress. There was some resistance felt (spongy like feel) upon pressing the brake lever.

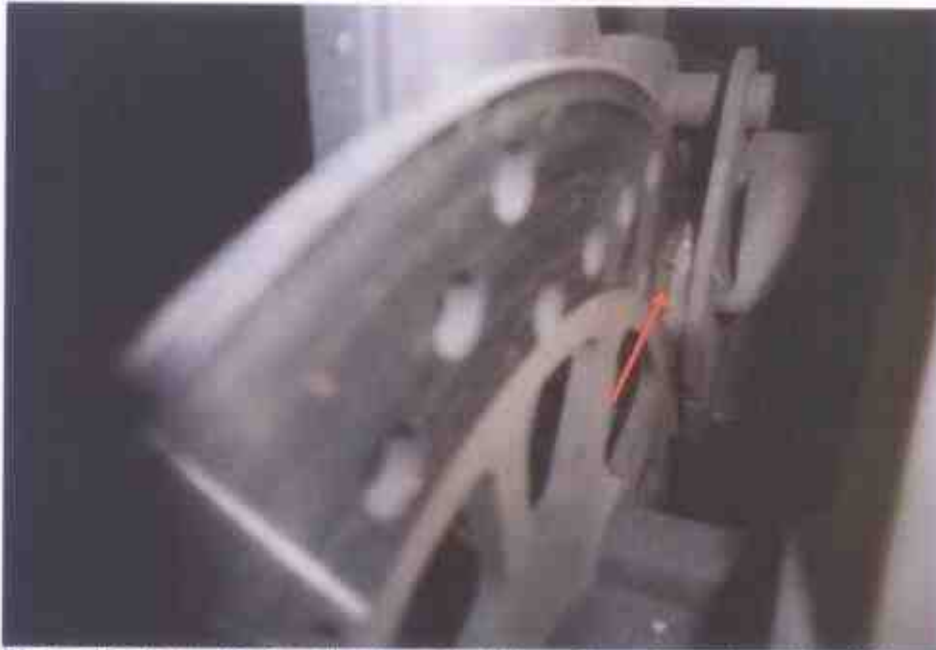
Photo 18 shows the front brake pad at time of our inspection. The frictional material was observed to be sufficient for operational purposes.
