Your Ref: TP/IP/48921/2018
Our Ref :CI/TPD18022474/Z

16th January 2019

MECHANICAL INSPECTION REPORT OF MOTORCYCLE FBG 3474K

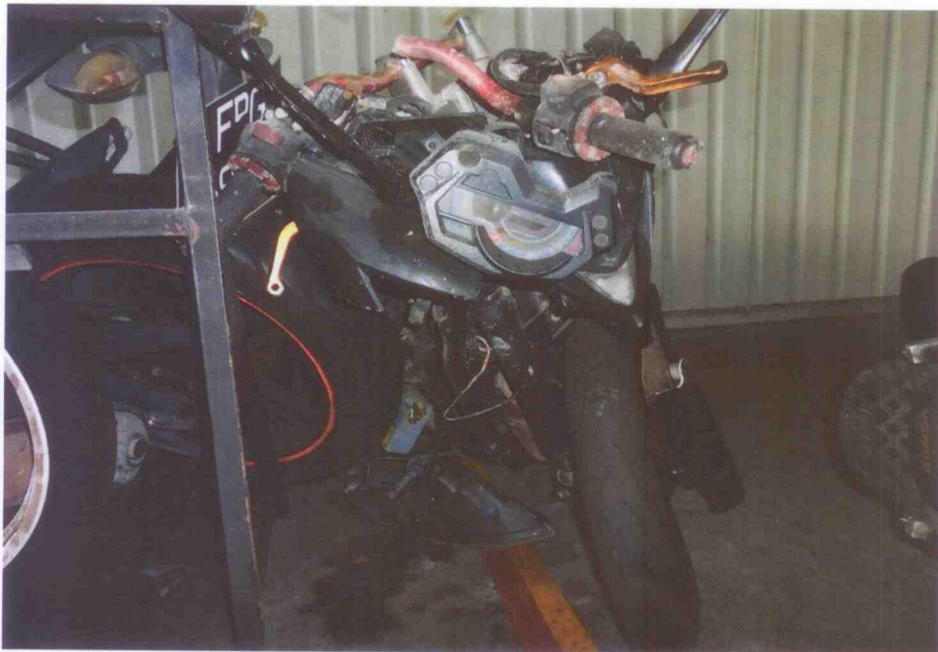
Photo 1 shows the general view of the frontal portion of the Motorcycle at time of our examination. It was observed to sustained severe damages due to the accident's impact collision.

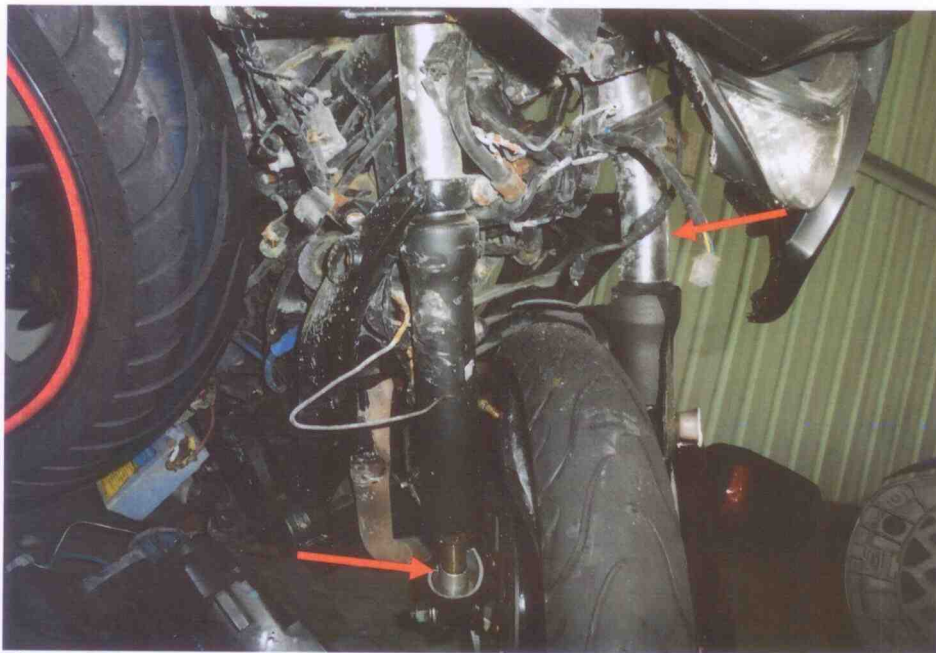
Photo 3 shows a general view of the front portion of the Motorcycle at the time of our inspection. The Motorcycle was observed to have sustained with relatively extensive impact due to the accident collision. Amongst the body parts damaged was its front fork (arrowed), which was observed to be broken and buckled inwards.

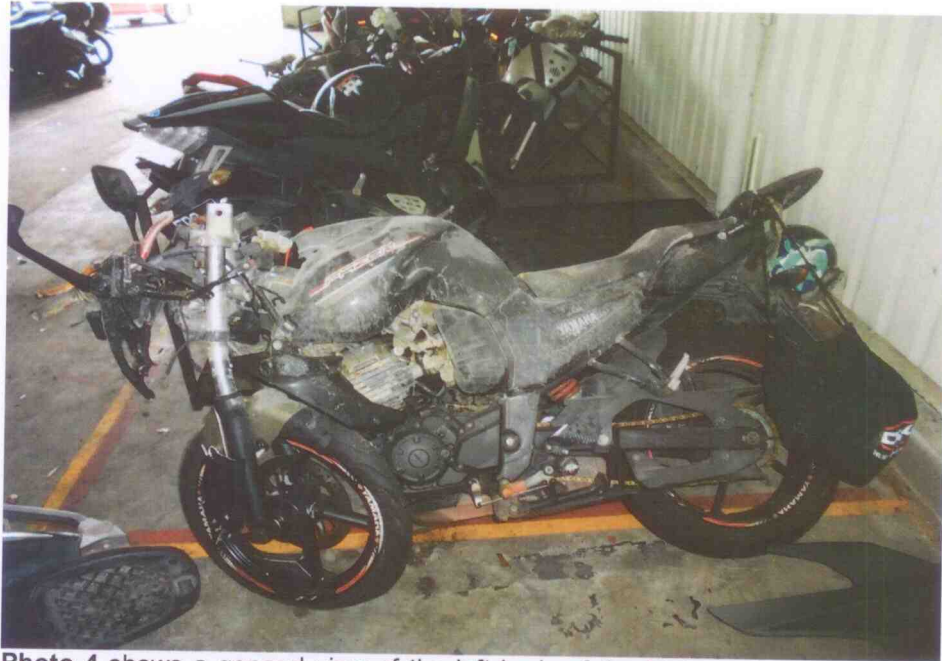
Photo 4 shows a general view of the left body of the Motorcycle at the time of our inspection. The Motorcycle was observed to have sustained damages at the frontal portion, rear portion, along both its left side and right side.

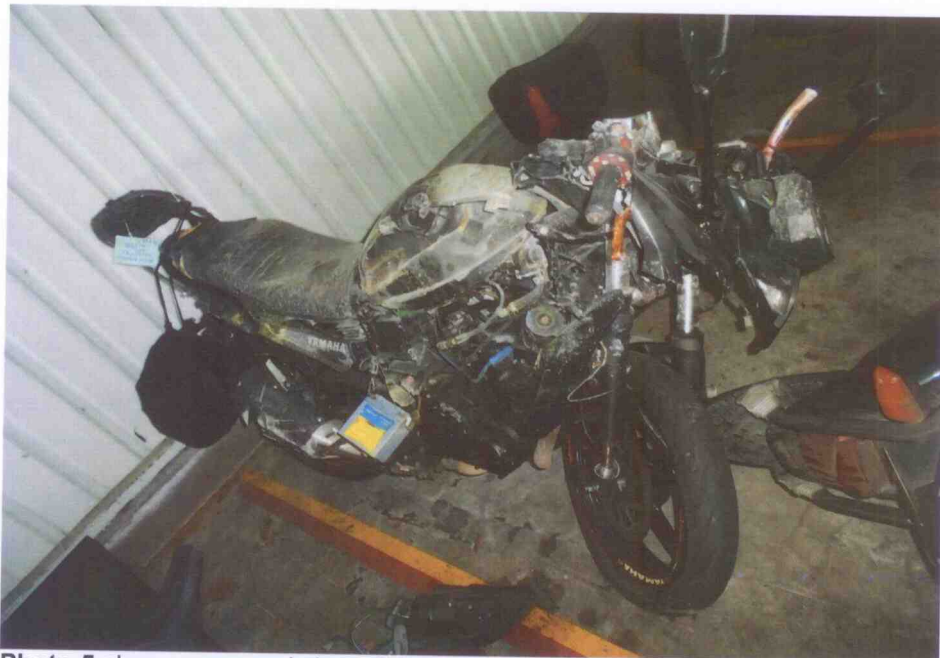
Photo 5 shows a general view of the right portion of the Motorcycle at the time of our inspection. The Motorcycle was observed to have sustained relatively extensive impact due to the accident collision.

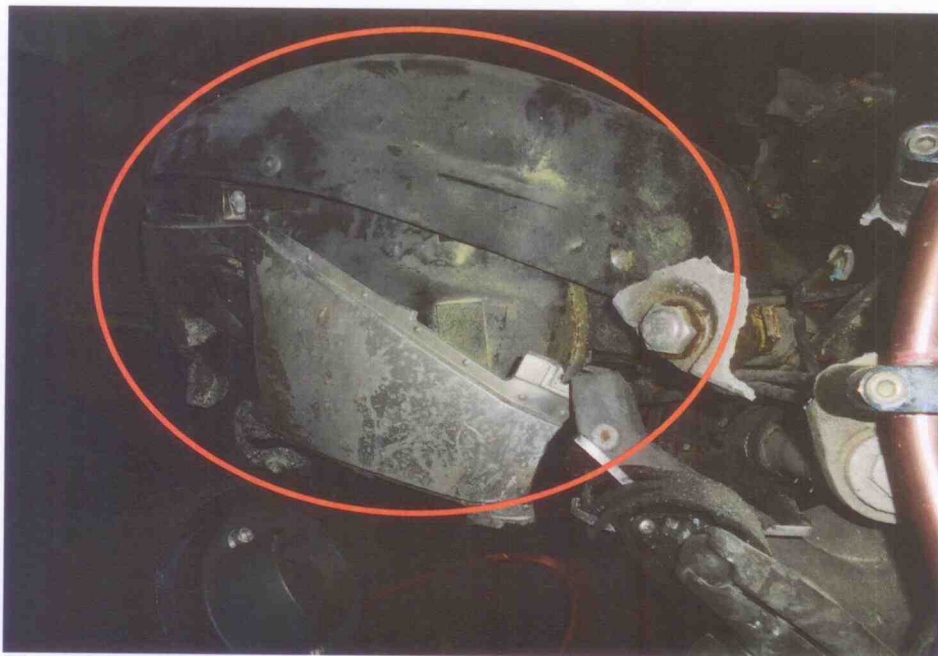
Photo 6 shows a close-up view of the frontal portion of the Motorcycle at the time of our inspection. The Motorcycle was observed to have sustained relatively extensive impact including damages to the fuel tank due to the accident collision.

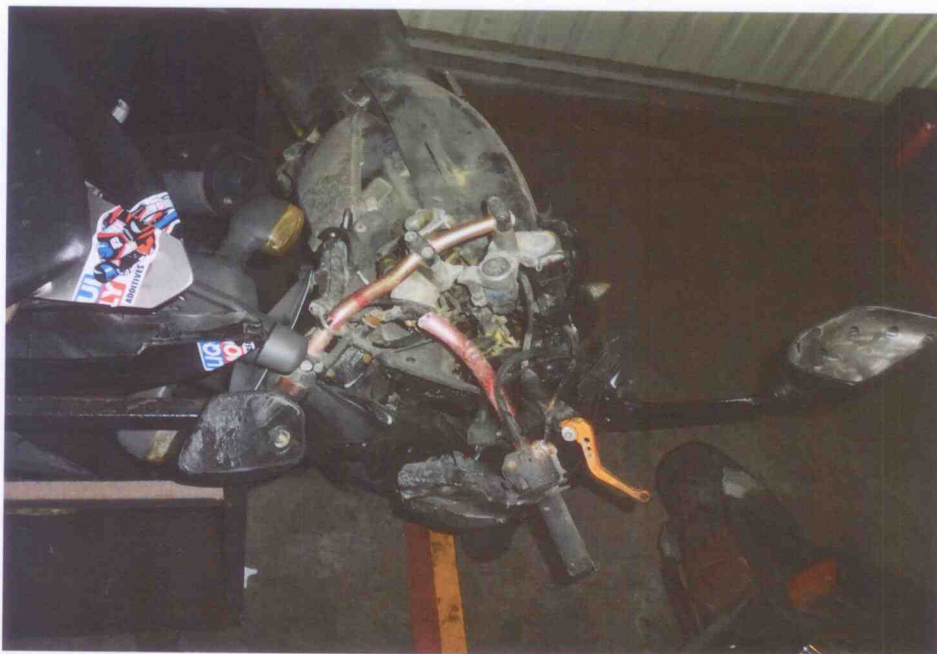
Photo 7 shows a semi close-up view of the front portion of the Motorcycle at the time of our inspection. The Motorcycle was observed to have sustained relatively extensive impact due to the accident collision which includes a broken handle bar.

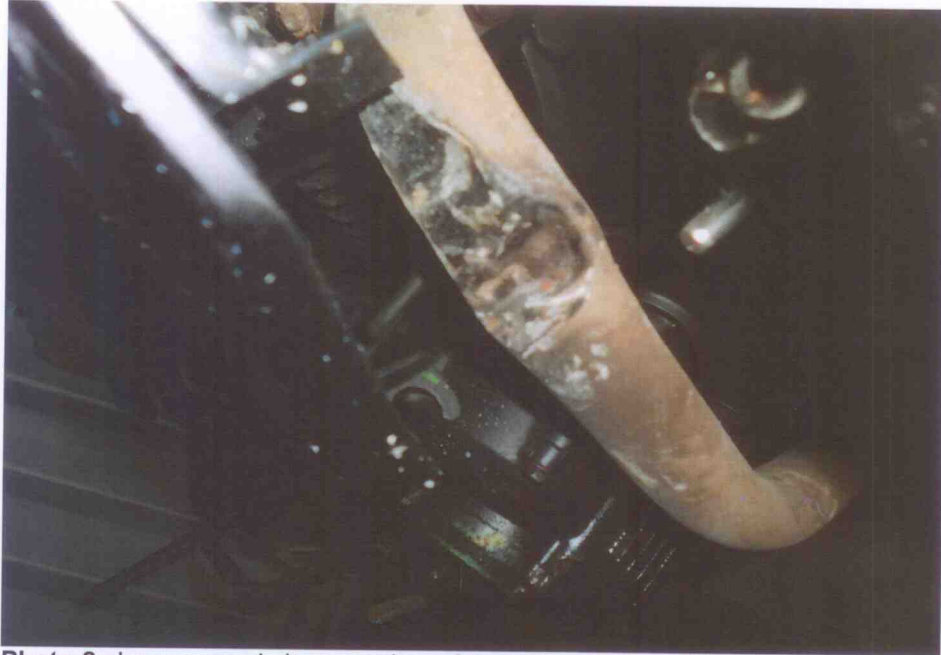
Photo 8 shows a semi close-up view of the exhaust pipe of the Motorcycle at the time of our inspection. It was observed to have sustained relatively extensive impact due to the accident collision which includes crushed exhaust pipe.

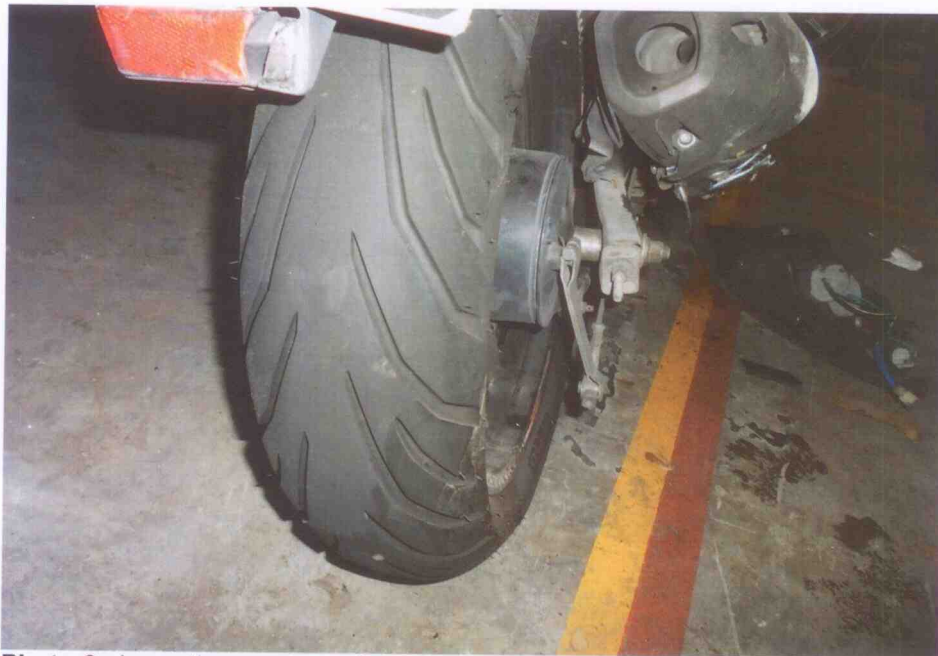
Photo 9 shows the rear tyre of the Motorcycle at the time of our inspection. The rear tyre was observed to be in serviceable condition with remaining tread depth of approximately 5mm. The tyre was also observed to be sufficiently inflated for vehicular operation. There was no significant damage observed on the rear wheel rim & tyre.

19. The condition of the Motorcycle's rear tyre was observed to be in serviceable condition. The tread pattern of the rear tyre was clearly visible. We did not observe any tear, burst mark(s) and/or punctured hole(s) on the sidewalls as well as across the tread of the rear tyre. Its tread depth was measured & found to be around approximately 5mm.

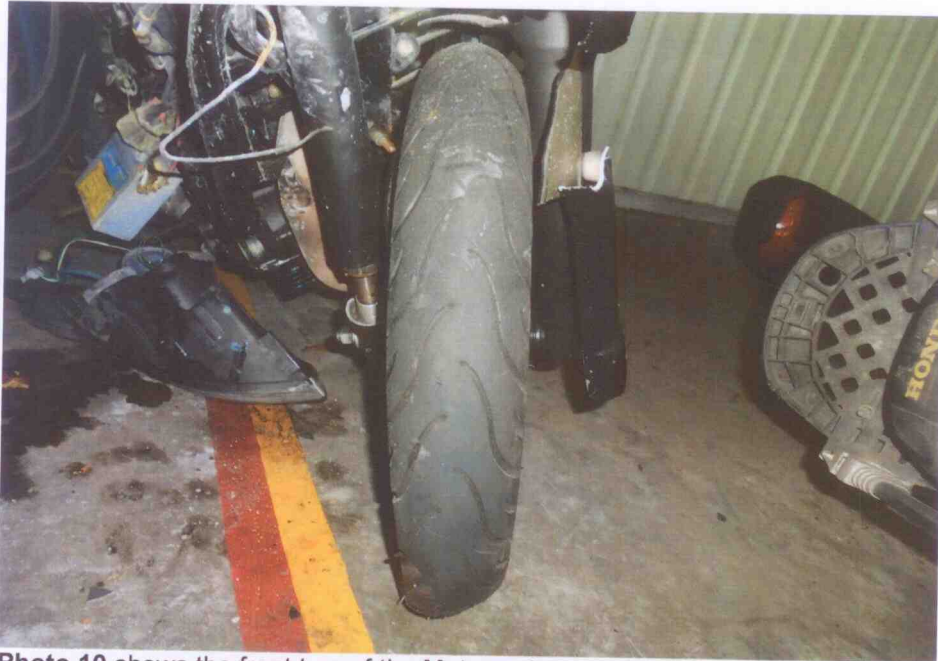
Photo 10 shows the front tyre of the Motorcycle at the time of our inspection. The pattern of the tread was clearly visible. There was no tear, burst mark(s) and/or punctured hole(s) on the sidewalls as well as across the tread of the front tyre with remaining tread depth of approximately 5mm. It was also observed to be deflated as a result of the accident.

20. As for the front tyre, it was found to be deflated likely due to the broken wheel rim as a result of the accident's collision. However, the tread pattern of the front tyre was clearly visible with tread depth of 4mm. We did not observe any tear, burst mark(s) and/or punctured hole(s) on the sidewalls as well as across the tread of the front tyre.

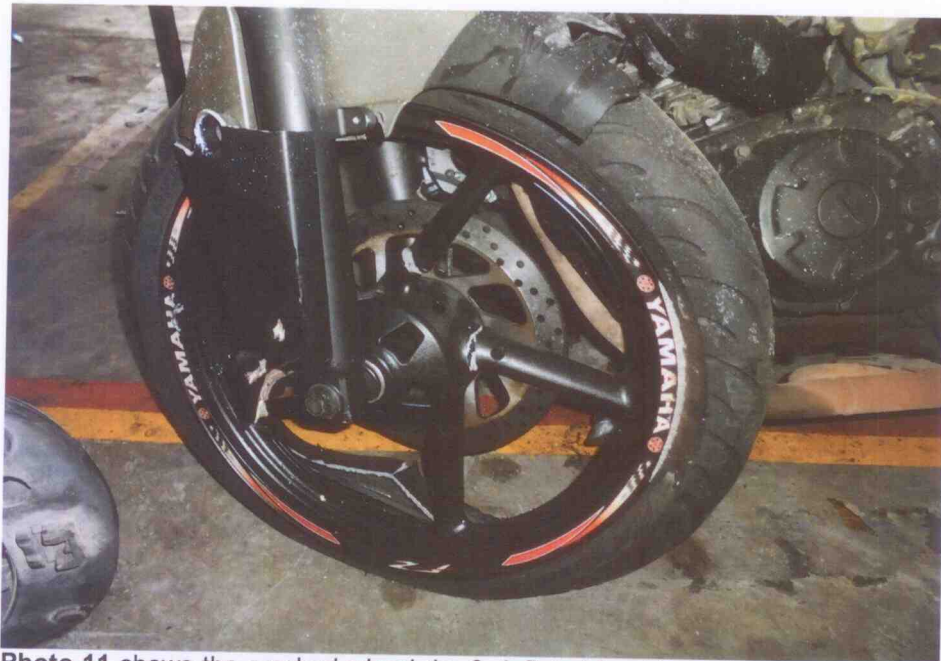
9. The rear tyre was observed to be wrapped around alloy wheel rims that were found to be without any significant damage. It was found to be in serviceable condition with adequately inflated for operational purpose.
10. As for the front wheel rim, it was noted to have sustained with damages (broken) at time of our inspection. The front tyre was found to be deflated due to the broken wheel rim as a result of the accident's collision. See photo 9 – 12 below

Photo 11 shows the cracked wheel rim & deflated front tyre of the Motorcycle at the time of our inspection.

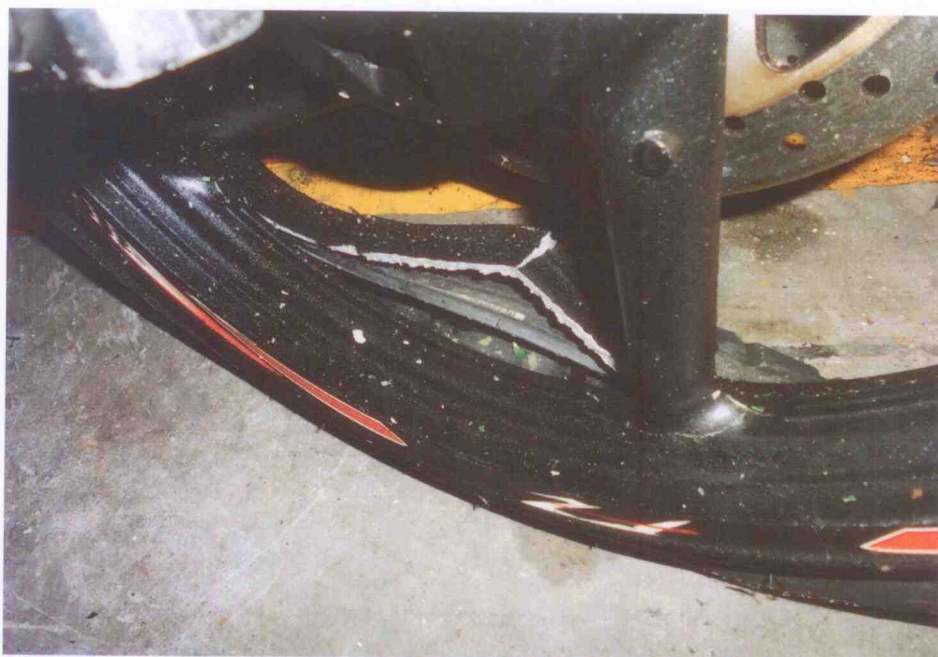
Photo 12 shows the cracked wheel rim on front tyre of the Motorcycle at the time of our inspection.

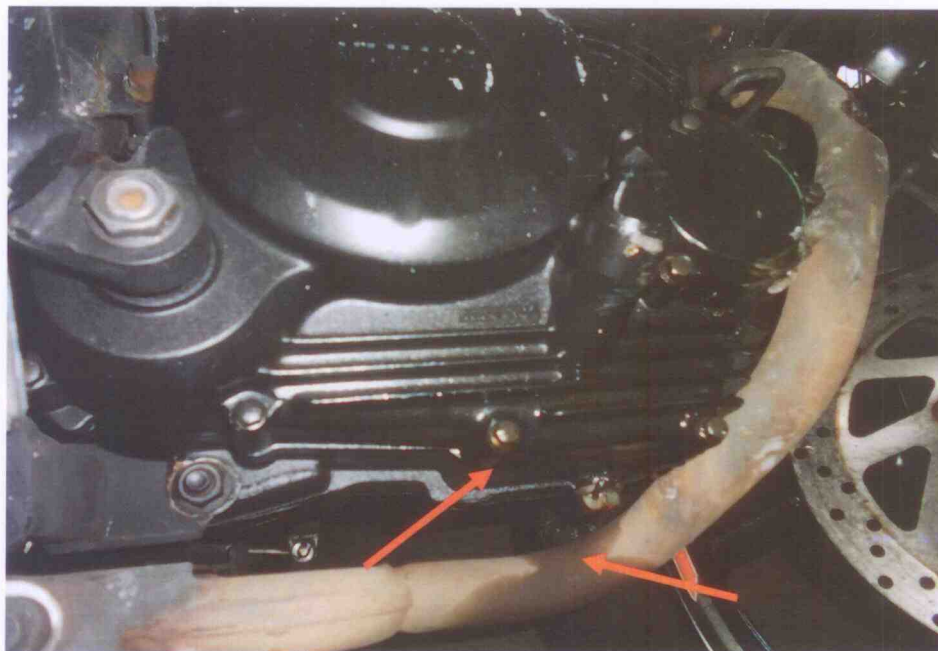
11. Upon examination of the engine area of the Motorcycle, we had observed that the various engine related parts and components were intact with no visible damage. The engine underside was however observed to be covered with reddish fluid, suggesting leakage of fluid. There was no accumulation of dust and/or dirt particles on the engine housing where the fluid stains had formed. This would indicate that the fluid leakage was a fresh leak and likely to be a result of the accident.
12. The gear chain of the Motorcycle was found to be intact without any misalignment. It was also adequately lubricated for operating purposes. See photo 13 – 16 below.

Photo 13 shows sign(s) or indication(s) of fluid leakage observed around the engine's underside area of the Motorcycle.

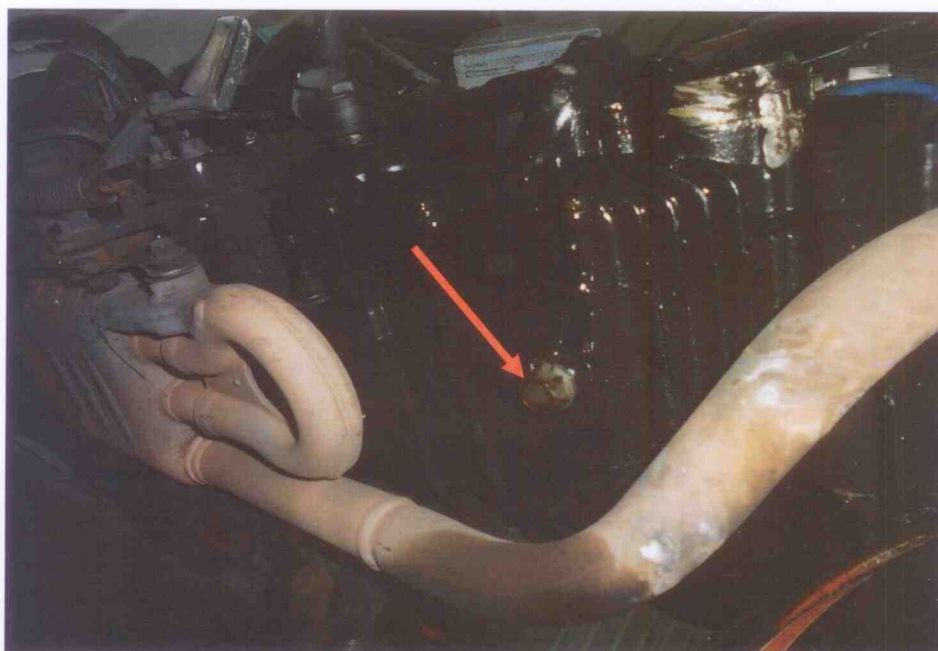
Photo 14 shows sign(s) or indication(s) of fluid leakage observed around the engine's area of the Motorcycle.

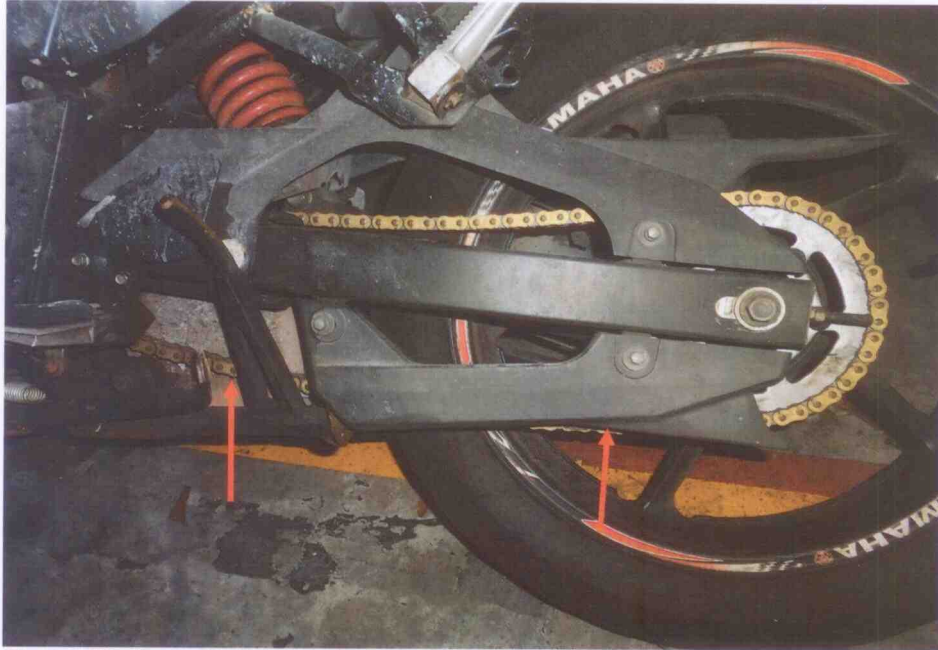
Photo 15 shows the general view of the gear train (arrowed) of the Motorcycle, which was observed to be intact with no misalignment. It was also adequately lubricated for operating purposes.

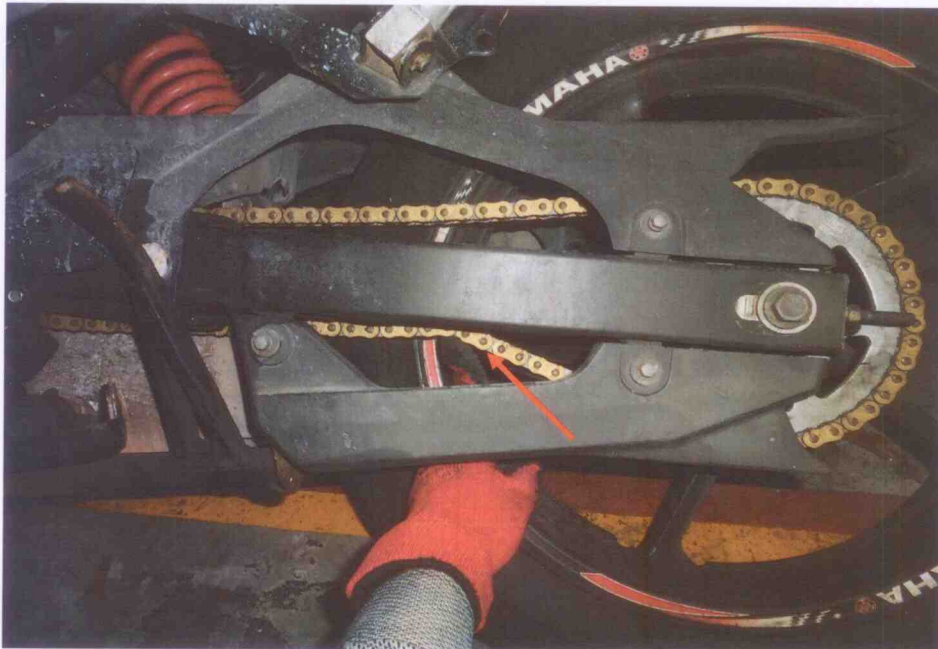
Photo 16 shows the general view of the gear train (arrowed) of the Motorcycle, which was observed to be intact with no misalignment. It was also adequately lubricated for operating purposes.

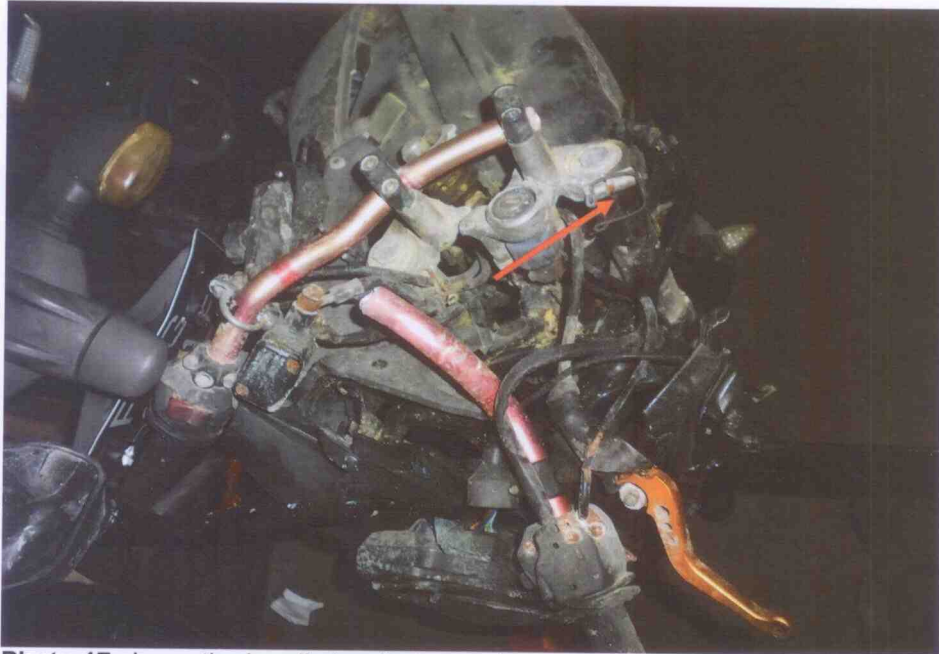
13. For this case, we were not able to conduct any test(s) on the steering system of the Motorcycle due to the damages on its front fork & handle bar. The front fork was found to be buckled inwards & broken handle bar as a result of the accident, hence causing the whole steering system to be in a state of immobility.

Photo 17 shows the handle bar that was observed to be broken due to the result of the accident. Hence, we are unable to conduct any tests on the steering system & braking system of the Motorcycle.

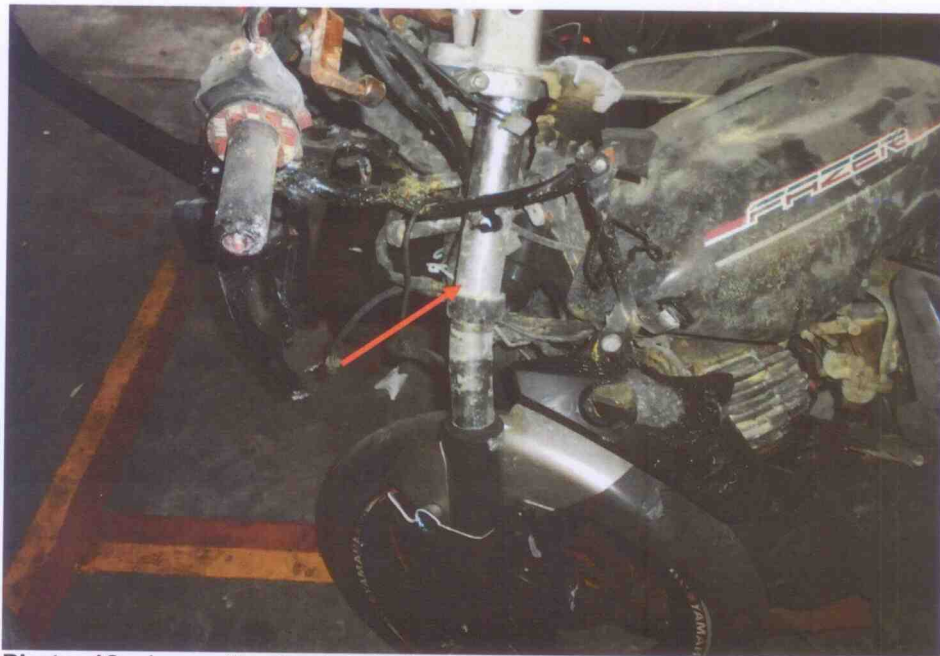
Photo 18 shows the front fork (arrowed) that was observed to be buckled inwards as a result of the accident. Hence, we are unable to conduct any tests on the steering system of the Motorcycle.

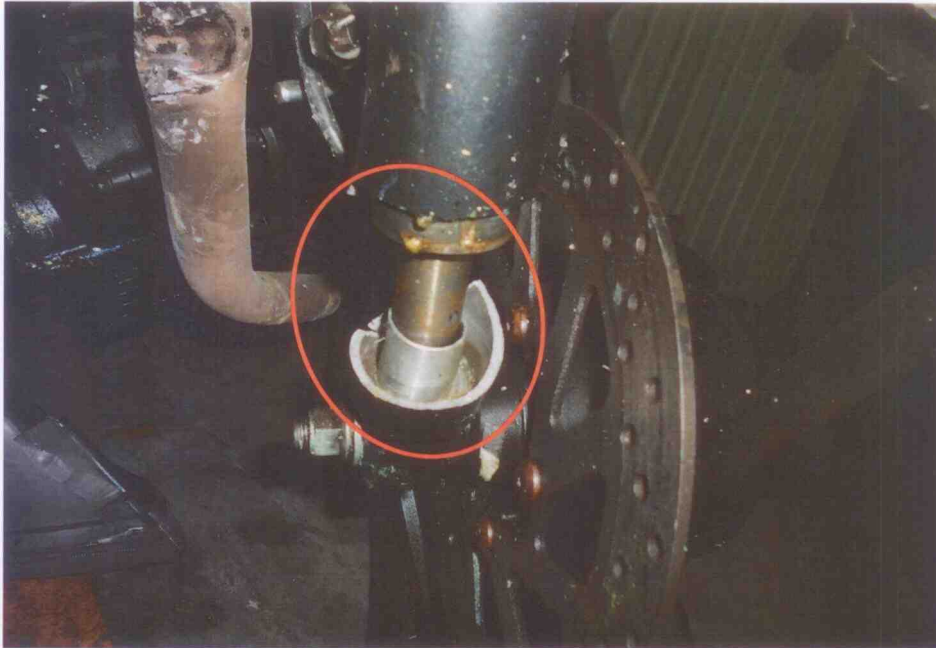
Photo 19 shows the front fork (circled) was observed to be damaged as a result of the accident. Hence, we are unable to conduct any tests on the steering system of the Motorcycle.

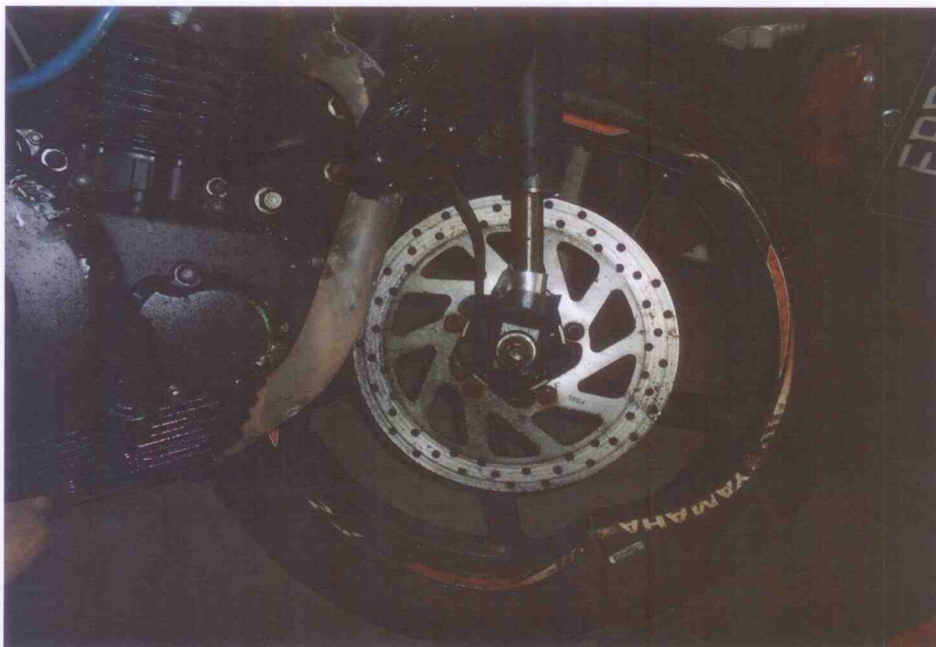
15. Static brake tests for the front brake was unable to be conducted on the Motorcycle braking system due to missing front brake calliper & brake fluid leakage (broken brake hose) at the material time of our inspection.

Photo 20 shows the missing front brake calliper at the front brake disc of the Motorcycle due to the accident's impact collision. Hence, we are unable to conduct any tests on the braking system of the Motorcycle.

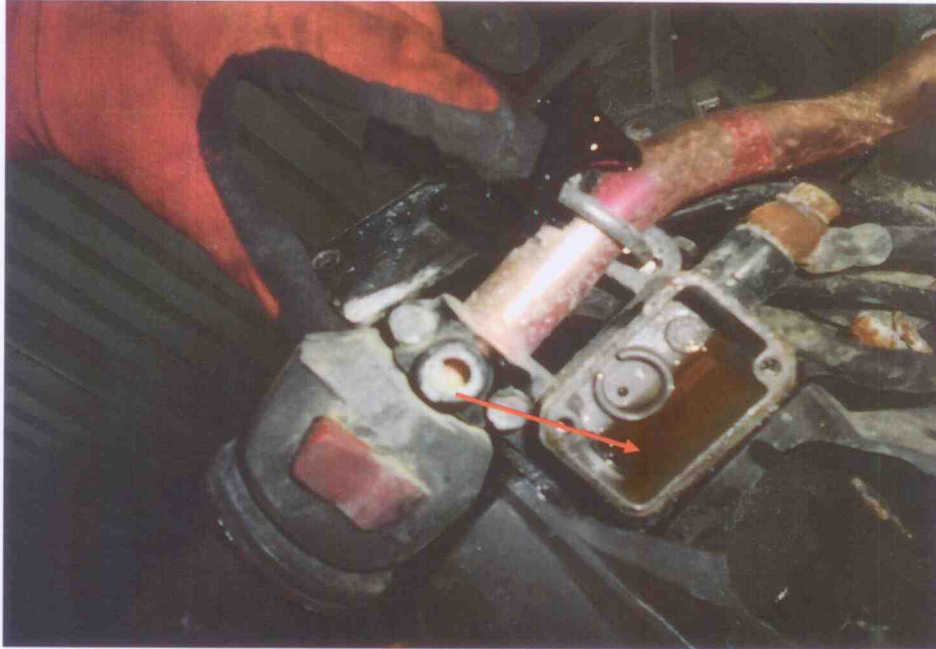
Photo 21 shows the front brake fluid reservoir of the Motorcycle. The brake fluid was observed to be in an insufficient level due to the damages sustained as a result of the accident.

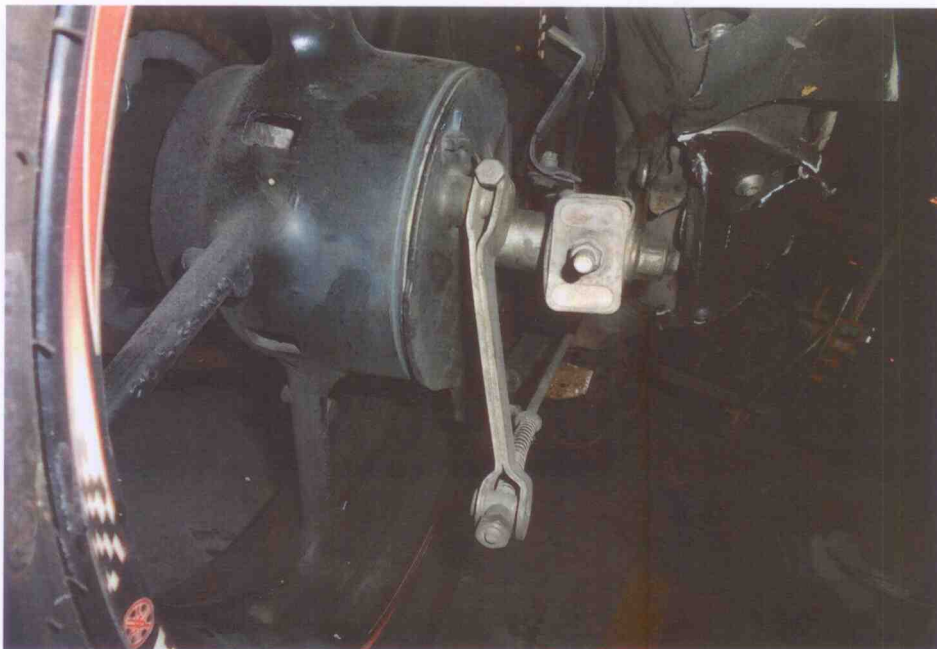
16. As for the rear, a static brake test that was conducted on the Motorcycle had appeared to indicate that the rear braking system of the Motorcycle was in serviceable condition. There was some resistance felt (spongy like feel) upon stepping on the rear brake foot paddle. This would indicate that there was no damage sustained to the rear brake drum & other supporting mechanical components.

Photo 22 shows the rear brake components of the Motorcycle which was observed to be in serviceable condition. No damages was found at time of our inspection
