Your Ref: TP/IP/65075/2018
Our Ref :CI/TPD18022475/Z

16th January 2019

MECHANICAL INSPECTION REPORT OF MOTORCYCLE BNK 6422

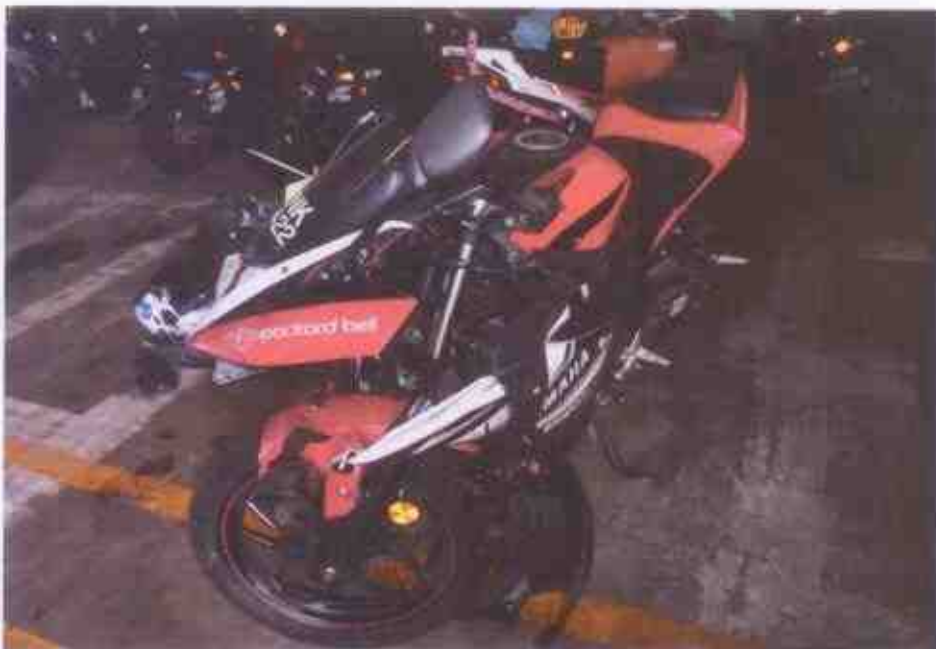
5. The Motorcycle was observed to have sustained damages at the frontal portion & along both its left side and right side. The body parts that were found to have been damaged include its front head lamp (dislodged), missing right wing mirror, front left & right fairing, radiator, exhaust manifold, foot gear shift pedal and handle bar amongst others. Its steering system (handle bar & front fork) was also observed to be dislocated as a result of the accident.

Photo 1 shows a general view of the front body of the Motorcycle at the time of our inspection. The Motorcycle was observed to be sustained with relatively extensive impact due to the accident collision. Amongst the body parts damaged was its steering system, which was observed to be buckled inwards.

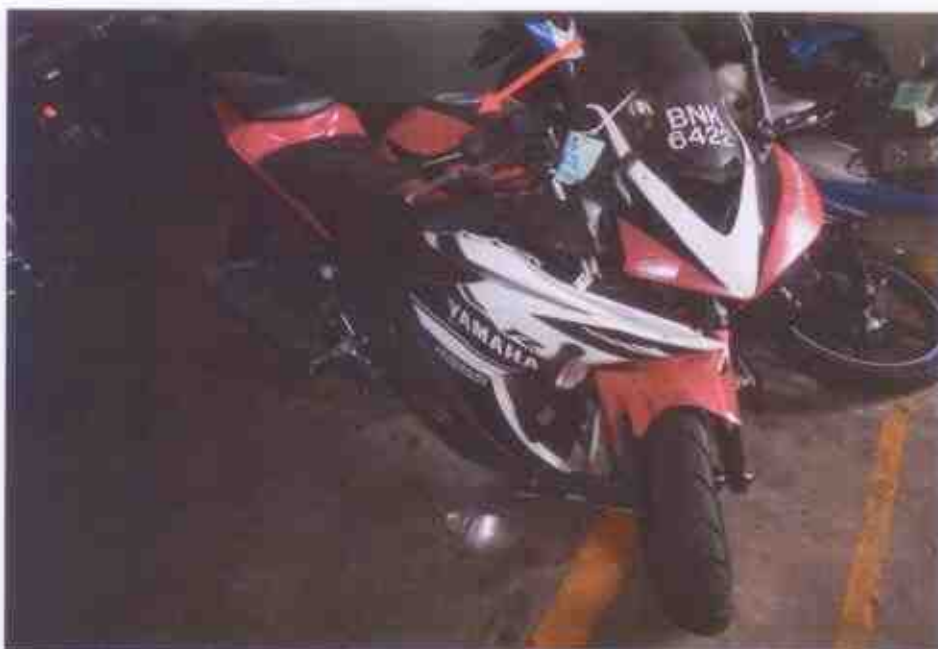
Photo 2 shows a general view of the front right body of the Motorcycle at the time of our inspection. The Motorcycle was observed to be sustained with relatively extensive impact due to the accident collision. Amongst the body parts damaged was its handle bar-steering system, which was observed to be broken.

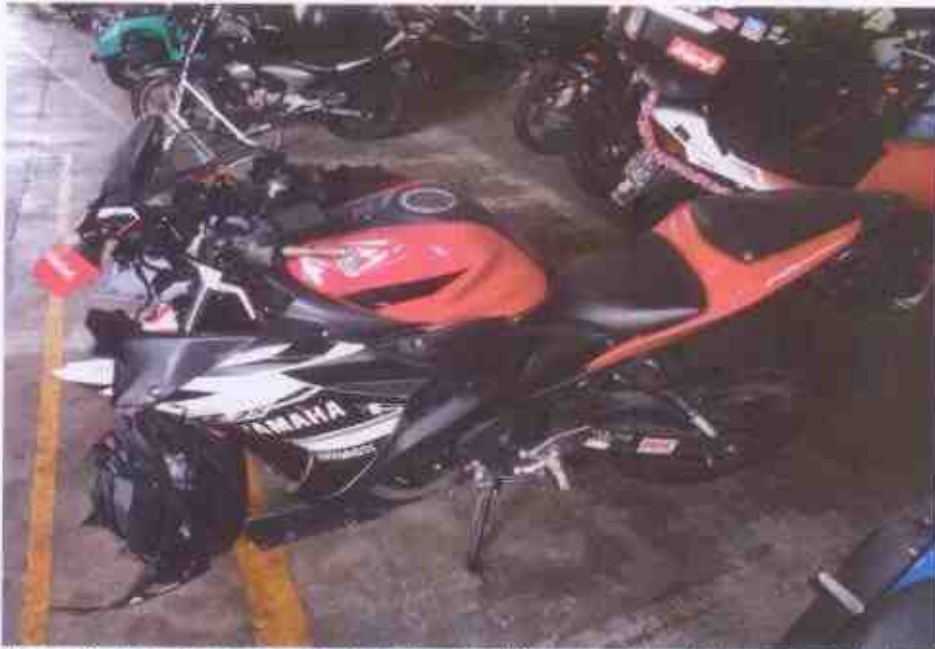
Photo 3 shows a general view of the rear left body of the Motorcycle at the time of our inspection. The Motorcycle was observed to have sustained damages at the frontal, along both its left side and right side as a result of the accident.

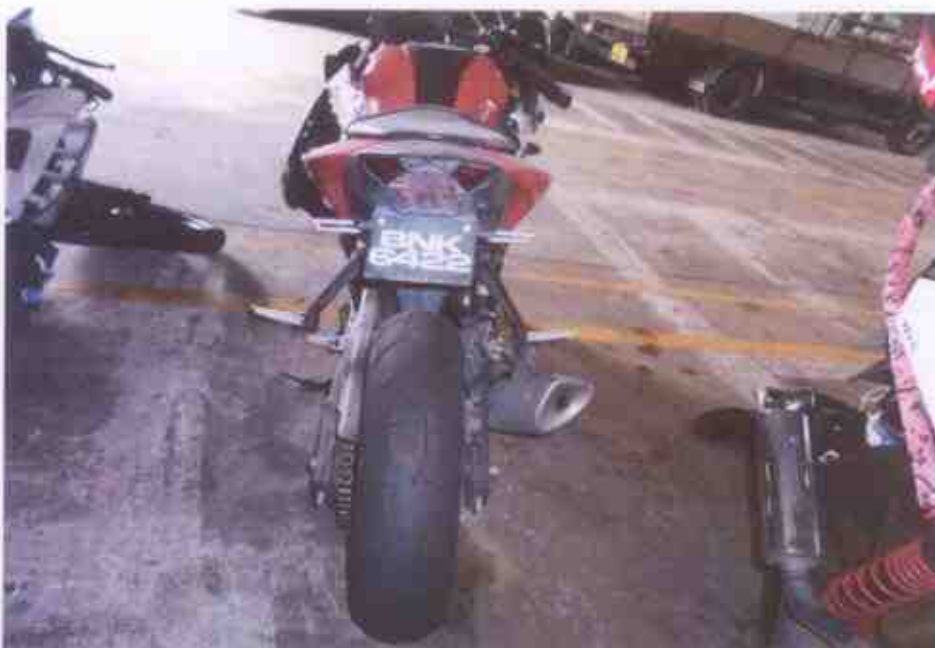
Photo 4 shows a general view of the rear portion of the Motorcycle at the time of our inspection. It was observed to be in good condition not affected by the accident's impact.

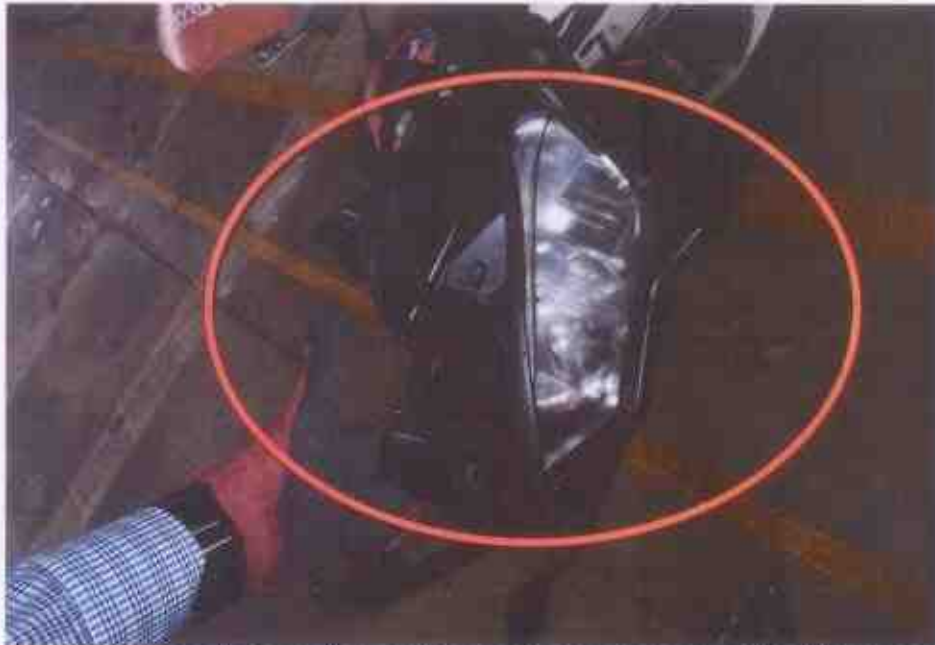
Photo 5 shows a close-up view of the head lamp of the Motorcycle at the time of our inspection. It was observed to be dislodged due to the accident collision.

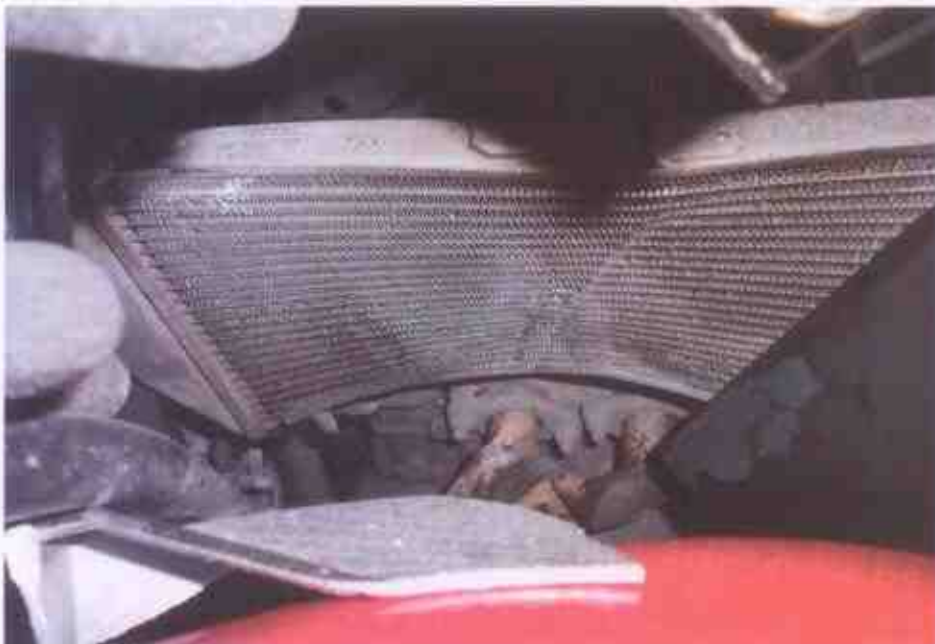
Photo 6 shows a close-up view of the radiator of the Motorcycle at the time of our inspection. It was observed to have sustained with damages due to the accident collision.

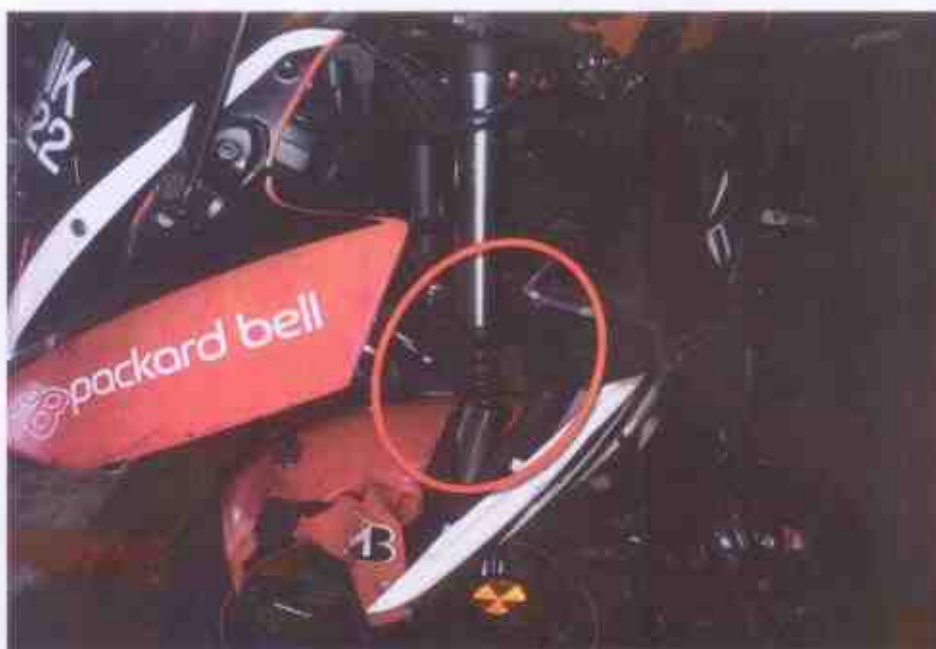
Photo 7 shows a close-up view of the broken front fork of the Motorcycle at the time of our inspection. It was observed to be damage due to the accident collision.

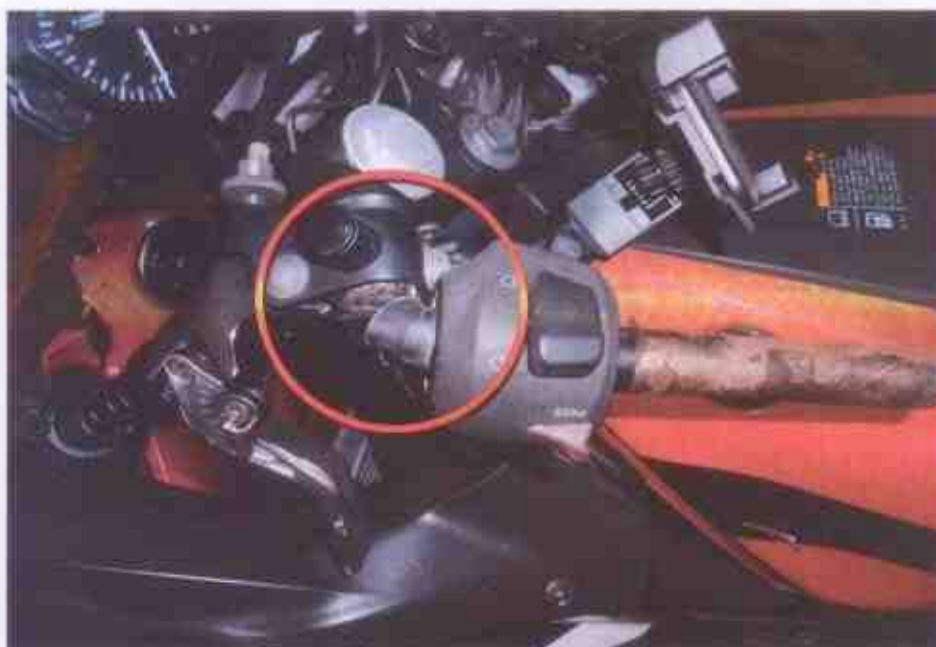
Photo 8 shows a close-up view of the broken handle bar of the Motorcycle at the time of our inspection. It was observed to be damaged due to the accident collision.

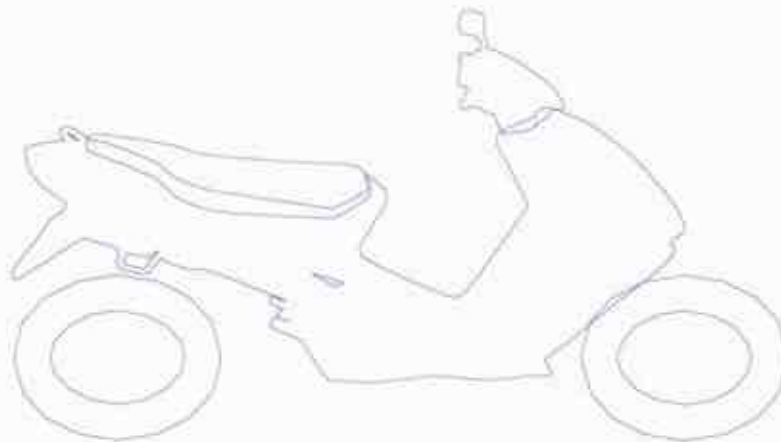
Metzeler Sportec Street
150/60-17 (6mm)

Metzeler Sportec Street
120/70-17 (6mm)-(Deflated)-
(Wheel rim broken)

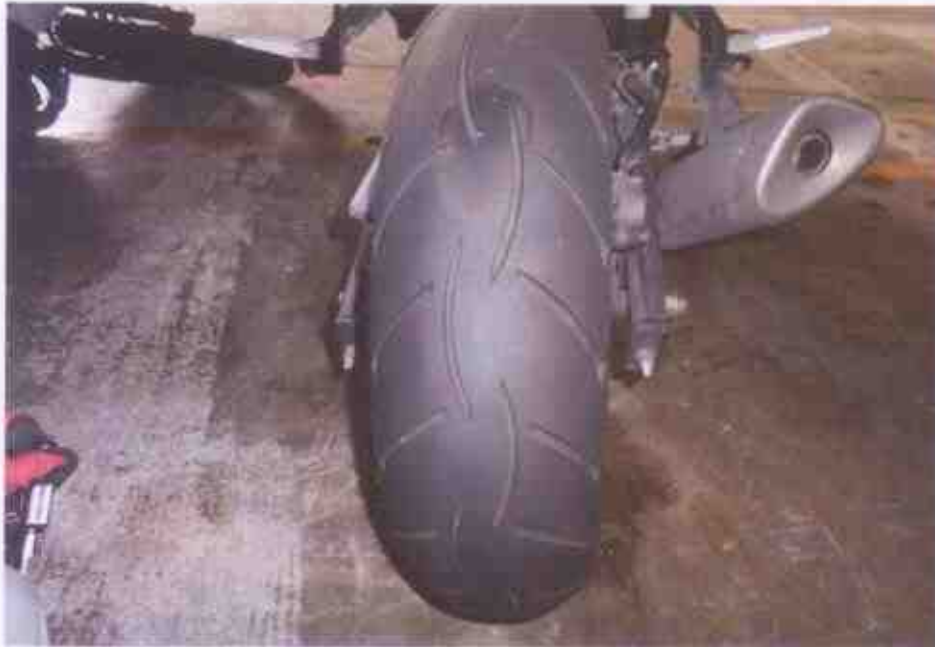
Photo 9 shows the rear tyre of the Motorcycle at the time of our inspection. The rear tyre was observed to be in serviceable condition with remaining tread depth of approximately 6mm. The tyre was also observed to be sufficiently inflated for vehicular operation. There was no significant damage observed on the rear wheel rim & tyre.

20. The condition of the Motorcycle's rear tyre was observed to be in serviceable condition. The tread pattern of the rear tyre was clearly visible. We did not observe any tear, burst mark(s) and/or punctured hole(s) on the sidewalls as well as across the tread of the rear tyre. Its tread depth was measured & found to be around approximately 6mm.

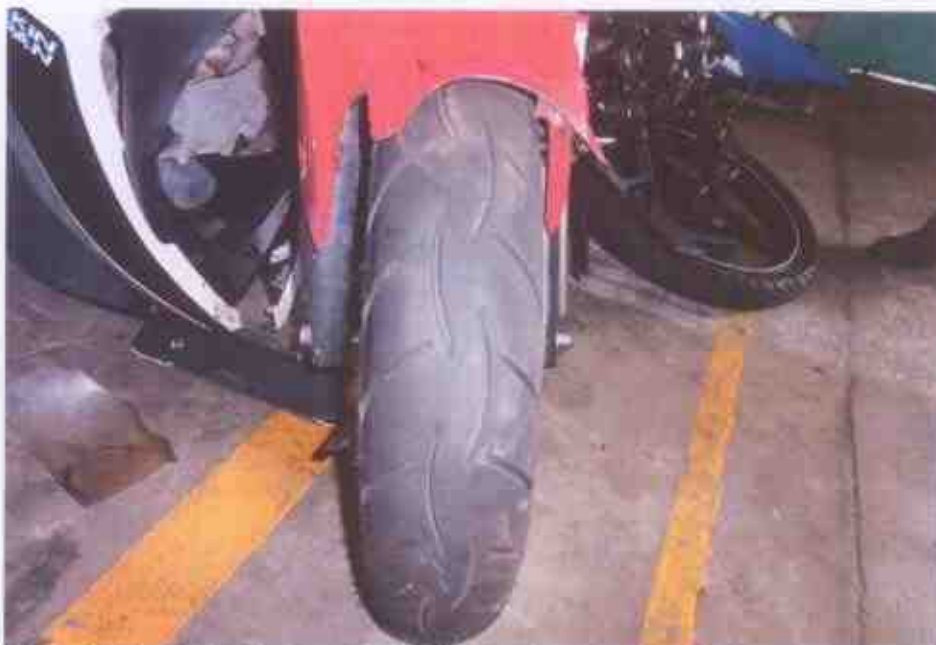
Photo 10 shows the front tyre of the Motorcycle at the time of our inspection. The pattern of the tread was clearly visible. There was no tear, burst mark(s) and/or punctured hole(s) on the sidewalls as well as across the tread of the front tyre with remaining tread depth of approximately 6mm. However, it was observed to be deflated as a result of the accident.

21. As for the front tyre, it was found to be deflated likely due to the broken wheel rim as a result of the accident's collision. However, the tread pattern of the front tyre was clearly visible with tread depth of 6mm. We did not observe any tear, burst mark(s) and/or punctured hole(s) on the sidewalls as well as across the tread of the front tyre.

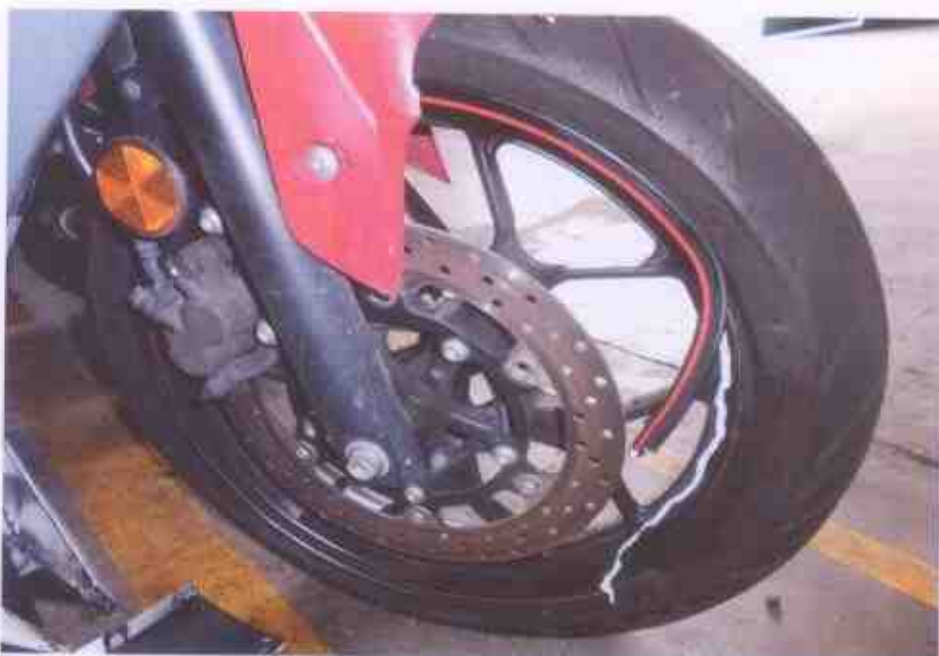
Photo 11 shows the cracked wheel rim & deflated front tyre of the Motorcycle at the time of our inspection.

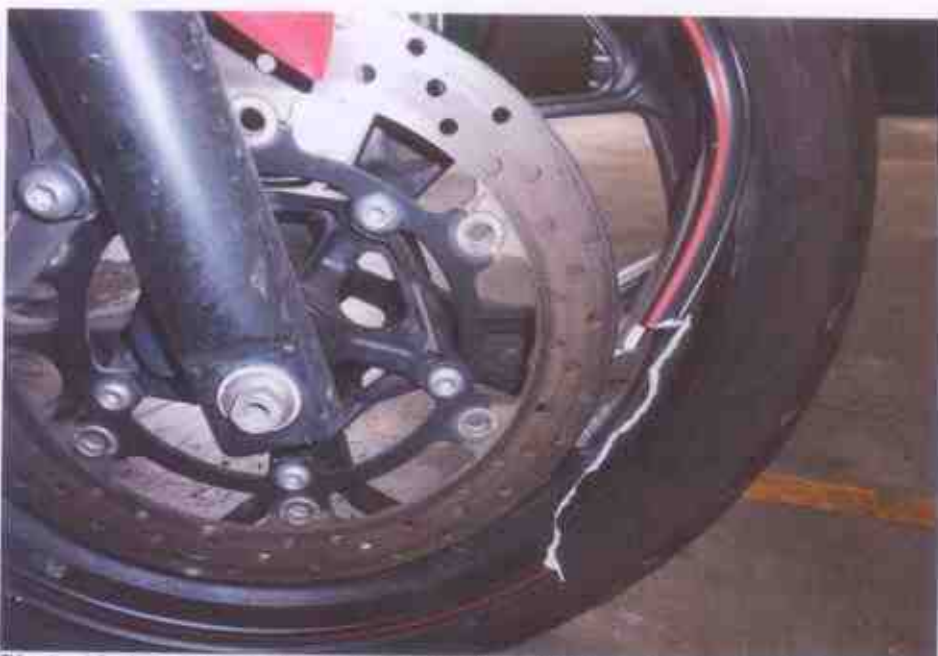
Photo 12 shows the cracked wheel rim on front tyre of the Motorcycle at the time of our inspection.

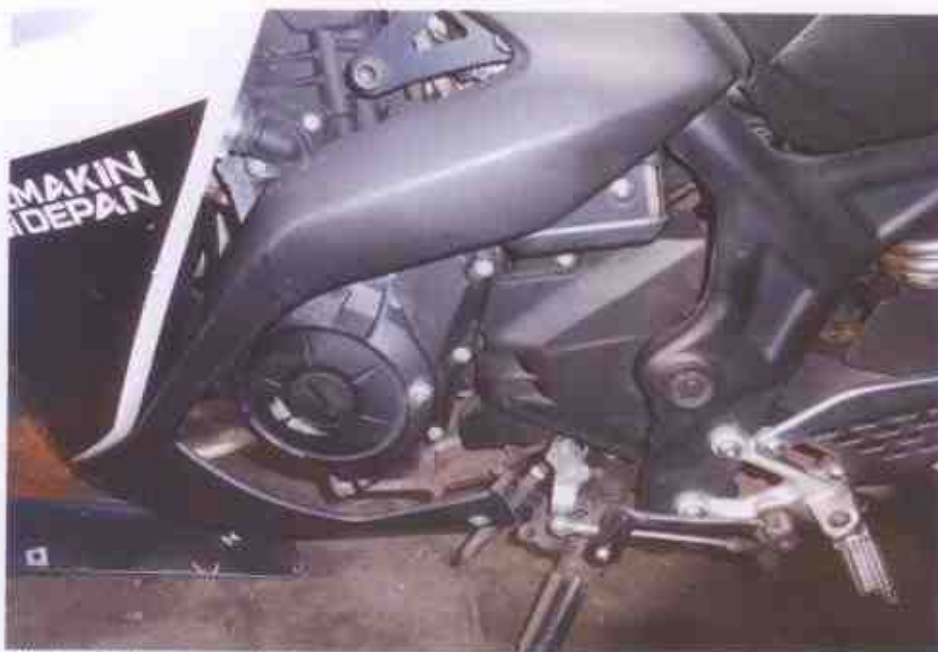
Photo 13 shows no sign(s) or indication(s) of fluid leakage stain observed around the engine undercarriage area of the Motorcycle.

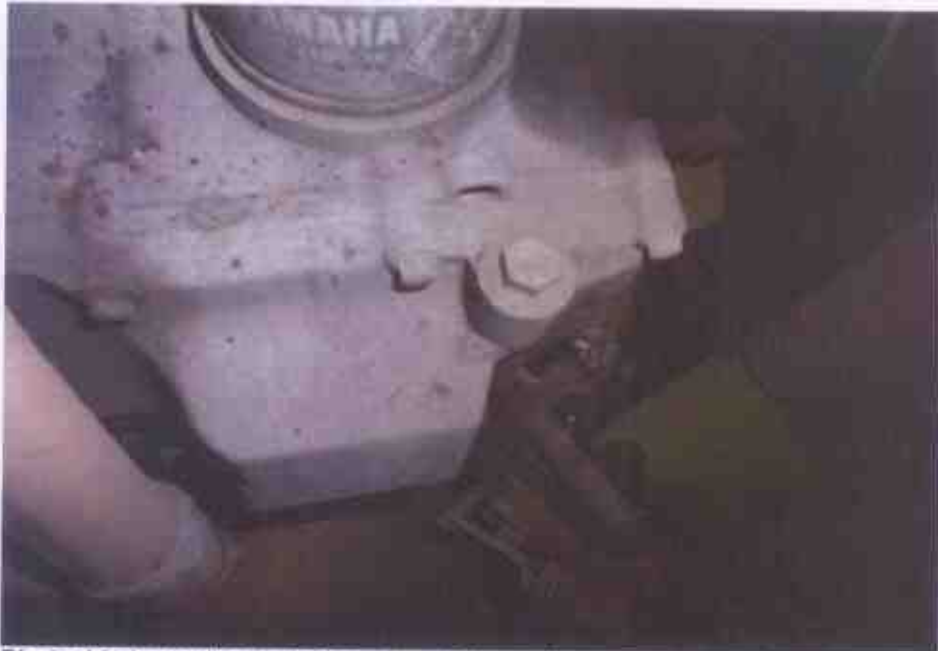
Photo 14 shows the semi-close view of the engine compartment. It was observed to be intact & undamaged unaffected by the accident's impact.

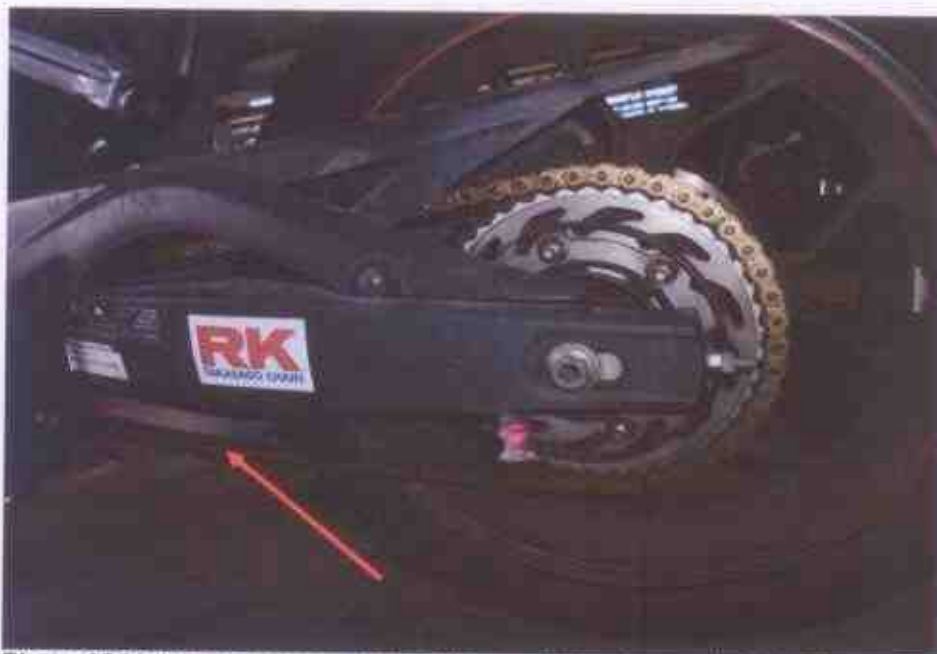
Photo 15 shows the general view of the gear train (arrowed) of the Motorcycle, which was observed to be intact with no misalignment. It was also adequately lubricated for operating purposes.

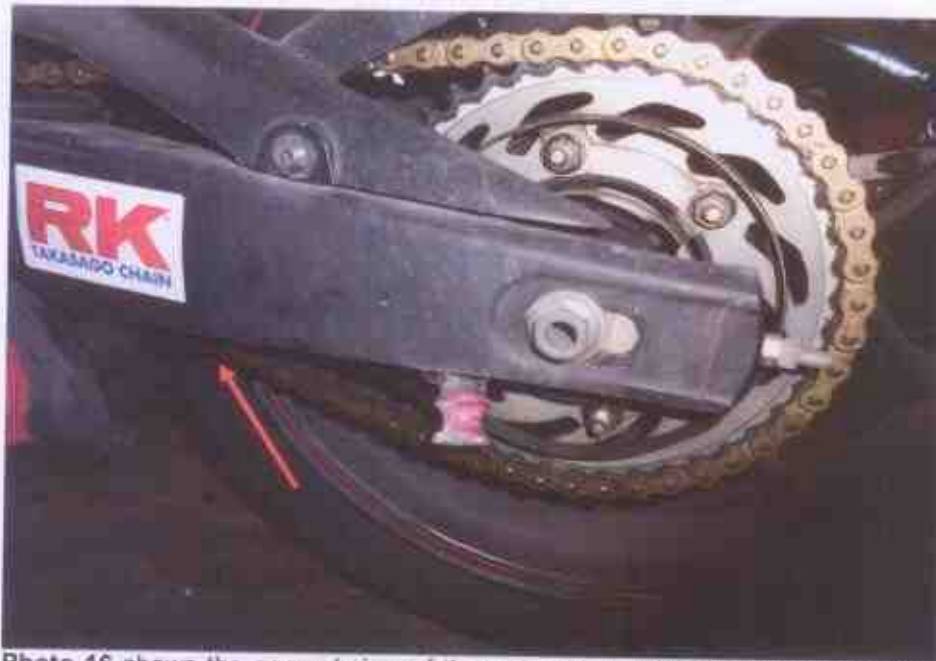
Photo 16 shows the general view of the gear train (arrowed) of the Motorcycle, which was observed to be intact with no misalignment. It was also adequately lubricated for operating purposes. Free play tension was also observed & found adequately acceptable.

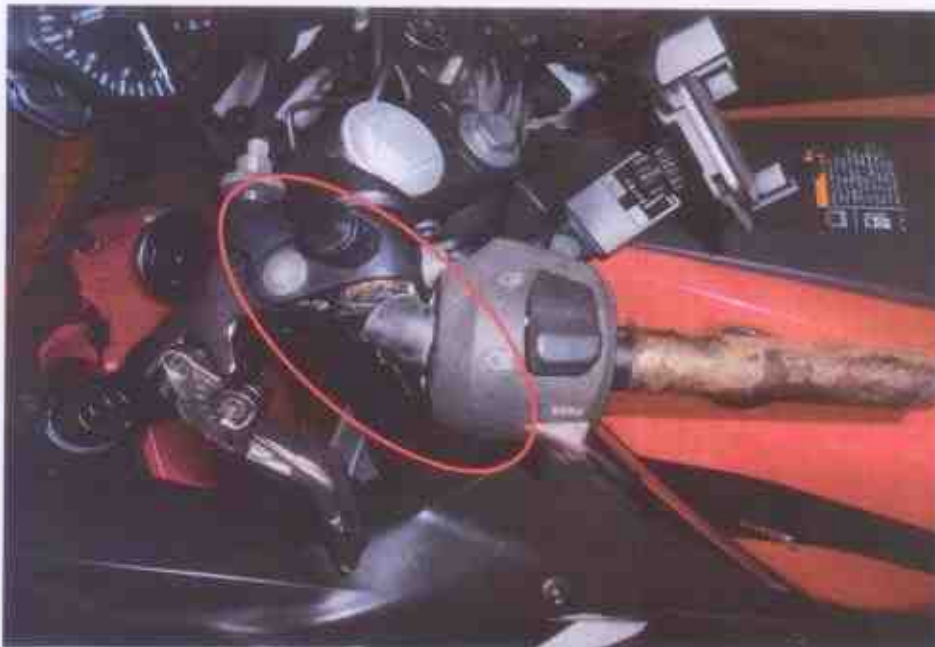
14. For this case, we were not able to conduct any test(s) on the steering system of the Motorcycle due to the damage on its handle bar & front fork. The handle bar was found to be broken & the front fork was observed to be buckled inwards as a result of the accident, hence causing the whole steering system to be in an abnormal condition.
15. The brake system of the Motorcycle was of a fully-hydraulic type, where hydraulic (brake fluid) pressure controls the brake for the front & rear wheel. Our visual examination of the various components in the brake system, like the brake disc, brake calliper, drum and brake foot pedal, revealed all to be intact. There was also no visible tear or cut observed on the connecting hoses and cables.

Photo 17 shows the handle bar (circled) was observed to be broken as a result of the accident. Hence, we are not able to conduct any tests on the steering system of the Motorcycle.

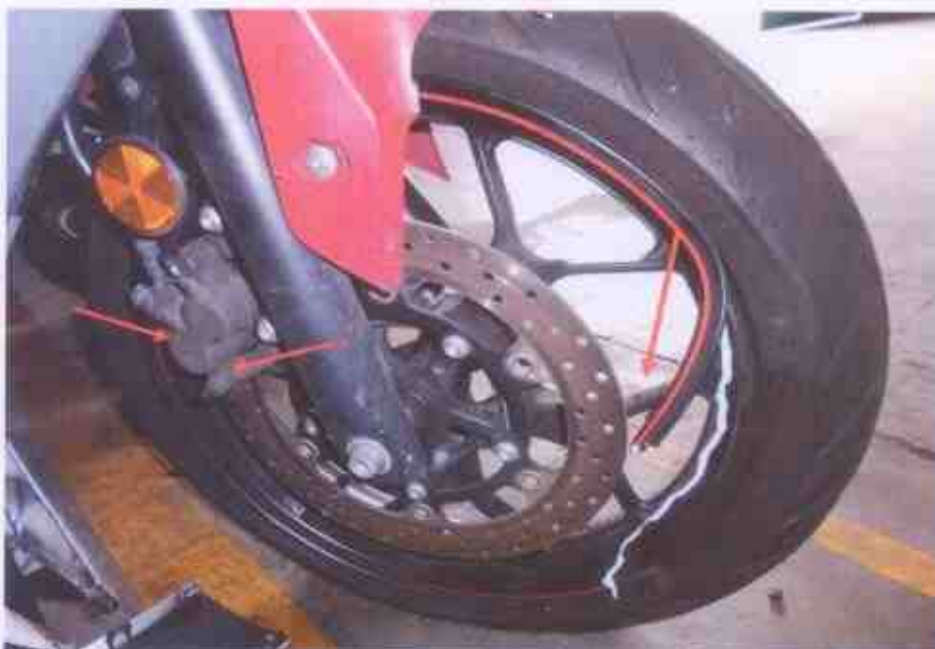
Photo 18 shows the front brake calliper, front brake disc and front brake hose of the Motorcycle (arrowed), which are all part of the components in the front brake system of the Motorcycle. Our visual checks of these various components had revealed all to be intact with no visible damage. No leakage of brake fluid was also observed.

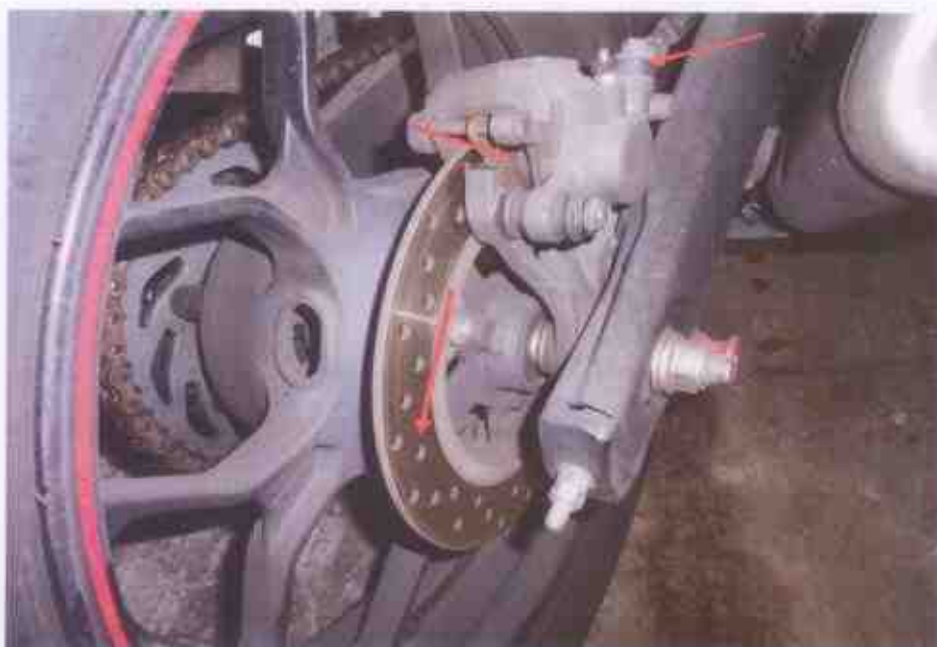
Photo 19 shows the rear brake calliper, rear brake disc and rear brake hose of the Motorcycle (arrowed), which are all part of the components in the front brake system of the Motorcycle. Our visual checks of these various components had revealed all to be intact with no visible damage. No leakage of brake fluid was also observed.

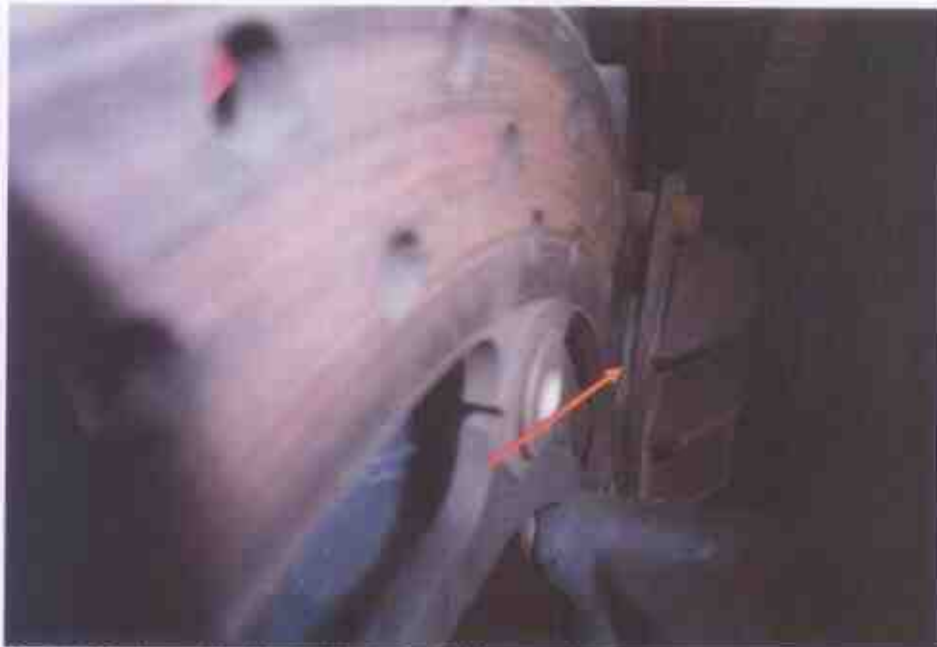
Photo 20 shows the front wheel of the Motorcycle. The type of brake system for the rear wheel was of hydraulic type, controlled by the hand brake lever of the Motorcycle. Our checks of the calliper (arrowed) & brake pad which are all part of the components in the rear brake system of the Motorcycle reveal all to be intact and without damage.

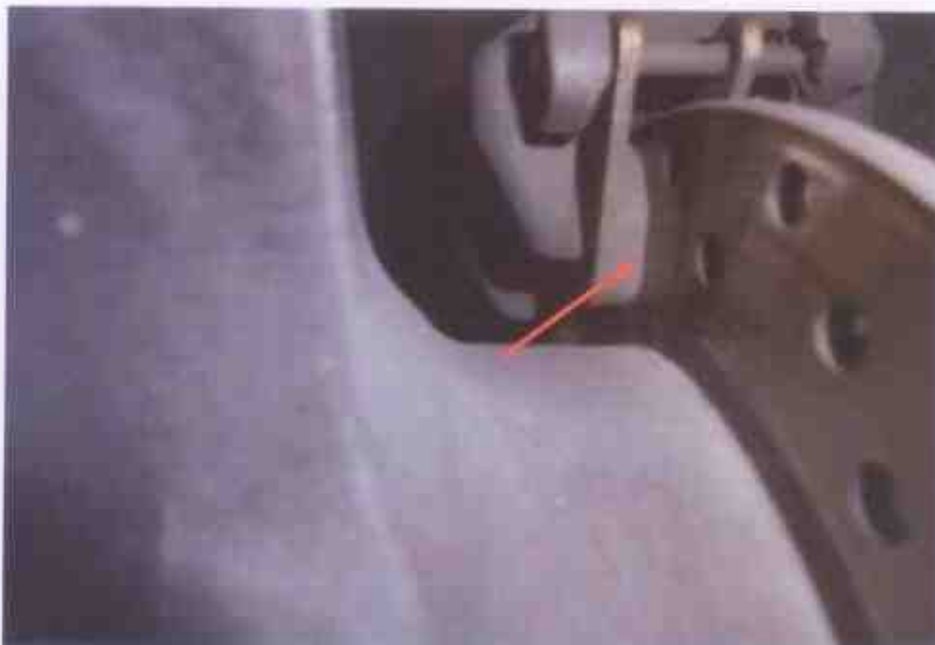
Photo 21 shows the rear wheel of the Motorcycle. The type of brake system for the rear wheel was of hydraulic type, controlled by the brake foot pedal of the Motorcycle. Our checks of the calliper (arrowed) & brake pad which are all part of the components in the rear brake system of the Motorcycle reveal all to be intact and without damage.

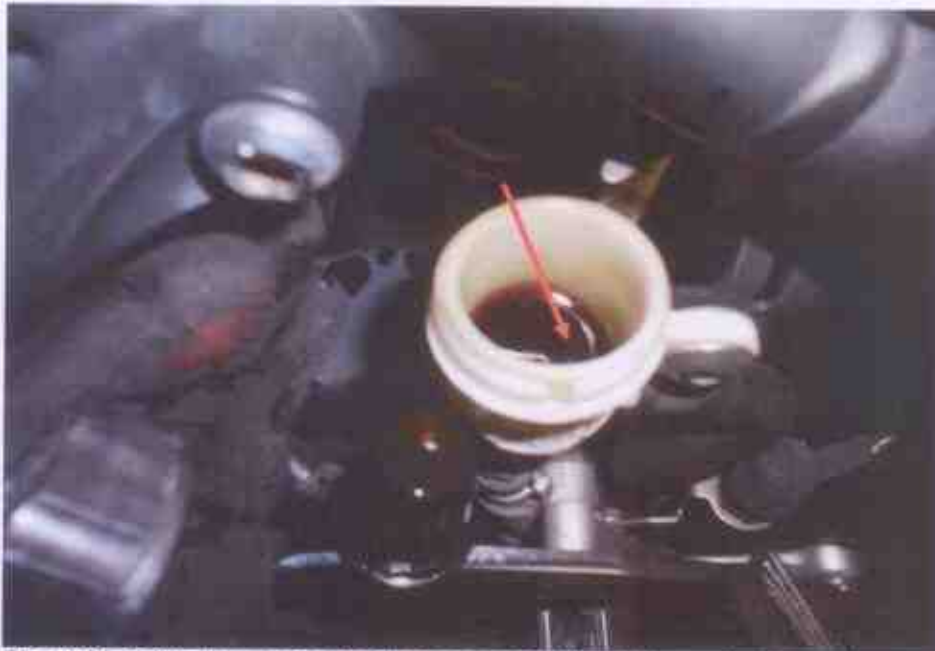
Photo 22 shows the rear brake fluid reservoir of the Motorcycle. It was observed to be of sufficient level without any contamination at time of our inspection.

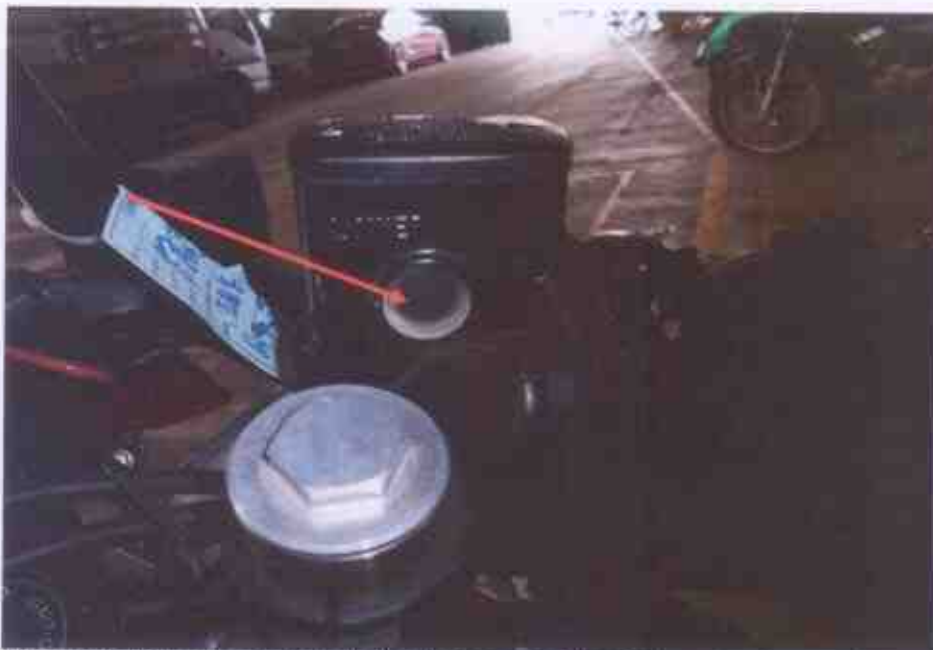
Photo 23 shows the front brake fluid reservoir of the Motorcycle. It was observed to be of sufficient level without any contamination at time of our inspection.

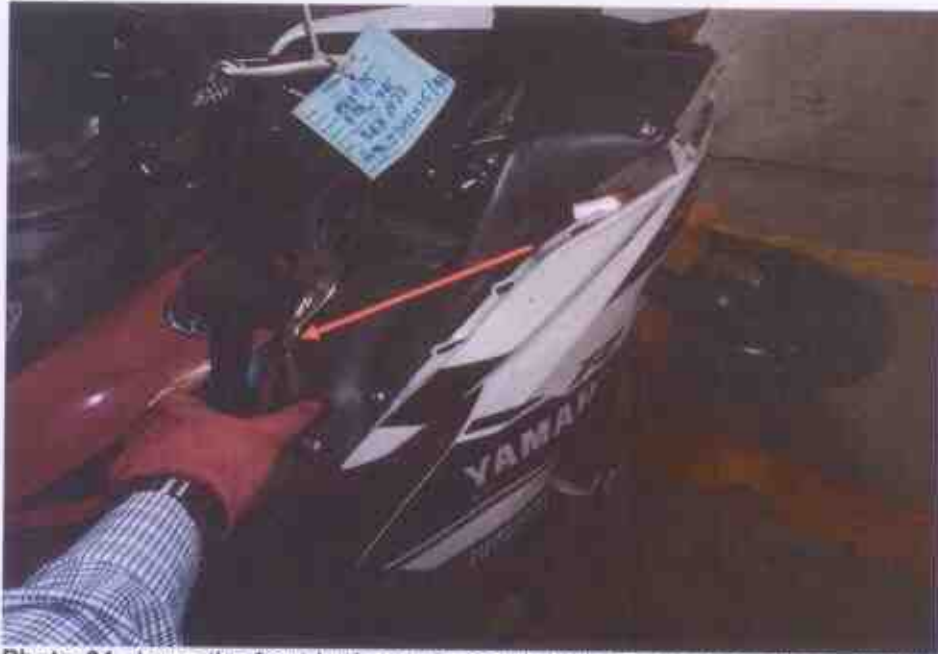
Photo 24 shows the front brake static test. It had appeared to indicate that the brake system of the Motorcycle was in serviceable condition. There was some resistance felt (spongy like feel) upon gripping the hand brake lever.

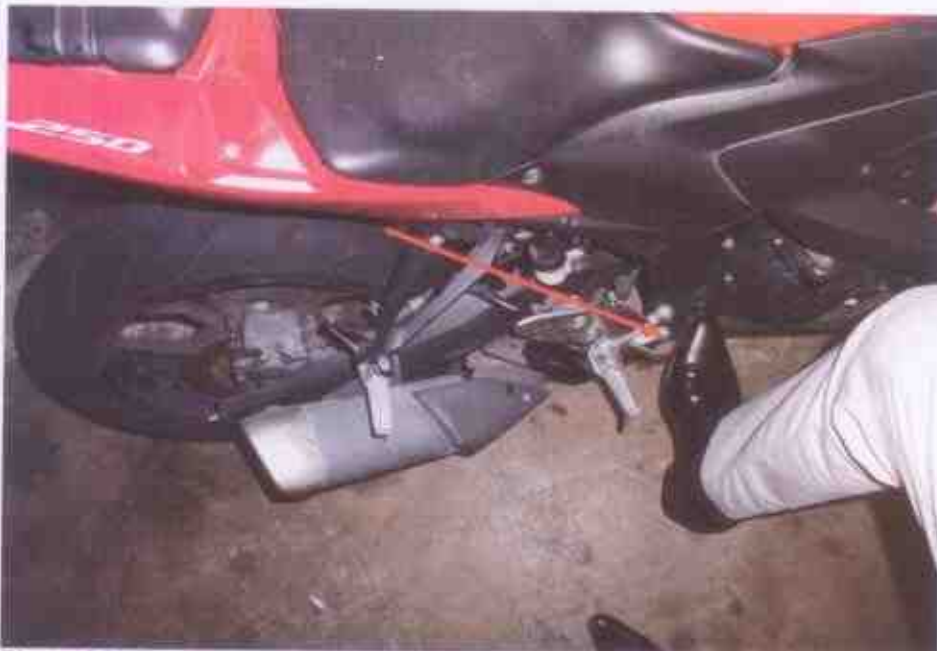
Photo 25 shows the rear brake static test. It had appeared to indicate that the brake system of the Motorcycle was in serviceable condition. There was some resistance felt (spongy like feel) upon stepping on the rear brake foot paddle. This would indicate that there was no abnormality in the brake system also on the rear brake drum mechanical parts.
