Your Ref: TP/IP/60191/2018
Our Ref :CI/TPD18022476/Z

18th January 2019

MECHANICAL INSPECTION REPORT OF MOTORCYCLE FBC 9140E

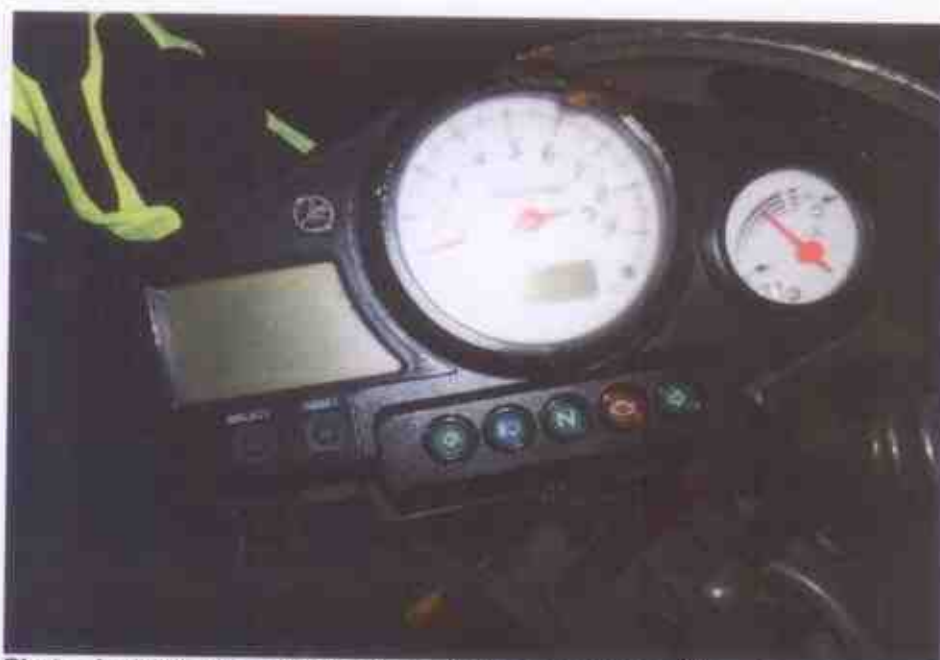
4. The mileage of the Motorcycle was not recorded at time of inspection due to the severe damages to the ignition system as a result of the accident.
5. The Motorcycle was observed to have sustained severe damages at the frontal portion & along both its left side and right side. The body parts that were found to have been damaged includes its missing front head lamp, ERP unit & bracket, handle bar, front wing mirrors, seat assembly, fuel tank, radiator, exhaust manifold and broken front wheel rim amongst others. Its front forks assemblies were also observed to be dislodged as a result of the accident.

Photo 1 shows the speedo meter of the Motorcycle. The mileage was not recorded at time of inspection due to the severe damages to the ignition system as a result of the accident.

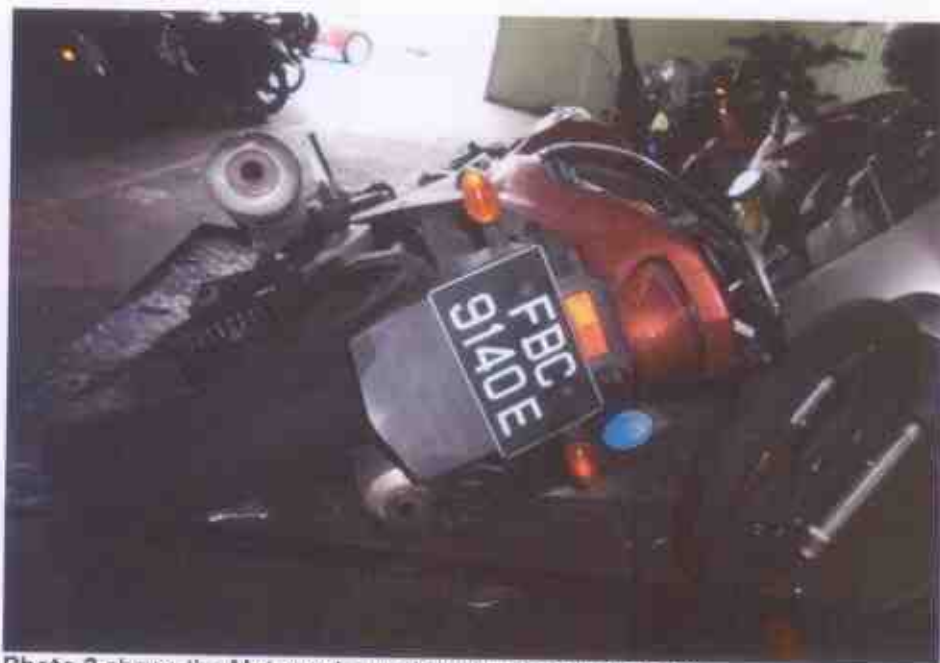
Photo 2 shows the Motorcycle number plate for identification.

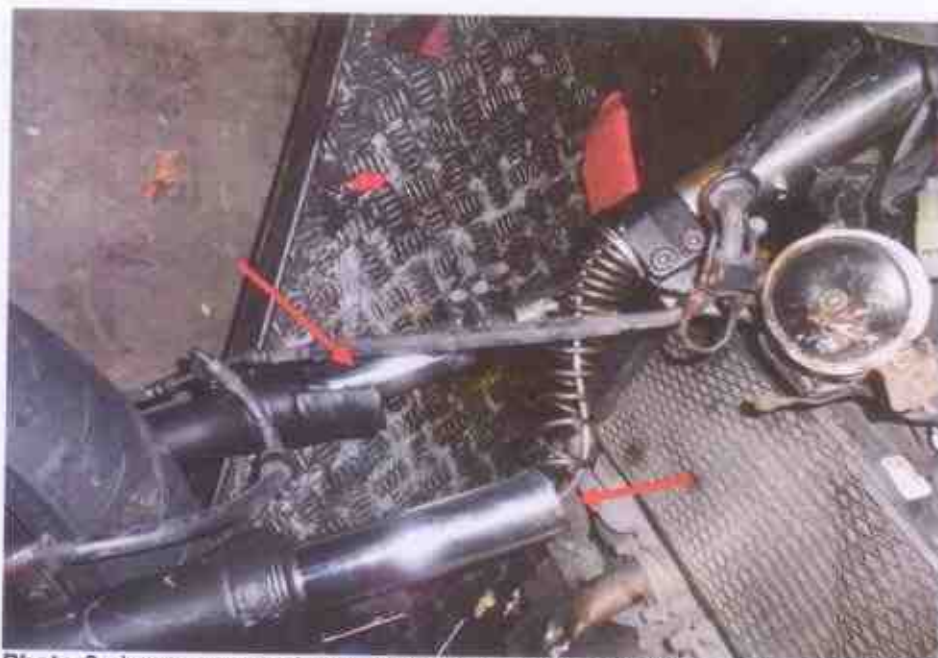
Photo 3 shows a general view of the front body of the Motorcycle at the time of our inspection. The Motorcycle was observed to have sustained with relatively extensive impact due to the accident collision. Amongst the body parts damaged was its front fork (arrowed), which was observed to be dislodged from the Motorcycle body.

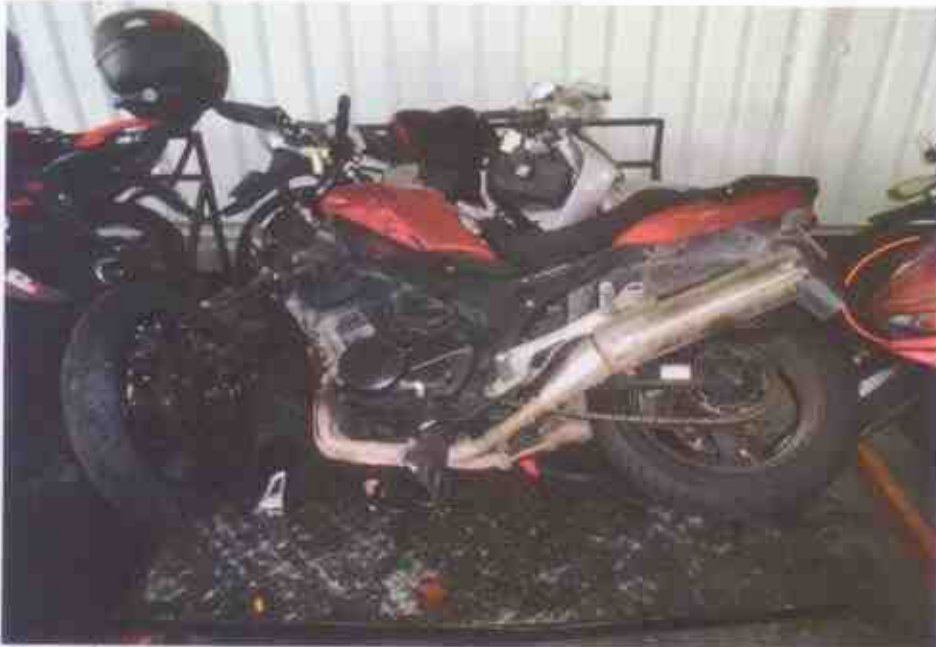
Photo 4 shows a general view of the left body of the Motorcycle at the time of our inspection. The Motorcycle was observed to have sustained damages at the frontal portion, rear portion, along both its left side and right side.

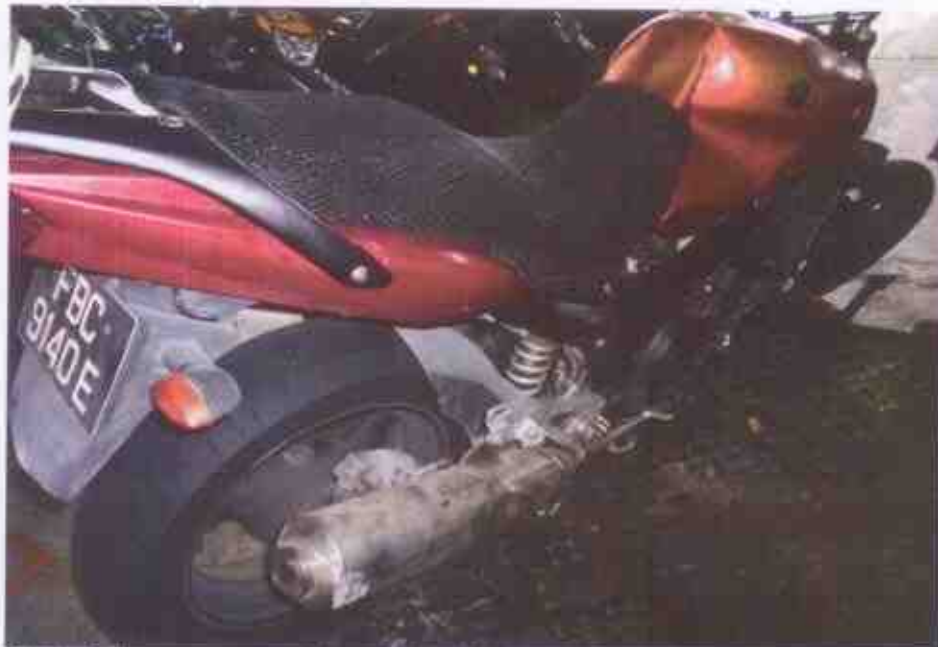
Photo 5 shows a general view of the right body of the Motorcycle at the time of our inspection. The Motorcycle was observed to have sustained damages at the frontal portion, rear portion, along both its left side and right side.

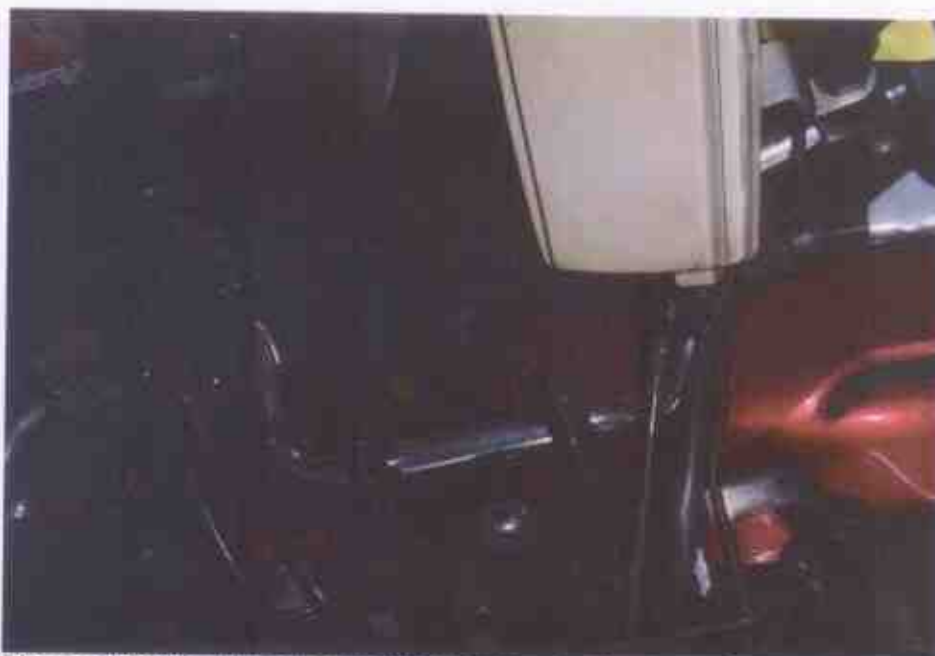
Photo 6 shows a close-up view of the Motorcycle steering system at the time of our inspection. The Motorcycle was observed to have sustained relatively extensive damages on the handle bar due to the accident collision.

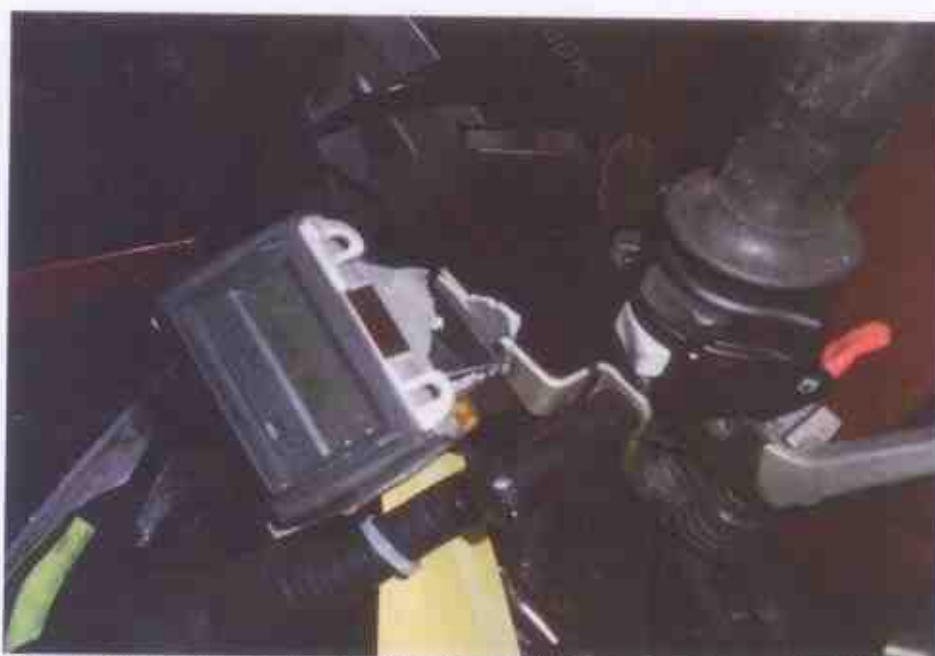
Photo 7 shows a close-up view of the in-vehicle unit of the Motorcycle at the time of our inspection. It was observed to have sustained relatively extensive impact damages to the in-vehicle unit due to the accident collision.

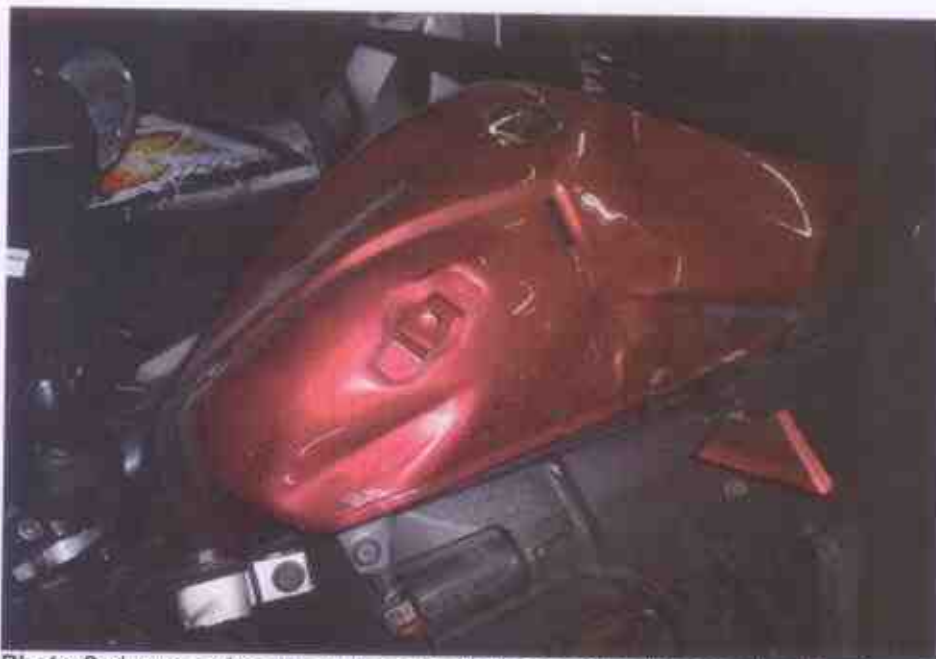
Photo 8 shows a close-up view of the fuel tank of the Motorcycle at the time of our inspection. It was observed to have sustained relatively extensive impact including damages to the fuel tank due to the accident collision.

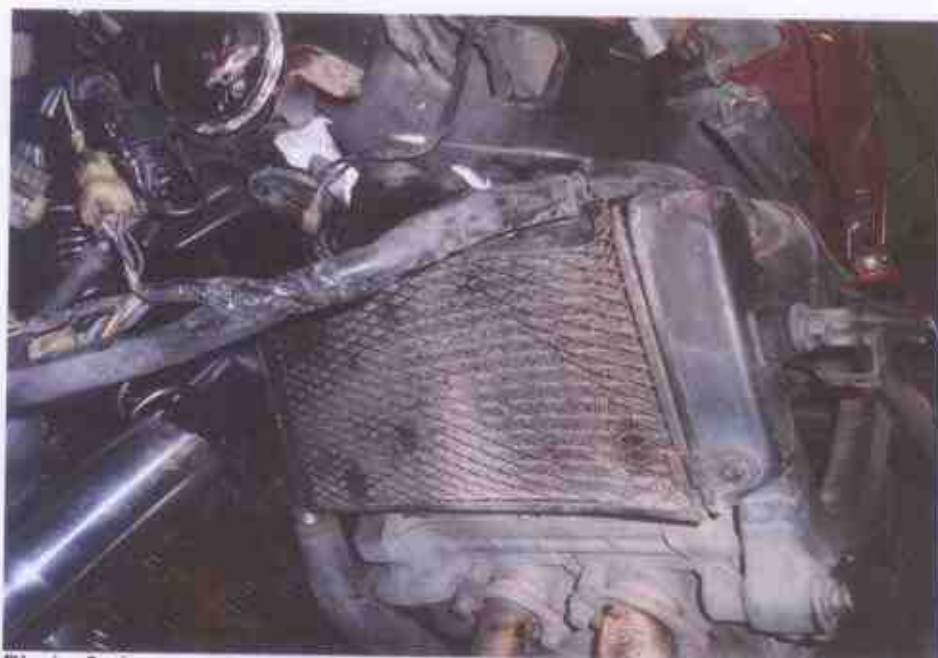
Photo 9 shows a close-up view of the front portion of the Motorcycle at the time of our inspection. The Motorcycle engine components such as radiator, front fork & other components were observed to have sustained relatively extensive impact due to the accident collision.

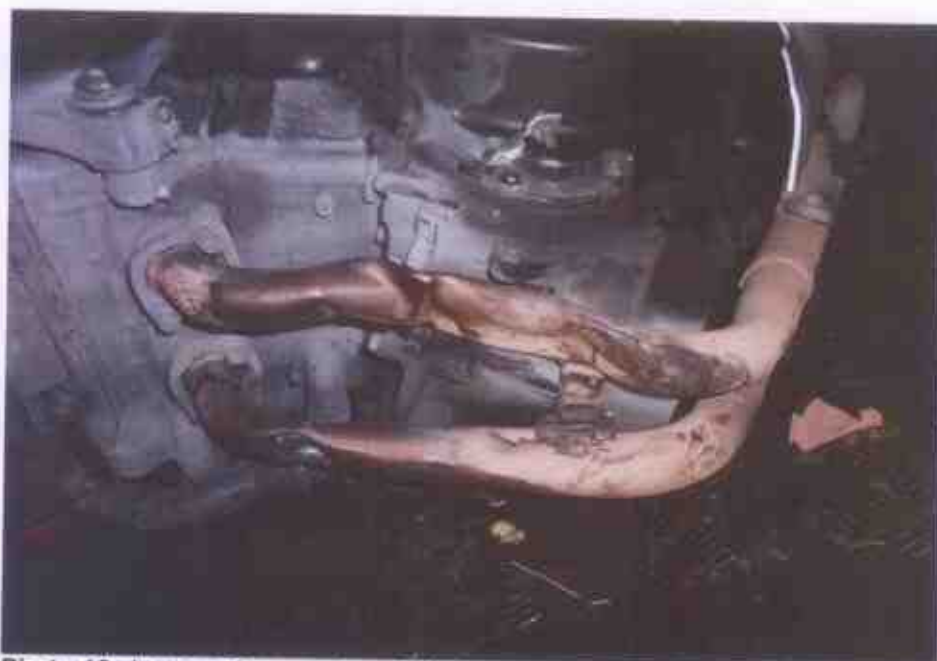
Photo 10 shows a close-up view of the front portion of the Motorcycle at the time of our inspection. The Motorcycle's engine components such as exhaust manifold observed to have sustained relatively extensive impact due to the accident collision.

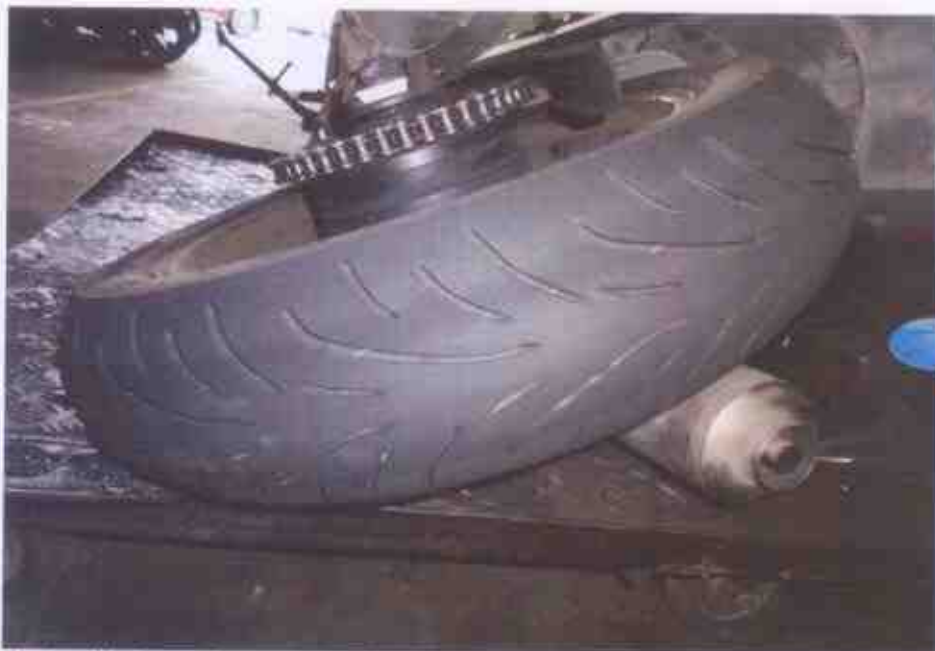
Photo 11 shows the rear tyre of the Motorcycle at the time of our inspection. The rear tyre was observed to be in serviceable condition with remaining tread depth of approximately 5mm. The tyre was also observed to be sufficiently inflated for vehicular operation. There was no significant damage observed on the rear wheel rim & tyre.

19. The condition of the Motorcycle's rear tyre was observed to be in serviceable condition. The tread pattern of the rear tyre was clearly visible. We did not observe any tear, burst mark(s) and/or punctured hole(s) on the sidewalls as well as across the tread of the rear tyre. Its tread depth was measured & found to be around approximately 5mm.

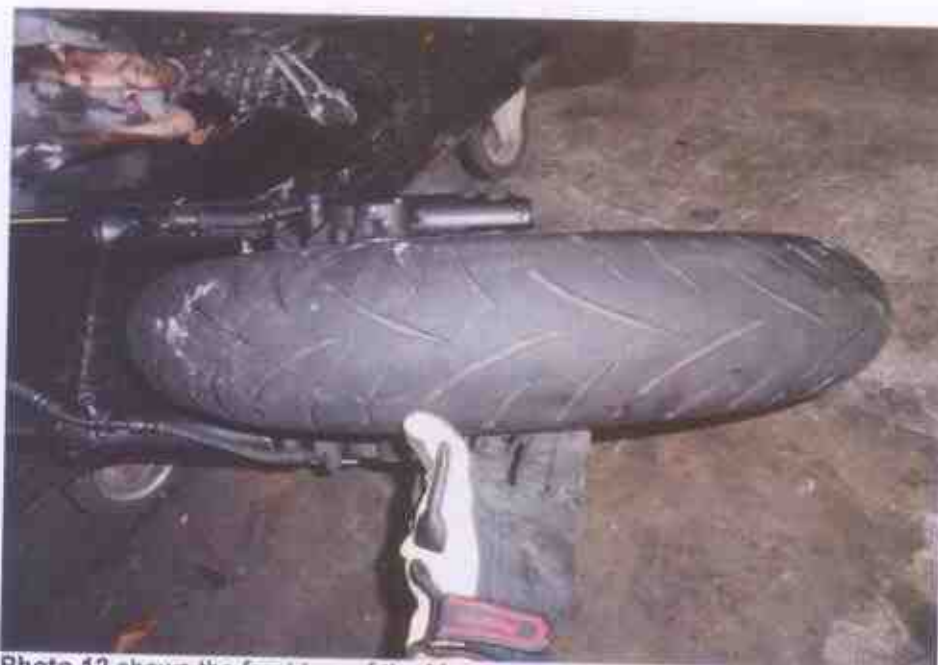
Photo 12 shows the front tyre of the Motorcycle and the tread pattern was clearly visible. There was no tear, burst mark(s) and/or punctured hole(s) on the sidewalls as well as across the tread of the front tyre with remaining tread depth of approximately 4mm. However, the wheel rim was observed to be broken & deflated as a result of the accident.

20. As for the front tyre, it was found to be deflated due to the cracked wheel rim as a result of the accident's collision. However, the tread pattern of the front tyre was clearly visible with tread depth of 4mm. We did not observe any tear, burst mark(s) and/or punctured hole(s) on the sidewalls as well as across the tread of the front tyre.

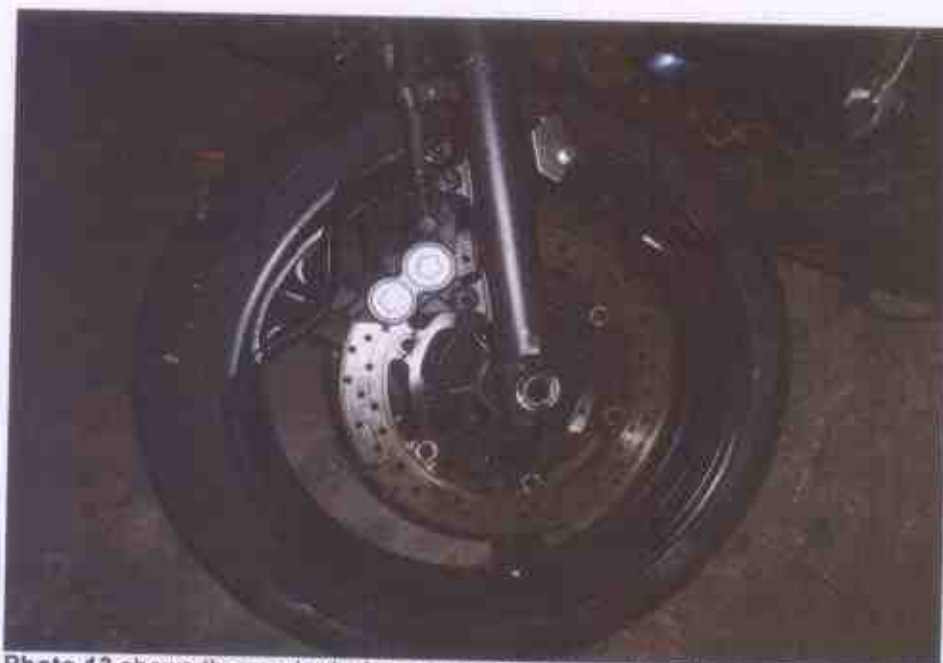
9. The rear tyre was observed to be wrapped around alloy wheel rims that were found to be without any significant damage. It was found to be in serviceable condition with adequately inflated for operational purpose.
10. As for the front wheel rim, it was noted to have sustained with damages (broken) at time of our inspection. The front tyre was still found to be intact despite the broken wheel rim as a result of the accident's collision. See photo 11 – 13 below

Photo 13 shows the cracked wheel rim on front tyre of the Motorcycle at the time of our inspection.

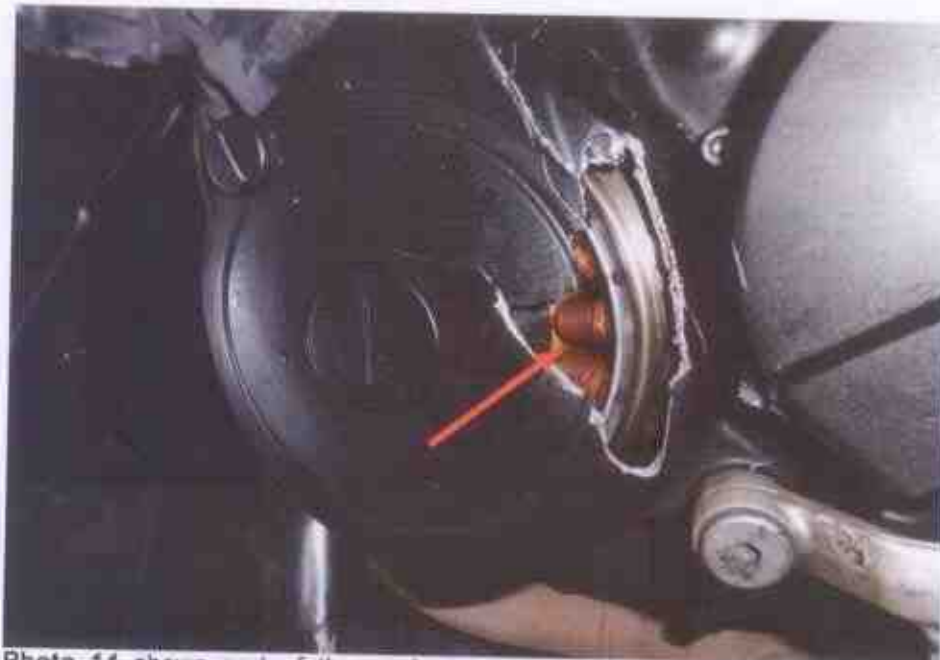
Photo 14 shows part of the engine compartment was damaged due to the accident's impact collision.

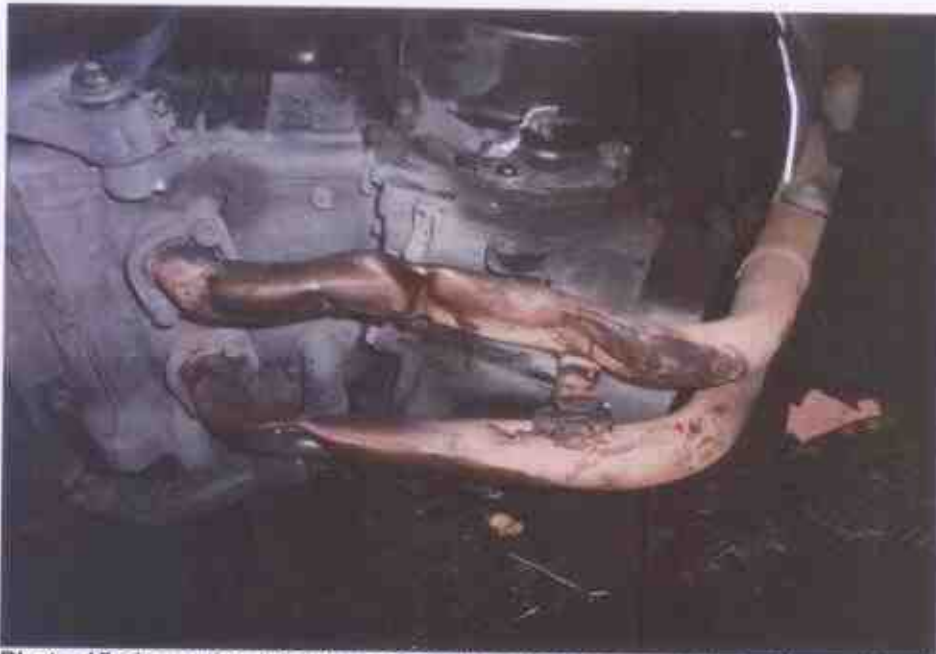
Photo 15 shows the exhaust manifold that was damaged due to the accident's impact collision.

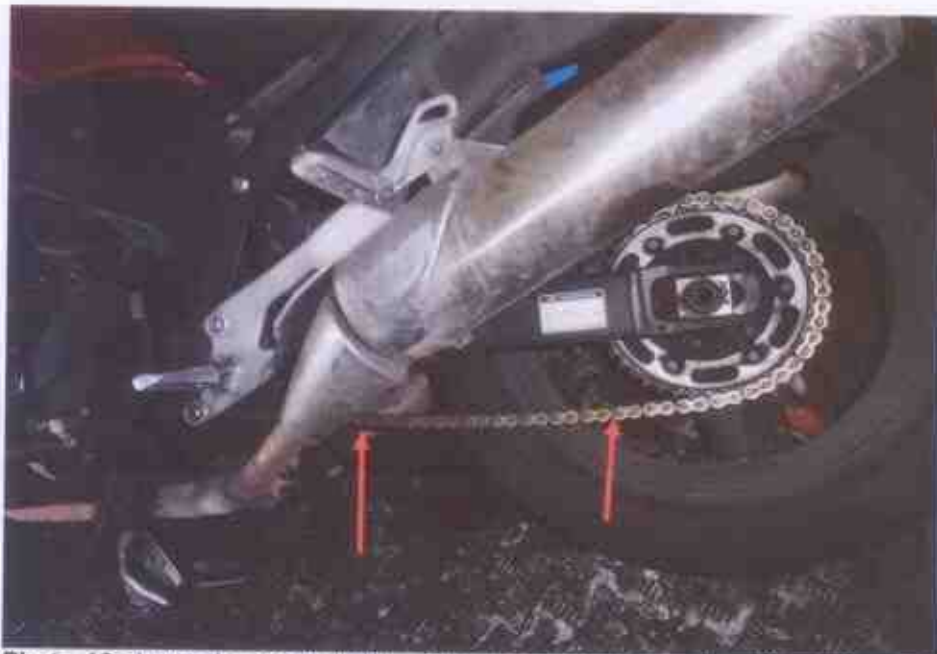
Photo 16 shows the general view of the gear train (arrowed) of the Motorcycle, which was observed to be intact with no misalignment. It was also adequately lubricated for operating purposes.

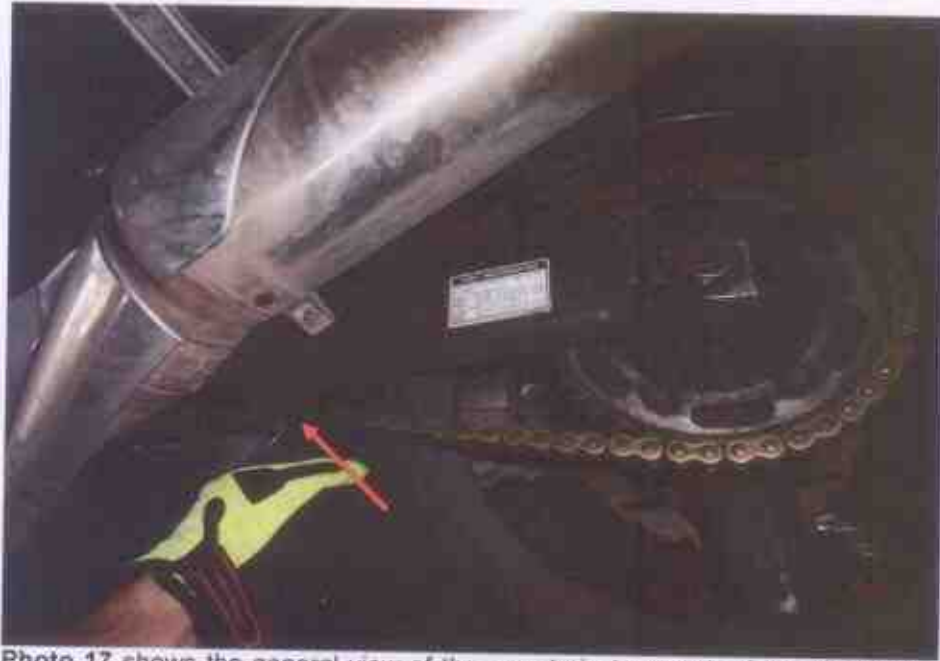
Photo 17 shows the general view of the gear train (arrowed) of the Motorcycle, which was observed to be intact with no misalignment. It was also adequately lubricated for operating purposes.

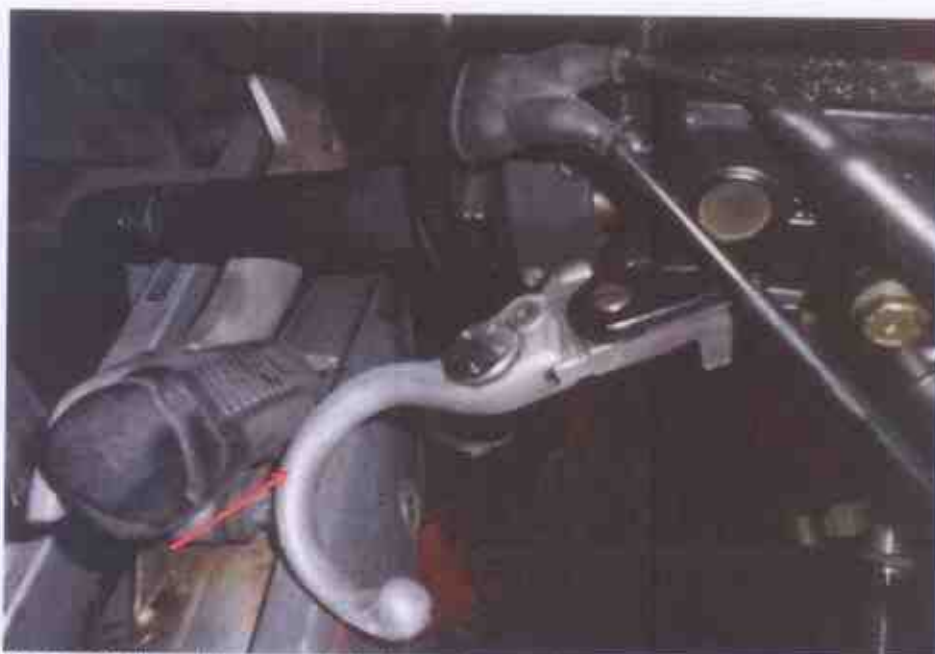
Photo 18 shows the hand brake lever (arrowed) was observed to be broken due to the result of the accident. Hence, we are unable to conduct any tests on the braking system of the Motorcycle.

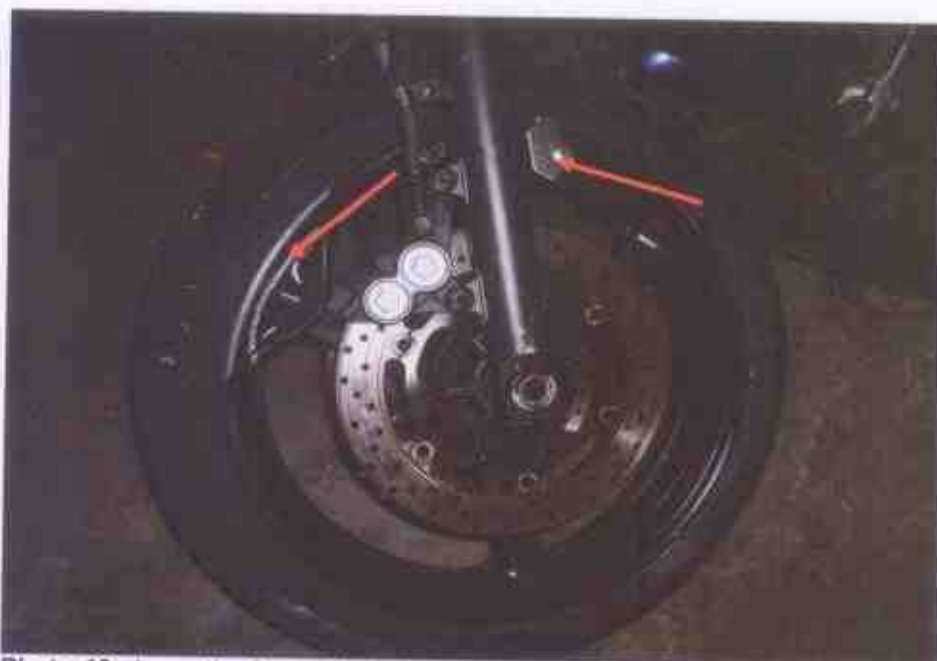
Photo 19 shows the front wheel rim (arrowed) was observed to be broken as a result of the accident. Hence, we are unable to conduct any tests on the braking system of the Motorcycle.

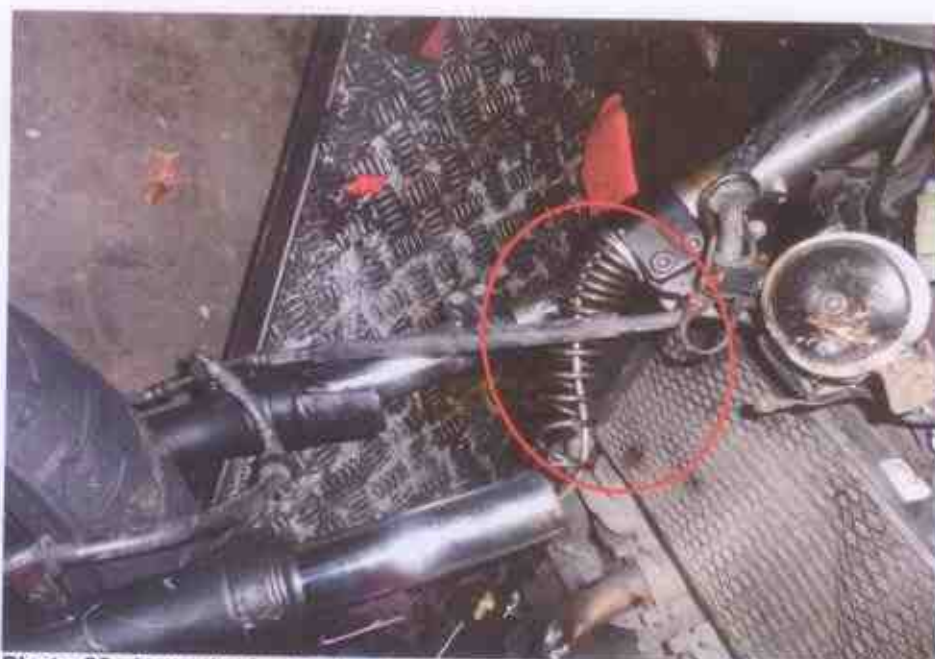
Photo 20 shows the front fork (circled) was observed to be dislodged as a result of the accident. Hence, we are unable to conduct any tests on the steering system of the Motorcycle.

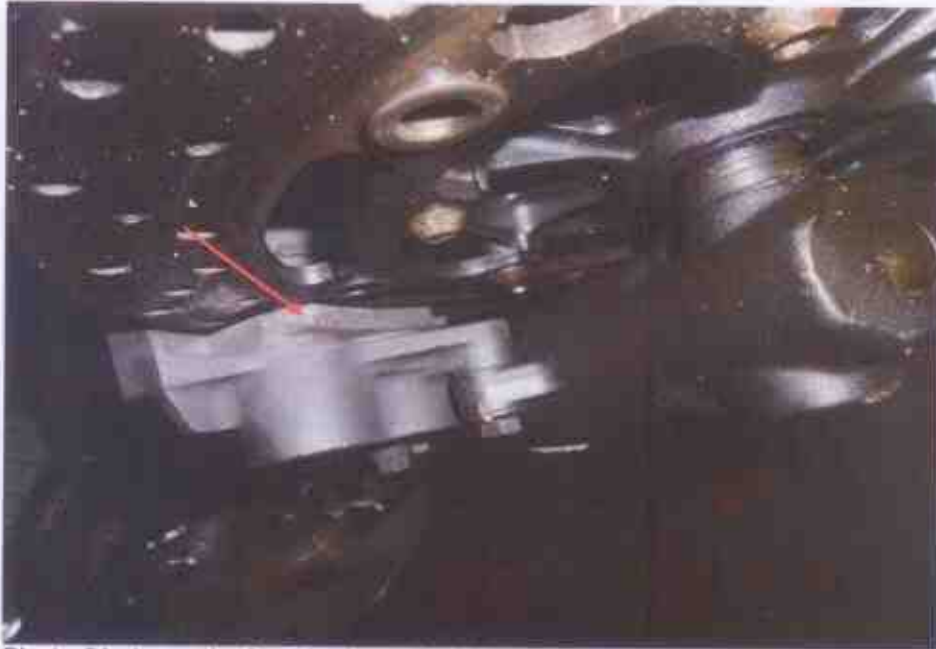
Photo 21 shows the front brake pad, which is part of the components in the front brake system of the Motorcycle. Our visual checks had revealed that it was still in serviceable condition, intact with no visible damage & sufficient frictional padding.

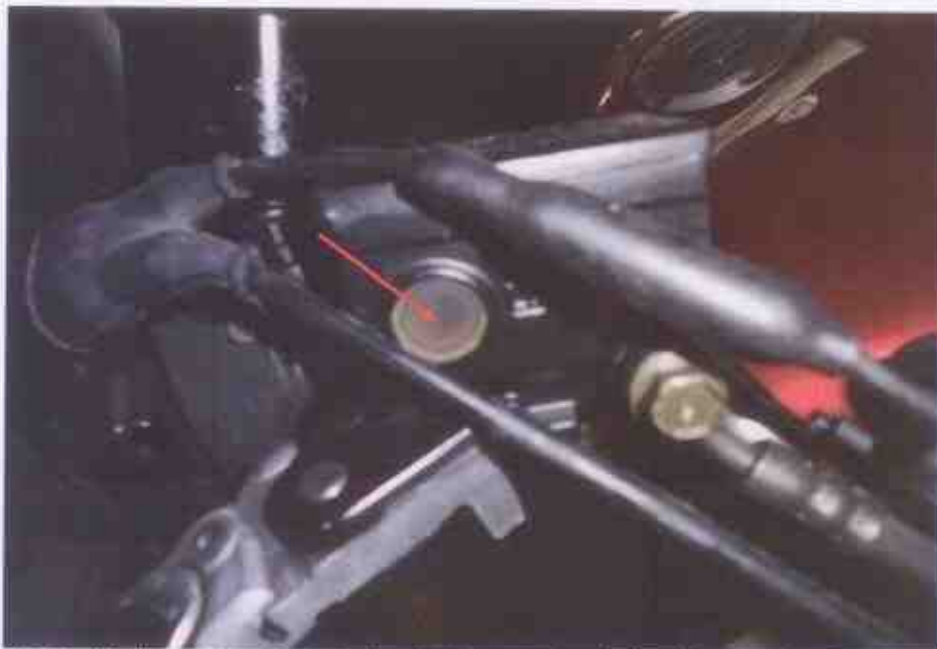
Photo 22 shows the front brake fluid reservoir of the Motorcycle. Our visual checks had revealed that it was still at a sufficient level & without contamination at time of our examination.

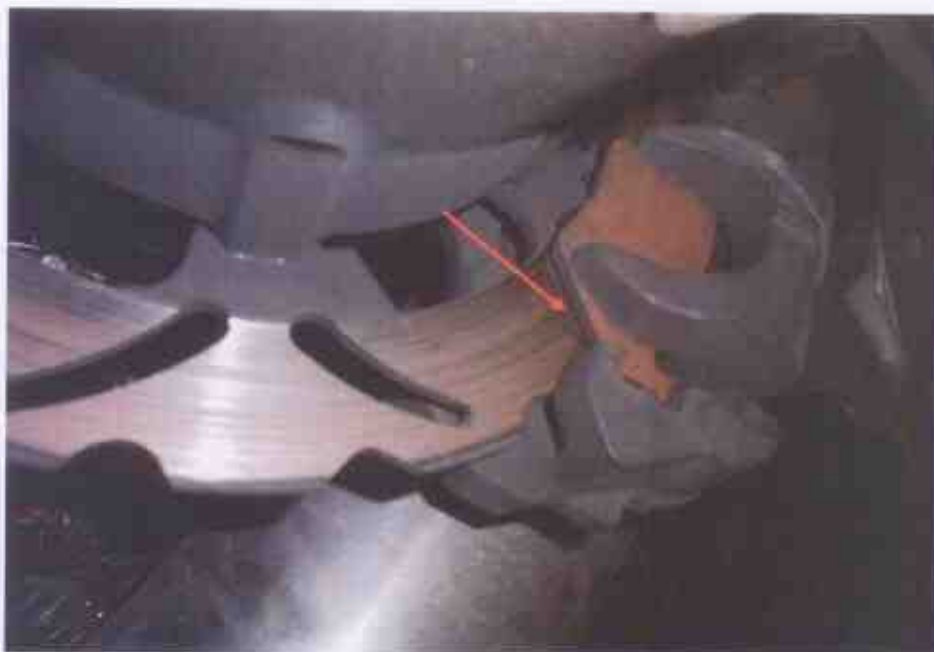
Photo 23 shows the rear brake pad of the Motorcycle which was observed to be in serviceable condition. No damages were found at time of our inspection to the rear braking components.

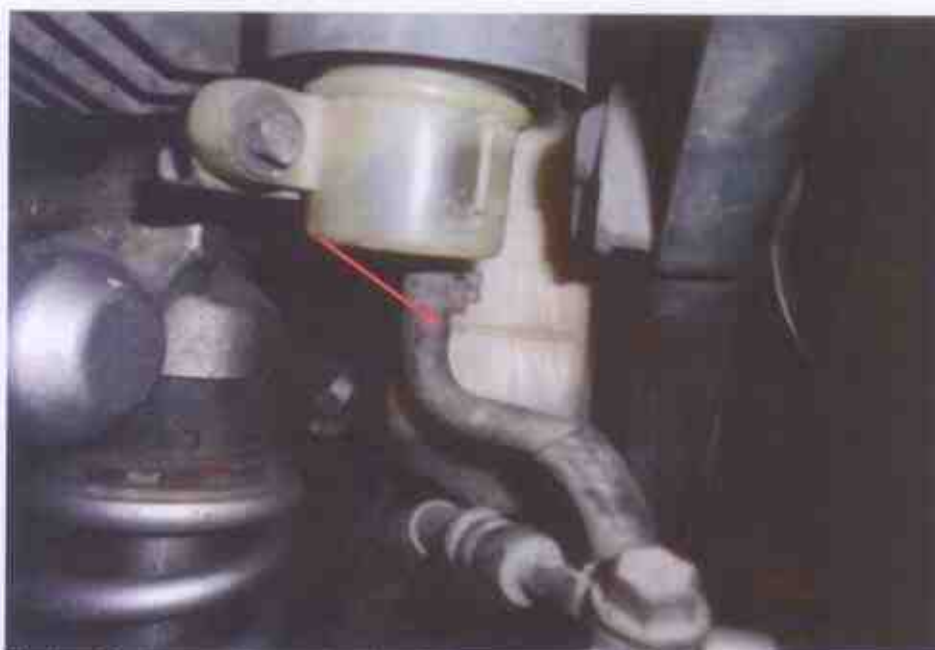
Photo 24 shows the rear brake fluid reservoir of the Motorcycle. Our visual checks had revealed that it was still at a sufficient level & without contamination at time of our examination.
