Your Ref: TP/IP/64873/2018
Our Ref : CI/TPD18022478/Z

Fatal Accident Investigation Team

MECHANICAL INSPECTION REPORT OF MOTOR TRAILER XD 2654U

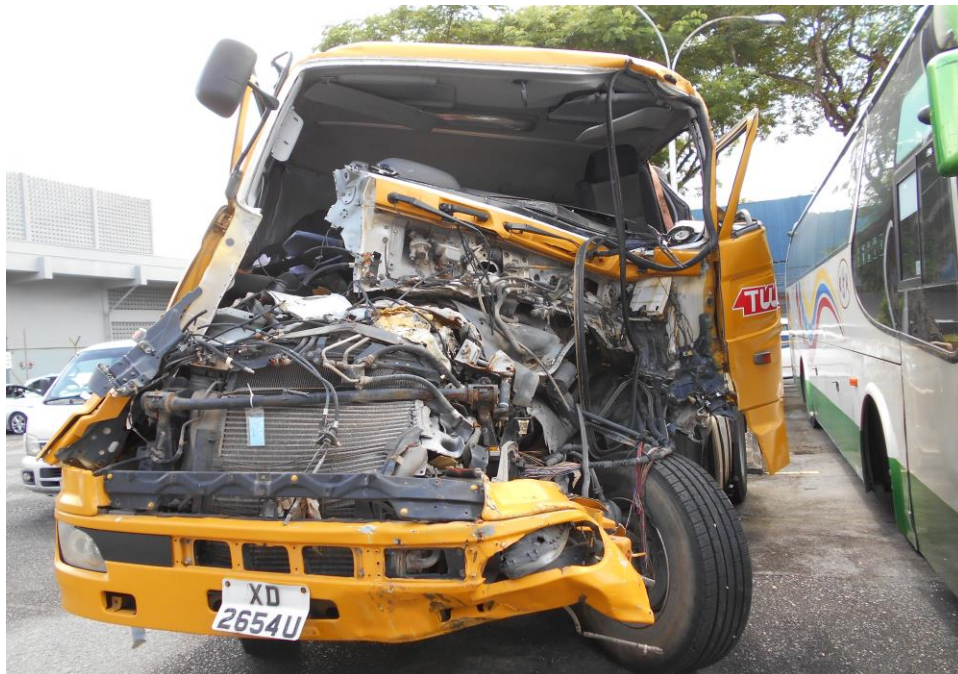
4. The mileage of the Motor Trailer at the time of our inspection was not recorded as its ignition system and front cabin was severely damaged by the collision.
5. The Motor Trailer had sustained extensive impact damage at its frontal portion. The impact force was relatively significant, causing its entire front cabin to be buckled and crumpled. Several mechanical parts and components at the frontal portion were also severely damaged as a result of the accident.
6. The dashboard, windshield, steering wheel, seats, floor panel and roof panel inside the front cabin were all observed to be pushed/buckled inwards, towards the rear of the Motor Trailer.

Photo 1 shows a general view of the frontal portion of the Motor Trailer at the time of our inspection. The Motor Trailer was observed to have sustained extensive impact damage at its frontal portion. The impact force was relatively significant, causing its entire front portion to be buckled and crumpled pushed inwards towards to rear portion of the Motor Trailer.

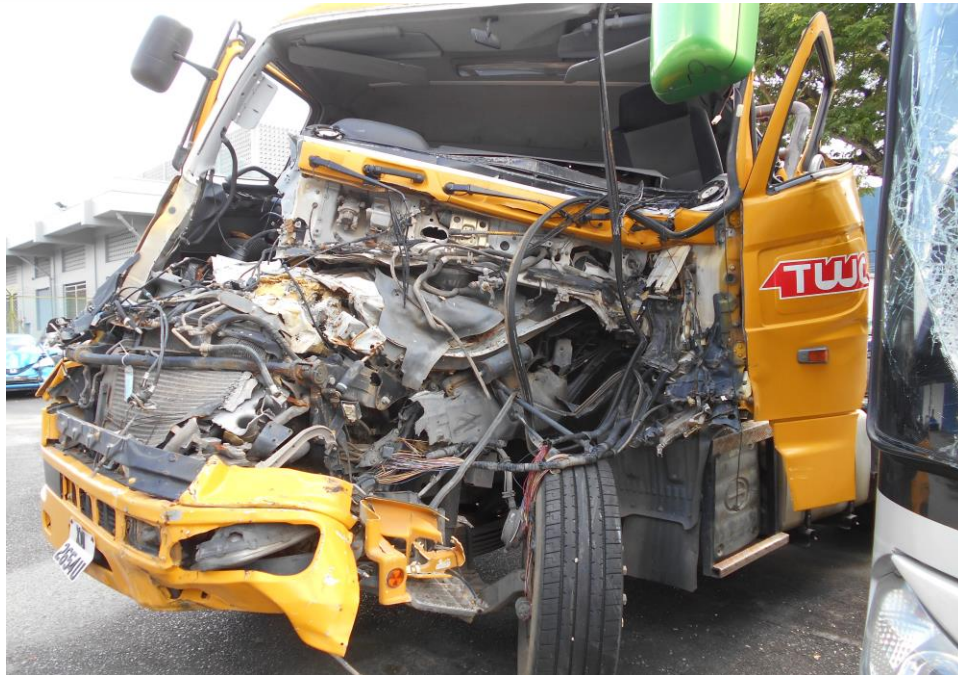
Photo 2 shows a closer view of the frontal left portion of the Motor Trailer at the time of our inspection. A number of mechanical parts and components at the frontal portion were also severely damaged as a result of the accident.

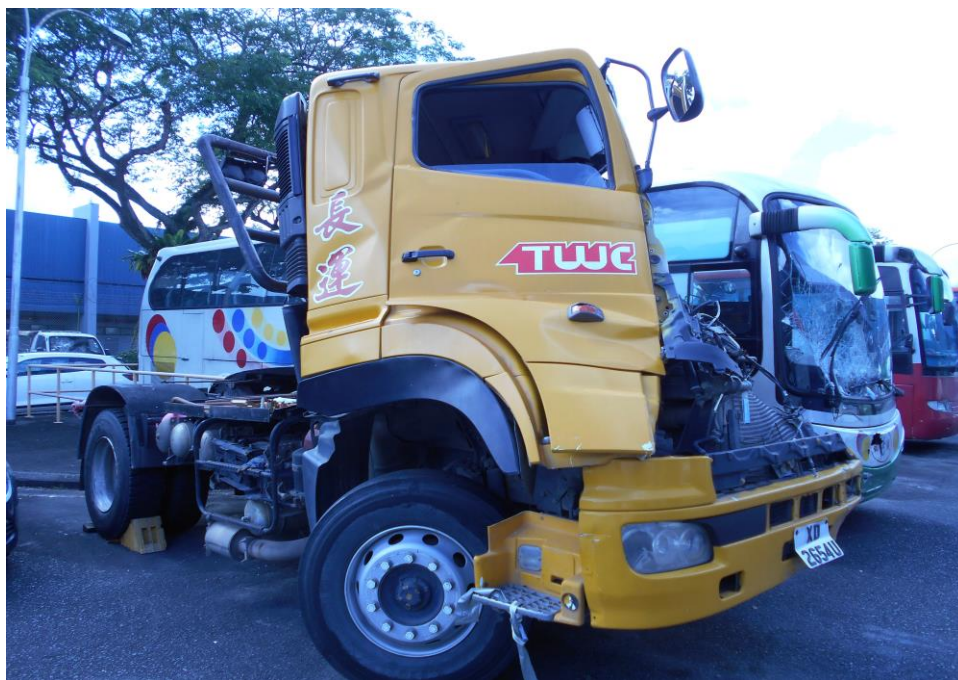
Photo 3 shows a general view of the front right portion of the Motor Trailer at the time of our inspection. The Motor Trailer was observed to have sustained extensive impact damage at its front right portion. The impact force was relatively significant, causing its entire front portion to be buckled and crumpled.

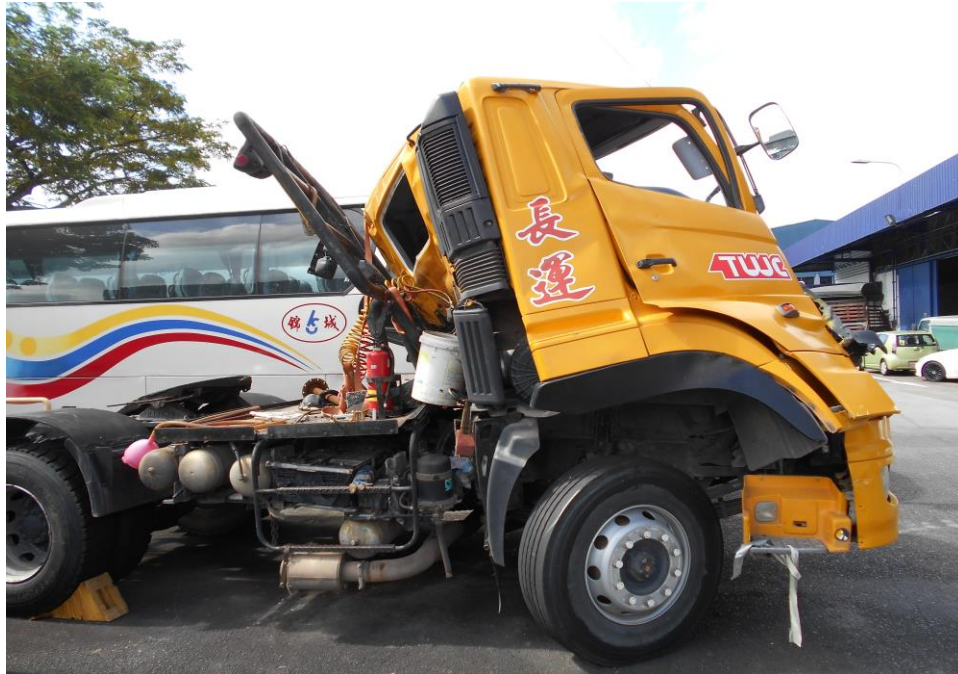
Photo 4 shows from a right side view of the Motor Trailer at the time of our inspection. The Motor Trailer was observed to have sustained extensive impact damage at its front portion. The impact force was relatively significant, causing its entire front cabin to be buckled and crumpled.

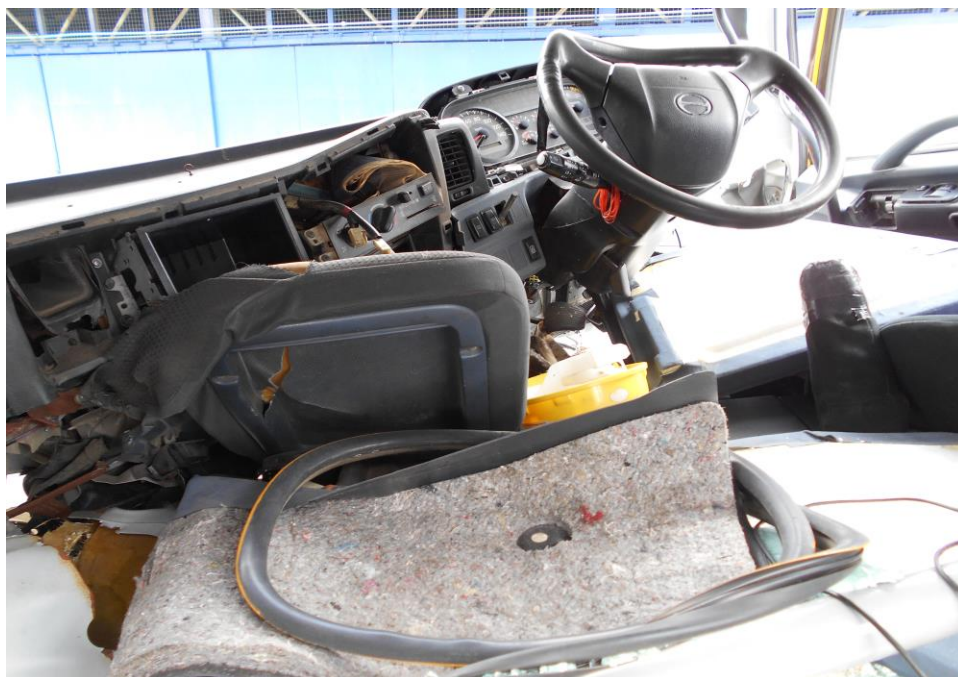
Photo 5 shows the interior of the front cabin. The dashboard, steering wheel, seats, floor panel and roof panel inside the front cabin were all observed to be pushed/buckled inwards, towards the rear of the Motor Trailer. This is consistent to the nature of this accident where the direction of impact onto the Motor Trailer was from the front to rear direction.

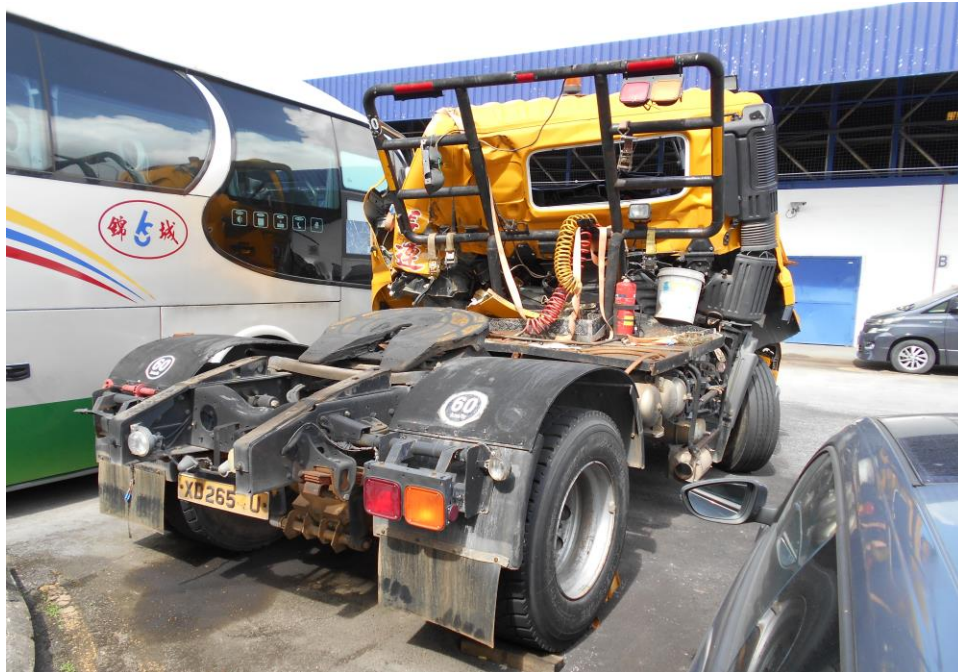
Photo 6 shows a general view of the rear right portion of the Motor Trailer at the time of our inspection. The rear portion was observed to be relatively unaffected by the accident.

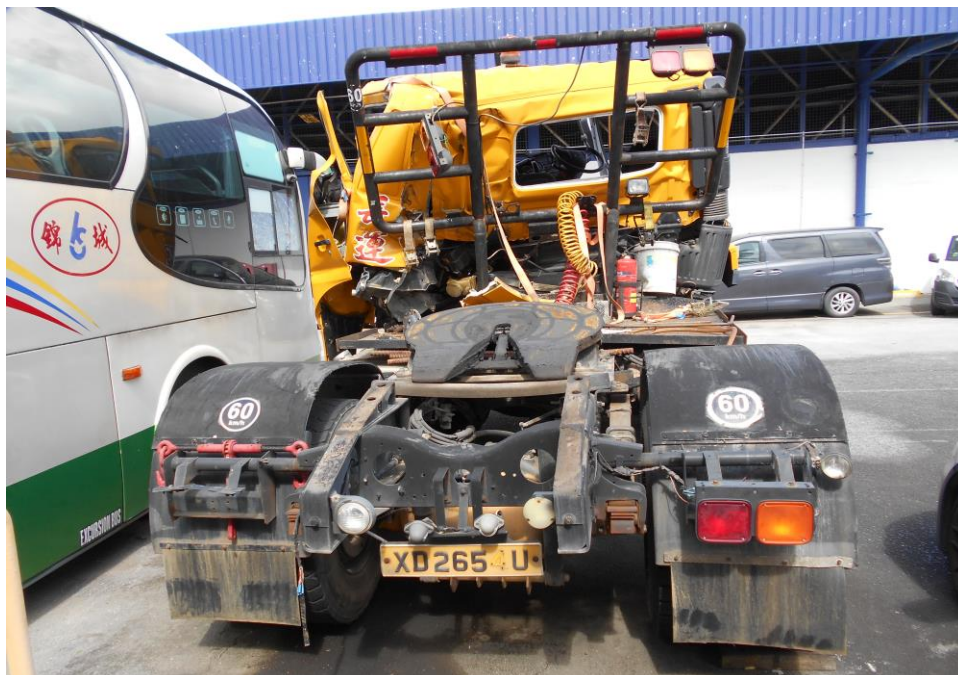
Photo 7 shows a general view of the rear portion of the Motor Trailer at the time of my inspection. The rear portion was observed to be relatively unaffected by the accident.

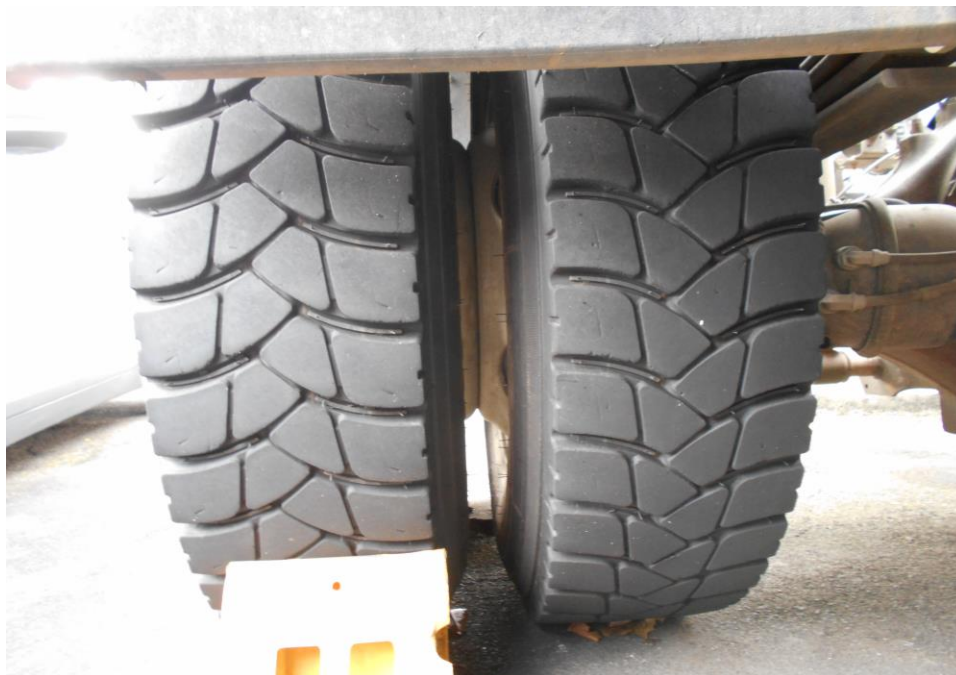
Photo 8 shows the condition of the rear right tyres of the Motor Trailer, which was observed to be in serviceable condition with remaining tread depth of approximately 8mm. There was no tear, cut or burst mark(s) on the outer and the inner sidewalls as well as across the tread of this 2 tyres. The 2 tyres, which were wrapped around alloy wheel rim, were also observed to be sufficiently inflated for vehicular operation.

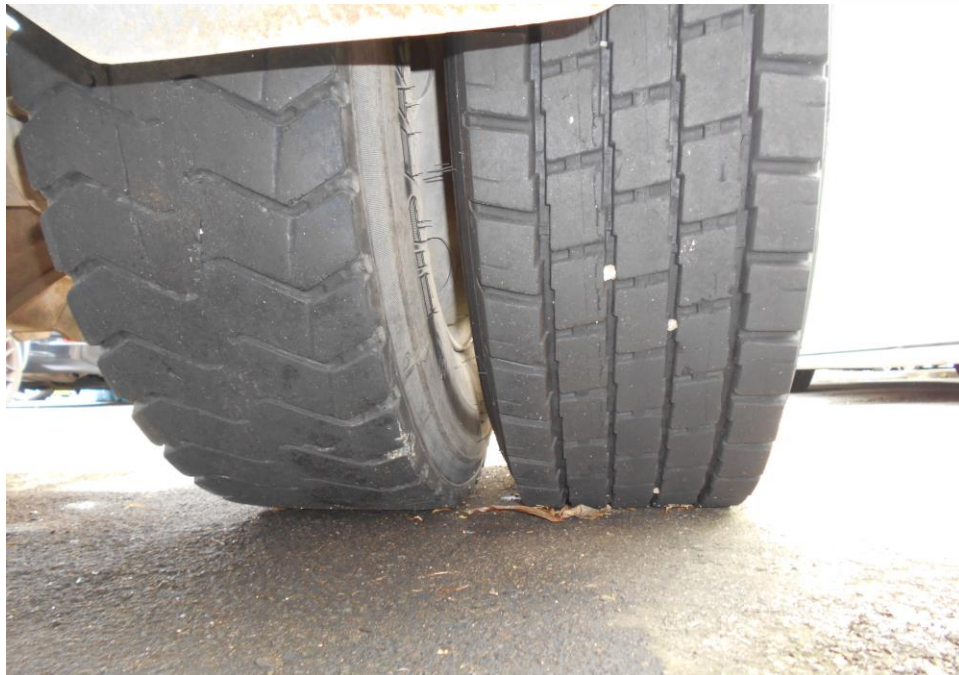
Photo 9 shows the condition of the rear left tyres of the Motor Trailer, which was observed to be in serviceable condition with remaining tread depth of approximately 7mm. There was no tear, cut or burst mark(s) on the outer and the inner sidewalls as well as across the tread of these 2 tyres, which were also observed to be sufficiently inflated for vehicular operation.

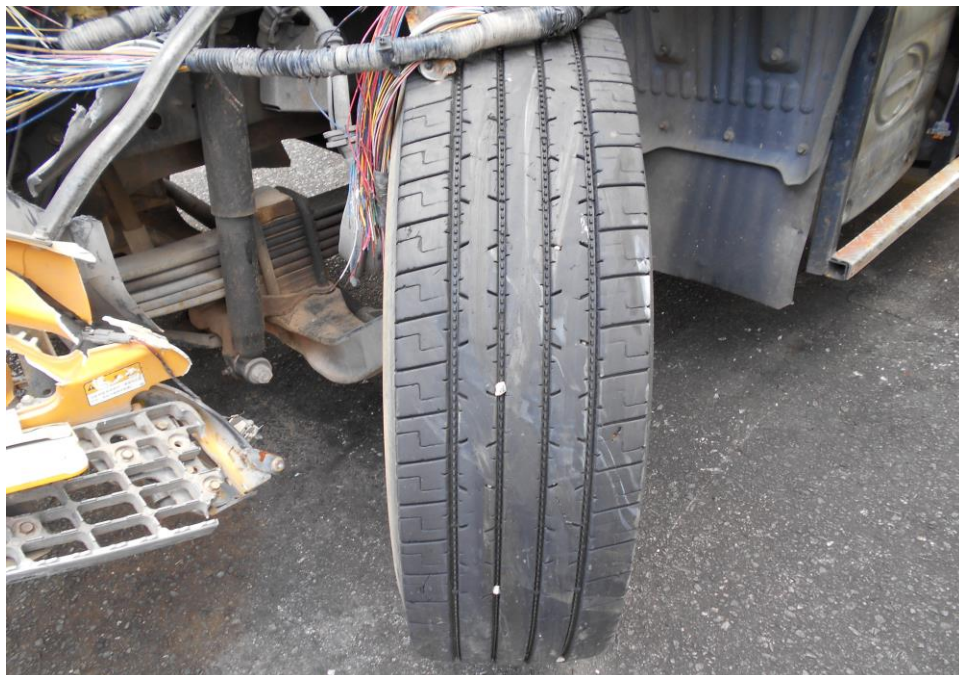
Photo 10 shows the condition of the front left tyre of the Motor Trailer, which was observed to be in serviceable condition with remaining tread depth of approximately 7mm. There was also no tear, cut or burst mark(s) on the outer and the inner sidewalls as well as across the tread of this tyre.

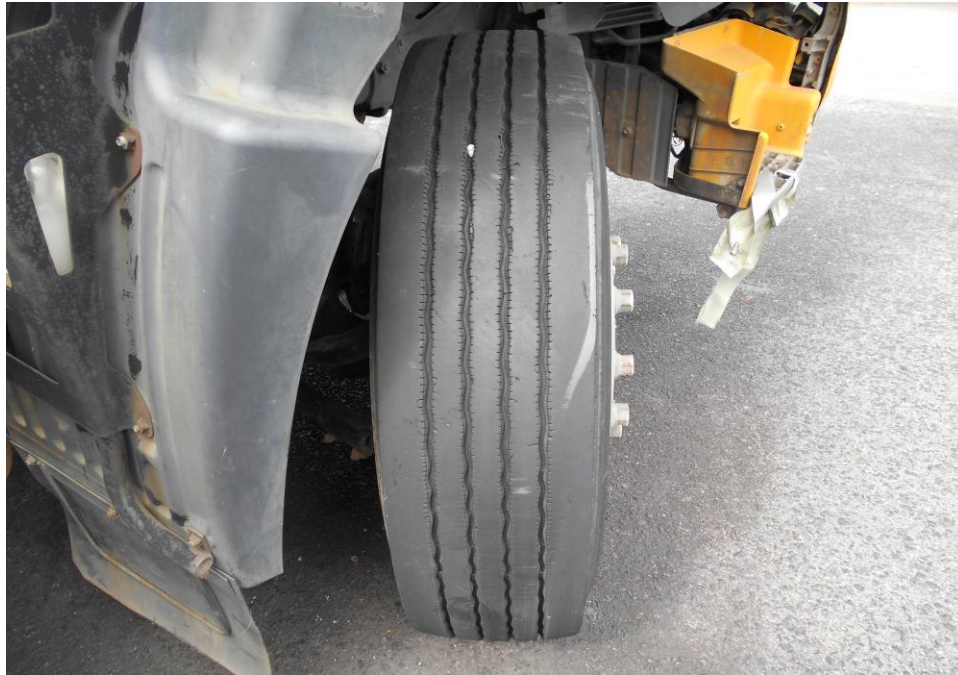
Photo 11 shows the condition of the front right tyre of the Motor Trailer. The front right tyre was observed to be in serviceable condition with remaining tread depth of approximately 7mm. There was also no tear, cut or burst mark(s) on the outer and the inner sidewalls as well as across the tread of this tyre.

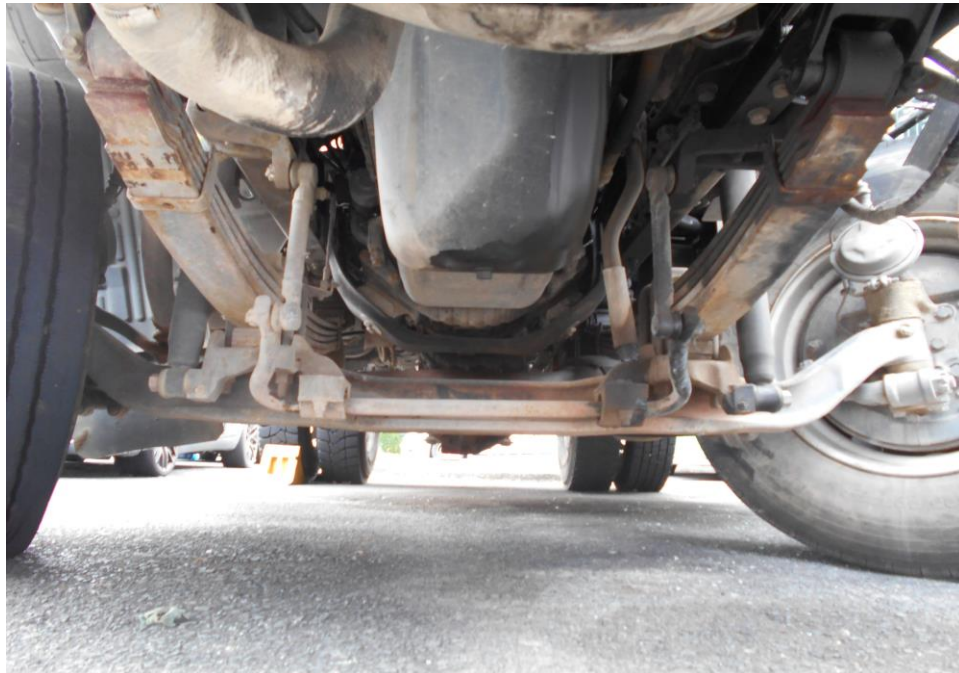
10. The engine compartment of the Motor Trailer, which was located beneath the front cabin, could not be closely inspected given the extensive damages to the front cabin. Our visual checks from the underside of the Motor Trailer had however appear to indicate that the engine assembly and transmission assembly were both intact and unaffected by the collision.

Photo 12 shows the underside of the Motor Trailer, at the area where the engine is located. We were not able to closely inspect the engine compartment of the Motor Trailer due to the extensive damage to its front cabin. Our visual checks from the underside had however appear to indicate that the engine assembly and transmission assembly were both intact and unaffected by the collision.

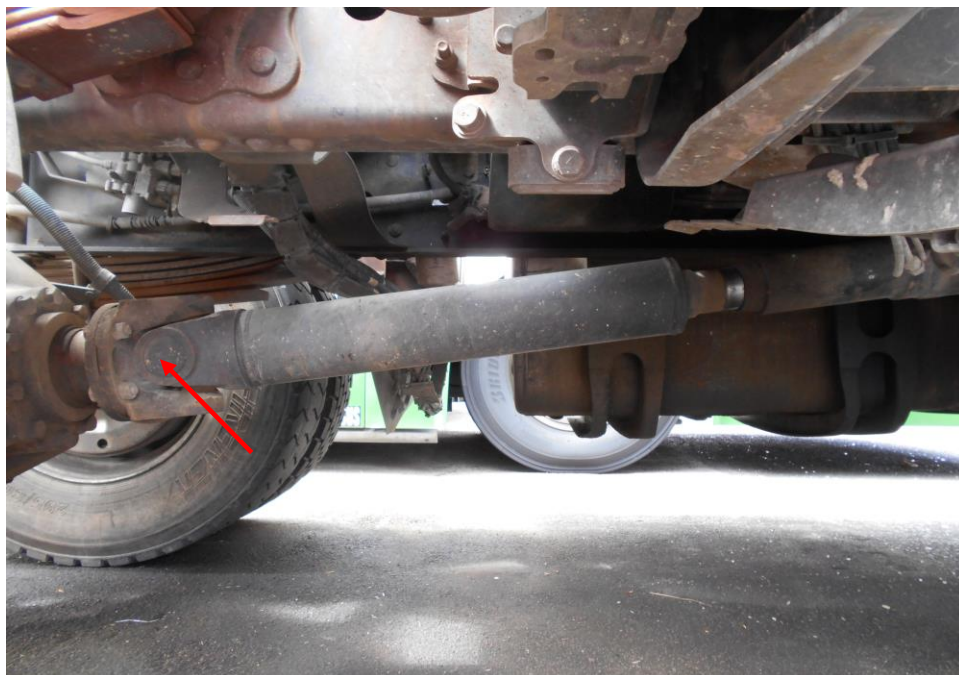
Photo 13 shows the transmission assembly (arrowed) of the Motor Trailer intact and unaffected by the collision.

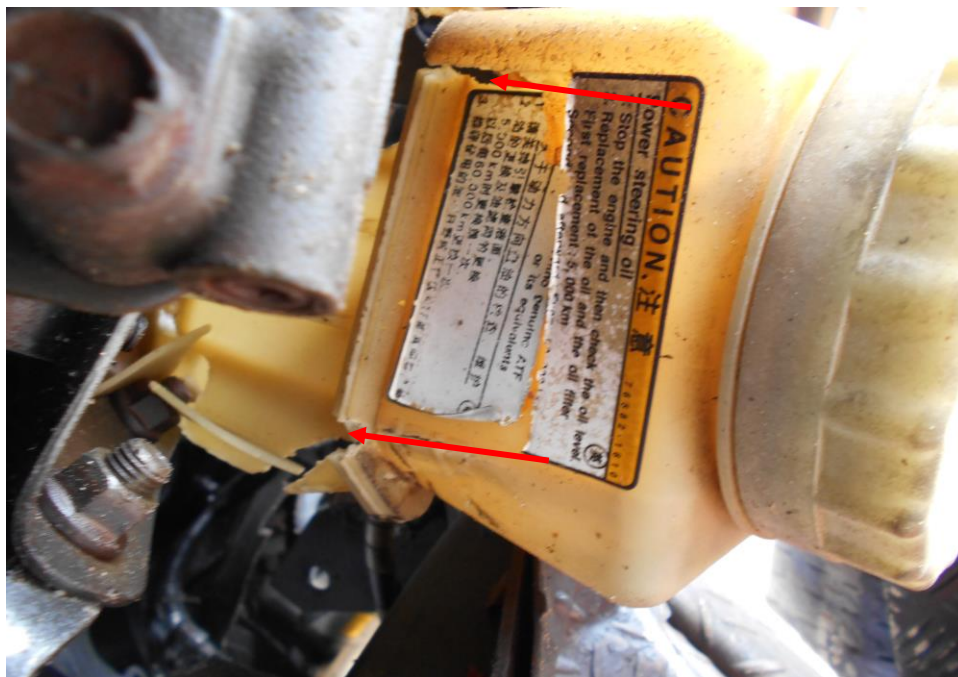
12. With regard to the operating fluids, we were unable to inspect most of the fluids. This is due to their reservoir tanks and/or dip stick being within the damaged area of the Motor Trailer. However, for power steering fluid it shows an insufficient level due to damage sustained to the reservoir tank as a result of the accident.

Photo 14 shows the damaged power steering reservoir which caused fluid leakage that disabling the operational of the steering system due to the accident.

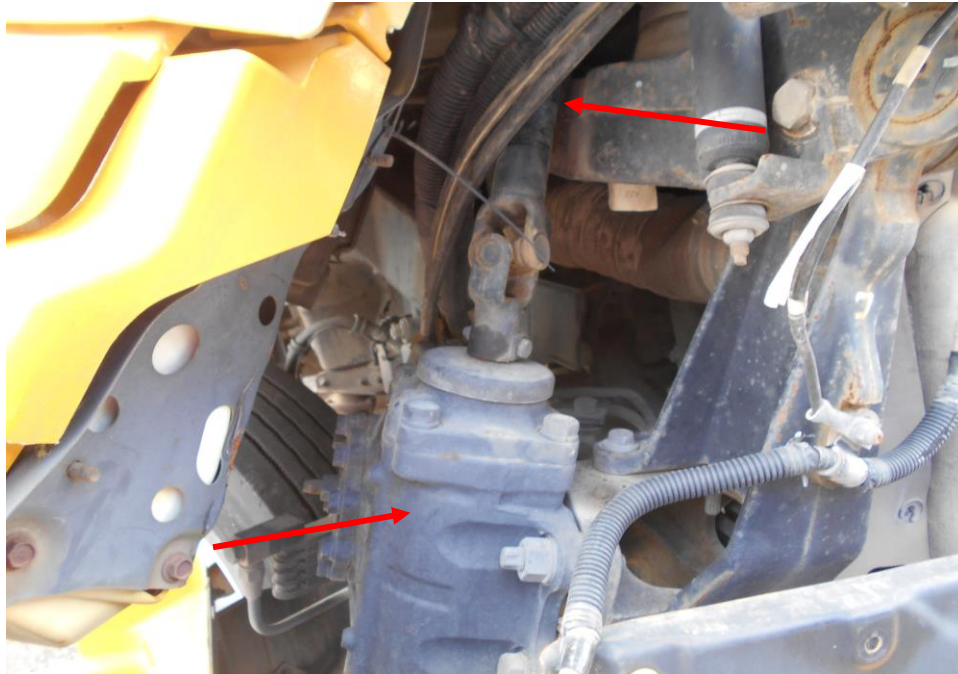
14. We were not able to conduct any tests on the steering system and braking system of the Motor Trailer. This was mainly due to the extensive damage of the Motor Trailer's front cabin, which had affected several mechanical components of the steering system and braking system like the steering wheel, steering box, brake booster and brake pedal amongst others. Power steering fluids was also observed to be insufficient likely due to the damages to the power steering reservoir as a result of the accident. See photo 14 & 15 below.

Photo 15 shows the damaged steering wheel box & shaft due to the accident.

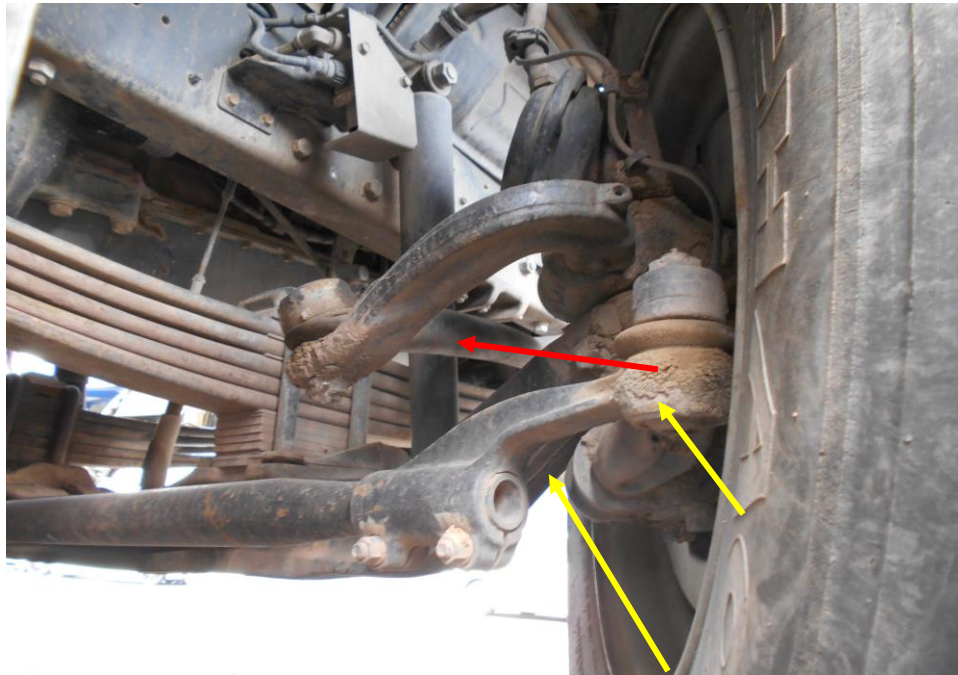
Photo 16 shows the undamaged steering shaft (red arrow) of the front right wheel of the Motor Trailer. The steering shaft and steering rack (yellow arrow) of the Motor Trailer were however observed to be intact and securely attached to the front right wheel. The steering ball joints were also observed to be in a serviceable condition.

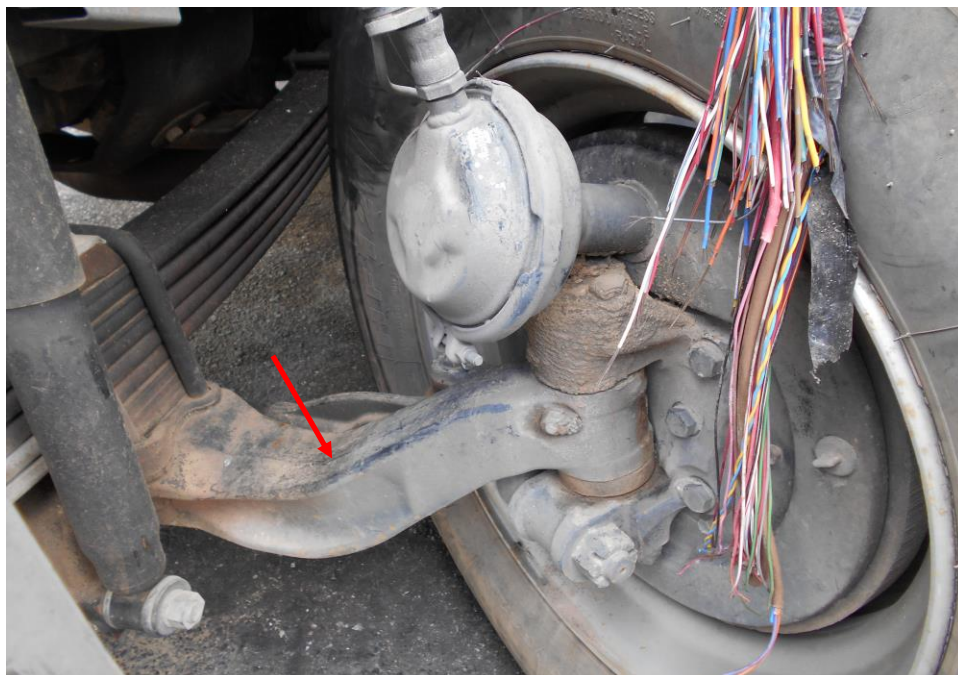
Photo 17 shows the undercarriage components at the front left wheel of the Motor Trailer. The various undercarriage components of the Motor Trailer were all observed to be intact and without any visible damage. This had included the steering rack (arrowed) of the Motor Trailer.

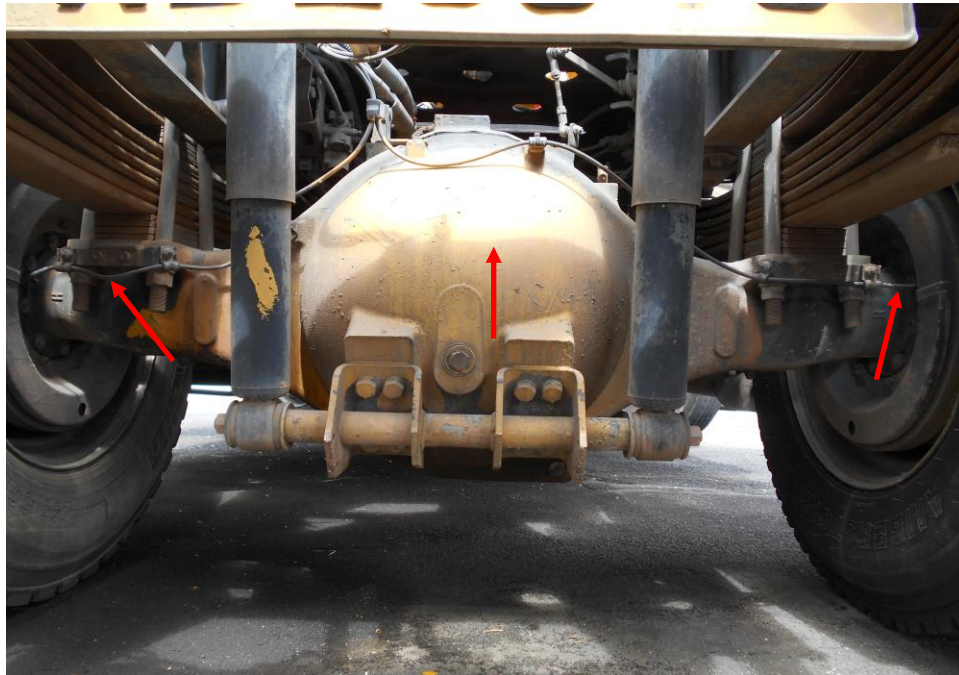
Photo 18 shows the brake hose (arrowed) at the rear right wheel of the Motor Trailer. At the time of our inspection, we did not find any sign(s) of brake fluid leakage along the brake hoses and brake pipes.

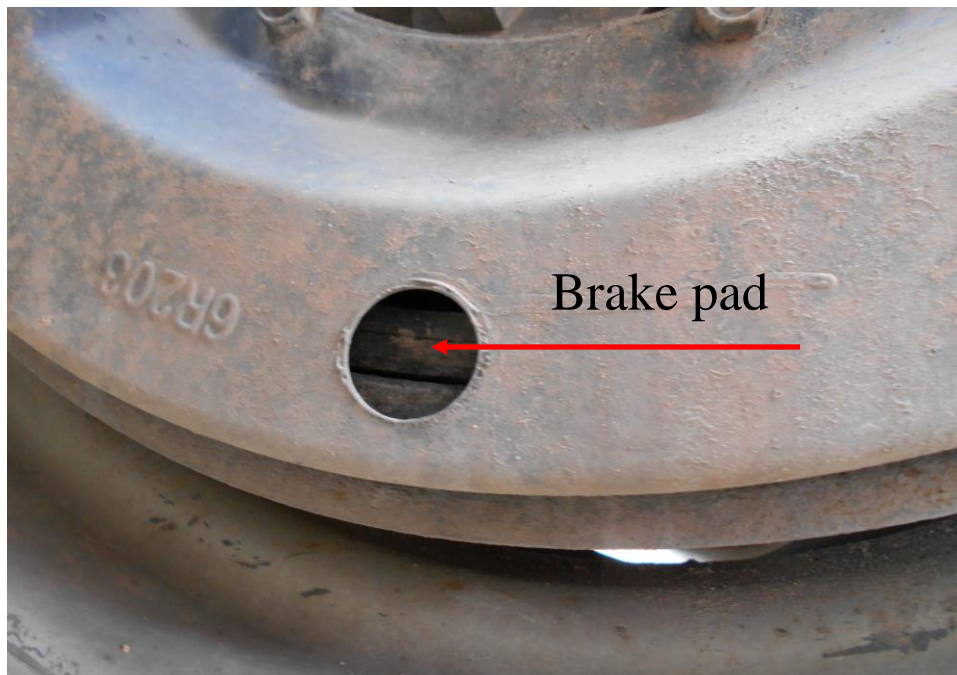
Photo 19 shows the sufficient rear right brake frictional material which was observed to be in serviceable condition.

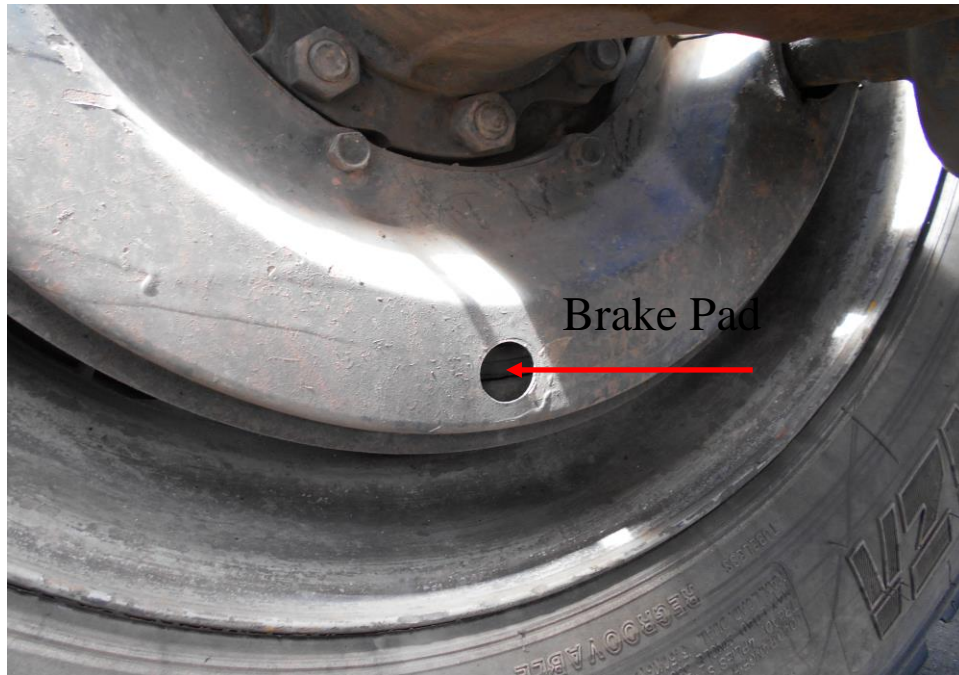
Photo 20 shows the sufficient rear right brake frictional material which was observed to be in serviceable condition.

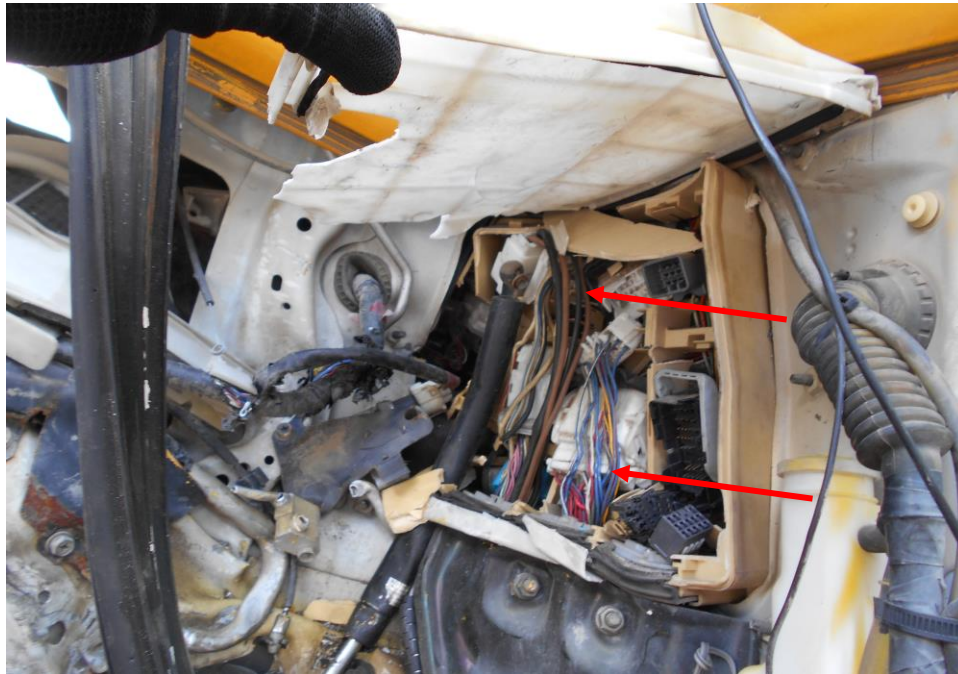
16. The Motor Trailer was not fitted with any electronic safety feature(s) like Anti-Brake Lock System (ABS), Supplemental Restraint System (SRS) etc. There was hence no test carried out on the functionality of these systems. In any case, as the test would involve cranking of the Motor Trailer's engine, the severe damages to the ignition system itself did not allow me to perform this test. See photo 21 below.

Photo 21 shows the damaged electrical module which caused ignition failure that disabled the ignition system & related systems due to the accident.
