28<sup>th</sup> February 2019

**General Investigation Team 'B'**

**MECHANICAL INSPECTION REPORT OF MOTOR TRAILER XD 2654U**

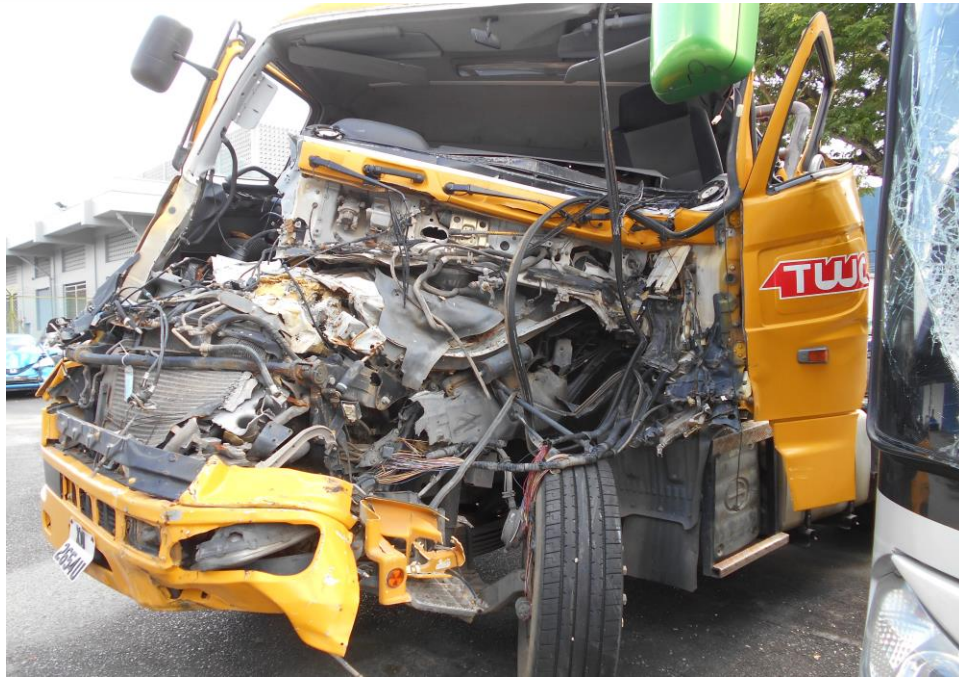
**Photo 2** shows a closer view of the frontal left portion of the Motor Trailer at the time of our inspection. A number of mechanical parts and components at the frontal portion were also severely damaged as a result of the accident.

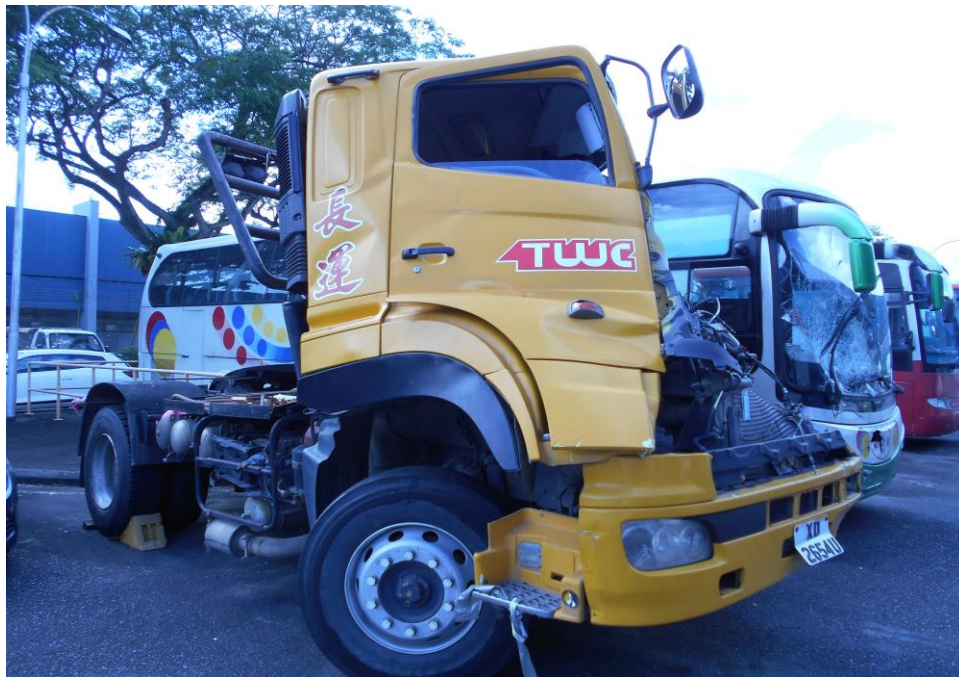
**Photo 3** shows a general view of the front right portion of the Motor Trailer at the time of our inspection. The Motor Trailer was observed to have sustained extensive impact damage at its front right portion. The impact force was relatively significant, causing its entire front portion to be buckled and crumpled.

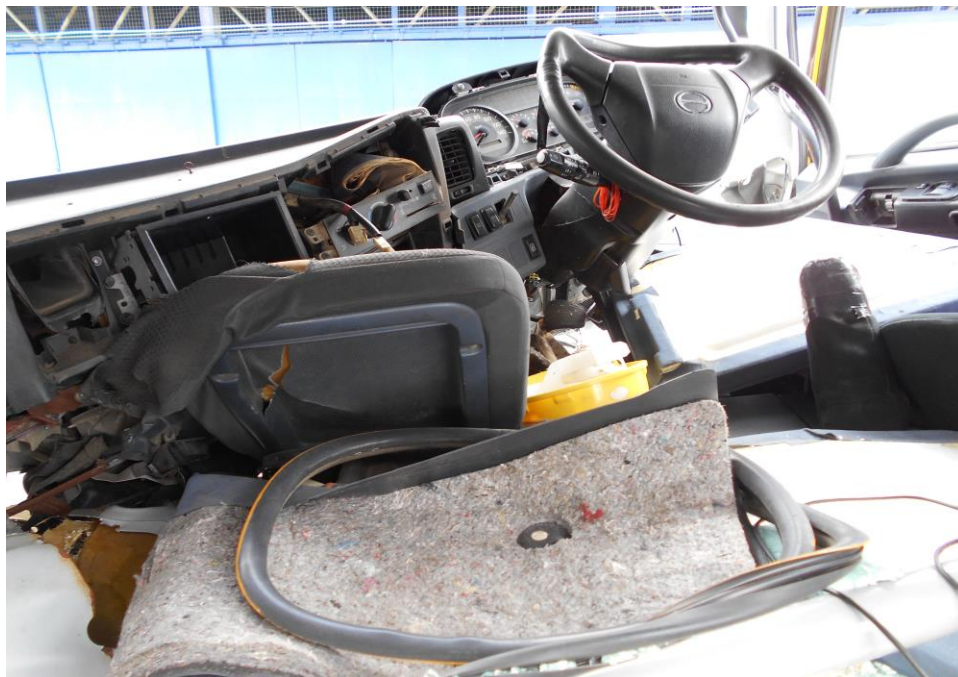
**Photo 5** shows the interior of the front cabin. The dashboard, steering wheel, seats, floor panel and roof panel inside the front cabin were all observed to be pushed/buckled inwards, towards the rear of the Motor Trailer. This is consistent to the nature of this accident where the direction of impact onto the Motor Trailer was from the front to rear direction.

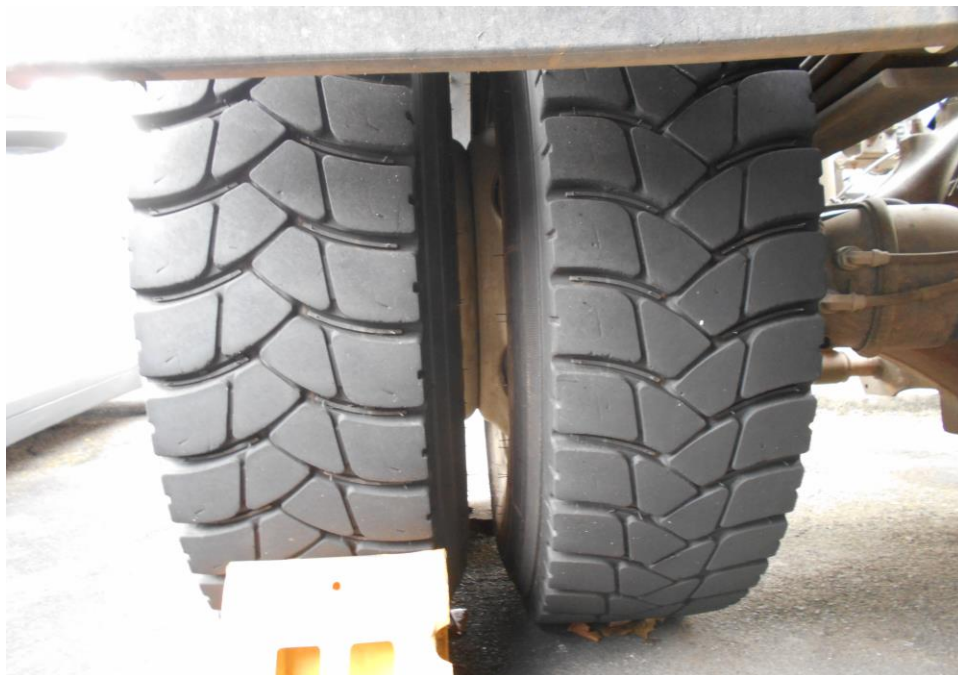
**Photo 8** shows the condition of the rear right tyres of the Motor Trailer, which was observed to be in serviceable condition with remaining tread depth of approximately 8mm. There was no tear, cut or burst mark(s) on the outer and the inner sidewalls as well as across the tread of this 2 tyres. The 2 tyres, which were wrapped around alloy wheel rim, were also observed to be sufficiently inflated for vehicular operation.

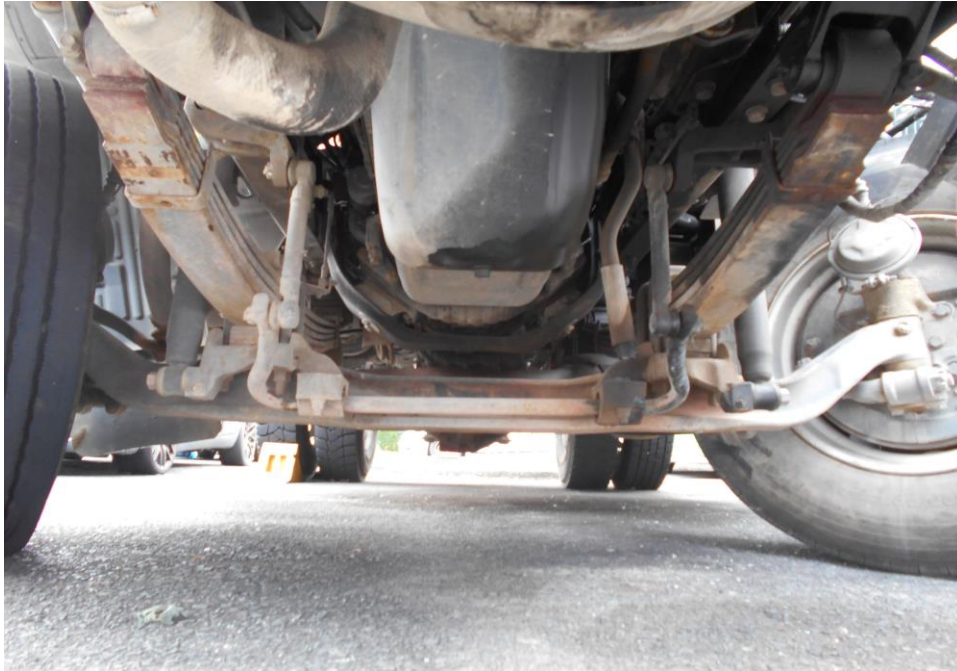
10. The engine compartment of the Motor Trailer, which was located beneath the front cabin, could not be closely inspected given the extensive damages to the front cabin. Our visual checks from the underside of the Motor Trailer had however appear to indicate that the engine assembly and transmission assembly were both intact and unaffected by the collision.

**Photo 12** shows the underside of the Motor Trailer, at the area where the engine is located. We were not able to closely inspect the engine compartment of the Motor Trailer due to the extensive damage to its front cabin. Our visual checks from the underside had however appear to indicate that the engine assembly and transmission assembly were both intact and unaffected by the collision.

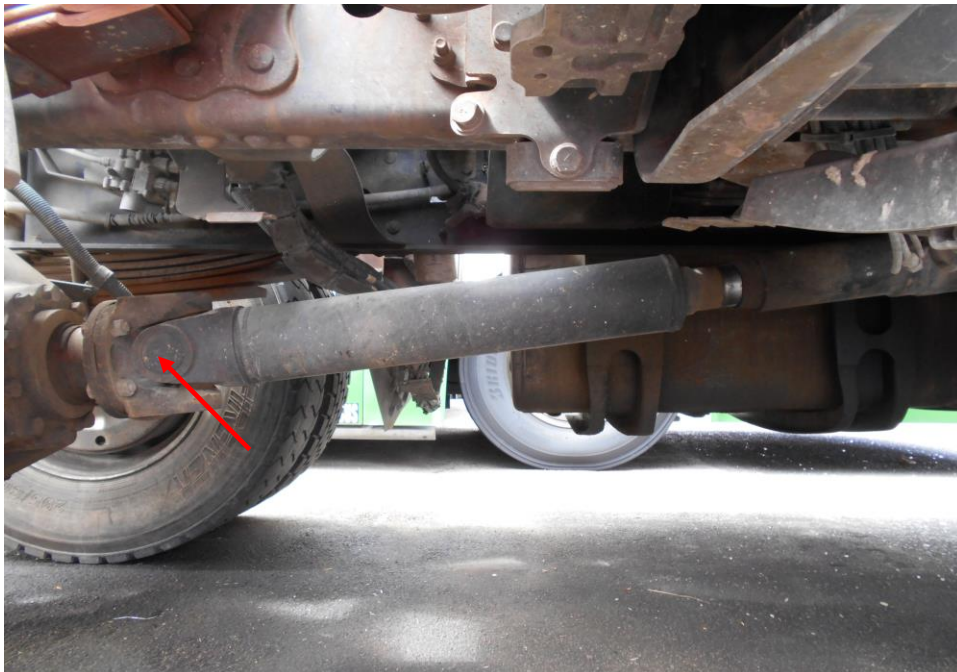
**Photo 13** shows the transmission assembly (arrowed) of the Motor Trailer intact and unaffected by the collision.

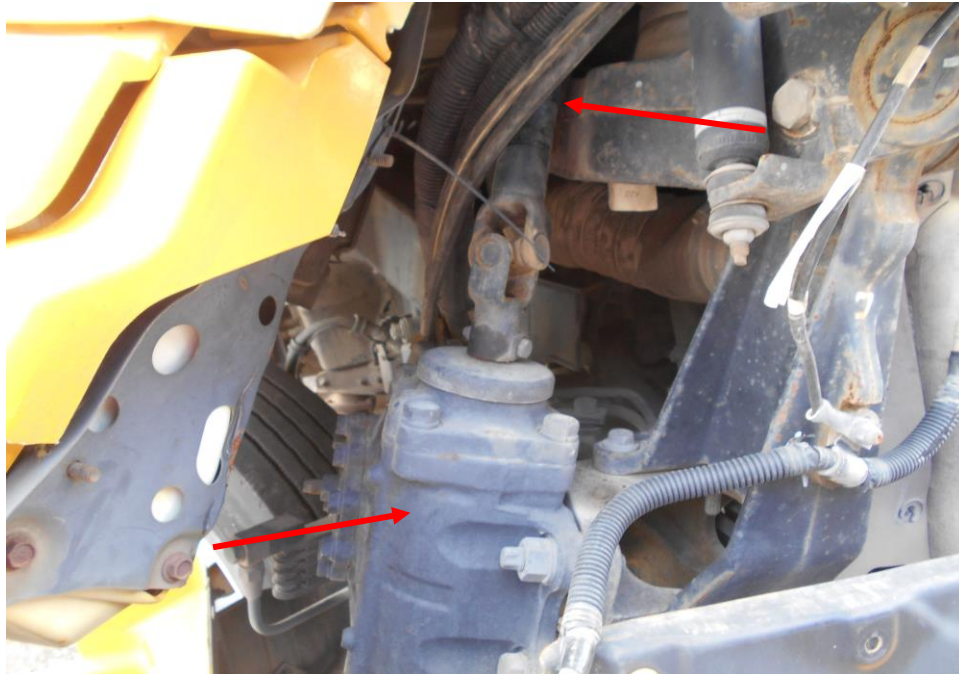
**Photo 15** shows the damaged steering wheel box & shaft due to the accident.

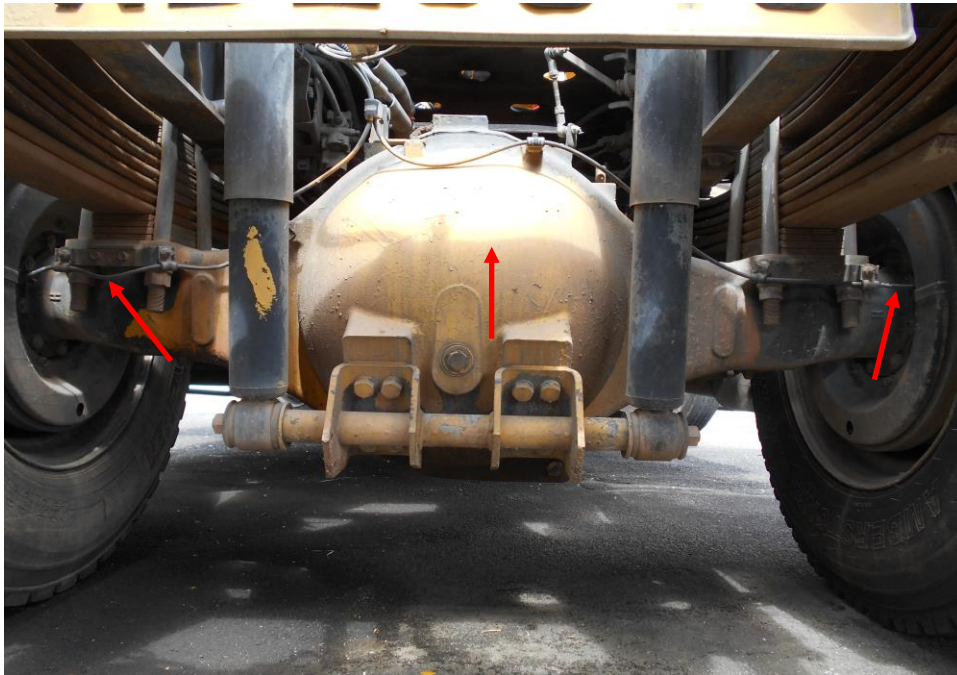
**Photo 18** shows the brake hose (arrowed) at the rear right wheel of the Motor Trailer. At the time of our inspection, we did not find any sign(s) of brake fluid leakage along the brake hoses and brake pipes.

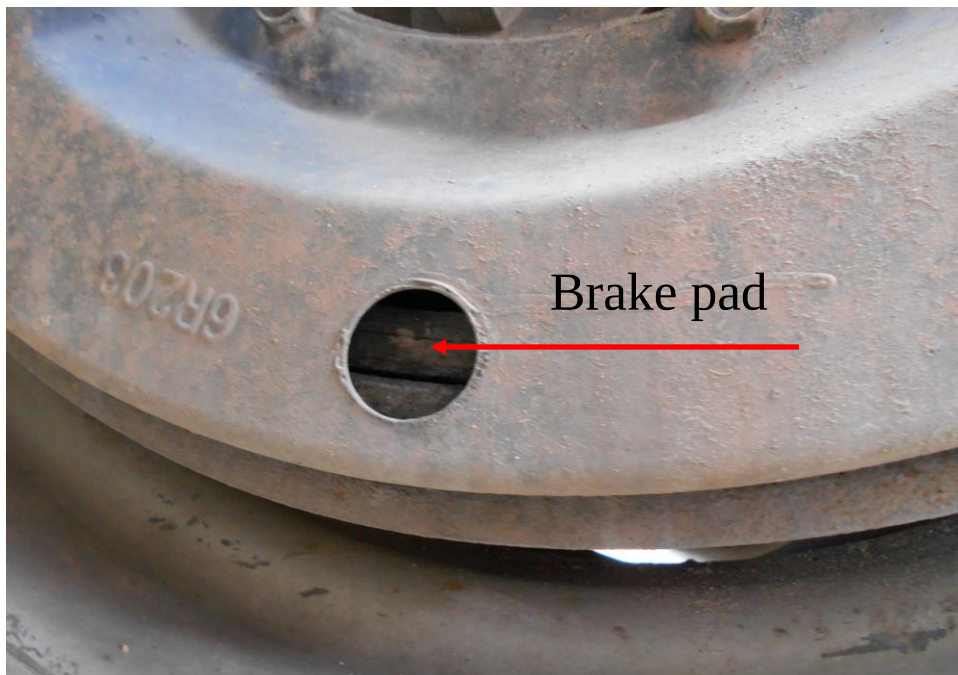
**Photo 19** shows the sufficient rear right brake frictional material which was observed to be in serviceable condition.

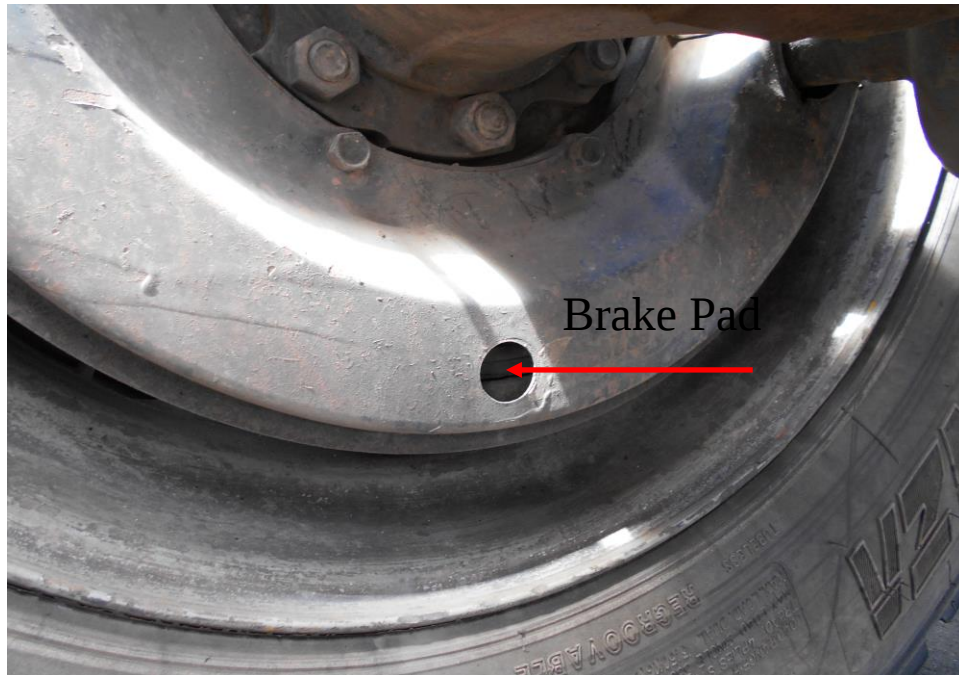
**Photo 20** shows the sufficient rear right brake frictional material which was observed to be in serviceable condition.
