Your Ref: 1756228826SG
Our Ref : CI/AIG18022608/N

14 December 2018

**TECHNICAL INVESTIGATION REPORT OF FIRE INCIDENT INVOLVING THE
INSURED VEHICLE SGY 1669A ON 28 NOVEMBER 2018**

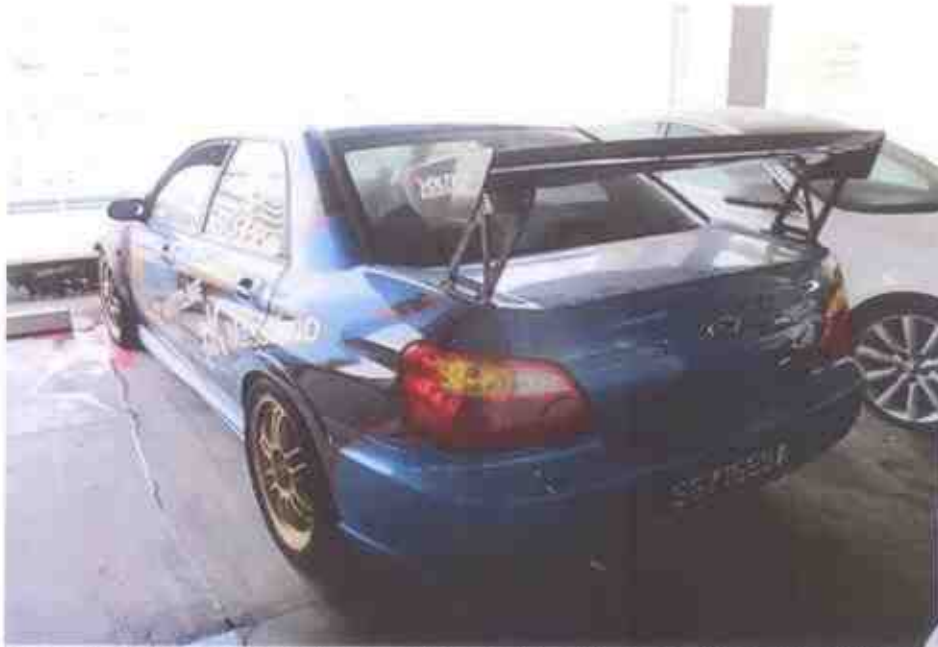
Photo 1 shows the general view of the rear left body of the Insured Vehicle at the time of our inspection. The rear portion of the Insured Vehicle was observed to be unaffected by the fire.

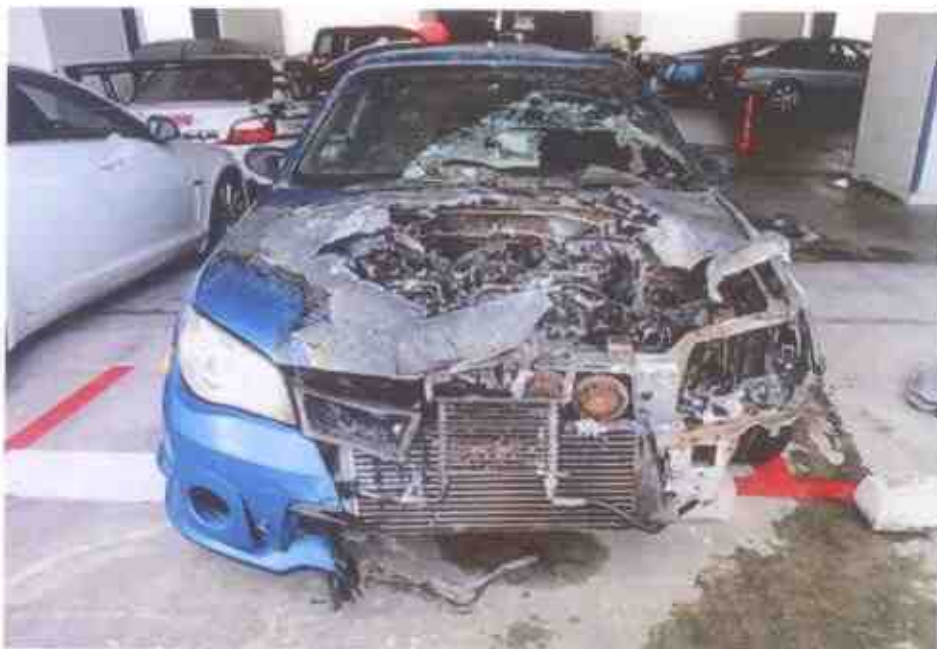
Photo 2 shows the general view of the front portion of the Insured Vehicle at the time of our inspection. The exterior body of the Insured Vehicle had sustained visible fire damage. This included its front windscreen, front bonnet, headlights, front bumper, side panels, front rims and front tires.

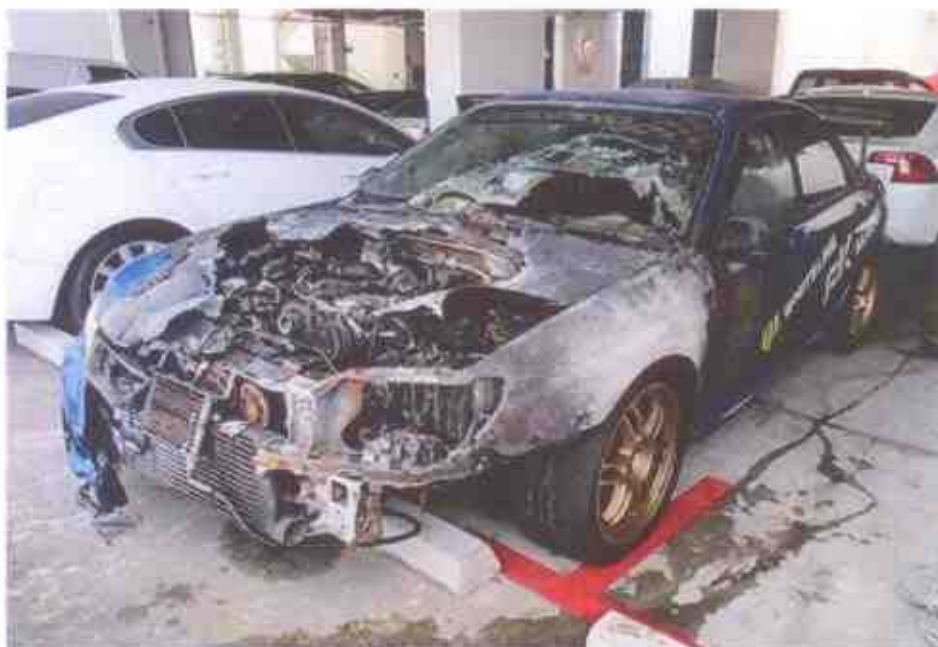
Photo 3 shows the general view of the left portion of the Insured Vehicle at the time of our inspection. The exterior body of the Insured Vehicle had sustained visible fire damage. This included its front windscreen, front bonnet, left headlight, front bumper, left side panel, left front rim and left front tire.

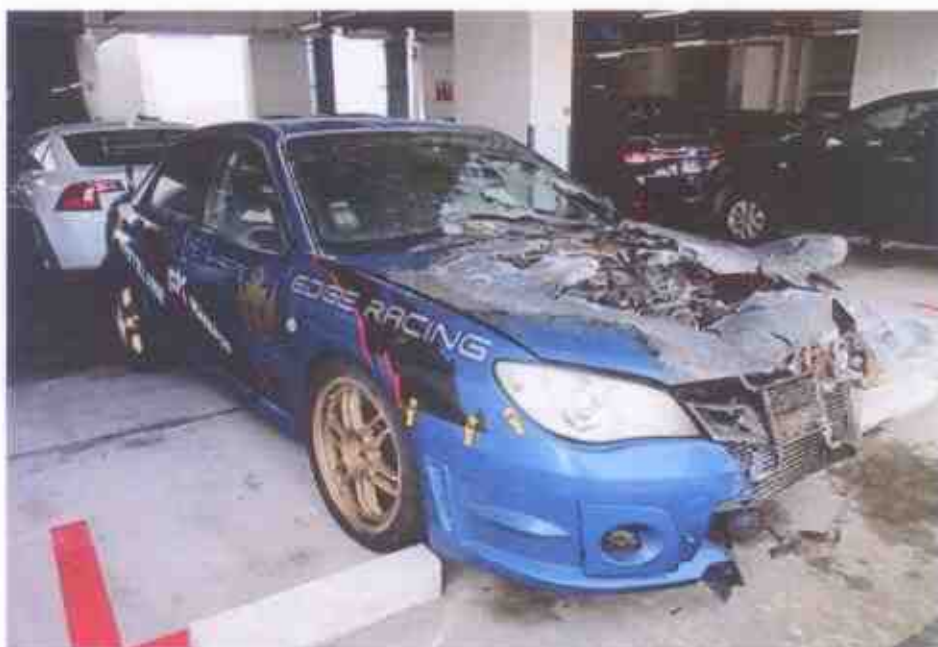
Photo 4 shows the general view of the right portion of the Insured Vehicle at the time of our inspection. The exterior body of the Insured Vehicle had sustained visible fire damage. This included its front windscreen, front bonnet, right headlight, front bumper, right side panel, right front rim and right front tire.

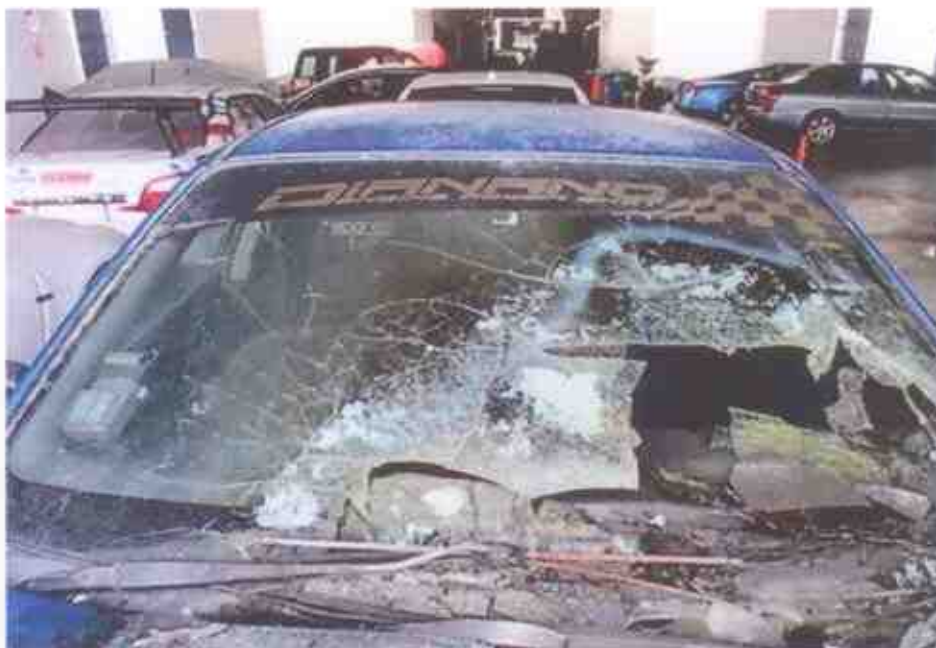
Photo 5 shows a closer view of the front windscreen of the Insured Vehicle at the time of our inspection. The front windscreen had sustained serious fire damage.

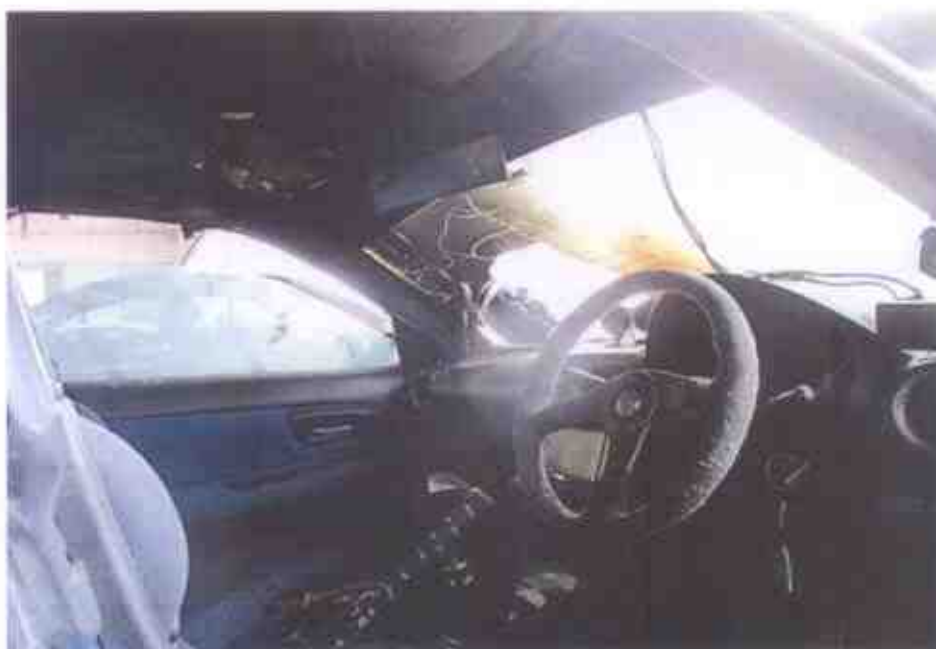
Photo 6 shows the interior compartment of the Insured Vehicle at the time of our inspection. The interior compartment of the Insured Vehicle was relatively unaffected by the fire, except for the left portion.

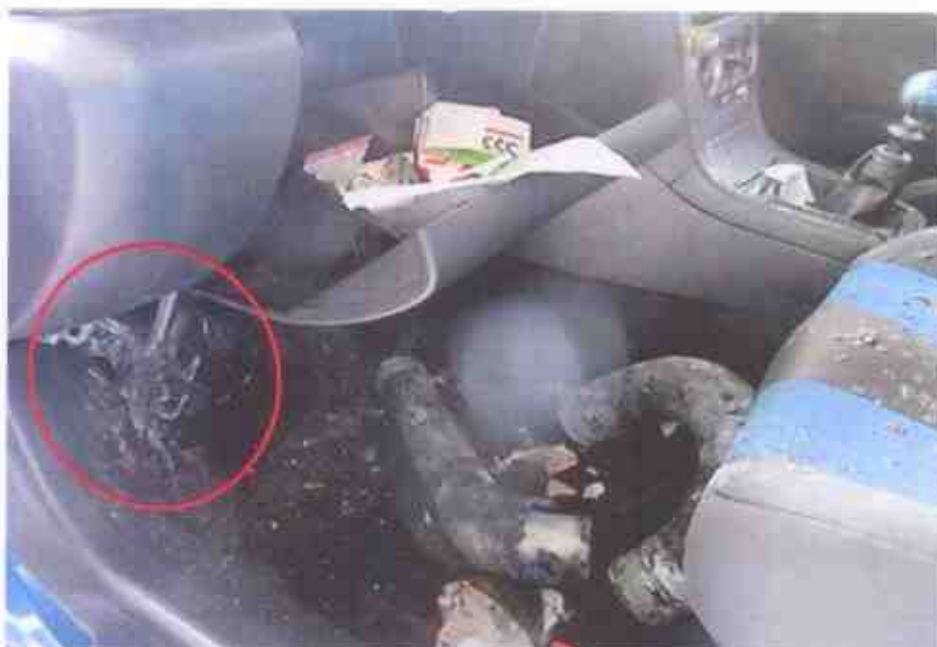
Photo 7 shows a closer view of the lower left portion of the Insured Vehicle's interior compartment at the time of our inspection which was significantly affected by the fire (circled).

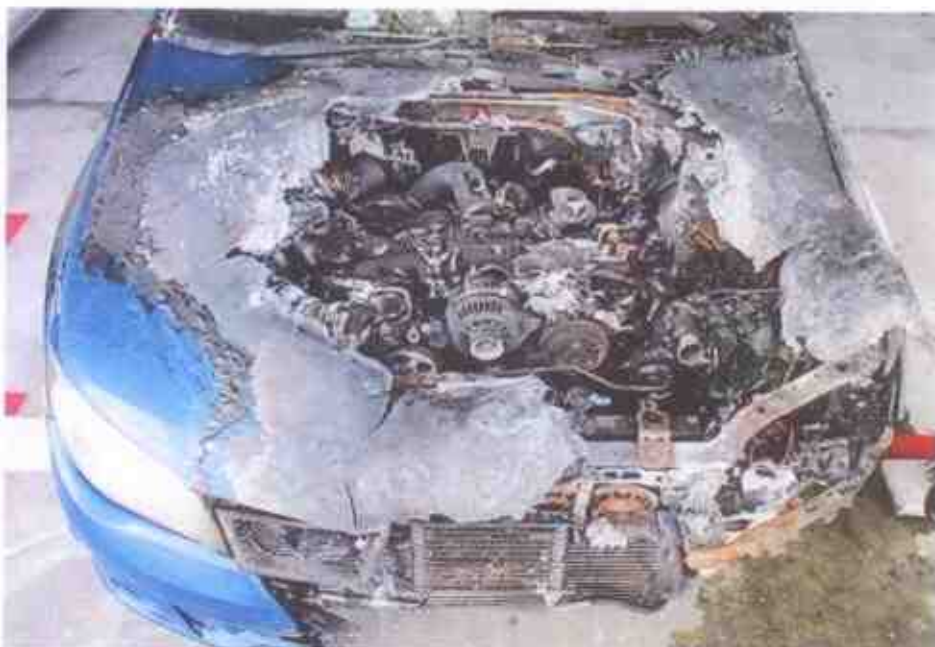
Photo 8 shows a general view of the engine compartment of the Insured Vehicle at the time of our inspection. Most of the components inside the engine compartment were found to be severely burnt and/or melted as a result of the fire.

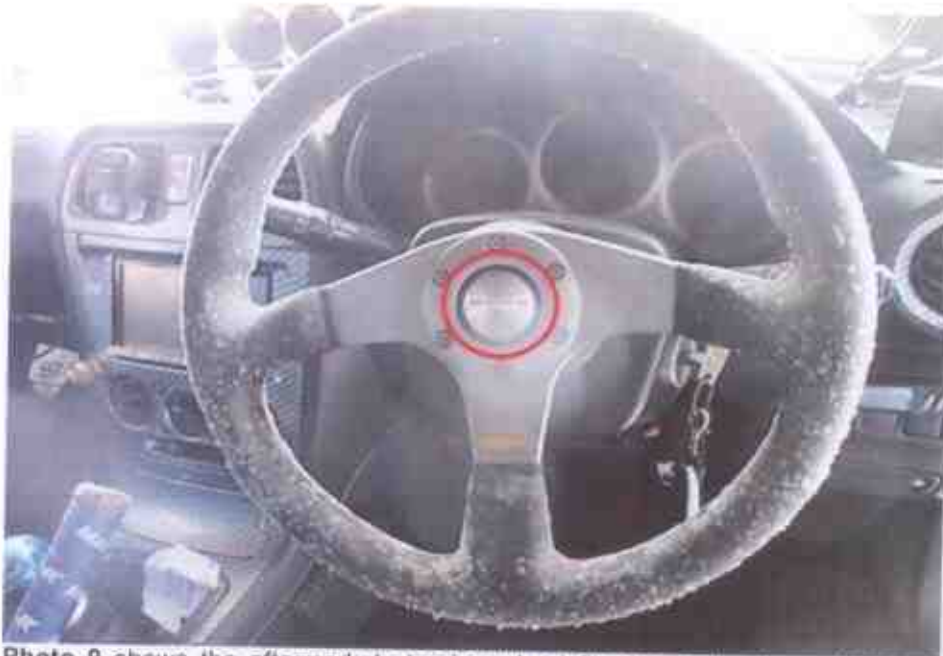
Photo 9 shows the aftermarket steering wheel fitted onto the Insured Vehicle upon our inspection. The brand of the steering wheel was 'MOMO' (circled).

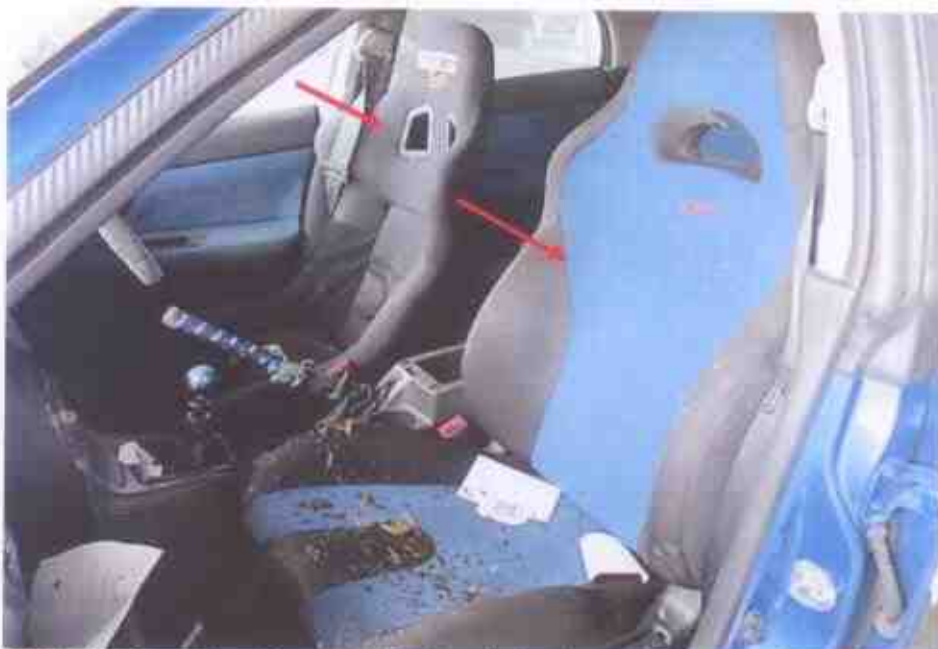
Photo 10 shows the aftermarket front seats (red arrows) that were fitted onto the Insured Vehicle upon our inspection.

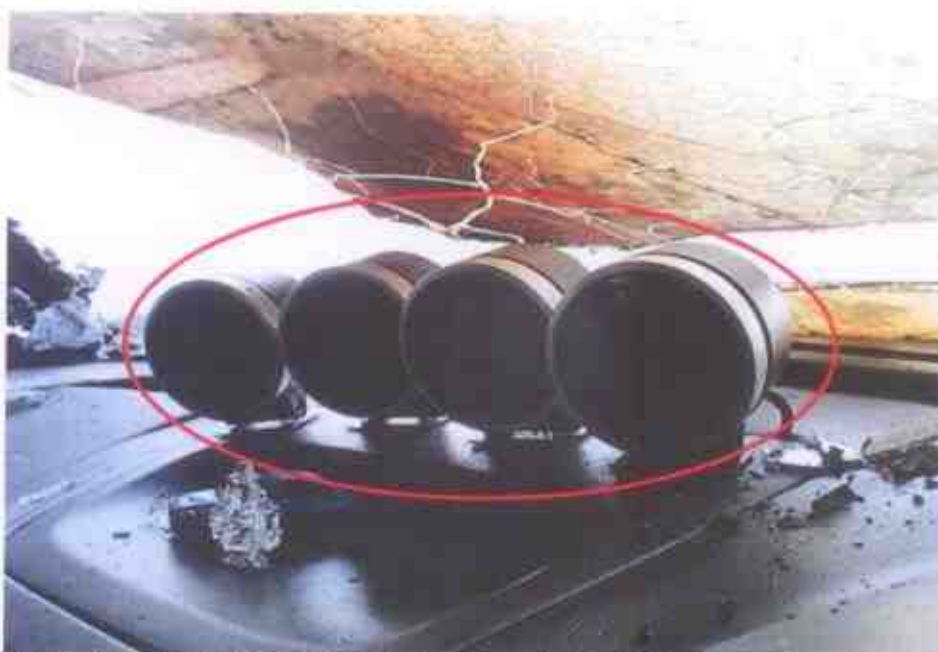
Photo 11 shows the aftermarket gauges (circled) that were found to be additionally fitted onto the Insured Vehicle upon our inspection.

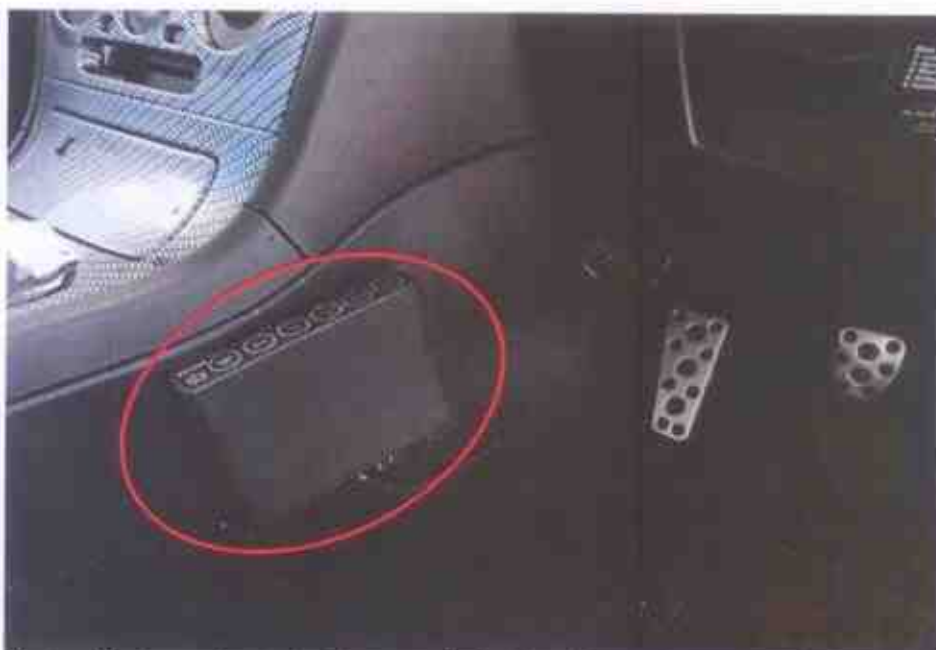
Photo 12 shows the controller console for the aftermarket gauges (circled) that was found to be additionally fitted onto the Insured Vehicle upon our inspection. The brand of the controller console was 'DEFI' (circled).

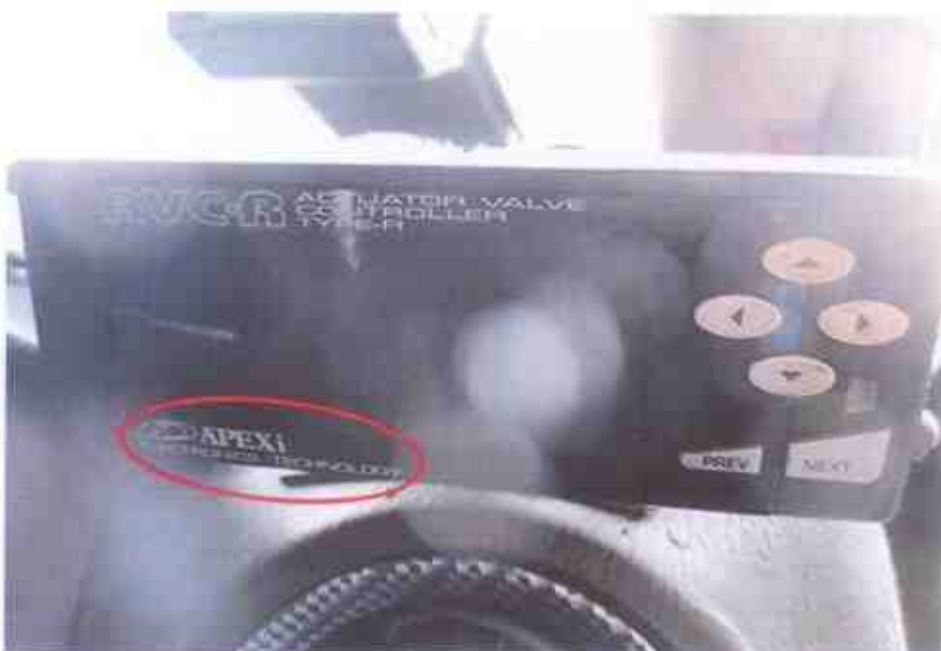
Photo 13 shows the actuator valve controller that was found to be additionally fitted onto the Insured Vehicle upon our inspection. The brand of the controller was 'APEXI' (circled).

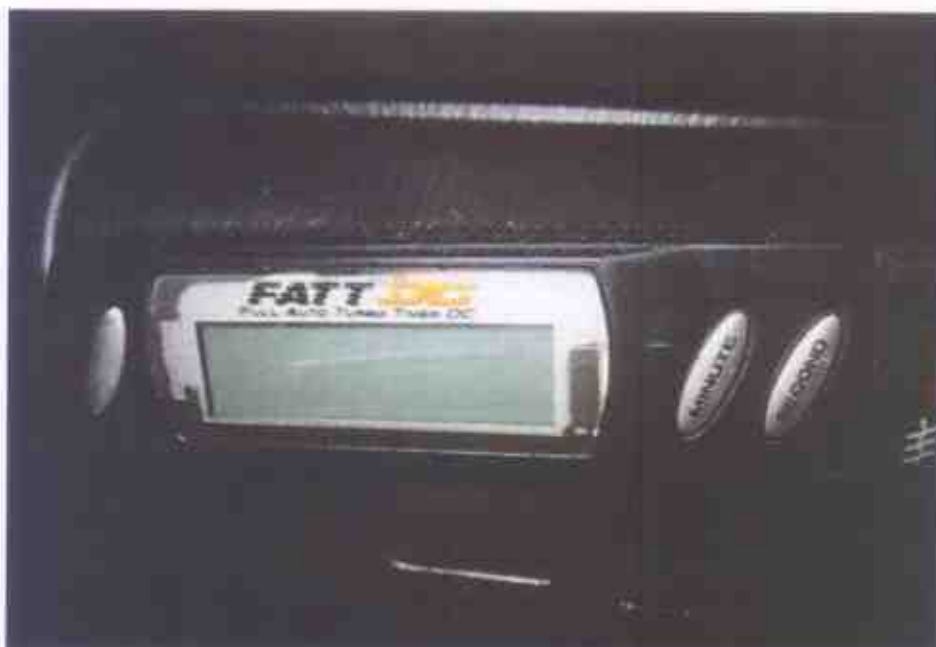
Photo 14 shows the turbo timer that was found to be additionally fitted onto the Insured Vehicle upon our inspection.

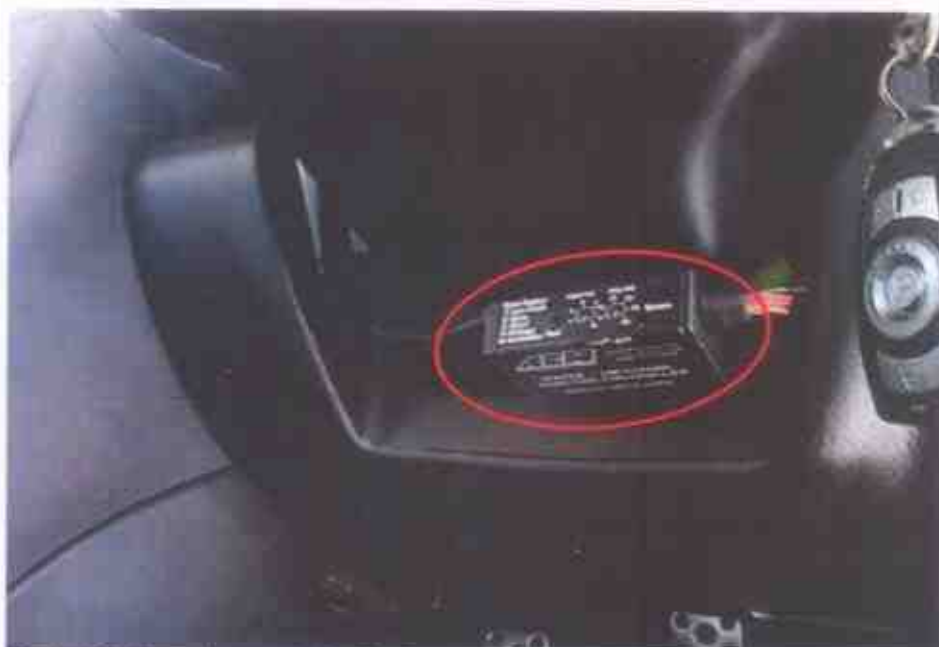
Photo 15 shows the controller for the water injection system that was found to be additionally fitted under the steering wheel of the Insured Vehicle upon our inspection (circled).

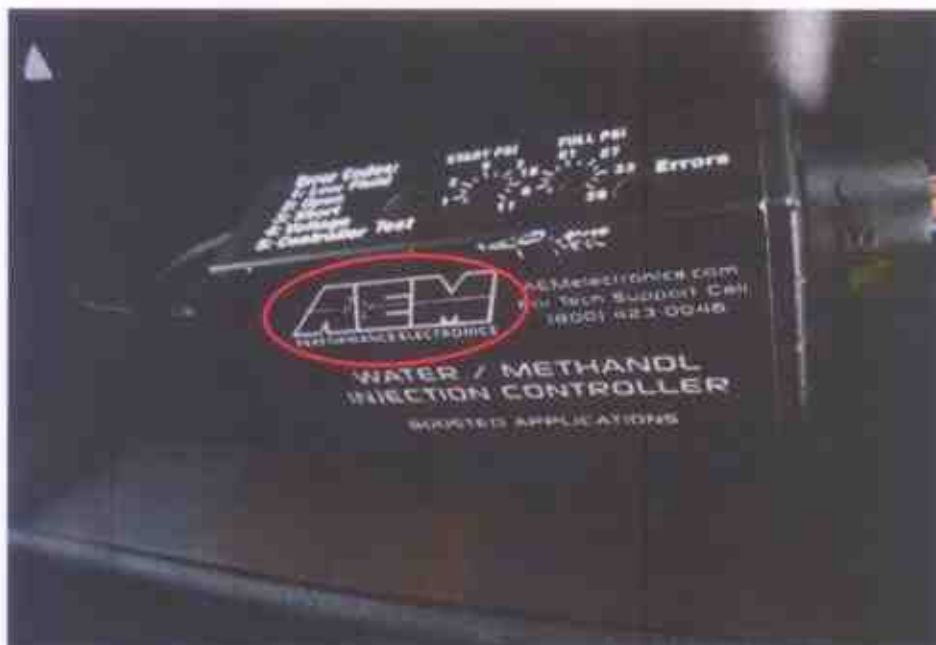
Photo 16 shows a close up view of the controller for the water injection system that was found to be additionally fitted under the steering wheel of the Insured Vehicle upon our inspection. The brand of the controller was 'AEM' (circled).

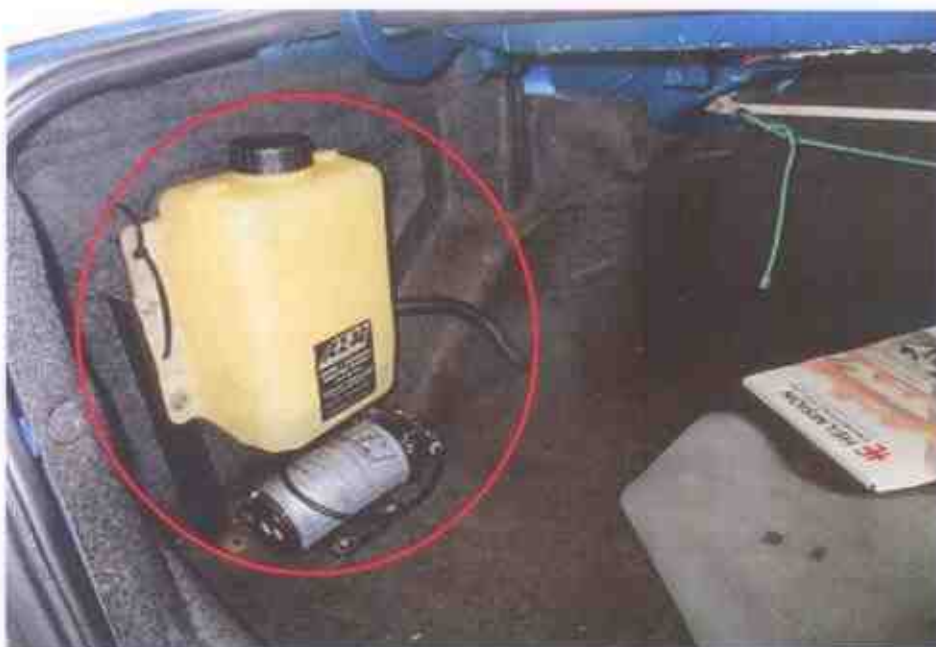
Photo 17 shows the water tank and motor for the water injection system that was found to be additionally fitted at the left portion of the Insured Vehicles' rear boot compartment upon our inspection (circled).

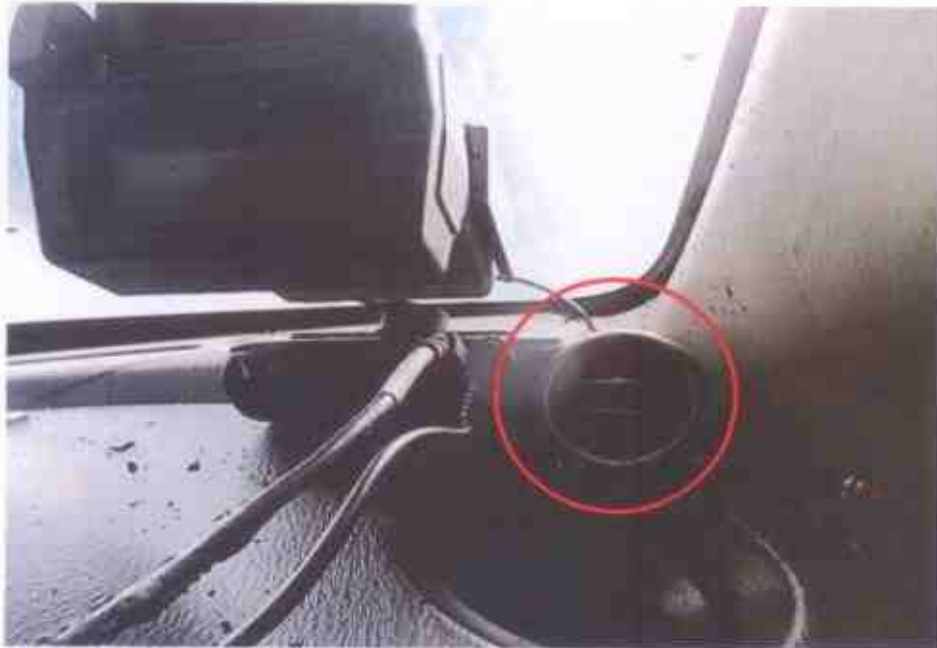
Photo 18 shows the 1st aftermarket twitter fitted onto the right corner of the dashboard of the Insured Vehicle upon our inspection which had sustained minor fire damage (circled).

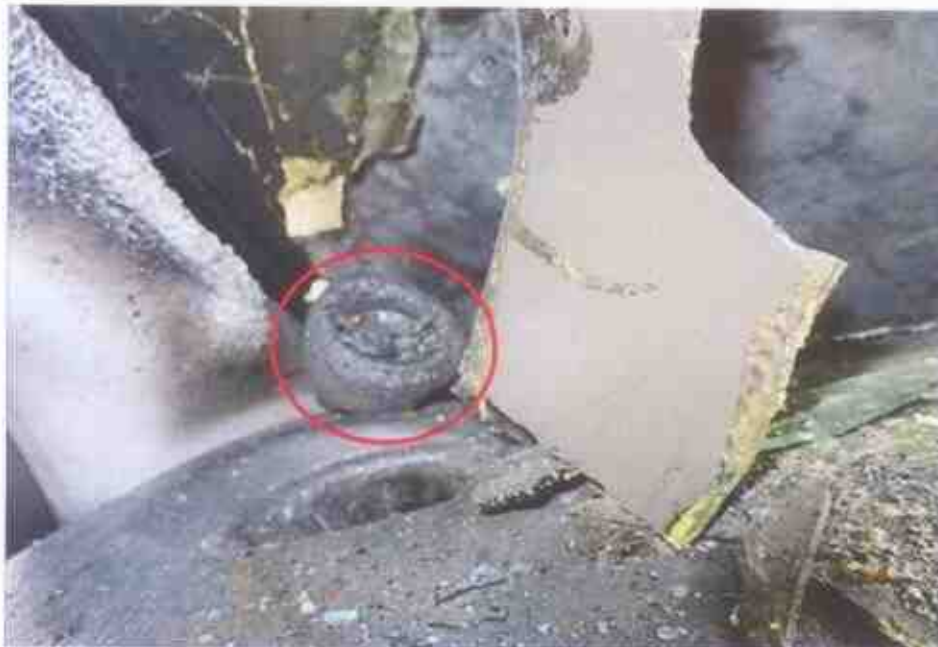
Photo 19 shows the 2nd aftermarket twitter fitted onto the left corner of the dashboard of the Insured Vehicle upon our inspection which had sustained serious fire damage (circled).

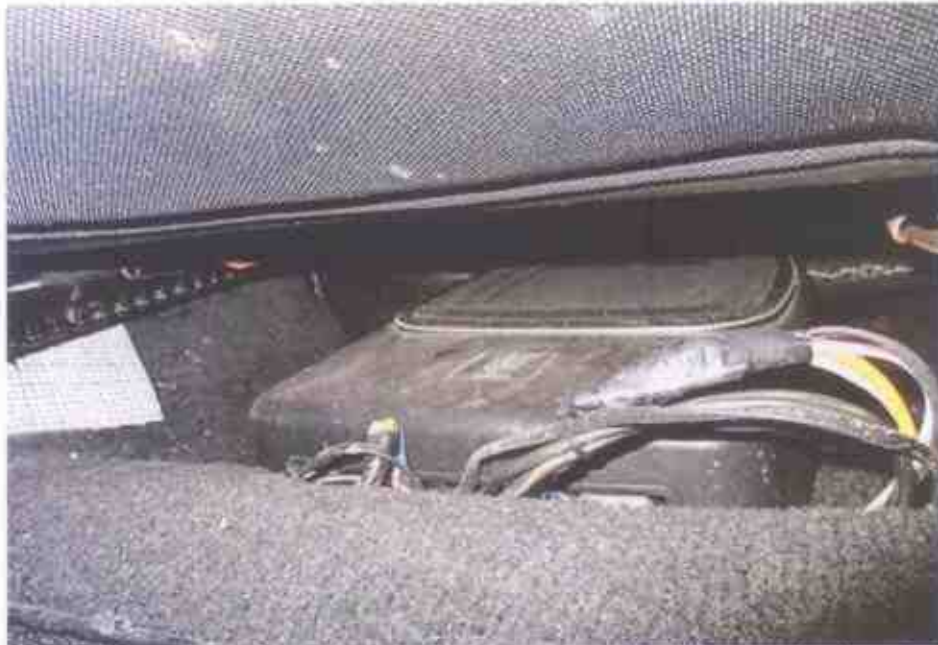
Photo 20 shows the aftermarket active subwoofer fitted under the front passenger seat of the Insured Vehicle upon our inspection.

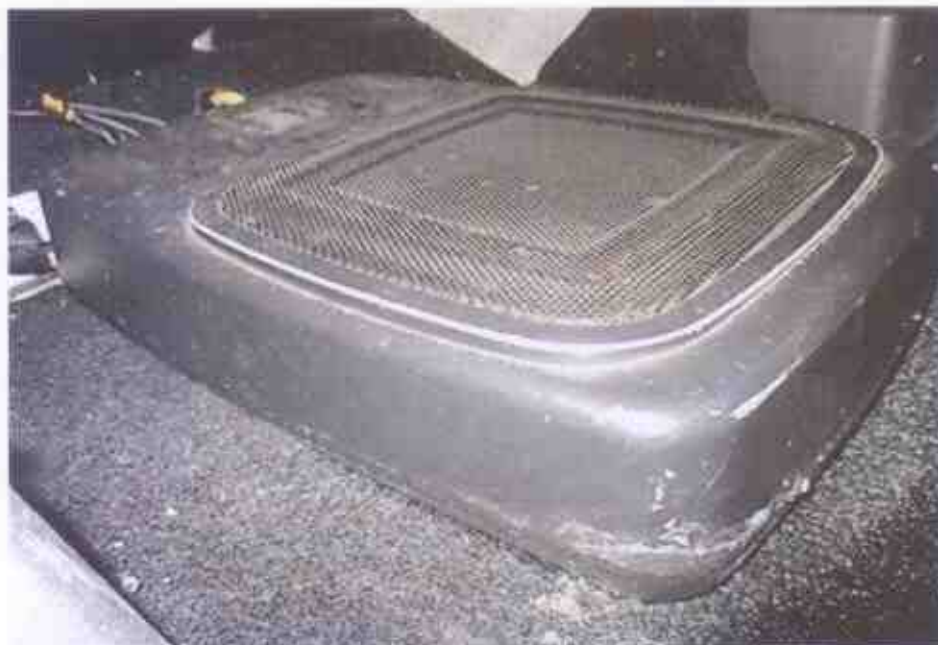
Photo 21 shows a close up view of the aftermarket active subwoofer fitted under the front passenger seat of the Insured Vehicle upon our inspection.

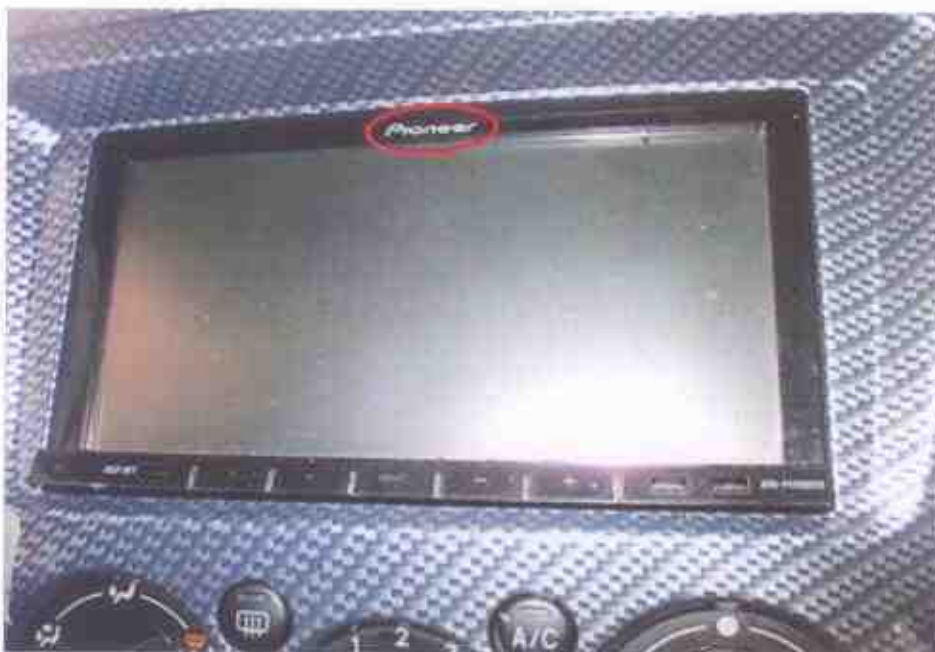
Photo 22 shows the in-car DVD player that was fitted at the centre portion of the front dashboard of the Insured Vehicle which had sustained minor fire damage. The brand of the in-car DVD player was 'PIONEER' (circled).

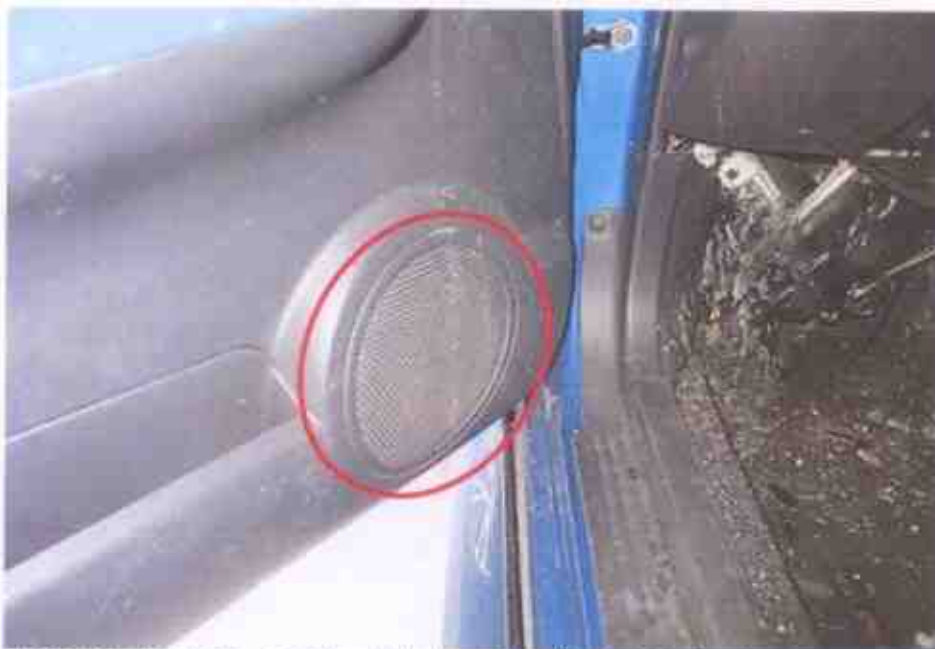
Photo 23 shows the 1st aftermarket speaker fitted at the front passenger door panel (circled).

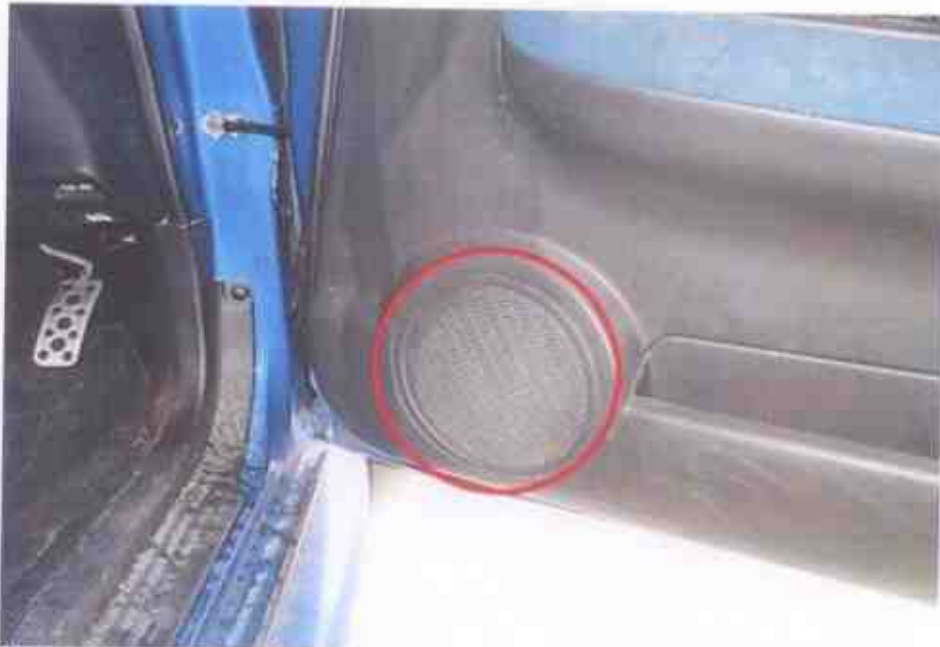
Photo 24 shows the 2nd aftermarket speaker fitted at the driver door panel (circled).

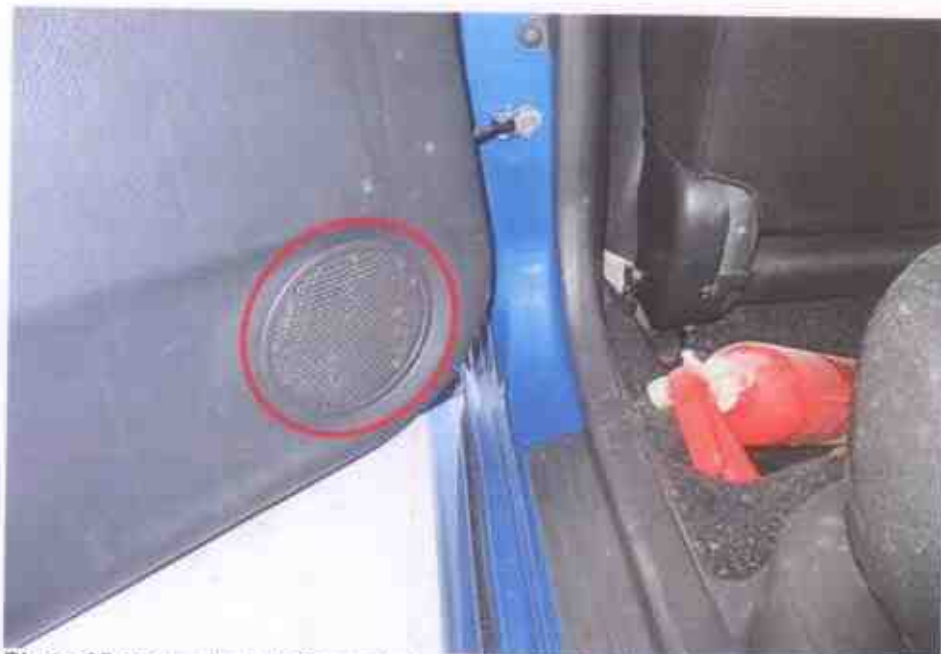
Photo 25 shows the 3rd aftermarket speaker fitted at the left rear passenger door panel (circled).

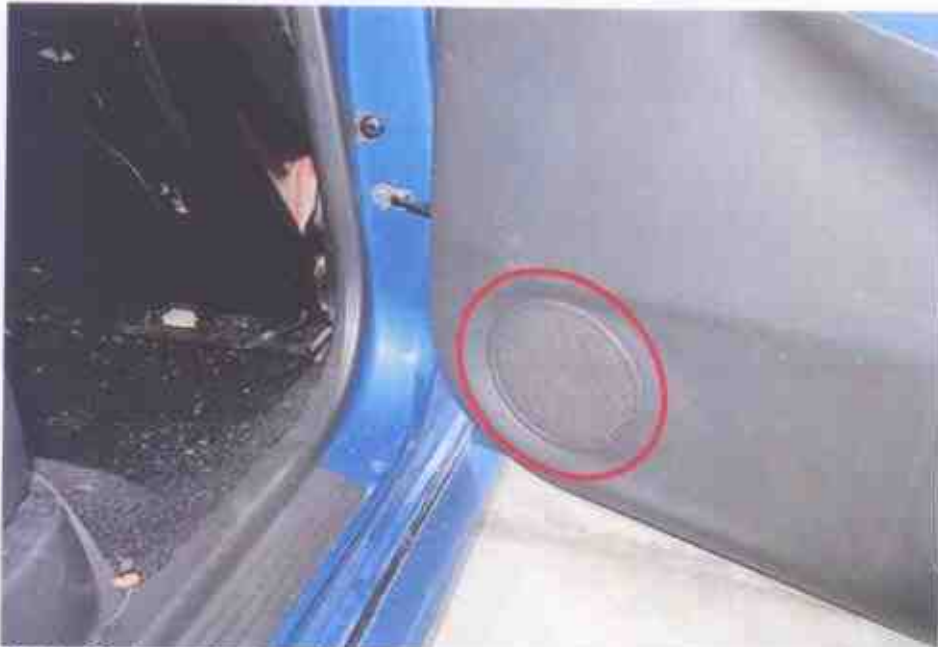
Photo 26 shows the 4th aftermarket speaker fitted at the right rear door panel (circled).

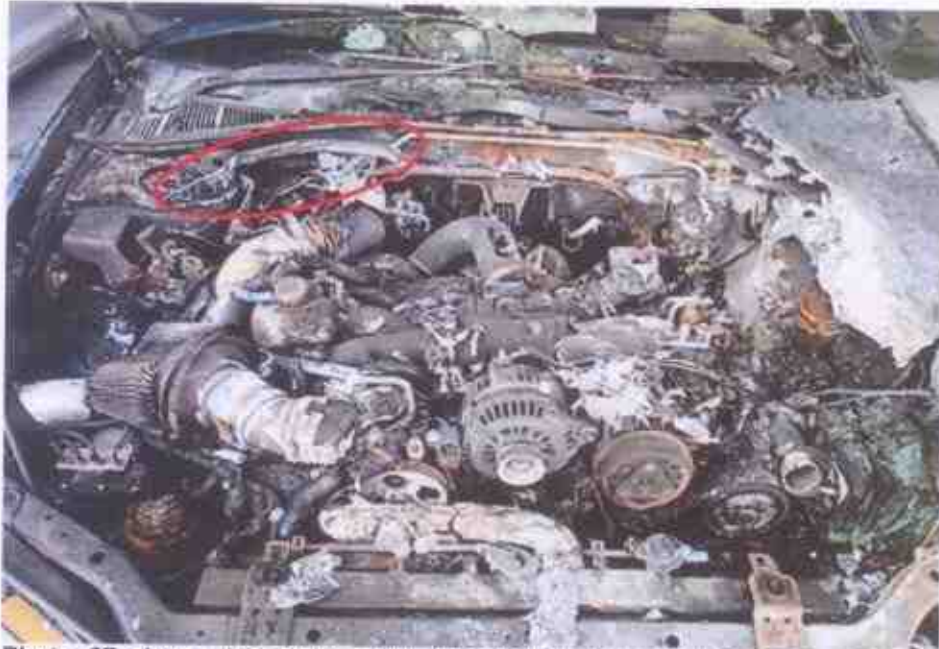
Photo 27 shows the engine strut bar (circled) fitted on the Insured Vehicle. However it had sustained serious fire damage.

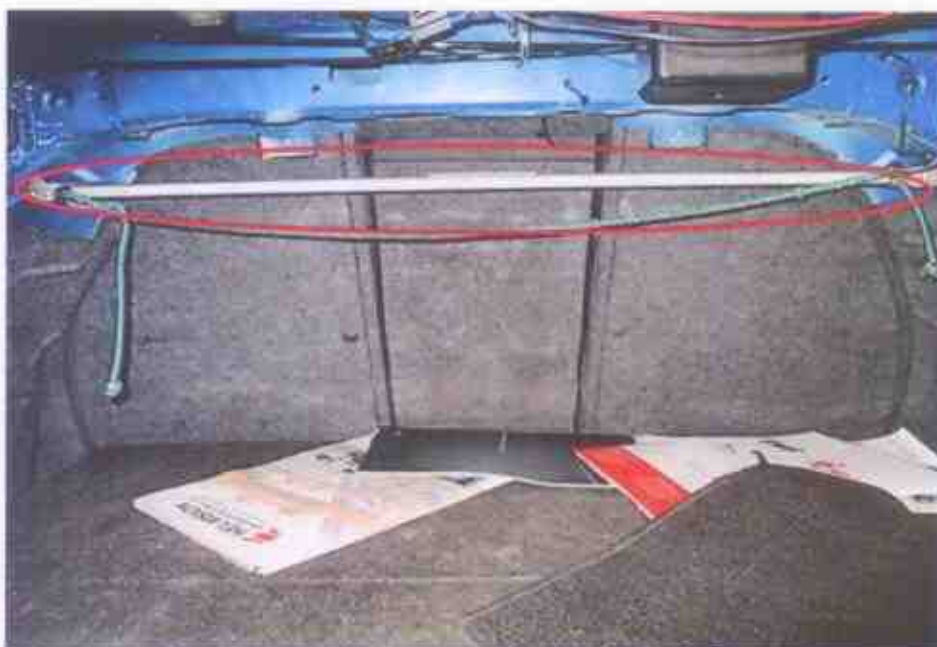
Photo 28 shows the rear strut bar (circled) fitted onto the rear boot compartment of the Insured Vehicle. The rear strut bar was found to be relatively unaffected by the fire.

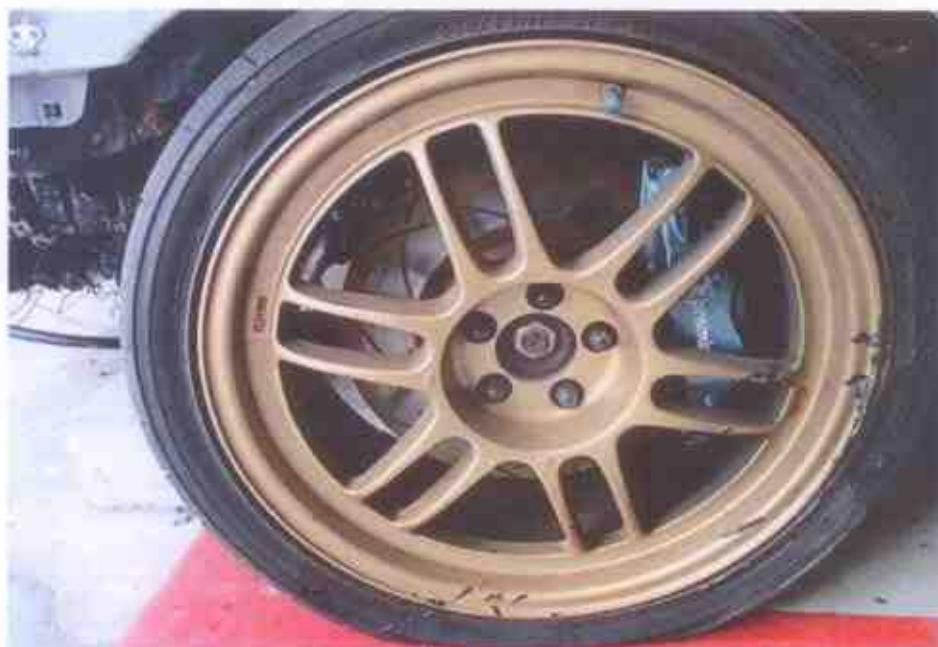
Photo 29 shows the non-standard rim found to be fitted on the Insured Vehicle at the time of our inspection. The 18- inch alloy rims fitted on the Insured Vehicle were not the standard type for the Insured Vehicle.

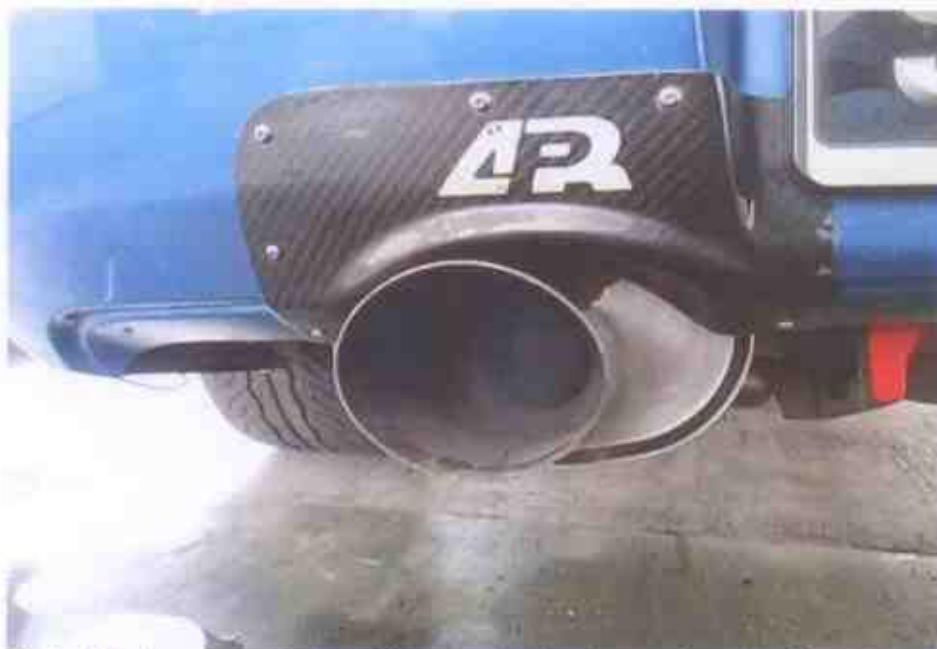
Photo 30 shows a front view of the non-standard rear exhaust muffler that was found to be fitted on the Insured Vehicle at the time of our inspection.

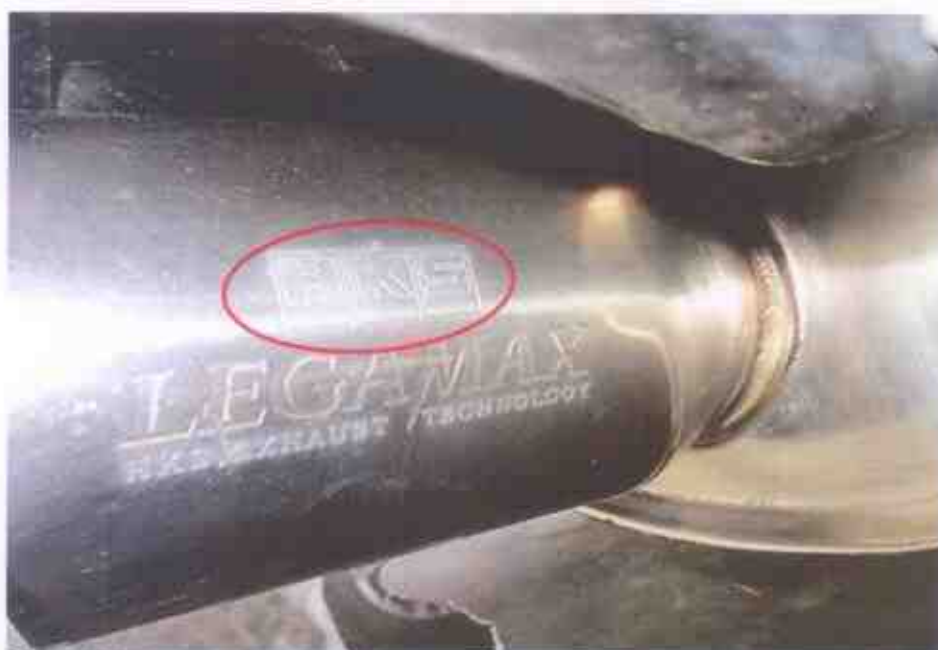
Photo 31 shows a close up side view of the non-standard rear exhaust muffler that was found to be fitted on the Insured Vehicle at the time of our inspection. The brand of the rear exhaust muffler was 'HKS' (circled).

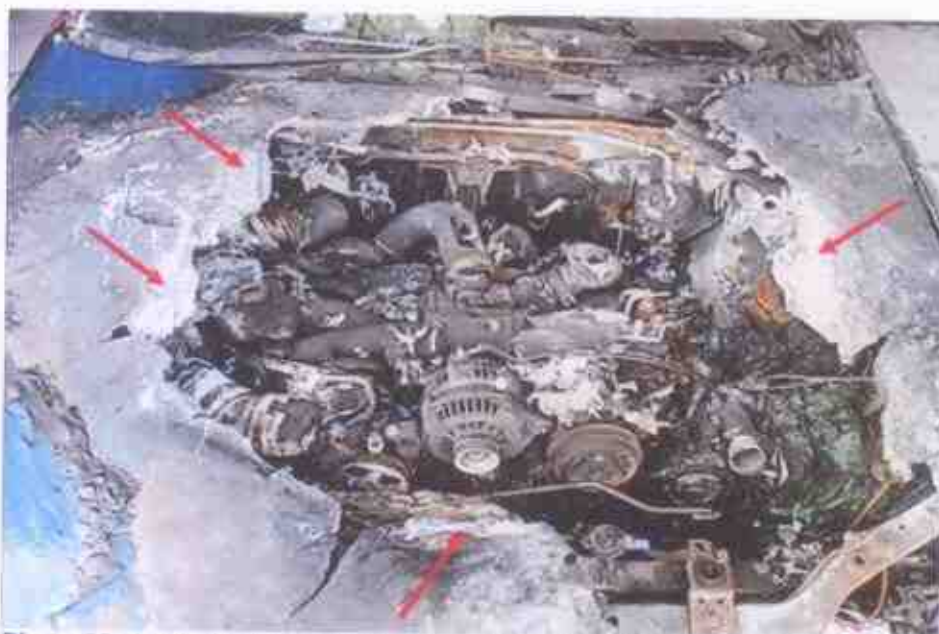
8. For this particular case, the fire appears to have originated within the engine compartment of the Insured Vehicle, somewhere around the left rear portion of the engine compartment due to the nature of the fire damage which was more extensive at the left rear portion. Furthermore, the intense whitish burn marks on the left front fender and hole found in the front bonnet of the Insured Vehicle indicate that the front left portion of the Insured Vehicle was exposed to prolonged high heat intensity. The right front fender had sustained minimal fire damage. Following the characteristic of heat (hot air rises), the origin of fire can then be determined to be from the engine compartment of the Insured Vehicle as the engine compartment is covered by the front bonnet and front fenders. Flames from the confined spaces of the engine compartment would travel outwards and upwards, exposing the front bonnet and front fenders of the Insured Vehicle to high heat intensity hence leaving a hole in the front bonnet as seen.

Photo 32 shows the hole found in the front bonnet of the Insured Vehicle which indicates that the front portion of the Insured Vehicle was exposed to prolonged high heat intensity. The whitish burn marks (arrowed) are a result of exposure to prolonged heat intensity.

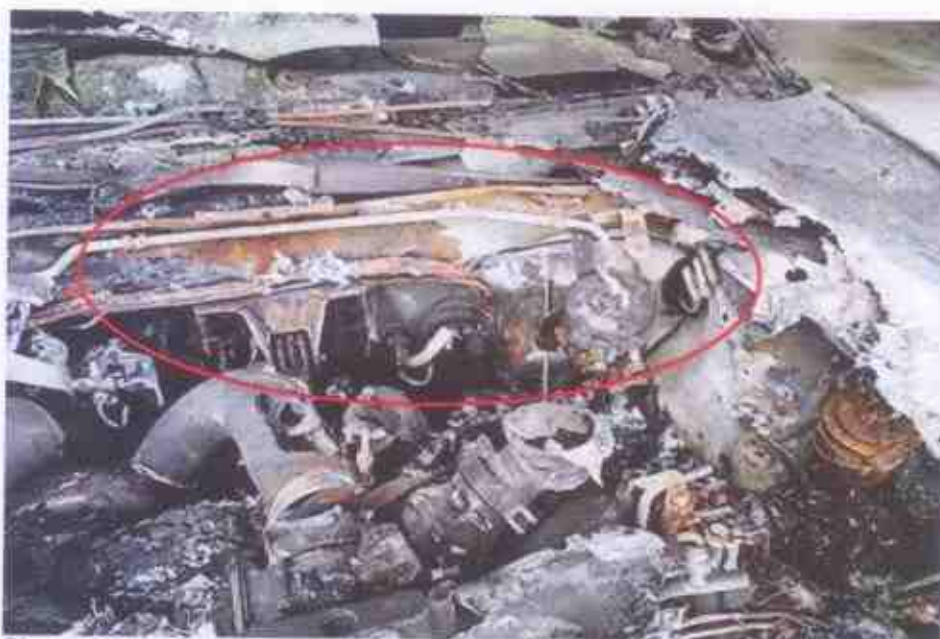
9. The whitish burn marks are a result of exposure to prolonged heat intensity. Rust would normally start to develop around these areas soon after a fire as prolonged exposure to high heat intensity usually causes steel/metal material body parts to be exposed to natural environmental condition. The rust that had developed on the left rear portion of the engine compartment is an indication that the left rear portion of the engine compartment had sustained exposure to prolonged high heat intensity. See photos 32 - 35 below.

Photo 33 shows a closer view of the rust that had developed on the left rear portion of the engine compartment (circled). The development of rust is an indication that this area was subjected to prolonged exposure to high heat intensity, which had caused the steel/metal material of the front bonnet to be exposed to natural environmental condition. Hence the fire to the Insured Vehicle can be determined to have originated towards the left rear portion of the engine compartment.

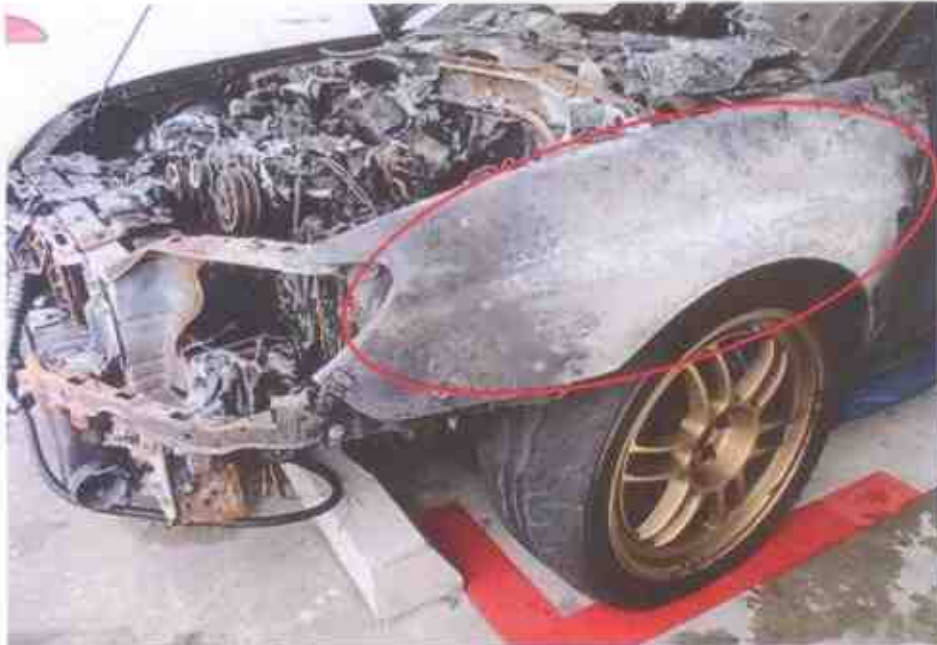
Photo 34 shows the whitish burn marks that were found on the left front fender of the Insured Vehicle (circled). Such whitish burn marks are a result of exposure to prolonged heat intensity, which may indicate where the fire had started. Rust would also begin to develop on these areas soon after the fire.
