Your Ref: 1756228826SG
Our Ref : CI/AIG18022608/N

14 December 2018

**TECHNICAL INVESTIGATION REPORT OF FIRE INCIDENT INVOLVING THE
INSURED VEHICLE SGY 1669A ON 28 NOVEMBER 2018**

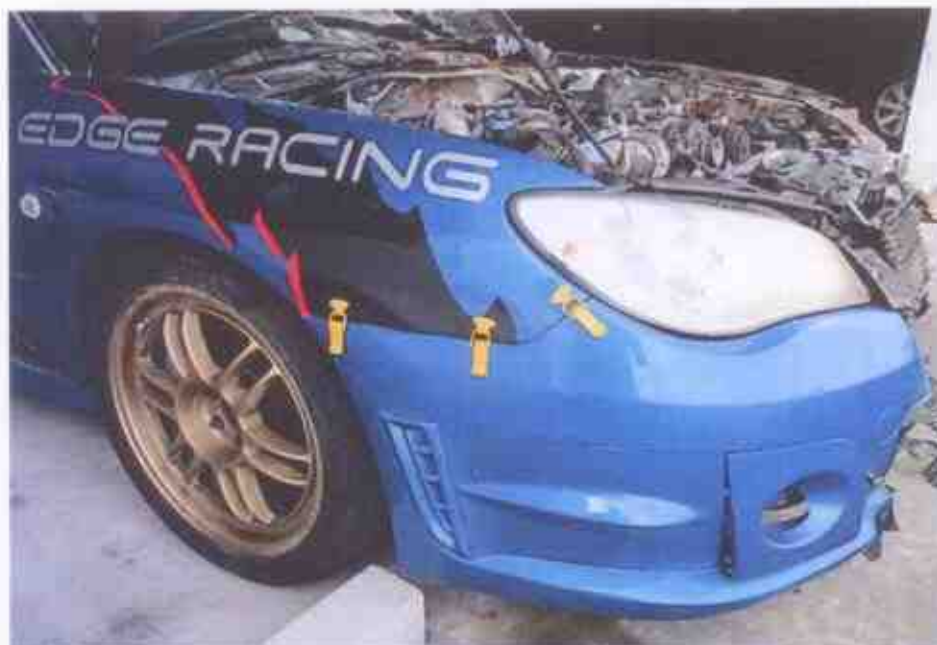
Photo 35 shows the right front fender of the Insured Vehicle which had sustained minimal fire damage.

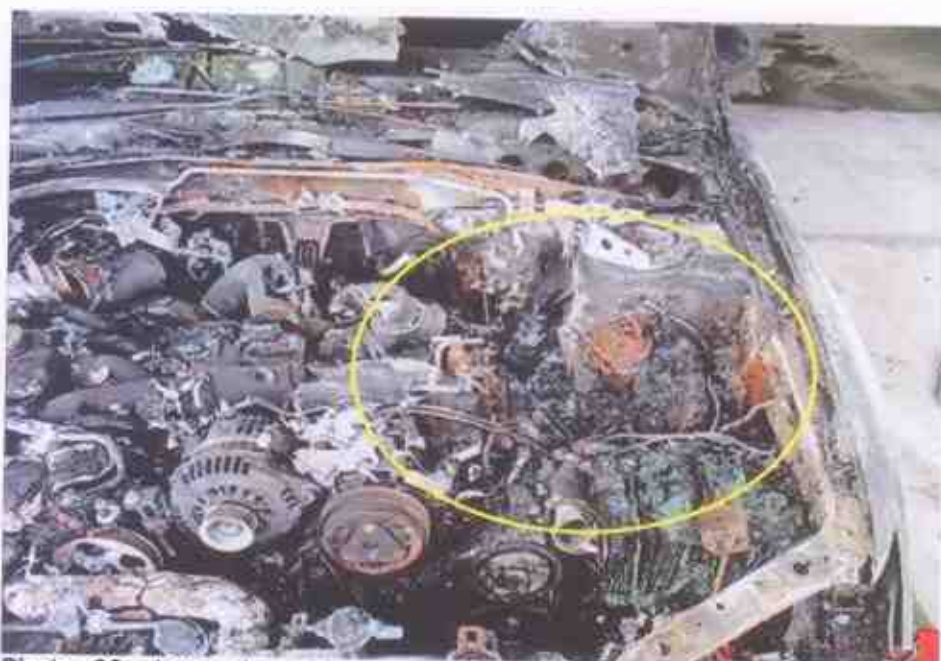
10. Upon closer examination of the left rear portion of the engine compartment which was where the fire to the Insured Vehicle had likely started, we had found several stretches of wirings with greenish residue. These wirings were original factory fitted wirings that were mainly around the left rear portion of the engine compartment. The presence of greenish residue indicates internal heating of copper wires, a sign of an electrical short circuit occurring. The greenish residue is normally left behind from oxidation as a result of chemical reaction involving the copper wires. This physical evidence would appear to suggest that the cause of fire to the Insured Vehicle could have possibly been due to electrical in nature. See photos 36 – 40 below.

Photo 36 shows the wirings around the left rear portion of the engine compartment which is near to the vicinity where the fire to the Insured Vehicle had likely started. We observed greenish residue on the wirings at the left rear portion of the engine compartment (circled). The presence of greenish residue indicates internal heating of copper wires, a sign of an electrical short circuit occurring. The greenish residue is normally left behind from oxidation as a result of chemical reaction involving the copper wires.

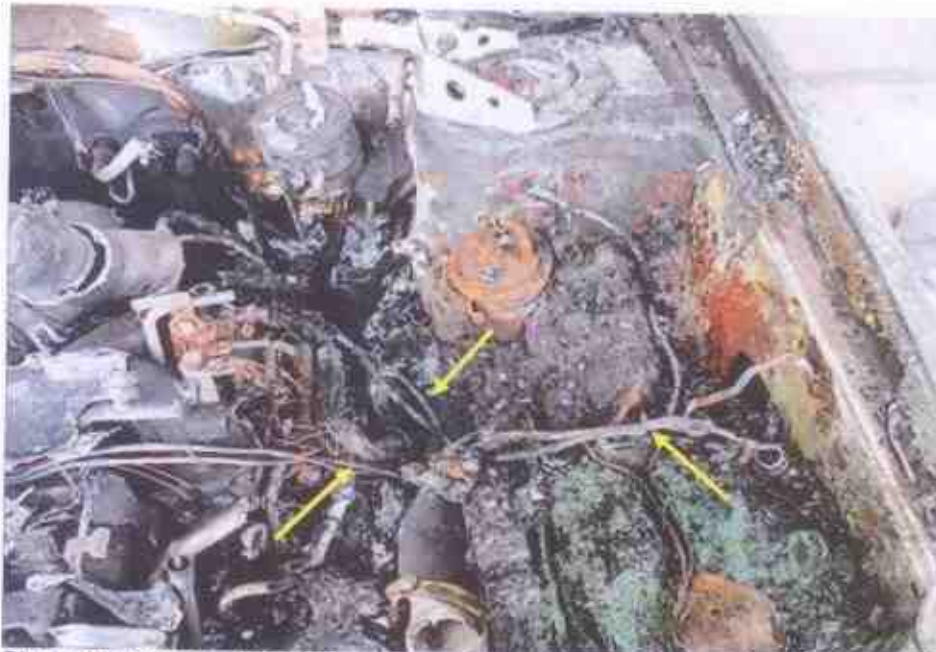
Photo 37 shows a closer view the greenish residue on the wirings at the left rear portion of the engine compartment (yellow arrows). The presence of such greenish residue suggests occurrence of an electrical short circuit.

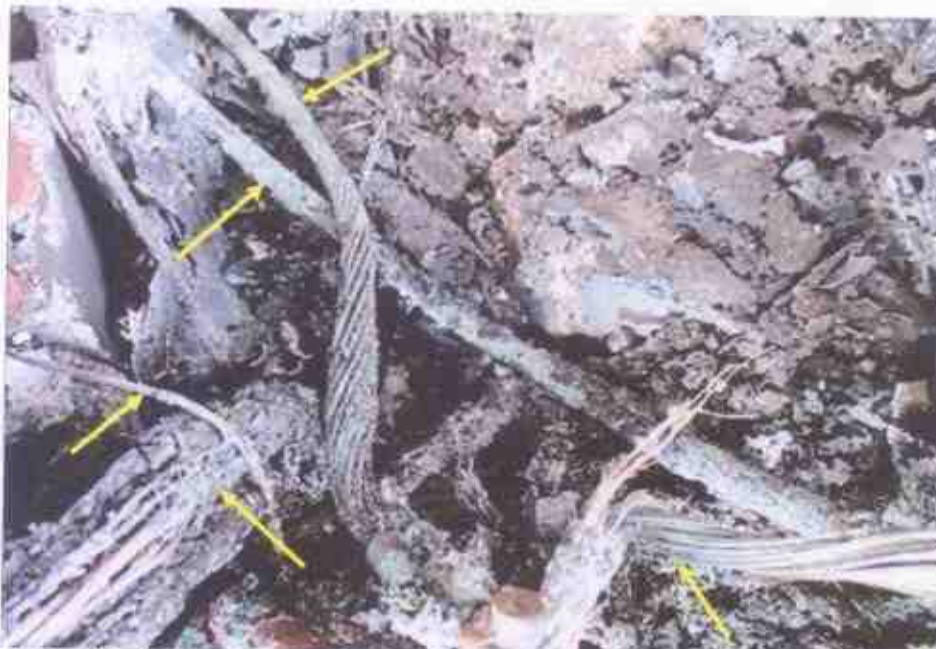
Photo 38 shows a close up view of the greenish residue on the wirings (yellow arrows) at the left rear portion of the engine compartment. The presence of such greenish residue suggests occurrence of an electrical short circuit.

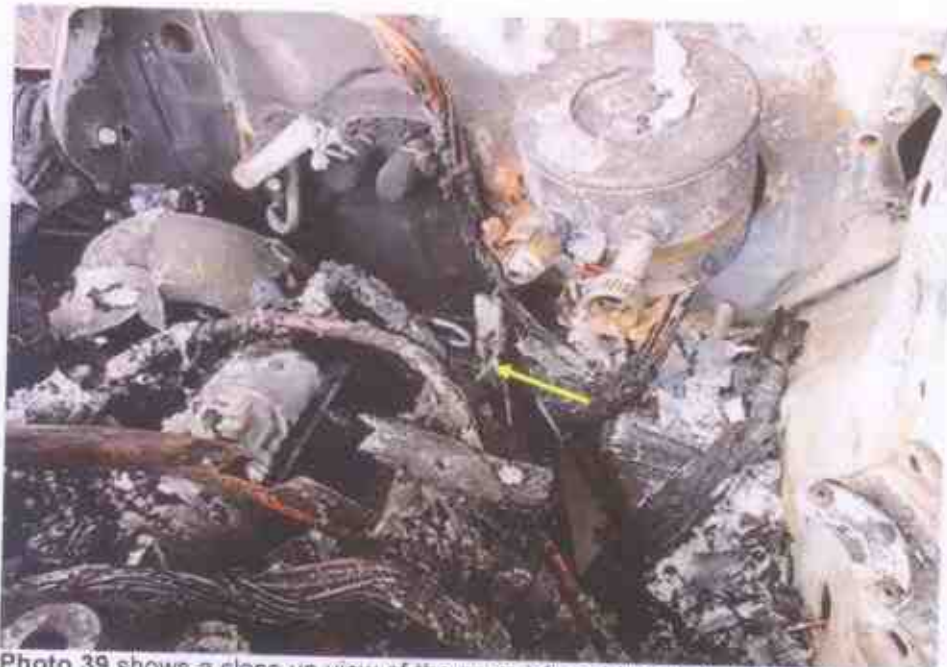
Photo 39 shows a close up view of the greenish residue on the wirings (arrowed) at the left rear portion of the engine compartment arrows). The presence of such greenish residue suggests occurrence of an electrical short circuit.

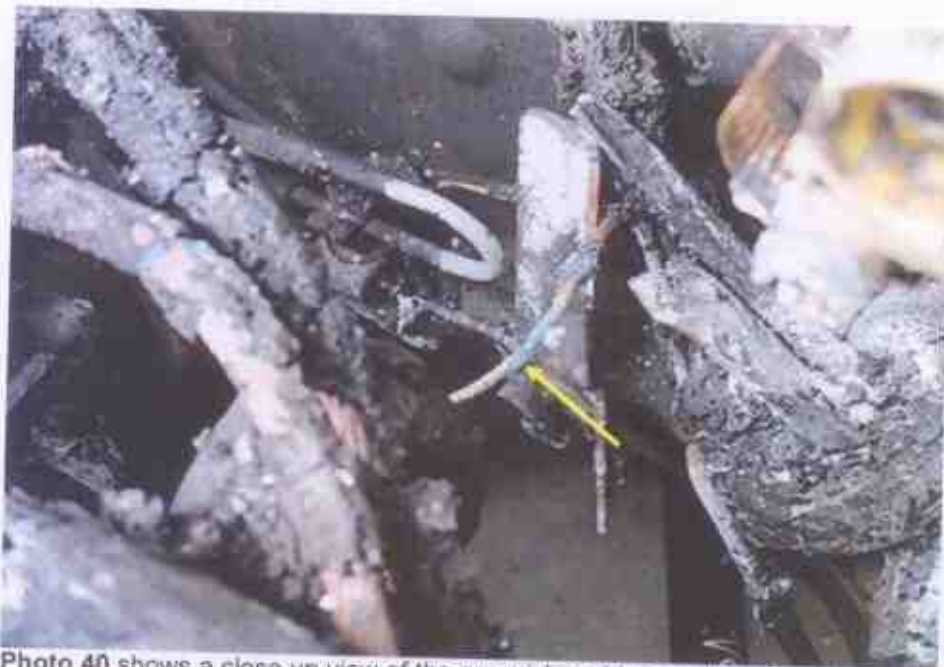
Photo 40 shows a close up view of the greenish residue on the wirings (arrowed) at the left rear portion of the engine compartment. The presence of such greenish residue suggests occurrence of an electrical short circuit.

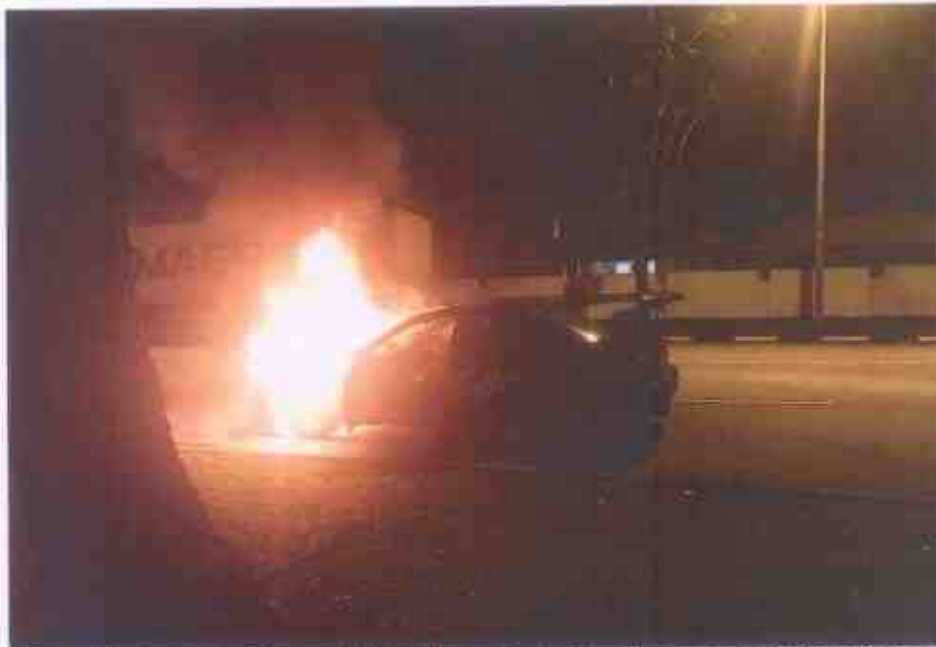
Photo 43 shows the Insured Vehicle on fire before the arrival of the SCDF. In general, the information that could be gathered from this photograph had corresponded to the events that were related to us by Mr Poh, which is the fire started from the front bonnet.

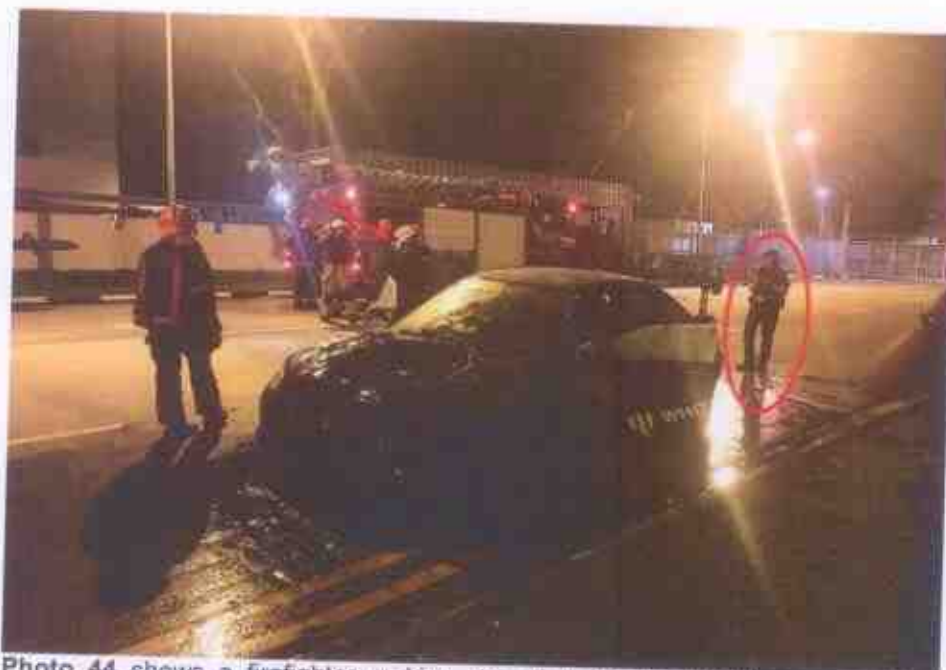
Photo 44 shows a firefighter making sure that the fire had been completely extinguished (arrowed). In general, the information that could be gathered from this photograph had corresponded to the events that were related to us by Mr Poh, which is the police (circled) and SCDF were present at the incident location.
