Your Ref: SHA 4029S  
Our Ref : CI/TP18022837/D

### **INSPECTION REPORT OF A MOTOR TAXI SHA 4029S**

Vehicle Registration No.	: SHA 4029S
Make / Model	: Hyundai AE IONIQ HEV 1.6 DCT
Chassis No	: KMHC851CVKU114848
Year of Registration	: 2018 (October)
Mileage	: N.A. (engine and wiring removed)
6. At the time of my inspection, I had observed that parts at the frontal portion of the motor taxi were removed prior to my inspection. This had included all wiring harness, the engine and the transmission. As a result, the front chassis of the motor taxi was visible.
7. Upon my examination of the front chassis, I note that the left and right front chassis were both bent towards the right, indicating an impact force that was from a left to right direction, at the frontal portion of the motor taxi. See photo 1 – 6 below.

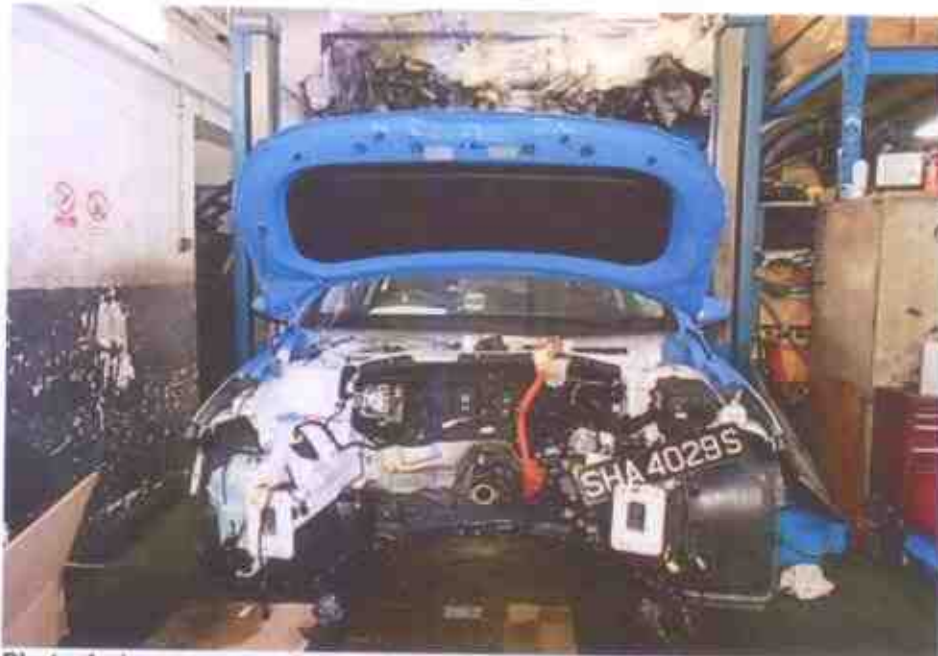
Photo 1 shows a general view of the motor taxi SHA 4029S. Parts at the frontal portion of the motor taxi were removed prior to my inspection. This had included all wiring harness, the engine and the transmission. As a result, the front chassis of the motor taxi was visible

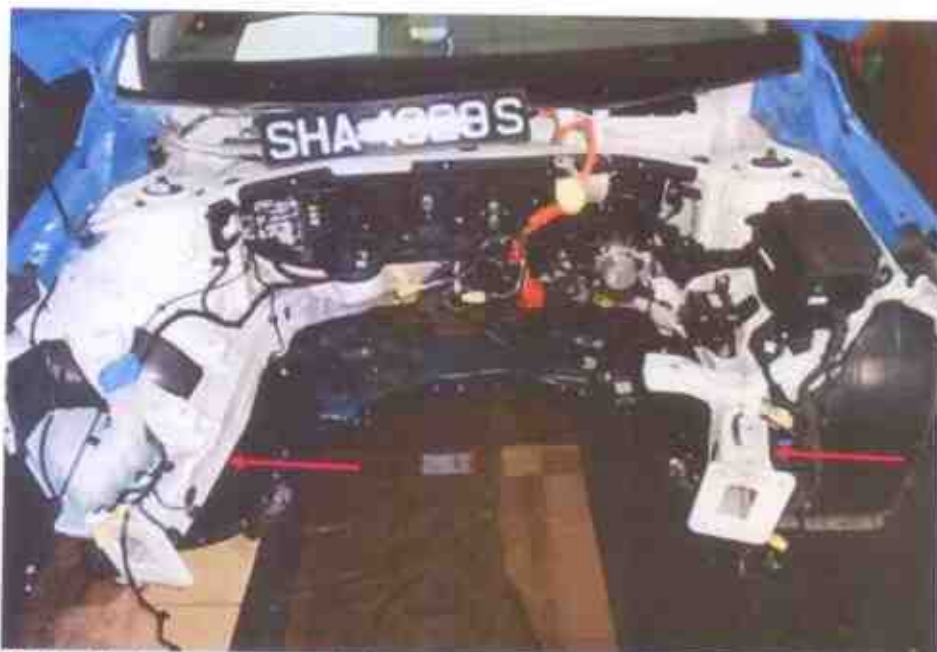
Photo 2 shows a general view of the motor taxi's front chassis. Upon examination of the front chassis, I had observed that the left and right front chassis (arrowed) were both bent towards the right, indicating an impact force that was from a left to right direction, at the frontal portion of the motor taxi.

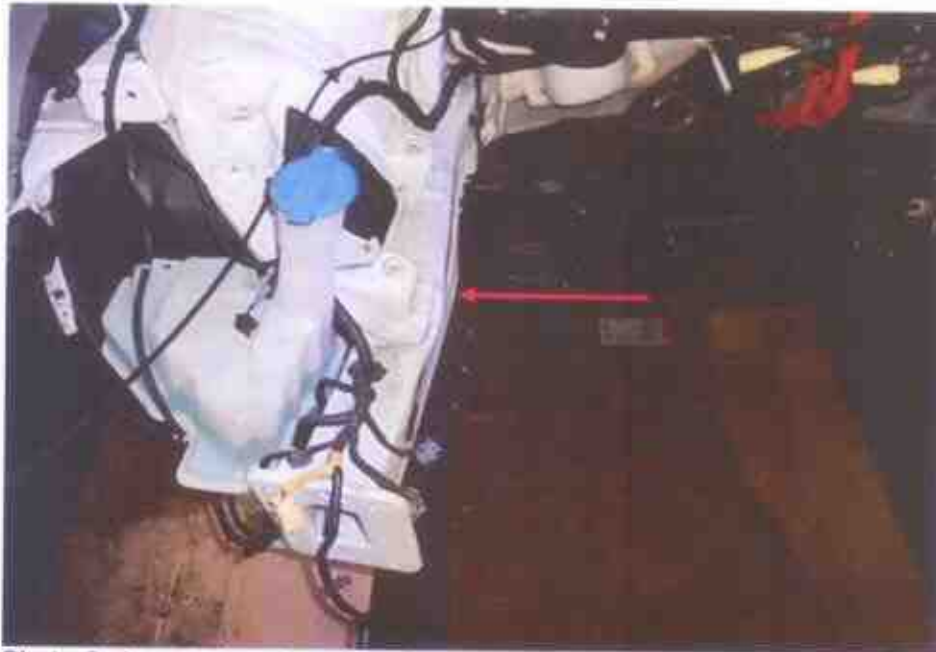
Photo 3 shows a top view of the front right chassis of the motor taxi. The front right chassis was bent towards the right. The centre section (arrowed) of the front right chassis was found to be bent.

8. Given that both the front right and front left chassis of the motor taxi were bent at the centre section, I am of the view that both front right and front left chassis would have to be replaced. Repairing both or either one of the front chassis may compromise or weaken the structural integrity of the motor taxi.

I am therefore of the opinion that the motor taxi should be written off as "Total Loss"

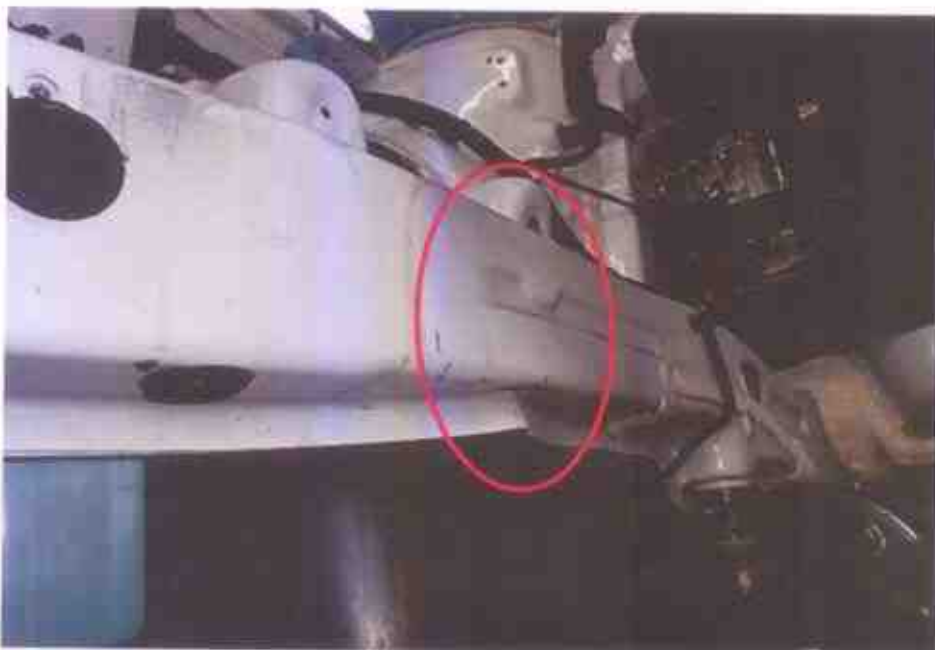
Photo 4 shows a closer view of the centre section of the front right chassis that was found to be bent (circled).

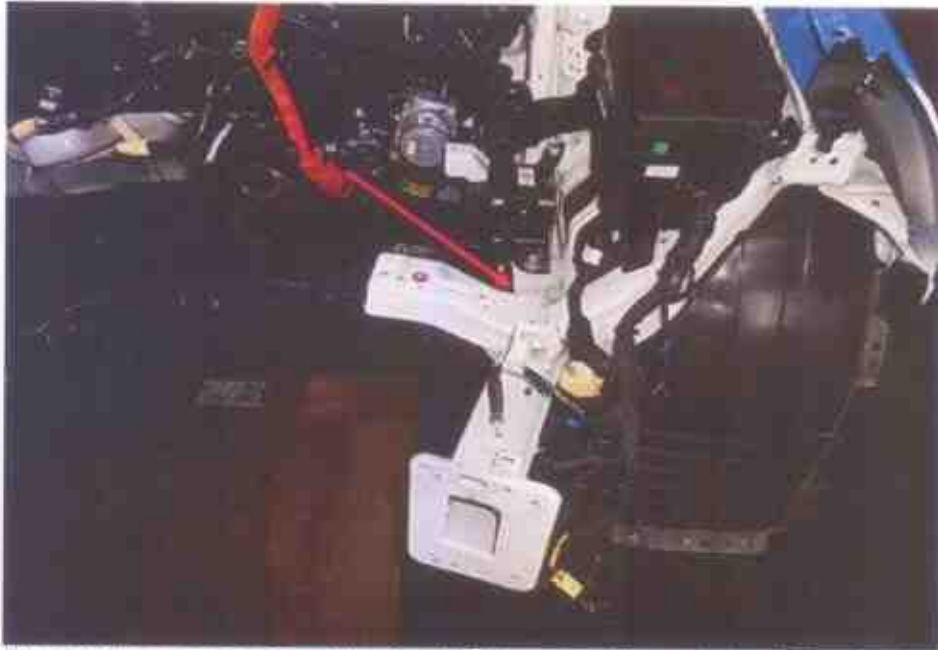
Photo 5 shows a top view of the front left chassis of the motor taxi. The front left chassis was bent towards the right. The centre section (arrowed) of the front left chassis was found to be bent.

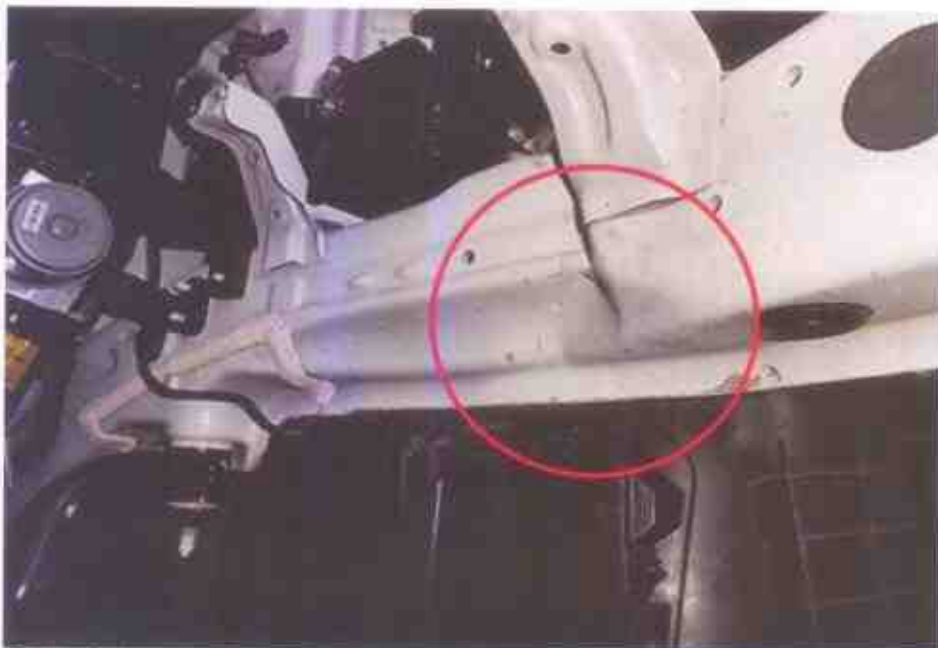
Photo 6 shows a closer view of the centre section of the front left chassis that was found to be bent (circled).
