PRELIMINARY ADVICE OF VEHICLE NO.

SHB 9925S

Please be informed that we had conducted the inspection of the above mentioned vehicle on
20/03/2014 at the premises of M/s Trans-Cab Auto Services Pte Ltd and have the following to report:-

ADJUSTMENT ON REPAIR COST FOR VEHICLE NO. SHB 9925S

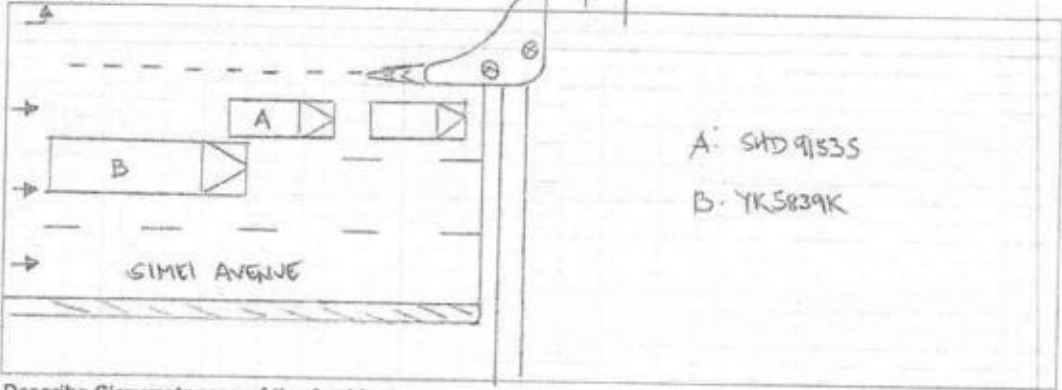
Sketch Plan

PLS. REFER TO GIA REPORT
