Your Ref: BMW 430i
(chassis number WBA4S72060AC38544)
Our Ref : CI/TP18022969/D

24 December 2018

INSPECTION REPORT OF AN UNREGISTERD BMW 430i MOTOR CAR WITH CHASSIS NUMBER WBA4S72060AC38544

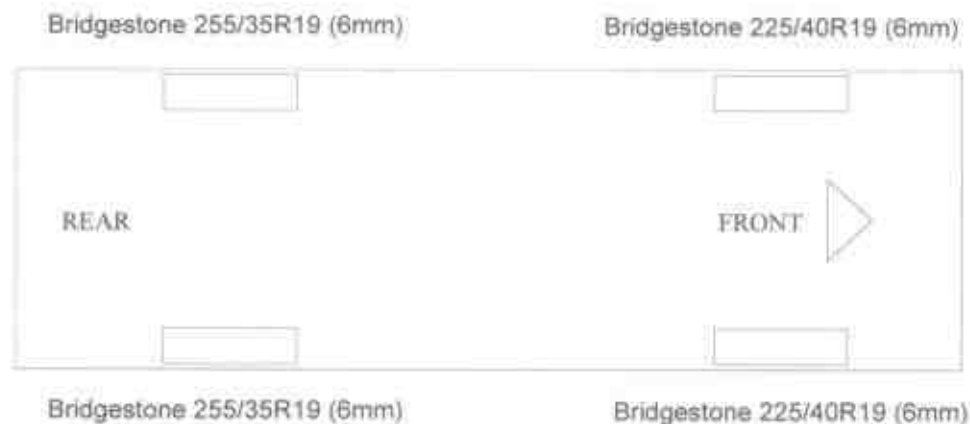
6. It was fitted with 19inch sport wheel rims that were wrapped with tyres that were observed to be of serviceable condition. The tyres were also sufficiently inflated for vehicular operation. The tyre brand, tyre size and approximate remaining tread depth of the 4 tyres of the Motor Car were recorded as follows: -

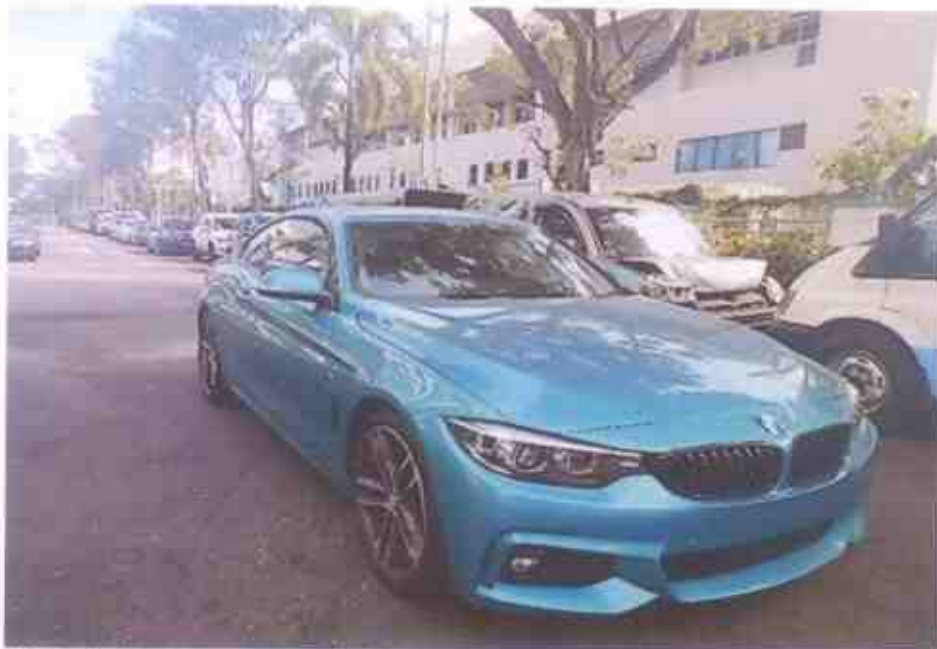
Photo 1 shows a general view of the front right body of the Motor Car at the time of my inspection. The Motor Car was observed to be in relatively good general condition with no loose exterior fittings observed.

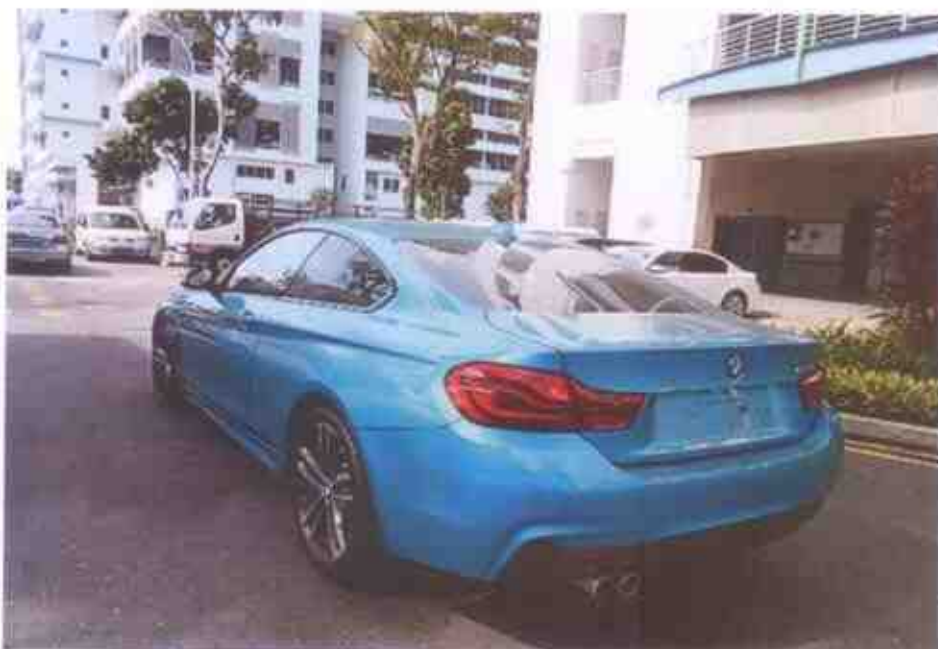
Photo 2 shows a general view of the rear left body of the Motor Car at the time of my inspection. The Motor Car was observed to be in relatively good general condition with no loose exterior fittings observed.

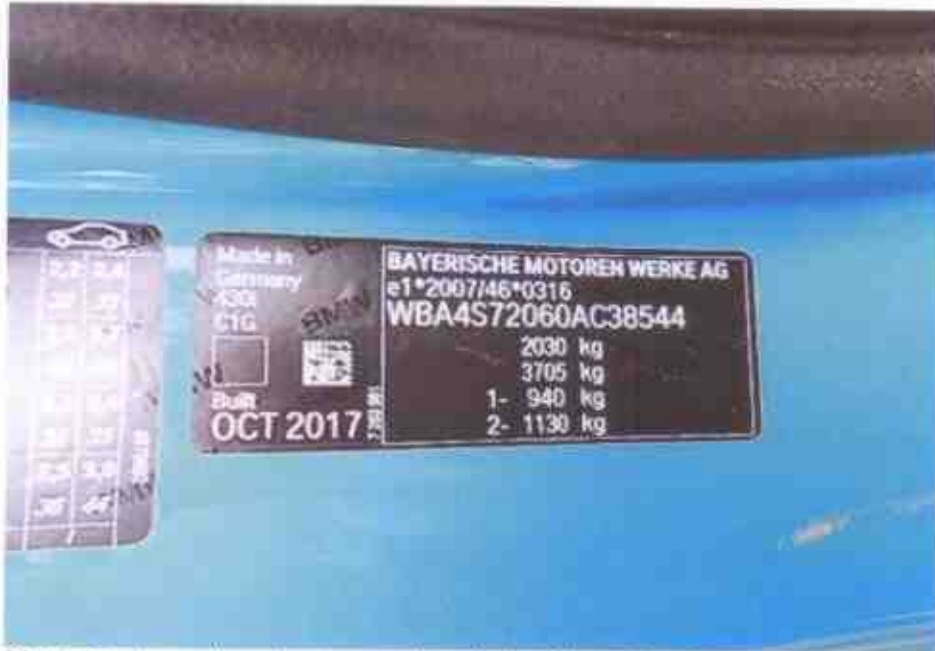
Photo 3 shows the chassis number of the Motor Car. The chassis number recorded was WBA4S72060AC38544.

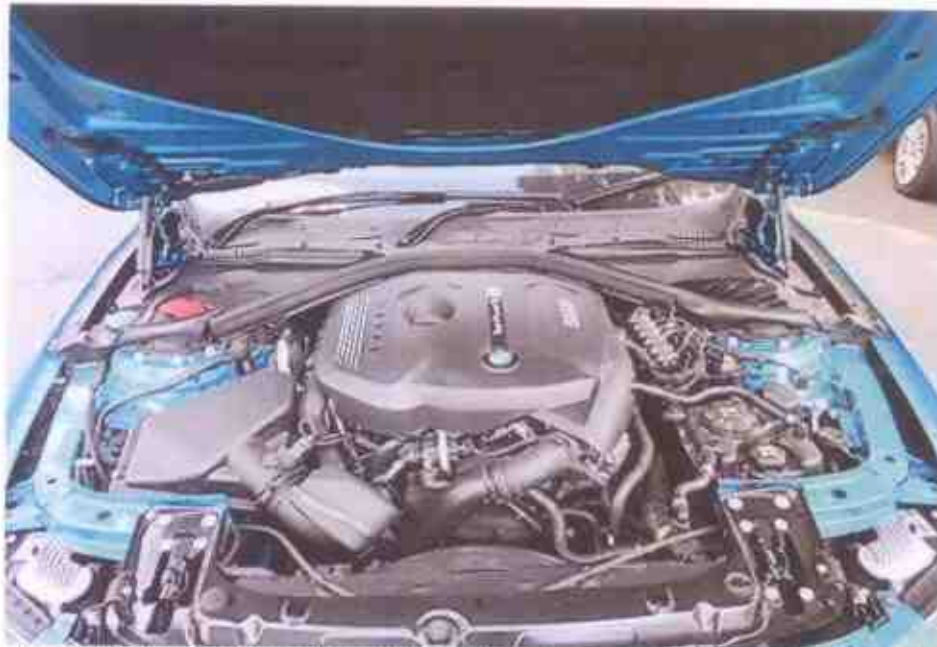
12. My examination of the engine compartment of the Motor Car revealed that the various parts and components inside the engine compartment were all intact and properly fitted. The engine oil, brake fluid and engine coolant were all found to be of sufficient level for operating purposes. Visually, there was also no contamination found to these fluids.
13. My checks on the underside of the Motor Car revealed no sign(s) or indication(s) of fluid leakage and/or fluid stain(s). The engine block and automatic transmission assembly were both secured properly. They were not mounted onto the chassis body or any integral body part of the Motor Car. All undercarriage components of the Motor Car were also observed to be intact and secured in an appropriate manner.

Photo 4 shows a general view of the engine compartment of the Motor Car at the time of my inspection. The various parts and components inside the engine compartment were all observed to be intact and properly fitted. There was also no sign(s) or indication(s) of fluid leak and/or fluid stain found inside the engine compartment.

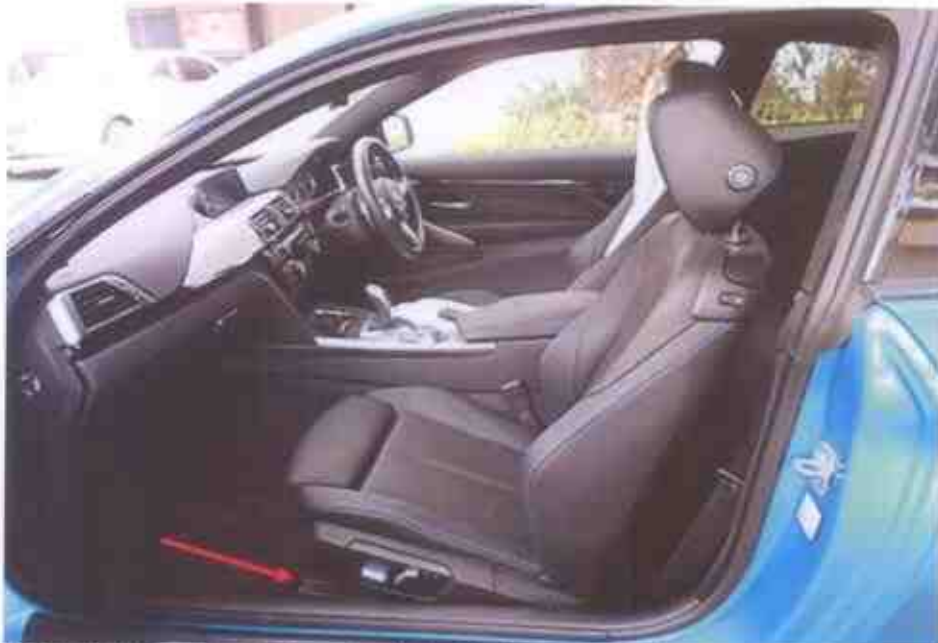
10. The seats of the Motor Car were found to be secured to the floor board of the Motor Car via seat rails bolted onto the floor board. Retractable seat belt reels and pre-tensioners were fitted on all seats of the Motor Car. The seat belt reels were able to be fastened securely to the respective pre-tensioner that is fixed to the side of all the seats.

Photo 5 shows the front seats of the Motor Car, which were secured via seat rails (arrowed) to the floor board. All the seats of the Motor Car were fitted with a retractable seat belt reel and pre-tensioner. The seat belts were also able to be fastened to the pretension that were fitted on the side of each individual seat.

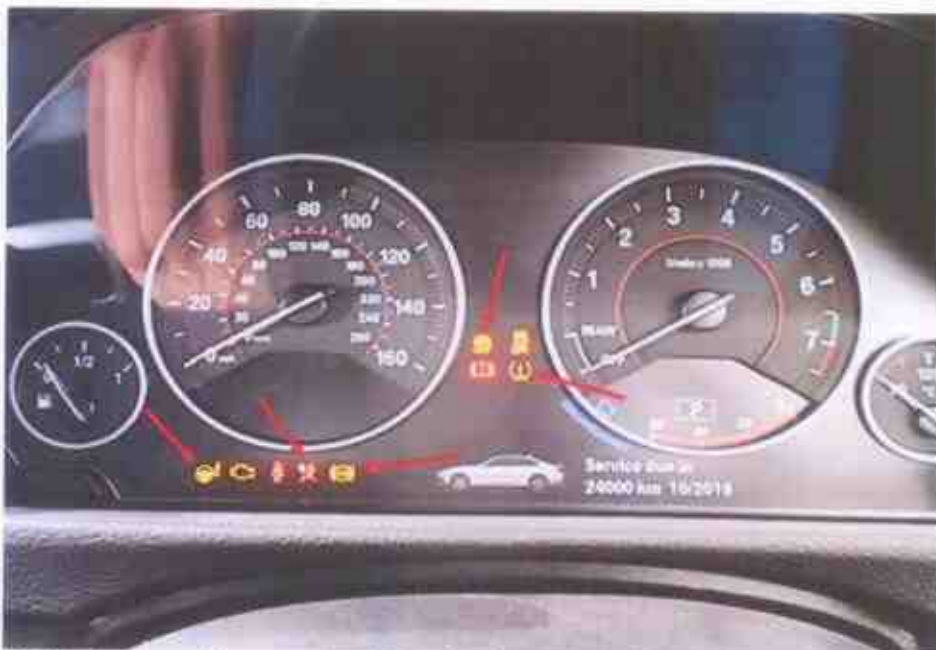
Photo 6 shows the warning lights for the various electronic safety features appearing on the instrument panel of the Motor Car during its self-test when the engine is cranked, in particular the ABS, SRS, IAS, TPM and DSC lights (arrowed).

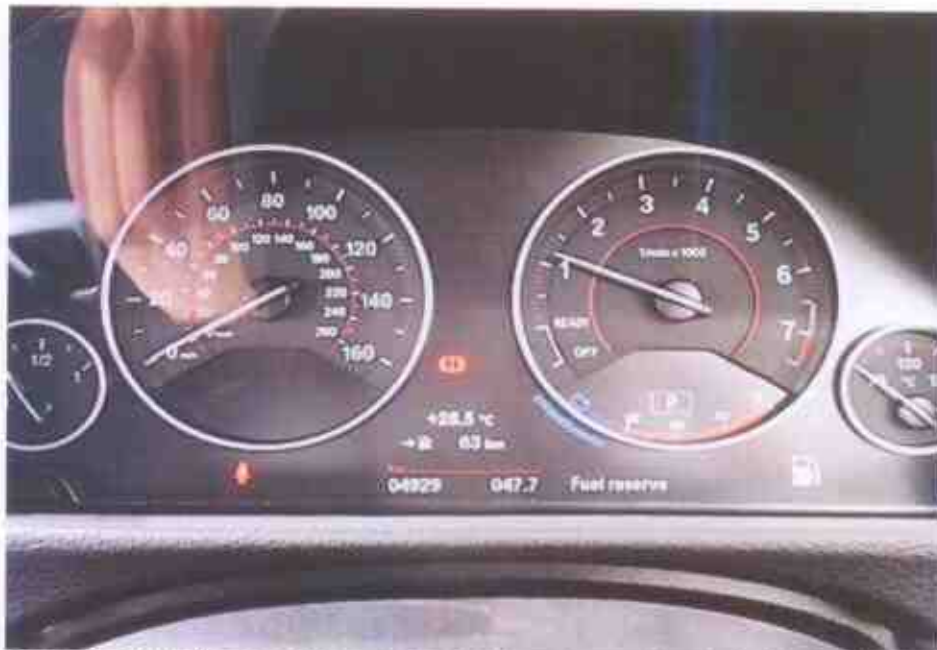
11. The Motor Car's automatic self-test of the functionality of its various electronic safety features like the Anti-Brake Lock System (ABS), Supplemental Restraint System (SRS), Integral Active Steering (IAS), Tyre Pressure Monitor (TPM) and Dynamic Stability Control (DSC) during cranking of the engine had indicated that these electronic systems were in working condition. This was determined from the respective warning lights disappearing from the instrument panel after the self-test.

Photo 7 shows the respective warning lights no longer illuminated, indicating that there is no fault detected to the ABS, SRS, IAS, TPM and DSC systems of the Motor Car during the self-test. These electronic systems were hence in working condition at the time of my inspection.

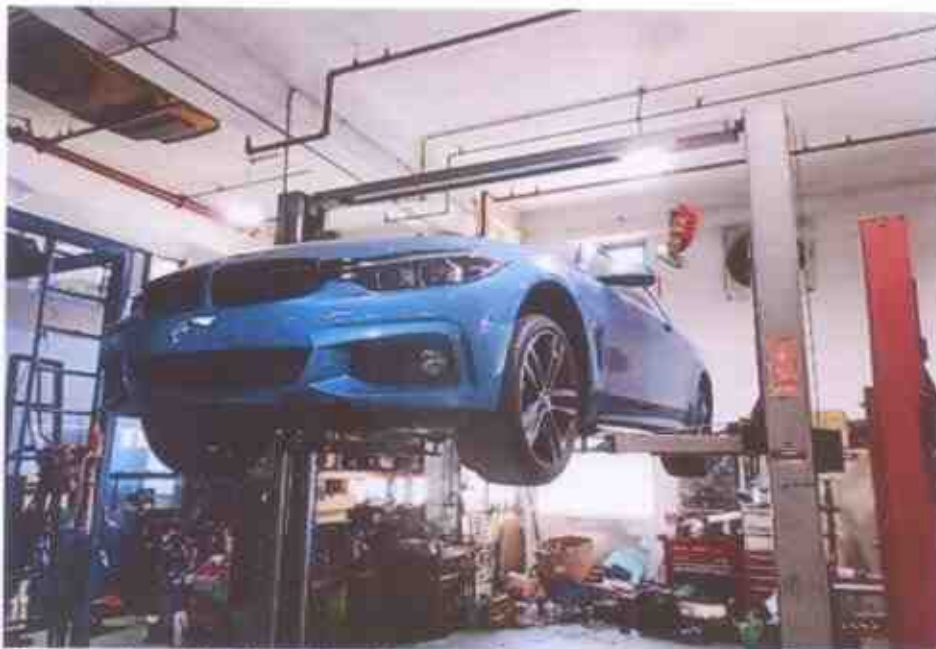
Photo 8 shows the Motor Car hoisted up for checks on its undercarriage. There was no sign(s) or indication(s) of fluid leakage and/or fluid stain(s). The undercarriage components of the Motor Car were also all observed to be intact and secured in an appropriate manner.

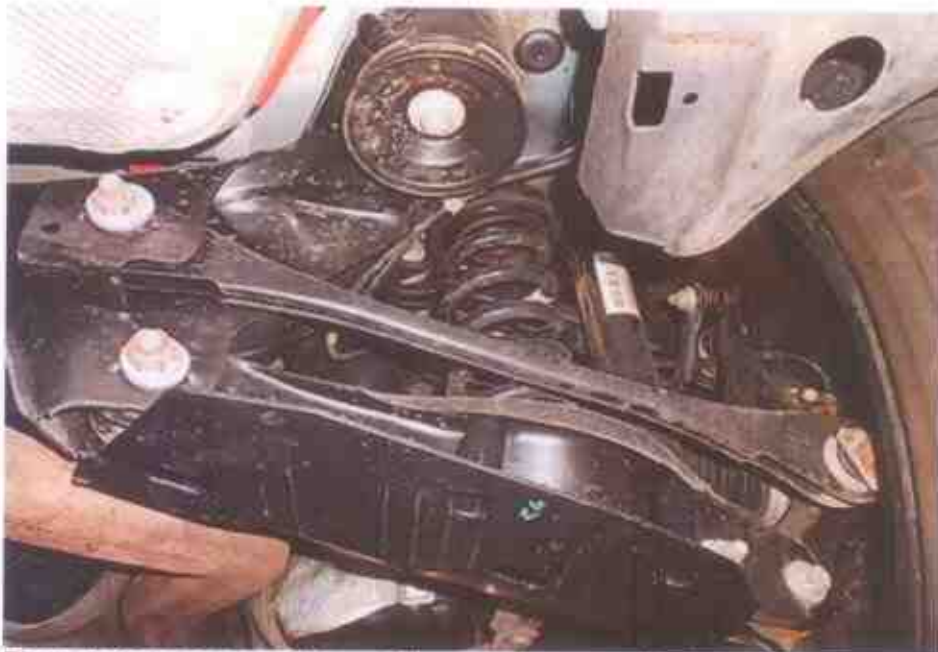
Photo 9 shows a general view of the control arms and linkages at the rear right wheel of the Motor Car. I did not observe any fluid leak and/or fluid stain on the underside of the Motor Car. All of the Motor Car's undercarriage components were observed to be intact and secured in an appropriate manner.

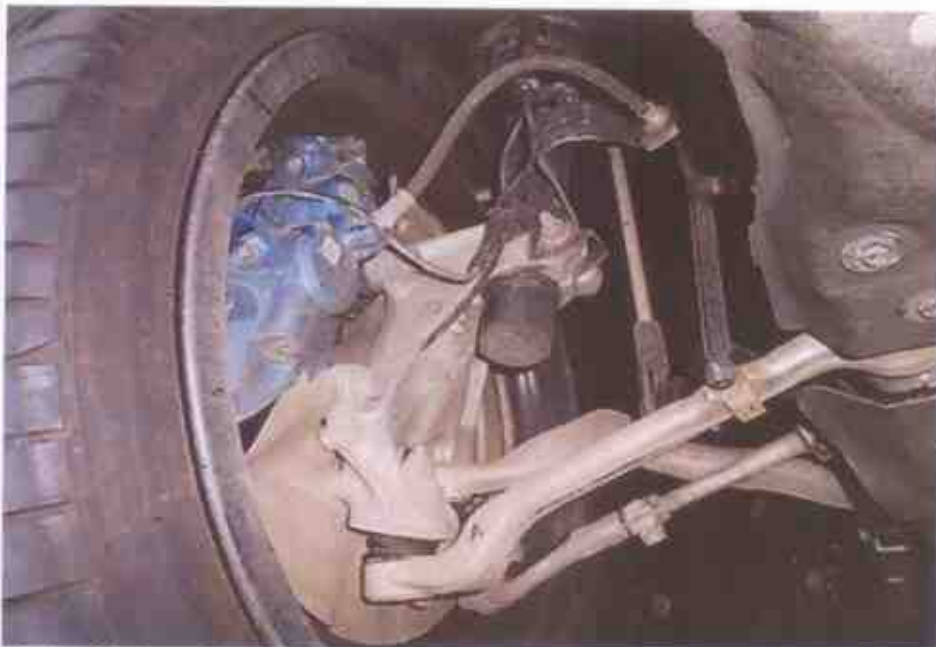
Photo 10 shows the various undercarriage components at the front left wheel of the Motor Car. The mechanical components, control arms and linkages were all found to be intact and secured in an appropriate manner.

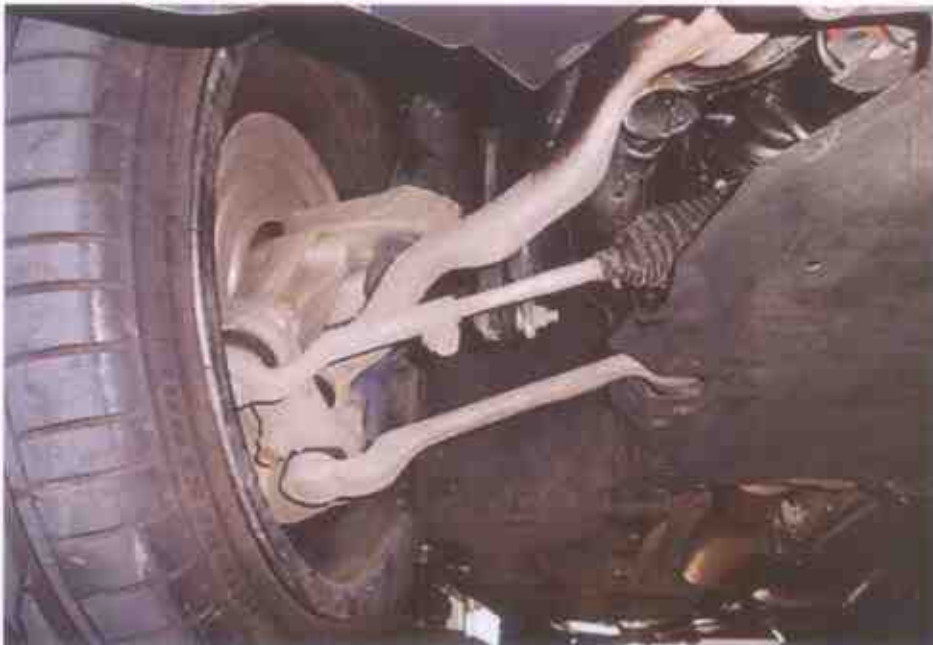
Photo 11 shows the various undercarriage components at the front right wheel of the Motor Car. The mechanical components, control arms and linkages were all found to be intact and secured in an appropriate manner. I also did not observe any fluid leak and/or fluid stain on the underside of the Motor Car.

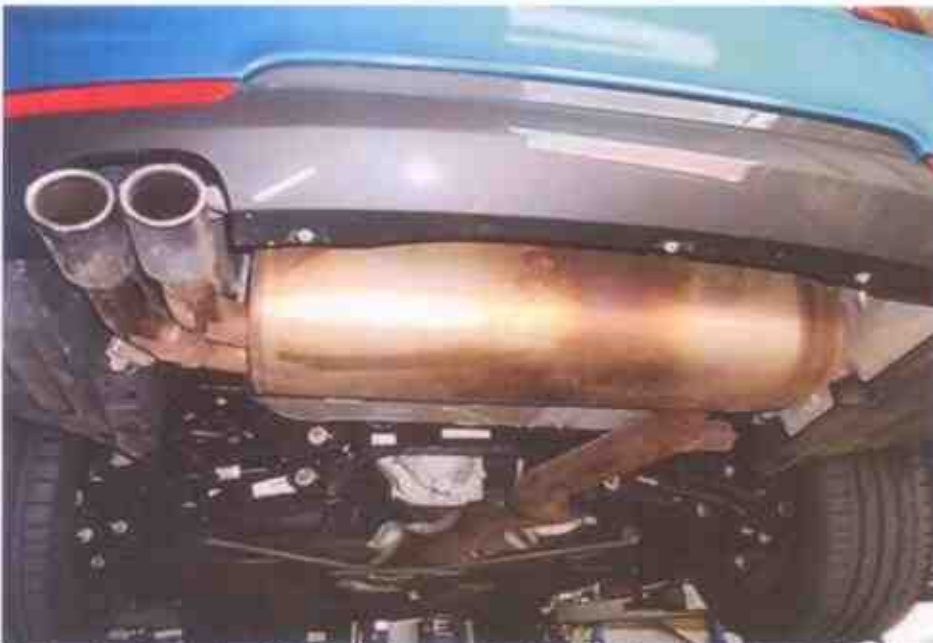
Photo 12 shows the Motor Car's rear exhaust muffler. My examination of the Motor Car's exhaust system revealed no sign(s) or indication(s) of any cut or weld marks along its exhaust pipes and on its rear mufflers.

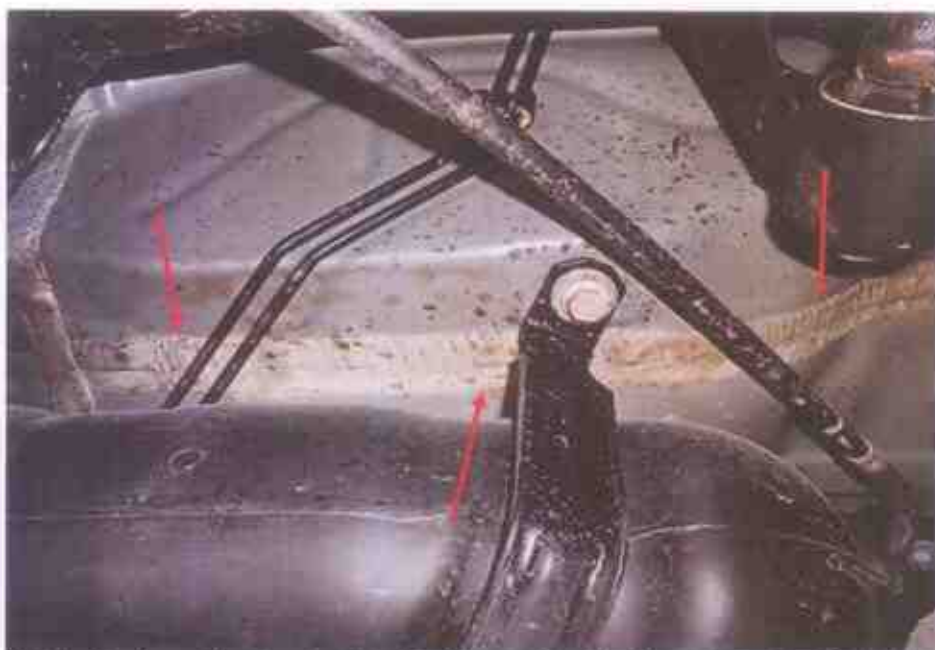
9. Visually, I did not find any weld marks; other than the original spot weld marks, on the chassis body of the Motor Car. The original factory sealant at the joints along the chassis body was also untouched, again indicating that no replacement of the chassis body was carried out; and that the chassis body was originally fitted.

Photo 13 shows the structural body at the underside left centre of the Motor Car. Visually, I did not find any weld marks other than original spot weld marks on the chassis body of the Motor Car. The original factory sealant (arrowed) at the joints along the chassis body was also untouched, indicating no work was done on the chassis body of the Motor Car and that the chassis body was originally fitted.

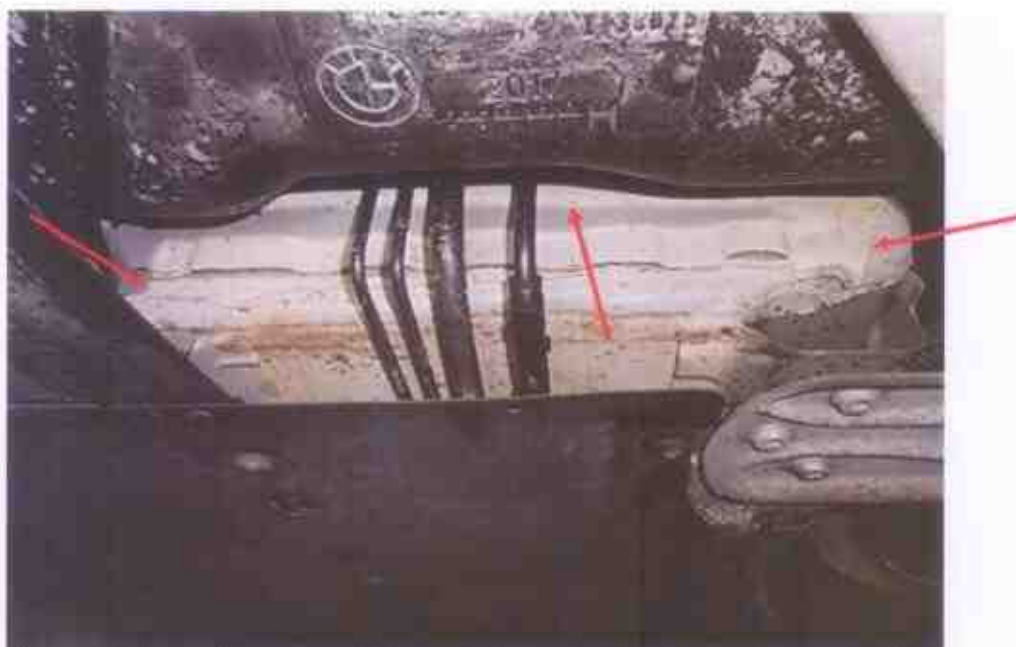
Photo 14 shows the structural body at the underside right centre of the Motor Car. The original factory sealant (arrowed) at the joints along the chassis body was untouched, indicating no work was done on the chassis body of the Motor Car and that the chassis body was originally fitted.

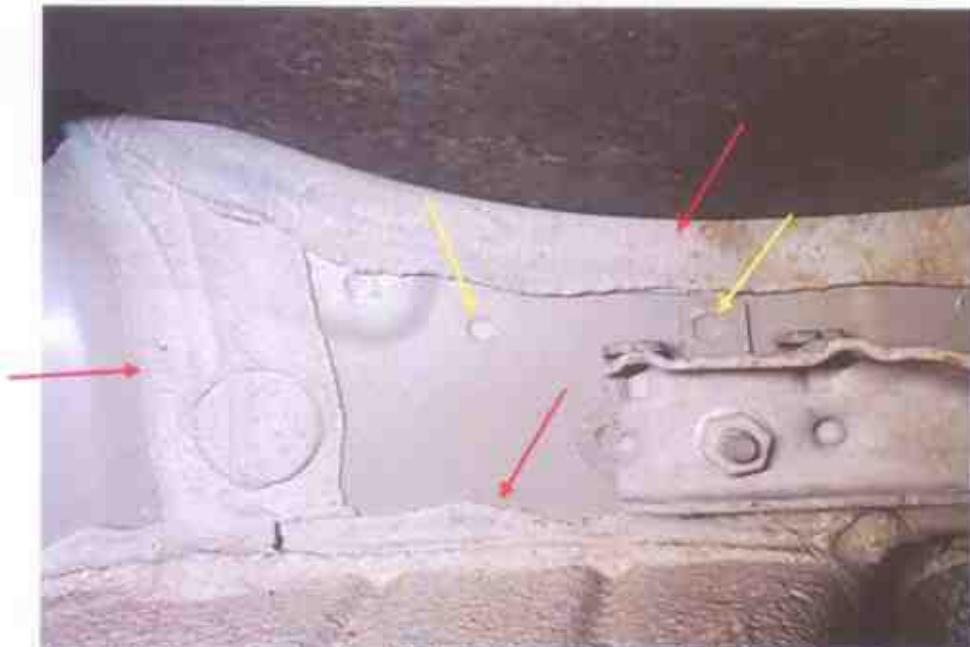
Photo 15 shows the structural body at the rear centre of the Motor Car. Visually, I did not find any weld marks other than original spot weld marks (yellow arrow) on the chassis body of the Motor Car. The original factory sealant (red arrow) at the joints along the chassis body was also untouched, indicating no work was done on the chassis body of the Motor Car and that the chassis body was originally fitted.

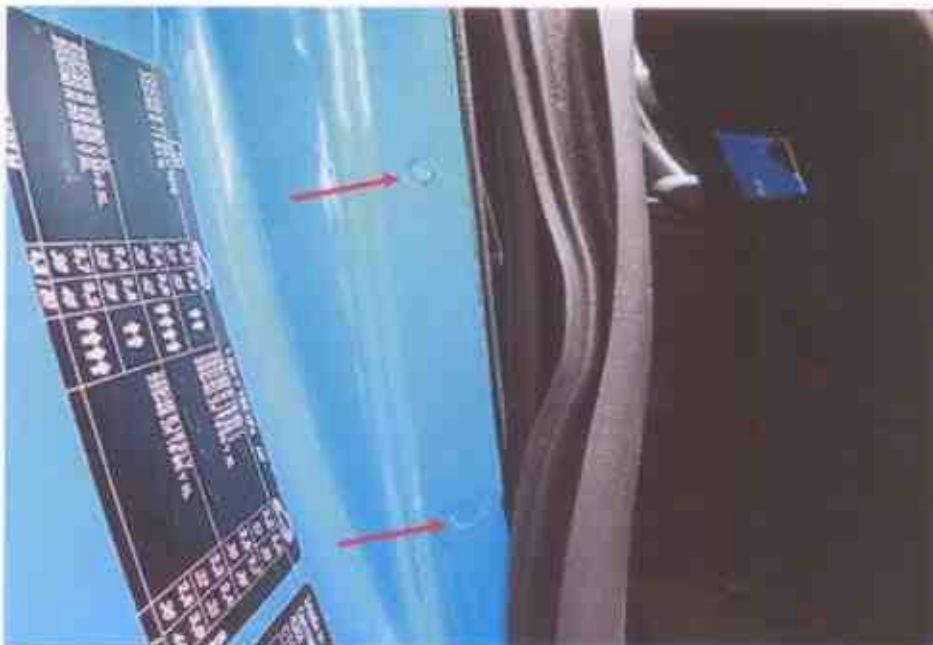
Photo 16 shows the right "B" pillar of the Motor Car. I did not find any weld marks other than original spot weld marks (arrowed) on the body panels of the Motor Car, indicating that there was no re-welding works carried out, and that the body panels of the Motor Car were originally fitted.

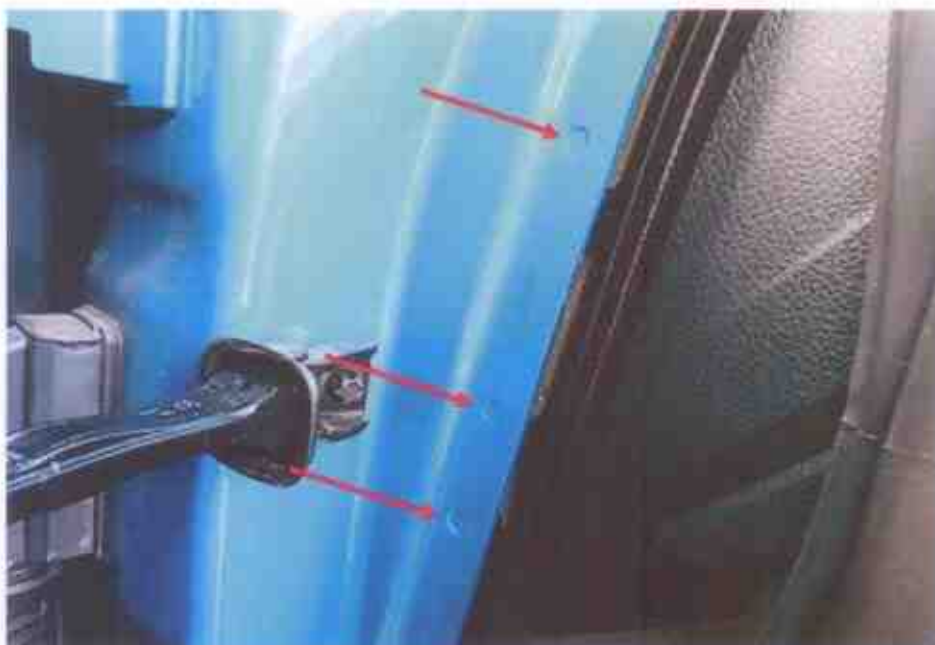
Photo 17 shows the left "A" pillar of the Motor Car. I did not find any weld marks other than original spot weld marks (arrowed) on the body panels of the Motor Car, indicating that there was no re-welding works carried out; and that the body panels of the Motor Car were originally fitted.
