Your Ref: M1806615
Our Ref :CS/TMI18023192/D

04 January 2019

Tokio Marine Insurance Singapore Ltd

TECHNICAL INVESTIGATION REPORT OF FIRE INCIDENT INVOLVING THE INSURED VEHICLE SGR 5364P ON 25 DECEMBER 2018

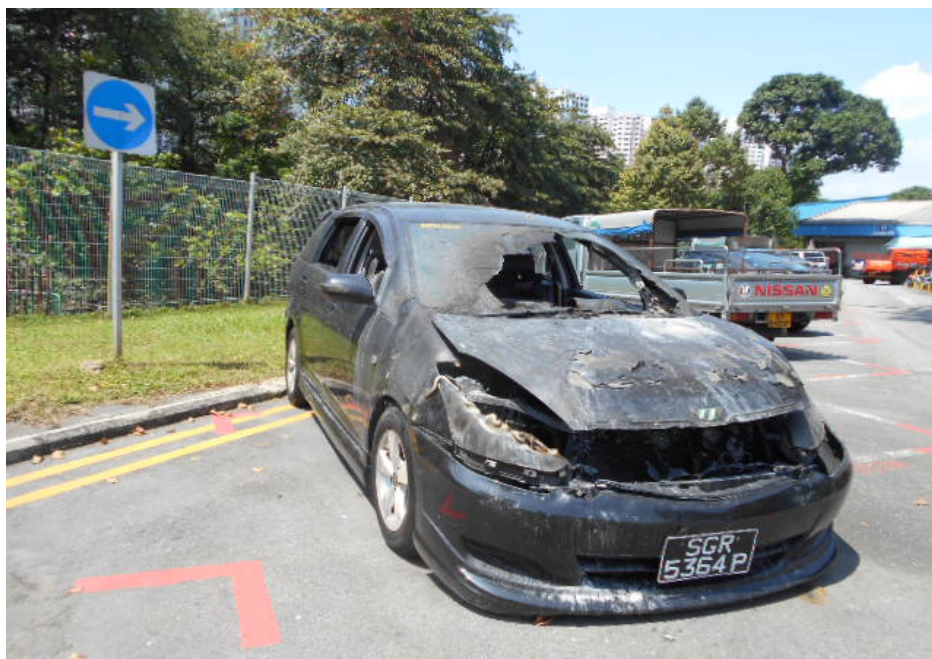
Photo 1 shows a general view of the front right portion of the Insured Vehicle at the time of my inspection. The fire damage to the Insured Vehicle was confined to its frontal portion. Its front bumper, front bonnet, front grille, front right headlamp and front right fender were amongst the body parts that were found to have been affected as a result of the fire.

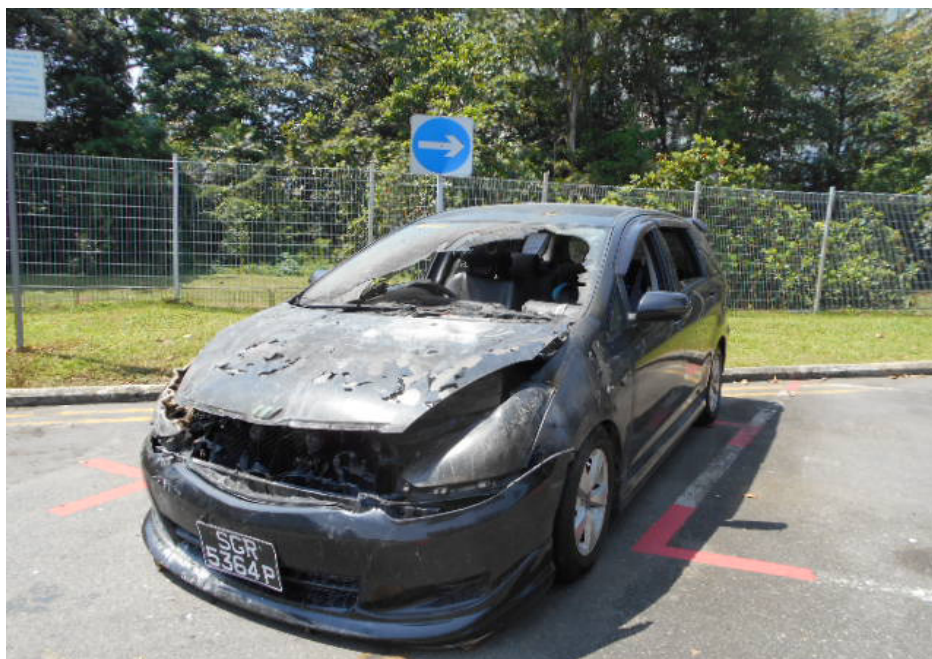
Photo 2 shows a general view of the front left portion of the Insured Vehicle. The fire damage to the Insured Vehicle was confined to its front portion. Its front bumper, front bonnet, front left headlamp and front left fender were affected as a result of the fire. Its front windscreen was also shattered.

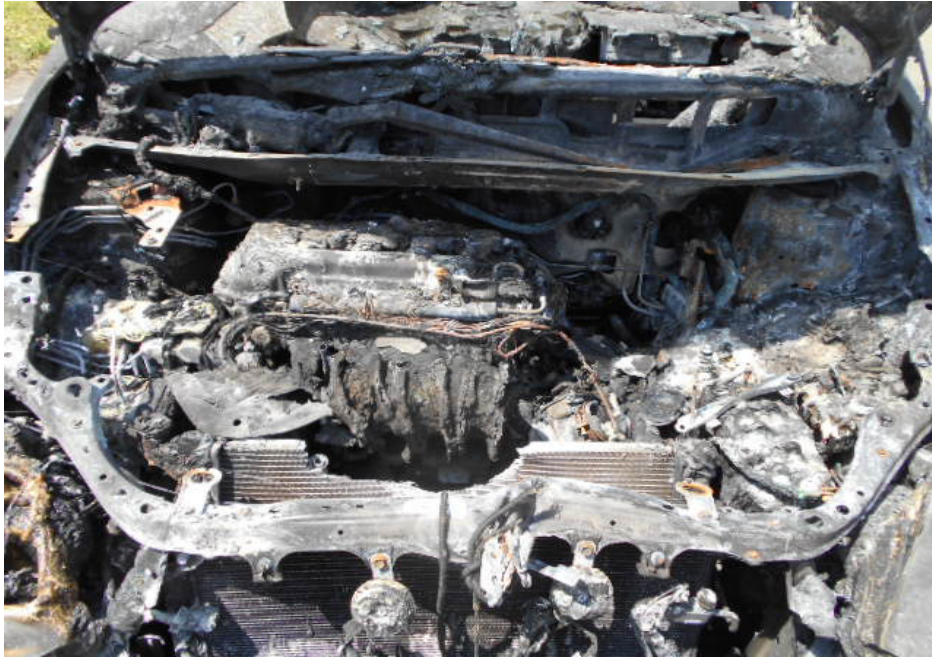
Photo 3 shows the engine compartment of the Insured Vehicle at the time of my inspection. The entire engine compartment of the Insured Vehicle was observed to be severely burnt. Most of the parts inside the engine compartment were burnt and/or melted as a result of the fire. This include the radiator, air intake manifold, fuse box, various rubber hoses and pipes amongst others.

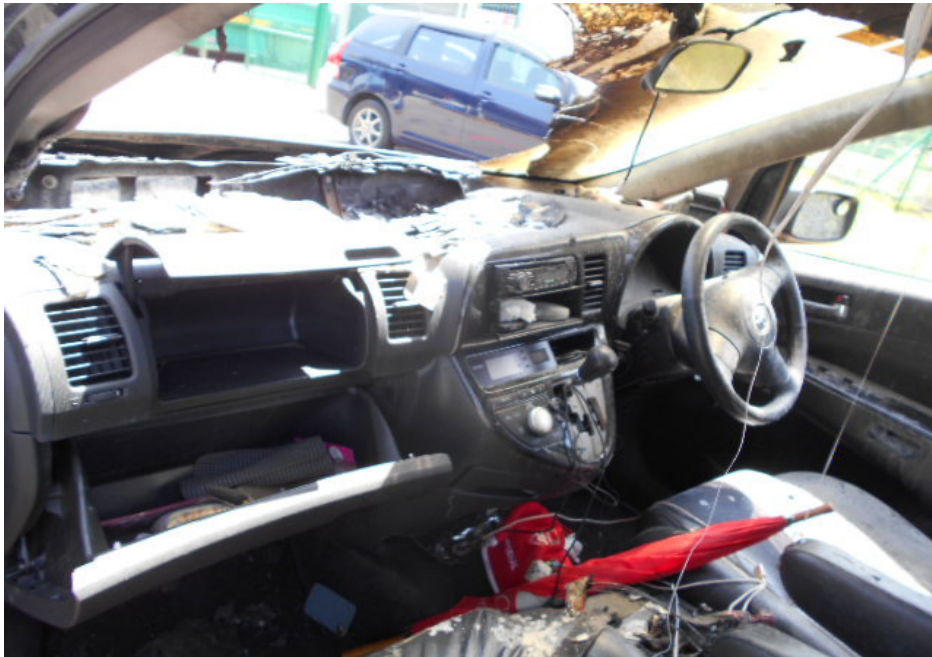
Photo 4 shows the interior compartment of the Insured Vehicle, which was observed to be partially burnt and/or melted at the front area. The front dashboard, various trims and roof upholstery were amongst the parts that were burnt and/or melted as a result of the fire.

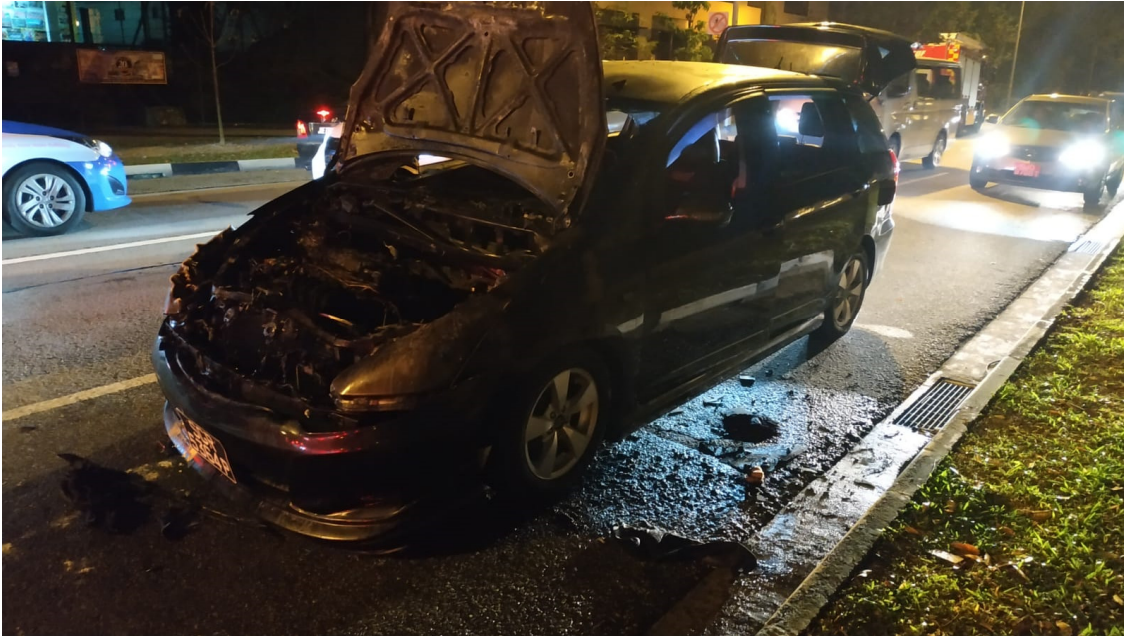
Photo 5 shows a general view of the Insured Vehicle at the incident scene after the fire was extinguished. The Insured Vehicle could be seen stopped along the left side of a 2-lane dual direction roadway. Generally, the information that could be gathered from the incident scene photographs provided by Mr Lee had corresponded to the events that he had related to me.

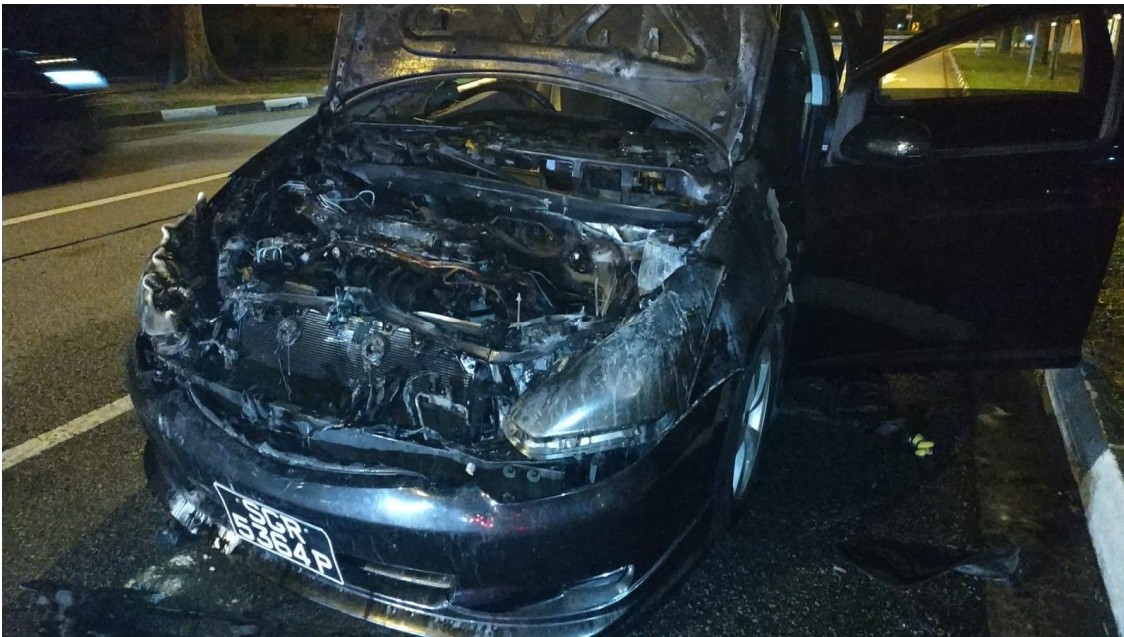
Photo 6 shows a general view of the Insured Vehicle with its frontal portion burnt as a result of the fire. The damage of fire nature to the Insured Vehicle, as seen from the photographs provided, was similar to what I had observed during my inspection of the Insured Vehicle.

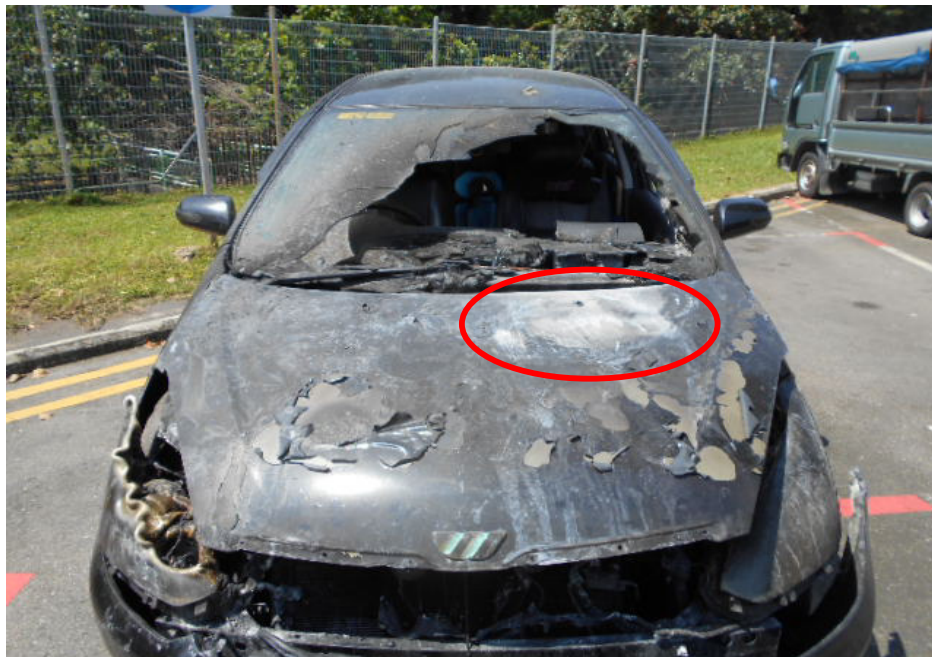
17. Firstly, the burnt pattern of the Insured Vehicle indicates that the fire had occurred from its engine compartment. High heat intensity burned marks (whitish burn marks) were formed at the rear left area of the front bonnet. These whitish burn marks are a result of exposure to prolong heat intensity. Rust would normally start to develop around these areas soon after a fire as prolonged exposure to high heat intensity usually causes steel/metal material body parts to be exposed to natural environmental condition.

Photo 7 shows the whitish burn marks (circled) that were formed on the rear left area of the Insured Vehicle's front bonnet. Such whitish burn marks are a result of exposure to prolong heat intensity. Following the characteristic of heat rising upwards, the fire to the Insured Vehicle can then be determined to have originated around the rear left area of the engine compartment.

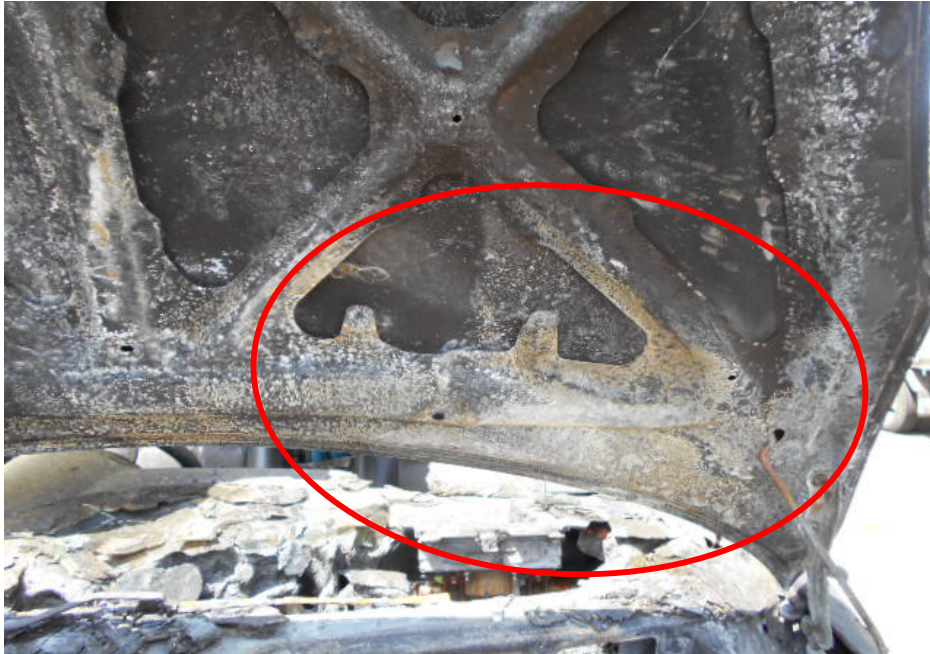
18. Correspondingly, the underside of the front bonnet at the rear left area was found with similar high heat intensity burn marks (whitish burn marks). Rust had also started to develop at this area. Following the characteristic of heat rising upwards, the burn pattern of the front bonnet would therefore indicate that the origin of fire was at the rear left area of the Insured Vehicle's engine compartment. See photo 7 - 9 below.

Photo 8 shows the whitish burn marks and rust that had developed (circled) on the underside of the front bonnet, directly under the area where similar whitish burn marks were formed. These whitish burn marks are a result of exposure to prolong heat intensity and can typically be used to determine the origin of fire.

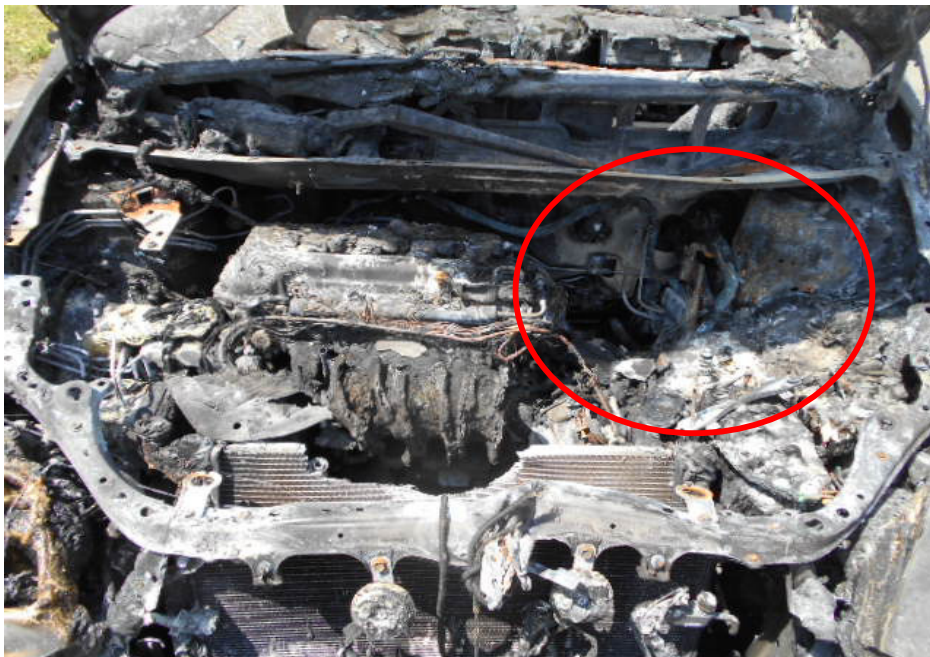
Photo 9 shows a general view of where the fire to the Insured Vehicle had originated, which was around the rear left area of the engine compartment (circled). This was established basing on the burn pattern (whitish burn marks and rust) that was formed on the Insured Vehicle's front bonnet.

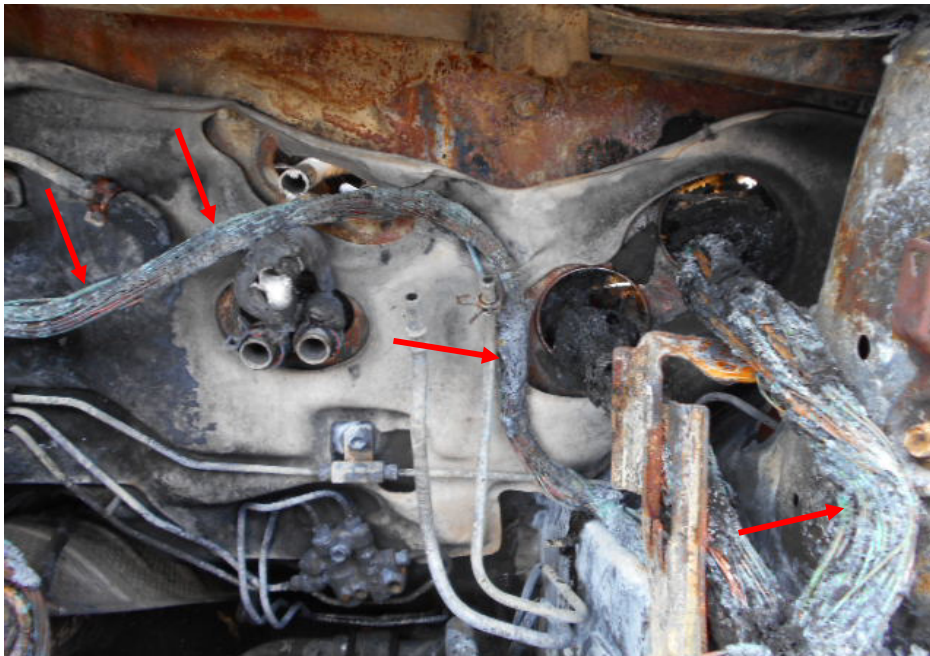
19. Upon closer examination of the area around the rear left of the engine compartment, which was where the fire to the Insured Vehicle had likely started, I had found greenish residue on several stretches of original factory fitted wirings. The presence of greenish residue indicates internal heating of copper wires, a sign of an electrical short circuit occurring. The greenish residue is normally left behind from oxidation as a result of chemical reaction involving the copper wires. This physical evidence would then appear to suggest that the cause of fire to the Insured Vehicle was due to electrical in nature. See photo 10 – 12 below.

20. To further explain briefly, the rubber insulation of the wires and/or wiring harness in motor vehicles may lose its flexibility and become hardened after a prolong period of time. The hardened rubber insulation may then become brittle and break off bits by bits, exposing live wires that may come into contact with each other and/or the metal body of the vehicle, creating sparks that could ignite a fire. Heat within the engine compartment during engine operation could accelerate this hardening of rubber insulations, and any other rubber material parts within the engine compartment.

Photo 10 shows the wirings around the rear left of the engine compartment, which was where the fire to the Insured Vehicle had likely started. Greenish residue (arrowed) was found on multiple stretches of wirings. These wirings were original factory fitted wirings. The presence of such greenish residue suggests occurrence of an electrical short circuit. This physical evidence would then appear to suggest that the cause of fire to the Insured Vehicle was due to electrical in nature.

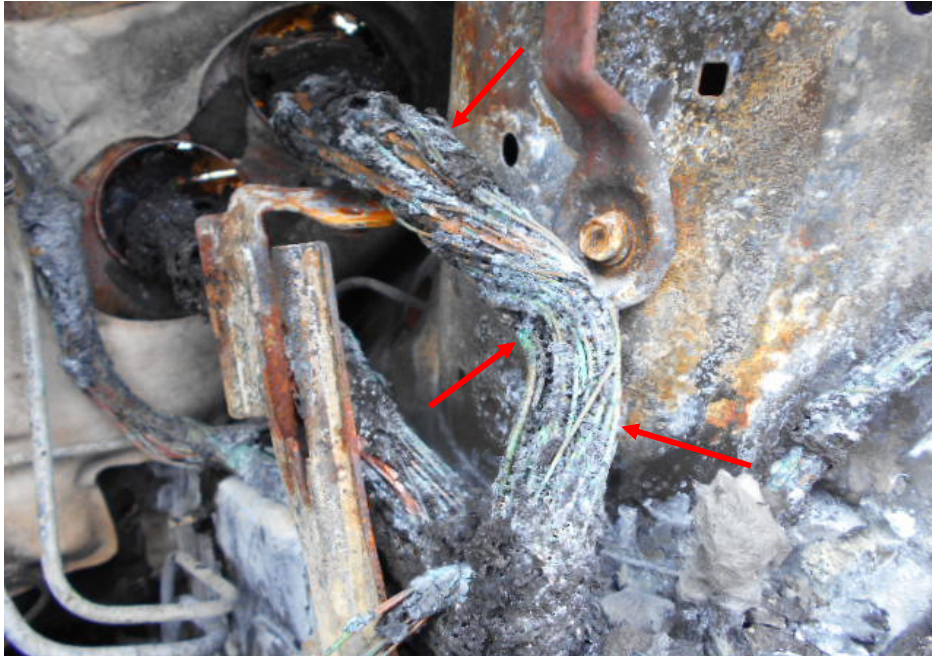
Photo 11 shows a closer view the wirings at the rear left area of the Insured Vehicle's engine compartment that were found with greenish residue (arrowed) The presence of such greenish residue suggests occurrence of an electrical short circuit.

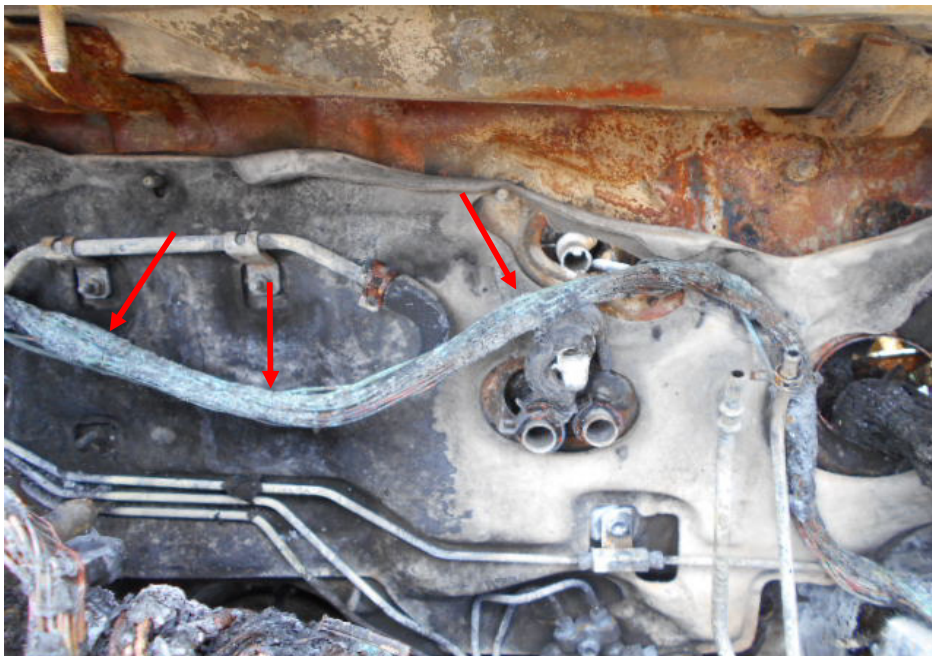
Photo 12 shows another stretch of wirings in the vicinity of the rear left area of the Insured Vehicle's engine compartment that were found with greenish residue (arrowed) The presence of such greenish residue suggests occurrence of an electrical short circuit. This physical evidence would then appear to suggest that the cause of fire to the Insured Vehicle was due to electrical in nature.

23. Having investigated and technically analysed the damages of burnt nature to the Insured Vehicle, I am of the view that the cause of fire to the Insured Vehicle was of electrical in nature. For this particular case, the fire had originated along the wirings inside the engine compartment, around the rear left of the engine compartment. The wirings were original factory wirings of the Insured Vehicle.

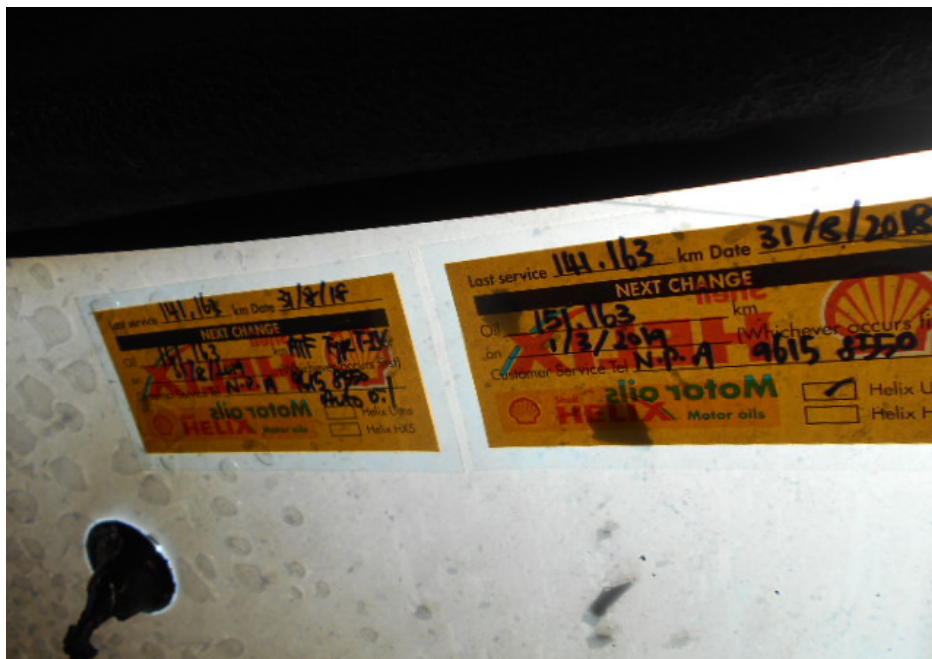
22. With regard to the servicing and maintenance of the Insured Vehicle, I had found, at the time of my inspection. 2 sticker decals pasted on the front windscreen of the Insured Vehicle. The date written on the decals were 31 August 2018 for the replacement of transmission fluid and engine oil of the Insured Vehicle. The mileage of the Insured Vehicle at 31 August 2018 was 141,163km as seen from the 2 decals. During my telephone conversation with Mr Lee, he had informed me that the last servicing of the Insured Vehicle was in August 2018 and the information that I was able to gather from the 2 decals had corresponded to the information that was provided by him. See photo 13 below.

Photo 13 shows the 2 sticker decals that were pasted on the front windscreen of the Insured Vehicle. The decals were related to the last servicing of the Insured Vehicle and the information written on the 2 decals had corresponded to the information pertaining to the last servicing of the Insured Vehicle that was related to me by Mr Lee during my telephone conversation with him on 28 December 2018.
