SH 8159G - CCS / AT113013429 / Ysb392

**INITIAL INSPECTION REPORT OF VEHICLE NO. SH 8159G**

**1. Policy Particulars :- THIRD PARTY CLAIM**

### ADJUSTMENT ON REPAIR COST FOR VEHICLE NO. SH 8159G

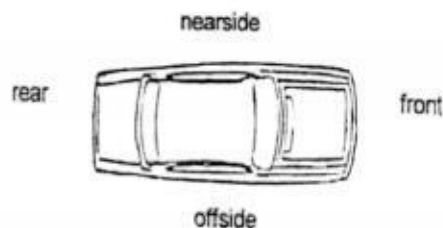
The vehicle sustained damages at the n/s front and o/s front portion

Comments/Present Status:  
Damages Consistent
