Your Ref: D19000011MFSH  
Our Ref : CI/FCI19000288/D

05 January 2019

**TECHNICAL INVESTIGATION REPORT OF FIRE INCIDENT INVOLVING THE INSURED VEHICLE SHC 8497L ON 23 DECEMBER 2018**

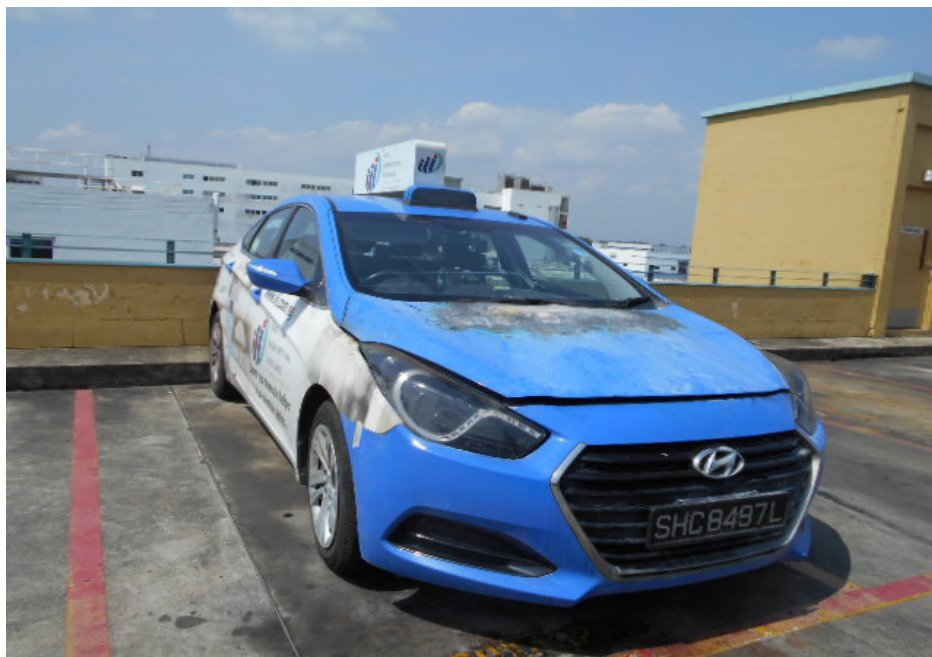
**Photo 1** shows a general view of the front right body of the Insured Vehicle at the time of my inspection. The fire damage was confined to the engine compartment of the Insured Vehicle. Exteriorly, only the front bonnet and front windscreen were affected by the incident. The interior compartment and the rear portion of the Insured Vehicle were unaffected.

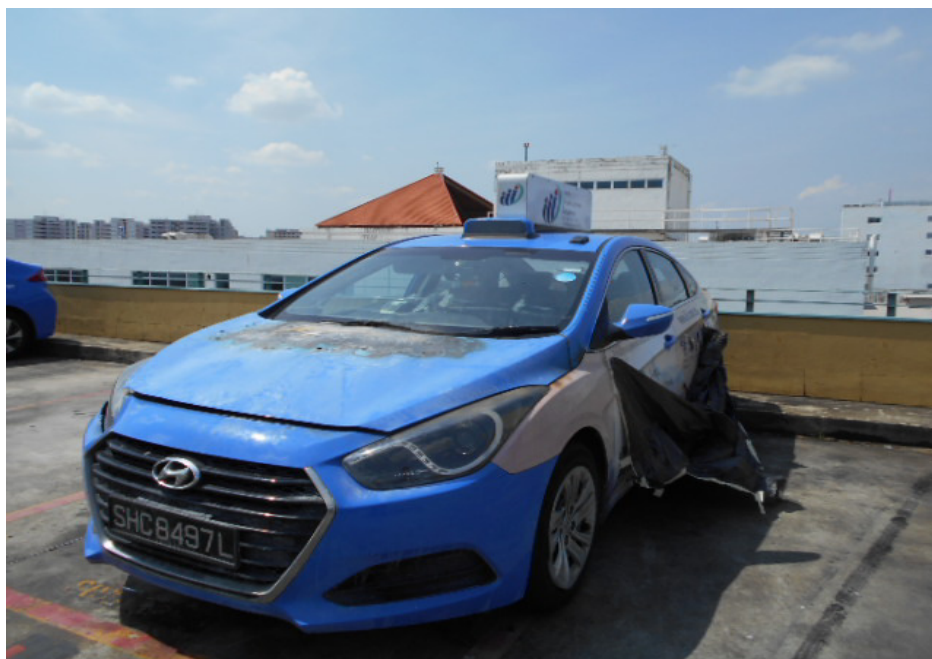
**Photo 2** shows a general view of the front left body of the Insured Vehicle at the time of my inspection. The fire damage was confined to the engine compartment of the Insured Vehicle. Exteriorly, only the front bonnet and front windscreen were affected by the incident. The mileage of the Insured Vehicle could not be recorded due to its wirings being affected by the fire.

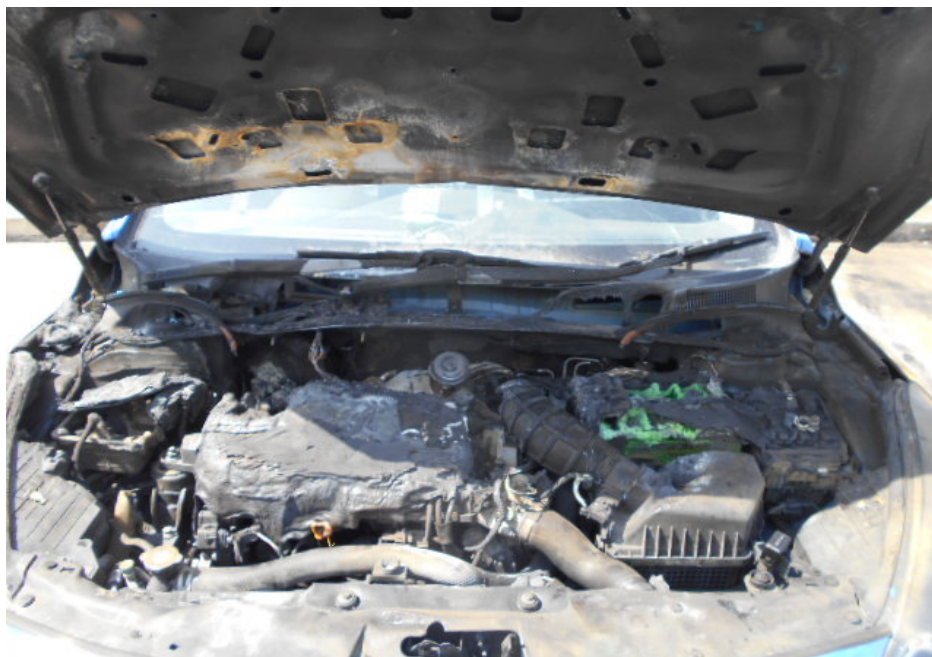
**Photo 3** shows a general view of the Insured Vehicle's engine compartment at the time of my inspection. Most of the parts and components within the engine compartment were burnt and/or melted. This had included various rubber hoses, wiper panel, battery, air intake duct, bonnet insulator, brake fluid reservoir, cooling fan, radiator, intake manifold and alternator amongst others.

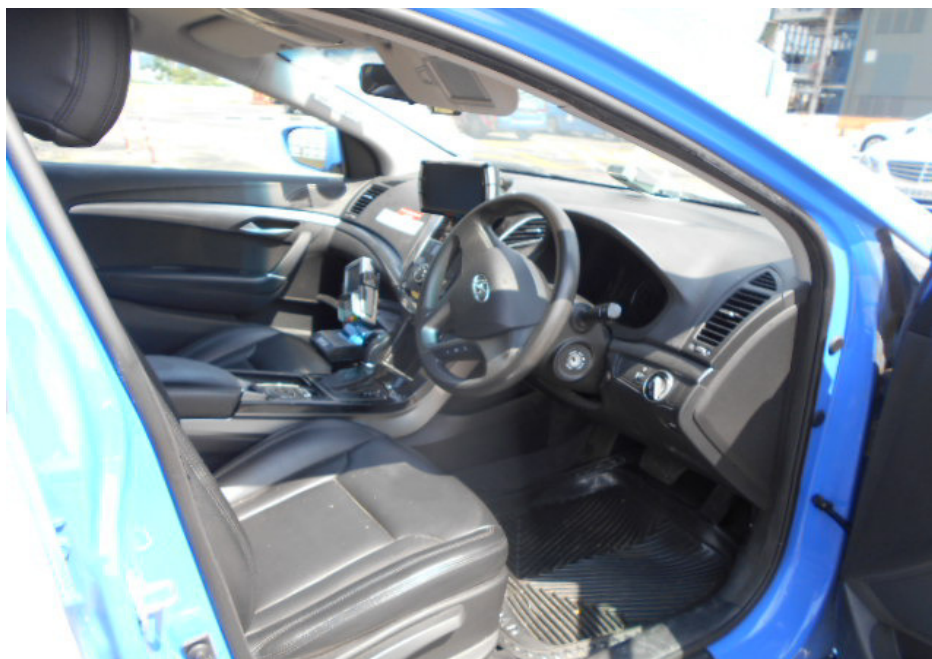
**Photo 4** shows the interior compartment of the Insured Vehicle, which was unaffected by the incident. Apart from the normal standard additional equipment(s), there appears to be no modification(s) and/or additional electronic and/or electrical component(s) fitted on the Insured Vehicle.

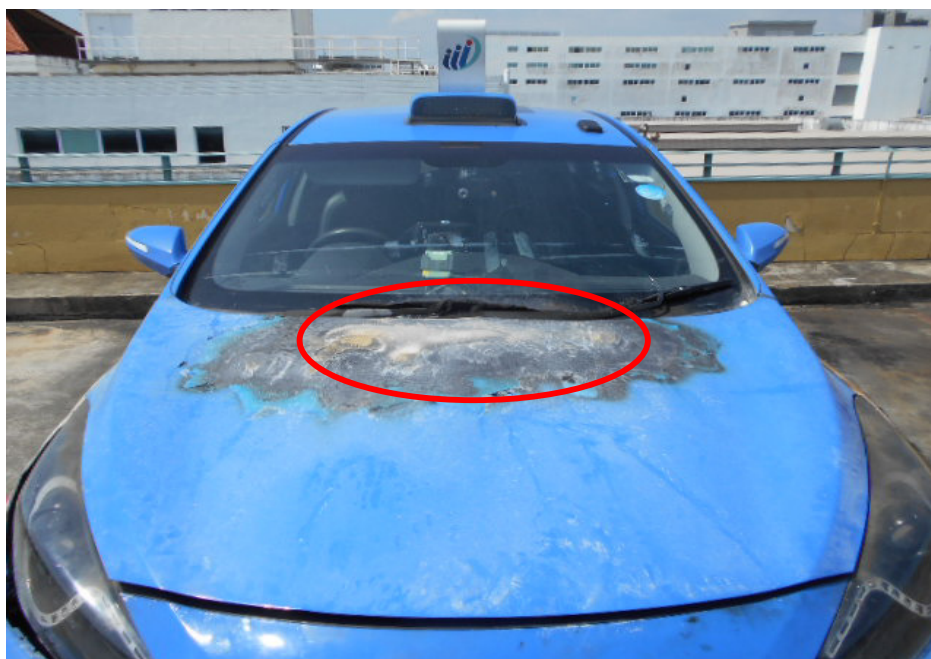
7. For this particular case, the fire can be established to have originated within the engine compartment of the Insured Vehicle, given the single area of fire damage that the Insured Vehicle had sustained (interior compartment and rear portion unaffected). The burn mark found at a single area at the top side of its front bonnet further indicates that the fire had originated somewhere around the rear centre of the engine compartment.

**Photo 5** shows the burn mark (circled) that was formed at a single area on the top side of the Insured Vehicle's front bonnet. Apart from this burn mark, there was no other mark(s) of burnt nature found on the exterior body of the Insured Vehicle. Given this single burn mark on the exterior body and the physical evidence that only the parts and components within the engine compartment were burnt and/or melted, the fire can then be established to have originated within the engine compartment of the Insured Vehicle, somewhere around the rear centre of the engine compartment.

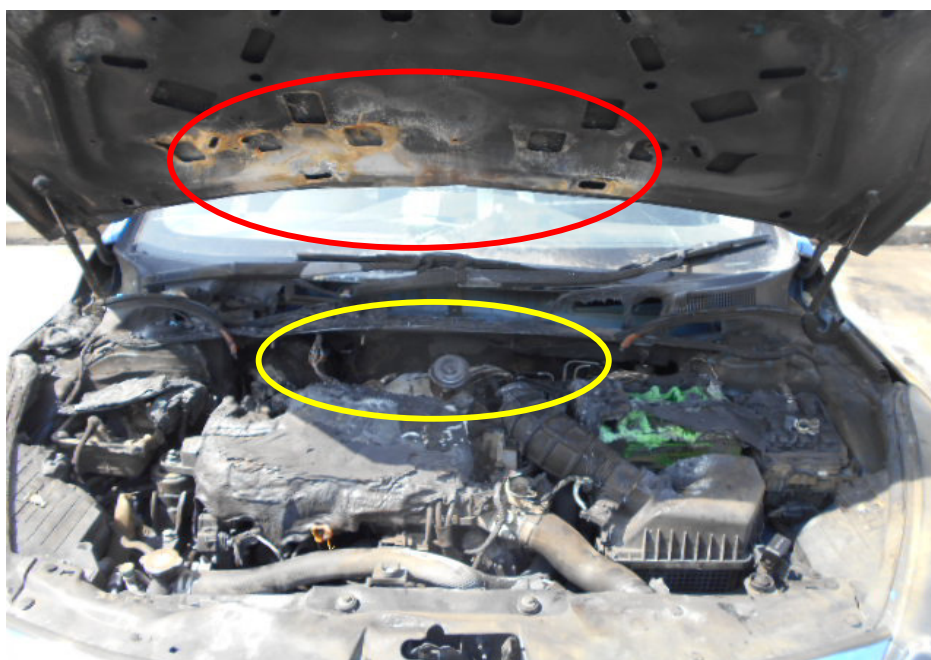
8. Following the characteristic of heat rising upwards, high heat intensity burn marks (whitish burn marks) were correspondingly found on the underside of the Insured Vehicle's front bonnet, directly below the area where the burn mark was formed on the top side of the front bonnet. These whitish burn marks are a result of exposure to prolong heat intensity. Rust would normally start to develop around these areas soon after a fire as prolonged exposure to high heat intensity usually causes steel/metal material body parts to be exposed to natural environmental condition. See photo 5 & 6 below.

**Photo 6** shows the whitish burn mark (red circle) that was found on the underside of the Insured Vehicle's front bonnet, directly under the area where the single burn mark was formed on the top side of the front bonnet. Such whitish burn marks are a result of exposure to prolong heat intensity. The fire to the Insured Vehicle can then be established to have originated around the rear centre of the engine compartment (yellow circle).

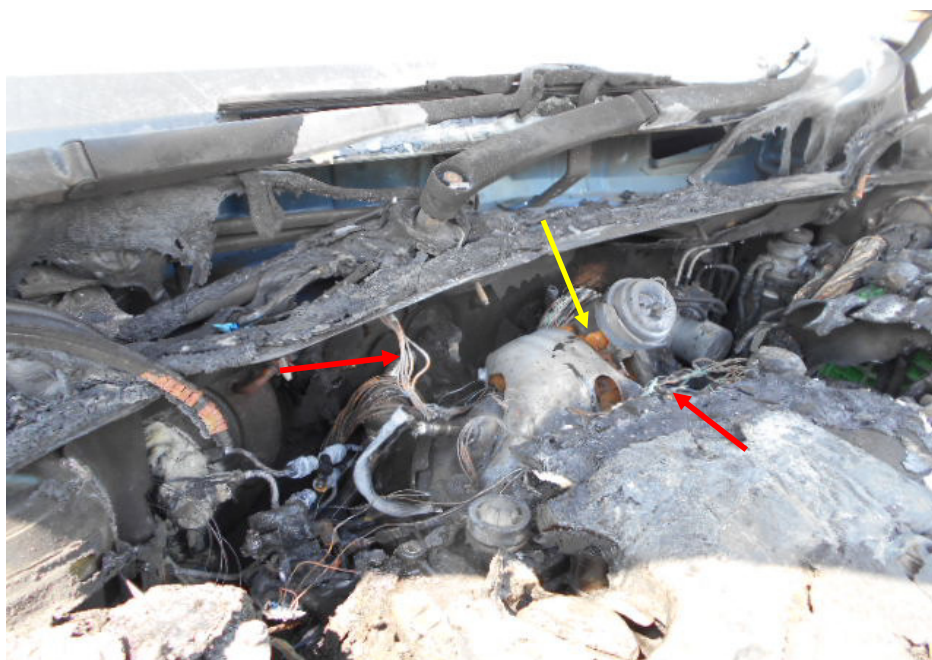
9. My examination of the rear centre area of the engine compartment, during my inspection of the Insured Vehicle, revealed greenish residue on several stretches of original factory fitted wirings. The presence of greenish residue indicates internal heating of copper wires, a sign of an electrical short circuit occurring. The greenish residue is normally left behind from oxidation as a result of chemical reaction involving the copper wires. This physical evidence would then appear to suggest that the cause of fire to the Insured Vehicle was due to electrical in nature. See photo 7 & 8 below.

10. To further explain briefly, heat from engine operation could cause the rubber insulation of the wires and/or wiring harness within the engine compartment to lose its flexibility and become hardened after a prolong period of time. The hardened rubber insulation may then become brittle and break off bits by bits, exposing live wires that may come into contact with each other and/or the metal body of the vehicle, creating sparks that could ignite a fire. Unlike countries with different seasons, the hot local climate increases the heat within the engine compartment of locally used vehicles, and this could accelerate the hardening of rubber insulations, and any other rubber material parts within the engine compartment.

**Photo 7** shows a closer view of the rear centre area of the Insured Vehicle's engine compartment, which was where the fire had originated. The wirings (red arrow) were found with greenish residue. These are original factory fitted wirings. The presence of such greenish residue suggests occurrence of an electrical short circuit. This physical evidence would then appear to suggest that the cause of fire to the Insured Vehicle was due to electrical in nature. The turbocharger housing (yellow arrow) of the Insured Vehicle, which is made of cast iron, was noted to be of bright red colour at the time of my inspection. This is an indication that the turbocharger was overheated (unable to cool down sufficiently). The heat dissipated from overheated the turbocharger affected the rubber wire insulators and/or melted other combustible materials in the vicinity, ultimately leading to the fire.

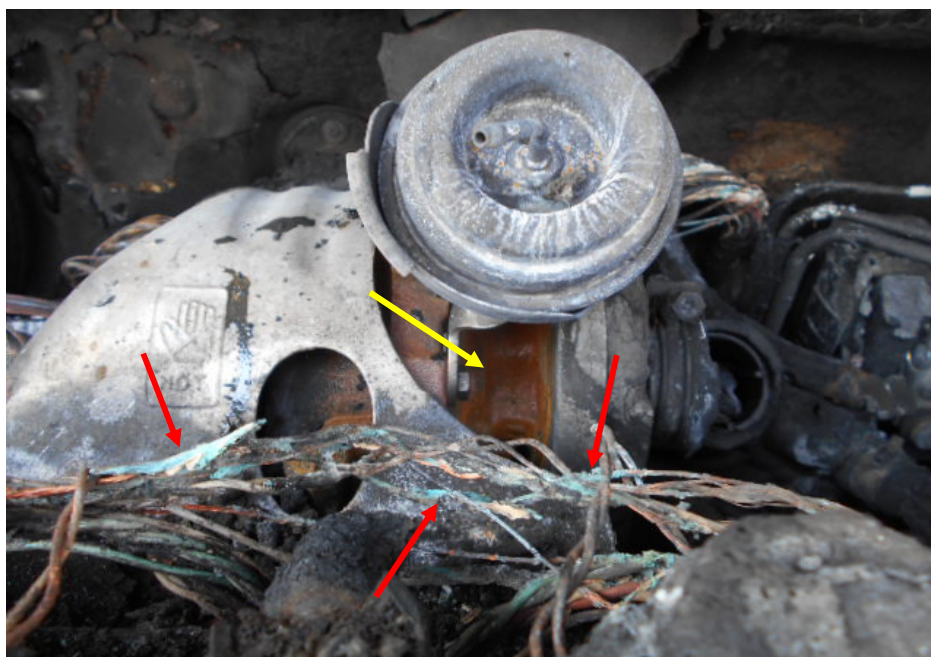
11. For the Insured Vehicle, the factory fitted turbocharger and exhaust manifold/pipe were also fitted at the rear centre of its engine compartment. These parts tend to become hot during engine operation. Heat dissipation from these parts would naturally rise upwards and this could also affect the rubber wire insulators within the vicinity of the rear centre of engine compartment. In fact, the turbocharger housing of the Insured Vehicle, which is made of cast iron, was noted to be of bright red colour at the time of my inspection. This is an indication that the turbocharger was overheated (unable to cool down sufficiently). The heat dissipated from the turbocharger affected the rubber wire insulators and/or melted other combustible materials in the vicinity, ultimately leading to the fire.

**Photo 8** shows a closer view of the original factory fitted wirings with greenish residue (red arrow) and bright red colour of the turbocharger housing (yellow arrow). The presence of greenish residue suggests occurrence of an electrical short circuit while the bright red colour of the turbocharger housing indicates that the turbocharger had overheated (unable to cool down sufficiently).
