Report Reference : TP / 12-18001/DY / 2018

## THIRD PARTY SURVEY

ACCIDENT HAPPENED ON 29 Nov 2018

## VEHICLE DAMAGE INSPECTION REPORT

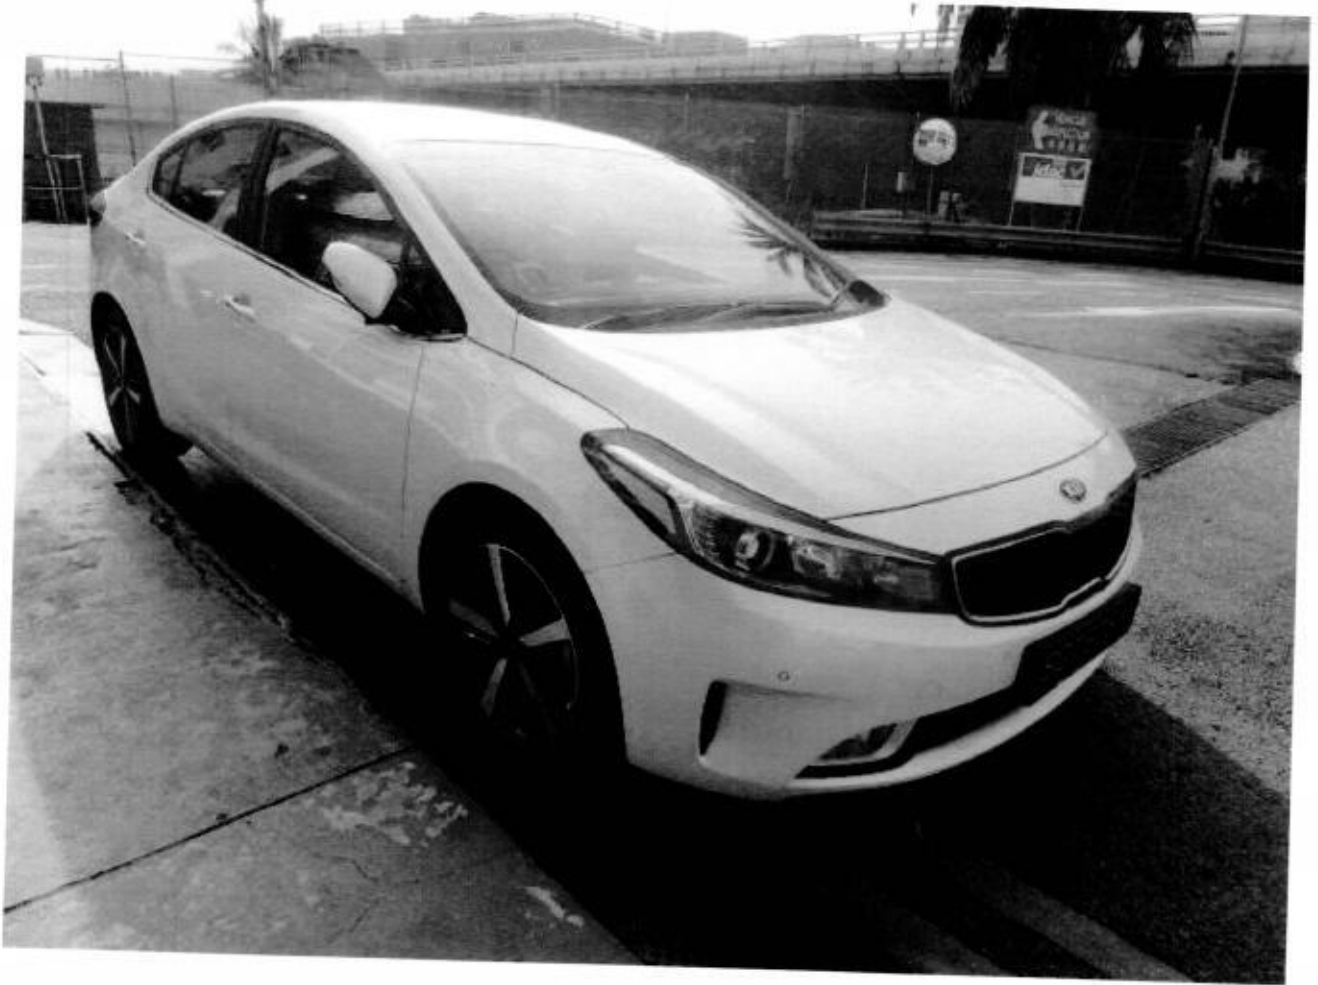
Accident Photo

At the time of inspection, we noted that the vehicle has sustained an impact damages on the front n/s portion(s). For more detail of the damages, please see photograph attached.
