Your Ref: SFG 28M
Our Ref : CI/AIG19000498/D

DAMAGE CONSISTENCY REPORT OF INSURED VEHICLE SFG 28M

1. I refer to your request dated 27 December 2018 to conduct an investigation and analysis to determine whether the damage sustained to the insured vehicle SFG 28M (herein referred to as "**Insured Vehicle**") was due to a lightning incident on 13 December 2018.

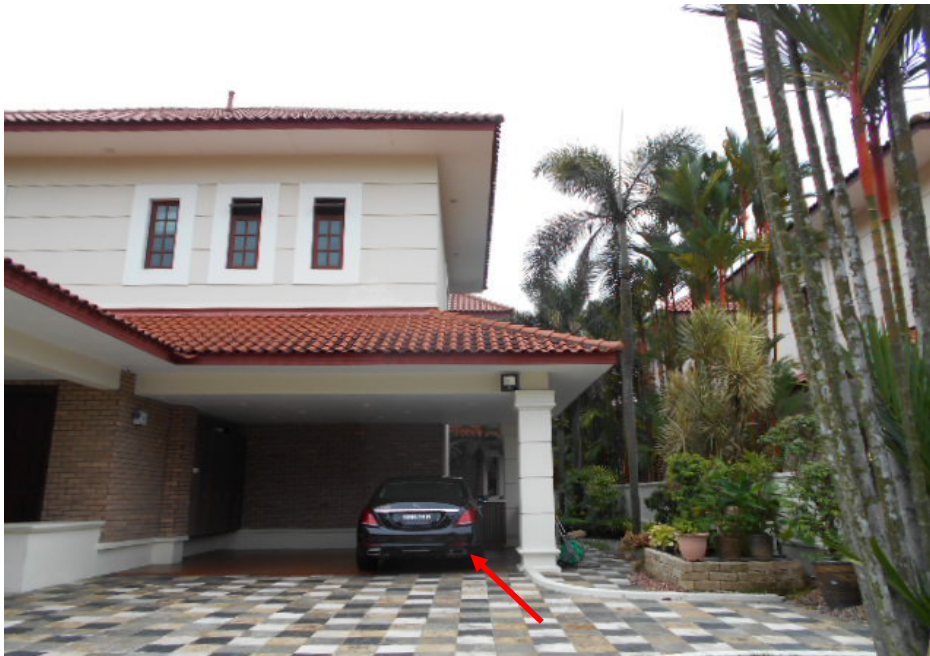
Photo 1 shows a general view of the front entrance of 30 Bukit Sedap Road, which was the reported incident location. At the material time of incident, the Insured Vehicle was parked at the porch area, where the vehicle seen in the photograph is parked (arrowed). According to Mr Tan, the lightning had struck one of the trees also the side of the house, on the right of where the Insured Vehicle was parked.

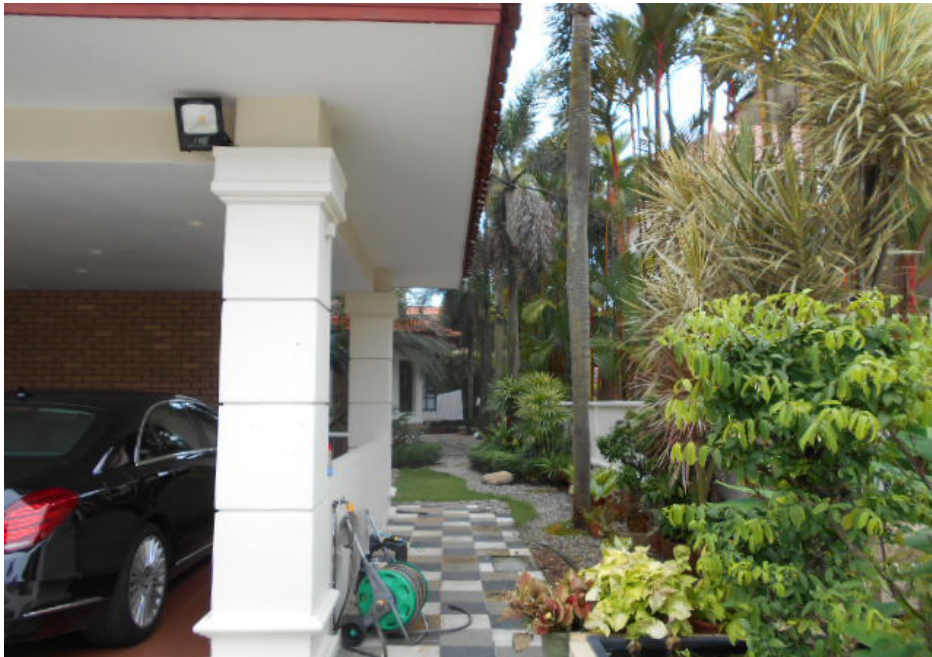
Photo 2 shows a general view of the side of the house, on the right of where the Insured Vehicle was parked at the material time. According to Mr Tan, the lightning had struck one of the trees along this side of the house.

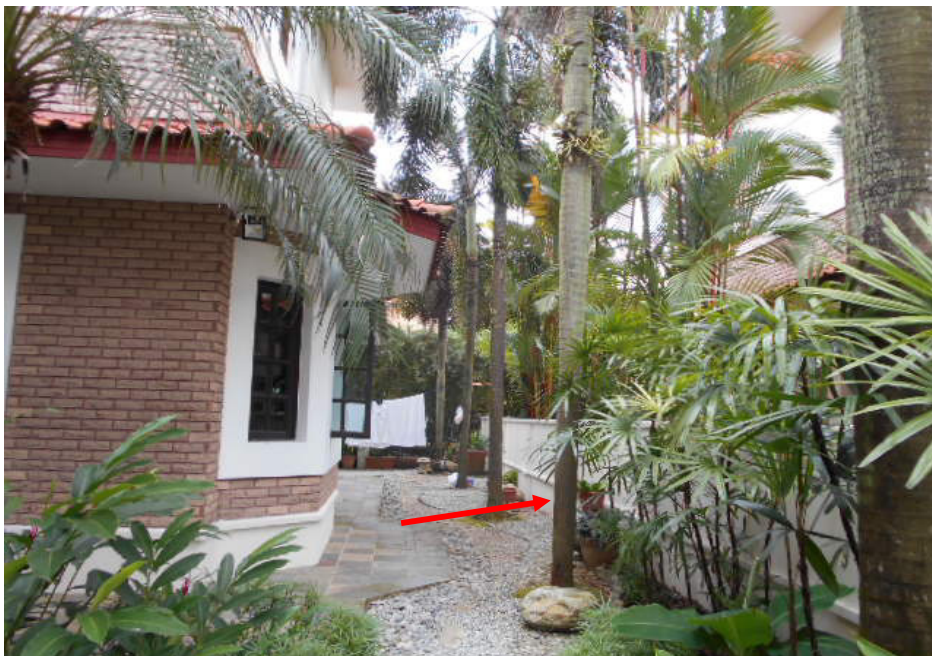
Photo 3 shows the tree (arrowed) that Mr Tan had pointed out to me that was struck by lightning. The tree is known as a fox tail tree and had a sharp vertical pointed end at the top. According to Mr Tan, this tree was identified as his mother had seen a bright flash of light along the tree truck. The bright flash of light subsequently touched the ground and split towards the left and right of the tree before disappearing.

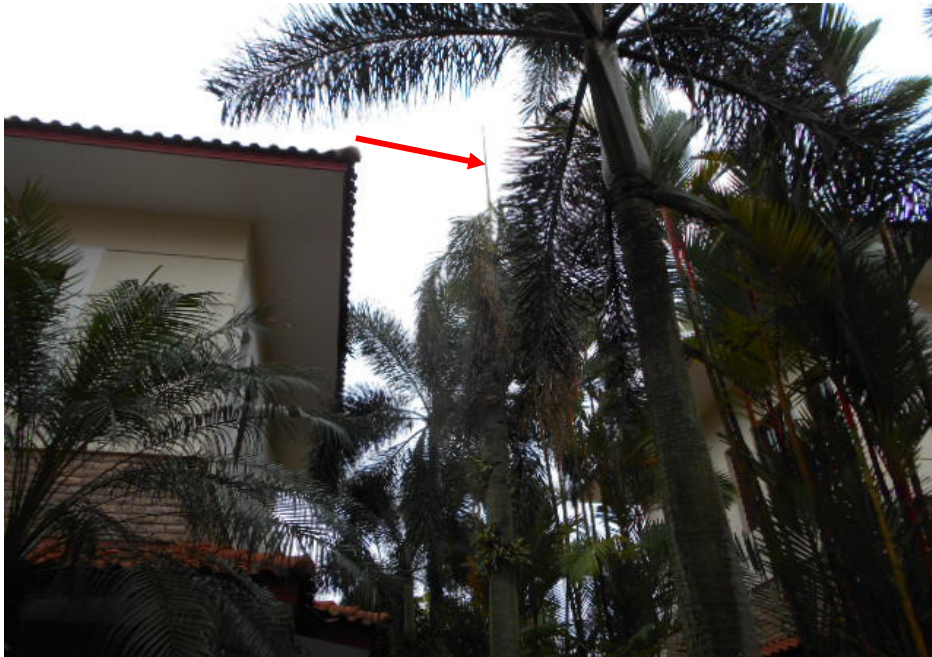
Photo 4 shows the sharp vertical pointed end (arrowed) of the tree that was stuck by lightning, as pointed out to me by Mr Tan. From a distance, this sharp vertical pointed end appears to be higher than the lightning conductors that were situation at the roof of the house.

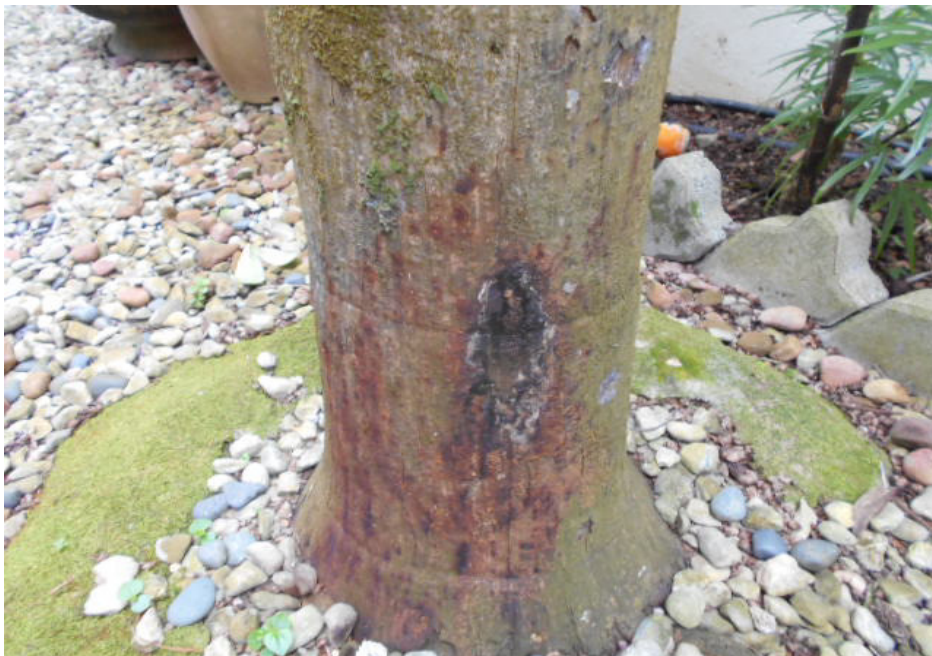
Photo 5 shows what appears to be a burnt mark that I had observed on the truck at the bottom of the tree that was stuck by lightning, as pointed out to me by Mr Tan.

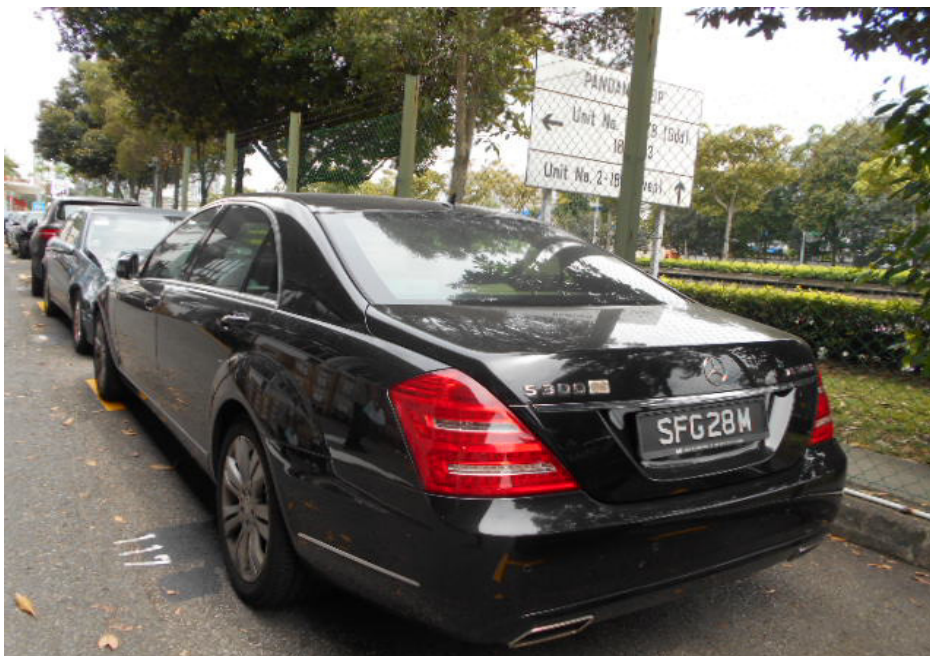
8. There was no burn mark(s) found on the exterior body, interior compartment and engine compartment of the Insured Vehicle. The tyres and wheel rims were similarly found to be without any burn marks.

Photo 6 shows a general view of the rear left body of the Insured Vehicle at the time of my inspection. There was no burn mark(s) found on the exterior body of the Insured Vehicle, including its tyres and wheel rims.

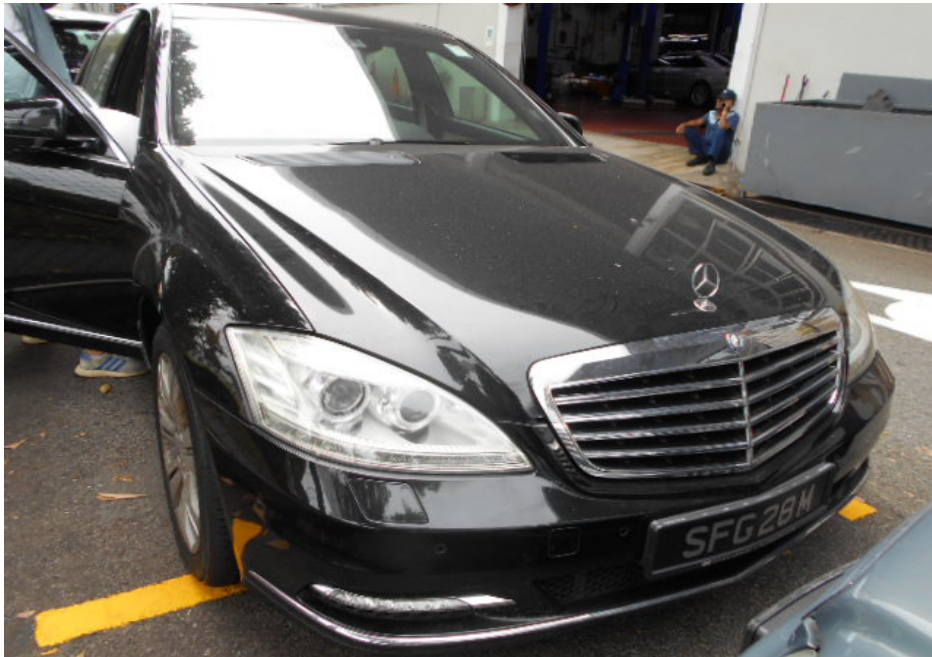
Photo 7 shows a general view of the front right body of the Insured Vehicle at the time of my inspection. There was no burn mark(s) found on the exterior body of the Insured Vehicle, including its tyres and wheel rims.

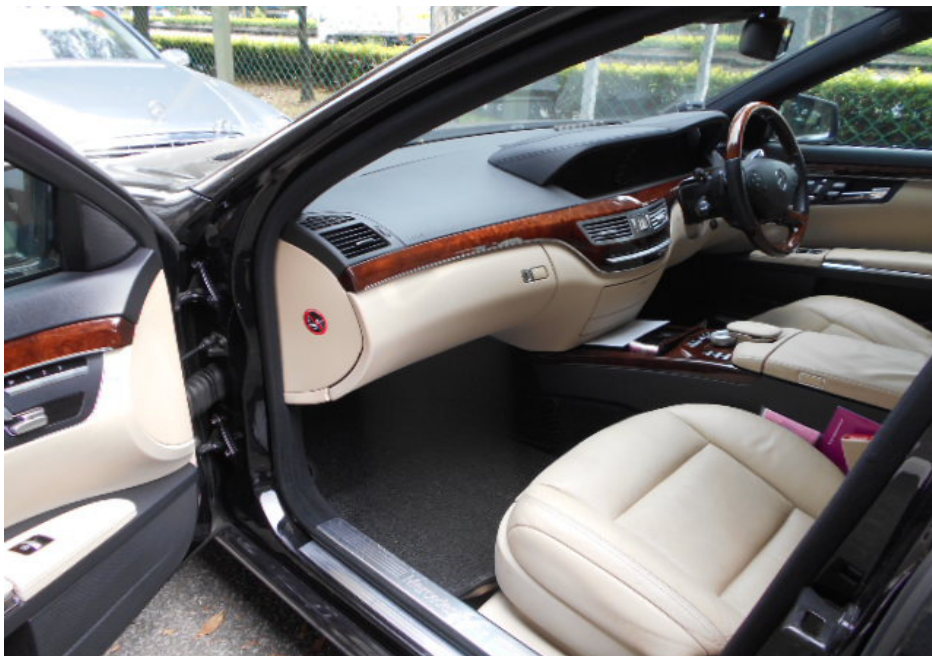
Photo 8 shows a general view of the interior compartment of the Insured Vehicle. There were no burn mark(s) found in the interior compartment of the Insured Vehicle.

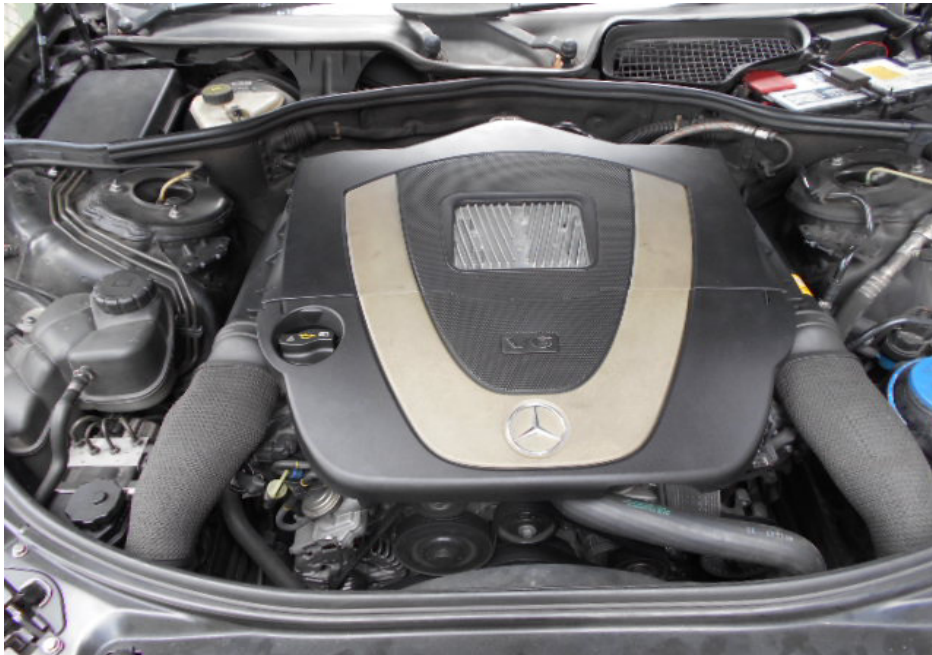
Photo 9 shows a general view of the Insured Vehicle's engine compartment. I did not find any burn mark(s) within the engine compartment of the Insured Vehicle.

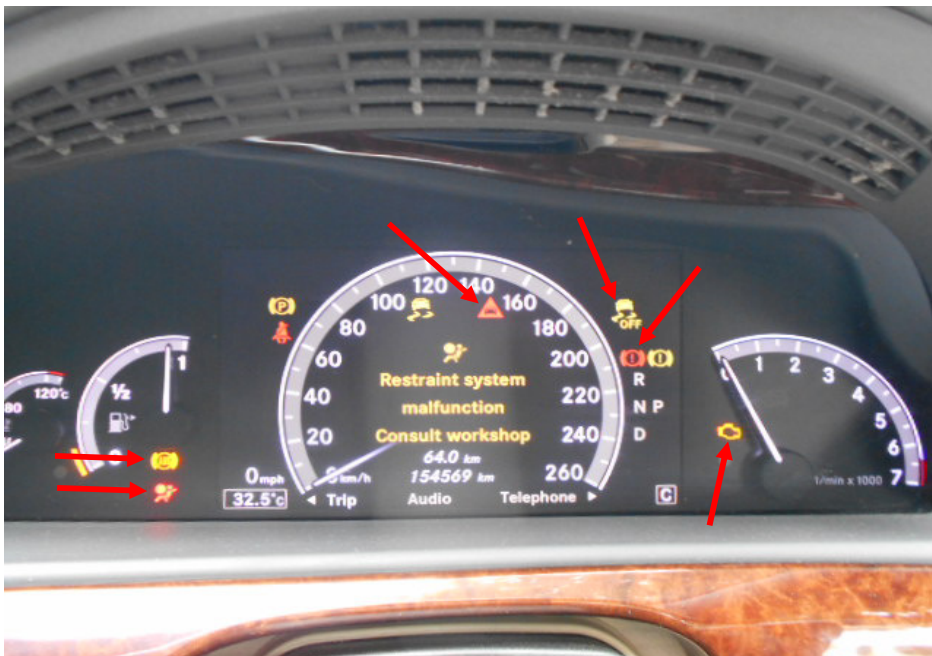
9. About 1min to 2mins after the engine was started, multiple warning messages started appearing on the instrument cluster of the Insured Vehicle. The warning messages were for various electronic safety features like the Anti-Lock Brake System (ABS), Electronic Stability Program (ESP) and Supplemental Restraint System (SRS) of the Insured Vehicle. Warning messages relating to some operating systems like the power steering system, transmission system, and various pre-safe features like brake assist, lane departure etc had also appeared on the instrument cluster. See photo 6 – 11 below.

Photo 10 shows the various warning messages (arrowed) appearing on the instrument panel of the Insured Vehicle. This was after about 1min to 2mins upon starting the engine of the Insured Vehicle.

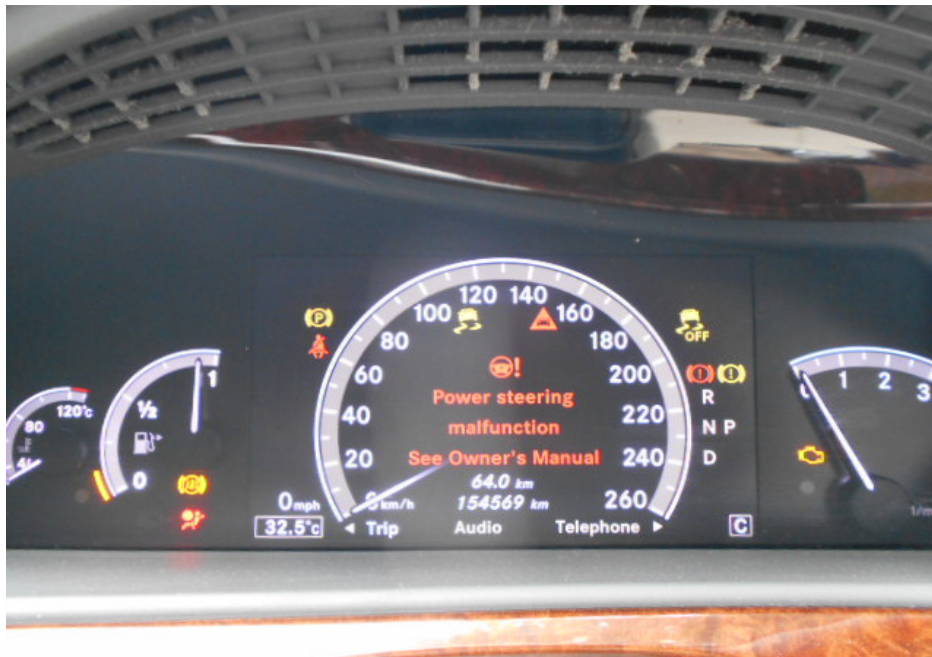
Photo 11 shows the “power steering malfunction” warning message appearing on the instrument panel of the Insured Vehicle. This was after about 1min to 2mins upon starting the engine of the Insured Vehicle.

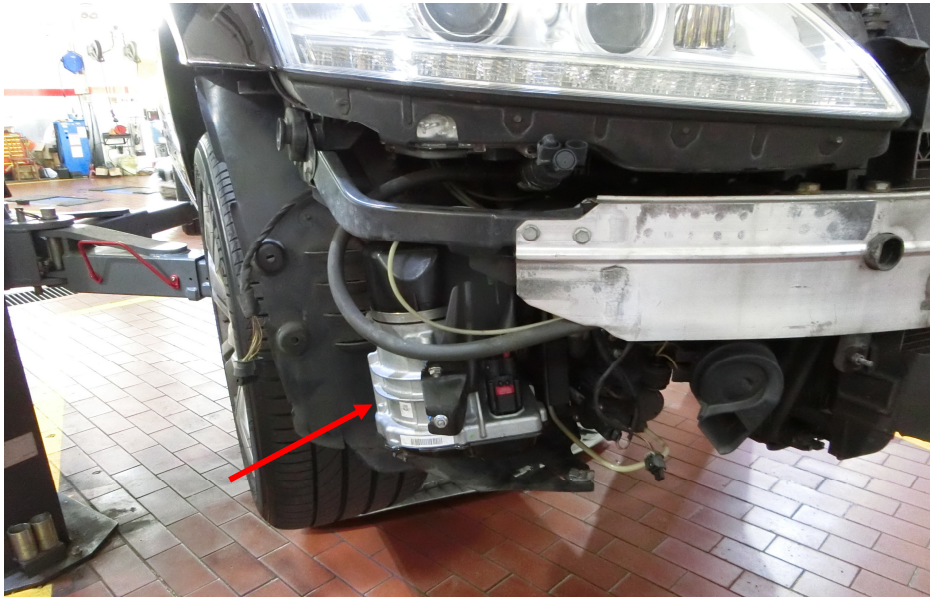
Photo 12 shows the power steering pump of the Insured Vehicle, which was found to be newly replaced during initial investigations by AIG in-house surveyor and Cycle & Carriage Industries Pte Ltd (photograph provided to me).

11. I was subsequently able to obtain a document relating to the replacement of the power steering pump from Mr Tan. From the information contained in the document, I note that the power steering pump was replaced on 04 December 2018; the mileage of the Insured Vehicle during the replacement was 154,370km. This was 9 days before the reported lightning incident with the Insured Vehicle having travelled a distance of 199km during this period. Basing on the document, a general servicing of the Insured Vehicle was also carried out on 04 December 2018 where the engine oil, oil filter and air filter were replaced. See photo 15 below.

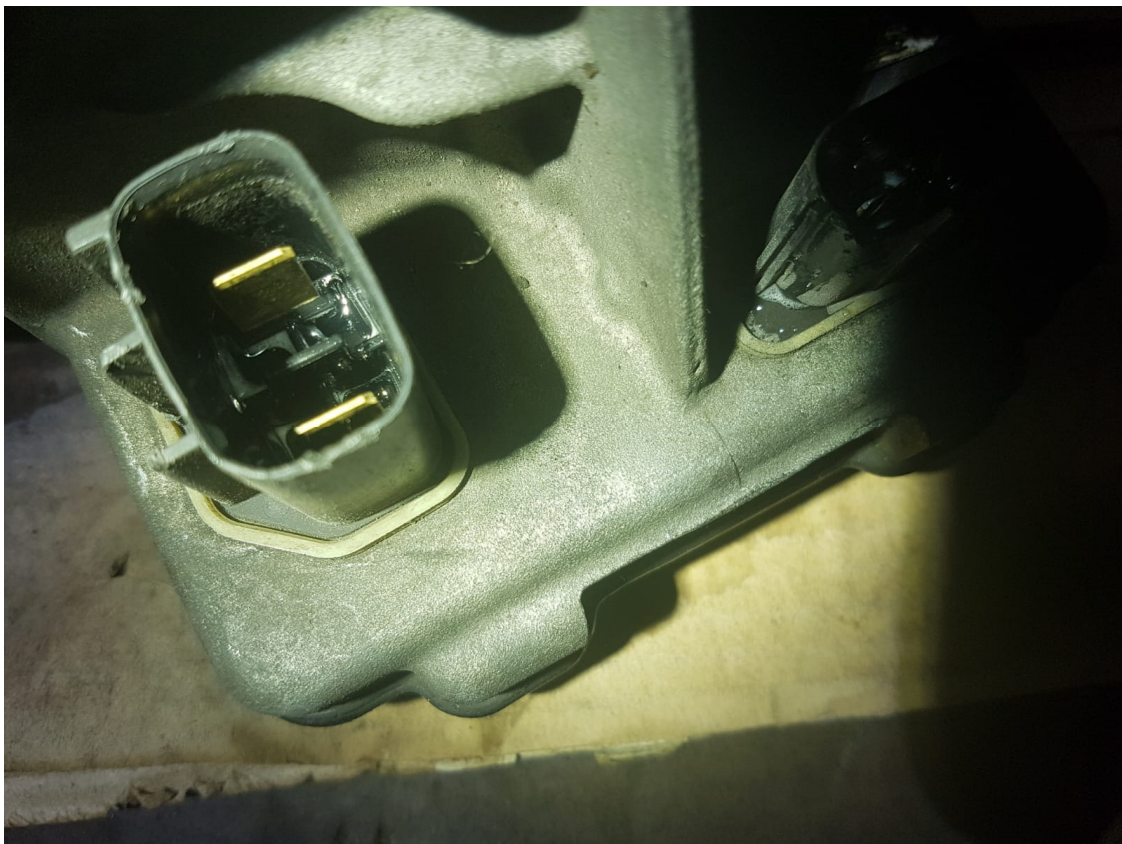
Photo 13 shows the connector for the wiring socket of the power steering pump with water trapped at the bottom of the connector (photograph provided to me).

15. Common cause(s) of communication failure within the CAN include shorted CAN wires and electronic control units that had malfunctioned. Since the wiring socket for the power steering pump of the Insured Vehicle was found slightly melted with burn marks; and water also seen at the bottom of the connector, which connects this wiring socket, the "No CAN message was received" could have been due to this slightly burnt wiring socket. CAN messages or data from the power steering pump control unit of the Insured Vehicle could not be sent through the CAN, triggering "No Can message was received" from the various electronic control units when communication failed.

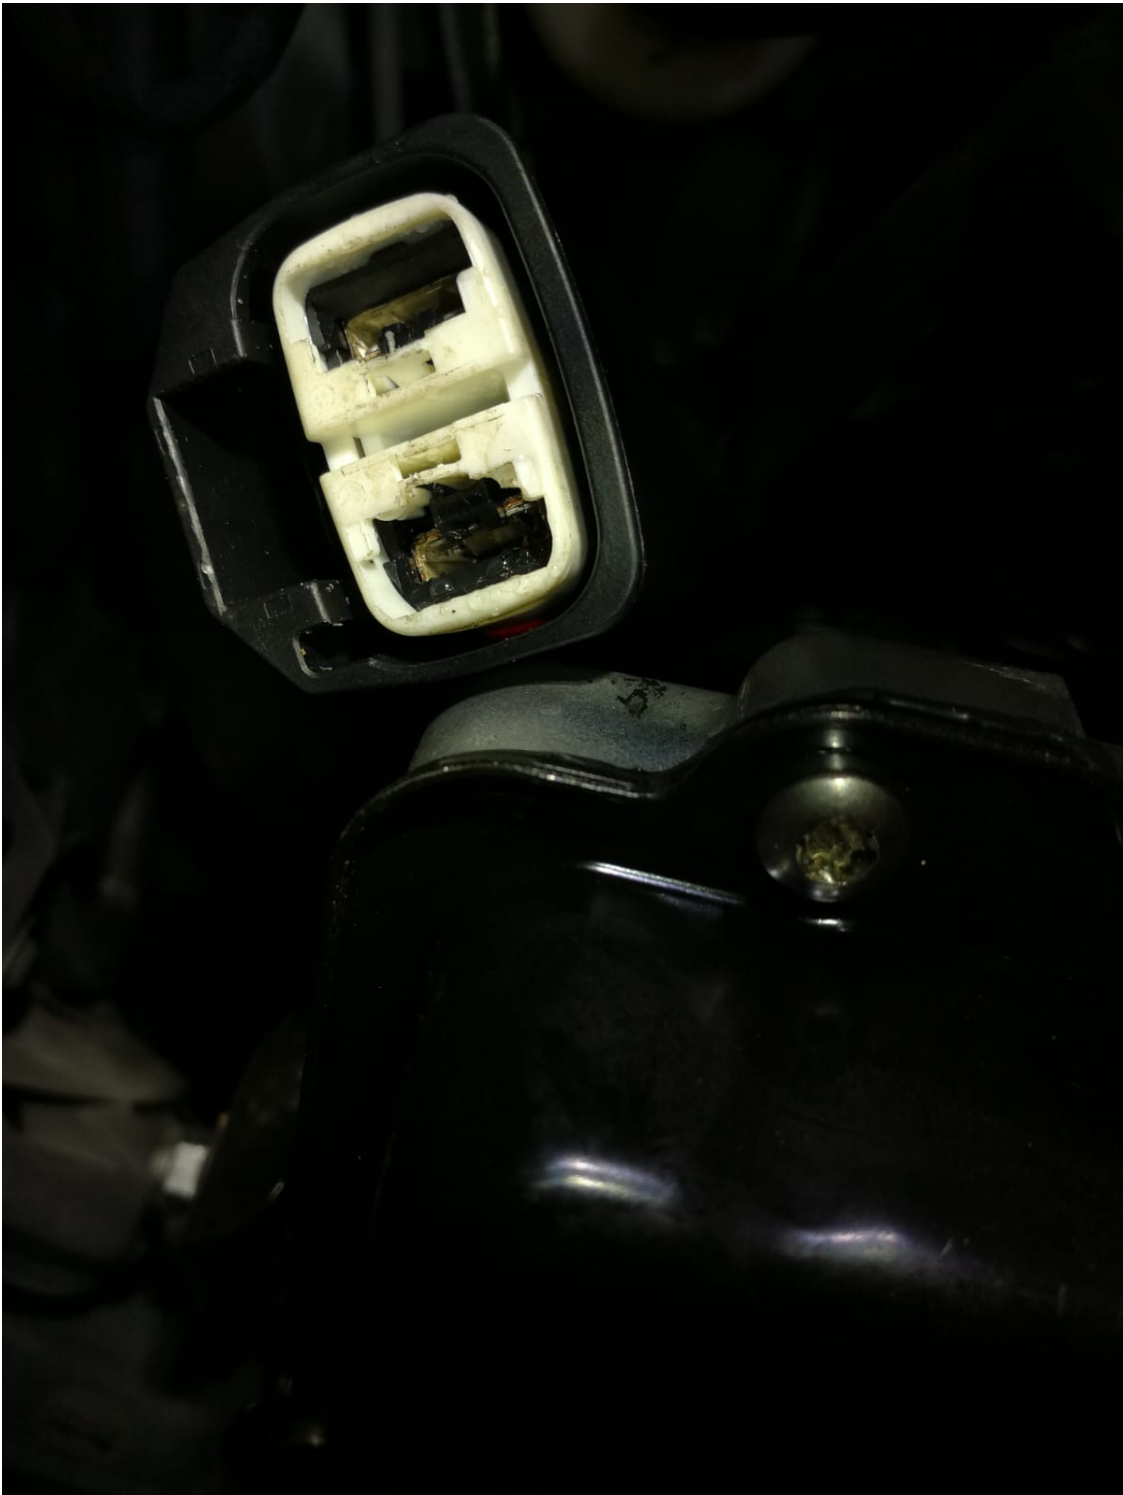
10. For this case, preliminary investigations by AIG in-house surveyor and Cycle & Carriage Industries Pte Ltd revealed that the power steering pump was newly replaced. Upon further checks, the wiring socket for the power steering pump was found slightly melted with burn marks. Water was also seen at the bottom of the connector, which connects this wiring socket. The power steering system of the Insured Vehicle is of electro-hydraulic type where the hydraulic pressure comes from a pump that is driven by an electric motor instead of conventional belting. See photo 12 – 14 below.

Photo 14 shows the wiring socket of the power steering pump that was found to be slightly melted with burn marks during initial investigations by AIG in-house surveyor and Cycle & Carriage Industries Pte Ltd (photograph provided to me).
