Veh No: SHD 4065 X Yt Regn: 2012 Feb  
 Type: M.Car / M.Cycle / Bus / Van / Lorry / Taxi / Prime Mover /  
 Truck / Trailer or  
 Make: Hyundai Sonata C.C. 1991  
 Colour: Blue A/C Insured / Std / NI / NA  
 Sp. Reading: 131791 T/Radio: Insured / Std / NI / NA  
 Eng/No: D4EA9806395  
 C/No: KMHET41VMCA821213  
 Gen. Cond: Good / Fair / Poor / Burnt  
 Steering: In order / Jammed / Leaked / Burnt or  
 Brake: In order / Jammed / Leaked / Burnt or  
 Modi: Nil S/Rim / STD A/Rim or

**INITIAL INSPECTION REPORT OF VEHICLE NO. SHD 4065X**

## ADJUSTMENT ON REPAIR COST FOR VEHICLE NO. SHD 4065X

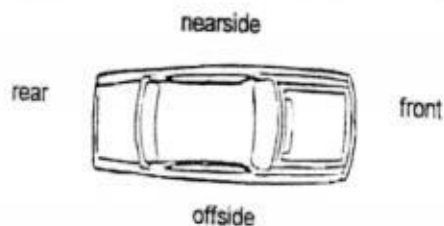
The vehicle sustained damages at the o/s front portion

Comments/Present Status:  
Damages Consistent
