Your Ref: TP/IP/63127/2018
Our Ref : CI/TPD19000745/N

30 April 2019

MECHANICAL INSPECTION REPORT OF MOTOR TAXI SHC 1995L

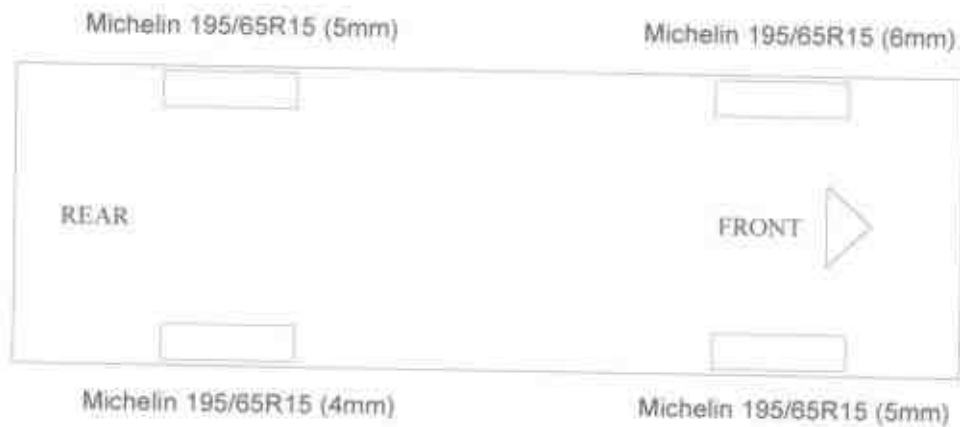
6. The condition of the Motor Taxi's 4 tyres was observed to be in serviceable condition. We did not find any tear, cut or burst mark(s) on the outer and the inner sidewalls as well as across the tread of the 4 tyres. The 4 tyres were also observed to be sufficiently inflated for vehicular operation. The tyre brand, tyre size and remaining tread depth of the 4 tyres were recorded as follows:-

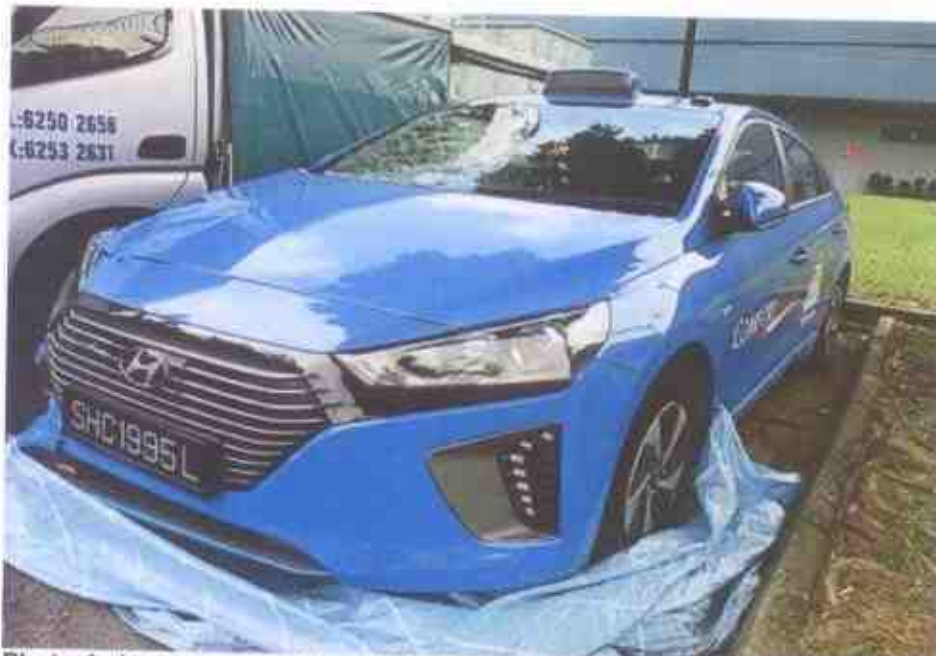
Photo 1 shows a general view of the front left body of the Motor Taxi at the time of our inspection. The Motor Taxi was observed to be in good general condition except for some relatively minor impact damage at its right frontal portion. The mileage of the Motor Taxi was recorded to be 23, 179km.

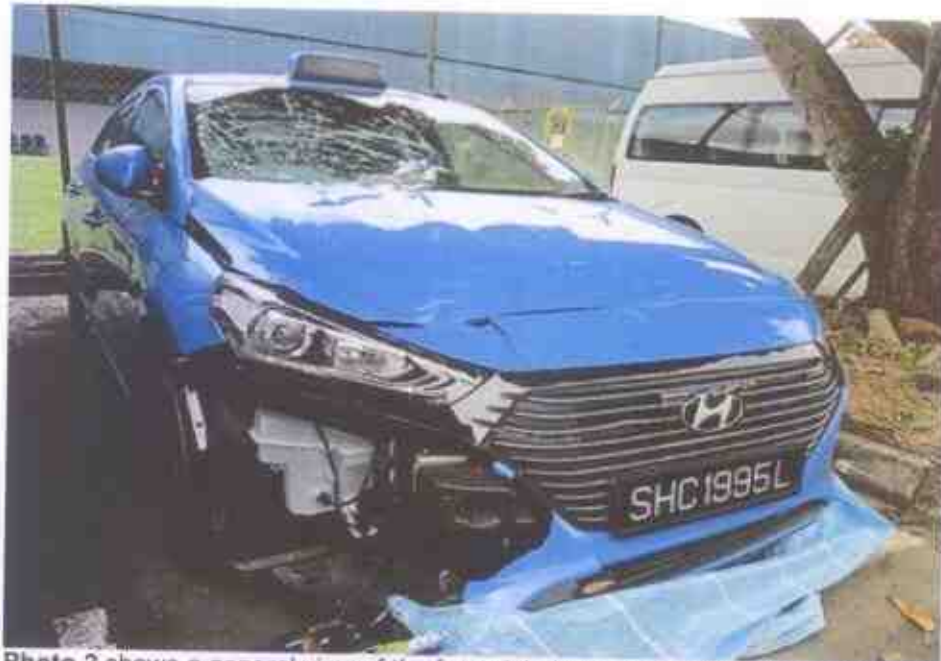
4. The mileage of the Motor Taxi at the time of our inspection was 23, 179km.
5. The Motor Taxi had sustained relatively minor impact damage that was confined to its right frontal portion. Its front bonnet was observed to have been dented; its front bumper was observed to have been dislodged and its front windscreen as well as right headlight was observed to have cracked.

Photo 2 shows a general view of the front right body of the Motor Taxi at the time of our inspection. The Motor Taxi was observed to be in good general condition. However we had observed relatively minor impact damage that was confined to its right frontal portion. Its front bonnet was observed to have been dented; its front bumper was observed to have been dislodged and its front windscreen as well as right headlight was observed to have cracked.

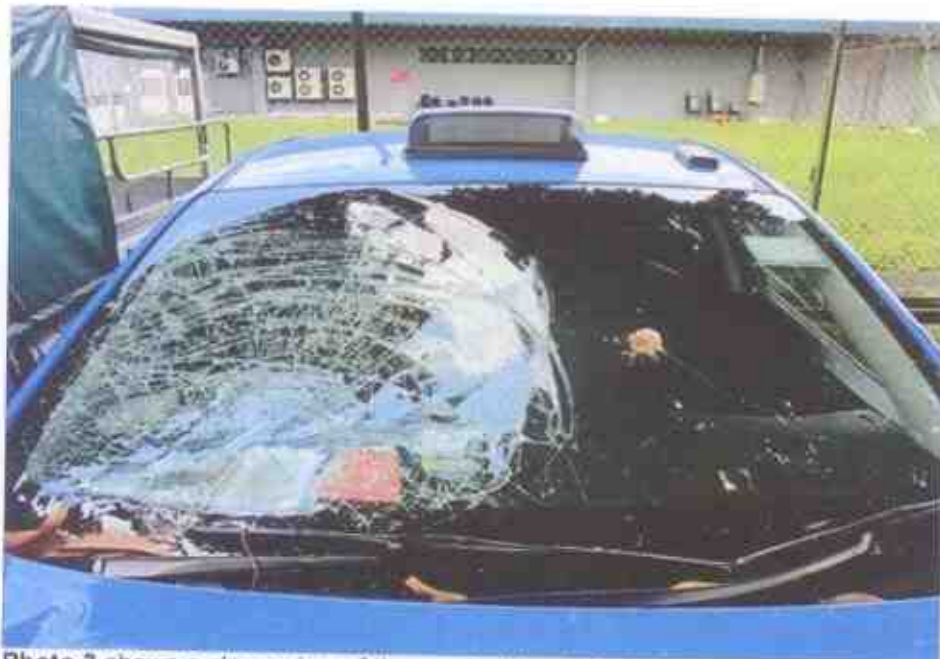
Photo 3 shows a closer view of the cracked front windscreen of the Motor Taxi at the time of our inspection.

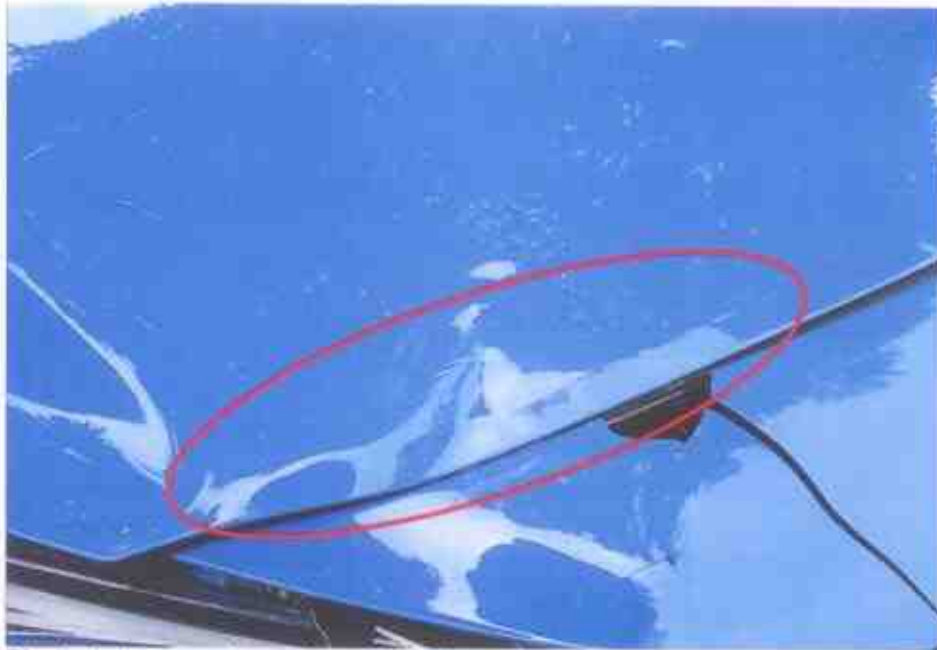
Photo 4 shows a closer view of the dented front bonnet of the Motor Taxi at the time of our inspection (circled).

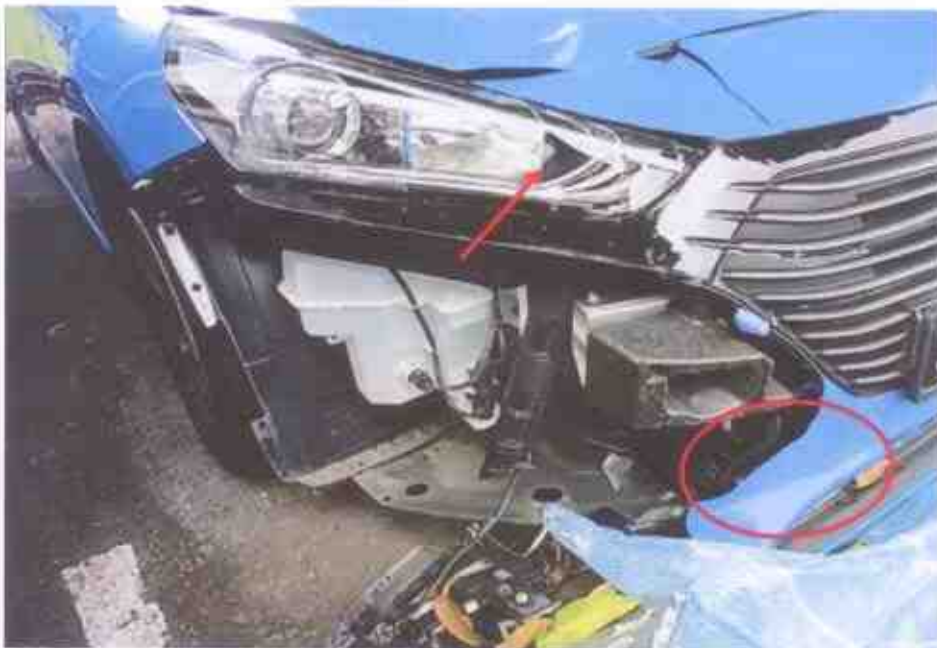
Photo 5 shows a closer view of the cracked right headlight (arrowed) as well as the dislodged front bumper (circled) of the Motor Taxi at the time of our inspection.

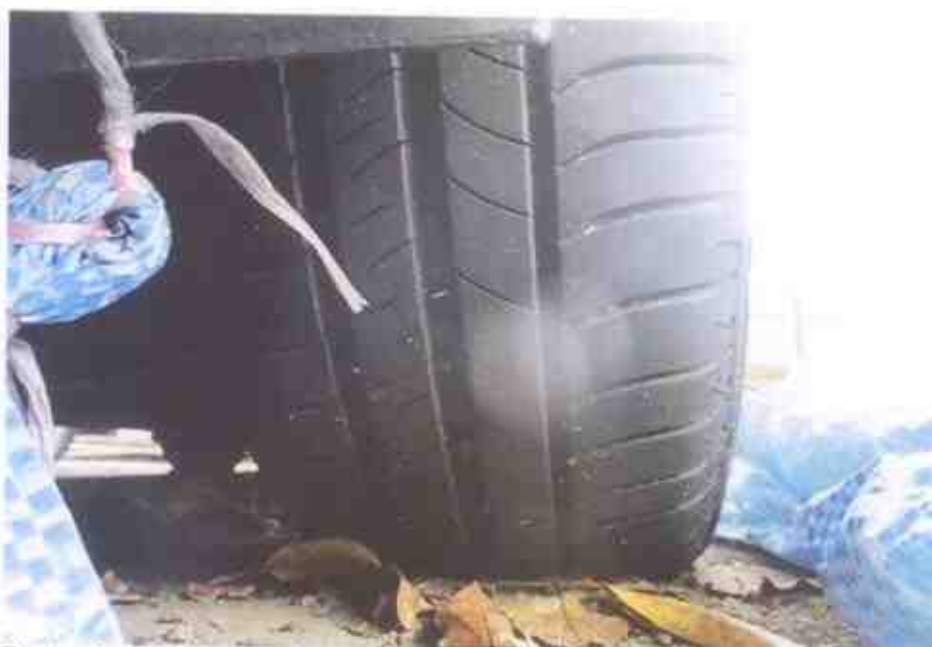
Photo 6 shows the condition of the front left tyre of the Motor Taxi, which was observed to be in serviceable condition with remaining tread depth of approximately 6mm. The tyre, which was wrapped around alloy wheel rim, was also observed to be sufficiently inflated for vehicular operation. There was no tear, cut or burst mark(s) on the outer and the inner sidewalls as well as across the tread of the 4 tyres.

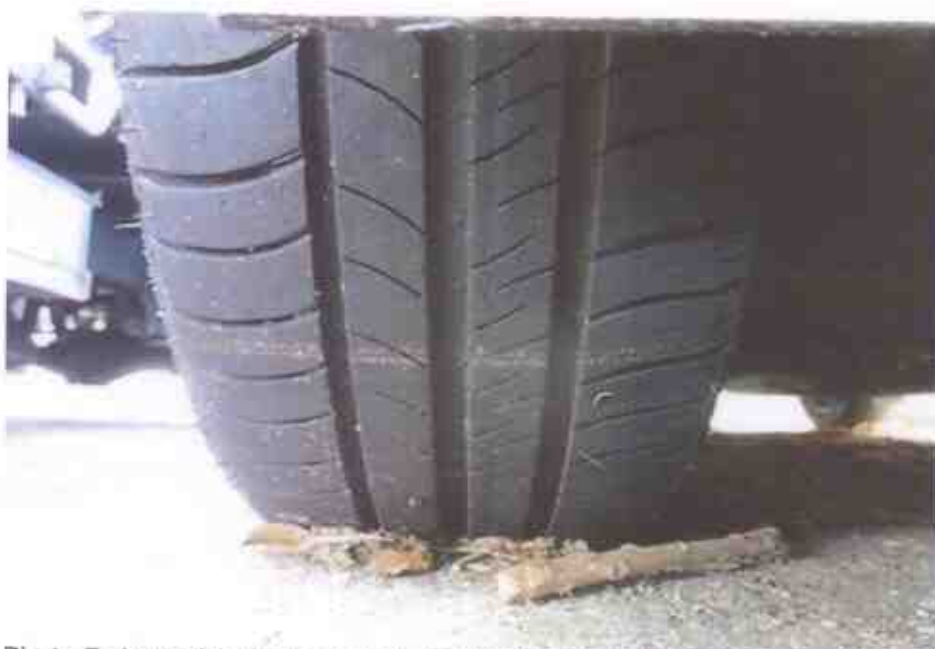
Photo 7 shows the condition of the front right tyre of the Motor Taxi, which was observed to be in serviceable condition with remaining tread depth of approximately 5mm. The tyre, which was wrapped around alloy wheel rim, was also observed to be sufficiently inflated for vehicular operation.

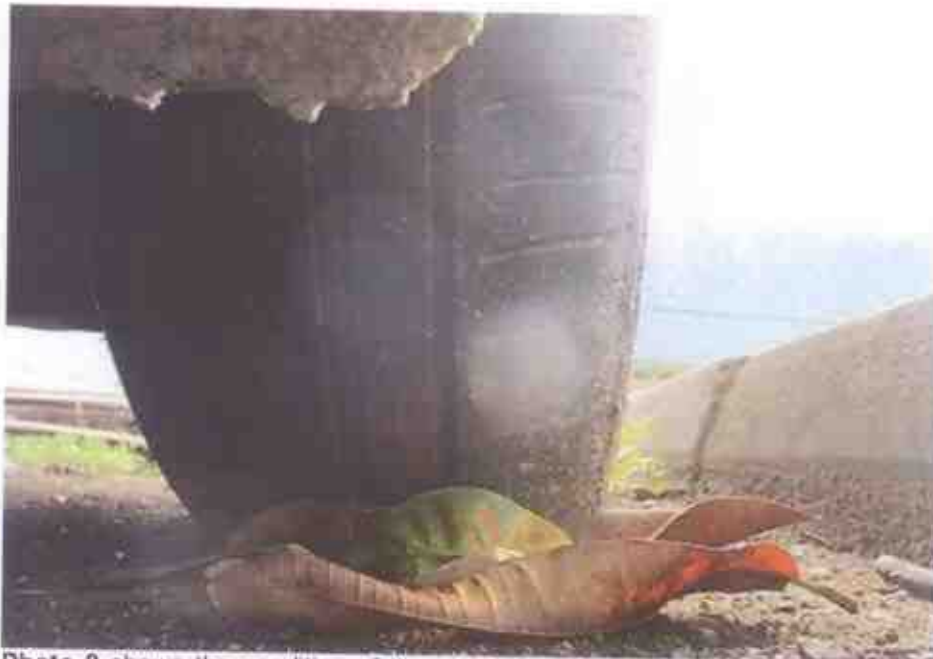
Photo 8 shows the condition of the rear left tyre of the Motor Taxi, which was observed to be in serviceable condition with remaining tread depth of approximately 5mm. The tyre, which was wrapped around alloy wheel rim, was also observed to be sufficiently inflated for vehicular operation. There was also no damage found on the 4 wheel rims of the Motor Taxi.

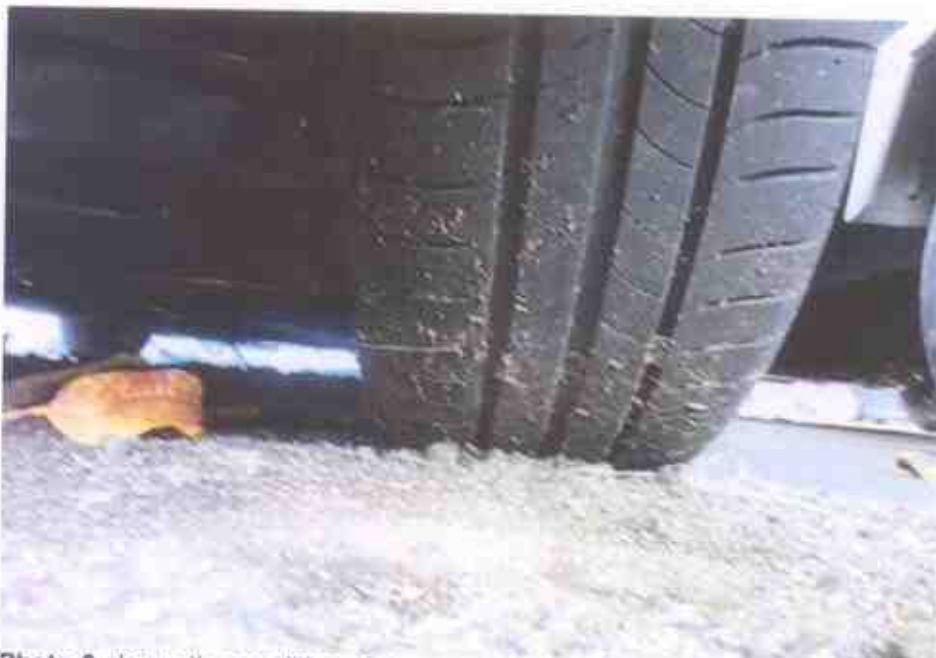
Photo 9 shows the condition of the rear right tyre of the Motor Taxi, which was observed to be in serviceable condition with remaining tread depth of approximately 4mm. There was also no tear, cut or burst mark(s) on the outer and the inner sidewalls as well as across the tread of the 4 tyres.

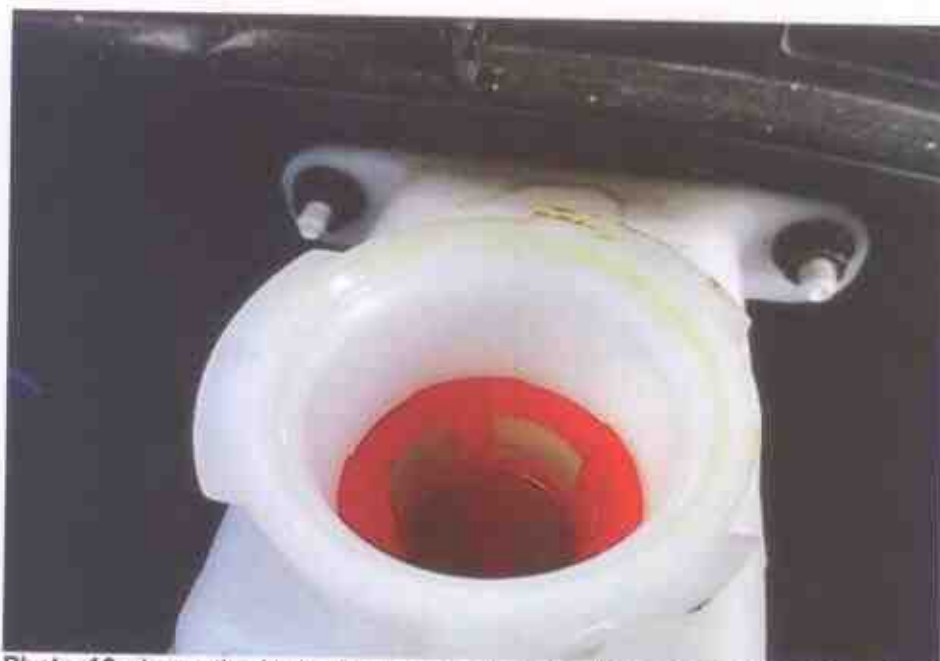
Photo 10 shows the brake fluid reservoir of the Motor Taxi at the time of our inspection. The brake fluid was observed to be of sufficient level and without any visible contamination.

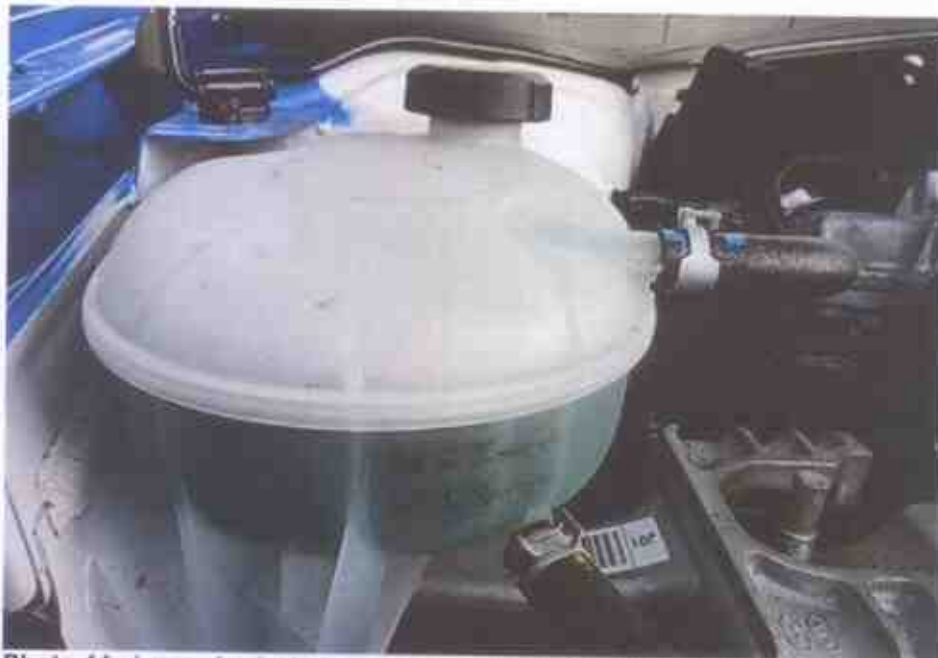
Photo 11 shows checks being carried out to the engine coolant of the Motor Taxi at the time of our inspection. The engine coolant was observed to be of sufficient level and without any visible contamination.

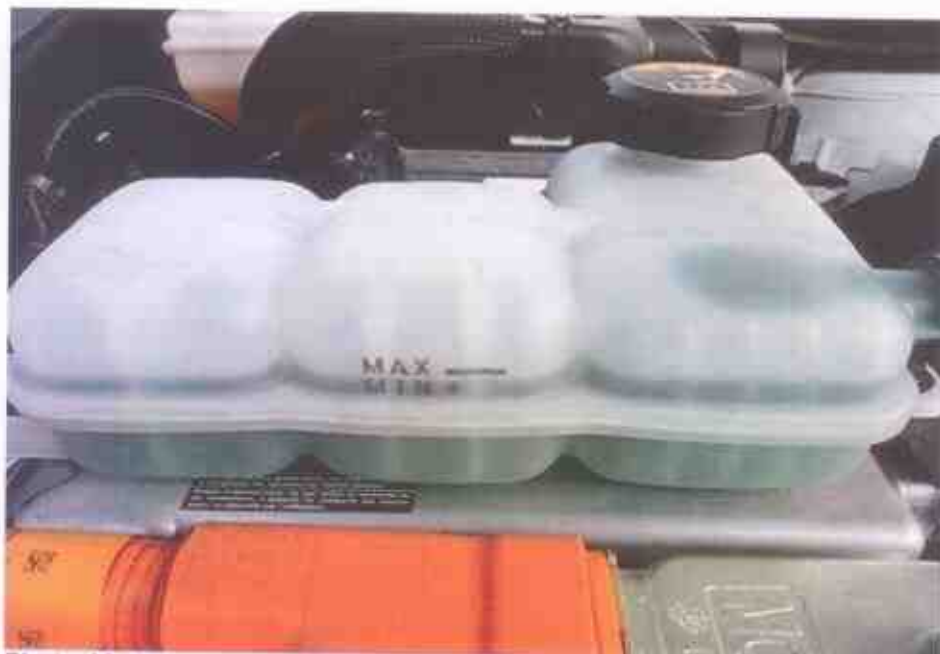
Photo 12 shows the coolant reservoir for the hybrid system of the Motor Taxi at the time of our inspection. The hybrid system coolant was observed to be of sufficient level and without any visible contamination.

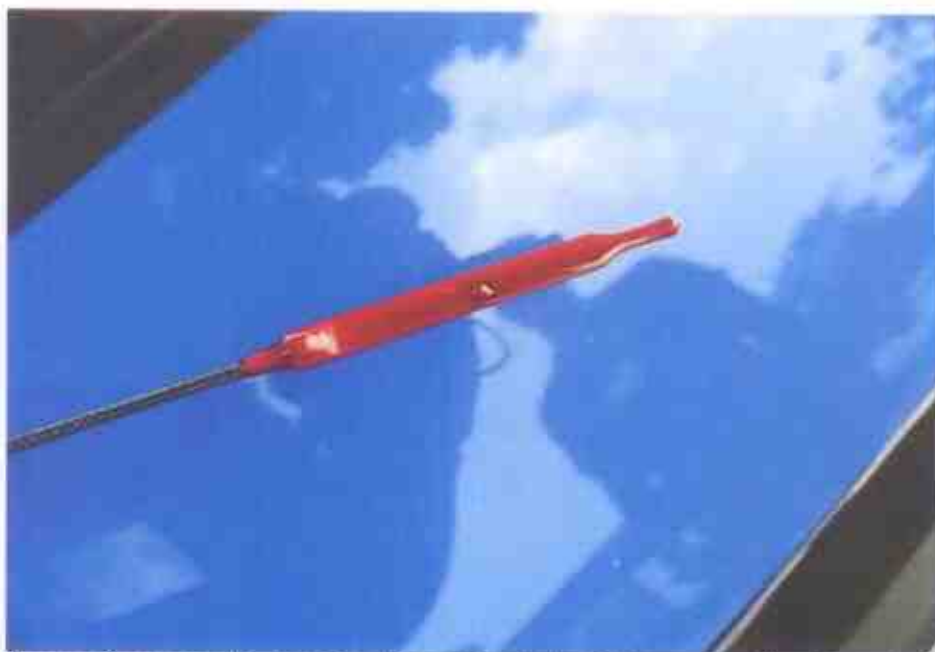
Photo 13 shows the engine oil dip stick of the Motor Taxi at the time of our inspection. The engine oil was observed to be of sufficient level and without any visible contamination.

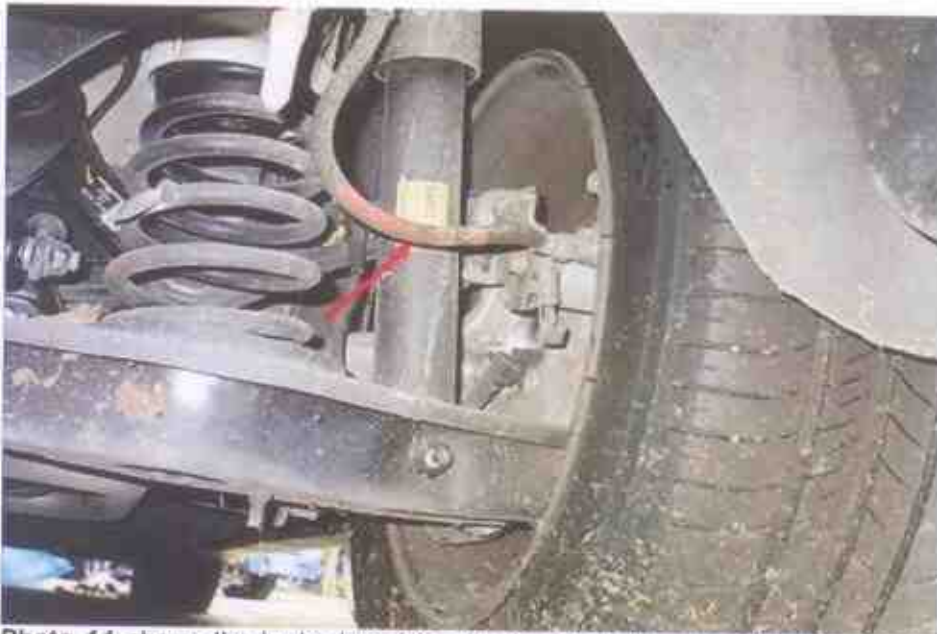
11. Static brake tests conducted on the Motor Taxi revealed no abnormality. There was no abnormal movement of the brake pedal when it was depressed. In general, the static brake tests had suggested that there was no internal leakage of pressure/vacuum in the braking system of the Motor Taxi. The braking system of the Motor Taxi was likely to be in serviceable condition at the material time. This was taking into consideration that the brake fluid was of sufficient level, and also that there was no sign(s) of brake fluid leakage along the brake hoses and brake pipes.

Photo 14 shows the brake hose/pipe (arrowed) at the rear right wheel of the Motor Taxi. We did not observe any leakage of brake fluid at the time of our inspection of the Motor Taxi. Static tests of the Motor Taxi's braking system had indicated that there was no internal leakage of pressure/vacuum. Hence the braking system was likely to be in serviceable condition at the material time of accident. The undercarriage components of the Motor Taxi were also all found to be intact and without any visible damage.

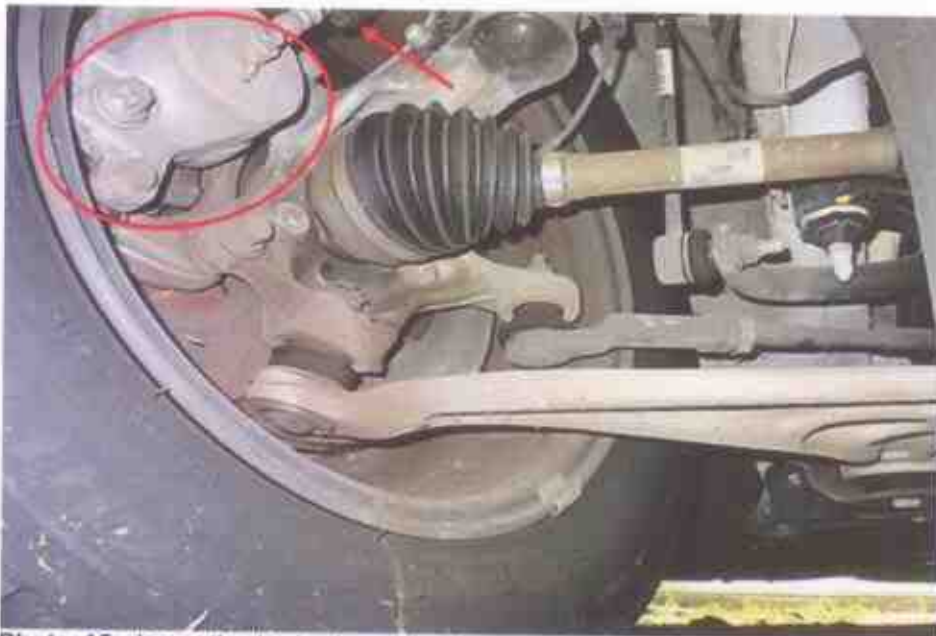
Photo 15 shows the brake hose/pipe (arrowed) at the front right wheel of the Motor Taxi. No leakage of brake fluid was observed. Visual examination of the various components of the braking system like the brake caliper (circled), brake pedal etc. had revealed all to be intact and without visible damage.

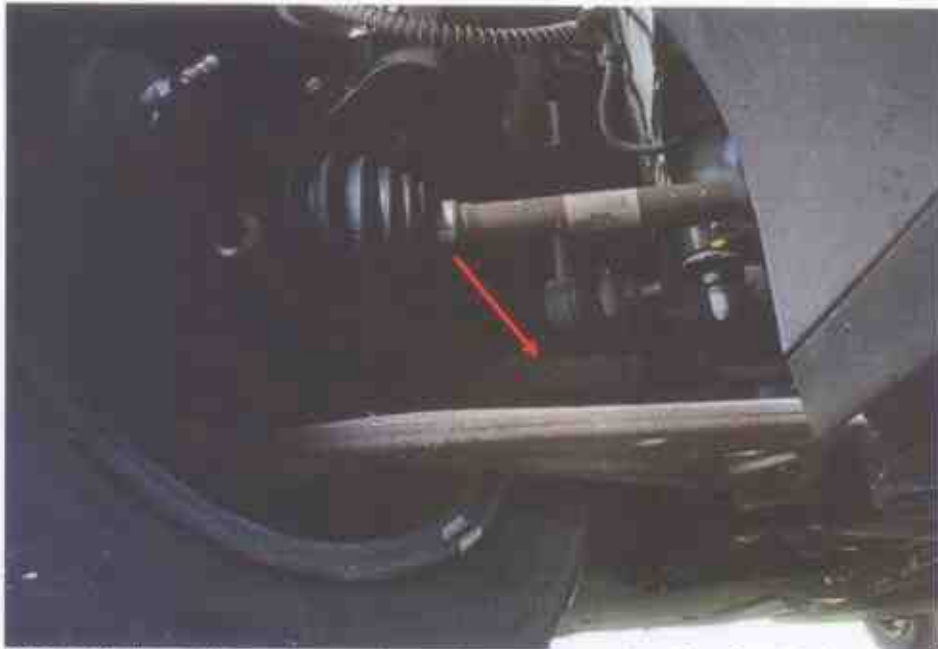
Photo 16 shows the various undercarriage components at the front right wheel of the Motor Taxi, in particular the steering tie rod (arrowed). The various steering components were all found to be intact, suggesting that the steering system of the Motor Taxi was likely to be in serviceable condition at the material time of accident. There was also no sign of fluid stain observed on the various undercarriage components at the front right wheel of the Motor Taxi.

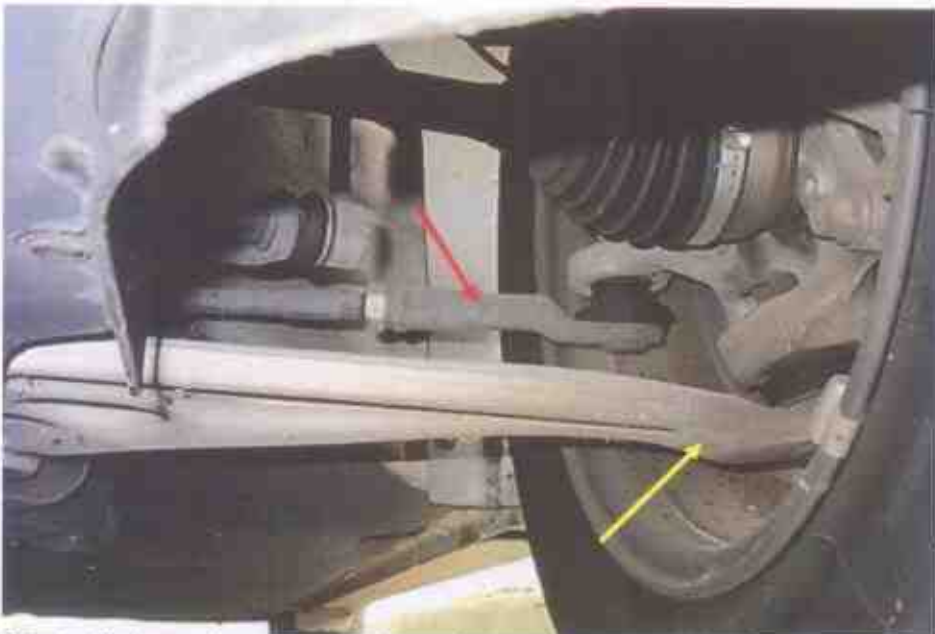
Photo 17 shows the various undercarriage components at the front left wheel of the Motor Taxi, which had included the steering tie rod (red arrow) and left drive shaft (yellow arrow). The various undercarriage components of the Motor Taxi were all found to be intact without any visible damage.

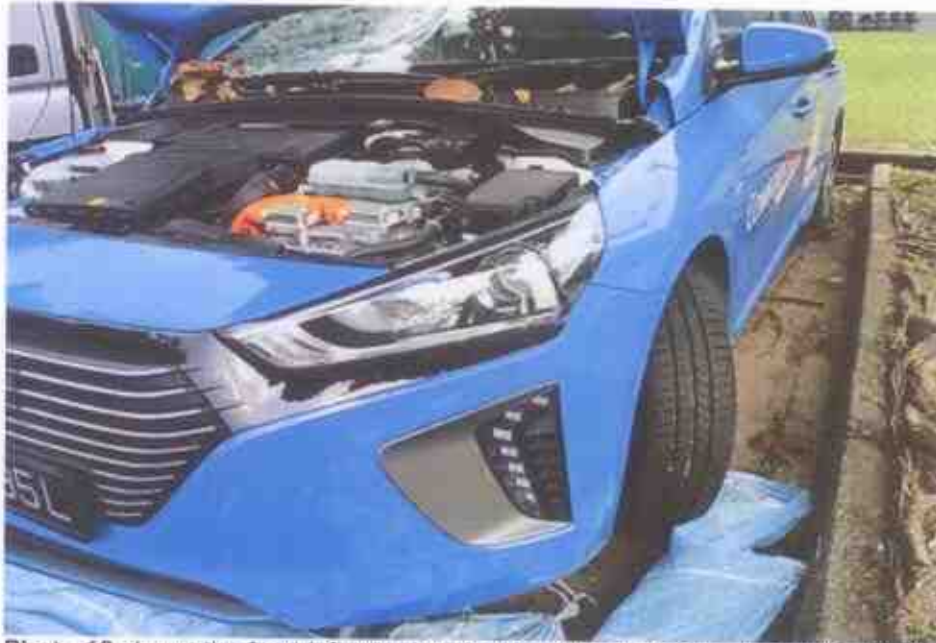
Photo 18 shows the front left wheel of the Motor Taxi turned to its full left. During our steering system test, we did not experience any abnormal free play and/or resistance when we had turned the steering wheel towards the left and right. This would suggest that the steering system of the Motor Taxi was likely to be in serviceable condition at the material time of accident.

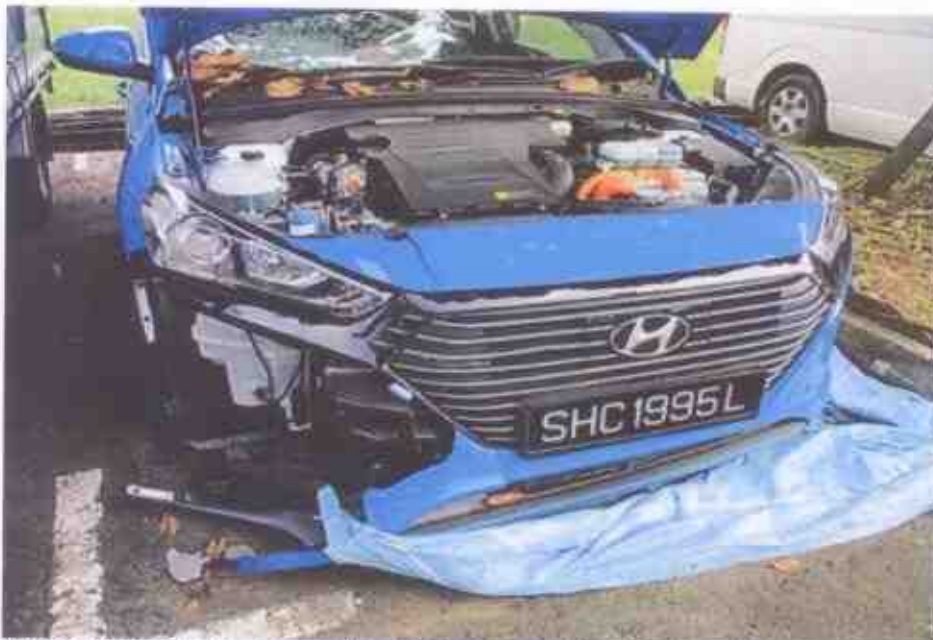
Photo 19 shows the front right wheel of the Motor Taxi turned to its full right. During our steering system test, we did not experience any abnormal free play and/or resistance when we had turned the steering wheel towards the left and right. This would suggest that the steering system of the Motor Taxi was likely to be in serviceable condition at the material time of accident.

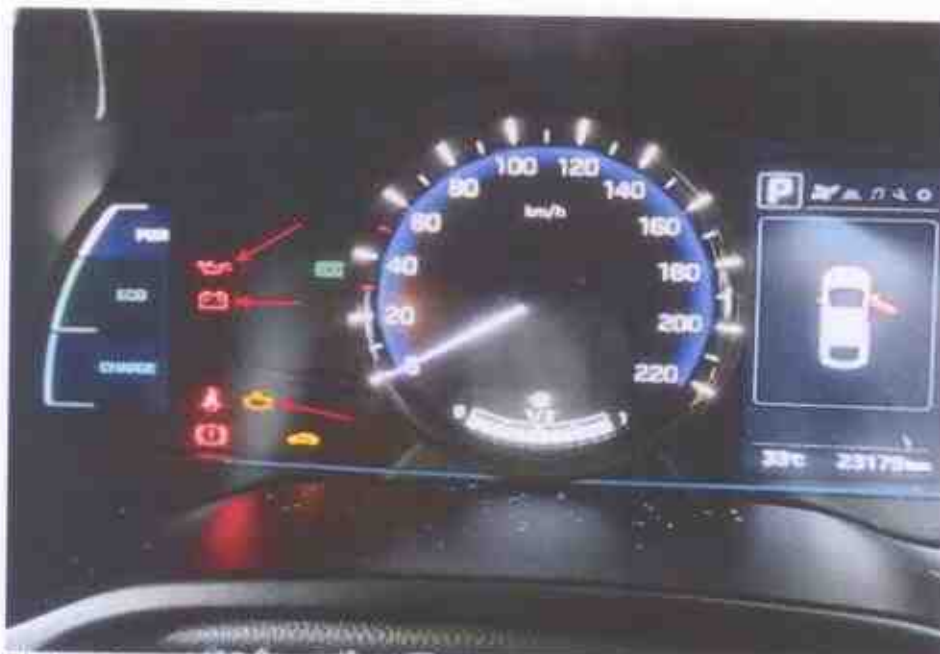
Photo 20 shows the warning lights for the various engine and electrical components of the Motor Taxi appearing on its instrument panel during the self-test when the engine is cranked, in particular the engine light, battery light and oil light (arrowed).

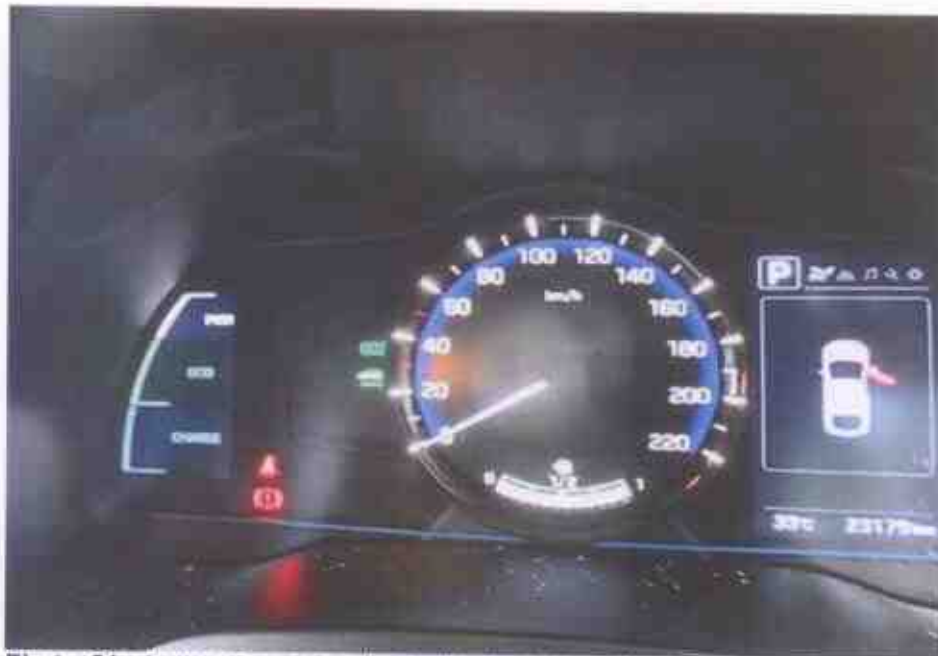
Photo 21 shows no warning lights illuminated on the instrument panel of the Motor Taxi after the engine was cranked. This would suggest that there was no abnormality to the various engine and electrical components of the Motor Taxi.
