**Fatal Accident Investigation Team**

**MECHANICAL INSPECTION REPORT OF MOTORCYCLE JSC 3025**

1. We refer to your request dated 28<sup>th</sup> December 2018 to conduct a physical inspection of a motorcycle bearing registration number JSC 3025 (herein referred to as "**Motorcycle**"), which was involved in a fatal road traffic accident on 14<sup>th</sup> December 2018.
2. The purpose of this inspection is to primarily determine if there was any possible mechanical failure to the Motorcycle that may have contributed to the accident.
3. Following the request, we had carried out a physical inspection of the Motorcycle on 19<sup>th</sup> December 2019 at the premises of Traffic Police vehicle pound, 517 Airport Road Singapore 539942. We now set out below our observations and comments with respect to this inspection.

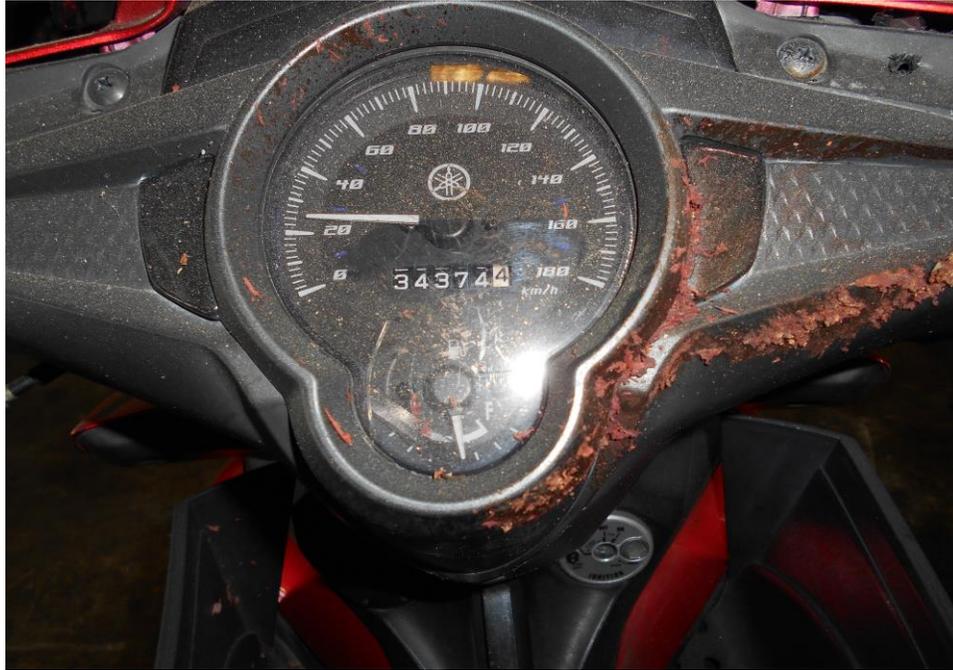
**Photo 1** shows a close-up view of the mileage meter at time of our inspection. The mileage was recorded at 343744km.

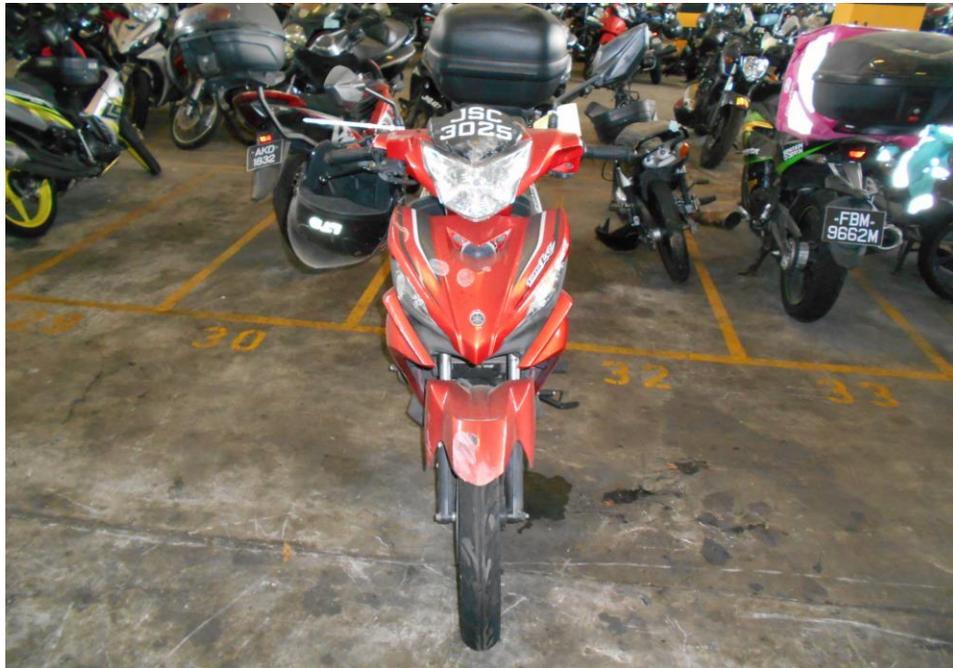
**Photo 2** shows a general view of the front body of the Motorcycle at the time of our inspection. The Motorcycle was observed to have sustained relatively minor damages at time of inspection. The damages were observed to be confined to its frontal & right side of the Motor Cycle.

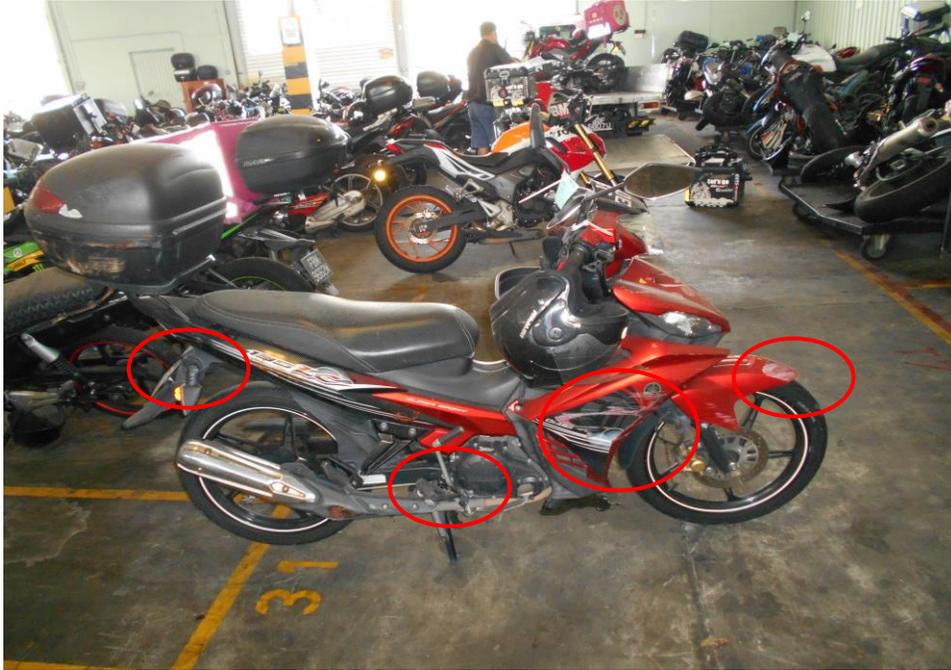
**Photo 3** shows a general view of the right body of the Motorcycle at the time of our inspection. The damages were observed to be confined to its frontal & right side of the Motor Cycle.

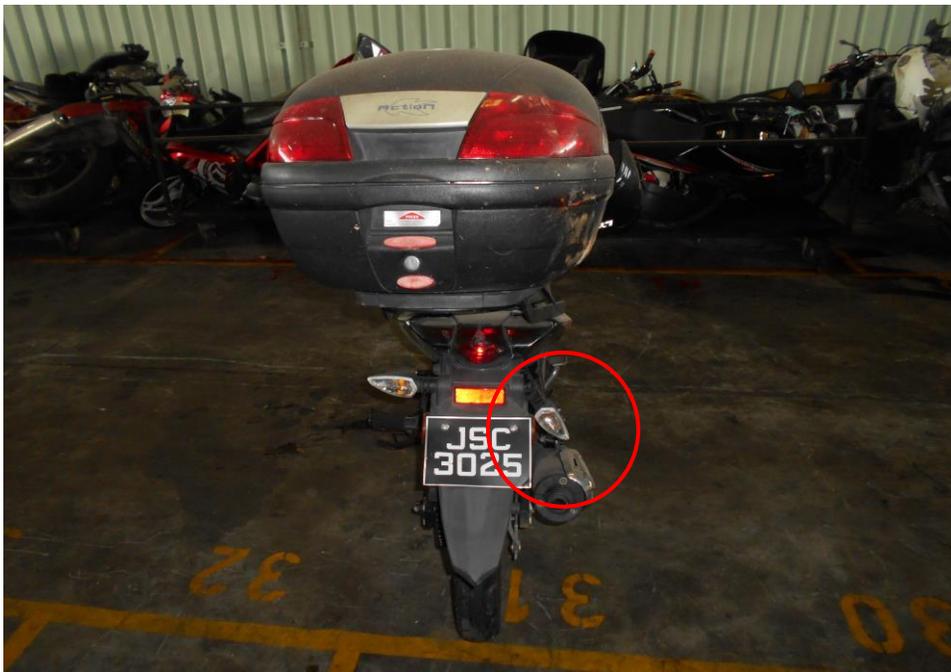
**Photo 4** shows a general view of the rear body of the Motorcycle at the time of our inspection. The Motorcycle was observed to have sustained relatively minor damage on the rear compartment bracket and right side signal lamp at time of our inspection.

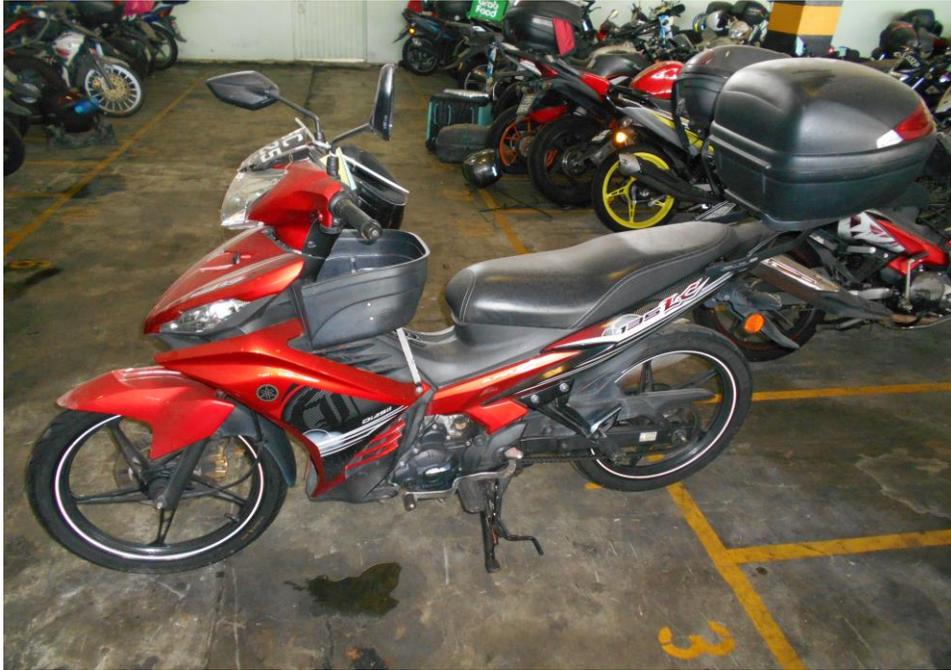
**Photo 5** shows a general view of the left body of the Motorcycle at the time of our inspection. The damages were observed to be confined to its frontal & right side of the Motor Cycle at time of our inspection.

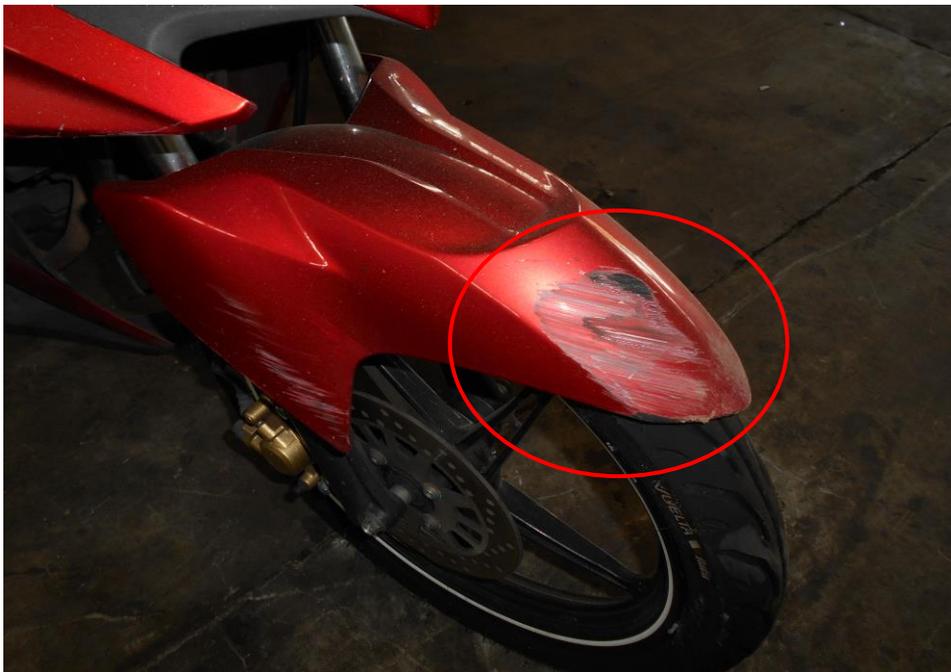
**Photo 6** shows a closer view of the front mud-guard of the Motorcycle at the time of our inspection. It was observed to sustain deep grazing due to the accident collision. (Circled)

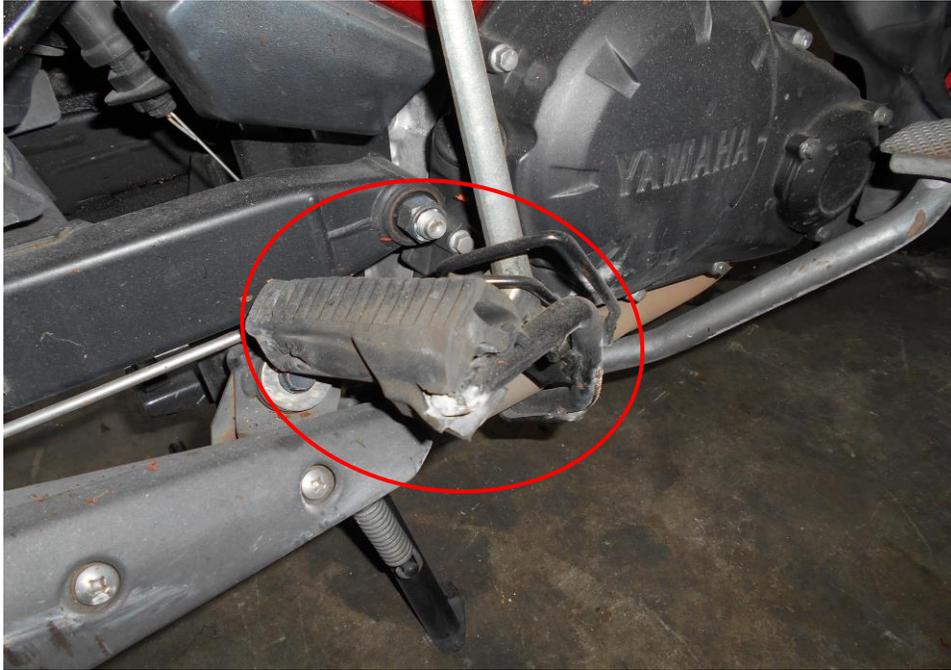
**Photo 7** shows a closer view of the right side foot rest of the Motorcycle at the time of our inspection. It was observed to be buckled inwards due to the accident collision. (Circled)

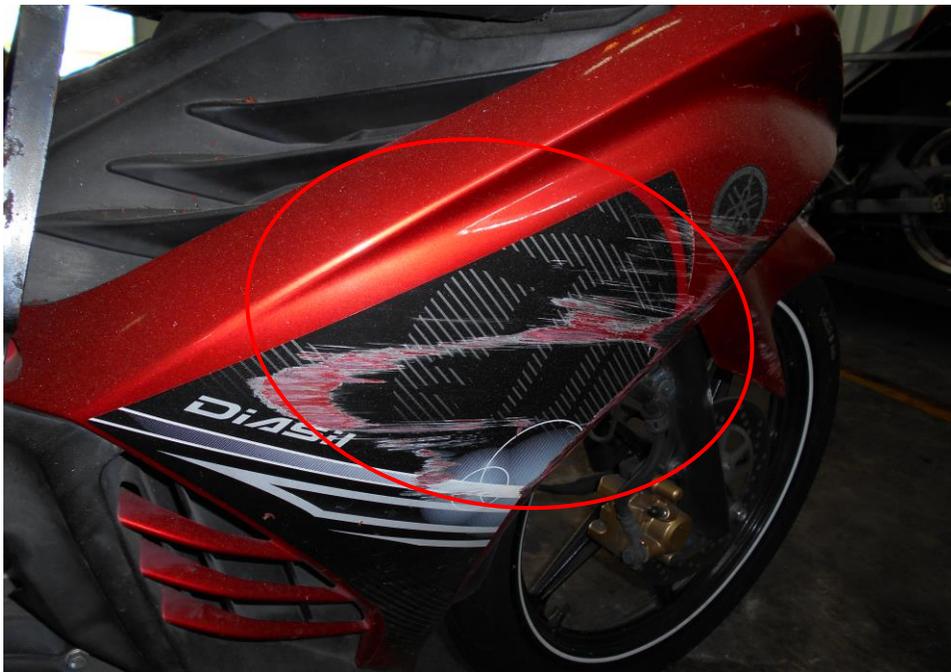
**Photo 8** shows a closer view of the right side fairing of the Motorcycle at the time of our inspection. It was observed to sustained deep scratches due to the accident collision. (Circled)

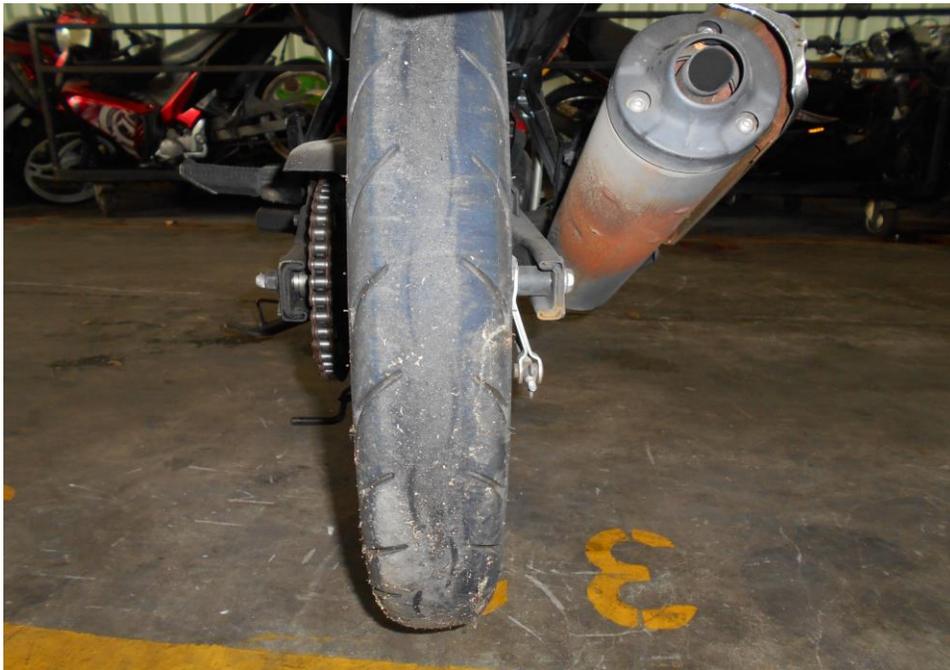
**Photo 9** shows the rear tyre of the Motorcycle. The rear tyre was observed to be in serviceable condition with remaining tread depth of approximately 2mm. The tyre was also observed to be sufficiently inflated for vehicular operation.

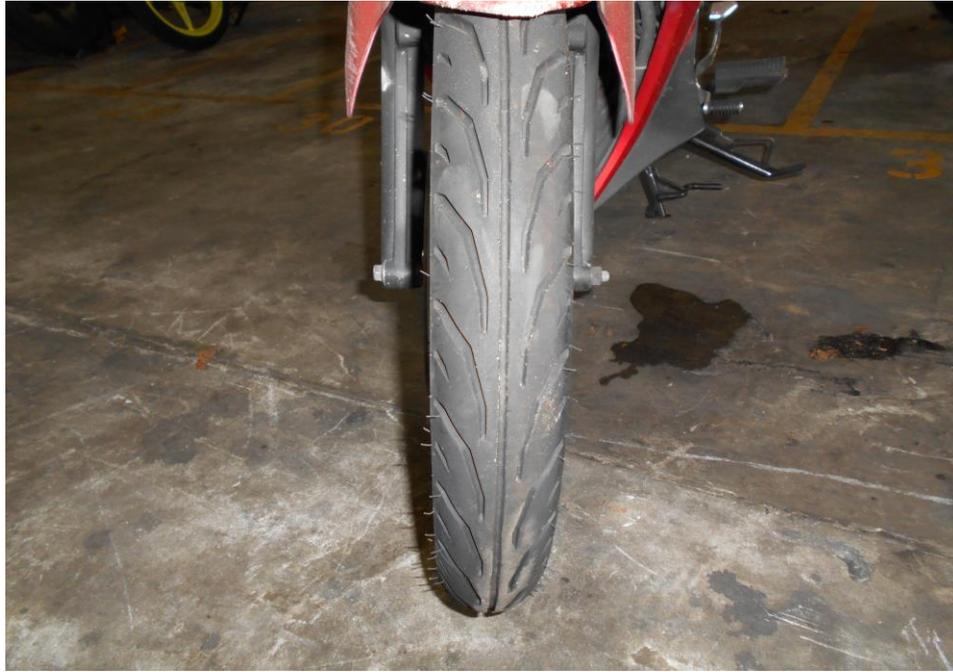
**Photo 10** shows the front tyre of the Motorcycle. The front tyre was observed to be in serviceable condition with remaining tread depth of approximately 4mm. The tyre was also observed to be sufficiently inflated for vehicular operation.

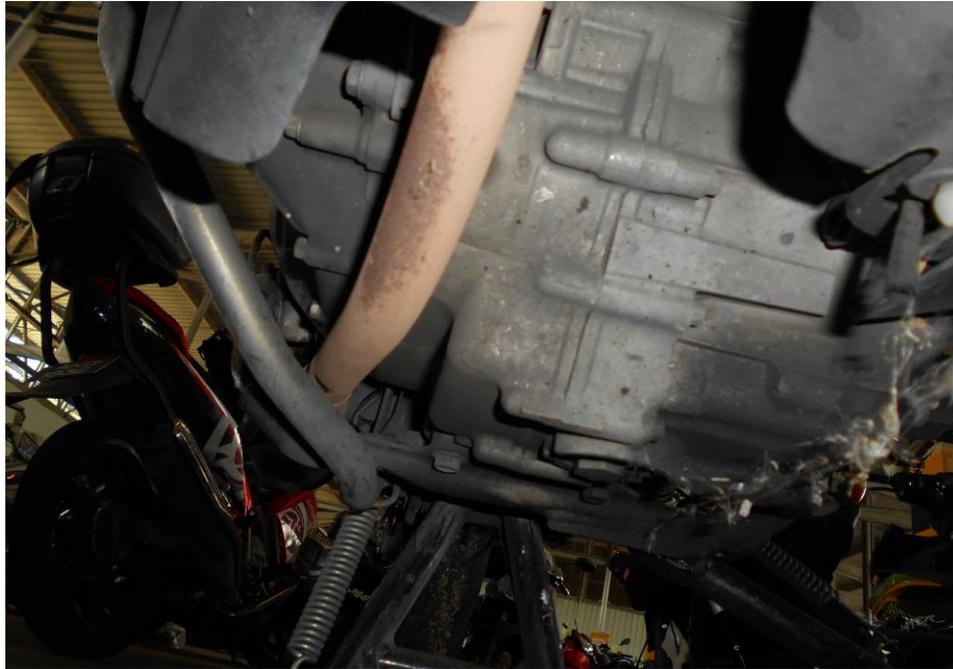
**Photo 11** shows no sign(s) or indication(s) of fluid leak observed around the underside of the engine area of the Motorcycle.

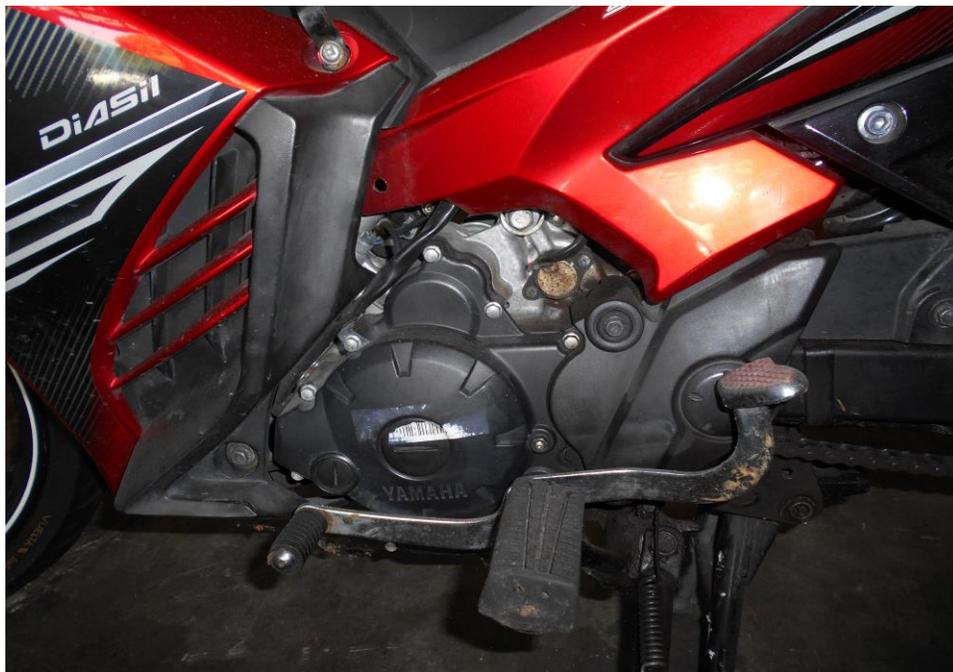
**Photo 12** shows no sign(s) or indication(s) of fluid leakage stain observed around the engine area of the Motorcycle.

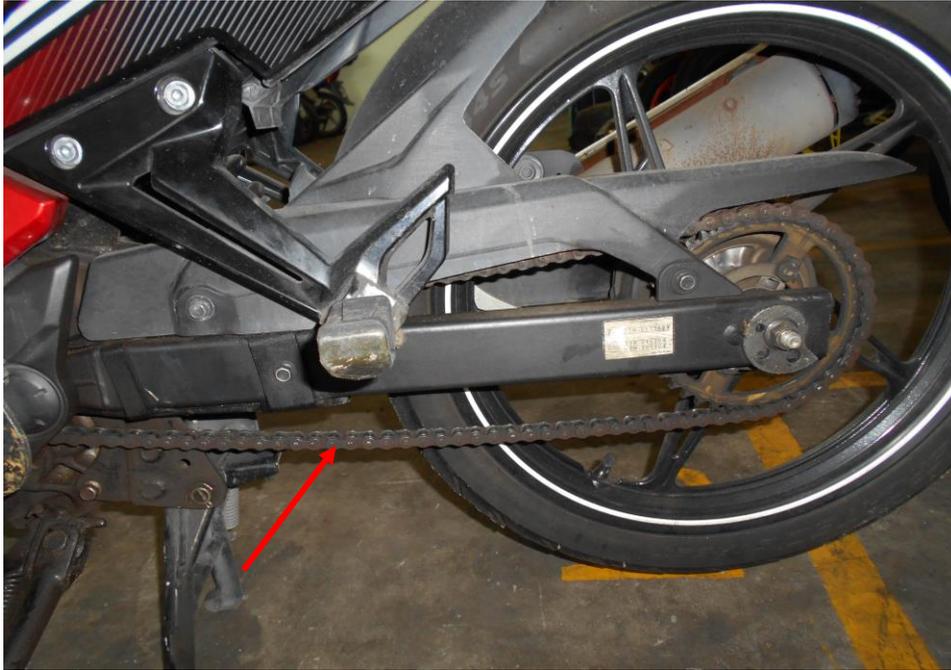
**Photo 13** shows the general view of the gear train (arrowed) of the Motorcycle, which was observed to be intact with no misalignment. It was also adequately lubricated for operating purposes.

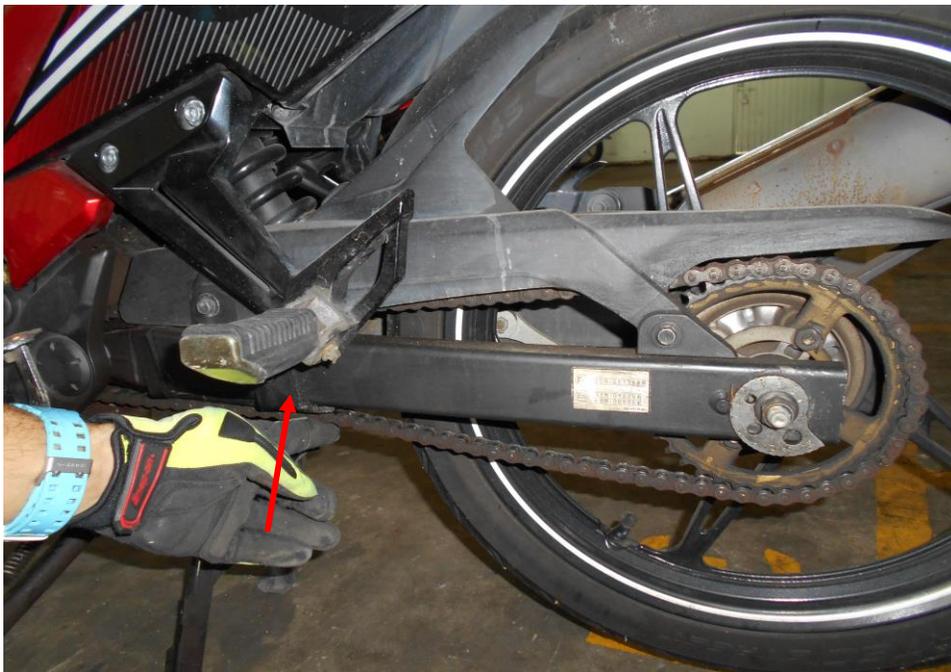
**Photo 14** shows the general view of the gear train (arrowed) of the Motorcycle, which was observed to be intact with no misalignment. It was also adequately lubricated for operating purposes. Free play tension was also observed & found adequately acceptable.

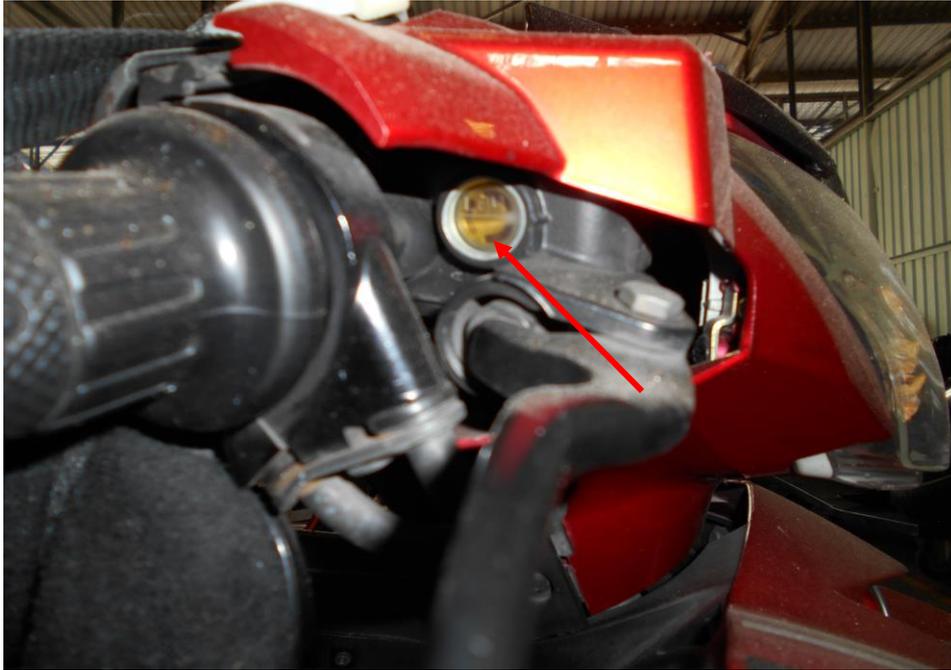
**Photo 15** shows our checks on the brake fluid (front) reservoir had also indicated that the brake fluid was of sufficient level for operational purposes, and without contamination.

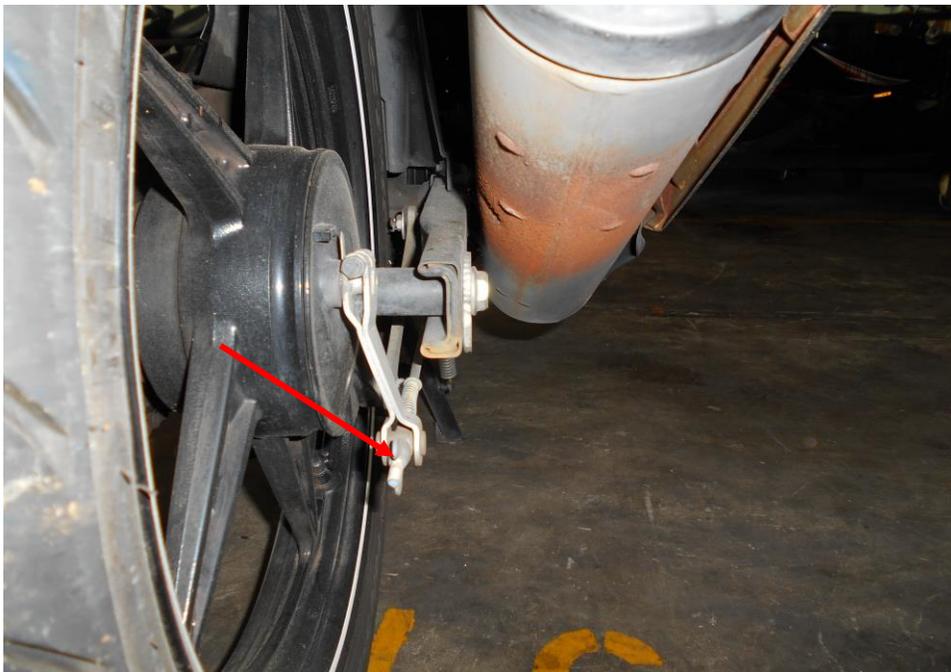
**Photo 16** shows our checks on the rear braking system. The rear braking components were found to be unaffected by the accident impact such as rear brake drum, springs and cables which are the supporting components of the rear brake.

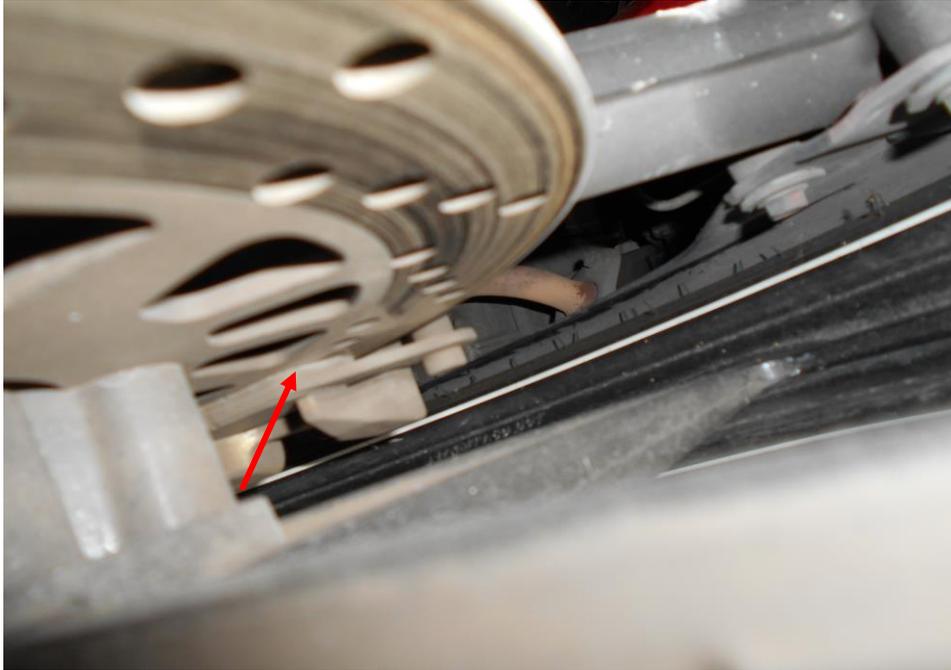
**Photo 17** shows the front brake pad at time of our inspection. The frictional material was observed to be sufficient for operational purposes.
