Your Ref: TP/IP/69185/2018
Our Ref :CI/TPD19000747/Z

26th March 2019

MECHANICAL INSPECTION REPORT OF MOTORCYCLE FBN 439X

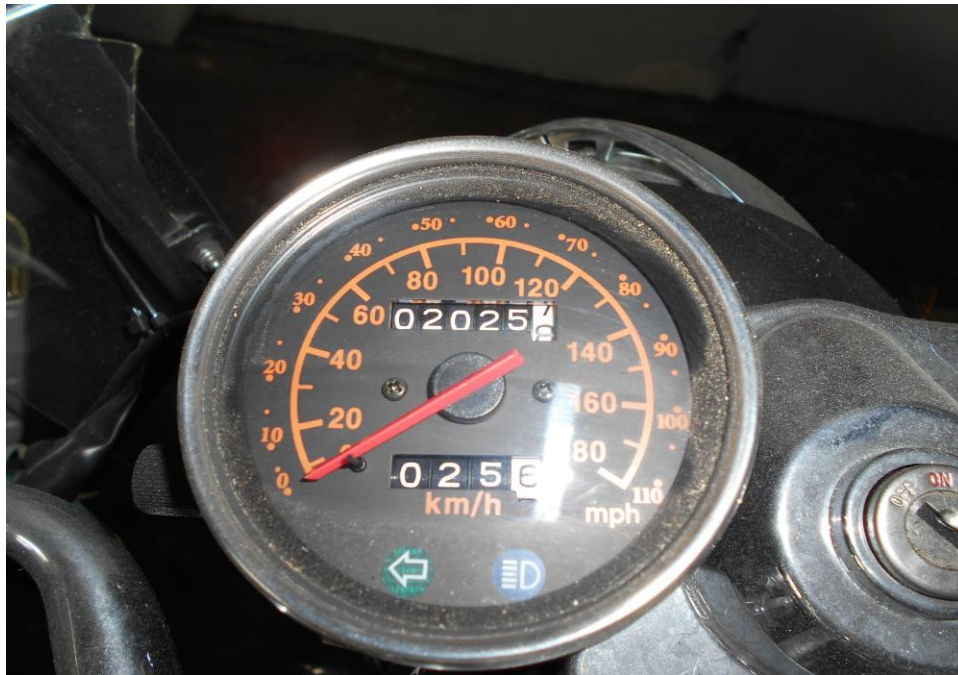
Photo 1 shows the mileage that was recorded at time of our inspection. The mileage recorded at 020258km.

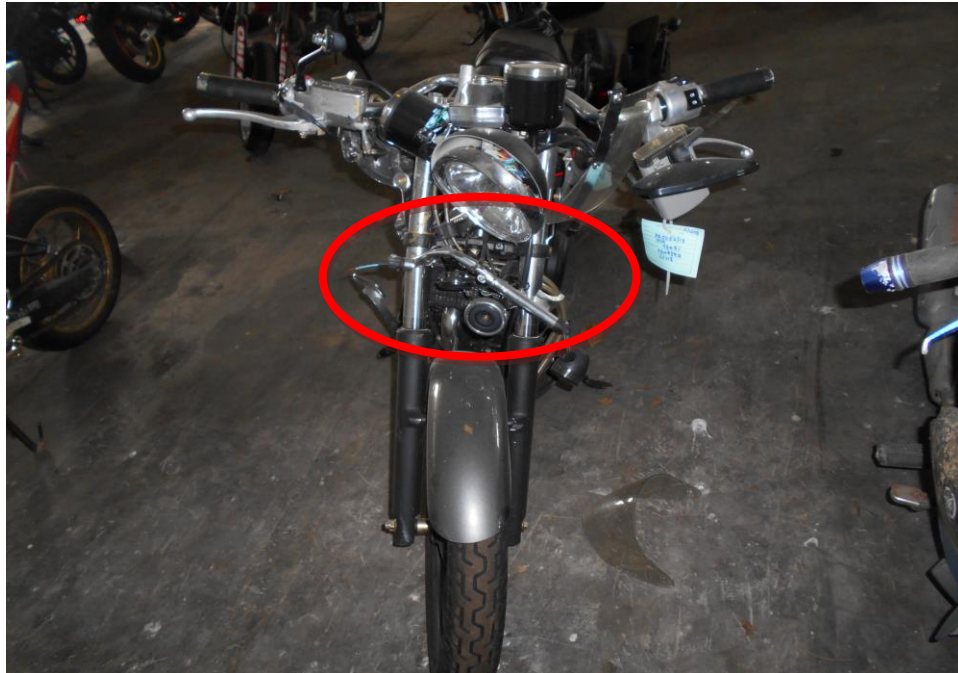
Photo 2 shows a general view of the front body of the Motorcycle at the time of our inspection. The Motorcycle was observed to be sustained with relatively extensive impact due to the accident collision. Amongst the body parts damaged was its steering system (circled), which was observed to be bent inwards.

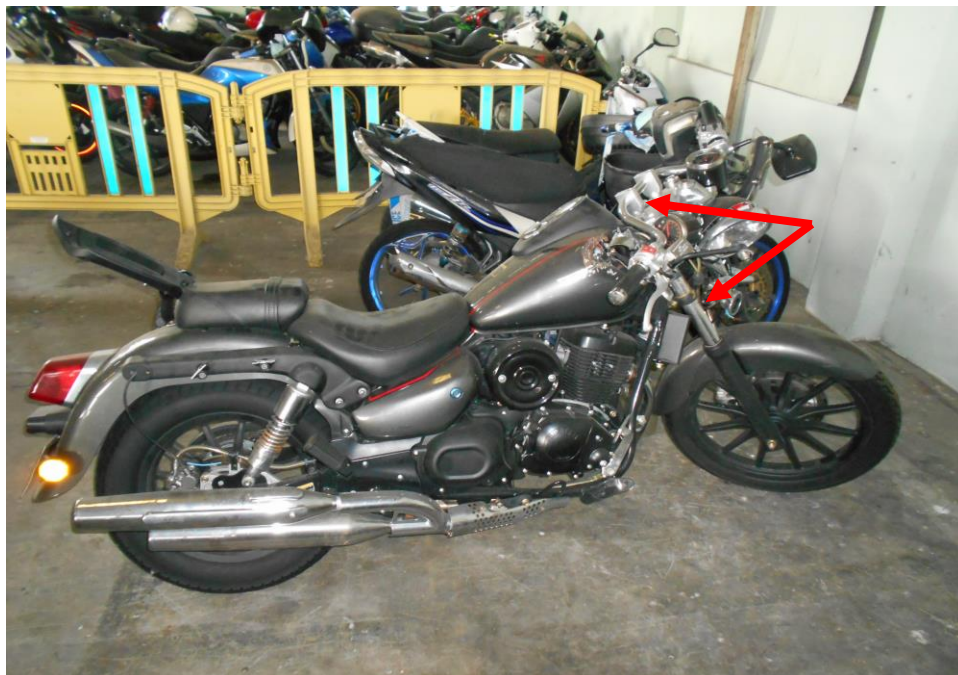
Photo 3 shows a general view of the front right body of the Motorcycle at the time of our inspection. The Motorcycle was observed to be sustained with relatively extensive impact due to the accident collision. Amongst the body parts damaged was its handle bar & front fork-steering system (arrowed), which was observed to be bent inwards.

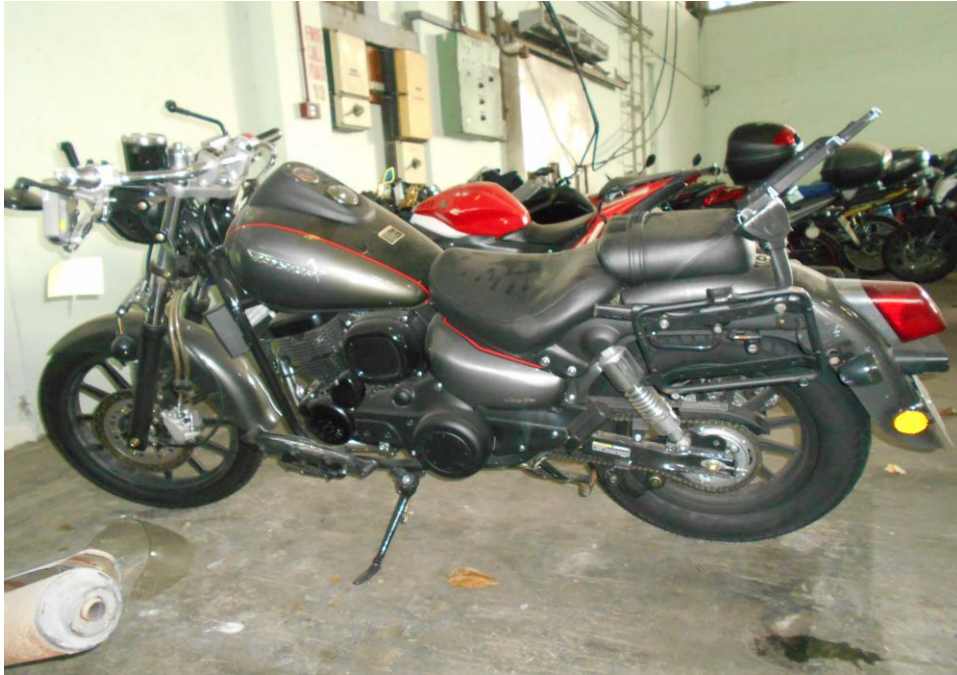
Photo 4 shows a general view of the rear left body of the Motorcycle at the time of our inspection. The Motorcycle was observed to have sustained damages at the frontal & rear portion, along both its left side and right side.

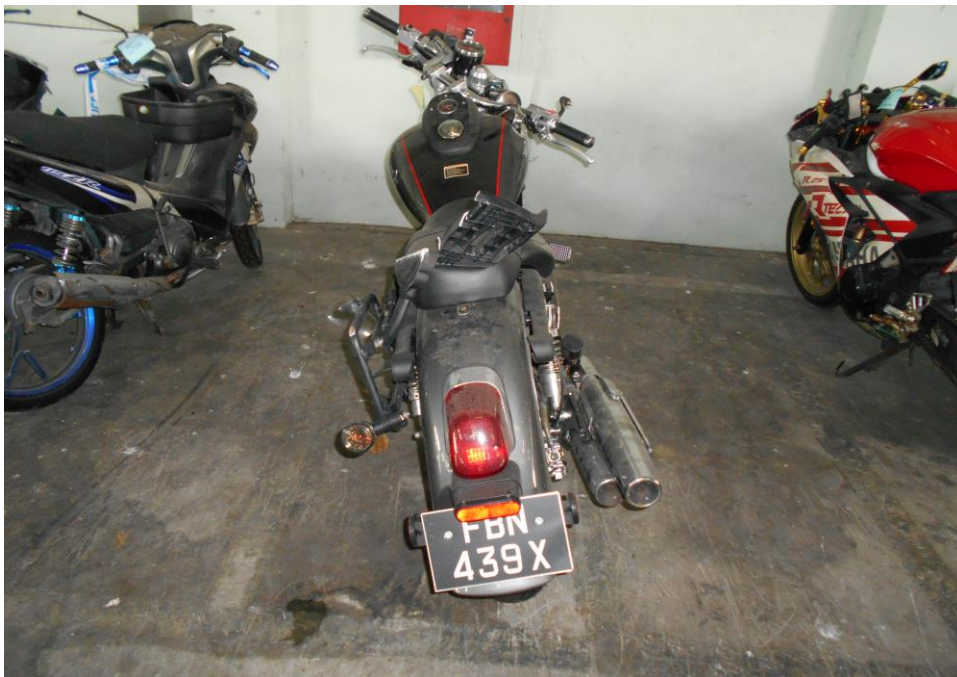
Photo 5 shows a general view of the rear portion of the Motorcycle at the time of our inspection. It was observed to have sustained damages affected by the accident's impact.

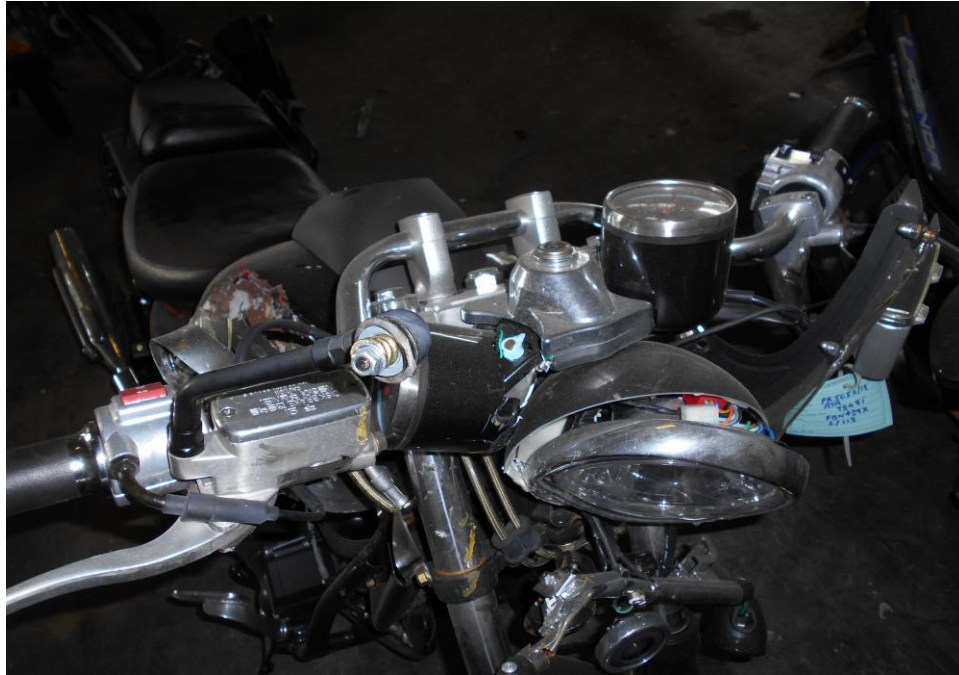
Photo 6 shows a close-up view of the head lamp & handle bar of the Motorcycle at the time of our inspection. It was observed to have sustained with damages due to the accident collision.

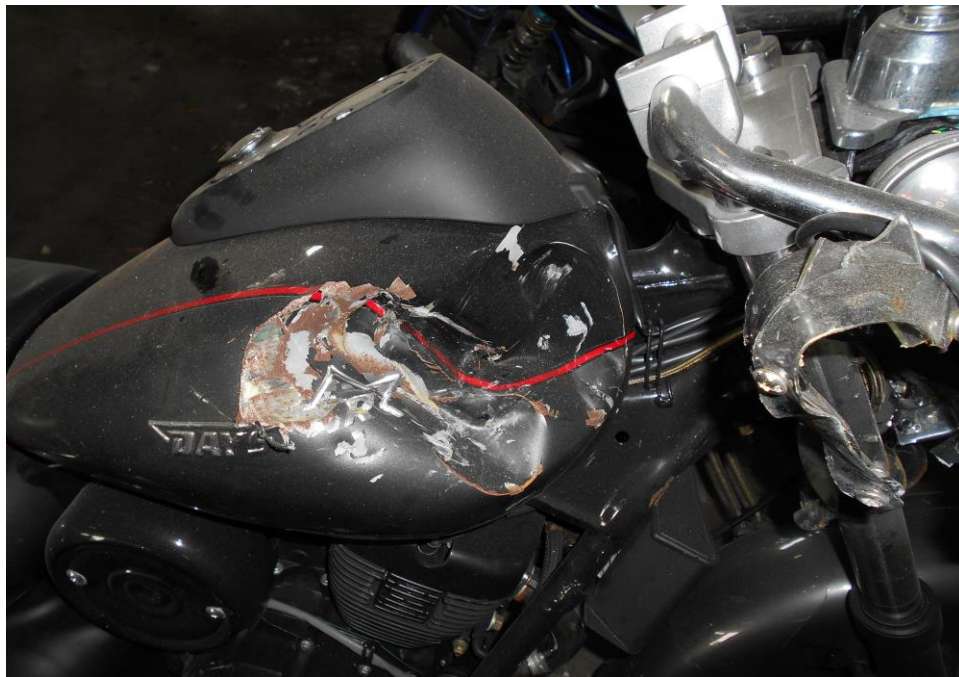
Photo 7 shows a close-up view of the fuel tank of the Motorcycle at the time of our inspection. It was observed to have sustained with damages due to the accident collision.

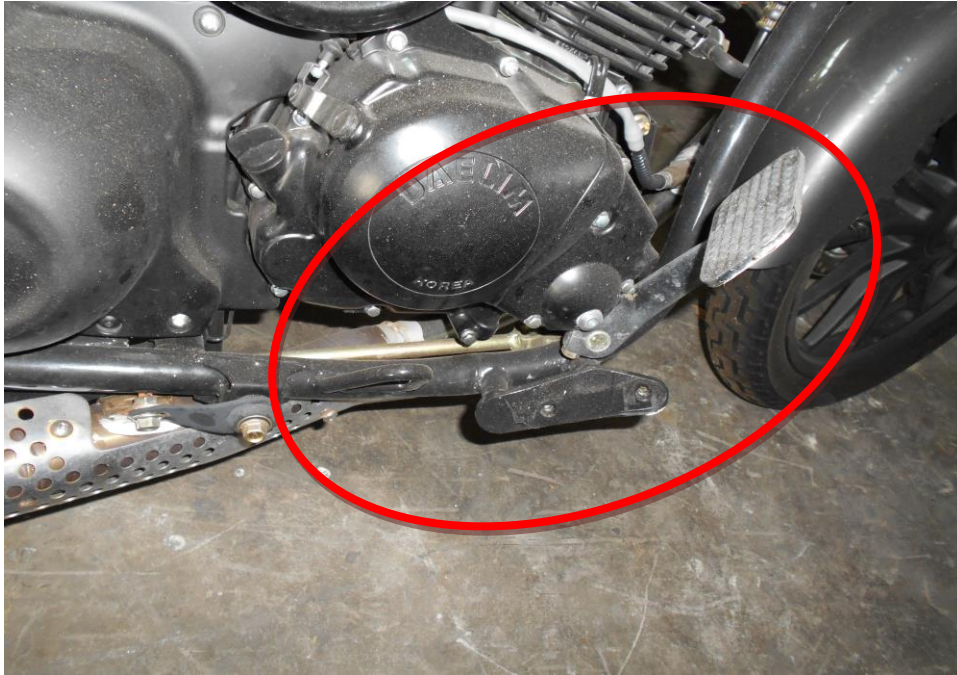
Photo 8 shows a close-up view of the missing right side foot rest of the Motorcycle at the time of our inspection. It was observed to be missing due to the accident collision.

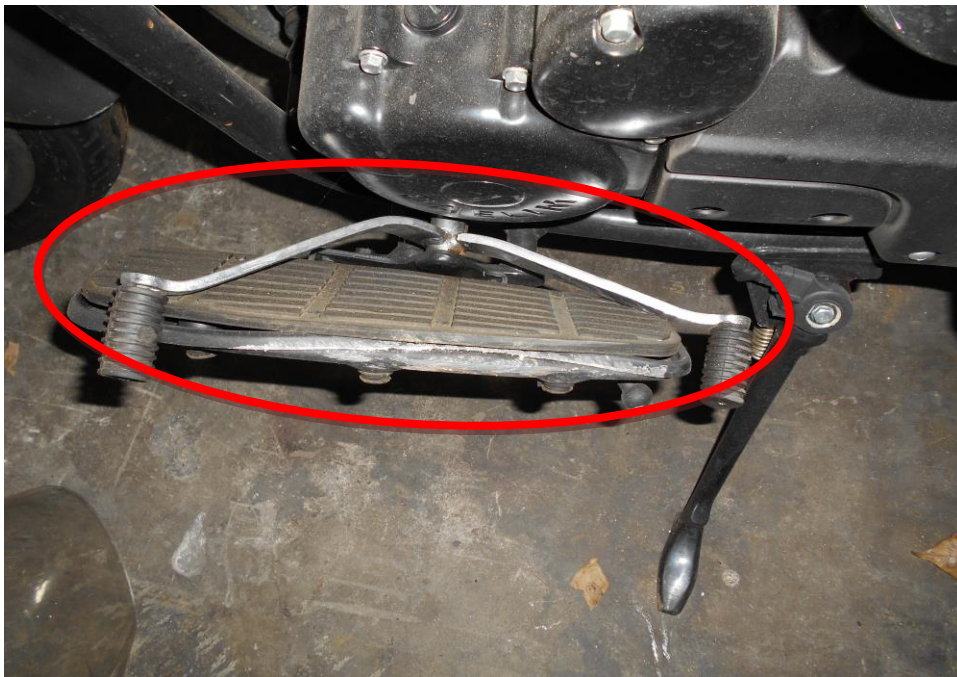
Photo 9 shows a close-up view of the stuck left side foot rest and gear shifter of the Motorcycle at the time of our inspection. It was observed to have sustained with damages due to the accident collision.

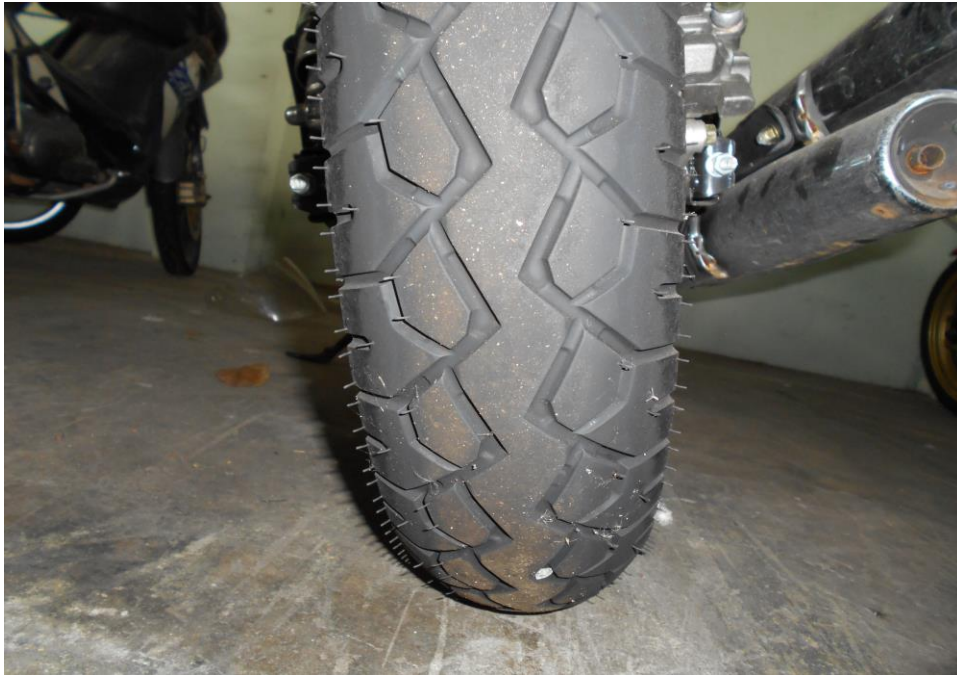
Photo 10 shows the rear tyre of the Motorcycle at the time of our inspection. The rear tyre was observed to be in serviceable condition with remaining tread depth of approximately 6mm. The tyre was also observed to be sufficiently inflated for vehicular operation. There was no significant damage observed on the rear wheel rim & tyre.

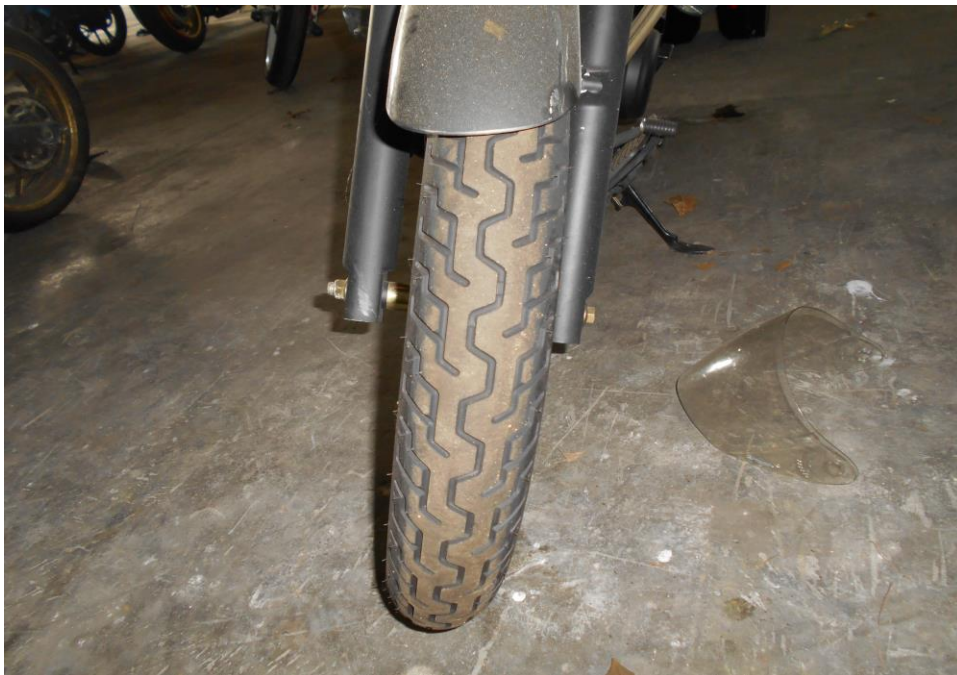
Photo 11 shows the front tyre of the Motorcycle. The pattern of the tread was clearly visible with remaining tread depth of approximately 5mm. There was no tear, burst mark(s) and/or punctured hole(s) on the sidewalls as well as across the tread of the front tyre.

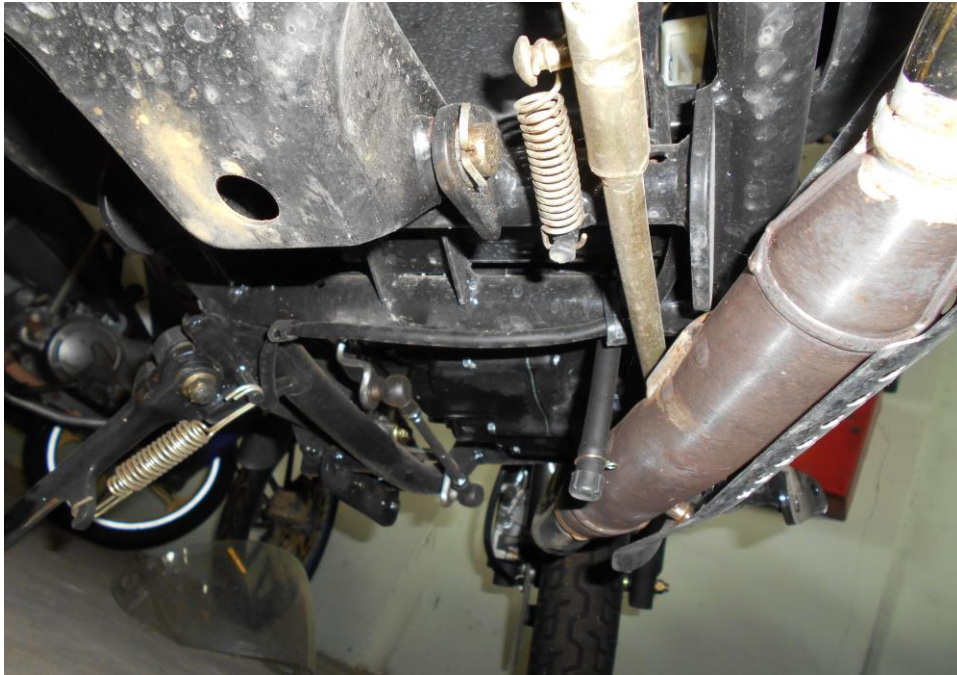
Photo 12 shows no sign(s) or indication(s) of fluid leakage stain observed around the engine undercarriage area of the Motorcycle.

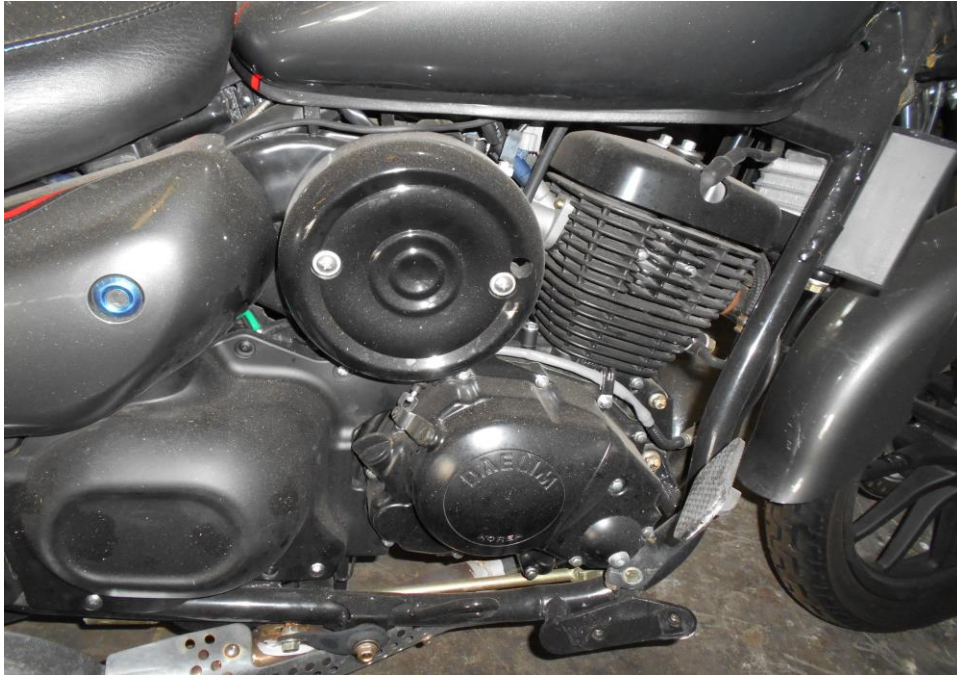
Photo 13 shows the semi-close view of the engine compartment. It was observed to be intact & undamaged unaffected by the accident's impact.

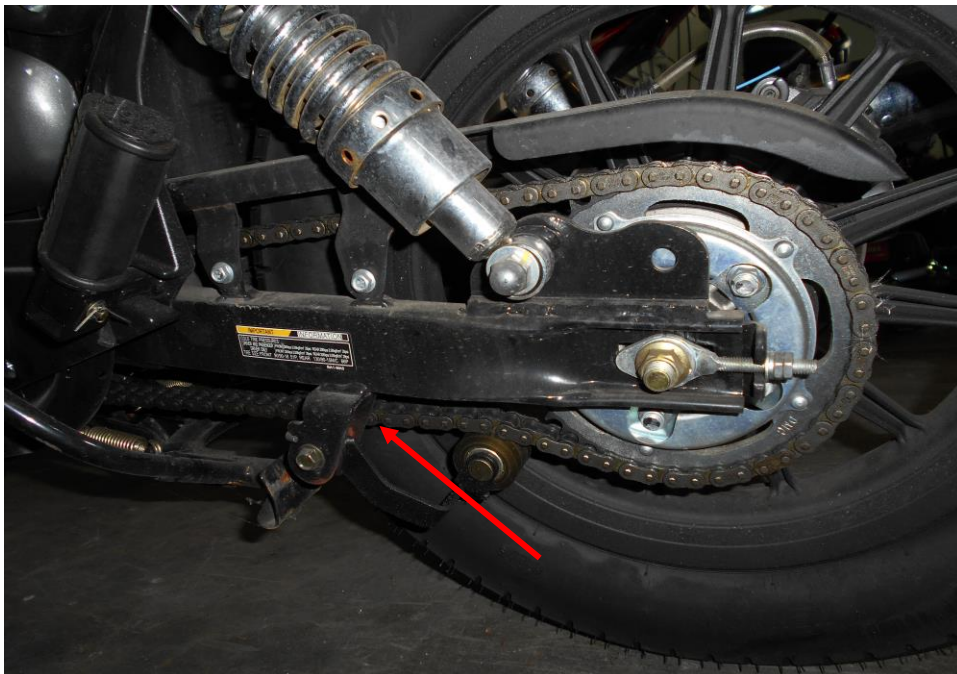
Photo 14 shows the general view of the gear train (arrowed) of the Motorcycle, which was observed to be intact with no misalignment. It was also adequately lubricated for operating purposes.

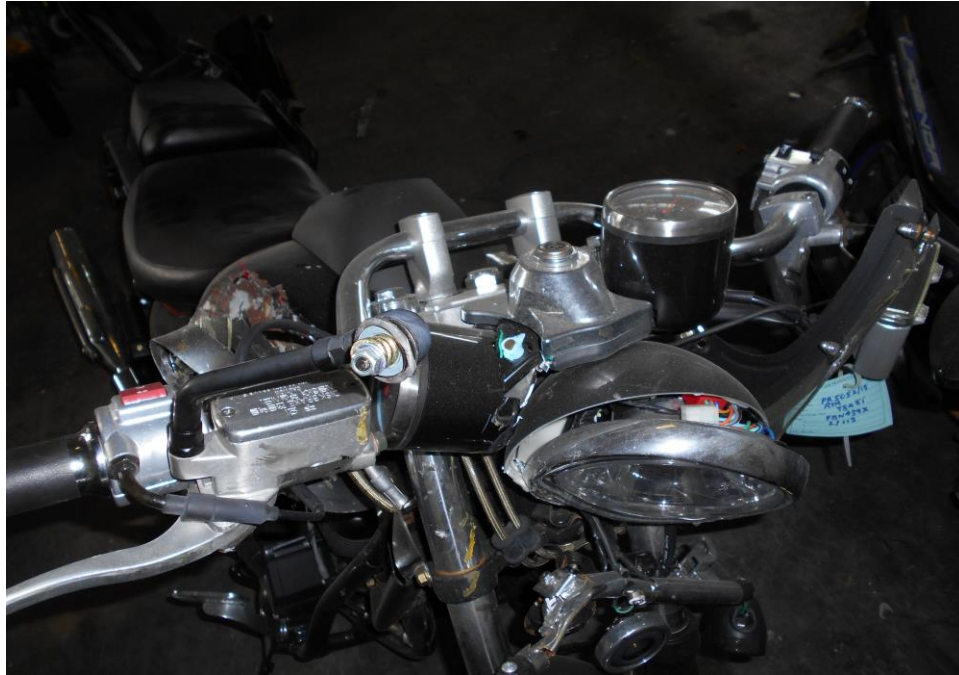
11. For this case, we were not able to conduct any test(s) on the steering system of the Motorcycle due to the damage on its handle bar and front fork. It was found to be bent inwards as a result of the accident, hence causing the whole steering system to be in an abnormal condition.

Photo 15 shows the handle bar and front fork was observed to be bent inwards as a result of the accident. Hence, we are not able to conduct any tests on the steering system of the Motorcycle.

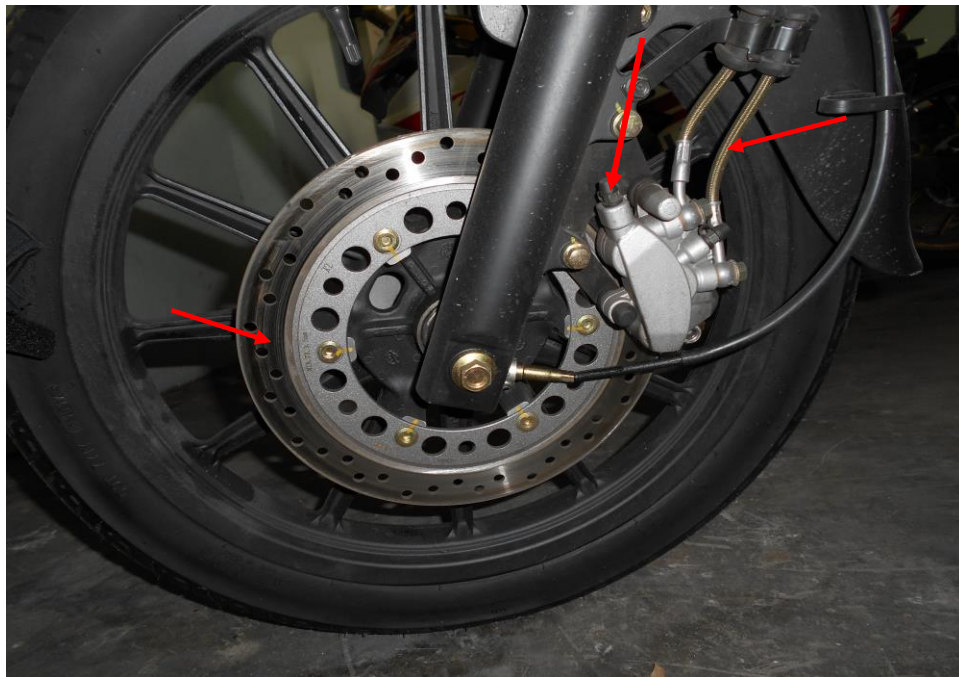
Photo 16 shows the front brake calliper, front brake disc and front brake hose of the Motorcycle (arrowed), which are all part of the components in the front brake system of the Motorcycle. Our visual checks of these various components had revealed all to be intact with no visible damage. No leakage of brake fluid was also observed.

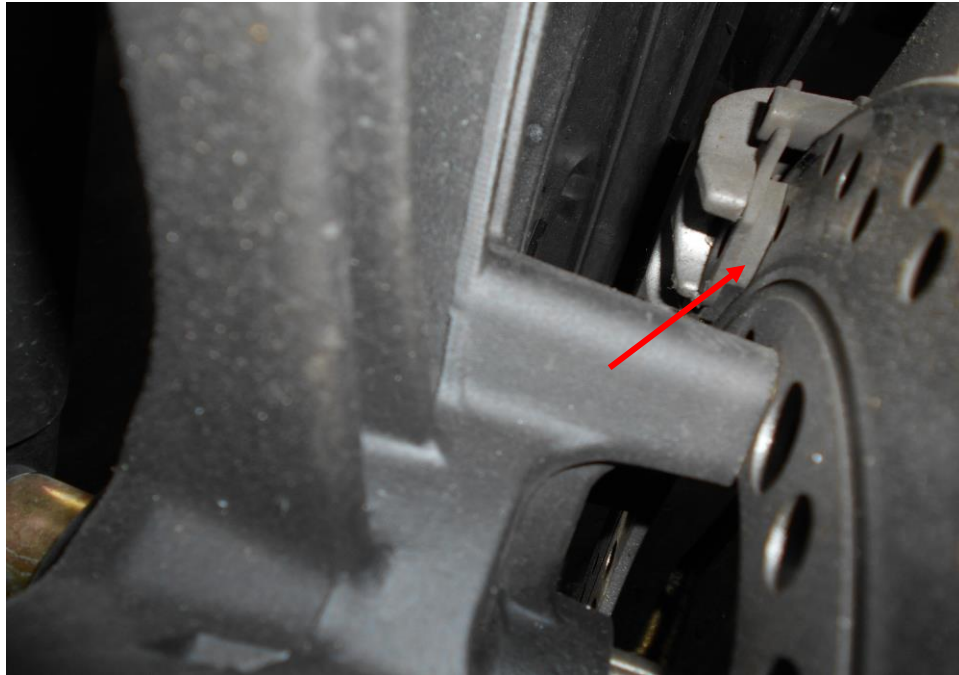
Photo 17 shows the front wheel of the Motorcycle. The type of brake system for the rear wheel was of hydraulic type, controlled by the hand brake lever of the Motorcycle. Our checks of the calliper (arrowed) & brake pad which are all part of the components in the rear brake system of the Motorcycle reveal all to be intact and without damage.

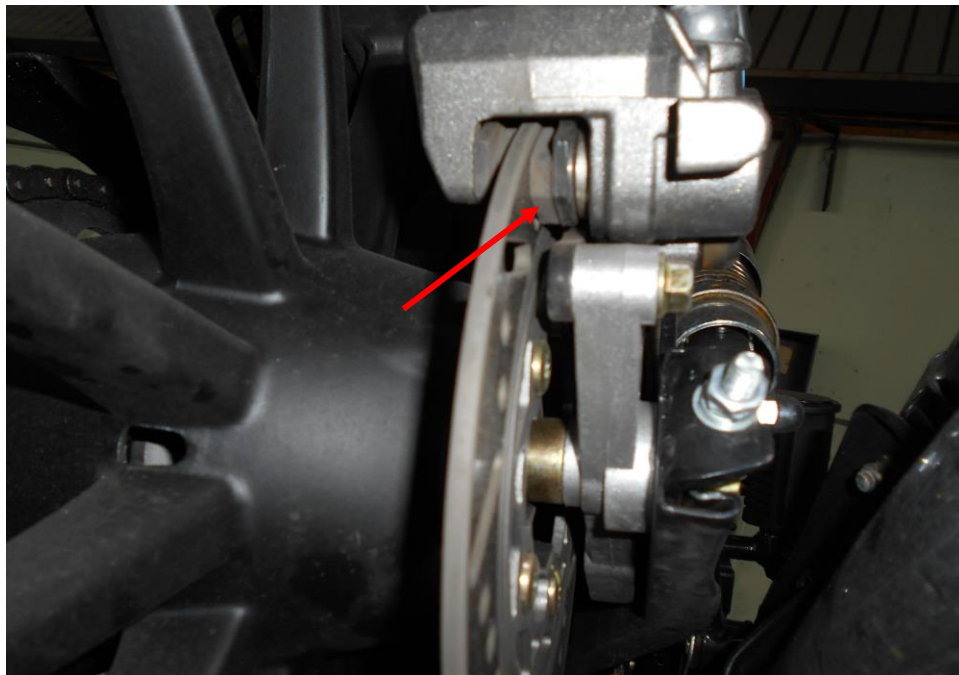
Photo 18 shows the rear wheel of the Motorcycle. The type of brake system for the rear wheel was of hydraulic type, controlled by the brake foot pedal of the Motorcycle. Our checks of the calliper (arrowed) & brake pad which are all part of the components in the rear brake system of the Motorcycle reveal all to be intact and without damage.

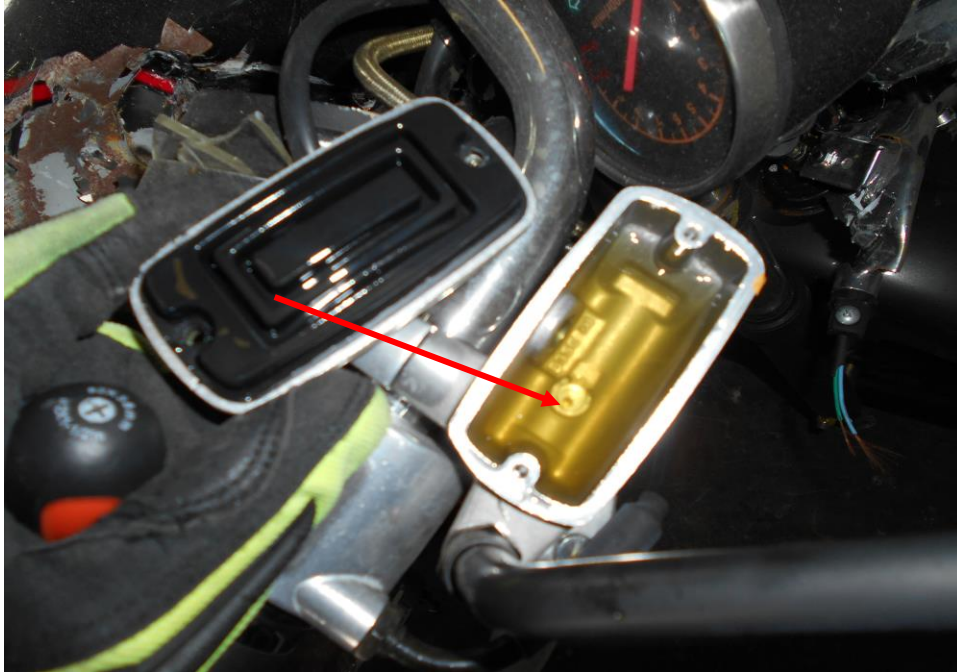
Photo 19 shows the front brake fluid reservoir of the Motorcycle. It was observed to be of sufficient level without any contamination at time of our inspection.
