Your Ref: TP/IP/65429/2018
Our Ref: CI/TPD19000750/P

Fatal Accident Investigation Team

MECHANICAL INSPECTION REPORT OF MOTOR LORRY GBA 4238B

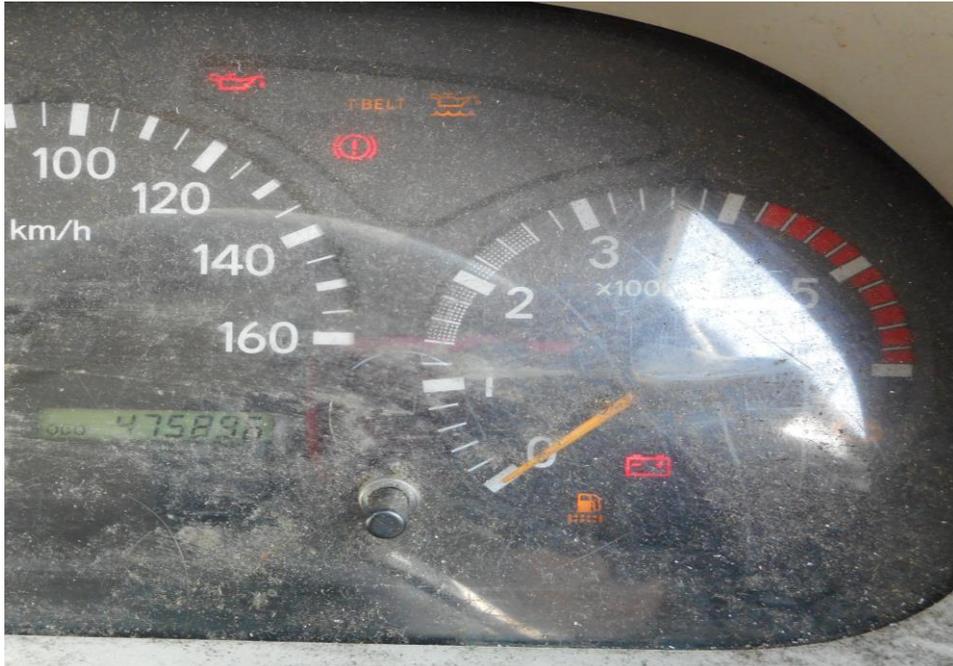
Photo 1 shows the mileage of the Motor Lorry at the time of our inspection was recorded as 475,896km.

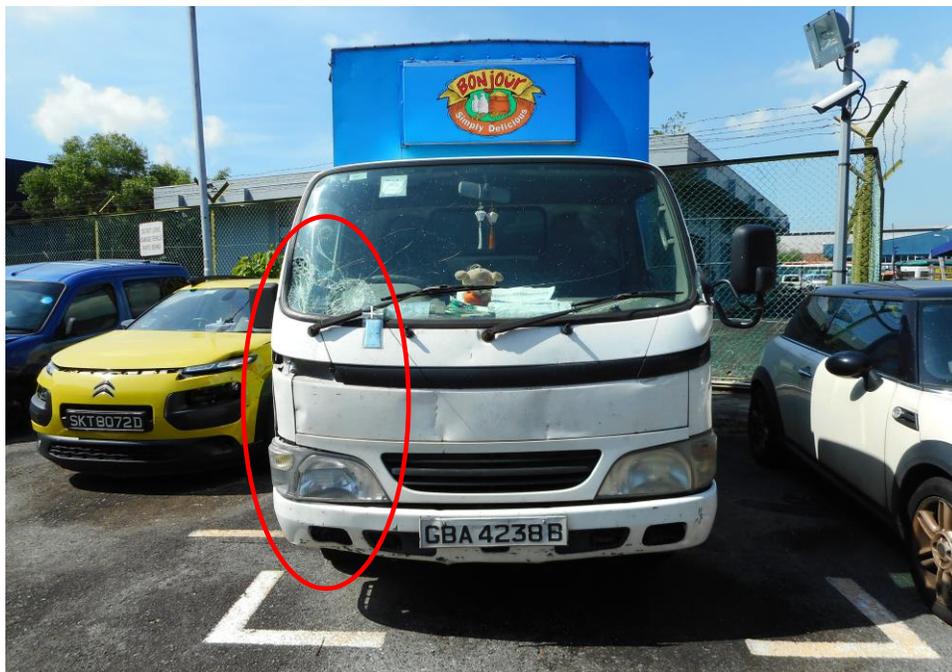
4. The mileage of the Motor Lorry at the time of our inspection was recorded as 475,896km.
5. The Motor Lorry was observed to have sustained minor damage at its right windscreen that was damaged as a result of the accident. See photo 1 – 4.

Photo 2 shows a general view of the front portion of the Motor Lorry at the time of our inspection. The Motor Lorry was observed to have sustained minor damage at its right windscreen that was damaged as a result of the accident.

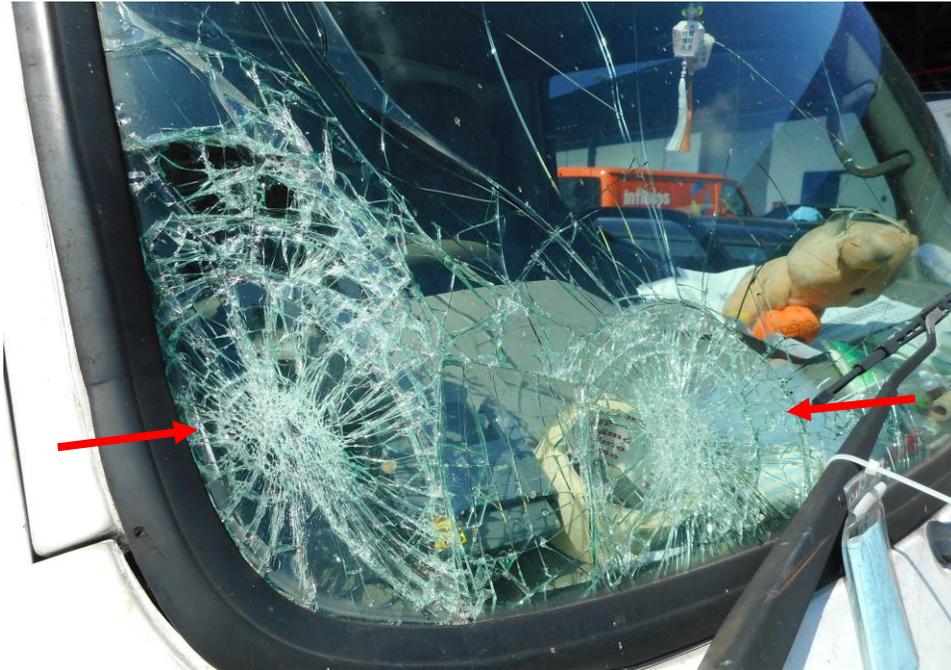
Photo 3 shows the close up view of the front right windscreen, of the Motor Lorry. It was observed to have sustained damages as a result of the accident.

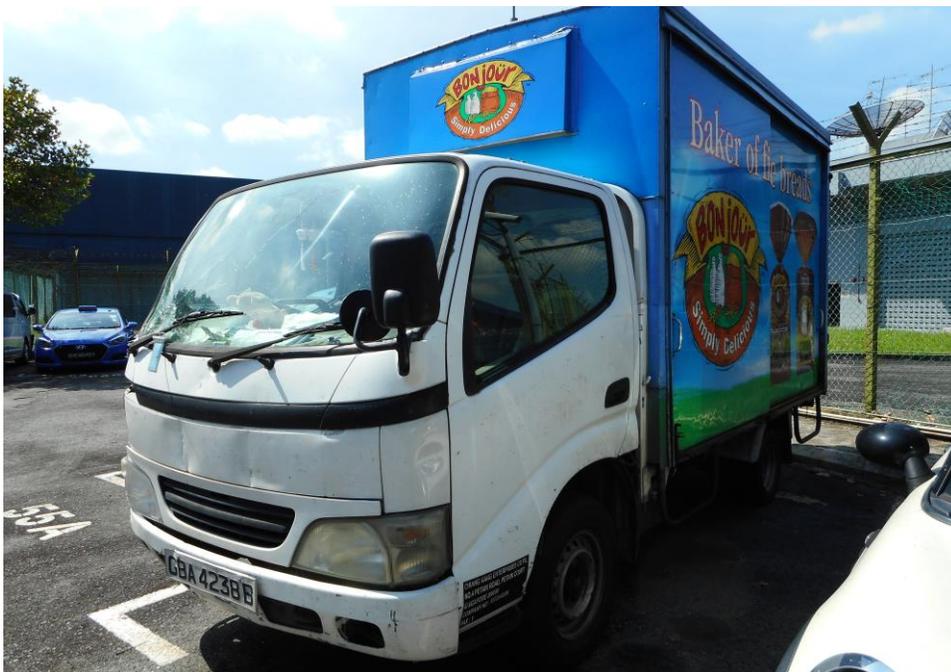
Photo 4 shows a general view of the left portion of the Motor Lorry at the time of our inspection. The Motor Lorry was observed to be in good condition unaffected by the accident's impact.

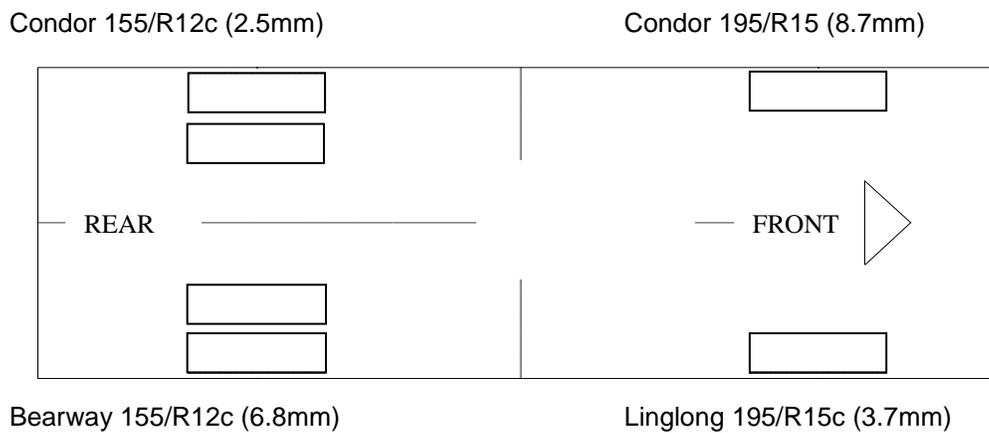
6. The 2 front tyres and 4 rear tyres of the Motor Lorry were observed to be in serviceable condition and sufficiently inflated for vehicular operation. We did not find any tear, cut or burst mark(s) on the outer and the inner sidewalls as well as across the tread of the 6 tyres. The tyre brand, tyre size and remaining tread depth of the 6 tyres of the Motor Lorry were recorded as follows:-

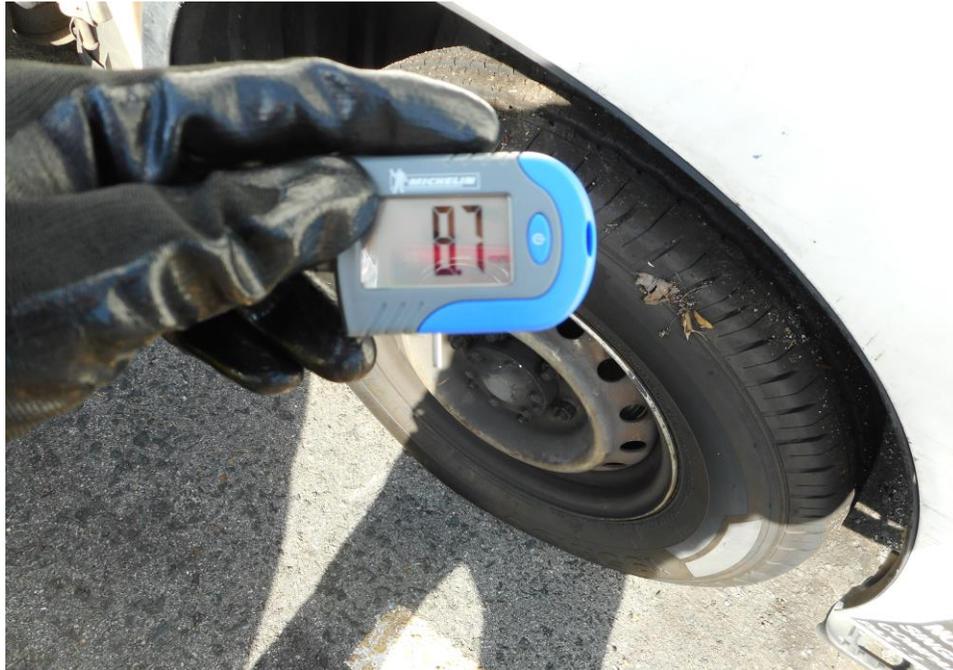
Photo 5 shows the condition of the front left tyre of the Motor Lorry, which was observed to be in serviceable condition with remaining tread depth of approximately 8.7mm. The tyre, which was wrapped around standard alloy wheel rim, was also observed to be sufficiently inflated for vehicular operation.

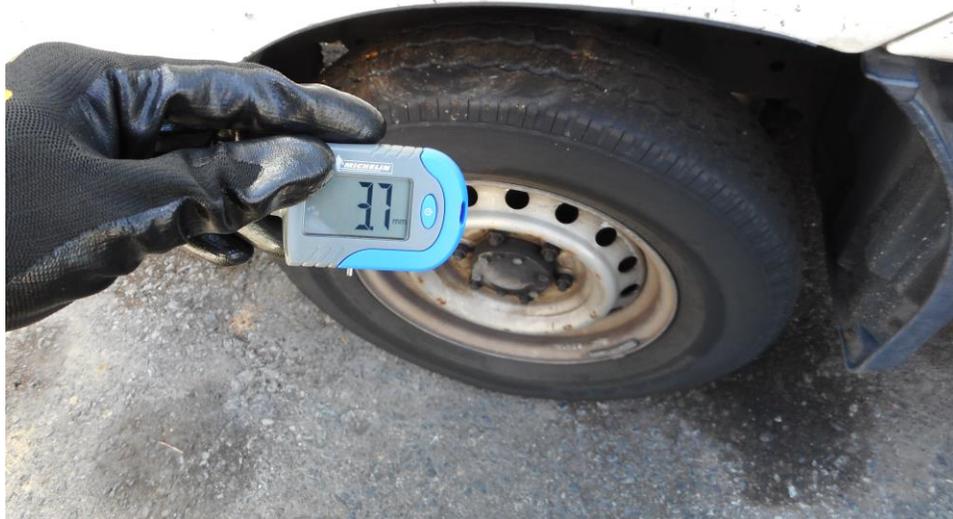
Photo 6 shows the condition of the front right tyre of the Motor Lorry, which was observed to be in serviceable condition with remaining tread depth of approximately 3.7mm. The tyre, which was wrapped around standard alloy wheel rim, was also observed to be sufficiently inflated for vehicular operation.

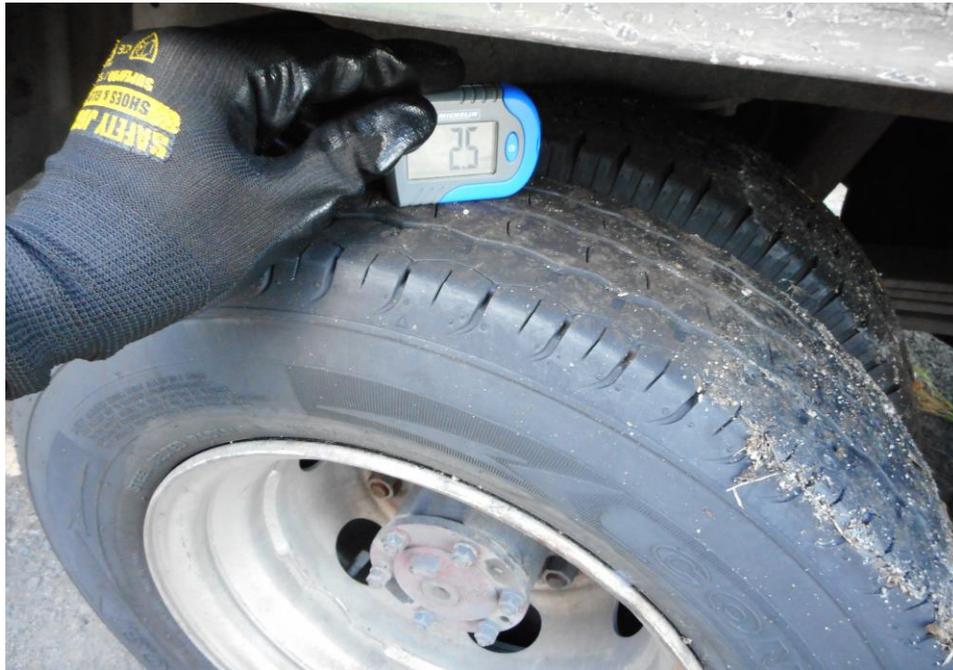
Photo 7 shows the condition of the rear left tyres of the Motor Lorry, which observed to be in serviceable condition with remaining tread depth of approximately 2.5mm. The tyres, which were wrapped around standard alloy wheel rim, were also observed to be sufficiently inflated for vehicular operation.

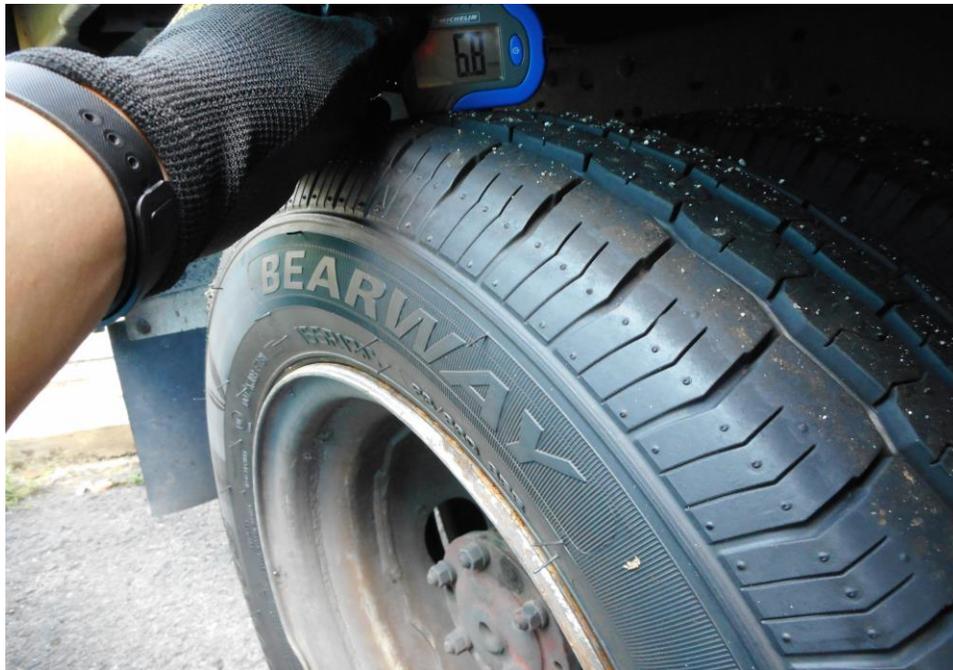
Photo 8 shows the condition of the rear right tyres of the Motor Lorry, which were observed to be in serviceable condition with remaining, tread depth of approximately 6.8mm. See above

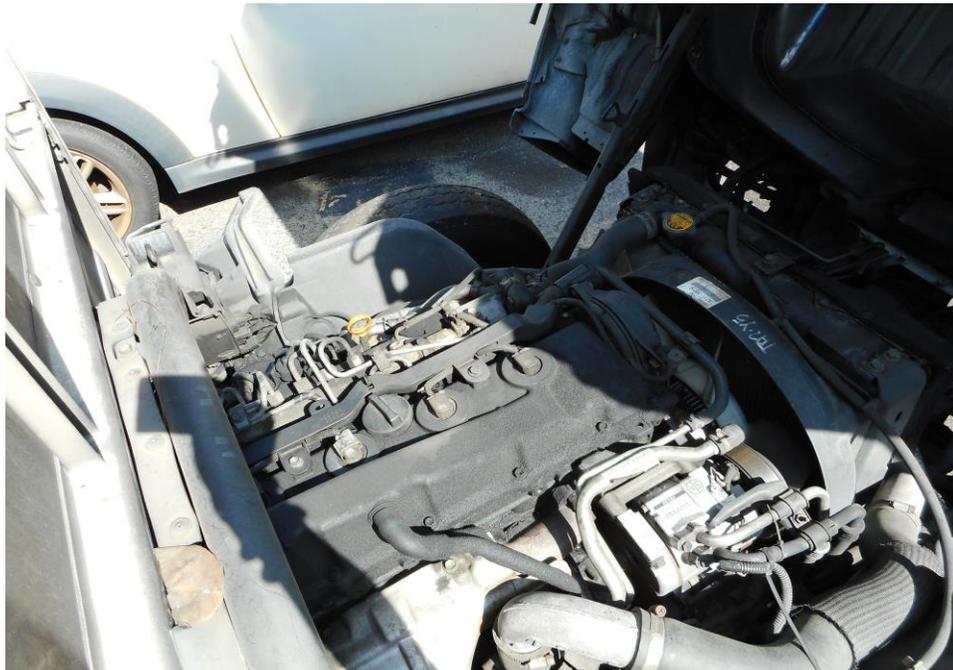
Photo 9 shows a general view of the Motor Lorry's engine compartment, which was accessed by lifting the front cabin of the Motor Lorry. The various parts and components inside the engine compartment were unaffected by the accident. There was also no sign(s) or indication(s) of fresh fluid leakage and/or fluid stain within the engine.

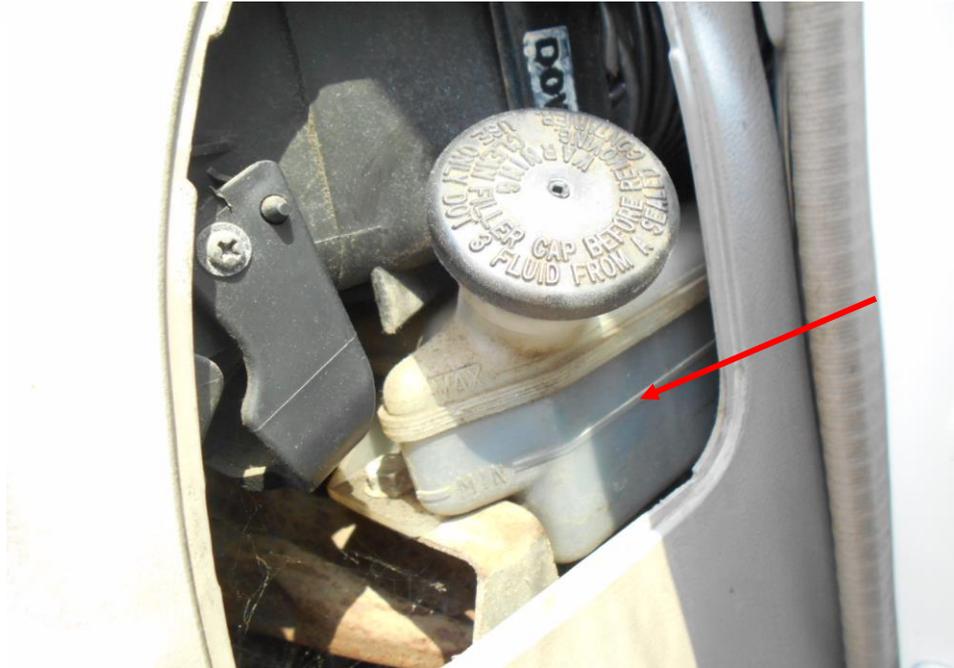
Photo 10 shows the brake fluid reservoir of the Motor Lorry at the time of our inspection. The brake fluid was observed to be of sufficient level and without any visible contamination (arrowed).

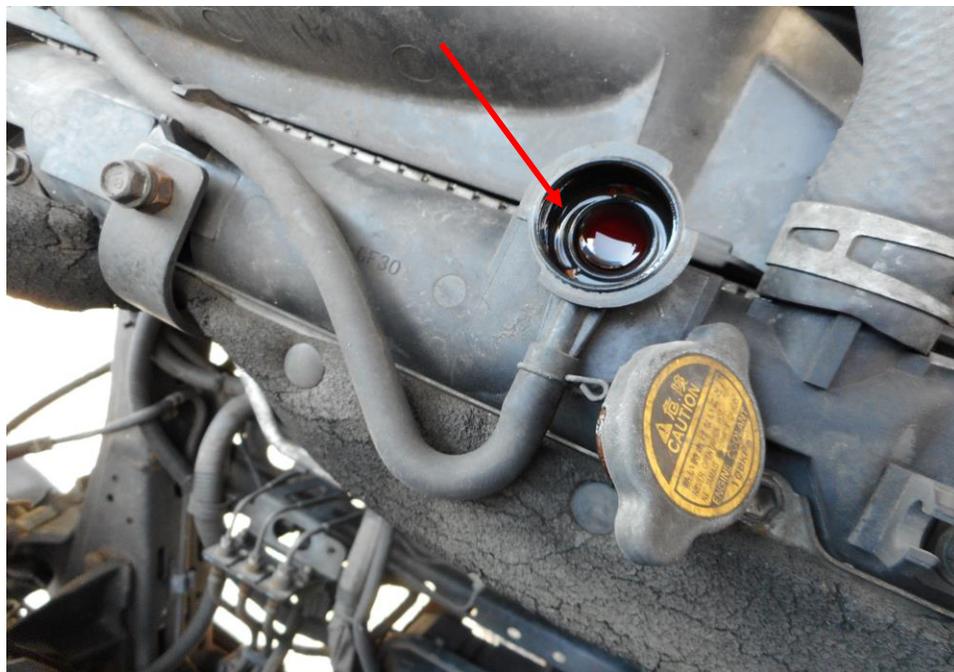
Photo 11 shows the engine coolant reservoir of the Motor Lorry at the time of our inspection. The engine coolant was observed to be of sufficient level and without any visible contamination (arrowed).

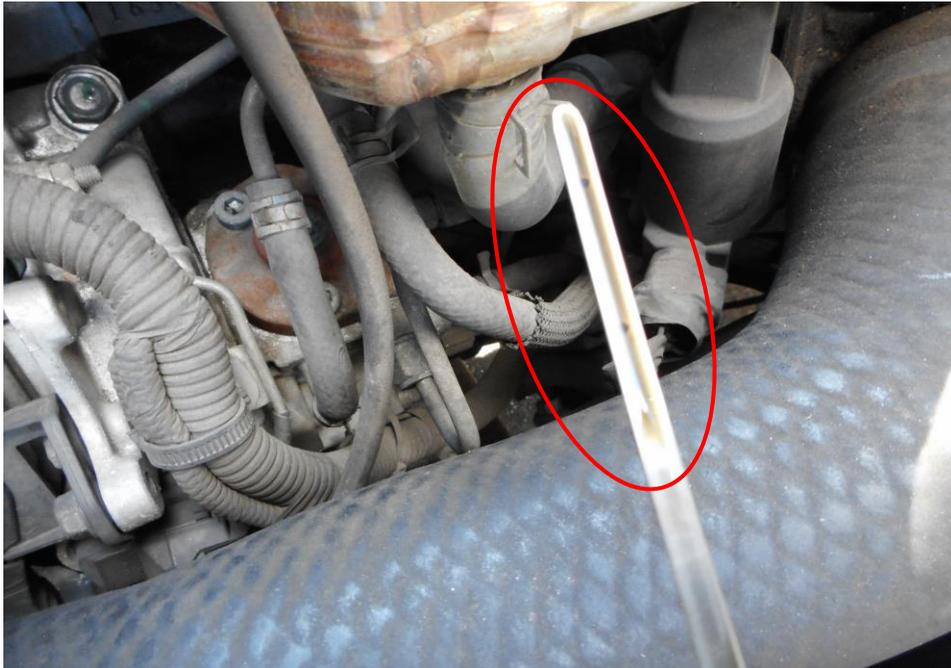
Photo 12 shows the engine dip stick of the Motor Lorry at the time of our inspection. The engine oil was observed to be of sufficient level and without any visible contamination (circled).

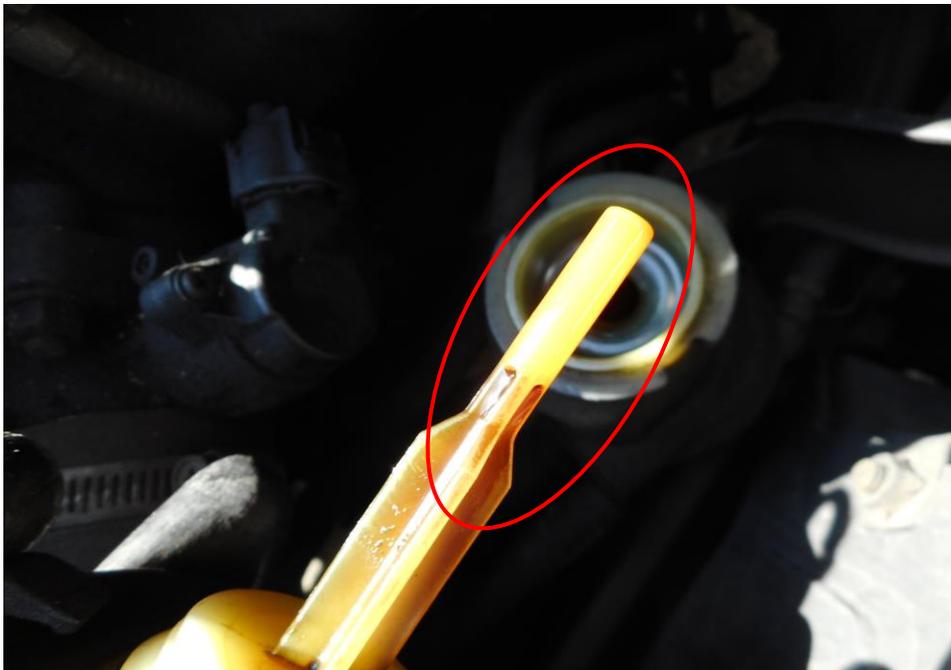
Photo 13 shows the power steering dip stick of the Motor Lorry at the time of our inspection. The steering fluid was observed to be of sufficient level and without any visible contamination (circled).

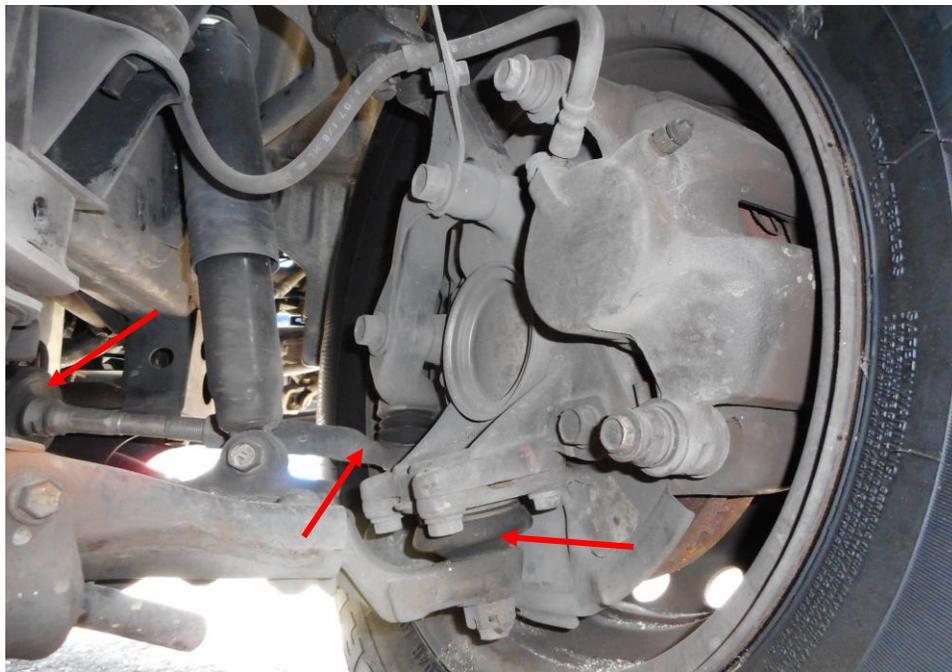
Photo 14 shows the various undercarriage components at the front left wheel of the Motor Lorry, in particular the steering tie rod end and ball joints (arrowed). The various undercarriage components of the Motor Lorry were all found to be intact without any visible damage. There was also no sign of fluid stain(s) observed on the various undercarriage components.

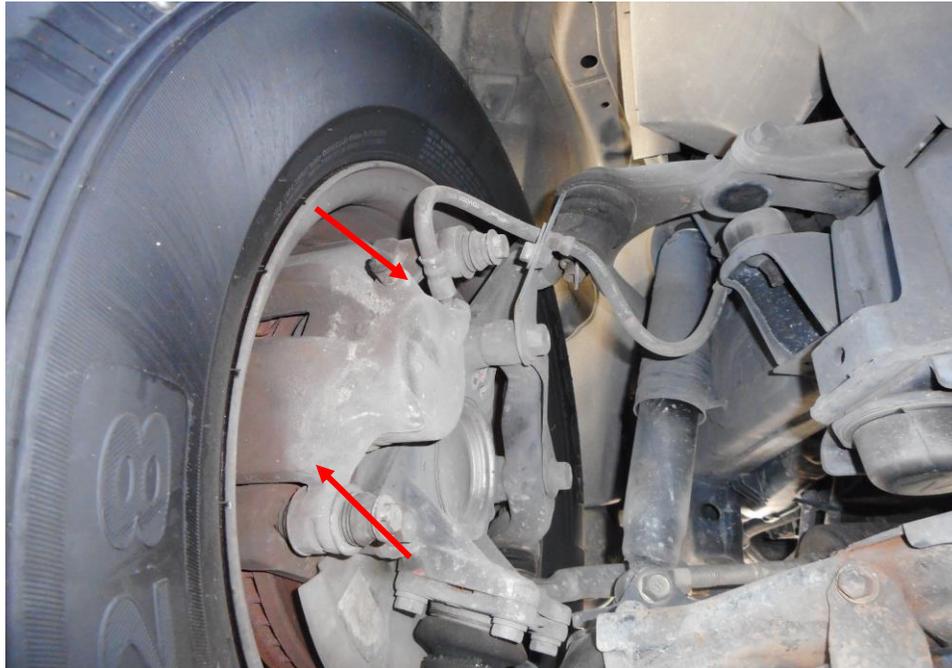
Photo 15 shows the various undercarriage components at the front right wheel of the Motor Lorry, in particular the brake hose and callipers (arrowed). The various undercarriage components of the Motor Lorry were all found to be intact without any visible damage. There was also no sign of fluid stain(s) observed on the various undercarriage components.

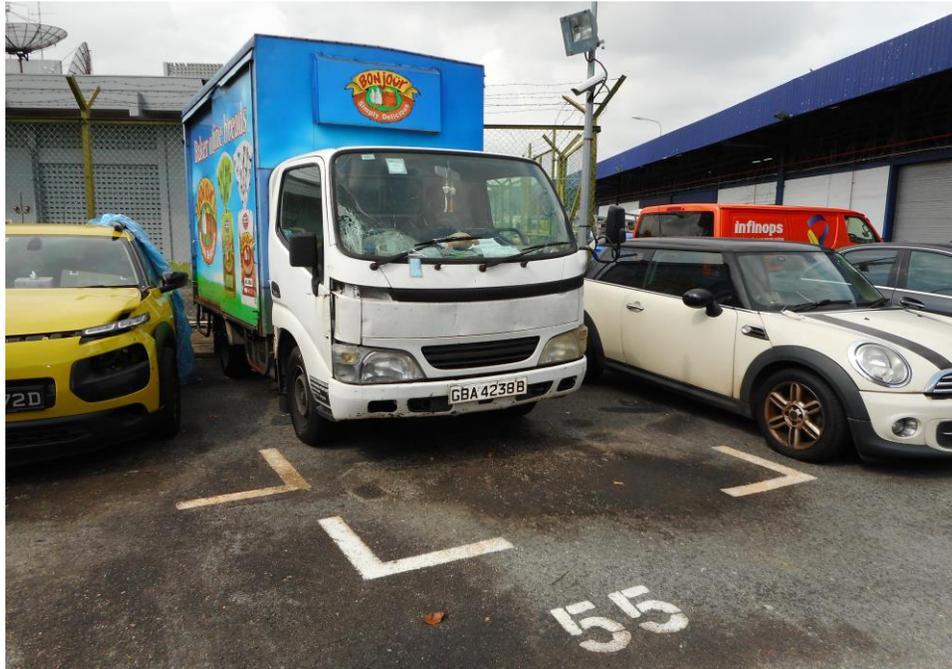
Photo 16 shows the operational test on the Motor Lorry. It was observed to be in serviceable condition. Operational test such as moving forward, braking test on the Motor Lorry was conducted successfully.

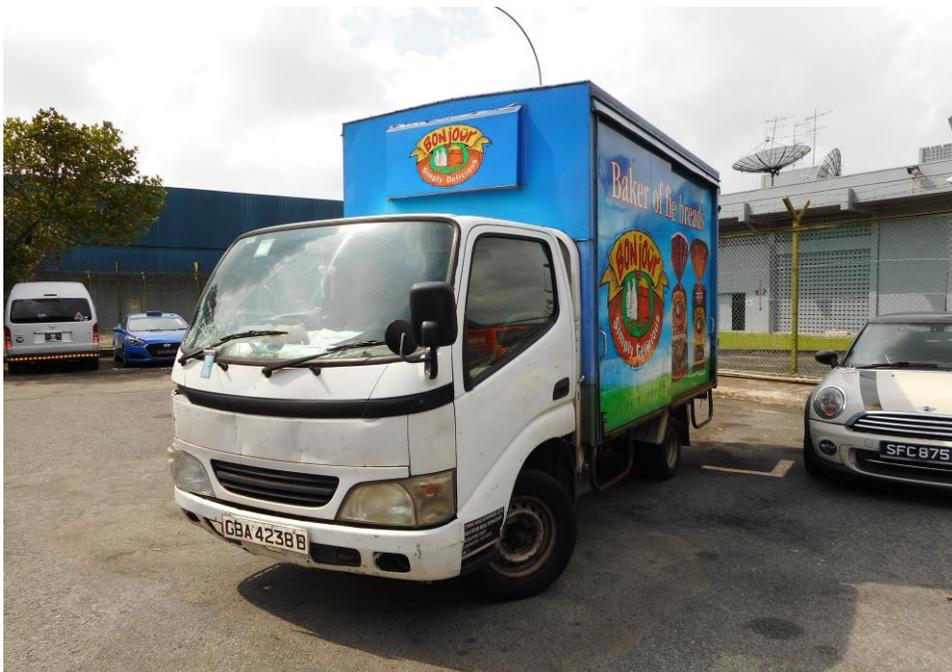
Photo 17 shows the operational test on the Motor Lorry. It was observed to be in serviceable condition. Operational test such as moving forward, braking test on the Motor Lorry was conducted successfully.
