Your Ref: TP/IP/68603/2018  
Our Ref: CI/TPD19000751/P

26<sup>th</sup> April 2019

**MECHANICAL INSPECTION REPORT OF MOTOR LORRY GBG 7101K**

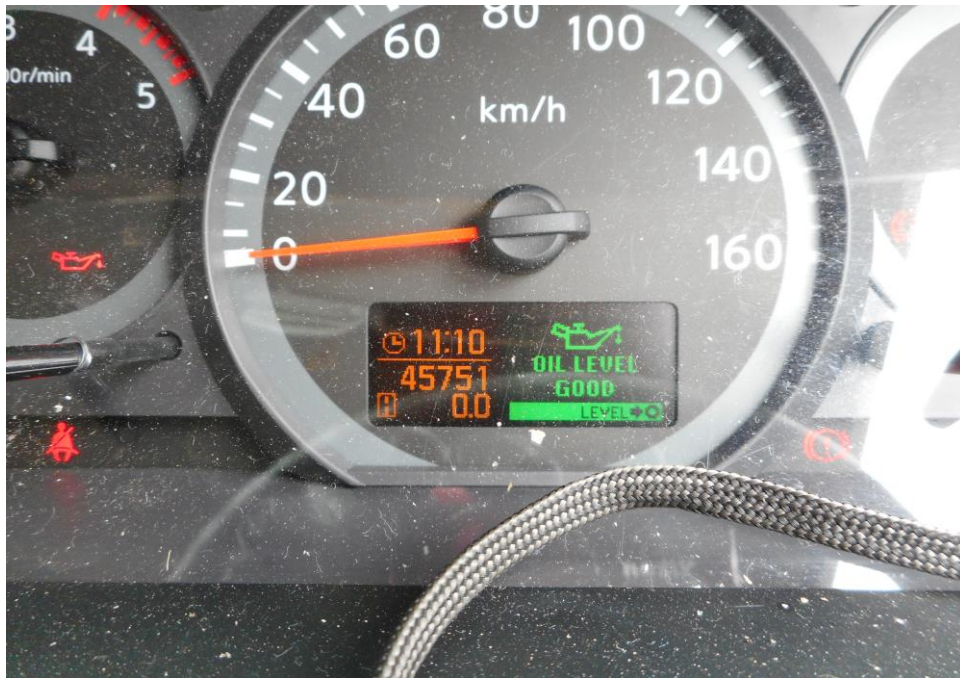
**Photo 1** shows the mileage of the Motor Lorry at the time of our inspection was recorded as 45,751km.

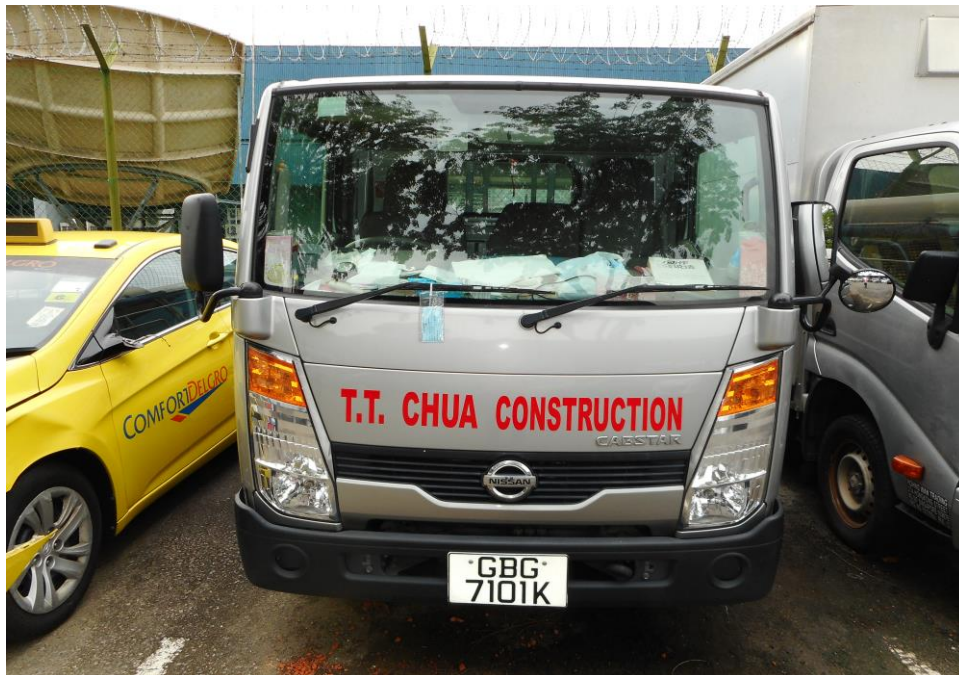
**Photo 2** shows a general view of the front portion of the Motor Lorry at the time of our inspection. The Motor Lorry was observed to be in good condition unaffected by the accident's impact.

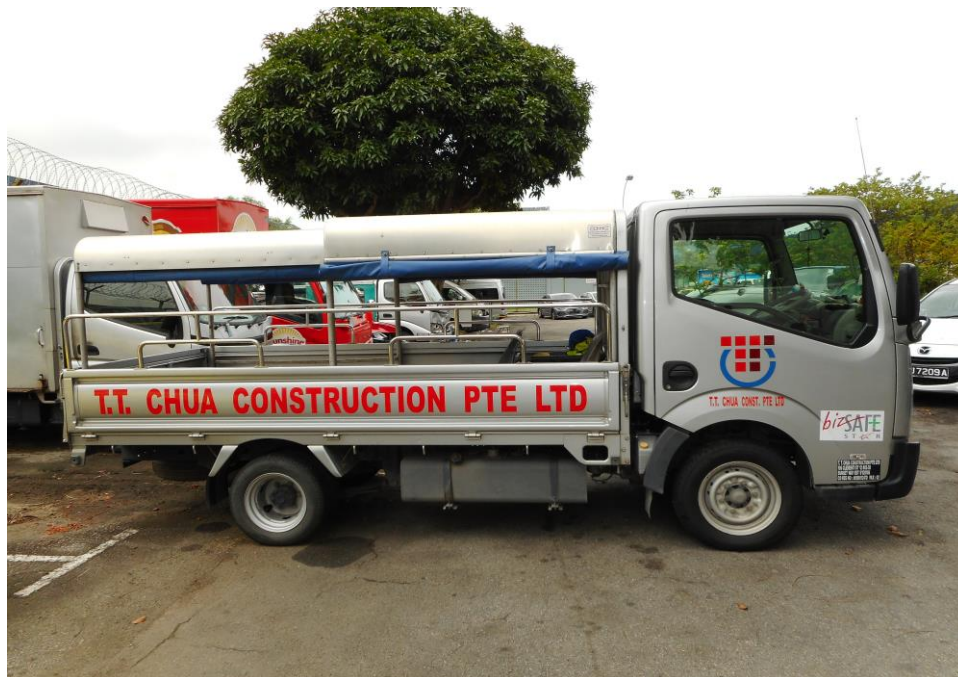
**Photo 3** shows a general view of the right body of the Motor Lorry at the time of our inspection. The Motor Lorry was observed to be in good condition unaffected by the accident's impact.

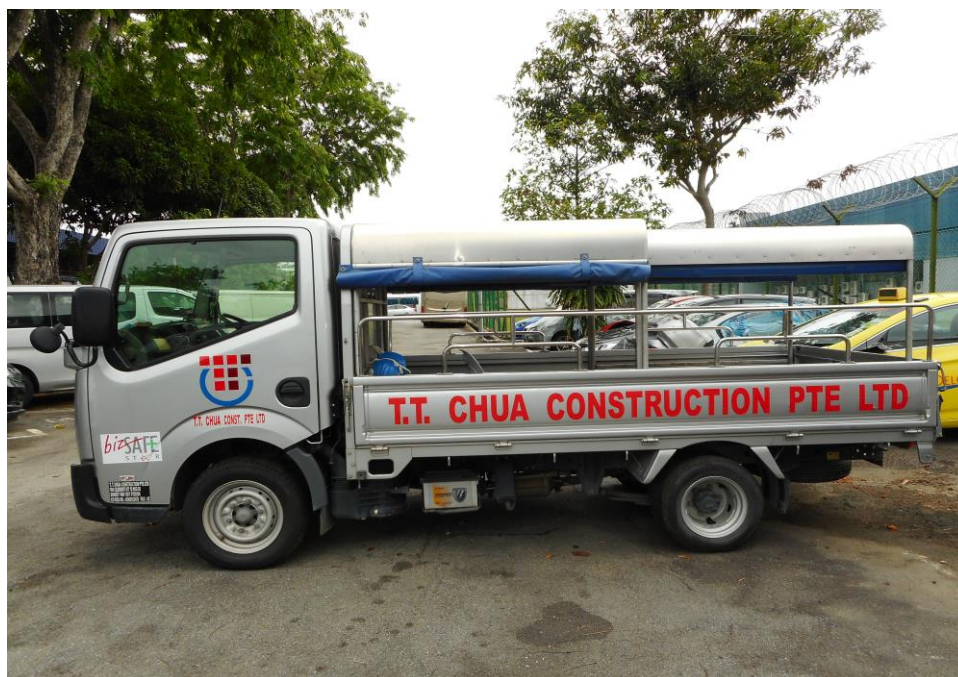
**Photo 4** shows a general view of the left body of the Motor Lorry at the time of our inspection. The Motor Lorry was observed to be in good condition unaffected by the accident's impact.

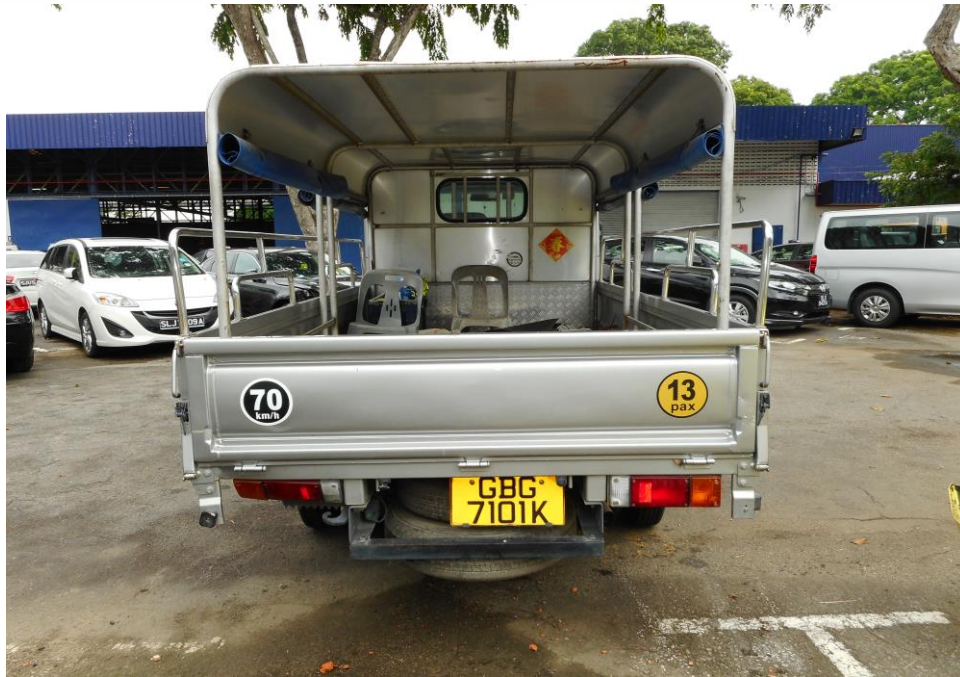
4. The mileage of the Motor Lorry at the time of our inspection was recorded as 45,751km.
5. The Motor Lorry was observed to have sustained minor damage at its rear left tailgate that was likely due to a result of the accident. See photo 1 – 6.

**Photo 5** shows the general view of the rear tailgate of the Motor Lorry. It was observed to have sustained damages around the rear left portion as a result of the accident.

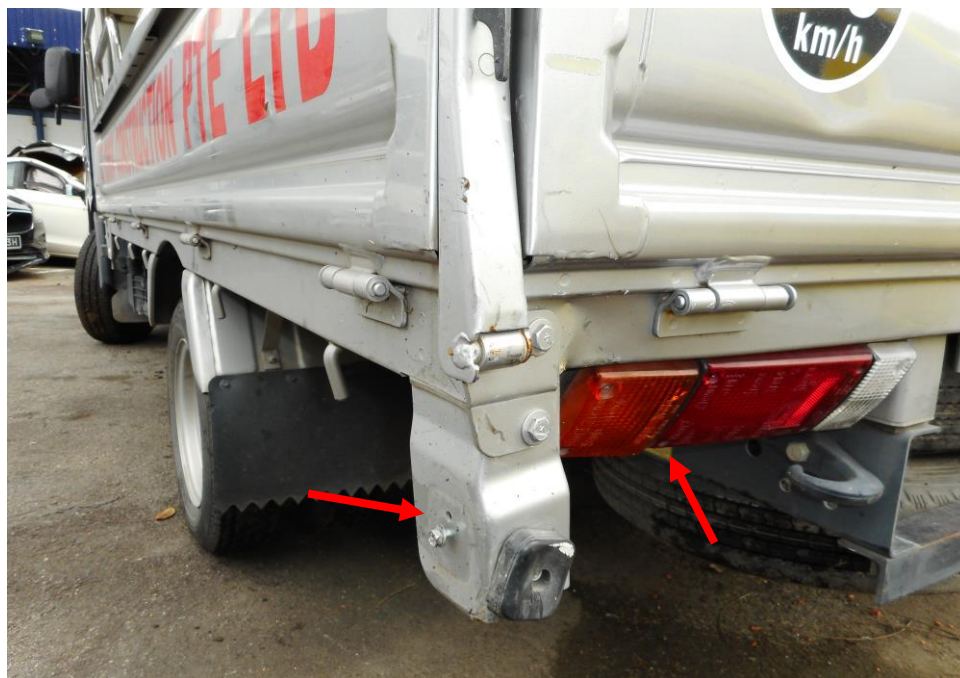
**Photo 6** shows the close up view of the rear tailgate of the Motor Lorry. It was observed to have sustained damages around the rear left brake lamps and body panel (Arrowed) as a result of the accident.

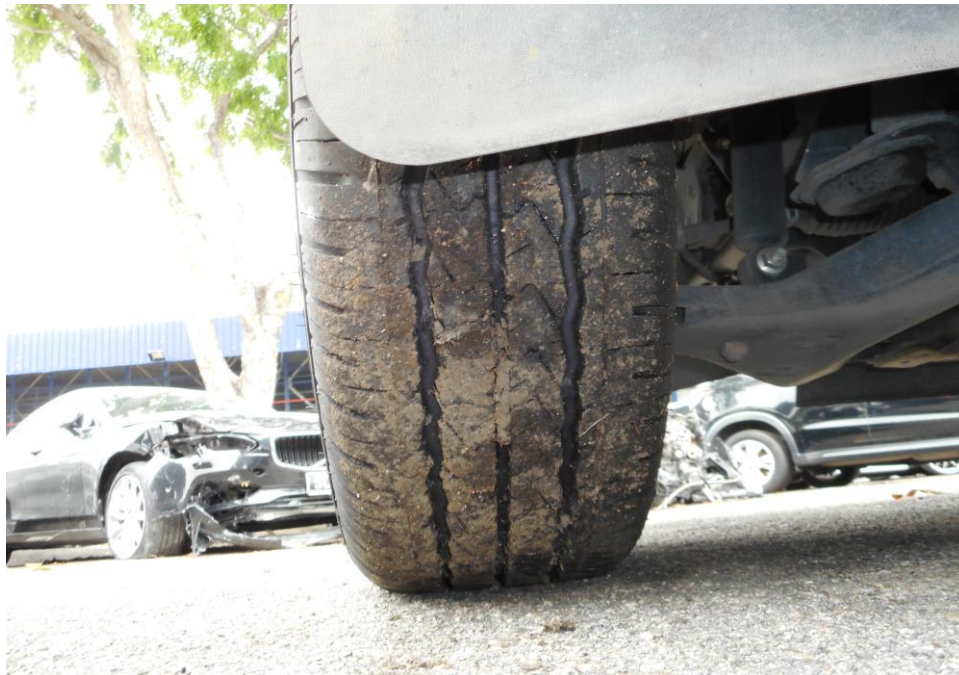
**Photo 7** shows the condition of the front left tyre of the Motor Lorry, which observed to be in serviceable condition with remaining tread depth of approximately 8.1mm. The tyre, which was wrapped around standard alloy wheel rim, was also observed to be sufficiently inflated for vehicular operation.

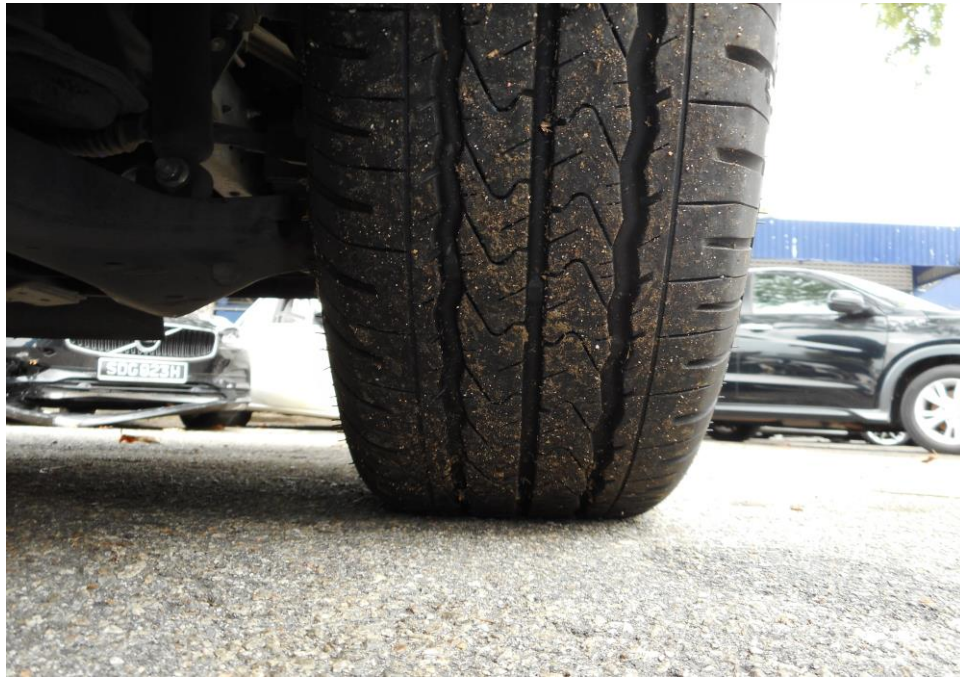
**Photo 8** shows the condition of the front right tyre of the Motor Lorry, which was observed to be in serviceable condition with remaining tread depth of approximately 9.1mm. The tyre, which was wrapped around standard alloy wheel rim, was also observed to be sufficiently inflated for vehicular operation.

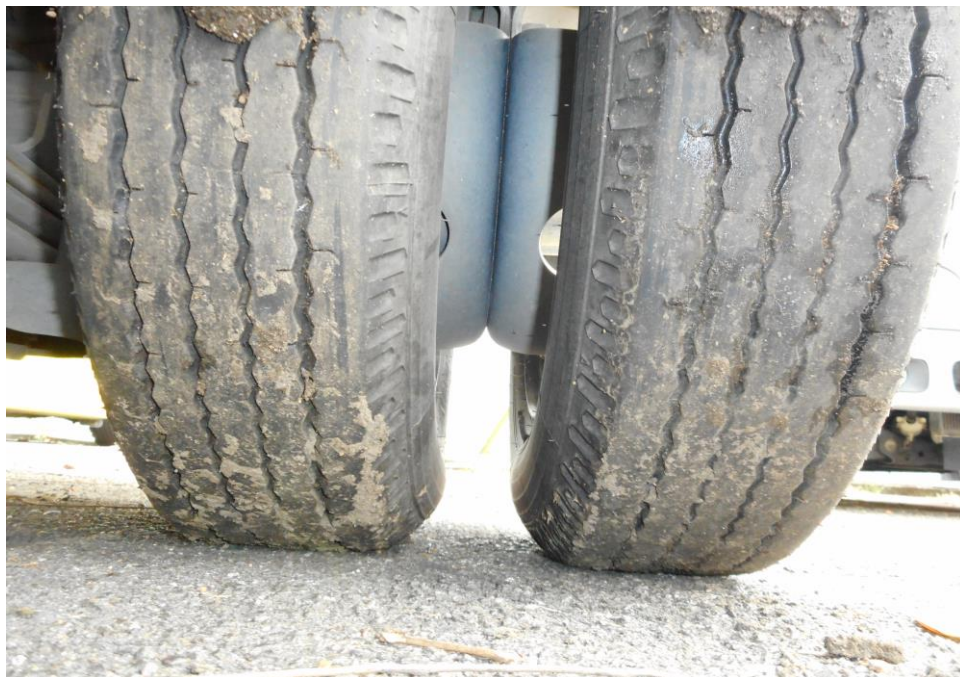
**Photo 9** shows the condition of the rear left tyres of the Motor Lorry, which observed to be in serviceable condition with remaining tread depth of approximately 4.4mm. The tyres, which were wrapped around standard alloy wheel rim, were also observed to be sufficiently inflated for vehicular operation.

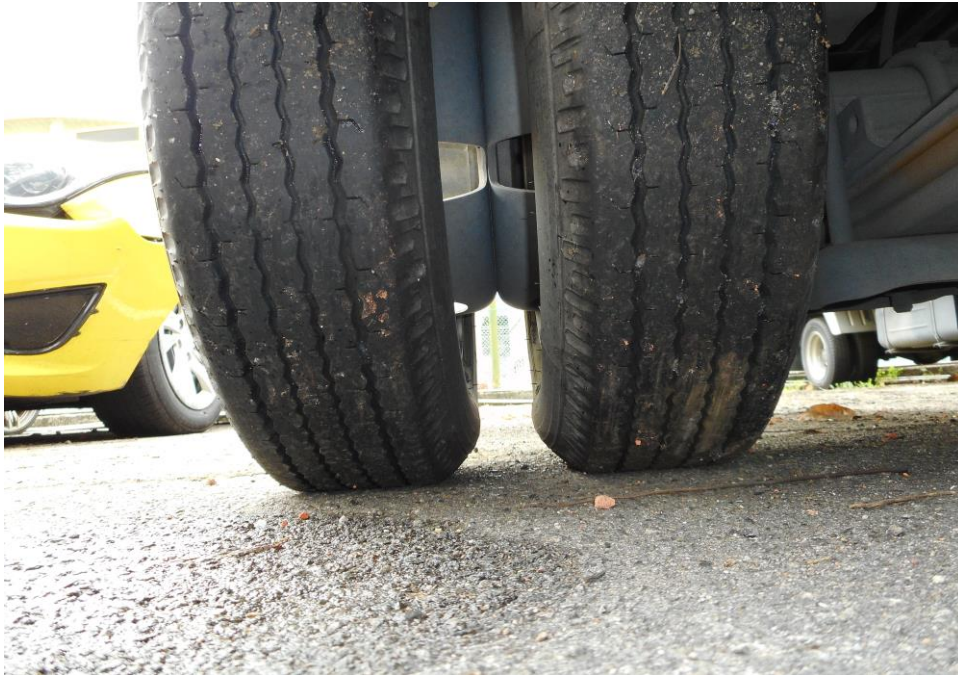
**Photo 10** shows the condition of the rear right tyres of the Motor Lorry, which were observed to be in serviceable condition with remaining, tread depth of approximately 3.4mm.

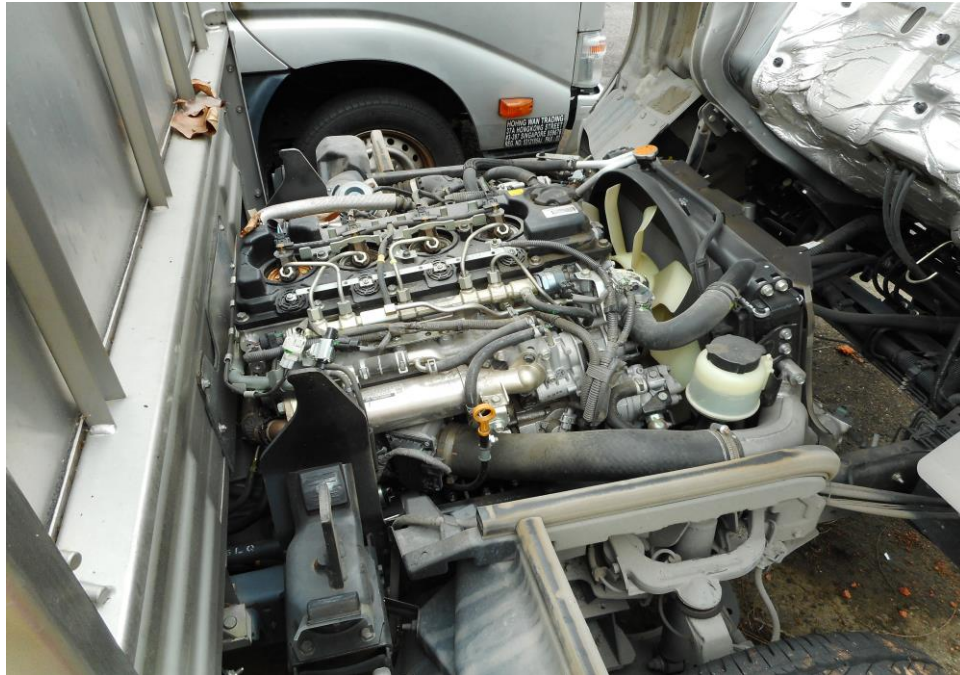
**Photo 11** shows a general view of the Motor Lorry's engine compartment, which was accessed by lifting the front cabin of the Motor Lorry. The various parts and components inside the engine compartment were unaffected by the accident. There was also no sign(s) or indication(s) of fresh fluid leakage and/or fluid stain within the engine.

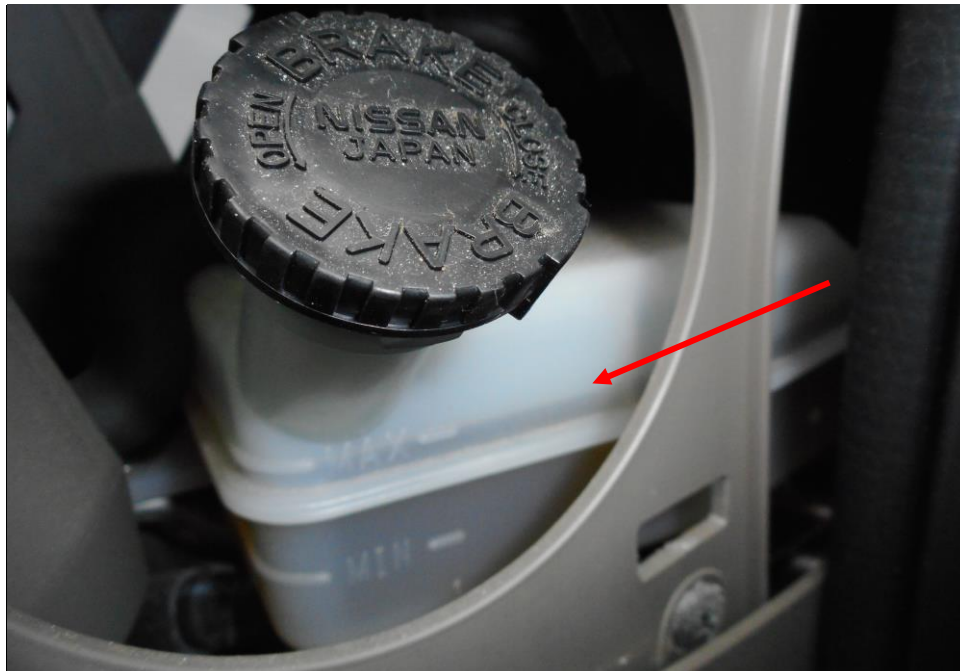
**Photo 12** shows the brake fluid reservoir of the Motor Lorry at the time of our inspection. The brake fluid was observed to be of sufficient level and without any visible contamination (arrowed).

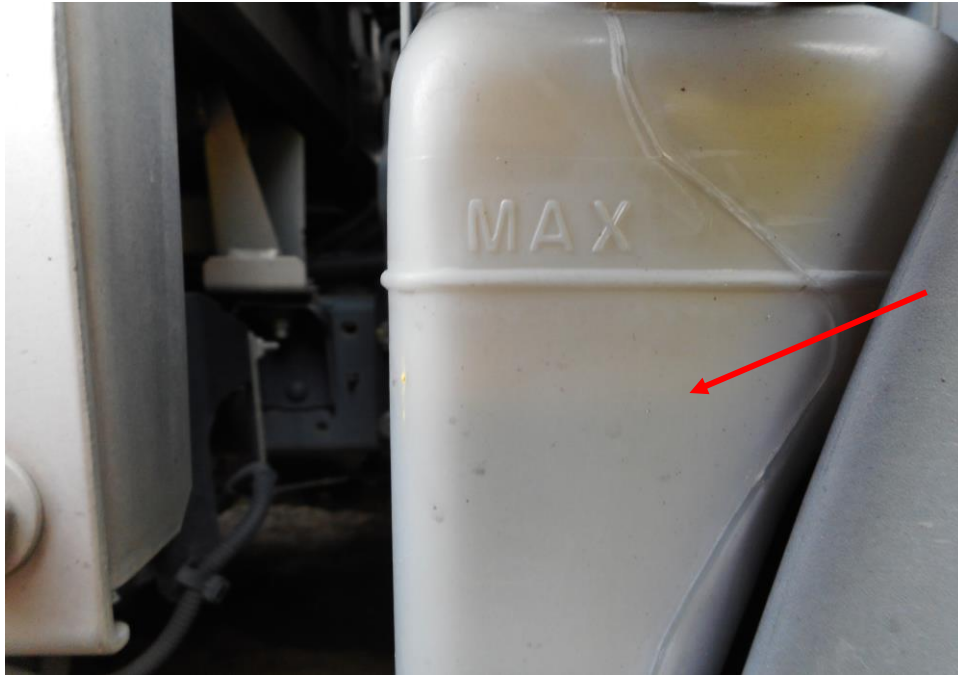
**Photo 13** shows the engine coolant reservoir of the Motor Lorry at the time of our inspection. The engine coolant was observed to be of sufficient level and without any visible contamination (arrowed).

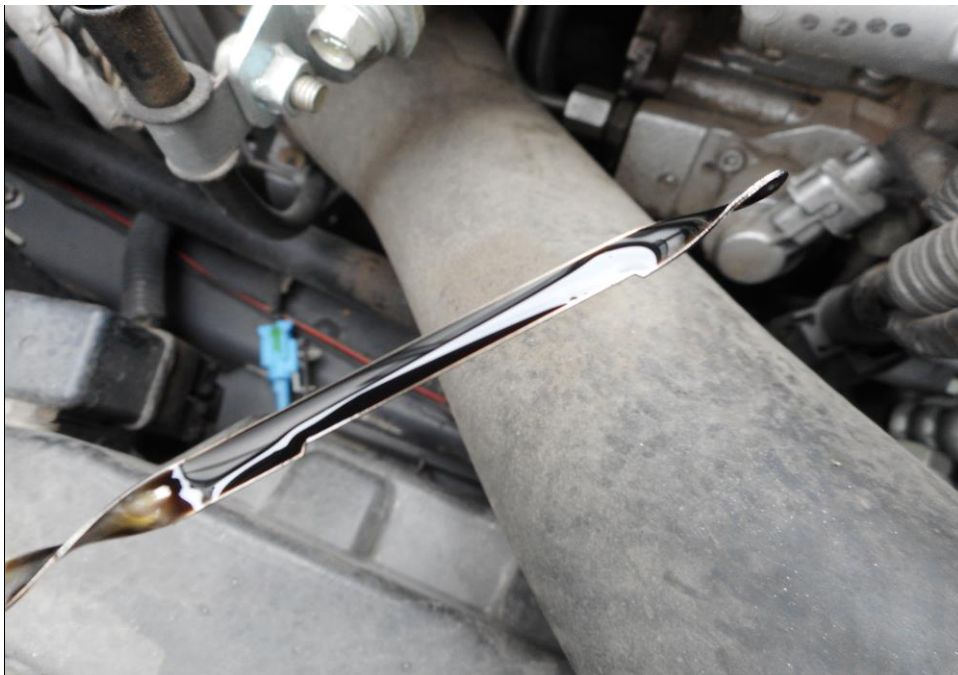
**Photo 14** shows the engine dip stick of the Motor Lorry at the time of our inspection. The engine oil was observed to be of sufficient level and without any visible contamination.

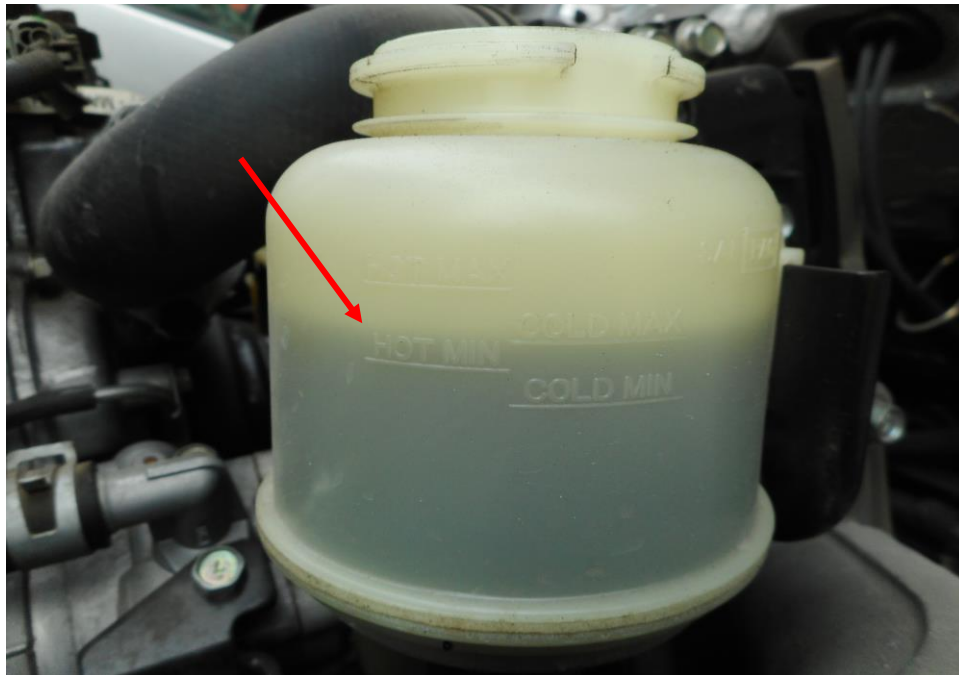
**Photo 15** shows the power steering reservoir of the Motor Lorry at the time of our inspection. The power steering fluid was observed to be of sufficient level and without any visible contamination (circled).

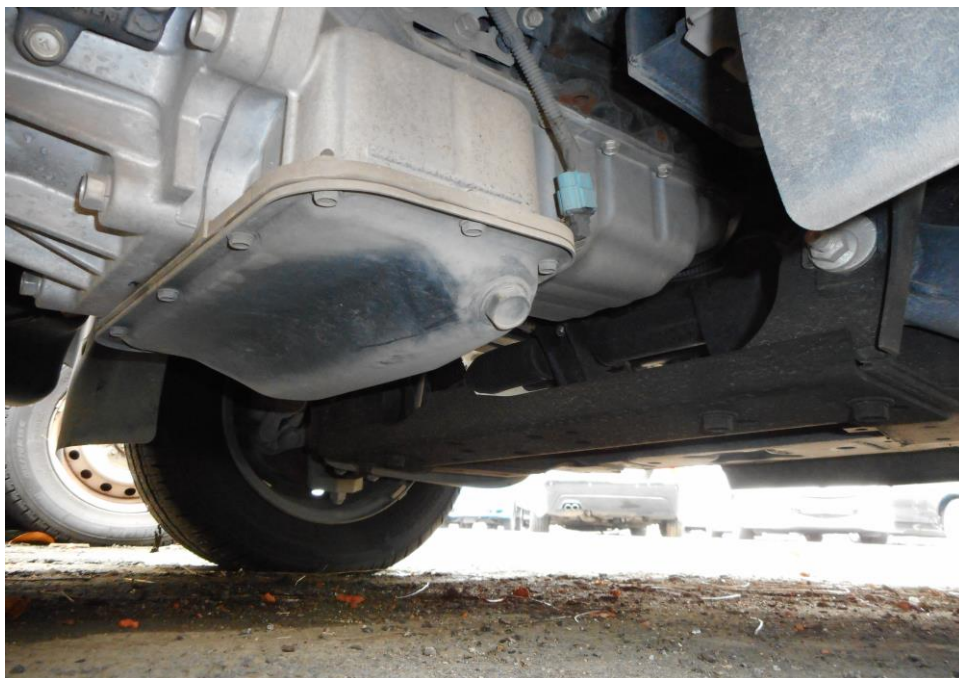
**Photo 16** shows the undercarriage of the engine of the Motor Lorry at the time of our inspection. There was also no sign(s) or indication(s) of fresh fluid leakage and/or fluid stain within the engine.

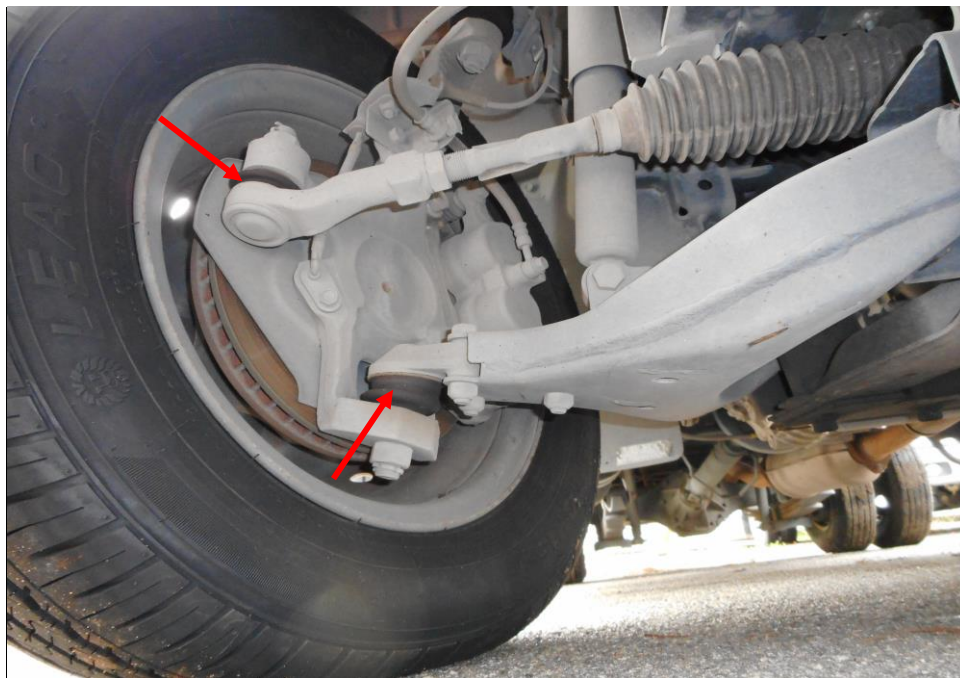
**Photo 17** shows the various undercarriage components at the front left wheel of the Motor Lorry, in particular the steering tie rod end and ball joints (arrowed). The various undercarriage components of the Motor Lorry were all found to be intact without any visible damage. There was also no sign of fluid stain(s) observed on the various undercarriage components.

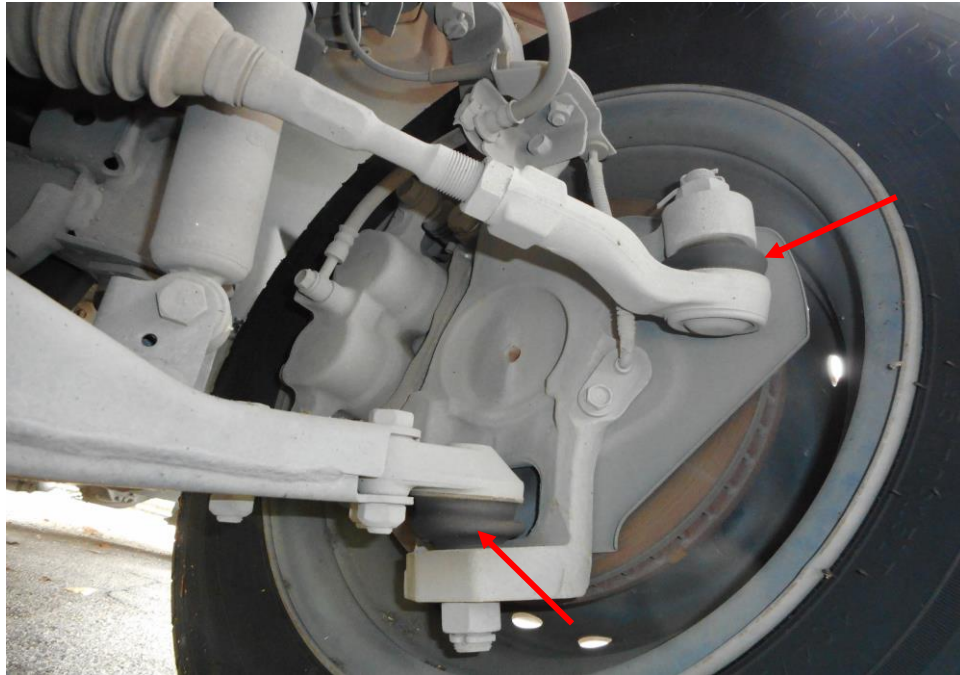
**Photo 18** shows the various undercarriage components at the front right wheel of the Motor Lorry, in particular the steering tie rod end and ball joints (arrowed). The various undercarriage components of the Motor Lorry were all found to be intact without any visible damage. There was also no sign of fluid stain(s) observed on the various undercarriage components.

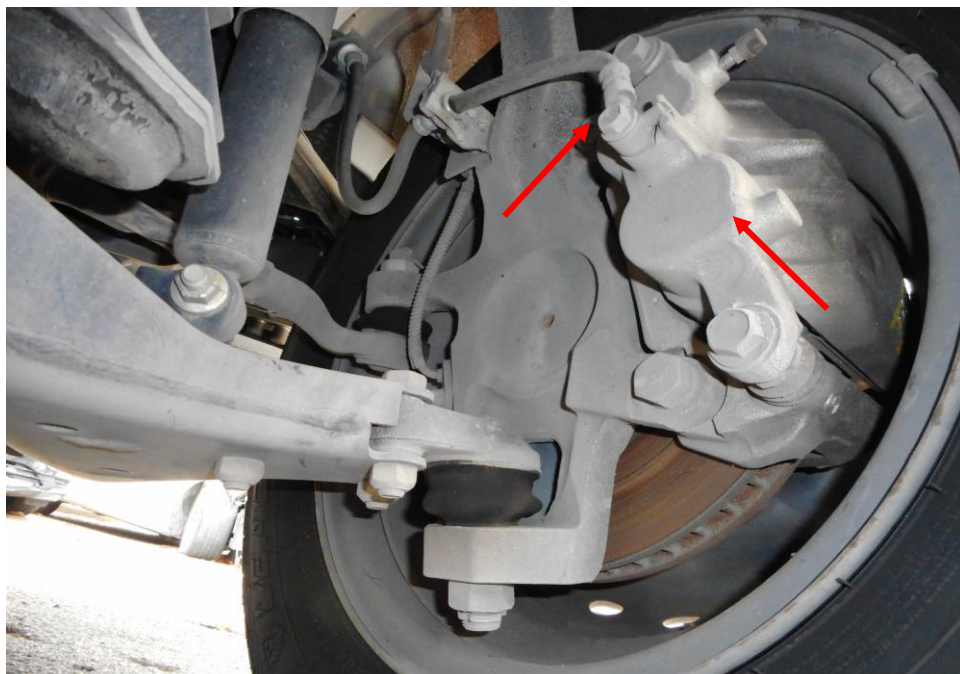
**Photo 19** shows the various undercarriage components at the front left wheel of the Motor Lorry, in particular the brake hose and callipers (arrowed). The various undercarriage components of the Motor Lorry were all found to be intact without any visible damage. There was also no sign of fluid stain(s) observed on the various undercarriage components.

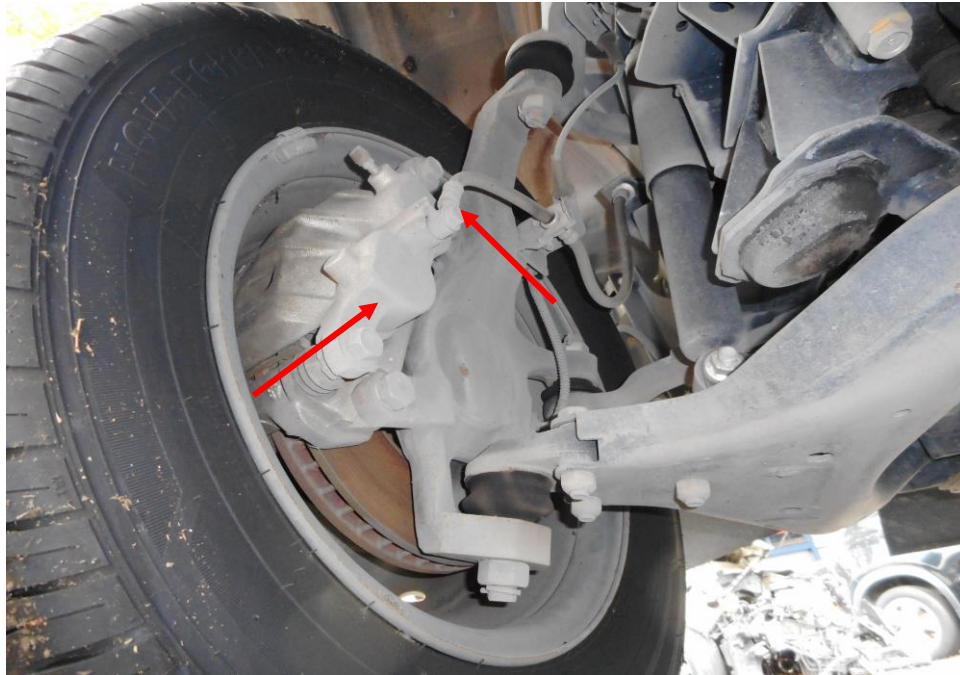
**Photo 20** shows the various undercarriage components at the front and right wheel of the Motor Lorry, in particular the brake hose and callipers (arrowed). The various undercarriage components of the Motor Lorry were all found to be intact without any visible damage. There was also no sign of fluid stain(s) observed on the various undercarriage components.

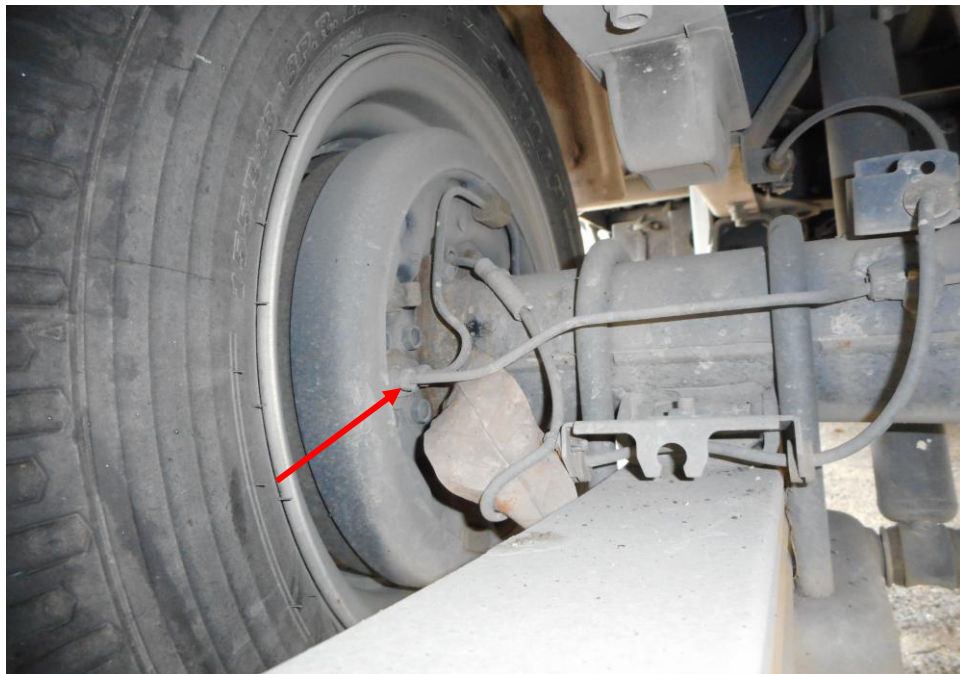
**Photo 21** shows the various undercarriage components at the rear left wheel of the Motor Lorry, in particular the brake hose and drum brake (arrowed). The various undercarriage components of the Motor Lorry were all found to be intact without any visible damage. There was also no sign of fluid stain(s) observed on the various undercarriage components.

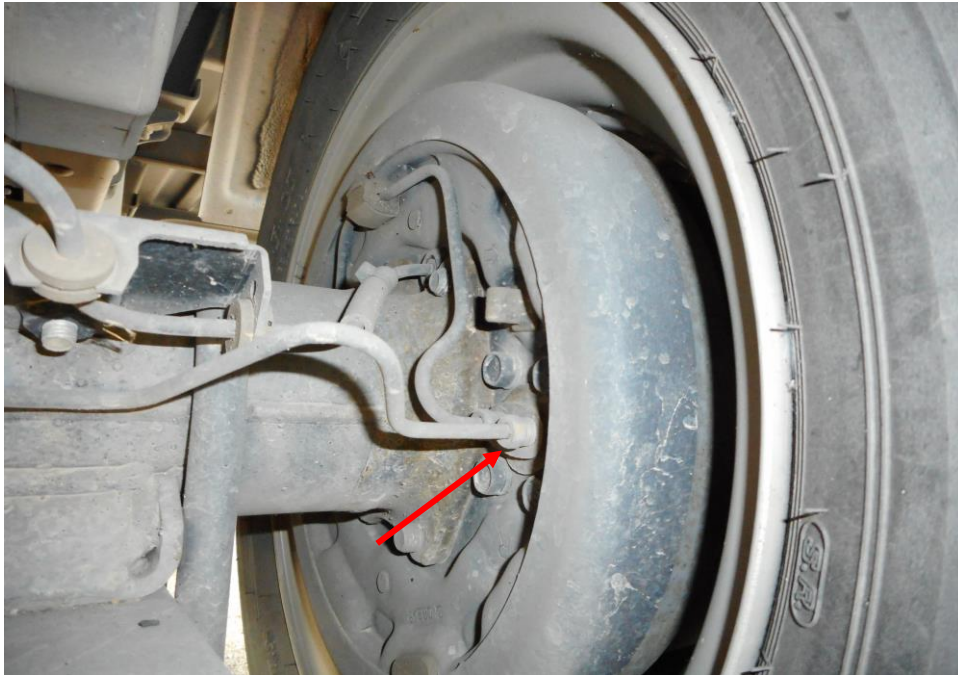
**Photo 22** shows the various undercarriage components at the rear right wheel of the Motor Lorry, in particular the brake hose and drum brake (arrowed). The various undercarriage components of the Motor Lorry were all found to be intact without any visible damage. There was also no sign of fluid stain(s) observed on the various undercarriage components.

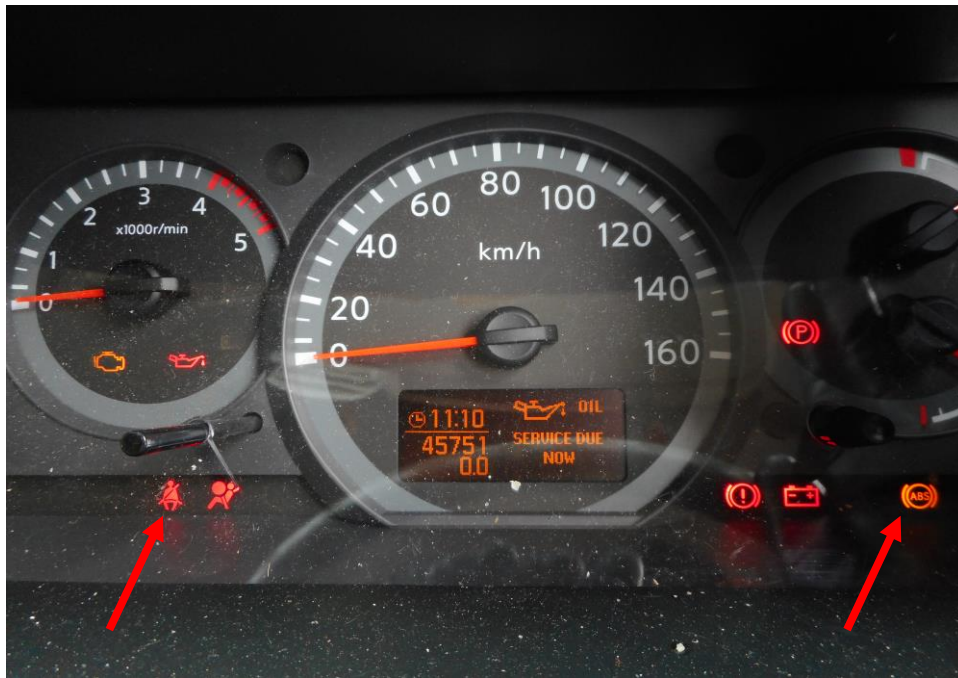
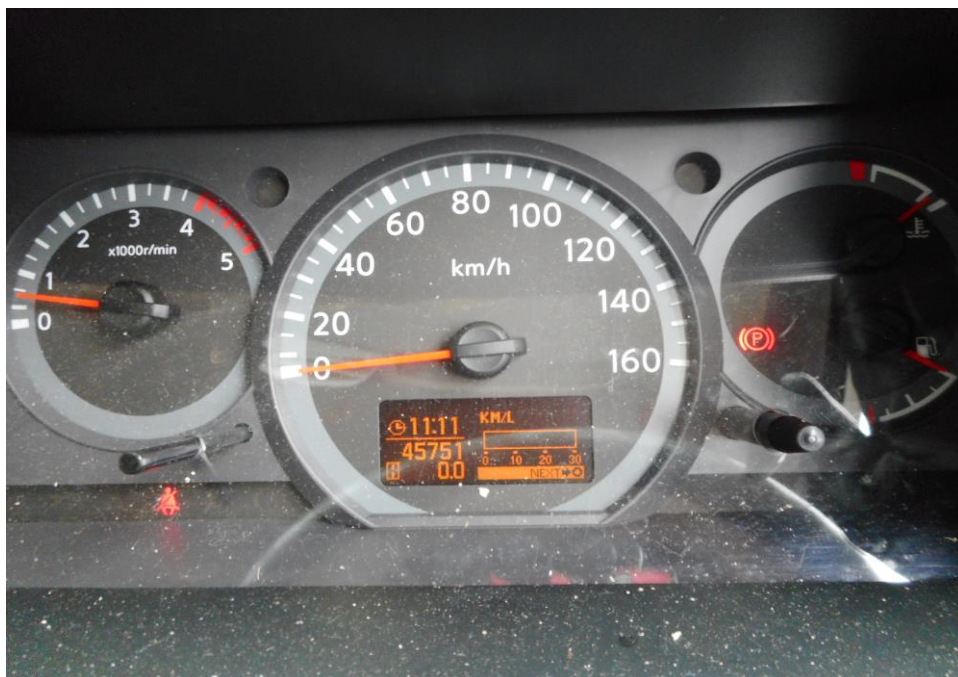
**Photo 23 & 24** shows the Motor Lorry electronic safety feature(s) like Anti-Brake Lock System (ABS), Supplemental Restraint System (SRS) before and after the engine was started. All was in serviceable condition at the material time of accident. See above

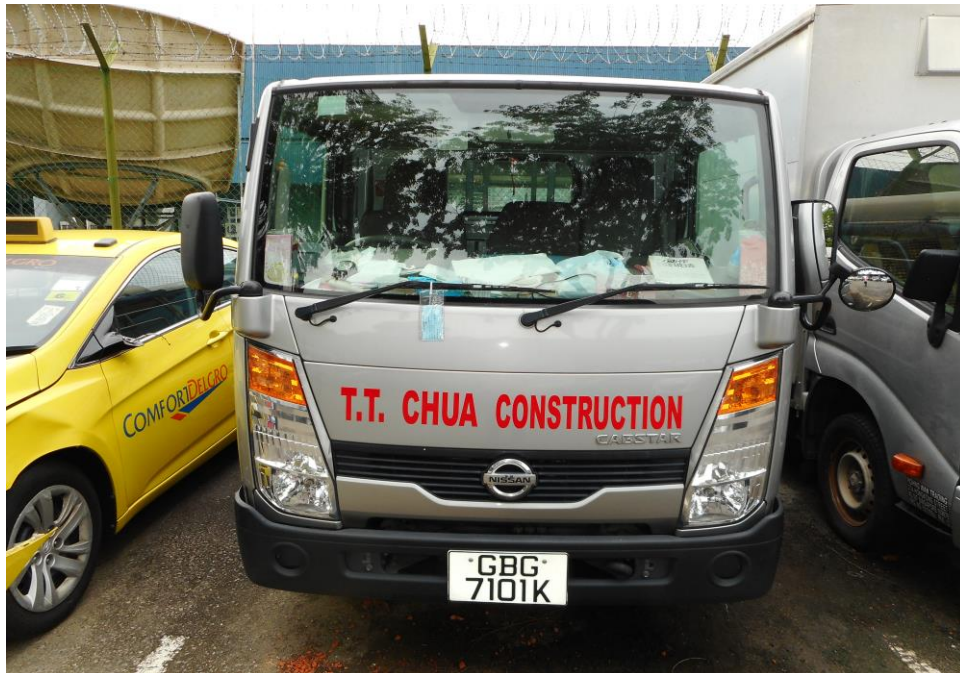
**Photo 25** shows the operational test. The Motor Lorry is in serviceable condition at the time tested.

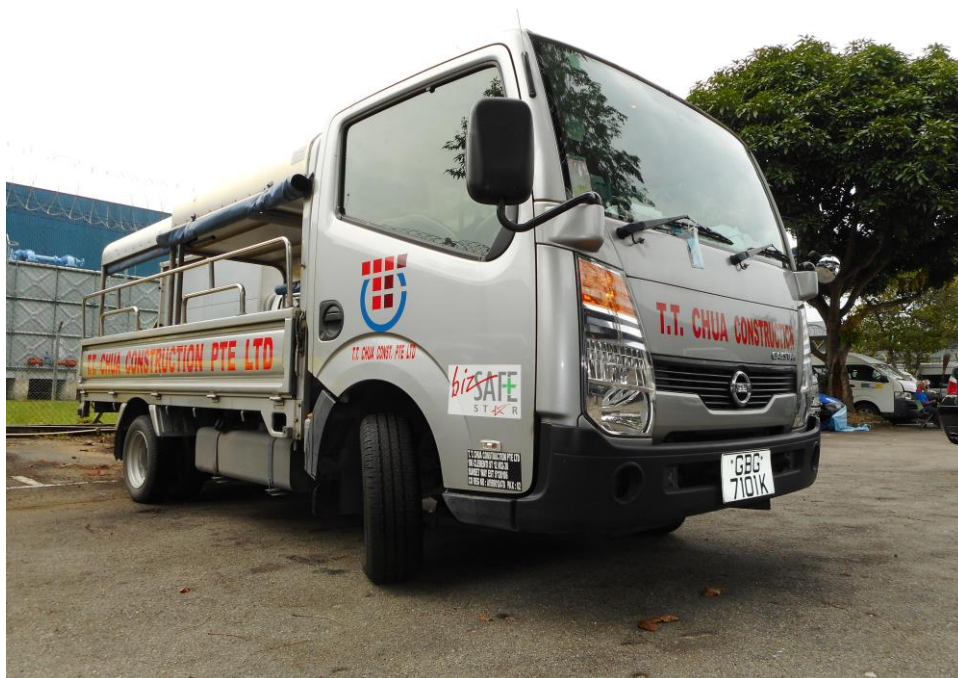
**Photo 26** shows the operational test. The Motor Lorry is in serviceable condition at the time tested.

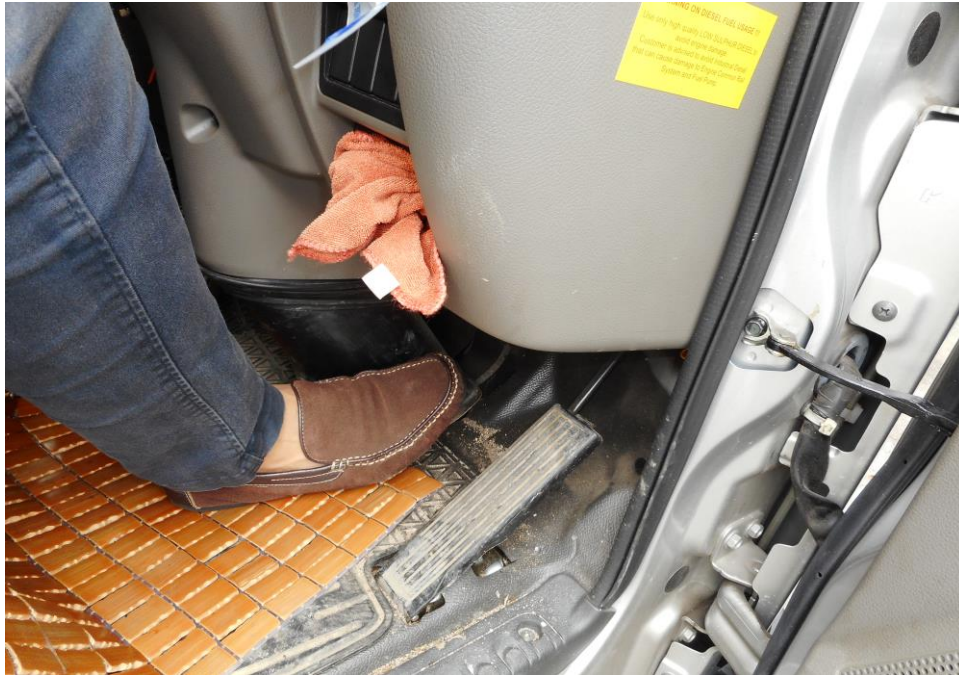
**Photo 27** shows the operational test on the Motor Lorry. It was observed to be in serviceable condition. Operational test such as moving forward, braking test on the Motor Lorry was conducted successfully.

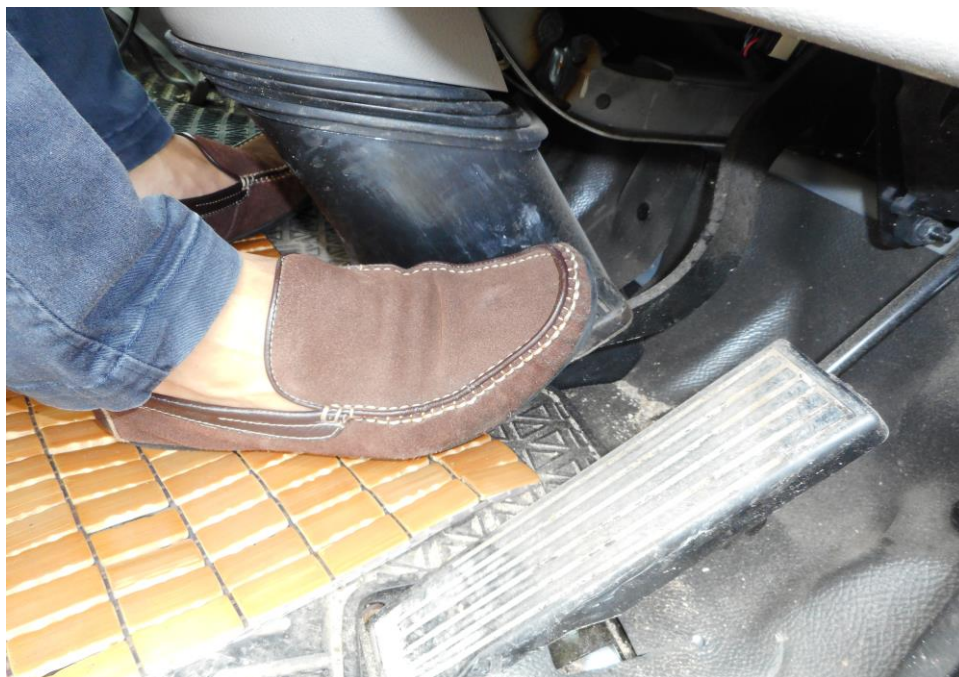
**Photo 28** above shows the operational test on the Motor Lorry. It was observed to be in serviceable condition. Operational test such as moving forward, braking test on the Motor Lorry was conducted successfully.
