Your Ref: TP/IP/68603/2018
Our Ref: CI/TPD19000753/P

Fatal Accident Investigation Team

MECHANICAL INSPECTION REPORT OF MOTORCYCLE FBL 2650Z

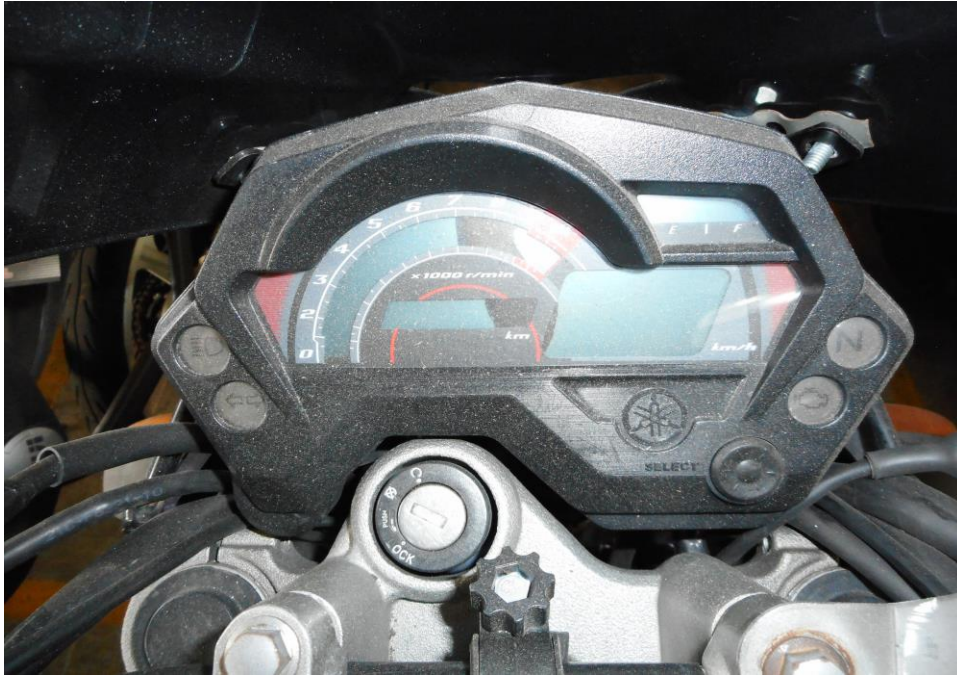
Photo 1 shows a view of the instrument cluster the mileage could not be read due to the damage caused to the battery from the accident at time of our inspection.

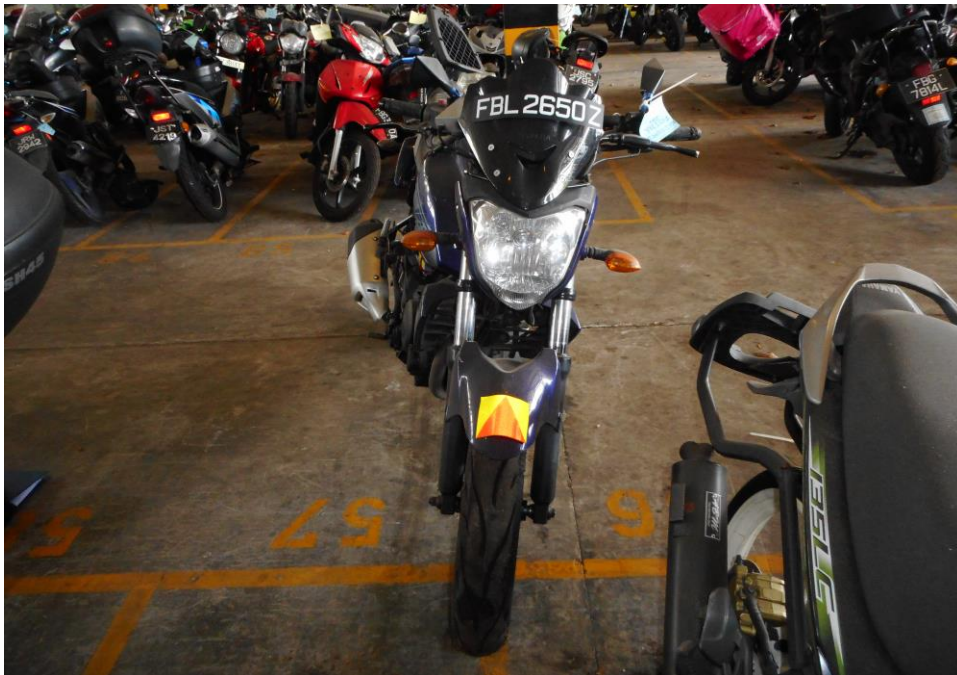
Photo 2 shows the general front view of the Motorcycle at the time of our inspection. The Motorcycle was observed to have no damages at time of inspection.

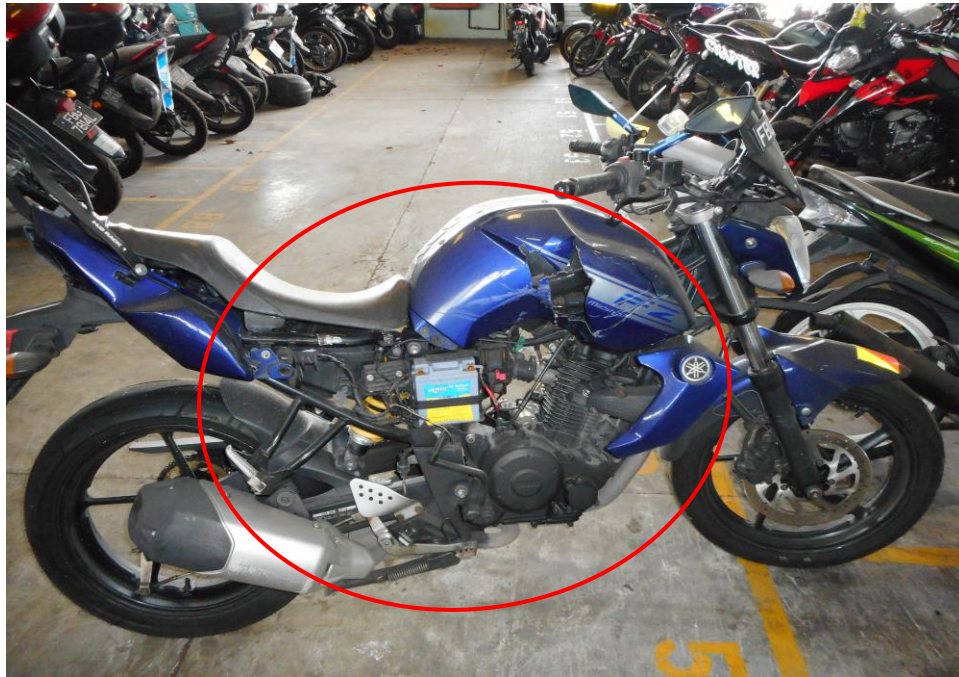
Photo 3 shows a general view of the right side of the Motorcycle at the time of our inspection. The Motorcycle was observed to have sustained relatively moderate damages at time of inspection.

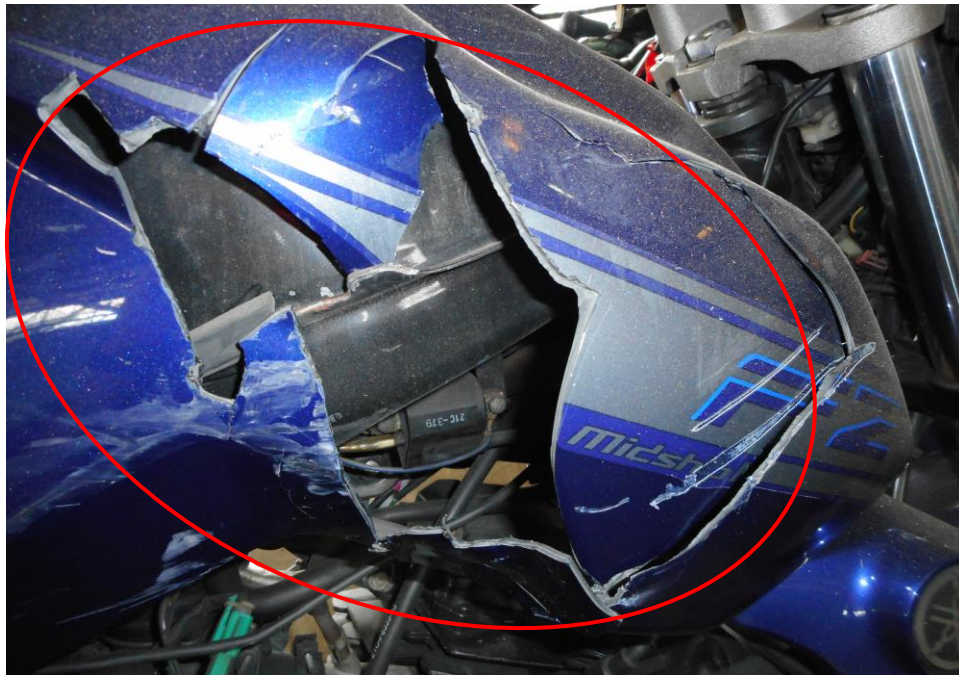
Photo 4 shows a close up view of the damages to the fuel tank cover and the battery panel at time of inspection likely due to the cause of the accident. See above

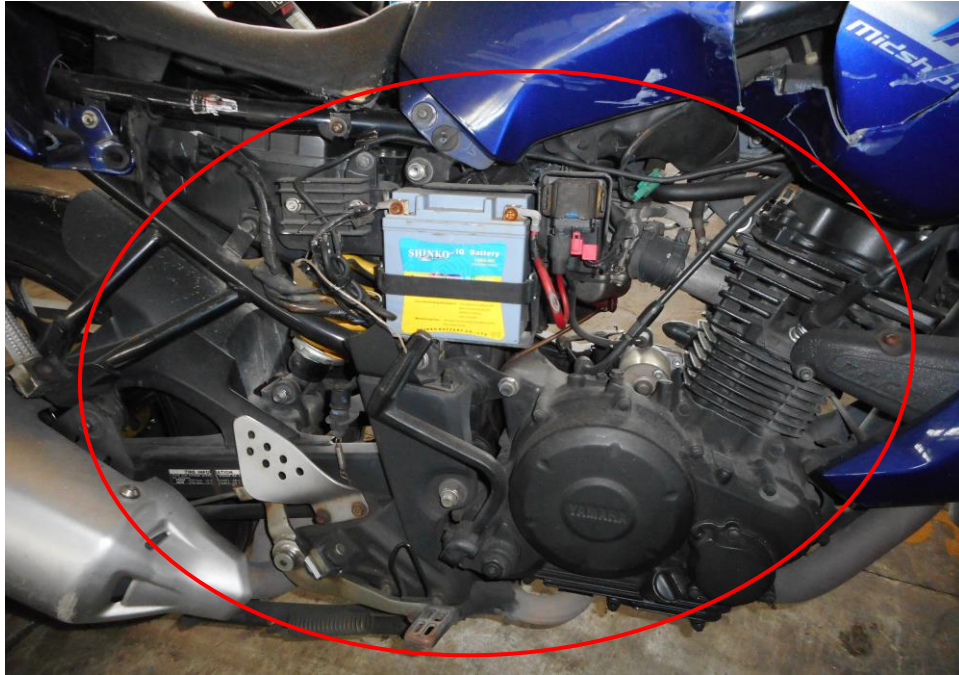
Photo 5 shows a close up view of the damages to the battery panel at time of inspection likely due to the cause of the accident.

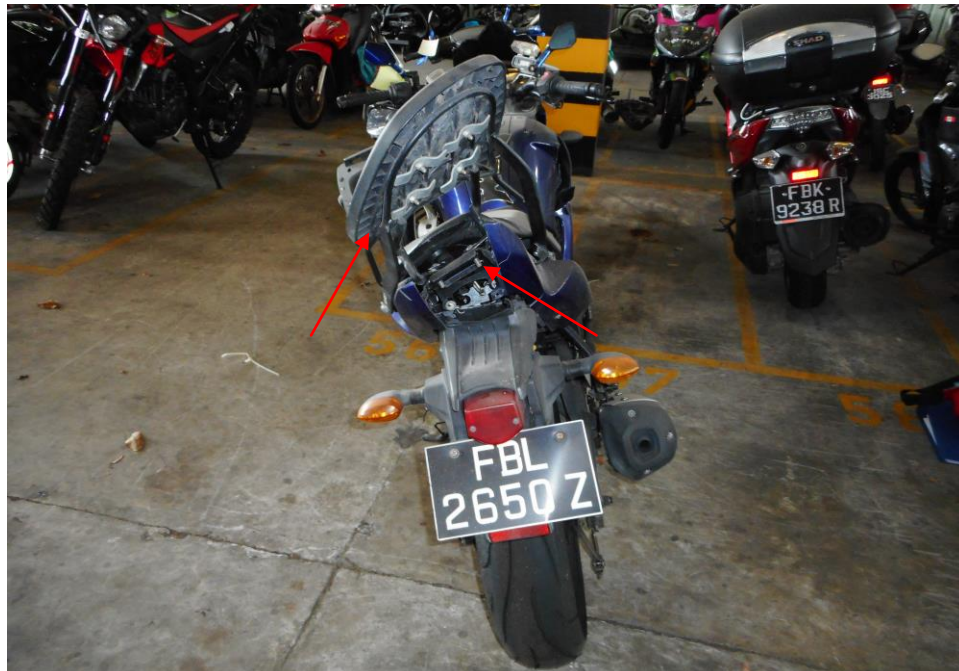
Photo 6 shows a general view of the rear body of the Motorcycle at the time of our inspection. The Motorcycle was observed to have sustained damages at the rear box carrier likely due to the cause of the accident.

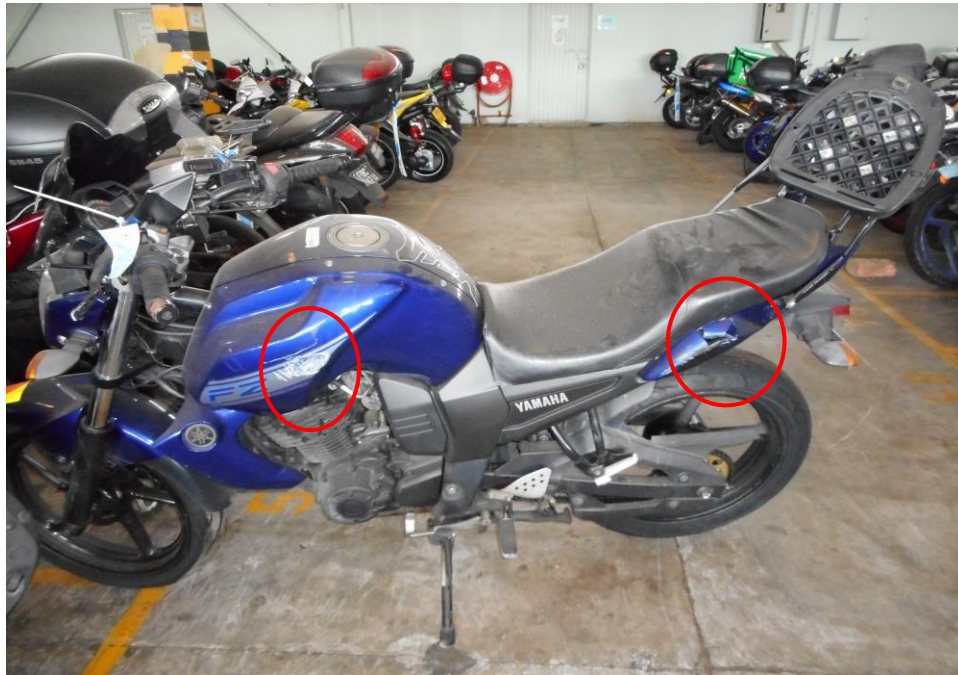
Photo 7 shows a general view of the left side of the Motorcycle at the time of our inspection. The Motorcycle was observed to have sustained relatively minor damages at time of inspection.

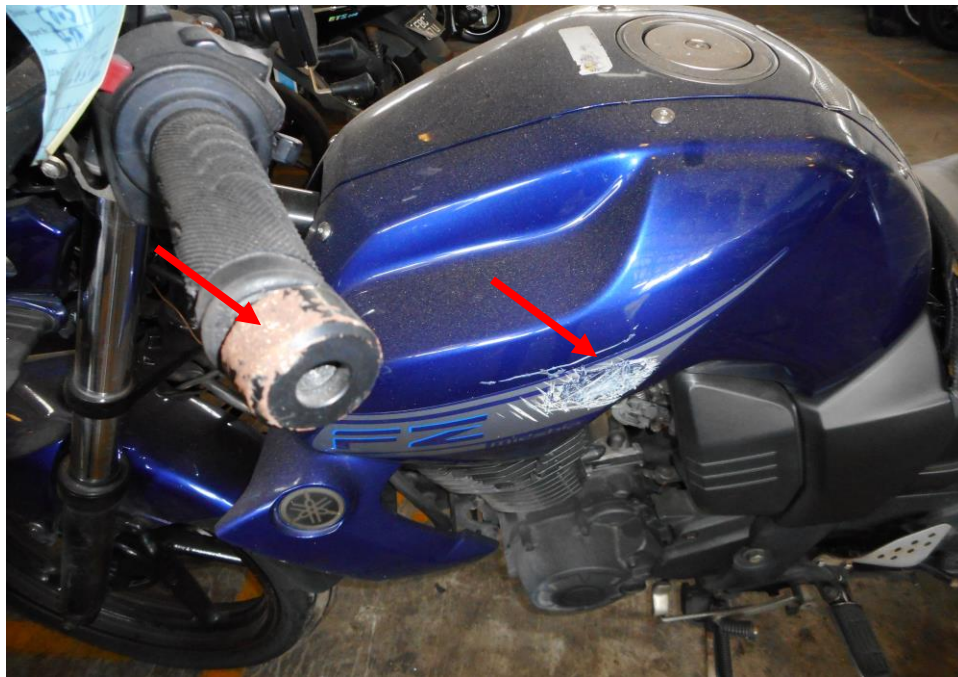
Photo 8 shows a close up view of the damages to the fuel tank cover and the rear panel at time of inspection likely due to the cause of the accident.

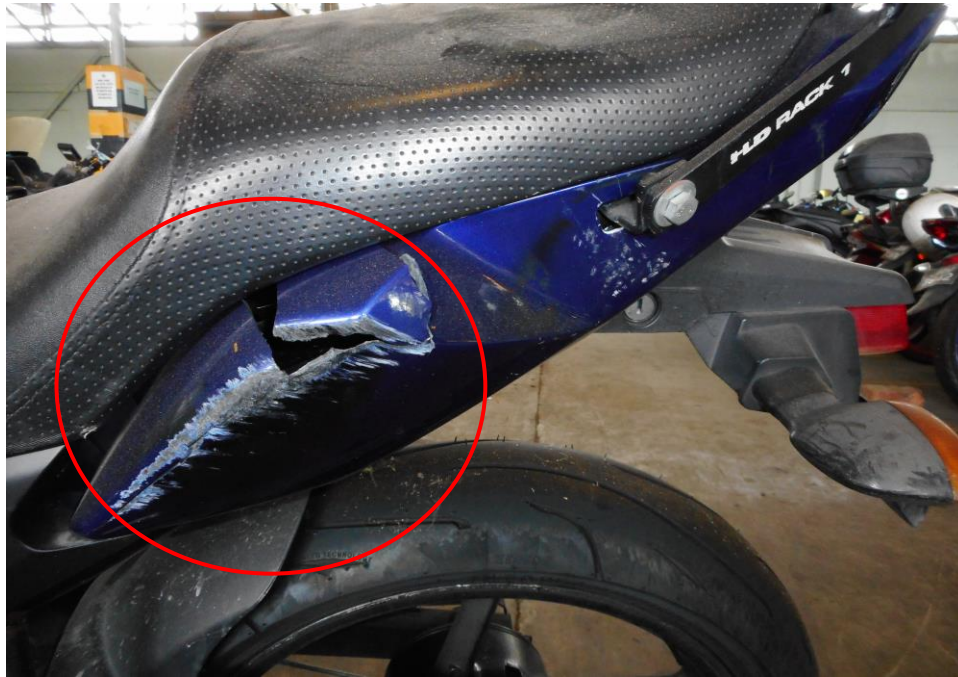
Photo 9 shows a close up view of the damages to the rear panel at time of inspection likely due to the cause of the accident.

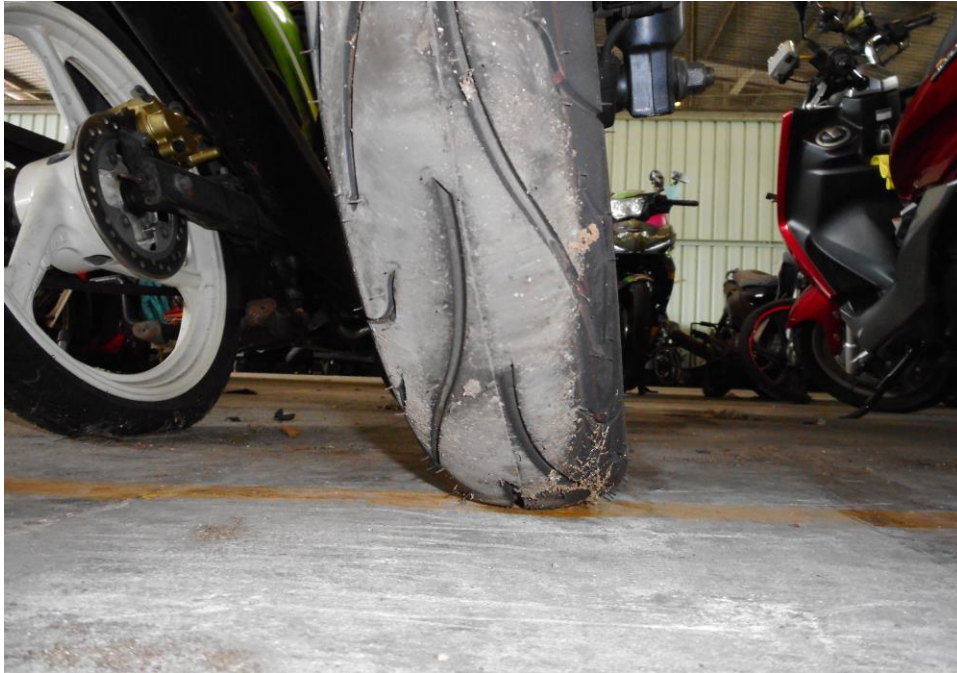
Photo 9 shows the front tyre of the Motorcycle. The rear tyre was observed to be in serviceable & the tyre was also observed to be sufficiently inflated for vehicular operation.

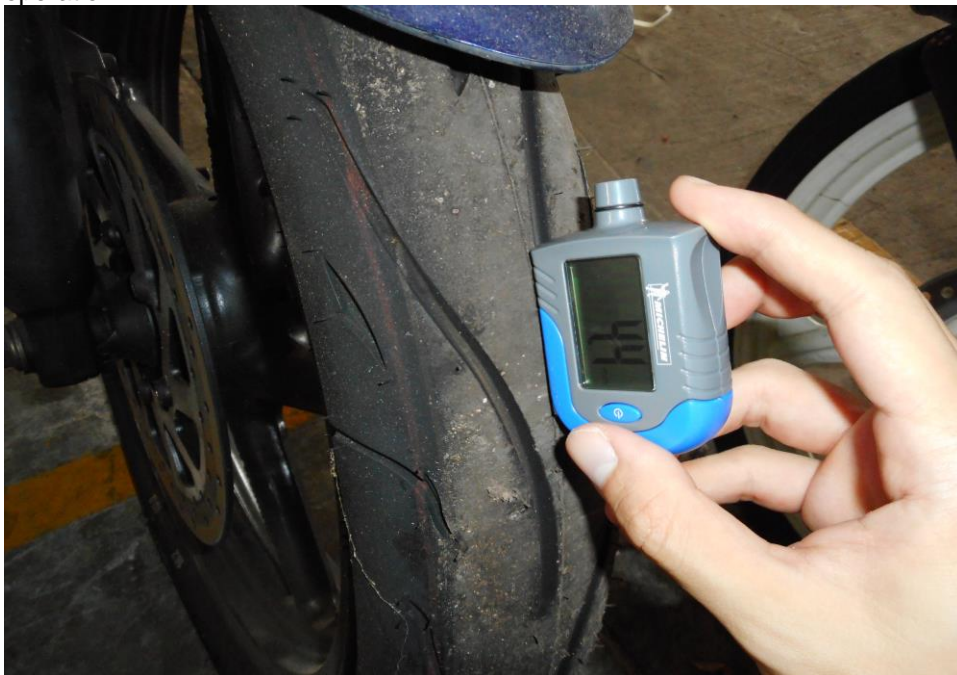
Photo 10 shows the front tyre of the Motorcycle. The rear tyre was observed with remaining tread depth of approximately 4.4mm. The tyre was also observed to be sufficiently inflated for vehicular operation.

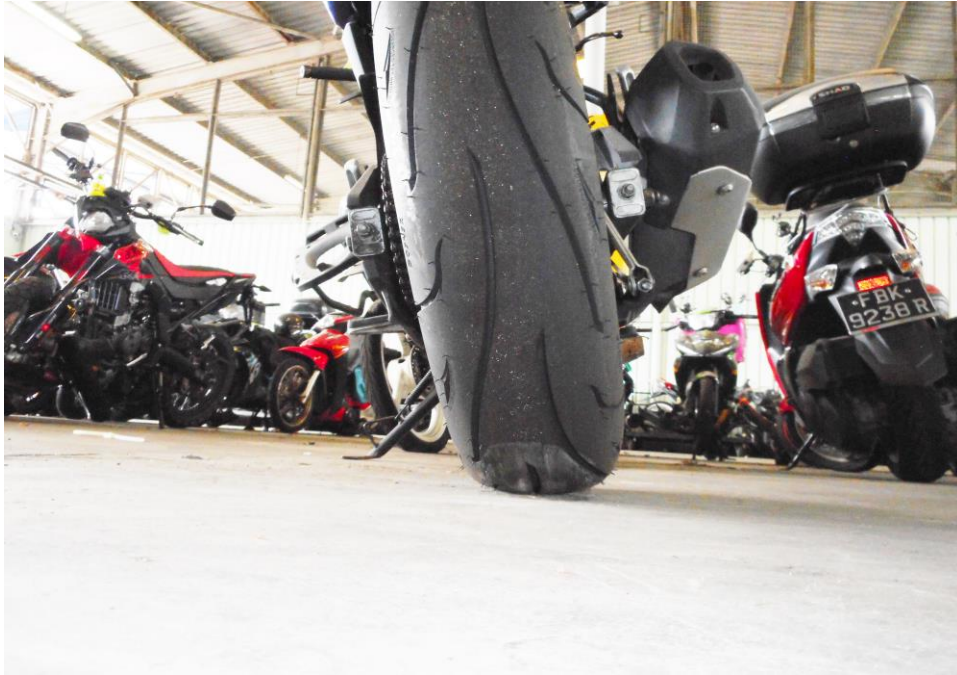
Photo 11 shows the rear tyre of the Motorcycle. The front tyre was observed to be in serviceable & the tyre was also observed to be sufficiently inflated for vehicular operation.

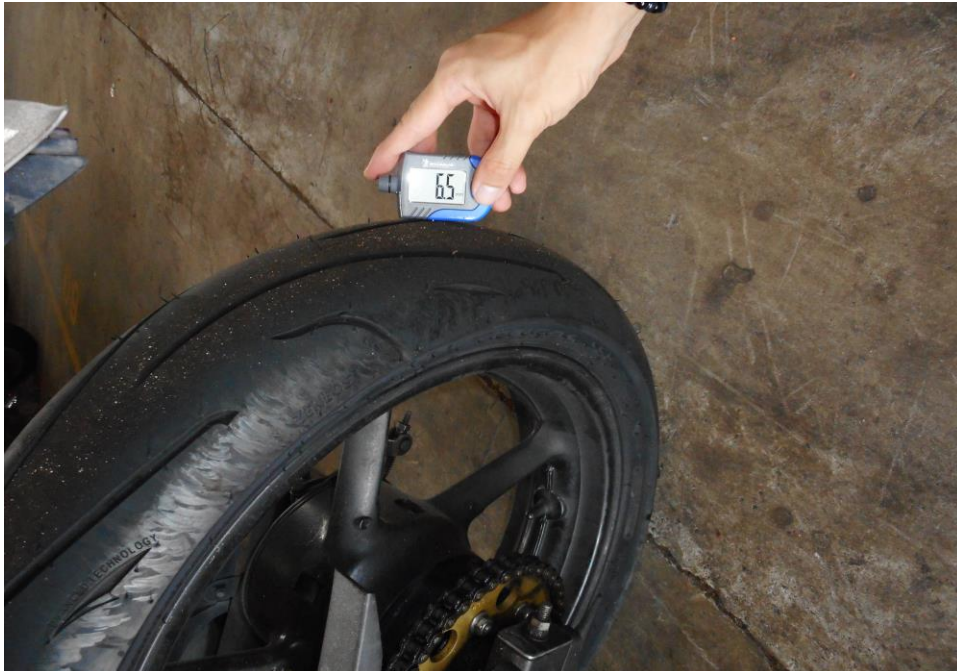
Photo 12 shows the rear tyre of the Motorcycle. The front tyre was observed with remaining tread depth of approximately 6.5mm. The tyre was also observed to be sufficiently inflated for vehicular operation.

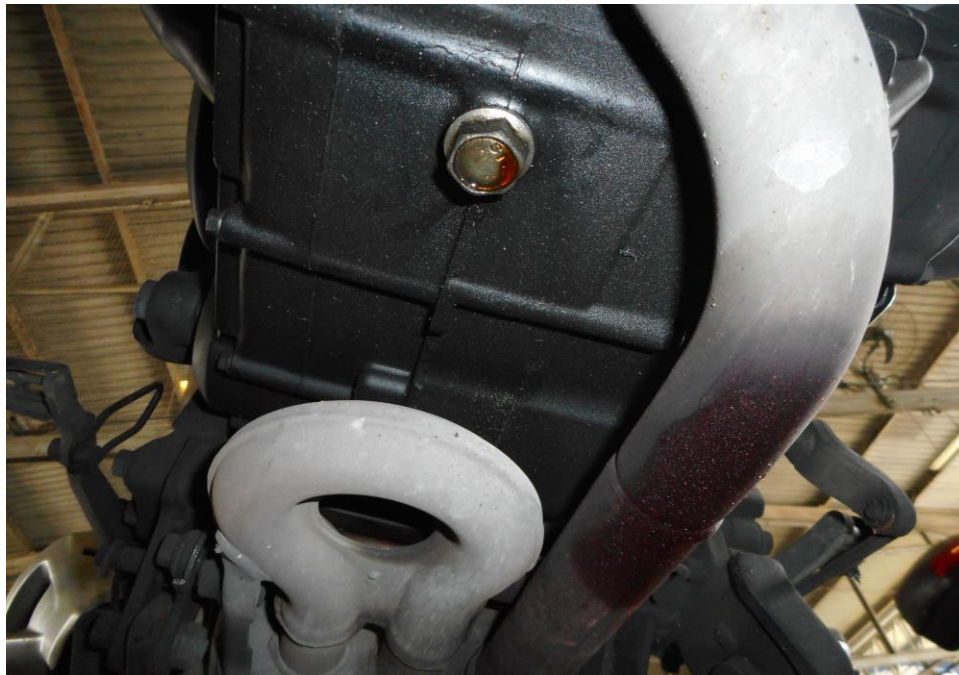
8. Upon examination of the Motorcycle's engine area, we had observed that the various engine related parts and components were intact with no visible damage. There was minimal fluid leakage observed underneath the engine area of the Motorcycle.
9. The gear chain of the motorcycle was found to be intact without any misalignment. It was also adequately lubricated for operating purposes. Free play tension test was also conducted & found adequately acceptable. See photo 13 – 17 below.

Photo 13 shows minimal flesh fluid leakage observed around the drain plug and the exhaust area underneath the engine area of the Motorcycle.

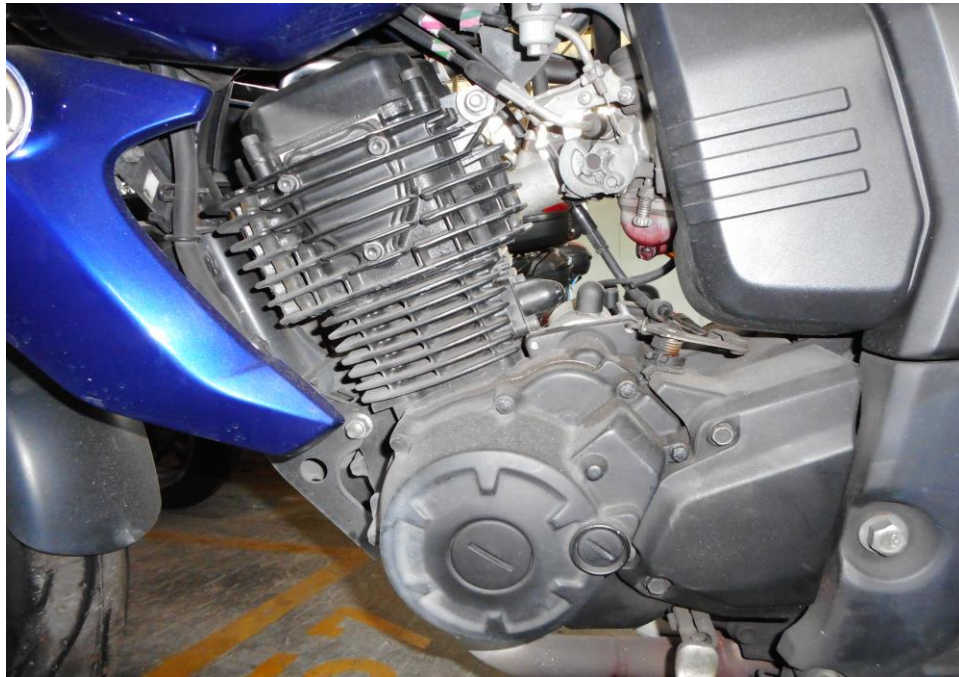
Photo 14 shows no sign(s) or indication(s) of fluid leakage stain observed around the left engine area of the Motorcycle.

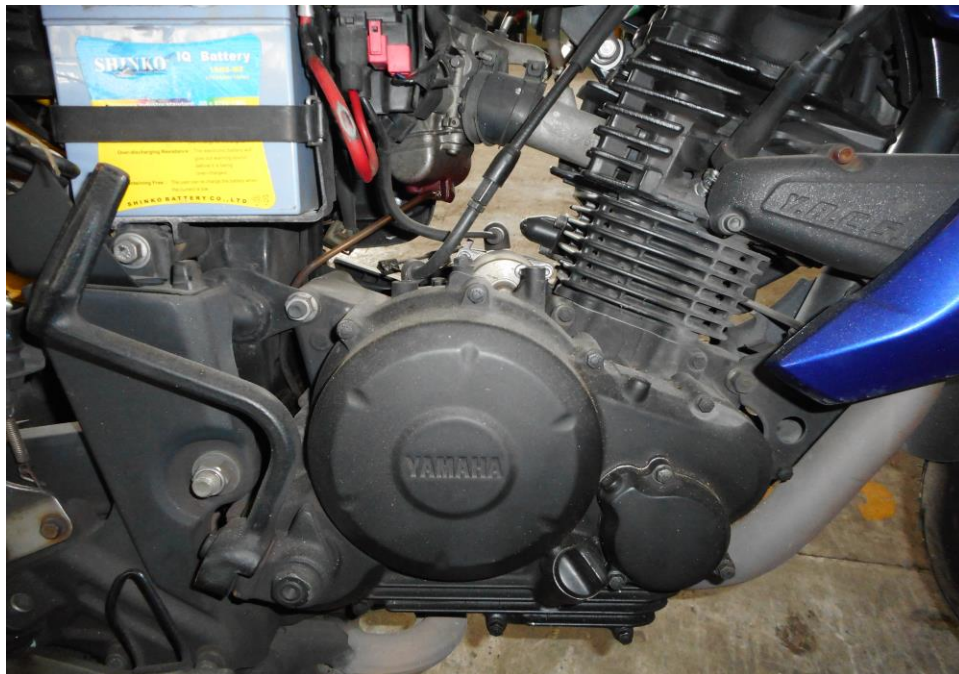
Photo 15 shows no sign(s) or indication(s) of fluid leakage stain observed around the right engine area of the Motorcycle.

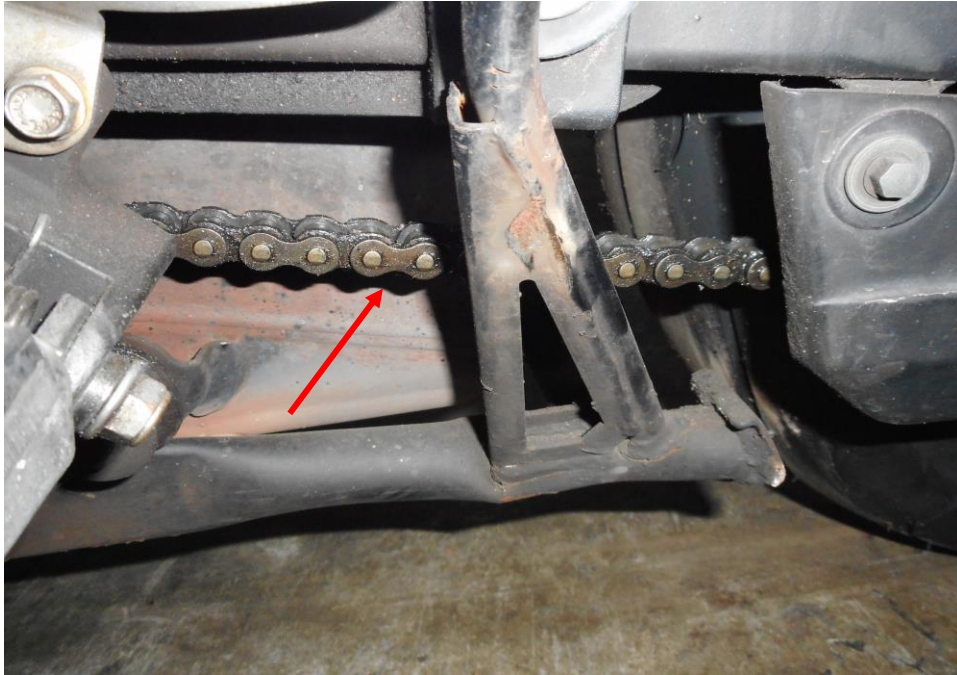
Photo 16 shows the general view of the gear train (arrowed) of the Motorcycle, which was observed to be intact with no misalignment. It was also adequately lubricated for operating purposes.

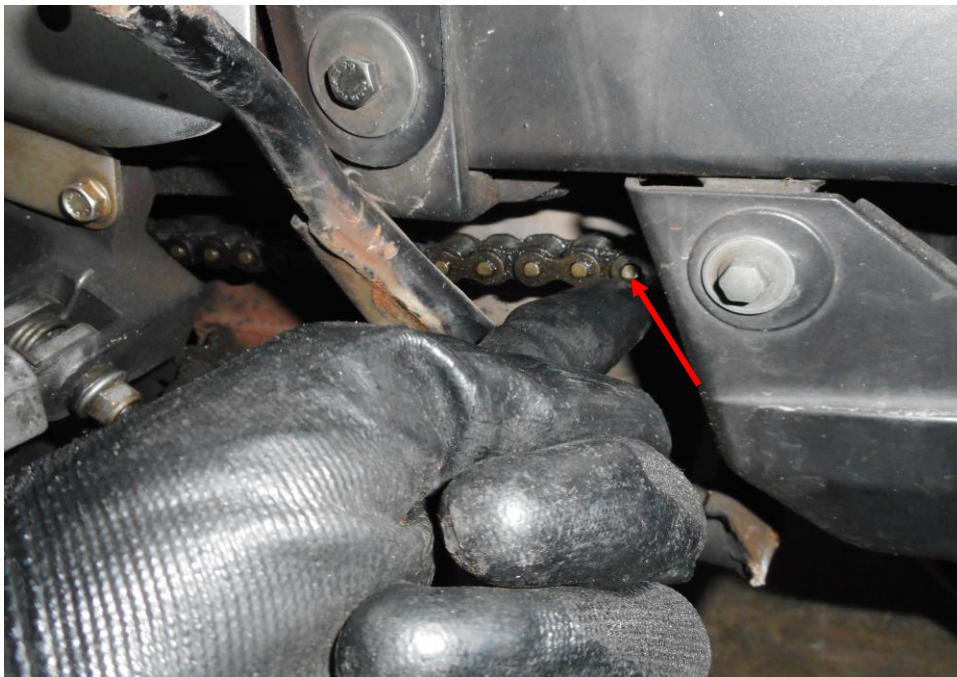
Photo 17 shows the general view of the gear train (arrowed) of the Motorcycle, which was observed to be intact with no misalignment. It was also adequately lubricated for operating purposes. Tension was also observed & found adequately acceptable.

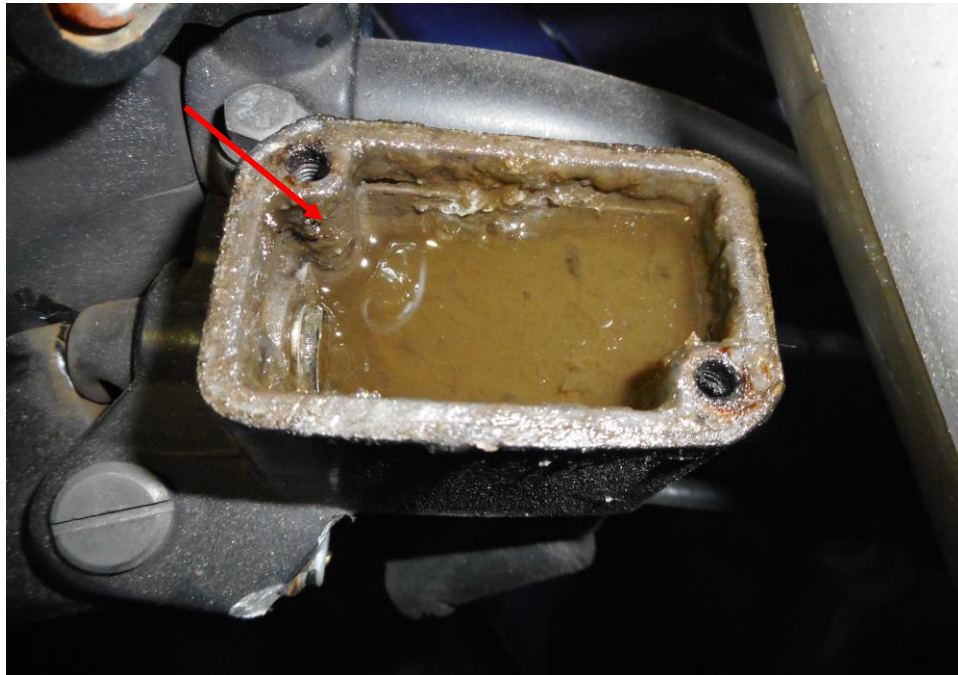
Photo 18 shows our checks on the brake fluid (front) reservoir had also indicated that the brake fluid is sufficient level and in serviceable operational purposes.

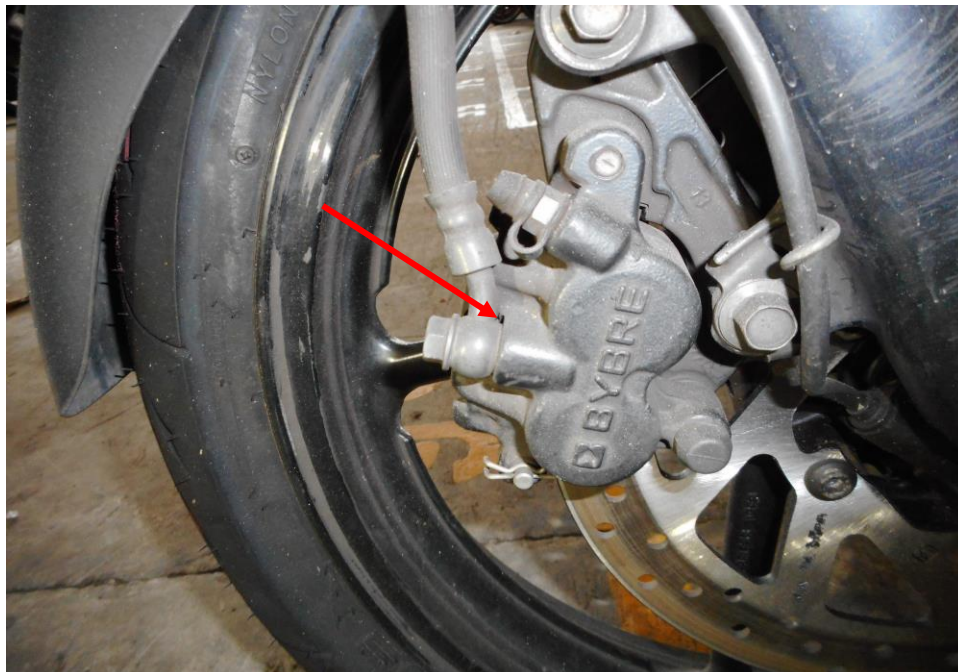
Photo 19 shows our checks on the brake callipers housing (front). There was also no sign(s) or indication(s) of fluid leak observed around the brake calliper housing.

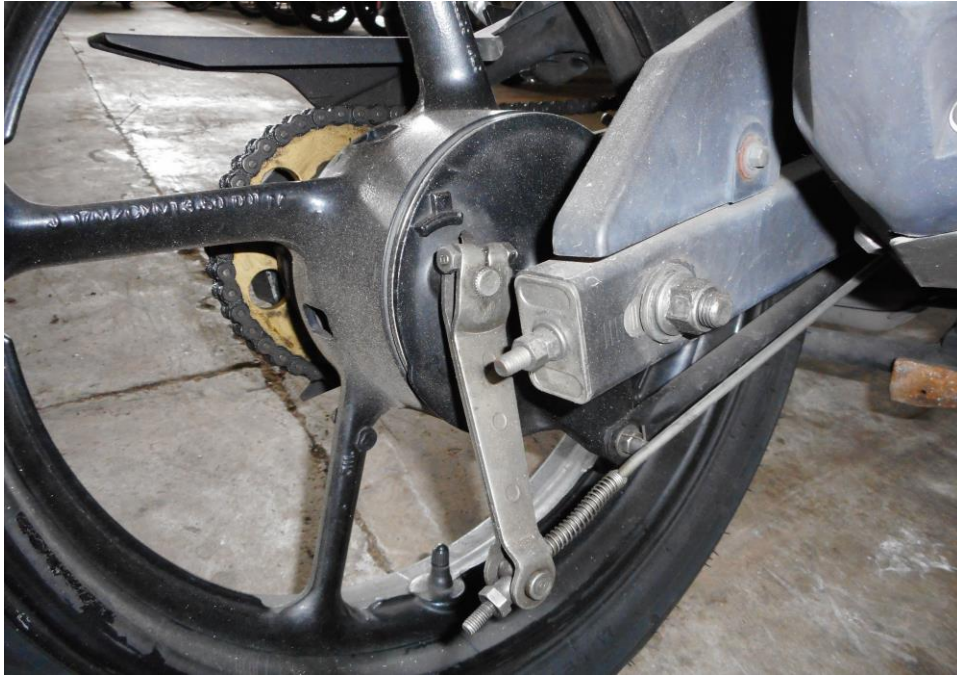
Photo 20 shows our checks on the drum brake housing (rear) no leakage or fluids is found present around it

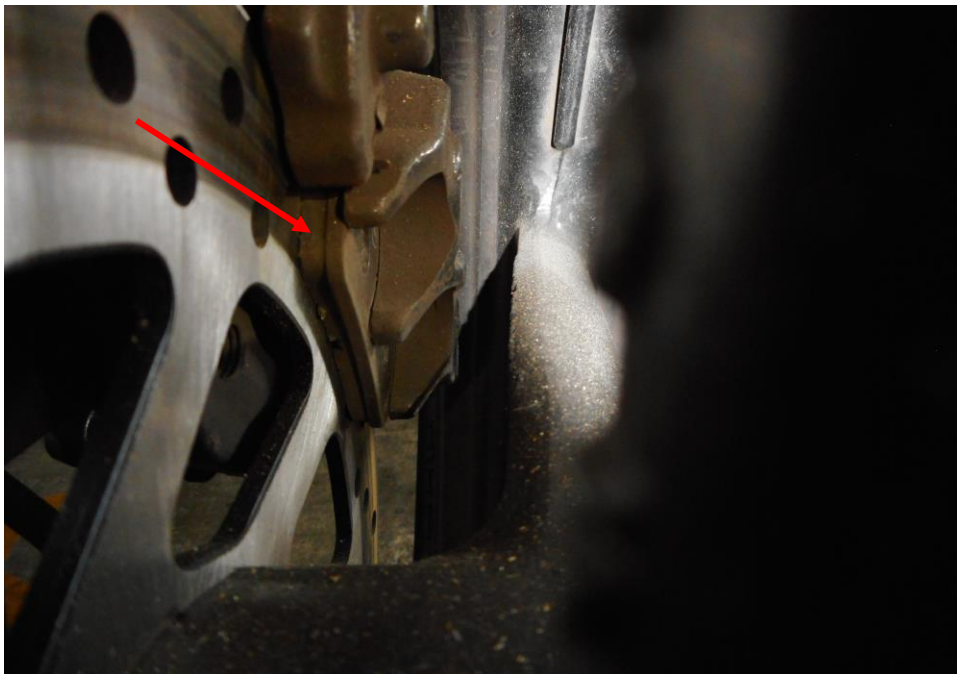
Photo 21 shows a close-up view our checks on the brake pad (front). The frictional material was observed to be in a sufficient level for operational purposes.

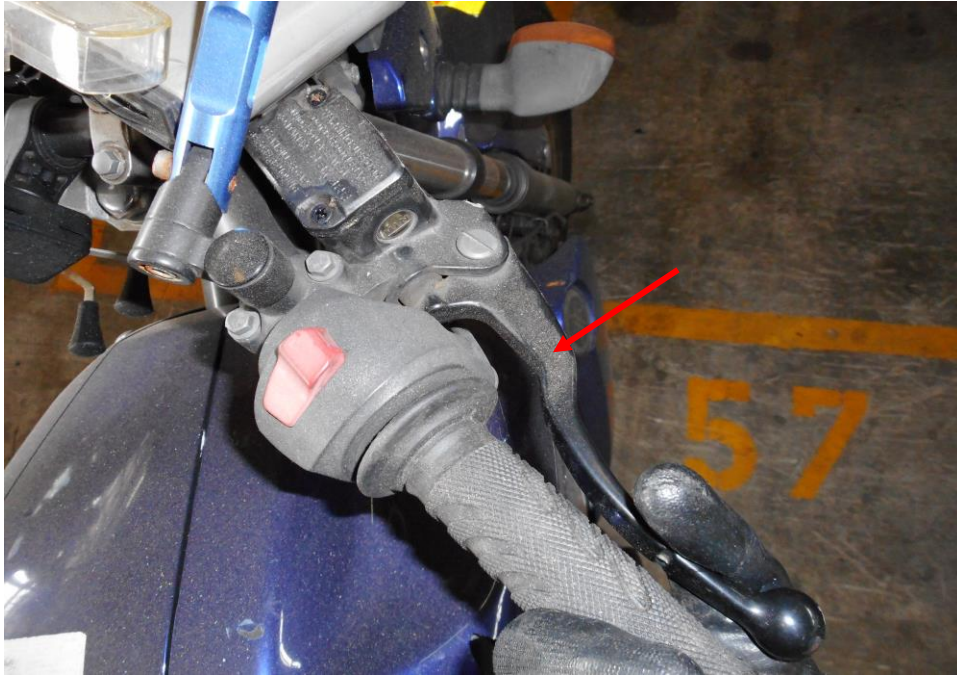
12. Static brake tests conducted on the Motorcycle front brake could not be done as the brake lever was damaged and resulted in the brake applied to a permanent full lock position; thus immobilising the movement of the front wheel of the Motor Cycle. The static test of the rear brakes was conducted by stepping on the brake pedal at the right side foot rest of the Motorcycle and had appeared to be in serviceable condition. Other than the damage on the front brake lever the other components of the Motorcycle's braking system like the brake discs, brake callipers, brake lever, brake pads brake drum, brake foot pedal and brake hoses revealed all to be intact and without damage. See photo 18 - 23 below.

13. No operational test could be conducted due to the damage cause to the right brake handle which rendered the front wheel to be locked,(unable to operate)

Photo 22 shows testing of the braking of the front brake in progress. The braking force was not felt upon pressing the brake lever as the damage likely due to the accident.

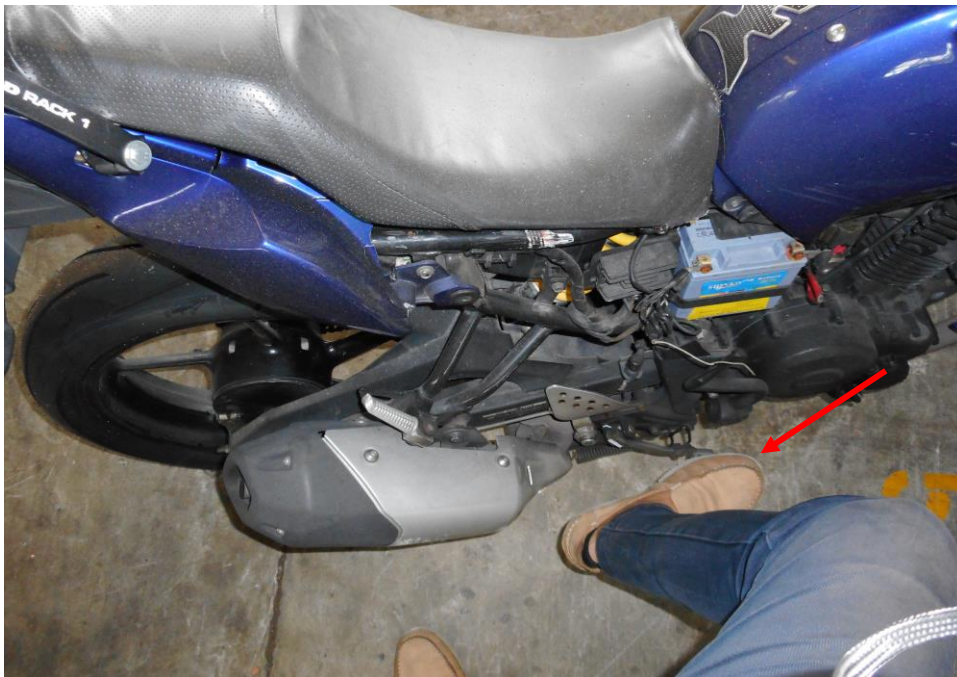
Photo 23 shows testing of the braking of the rear brake in progress. The braking force was felt upon stepping on the brake lever. The brakes are in serviceable condition.
