Your Ref: TP/IP/66447/2018
Our Ref: CI/TPD19000754/P

26th April 2019

MECHANICAL INSPECTION REPORT OF MOTORCYCLE JSM 2826

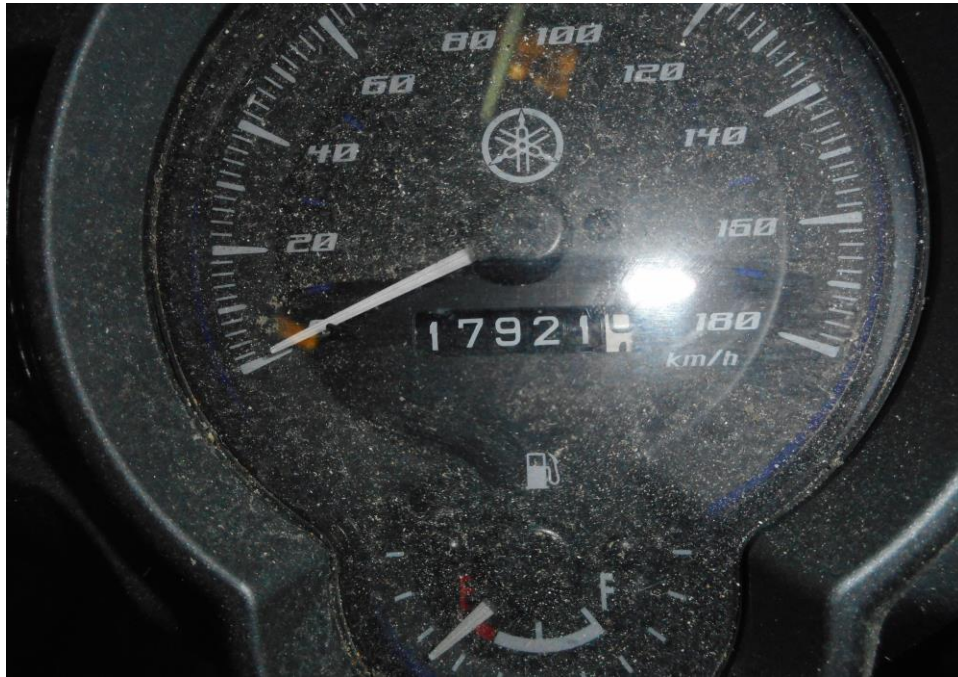
Photo 1 shows a general view of the mileage 17,921KM at time of our inspection.

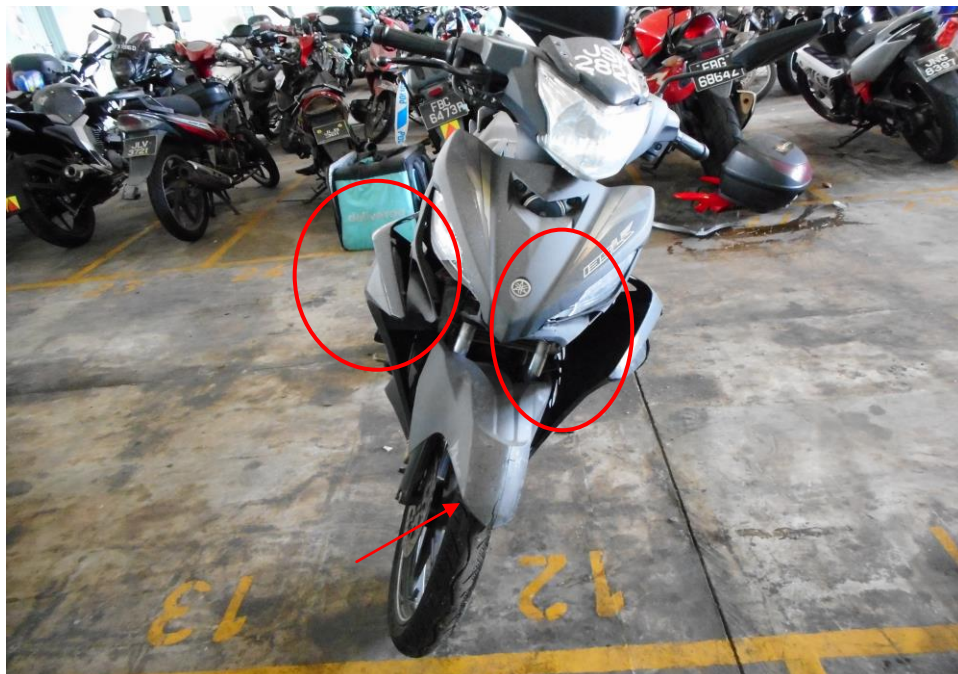
Photo 2 shows a general view of the front body of the Motorcycle at the time of our inspection. The Motorcycle was observed to have sustained relatively minor damages at time of inspection. The damages were observed to be confined to its front & both sides of the Motorcycle.

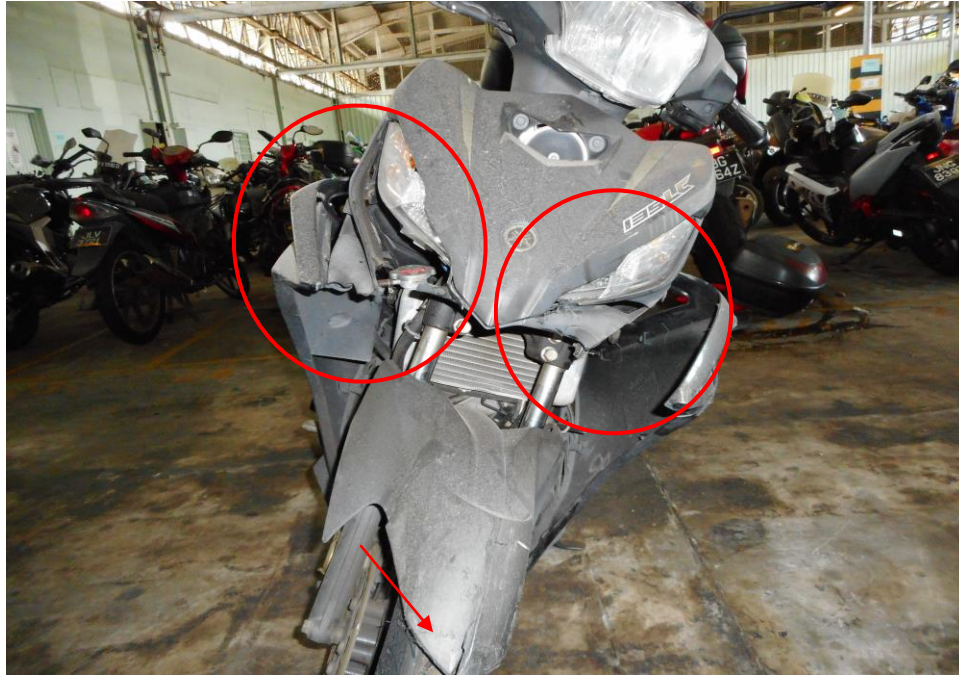
Photo 3 shows a general view of the front body of the Motorcycle at the time of our inspection. The Motorcycle was observed to have sustained relatively minor damages at time of inspection. The damages were observed to be confined to its front & both sides of the Motorcycle.

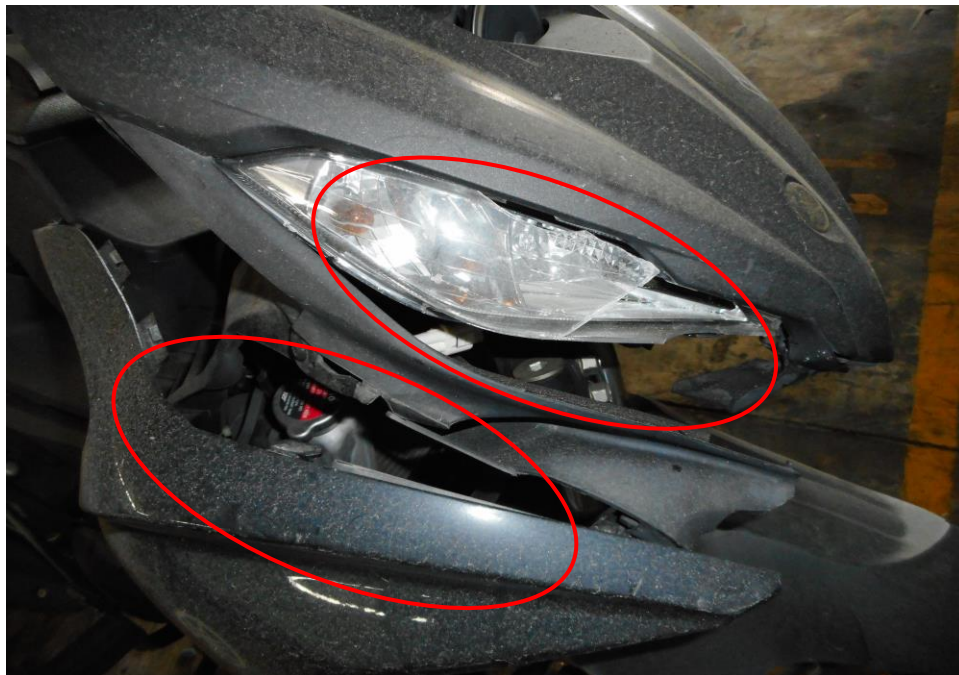
Photo 4 shows a close up view of the front right body of the Motorcycle at the time of our inspection. The Motorcycle was observed to have sustained damages at time of inspection. The damages were observed to be at its right headlamp & side fairing of the Motorcycle.

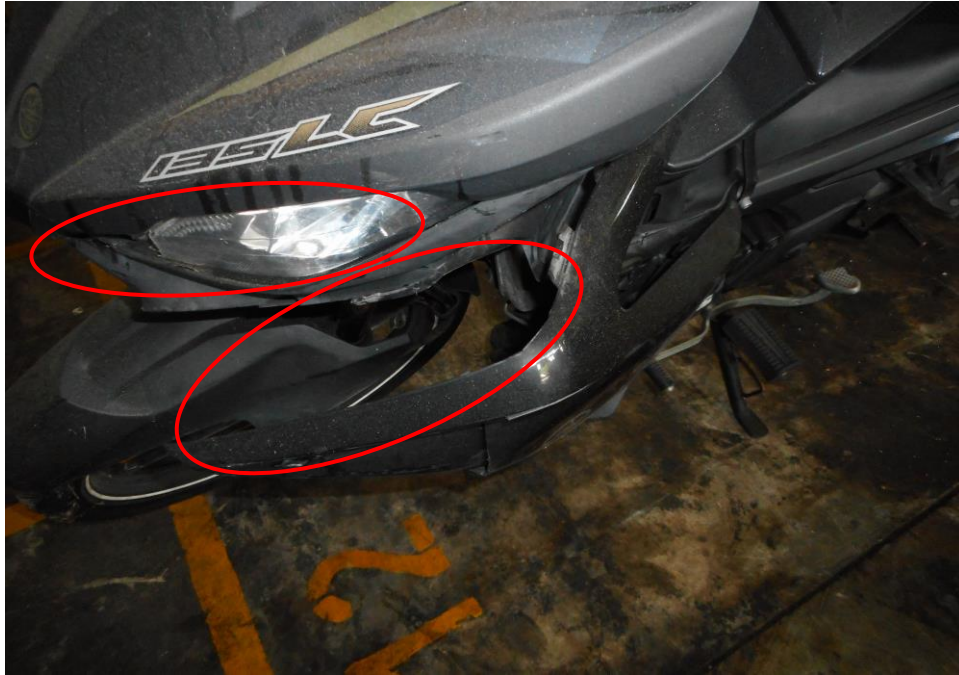
Photo 5 shows a close up view of the front right body of the Motorcycle at the time of our inspection. The Motorcycle was observed to have sustained damages at time of inspection. The damages were observed to be at its left headlamp & side fairing of the Motorcycle.

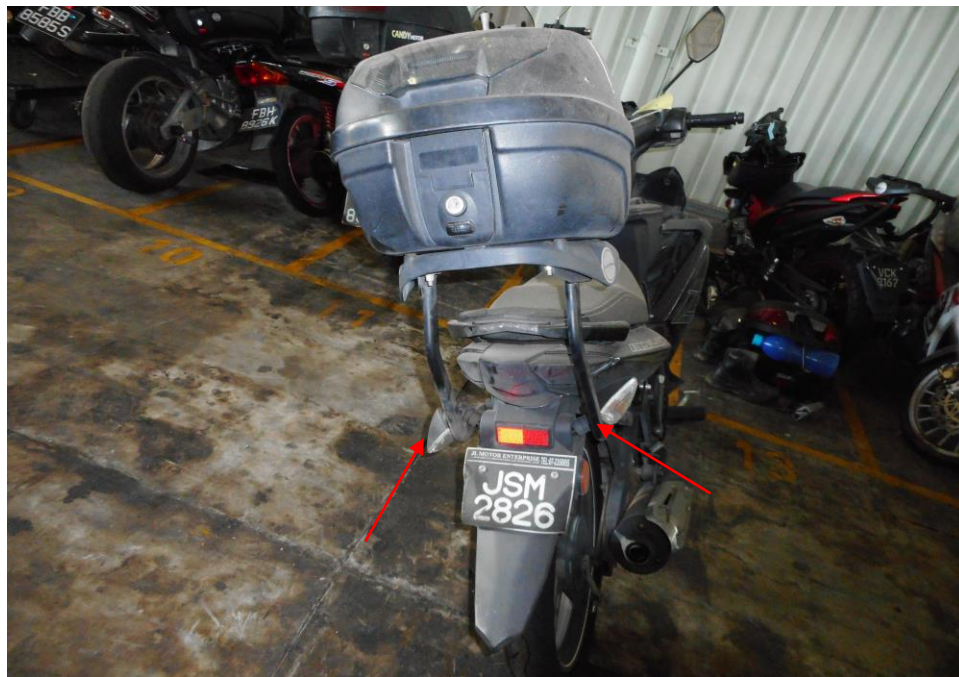
Photo 6 shows a general view of the rear body of the Motorcycle at the time of our inspection. The Motorcycle was observed to have sustained damages at time of inspection. The damages were observed to be at its left & right signal lamps of the Motorcycle.

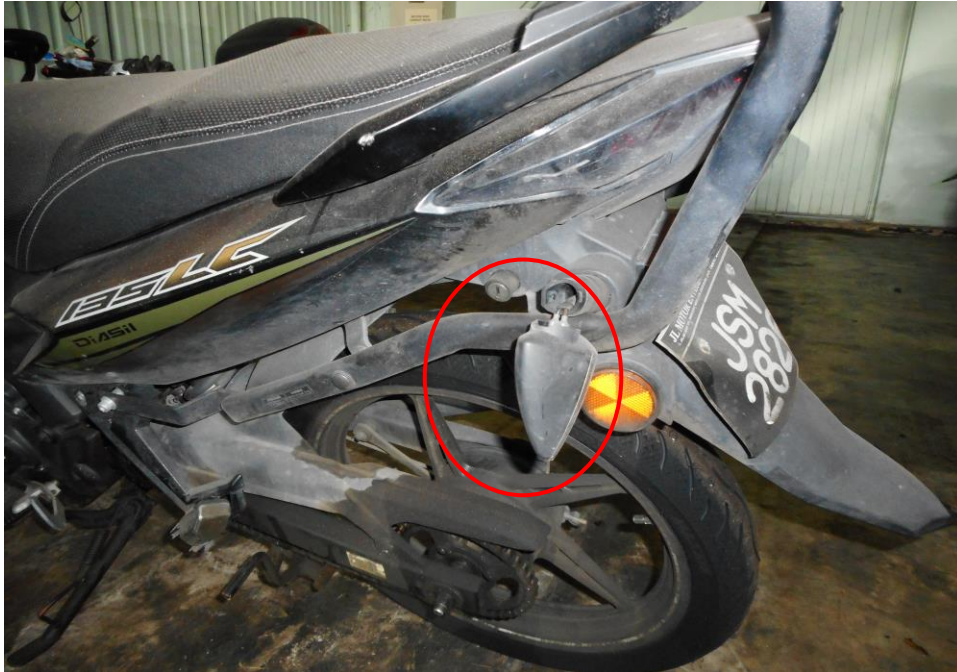
Photo 7 shows a close up view of the left signal lamp of the Motorcycle at the time of our inspection. The Motorcycle was observed to have sustained relatively minor damages at time of inspection.

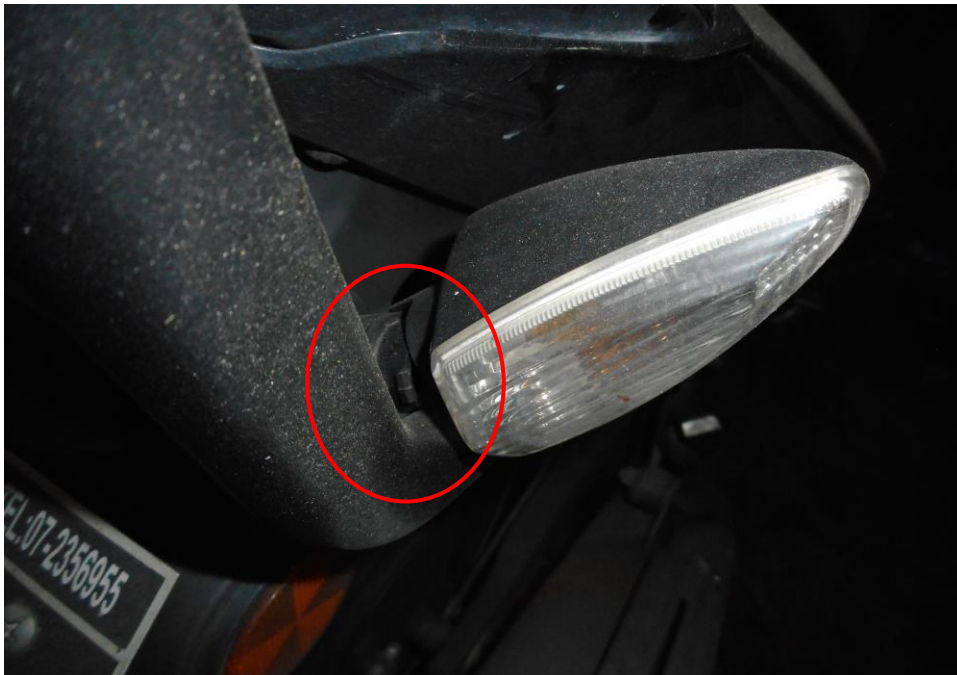
Photo 8 shows a close up view of the right signal lamp of the Motorcycle at the time of our inspection. The Motorcycle was observed to have sustained relatively minor damages at time of inspection.

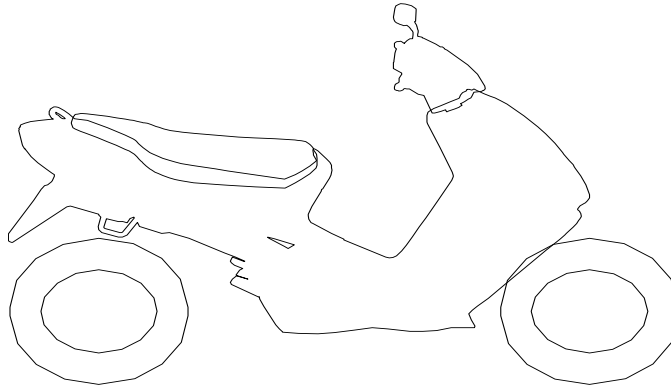
6. The condition of the Motorcycle's 2 tyres was observed to be in serviceable condition. The tread pattern of the 2 tyres was clearly visible. We did not observe any tear, burst mark(s) and/or punctured hole(s) on the sidewalls as well as across the tread of the 2 tyres. The 2 tyres were both observed to be sufficiently inflated for vehicular operation. The tyre brand, tyre size and remaining tread depth of the 2 tyres were recorded as follows:-

Maxxis Volans
80/ 70/ 90 - 17 (4.2mm)

Maxxis Volans
70/90 - 17 (3.2mm)

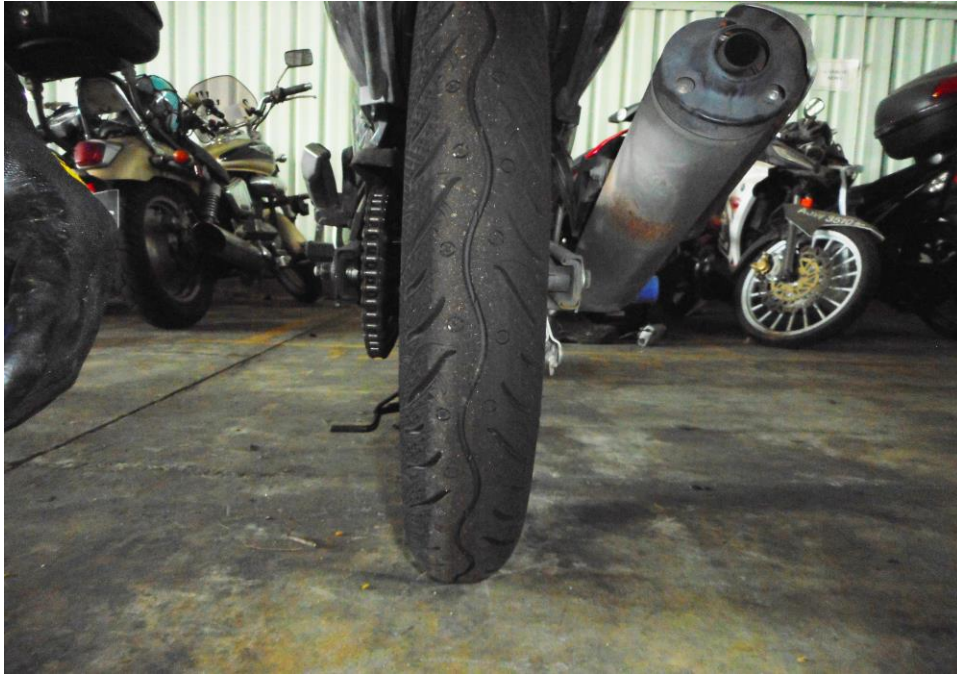
Photo 9 shows the rear tyre of the Motorcycle. The rear tyre was observed to be in serviceable condition & was also observed to be sufficiently inflated for vehicular operation.

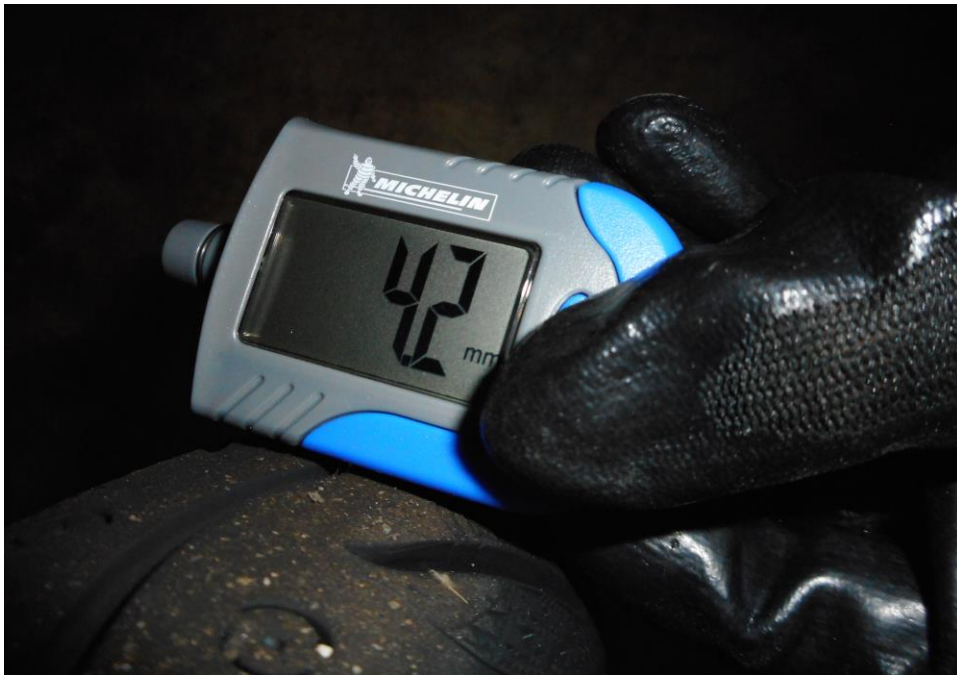
Photo 10 shows the rear tyre of the Motorcycle. The rear tyre was observed remaining tread depth of 4.2mm. The tyre was also observed to be sufficiently inflated for vehicular operation.

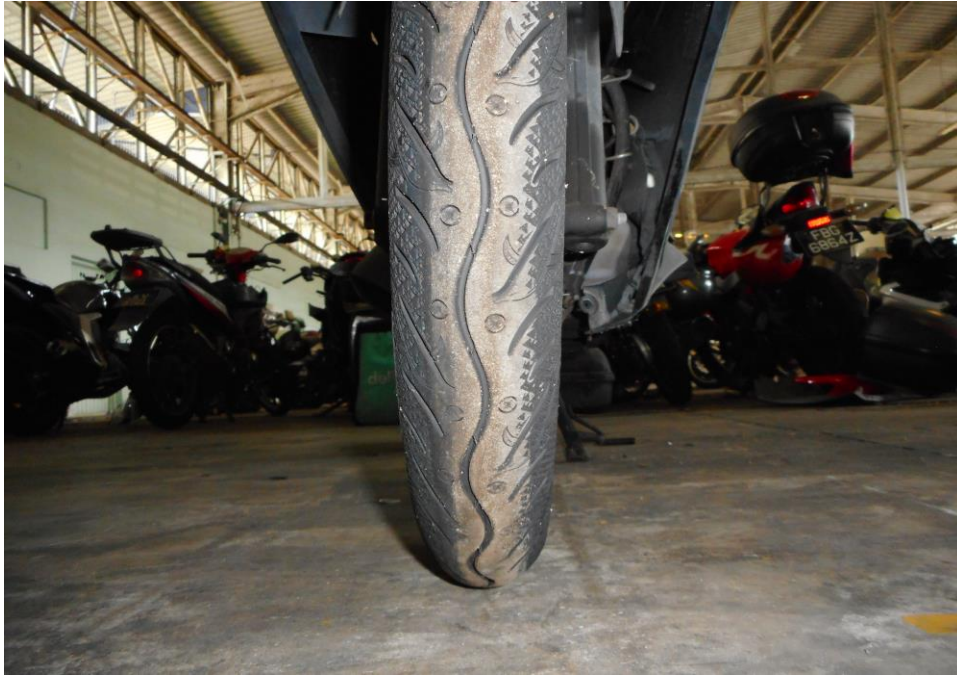
Photo 11 shows the rear tyre of the Motorcycle. The front tyre was observed to be in serviceable condition & was also observed to be sufficiently inflated for vehicular operation.

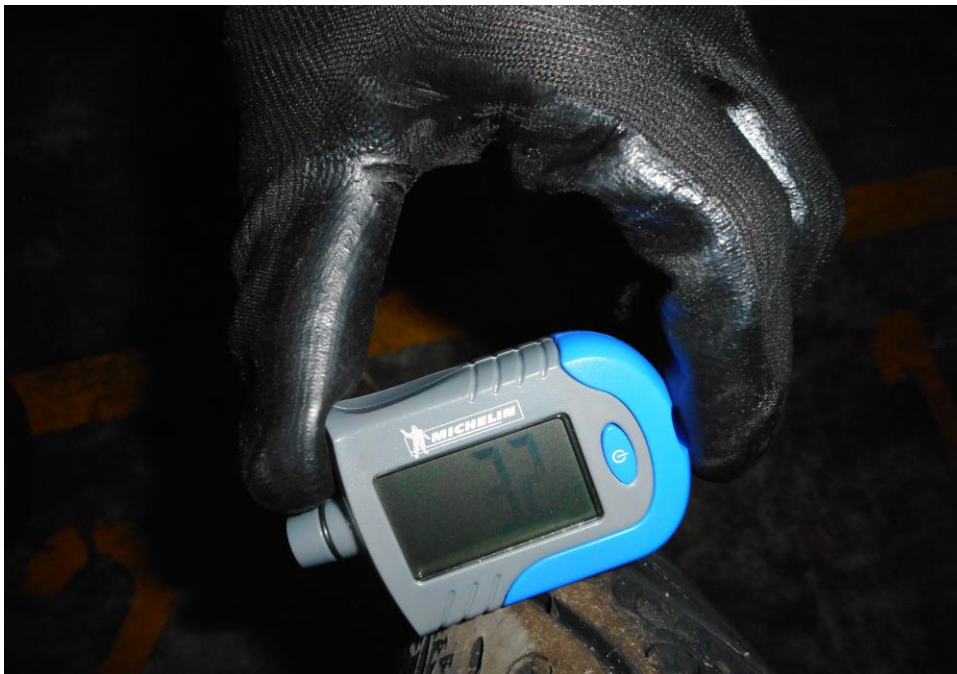
Photo 12 shows the front tyre of the Motorcycle. The front tyre was observed remaining tread depth of 3.2mm & was also observed to be sufficiently inflated for vehicular operation.

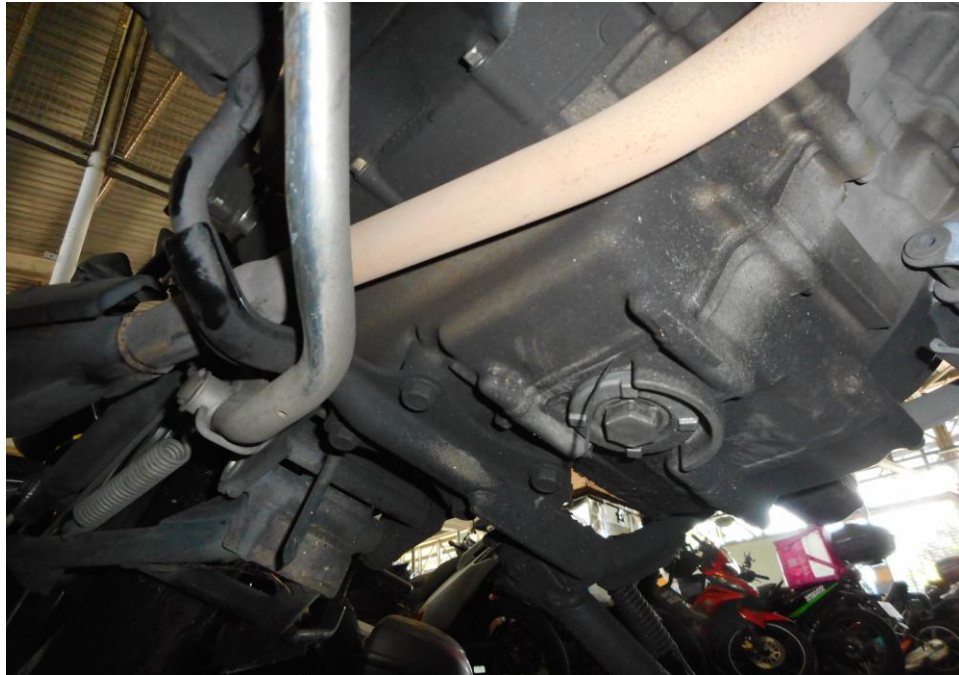
Photo 13 shows no sign(s) or indication(s) of fluid leak observed around the undercarriage of the engine area of the Motorcycle.

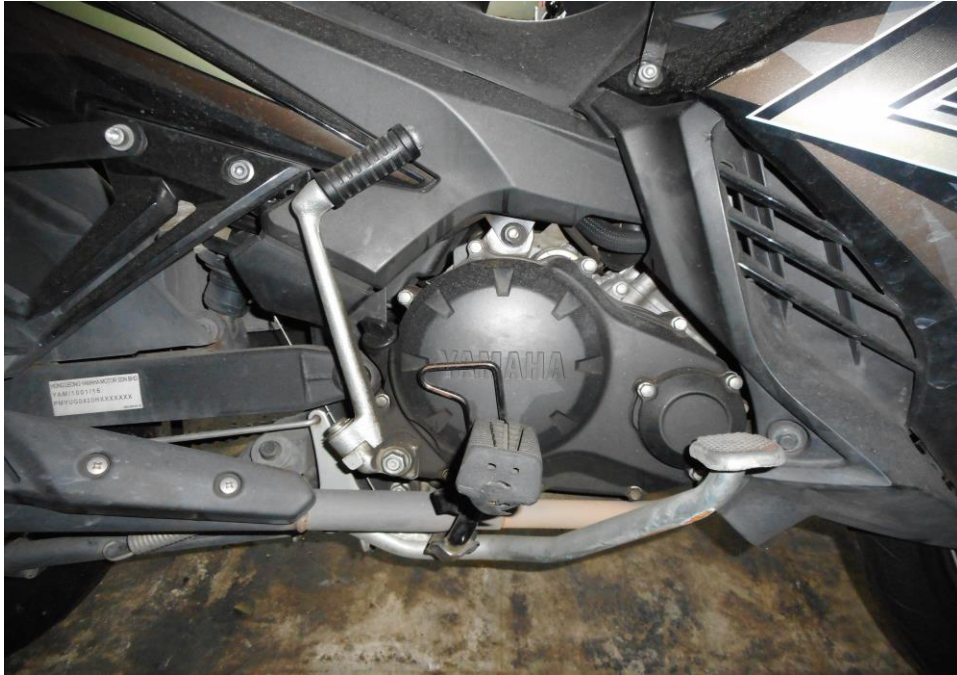
Photo 14 shows no sign(s) or indication(s) of fluid leakage stain observed around the right side engine area of the Motorcycle.

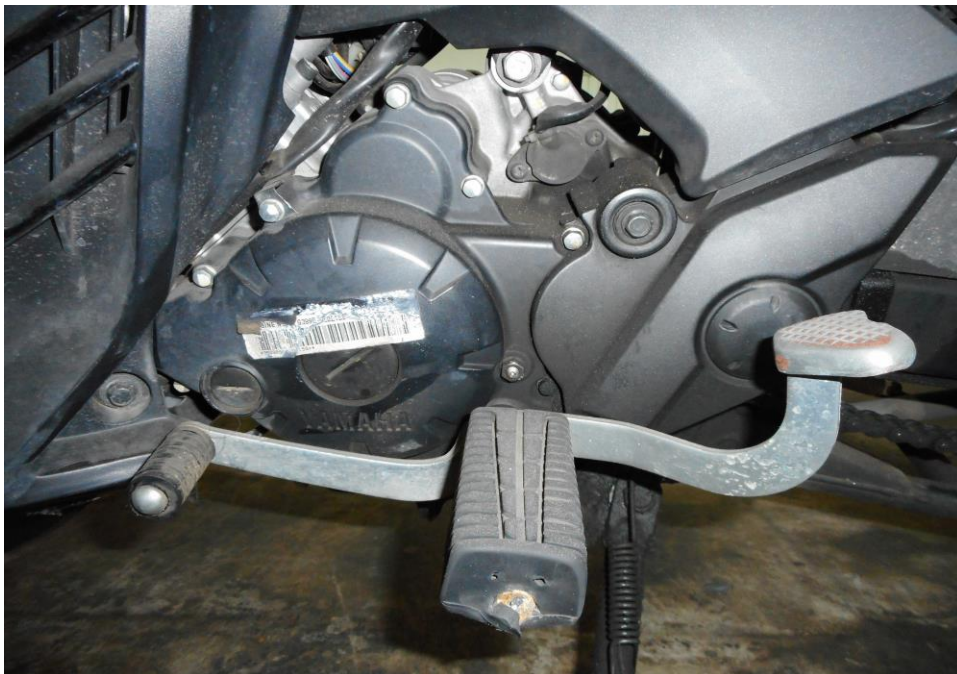
Photo 15 shows no sign(s) or indication(s) of fluid leakage stain observed around the left engine area of the Motorcycle.

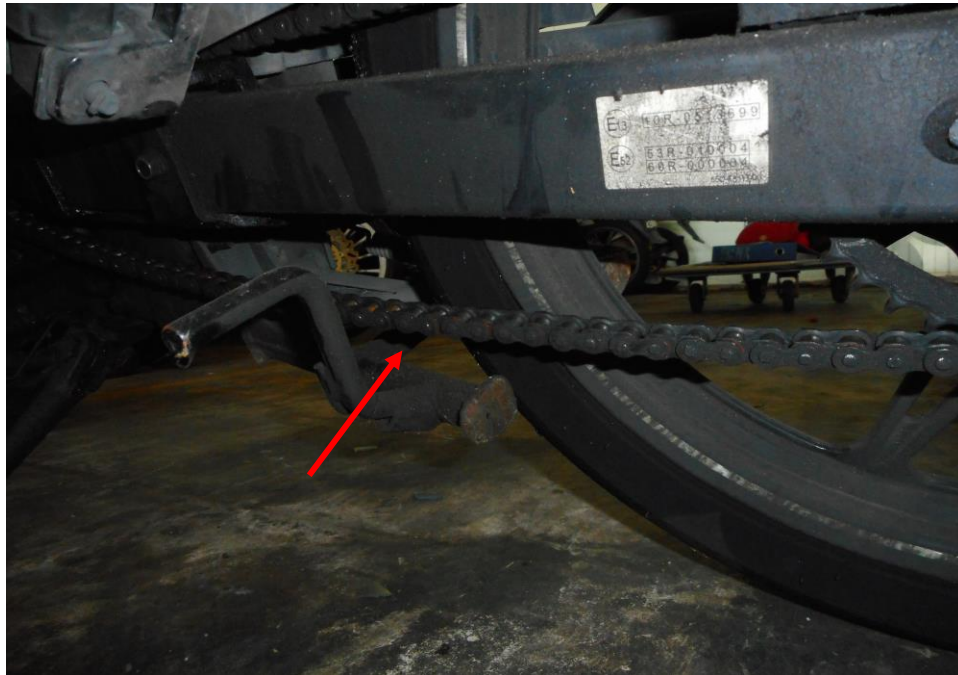
Photo 16 shows the general view of the gear train (arrowed) of the Motorcycle, which was observed to be intact with no misalignment. It was also adequately lubricated for operating purposes.

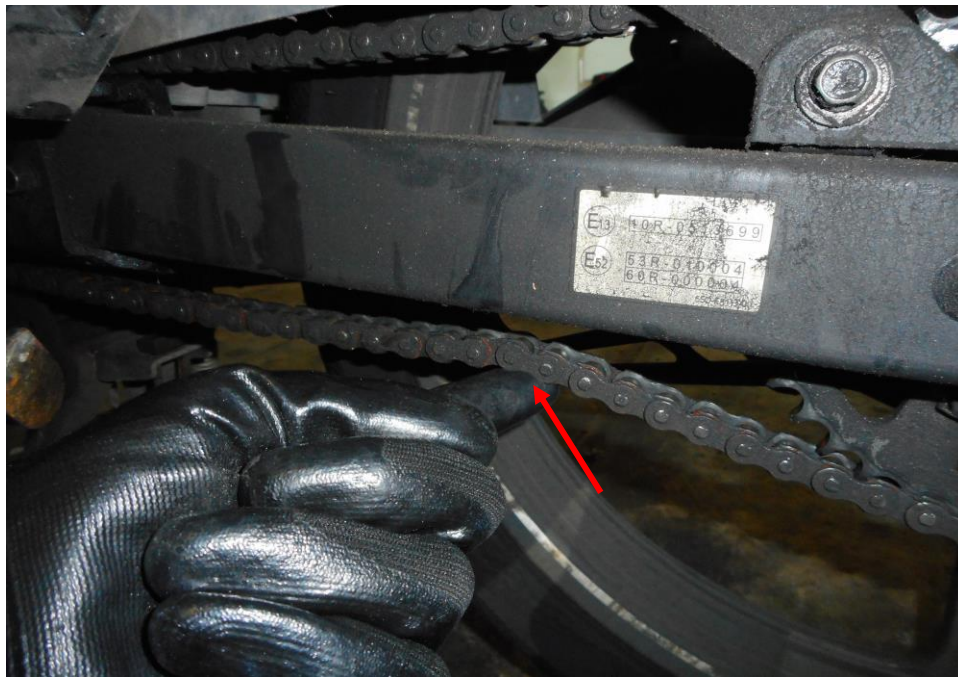
Photo 17 shows the general view of the gear train (arrowed) of the Motorcycle, which was observed to be intact with no misalignment. It was also adequately lubricated for operating purposes. Free play tension was also observed & found adequately acceptable.

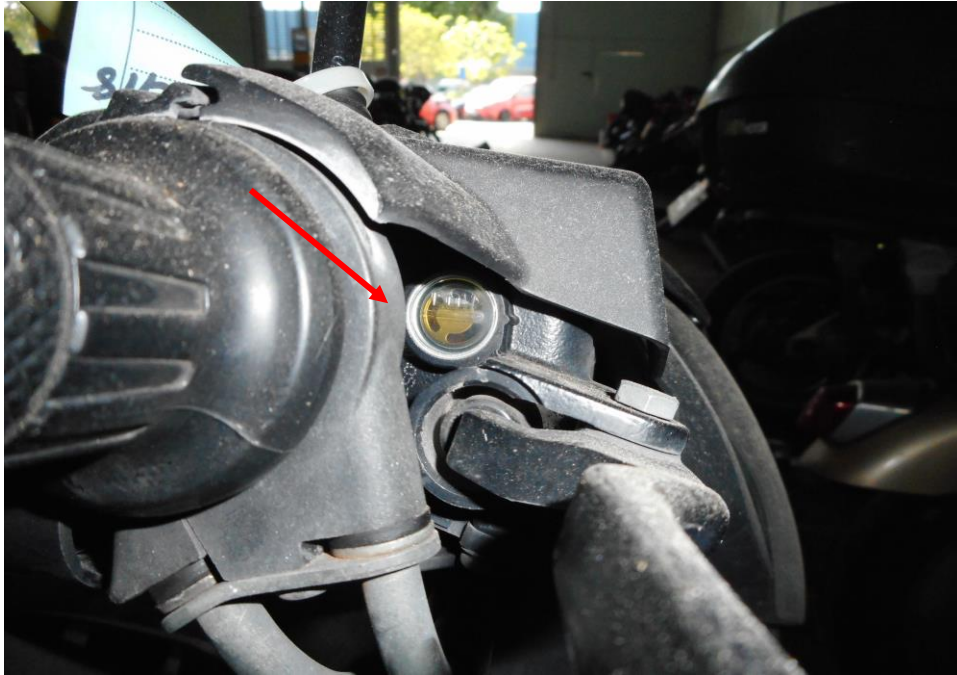
Photo 17 shows our checks on the brake fluid (front) reservoir had also indicated that the brake fluid was of sufficient level for operational purposes, and without contamination.

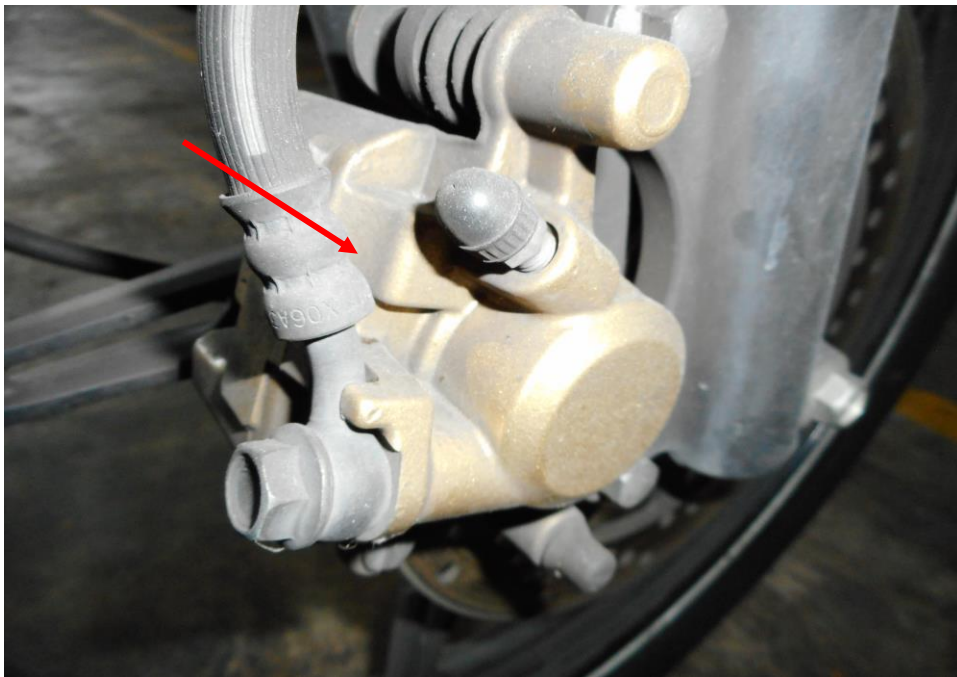
Photo 18 shows our checks on the brake callipers housing (front). There was also no sign(s) or indication(s) of fluid leak observed around the Motorcycle.

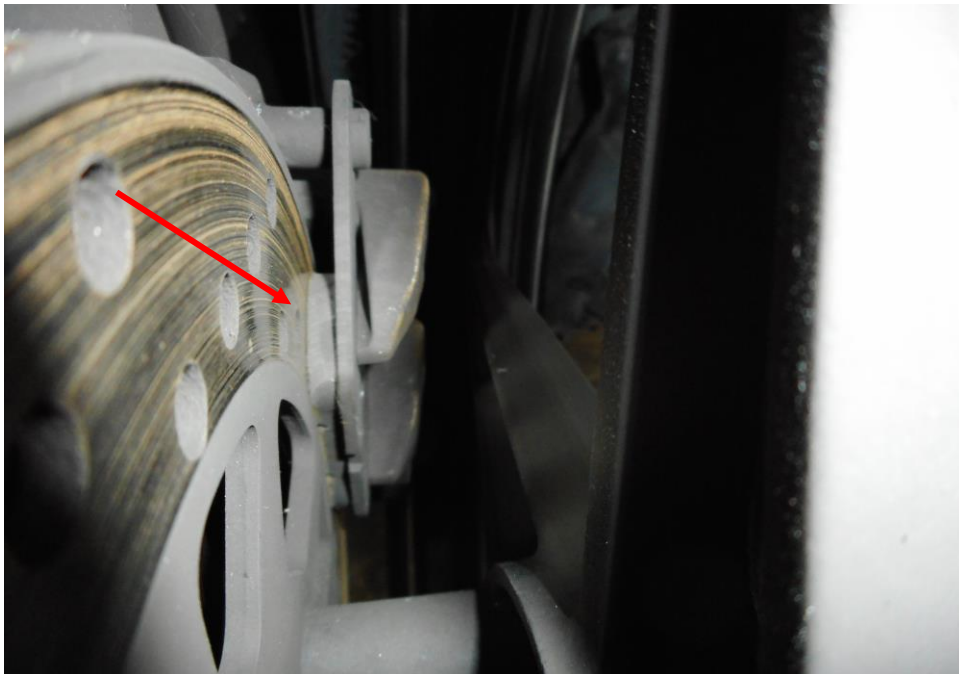
Photo 20 shows a close-up view our checks on the brake pad (front). The frictional material was observed to be in a sufficient level for operational purposes.

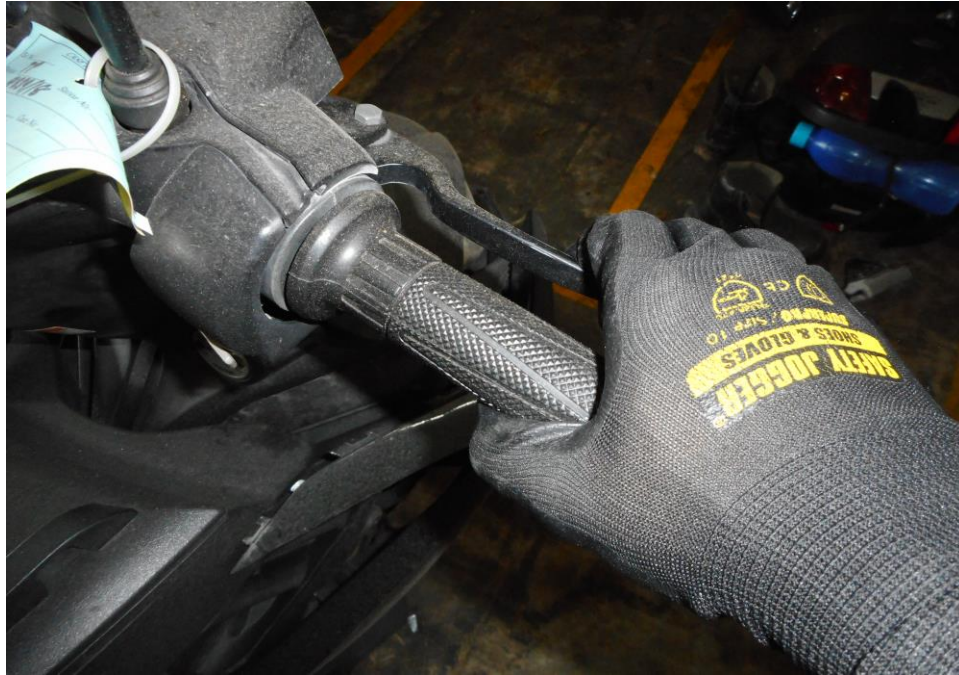
Photo 21 shows testing of the braking of the front brake in progress. The braking force was felt upon pressing the brake lever. The brakes is in serviceable condition

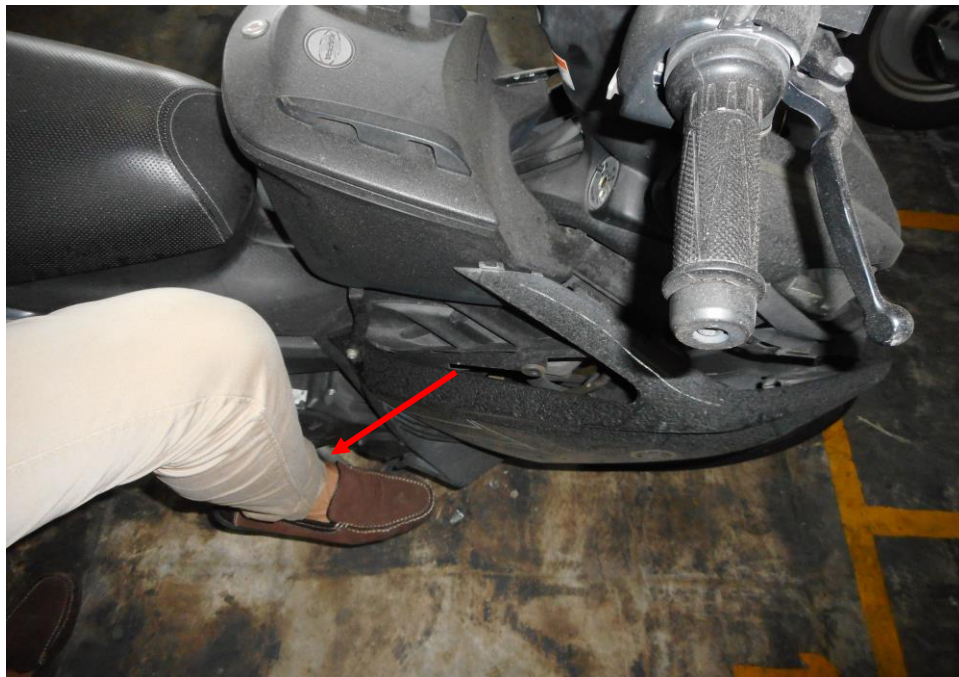
Photo 22 shows testing of the braking of the rear brake in progress. The braking force was felt upon pressing the brake lever. The brakes are in serviceable condition.
