Your Ref: TP/IP/66447/2018
Our Ref: CI/TPD19000755/P

Fatal Accident Investigation Team

MECHANICAL INSPECTION REPORT OF MOTORCYCLE JTA 5221

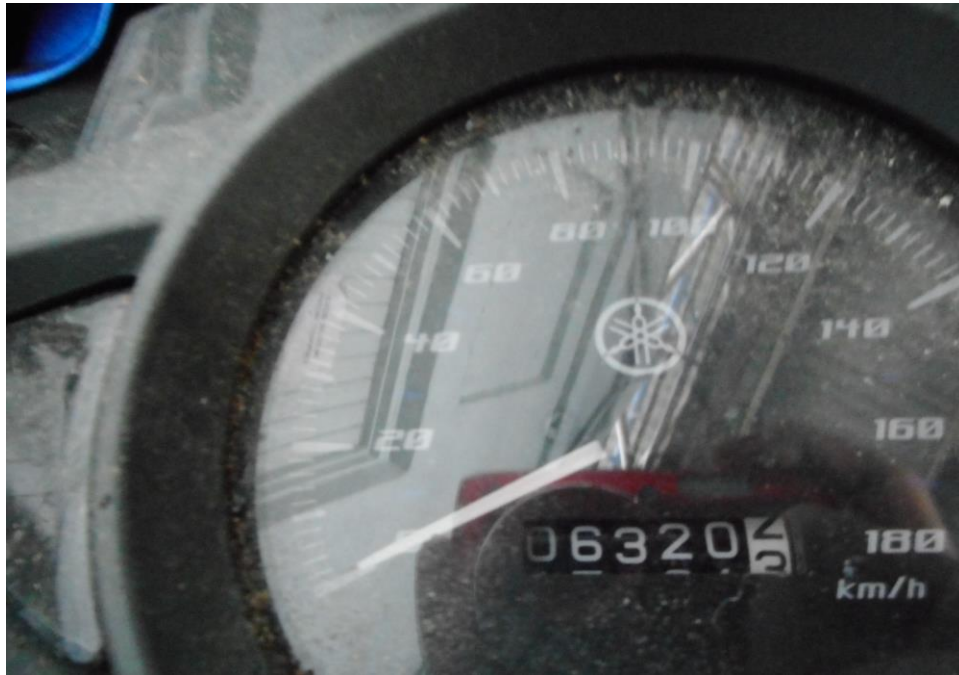
Photo 1 shows a general view of the mileage 6320KM at time of our inspection.

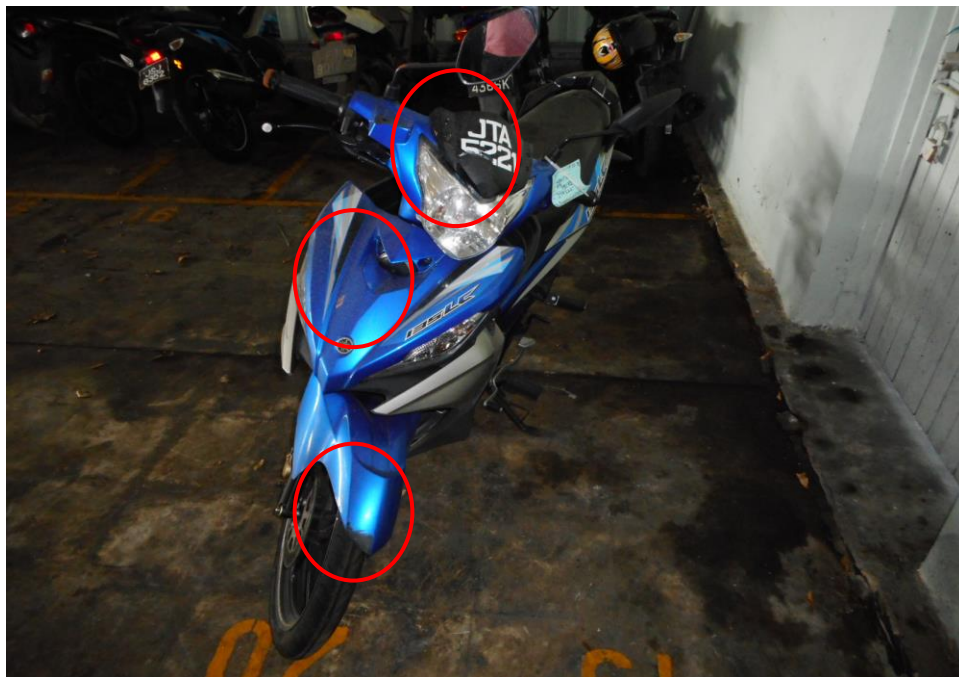
Photo 2 shows a general view of the front body of the Motorcycle at the time of our inspection. The Motorcycle was observed to have sustained relatively minor damages at time of inspection. The damages were observed to be confined to its front & right side of the Motorcycle.

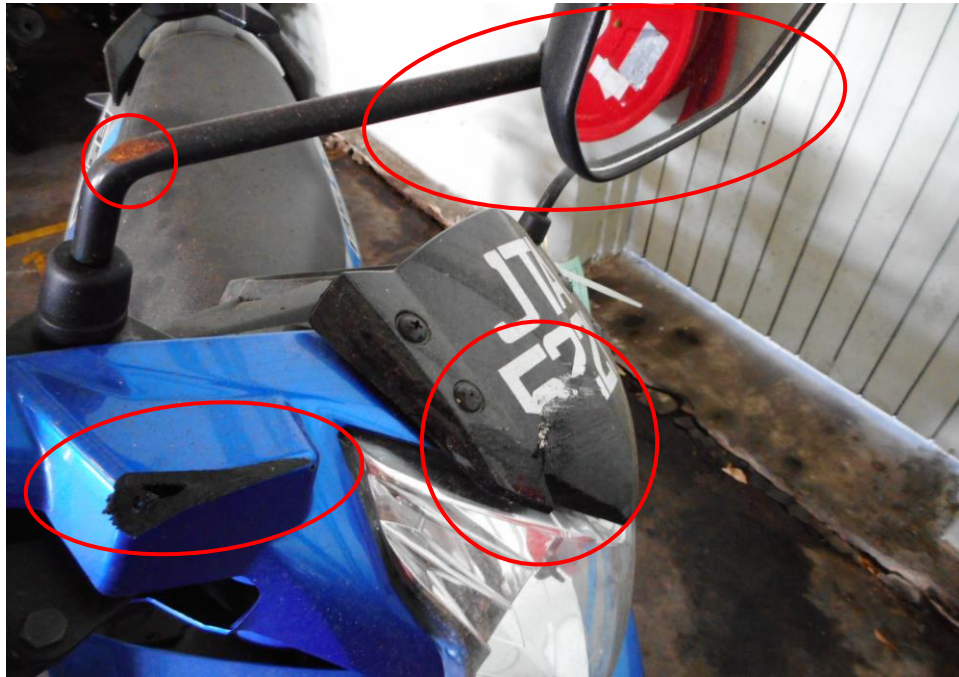
Photo 3 shows a close up view of the front right body of the Motorcycle at the time of our inspection. The Motorcycle was observed to have sustained relatively minor damages at time of inspection. The damages were observed to be confined to its front, right side of the Motorcycle.

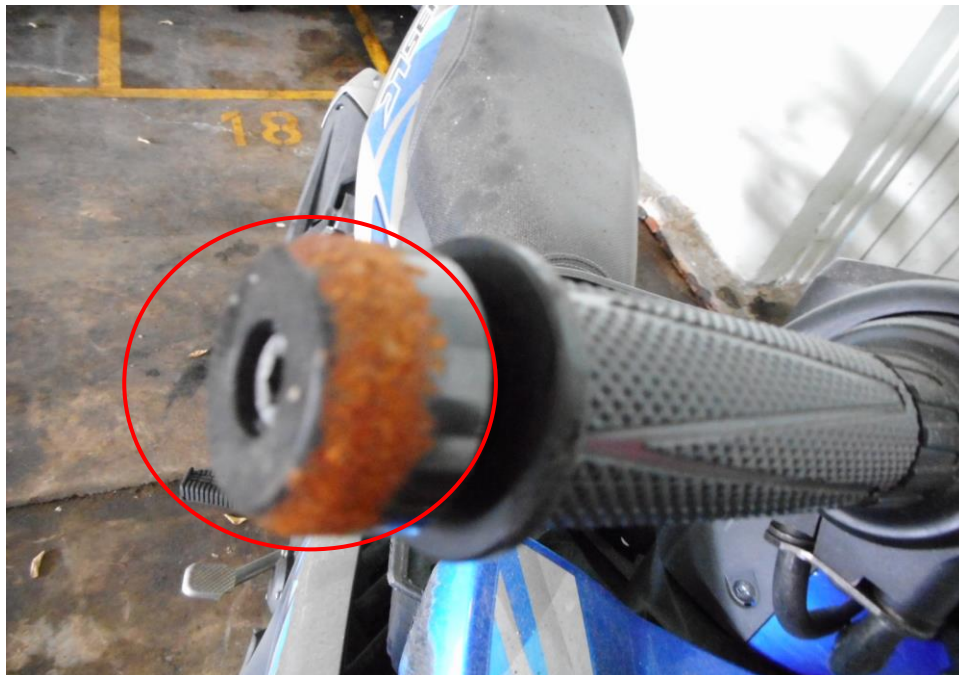
Photo 4 shows a close up view of the front right body of the Motorcycle at the time of our inspection. The Motorcycle was observed to have sustained relatively minor damages at time of inspection. The damages were observed to be confined to its front, right side handle bar of the Motorcycle.

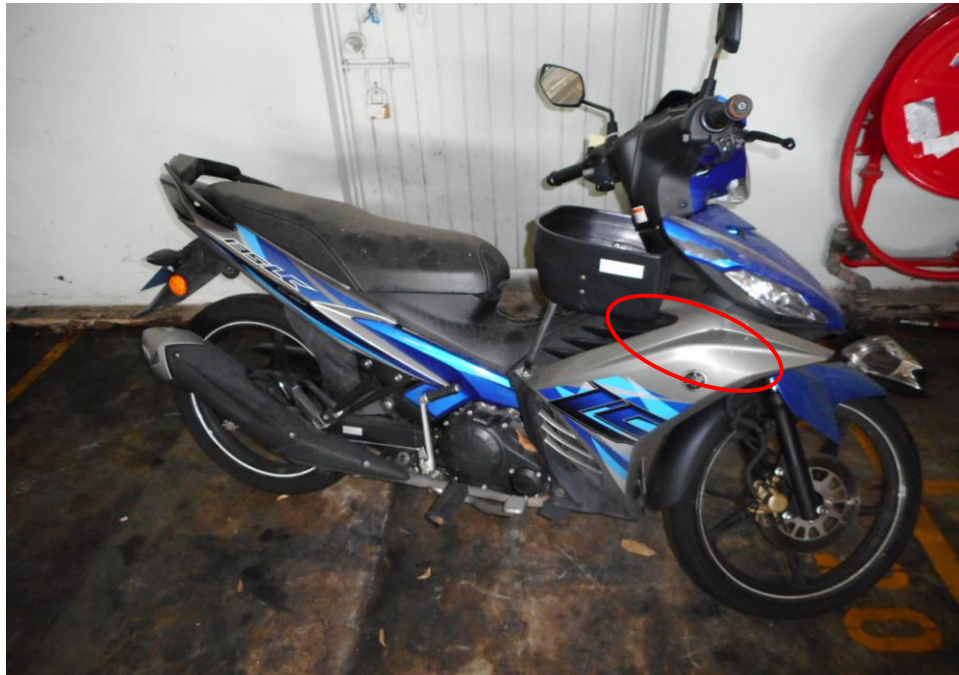
Photo 5 shows a general view of the front right body of the Motorcycle at the time of our inspection. The Motorcycle was observed to have sustained relatively minor damages at time of inspection. The damages were observed to be at its front & right side fairing of the Motorcycle.

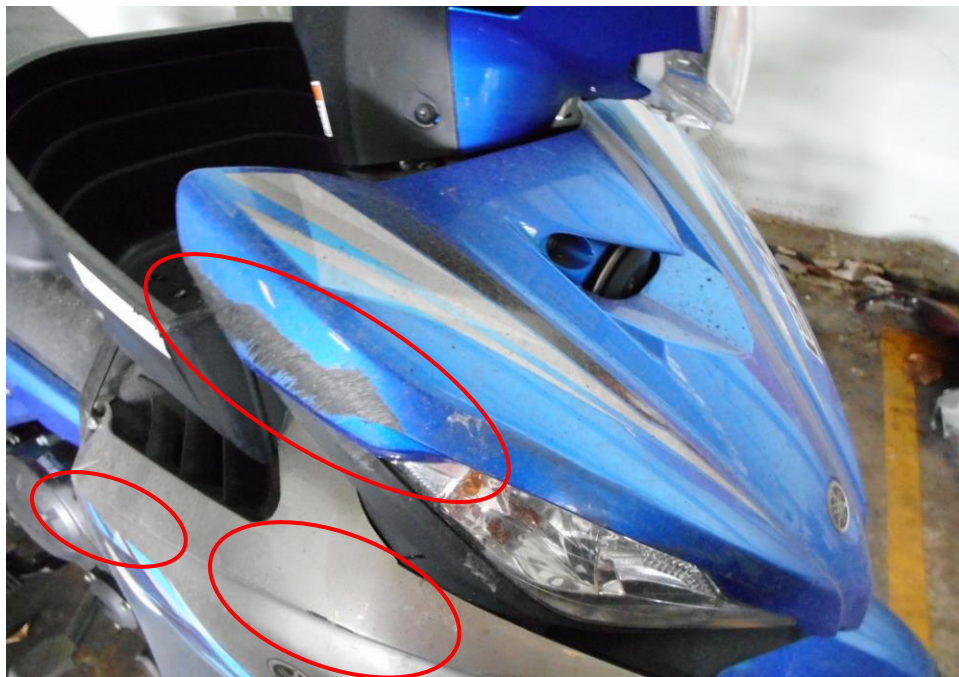
Photo 6 shows a close up view of the front right body of the Motorcycle at the time of our inspection. The Motorcycle was observed to have sustained relatively minor damages at time of inspection. The damages were observed to be at its front & right side fairing of the Motorcycle.

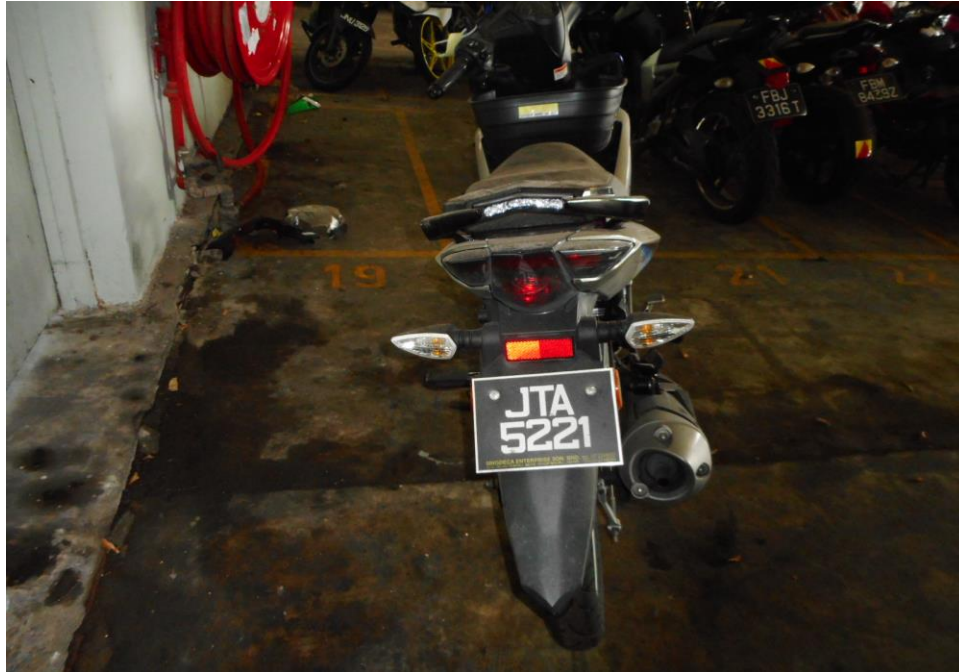
Photo 7 shows a general view of the rear body of the Motorcycle at the time of our inspection. The Motorcycle was observed to be in good condition unaffected by the accident's impact.

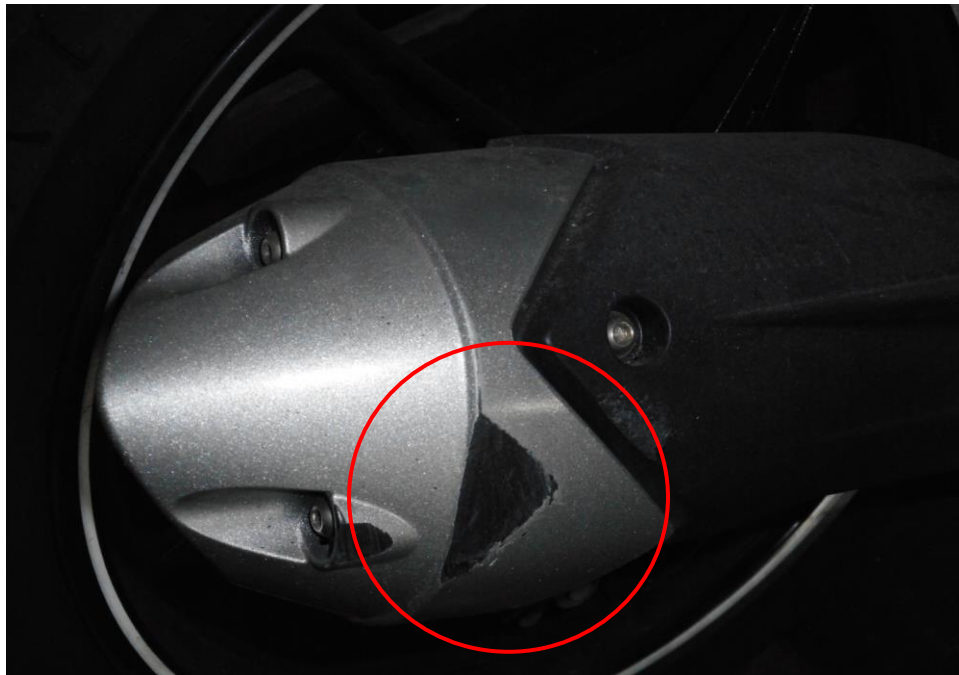
Photo 8 shows a close up view of the exhaust area of the Motorcycle at the time of our inspection. The Motorcycle was observed to have sustained relatively minor damages at time of inspection. The damages were observed to be at the exhaust muffer of the Motorcycle.

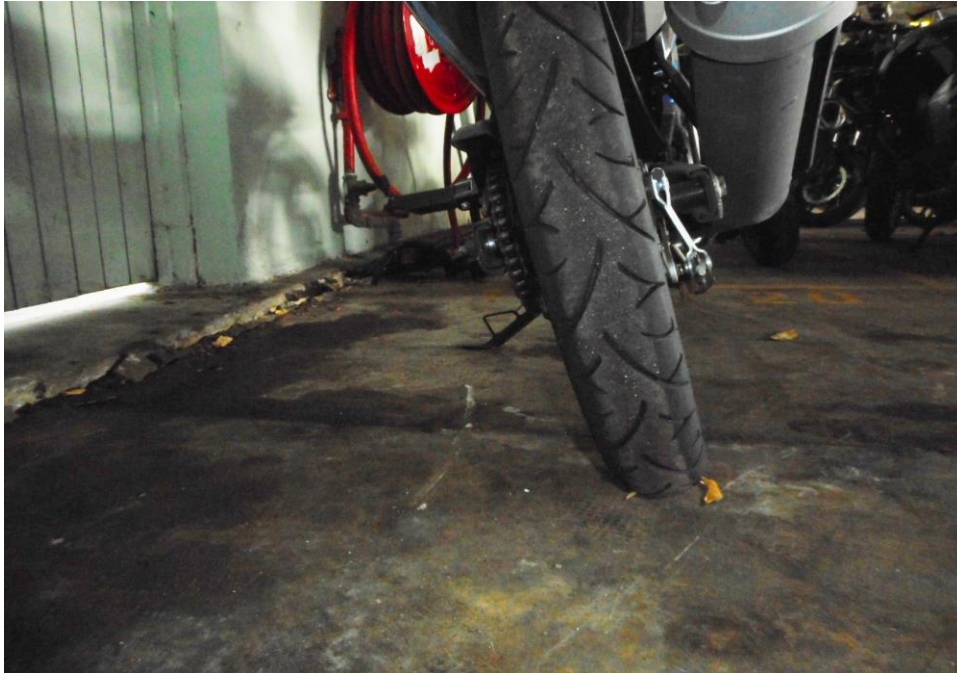
Photo 9 shows the rear tyre of the Motorcycle. The rear tyre was observed to be in serviceable condition & the tyre was also observed to be sufficiently inflated for vehicular operation.

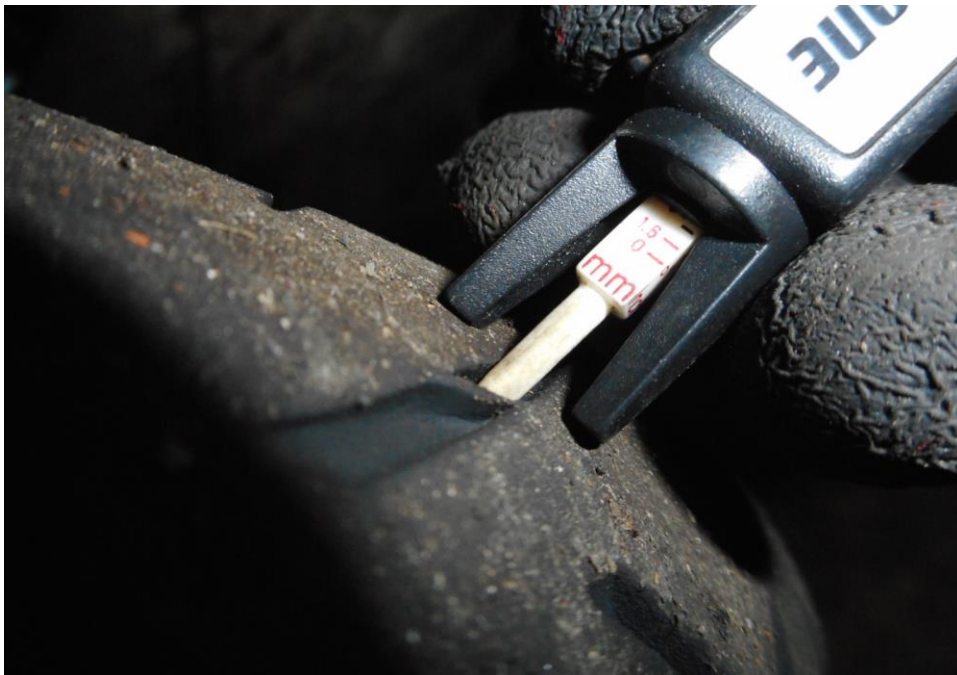
Photo 10 shows the rear tyre of the Motorcycle. The rear tyre was observed with remaining tread depth of approximately 2mm. The tyre was also observed to be sufficiently inflated for vehicular operation.

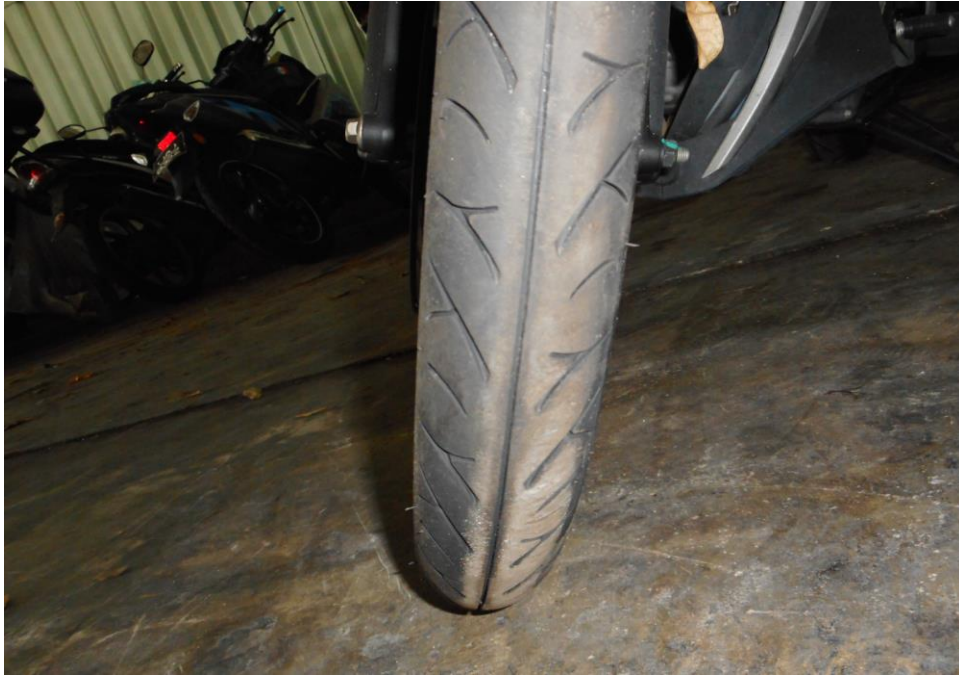
Photo 11 shows the front tyre of the Motorcycle. The front tyre was observed to be in serviceable condition & the tyre was also observed to be sufficiently inflated for vehicular operation.

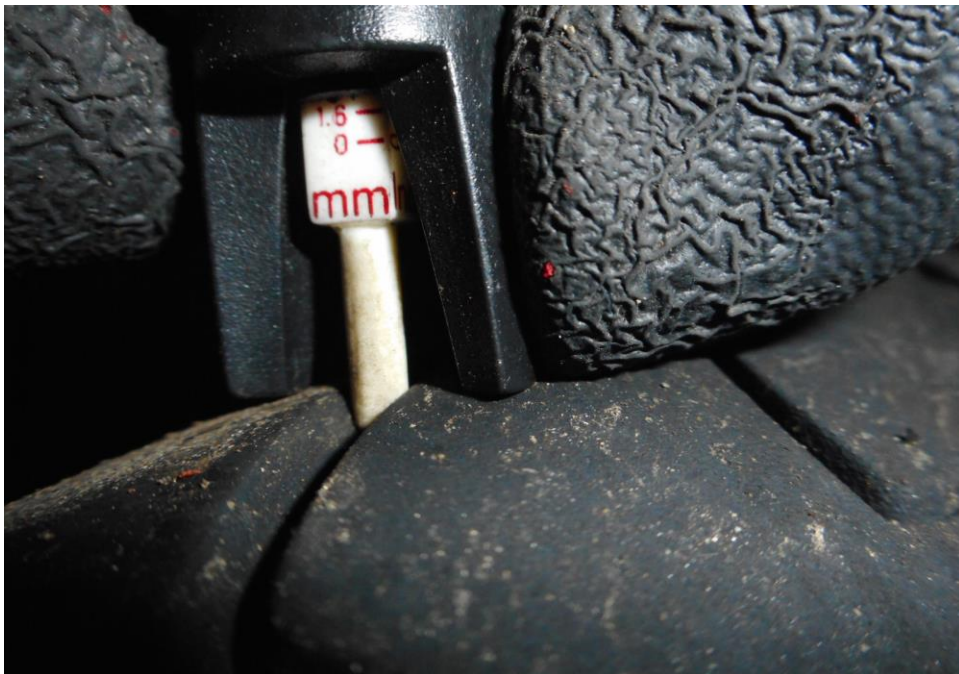
Photo 12 shows the front tyre of the Motorcycle. The front tyre was observed with remaining tread depth of approximately 2mm. The tyre was also observed to be sufficiently inflated for vehicular operation.

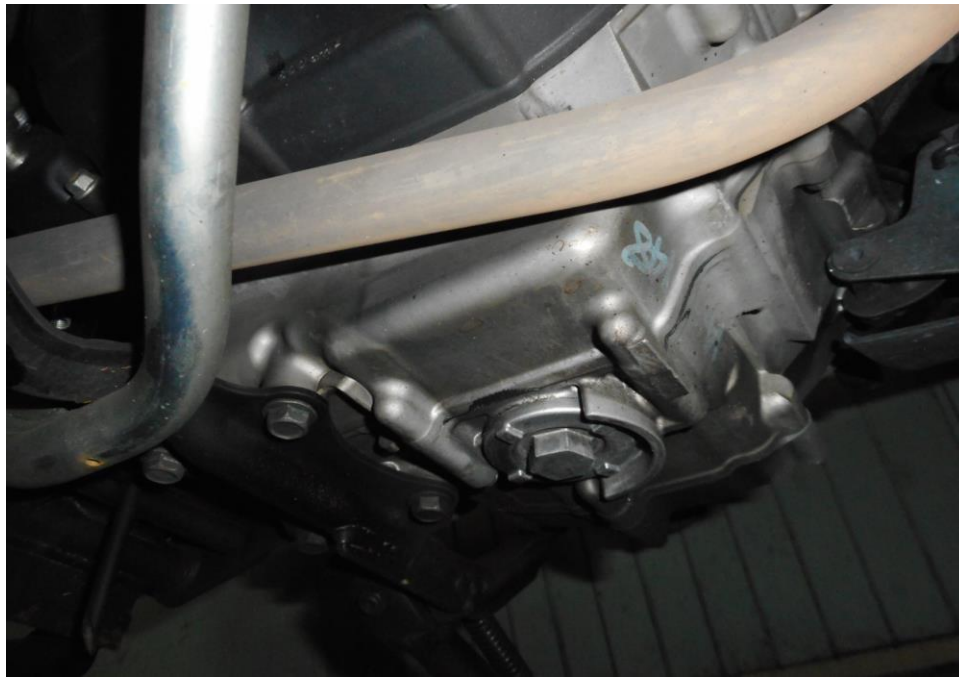
Photo 13 shows no sign(s) or indication(s) of fluid leak observed around the underside of the engine area of the Motorcycle

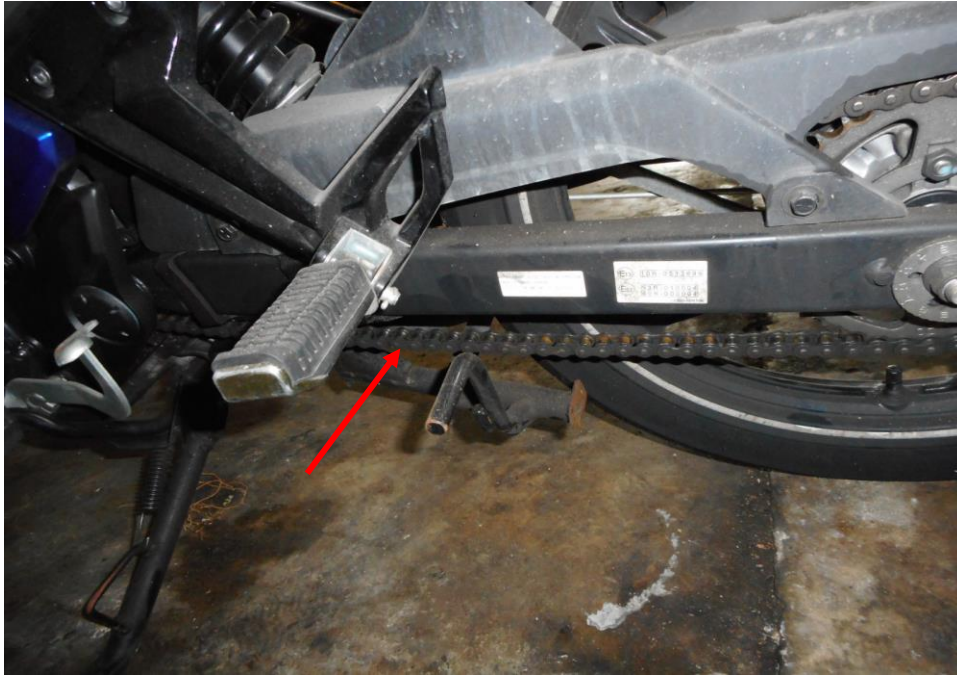
Photo 14 shows the general view of the gear train (arrowed) of the Motorcycle, which was observed to be intact with no misalignment. It was also adequately lubricated for operating purposes.

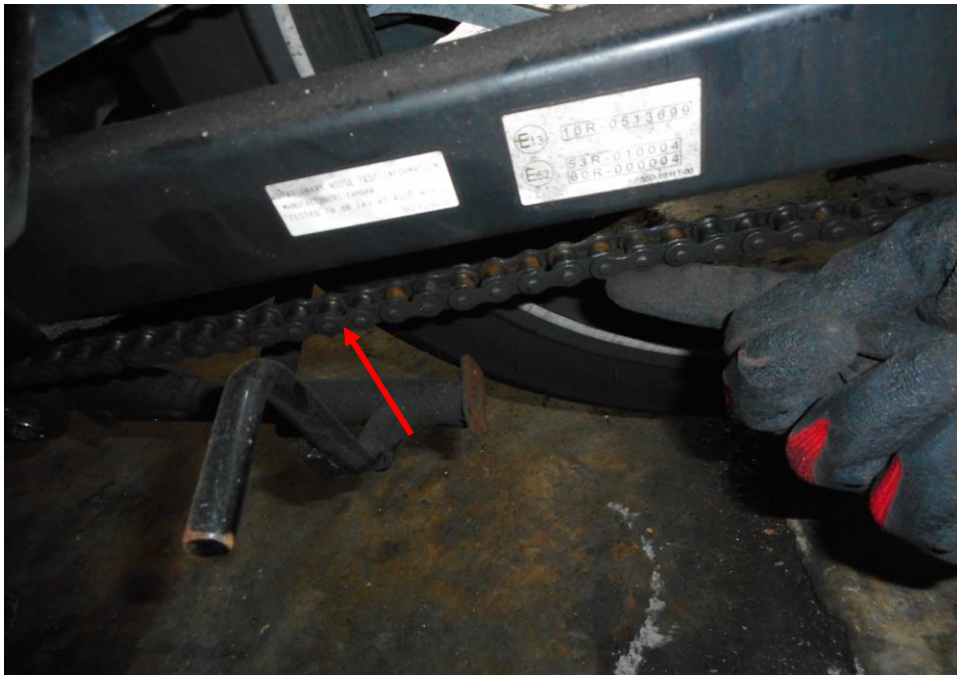
Photo 15 shows the general view of the gear train (arrowed) of the Motorcycle, which was observed to be intact with no misalignment. It was also adequately lubricated for operating purposes. Free play tension was also observed & found adequately acceptable.

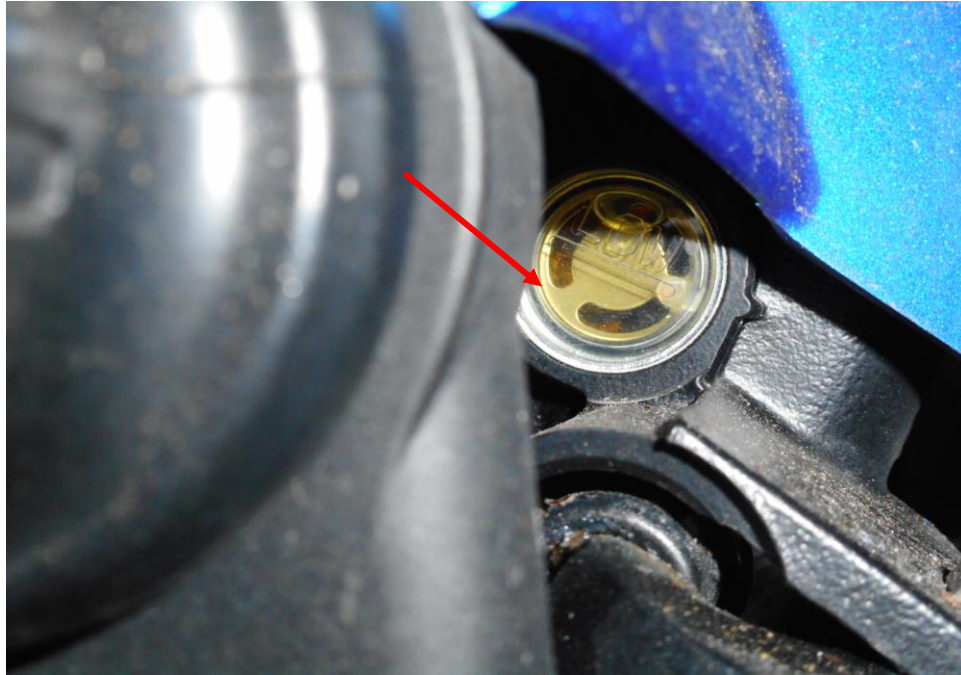
Photo 15 shows our checks on the brake fluid (front) reservoir had also indicated that the brake fluid was of sufficient level for operational purposes, and without contamination.

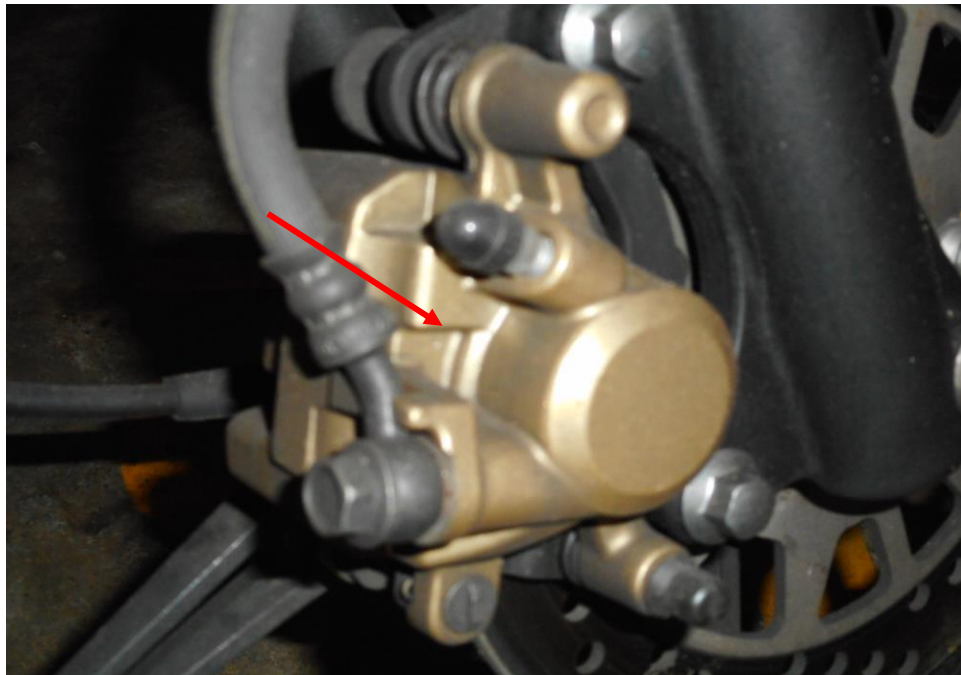
Photo 16 shows our checks on the brake callipers housing (front), there was also no sign(s) or indication(s) of fluid leak observed around the Motor Cycle.

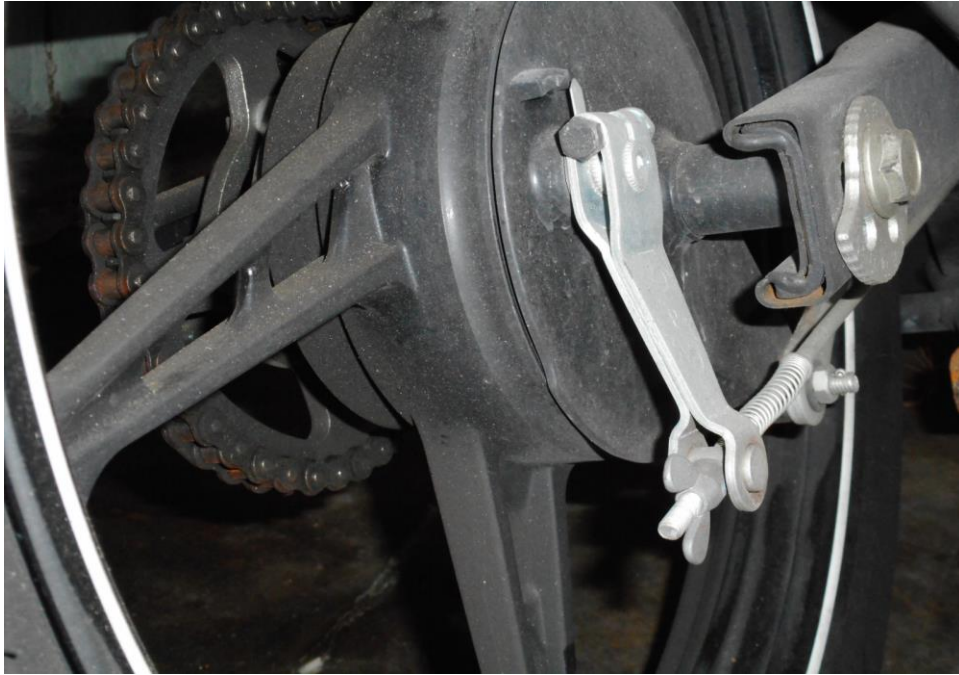
Photo 17 shows our checks on the drum brake housing (rear) no leakage or fluids is found present around it, and without contamination.

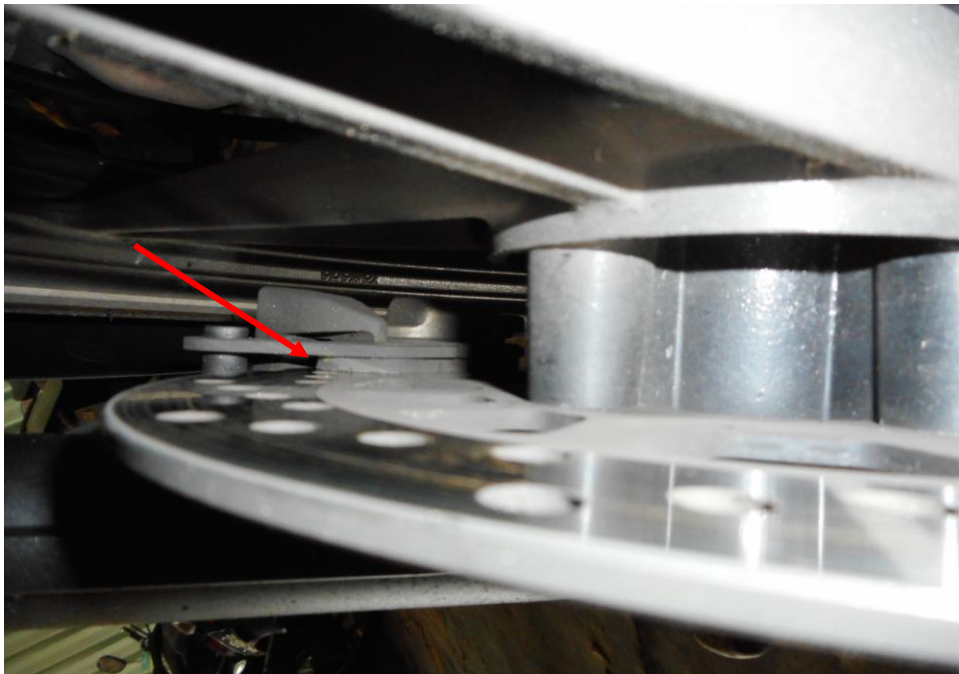
Photo 18 shows a close-up view our checks on the brake pad (front). The frictional material was observed to be in a sufficient level for operational purposes.

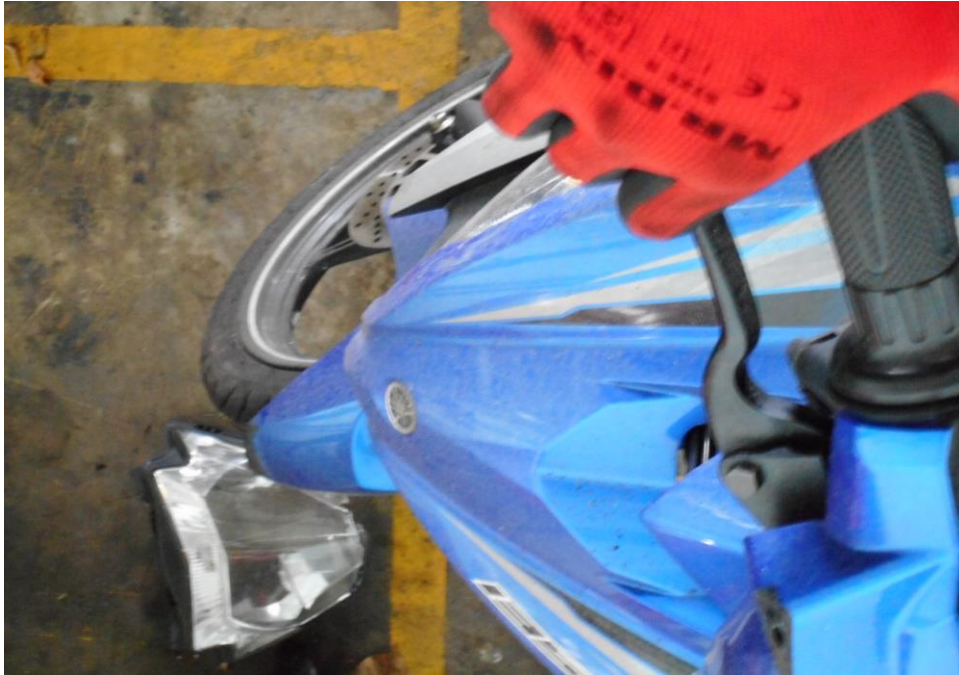
Photo 19 shows testing of the braking of the front brake in progress. The braking force was felt upon pressing the brake lever. The brakes are in serviceable condition.

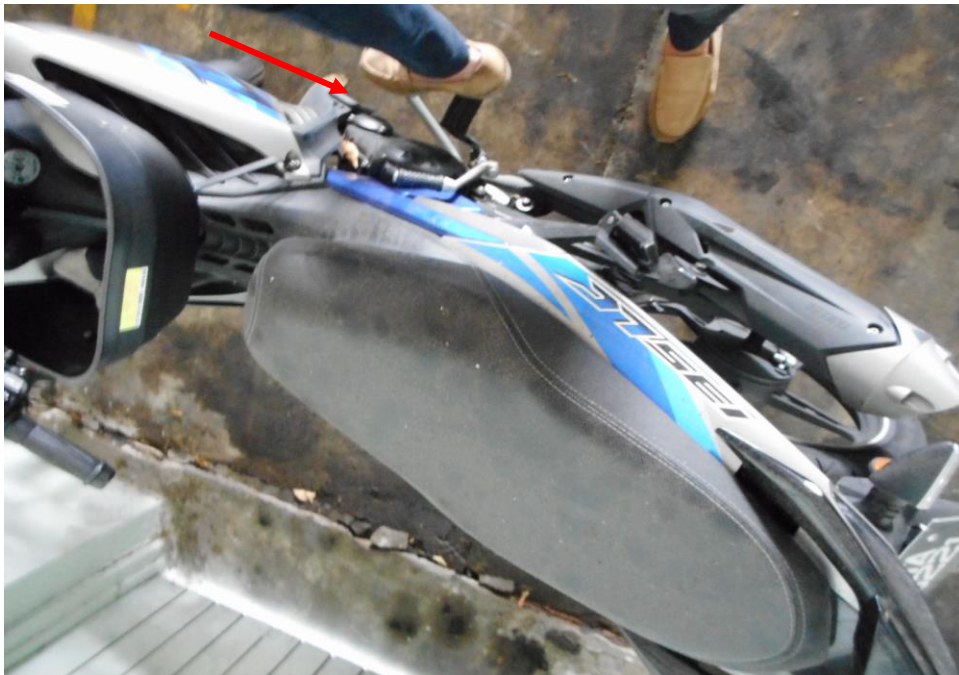
Photo 20 shows testing of the braking of the rear brake in progress. The braking force was felt upon pressing the brake lever. The brakes are in serviceable condition.
