Your Ref: TP/IP/69085/2018  
Our Ref: CI/TPD19000756/P

**Fatal Accident Investigation Team**

**MECHANICAL INSPECTION REPORT OF MOTOR LORRY UU 8651**

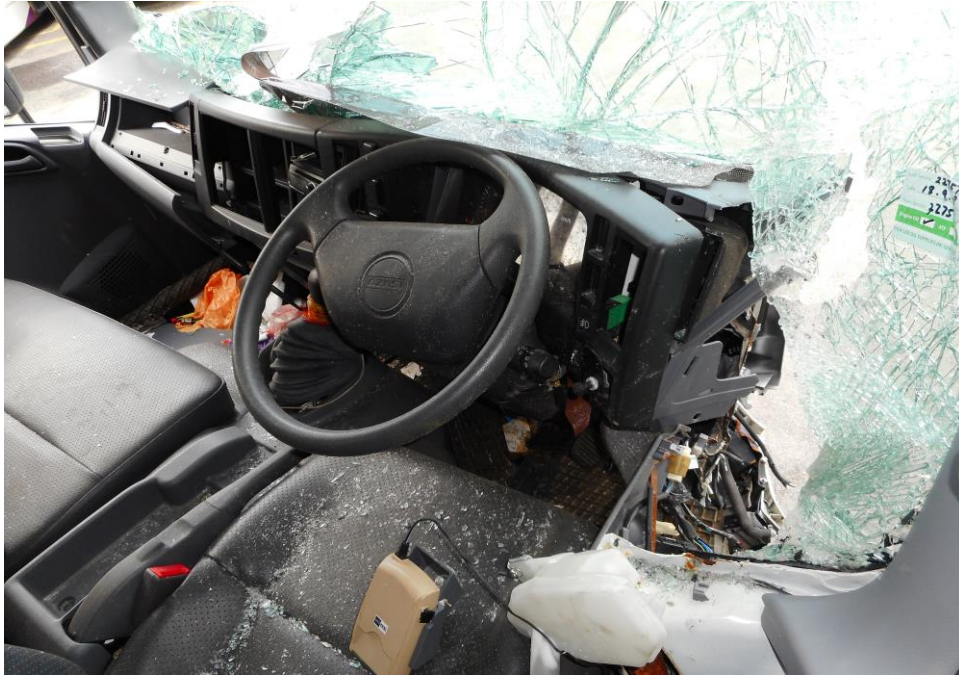
4. The mileage of the Motor Lorry was not able to be recorded as the odometer in the instrument cluster has been damage due to the accident at the time of our inspection.
5. The Motor Lorry was observed to have sustained major damage at its front cabin, front windscreen portion as well as its left and right doors, was likely due to a result of the accident. See photo 1 and 9 below.

**Photo 1** shows no mileage readings were recorded due to the damaged to the instrument cluster which holds the odometer of the Motor Lorry at the time of our inspection.

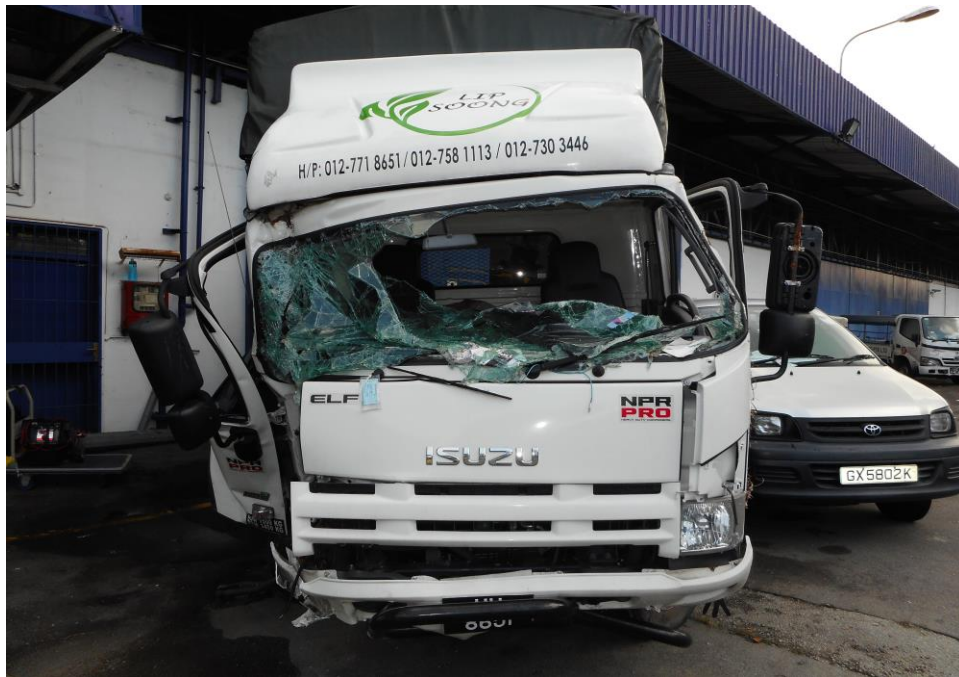
**Photo 2** shows a general view of the front windscreen and body panel of the Motor Lorry at the time of our inspection. The Motor Lorry was observed sustained major damages to its frontal likely due to the accident's impact.

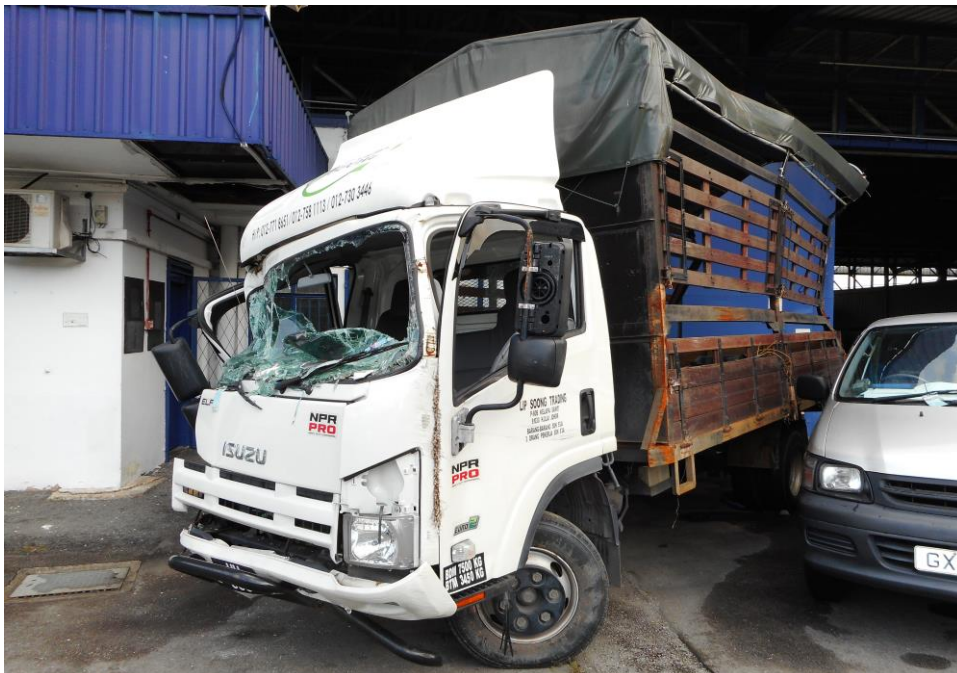
**Photo 4** shows a general view of the left body of the Motor Lorry at the time of our inspection. The Motor Lorry was observed to have sustained major damages to its front windscreen, doors that was crushed and dislodged due to the accident's impact.

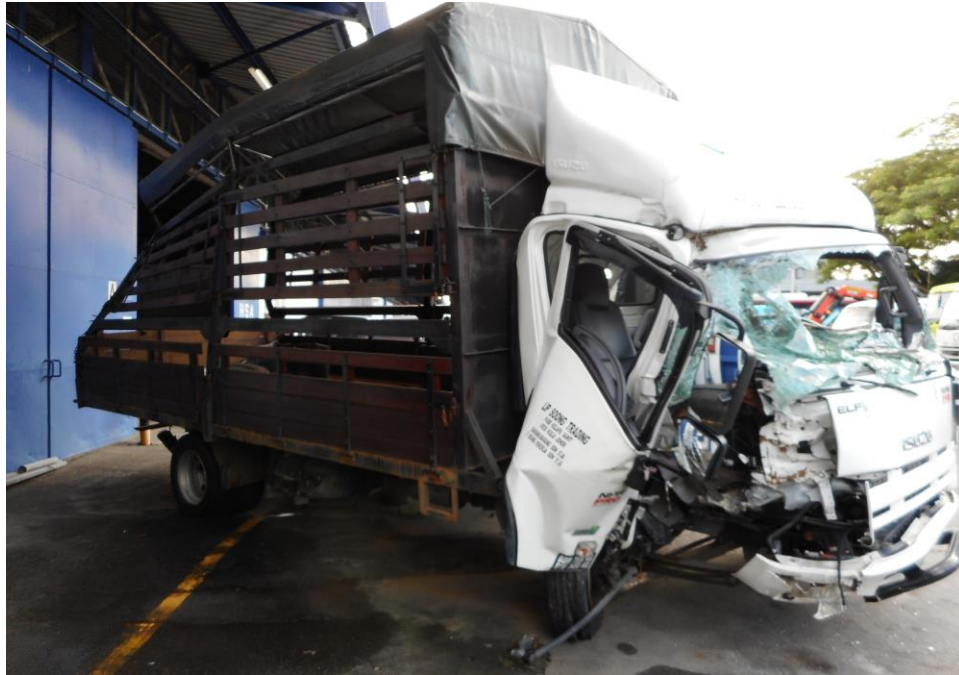
**Photo 5** shows a general view of the right body of the Motor Lorry at the time of our inspection. The Motor Lorry was observed to have sustained major damages to its front windscreen, doors that was crushed and dislodged due to the accident's impact.

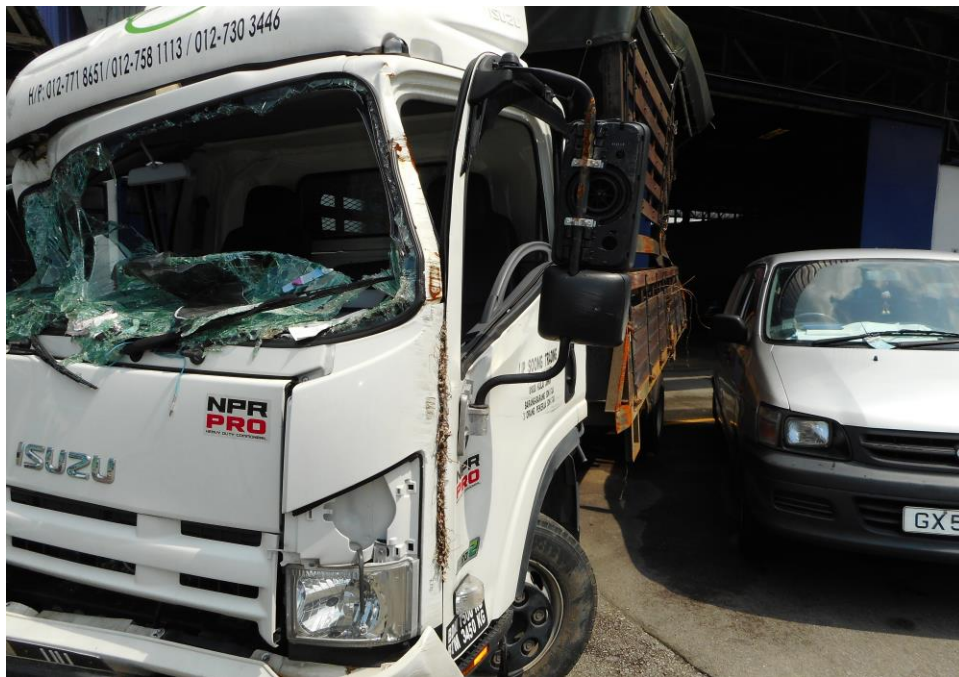
**Photo 6** shows the close up view of the left door of the Motor Lorry at the time of our inspection. The Motor Lorry was observed to have sustained major damages to its front windscreen, doors that was crushed and dislodged due to the accident's impact.

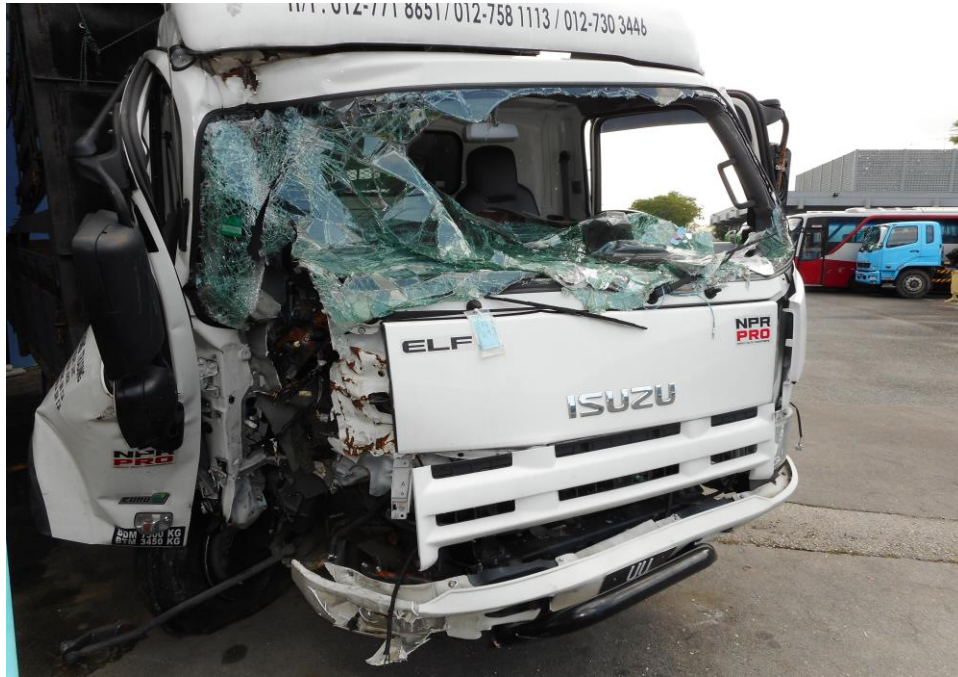
**Photo 7** shows the close up view of the right door of the Motor Lorry at the time of our inspection. The Motor Lorry was observed to have sustained major damages to its front windscreen, doors that was crushed and dislodged due to the accident's impact.

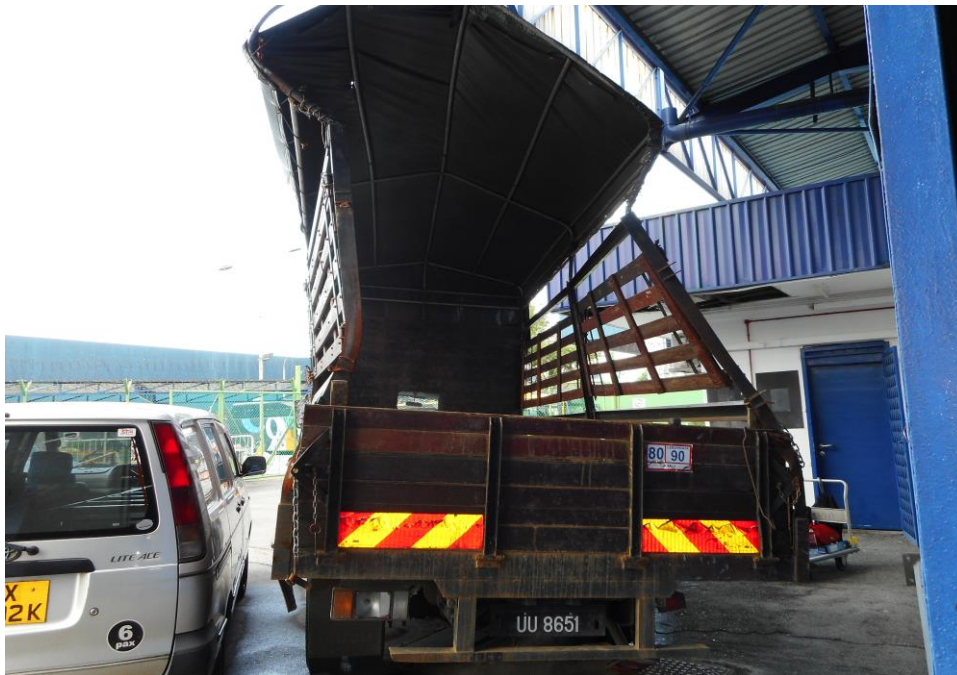
**Photo 8** shows the general view of the cabin from the rear of the Motor Lorry. It was observed to have sustained damages due to the induced impact as a result of the accident.

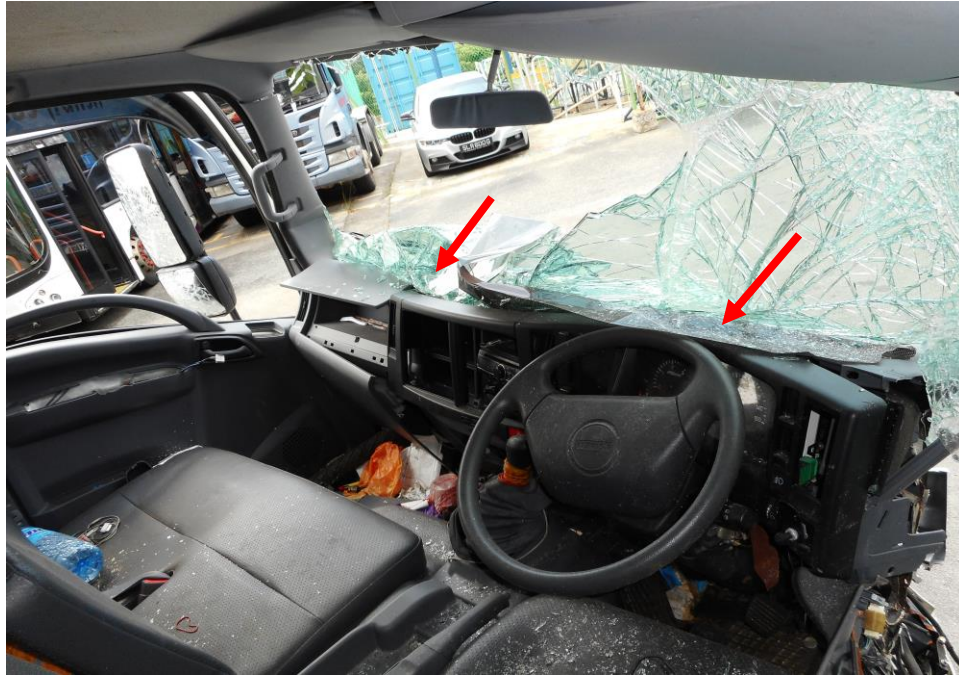
**Photo 9** shows the close up view of the interior cabin of the Motor Lorry. It was observed to have sustained extensive induced damages to the dashboard and foot well which caused the whole to shift inwards the cabin.

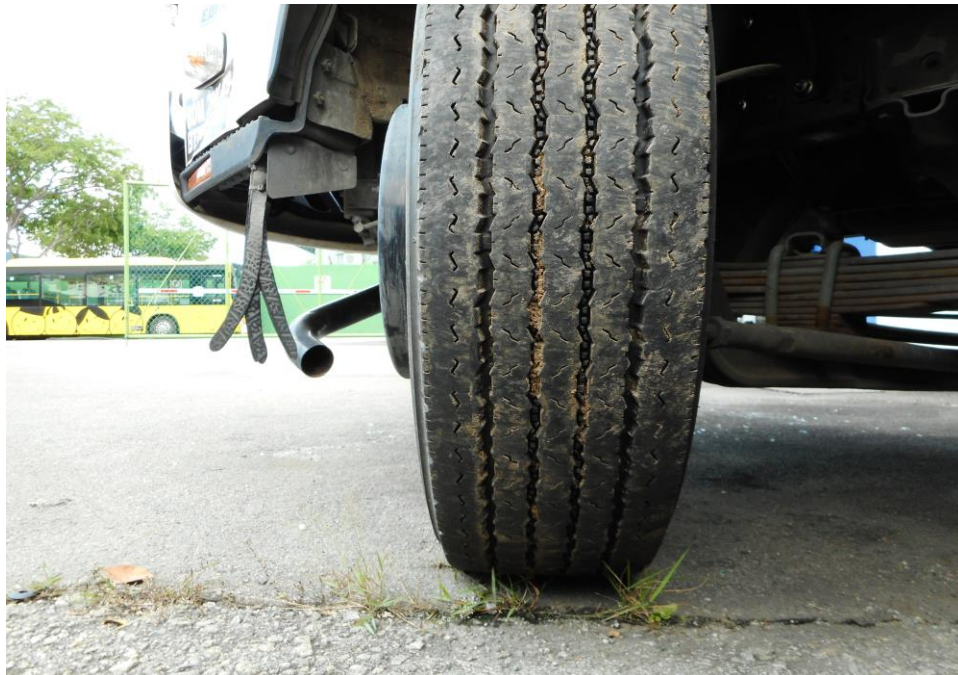
**Photo 10** shows the condition of the front left tyre of the Motor Lorry, which observed to be in serviceable condition with remaining tread depth of approximately 10.7mm. The tyre, which was wrapped around standard alloy wheel rim, was also observed to be sufficiently inflated for vehicular operation.

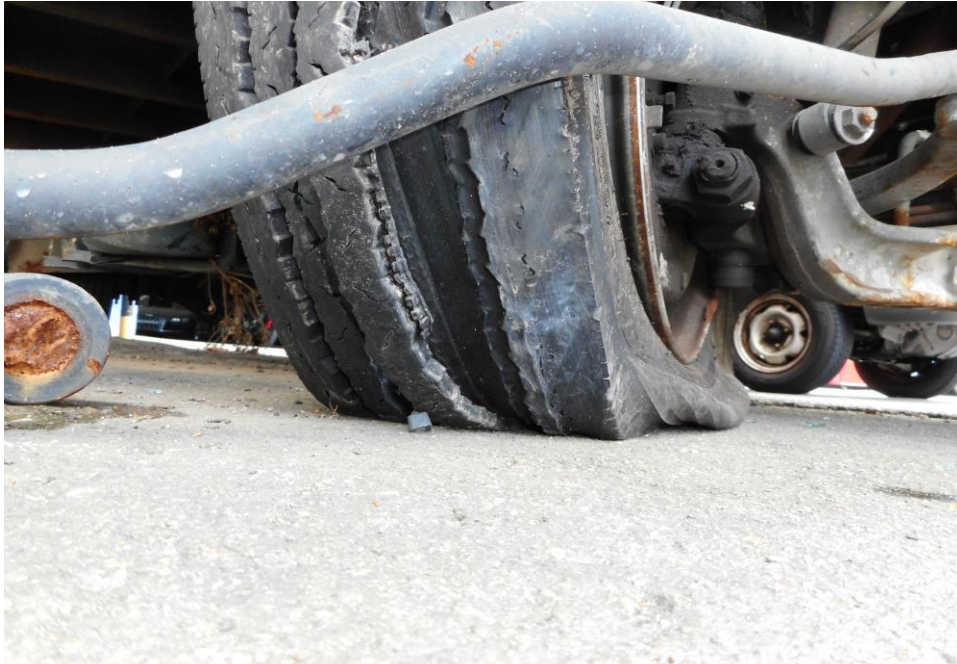
**Photo 11** shows the condition of the front right tyre of the Motor Lorry, which was observed to have been cut and delated likely caused by the accident with remaining tread depth of approximately 9.1mm. The tyre was wrapped around standard alloy wheel rim.

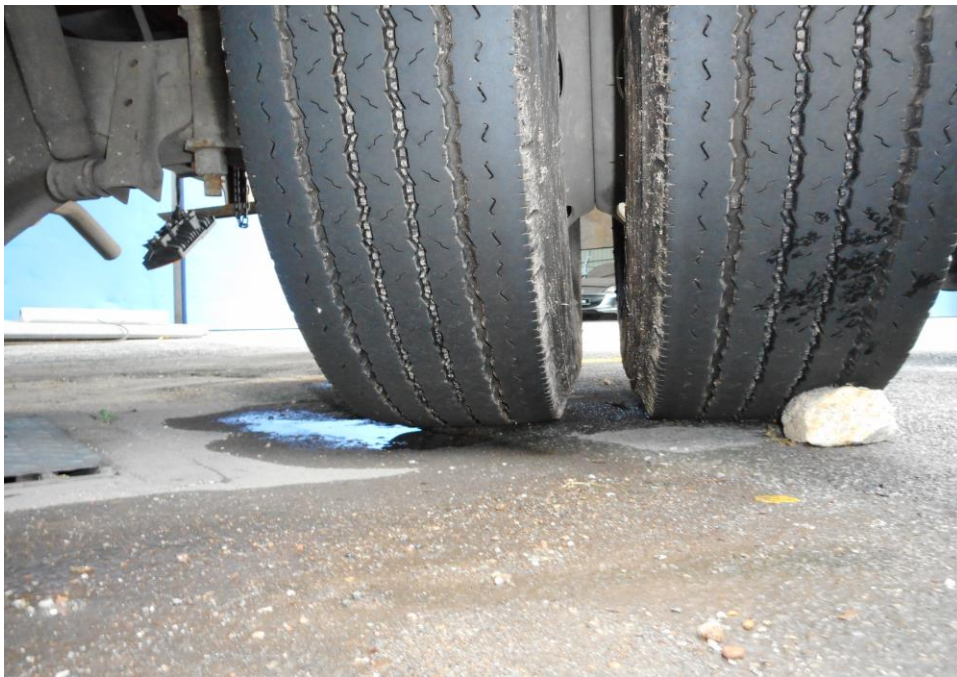
**Photo 12** shows the condition of the front left tyre of the Motor Lorry, which observed to be in serviceable condition with remaining tread depth of approximately 8.6mm. The tyre, which was wrapped around standard alloy wheel rim, was also observed to be sufficiently inflated for vehicular operation.

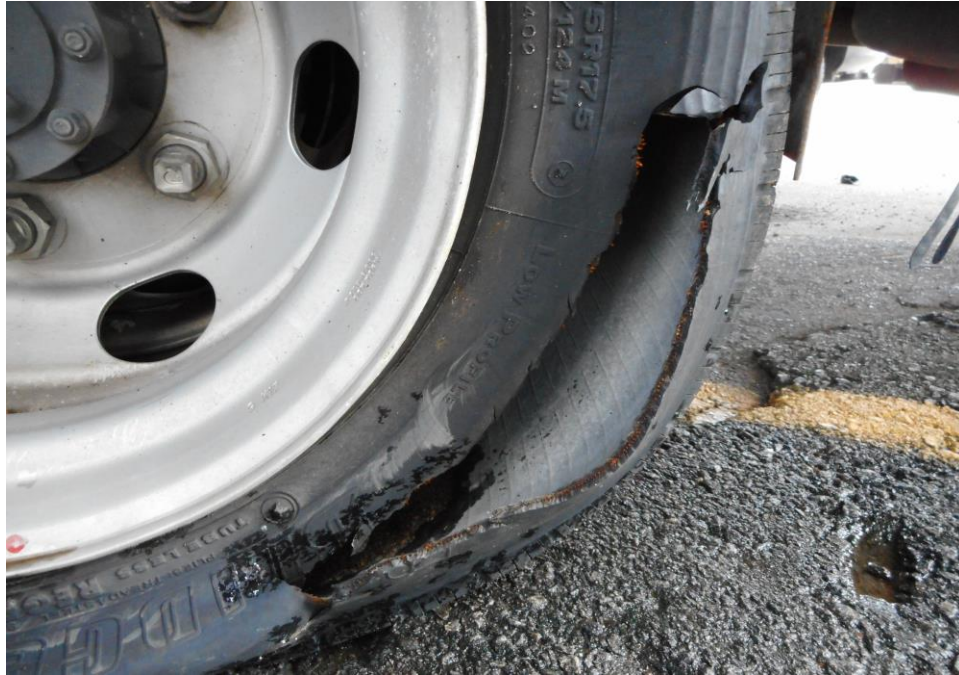
**Photo 13** shows the condition of the rear right tyre of the Motor Lorry, which was observed to have been cut and delated likely caused by the accident with remaining tread depth of approximately 8.7mm. The tyre was wrapped around standard alloy wheel rim.

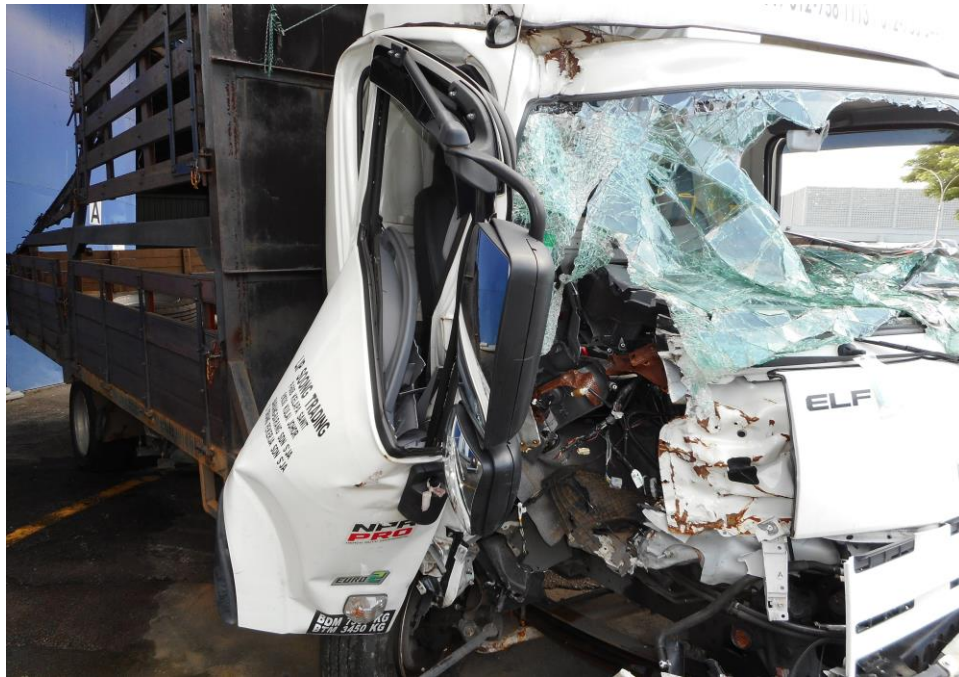
8. Upon examination of the Motor Lorry's engine compartment, we had observed that all the parts, components and fluids could not be inspected as due to the damage induced has crushed and deformed the cabin of the Motor Lorry which immobilized its opening and viewing.
9. Our subsequent checks on the underside of the Motor Lorry also revealed no sign of fluid stain. Visually, the various undercarriage components of the Motor Lorry were all observed to be intact and without any visible damage. See photo 15 & 16 below.

**Photo 15** shows the induced damage to the cabin of the Motor Lorry's which immobilised the opening and viewing of the various parts and components inside the engine compartment, a result of the accident.

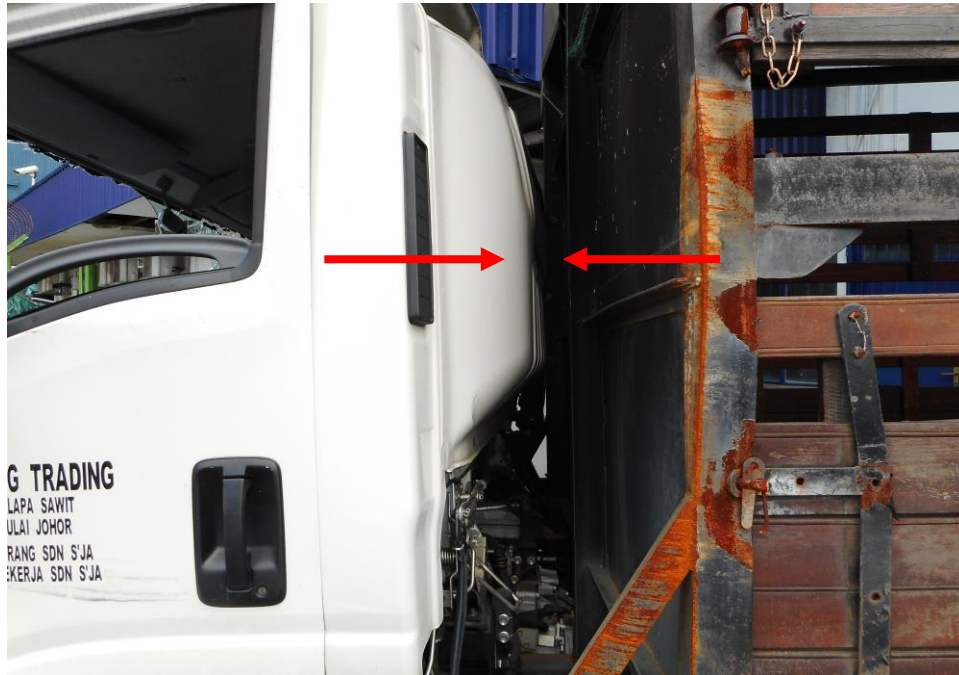
**Photo 16** shows the induced damage to the cabin (arrowed) of the Motor Lorry's which immobilised the opening and viewing of the various parts and components inside the engine compartment, a result of the accident.

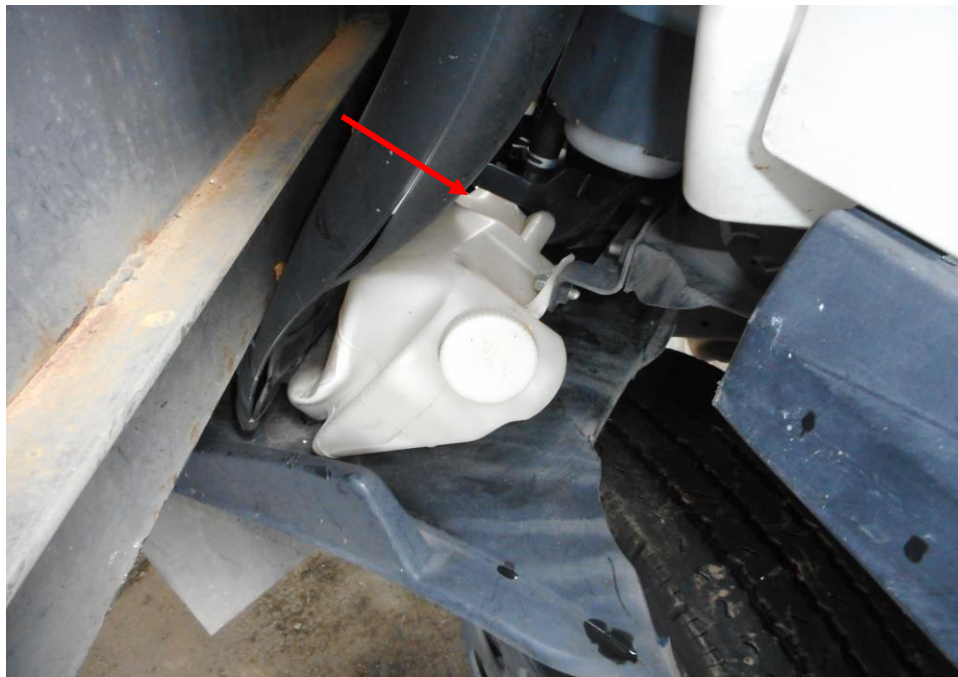
**Photo 17** shows the engine coolant reservoir (arrowed) of the Motor Lorry crushed and emptied at the time of our inspection due to the induced damage from the accident.

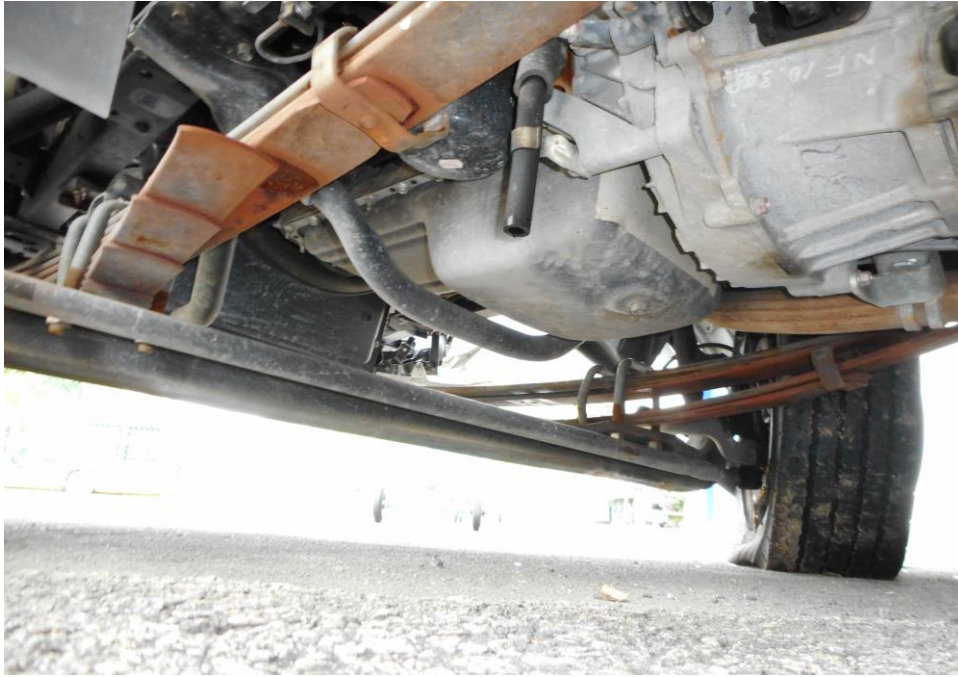
**Photo 18** shows the undercarriage of the engine of the Motor Lorry at the time of our inspection. There was also no sign(s) or indication(s) of fresh fluid leakage and/or fluid stain within the engine area.

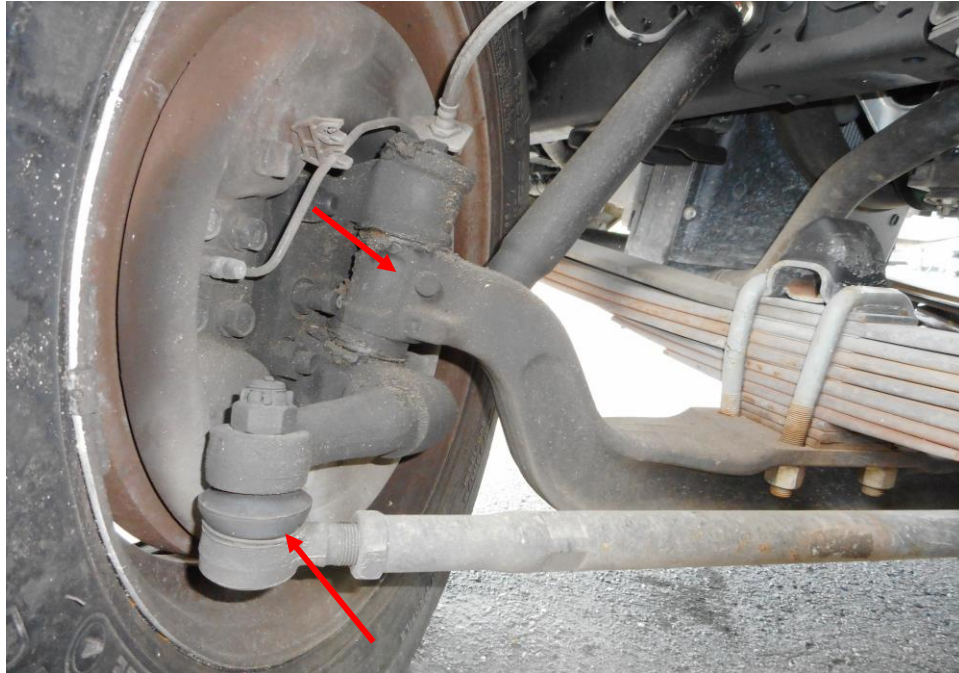
**Photo 19** shows the various undercarriage components at the front left wheel of the Motor Lorry, in particular the steering tie rod end and ball joints (arrowed). The various undercarriage components of the Motor Lorry were all found to be intact without any visible damage. There was also no sign of fluid stain(s) observed on the various undercarriage components.

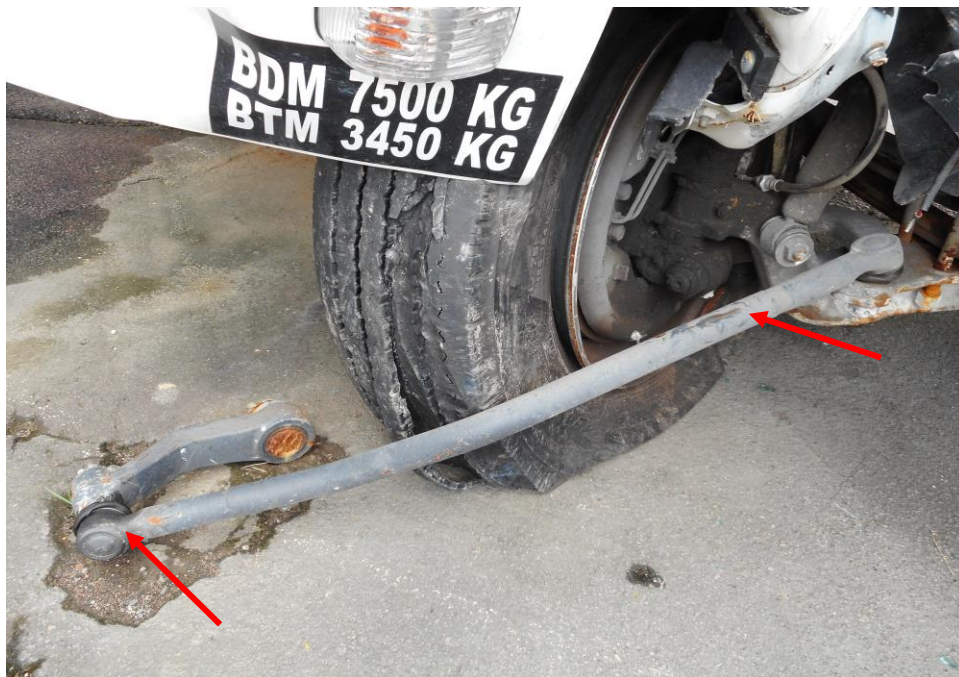
10. The mechanical components of the Motor Lorry's right steering tie rods were found to be damaged and dislodged off from the steering box. The drive shafts and ball joints of the Motor Lorry were observed to be intact and securely attached to the front left wheel and front right wheel.
11. Static test on the steering system of the Motor Lorry could not be inspection due to the damages that immobilized the movement. Our visual examination of the various steering components of the left side which had included the, tie rods, tie rod ends and ball joints had revealed that these components were all generally in good condition, the damage on the right side is as shown. See photo 17 - 20 below.

**Photo 20** shows the various undercarriage components at the front right wheel of the Motor Lorry, in particular the steering tie rod end and ball joints (arrowed). were all found to be damage and dislodged from the steering box.

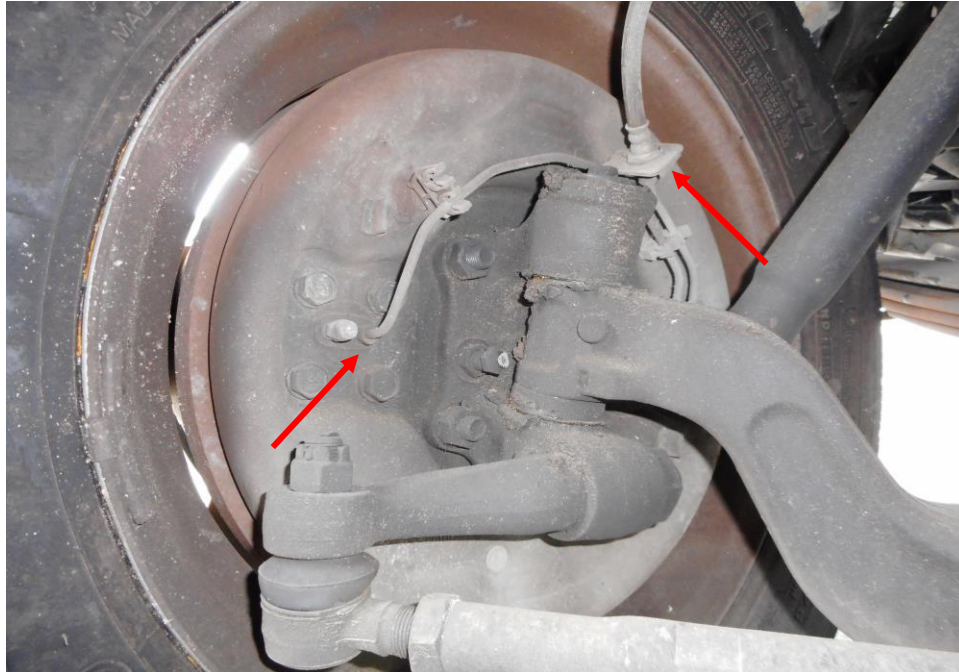
**Photo 21** shows the various undercarriage components at the front left wheel of the Motor Lorry, in particular the brake hose and callipers (arrowed). The various undercarriage components of the Motor Lorry were all found to be intact without any visible damage. There was also no sign of fluid stain(s) observed on the various undercarriage components.

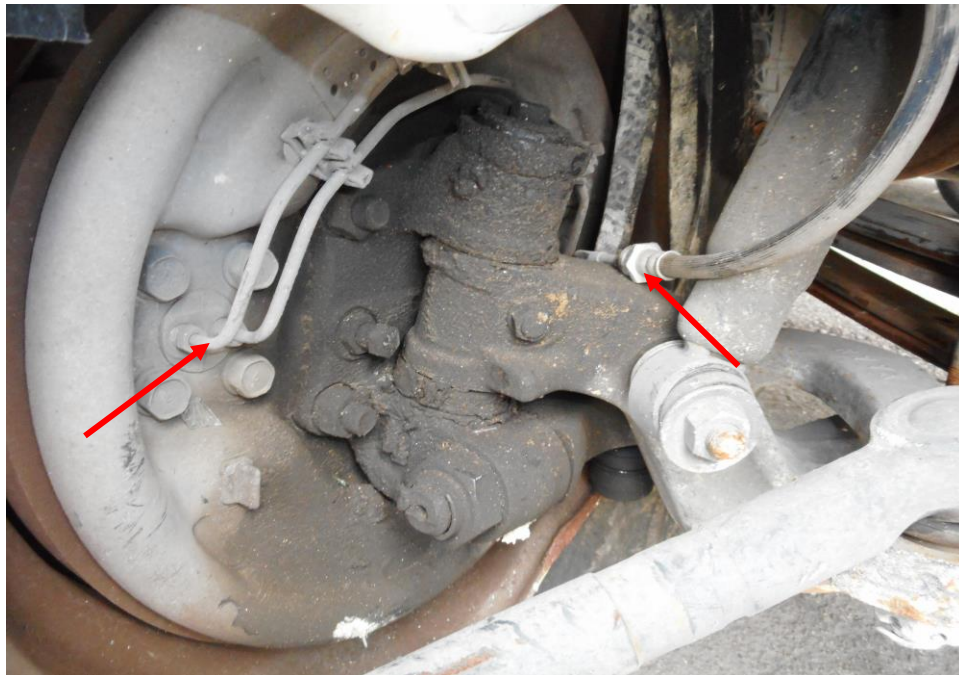
**Photo 22** shows the various undercarriage components at the front right wheel of the Motor Lorry, in particular the drum brake covered in fluid stain and brake hose cut (arrowed) likely caused by the accident.

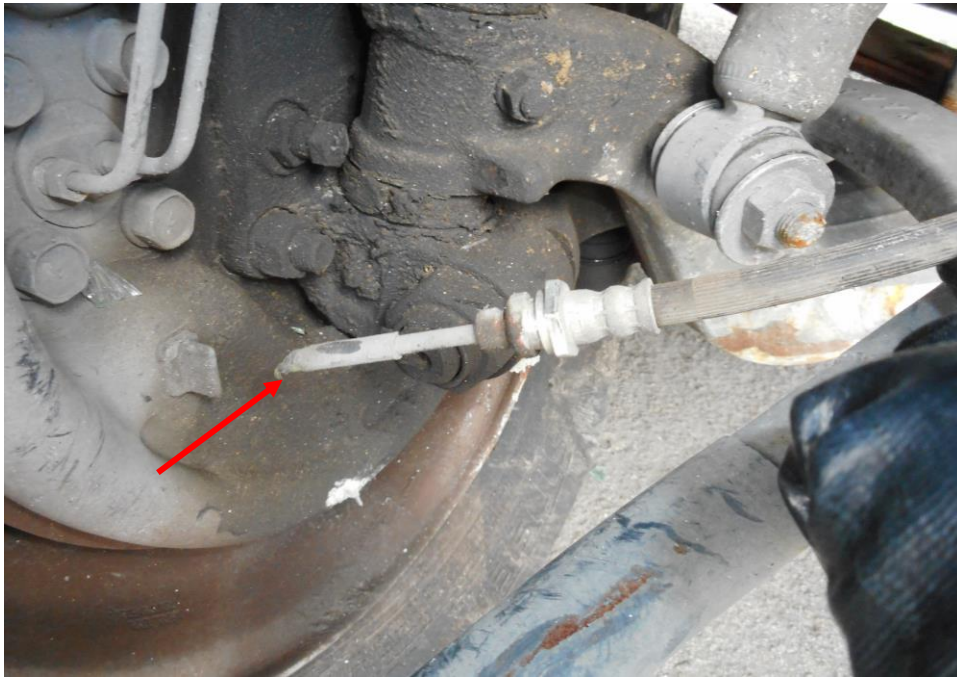
**Photo 23** shows the close up of the various undercarriage components at the front right wheel of the Motor Lorry, in particular the drum brake covered in fluid stain and brake hose cut (arrowed) likely caused by the accident. See above.

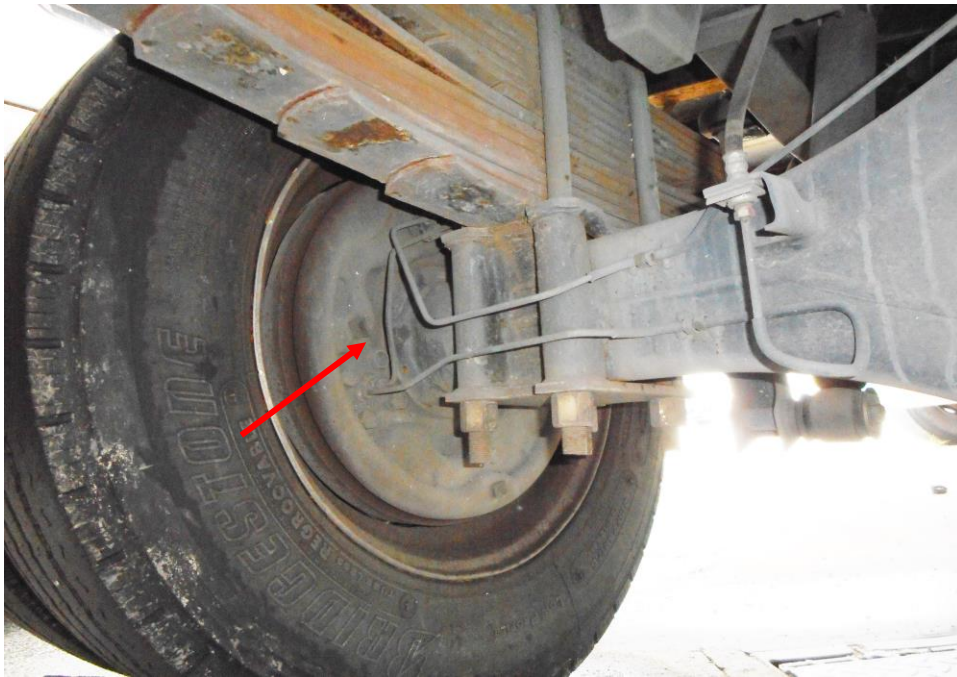
**Photo 24** shows the various undercarriage components at the rear right wheel of the Motor Lorry, in particular the brake hose and drum brake (arrowed). The various undercarriage components of the Motor Lorry were all found to be intact without any visible damage. There was also no sign of fluid stain(s) observed on the various undercarriage components.

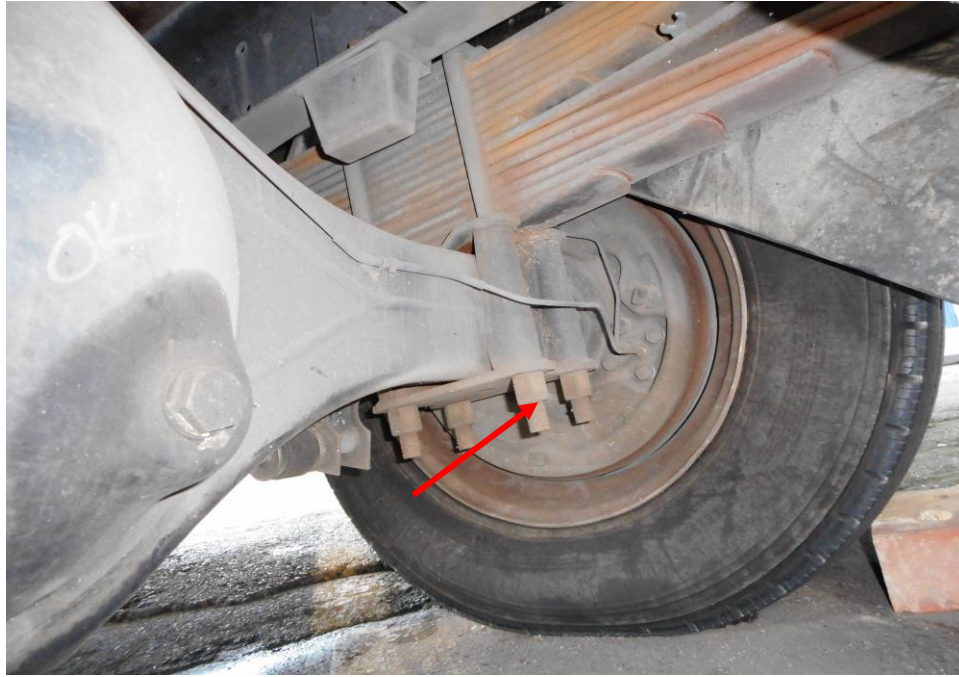
**Photo 25** shows the various undercarriage components at the rear left wheel of the Motor Lorry, in particular the brake hose and drum brake (arrowed). The various undercarriage components of the Motor Lorry were all found to be intact without any visible damage. There was also no sign of fluid stain(s) observed on the various undercarriage components.

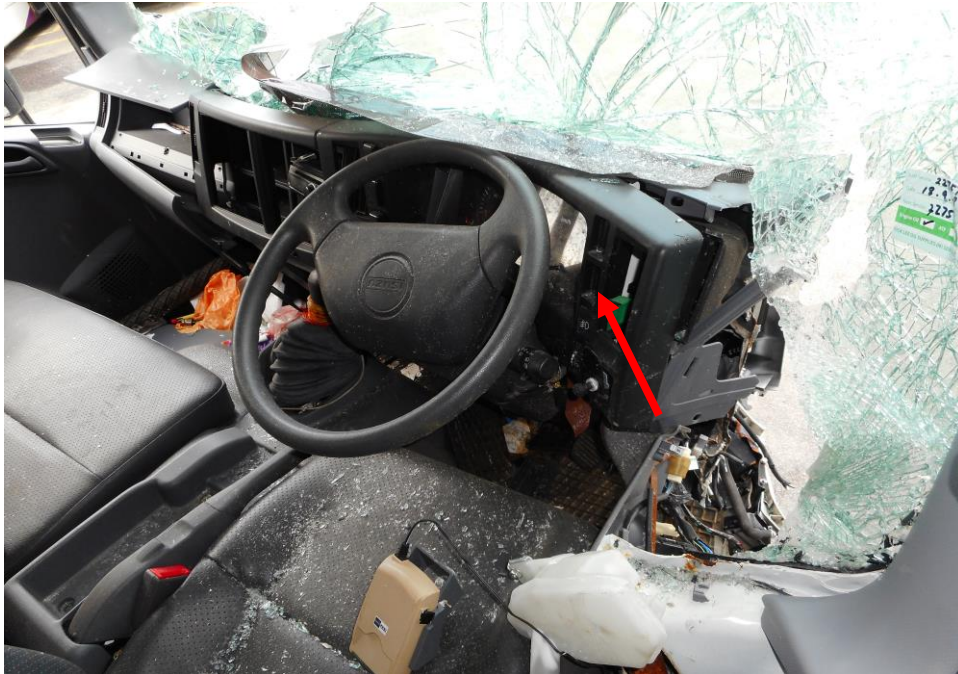
15. The static test of the Motor Lorry electronic safety system could not be inspected as the instrument cluster was damaged due to the induce impact from the accident.

**Photo 26** shows the damages on the Motor Lorry's instrument cluster induce impact from the accident rendering it not serviceable at the time of inspection. (Unable to operate)
