Your Ref: TP/IP/69085/2018
Our Ref: CI/TPD19000757/P

24th April 2019

MECHANICAL INSPECTION REPORT OF MOTOR LORRY GBF 6627Y

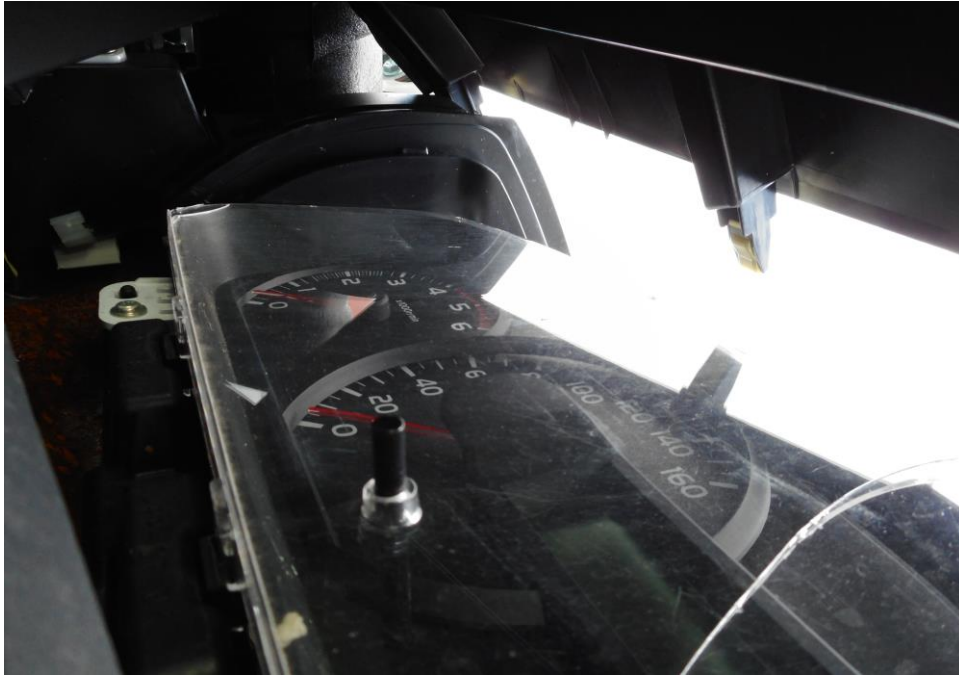
4. The mileage of the Motor Lorry was not able to be recorded as the odometer in the instrument cluster has been damage due to the accident at the time of our inspection.
5. The Motor Lorry was observed to have sustained major damage at its front cabin & windscreen portion as well as its left and right doors, was likely due to a result of the accident. See photo 1 and 9 below.

Photo 1 shows no mileage readings were recorded due to the damaged odometer in the instrument cluster of the Motor Lorry at the time of our inspection.

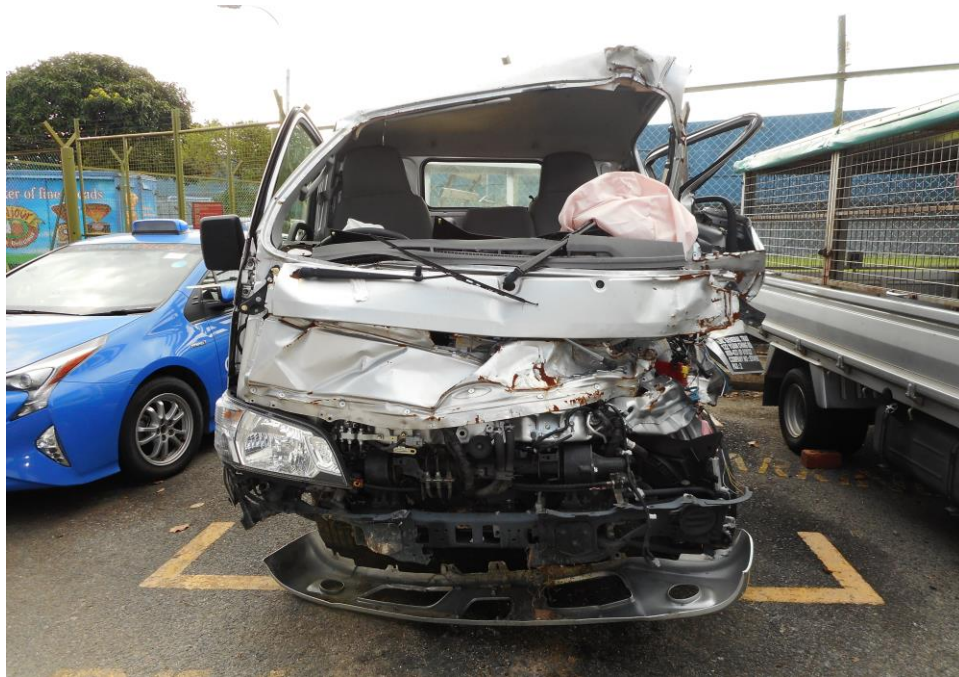
Photo 2 shows a general view of the front windscreen and body panel of the Motor Lorry at the time of our inspection. The Motor Lorry was observed sustained major damages to its frontal likely due to the accident's impact.

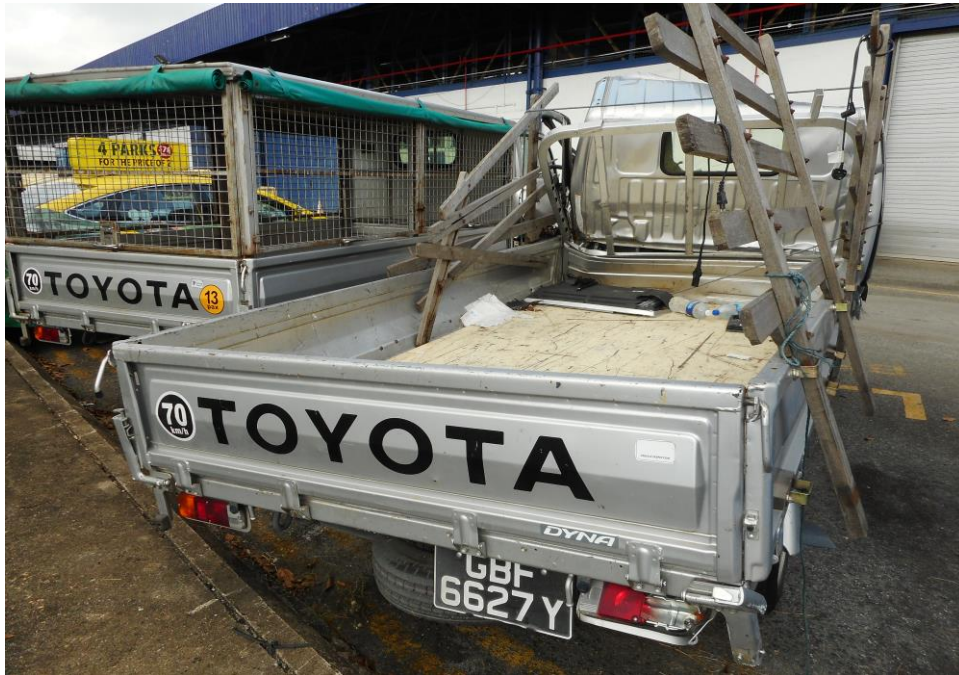
Photo 3 shows the number plate and the general view of the rear portion of the Motor Lorry at the time of our inspection. The Motor Lorry was observed sustained major damages to its rear which the tailgate was shifted out of place, likely due to the accident's impact.

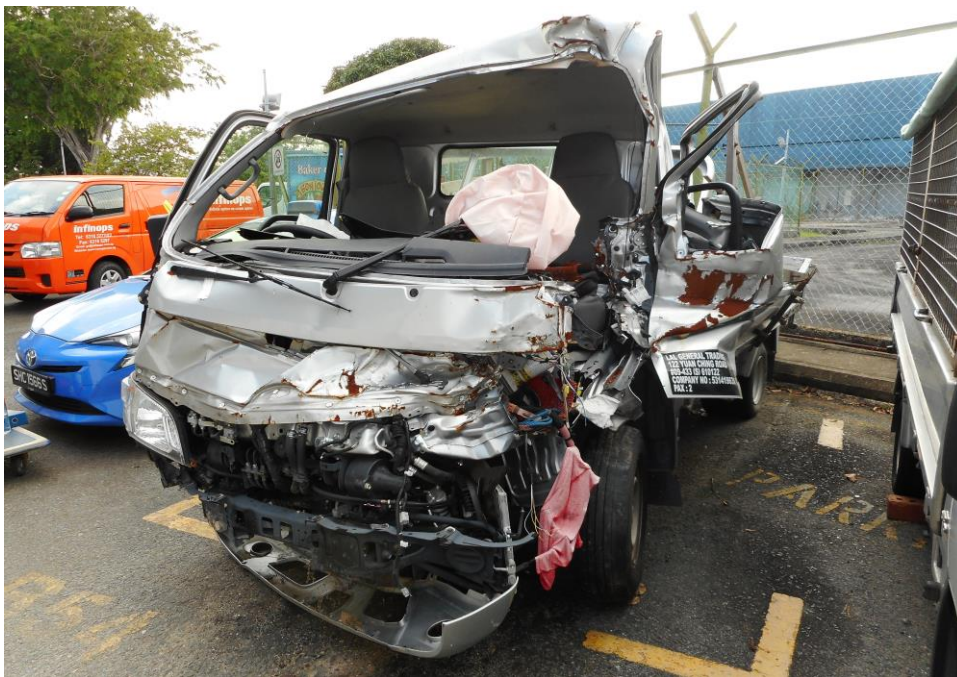
Photo 4 shows a general view of the left body of the Motor Lorry at the time of our inspection. The Motor Lorry was observed to have sustained major damages to its doors that was crushed and dislodged due to the accident's impact.

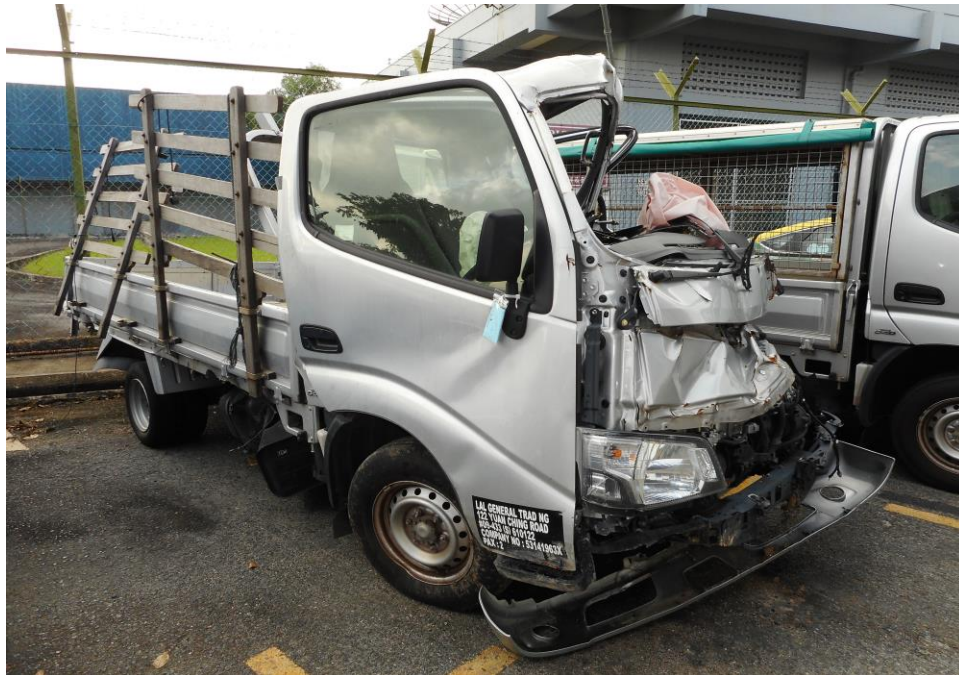
Photo 5 shows a general view of the right body of the Motor Lorry at the time of our inspection. The Motor Lorry was observed to have sustained major damages to its doors that was crushed and dislodged due to the accident's impact.

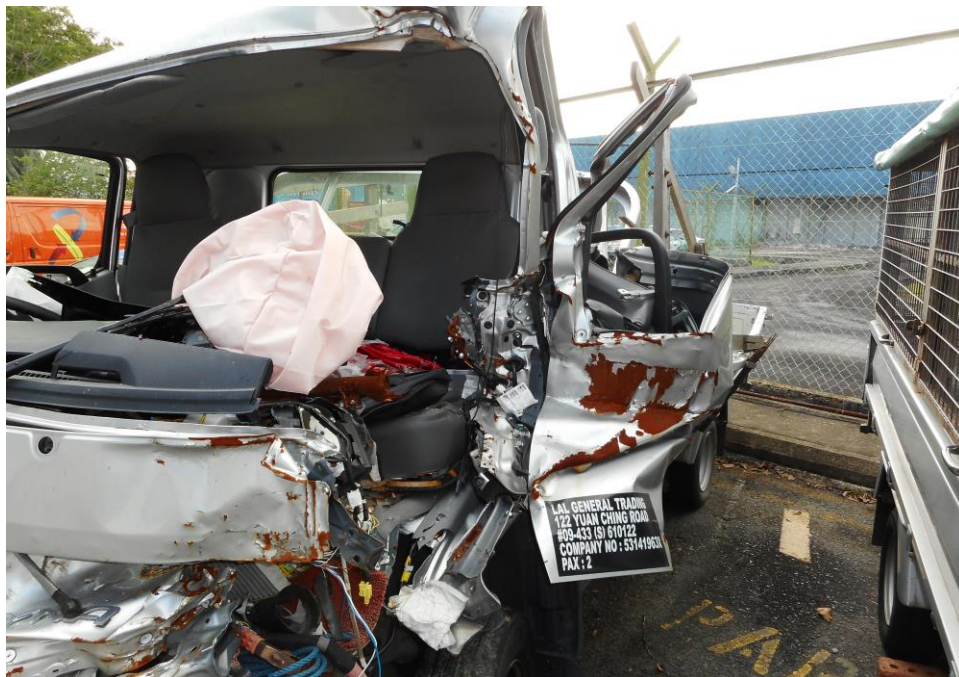
Photo 6 shows the close up view of the left door of the Motor Lorry at the time of our inspection. The Motor Lorry was observed to have sustained major damages to its doors that was crushed and dislodged due to the accident's impact.

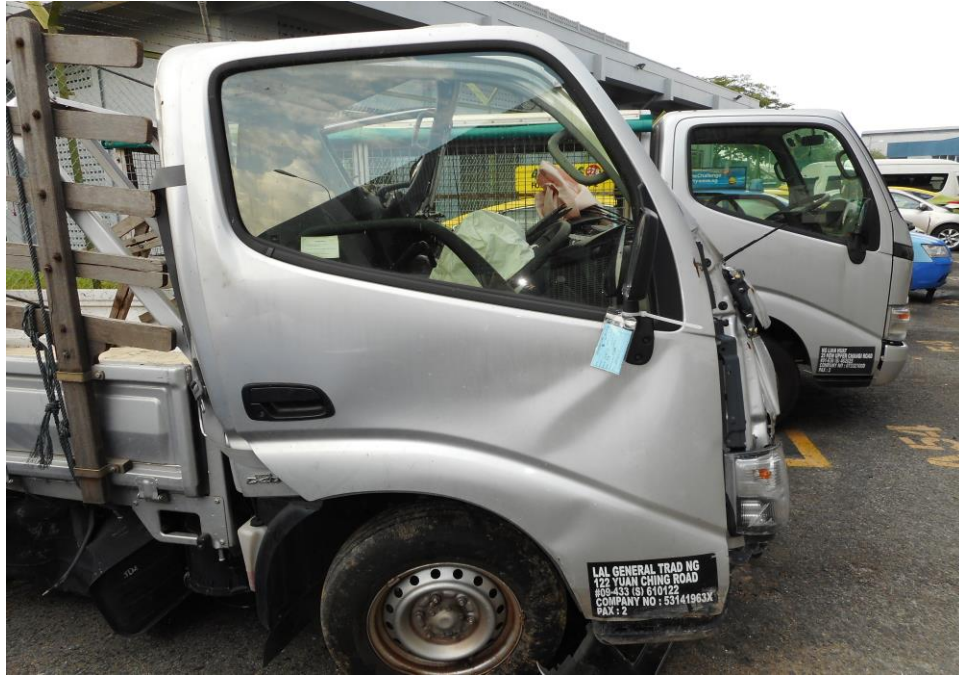
Photo 7 shows the close up view of the right door of the Motor Lorry at the time of our inspection. The Motor Lorry was observed to have sustained major damages to its doors that was crushed and dislodged due to the accident's impact.

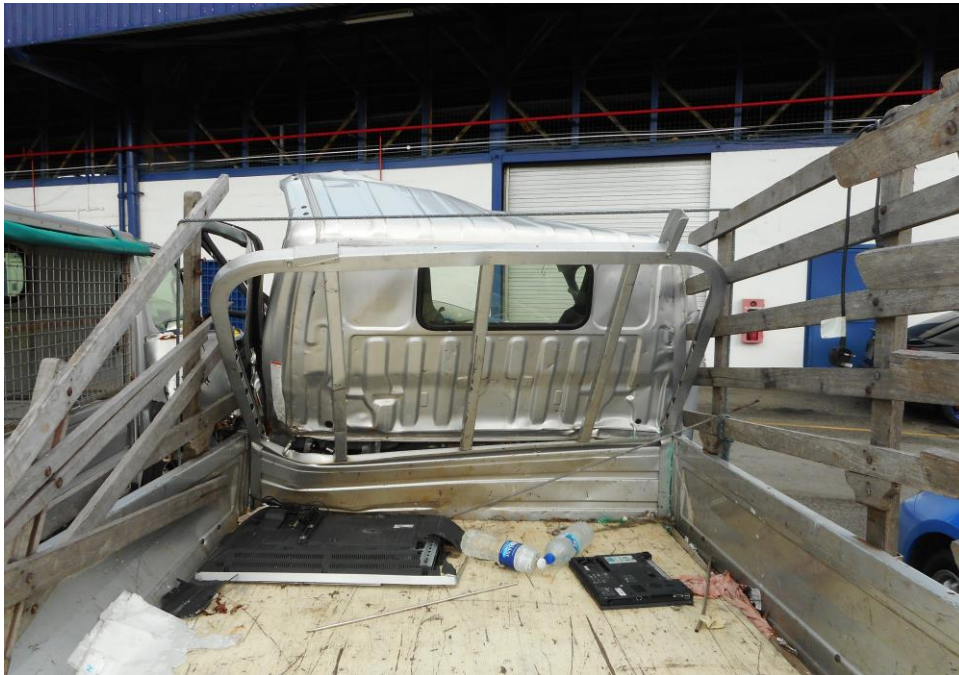
Photo 8 shows the general view of the cabin from the rear of the Motor Lorry. It was observed to have sustained damages due to the induced impact as a result of the accident.

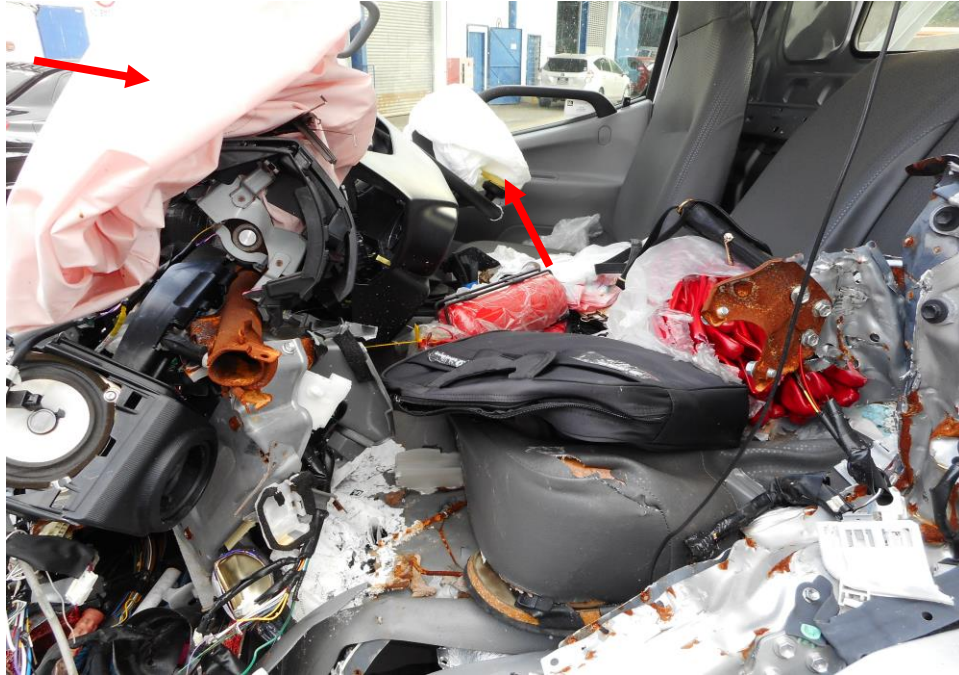
Photo 9 shows the close up view of the interior cabin of the Motor Lorry. It was observed to have sustained extensive induced damages to the dashboard, foot well and triggering both the driver and passenger's (SRS) airbags to be deployed as a result of the accident.

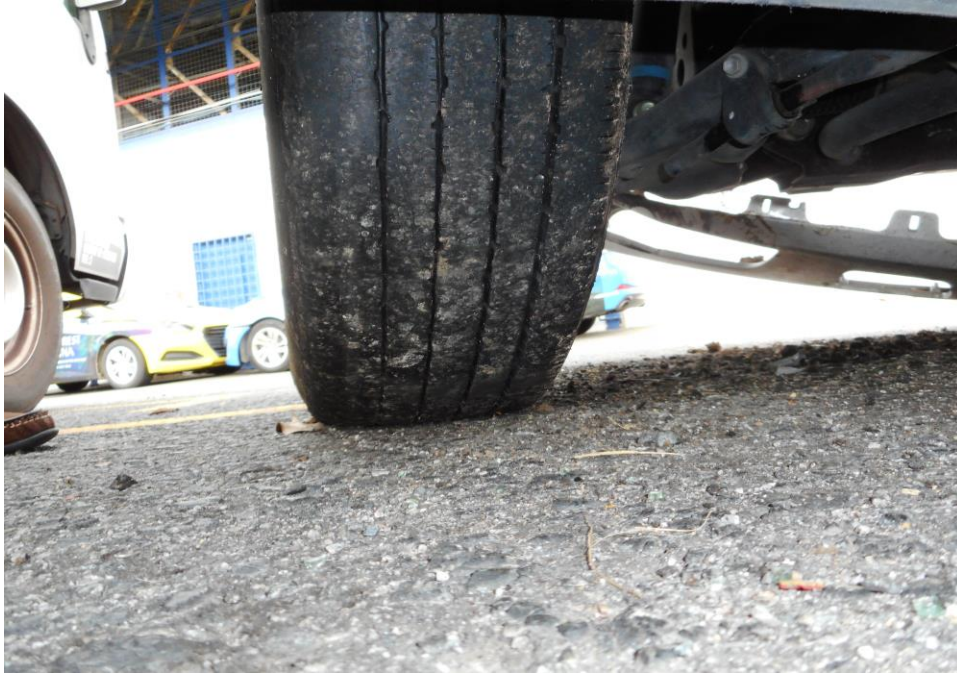
Photo 10 shows the condition of the front left tyre of the Motor Lorry, which observed to be in serviceable condition with remaining tread depth of approximately 3.7mm. The tyre, which was wrapped around standard alloy wheel rim, was also observed to be sufficiently inflated for vehicular operation.

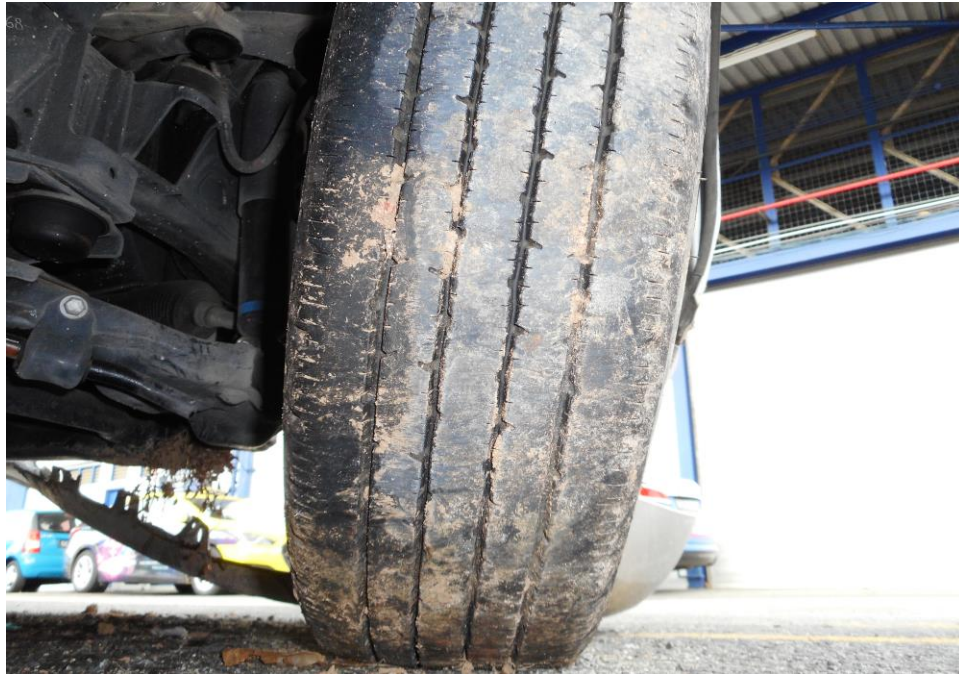
Photo 11 shows the condition of the front right tyre of the Motor Lorry, which was observed to be in serviceable condition with remaining tread depth of approximately 5.5mm. The tyre, which was wrapped around standard alloy wheel rim, was also observed to be sufficiently inflated for vehicular operation.

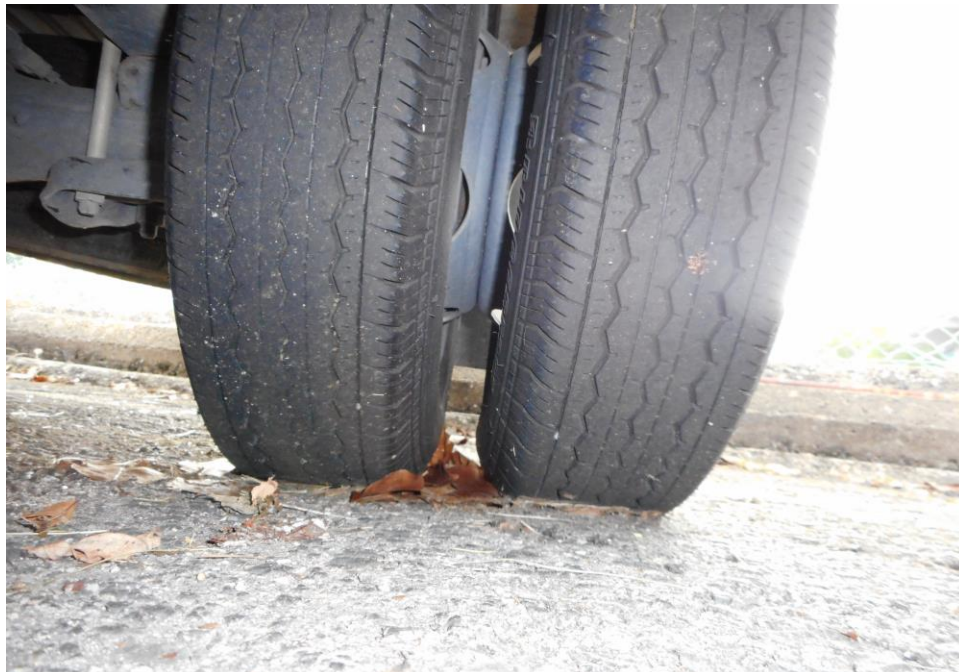
Photo 12 shows the condition of the rear left tyres of the Motor Lorry, which observed to be in serviceable condition with remaining tread depth of approximately 3.3mm. The tyres, which were wrapped around standard alloy wheel rim, were also observed to be sufficiently inflated for vehicular operation.

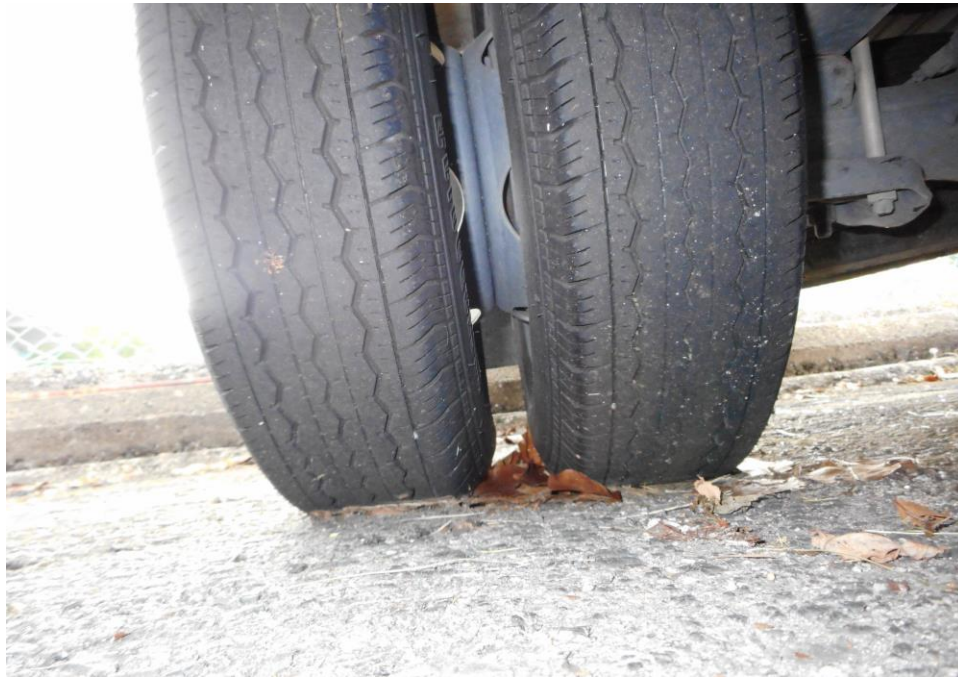
Photo 13 shows the condition of the rear right tyres of the Motor Lorry, which were observed to be in serviceable condition with remaining, tread depth of approximately 2.2mm. See above.

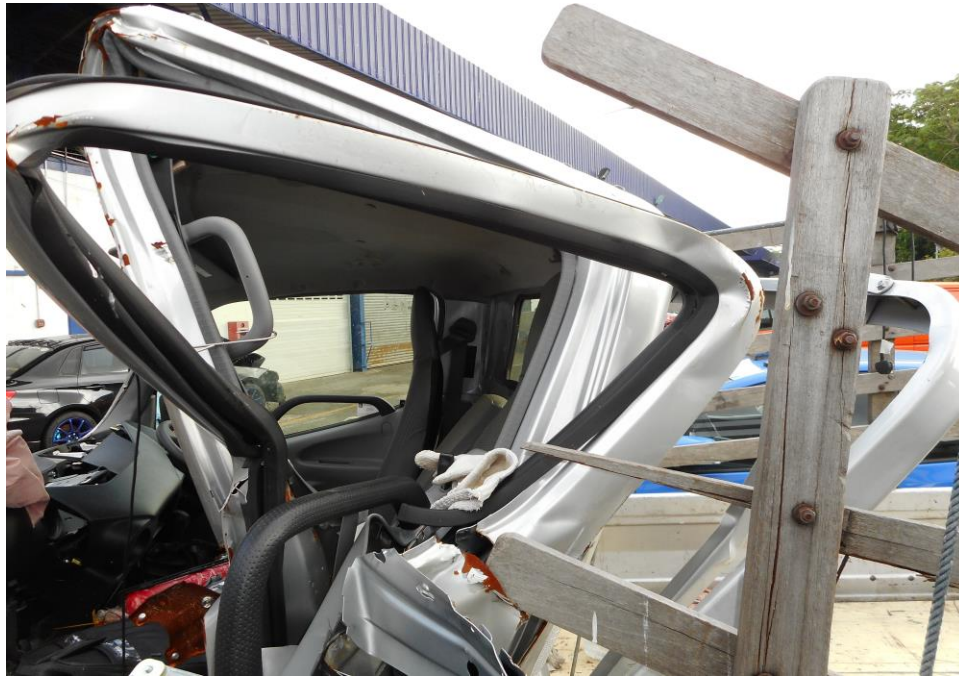
8. Upon examination of the Motor Lorry's engine compartment, we had observed that all the parts, components and fluids could not be inspected as due to the damage induced has crushed and deformed the cabin of the Motor Lorry which immobilized its opening and viewing.
9. Further examination of the engine compartment found that there was no sign(s) or indication(s) of fresh fluid leakage and/or fluid stain within the engine compartment of the Motor Lorry.
10. Our subsequent checks on the underside of the Motor Lorry also revealed no sign of fluid stain. Visually, the various undercarriage components of the Motor Lorry were all observed to be intact and without any visible damage. See photo 14 & 18.

Photo 14 shows the induced damage to the cabin of the Motor Lorry's which immobilised the opening and viewing of the various parts and components inside the engine compartment, a result of the accident.

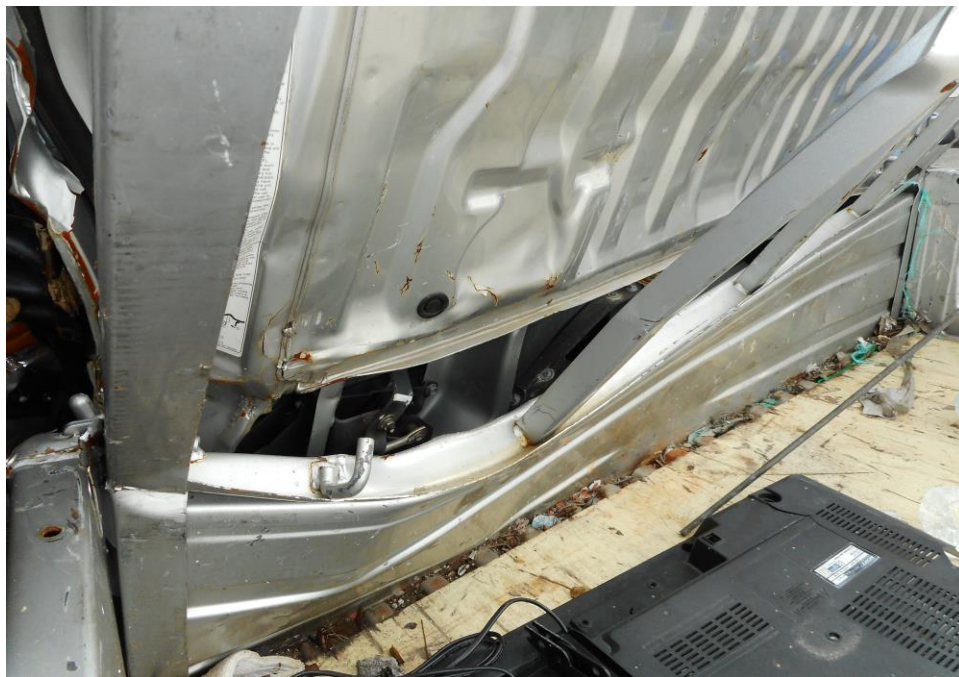
Photo 15 shows the induced damage to the cabin of the Motor Lorry's which immobilised the opening and viewing of the various parts and components inside the engine compartment, a result of the accident.

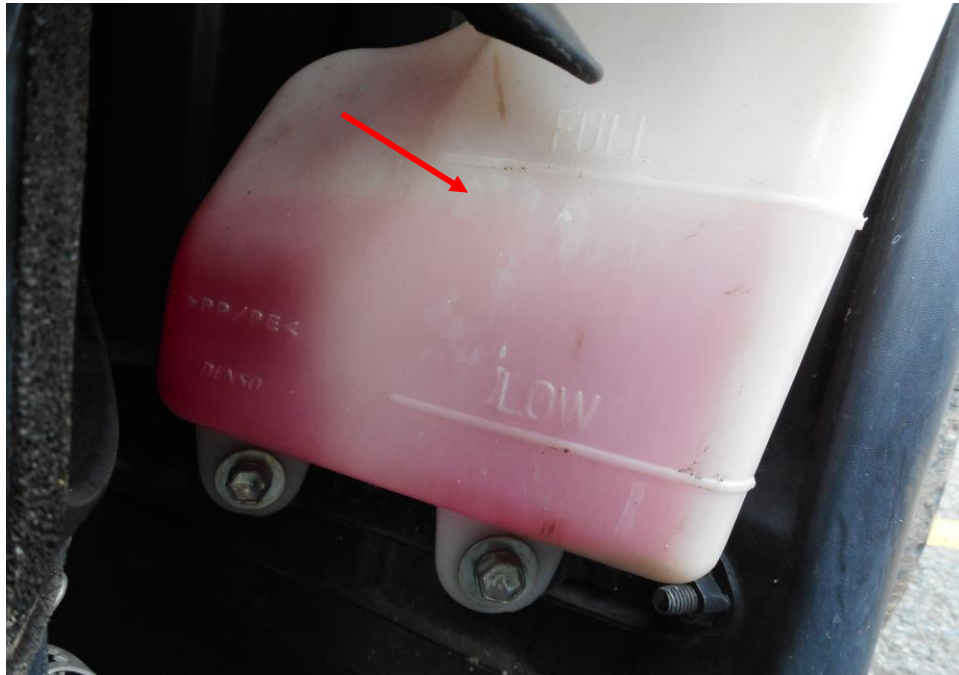
Photo 16 shows the engine coolant reservoir of the Motor Lorry at the time of our inspection. The engine coolant was observed to be of sufficient level and without any visible contamination (arrowed).

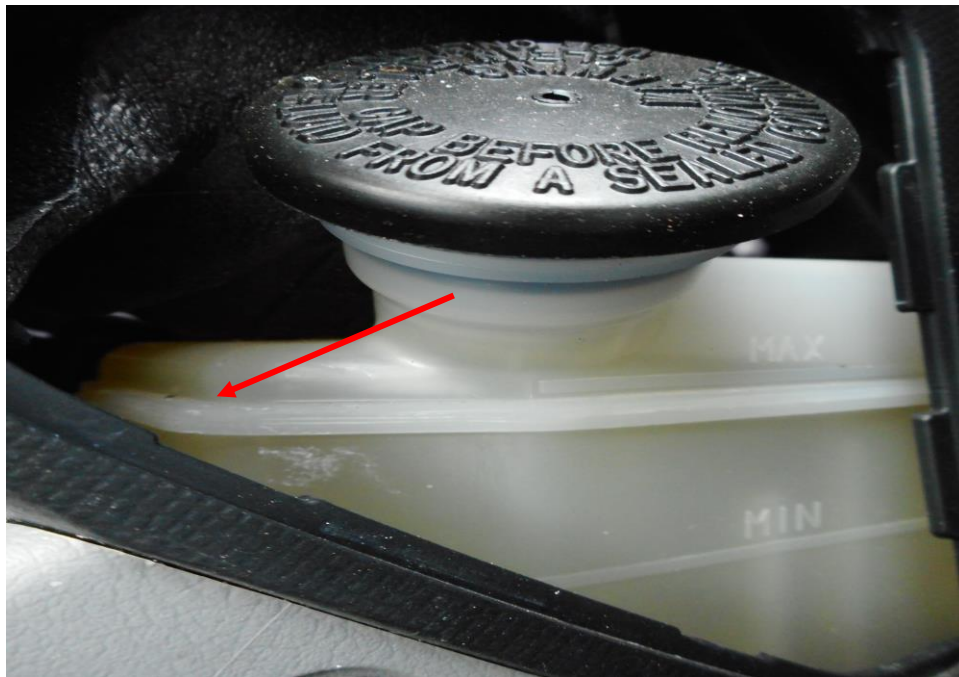
Photo 17 shows the brake fluid reservoir of the Motor Lorry at the time of our inspection. The brake fluid is all tilted to one side was due to the induced damages that tilted the cabin, but was observed to be of sufficient level and without any visible contamination (arrowed).

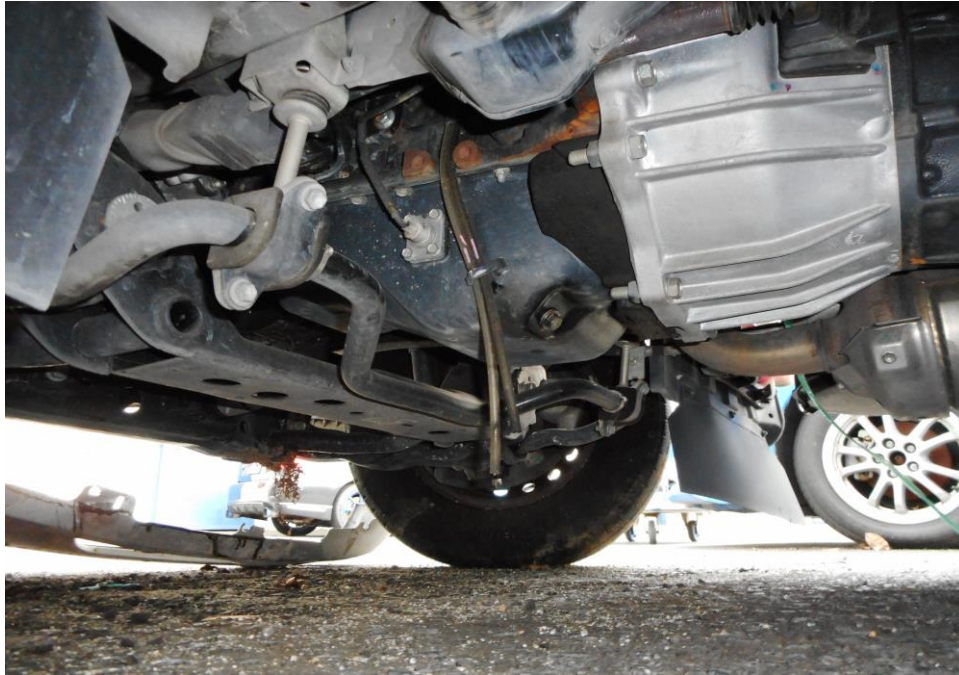
Photo 18 shows the undercarriage of the engine of the Motor Lorry at the time of our inspection. There was also no sign(s) or indication(s) of fresh fluid leakage and/or fluid stain within the engine area.

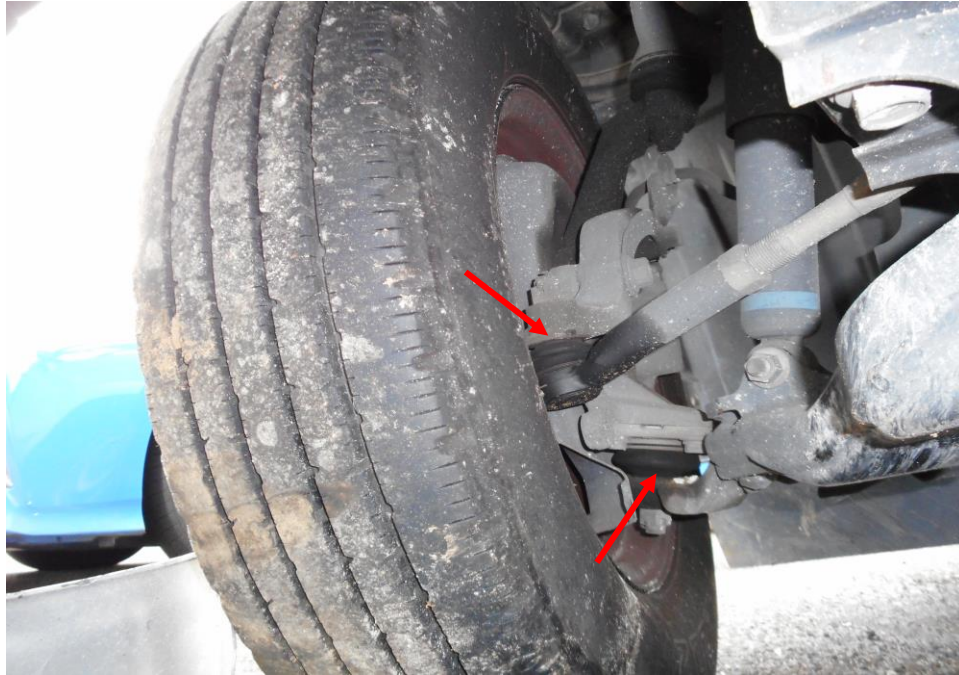
Photo 19 shows the various undercarriage components at the front left wheel of the Motor Lorry, in particular the steering tie rod end and ball joints (arrowed). The various undercarriage components of the Motor Lorry were all found to be intact without any visible damage. There was also no sign of fluid stain(s) observed on the various undercarriage components.

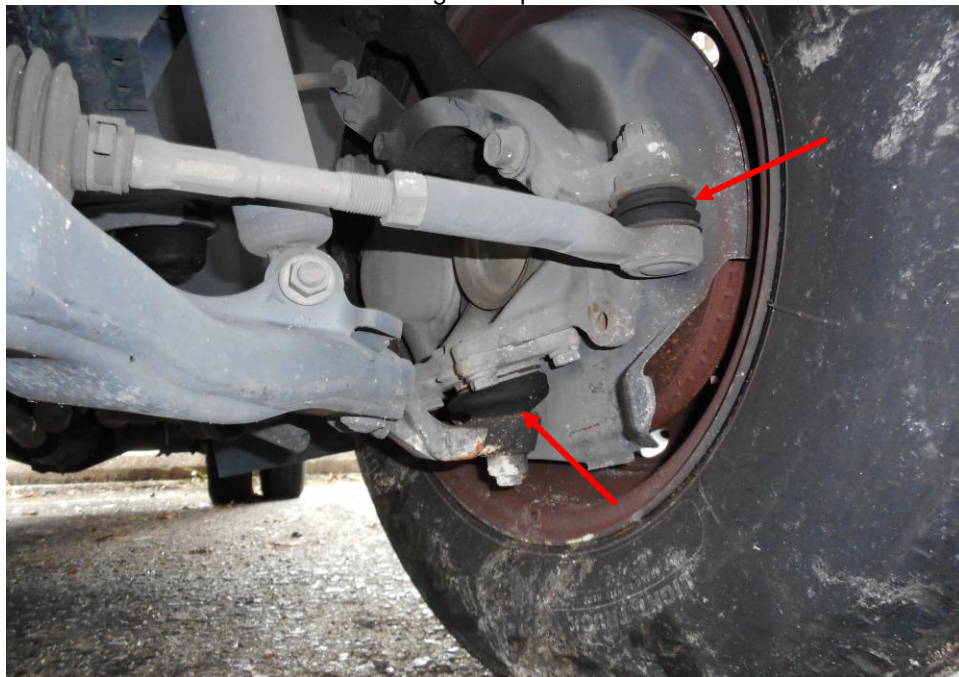
Photo 20 shows the various undercarriage components at the front right wheel of the Motor Lorry, in particular the steering tie rod end and ball joints (arrowed). The various undercarriage components of the Motor Lorry were all found to be intact without any visible damage. There was also no sign of fluid stain(s) observed on the various undercarriage components.

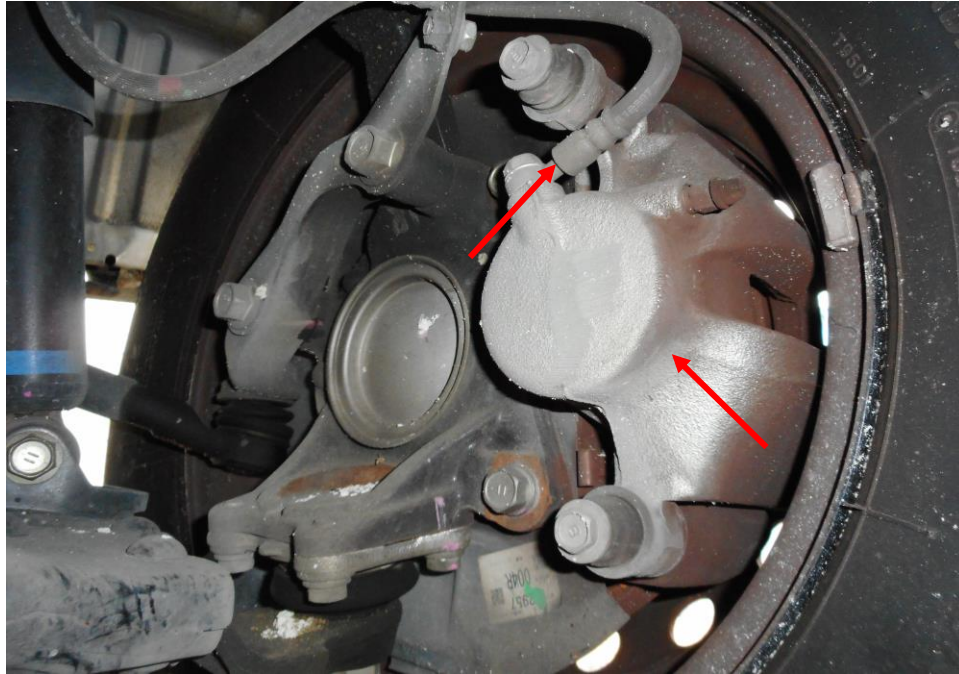
Photo 21 shows the various undercarriage components at the front left wheel of the Motor Lorry, in particular the brake hose and callipers (arrowed). The various undercarriage components of the Motor Lorry were all found to be intact without any visible damage. There was also no sign of fluid stain(s) observed on the various undercarriage components.

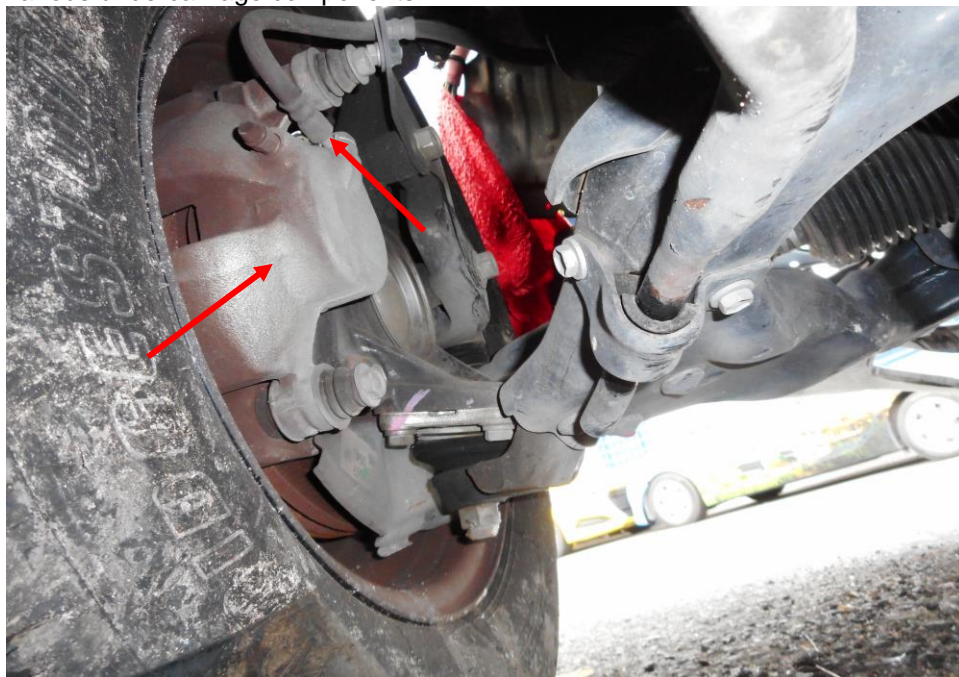
Photo 22 shows the various undercarriage components at the front right wheel of the Motor Lorry, in particular the brake hose and callipers (arrowed). The various undercarriage components of the Motor Lorry were all found to be intact without any visible damage. There was also no sign of fluid stain(s) observed on the various undercarriage components.

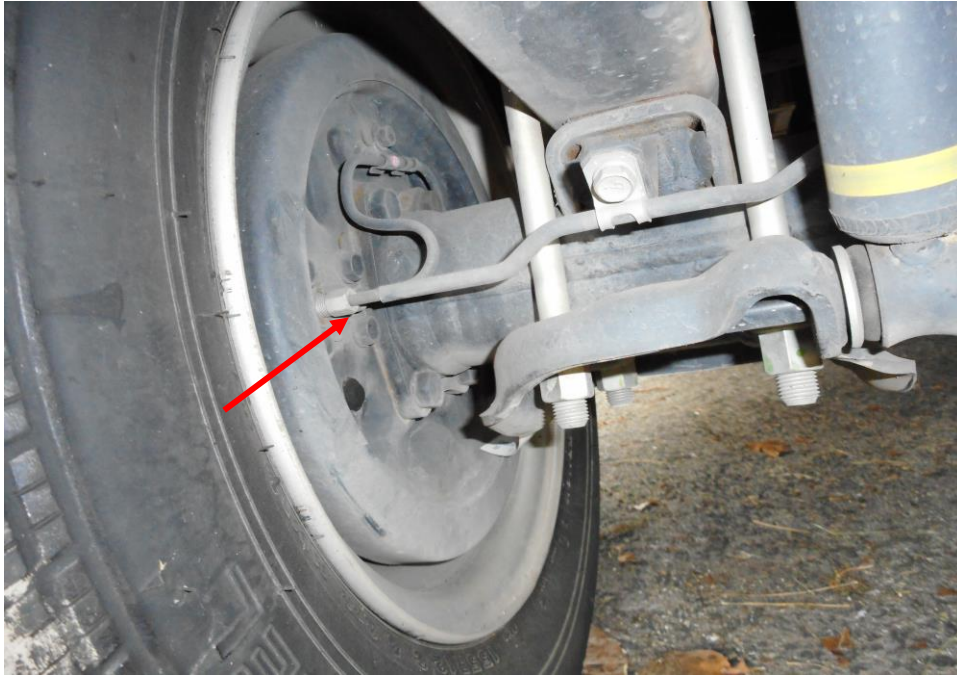
Photo 23 shows the various undercarriage components at the rear left wheel of the Motor Lorry, in particular the brake hose and drum brake (arrowed). The various undercarriage components of the Motor Lorry were all found to be intact without any visible damage. There was also no sign of fluid stain(s) observed on the various undercarriage components.

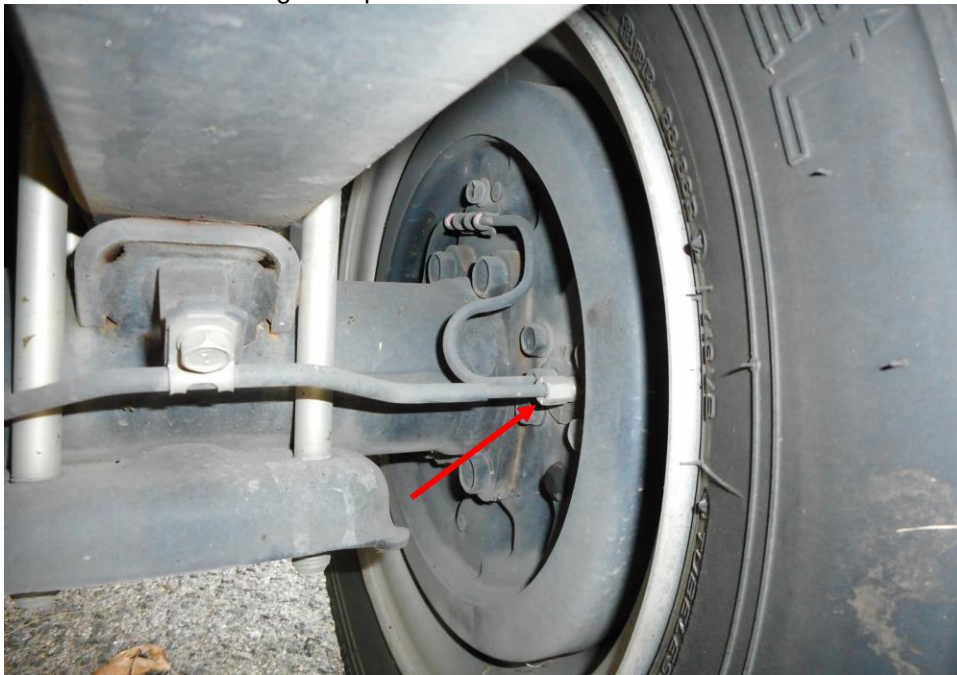
Photo 24 shows the various undercarriage components at the rear right wheel of the Motor Lorry, in particular the brake hose and drum brake (arrowed). The various undercarriage components of the Motor Lorry were all found to be intact without any visible damage. There was also no sign of fluid stain(s) observed on the various undercarriage components.

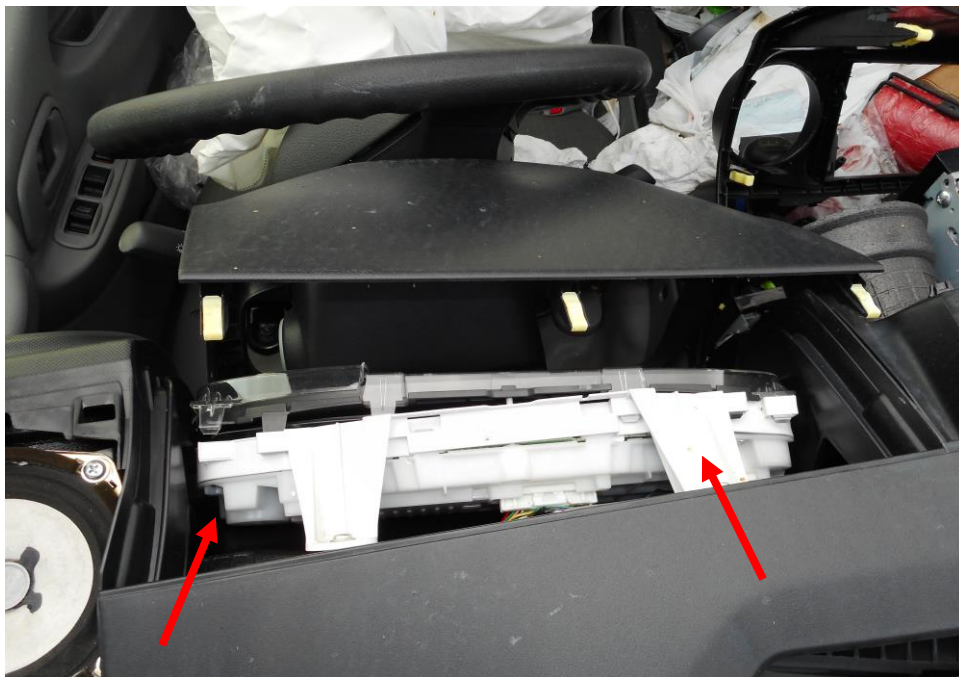
15. The static test of the Motor Lorry electronic safety system could not be inspected as the instrument cluster was damaged due to the induce impact from the accident. See photo 25.

Photo 25 shows the damages on the Motor Lorry's instrument cluster induce impact from the accident rendering it not serviceable at the time of inspection.
