Your Ref: TP/IP/62509/2018
Our Ref: CI/TPD19000758/P

24th April 2019

MECHANICAL INSPECTION REPORT OF MOTOR CAR SLJ 1342L

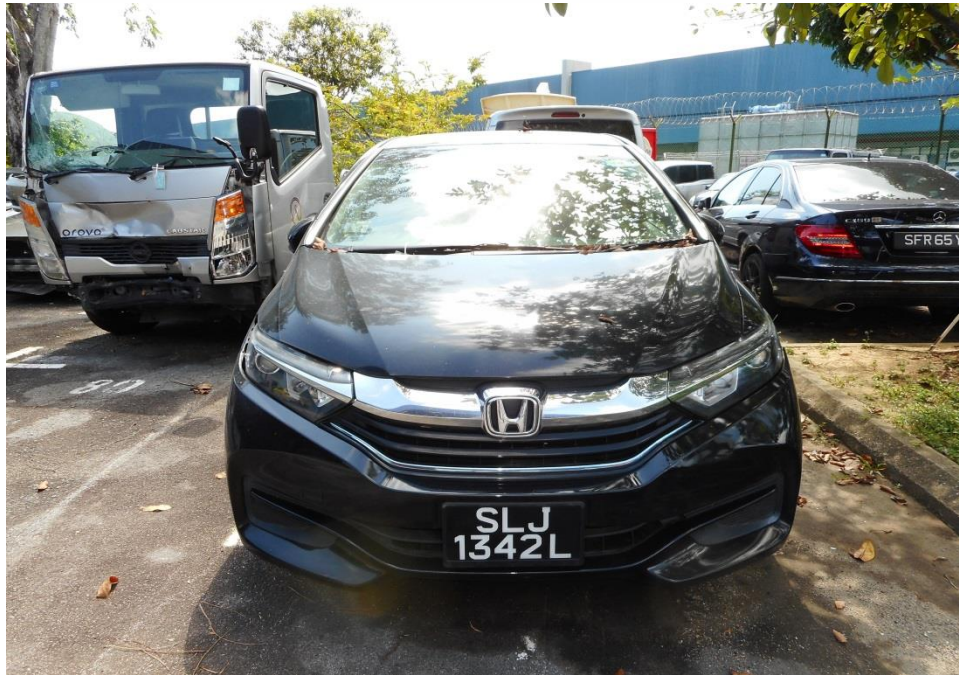
4. The mileage of the Motor Car at the time of my inspection was 111,924KM
5. The Motor Car had sustained impact damage on the front right. Body parts at the right front fender portion, front bumper portion were observed to have been damaged. The front windscreen observed to have cracks as a result of the accident. See photo 1- 4.

Photo 1 shows a general view of the front of the Motor Car at the time of my inspection. The front right fender & the windscreen are amongst the body parts that were damaged as a result of the accident.

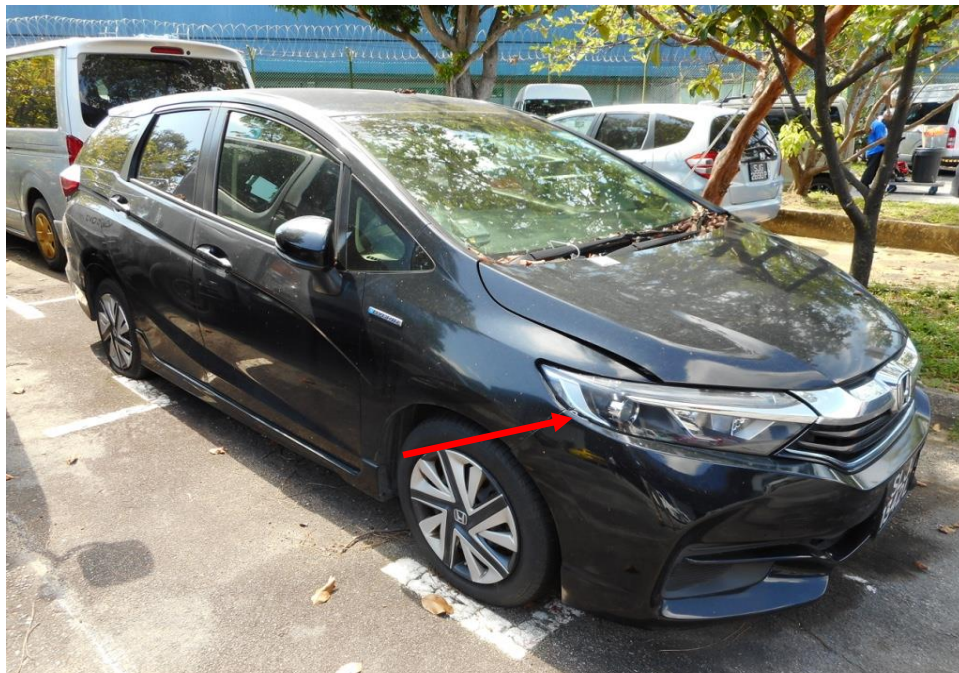
Photo 2 shows a general view of the front right portion of the Motor Car at the time of my inspection. The front right fender are amongst the body parts that were damaged as a result of the accident.

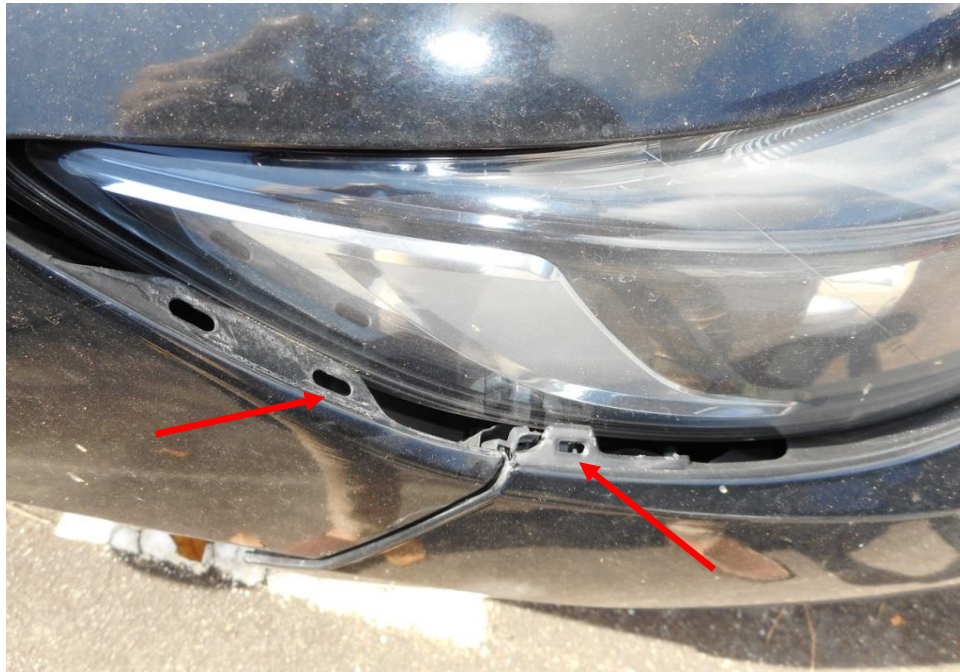
Photo 3 shows a close up view of the front right portion of the Motor Car at the time of my inspection. The front right fender & bumper were amongst the body parts that were damaged as a result of the accident.

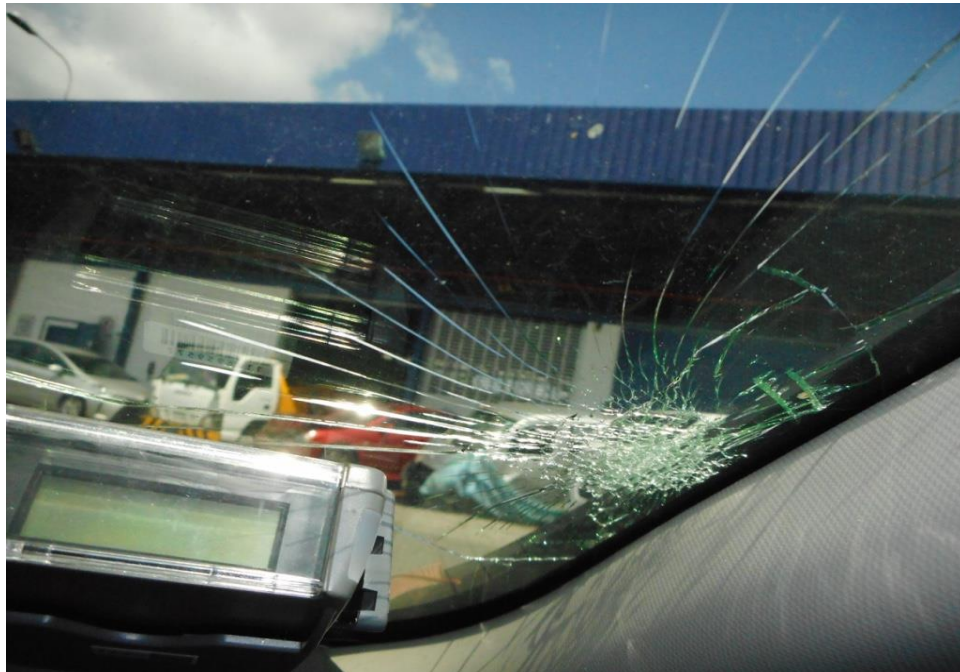
Photo 4 shows a close up interior view of the front right portion of the Motor Car at the time of my inspection. The front windscreen and fender were amongst the body parts that were damaged as a result of the accident.

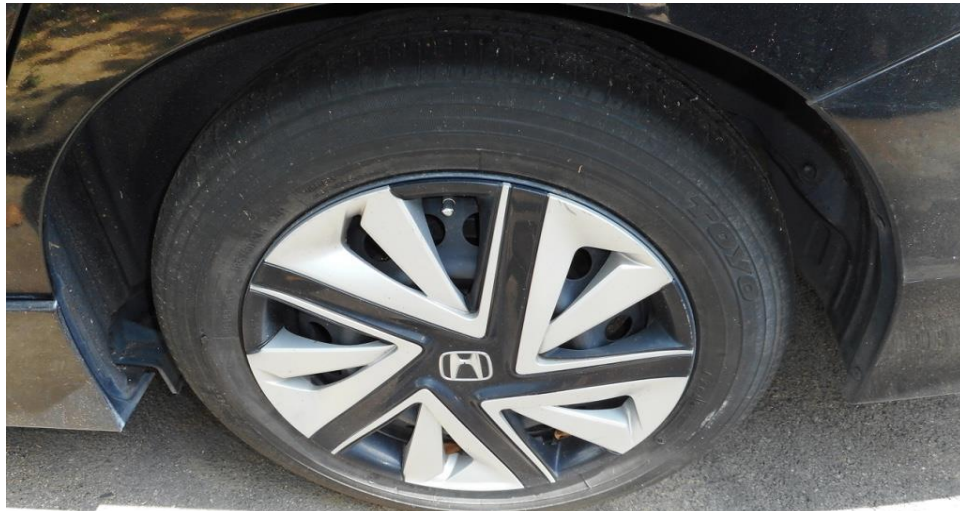
Photo 6 shows the condition of the rear left tyre of the Motor Car, which was observed to be in serviceable condition with remaining tread depth of approximately 4.8mm. There was no tear, cut or burst mark(s) on the outer and the inner sidewalls as well as across the tread of this tyre. The tyre, which was wrapped around alloy wheel rim, was also observed to be sufficiently inflated for vehicular operation.

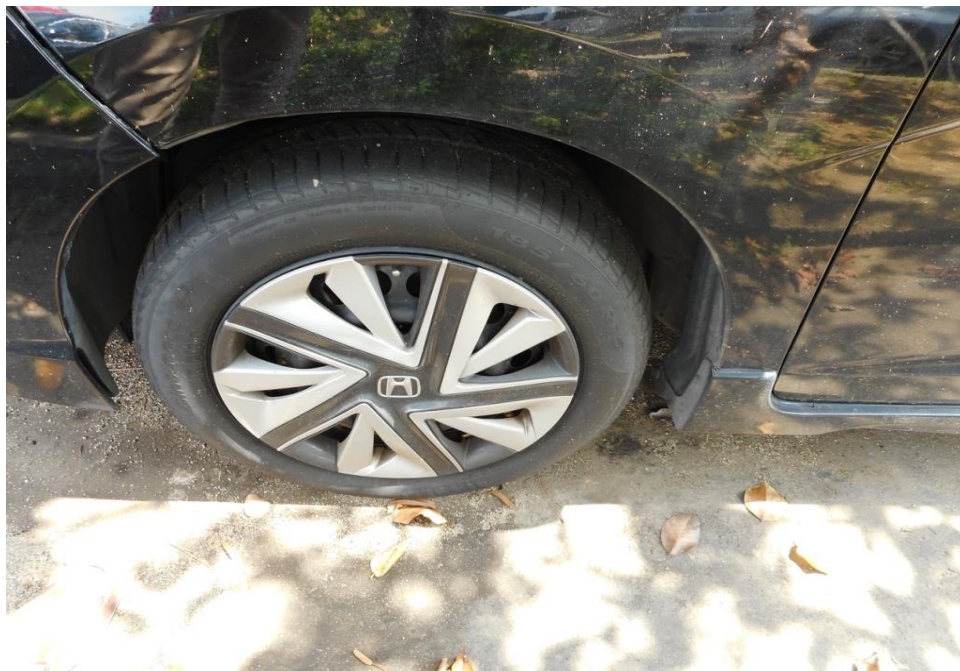
Photo 7 shows the condition of the front left tyre of the Motor Car, which was observed to be in serviceable condition with remaining tread depth of approximately 4.1mm. There was no tear, cut or burst mark(s) on the outer and the inner sidewalls as well as across the tread of this tyre. The tyre, which was wrapped around alloy wheel rim, was also observed to be sufficiently inflated for vehicular operation.

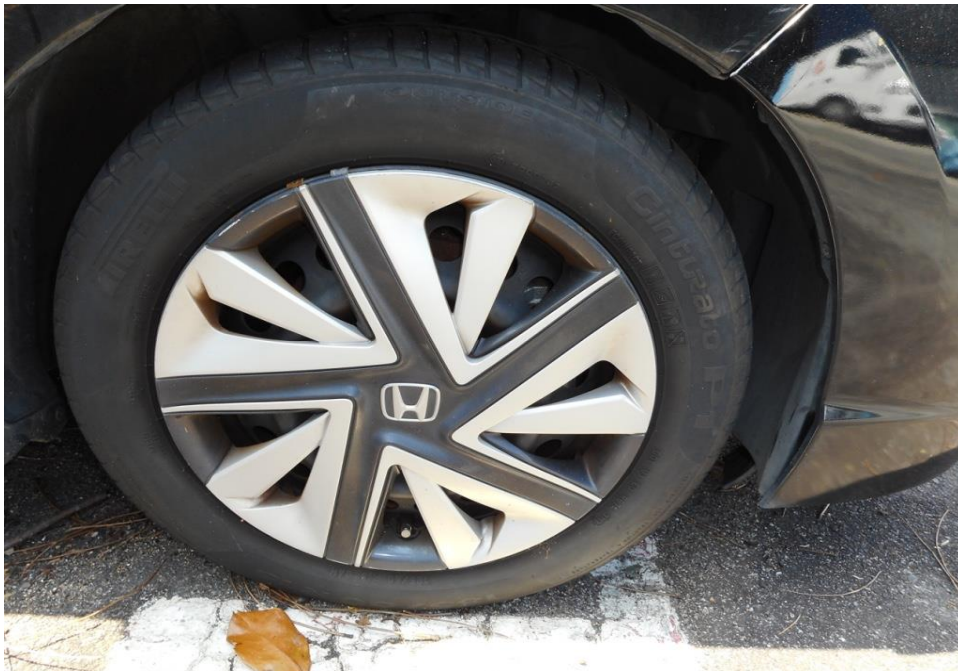
Photo 9 shows the condition of the front left tyre of the Motor Car, which was observed to be in serviceable condition with remaining tread depth of approximately 4.5mm. There was no tear, cut or burst mark(s) on the outer and the inner sidewalls as well as across the tread of this tyre. The tyre, which was wrapped around alloy wheel rim, was also observed to be sufficiently inflated for vehicular operation.

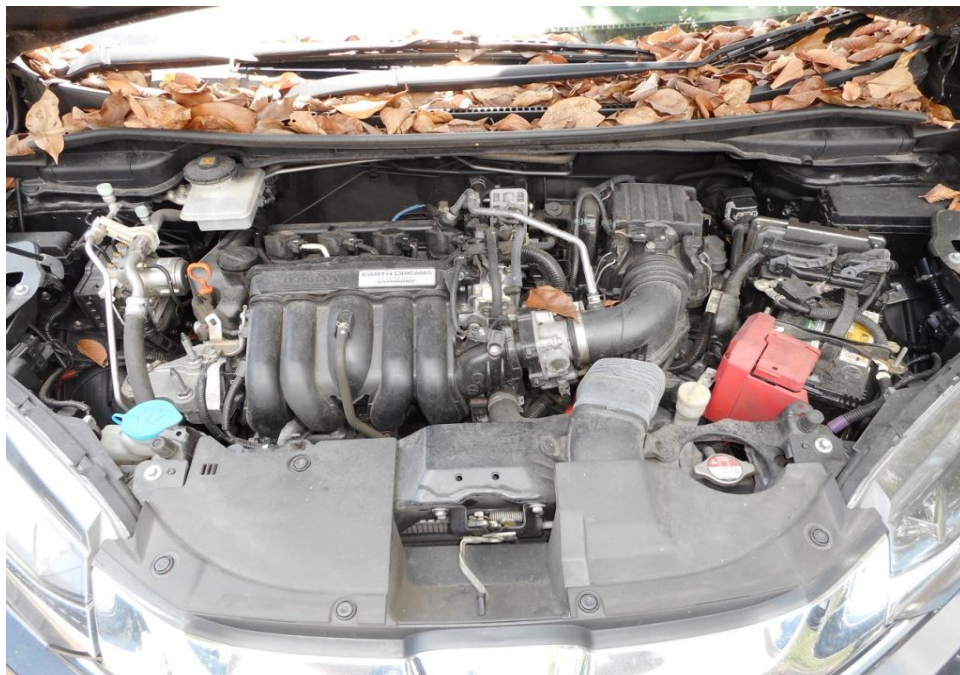
Photo 10 shows a general view of the Motor Car's engine compartment. The various parts and components inside the engine compartment were unaffected by the accident. There was also no sign(s) or indication(s) of fluid leakage and/or fluid stain within the engine compartment.

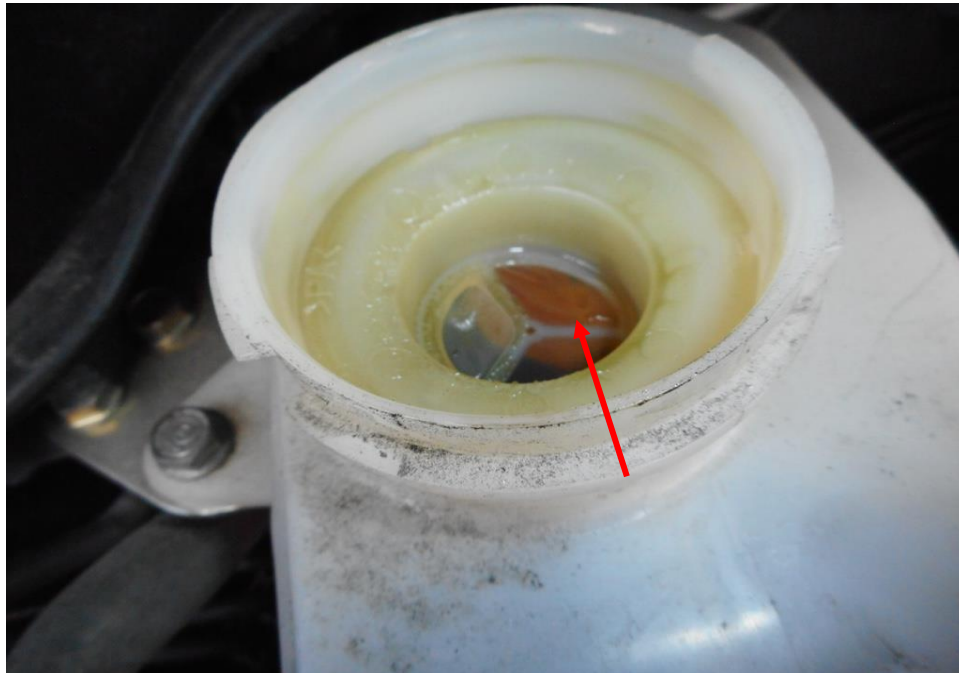
Photo 11 shows the brake fluid reservoir of the Motor Car at the time of my inspection. The brake fluid was observed to be of sufficient level (as indicated by the red arrows) and without any visible contamination.

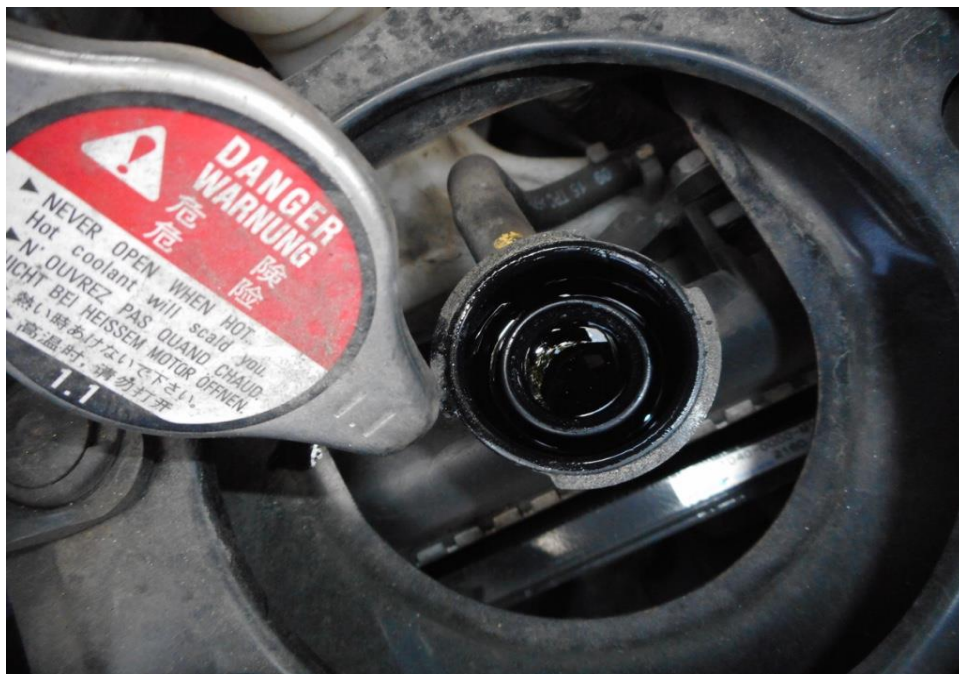
Photo 12 shows checks being carried out to the engine coolant of the Motor Car at the time of my inspection. The engine coolant was observed to be of sufficient level and without any visible contamination.

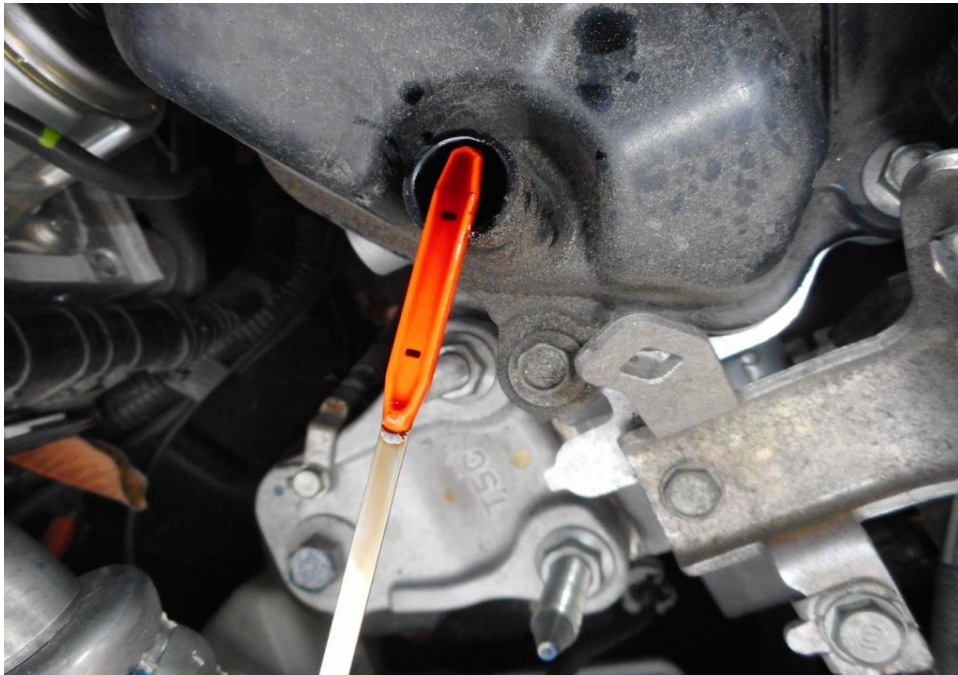
Photo 13 shows the engine oil dip stick of the Motor Car at the time of my inspection. The engine oil was observed to be of sufficient level and without any visible contamination.

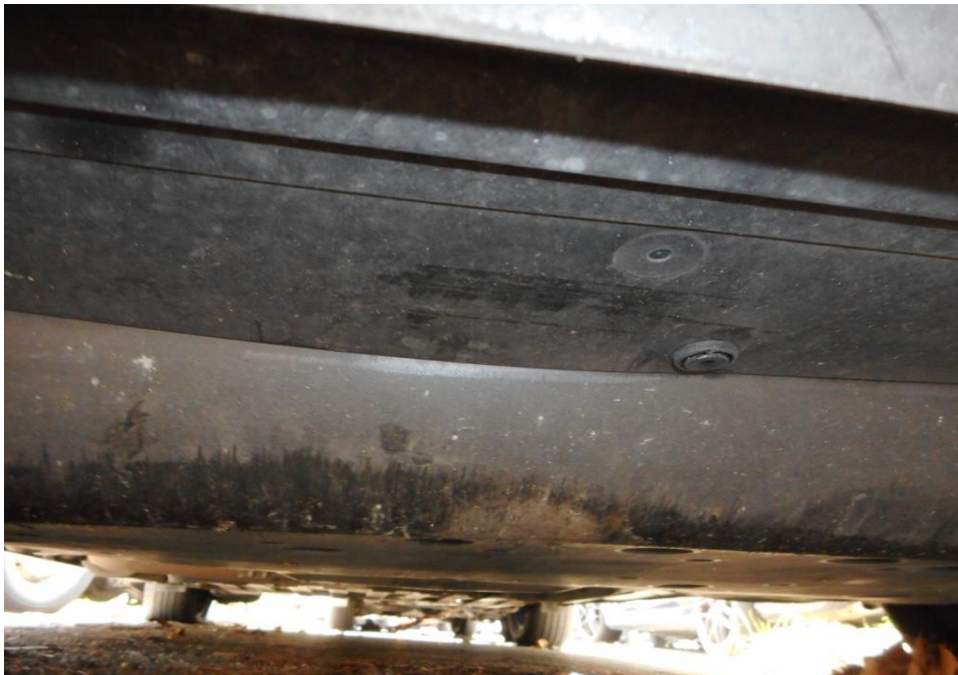
Photo 14 shows the front underside of the Motor Car. I did not find any sign(s) or indication(s) of fluid leak and/or fluid stain(s) on the underside.

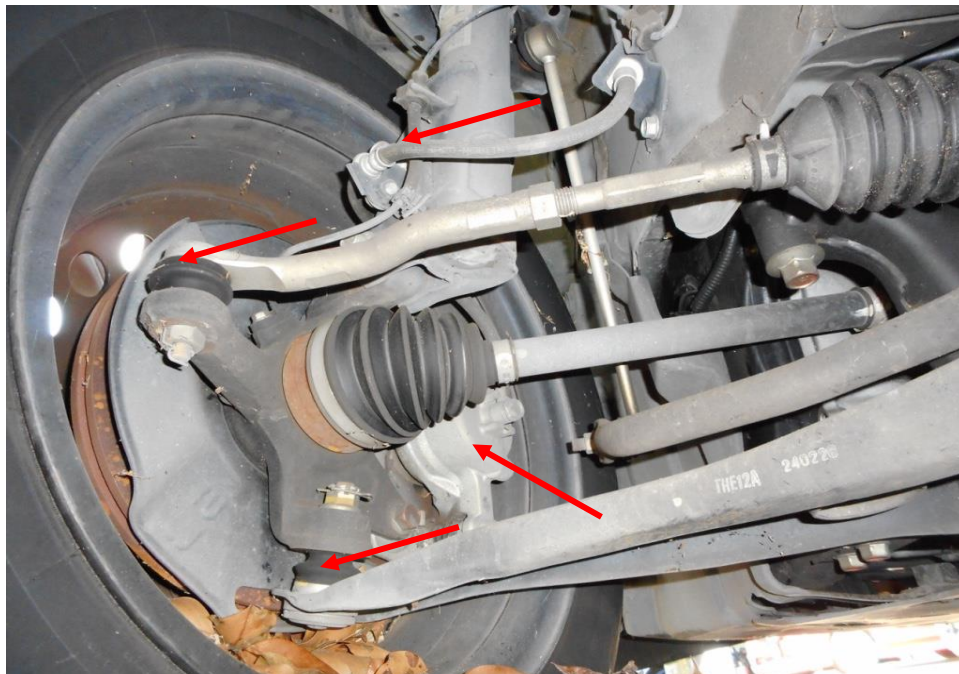
Photo 15 shows the brake hose and ball joints (arrowed) at the front left wheel of the Motor Car. I did not observe any leakage of brake fluid. My visual inspection of the mechanical components of the braking system, including its brake callipers, revealed all to be intact and without visible damage, indicating that the braking system was likely to be in serviceable condition at the material time of accident.

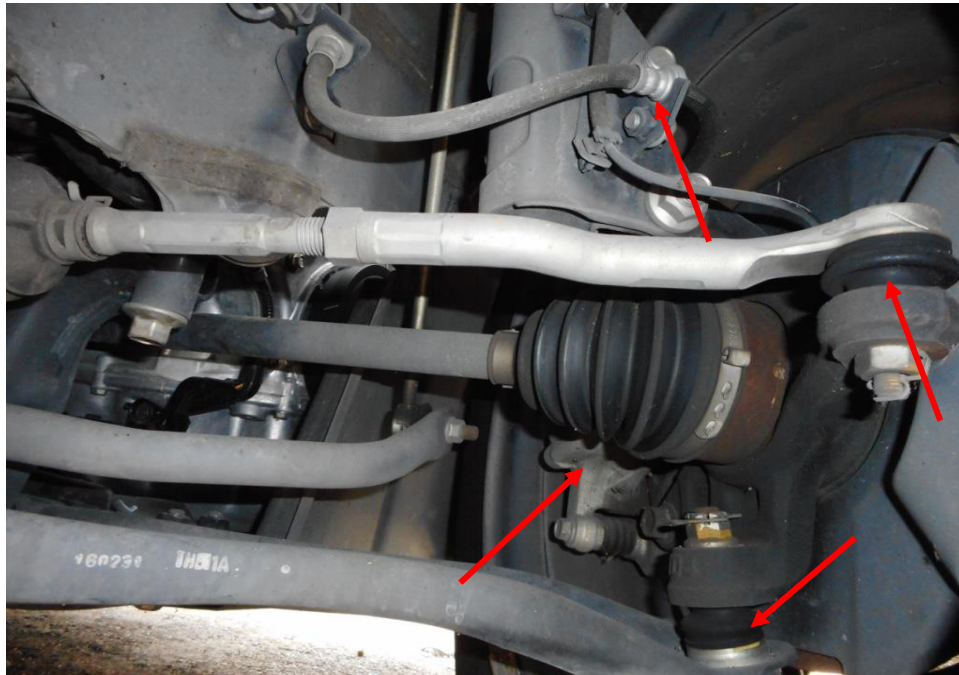
Photo 16 shows the brake hose and ball joints (arrowed) at the front right wheel of the Motor Car. I did not observe any leakage of brake fluid. My visual inspection of the mechanical components of the braking system, including its brake callipers, revealed all to be intact and without visible damage, indicating that the braking system was likely to be in serviceable condition at the material time of accident.

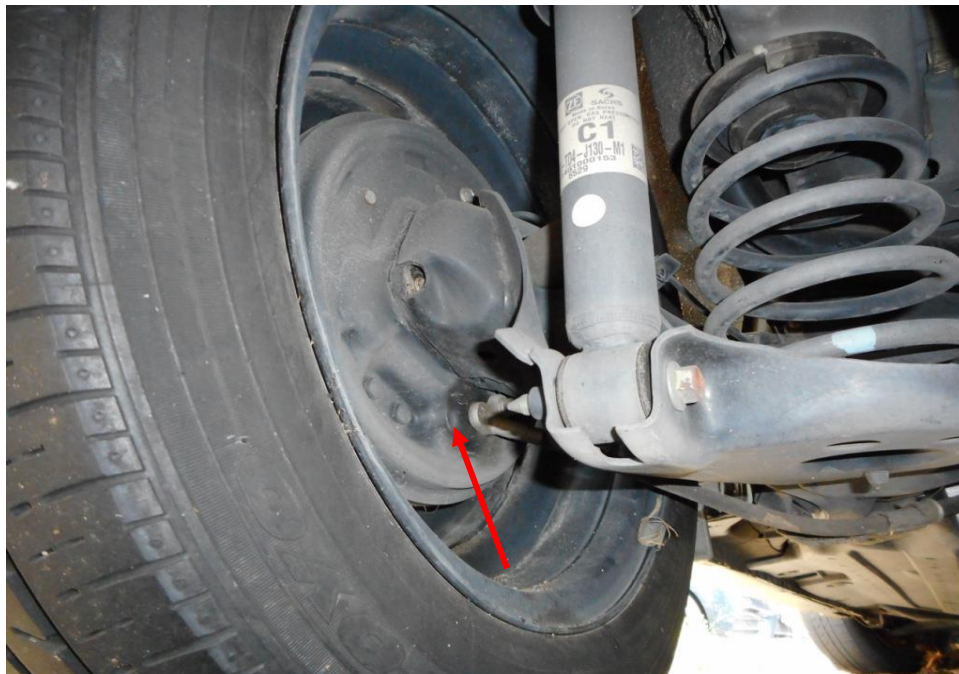
Photo 17 shows the various undercarriage components at the rear left wheel of the Motor Car, the brake hoses (arrowed). I did not observe any leakage of brake fluid & my visual inspection of the various mechanical components of the braking system revealed all to be intact and without visible damage, indicating that the braking system was likely to be in serviceable condition at the material time of accident.

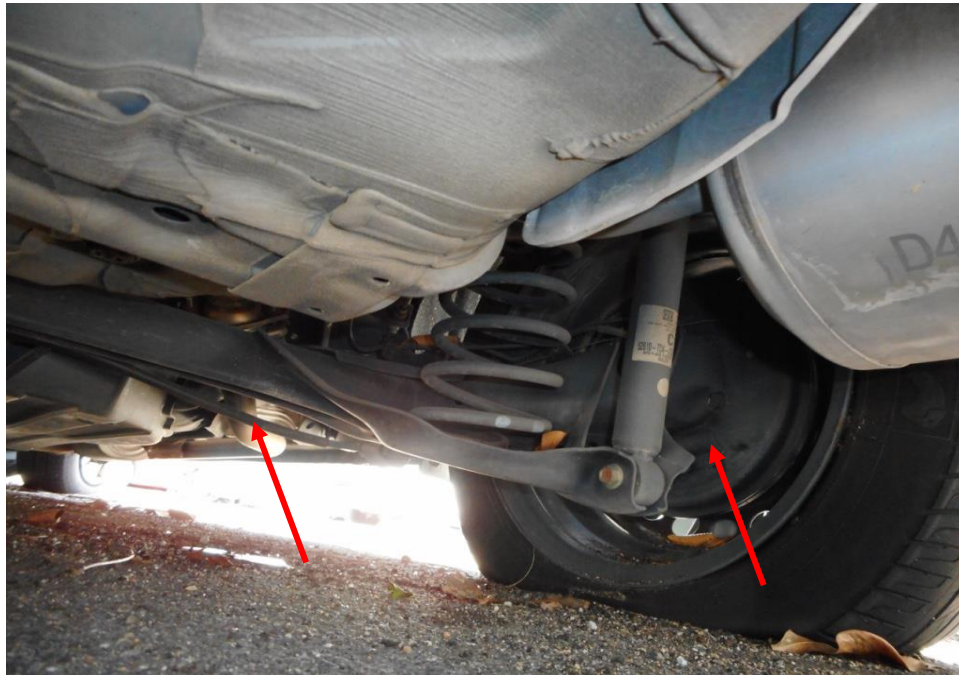
Photo 18 shows the various undercarriage components at the rear right wheel of the Motor Car, the brake hoses (arrowed). I did not observe any leakage of brake fluid & my visual inspection of the various mechanical components of the braking system revealed all to be intact and without visible damage, indicating that the braking system was likely to be in serviceable condition at the material time of accident.

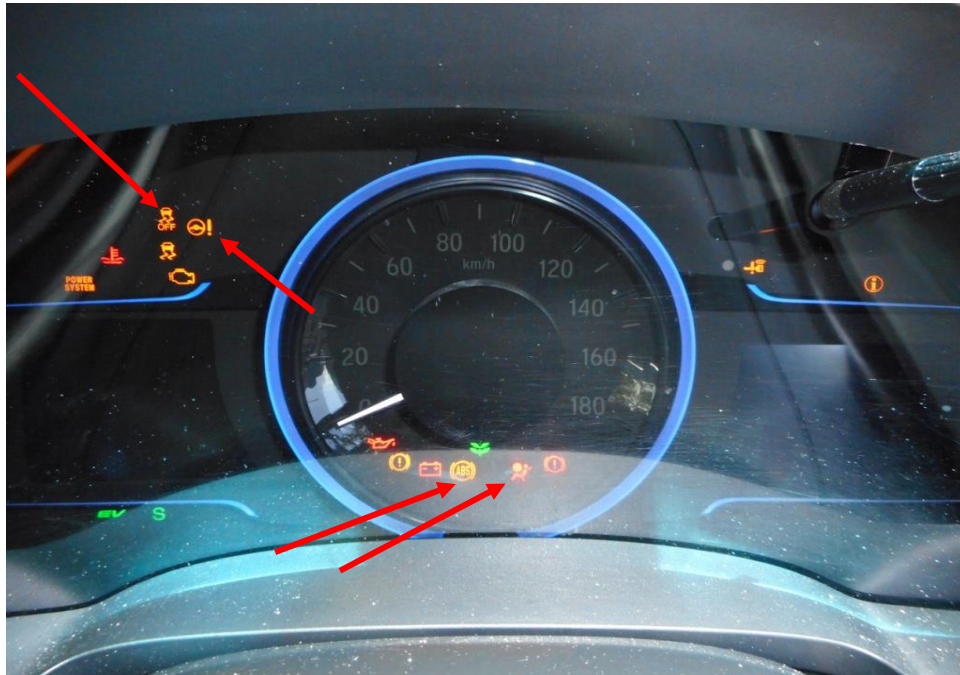
Photo 19 shows the warning light for Anti-Lock Brake System (ABS), Electric Power Steering System (EPS), Traction Control (TC) and Supplemental Restraint System (SRS) appearing on the instrument panel of the Motor Car during the self-test of its various electronic operating systems when its engine was cranked.

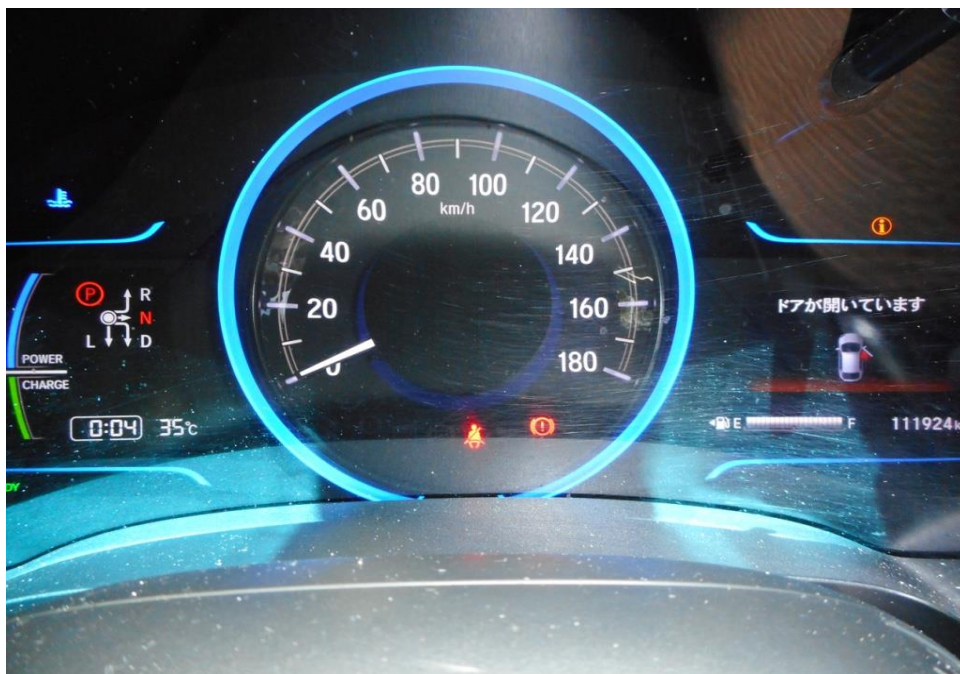
Photo 20 shows no warning lights illuminated on the instrument panel of the Motor Car after the engine was cranked. This would suggest that there was no abnormality to the various electronic operating systems of the Motor Car, like the ABS, EPS, TC and SRS etc.
