Your Ref: TP/IP/69599/2018  
Our Ref : CI/TPD19000759/N

**Fatal Accident Investigation Team**

**MECHANICAL INSPECTION REPORT OF MOTOR LORRY GBD 7327S**

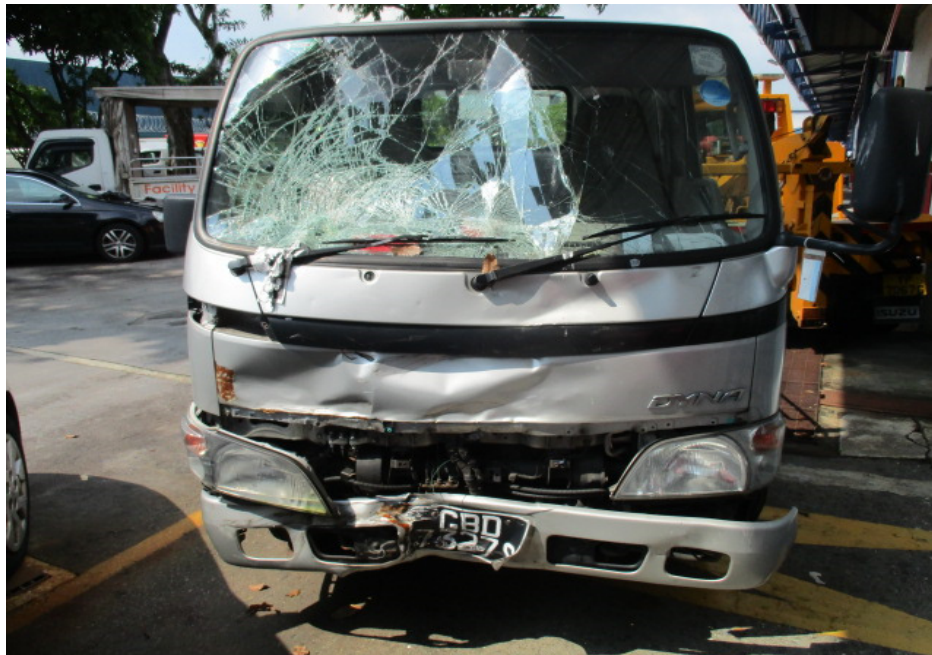
4. The mileage of the Motor Lorry at the time of our inspection was 128, 788km.
5. The Motor Lorry had sustained relatively moderate impact damage that was confined to its frontal portion. Its front bumper was observed to be dislodged; its front bonnet as well as front panel was observed to have been dented; its front windscreen was observed to be shattered while its right headlight was observed to be cracked.

**Photo 1** shows a general view of the front body of the Motor Lorry at the time of our inspection. The Motor Lorry had sustained relatively moderate impact damage that was confined to its frontal portion. Its front bumper was observed to be dislodged; its front bonnet as well as front panel was observed to have been dented, its front windscreen was observed to be shattered while its right headlight was observed to be cracked. The mileage of the Motor Lorry at the time of our inspection was 128, 788km.

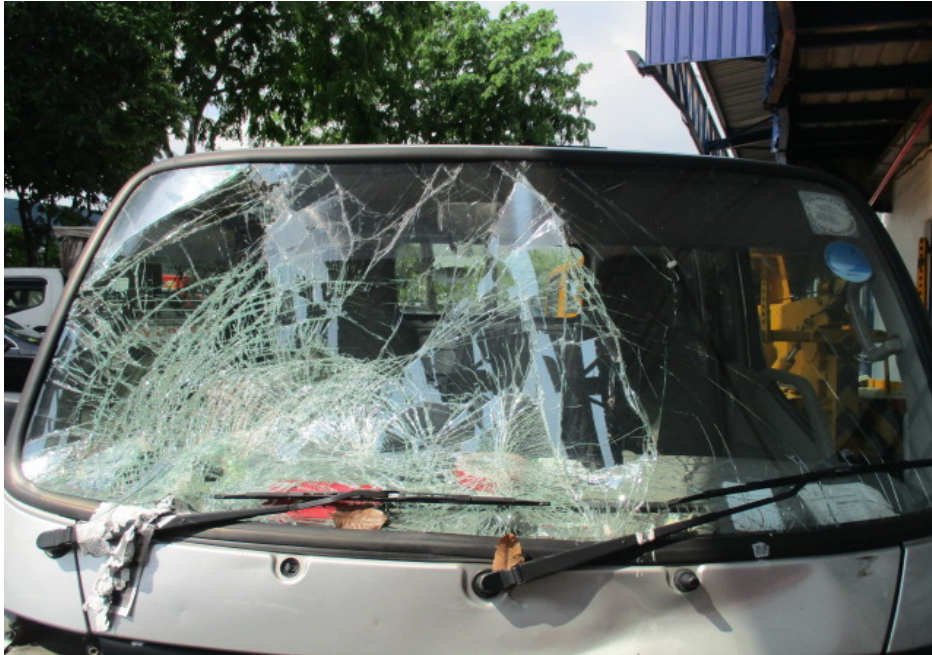
**Photo 2** shows a closer view of the shattered front windscreen of the Motor Lorry at the time of our inspection.

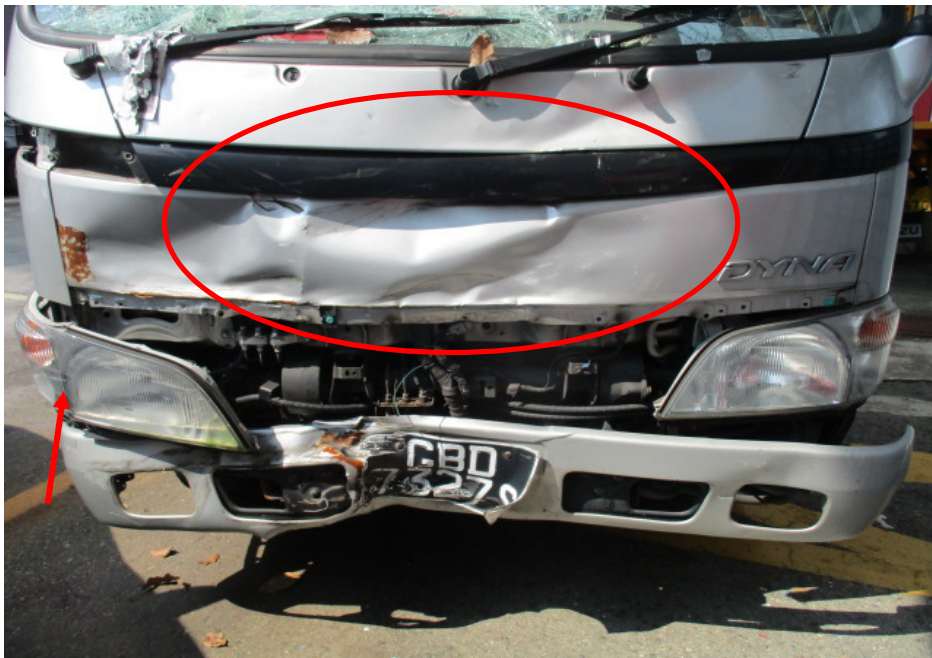
**Photo 3** shows a closer view of the dislodged front bumper, dented front bonnet, dented front panel (circled) and cracked right headlight (arrowed) of the Motor Lorry at the time of our inspection.

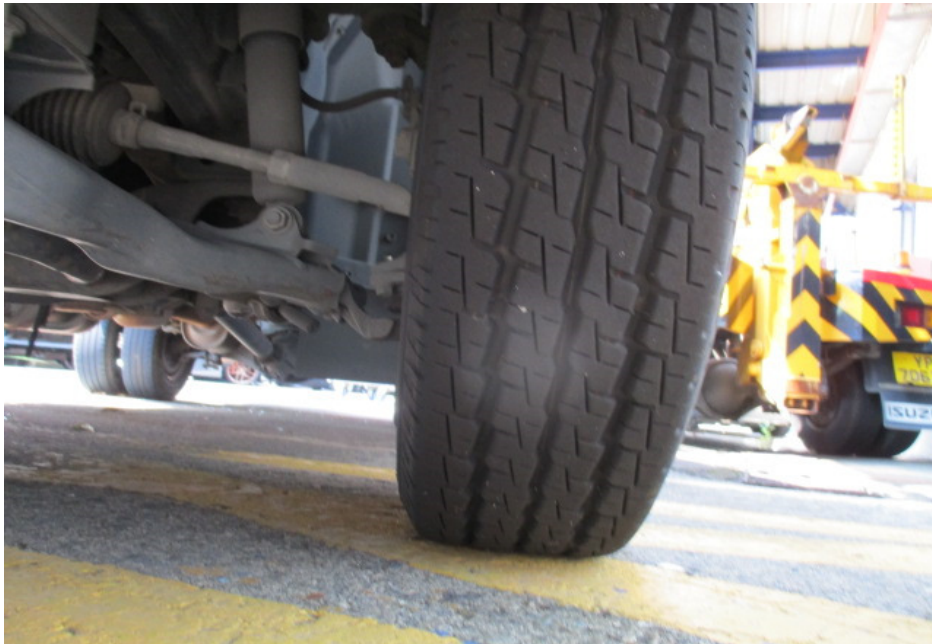
**Photo 4** shows the condition of the front left tyre of the Motor Lorry, which was observed to be in serviceable condition with remaining tread depth of approximately 11mm. The tyre, which was wrapped around standard alloy wheel rim, was also observed to be sufficiently inflated for vehicular operation. There was no tear, cut or burst mark(s) on the outer and the inner sidewalls as well as across the tread of the 6 tyres that were fitted on the Motor Lorry.

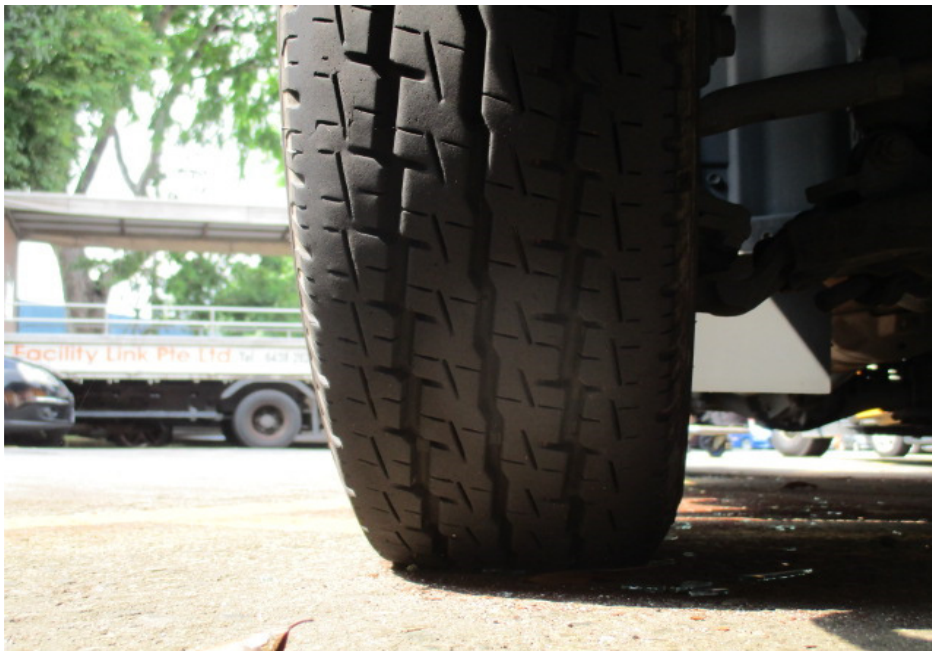
**Photo 5** shows the condition of the front right tyre of the Motor Lorry, which was observed to be in serviceable condition with remaining tread depth of approximately 6mm. The tyre, which was wrapped around standard alloy wheel rim, was also observed to be sufficiently inflated for vehicular operation.

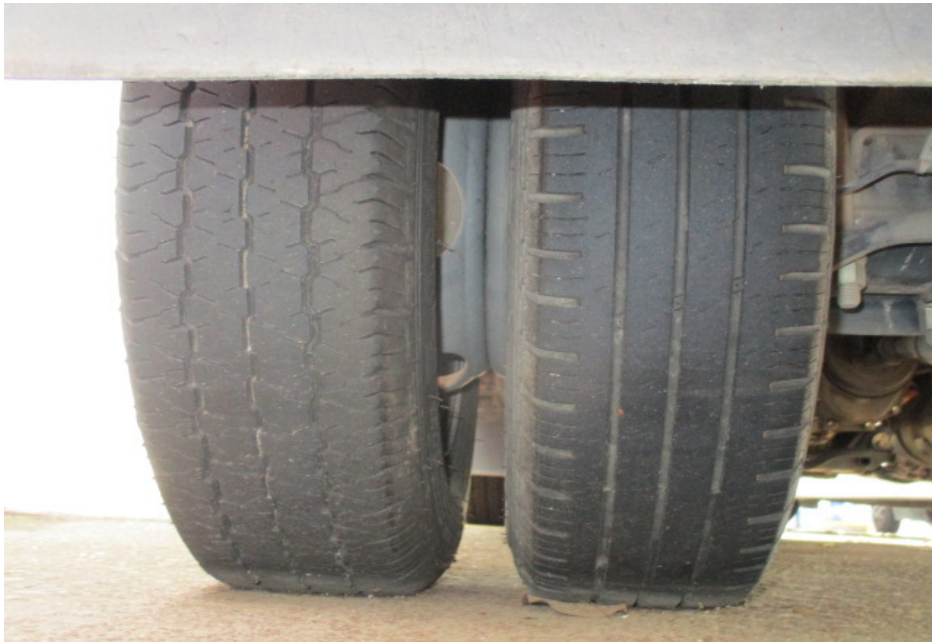
**Photo 6** shows the condition of the rear left tyres of the Motor Lorry, which was observed to be in serviceable condition with remaining tread depth of approximately 3mm. The tyres, which were wrapped around standard alloy wheel rim, were also observed to be sufficiently inflated for vehicular operation. There was also no damage found on all 6 alloy wheel rims of the Motor Lorry.

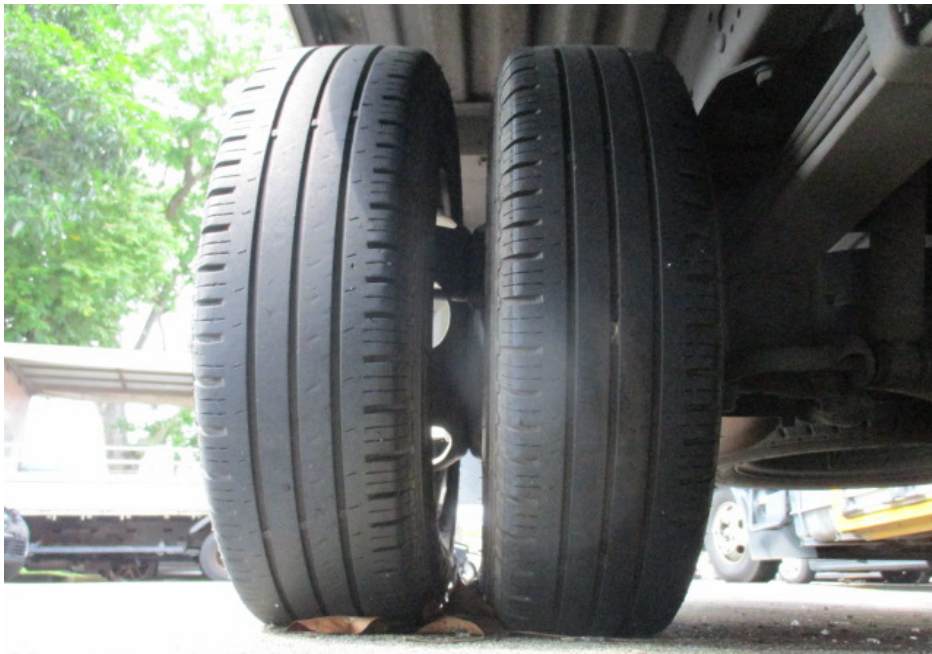
**Photo 7** shows the condition of the rear right tyres of the Motor Lorry, which were observed to be in serviceable condition with remaining tread depth of approximately 3mm. There was also no tear, cut or burst mark(s) on the outer and the inner sidewalls as well as across the tread of the 6 tyres that were fitted on the Motor Lorry.

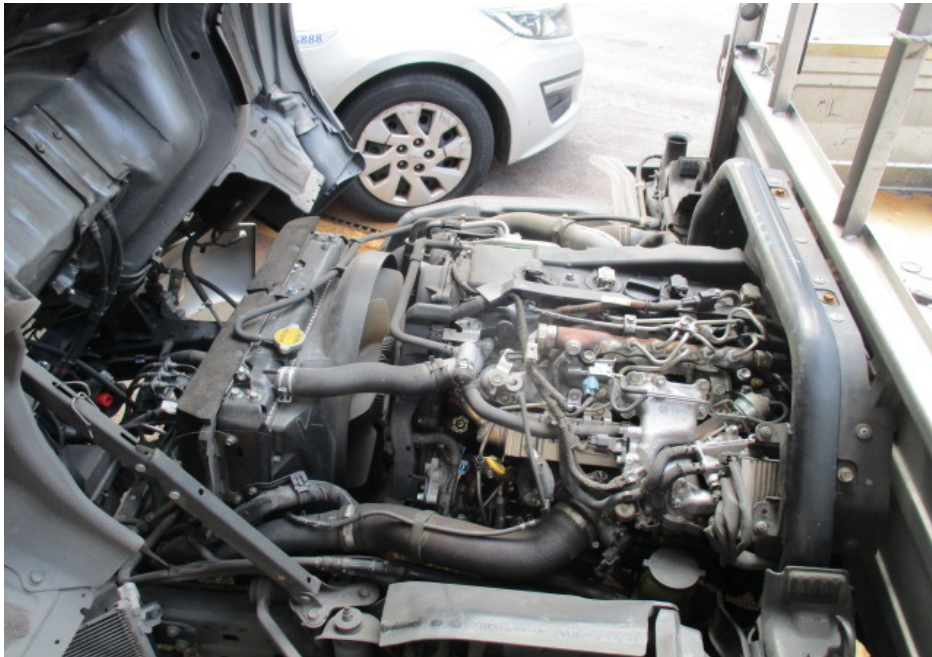
**Photo 8** shows a general view of the Motor Lorry's engine compartment, which was accessed by lifting the front cabin of the Motor Lorry. The various parts and components inside the engine compartment were unaffected by the accident. There was also no sign(s) or indication(s) of fresh fluid leakage and/or fluid stain within the engine compartment (photograph shows the engine compartment as viewed from the left front side of the Motor Lorry).

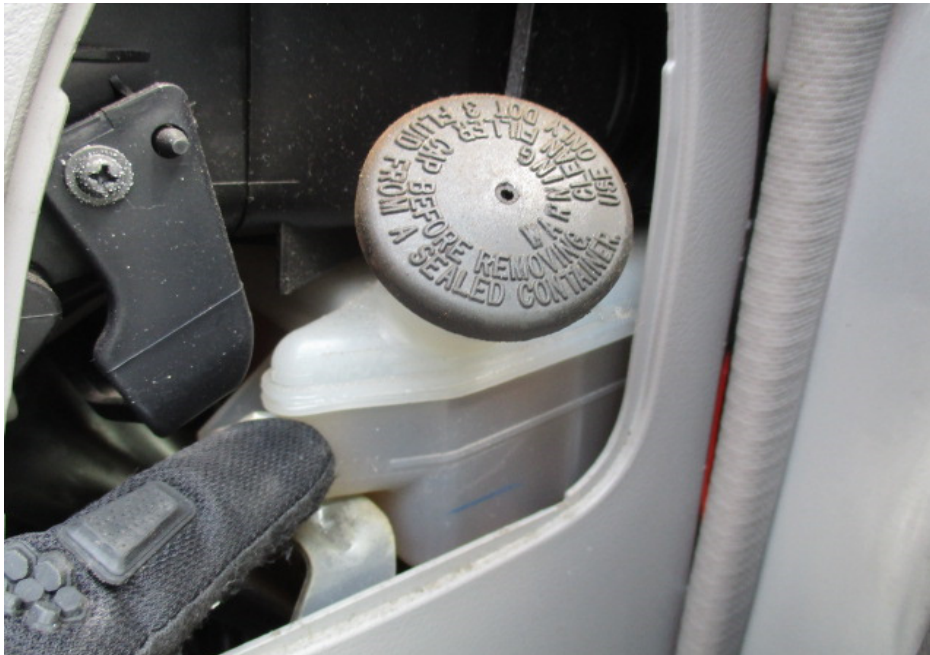
**Photo 9** shows the brake fluid reservoir of the Motor Lorry at the time of our inspection. The brake fluid was observed to be of sufficient level and without any visible contamination.

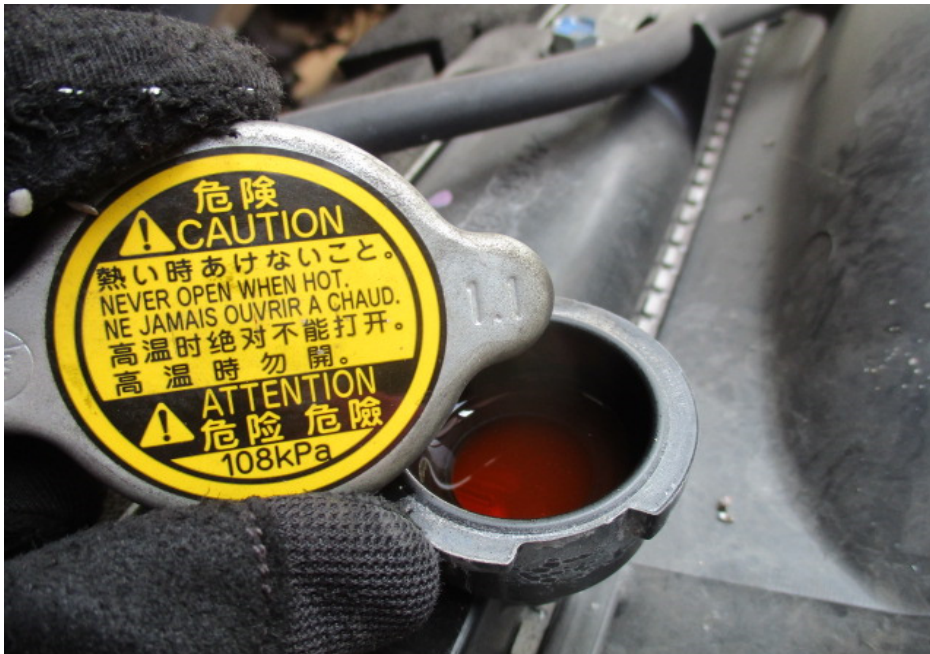
**Photo 10** shows the engine coolant of the Motor Lorry at the time of our inspection. The engine coolant was observed to be of sufficient level and without any visible contamination.

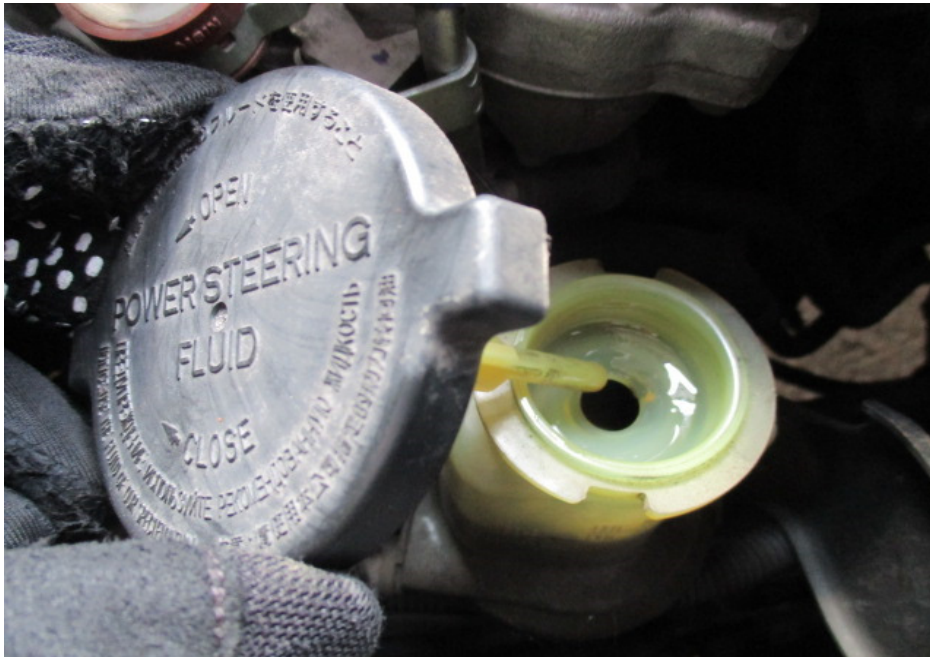
**Photo 11** shows the power steering fluid reservoir of the Motor Lorry at the time of our inspection. The power steering fluid was observed to be of sufficient level and without any visible contamination.

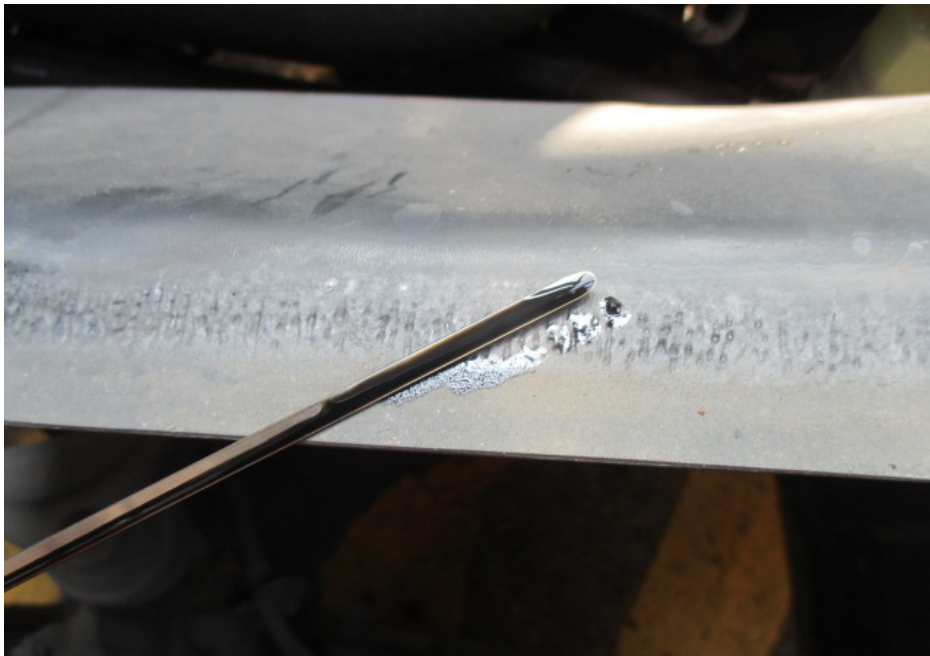
**Photo 12** shows the engine dip stick of the Motor Lorry at the time of our inspection. The engine oil was observed to be of sufficient level and without any visible contamination.

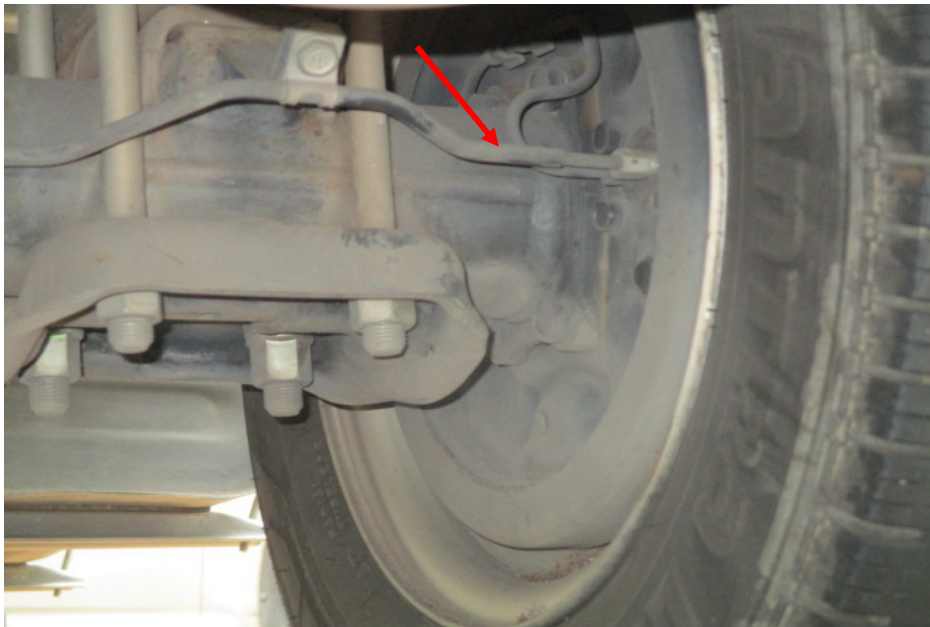
11. Static brake tests conducted on the Motor Lorry revealed no abnormality. The brake booster had responded well to the various tests conducted. There was also no abnormal movement of the brake pedal when it was depressed. In general, the static brake tests had suggested that there was no internal leakage of pressure/vacuum in the braking system of the Motor Lorry. The braking system of the Motor Lorry was likely to be in serviceable condition at the material time. This was also taking into consideration that the brake fluid was of sufficient level, and also that there was no sign(s) of brake fluid leakage along the brake hoses and brake pipes.

**Photo 13** shows the brake pipe (arrowed) at the rear right wheel of the Motor Lorry. We did not observe any leakage of brake fluid at the time of our inspection of the Motor Lorry. Our static tests of the Motor Lorry's braking system, along with our visual examination of the various mechanical components in the braking system, had indicated that there was no internal leakage of pressure/vacuum. Hence the braking system of the Motor Lorry was likely to be in serviceable condition at the material time of accident.

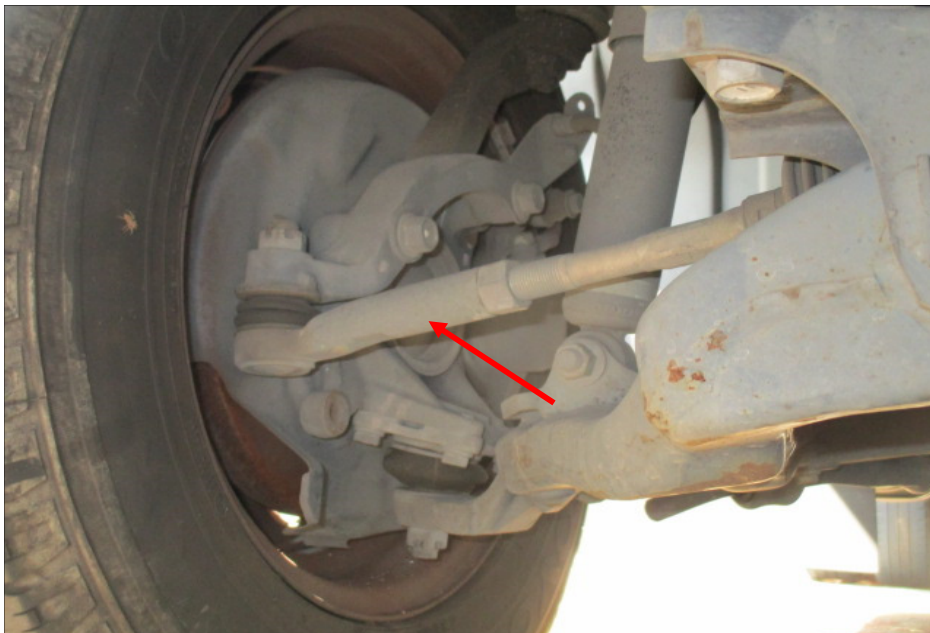
**Photo 15** shows the various undercarriage components at the front right wheel of the Motor Lorry, in particular the steering tie rod end (arrowed). The various steering components were all found to be intact, suggesting that the steering system of the Motor Lorry was likely to be in serviceable condition at the material time of accident. There was also no sign of fluid stain(s) observed on the various undercarriage components.

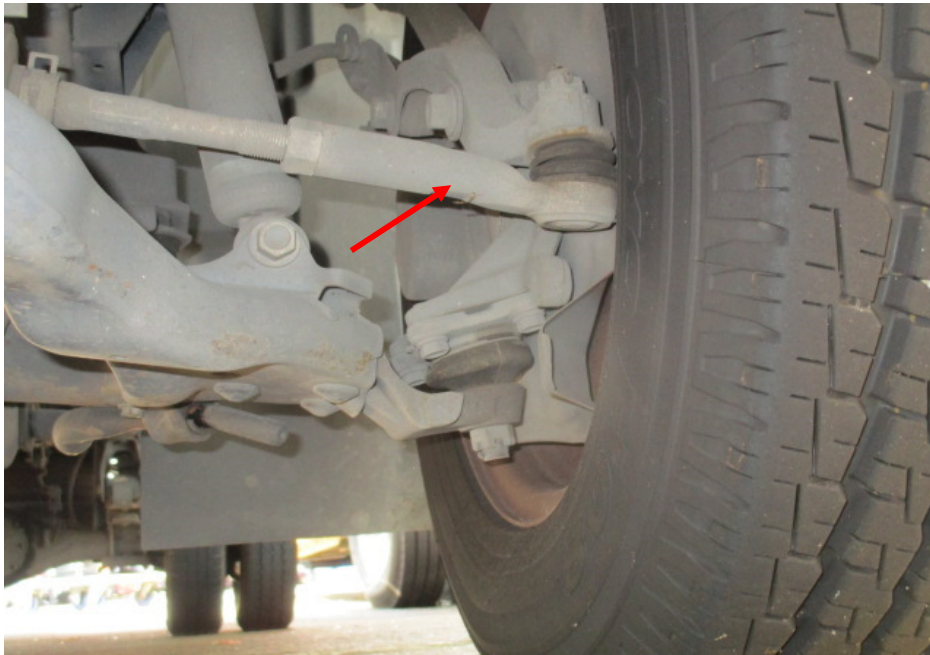
**Photo 16** shows the various undercarriage components at the front left wheel of the Motor Lorry, in particular the steering tie rod end (arrowed). The various undercarriage components of the Motor Lorry were all found to be intact without any visible damage. There was also no sign of fluid stain(s) observed on the various undercarriage components.
