Your Ref: TP/IP/69599/2018  
Our Ref :CI/TPD19000760/Z

**Fatal Accident Investigation Team**

**MECHANICAL INSPECTION REPORT OF MOTORCYCLE FBB 8612Y**

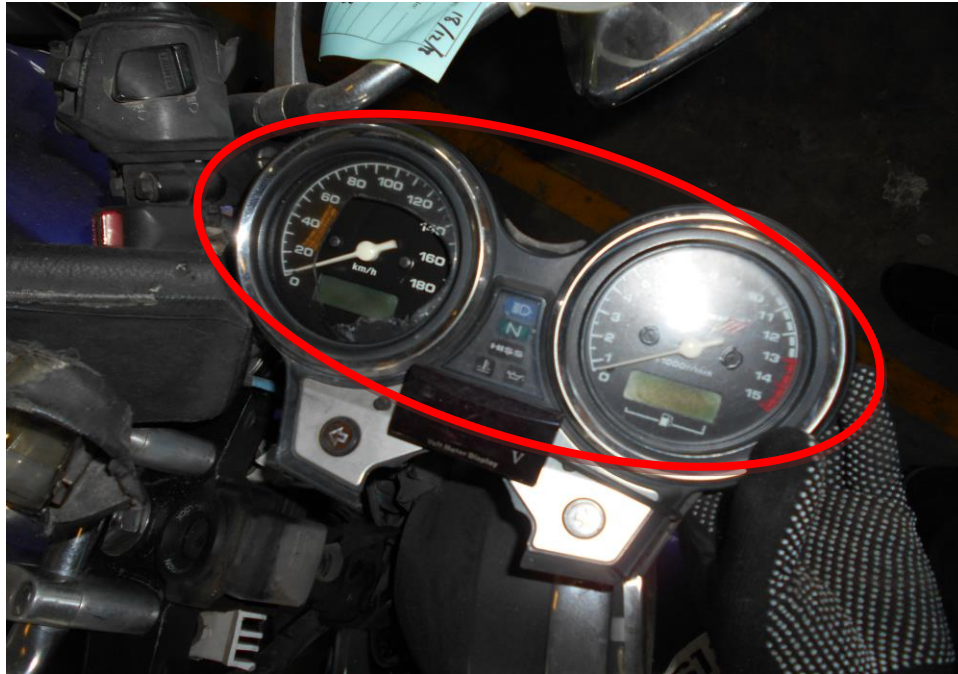
**Photo 1** shows the speedo-meter of the Motorcycle where it was found dislodged from the original installation.

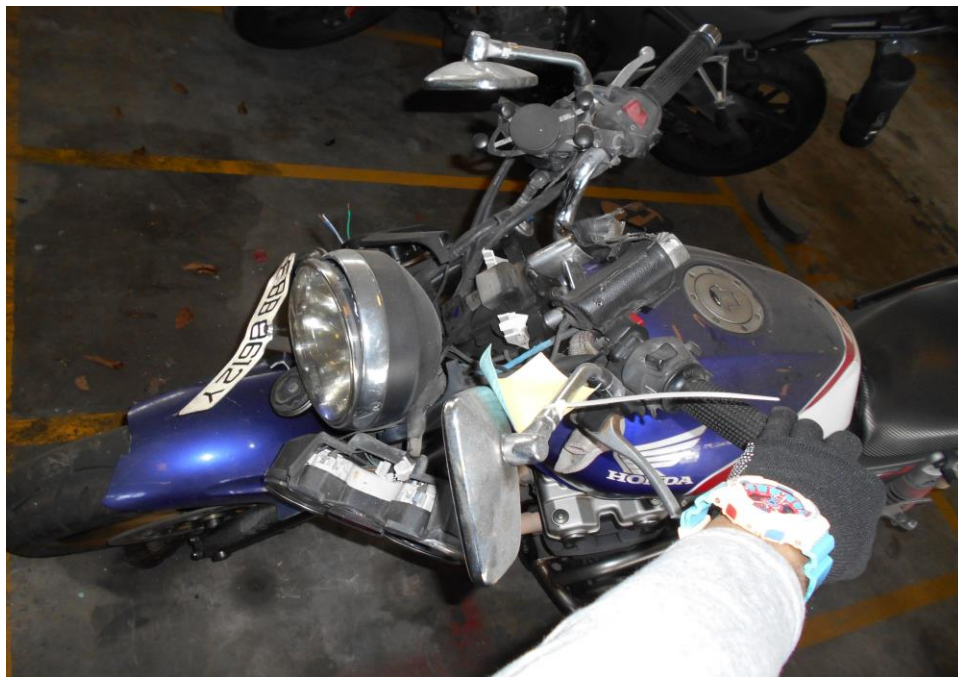
**Photo 2** shows a general view of the front portion of the Motorcycle at the time of our inspection. The Motorcycle was observed to be sustained with damages due to the accident collision.

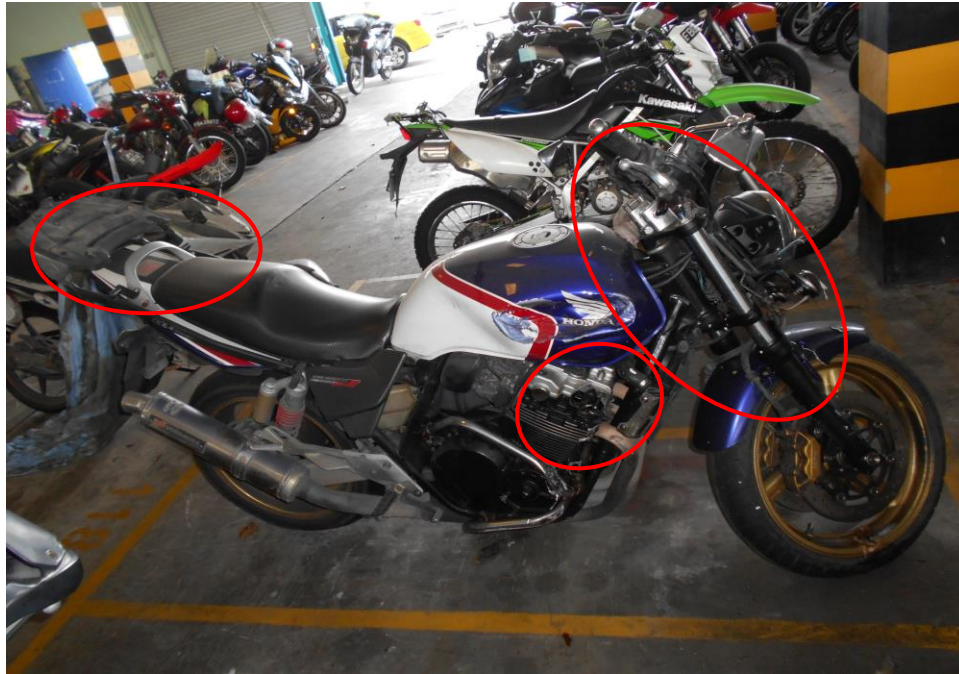
**Photo 3** shows a general view of the right body of the Motorcycle at the time of our inspection. The Motorcycle was observed to have sustained extensive damages at the frontal, rear portion & along its right side. (Circled)

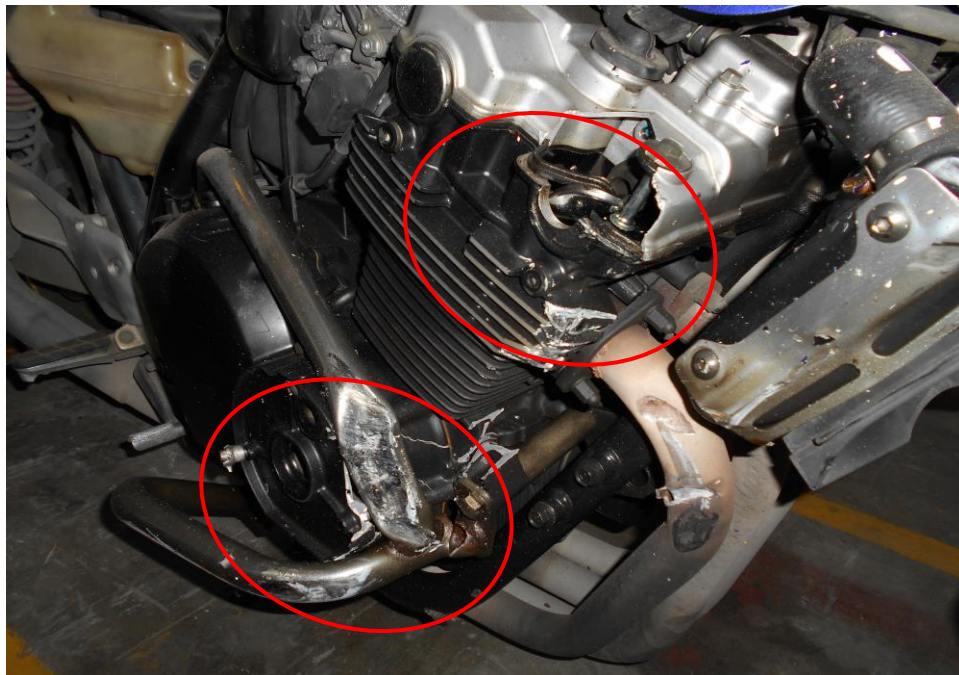
**Photo 4** shows a closer view of the right side of the engine of the Motorcycle at the time of our inspection that was observed to have sustained with extensive damages due to the accident collision. (Circled)

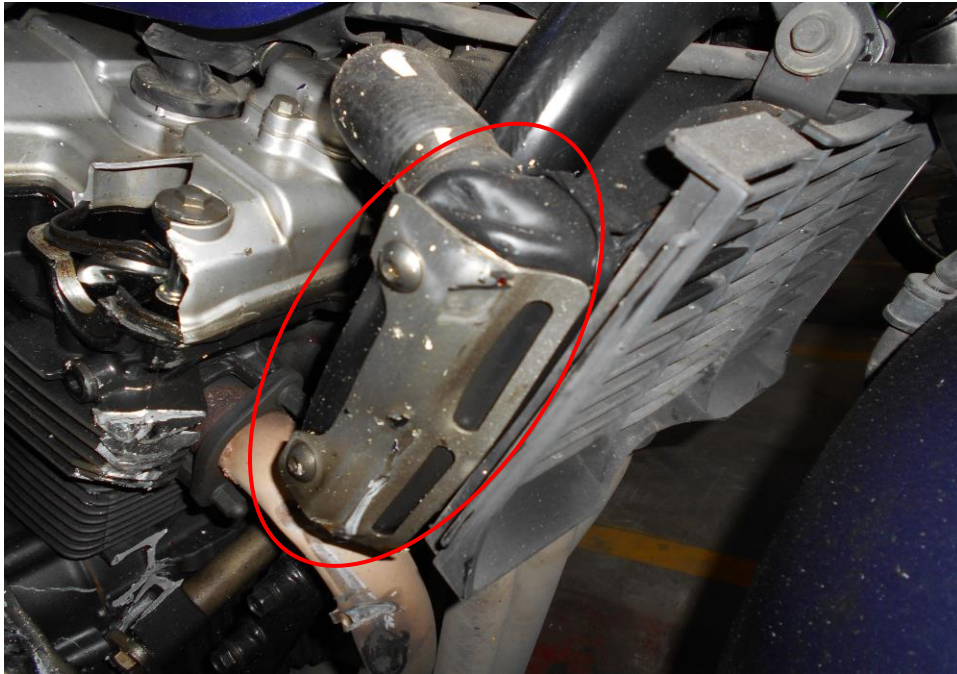
**Photo 5** shows the damaged radiator as a result of the accident.(Circled)

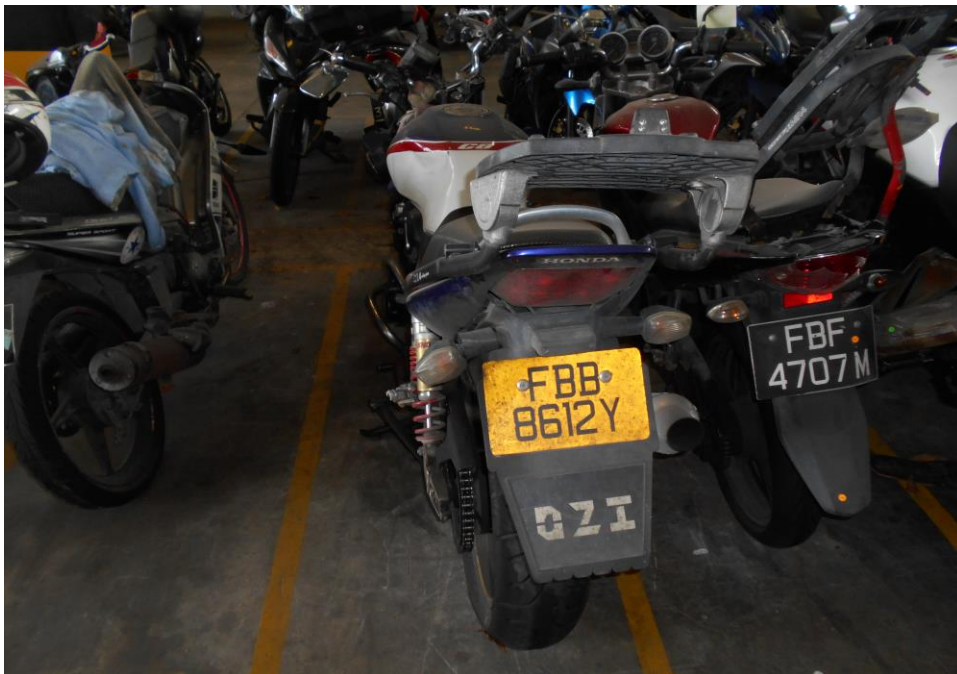
**Photo 6** shows a rear view of the Motorcycle at the time of our inspection. It was observed to sustain damages caused by the accident.

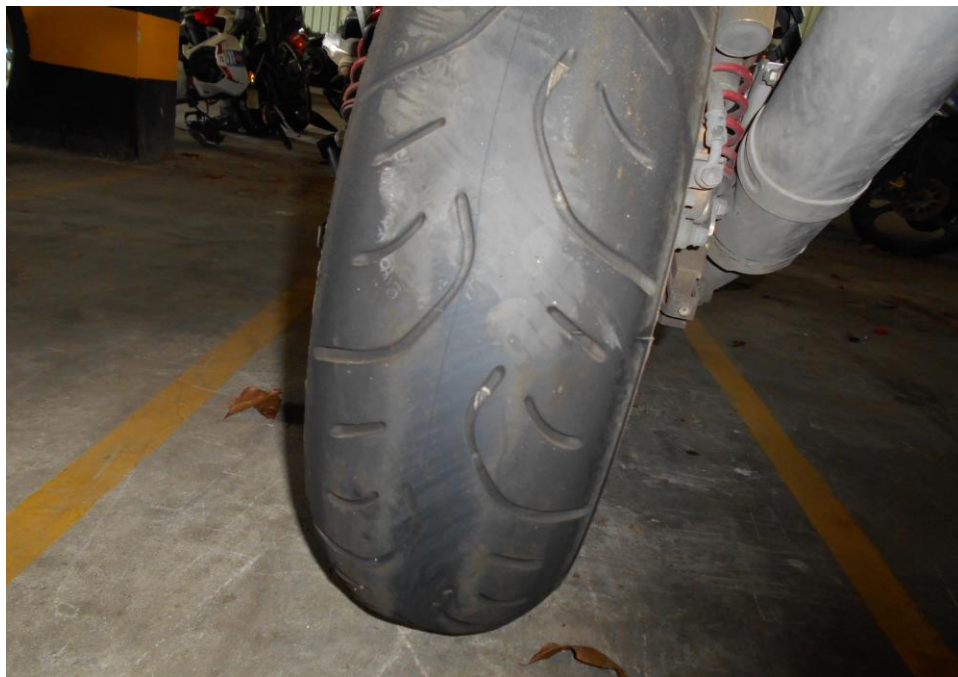
**Photo 7** shows the rear tyre of the Motorcycle. The rear tyre was observed to be in serviceable condition with remaining tread depth of approximately 4mm. However, it was observed to be deflated likely due to the accident's impact.

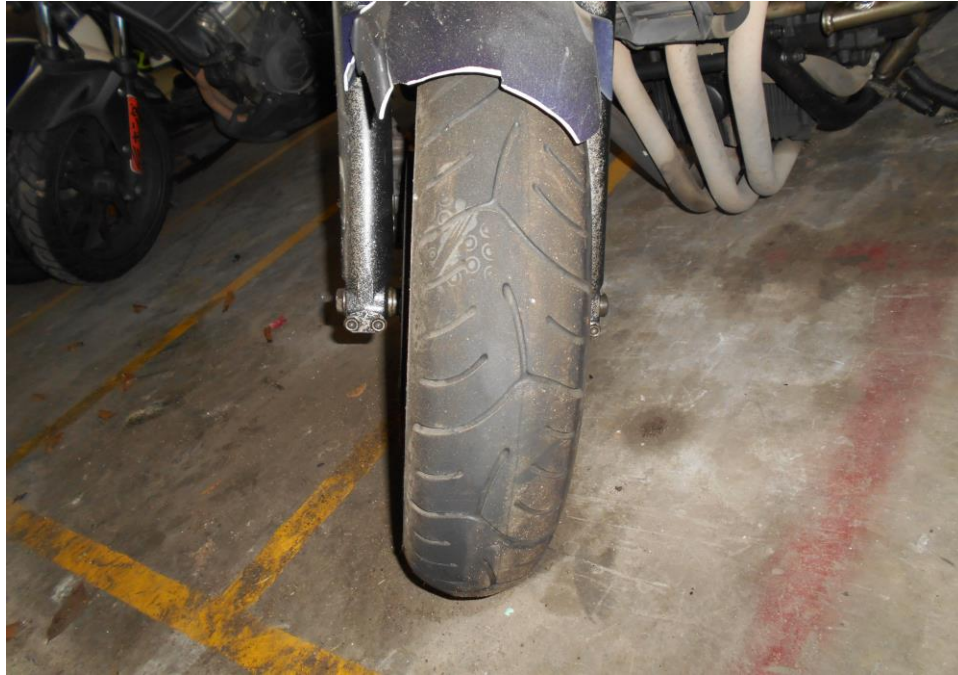
**Photo 8** shows the front tyre of the Motorcycle. The pattern of the tread was clearly visible. There was no tear, burst mark(s) and/or punctured hole(s) on the sidewalls as well as across the tread of the front tyre with thread depth of 4mm.

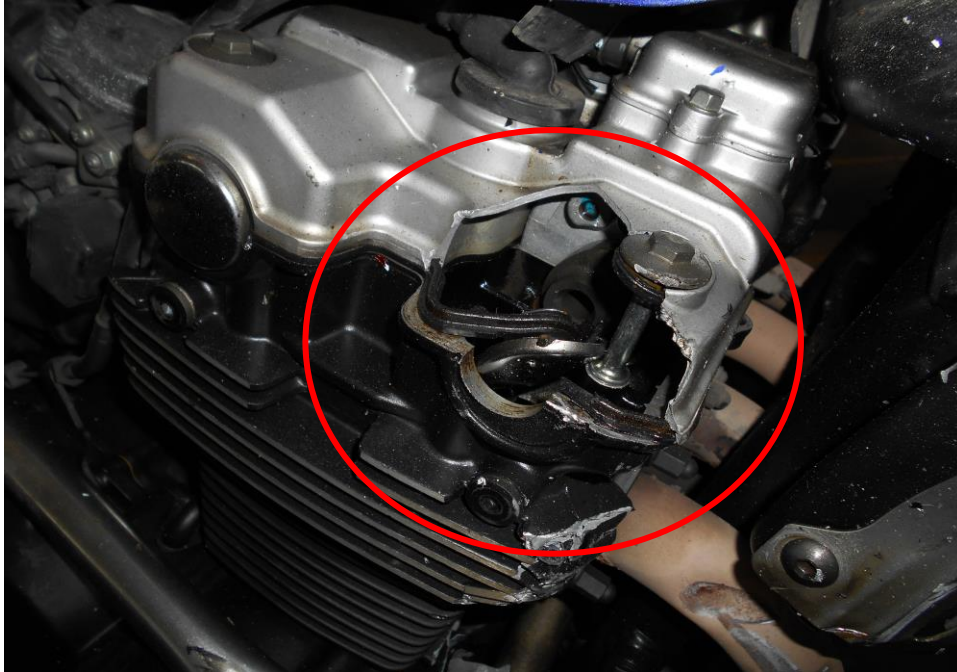
9. Upon examination of the Motorcycle's engine area, we had observed that the engine block had sustained with extensive damages due to the accident's collision impact. Hence, causing the operating fluids such as engine fluid to leak from the cracked/ damage areas.
10. The gear chain of the motorcycle was found to be intact at time of our examination. However, it was observed to be misaligned likely due to the accident's impact collision. Free play tension test was unable to be conducted due to the misalignment of the gear train system. Hence, it was unacceptable for operating purposes. See photo 9 – 12 below.

**Photo 9** shows extensive damages on the engine block. It was observed to be damaged as a result of the accident.

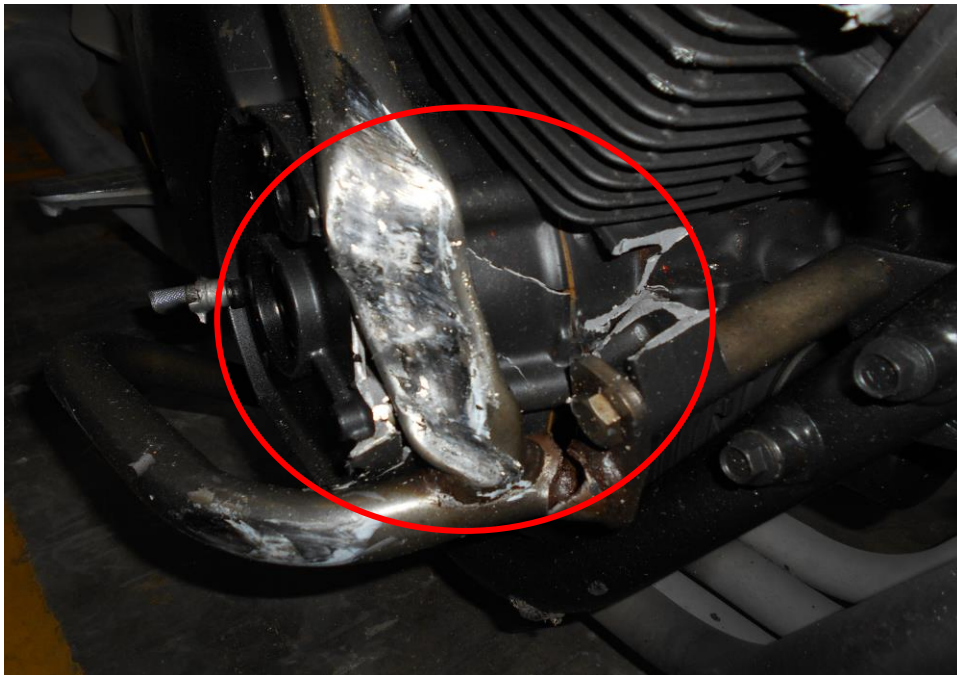
**Photo 10** shows the damaged crash bar as a result of the accident.

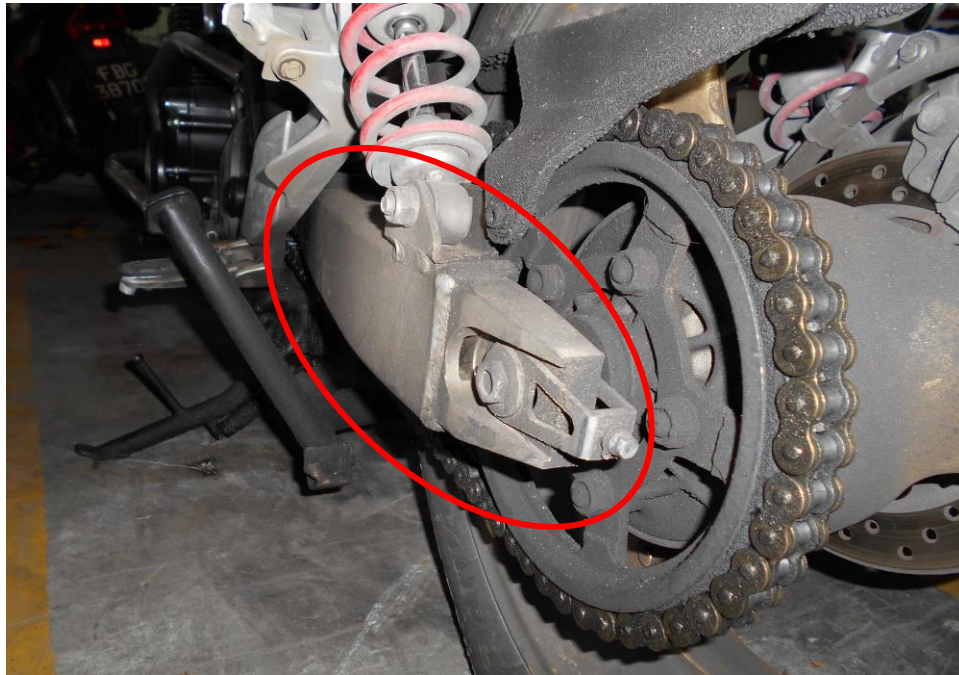
**Photo 11** shows the gear chain of the motorcycle was found to sustained slight misalignment due to the accident's impact. However, it was observed to be adequately lubricated for operating purposes.

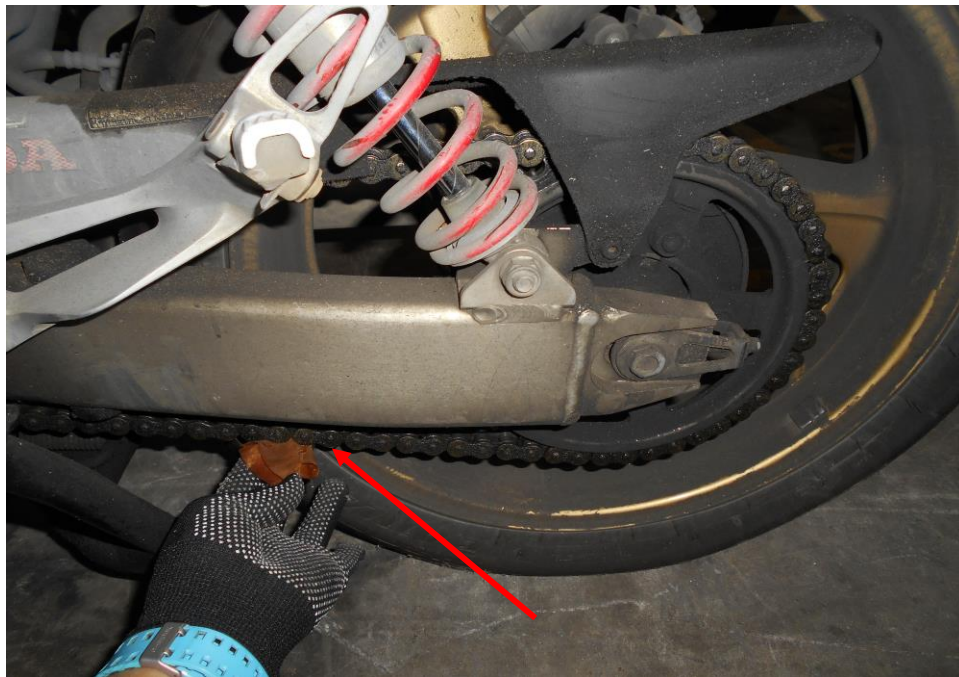
**Photo 12** shows the general view of the gear train (arrowed) of the Motorcycle, which was observed to be tight due to the misalignment. Free play tension was unable to be established. Conclusively, it was unacceptable for operating purposes.

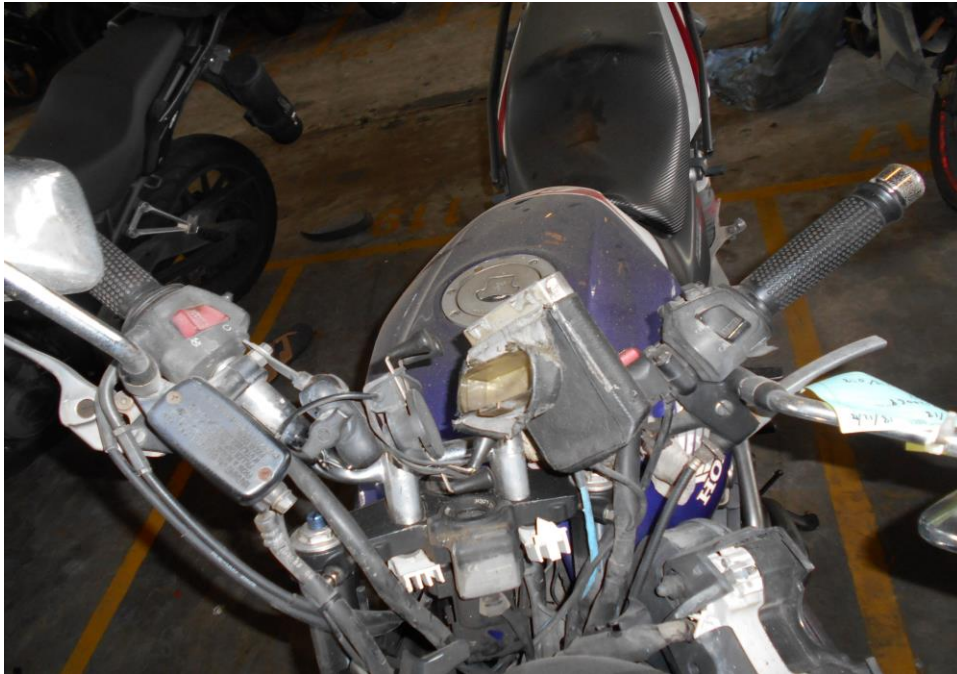
11. Our checks on the various steering components of the Motorcycle had revealed that its steering system was not in serviceable condition. Its handle bar was found to be bent/ damage likely due to the accident's impact collision.

**Photo 13** shows the handle bar was observed to be damaged by the accident's impact. It was observed to be misaligned likely due to the accident's impact.

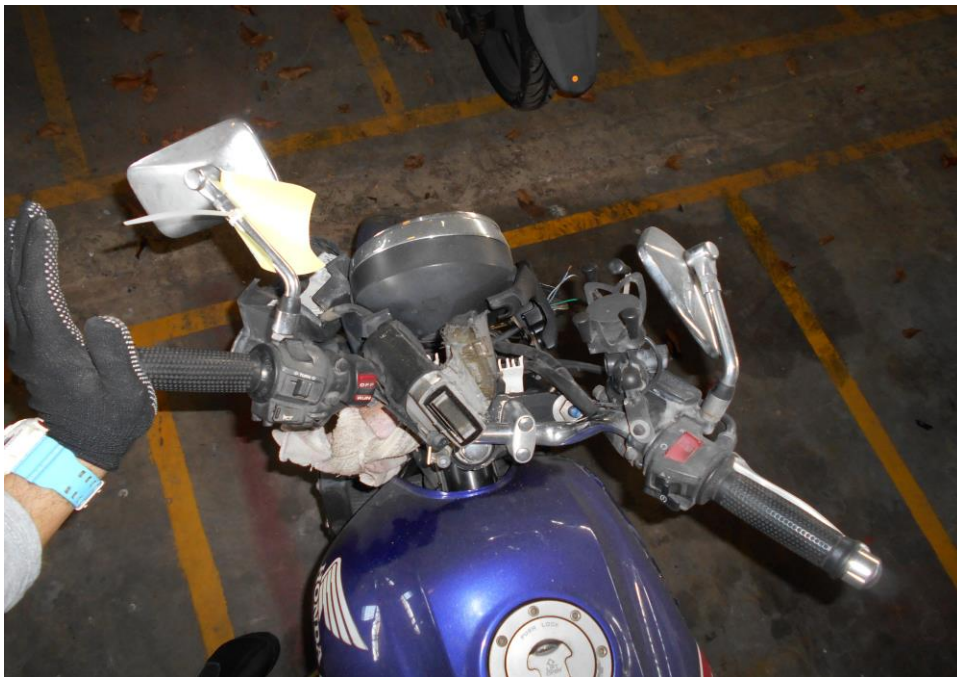
**Photo 14** shows the steering system was observed to be damaged likely due to the accident's impact.

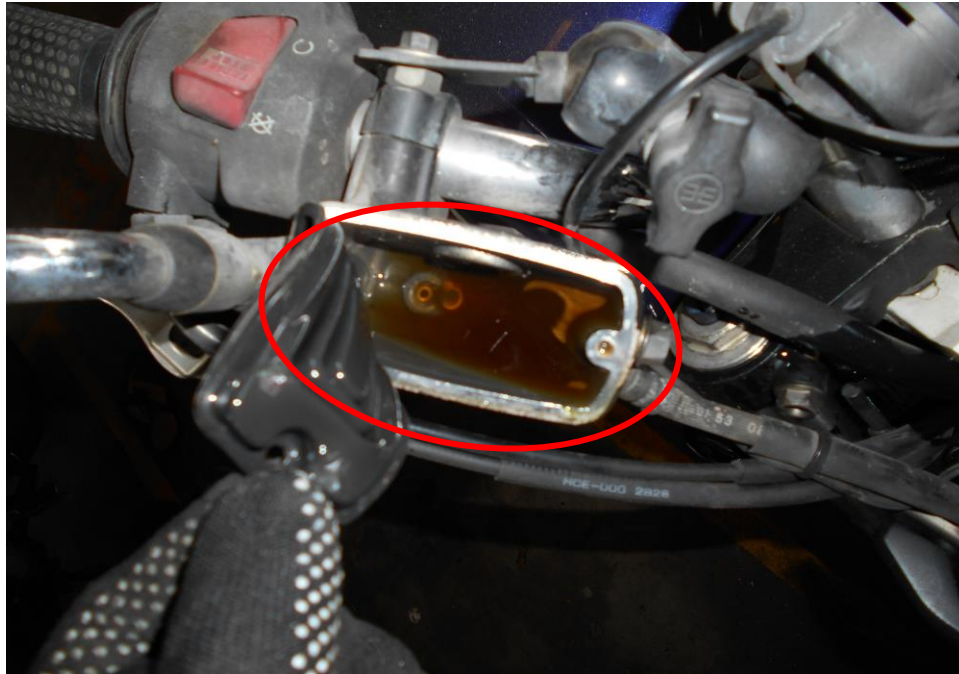
**Photo 15** shows the fluid brake reservoir for the front brake that was observed to be unaffected by the accident. It was observed to be with sufficient level of brake fluid without any contamination.

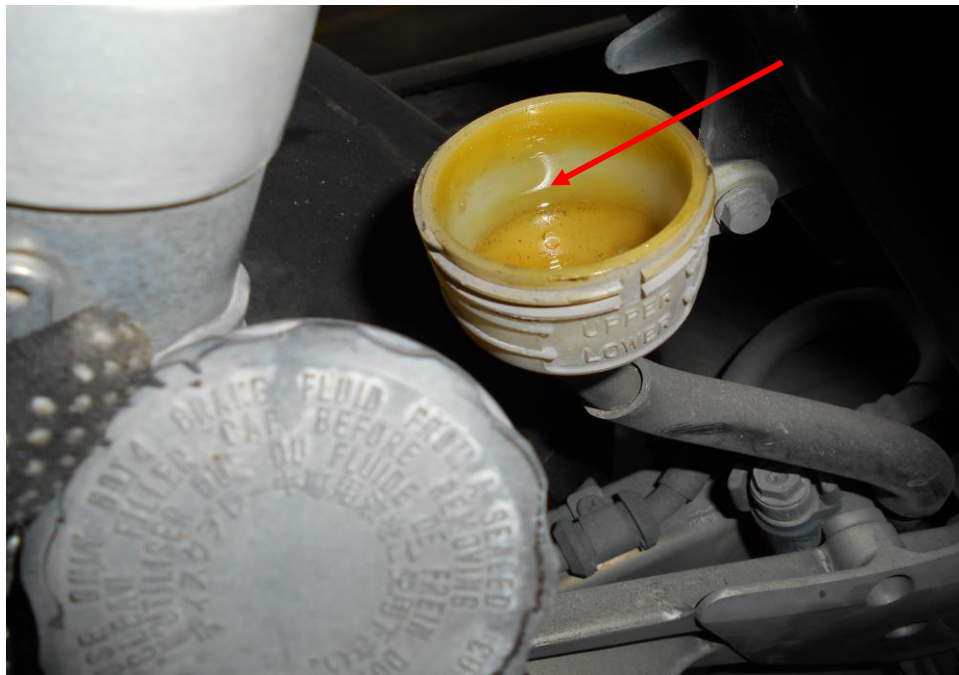
**Photo 16** shows the brake fluid reservoir for the rear brake. It was observed to be at sufficient level not affected by the accident.

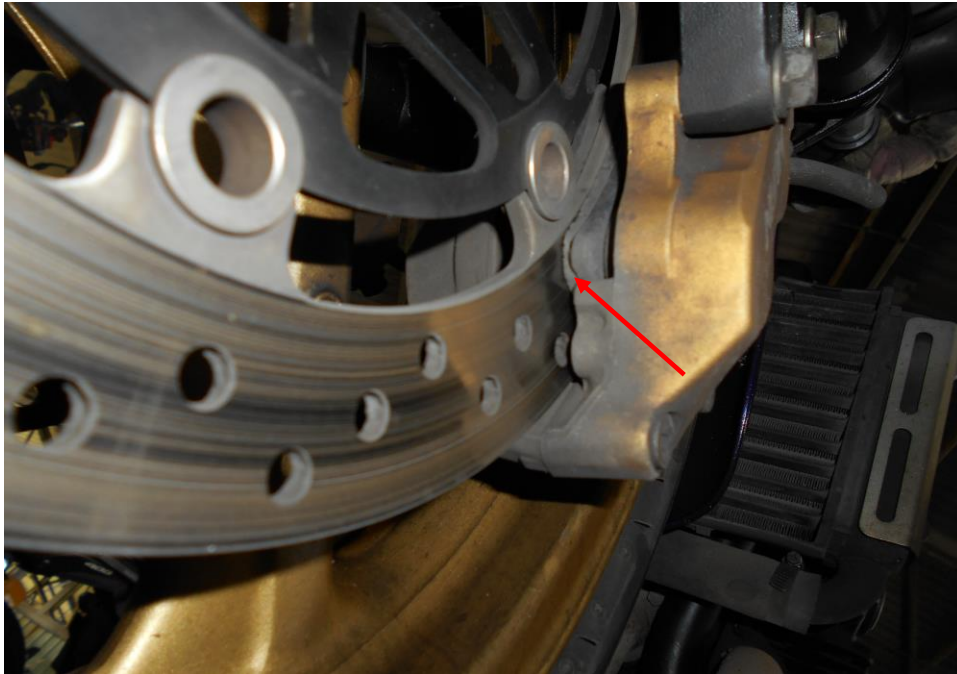
**Photo 17** shows the brake pad for the front brake, observed to be in serviceable condition at time of our inspection. The frictional material found to be sufficient for operational purposes.

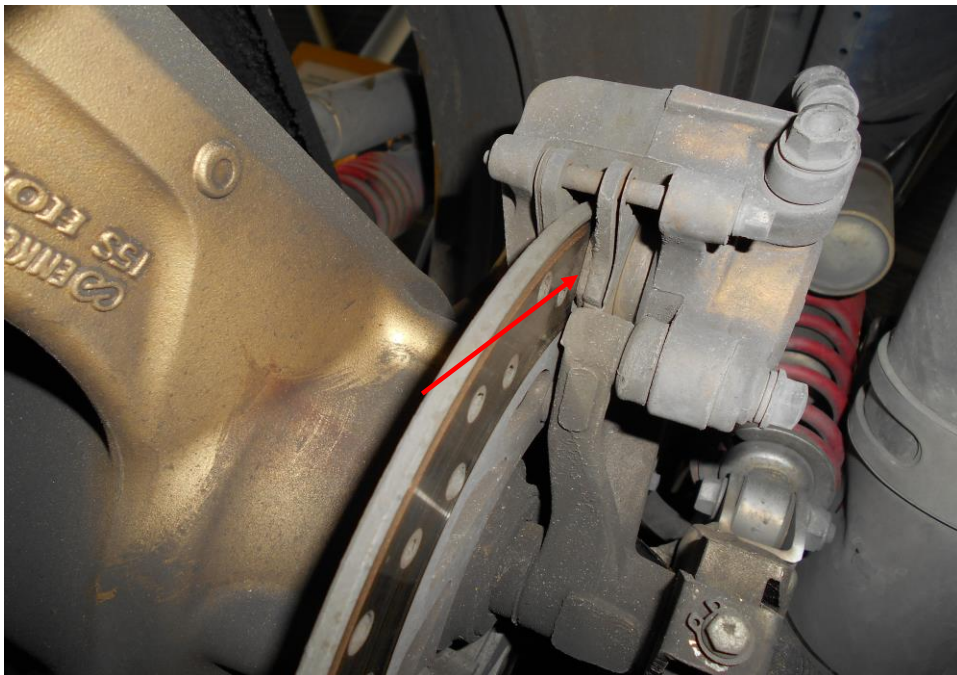
**Photo 18** shows the brake pad for the rear brake observed to be in serviceable condition at time of our inspection. The frictional material found to be sufficient for operational purposes.
