Your Ref: Mercedes Benz C200
(chassis number WDD2050422F329312)
Our Ref : CI/TP19001102/D

**INSPECTION REPORT OF AN UNREGISTERD MERCEDES BENZ C200
MOTOR CAR WITH CHASSIS NUMBER WDD2050422F329312**

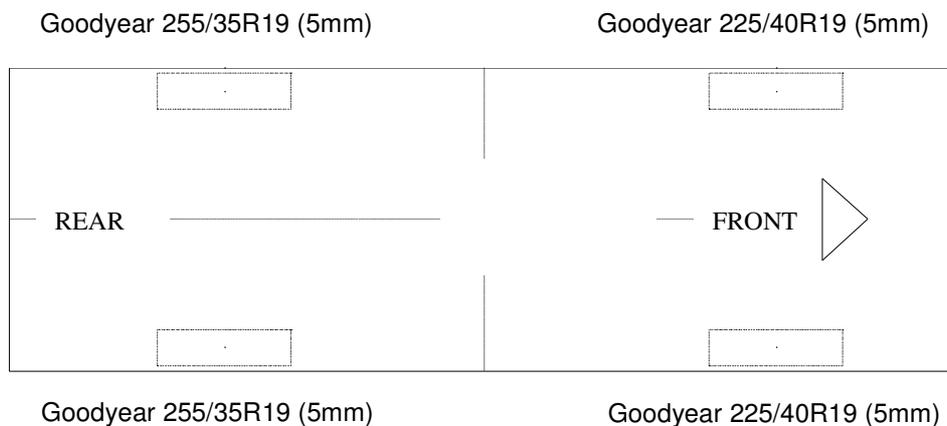
6. It was fitted with 19inch sport wheel rims that were wrapped with tyres that were observed to be of serviceable condition. The tyres were also sufficiently inflated for vehicular operation. The tyre brand, tyre size and approximate remaining tread depth of the 4 tyres of the Motor Car were recorded as follows: -

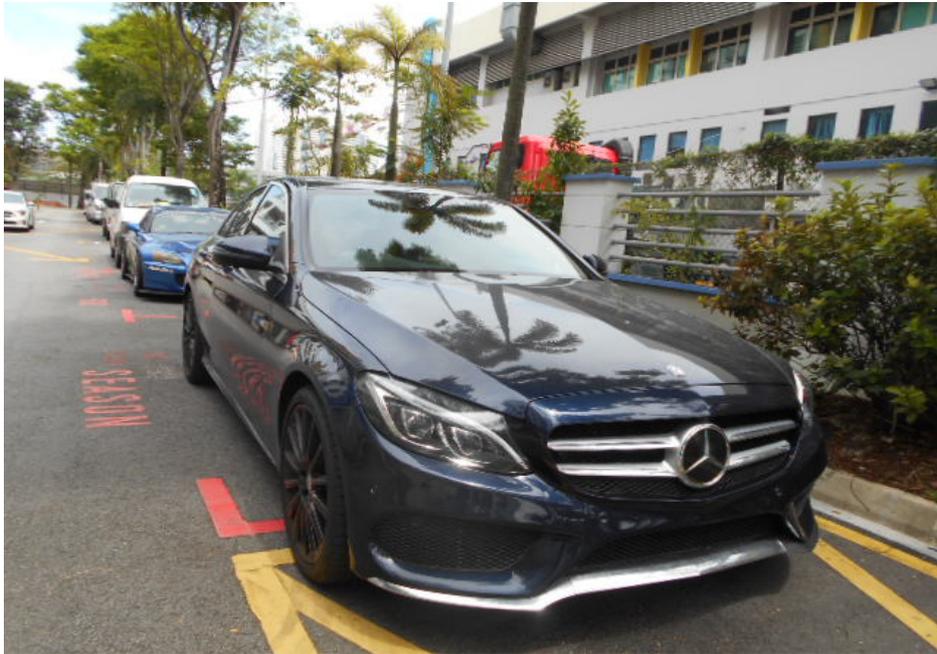
Photo 1 shows a general view of the front right body of the Motor Car at the time of my inspection. The Motor Car was observed to be in relatively good general condition with no loose exterior fittings observed.

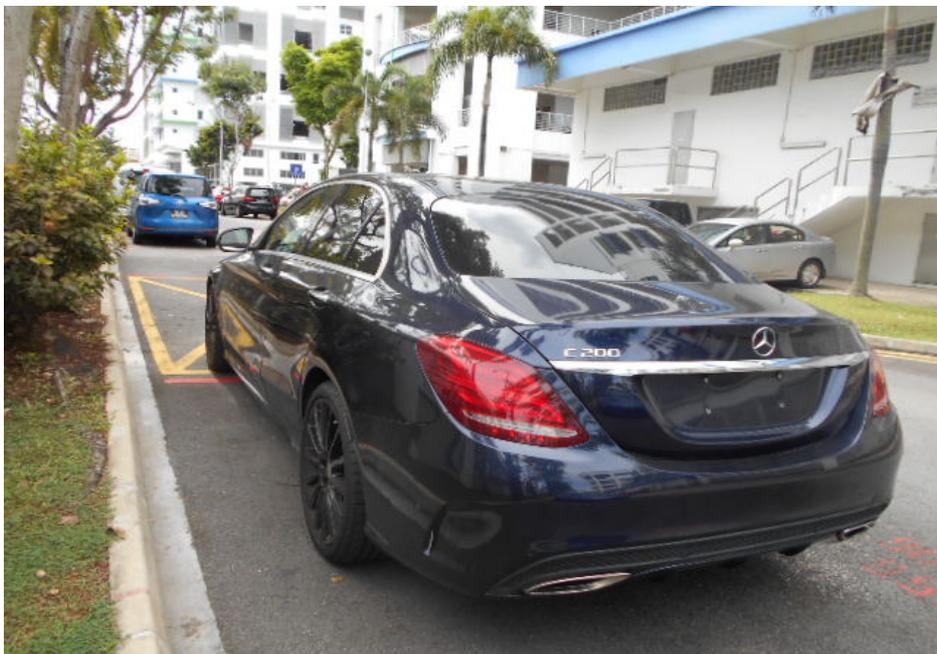
Photo 2 shows a general view of the rear left body of the Motor Car at the time of my inspection. The Motor Car was observed to be in relatively good general condition with no loose exterior fittings observed.

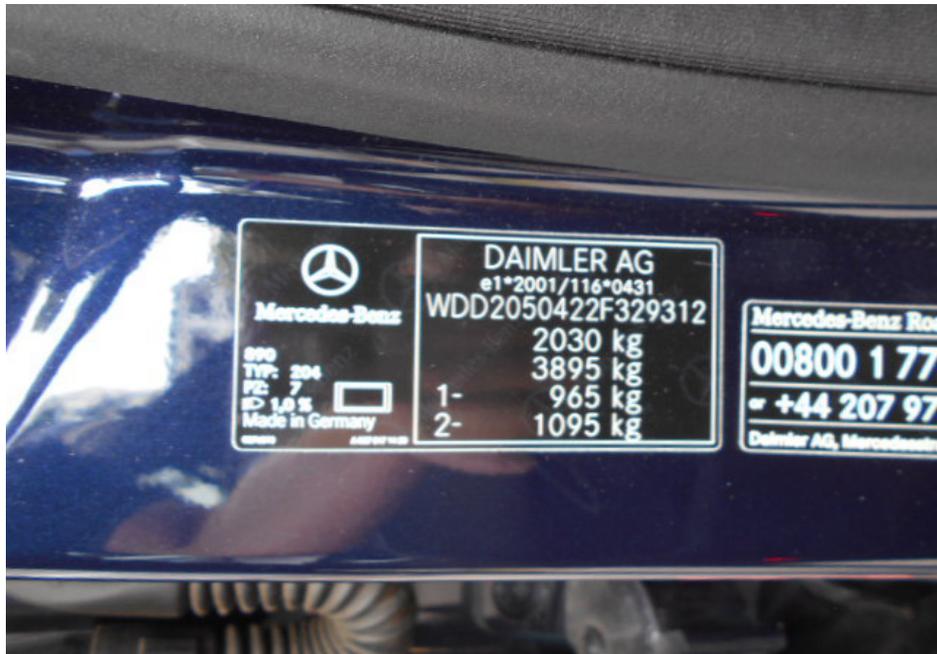
Photo 3 shows the chassis number of the Motor Car. The chassis number recorded was WDD2050422F329312.

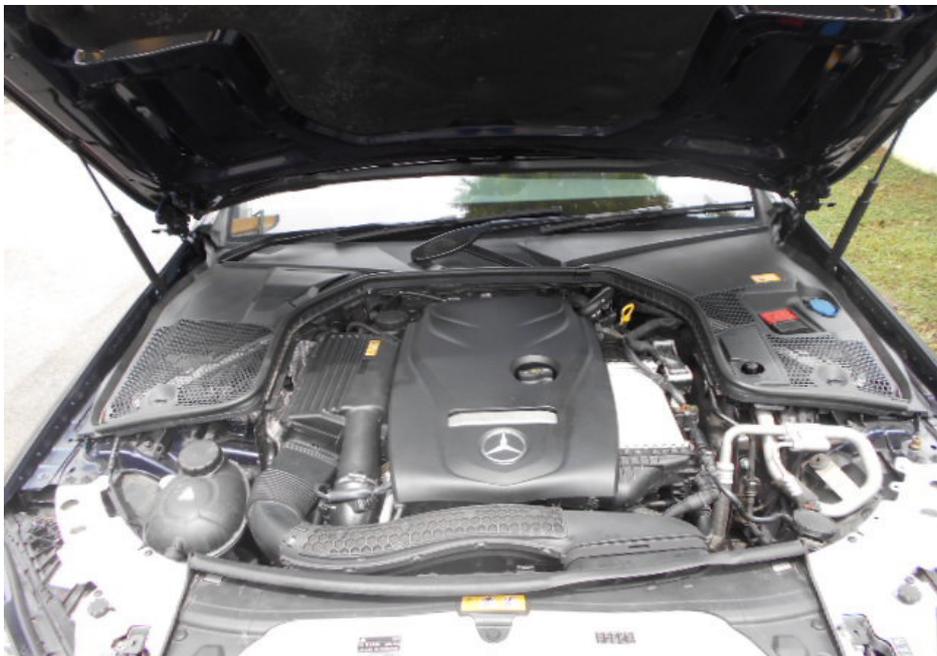
12. My examination of the engine compartment of the Motor Car revealed that the various parts and components inside the engine compartment were all intact and properly fitted. The engine oil, brake fluid and engine coolant were all found to be of sufficient level for operating purposes. Visually, there was also no contamination found to these fluids.

Photo 4 shows a general view of the engine compartment of the Motor Car at the time of my inspection. The various parts and components inside the engine compartment were all observed to be intact and properly fitted. There was also no sign(s) or indication(s) of fluid leak and/or fluid stain found inside the engine compartment. The engine oil, brake fluid and engine coolant were all found to be of sufficient level for operating purposes. Visually, there was also no contamination found to these fluids.

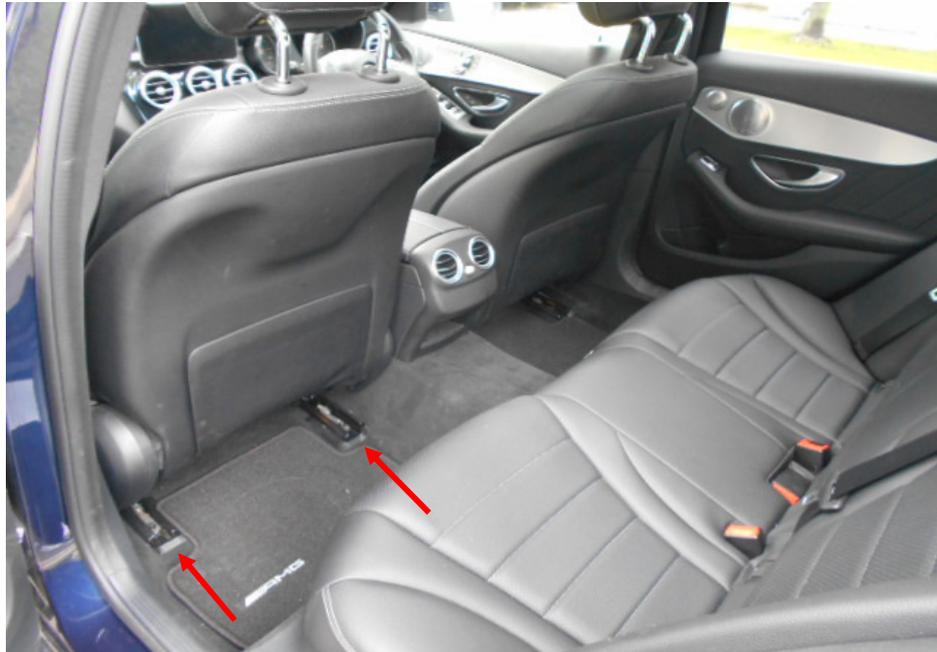
10. The seats of the Motor Car were found to be secured to the floor board of the Motor Car via seat rails bolted onto the floor board. Retractable seat belt reels and pre-tensioners were fitted on all seats of the Motor Car. The seat belt reels were able to be fastened securely to the respective pre-tensioner that is fixed to the side of all the seats.

Photo 5 shows the rear seats of the Motor Car. All the seats were secured via seat rails (arrowed) to the floor board. The seats were also fitted with a retractable seat belt reel and pre-tensioner. The seat belts were tested and able to be fastened to the pretensioners that were fitted on the side of each individual seat.

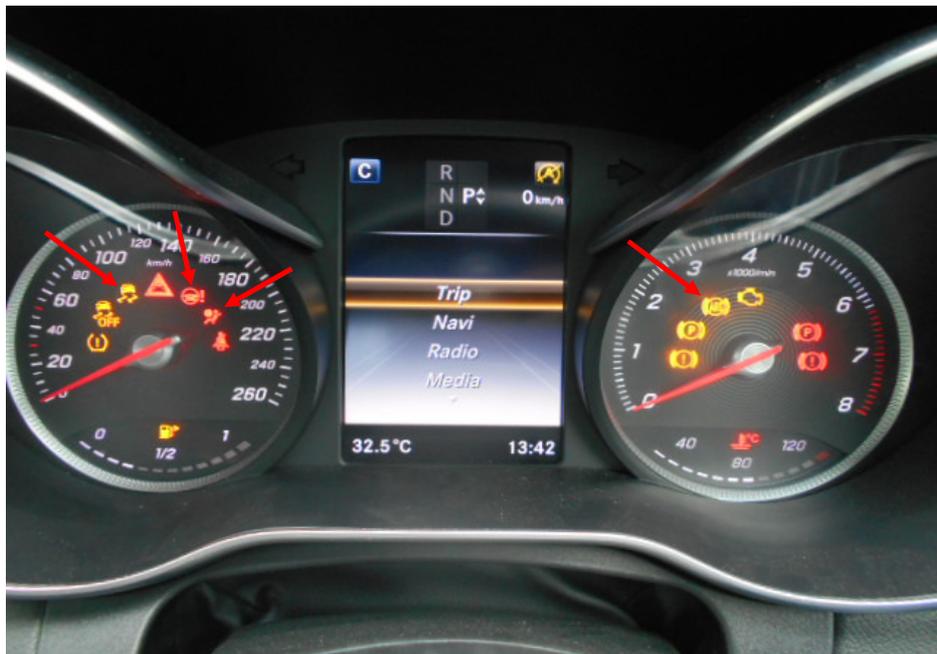
Photo 6 shows the warning lights for the various electronic safety features appearing on the instrument panel of the Motor Car during its self-test when the engine is cranked, in particular the ABS, SRS, PSA and TCS lights (arrowed).

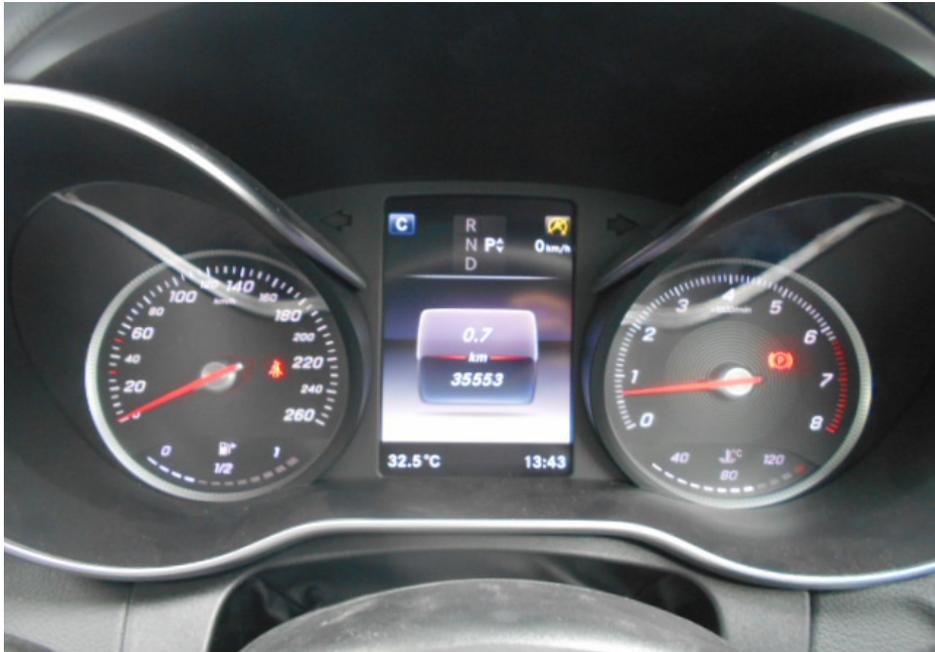
11. The Motor Car's automatic self-test of the functionality of its various electronic safety features like the Anti-Brake Lock System (ABS), Supplemental Restraint System (SRS), Power Steering Assist (PSA) and Traction Control System (TCS) during cranking of the engine had indicated that these electronic systems were in working condition. This was determined from the respective warning lights disappearing from the instrument panel after the self-test.

Photo 7 shows the respective warning lights no longer illuminated, indicating that there is no fault detected to the ABS, SRS, PSA and TCS systems of the Motor Car during the self-test. These electronic systems were hence in working condition at the time of my inspection.

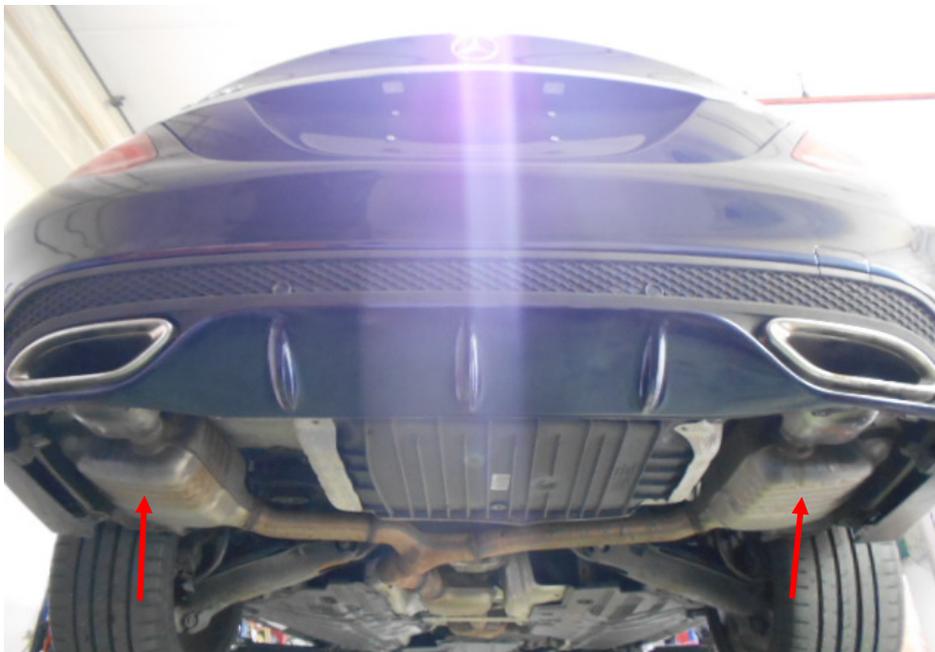
13. My checks on the underside of the Motor Car revealed no sign(s) or indication(s) of fluid leakage and/or fluid stain(s). The engine block and automatic transmission assembly were both secured properly. They were not mounted onto the chassis body or any integral body part of the Motor Car. All undercarriage components of the Motor Car were also observed to be intact and secured in an appropriate manner.

Photo 8 shows the Motor Car hoisted up for checks on its undercarriage. There was no sign(s) or indication(s) of fluid leakage and/or fluid stain(s). The undercarriage components of the Motor Car were all observed to be intact and secured in an appropriate manner. My examination of the Motor Car's exhaust system revealed no sign(s) or indication(s) of any cut or weld marks along its exhaust pipes and on its rear mufflers (arrowed).

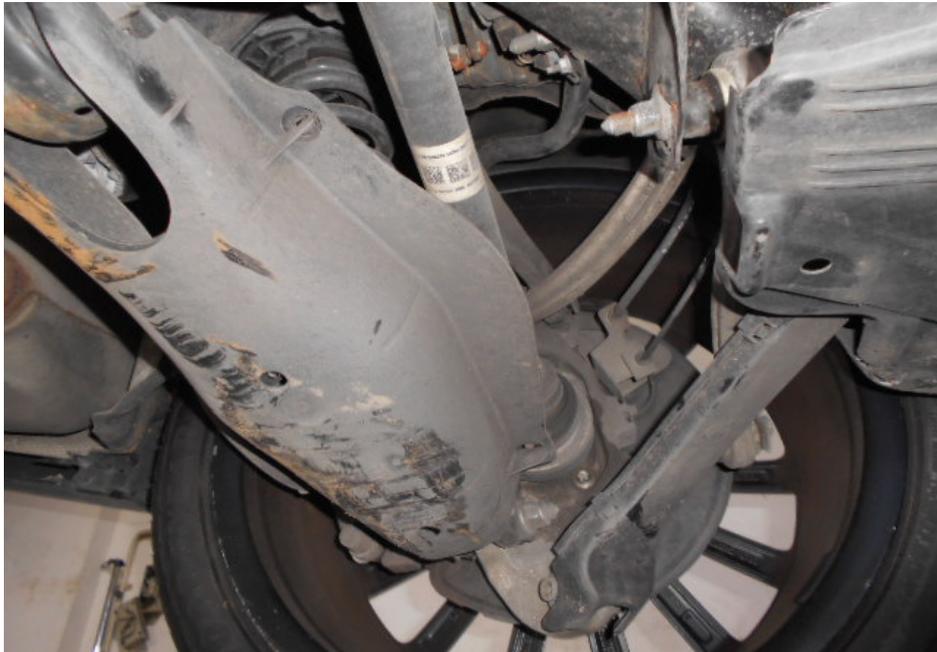
Photo 9 shows a general view of the control arms and linkages at the rear left wheel of the Motor Car. I did not observe any fluid leak and/or fluid stain on the underside of the Motor Car. All of the Motor Car's undercarriage components were observed to be intact and secured in an appropriate manner.

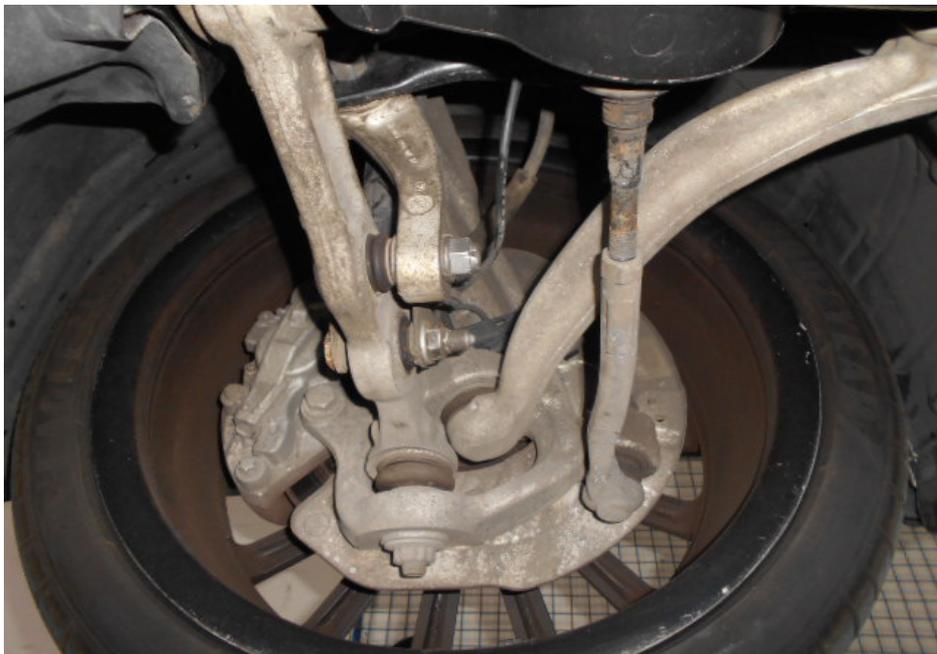
Photo 10 shows the various undercarriage components at the front left wheel of the Motor Car. The mechanical components, control arms and linkages were all found to be intact and secured in an appropriate manner.

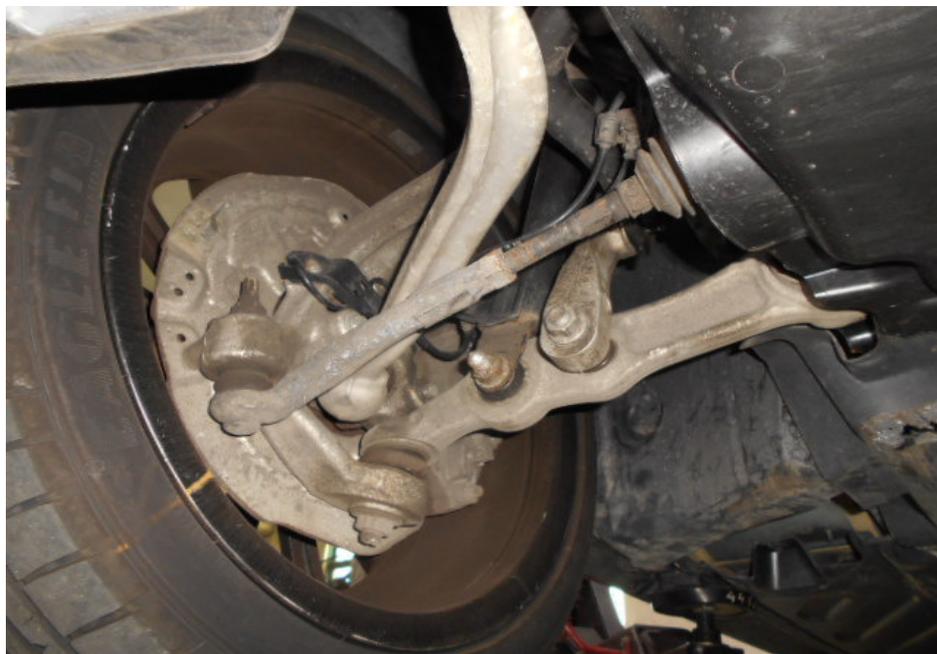
Photo 11 shows the various undercarriage components at the front right wheel of the Motor Car. The mechanical components, control arms and linkages were all found to be intact and secured in an appropriate manner.

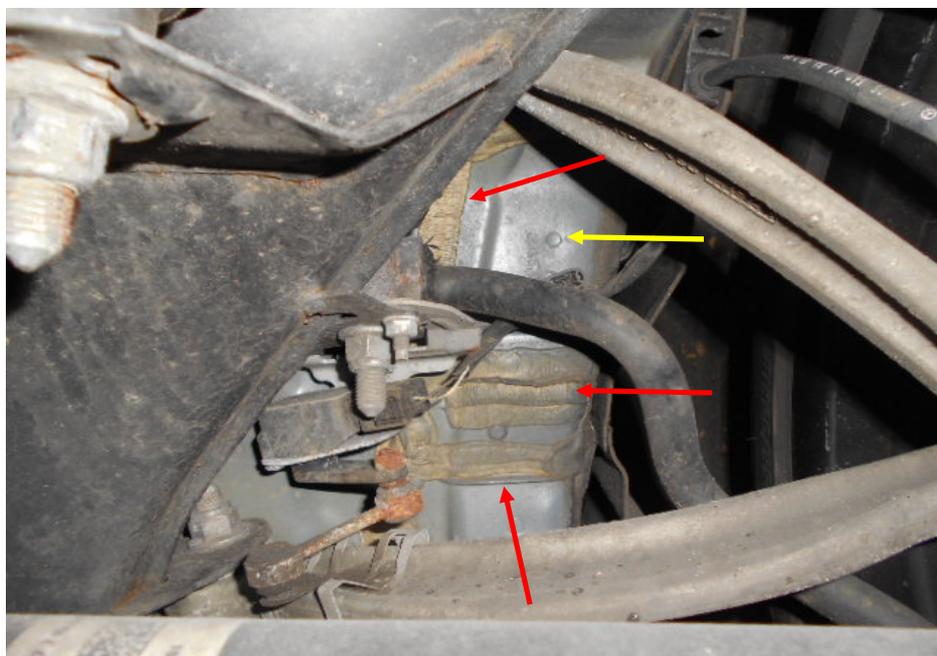
9. Visually, I did not find any weld marks, other than the original spot weld marks, on the chassis body of the Motor Car. The original factory sealant at the joints along the chassis body was also untouched, again indicating that no replacement of the chassis body was carried out; and that the chassis body was originally fitted.

Photo 12 shows the structural body at the rear left underside of the Motor Car. Visually, I did not find any weld marks other than original spot weld marks (yellow arrow) on the chassis body of the Motor Car. The original factory sealant (red arrow) at the joints along the chassis body was also untouched, indicating no work was done on the chassis body of the Motor Car and that the chassis body was originally fitted.

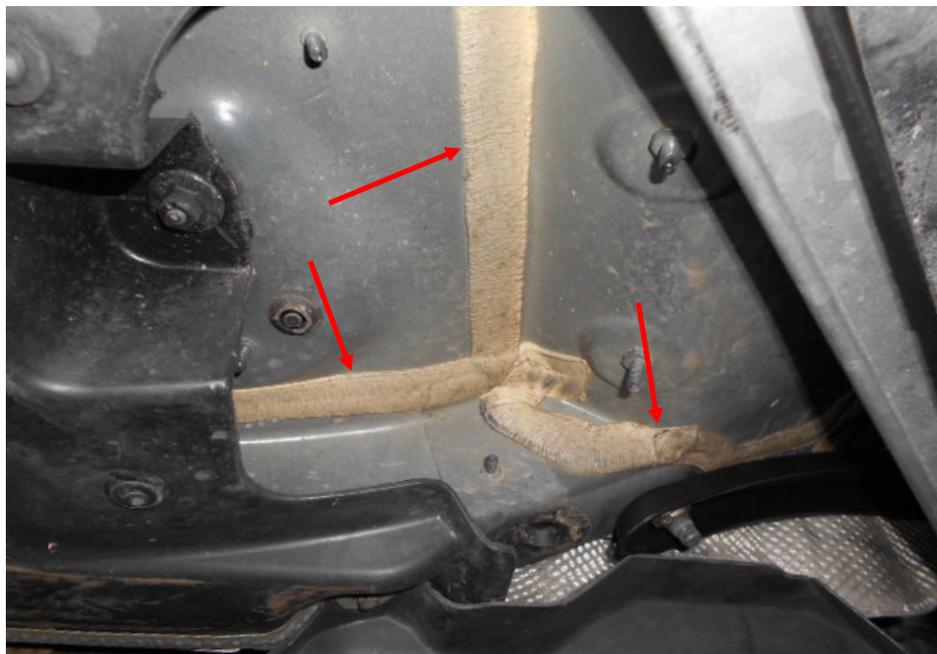
Photo 13 shows the structural body at the centre right of the Motor Car. The original factory sealant at the joints (arrowed) along the chassis body was untouched, indicating no work was done on the chassis body of the Motor Car and that the chassis body was originally fitted.

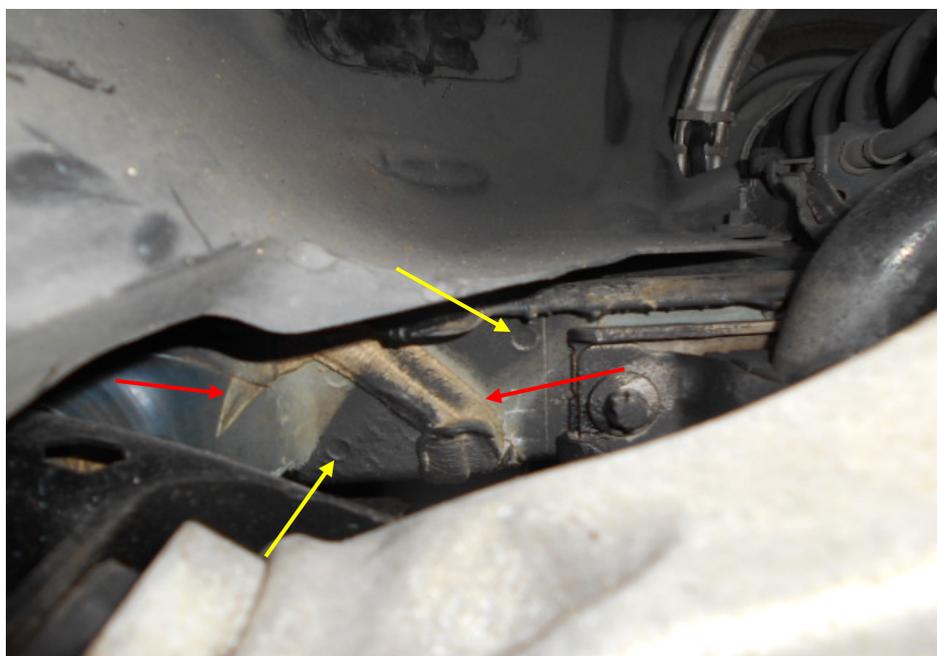
Photo 14 shows the structural body and wheel house panel at the front left of the Motor Car. I did not find any weld marks other than original spot weld marks (yellow arrow) on the chassis body of the Motor Car. The original factory sealant (red arrow) at the joints along the chassis body was also untouched, indicating no work was done on the chassis body of the Motor Car and that the chassis body was originally fitted.

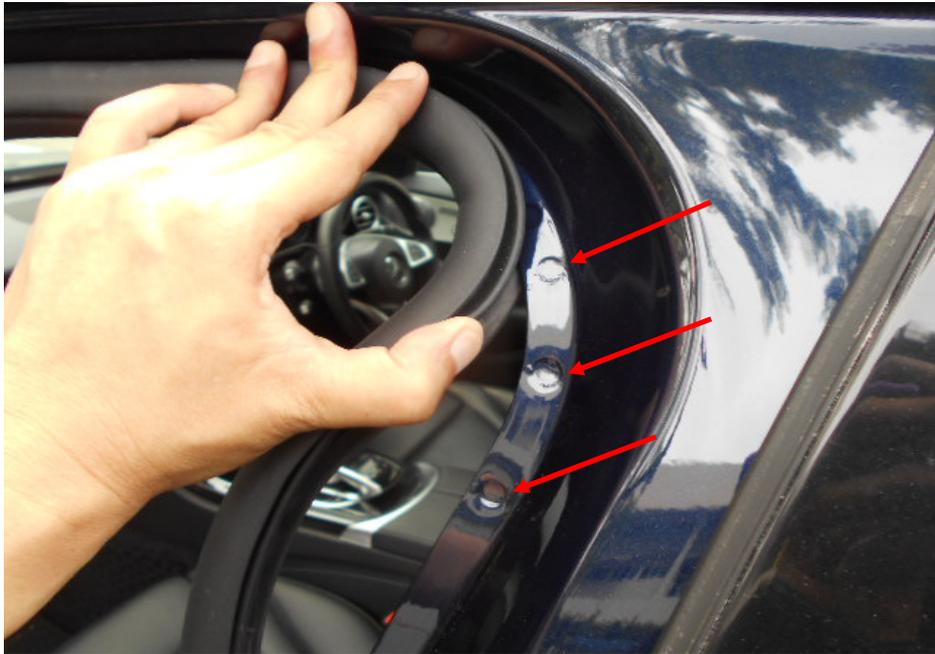
Photo 15 shows the left "B" pillar of the Motor Car. I did not find any weld marks other than original spot weld marks (arrowed) on the body panels of the Motor Car, indicating that there was no re-welding works carried out; and that the body panels of the Motor Car were originally fitted.

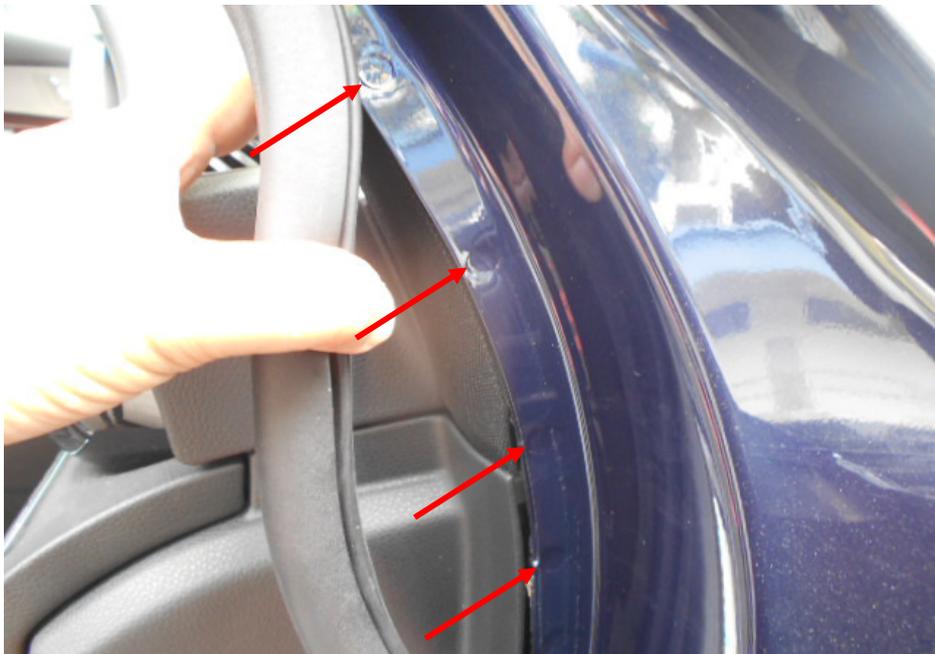
Photo 16 shows the front right "A" pillar of the Motor Car. I did not find any weld marks other than original spot weld marks (arrowed) on the body panels of the Motor Car, indicating that there was no re-welding works carried out; and that the body panels of the Motor Car were originally fitted.

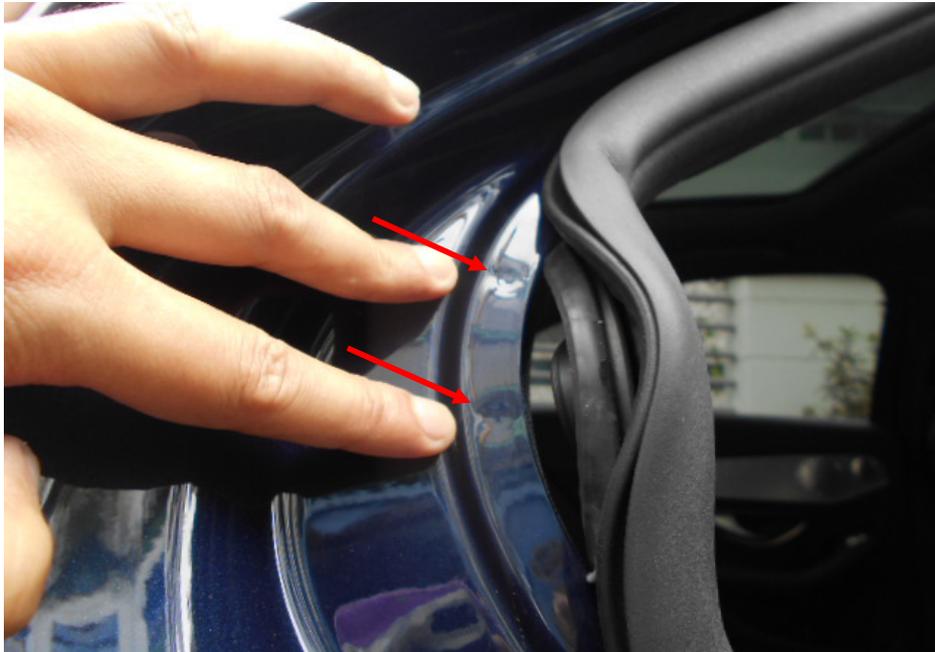
Photo 17 shows the rear right “C” pillar of the Motor Car. I did not find any weld marks other than original spot weld marks (arrowed) on the body panels of the Motor Car, indicating that there was no re-welding works carried out; and that the body panels of the Motor Car were originally fitted.
