Your Ref: Honda Engine
(number K20A5820699)
Our Ref : CI/TP19001185/D

18 January 2019

INSPECTION REPORT OF A HONDA ENGINE WITH NUMBER K20A5820699

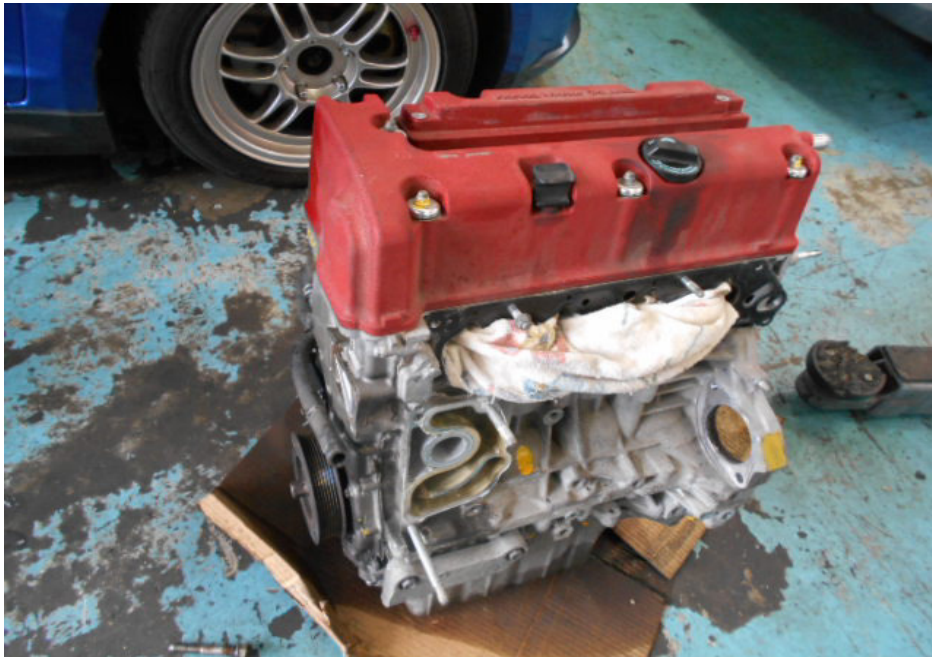
Photo 1 shows a general view of the Honda engine that I had inspected. The Honda engine was observed to be a used engine and was not fitted on any motor car. It was also observed to be a complete assembly with all mechanical parts still intact, within the engine housing.

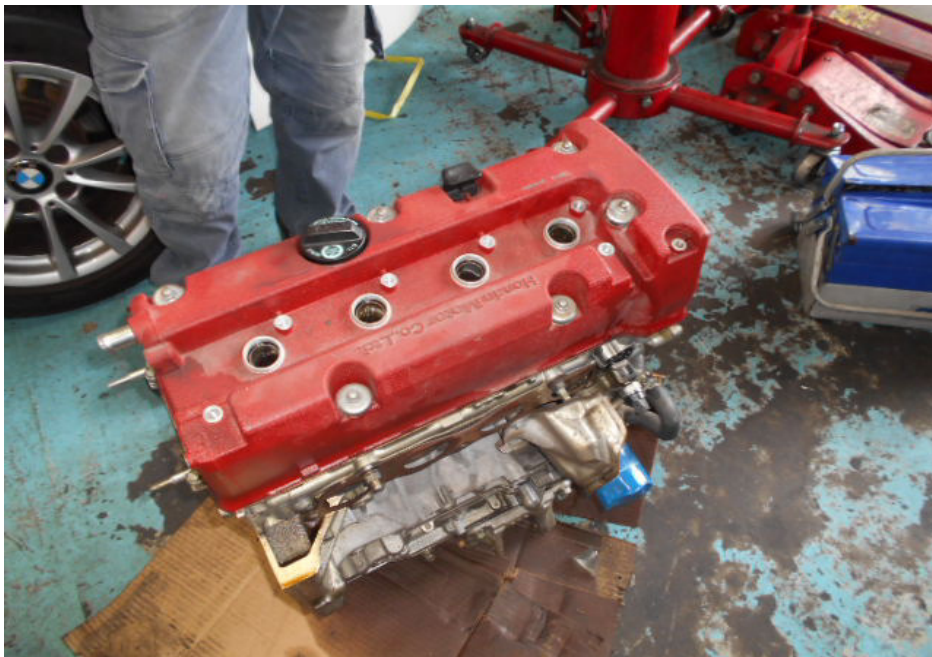
Photo 2 shows a general view of the Honda engine that I had inspected. My visual examination of the engine housing revealed the housing to be of serviceable/satisfactory condition. There was no crack and/or hole observed on the engine housing.

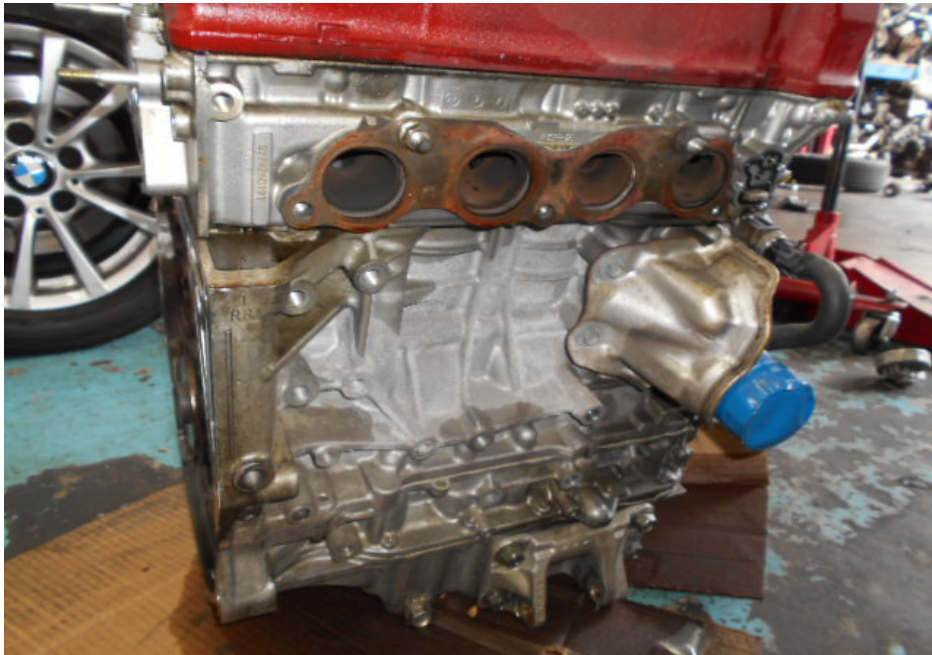
Photo 3 shows a general view of the Honda engine that I had inspected. My visual examination of the engine housing revealed the housing to be of serviceable/satisfactory condition. There was no crack and/or hole observed on the engine housing.

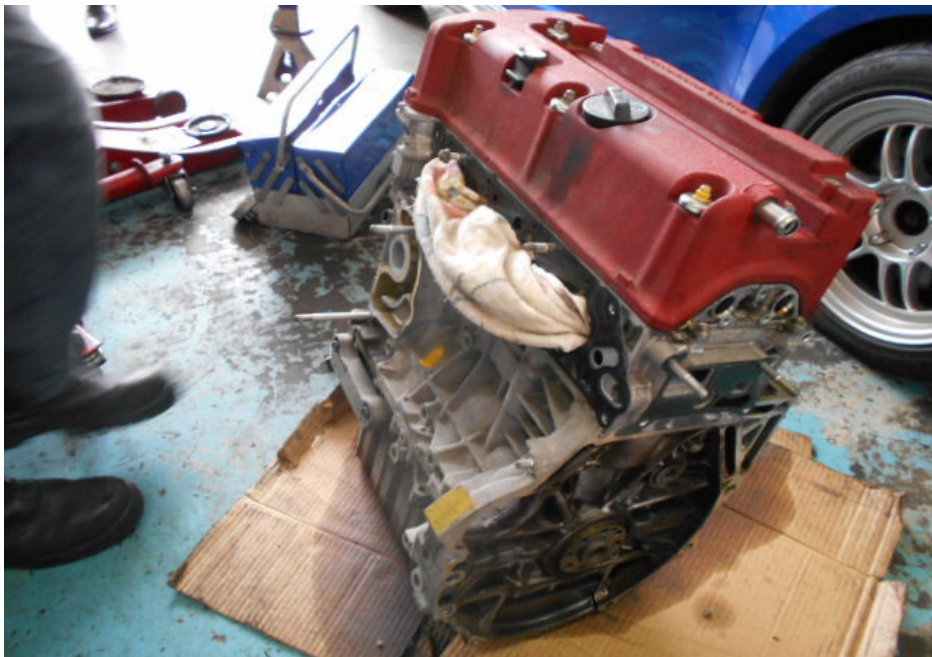
Photo 4 shows a general view of the Honda engine that I had inspected. My visual examination of the engine housing revealed the housing to be of serviceable/satisfactory condition. There was no crack and/or hole observed on the engine housing.

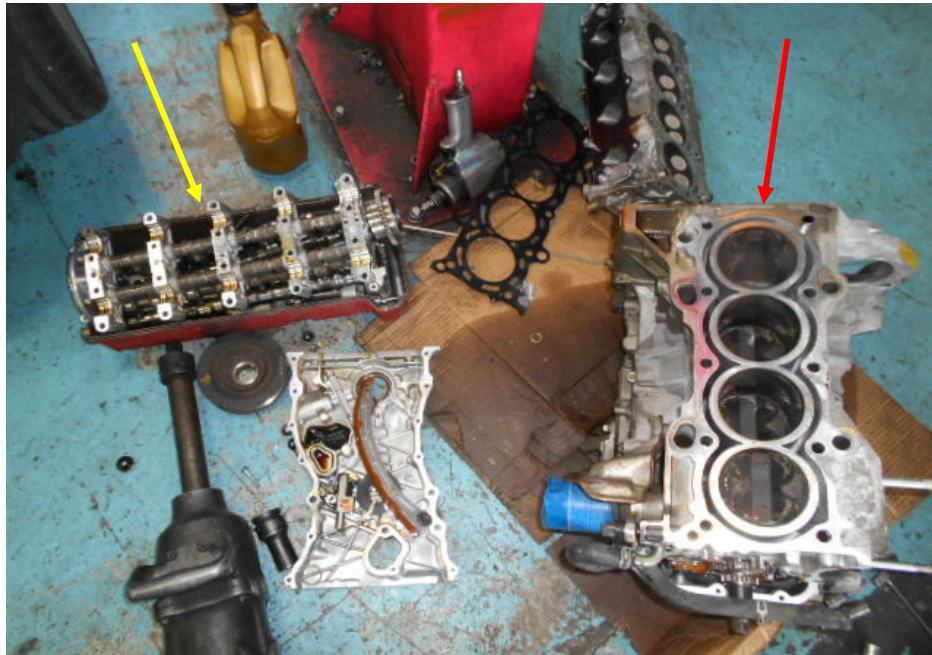
Photo 5 shows the top block (yellow arrow) of the Honda engine separated from its bottom block (red arrow). This was to enable me to carry out measurements of its cylinders, in particular the bore and stroke measurements of each cylinder, which typically can be used to determine the engine displacement or more commonly referred to as engine cc.

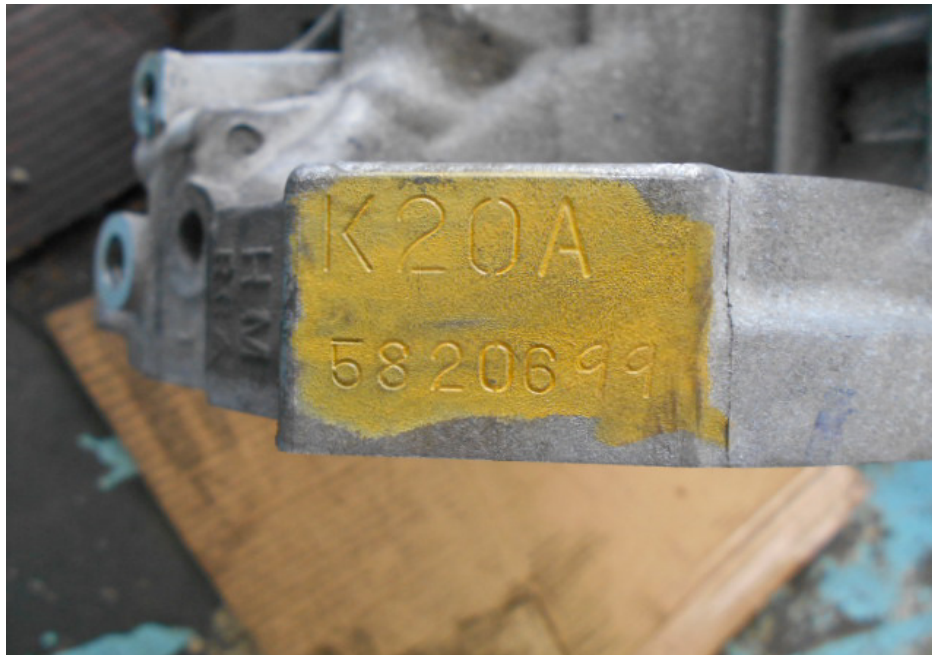
Photo 6 shows the engine number engraved on the housing of the Honda engine that I had inspected. The engine number was K20A5820699.

13. In summary, the Honda engine that I had inspected was a Honda K20A model engine. The engine number engraved on the housing of this Honda engine was K20A5820699.

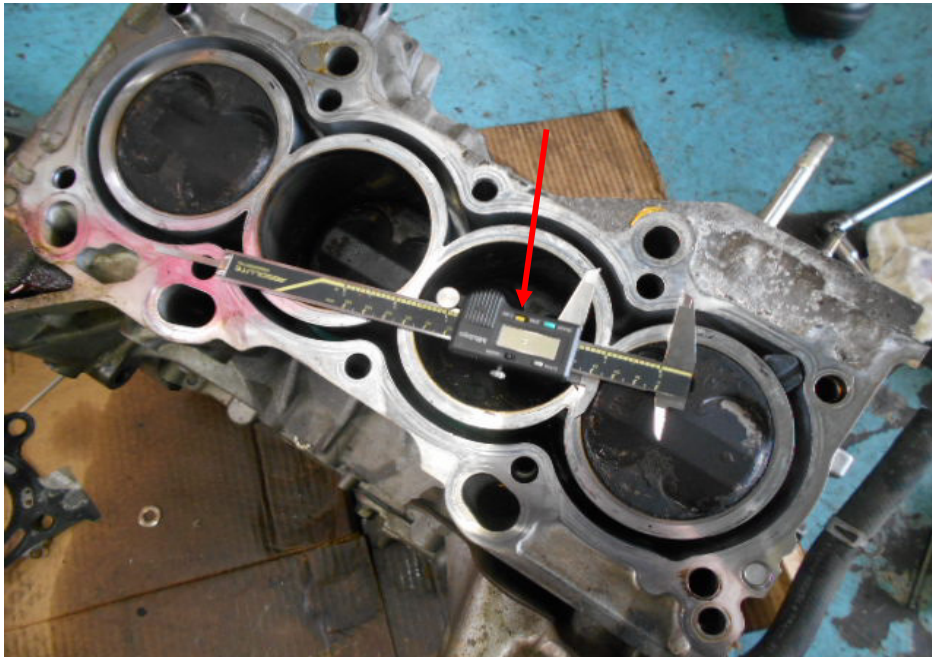
Photo 7 shows the bottom block of the Honda engine and the digital Vernier Caliper (arrowed) that was used to measure the bore and stroke measurements of each cylinder, which typically can be used to determine the engine displacement or more commonly referred to as engine cc. The digital Vernier Caliper was calibrated before the start of the measurements.

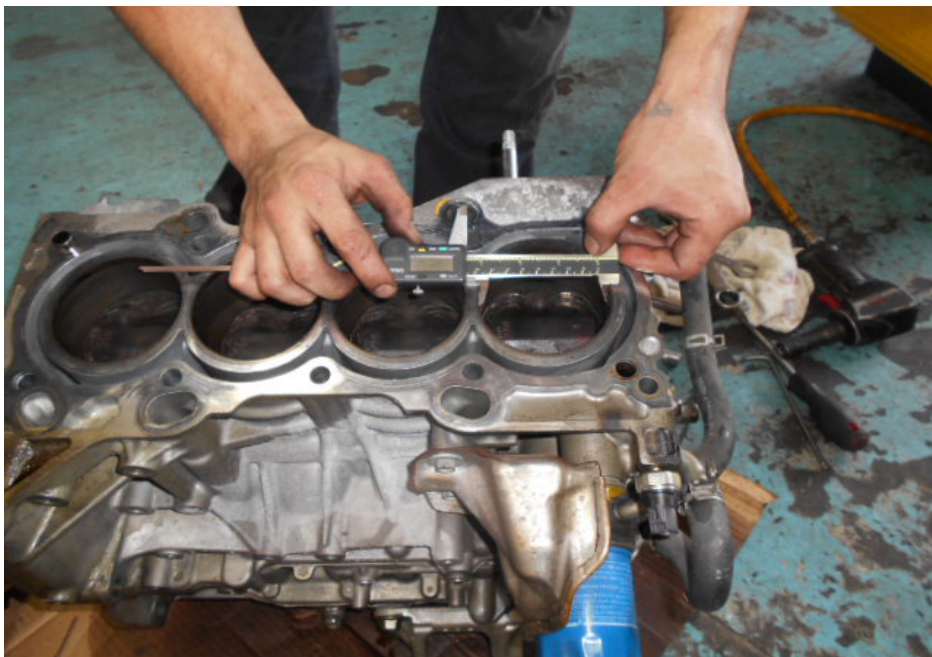
Photo 8 shows measurement being carried out to the bore of cylinder 1 of the Honda engine. The measurements were carried out using a digital Vernier Caliper that was calibrated before the start of the measurements.

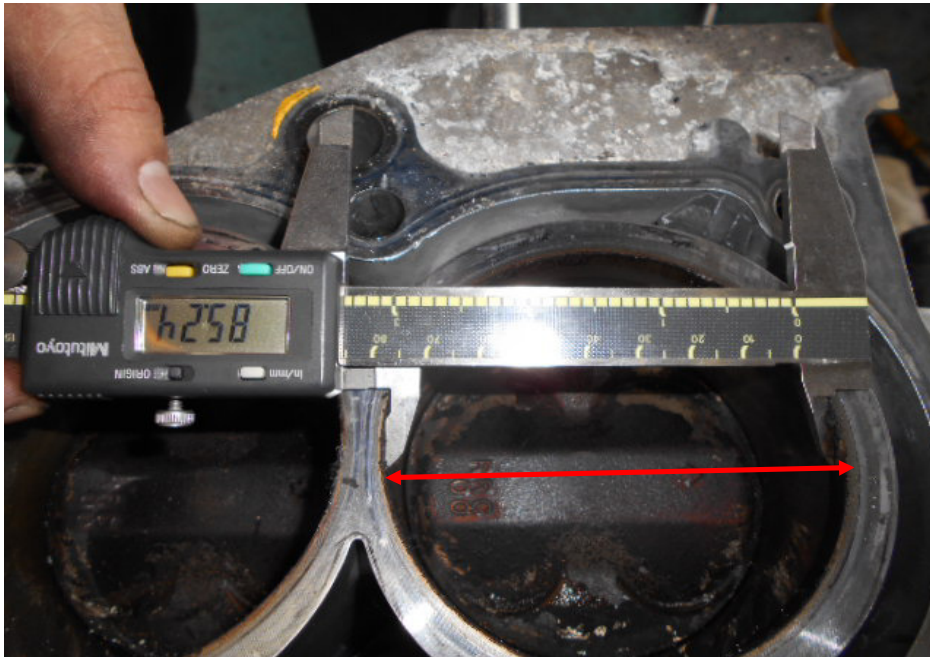
Photo 9 shows the bore measurement of cylinder 1, which was recorded to be 85.24mm.

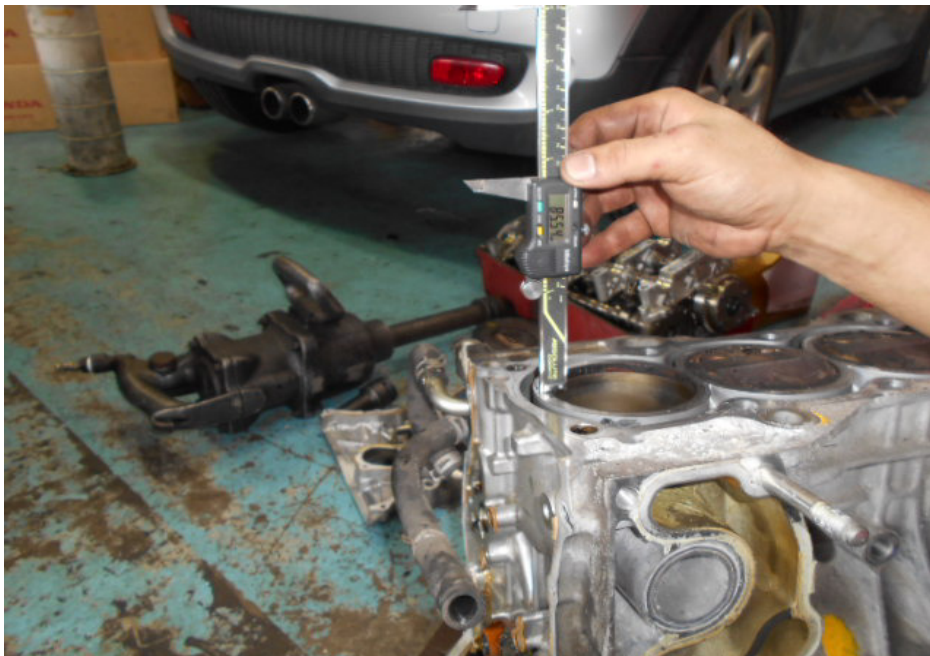
Photo 10 shows measurement being carried out to the stroke of cylinder 1 of the Honda engine. The bore and stroke measurements of the Honda engine were carried out using a digital Vernier Caliper.

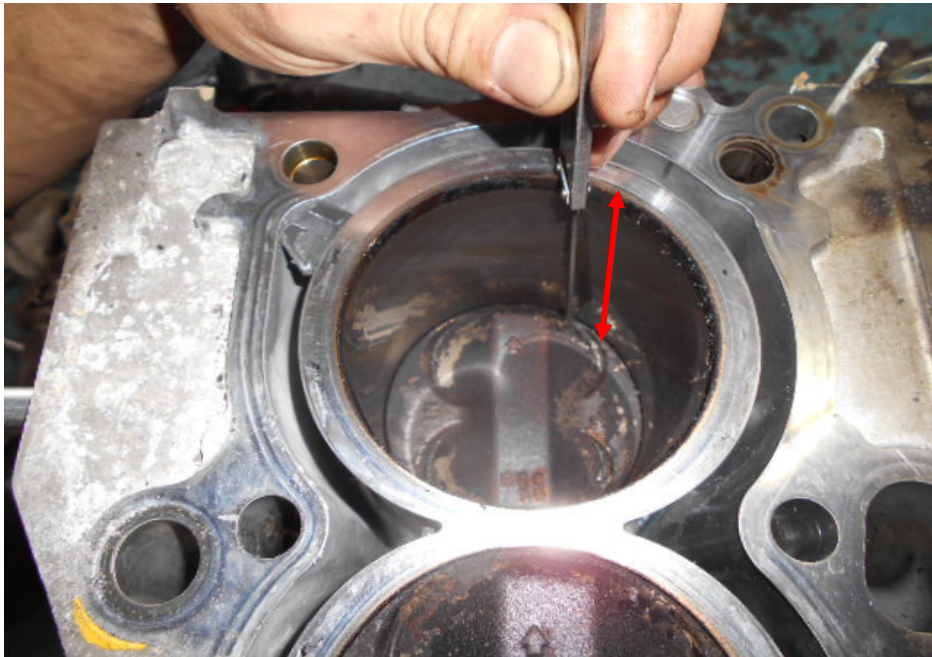
Photo 11 shows measurement being carried out to the stroke (arrowed) of cylinder 1 of the Honda engine. The bore and stroke measurements of the Honda engine were carried out using a digital Vernier Caliper that was calibrated before the start of the measurements,

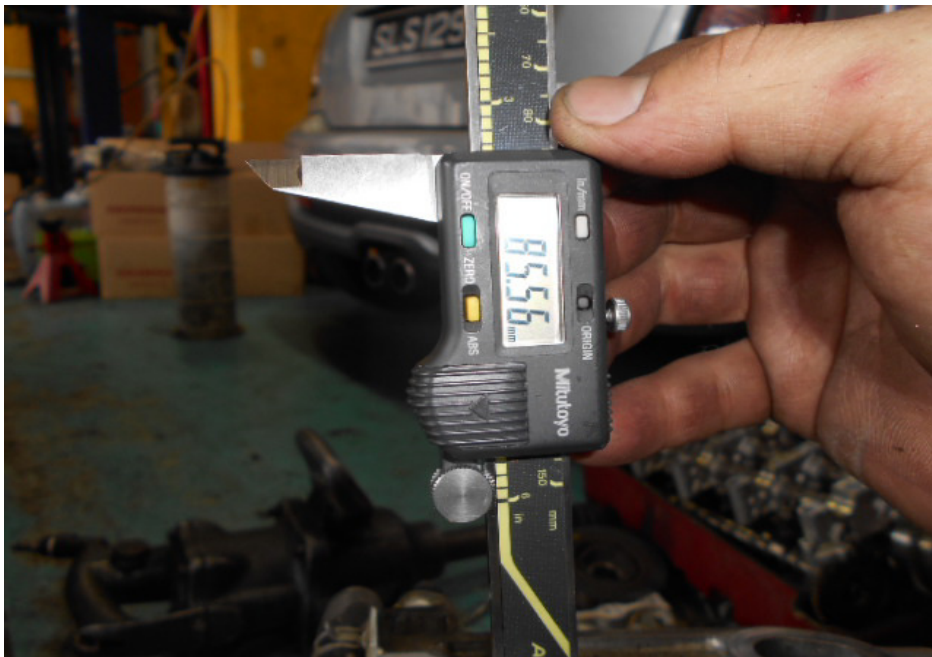
Photo 12 shows the stroke measurement of cylinder 1, which was recorded to be 85.56mm.

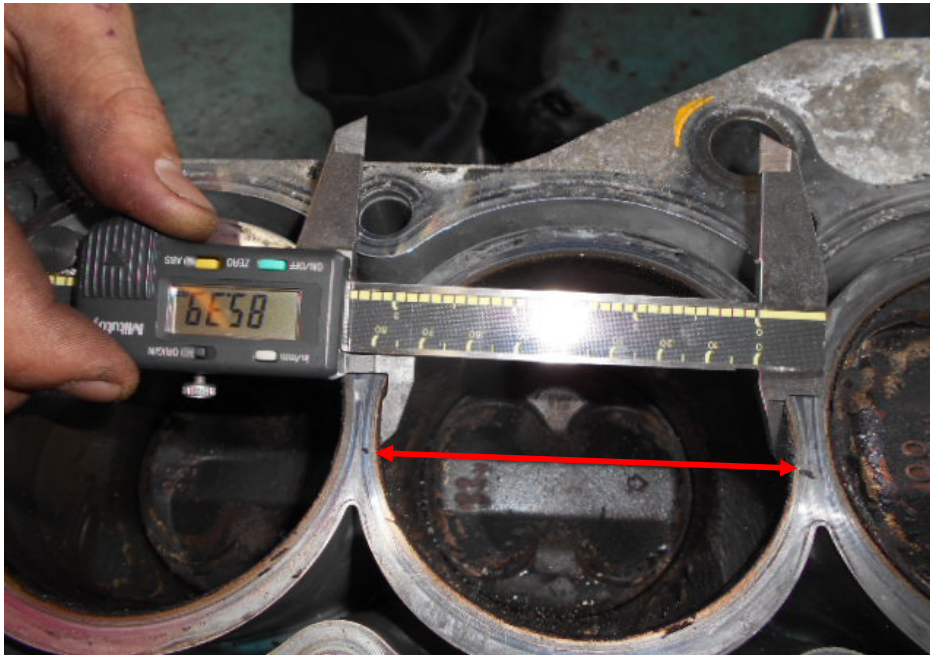
Photo 13 shows measurement being carried out to the bore (arrowed) of cylinder 2 of the Honda engine. The bore measurement of cylinder 2 was recorded to be 85.39mm.

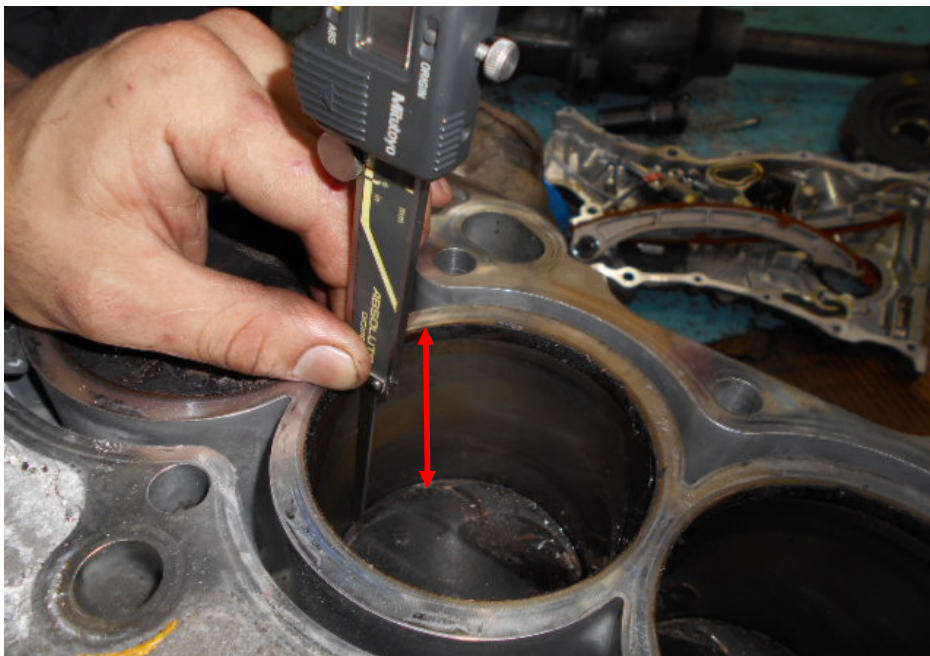
Photo 14 shows measurement of the stroke (arrowed) for cylinder 2 of the Honda engine that I had inspected.

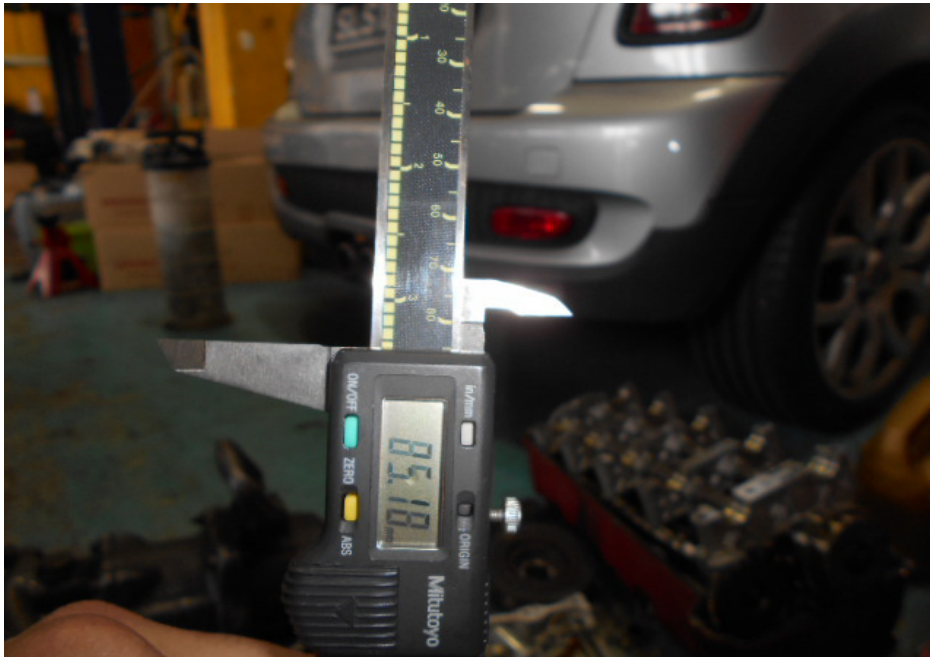
Photo 15 shows the stroke measurement of cylinder 2, which was recorded to be 85.18mm.

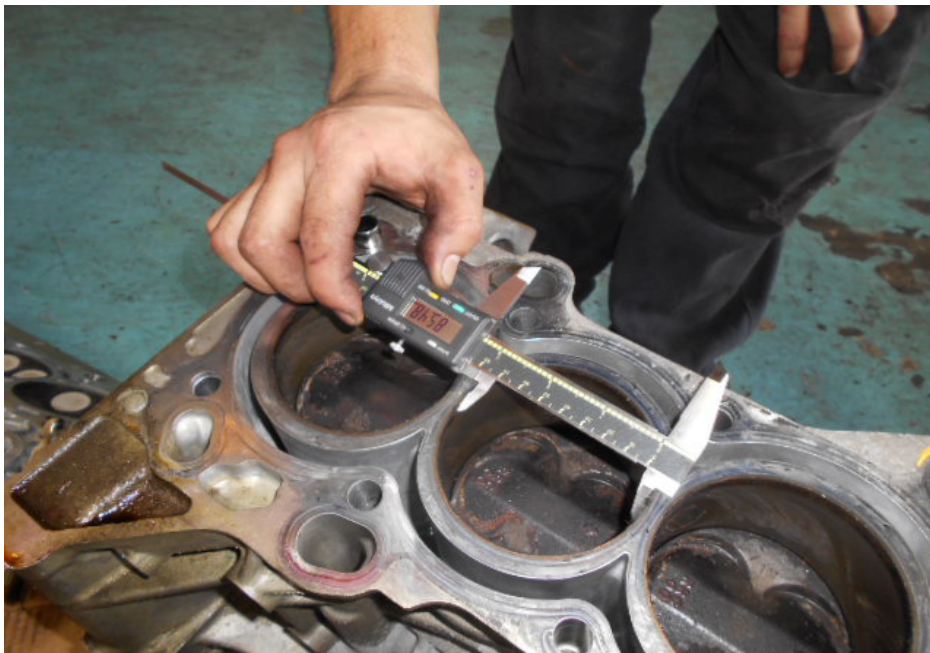
Photo 16 shows measurement being carried out to the bore of cylinder 3 of the Honda engine. The bore and stroke measurements of the Honda engine were carried out using a digital Vernier Caliper.

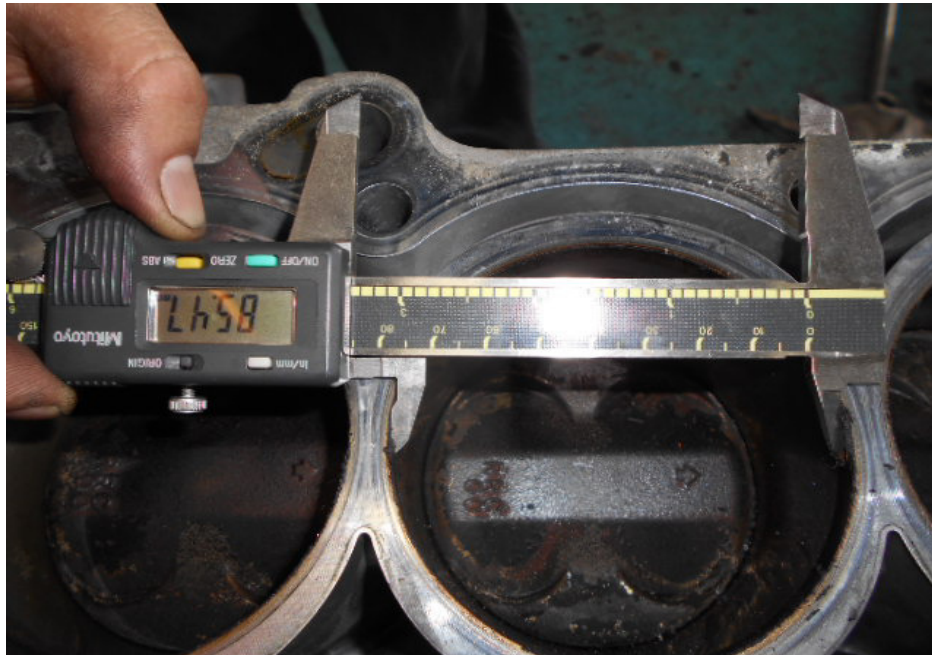
Photo 17 shows measurement being carried out to the bore (arrowed) of cylinder 3 of the Honda engine. The bore measurement of cylinder 3 was recorded to be 85.47mm.

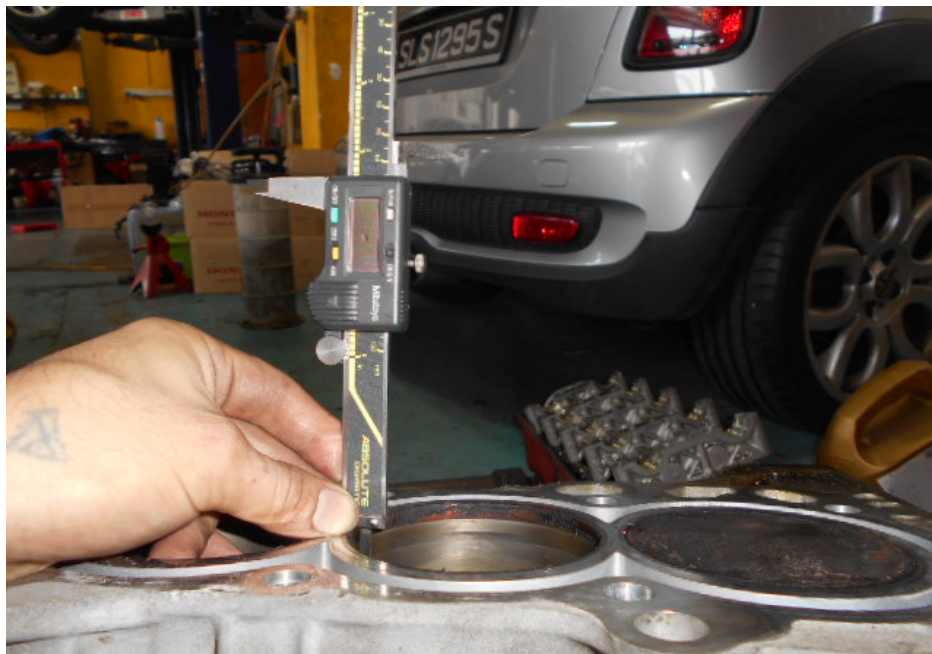
Photo 18 shows measurement of the stroke for cylinder 3 of the Honda engine that I had inspected. The bore and stroke measurements of the Honda engine were carried out using a digital Vernier Caliper that was calibrated before the start of measurements.

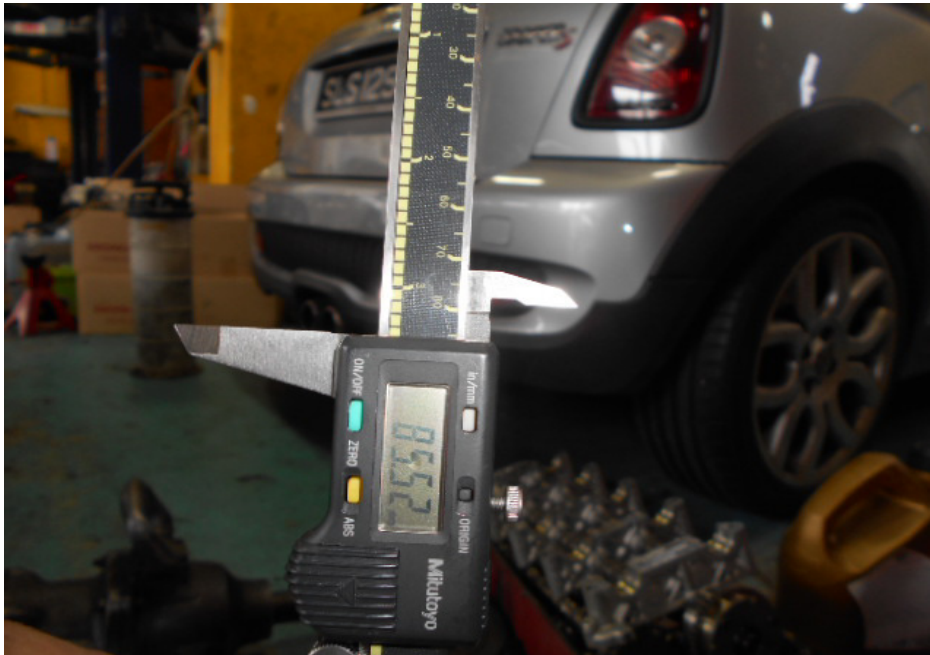
Photo 19 shows the stroke measurement of cylinder 3, which was recorded to be 85.52mm.

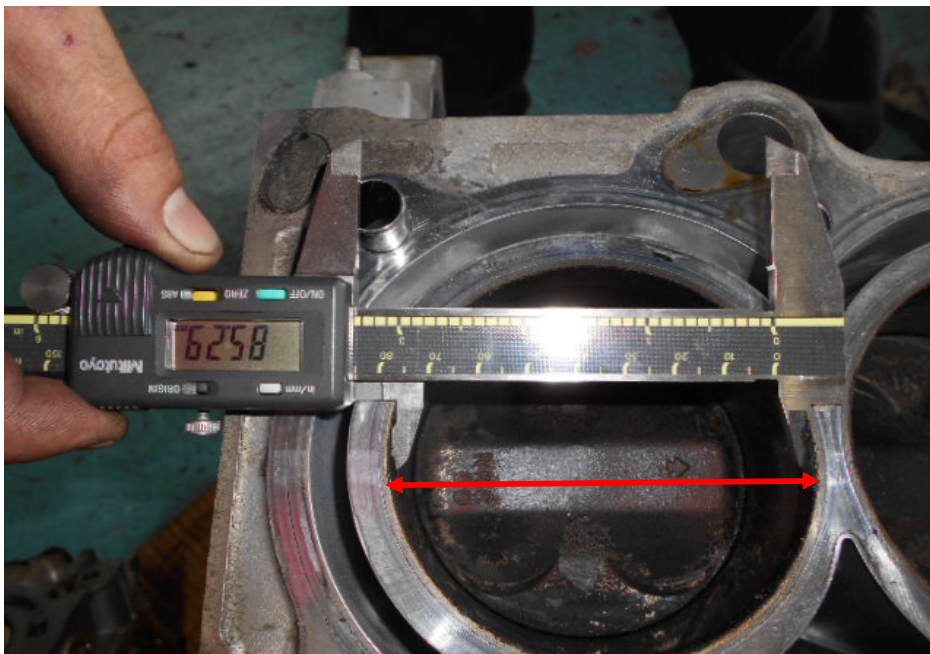
Photo 20 shows measurement being carried out to the bore (arrowed) of cylinder 4 of the Honda engine. The bore and stroke measurements of the Honda engine were carried out using a digital Vernier Caliper. The bore measurement of cylinder 4 was recorded to be 85.29mm.

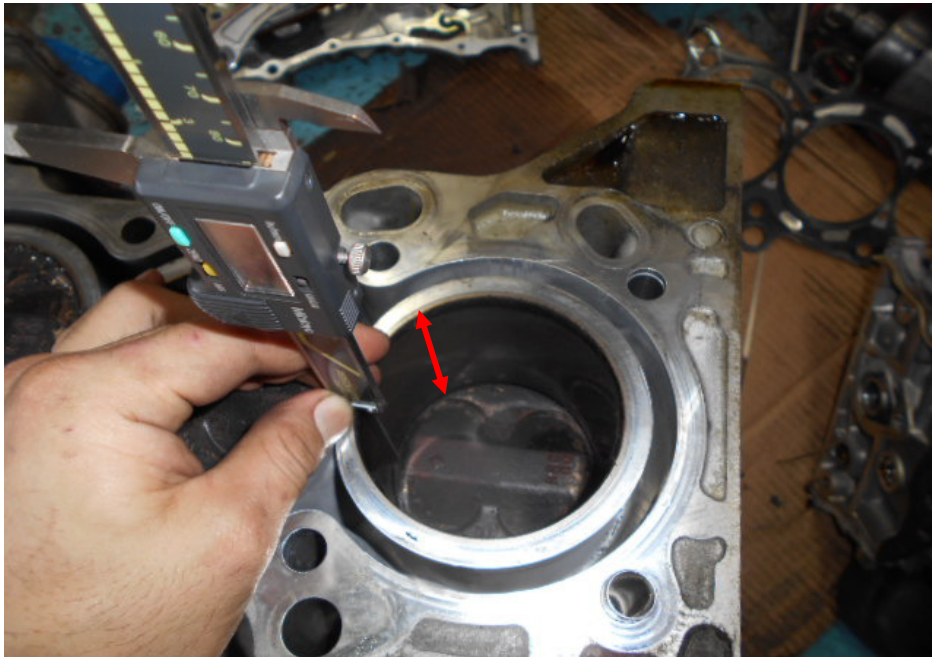
Photo 21 shows measurement being carried out to the stroke (arrowed) of cylinder 4 of the Honda engine. The bore and stroke measurements of the Honda engine were carried out using a digital Vernier Caliper that was calibrated prior to the start of measurements.

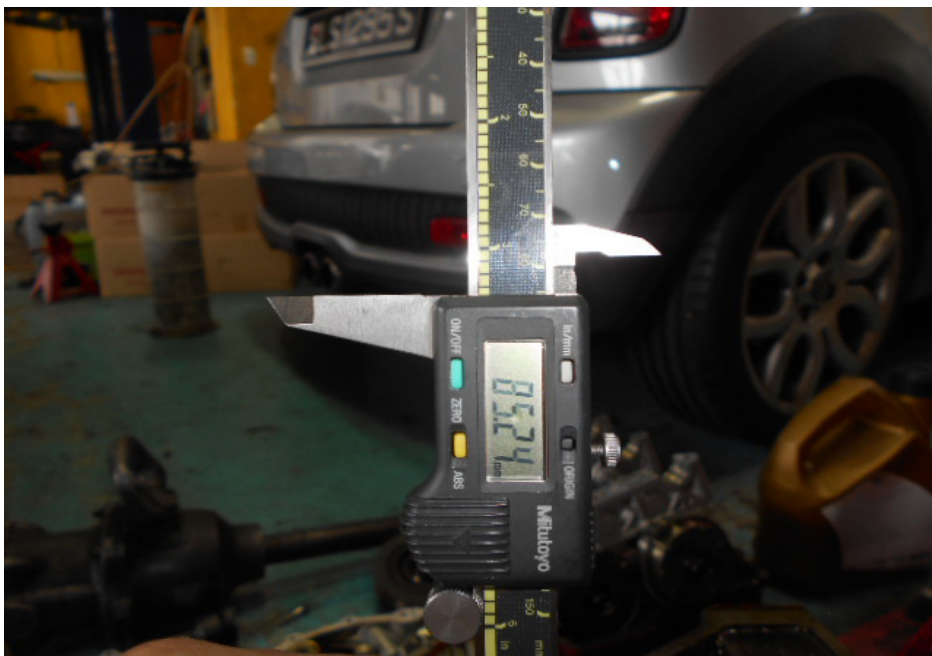
Photo 22 shows the stroke measurement of cylinder 4, which was recorded to be 85.24mm.
